Article Dry Sliding Friction Study of ZrN/CrN Multi-Layer Coatings Characterized by Vibration and Acoustic Emission Signals

Abstract: In this work, we studied single-layer ZrN and CrN coatings, as well as multi-layer ZrN/CrN coatings deposited by the vacuum-arc method on WC-8 wt.% Co substrates. The sliding friction parameters were preset to simulate different operating conditions for coatings, i.e., severe and zero wear regimes. During the tests, the friction coefficient, acoustic emission (AE) and vibration signals were recorded. After testing, the worn surfaces of the samples were studied using confocal laser scanning and scanning electron microscopy, elemental microanalysis and synchrotron XRD. Estimation of vibration accelerations and AE energy turned out to be very effective means of monitoring the wear of coatings, while median AE frequency turned out to be a less informative one. With the increase in the normal load applied on the samples after testing at zero wear regime, the coefficient of friction increased and wear transition to severe wear regime occurred but vibration acceleration decreased. The multi-layer ZrN/CrN coatings demonstrated much higher wear resistance as

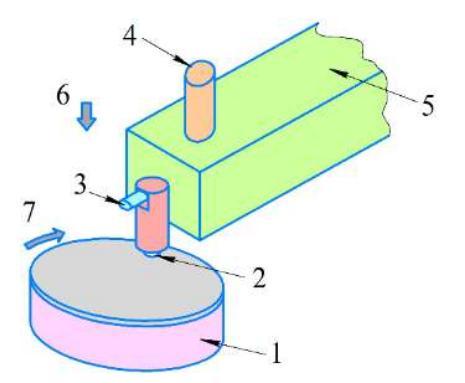
Figure 1. Scheme of the experiment. 1—disk with coatings, 2—steel ball, 3—AE sensor, 4—accelerometer, 5—tribometer, 6—normal load, 7—sliding direction.

Sliding wear testing was carried out using a ball-on-disk scheme with AISI52100 \oslash 6 mm steel ball rubbed against the coated disk surface (Figure 1). A tribometer (TRI-BOtechnic, Clichy, France) was used for testing using the test parameters preset for simulating the different sliding wear conditions of the coatings. In particular, the normal load values, such as 1 and 6N, were chosen based on the preliminarily obtained results when the 1N load provided almost wearless sliding without any observable damage to all the coatings, while the 6N load corresponded to sliding with some degree of wear that varied with the type of coating. The results of sliding tests with the use of some intermediate load values were not included in this work since they essentially repeated the results and conclusions obtained in the course of this work. The sliding speed was 0.1 m/s.

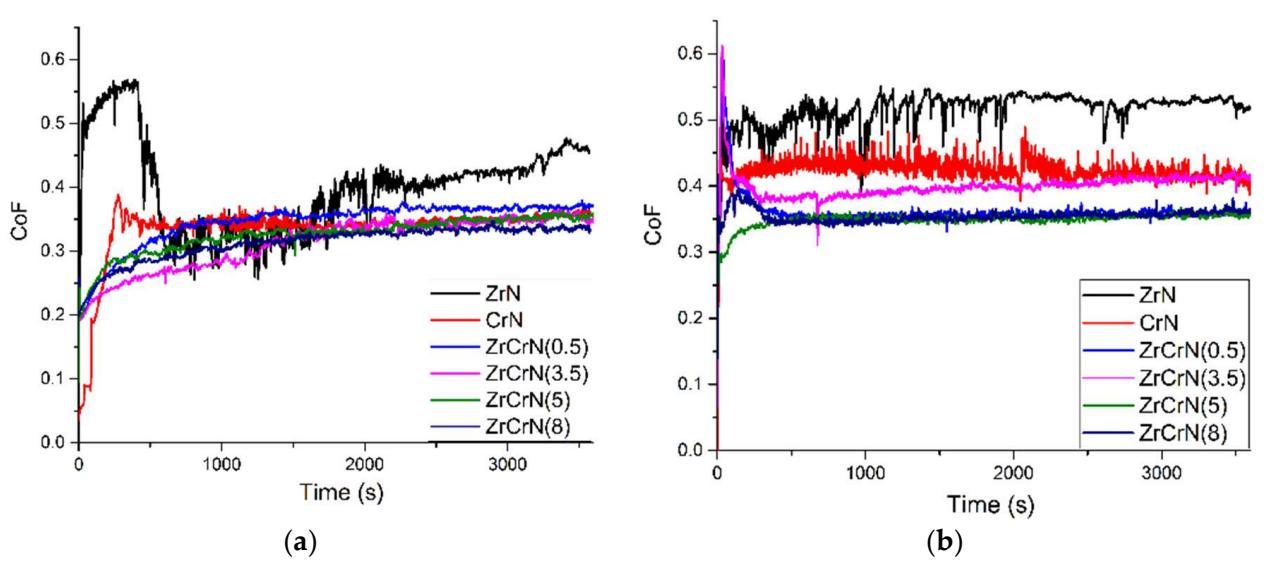
Figure 2. CoFs vs. time dependencies for sliding at 1N (a) and 6N (b) normal load.

Sliding at the normal load of 1N on samples coated with single-layer CrN and multilayers of (ZrCrN(0.5)-ZrCrN(8)) is characterized by the presence of the running-in stage, during which the friction coefficient gradually increased (Figure 2a). The running-in stage duration was about ~250 s for the CrN-coated sample and 600 s for the multi-layer-coated samples. The next stage was relatively steady friction with the CoF value maintained in the range 0.31-0.34.

When a ZrN-coated sample was tested, the friction coefficient changed as follows. First, there was a rapid increase to ~0.57, followed by a sharp decrease to ~0.31, after which a small plateau was observed, with the CoF dynamically changing within the 0.26-0.36

According to the data obtained, the CoF of the multi-layer coatings decreased by 0.03–0.09 as compared with those of ZrN and CrN coatings. Increasing the normal load to 6N led to significant changes in friction dynamics (Figure 2b). The running-in stage of these samples took ~250 s, while the CoF values varied with the type of coating. During sliding on ZrCrN(0.5) and ZrCrN(3.5) multi-layer coatings, the CoF reached ~0.6 value from the very beginning of the test and then decreased exponentially to 0.35 and 0.38, respectively. For the rest of the samples, running-in is accompanied by a gradual increase in CoF. After the running in, the sliding of samples with ZrN and CrN coatings occurred, with significant CoF fluctuations within 0.39–0.55 and 0.38–0.48 ranges, respectively. However, the trend remained constant and CoF amounted to 0.51 and 0.42 for samples coated with ZrN and CrN, respectively. Sliding on samples with multi-layer coatings was not accompanied by any significant CoF oscillations. The average CoF values are 0.34, 0.35, 0.36 and 0.4 for the ZrCrN(5), ZrCrN(8), ZrCrN(0.5) and ZrCrN(3.5) samples, respectively. According to the data obtained, the CoF decreased by 0.02–0.16 as compared with those of samples with ZrN and CrN coatings.

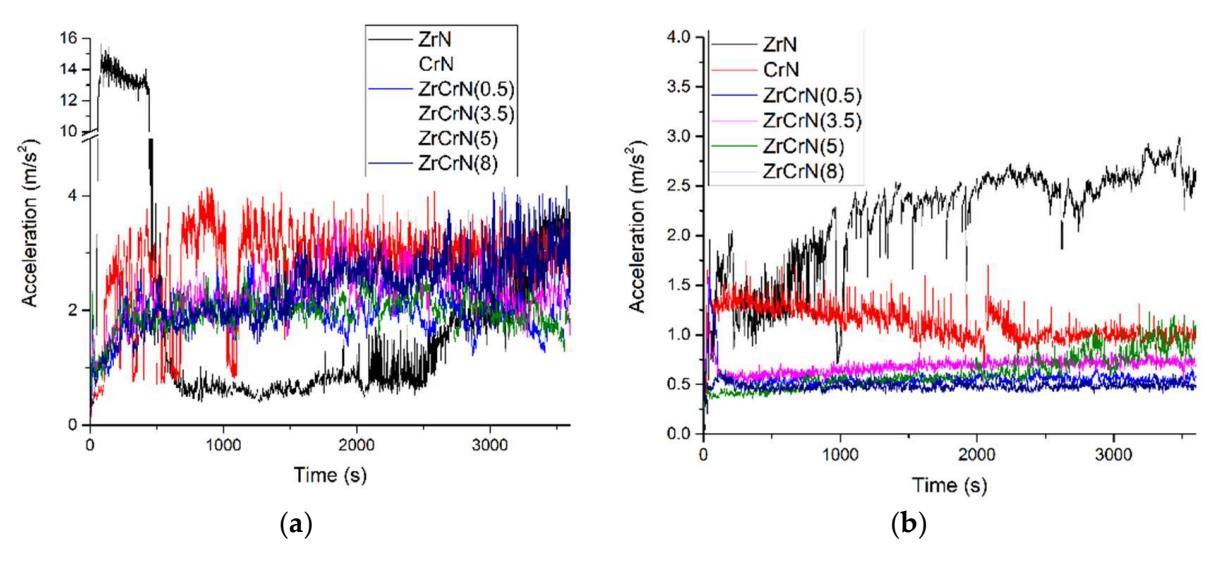
Figure 3. Vibration acceleration waveforms from sliding at 1N (a) and 6N (b).

During sliding, friction force oscillations occurred that were recorded using an accelerometer. From the beginning of the sliding at 1N, the vibration acceleration signal amplitude increased (Figure 3a) for samples coated with CrN as well as for those with (ZrCrN(0.5)-ZrCrN(8)) multi-layer coatings. Then, the vibrations acquired a quasi-constant behavior but in the amplitude range as high as $1.5-4 \text{ m/s}^2$. For a sample coated with ZrN, the vibration acceleration amplitude reached ~ 14.5 m/s^2 level from the very beginning of the test but then sharply decreased to 0.53 and, after 2000 s, gradually increased again until the end of the test. The average values of vibration accelerations are (m/s²) 2.65, 2.83, 1.88, 2.26, 1.86 and 2.32 for samples coated with ZrN, CrN, ZrCrN(0.5), ZrCrN(3.5), ZrCrN(5) and ZrCrN(8), respectively.

The increase in the normal load to 6N in sliding on samples coated with CrN and (ZrCrN(0.5)-ZrCrN(8)) multi-layers led to a factor of 2.5–4.9 decrease in the vibration acceleration amplitude (Figure 3b) as compared with the those of tested at 1N load. In contrast to the multi-layer samples, sliding on the sample coated with ZrN showed a clear tendency for increasing the vibration acceleration amplitude as the friction process developed. It can be seen from the obtained data that in the main part of the tests (excluding the first 500 s of the running-in stage) vibration acceleration amplitudes obtained from this sample in sliding at 6N (Figure 3b) were higher than those from sliding at the 1N (Figure 3a). The average values of vibration accelerations were $(m/s^2) 2.17, 1.11, 0.56, 0.67$,

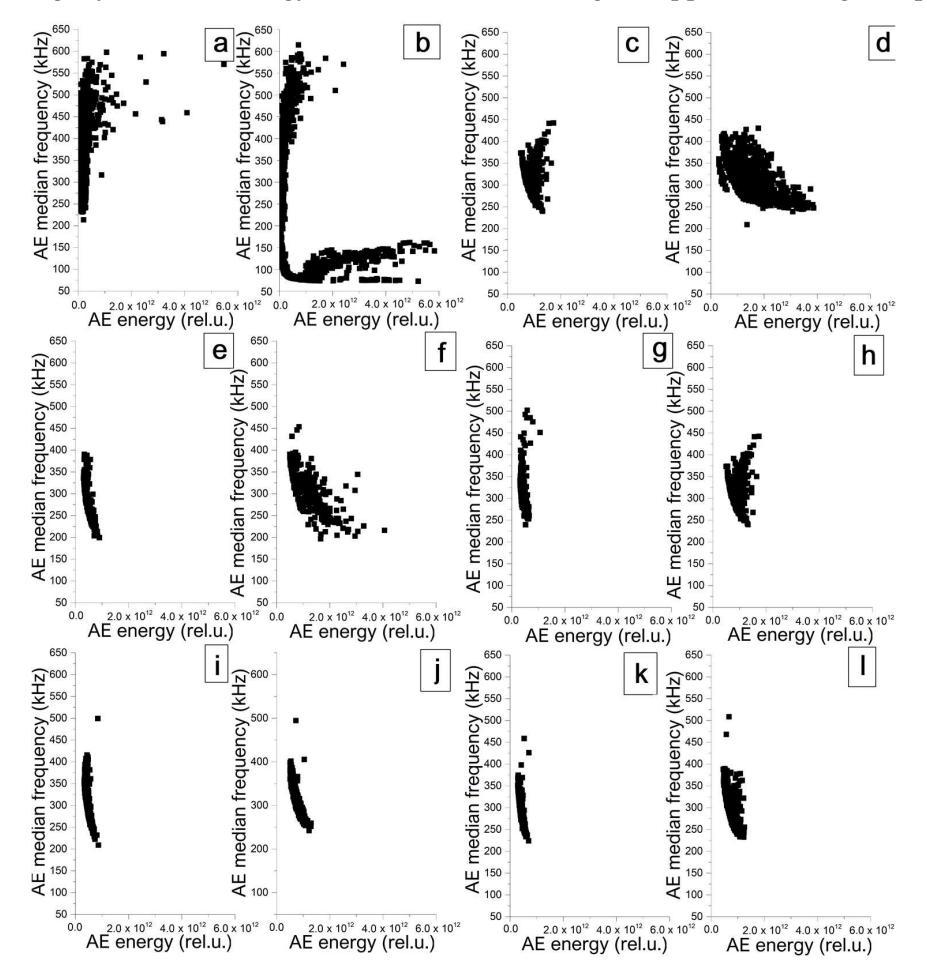
Figure 4. Relationships between AE median frequency and AE energy for the samples slid (**a**,**b**), CrN (**c**,**d**), ZrCrN(0.5) (**e**,**f**), ZrCrN(3.5) (**g**,**h**), ZrCrN(5) (**i**,**j**) ZrCrN(8) (**k**,**l**). Normal load 1N (**a**,**c**,**e**,**g**,**i**,**k**) and 6N (**b**,**d**,**f**,**h**,**j**,**l**).

Below are the results of estimating the AE signal parameters obtained during sliding. The signals were recorded as separate frames with a duration of 21 ms. Then, for each of these signals, the values of the median frequency and energy have been calculated. It can be seen from the experimental data that, in the case of "wearless" sliding at 1N, (Figure 4a,c,e,g,i,k), the AE signals predominantly have frequencies in the range 200 to 625 kHz and low energy (less than 2×1012 rel.u.). When more severe wear begins with the increase in load, then additional high energy signals appear in the lower frequency end (Figure 4b,d,f,h,j,l). This is expressed most intensively in formation of a whole plume of low-frequency (60–175 kHz) signals from sliding on a sample coated with ZrN (Figure 4b). This is also noticeable in sliding on samples coated with both CrN (Figure 4d) and multilayer-coated ZrCrN(0.5) (Figure 4f). In all these cases, a group of high-frequency signals are retained. It will be shown below that these three samples experienced the most intensive wear. On the contrary, minimal wear was observed on the ZrCrN(3.5), ZrCrN(5) and ZrCrN(8) samples, as could be followed from the AE signal parameters. As can be seen from the data obtained (Figure $4h_{ij}$, l), the signals grouped in the regions look like crescents. These signals, in comparison with the signals recorded in the absence of wear (Figure 4g,i,k), have slightly increased energy values and additional signals appear in the high-frequency region.

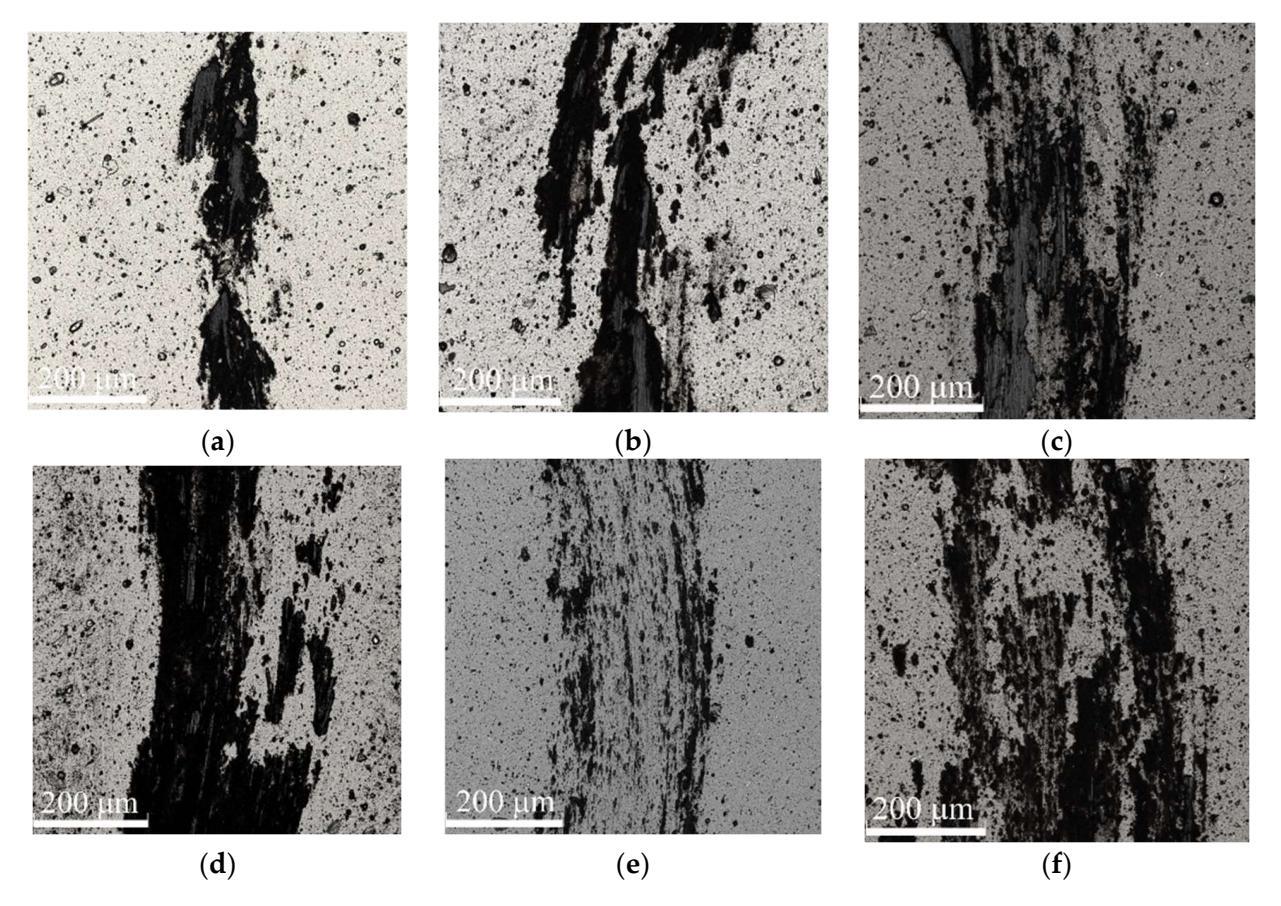
Figure 5. Optical micrographs of the worn surfaces on the ZrN (**a**), CrN (**b**), ZrCrN(0.5) (**c**), ZrCrN(3.5) (**d**), ZrCrN(5) (**e**) and ZrCrN(8) (**f**) samples after sliding at 1 H.

After sliding at 1N, the dark areas elongated with respect to sliding direction were observed on the worn surfaces of all the samples with coatings (Figure 5). Using laser scanning microscopy, it was revealed that, in all cases, the dark areas were formed by oxidized and transferred material of the ball (Figure 6) since no traces of wear or deterioration were found on the worn surface of the coatings. The mean thickness of the transfer layers adhered to the coating sis about 1–4 microns (Figure 6). These transfer layer areas are located as patches on the coating surface, which is most likely due to their low adhesion to the coating material. As a result, these transfer layer patches can be transferred back to the ball, carried away and again adhere to the coating or be removed from it in the form of wear debris.

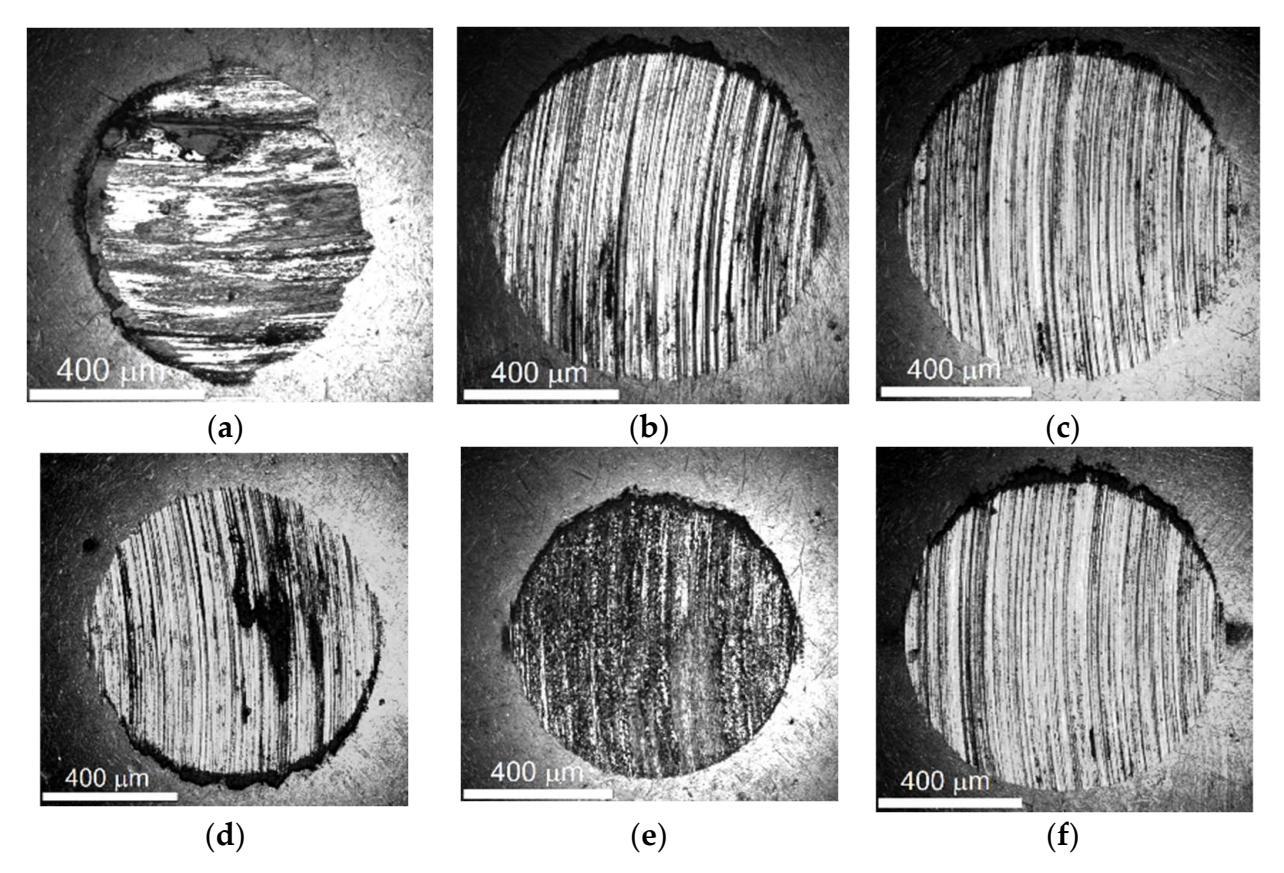
Figure 7. The wear scar images on steel balls rubbed against ZrN (**a**), CrN (**b**), ZrCrN(0.5) (**c**), Zr-CrN(3.5) (**d**), ZrCrN(5) (**e**) and ZrCrN(8) (**f**) samples at 1 H.

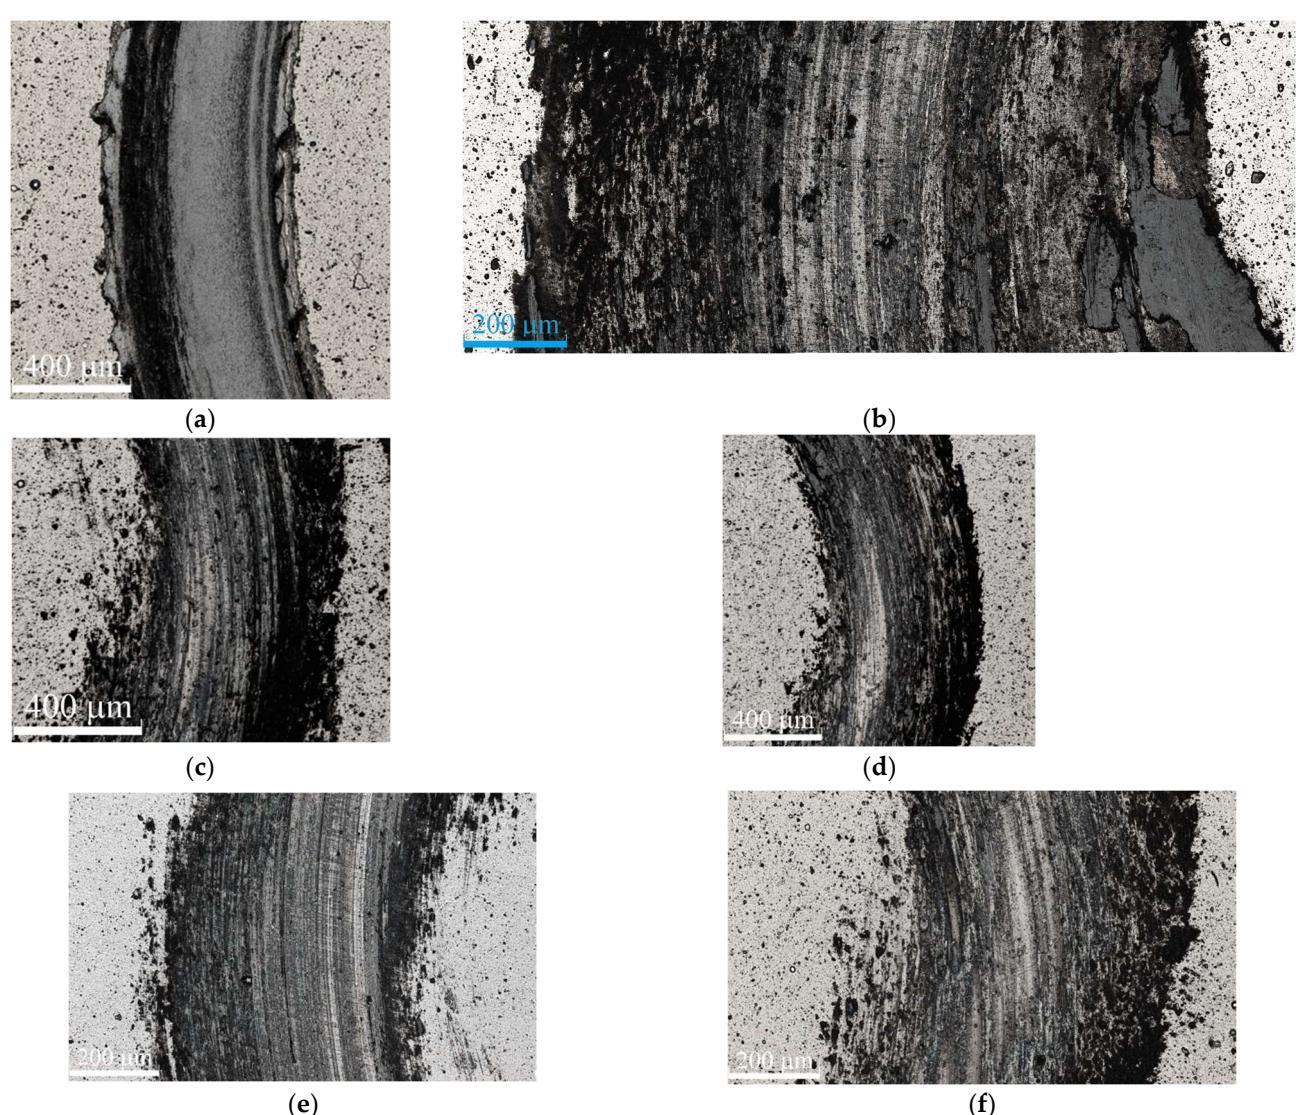
Figure 8. Optical images of wear tracks on ZrN (a), CrN (b), ZrCrN(0.5) (c), ZrCrN(3.5) (d), ZrCrN(5) (e) and ZrCrN(8) (f) after sliding at 6 H.

After sliding at 6N of normal load, the transfer layer areas become continuous as well as mechanical wear traces appear on the worn surfaces of coatings (Figure 8). The optical micrographs also indicate a noticeable increase in the wear track width as compared to those obtained after sliding at 1N load.

Based on the data obtained, it can be observed that the wear of multi-layer coatings is significantly less than that of both ZrN and CrN coatings. In all cases, the wear track depth did not exceed the thickness of the coatings. The wear tracks were narrower, with fewer transfer layer areas in comparison with those on the worn CrN coating. The surface of the wear tracks looked irregular (Figure 8c–f), as can be observed from Figure 9c–f.

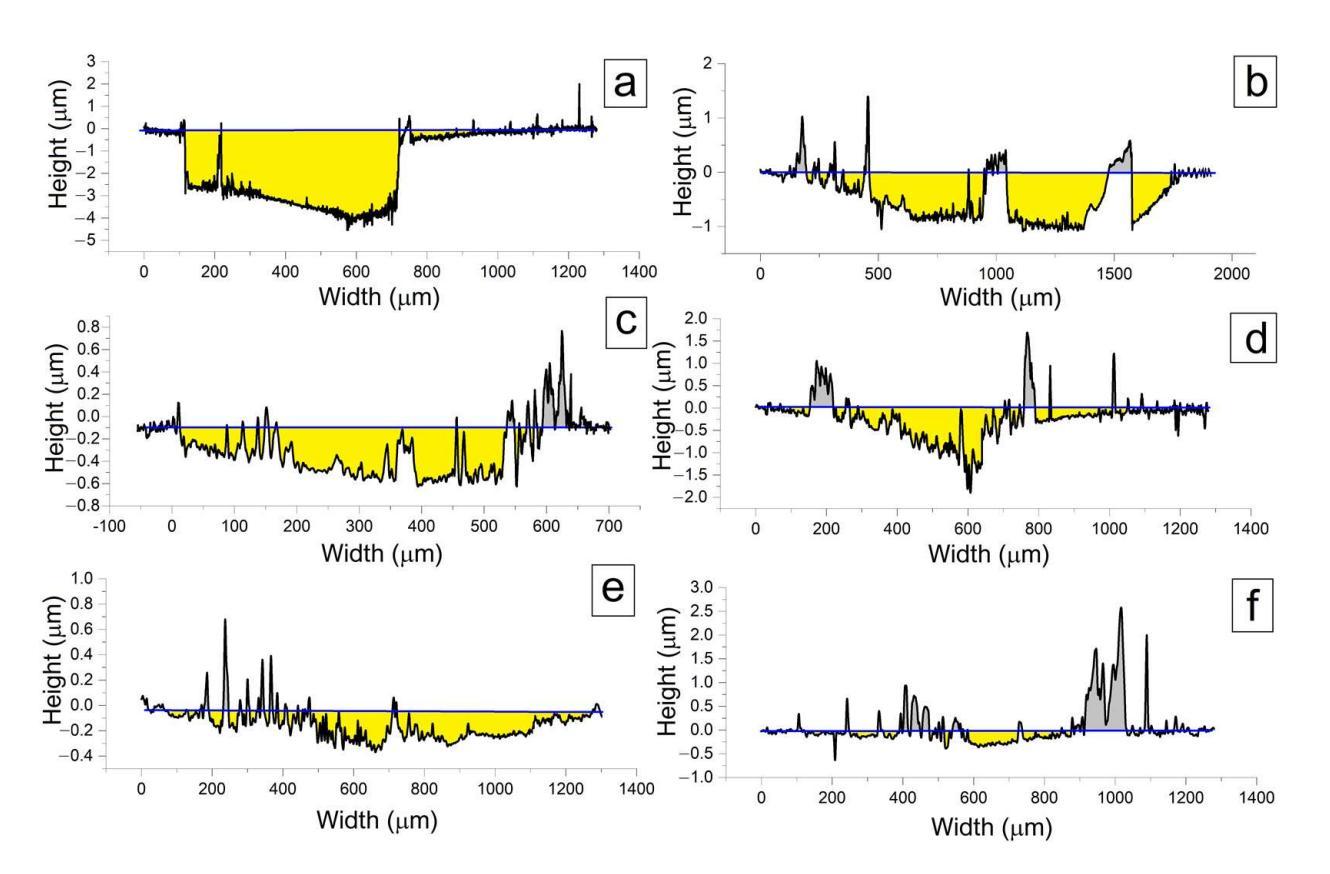
Figure 9. The wear track profiles on ZrN (**a**), CrN (**b**), ZrCrN(0.5) (**c**), ZrCrN(3.5) (**d**), ZrCrN(5) (**e**) and ZrCrN(8) (**f**) after sliding at 6 H.

The wear track cross-section profiles were reconstructed (Figure 9), which allowed assessing the degree of wear of the coatings and thus confirming the presence of transfer layer areas. As can be seen from the presented profiles, the wear of coatings varies significantly. Thus, the ZrN coating was completely destructed (Figures 8a and 9a) so that traces of material extrusion became visible on the periphery of the wear track. A narrow black band is clearly visible on the surface of this wear track, which is the result of adhesion of oxidized wear products.

The CrN coating experienced intensive wear, but some of the coating thickness is still retained, which means that it had higher wear resistance as compared to that of the ZrN coating. In this case, the wear track width was the largest, and transfer layer fragments were observed on its surface. This is partly due to the wear of the coating, but, to a greater extent, it is the result of the ball wearing that the wear track width increased as compared to those in other cases. In addition, a large number of wear particles were formed, which were then trapped in the micro-roughness of the wear track and created an oxidized layer on the surface of the coating.

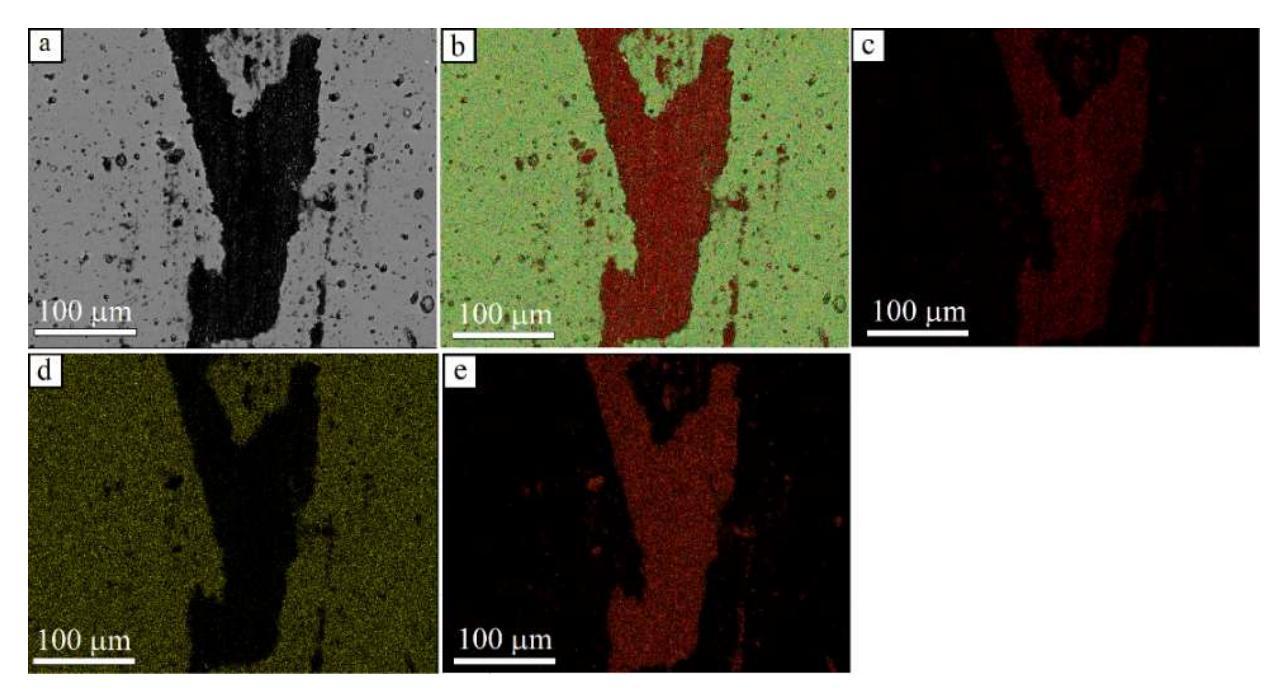
Figure 11. SEM image (**a**) and EDS element distribution maps for Zr, Fe and O (**b**), O (**c**), Zr (**d**) and Fe (**e**) obtained from the worn surface of the ZrN coating after sliding at 1N.

Scanning electron microscopy (SEM) with EDS was used to analyze the transfer layer as well as oxidized areas on the wear track surfaces. Two sets of samples with the most characteristic wear features were used. First, these were samples with a ZrN coating, which showed their sufficient wear-resistance in sliding at 1N load, contained oxides on the worn surface and were severely worn in sliding at 6N.

Second, these were ZrCrN(5) samples that were typical representatives of the multilayer coatings studied in this work and whose wear resistance depended on the load being either high or sufficient. Figure 11a shows an SEM image from the wear track surface with a characteristic dark spot similar to those observed in Figure 5a and formed after sliding at 1N. The EDS element distribution maps in Figure 11b show the composition difference between the transfer layer and ZrN coating. Upon closer examination, it becomes obvious that this transfer layer is composed of iron oxide since Fe (Figure 11c) and O (Figure 11e) are its main components, whereas Zr (Figure 11d) is detected outside of the spot. (a)

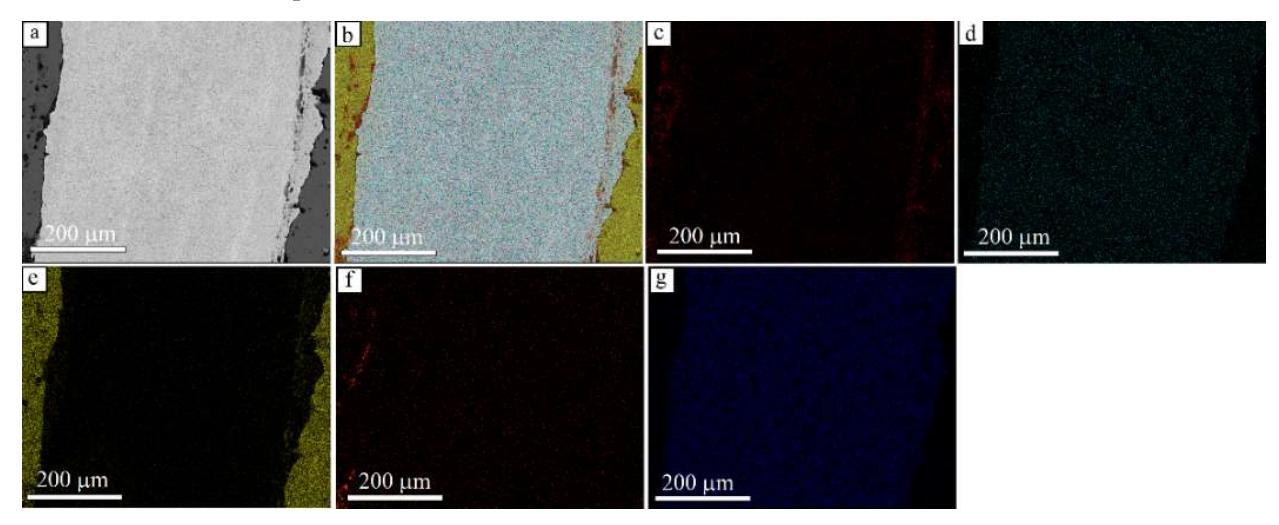
Figure 12. SEM image (**a**) and EDS element distribution maps for all elements (**b**), O (**c**), W (**d**), Zr (**e**), Fe (**f**) and Co (**g**) obtained from the worn surface of the ZrN coating after sliding at 6N.

Because of increasing the load to 6N, a distinct wear track was formed on the surface, as demonstrated by the SEM image in Figure 12a. The combined image (Figure 12b) obtained for the sum of chemical elements Zr, Fe, O, W and Co shows that the coating was completely removed from the track surface while retained on its edges (Figure 12e). Oxidation is partially present precisely on the retained part of the coating (Figure 12c), and

only barely noticeable presence of O is observed on the surface of the WC-Co substrate. In addition, there are only traces of Fe remaining on the retained part of the coating (Figure 12f), which coincide in location with the area containing O and thus indicate the presence of iron oxides.

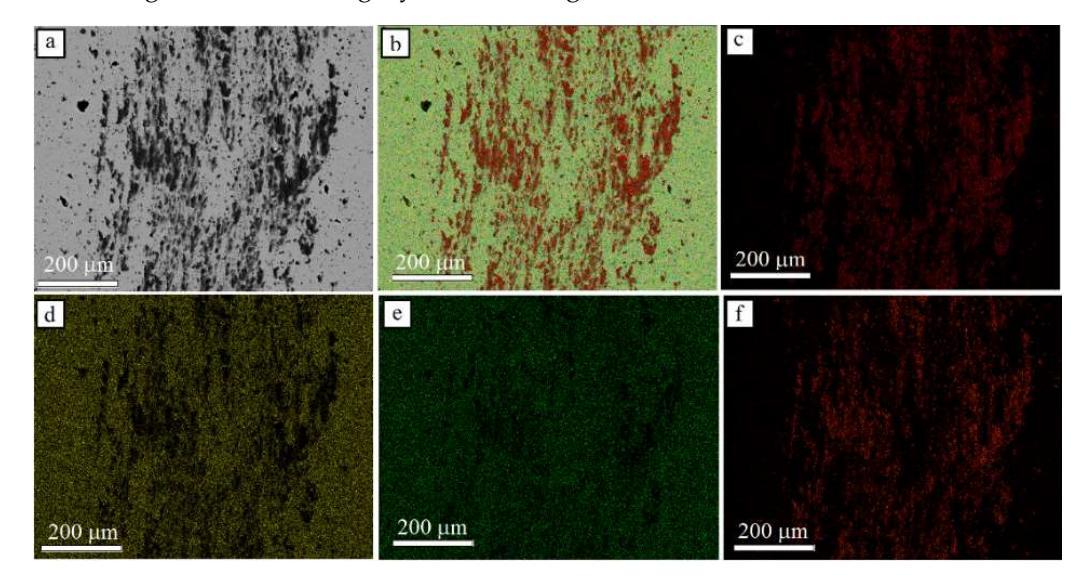
Figure 13. SEM image (**a**) and EDS element distribution maps for all elements (**b**), O (**c**), W (**d**), Zr (**e**), and Fe (**f**) obtained from the worn surface of the ZrCrN(5) coating after sliding at 1N.

As a rule, a patchy layer of oxidized transfer material is formed on the worn surfaces of the samples of the multi-layer coatings rubbed at 1N and studied in this work (Figure 5c–f). The SEM image of a typical sample shows that its worn surface is covered with fragments of iron oxides. This is confirmed by the results of EDS analysis. Judging by the obtained data, O (Figure 13c) and Fe (Figure 13a) are detected exactly within the dark spots (Figure 13a), while Zr (Figure 13d) and Cr (Figure 13e) are located on the friction track surface, thus confirming the retained integrity of the coating.

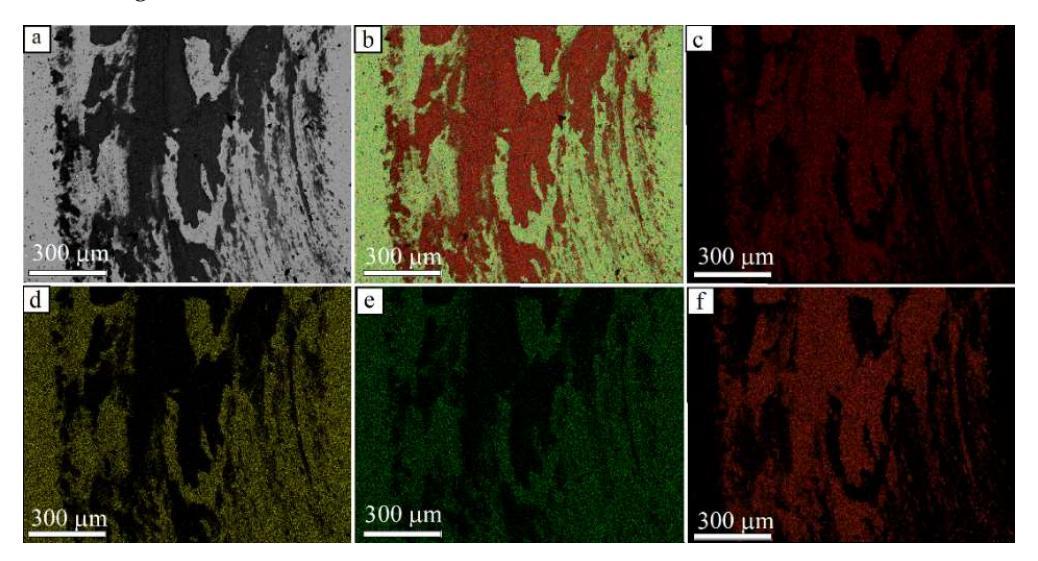
Figure 14. SEM image (**a**) and EDS element distribution maps for all elements (**b**), O (**c**), Zr (**d**), Cr (**e**) and Fe (**f**) obtained from the worn surface of the ZrCrN(5) coating after sliding at 6N.

As the load increased to 6N, the layer of oxidized material on the surface of the multilayer-coated sample began to occupy noticeably larger areas on the wear track (Figure 14a) as compared to those resulting from sliding at 1N. As discussed above, both O (Figure 14c) and Fe (Figure 14f) are concentrated in the dark areas on the SEM image (Figure 14a). The rest of the surface is characterized by the presence of only Zr (Figure 14d) and Cr

(Figure 14e), which confirms retention despite some wear (Figures 8e and 9e) integrity of the coating.

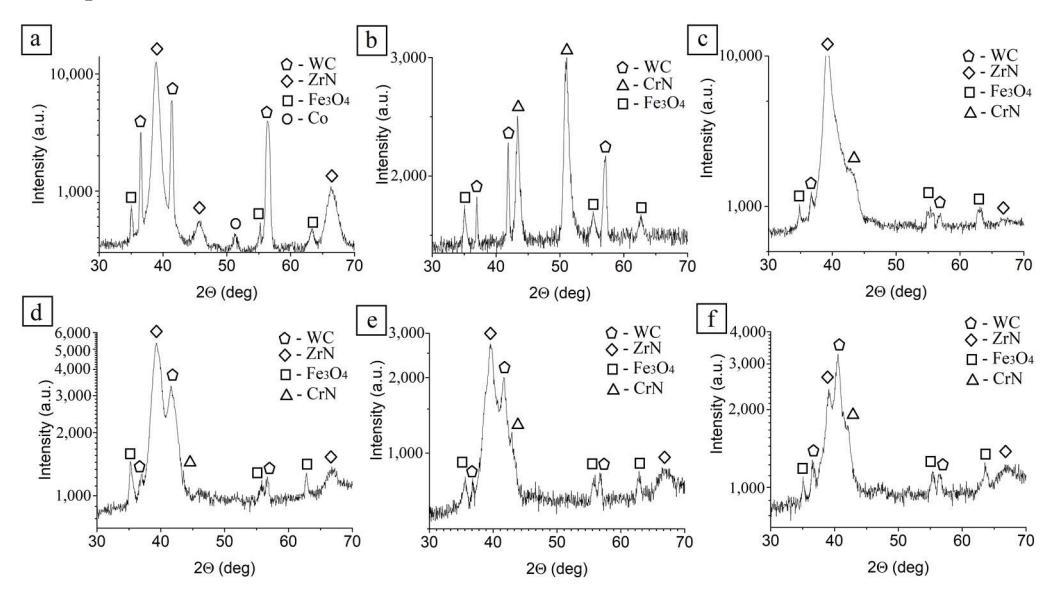
Figure 15. X-ray diffractograms obtained from the worn surfaces of coatings rubbed against the steel balls at 6N. Samples: ZrN (**a**), CrN (**b**), ZrCrN(0.5) (**c**), ZrCrN(3.5) (**d**), ZrCrN(5) (**e**) and ZrCrN(8) (**f**).

To identify the oxides formed on the surface of the samples with coatings after testing, X-ray diffraction analysis was carried out (Figure 15). Samples obtained after sliding at 6N will be further considered here as typical examples. When reconstructing the diffractograms, the logarithmic scale of the reflection intensity axis was used for better identification of the phases. All the diffraction patterns clearly show WC reflections, which may originate from the WC-Co substrate. When examining a sample coated with ZrN, Co reflections were also detected due to the fact that part of the ZrN coating was removed. In other cases, the Co reflections have not been observed unless there was full deterioration of the coating and exposure of the substrate. The reflections of both ZrN and CrN are well distinguishable when obtained from the single-layer coatings (Figure 15a,b). Based on the analysis of other reflections observed in all cases, the sliding-formed oxides can be identified as Fe_3O_4 . No other phases or oxides were found.

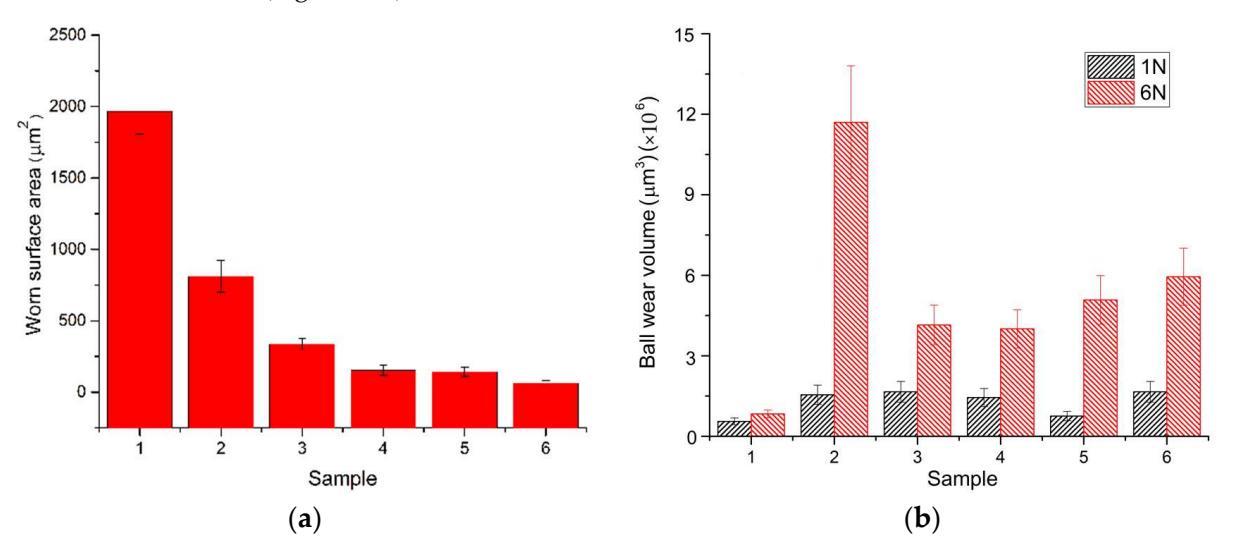
Figure 16. The wear track cross-section profile areas on coatings (**a**) and steel ball volume losses (**b**) resulted from sliding at 6N. Sample: 1—ZrN, 2—CrN, 3—ZrCrN(0.5), 4—ZrCrN(3.5), 5—ZrCrN(5) and 6—ZrCrN(8).

To analyze the results, the wear characteristics were obtained and plotted in the form of graphs in Figure 16. These wear characteristics were represented by the wear track cross-section profile areas on the coatings (Figure 16a) and volume losses on steel balls (Figure 16b).

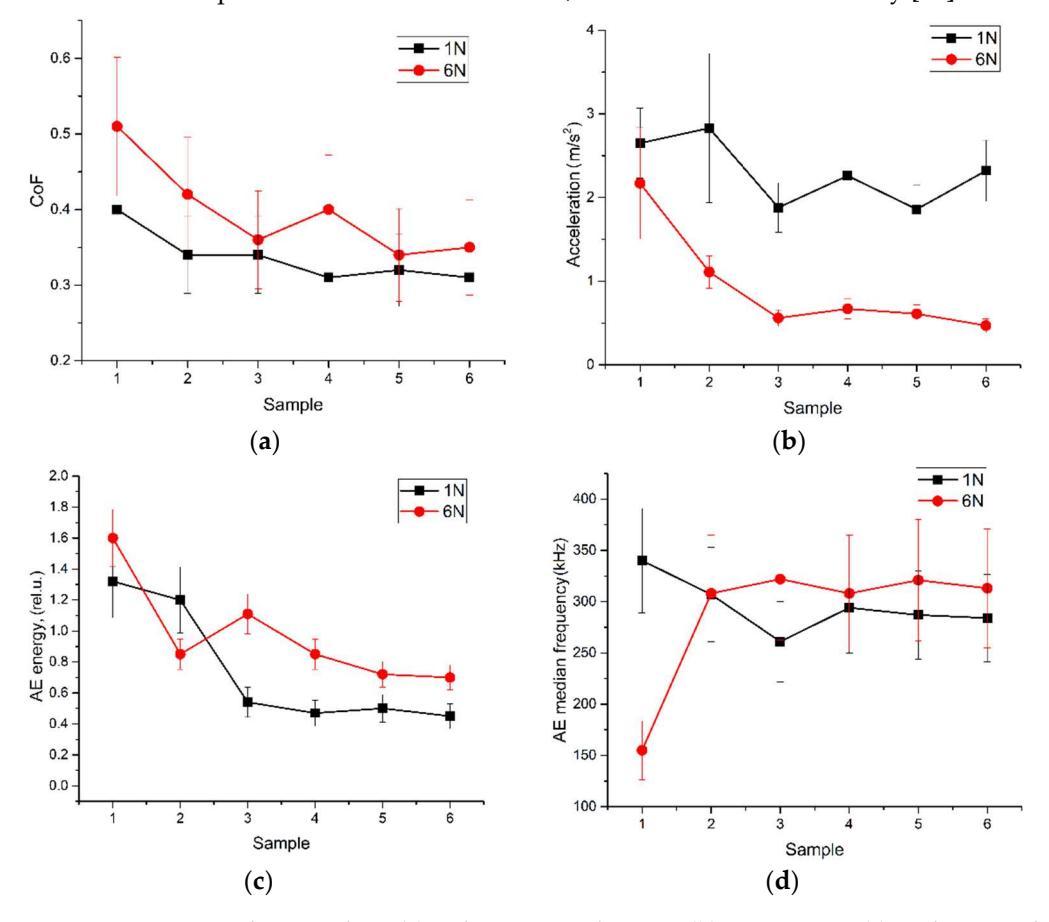
Figure 17. Averaged CoF values (**a**), vibration acceleration (**b**), AE energy (**c**) and AE median frequency (**d**) obtained from samples in sliding at 1N and 6N normal load: 1—ZrN, 2—CrN, 3—ZrCrN(0.5), 4—ZrCrN(3.5), 5—ZrCrN(5) and 6—ZrCrN(8).

Summarizing the data on the CoF value, vibration and AE signal parameters, the graphs were reconstructed that showed the average values of these characteristics during sliding at 1N (Figure 17a) and 6N (Figure 17b). The higher value of CoF in sliding at 6N is due to a change in the tribocontact conditions. At a load of 1N, a layer of iron oxides is observed on the surface of the samples, which contributes to the decrease in CoF. During friction with a load of 6N, more intensive wear of the coatings is observed; therefore, the oxide layer is less stable and might be carried away so that contacting occurs on the denuded coating surfaces. The third body (transfer layer) is removed, and, as a result, adhesion between the surfaces increases, thus causing the increase in CoF. A similar analogy can be followed when analyzing the adhesion during sliding between the steel surfaces [44], as well as in the presence friction modificators, which serve as a third body [45].
