Article Effect of Solution Temperature on the Microstructure and Properties of 17-4PH High-Strength Steel Samples Formed by Selective Laser Melting

Abstract: Samples of 17-4PH high-strength steel were processed by selective laser melting (SLM) and solution-processed. The effects of the solution temperature on the microstructure and mechanical properties of the samples were studied. The 17-4PH high-strength steel is primarily composed of martensite, with a small number of austenite phases, and contains many dislocations. After the solution treatment, the grain size gradually increased, yielding typical martensite. The samples were subjected to an aging treatment after the solution treatment. Precipitates formed in the samples, conducive to improving their strength and hardness. The Vickers hardening and wear properties of the 17-4PH high-strength steel samples first increased and then decreased with increasing solution temperature. After the solution treatment at 1040 °C for 2 h and aging at 480 °C for 4 h, the Vickers hardening of the 17-4PH high-strength steel increased to 392 HV0.5, and the friction coefficient was approximately 0.6. These values were, respectively, 7% and 5% hi

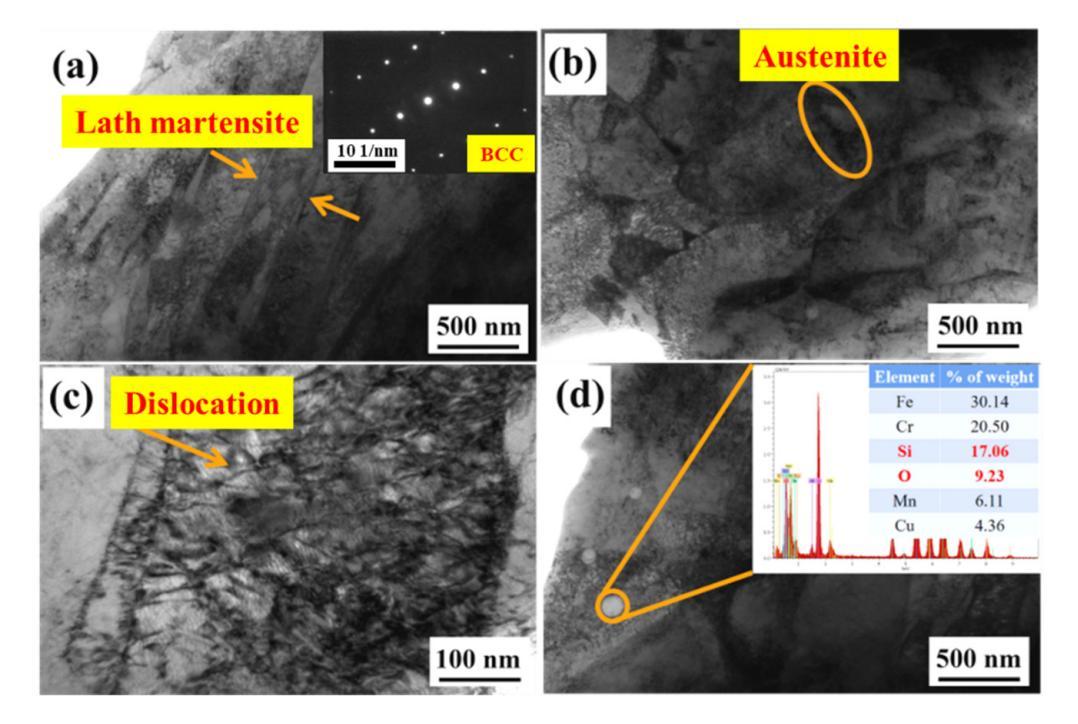
Figure 2. TEM images of the morphology of the 17-4PH high-strength steel formed by SLM: (a) martensite; (b) austenite; (c) dislocation; (d) precipitates.

The TEM morphological images of the 17-4PH high-strength steel samples formed by SLM are shown in Figure 2. As the TEM sample becomes thinner, perforations tend to form in the fine grain at the boundary of the molten pool. Examining the TEM images, the samples' structure mainly included lath martensite with the body-centered cubic (BCC) crystal structure and austenite grain with the face-centered cubic (FCC) crystal structure. As shown in Figure 2a, the width of the lath martensite was 200–300 nm. As shown in Figure 2b, the trace width of residual austenite along the boundary of the martensite lath was 200–300 nm. The crystal structure of the martensite was BCC, and a high density of dislocations was observed as shown in Figure 2c. Moreover, as shown in Figure 2d, many spherical inclusions (with particle sizes in the 50–170 nm range) were also present in the TEM images. According to the EDS composition analysis of the precipitates, the contents of the O and Si elements were high, and these spherical inclusions were determined to be Si-rich oxides.

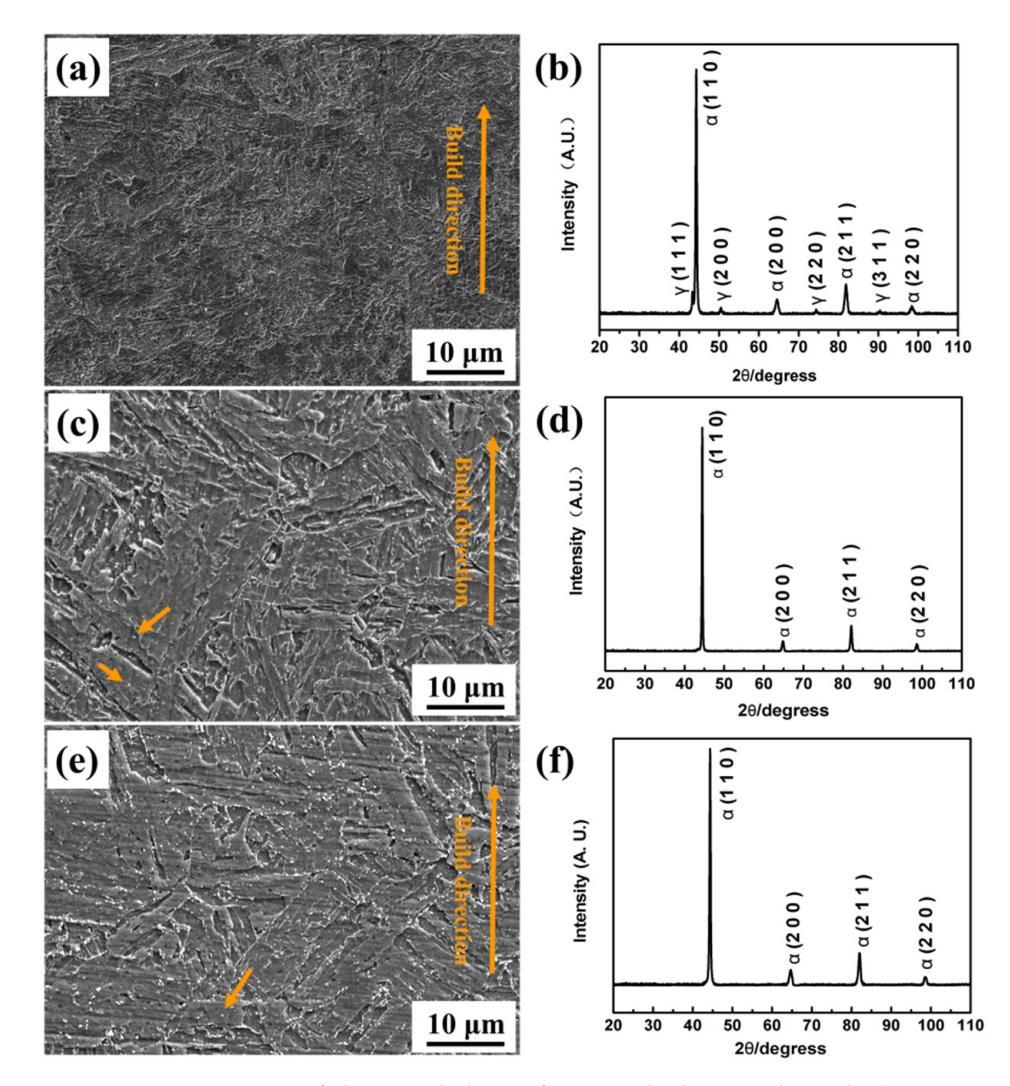
Figure 3. SEM images of the morphology of 17-4PH high-strength steel: (a) SLM-processed; (c) heat-treated in solution at 940 °C; (e) heat-treated in solution at 990 °C. XRD patterns of 17-4PH high-strength steel: (b) SLM-processed; (d) heat-treated in solution at 940 °C; (f) heat-treated in solution at 990 °C.

Figures 3 and 4 show the SEM morphology and XRD patterns of the 17-4PH highstrength steel samples formed by SLM-based processing and subsequent heat treatment. Because the transformation point temperatures of 17-4PH high-strength steel are 670 °C for Ac1, 740 °C for Ac3, 140 °C for Ms, and 32 °C for Mf, the best performance requirements can be obtained by adjusting different heat treatment processes. Figure 3a shows a sample that was formed using SLM, and the structure is composed of lath martensite. Corresponding to the XRD pattern shown in Figure 3b, the structure also features the γ -austenite peak. After the heat treatment, the samples gradually formed a typical martensite microstructure as the temperature of the solution treatment increased. As shown in Figure 3c, the grain size increased as the solution temperature increased up to 940 °C, and all of the structures were transformed into α -martensite, as shown in Figure 3d.

As shown in Figures 3 and 4, in terms of the XRD patterns, the structure of the 17-4PH high-strength steel samples formed by SLM consisted of the intensive and main peaks of α -martensite and a weak peak of γ -austenite. A complete martensite structure was achieved after the heat treatment. When the solution temperature reached 1140 °C, the characteristic peak of γ (220) appeared again. Owing to the high temperature, Ms

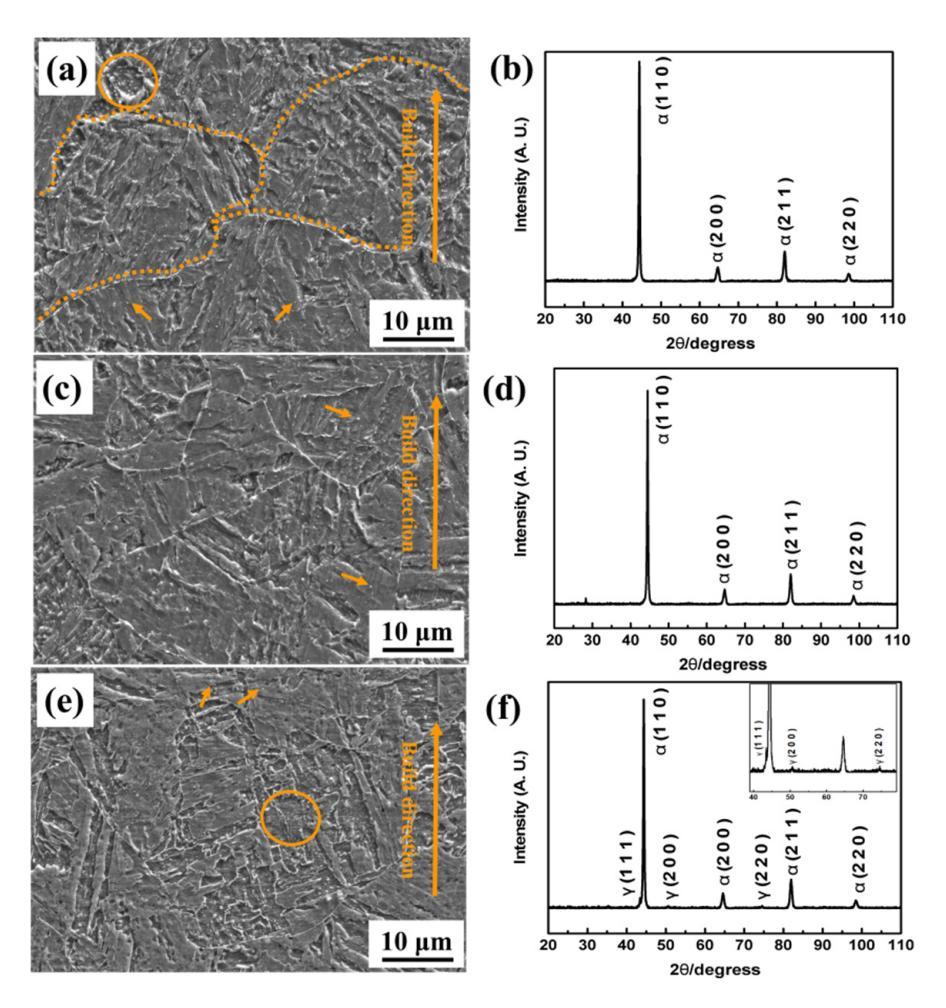
Figure 4. SEM images of the morphology of 17-4PH high-strength steel: (**a**) heat-treated in solution at 1040 °C; (**c**) heat-treated in solution at 1090 °C; (**e**) heat-treated in solution at 1140 °C. XRD patterns of 17-4PH high-strength steel: (**b**) heat-treated in solution at 1040 °C; (**d**) heat-treated in solution at 1090 °C; (**f**) heat-treated in solution at 1140 °C.

The structures were completely austenitized during the heating of the solution and were transformed into lath martensite during the rapid cooling of the solution. When the solution temperature was 1040 °C, as shown in Figure 4a, the original austenite grains were arranged into package shapes (as indicated by the dotted line). Fine equiaxial grains were observed in the structure (the circle mark in the figure). A weak peak of γ -austenite was observed in the spectra of the specimens that were solution-treated at 1140 °C and the XRD patterns are shown in Figure 4f. The main peaks of α -martensite, as well as fine equiaxial grains, were observed (the circle mark in the figure). The starting temperature Ms of the austenite-to-martensite transformation was above room temperature. The solution temperature was too high; thus, Ms decreased and the retained austenite δ -ferrite also increased, but the hardness decreased. At this temperature, the heat treatment effect was not good. The orange arrows in Figures 3 and 4 indicate the precipitated phase. During the aging process, the precipitation of precipitates such as ε -Cu was observed. A high density of dislocations was observed in the martensite, which is conducive to the diffusion of the copper phase. This is likely to improve the strength and hardness of the samples [18].

decreased, the temperature decreased, some austenite did not transform into martensite, and the amount of residual austenite increased.

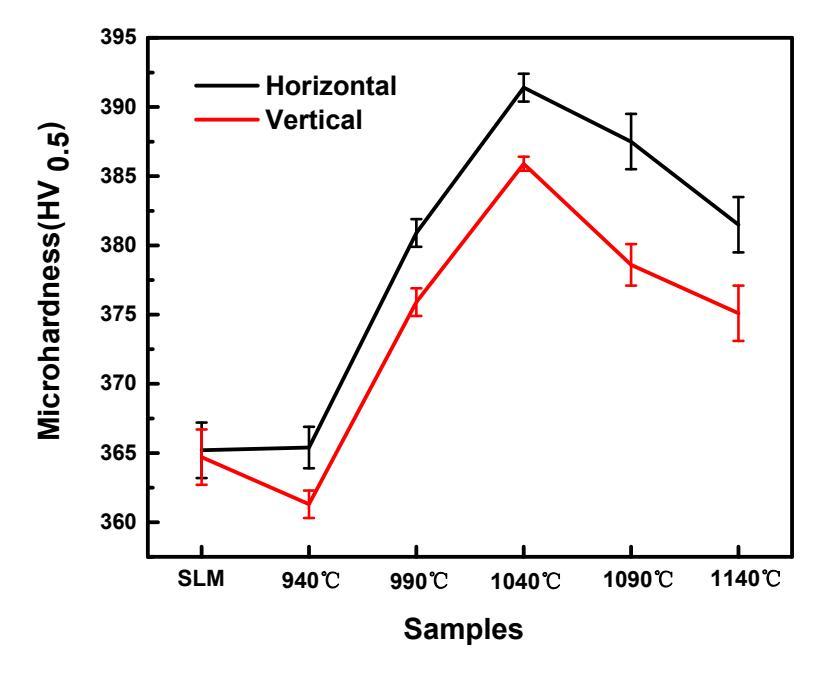
Figure 5. Microhardness of SLM-formed samples and heat-treated samples.

Figure 5 shows the hardness values of the studied 17-4PH high-strength steel samples that were obtained using the SLM-based method and different solution treatment methods. The hardness improved owing to the heat treatment (the horizontal build direction was the X-Y section, and the vertical build direction was the X-Z section). When the solution temperature was increased to 1040 °C, the X-Y section hardness of the alloy samples peaked at approximately 392 $HV_{0.5}$, while the X-Z section hardness peaked at approximately $381 \text{ HV}_{0.5}$. Following that, the hardness of the alloy samples decreased as the solution temperature increased. The increase in the samples' hardness was due to the strengthening effect caused by the complete martensite structure and small precipitates in the samples. The hardness values for the X-Y sections and the X-Z sections of the untreated samples that were made using the SLM-based method were the same. After the heat treatment, the hardness values of the X-Y and X-Z sections were different; the hardness of the X-Z section was lower than that of the X-Y section. For the solution temperature of 940 $^{\circ}$ C, the hardness was in the $360 \text{ HV}_{0.5}$ - $365 \text{ HV}_{0.5}$ range, similar to that of the non-heat-treated samples that were made using the SLM-based method. For the solution temperature of 1140 °C, the hardness of the X-Y section samples decreased to 383 $HV_{0.5}$ and that of the X-Z section decreased to $375 \text{ HV}_{0.5}$. This was because, at a solution temperature that was too high, the stability of the austenite increased and the transformation temperature Ms of the martensite decreased, resulting in an uneven martensite structure, a higher amount of retained austenite, higher ferrite content, and lower hardness. After the solution treatment, the microstructure became hard-phase martensite. The dispersed precipitation hardening phase that precipitates on the martensite lath during aging was shown to improve the matrix hardness [22]. Additionally, many dislocations were observed in the structure, which also affected the samples' hardness.

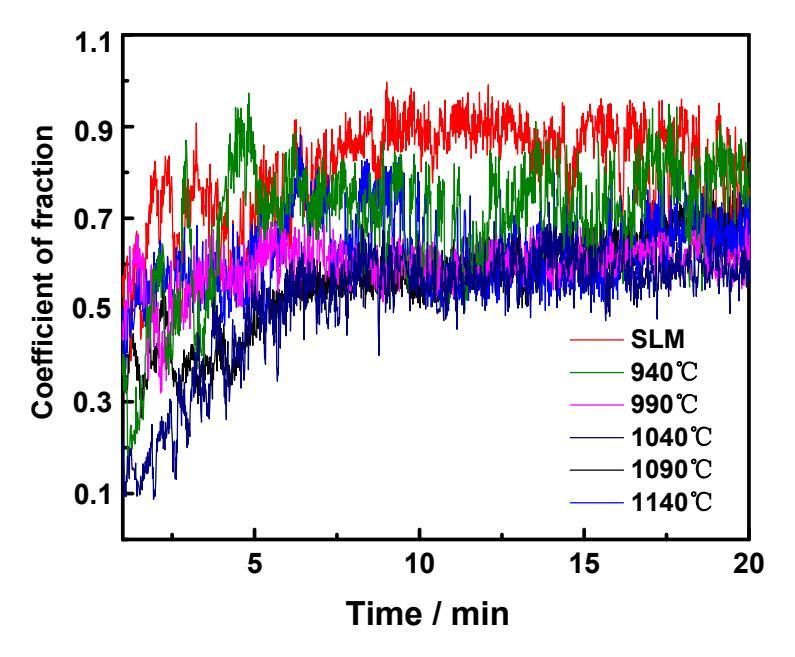
Figure 6. The friction coefficient of SLM-formed samples and samples heat-treated at different solution temperatures.

Figure 6 shows the friction coefficient curves of the 17-4PH high-strength steel samples formed using the SLM-based method and heat-treated at solution temperatures in the 940–1140 °C range. Smooth friction coefficient curves were observed. According to the friction coefficient curves, for all samples, the friction coefficient tended to stabilize after the initial run-in period. The friction coefficient of the untreated samples was approximately 1, while the friction coefficients of the samples obtained for the solution temperatures of 940 °C, 990 °C, and 1140 °C fluctuated strongly around 0.8. The friction coefficient of the sample obtained for the solution temperature of 1040 °C increased rapidly during the first 6 min, and tended to stabilize after 6 min. The average friction coefficient decreased, the friction coefficient was approximately 0.6, and the antifriction performance improved. During friction, the microstructure of the sample's surface was plastically deformed, which increased the actual contact area, resulting in a rapid increase in the friction coefficient. The solution temperature was 1140 °C. Owing to the high solution temperature, the Ms point decreased and the retained austenite δ -ferrite also increased.

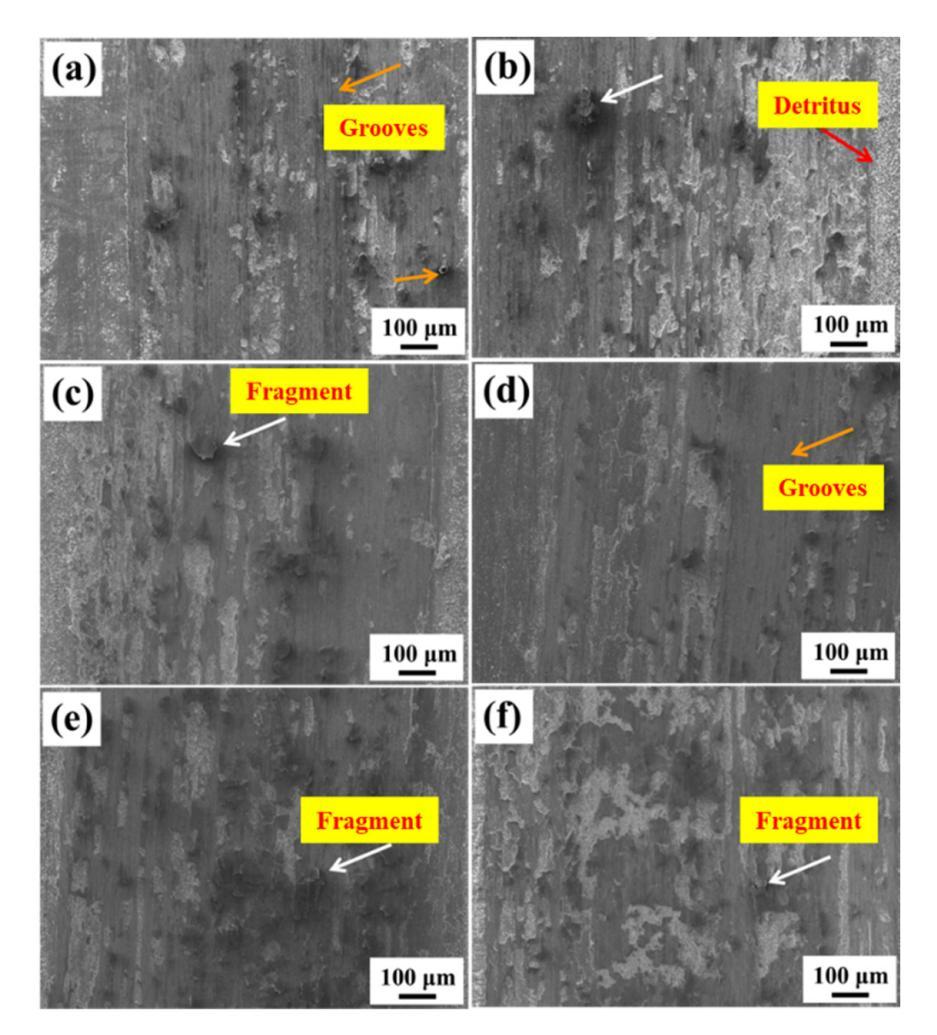
Figure 7. SEM images of the morphology of the wear surface of 17-4PH high-strength steel formed by SLM. (a) SLM-formed sample; (b) sample heated-treated in solution at 940 °C; (c) sample heated-treated in solution at 990 °C; (d) sample heated-treated in solution at 1040 °C; (e) sample heated-treated in solution at 1090 °C; (f) sample heated-treated in solution at 1140 °C.

Figure 7 shows the SEM morphologies of the wear surfaces of the 17-4PH high-strength steel samples obtained using the SLM-based method and heat-treated at different solution temperatures in the 940–1140 °C range. The types of wear that manifested were abrasive wear, adhesive wear, and fatigue wear. During friction, compressive and shear stresses were generated on the samples' surfaces. As shown in Figure 7a, the samples' surfaces became exfoliated, deformed, and scratched during the experiment, which led to the obvious roughening and tearing of the surfaces, as well as to the generation of plate-like wear debris. The material that was peeled off from the specimens' surfaces owing to the propagation of microcracks was the main reason for the observed high wear rates. Figure 7b shows that the adhesive wear for the sample treated at 940 °C was the most obvious, resulting in a large amount of adhesive fine debris. Figure 7c shows that for the solution temperature of 990 °C, the hardness of the corresponding sample increased, and the adhesive wear and lamellar phenomena decreased. Figure 7d shows that for the solution temperature of 1040 °C, the surface of the corresponding sample was the smoothest. Owing to the high hardness and the low degree of wear, the main wear types

were abrasive and slight adhesive wear. When the strength of the adhesive joint was lower than that of the two materials engaged in friction, shear occurred at the interface between the two materials. At this time, although the friction coefficient increased, the amount of wear was very small and the material transfer was minimal. Figure 7e shows that, for the solution temperature of 1090 $^{\circ}$ C, the fatigue wear was clear, and the surface of the sample could be peeled off in flakes, suggesting a high degree of damage. Figure 7f shows that, for the solution temperature of 1140 $^{\circ}$ C, delamination occurred, yielding a large number of loose wear particles. Some hard particles fell off and wore the surface materials of the contact surface owing to extrusions or relative motion. There were two specific mechanisms of plastic deformation and fracture during the wear process of abrasive particles. When the surface plasticity of the material was high, the abrasive particles scratched, with most of them producing grooves, and accumulation occurred on both sides. Subsequent repeated friction experiments will flatten the accumulated debris. In this way, an external force would eventually cause the formation of cracks and spalling.

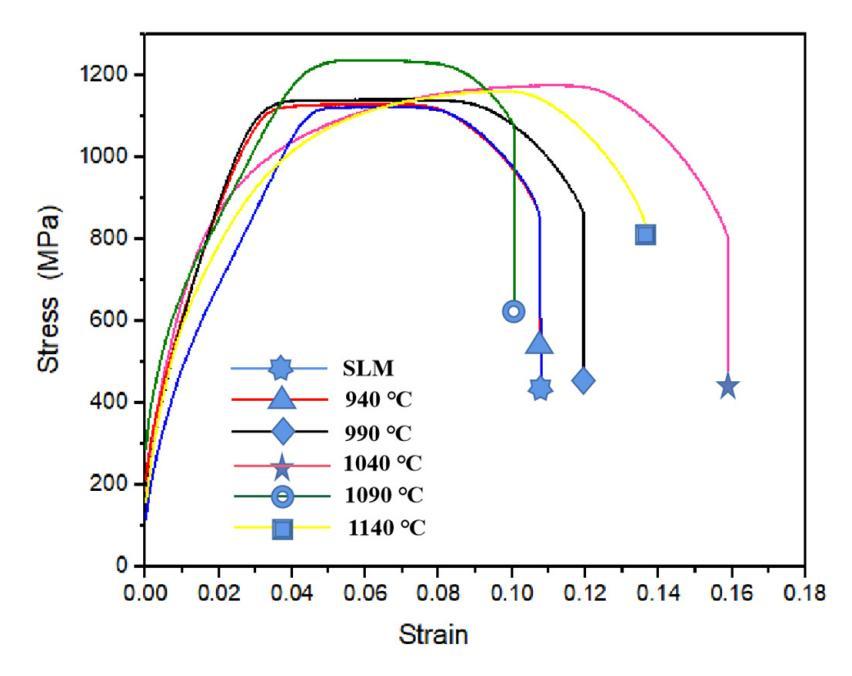
Figure 8. Stress-strain curves of SLM-formed specimens and heat-treated specimens.

Figure 8 shows the stress–strain curves of 17-4PH high-strength steel formed by SLM and samples heat-treated at different solution temperatures in the 940–1140 °C range. On the whole, the tensile strength of the specimens after heat treatment is improved in different degrees compared with that before heat treatment. Particularly, when the

solution temperature is 1040 °C, the trade-off between tensile strength and ductility is better displayed (the tensile strength is 1180 MPa, the strain is 0.16). Compared with Li et al. 's the tensile properties after the homogenizing heat treatment [23], the tensile properties at the solution temperature of 1040 °C are mainly characterized by the fact that the tensile strength is improved to a certain extent compared with that before the heat treatment without sacrificing its toughness. Similarly, compared with Huber et al.'s modified heat treatments (involving prolonged solution annealing and deep-cooling) [24], the trade-off between tensile strength and ductility under the 1040 °C solution heat treatment in this study was also improved.

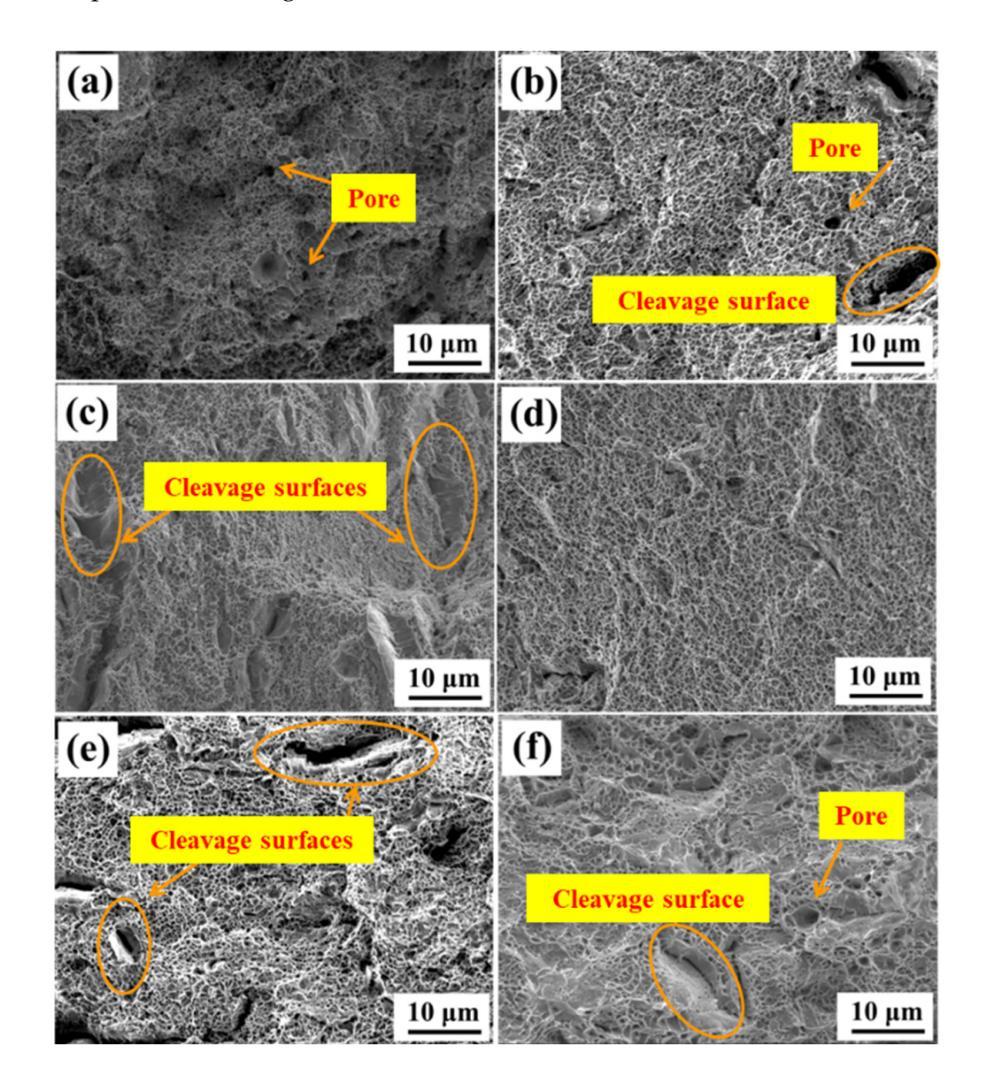
Figure 9. SEM images of the morphology of the tensile fracture of 17-4PH high-strength steel formed by SLM. (**a**) SLM-formed sample; (**b**) sample heat-treated in solution at 940 °C; (**c**) sample heat-treated in solution at 990 °C; (**d**) sample heat-treated in solution at 1040 °C; (**e**) sample heat-treated in solution at 1090 °C; (**f**) sample heat-treated in solution at 1140 °C.

Figure 9 shows the SEM morphology results for the tensile fracture of the 17-4PH high-strength steel samples formed using the SLM-based method and processed at different solution temperatures in the 940–1140 °C range. After heat treatment, the tensile strength reached 1200 MPa. The elongation was in the range of 0.10 to 0.16. The tensile fracture surface consists of three distinct regions: the fiber, radiation, and shear lip regions. Figure 9a shows that many dimples and some micropores (orange arrows) formed on the surface of the untreated SLM-formed sample, and the sample exhibited a ductile fracture. As shown in Figure 9b, the sample that was treated at the solution temperature of 940 °C exhibited an obvious cleavage surface (marked by the orange circle) and shallow holes. Dimples were large and uneven, indicating a mixture of ductile and brittle fractures. With an increase in the solution temperature (as shown in Figure 9c for the solution temperature of 990 $^{\circ}$ C), the torn edge of the tensile part decreased and shortened, and the dimples became finer. As shown in Figure 9d, when the solution temperature increased to 1040 °C, the dimples on the fracture surface of the sample became similar in size and evenly distributed, which was also the reason for the high degree of elongation. The fracture surface of the sample exhibited an obvious necking phenomenon, which is a typical ductile fracture mechanism. As shown in Figure 9e, for the solution temperature of 1090 °C, the tensile strength of the sample increased, but the elongation decreased, resulting in a large number of cleavage surfaces and holes in the sample. As shown in Figure 9f, for the solution temperature of 1140 °C, the austenite in the sample structure reduced the strength of the material but improved the plasticity, tensile rate, cleavage surface, and micropore content of the material. After the heat treatment, the precipitated phase caused the formation of micropores during tension. The speed of the microporous polymerization process affects the toughness of the sample.

The samples' good strength and toughness are related to their structural uniformity and the presence of fine grains.
