Article

Hydrogen-Related Fracture Behavior under Constant Loading Tensile Test in As-Quenched Low-Carbon Martensitic Steel

Citation: Shibata, A.; Takeda, Y.; Kimura, Y.; Tsuji, N. Hydrogen-Related Fracture Behavior under Constant Loading Tensile Test in As-Quenched Low-Carbon Martensitic Steel. *Metals* 2022, *12*, 440. https://doi.org/10.3390/ met12030440

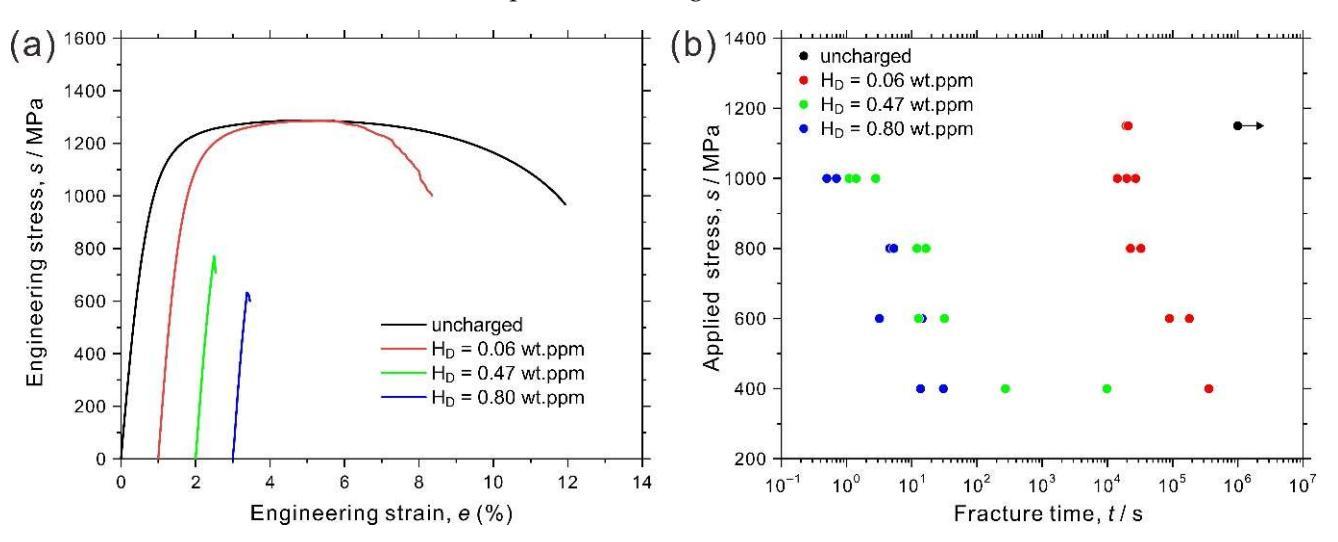
Figure 1a shows the engineering stress–engineering strain curves of the slow strain rate tensile tests. The 0.2% proof stress and ultimate tensile strength of the uncharged specimen were 931 MPa and 1283 MPa, respectively. The elongation decreased with increasing H_D , and the specimens with H_D of 0.47 wt. ppm and 0.80 wt. ppm exhibited premature fracture within the apparent elastic strain regime. The relationship between the applied stress and fracture time obtained from the constant loading tensile tests is presented in Figure 1b, where the plots of black, red, green, and blue indicate the data of the uncharged specimen with $H_D = 0.47$ wt. ppm, and hydrogen-charged specimen with $H_D = 0.80$ wt. ppm, respectively. The uncharged specimen did not fracture until 10⁶ s under an applied stress of 1150 MPa (maximum stress used in the present constant loading tensile tests). In contrast, fracture occurred within 10 s under an applied stress of 1000 MPa in the hydrogen-charged specimens with $H_D = 0.47$ wt. ppm and 0.80 wt. ppm. The fracture time tended to decrease with increasing applied stress and H_D .

Figure 1. (a) Engineering stress–engineering strain curves of the specimens with different H_D in the slow strain rate tensile tests and (b) relationship between the applied stress and fracture time in the constant loading tensile tests.

The hydrogen-related fracture was time-dependent: hence, the hydrogen-related fractures are sometimes called "delayed fractures". As shown in Figure 1b, the fracture time of the hydrogen-charged specimen decreased as the applied stress or H_D increased. Reportedly, the accumulation of a certain amount of hydrogen at a specific site is necessary for the initiation of a hydrogen-related fracture [27]. Figure 3 shows that the initiation site of the hydrogen-related fracture in the martensitic steel was the prior austenite grain boundaries. Moreover, recent studies using the hydrogen micro-print technique [20] have suggested that hydrogen accumulated around the prior austenite grain boundaries during deformation. Therefore, as shown in Figure 1b, a higher applied stress and larger global H_D facilitated hydrogen accumulation at the prior austenite grain boundaries. As shown in the fracture propagation process under a higher applied stress (Figure 5), several intergranular fractures were initiated inside the specimen. This may be attributed to the critical local hydrogen concentration being easily achieved at many sites when the applied stress is high. In contrast, it can be assumed that a lower applied stress retards hydrogen accumulation, leading to less nucleation of intergranular fracture. Therefore, once the intergranular crack is initiated, the fracture mainly proceeds by the propagation of the existing crack (Figure 4).

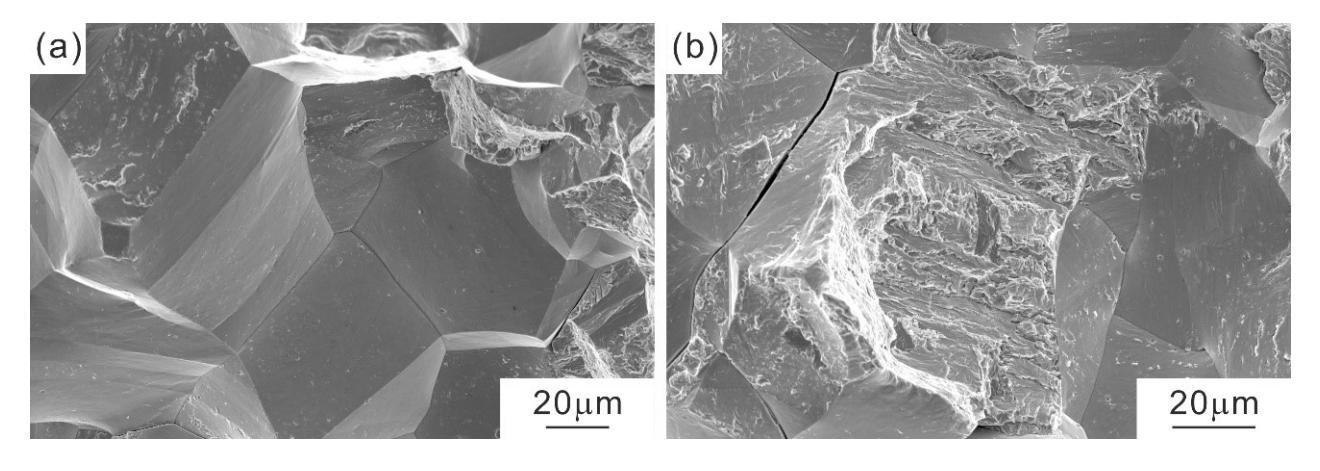
We confirmed that the fracture surfaces consisted of intergranular surfaces, quasicleavage surfaces, and ductile surfaces with dimple patterns, regardless of testing type (constant loading tensile test or slow strain rate tensile test), applied stress, and H_D . SEM images of the typical fracture surfaces are shown in Figure 2: intergranular surface (Figure 2a) and quasi-cleavage surface (center area of the image) (Figure 2b) observed in the hydrogencharged specimen with $H_D = 0.80$ wt. ppm after the slow strain rate tensile test. Previous studies [3–12] suggest that hydrogen-related intergranular fractures occur on the prior austenite grain boundaries and quasi-cleavage fracture propagates along the {011} crystallographic plane within the lath. Several micro-cracks were observed in the vicinity of the fracture surface after the slow strain rate tensile tests and constant loading tensile tests. Figure 3 presents the SEM images (Figure 3a,c) and corresponding EBSD orientation maps (Figure 3b,d) of the areas around the micro-cracks in the specimens with $H_D = 0.80$ wt. ppm after the constant loading tensile tests under an applied stress of 400 MPa (Figure 3a,b) and 800 MPa (Figure 3c,d). The colors in the EBSD orientation map express the crystallographic orientations along the normal direction of the observed section according to the stereographic triangle. In addition, the positions of the prior austenite grain boundaries identified

Figure 2. SEM images of the typical fracture surfaces; (**a**) intergranular surface and (**b**) quasi-cleavage surface (center area of the image) of the hydrogen-charged specimen with $H_D = 0.80$ wt. ppm after the slow strain rate tensile test.

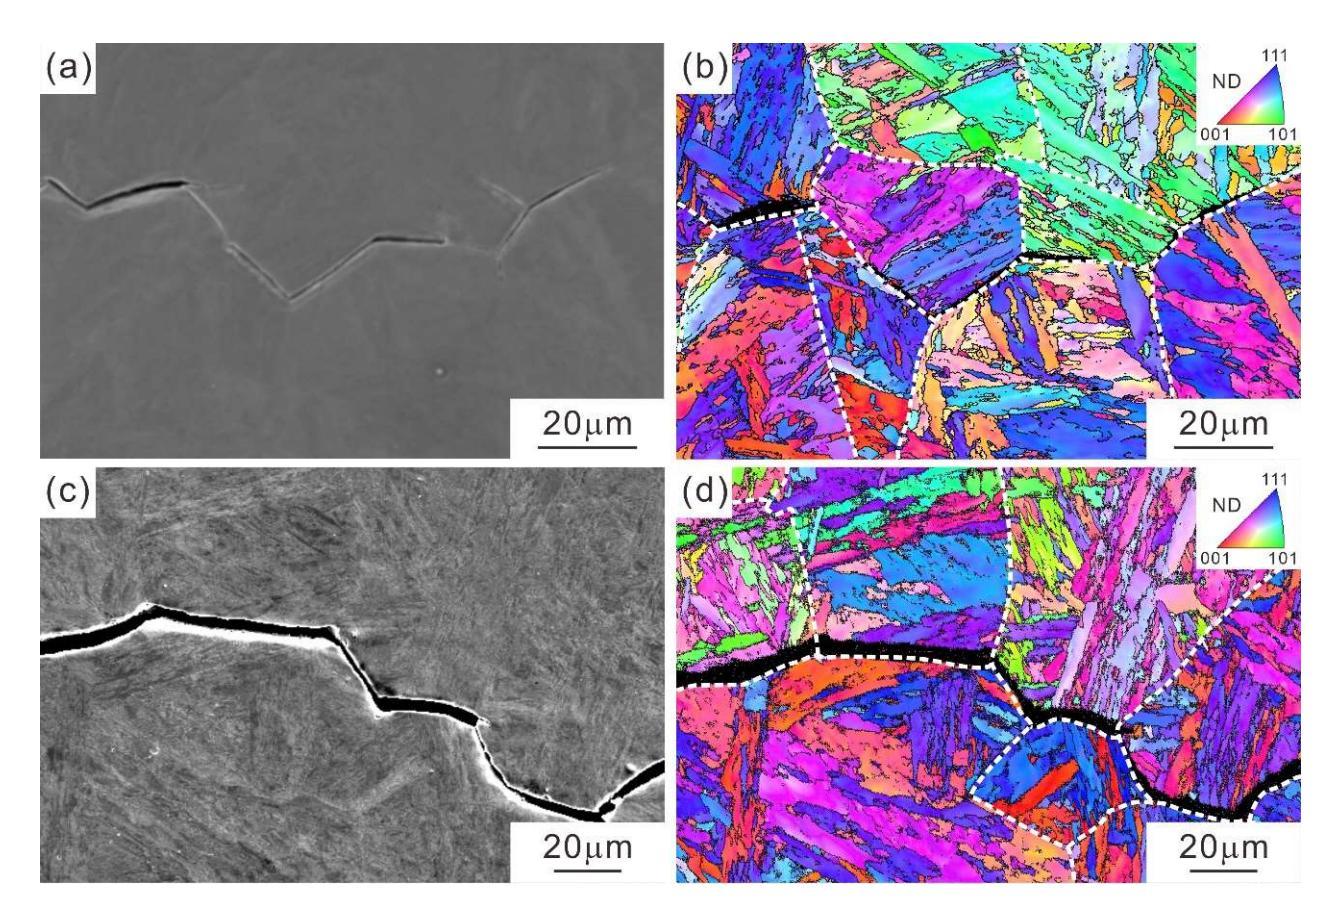
by orientation analysis are indicated by the broken white lines. In both specimens, after constant loading tensile tests under an applied stress of 400 MPa and 800 MPa, micro-cracks formed along the prior austenite grain boundaries. Because the formation of micro-cracks can be regarded as the initial stage of fracture, the results indicate that the initiation site of the hydrogen-related fracture was prior austenite grain boundaries and did not change with the applied stress. Previous studies also reported that hydrogen-related cracks were initiated around prior austenite grain boundaries [7,22].

Figure 3. (**a**,**c**) SEM images and (**b**,**d**) corresponding EBSD orientation maps of the areas around the micro-cracks in the specimens with $H_D = 0.80$ wt. ppm after the constant loading tensile tests under an applied stress of (**a**,**b**) 400 MPa and (**c**,**d**) 800 MPa. The positions of the prior austenite grain boundaries identified by orientation analysis are indicated by the broken white lines.

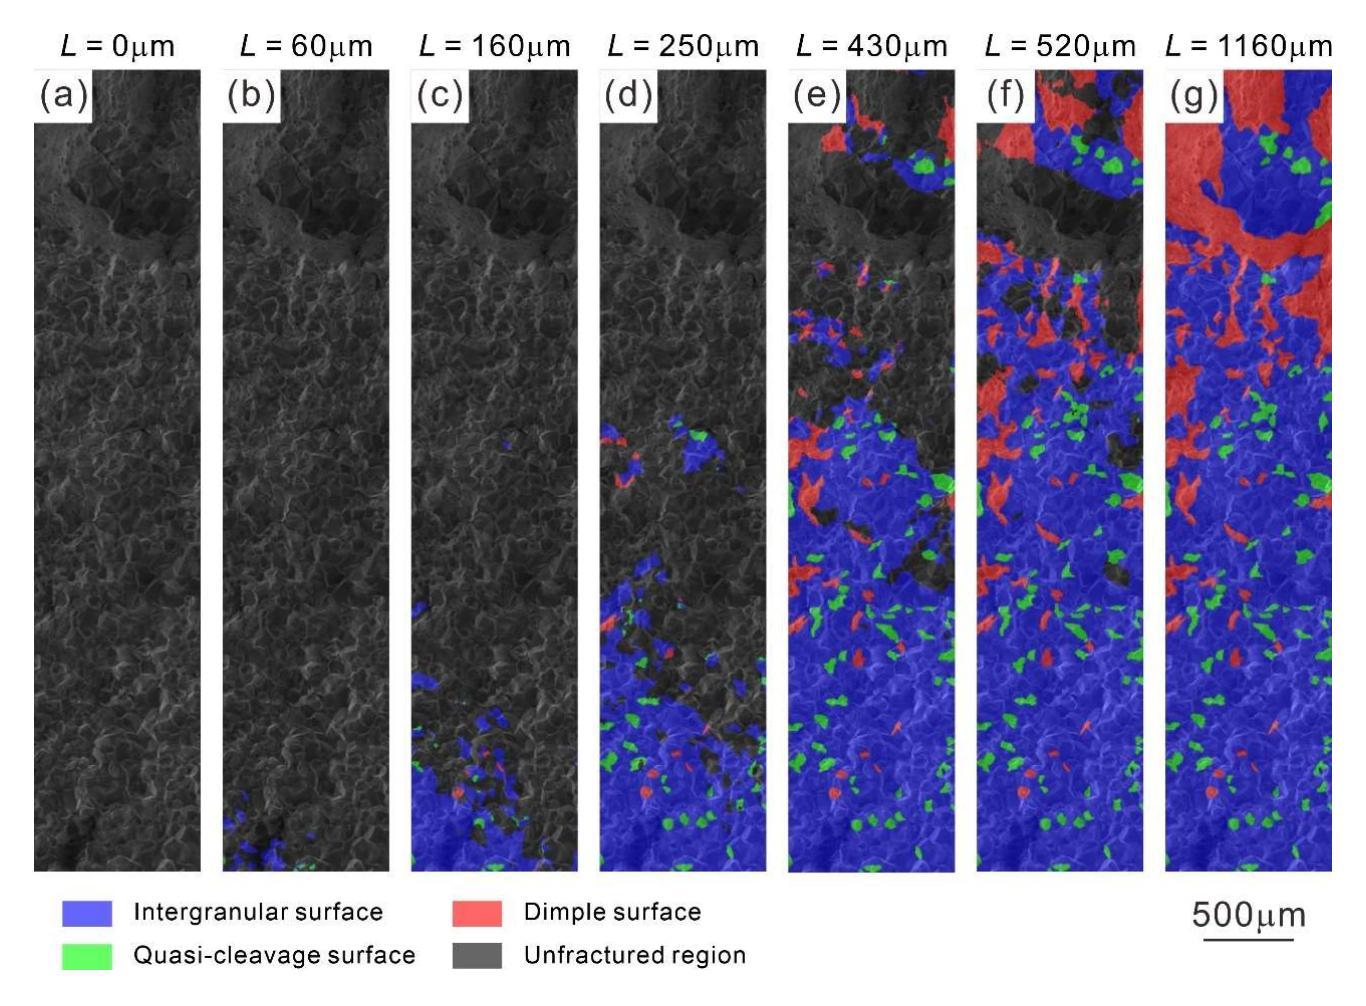
The hydrogen-related fracture propagation process in the specimen with $H_D = 0.80$ wt. ppm after the constant loading tensile test with an applied stress of 400 MPa (lower than the 0.2% proof stress) (Figure 1a) was reconstructed by FRASTA, and the results superimposed on the fracture surface SEM images are presented in Figure 4. L in the figure is the distance between the two fracture surface topographic maps and is defined as 0 when all the areas of the two topographic maps completely overlap (Figure 4a). The fractured areas, that is, the gaps between two topographic maps, are represented by blue, green, and red, which correspond to the intergranular fracture at prior austenite grain boundaries, the quasi-cleavage fracture, and the ductile fracture with dimples, respectively. The intergranular fracture (blue area) initiated around the side surface of the specimen (lower part of Figure 4b) and gradually propagated toward the inner part of the specimen (Figure 4c-f). In contrast, the quasi-cleavage fracture (green area) was discontinuous. Almost all areas of quasi-cleavage fracture were connected to the intergranular fracture area, indicating that the quasi-cleavage fractures were initiated from the existing intergranular cracks. The ductile fracture (red area), accompanied by the formation of dimples, occurred in the final rupture process (upper part of Figure 4e-g). Previously, we studied the microscopic crack propagation behavior of hydrogen-related intergranular fractures in a low-carbon martensitic steel and reported that the intergranular crack occasionally deviated from the prior austenite grain boundary and propagated within the prior austenite grains in a quasi-cleavage manner [26]. Presumably, once the crack stops propagating along the prior austenite grain boundaries due to geometrical/crystallographic grain boundary parameters, the crack starts to propagate within the prior austenite grain in a quasi-cleavage manner. After reaching another prior austenite grain boundary, the crack propagates along the prior austenite grain boundary again. Figure 5 presents the hydrogen-related fracture

Figure 4. Fracture propagation process reconstructed by FRASTA in the specimen with $H_D = 0.80$ wt. ppm after the constant loading tensile test with an applied stress of 400 MPa (lower than the 0.2% proof stress). The fractured areas (blue: intergranular fracture, green: quasi-cleavage fracture, and red: ductile fracture) are superimposed on the fracture surface SEM images. *L* in the figure is the distance between the two fracture surface topographic maps; (**a**) 0 µm, (**b**) 60 µm, (**c**) 160 µm, (**d**) 250 µm, (**e**) 430 µm, (**f**) 520 µm, and (**g**) 1160 µm.

- 2. The fracture propagation process reconstructed via FRASTA revealed that when the applied stress was low (400 MPa), the intergranular fracture was initiated around the side surface of the specimen and gradually propagated into the inner part of the specimen. Quasi-cleavage fractures were initiated from existing intergranular cracks. In contrast, several intergranular fractures were initiated separately inside the specimen when the applied stress was high (1000 MPa).

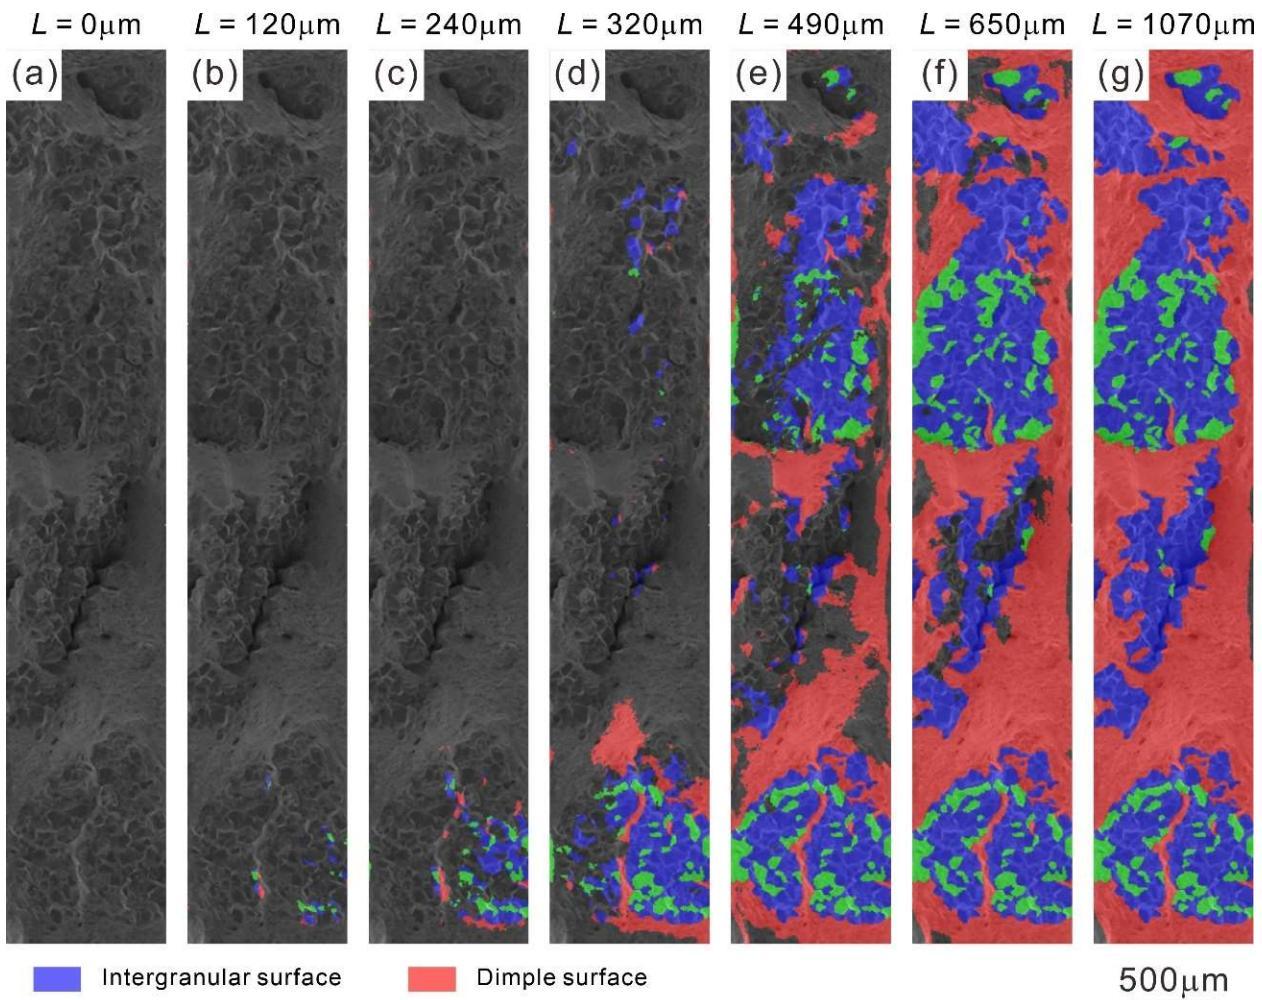
propagation process reconstructed by FRASTA in the specimen with $H_D = 0.80$ wt. ppm after the constant loading tensile test with an applied stress of 1000 MPa (higher than the 0.2 % proof stress) (Figure 1a). The results indicate that several intergranular fractures (blue area) were initiated separately inside the specimen (Figure 5b,d). This indicates that a higher applied stress facilitated the initiation of hydrogen-related cracks around the prior austenite grain boundaries. As the fracture proceeded, the fractions of the quasi-cleavage fracture (green area) and ductile fracture (red area) increased (Figure 5c–g). Compared with Figure 4 (applied stress: 400 MPa), the transition from intergranular to quasi-cleavage occurred at a relatively earlier stage of fracture when the applied stress was 1000 MPa (Figure 5).

Figure 5. Fracture propagation process reconstructed by FRASTA in the specimen with $H_D = 0.80$ wt. ppm after the constant loading tensile test with an applied stress of 1000 MPa (higher than the 0.2% proof stress). The fractured areas (blue: intergranular fracture, green: quasi-cleavage fracture, and red: ductile fracture) are superimposed on the fracture surface SEM images. *L* in the figure is the distance between the two fracture surface topographic maps; (**a**) 0 µm, (**b**) 120 µm, (**c**) 240 µm, (**d**) 320 µm, (**e**) 490 µm, (**f**) 650 µm, and (**g**) 1070 µm.

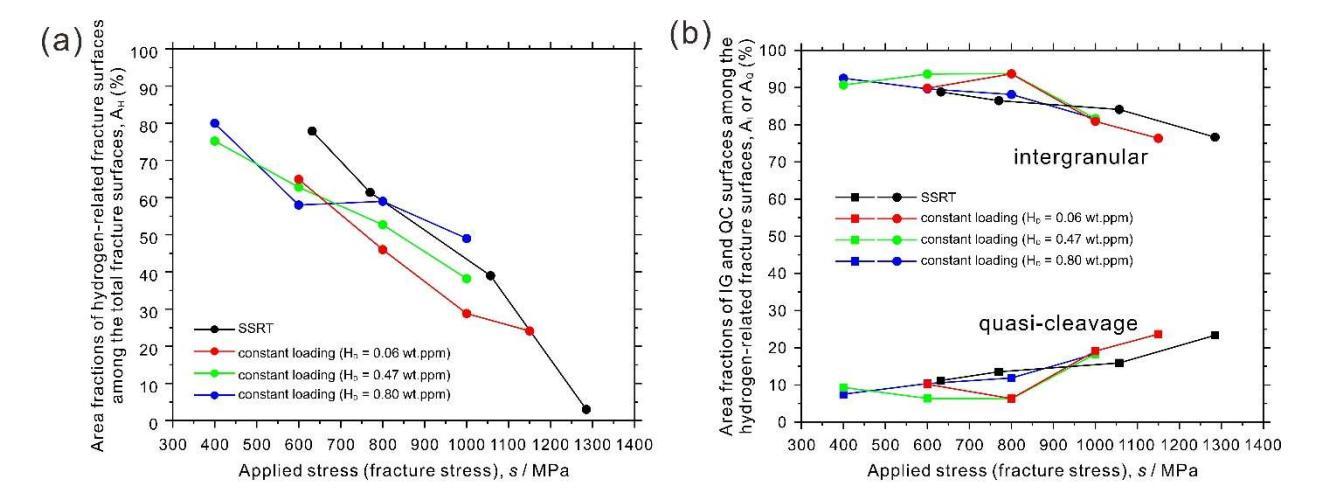
Figure 6a summarizes the area fractions of hydrogen-related fracture surfaces among the total fracture surfaces as a function of applied stress in the constant loading tensile test and fracture stress in the slow strain rate tensile test. The data were obtained using SEM images of the whole fracture surface. Each plot of the slow strain rate tensile test had a different H_D . We can confirm that the hydrogen-related fracture surface, that is, intergranular and quasi-cleavage, tended to decrease with increasing applied stress (or fracture stress). As shown in the fracture process reconstructed via FRASTA (Figures 4 and 5), ductile surfaces (other than hydrogen-related fracture surface) formed during the final rupture process. Thus, the results in Figure 6a indicate that the unstable final fracture occurred earlier when the applied stress was high. The area fractions of the intergranular and quasi-cleavage surfaces among the hydrogen-related fracture surfaces are plotted as a function of the applied stress (fracture stress) in Figure 6b. All specimens exhibited the same tendency regardless of H_D ; the fraction of quasi-cleavage fracture increased (i.e., the fraction of intergranular fracture decreased) with increasing applied stress. This indicates that a higher applied stress promoted a quasi-cleavage fracture. Notably, the fractions of quasi-cleavage and intergranular surfaces did not significantly change with H_D . That

is, H_D did not affect the mode of hydrogen-related fracture, although the fracture time significantly decreased with increasing H_D (Figure 1b).

Figure 6. (a) Area fractions of hydrogen-related fracture surfaces among the total fracture surfaces as a function of applied stress in the constant loading tensile test and fracture stress in the slow strain rate tensile test. (b) Area fractions of intergranular and quasi-cleavage surfaces among the hydrogen-related fracture surfaces as a function of applied stress in the constant loading tensile test and fracture stress in the slow strain rate tensile test. Each plot of the slow strain rate tensile test had a different H_D .

Because the mode of hydrogen-related fracture did not change significantly with H_D (Figure 6b), we propose that the fracture mode in hydrogen embrittlement is controlled by fracture stress and not by global H_D inside the specimen. We previously studied hydrogen-related fracture behavior using double-notched tensile test specimens with different stress concentration factors, and we showed that the intergranular cracks were initiated under almost the same local stress field and local hydrogen concentration, despite the stress concentration factors being different [22]. Therefore, the critical local hydrogen concentration for the initiation of hydrogen-related intergranular cracks can be simplified as a function of the applied stress. The increasing global H_D in the specimen decreases the period necessary for the accumulation of critical local hydrogen concentration at the fracture initiation site, leading to a decrease in fracture time (Figure 1b). However, the local state at the crack initiation site (particularly the local hydrogen concentration) is constant under a given applied stress, even when the global H_D is different. Accordingly, the fracture

mode (fractions of intergranular and quasi-cleavage) did not change with global H_D , as shown in Figure 6b. In contrast, it is well-known that the mode of hydrogen-related fracture changes with global H_D in tensile tests [16]. In contrast to the constant loading tensile test, the applied stress continuously increased during hydrogen accumulation at the fracture initiation site in the tensile test. We suppose that the fracture starts to occur when the local hydrogen concentration reaches a critical concentration for the applied stress at that time. That is, the fracture stress changes with the global H_D . The results in Figure 6b support this conclusion because the fracture mode was almost the same between the constant loading tensile test and slow strain rate tensile test when the fracture stresses were identical. Here, we should note that global H_D at the fracture could be different from the listed value. As described above, H_D was measured using the pre-charged specimen before testing. The hydrogen charging was performed during the constant loading tensile tests but not during the slow strain rate tensile tests. Therefore, the global H_D at the fracture could be larger in the constant loading tensile test and smaller in the slow strain rate tensile test than the listed H_D . However, the important finding in the present study was that the mode of hydrogen-related fracture was controlled by fracture stress and not by the global H_D . Accordingly, even when the global H_D at the fracture was different to that after pre-charging, the conclusion does not change at all as the global H_D itself did not affect the fracture mode.

Several studies suggest that plastic deformation plays a crucial role in hydrogenrelated quasi-cleavage fracture [28–32]. Takeda and McMahon reported that quasi-cleavage fractures corresponded to strain-controlled fractures [3]. Based on finite element simulation, we also demonstrated that the plastic strains were maximized at the quasi-cleavage crack initiation sites [22]. Because the higher applied stress promotes plastic deformation, the increase in quasi-cleavage fractures were observed as the applied stress increased (Figure 6b), which is consistent with previous studies.
