Article Hot Work Mold Repaired via Hot Isostatic Pressing towards High Red Hardness

Keywords: mold repair; hot isostatic pressing; defects; microstructure; mechanical properties

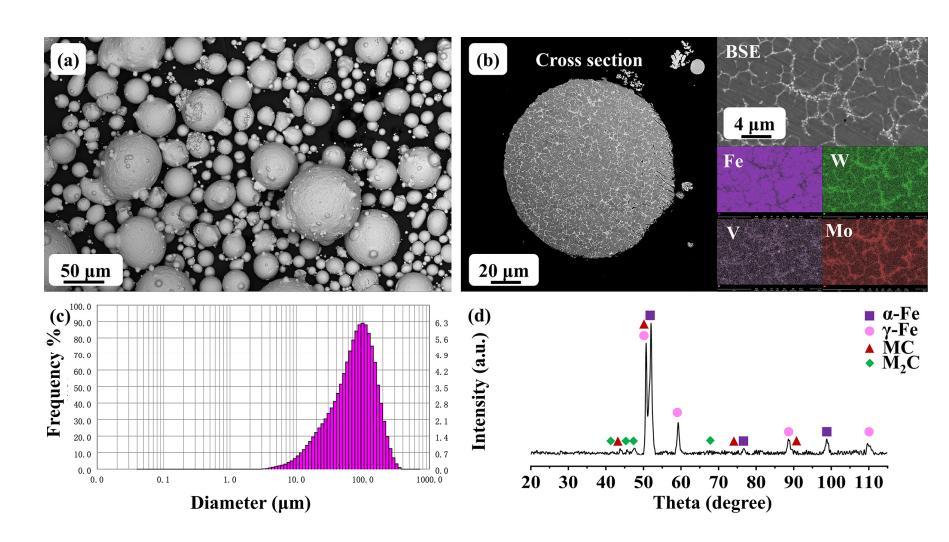
Figure 1. Characteristics of PM23 powder: (a) powder morphology; (b) powder cross section; (c) size distribution; (d) XRD patterns mainly consists of α -Fe, γ -Fe, MC, and M₂C.

The two types of materials utilized in the present study were PM23 HSS powder and H13 mold steel. Table 1 presents these materials' nominal chemical compositions, respectively. Figure 1 depicts the morphology and characteristics of the PM23 powder, which revealed an MC dendric structure on an iron matrix. The morphology of PM23 powders presented a spherical shape and a small number of satellited powders. It should be noted that the PM23 powder used in this study had a D₅₀ of 127 μ m.

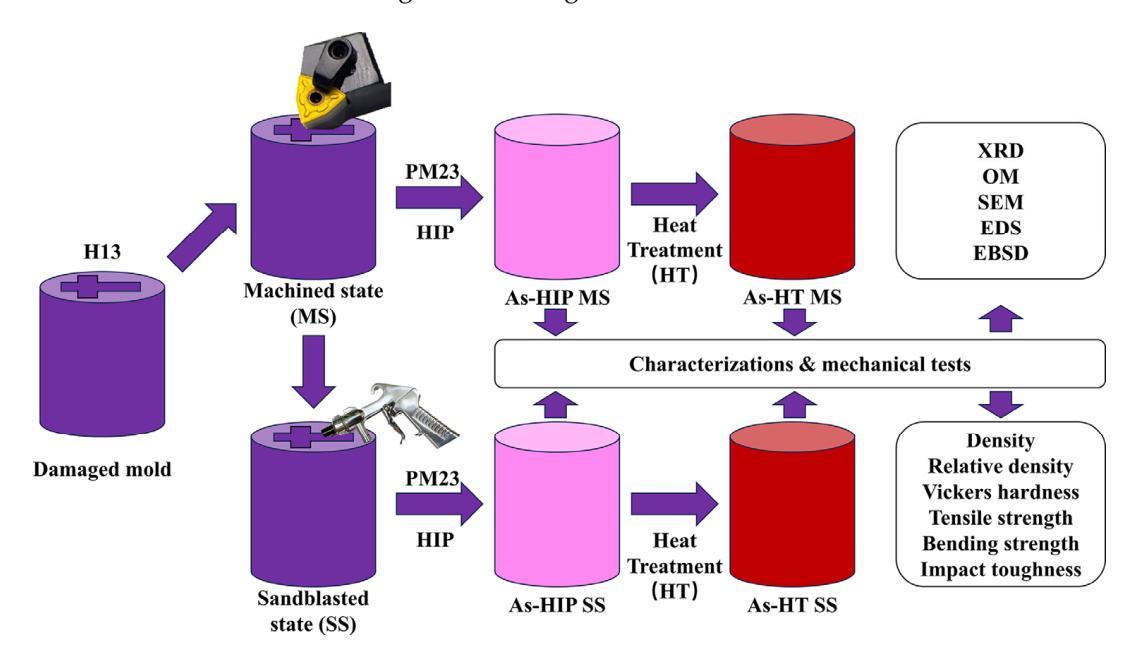
Figure 2. Schematic diagram of mold repair routes (MS and SS).

As shown in Figure 2, the mold that needed to be repaired had a 110 mm outer radius, and its complex inner cavity shape and dimensions are shown in Figure 3. The dimensions of the molds in this experiment were similar to those used for manufacturing complex aluminum alloy parts, and the shape of the inner cavity of the mold is presented as an inverted T shape. For the details of dimensions, the inner cavity is reported as a $10 \times 80 \times 50 \text{ mm}^3$ plate, with a $15 \times 8 \times 50 \text{ mm}^3$ flank at 20 mm of the plate in the length direction. Two kinds of inner cavity surface were investigated: a machined state (MS) and a sandblasted state (SS). The inner cavity was sandblasted for 15 s at an angle of 65° , and the working distance from the sandblast nozzle to the inner cavity surface was about 200 mm. The molds filled with PM23 powder were placed into low-carbon steel capsules after vacuuming and vibrating.

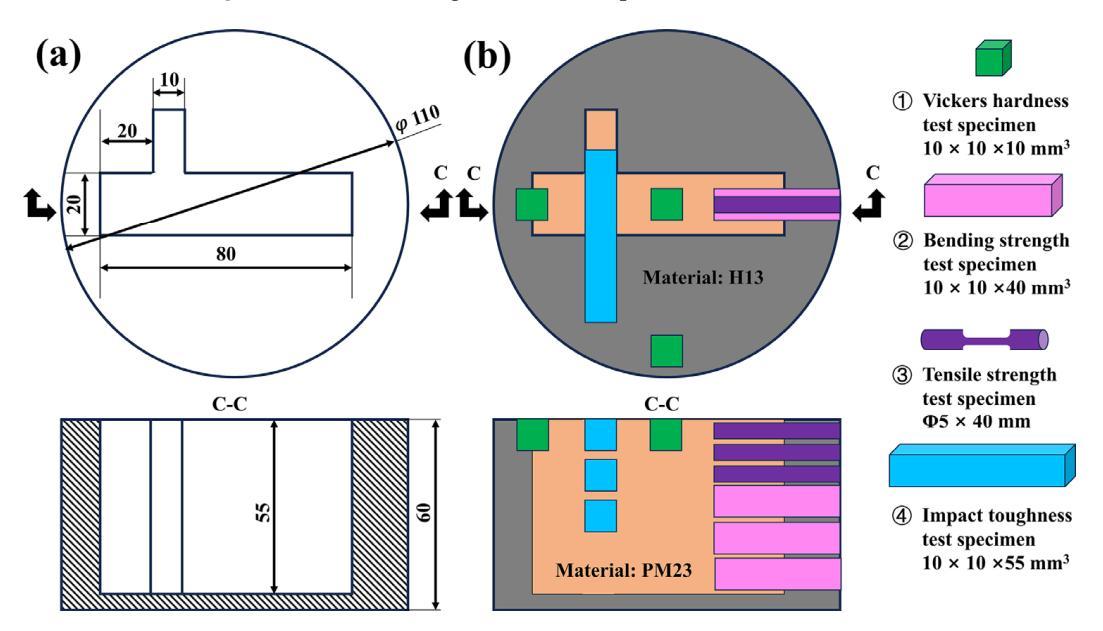
Figure 3. Schematic diagram: (a) H13 mold dimensions; (b) sampling position for mechanical tests (mm).

In the current study, the test specimens were obtained via wire-cutting using the electrical discharge machining of heat-treated, repaired molds. The sampling positions of the specimens are illustrated in Figure 1.

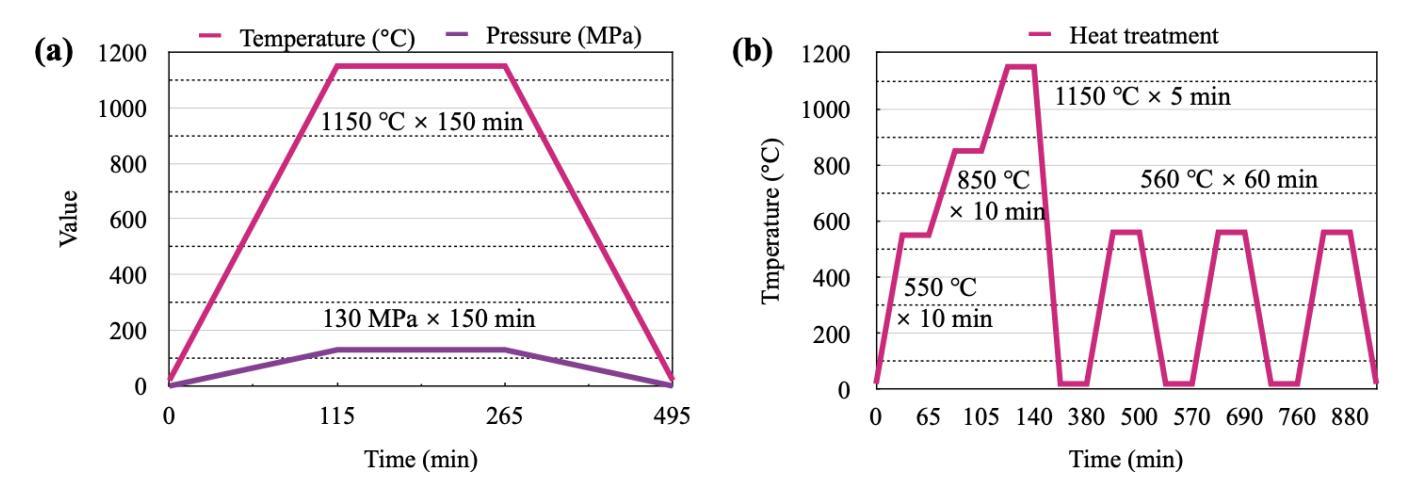
Figure 4. Heat-related curves: (a) HIP; (b) heat treatment.

The capsules were processed via HIP using an 1150 °C sintering temperature and 130 MPa of pressure. In the HIP process, the as-sintered billets were slowly cooled in the HIP furnace to 200 °C before being subjected to the air, with an average cooling rate of about 5 °C/min throughout the process. The HIP parameters have been referenced in other studies on consolidation parameters for PMHSS [19–21], and the pressure was reduced (by about 20–30 MPa), taking into account that damaged molds are more susceptible to secondary damage at high pressures. After the consolidation process, the as-HIP capsules were subjected to a pre-heating procedure (550 °C and 850 °C for ~10 min), and finally, austenitized at 1150 °C. The triple tempering treatment was conducted at 560 °C for 60 min. During austenitization, quench oil was used as the cooling medium, with a cooling rate of approximately 200 °C/min, while the cooling medium during three-stage tempering was air, with a cooling rate of about 10 °C/min. The capsules and decarburization surfaces were removed using the wire CUT EDM process. Consolidation and heat treatment curves are exhibited in Figure 4.

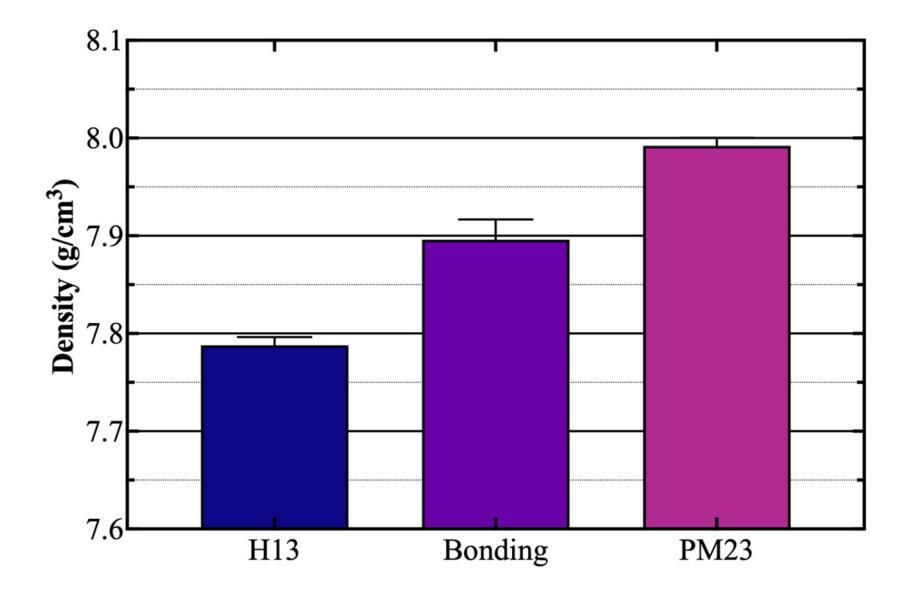
Figure 5. The density of as-HIP billet (H13 region, bonding region, and PM23 region).

The densities of various regions are illustrated in Figure 5. Notably, the HIP process enables the preparation of higher-density products. Thus, the density of the PM23 region (7.98 g/cm^3) is close to that of the theoretical PM23 material (8.00 g/cm^3) . The density in the H13 region is 7.79 g/cm³, which is similar to the theoretical density. The density of the bonding region (7.89 g/cm^3) represents almost the average of the two regions, and the pores in the bonding region contributed to its increased error. From the results, it is obvious that the HIP process could repair the mold at a high density. Figure 6 exhibits the micro and macro graphs of the bonding regions in two states. According to the captured images, the two materials presented a strong bonding region with a few sintering pores.

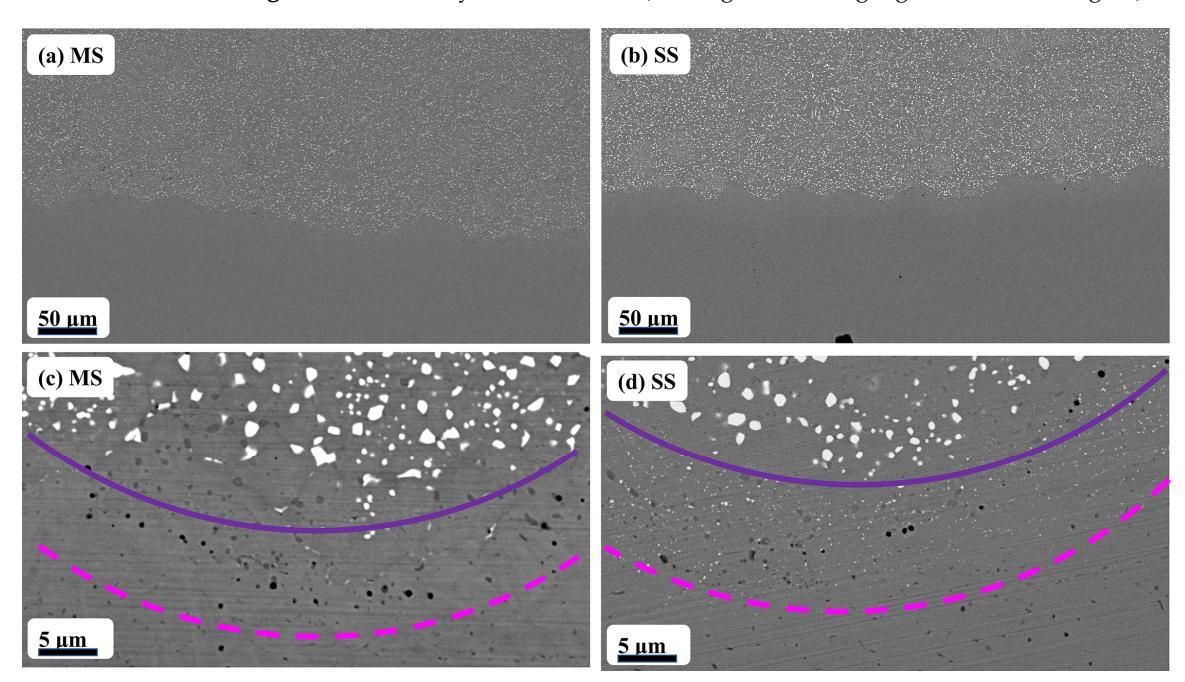
Figure 6. The micrographs of bonding regions: (**a**) MS macro-region; (**b**) SS macro-region; (**c**) MS micro-region; (**d**) SS micro-region.

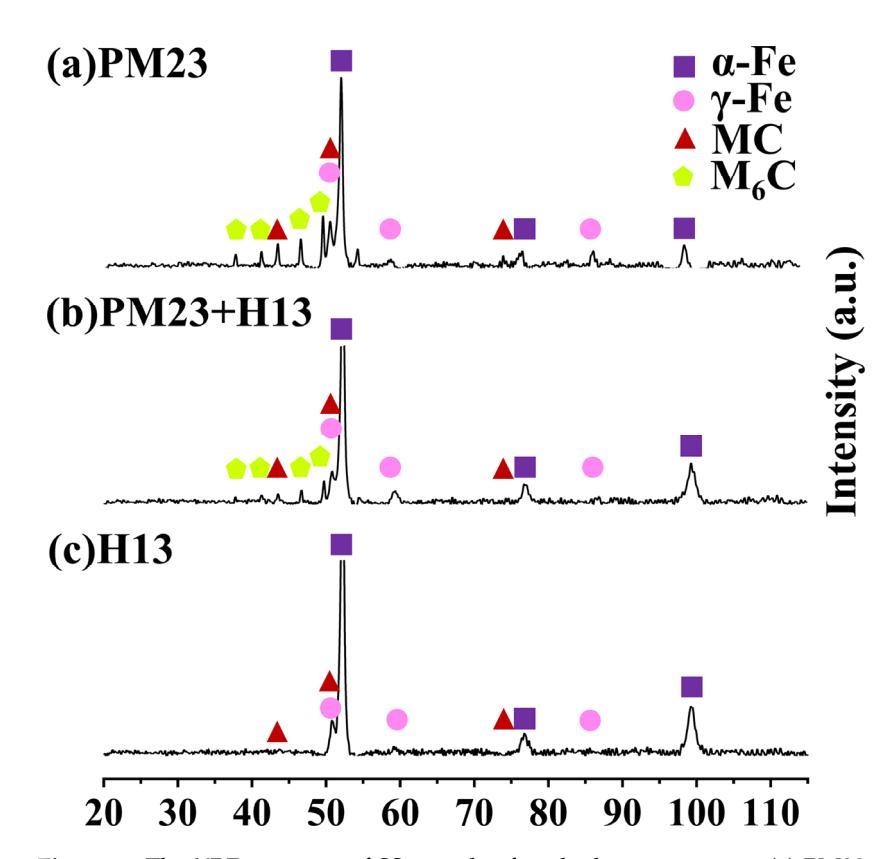
Figure 7. The XRD patterns of SS sample after the heat treatment: (**a**) PM23 region; (**b**) bonding region; (**c**) H13 region.

Figure 7 depicts the XRD patterns of three different regions (the PM23 region, the bonding region, and the H13 region) in the heat-treated sandblasted state sample. Prior to the heat treatment, the PM23 powder was primarily composed of α -Fe, γ -Fe, MC, and M₂C, whereas the XRD patterns of the sandblasted state sample PM23 region primarily contained diffraction peaks of α -Fe, γ -Fe, MC, and M₆C. The transformation from M₂C to M₆C was confirmed, and the presence of α -Fe suggests that tempered martensite formed after the heat treatment. The bonding region phase contained α -Fe, γ -Fe, MC, and M₆C, implying that the tungsten-rich particles at the microscale and nanoscale were M₆C carbides. α -Fe was also observed in the XRD patterns of the H13 mold region, and the critical enhancement phase was MC carbide. Several HSS-related studies have also reported the mechanism and phenomenon of phase transformation: M₂C + $\gamma \rightarrow$ M₆C + MC [24–26].

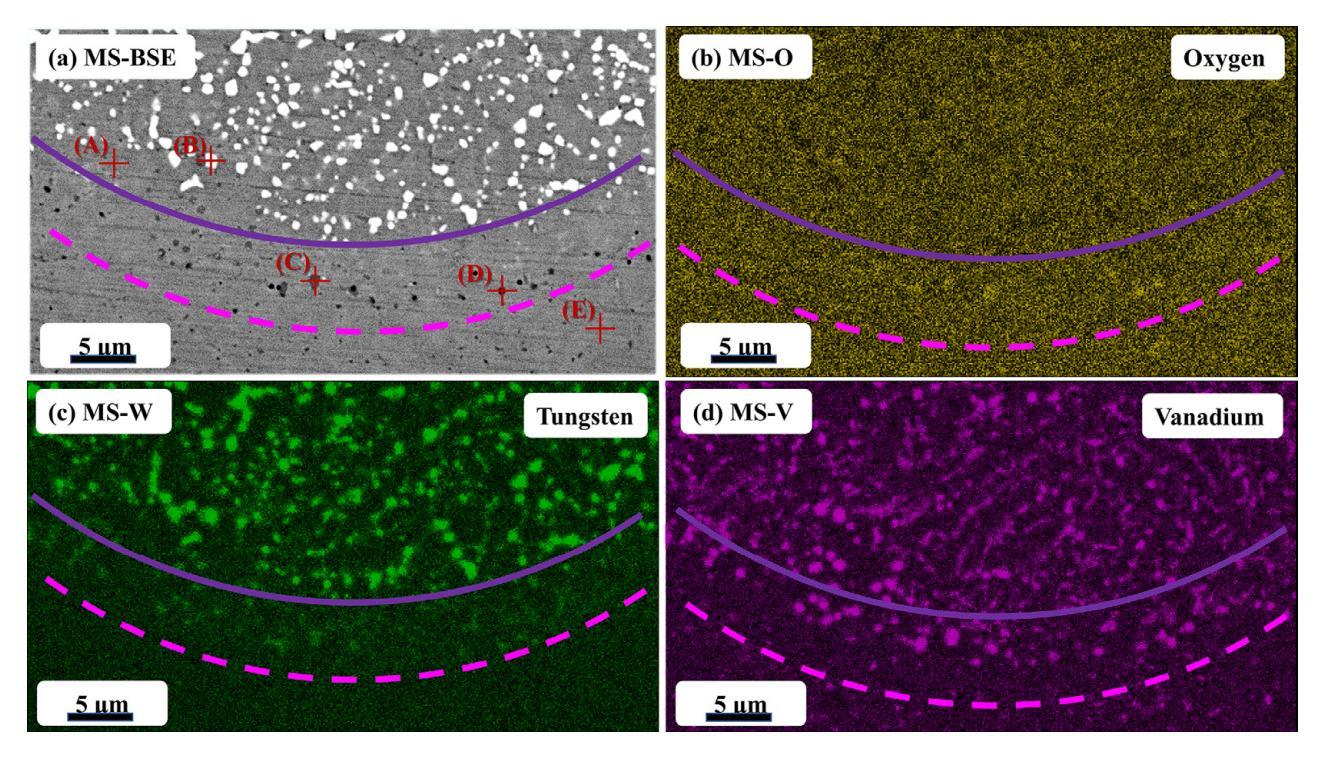
Figure 8. The EDS element mapping analysis of MS bonding region: (**a**) BSE; (**b**) Oxygen (O); (**c**) Tungsten (W); (**d**) Vanadium (V).

Figures 8 and 9 show the SEM BSE and EDS analyses results of the MS and SS samples. Table 3 lists the EDS analysis results of the composition of the points marked from (A) to (F) in Figures 8 and 9. The BSE images give an approximate state of the elemental distribution thorough a black-and-white contrast (the precipitation region of the elements with a higher relative atomic number is presented in white, and vice versa). The EDS element mapping figures illustrate the diffusion of elements and the distribution of phases in the bonding region. As shown in Figures 8b and 9b, the distribution of oxygen was only present in the bonding region and showed a point-like phase in the pores. Compared to the MS samples (machined state), the bonding interface of the SS samples (sandblasted state) has fewer point-like oxides, suggesting that the sandblasting process contributed to the reduction of the formation of point-like oxides. The formation of oxides was primarily related to the surface treatment process, and the oxides were usually poorly bonded to the iron matrix, and thus became stress concentration points during service. The XRD analysis results in Figure 7 reveal that the PM23 region consisted predominantly of tungsten-rich M_6C carbides and vanadium-rich MC carbides, while the H13 region consisted mainly of vanadium-rich MC carbides. By comparing Figures 8c and 9c, the distribution state of tungsten was found to be consistent with the white region in the BSE picture, which indicates that micron-sized M_6C carbide was in the PM23 region. Noticeably, the distribution of tungsten was also visible in the bonding region of the SS samples, which indicates that the sandblasting process could facilitate the formation of nanoscale M_6C carbides in the bonding region. By analyzing Figures 8d and 9d, the distribution of vanadium was more evident in the PM23 region, and vanadium was also distributed in the H13 region, suggesting that the MC carbides were more abundant in the PM23 region. Meanwhile, by comparing the distribution of tungsten, significant amounts of vanadium were found in the bonding region in both MS and SS samples, indicating that vanadium was more likely to diffuse to the bonding interface. Furthermore, by comparing the distribution of oxygen and the EDS

points results in Table 3, the presence of vanadium elements in the point-like oxides and pores indicates that vanadium oxide might have formed in the bonding region.

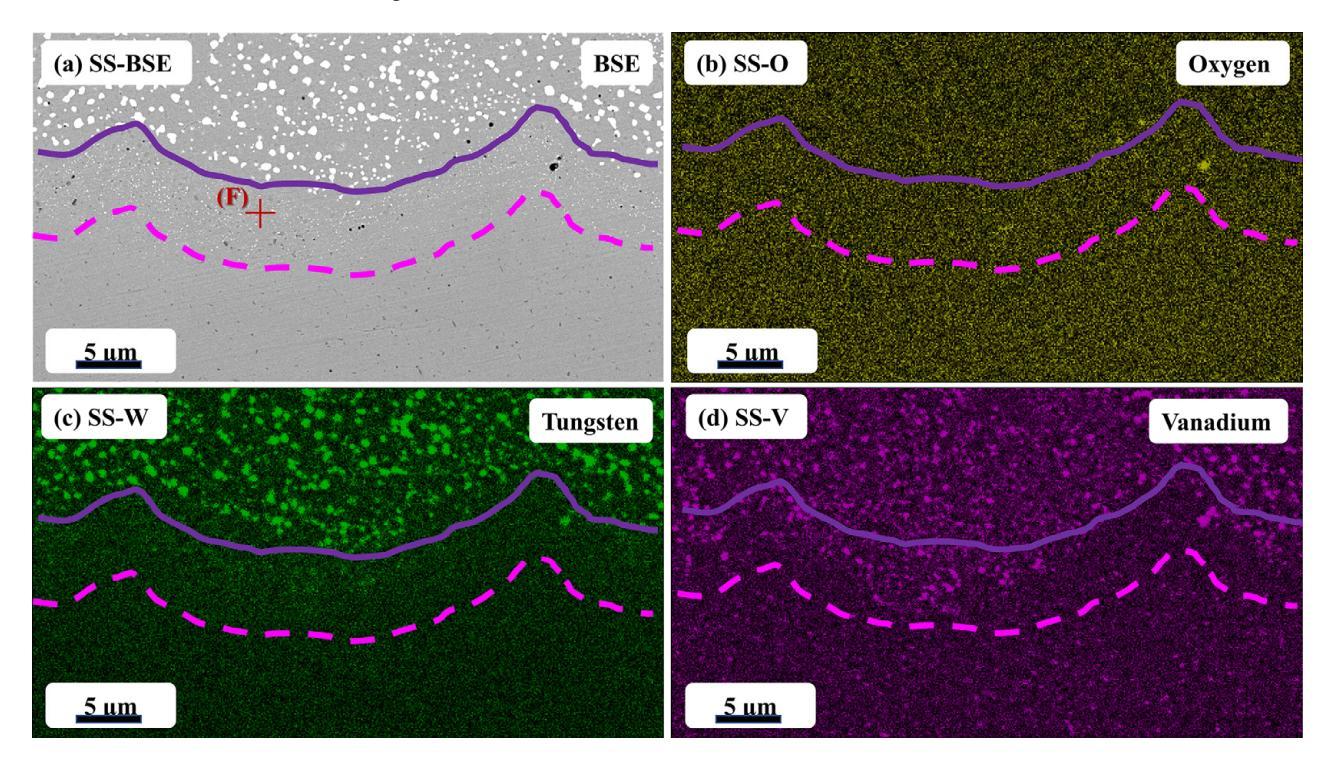
Figure 9. The EDS element mapping analysis of SS bonding region: (a) BSE; (b) Oxygen (O); (c) Tungsten (W); (d) Vanadium (V).

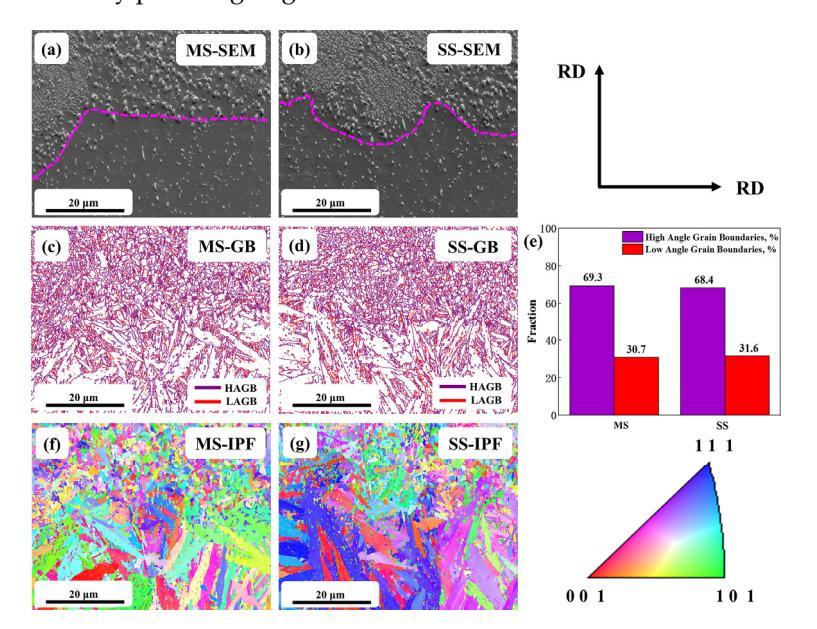
Figure 10. The EBSD analysis of the interface: (**a**) MS-SEM; (**b**) SS-SEM; (**c**) MS-GBs; (**d**) SS-GBs. (**e**) Statical analysis of low- and high-angle grain boundaries; (**f**) MS-IPF; (**g**) SS-IPF.

Figure 10 depicted the EBSD analysis of the bonding region. Figure 10a,b shows the detector signal images of the bonding regions with high quantities of hard carbide particles, which were primarily inherited from the vibratory polishing process. The particles in Figure 10a,b, which cross-reference Figures 8 and 9, were mainly M_6C and MC carbides. The distribution of carbides in the SS samples was significantly more irregular, which was associated with the sandblasting procedure. Interestingly, the interface of the SS sample had a jagged outline, whereas the interface of the MS sample had a flatter outline. Additionally, vibratory polishing might cause the nanoscale carbides to detach from the bonding region.

Figure 10c,d depicts the distribution of low- and high-angle grain boundaries (LAGBs and HAGBs, respectively). When the substructure size and grain boundary distributions of the PM23 region and H13 region of both states were compared, the PM23 region exhibited a more homogeneous martensite substructure and grain boundary distribution than the H13 region did. The low-density region's LAGBs were primarily concentrated in the carbides near the locations of the grain boundaries that were close to the HAGBs. This means that the figure depicting the grain's internal area is relatively clean. As demonstrated in Figure 10e, the proportions of LABGS and HAGBs in the MS sample and the SS sample were similar, suggesting that the cavity inner surface pretreatment had a minimal effect on substructures like LABGs and dislocation densities within the microstructures. However, the percentage of LAGBs in the SS sample was 31.6%, which is higher than that in the MS sample specimen (30.7%), suggesting that the specimen's interior in the SS condition contains more dislocation defects and distortion energy.

In Figure 10f,g, the matrix microstructures of the tempered H13 region were still dominated by martensite, which are typically distributed in the form of laths. The residual austenite had not yet been completely decomposed, and there was no obvious pattern of grain orientation, but the martensite lath size of the SS sample was slightly smaller than that of the MS sample, suggesting that the sandblasting process refined the surface layer microstructure. Large numbers of dispersed carbide particles, a fine-grained matrix microstructure, and a significant amount of residual austenite were all seen in the tempered PM23 HSS matrix. These observations are consistent with the corresponding regions' XRD patterns. In particular, the size of the carbides at the PM23 powder's prior particle boundaries (PPBs) was larger than the carbides precipitated in the PM23 powder particles. Other empirical studies on forged H13 and PM23 independently verified these findings [4,27–31].

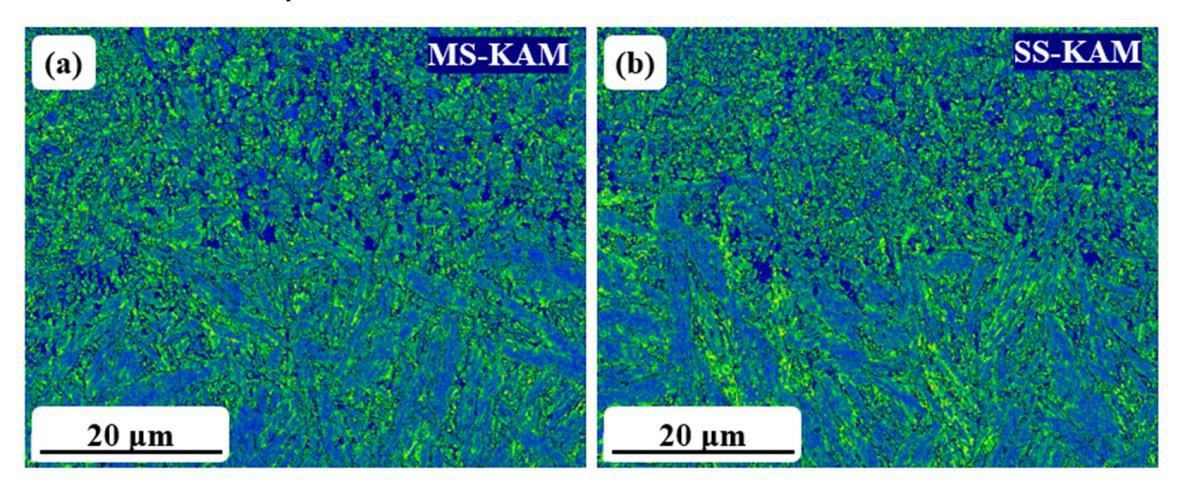
Figure 11. The EBSD kernel average misorientation (KAM) analysis of the interface: (a) MS; (b) SS.

Figure 11 exhibits the kernel average misorientation (KAM) map of the bonding region. The blue color in the figure indicates a distortion-free environment, mostly for the matrix microstructures, and the other colors all represent a certain distortion behavior; the green color is mostly distributed in the grain boundary position, the yellow color is mostly distributed in the carbide particles, and the red color is distributed in the composite interface. This is because a strong shear force was generated at the interface due to the need for coordinated deformation in the HIP process, which resulted in the accumulation of more strain energy in the microstructure near the interface and a higher dislocation density value, thus providing more nucleation points for the microstructure to undergo recrystallization.

As observed in Figure 11a,b, it can be seen that there is not much difference in the dislocation density of the microstructure on the H13 steel side, whereas on the PM23 high-speed steel side, due to the more concentrated residual strain after the sandblasting treatment, the strain energy level stored near the interface is the highest, the dislocation density was relatively high, the microstructures underwent recrystallization to a higher degree, and the cumulative aberration energy is higher than that of the MS sample, which corresponds to the analysis of the high–low-angle grain boundaries mentioned above.

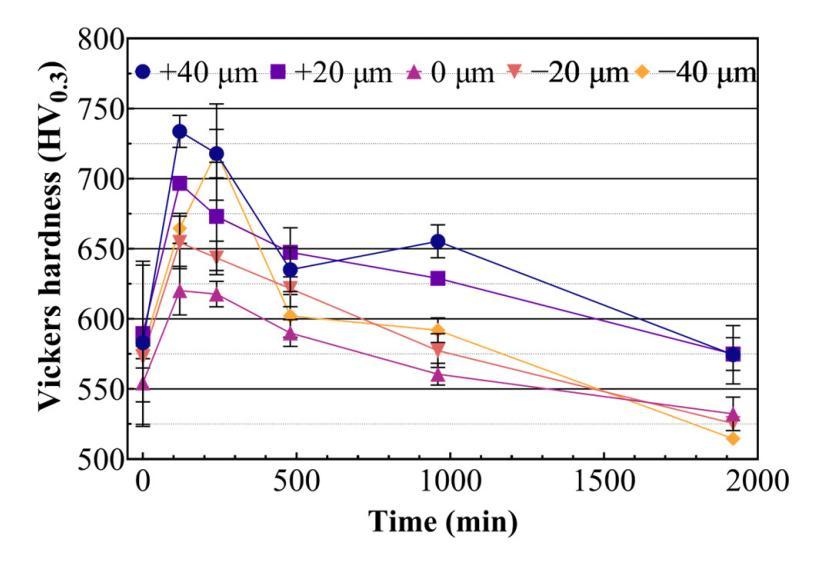
Figure 12. The red hardness of repaired regions in the SS sample.

Figure 12 displays the red hardness (550 °C) histogram of the SS sample. Along with the increase in the red hardness test time, the average hardness of the mold appeared to increase, and then decrease, with the overall highest average hardness (672.8 HV) appearing at 120 min. Comparing the hardness of the three regions during test, the PM23 region (+40 μ m and +20 μ m spots) has the highest hardness in the entire test, the H13 region (-40 μ m and -20 μ m spots) has the next hardest value, and the region with the lowest hardness is the bonding region (0 μ m spot). The microstructure of the PM23 region consisted of M₆C, MC, and the tempered martensite matrix, which has similar characteristics to

PMHSS. The main factors affecting the hardness of powder metallurgy HSS are dispersion strengthening, solid solution strengthening, and densification. For the +20 μ m spot, its red hardness is significantly lower than that of the +40 μ m spot; by combining the EDS analysis results in Figures 8 and 9, the decrease in hardness could be related to the diffusion of elements leading to the weakening of the effects of dispersion strengthening and solid solution strengthening. Moreover, despite the diffusion of vanadium and tungsten elements occurring in the bonded region, the presence of nanoscale pores results in a limited improvement in hardness, which is similar to that of the H13 region. Corresponding investigations have also discovered that abrupt changes in mechanical characteristics, typically a deterioration in mechanical characteristics, such as the formation of certain intermetallic compounds and nanophases that raise the hardness and lower the toughness, tend to occur at the bonding interface between two metallic materials [16,32–34].

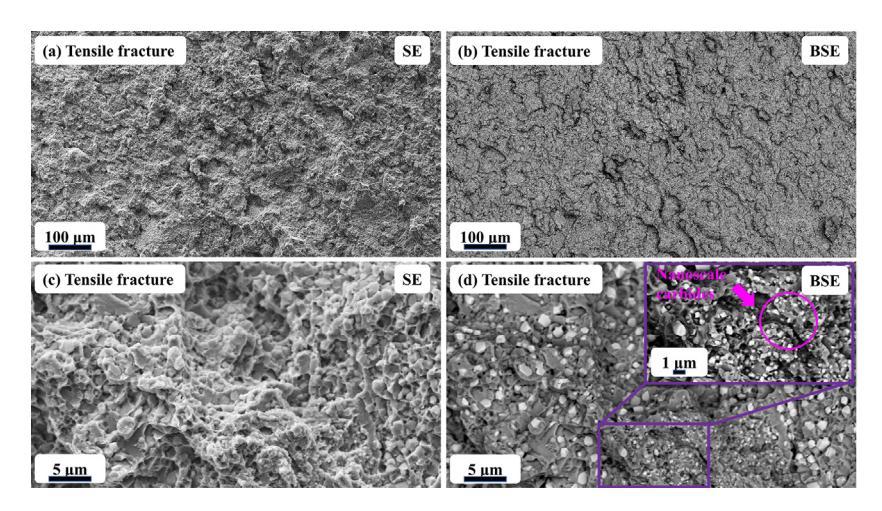
Figure 13. The fracture surface of SS sample tensile test bars: (**a**) macro-SE; (**b**) macro-BSE; (**c**) micro-SE; (**d**) micro-BSE.

Table 4 lists the mechanical characteristics of the bonding region, while contrasting two samples that have undergone various surface treatments. For the SS sample, a higher value was generally obtained. The tensile strength value of the SS sample was 1195.42 ± 61.58 MPa, which was greater than the MS sample's value of 1158.67 ± 45.23 MPa. The bending strength difference was more than 21%, with the SS sample outperforming the others, with 420.19 \pm 14.57 MPa in the bending test. They had similar impact toughness values; the MS sample's impact toughness was 65 \pm 2.78 J, which was 5 J less than the SS samples' value. Figure 13 depicts the fracture surface of a tensile test bar. This represents the typical fractography of quenched and tempered high-speed steel. The fracture surface was described as a quasi-cleavage fracture with a flat morphology and small facets [35–37]; thus, the fracture mode of the material is brittle. Further information regarding the location of the fracture is provided in Figure 13c,d. This shows that the fracture occurred in the PM23 region, and that the bonding region strengthened the metallurgical bond between the PM23 powder and the H13 mold. Nearly all of the fracture surfaces had dents and protruding carbides with a diameter of approximately 1.7 µm. Some nanoscale carbides were also visible.

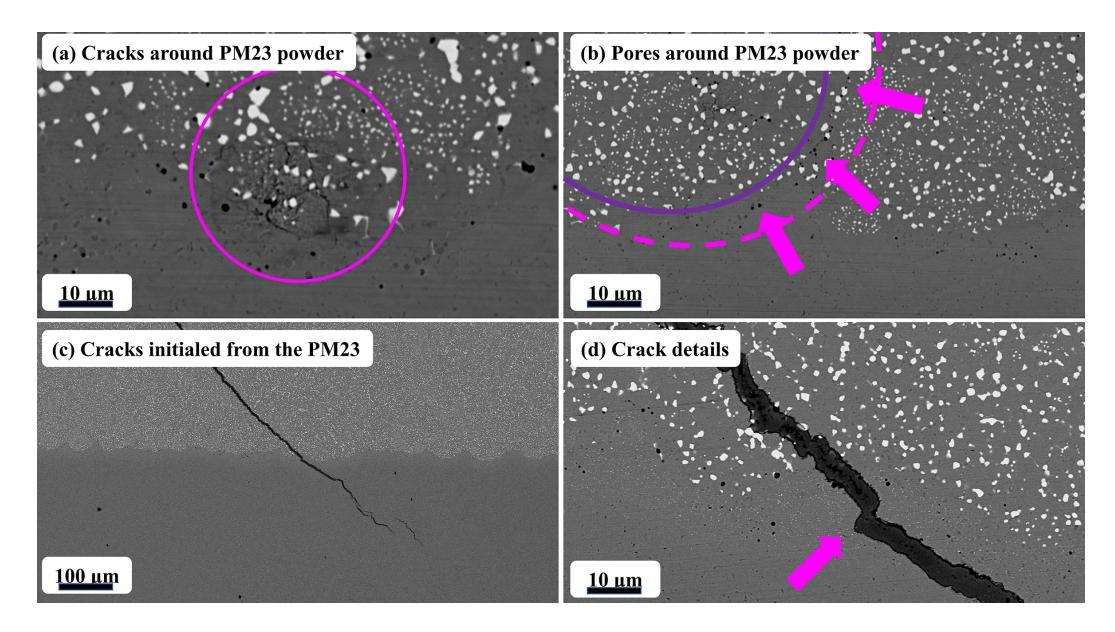
Figure 14. The failure modes of the repaired molds: (**a**) cracks around PM23 powder; (**b**) pores around PM23 powder; (**c**) cracks initialed from the PM23; (**d**) crack details.

Figure 14 shows the two typical powder-related defects of the repaired molds. As illustrated in Figure 14a, the discontinuity of the interface was witnessed around the powder, with a diameter of around 10 µm, and the precipitated carbides were not distributed evenly in the circled PM23 high-speed steel powder. To acquire an excellent repaired interface, the amount of the powder with a small diameter ($\leq 10 \,\mu$ m) should be controlled. As exhibited in Figure 14b, nanoscale pores were not only captured around the interface, but were observed around the PPBs of the PM23 high-speed steel powder, and the distribution of these pores might influence crack nucleation and growth. Cracks are the one of the major failure forms of molds. Figure 14c depicts a crack that initialed from the PM23 side and went through to the H13 side, and its growth, which does not run along the interface, confirms the matched performances of PM23 and H13. A magnified microstructure of a crack and an interface is presented in Figure 14d; on the PM23 side, the crack grew along the carbides, which was attributed to the poor cohesion of martensite and M_6C . In the interface region, the direction of the crack slightly altered, which could be explained by the occurrence of nanoscale M_6C and pores. On the H13 side, limited crack growth also supports that the H13 mold retained toughness under the heat treatment.
