# Article Assessment of the Pitting, Crevice Corrosion, and Mechanical Properties of Low-Temperature Plasma-Nitrided Inconel Alloy 718

Abstract: A comparative study on the mechanical properties, scratch resistance, and localized corrosion (pitting and crevice) of plasma-nitrided Inconel alloy 718 (UNS NO7718: IN 718) was carried out. Thermochemical treatment was performed at low temperatures (400 and 450 °C) for 4 h. The treatment formed layers with thicknesses of 7.17  $\pm$  0.89  $\mu$ m (400 °C) and 7.96  $\pm$  0.48  $\mu$ m (450 °C). The XRD and nanohardness analyses indicated the formation of a hard layer composed of the expanded austenite phase ( $\gamma_N$ ), CrN at 400 °C, and CrN +  $\gamma$  at 450 °C, with a maximum indentation hardness of 12 and 12.5 GPa, respectively, when compared to the 5 GPa substrate hardness. The scratching tests (2-8 N) showed that with increasing load, the nitrided surfaces had a transition from 100% microcutting to a combination of microplowing/cutting, with the presence of cracks. The critical load of the nitrided surfaces was 3 N for 400 °C and 4 N for 450 °C. The untreated condition maintained a crack-free combined mechanism regardless of

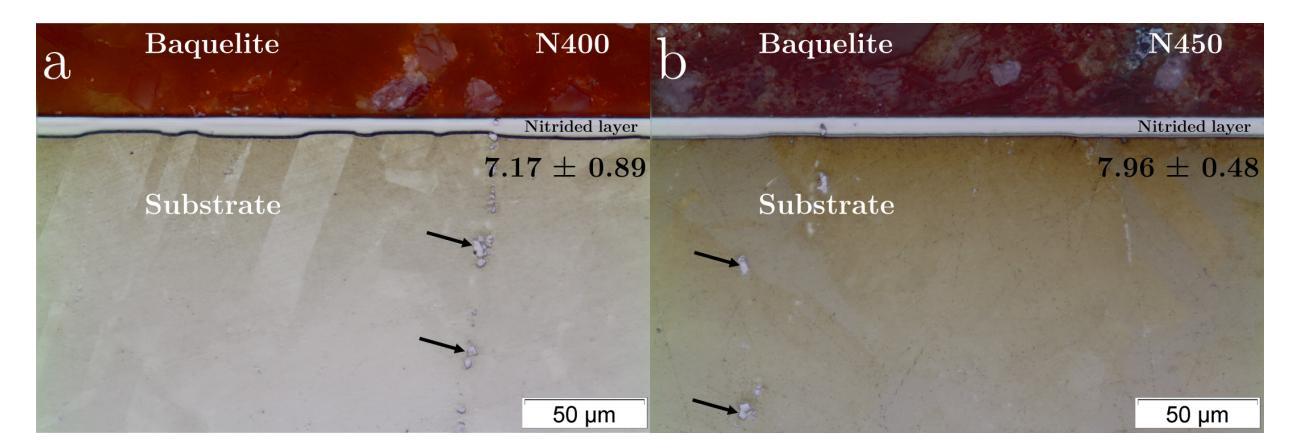
The nitriding process formed a homogeneous and continuous layer (Figure 1). As reported in several studies [1,3,4,15,16,18,19], the nitriding treatments generate an outstanding superficial nitride layer (Figure 1). Growth in layer thickness with increasing temperature, as widely reported in the literature [7,14,18,19], was observed. However, the increase was insignificant in this case when considering the standard deviation in Figure 1. The high dispersion in the N400 condition is associated with the noteworthy differences in the layer thickness influenced by the crystallographic orientations of the austenitic microstructure (Figure 1a), which has also been reported in other studies [6,16]. The arrows in Figure 1 indicate the presence of intermetallic precipitates, mainly composed of Ni, Al, Ti, and Nb. Their semi-quantitative compositions were identified using SEM-EDX, for which the values (wt.%) ranged from 0.99–50.89% for Ni, 0.27–0.44% for Al, 1.02–5.65% for Ti, and 4.74–72.65% for Nb. Those intermetallic compounds, known as  $\gamma'/\gamma''$ , resulted from the IN 718 precipitation hardening treatment.

**Figure 1.** Cross-section OM micrographs of the nitrided layers at (**a**) 400  $^{\circ}$ C and (**b**) 450  $^{\circ}$ C. Nitrided layer thickness values correspond to the white layer that stands out from the substrate.

The modification of surfaces of Inconel alloys using nitriding has been developed through different techniques (Table 1). The main common microstructural changes observed in Inconel alloy nitriding studies are (i) the dislocation, loss of symmetry, and generalized widening of the  $\gamma(111)$  and  $\gamma(200)$  crystallographic peaks in the XRD spectrum (Figure 3); (ii) the presence of CrN and  $\gamma_N$  peaks (Figure 3); (iii) the formation of a nitride layer differentiated from the substrate (Figure 1).

On the other hand, other authors also evidenced differences in layer thickness (as observed in Figure 1a, N400), attributed to the presence of slip lines or crystallographic orientations within the layer [6,14] and in the substrate [5,16]. In both situations, these lines appear due to the difficulty of the  $\gamma$ -FCC structure to deform and the formation of pile-up gaps and dislocations resulting from the introduction of nitrogen [16,34]. At higher nitriding temperatures (in this case, 450 °C, Figure 1b), extensive CrN precipitation and  $\gamma_N$  degradation occurred, promoting lattice relaxation and achieving a uniform layer thickness in N450.

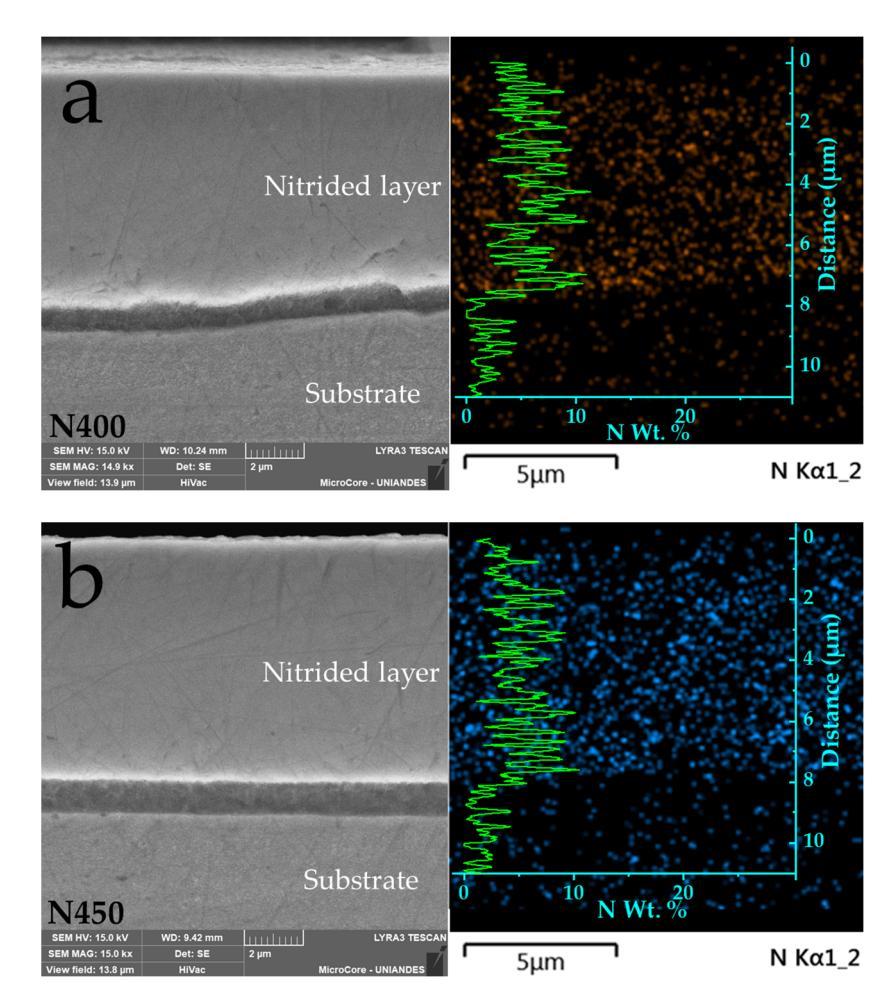
Figure 2 shows SEM cross-section micrographs on the left side, their respective EDX line scans, and the EDX maps for nitrogen on the right side. The nitrogen concentration (wt.%) as a function of depth from the surface shows a plateau trend, which correlates with the thickness of the nitride layer for both samples. The nitrogen content ranges from 2 to 10 wt.% in both nitrided layers (Figure 2). These results are consistent with the nitrogen distribution obtained through EDX mapping.

**Figure 2.** Cross-section SEM micrographs, their EDX line scans, and mapping for nitrogen (wt.%): plasma nitriding at (**a**) 400 °C and (**b**) 450 °C.

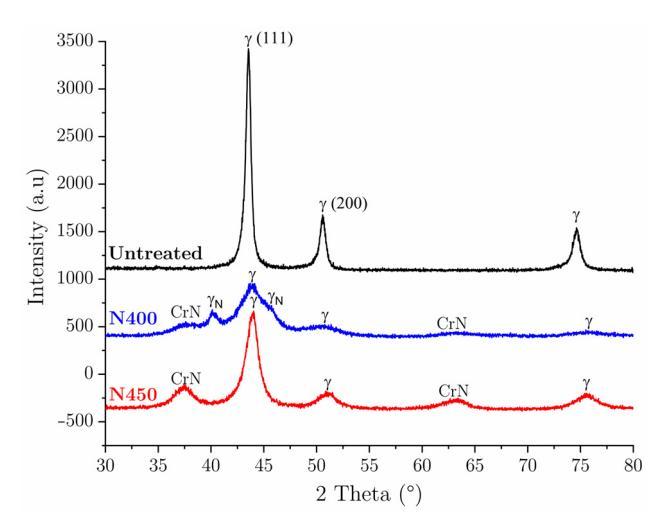
Figure 3. X-ray diffraction patterns.

Figure 3 shows the X-ray diffraction spectra of the material, as received from the manufacturer, and the nitrided conditions. Nitriding at 400 °C generated a layer composed of N-expanded austenite ( $\gamma_N$ ), chromium nitride (CrN), and austenite ( $\gamma$ , with increased full width at half maximum (FWHM)), which agrees with several works on IN 718 treated with LTPN [1,3,6,7,14,15]. However, nitriding at a higher temperature (450 °C) formed deleterious phases that were identified as CrN without the  $\gamma_N$  phase, as reported in other studies, and this increased the temperature or treatment time [4,6,7,14–16,18]. The broader,

asymmetric, and lower intensity austenite peaks  $\gamma$  in the N400 and N450 spectra do not represent substrate influence since the XRD penetration depths are less than the nitrided layer thickness (details in Section 2.3) [3,15].

Regarding the first change, (i) the peak characteristics indicate an alteration in the crystalline lattice parameter due to the introduction of nitrogen via microstresses, non-homogeneous chemicals, and microstructural composition, or the residual stress related to chemical gradients and crystalline lattice anisotropic expansion [3,6–8,10,11,13,34]. The peaks referring to the  $\gamma_N$  phase (Figure 3) appear due to the formation of the nitrogen interstitial solid solution in the austenitic structure of Inconel alloys, as reported by [1,3,6,7,14,15]. Regarding the second change (ii), the simultaneous presence of peaks referring to the CrN phases in N400 and the disappearance of the  $\gamma_N$  peaks in N450 indicate  $\gamma_N$  phase degradation in CrN +  $\gamma$ . This was observed when IN 718 was nitrided at higher temperatures ( $\geq$ 450 °C) [4,6,7,14,18,19] and also for longer periods (>8 h) [6,19]. A more detailed discussion on the formation of the  $\gamma_N$  phase and CrN is given elsewhere [3,6,15,34].

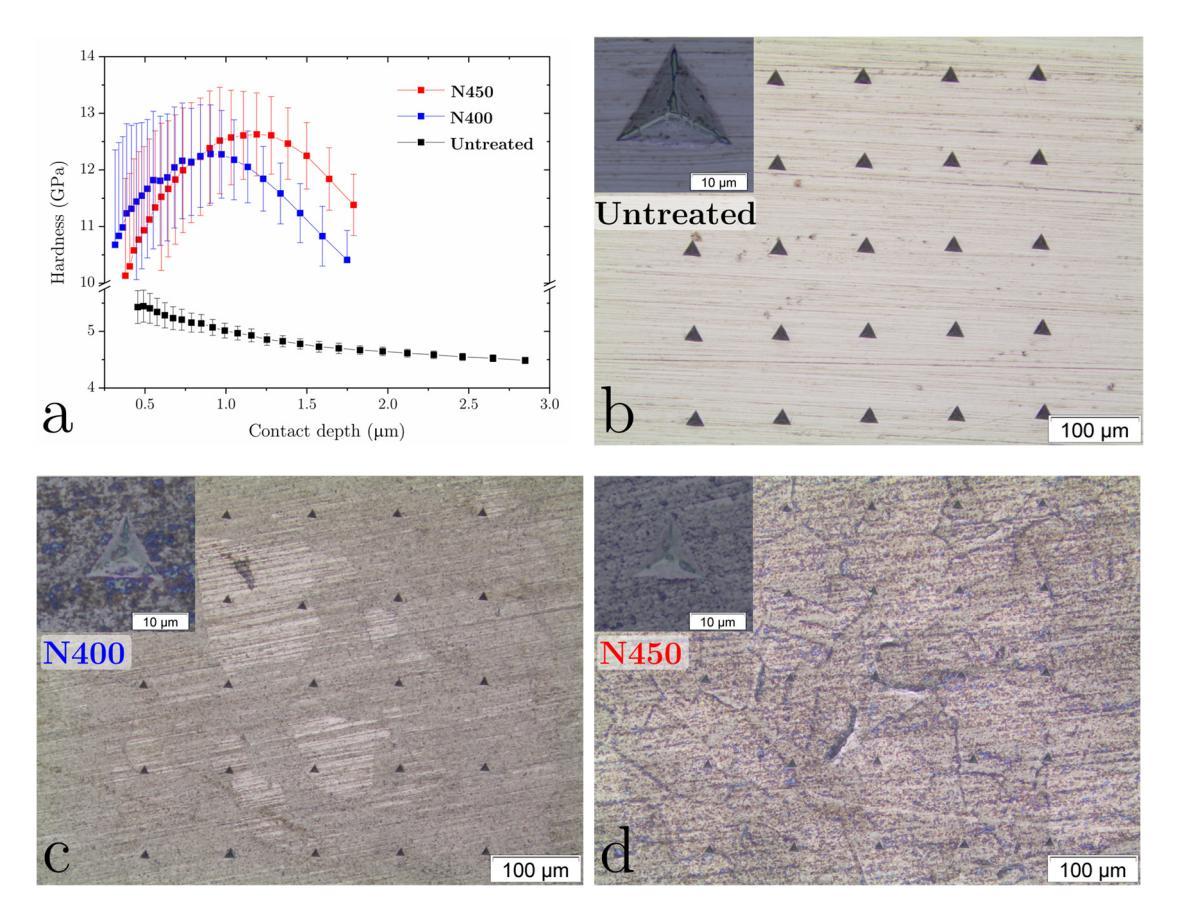
Indentation hardness was measured on the top of the sample surfaces. The nitrided samples showed higher hardness profiles when compared to the as-received IN 718 (Figure 4a). The indentation size of both N400 and N450 (Figure 4c,d) was reduced when compared to the untreated samples (Figure 4b). Increased hardness on the surface nitrided at 400 °C is explained by the formation of the  $\gamma_N$ , for which nitrogen saturation increased crystalline lattice stress [3,4,6,7,15,16]. However, the presence of CrN precipitates in the N400 layer also contributes [3,14,15]. On the other hand, the hardness of N450 is related to hard compound-layer (CrN) formation; the distribution of this within the layer prevents free dislocation movement, which has been extensively studied [3,7,14,16,18,19]. It is relevant to highlight that the Berkovich tip penetration depth remained within the nitrided layers (Figure 4a) but beyond 10% thickness [28]. Consequently, the substrate influenced the indentation measurement in both of the nitriding surfaces.

Moreover, the micrographs in Figure 4c–d exhibited the topography of the grain boundaries on the nitrided surfaces in contrast with the untreated sanded topography (Figure 4b). Further topographic information can be found in Table 4. The parabolic profile of the indentation hardness profiles as a function of depth (Figure 4a) responded to the significant effect of surface roughness due to nitriding treatment, as reported in other studies [3,14,15,18,28]. In addition, the indentations in the rougher nitrided surfaces also showed the non-negligible dispersion of the indentation hardness depth curves.

**Figure 4.** (a) Indentation hardness curves as a function of the indentation depth (QCSM method) (Error bars represent standard deviation). Instrumented nano-indentation matrix with enlarged indentation mark: (b) untreated; (c) N400; (d) N450.

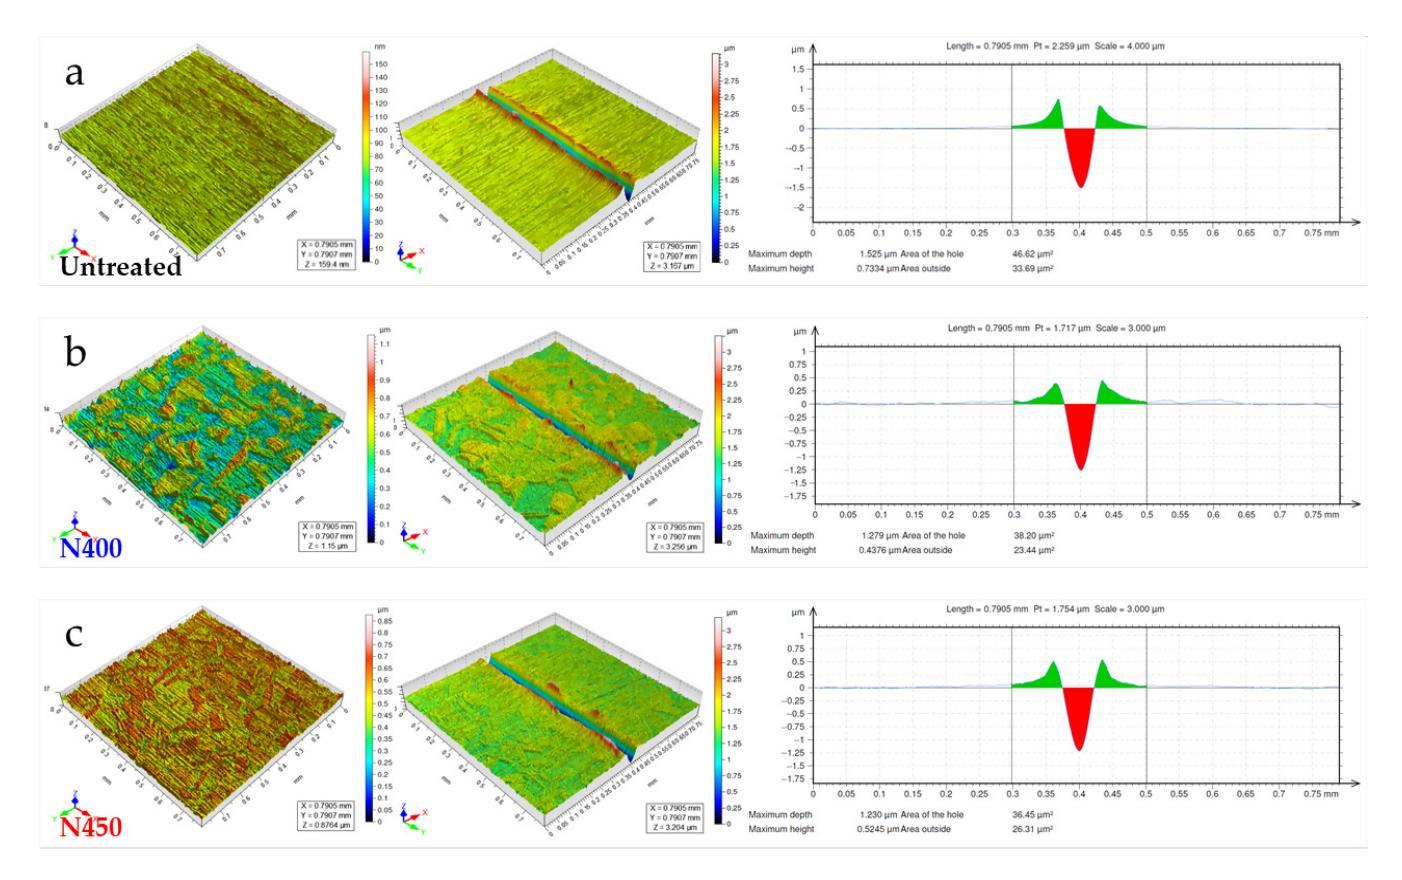
Scratch resistance was evaluated by producing constant load scratches from 2 N to 8 N on the sample surfaces. The first column in Figure 5 shows the topography results obtained using 3D interferometry before the test. The results of roughness characterization are presented below (Table 4). The second column in Figure 5 corresponds to the 3D reconstruction of a scratch section. The reconstruction of the mean cross-section profile along the scratch is shown in the third column. The results shown (Figure 5) correspond to a representative sample of each condition evaluated at 8 N. The same procedure was adopted for all loads (2–8 N), the results of which are summarized in the graphs below (Figure 6).

**Figure 5.** A sequence of surface analysis using 3D interferometry before and after the scratch tests: initial topography and the reconstruction of scratches and their cross-sections: (**a**) untreated, (**b**) N400, (**c**) N450 (the results presented in this figure correspond to the 8 N load).

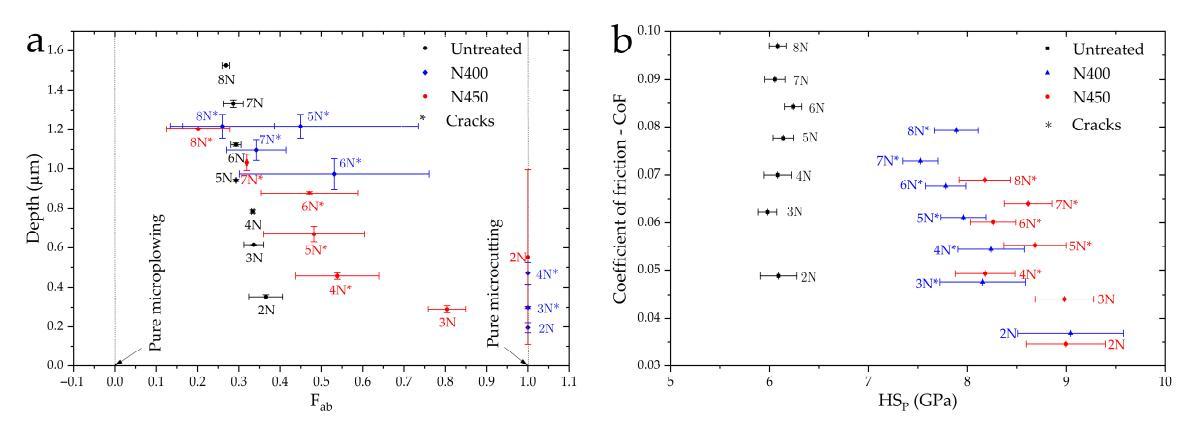
**Figure 6.** (a) Scratch depth as a function of abrasion factor ( $F_{ab}$ ). (b) Coefficient of friction as a function of the scratch hardness (HS<sub>P</sub>). Error bars represent confidence intervals.

The graph below (Figure 6a) depicts the scratch depth (in the cross-section) as a function of the abrasion factor ( $F_{ab}$ ) in all sample conditions and loads. The  $F_{ab}$  values indicate the predominant scratch wear mechanism. As shown in Figure 6a, a zero (0) value indicates pure microploughing wear, while a value of one (1) represents pure microcutting wear (Figure 6a). During the scratch tests, the friction coefficient (CoF) was recorded, and the results (as a function of scratch hardness (HS<sub>P</sub>)) are represented in Figure 6b for all conditions.

All samples showed increased scratch penetration as a function of load increase (Figure 6a). Regarding IN 718 (untreated), we observed that  $F_{ab}$  hardly depends on the load, keeping values around 0.25–0.4, showing a tendency for plastic deformation mechanisms without crack formation (microploughing). The nitrided surfaces presented cracks at the sides of the scratches from the 3 N load for N400 and from 4 N in N450. At low loads, the pure microcutting mechanism operates in both nitrided conditions, within the 2–4 N range for N400 and only 2 N in N450. From the loads mentioned, a mixed mechanism predominates with a plowing tendency when the load grows. When considering the penetration depth, the substrate did not influence the tests up to 4 and 5 N in N400 and N450, respectively. This occurred because the scratch depth did not exceed 10% of the nitride layer thickness [28]. Consequently, from those loads upwards, the substrate influenced the abrasion response on the nitrided surfaces.

At similar loads, the CoF (Figure 6b) was always lower for the nitrided surfaces when compared to the untreated ones. In addition, the CoF values were lower in the N450 condition when compared to N400. The surface hardening effect (Figure 6b) as a result of nitriding was observed since the nitrided surfaces presented higher scratch hardness values  $(HS_p)$  than those observed on the untreated surface. Additionally, the N450 condition showed a tendency for higher HS<sub>p</sub> mean values when compared to N400.

However, little difference was observed in the scratch depth between N400 and N450, which agrees with the similar indentation hardness and layer thickness. On the other hand, the N450 samples showed lower CoF and higher HS<sub>P</sub> values than N400 in loads of  $\geq$ 5 N (Figure 6b). Both results can be explained, as proposed by Aw, Batchelor, and Loh [19], since, for equivalent hardness, the negative effect of the topography of surfaces nitrided at 400 °C predominates (peak predominance). Nitriding resulted in wear micromechanism changes when compared to the untreated material (Figure 6a). The adhesive-abrasive combined mechanisms in untreated and nitrided IN 718 (using different techniques) were identified

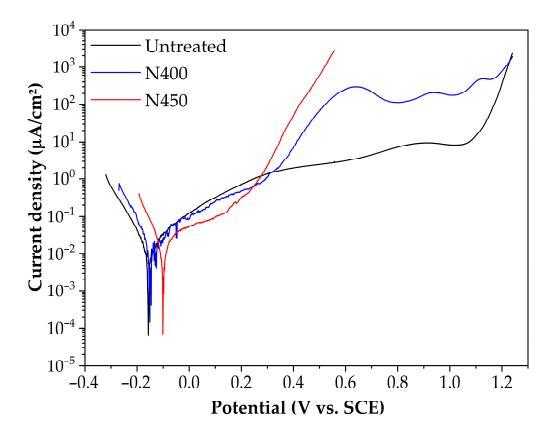
The most representative polarization curves of each condition are presented in Figure 7. The most relevant corrosion parameters are shown in Table 5. The tests revealed that the general corrosion resistance, measured based on the  $i_{corr}$ ,  $E_{corr}$ , and  $C_o$  parameters, is comparable between the untreated and the N450 conditions. The N400 samples showed  $E_{corr}$  values close to that of the untreated material and higher  $i_{corr}$  and  $C_o$  values. An increase of several orders of magnitude was observed for current density from E > 0.25 V in the nitrided conditions (Figure 7). Regarding N450, the appearance of bubbles on the surface of the samples was observed due to water oxidation reactions and the hydrolysis of the alloy metals [10,33]. Simultaneously, on the auxiliary electrode's surface, bubbles ascribed to oxygen and water reduction reactions were also observed from E > 0.25 [33]. The phenomena described did not occur when the current density increased in the N400 condition (E > 0.30 V). Therefore, it is possible to affirm that in the 0.65–1.00 V potential range for N400, second passivation occurred—actually, a pseudo-passivation—since the current was ~100  $\mu$ A/cm<sup>2</sup> (Table 5).

**Figure 7.** Polarization curves of untreated and nitrided samples (3.56 wt.% NaCl,  $20 \pm 2$  °C, 1 mV/s).

The linear polarization curves corresponding to IN 718 before and after nitriding are presented in Figure 7. The best performance of the N450 condition, when compared to the N400 condition up to the 0.20 V potential (that is, in  $E_{corr}$ ,  $i_{corr}$ , and  $C_0$ ), might be related to the better stability of the oxide layer formed on the surface composed of CrN (N450), as observed by Xue et al. [4] in salt bath-nitrided IN 718. Further studies are required to confirm this hypothesis. However, significant differences were observed for the Tafel region in both nitriding conditions when compared to the untreated IN 718.  $E_{pit}$  values close to the untreated condition (Table 5 and lower pit nucleation density in N400 (Figure 8b) indicate some improvements in pitting resistance in a NaCl (3.56 wt.%) solution. This result is ascribed to the  $\gamma_N$  phase, which demonstrated resistance to localized corrosion in Inconel [7,14–16] and other stainless-steel alloys [8–13,20] due to nitrogen enrichment. Nitrogen plays a role in neutralizing local pit acidification in anodic areas; further explanations can be found in other sources [23–26]. The polarization results revealed that CrN precipitation at 400 °C for 4 h (XRD results, Figure 3) is still insufficient to cause substantial damage to corrosion performance. These results agree with those reported in previous studies [15,16].

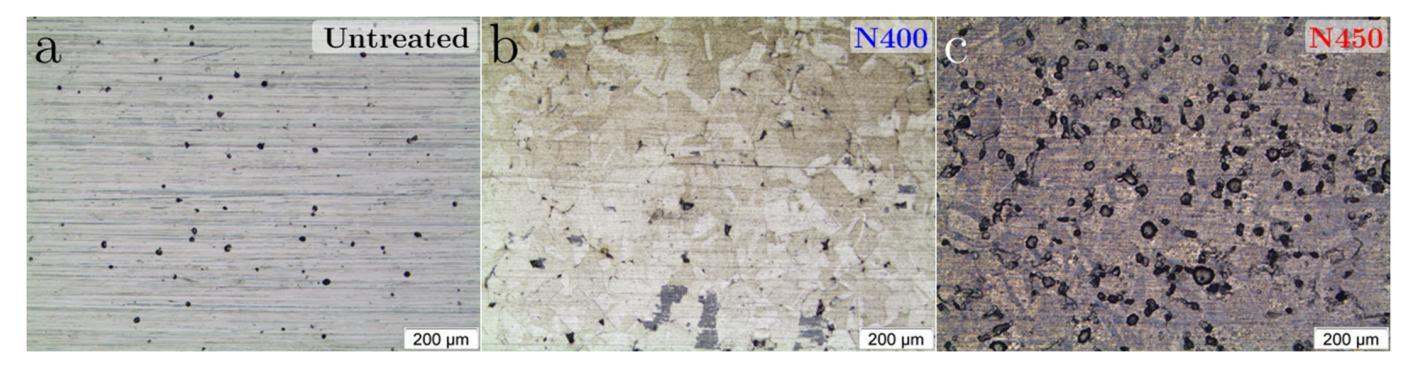
The micrographs (Figure 8) evidenced that the passivation layer failure occurred mainly due to the localized pitting corrosion in all samples. For this reason, the passive layer breakdown potential was named  $E_{pit}$  in the curves of Figure 7 and Table 5. The N450 nitriding revealed a sharp decrease in pitting resistance, observed as (i) a significantly lower  $E_{pit}$  value when compared to the untreated and N400 samples (Table 5); (ii) the formation of larger pits (Figure 8c), and (iii) greater pit nucleation density. On the other hand, the N400 samples showed slightly lower  $E_{pit}$  values than those presented by the untreated IN 718 (Table 5). On both nitrided surfaces, the pits were observed as starting mainly at the grain boundaries and were larger than those found in IN 718. However, the N400 condition showed lesser pit density when compared to the untreated and N450 conditions.

**Figure 8.** Micrographs of surfaces after the linear polarization tests: (**a**) Untreated, (**b**) N400 and (**c**) N450.

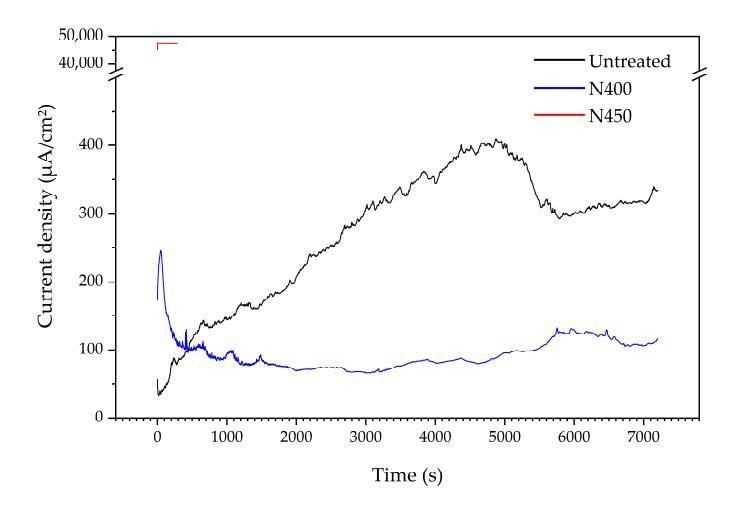
The potentiostatic polarization curves with crevice formers are shown in Figure 9 (representative curve of each sample). The N400 condition showed lower current densities than the untreated material, presenting improvements in crevice-corrosion resistance. However, the N450 condition showed very high current densities, reaching 50,000  $\mu$ A/cm<sup>2</sup> from the beginning of the polarization. Such densities indicate very high corrosion rates that go over the potentiostat tolerance limit, provoking the suspension of the measurement.

Figure 9. Potentiostatic polarization curves (1.00 V) in tests with crevice-former.

The results in Figures 9 and 10 showed that the formation of a layer composed of  $\gamma_N$  and CrN (N400) increases crevice corrosion resistance in IN 718. Nitriding at 450 °C harmed the resistance seen in the excessive current density. These results agree with the reduction in the passivation region and higher current densities in the linear polarization tests (N450: Figure 7, Table 5). Both results are due to the presence of Cr-depleted zones as a consequence of the transformation  $\gamma_N \rightarrow \text{CrN} + \gamma$ , already reported.

Therefore, the results confirmed that a layer composed of  $\text{CrN} + \gamma$  (without  $\gamma_{\text{N}}$ ) significantly reduced localized pitting and crevice corrosion resistance in IN 718. An improvement in the crevice corrosion resistance of IN 718 was obtained after nitriding at 400 °C, which was confirmed by a reduction in current density in potentiostatic tests (Figure 9) and a reduction in crevice corrosion depth (Figure 10).

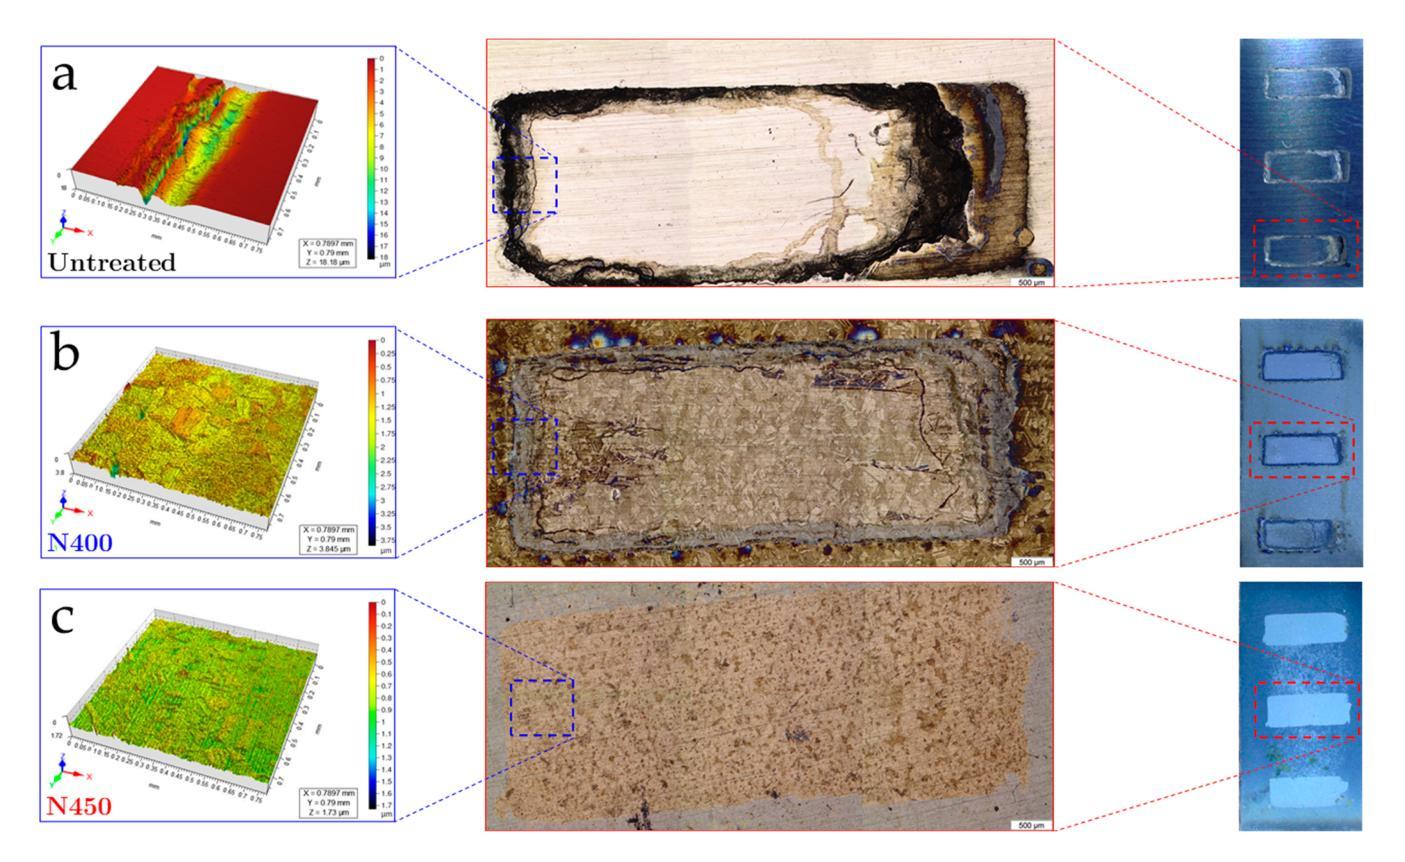
Crevice corrosion marks are seen in Figure 10. A reconstruction of the micrographs of the corrosion marks obtained using optical microscopy is shown in Figure 10 (center). On the left of Figure 10, the details of a corroded region analyzed using 3D interferometry can be observed. The micrographs of the untreated and N400 conditions revealed that the corrosion occurred preferentially on the boundaries of the crevice-former. The 3D interferometry analysis only evidenced a severe and profound attack in the untreated material (Figure 10a). The N400 samples did not present deep crevice corrosion but had extended corrosion in the surrounding areas of the crevice-former's contour (Figure 10b).

**Figure 10.** Potentiostatic polarization curves (1.00 V) of tests with crevice former: (**a**) untreated, (**b**) N400, and (**c**) N450.

The N450 sample tests were interrupted due to high current densities: only a few seconds were enough to generate corrosion on the whole surface, as observed in the

macrography (Figure 10c) (right side). Pitting corrosion was not observed inside or outside the crevice areas in any sample. This finding confirms that the potentiostatic test at 1.00 V exclusively evaluated the behavior of the material concerning the localized crevice corrosion.
