# Article The Effect of Cold Rolling on the Corrosion Behaviour of 5083 Aluminium Alloys

C. N. Panagopoulos <sup>1,\*</sup> and E. P. Georgiou <sup>2</sup>

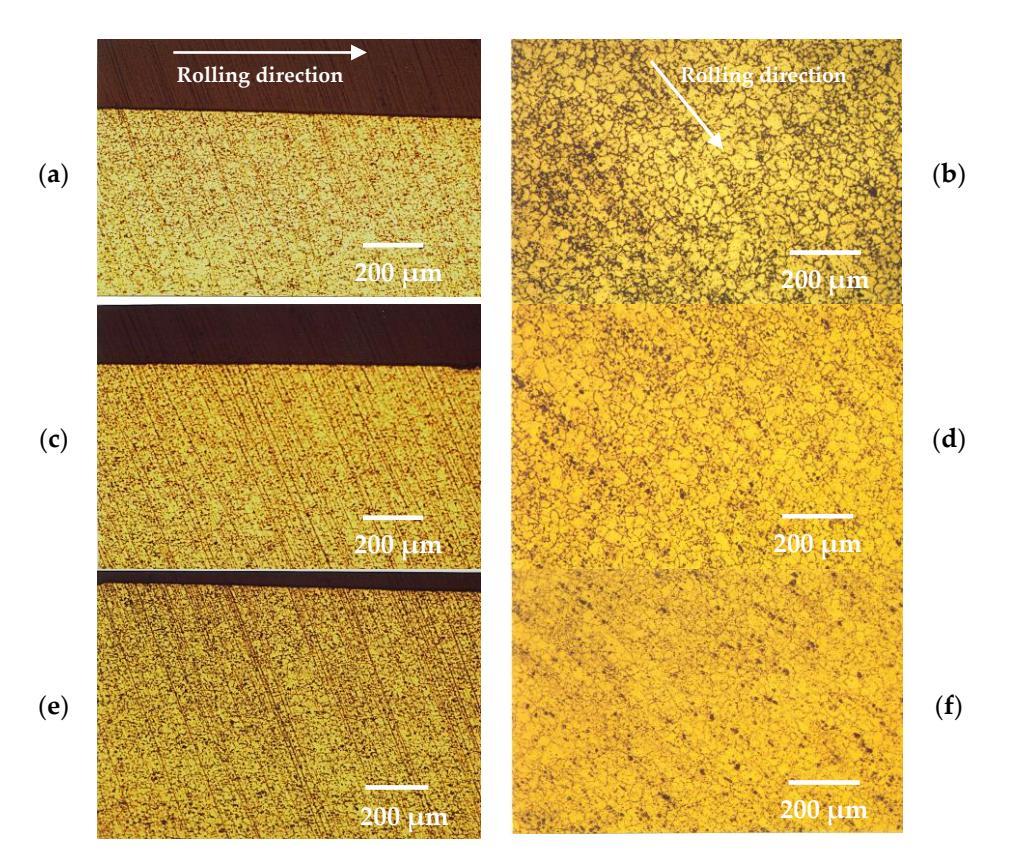
**Figure 1.** Optical metallography of surface layers from (**a**) cross section and (**b**) surface of as-received 5083 alloy, (**c**) cross section and (**d**) surface of 7% cold-rolled 5083 alloy and, (**e**) cross section and (**f**) surface of 15% cold-rolled 5083 alloy (Chemical etching Graff's reagent).

The metallographic microstructure of the surface layers in the 5083 aluminium alloy, both prior to and following the thickness reduction and deformation, is illustrated in Figure 1. It is evident from these micrographs that the increase in the percentage of cold rolling resulted in a decrease of the average grain size in the surface layers of the alloy. This reduction can be attributed to grain recrystallization induced by stress during the cold-forming process [27,28].

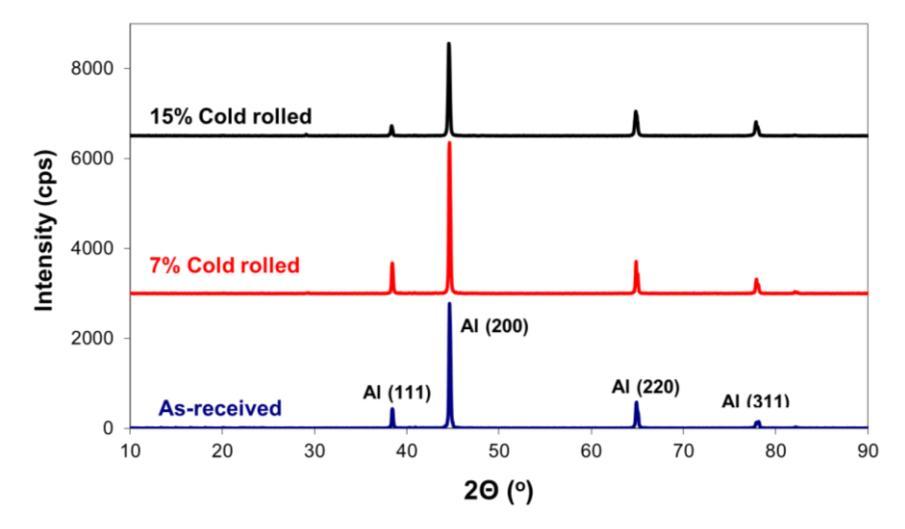
Figure 2. Effect of cold rolling on the X-ray diffraction patterns of 5083 Al alloy.

X-ray diffraction analysis of 5083 alloy, both with and without cold rolling, revealed identical aluminium crystallographic planes, Figure 2. No secondary intermetallic phases were detected, suggesting concentrations below the method's detection limit [29]. However, it is important to highlight that the relative intensity among these aluminium peaks changed, indicating the development of crystallographic texturing. To evaluate this phenomenon, texture coefficients (TC) were calculated for each orientation, as presented in Table 1 [30]. In accordance with these calculations, texture coefficients exceeding one signify a preferred

orientation. Therefore, under the specific cold-rolling conditions, preferred orientations for texture development were observed for crystallographic planes (200) and (220).

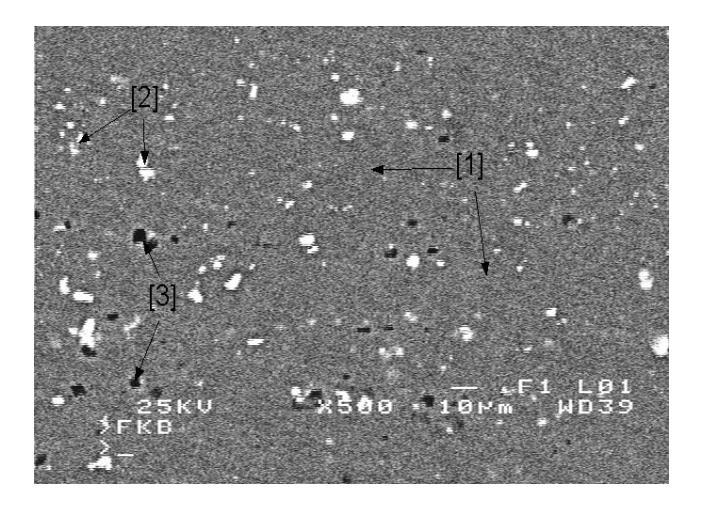
**Figure 3.** SEM image showing an indicative microstructure of as-received 5083 aluminium alloy (chemical etching Keller's reagent).

To obtain a better understanding of the microstructure of this alloy, scanning electron microscopy and EDS chemical spot analysis techniques were used. Across all instances, a similar microstructure was noticed, with the alloy comprising (1) aluminium solid solution, (2) Mg<sub>2</sub>Si intermetallic phases and (3) insoluble Si, as indicated in Figure 3.

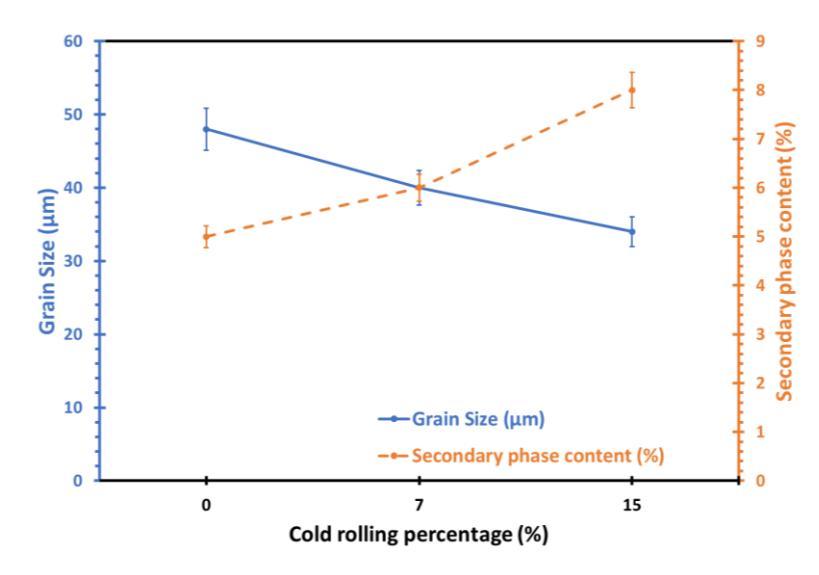
**Figure 4.** Effect of cold-rolling percentage on the average grain size and secondary phase content of 5083 Al alloy.

To quantify the changes in grain size and intermetallic content, post analysis of the optical microscopy and SEM images was conducted with the use of Image Pro Analysis software, Figure 4. The results revealed that the average grain size in the surface and deformed layers decreased from 48  $\mu$ m in the non-rolled alloy to 40  $\mu$ m with 7% cold rolling and further to 34  $\mu$ m with 15% cold rolling for the same alloy. Conversely, the percentage of secondary phases increased, rising from approximately 5% in the as-received alloy to around 6% and 8% for the 7% and 15% cold-rolled samples, respectively.

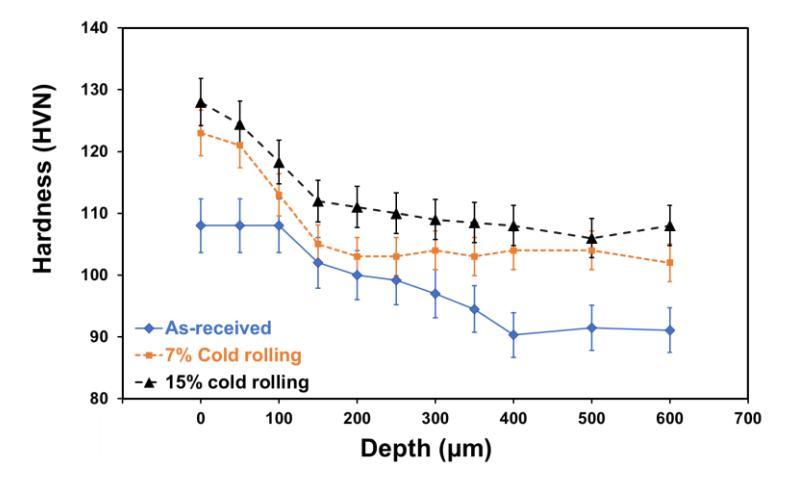
Figure 5. Effect of cold rolling on the microhardness profile of 5083 aluminium alloy.

Microhardness measurements were carried out on both the surface and cross section of the 5083 alloy with and without cold rolling, as shown in Figure 5. It is evident from this figure that the increase of cold deformation resulted in an increase of microhardness of the alloy. Moreover, the depth of strain hardening became more pronounced with a higher deformation percentage (thickness reduction). This phenomenon can be explained by the reduction in grain size and the increase in secondary phases, as illustrated in Figure 4. Notably, grain boundaries act as obstacles to dislocation movement and multiplication, and according to the Hall–Petch theory [31], the smaller the grain diameter, the greater the material's hardness. Additionally, higher concentration and better distribution of intermetallic phases in the alloy [32] contribute to increased hardness, attributed to precipitation hardening mechanisms [33].

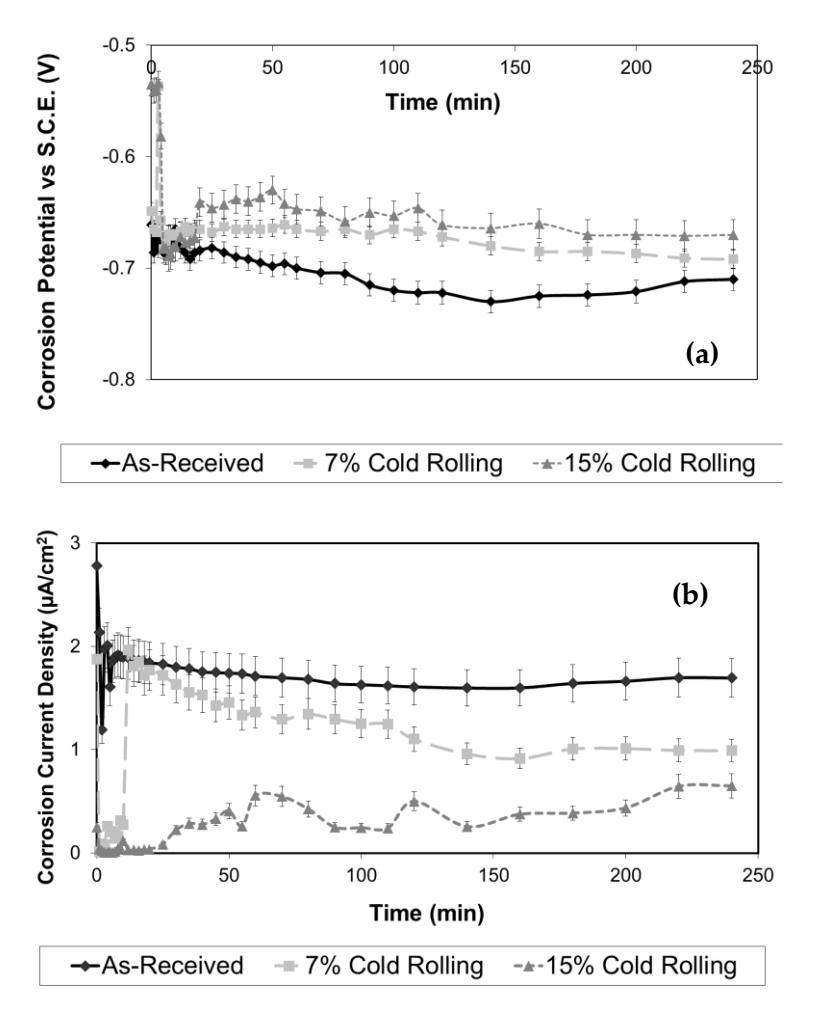
**Figure 6.** Effect of cold-rolling percentage on the evolution of (**a**) corrosion potential and (**b**) corrosion current density under free corrosion conditions in 3.5% NaCl solution.

In Figure 6a, typical potentiostatic V(t) corrosion curves are presented for both the as-received and cold-rolled 5083 aluminium alloy specimens. Upon comparison of these curves, it can be observed that the increase in cold deformation (thickness reduction) resulted in a shift of the potentiostatic curves towards more noble corrosion potential values versus the SCE electrode. It is well established that as the corrosion potential of a metallic material becomes more noble, its susceptibility to corrosion decreases. Consequently, the aluminium alloy specimens subjected to 15% cold rolling exhibited the highest corrosion

resistance, followed by the specimen with 7% cold rolling and the as-received specimen. Furthermore, all the potentiostatic curves exhibited a similar shape. This observation may be attributed to the fact that the cold-rolling process did not significantly affect the chemical composition of the surface layers of this alloy, indicating minimal impact on micro-segregation phenomena.

To assess the potentiostatic experiments, during the free corrosion experiments the corrosion current density of both the as-received and cold-rolled aluminium alloy specimens was continuously recorded, as shown in Figure 6b. It is apparent from this figure that the increase of the cold-rolling rate has led to lower corrosion current density values, indicating enhanced corrosion resistance of the alloy. These results are in full agreement with the potentiostatic V(t) curves presented previously, in Figure 6a.

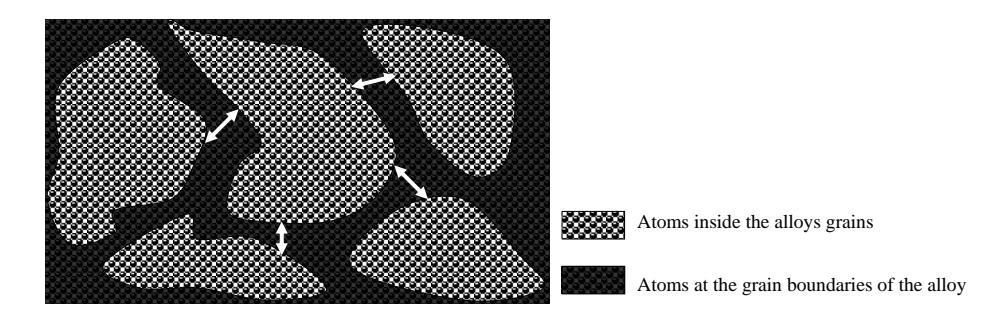
Figure 7. Schematic illustration of the increase of grain boundary width with enlargement of grains.

1. Grain refinement of the alloy. The grain boundaries in metallic materials are believed to play a crucial role in the corrosion process, acting as 'easy paths' for the diffusion of halide ions from the corrosive solution to the surface layers and bulk material. In this case, the cold-rolling process contributed to a decrease in the average grain size of the material (as shown in Figure 4). As the average grain size increases, the grain boundaries become enlarged, as indicated in Figure 7. According to Wagner's metal oxidation theory [34], the oxidation/corrosion process is determined by diffusion mechanisms that take place in the oxide phase (passivating film) and along the grain boundaries of the bulk material. If the grains are enlarged, more ions can diffuse over time. Moreover, a larger grain size results in the extension of individual grain boundaries deeper into the surface layers of the bulk material. Thus, this enlargement of the grain boundaries is thought to accelerate the corrosion process, as halide ions (Cl<sup>-</sup>) can diffuse more easily from the corrosive solution deeper into the surface layers of the material.

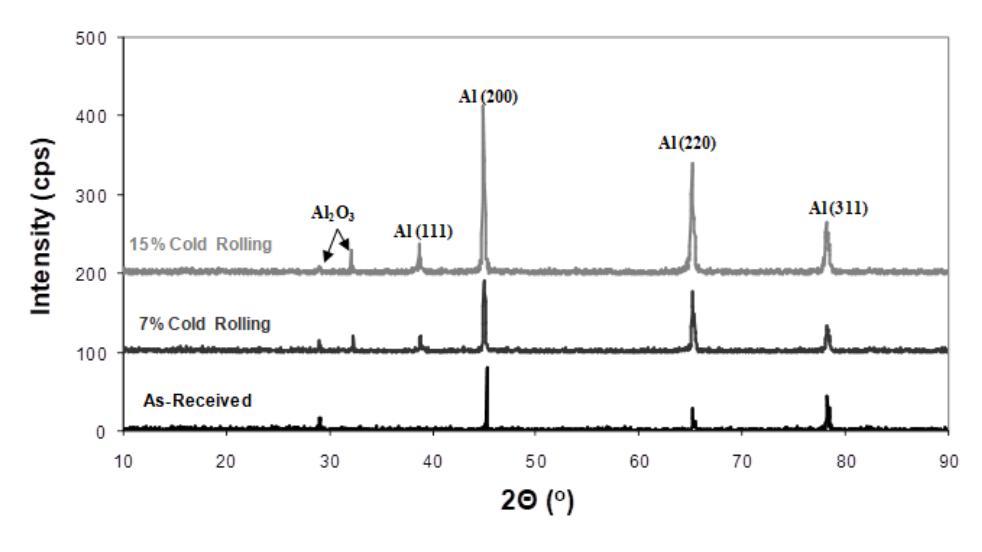
Figure 8. X-ray diffraction of corroded 5083 samples having different rolling percentages.

- 2. Formation of corrosion products. Another aspect to consider is the generation of corrosion products on the alloy's surface during corrosion. By utilizing X-ray diffraction (XRD), a structural analysis of the corroded surface layers in both the as-received and cold-rolled specimens was performed and is shown in Figure 8. The primary corrosion product identified was aluminium oxide (Al<sub>2</sub>O<sub>3</sub>). Peaks from the aluminium solid solution substrate (Mg dissolved in the Al matrix) were also noticeable. However, a comparison of X-ray diffraction patterns in Figure 8 reveals an increase in aluminium oxide peaks with a higher cold-rolling rate. The formation of aluminium oxides on the alloy's surface is believed to hinder the diffusion of halide ions and, consequently, the corrosion process.

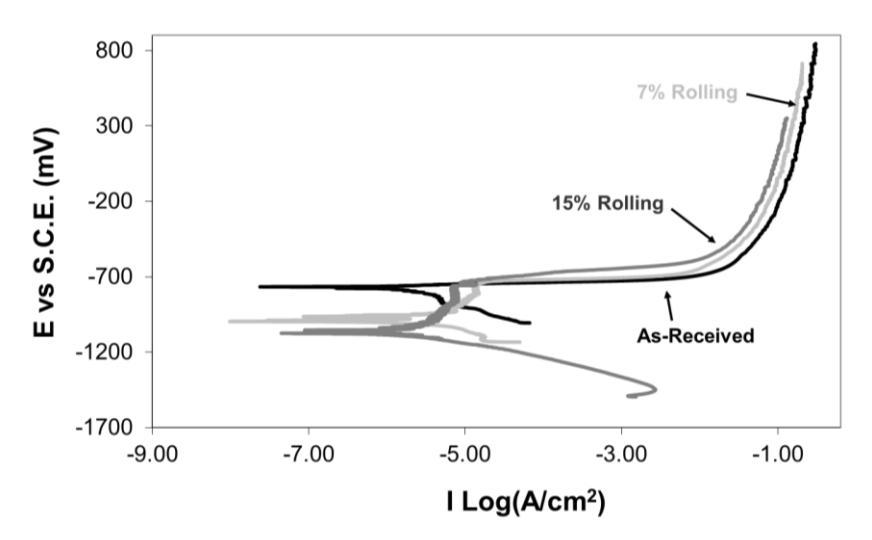
**Figure 9.** Effect of cold rolling on the potentiodynamic corrosion curves of 5083 Al alloy in 3.5% NaCl solution.

For further investigation of the corrosion behaviour of as-received and cold-rolled aluminium alloys, potentiodynamic corrosion experiments were conducted in a 3.5% NaCl solution. Figure 9 presents typical potentiodynamic corrosion graphs. The as-received specimen showed no passivity regions, indicating continuous corrosion along the anodic branch of the potentiodynamic graph. Conversely, specimens with 7% and 15% cold rolling exhibited small passivity areas at -1000 mV vs SCE and -1070 mV vs SCE, extending up to -720 mV vs SCE and -760 mV vs SCE, respectively. During the passivity region, it is believed that the developed aluminium oxide layer dissolves uniformly. However, after this electrochemical process, pitting occurs with subsequent repassivation up to the breakdown potential. Stable pit growth occurs at potentials higher than the breakdown potential [10]. Furthermore, the rolling process appears to have an influence on the breakdown potential of the passive film. According to the work of Szklarska-Smialowska [36], the breakdown potential depends upon the interaction between the halide ions of the corrosive solution and the structural characteristics of the oxide passive film. In this work, the cold deformation of the surface layers has resulted in an increase of micro-defects (vacancies, voids, etc.) at the surface layers of the alloy [37]. The existence of such micro-defects at and/or near the interface between the oxide film and the base material has been reported to affect the electronic properties and breakdown potential of the passive film [38].

Comparing the potentiodynamic corrosion curves for the as-received and cold-rolled aluminium specimens, an increase in cold deformation resulted in a shift of the potentiodynamic curves to lower corrosion current values. Thus, the chosen cold-rolling process improved the corrosion resistance of this alloy. This enhancement is attributed to the grain refinement of the alloy and the formation of a protective aluminium oxide film, as explained earlier. However, the open circuit potential of the cold-rolled specimens was observed to be less noble than that of the as-received specimen. The corrosion current (Icorr) and corrosion potential (Ecorr) of the as-received and cold-rolled aluminium alloy specimens obtained from the potentiodynamic curves in Figure 9 are presented in Table 2.

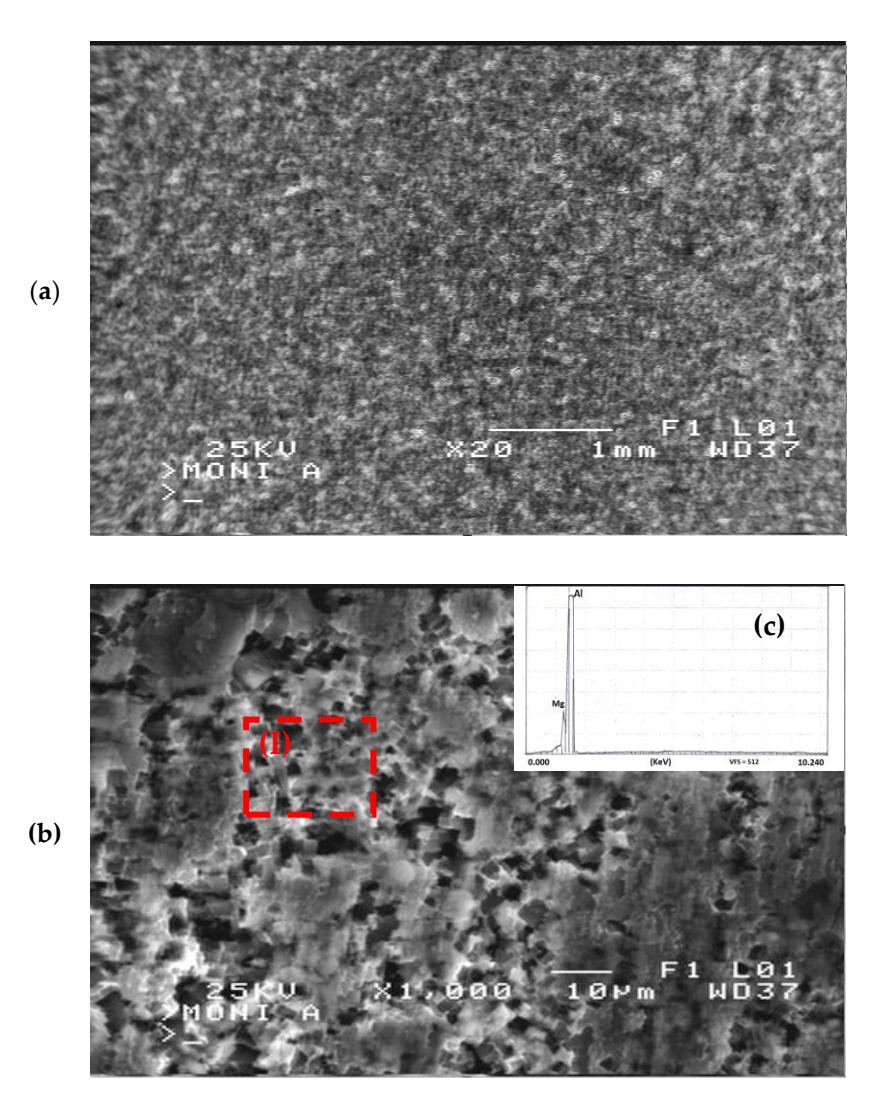
**Figure 10.** SEM surface morphology of 15% cold-rolled Al alloy after potentiodynamic corrosion in 3.5% NaCl solution at (**a**) lower and (**b**) higher magnification. (**c**) EDS chemical analysis on area (I) of Figure 9b.

In Figure 10a, a representative metallographic structure of the corroded surface of 15% cold-rolled 5083 aluminium alloy is presented. It is apparent from this figure that the dominant corrosion mechanism was dissolution–precipitation, as corrosion products were observed to form uniformly throughout the surface of the alloy.

Upon examining the corroded areas, as shown in Figure 10b, extensive pitting corrosion phenomena were identified. This pitting corrosion mechanism can be attributed to the presence of localized galvanic corrosion between the aluminium solid solution and Mg<sub>2</sub>Si intermetallic phases. According to Yasakau et al. [39], the difference in corrosion potential between the aluminium solid solution and Mg<sub>2</sub>Si intermetallic phase led to the formation of localized galvanic cells between them, subsequently resulting in the dissolution of the intermetallic phase. The electrochemical reactions that occur at the interface between the alloy and the corrosive solution can be described by the following corrosion mechanism:

The dissolution of the Mg<sub>2</sub>Si intermetallic phase was further validated by conducting localized chemical analyses using the EDS technique. Chemical analyses on area (I) of Figure 10b revealed 97.5 wt. % Al and 2.5 wt. % Mg, shown in Figure 10c. Consequently, the decrease in Mg concentration, coupled with the inability to detect Si, suggests that a portion of the Mg<sub>2</sub>Si intermetallic phases dissolved during the corrosion process, contributing to the formation of pits.
