# Mechanical Properties of Tool Steels with High Wear Resistance via Directed Energy Deposition

**Abstract:** This study focused on the mechanical and metallurgical characteristics of high-wearresistance steel (HWS) deposited using directed energy deposition (DED) for metal substrate hardfacing or repairing. As post-deposition heat treatment changes the metallurgical characteristics of deposits, the effect of post-deposition heat treatment on the mechanical properties was investigated via microstructure observation and by conducting hardness, wear, and impact tests. The obtained micro-images showed that the deposited HWS layers exhibit cellular and columnar dendrites, and the microstructure of heat-treated HWS (HT-HWS) transformed its phase during quenching and tempering. The hardness and wear resistance of the HT-HWS deposits were higher than those of the HWS deposited specimen, whereas the latter exhibited a higher fracture toughness. The matrix microstructure and carbide characteristics, which are characterized by the chemical composition of the materials, significantly influenced the mechanical properties.

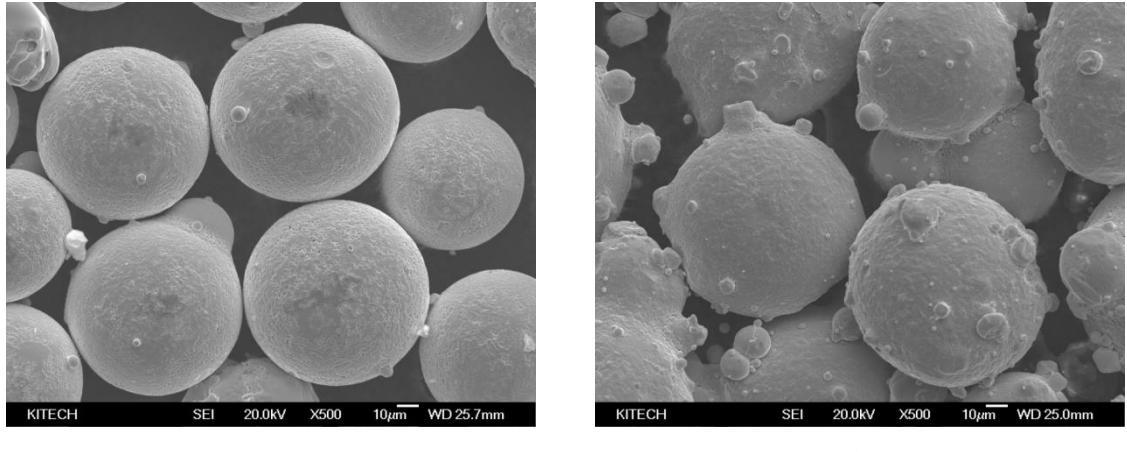
Figure 1. Micro-images of (a) M4 and (b) HWS (high-wear-resistance steel) spherical powders.

For the experiment, the substrate used was AISI D2 bulk steel, and AISI M4 (supplied by Carpenter Co., Philadelphia, PA, USA) and HWS (supplied by Rovalma S.A., Barcelona, Spain) powders were used as the depositing materials. The substrate was machined to dimensions of 50 mm × 100 mm × 10 mm. As shown in Figure 1, the powders of M4 and HWS comprise spherical particles with diameters in the range of  $50-150 \,\mu\text{m}$ . The powders are manufactured using a gas atomizer. Table 1 lists the chemical compositions of each material. The M4 material has a high carbon content and high W, Mo, Cr, and V contents. On the other hand, HWS has a higher Cr content than M4.

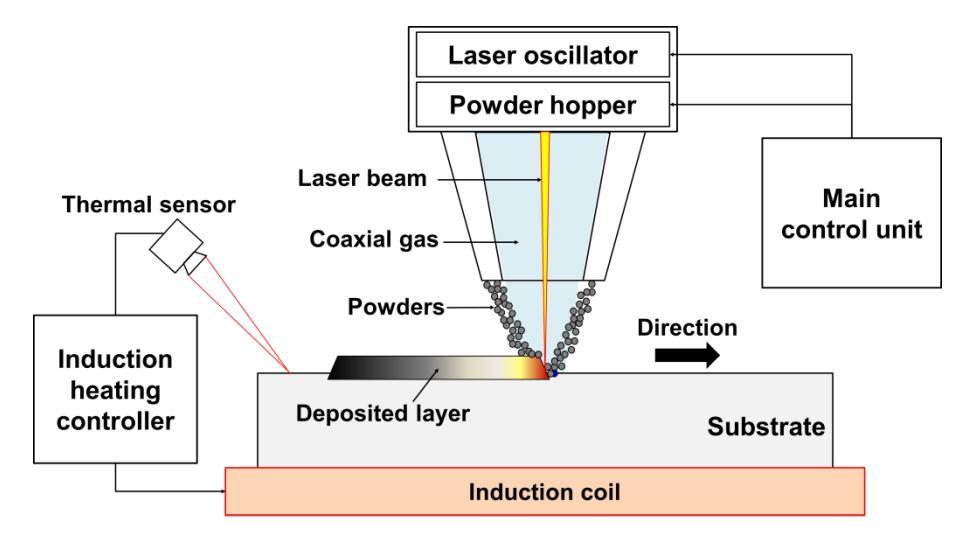
Figure 2. Schematic of the DED (direct energy deposition) process.

Figure 2 shows a schematic diagram of the DED process for the molten pool, in which the substrate and powder are melted. The equipment consists of a 4 kW CO<sub>2</sub> laser oscillator, a powder hopper, and a gas feeder (MX-3, INSTECH Co., Daejeon, Korea). These pieces of equipment are controlled by the main controller for the laser tool path, gas supply, laser power, etc. In this study, the laser power during the deposition was 800–900 W, and the argon gas was used in the coaxial and powder feeding. The beam spot diameter was 1.0 mm with a top-hat intensity distribution; thus, overlapping tracks were applied with a pitch of 0.5 mm. The slicing height was set to 0.5 mm, which was based on the single-layer height for a given depositing condition (as listed in Table 2).

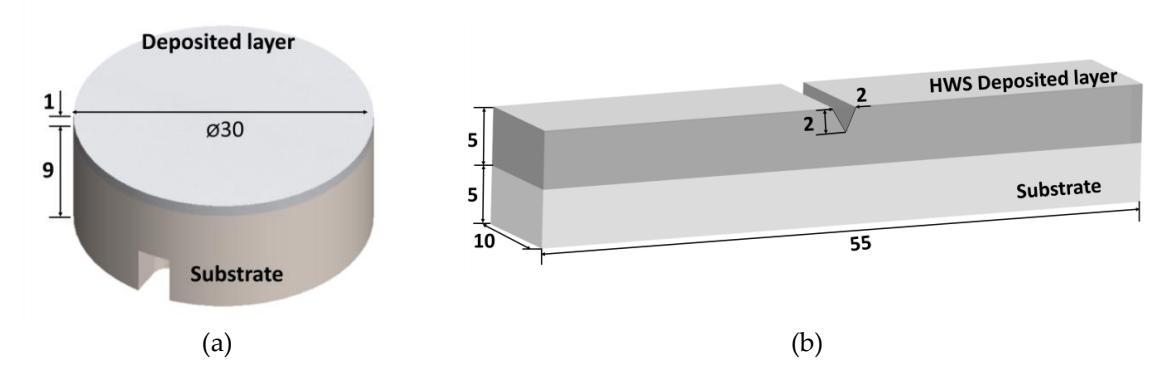
Figure 3. Schematics of the specimens for the (a) wear test and (b) Charpy impact test (unit: mm).

The wear specimens were prepared with a 1.0-mm-thick layer deposited onto a cylindrical substrate, as shown in Figure 3a. A ball-on-disk wear tester (R&B Inc., Daejeon, Korea) was used, and the cemented carbide ball (Ø12.7 mm) was set to be rotated on the top surface of the specimen for 10 min under a load of 147.1 N (15 kgf) and at a ball speed of 100 rpm.

To evaluate the toughness, which is the resistance against fracture, the Charpy impact test was performed. The specimen for the impact test was prepared with a 5 mm height of the deposited layer. A 2-mm-deep V-notch was formed in the specimen, in keeping with the ASTM E23 standard, as shown in Figure 3b. The impact test was performed at room temperature using a Charpy impact machine; the impact energy, impact velocity, and impact angle were set to 50 J, 3.8 m/s, and 150°, respectively. The impact absorption energy was calculated after the impact test, and the morphology of the fracture surface was examined using FE-SEM.

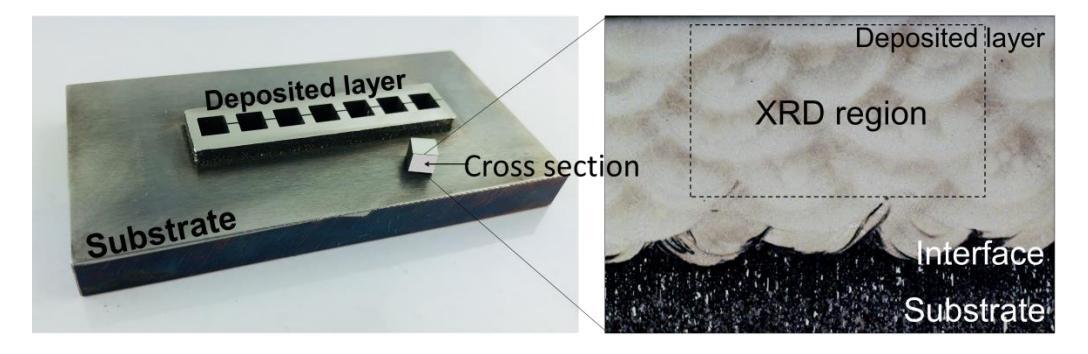
Figure 4. Images of the specimen and cross section for XRD (X-ray diffraction) analysis.

To confirm the phase, carbides, and crystal structure formed in the deposited layers, XRD analysis was performed such that the cross section (5 mm × 5 mm) of only the deposited layer was irradiated with x-ray (Figure 4). Figure 5a,b,c shows the X-ray diffraction patterns of M4, HWS, and HT-HWS, respectively. The results show different XRD patterns depending on the chemical compositions and post-deposition heat treatment, with gamma ( $\gamma$ , austenite, ICDD number 03-065-9094) and alpha prime peaks ( $\alpha'$ , martensite, ICDD number 03-065-4899) observed in common. The M4 spectrum is characterized by gamma, alpha prime, and  $M_6C$  peaks (Figure 5a). The quantitative analysis results show that the gamma content is 22%, and the alpha prime is 78%. Thus, the matrix structure in M4 was identified as austenite and martensite, and M6C carbides shown at 38° and 40° were identified from another study [5]. Nevertheless, MC carbide and M<sub>23</sub>C carbide precipitate in M4; however, they could not be identified in the XRD analysis in this study. In the HWS spectrum, only gamma and alpha prime are patterned (Figure 5b). The martensite and austenite structures are formed by melting and rapid cooling. The fraction of carbide observed in the microstructure is expected to be lower. The gamma and alpha prime contents are 61% and 39%, respectively. HWS contains a higher austenite fraction than M4, in accordance with their chemical compositions: HWS has both a lower C (i.e., austenite-stabilizing element) content and higher Si and Cr (ferritestabilizing) contents than M4. The HT-HWS exhibits a phase transformation in the microstructure, and the XRD pattern is different from the HWS because of the post-heat treatment, which reduced the austenite fraction and increased the martensite fraction in the matrix (Figure 5c). When quenched from an austenite state to room temperature with rapid cooling, there is not enough time for the carbon to diffuse. As a result, carbon remains in the solid solution state in  $\alpha$  iron, and the retained austenite in the deposited layer is transformed to martensite by quenching.

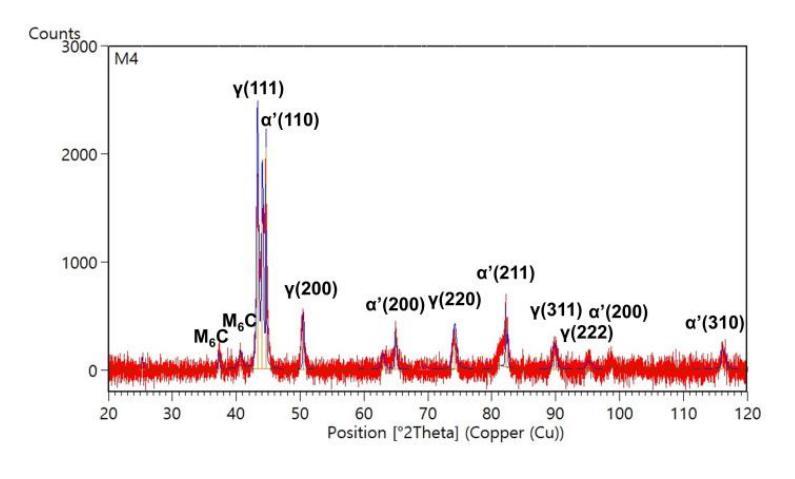
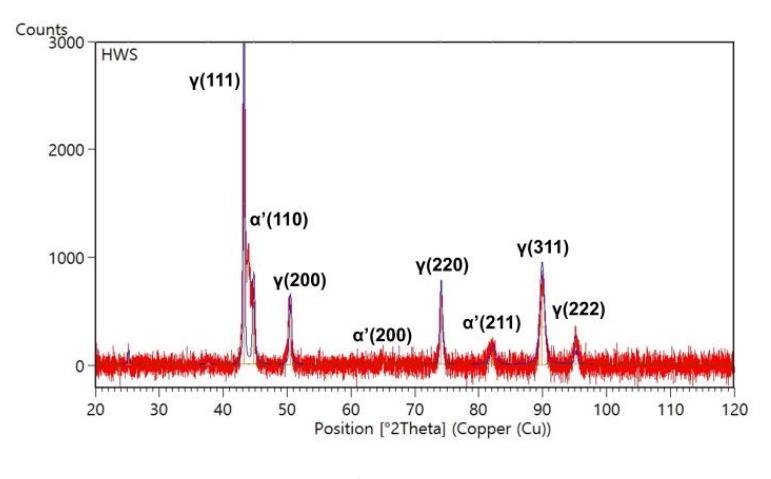
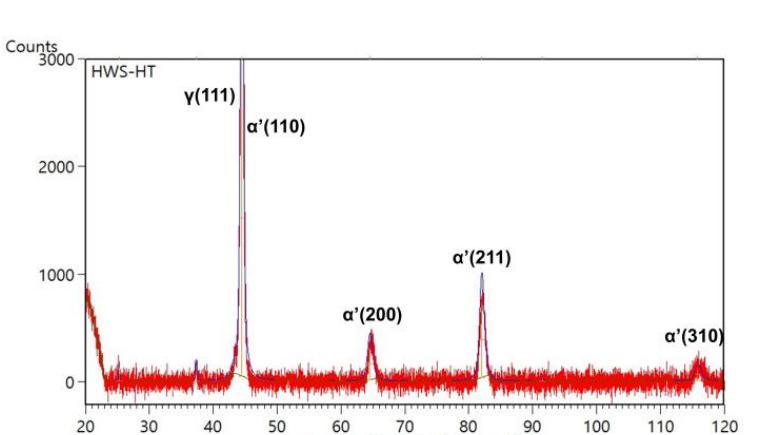
**Figure 5.** X-ray diffraction patterns of the (**a**) deposited M4 layer, (**b**) deposited HWS, and (**c**) HT-HWS.

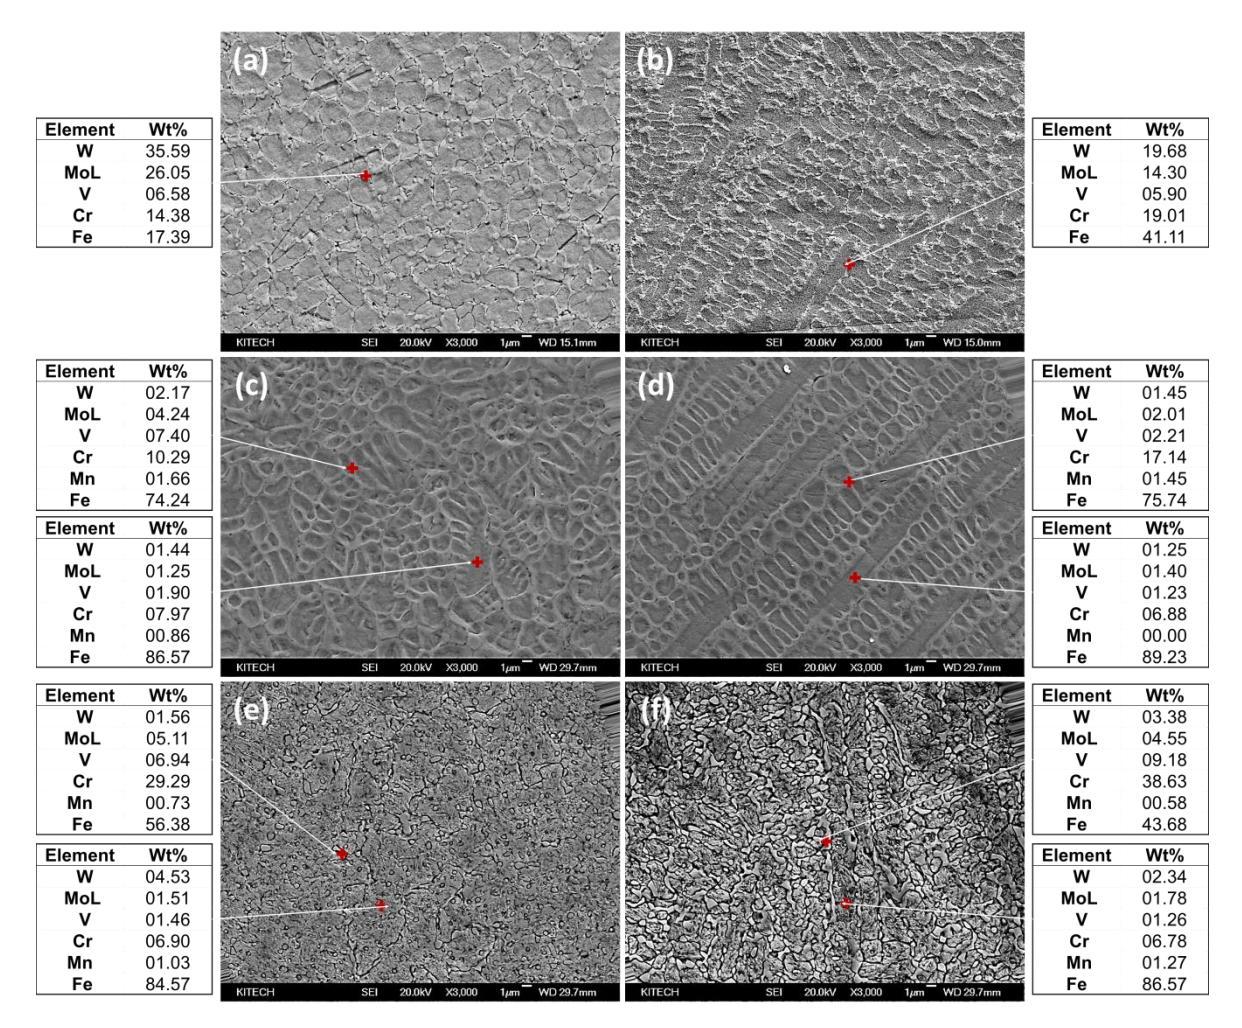
**Figure 6.** SEM image and elemental composition of deposition: (**a**) Deposited M4 region, (**b**) interface between M4 deposits and substrate, (**c**) deposited HWS region, (**d**) interface between HWS deposits and substrate, (**e**) post-deposition heat treated HWS (HT-HWS) region, and (**f**) interface region.

Elemental composition analysis (based on microstructure observation) and EDS were conducted for the metallurgical characterization in conjunction with the XRD analysis. Regarding the microstructures of the deposited M4, HWS, and HT-HWS, two regions of interest were observed: The deposited layer, including the coating and the dilution zones (Figure 6a,c,e), and the interface region (Figure 6b,d,f). As in previous studies [10–12], the cellular dendrites were observed in the deposited layer (Figure 6a) and columnar dendrites at the interface (Figure 6b) of the M4 deposited specimen the respective microstructures that depend on the cooling rate of the melting pool. The EDS results show that the carbides at the interface and in the deposited layer came from the precipitation-related tungsten-molybdenum-chromium-rich MC series. In the M4 tool steel, MC, M<sub>6</sub>C, and M<sub>23</sub>C<sub>6</sub> reportedly precipitated [13]. Notably, these carbides include vanadium-rich MC carbides, molybdenum-rich M<sub>6</sub>C carbides, and chromium-rich M<sub>23</sub>C<sub>6</sub> carbides.

The microstructure of the deposited HWS layer showed cellular and columnar dendrites (Figure 6c,d). The obtained micro-images show that the cellular structure of the HWS layer has fine grains. However, the secondary arm spacing of the dendrites is similar to that in the M4 structure. Although the microstructures are similar, the elemental compositions of the carbide are different, as demonstrated in the EDS analysis. Unlike the tungsten-molybdenum-rich carbides of the deposited M4, the precipitated carbides in the HWS have a rich chromium content. Leunda et al. [9] reported that the chromium content in the rod-like carbides of the HWS clad is considerable. At the point where no carbide precipitates, the chemical composition shows a matrix with a lower Cr content than carbide.

Meanwhile, the microstructure of the HT-HWS (Figure 6e,f) is different from that of the HWS deposits. The cellular dendrite could not be observed in the deposited layer or at the interface. During the post-heat treatment, phase transition reactions can occur and new precipitation phases are generated. The carbides that were indicated as dendrite and cellular at the deposited layer before the heat treatment were aggregated to the eutectic carbide during the post-heat treatment. Although the precipitated carbides could not be distinguished in this study, Ramírez et al. [14] identified the primary carbide as M<sub>7</sub>C<sub>3</sub> in the HWS. Therefore, the agglomerated carbides were considered to be chromium-rich M<sub>7</sub>C<sub>3</sub>.

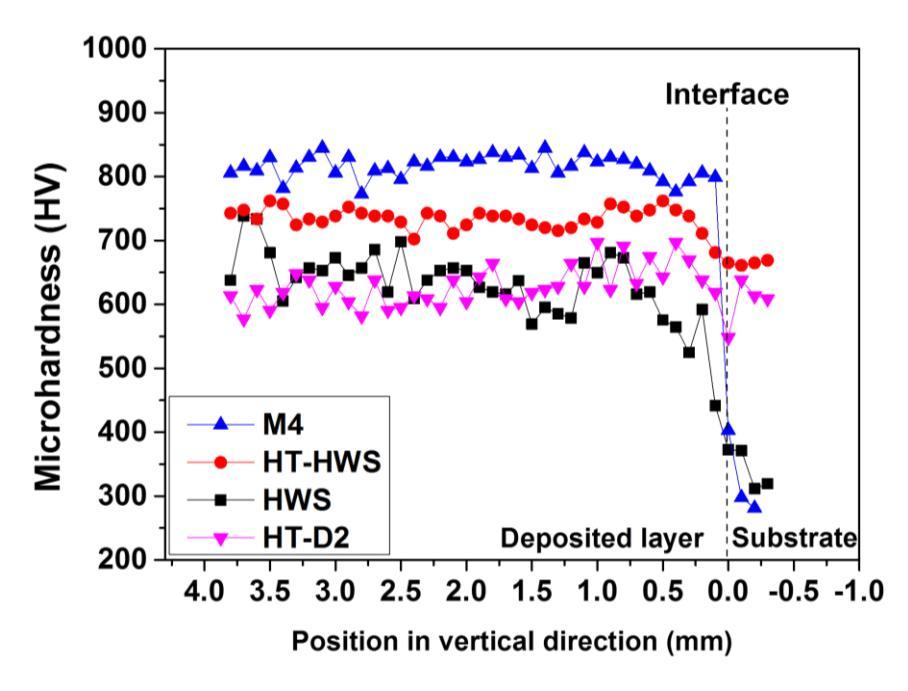
**Figure 7.** Distribution of micro-hardness measured from the top surface of the deposited region to the substrate.

Each deposited layer was found to exhibit different microstructures because of the differences in the chemical composition and post-heat treatment. As the different microstructures affect the mechanical properties, the hardness of each was measured and compared with that of a widely used heat-treated D2 material (HT-D2) [15]. Figure 7 shows the micro-hardness variation from the deposited layer to the substrate in the vertical direction for M4, HWS, and HT-HWS. HT-D2 shows a uniform hardness value of 625 HV. However, the hardness values of HWS, HT-HWS, and M4 differ depending on the location (deposited layer or interface). The hardness decreases in the interface, where the depositing powders and the substrate were melted and mixed together in the melting pool. In other words, the hardness of 644 HV, whereas those of HT-HWS and M4 are 737 HV and 818 HV, respectively. The hardness values of M4, HWS, and HT-HWS are higher than that of HT-D2.

The hardness of each can be explained in relation to the microstructure. The microstructure obtained using laser melting exhibits a fine carbide morphology and a solidification matrix structure, compared to that fabricated using casting or sintering. Therefore, although the carbon content of the HWS powders is relatively lower than that of the D2 material, uniform and fine carbides are precipitated in the deposits, and the matrix is made of martensite and fine carbides. Thus, the HWS deposits exhibit higher hardness. With respect to the difference in the hardness values between M4 and HWS, both microstructures formed using laser melting were found to be similar. However, the constituents of the carbides differed, and the martensite content in the matrix was higher in the M4

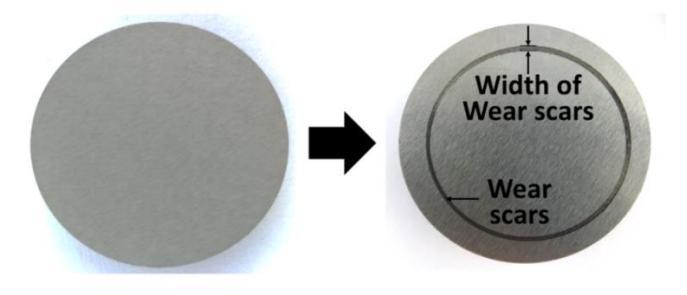
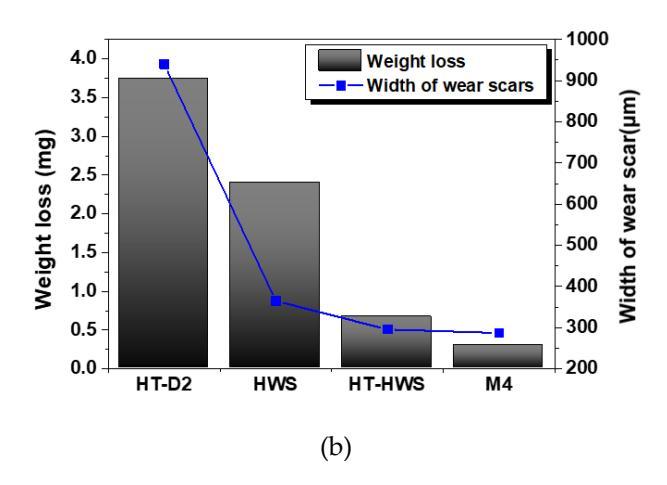
Figure 8. (a) Images of wear scars after the ball-on-disc wear test, and (b) comparison of weight loss and wear scars.

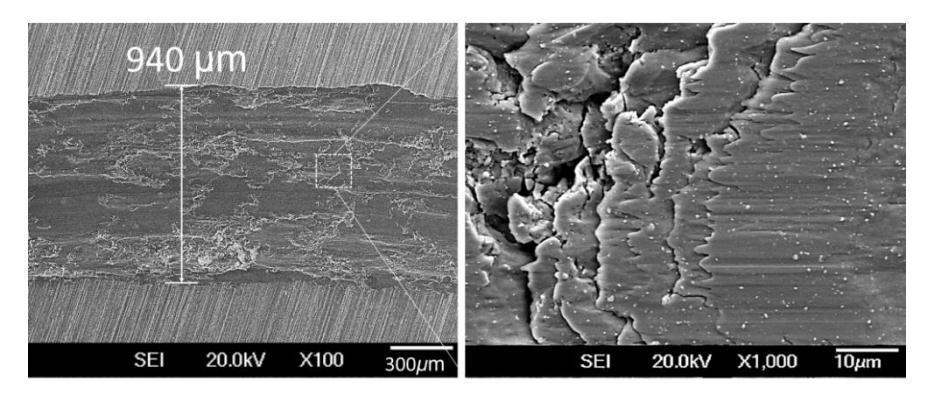
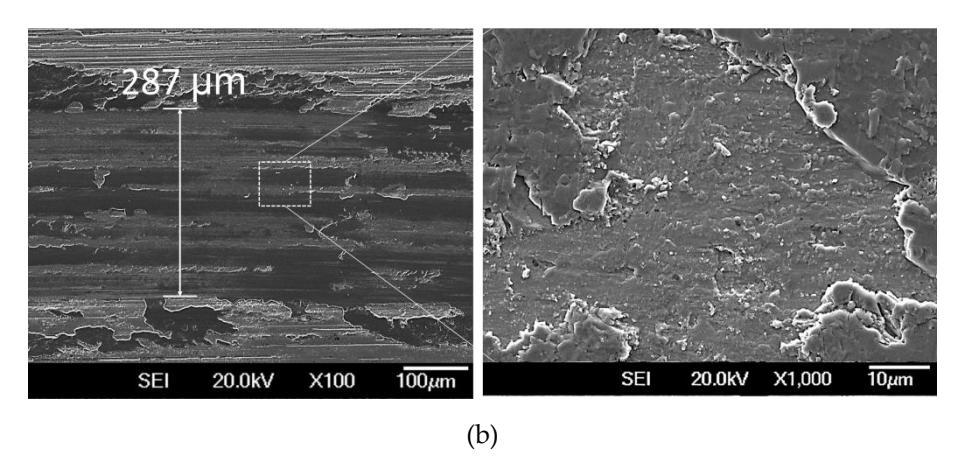
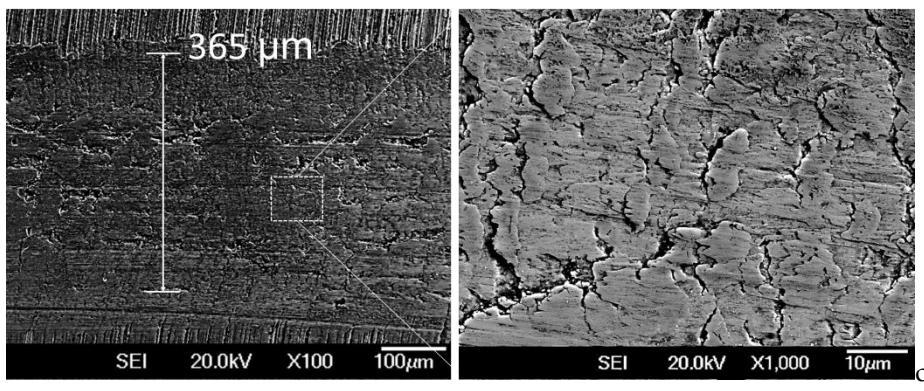
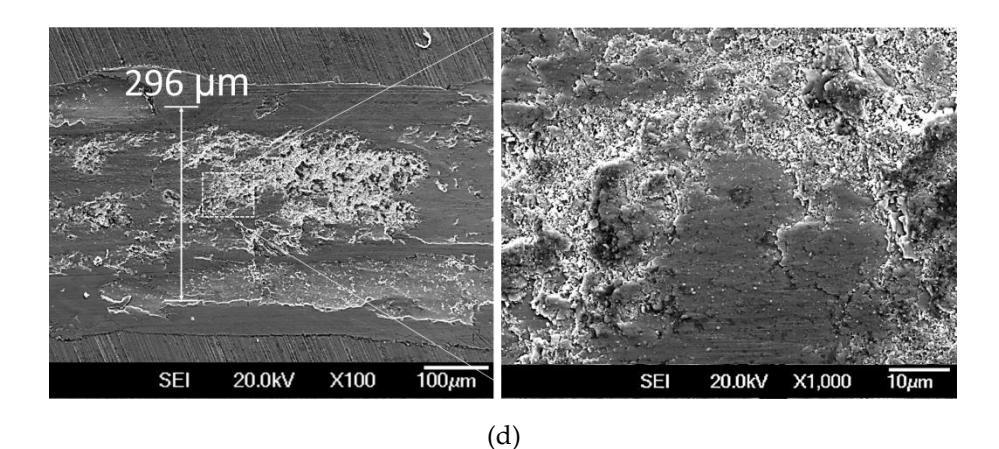
**Figure 9.** SEM images showing morphology of the wear scars: (**a**) HT-D2, (**b**) M4, (**c**) HWS, and (**d**) HT-HWS.

To observe the characteristics of the wear behavior, the surface on which the plastic deformation was induced was observed, as shown in Figure 9. The cemented carbide balls used in the wear test were subjected to repeated loads on the surface at the beginning of the sliding rotation, resulting in elastic and plastic deformations at the surface where friction occurs, thereby generating wear particles.

The wear behavior characteristics are affected by the load [17] in the wear test and vary depending on the mechanical properties, such as hardness and toughness [18]. These causes are very closely related to the microstructure. In general, a martensitic phase transformation increases the wear resistance of steels [19]. The wear resistance was also affected by carbide particles. As shown in Figure 9a, the comparison of the wear scars revealed that HT-D2 exhibits the largest wear scar because of its relatively low hardness. A high-magnification observation showed that the matrix collapses because of friction, and the wear particles adhere in the direction in which the wear proceeds. On the other hand, M4 with a high hardness exhibited a small scar width in the wear test (Figure 9b). The matrix structure partially collapsed, and a combination of adhesion wear and abrasive wear were observed. However, the weight loss was negligible and the scar width was small, because a martensite structure and fine carbides formed in the matrix. Although the HWS deposits exhibit a similar hardness to that of D2, there was little weight loss in the HWS deposited specimen (Figure 9c). A high-magnification observation showed a collapsed matrix, where the carbide formed along the grain boundary maintained its shape. The M<sub>7</sub>C<sub>3</sub> carbides formed along the grain boundaries were very effective at protecting the matrix on the HWS surface. In addition, the cellular fine microstructure formed by laser melting is considered to be excellent in terms of wear resistance. The wear width of HT-HWS is greater than that of M4 and lower than that of HWS. It can be concluded that the martensite in the matrix of the HT-HWS led to high resistance (Figure 9d).

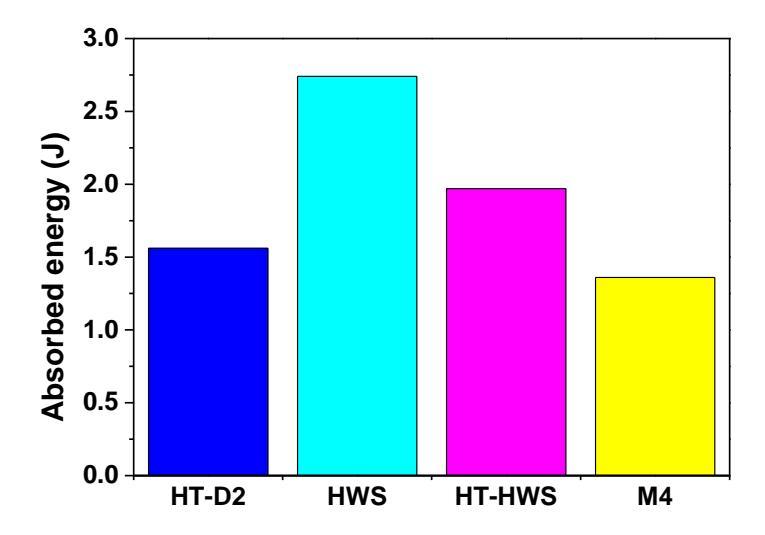
Figure 10. Total absorbed energy in the Charpy impact test.

The Charpy test was performed to evaluate the toughness of the deposited materials. Figure 10 shows the experimental results wherein the toughness values are compared. The Charpy test results show the opposite tendency with respect to the hardness and wear resistance. The total absorption energies of the HT-D2, HWS, HT-HWS, and M4-deposited specimens are 1.56 (SD: 0.01), 2.74 (SD: 0.01), 1.96 (SD: 0.352), and 1.36 (SD: 0.346) J, respectively. The hardness and wear resistance of the M4 deposits are higher than those of the HWS deposits, whereas the impact toughness of HWS is higher than those of HT-D2 and M4. Furthermore, the impact toughness of HT-HWS slightly decreases after the post-heat treatment.

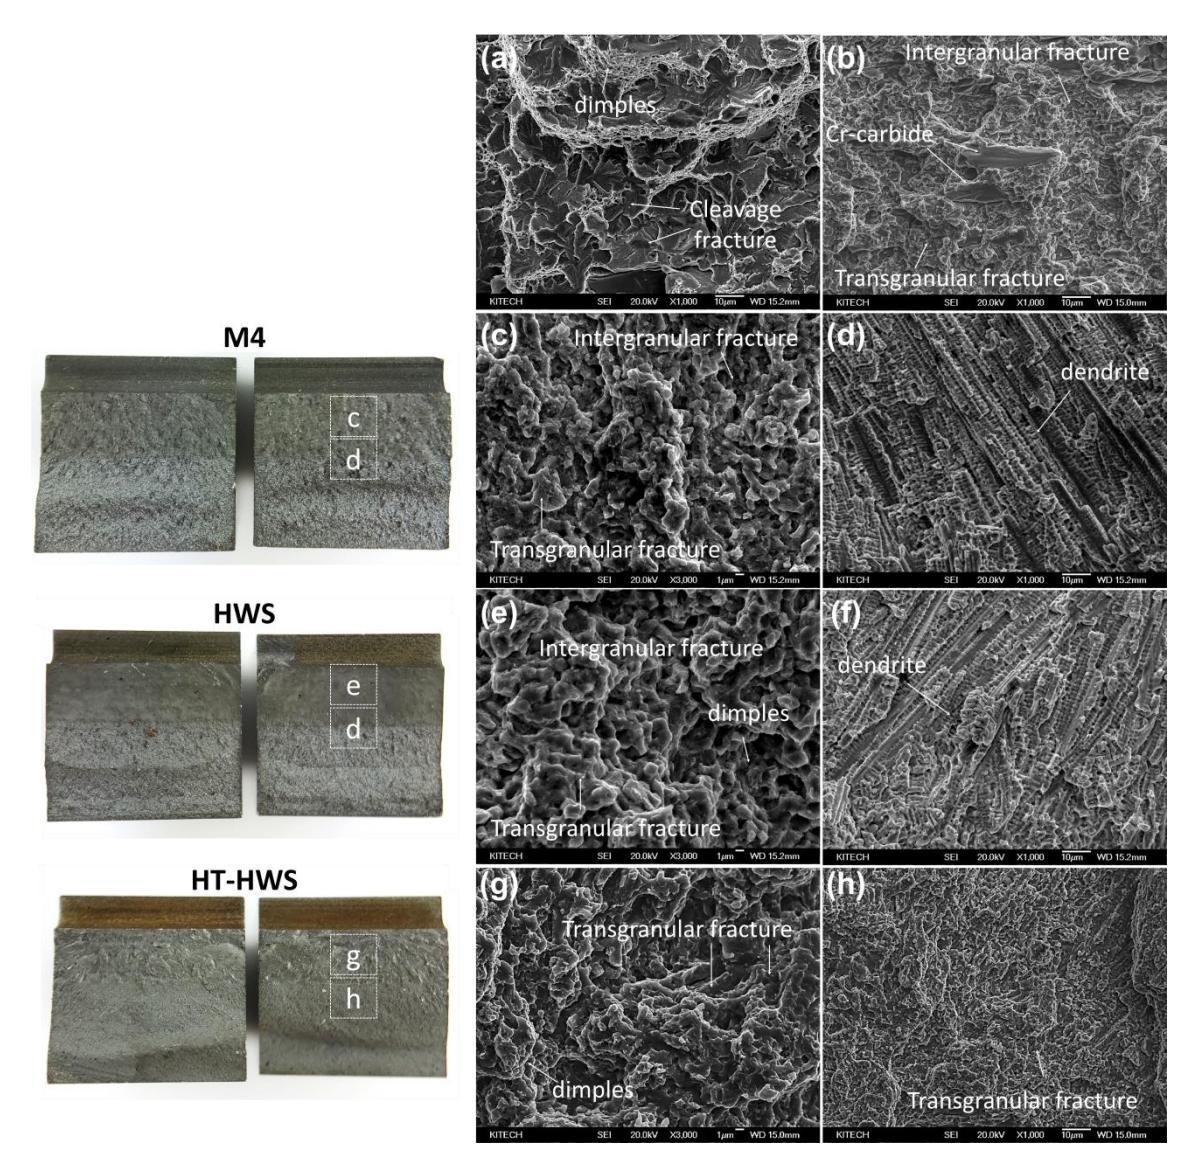
**Figure 11.** Micro-images of the fracture surface: (**a**) Substrate D2, (**b**) HT-D2, (**c**) deposited M4 layer, (**d**) interface of the M4 deposits, (**e**) deposited HWS layer, (**f**) interface of the HWS deposits, (**g**) deposited layer of HT-HWS, and (**h**) interface region of HT-HWS.

Figure 11 shows each of the fractured surfaces. In general, the impact toughness is highly related with the grain boundary and carbides' precipitation behavior. On the fracture surface of the D2 (substrate), cleavage fractures and fine dimples are observed (Figure 11a). Cleavage fractures are mainly observed in ferrite structures, and dimples represent a ductile fracture. A ductile fracture corresponds to a high absorbed energy. The HT-D2 surface exhibits the intergranular and transgranular fractures with fewer fine dimples (Figure 11b). The HT-D2 toughness was lower because the microstructure is transformed to martensite from ferrite by the heat treatment. In the deposited M4 layer (Figure 11c), intergranular and transgranular fractures were observed without dimples and plastic deformation, which shows the typical brittle characteristic. The cracks originating from the V-notch propagated along the grain boundaries and along the dendrite structure at the interface (Figure 11c,d). Figure 11e shows the fracture surface of the HWS-deposited specimen. The fracture behavior is characteristic of a complex intergranular fracture with dimples. Dendrites were observed at the interface of HWS (Figure 11f). Compared to the M4 deposits, fine dimples were observed in the HWS fracture surface because of the microstructure depending on the chemical composition. The highest toughness of HWS is also attributed to the austenitic matrix. The fracture surface of HT-HWS exhibited different crack propagation characteristics. Although the fracture surface of the deposited layer of HT-HWS is similar to that of the HWS deposited layer (Figure 11g), the martensite fraction in the HT-HWS increased and, in the interface region, the primary rod-like carbides precipitated along grain boundaries by the quenching and tempering, which decreases the toughness. In particular, the eutectic carbide aggregated during the post-heat treatment resulted in a concentration of the stresses, causing cracks to propagate more readily between the grain boundaries. Thus, the absorbed energy was reduced compared to that in HWS, while being higher than that of M4.
