Baking Effect on Desorption of Diffusible Hydrogen and Hydrogen Embrittlement on Hot-Stamped Boron Martensitic Steel

Hye-Jin Kim ¹^(b), Hyeong-Kwon Park ¹, Chang-Wook Lee ²^(b), Byung-Gil Yoo ¹ and Hyun-Yeong Jung ^{1,3,*}

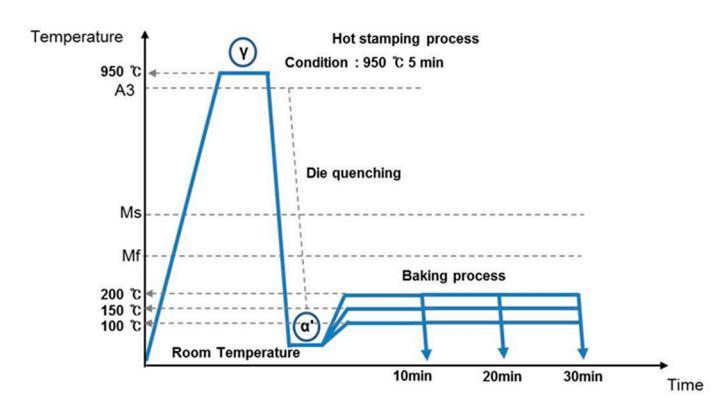
Figure 1. Schematic diagram of hot stamping process and baking conditions.

These samples were austenized for 5 min at 950 °C while keeping the dew point at +5 °C in a furnace. To transform the microstructure and the dramatic hardness value, blanks were austenized for 5 min at 950 °C in a furnace made by Shin-Sung company in Korea. Then, the baking process was performed right after hot stamping. The conditions of baking were as follows: The differential temperatures were 100, 150, and 200 °C (labeled as specimens BH100, BH150, and BH200), and the differential times were 10, 20, and 30 min. Figure 1 shows the hot stamping and baking procedure.

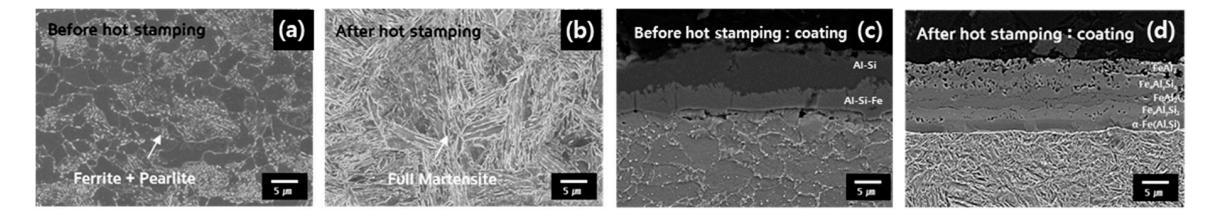
Figure 2. Micrographs of microstructure and coating as hot stamping procedure: (**a**) Microstructure before hot stamping, (**b**) microstructure after hot stamping, (**c**) composition of coating layers before hot stamping and (**d**) composition of coating layers after hot stamping.

To analyze the martensitic phases, all specimens were etched in a Nital solution. Micrographs of the hot-stamped steels are shown in Figure 2 before and after the hot stamping procedure. As shown in Figure 2, the as-received initial cold-rolled blanks had a pearlitic-ferritic dual phase before the hot stamping procedure. In the furnace, the microstructure had an austenitic phase. The final automotive parts had a fully martensitic microstructure with a grade of 1800 MPa, and the Al–Si coating was fully transformed into Fe_x –Al_y–(Si) compounds after hot stamping as shown in the Figure 3c,d. Table 2 lists the original mechanical properties with a typical tensile test in a specimen worked from the 300 × 300 sheet plates. The final specimens had a fully martensitic microstructure with a grade of 1800 MPa and an elongation with a value of about 8 El.%.

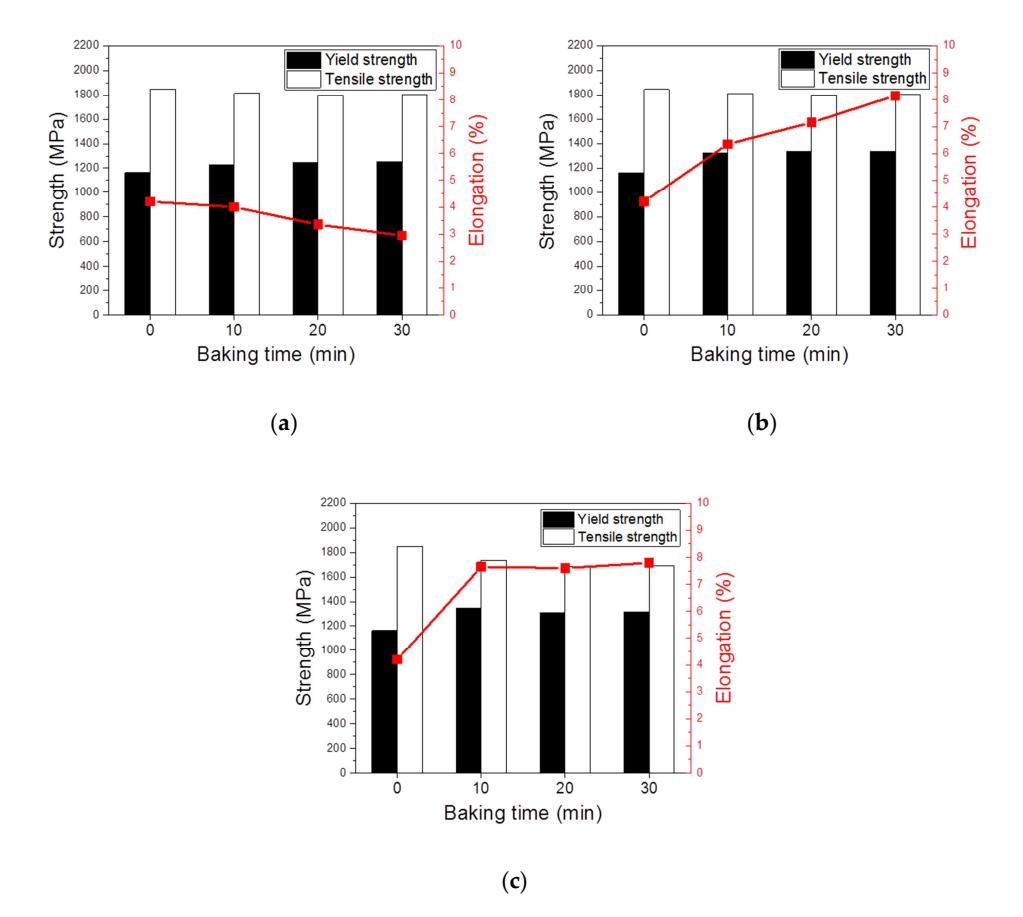
Figure 3. Effect of baking on estimated stress-strain curve depending on temperature and time of baking: (a) BH100 conditions, (b) BH150 conditions, and (c) BH200 conditions.

Right after the hot stamping and baking procedures, SSRTs were conducted for all specimens. Figure 3 shows the stress-strain values of SSRTs for the studied alloys and for differential baking conditions, and plots the actual estimated values of the yield strength, ultimate tensile strength, and elongation corresponding to the stress-strain curves for all specimens. The as-received alloys exhibited elongation reduction (4 El. %) with a hydrogen inflow right after hot stamping without an additional baking process, compared to the above 8%-El. % elongation value, whose specimen had no hydrogen inflow in the steels. Based on the estimated elongation values listed in Table 2, the tendency of elongation loss (El. loss), which indicates the degree of susceptibility of hydrogen embrittlement, was observed in the total elongation as a result of the baking conditions for each specimen.

Figure 3 shows the plots of the estimated elongation including the total elongations of those specimens that were charged with hydrogen in a furnace and those that were removed by the baking process. As shown in Figure 3, the BH100 conditions exhibited a reduction in the elongation loss after hydrogen charging from the identical to the as-received state. However, the BH150 and BH200 conditions exhibited a major increase in the elongation recovery, indicating a decrease in susceptibility to hydrogen embrittlement. When baking at 100 °C, as shown in Figure 3a, there was a slight loss of elongation as the baking time increased from 10 min to 30 min. The tensile strength had similar values for all baking times, and the yield strength increased depending on the baking time.

On the other hand, the BH150 conditions exhibited a proportional increase of reduction in elongation with similar tensile strength as shown in Figure 3b. In the case of the yield strength, the increase in this value occurred after baking for 10 min, but it maintained similar values as the baking time increased. In particular, as shown in Figure 3c, the BH200 conditions showed the most effective impact on the recovery of elongation with a short baking time of 10 min. The figure shows the original elongation in all conditions from 10 min to 30 min for the BH200 conditions. The yield strength increased with the same behavior shown in BH150 specimen, but there was some reduction in the ultimate tensile strength under the target value of 1800 MPa after baking for all specimens.

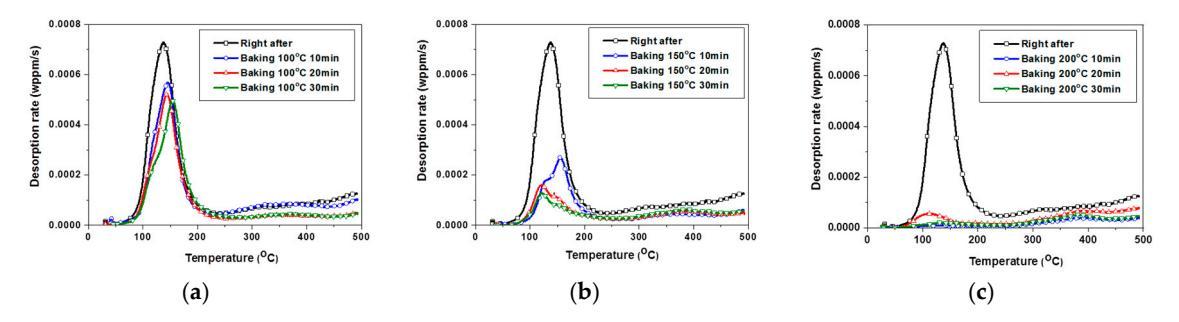
Figure 4. Thermal desorption spectroscopy (TDS) graph of hydrogen desorption behavior corresponding to baking temperature: (**a**) BH100 specimens, (**b**) BH150 specimens, and (**c**) BH200 specimens.

In our results, the reversible hydrogen content was mainly decreased by increasing the baking time and temperature, but the irreversible hydrogen content maintained a similar value regardless of the baking conditions for all specimens, as shown in Figure 4. For the BH100 specimens, no considerable difference in the hydrogen content appeared, and there was little desorption of hydrogen as the baking time increased, as shown in Figure 4a. The diffusible hydrogen in the BH150 specimens was released at a proportional tendency as the baking time increased from 10 min to 20 min compared with those under the BH100 conditions and the as-received specimens without baking. However, the desorption behavior between 20 min and 30 min was similar, with the same values of hydrogen content. The desorption behavior of diffusible hydrogen in the BH200 specimens indicated complete removal of the remaining hydrogen after baking regardless of the baking time, and it recovered up to non-charging cold-rolled specimen before hot stamping.

The hydrogen peaks of the desorption curves for all of the alloys occurred mainly at temperatures below 300 °C, acting as diffusible hydrogen with low activation energies. Table 3 and Figure 5 show the accumulated hydrogen content as separated into reversible trapping depending on the hydrogen charging conditions for all specimens below 300 °C. As shown in Figure 5a, the concentration of reversible hydrogen content is decreased by increasing the baking time and temperature compared with that (0.4 wppm) of the as-received state without the baking process. Figure 5b shows the ratio of remaining hydrogen compared with that of the as-received state. In the case of the BH100 conditions, the diffusible hydrogen concentration decreased slightly by up to 0.3 wppm with 80% remaining hydrogen after baking for 30 min. However, based on the SSRT tests, it was difficult for this desorption with a lower reduction of diffusible hydrogen to recover the elongation.

For the BH150 conditions, the diffusible hydrogen was proportionally reduced with an increase in baking time for 20 min and reached about 0.1 wppm, corresponding to a reduction in the remaining hydrogen with a value of about 20%. However, the hydrogen behavior after baking for 30 min was similar to that for 20 min of baking. For the BH200 specimens, the diffusible hydrogen under all baking times was completely removed up to about 0.05 wppm under remaining hydrogen of about 10%, corresponding to the cold-rolled state before hydrogen charging in a furnace. Based on the SSRTs, the recovery of the elongation reduction occurred completely in the BH200 specimens. This demonstrates that a short baking time at 200 °C is most effective for removing the diffusible hydrogen. However, baking at this temperature causes some reduction in the ultimate tensile strength under 1800 MPa, as shown in the above SSRT tests.

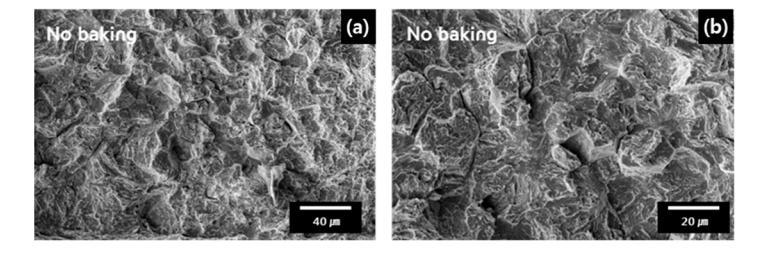
Figure 6. Fractography of slow-strain-rate tensile test (SSRT) specimens after tensile test of as-received state right after hot stamping process: (a) Brittle section of fracture surface and (b) enlarged section.

It can be observed in Figure 6a that there is a strong tendency between diffusible hydrogen and hydrogen embrittlement as it is all brittle-intergranular showing the severity of degradation. This is significantly related to segregation and pile-up hydrogen concentration at strong reversible trap sites such as the austenite grain boundary, as shown in Figure 6b. This mainly signifies that the crack initiation and propagation procedure in martensitic steels are entirely hydrogen-facilitated. The most pronounced portion of intergranular fractures occurs with a hairline crack in the crack initiation regions.

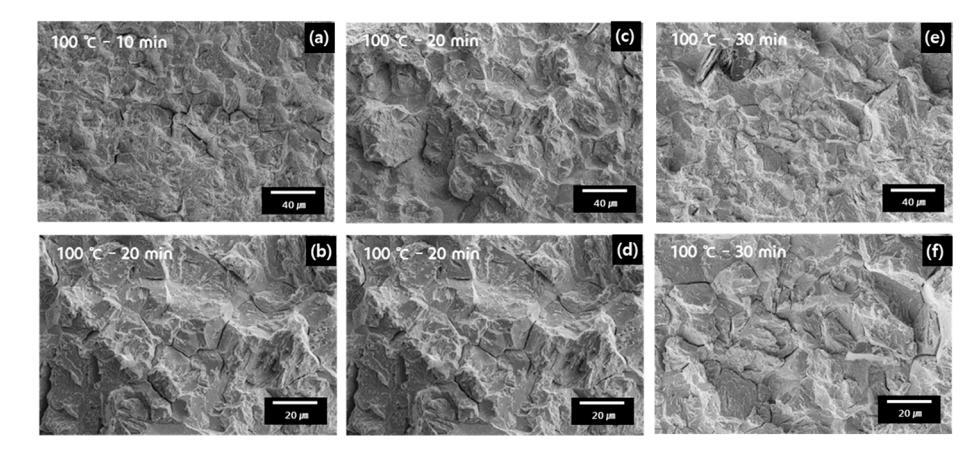
Figure 7. Fractography of SSRT specimens after tensile test of BH100 specimens after hot stamping and baking process: (a) Brittle section of fracture surface and (b) enlarged section in BH100 at 10 min, (c) brittle section of fracture surface and (d) enlarged section in BH100 at 20 min, and (e) brittle section of fracture surface and (f) enlarged section in BH100 at 30 min.

Figure 7 shows similar behavior as that of the as-received specimen regardless of baking time in the BH100 specimens, and crack propagation along mainly intergranular fractures with many brittle facets, as shown in Figure 7a,c,e. It seems that there is no strain of grain shape because this sample is cracking under elastic stress. In martensitic steels, the intergranularity combined with quasi-cleavage features are dominant, and flat facets of grains mixed with cleavage are also observed in some regions. Thus, crack initiation and propagation occur under the influence of combined diffusible hydrogen and the stress field in localized regions. As shown in Figure 7b,d,f, the same fracture behavior with intergranular facets and hairline cracks in boundaries is observed for different baking times from 10 to 30 min. This indicates that the BH100 specimens and their conditions are not effective for improving the hydrogen embrittlement in this study.

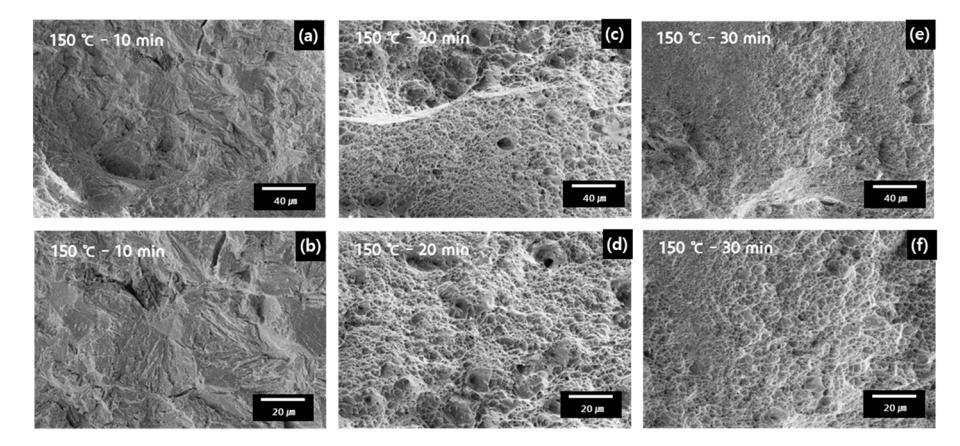
Figure 8. Fractography of SSRT specimens after tensile test of BH150 specimens after hot stamping and baking process: (a) Brittle section of fracture surface and (b) enlarged section in BH150 at 10 min, (c) brittle section of fracture surface and (d) enlarged section in BH150 at 20 min, and (e) brittle section of fracture surface and (f) enlarged section in BH150 at 30 min.

Meanwhile, the BH150 specimens show a threshold baking time in the ductile-to-brittle transition depending on the increase in baking time, as shown in Figure 8. The BH150 specimen at 10 min shows a still-brittle region in the fracture surface, as shown in Figure 8a,b. It appears that the remaining diffusible hydrogen plays a role in the embrittlement in this range of hydrogen concentration. However, in the BH150 specimen at 20 min, a transition of fractography was observed with mainly ductile fractures and microvoid ductile occurrences even though the remaining hydrogen existed at about 20%, as shown in Figure 8c. This indicates a mixed mode of microvoid coalescence, with several large flat regions connected to small areas of small ductile dimples, as shown in Figure 8d.

In addition, the fracture surface of the BH150 specimen at 30 min displays numerous ductile dimples and a small amount of cleavage. This is a similar tendency to the BH150 specimen at 20 min, as shown in Figure 8e,f. Additionally, the crack stabilization region from the center to the edge areas primarily displays microvoid coalescence failure with a ductile dimple. This indicates that the reduction of diffusible hydrogen is effective to generate unusual crack propagation that can stabilize the hydrogen movement and prevent brittle failure during tensile testing by glide plane decohesion, as observed under these conditions.

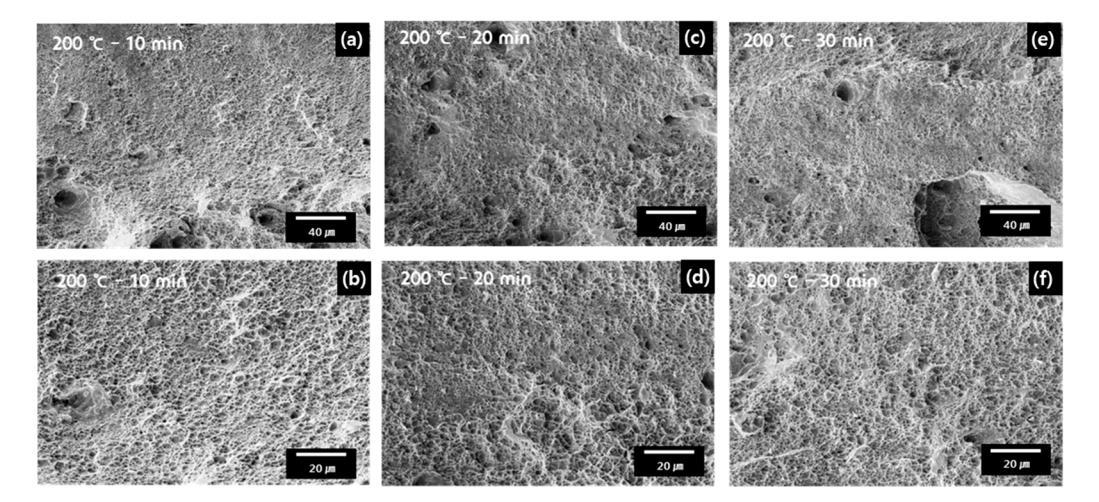
Figure 9. Fractography of SSRT specimens after tensile test of BH200 specimens after hot stamping and baking process: (a) Brittle section of fracture surface and (b) enlarged section in BH200 at 10 min, (c) brittle section of fracture surface and (d) enlarged section in BH200 at 20 min, and (e) brittle section of fracture surface and (f) enlarged section in BH200 at 30 min.

The BH200 specimens exhibit total recovery with the usual ductile fracture mode at all baking times, as shown in Figure 9. The BH200 specimen in a range of 10 min to 30 min shows no brittle region in any region of the fracture surface, as shown in Figure 9a,c,e. In total conditions of the BH200 specimen, a typical ductile-fracture fine dimple in ultrahigh strength steel without a brittle region in the fracture surface is shown in Figure 9b,d,f. It seems that the removal of diffusible hydrogen under 10% is effective to prevent delayed fractures and plays no role in embrittlement in this range of hydrogen concentration.

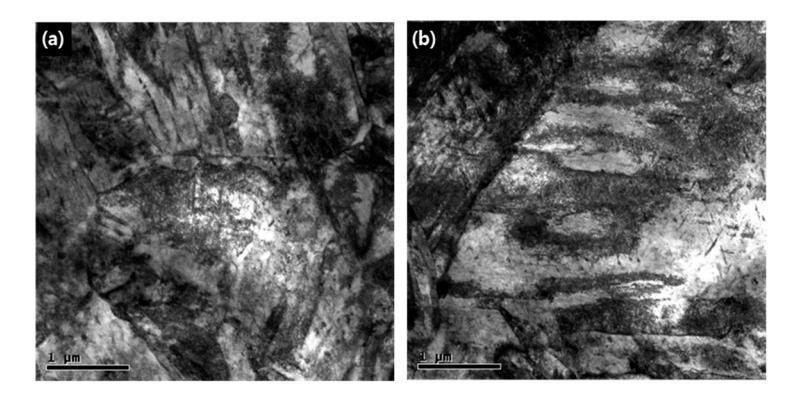
Figure 10. Transmission electron microscopy (TEM) images of martensitic steel: (**a**) As-received specimen after hot stamping and (**b**) specimen after baking process in BH150 for 20 min.

The softening of martensite that occurs during the baking process can be evaluated by comparing the ultimate tensile strength values [33]. Our results show a clear decrease in the R_m values owing to baking under some conditions. This phenomenon can also affect the improvement of hydrogen embrittlement owing to the baking process. However, it is difficult to demonstrate the movement of solute carbon and the reduction of dislocation density in terms of observation of microscopic techniques. Figure 10 shows TEM images of the as-received specimen without baking and the specimen after the baking cycle. It is difficult to observe a meaningful difference depending on the baking as shown in Figure 10b compared with the as-received specimen shown in Figure 10a.
