Article

The Effects of Electrochemical Hydrogen Charging on Room-Temperature Tensile Properties of T92/TP316H Dissimilar Weldments in Quenched-and-Tempered and Thermally-Aged Conditions

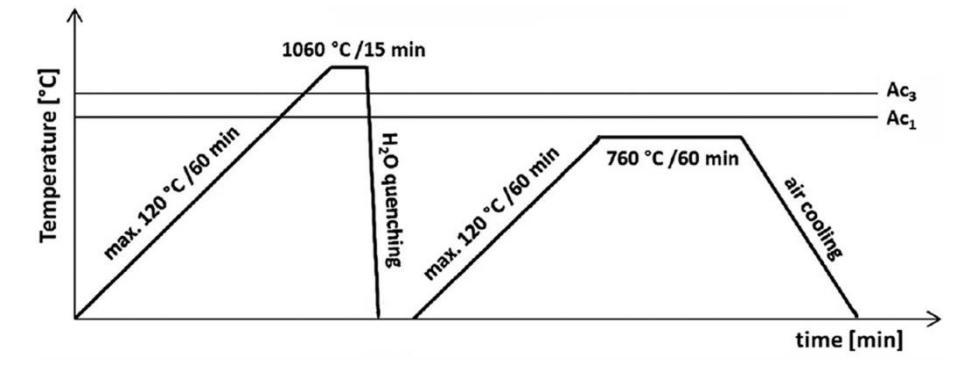
Figure 1. Scheme of unconventional "quenching-and-tempering" post-welding heat treatment (QT PWHT).

In the present study the same type of T92/TP316H dissimilar weldment was investigated as was also studied in our preceding work [14] about the ageing effects on its room-temperature tensile properties and fracture behavior. The tubes (outer diameter 38 mm, wall thickness 5.6 mm) of T92 tempered martensitic and TP316H austenitic heat-resistant steels were circumferentially welded in the company SES a.s. Tlmače, Slovakia by gas tungsten arc welding (GTAW) technique using "Inconel-type" filler metal Thermanit Nicro 82. The details concerning the weld preparation can be found in [14]. Chemical composition of individual base materials and Ni-based filler metal (Thermanit Nicro 82) is shown in Table 1. The produced weldments were subjected to unconventional QT PWHT (see Figure 1).

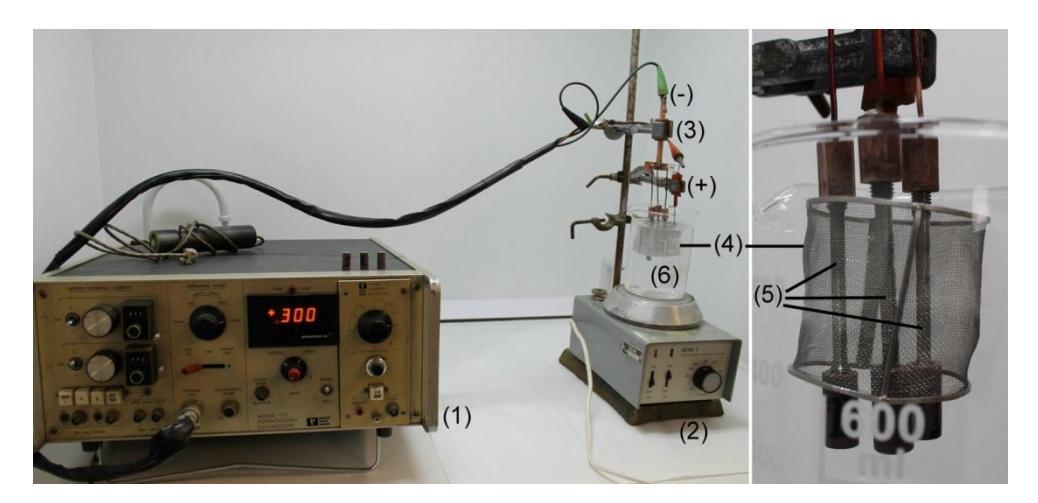
Figure 2. Experimental apparatus for electrochemical hydrogen charging: (1) potentiostat, (2) solute mixer, (3) samples holder, (4) platinum mesh electrode, (5) tensile samples, (6) electrolytic solution.

In the present investigation, two heat-treated material states of the weldment were considered, namely the initial "QT PWHT" state and thermally-aged "QT PWHT + 620 °C/2500 h" state. Both these material states were separately investigated in hydrogen-free and hydrogen-charged conditions. Electrochemical (cathodic) hydrogen charging of prepared cylindrical cross-weld (c-w) tensile specimens (M6 head, 4 mm in body diameter, 40 mm gauge length) was realized during 24 h, at ambient temperature in electrolytic solution of 1 M HCl with 0.1 N N₂H₆SO₄ at a current density of 300 A·m⁻². At once, three tensile specimens were hydrogen charged (see Figure 2), prior to tensile testing at room temperature.

The used experimental procedure has been optimized during our previous experience [25] which indicated full saturation of tensile specimens by hydrogen after 24 h of cathodic hydrogen charging. In the study of Nguyen et al. [29] it was observed that hydrogen concentration in 316L stainless steel reached its maximum after 24 h of cathodic charging. Experimental material in our study consists of joints of the two systems, T92 with bcc structure and the second one with fcc structure (Ni WM and TP316H). Because of the higher activation energy of diffusion in fcc structures, the diffusivity of hydrogen in fcc iron is lower than that in bcc iron [30]. Therefore, the selected time of electrochemical hydrogen charging in this study is quite reasonable.

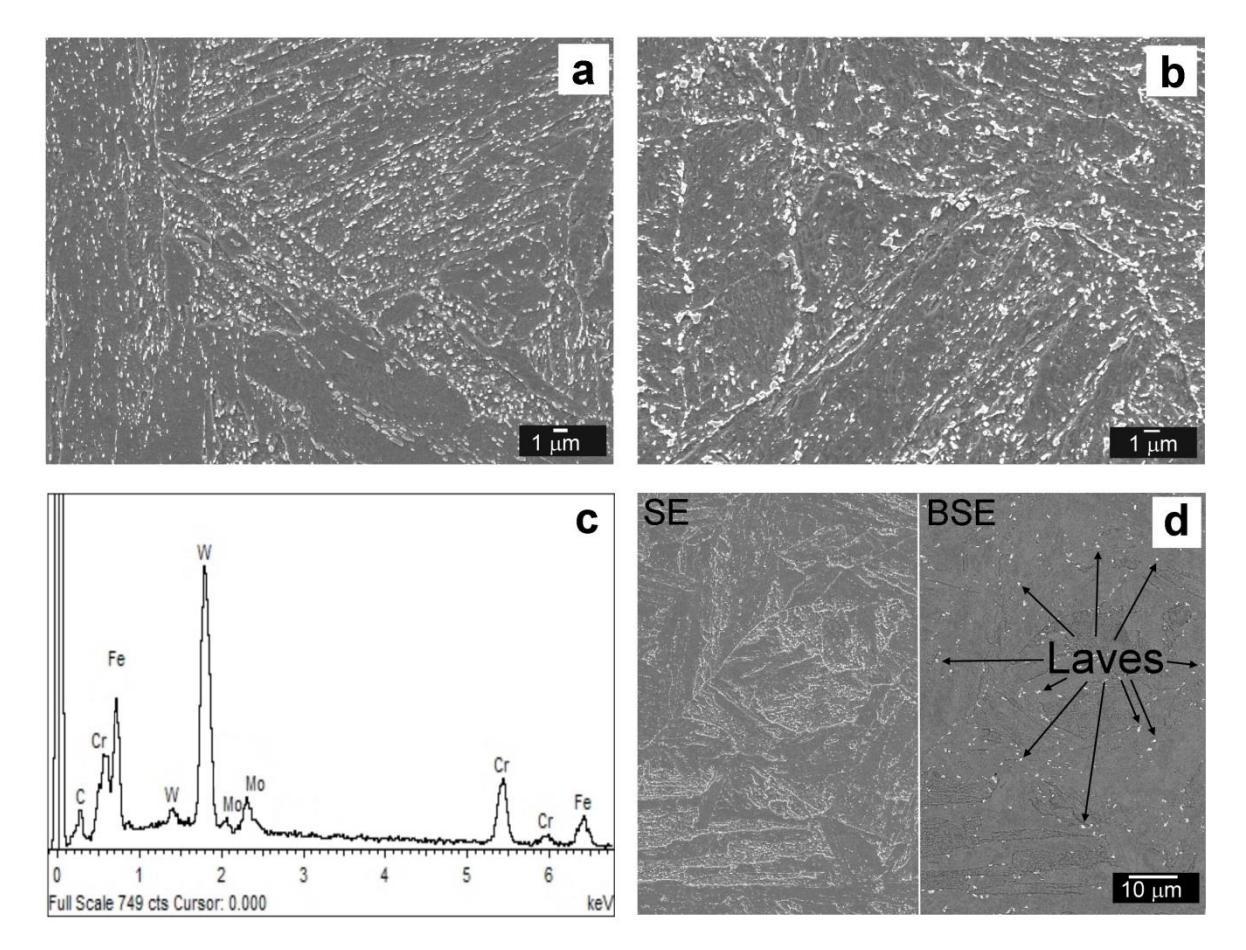
Figure 3. Microstructural characterization of the T92 base material (BM) region in different material states: QT PWHT (**a**); QT PWHT + 620 °C/2500 h (**b**) with typical EDX spectrum of $Fe_2(W,Mo)$ based Laves phase precipitates (**c**) and distribution of coarse Laves phase particles visualized in secondary electrons (SE) mode and back-scattered electrons (BSE) mode (**d**).

The microstructure of the T92 BM region in QT PWHT state (Figure 3a) consists of tempered martensitic laths inside the blocks and packets structures within prior austenitic grains. In thermally-aged T92 BM microstructure (Figure 3b) typical features of microstructure recovery have been indicated such as lath widening and/or formation of new subgrains. As it was discussed in our

previous paper [14], the phase composition of the T92 BM region in its initial condition consists of ferrite matrix and secondary phase precipitates $M_{23}C_6$ (M = Cr, Fe, ...) and MX (M = V, Nb, X = C, N) carbo-nitrides. As indicated by EDX analysis (Figure 3c), thermal aging led to additional precipitation of Fe₂(W,Mo) Laves phase and its rapid coarsening (Figure 3d). The results of microstructure and phase analyses are in agreement with the results of other studies about Grade 92 tempered martensitic steels published previously [31–36].

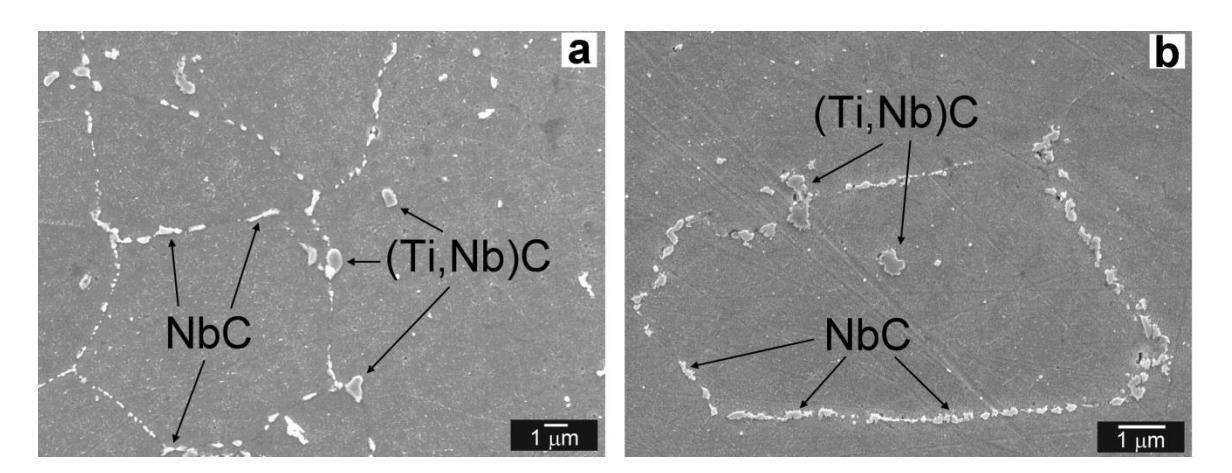
Figure 4. Microstructure of the Ni weld metal (WM) (Thermanit Nicro 82) region, states: QT PWHT (**a**); QT PWHT + 620 °C/2500 h (**b**).

The Ni WM region in QT PWHT state (Figure 4a) consists of "nickel-austenite" matrix with primary (Ti,Nb)(C,N) and (Ti,Nb,B)(C,N) precipitate particles [14] and secondary precipitates of mostly NbC type [14]. In Ni WM region located close to the T92 BM/Ni WM interface, grain-boundary carbides of $Cr_{23}C_6$ type have also been detected [14]. The primary precipitates were distributed randomly within Ni WM microstructure, i.e., they were located on grain boundaries as well as in grain interiors. Regardless of slight precipitate coarsening and thermally-activated grain boundaries migration, the microstructure of thermally-aged Ni WM (Figure 4b) preserved its original heterogeneous features as observed in its initial QT PWHT state. Near the T92/Ni WM interface parallel to the fusion boundary, a so-called "Type-II boundary" was observed in initial Ni WM microstructure (Figure 5a). The Type-II boundary is a specific microstructural object typically observed in Ni WM interfacial microstructure of Ni-based transition weldments [37–39]. The Type-II boundary formation in such dissimilar welded joints is known to be related to the phase transition of δ -bcc crystal structure of the base metal to γ -fcc phase during welding. As it was shown by Nelson et al. [40] and Lippold et al. [41], during allotropic δ -to- γ -transformation in austenite temperature range, a δ/γ boundary becomes a γ/γ boundary and it migrates into the weld metal as a result of temperature and compositional gradient. During thermal aging, the Type-II boundary can migrate further away from the fusion boundary [42]. This behavior was observed also in the present work (Figure 5b).

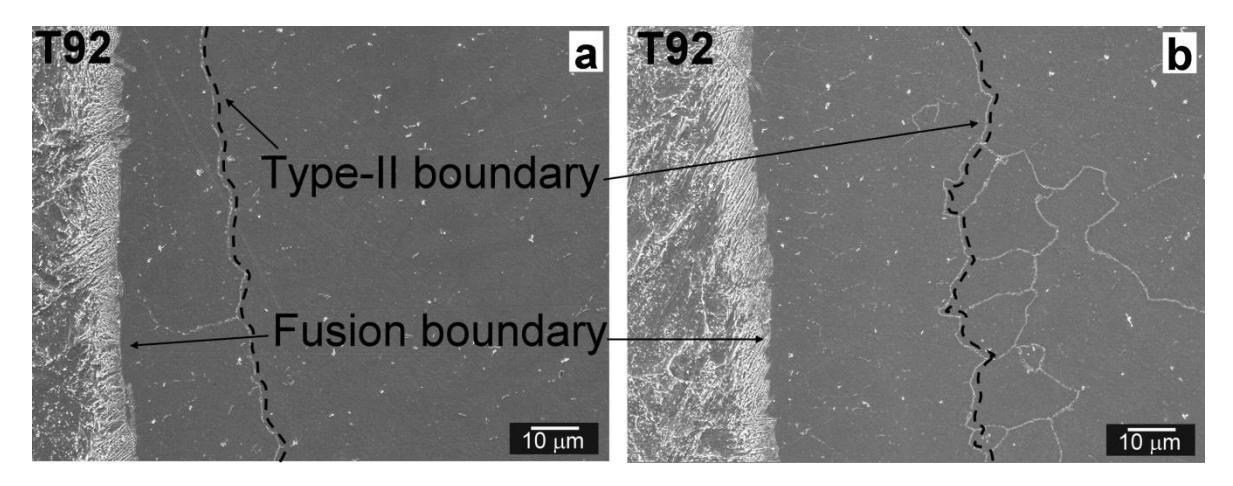
Figure 5. Microstructure of the Ni WM near T92 BM/Ni WM interface: Type-II boundary in initial QT PWHT material state (**a**); and migrating Type-II boundary observed after 620 °C/2500 h of thermal aging (**b**).

1. Type-II boundary was observed in the microstructure of Ni-based weld metal parallel to the T92 BM/Ni WM fusion boundary at a distance of about 10–20 μ m from the fusion boundary. The occurrence of Type-II boundary migration has been indicated after performed thermal exposure;

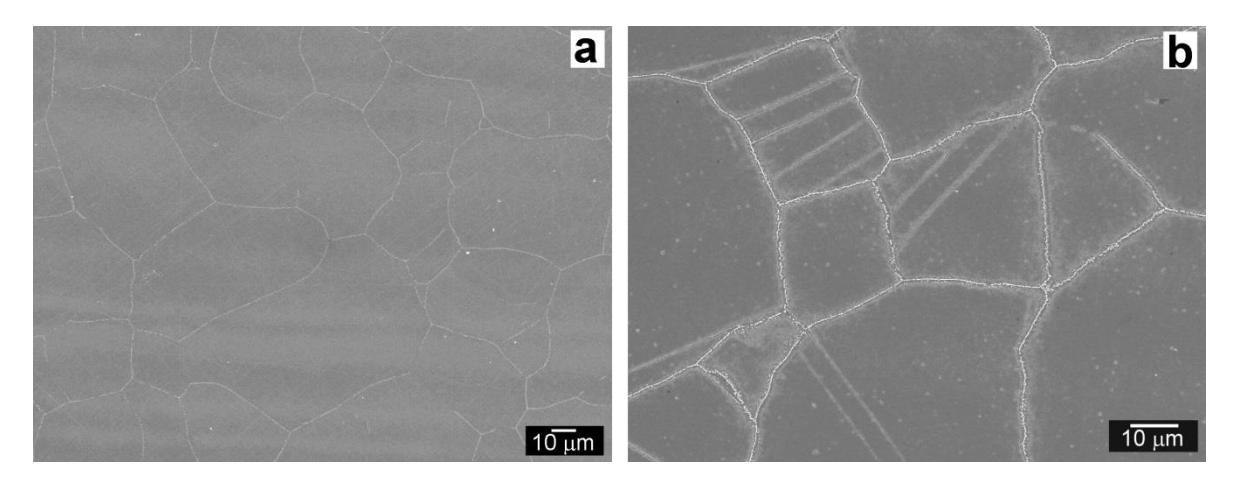
Figure 6. Microstructure of TP316H BM region, states: QT PWHT (a); QT PWHT + 620 °C/2500 h (b).

The TP316H BM region in QT PWHT state (Figure 6a) is formed of polygonal recrystallized austenitic grains with secondary phase precipitates of $M_{23}C_6$ carbide on grain boundaries [14]. The same phase composition was also observed in other studies on similar types of AISI 316 grade austenitic steels [43,44]. An obvious consequence of thermal exposure of austenitic TP316H BM is related to a formation of annealing twin boundaries after performed ageing (Figure 6b).

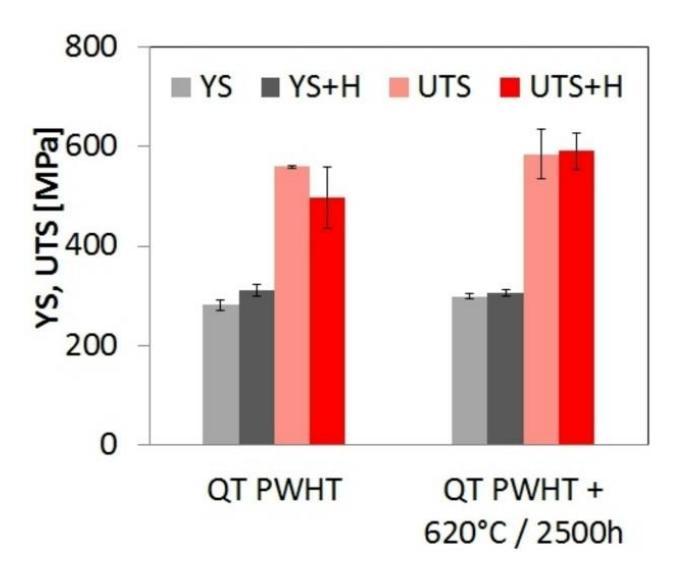
Figure 7. Effects of isothermal aging at 620 °C and electrochemical hydrogen charging on the room-temperature strength properties of T92/TP316H dissimilar weldments (YS—yield stress, UTS—ultimate tensile strength).

Figures 7 and 8 show the effects of isothermal aging at 620 °C and subsequent electrochemical hydrogen charging at room-temperature on tensile properties of the investigated weld joints. Figure 7 shows a variation of strength properties (YS and UTS), whereas Figure 8 shows a variation of plastic properties (EL, RA). The results presented in Figure 7 show that applied thermal exposure of studied weldments resulted in negligible changes of their strength properties (YS and UTS). Such a behavior is commonly observed for 9-12Cr heat resistant steels, austenitic steels, and their weld joints [13,26,28,31,39,45]. After the application of hydrogen charging, the values of YS and UTS were only slightly affected. The individual values varied within the range of their standard deviations. Rosenberg and Sinaiová [46] reported that influence of hydrogen on mechanical properties depends on the used mechanical testing conditions. However, they showed that for aged smooth specimens of high strength steels, hydrogenation practically did not affect the values of YS and UTS which qualitatively agrees with the results of present investigation.

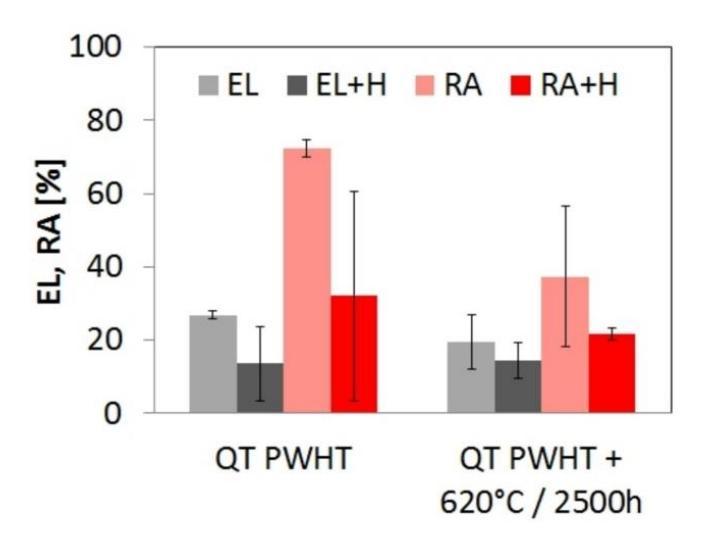
Figure 8. Effects of isothermal aging at 620 °C and electrochemical hydrogen charging on the room-temperature plastic properties of T92/TP316H dissimilar weldments (EL—total elongation, RA—reduction of area at fracture).

On the other hand, Figure 8 shows that the studied weldments exhibit clearly observable degradation of the plastic properties (EL and RA) after thermal aging. In accordance with the results of our previous studies [13,14,28,45], the observed plasticity deterioration can be related to thermal embrittlement effects, such as coarsening of secondary phase precipitates, namely $M_{23}C_6$ carbides and additional precipitation and coarsening of intermetallic Fe₂(W,Mo) Laves phase during thermal aging.

Figure 8 also indicates that hydrogen charging of the weldments resulted in further deterioration of the plastic properties. The mean values of EL and RA in hydrogenated material states drop almost to their half in comparison with the values obtained without hydrogen charging as a consequence of the hydrogen embrittlement [47]. The large scatter of plastic properties in Figure 8 is related to the weldments microstructural heterogeneity affecting the localization of plastic deformation and final failure occurrence, which will be discussed later. The corresponding engineering stress–strain curves are shown in Figure 9. It can be seen that the effects of both thermal exposure and hydrogen charging do strongly influence not only the course of individual stress–strain curves but also the final weld failure location. Moreover, it is clearly visible that deformation behavior of the welded joints in both QT PWHT and thermally aged (QT PWHT + 620 °C/2500 h) conditions is significantly deteriorated after hydrogen charging.

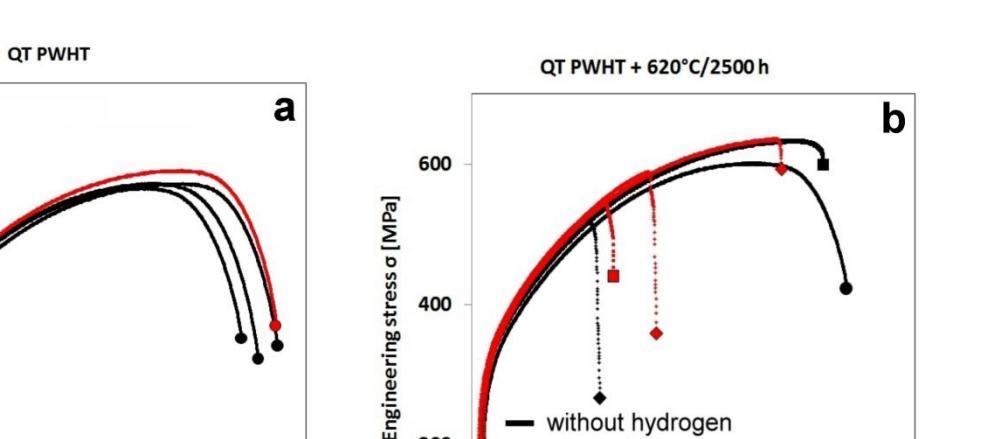
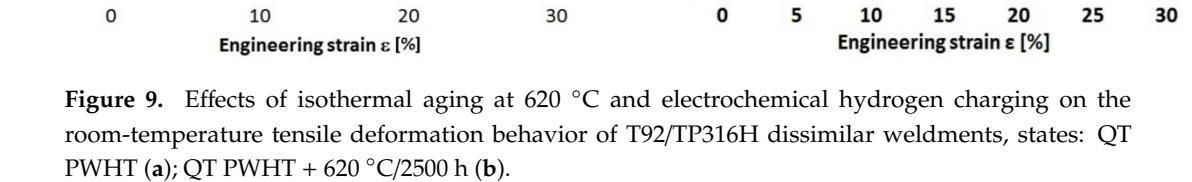
failure at T92/NiWM interface failure in TP316H BM

failure in TP316H BM

failure at T92/NiWM interface

failure at NiWM/TP316H interface

The overview of room-temperature tensile properties and failure locations which occurred after tensile tests for individual material states is summarized in Table 2. Figure 10 represents the results of cross-weld hardness measurements after the tensile tests.

The depicted interruptions in the graphs represent final failure locations, which according to our previous study [14], were found to be related to enhanced local microstructural degradation in specific weld regions by the applied thermal exposure. In the case of thermal ageing effects, it has been clearly indicated that the regions of TP316H BM and Ni WM exhibited mutually competitive tensile straining behavior. However, in the case of hydrogen effect on deformation and fracture behavior, the situation is even more complicated due to different hydrogen trapping capacity of specific microstructural constituents in individual microstructural regions. In hydrogen charged material states, it is reasonable to expect the occurrence of hydrogen-assisted failures in microstructural regions with increased local

hydrogen concentration. In the present study, the most of hydrogen charged tensile specimens were fractured after the room-temperature tensile tests in the vicinity of T92/Ni WM interface. The highly brittle interfacial failures occurred in both QT PWHT and thermally aged, i.e., QT PWHT + 620 °C/2500 h material states which indicated that hydrogen embrittlement effects were not much depending on the application of thermal exposure.

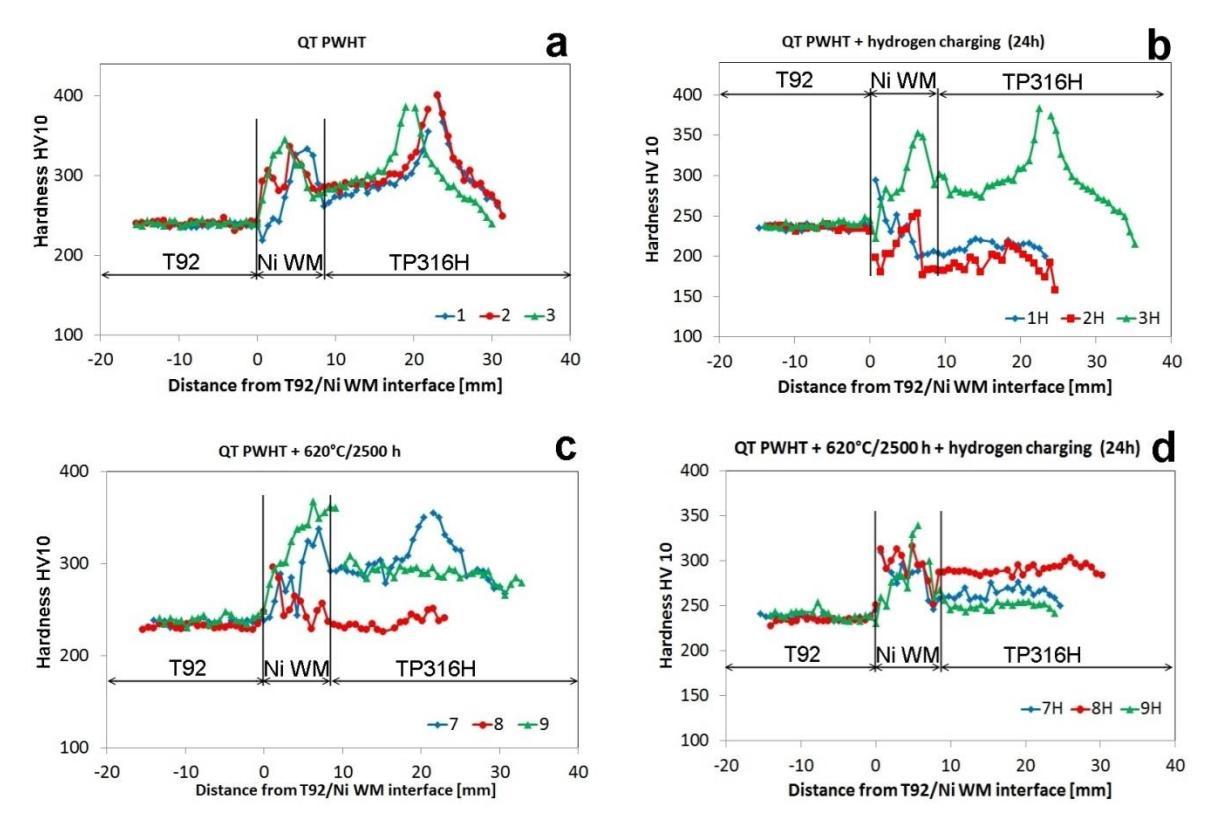
Figure 10. Effects of isothermal aging at 620 °C and electrochemical hydrogen charging at room temperature on the cross-weld hardness profiles determined after room-temperature tensile tests of T92/TP316H dissimilar weldments, states: QT PWHT (**a**); QT PWHT + H (**b**); QT PWHT + 620 °C/2500 h (**c**); QT PWHT + 620 °C/2500 h + H (**d**).

It was observed by Čiripová et al. [14] that in initial QT PWHT state without tensile deformation, the T92 region exhibited notably higher hardness values, compared to both Ni WM and TP316H austenitic regions. However, after room-temperature tensile tests, both TP316H and Ni WM regions showed much higher hardness values compared to those of T92 region. The increased hardness values of both austenitic regions after tensile tests are related to their intensive strain hardening due to their higher strain hardening capacity [48], while the T92 region remained macroscopically unstrained thanks to its significantly higher yielding point. This behavior was also observed for the majority of hydrogen charged test specimens after their tensile straining as well (Figure 10). Although in two specific cases (Figure 10b), the hardness in TP316H austenitic region was lower than that in T92 region, it can confirm the previous statement about strain hardening effect which was here localized in Ni WM region. Both samples of this material state (QT PWHT + H) failed relatively quickly in a brittle manner (Figure 9a) and thus there was not enough time for strain hardening evolution. As it was mentioned above, the failure occurred in the vicinity of the T92/Ni WM boundary. This premature failure can be attributed to the consequence of increased hydrogen inherence at this boundary. It was shown in the previous section that the Type-II boundary arose near the T92/Ni WM fusion line (Figure 5). Yoo et al. [42] observed that narrow zone between the fusion line and Type-II boundary is more susceptible to material degradation than the rest weld metal. Wang et al. [49] showed that Type-II boundary in dissimilar ferrite/austenite weldment cracked first before weld metal necking under tensile strain. Similarly, also other authors [37,38,41] refer to the Type-II boundary as a potential path for crack propagation and failure. The Type-II boundary is a specific type of high angle grain boundary [39,46] and therefore it acts like a reversible hydrogen trap [50]. Since high angle boundaries have lower hydrogen binding energy than precipitates [16], hydrogen is released during tensile straining and it induces the embrittlement [51] and final failure along the Type-II boundary (Figure 11).

The same interpretation can be applied to understanding of the brittle failure after thermal aging and hydrogen charging (Figure 10d).

As it follows from Figures 9a and 10a and Table 2, all samples of the initial QT PWHT state failed during tensile straining in the austenitic TP316H region. Figure 12a represents the fracture surface of the QT PWHT state with ductile dimple areas and some tear ridges as a result of intensive local plastic deformation. After hydrogen charging (state QT PWHT + H), the failure became brittle with the transgranular cleavage character (Figure 12b) and typical signs of hydrogen embrittlement ("fish-eye") on the fracture surface appears (Figure 12c). As it was already mentioned in previous sections, the samples fractured mostly in the fusion zone near the T92 BM/Ni WM interface (see, e.g., Figure 10b).

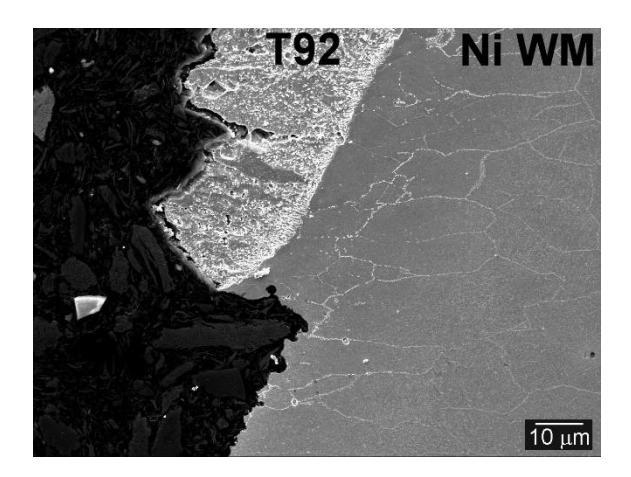
Figure 11. Fracture path along the Type-II boundary and the T92 BM/Ni WM fusion zone, material state QT PWHT + 620 °C/2500 h + H.

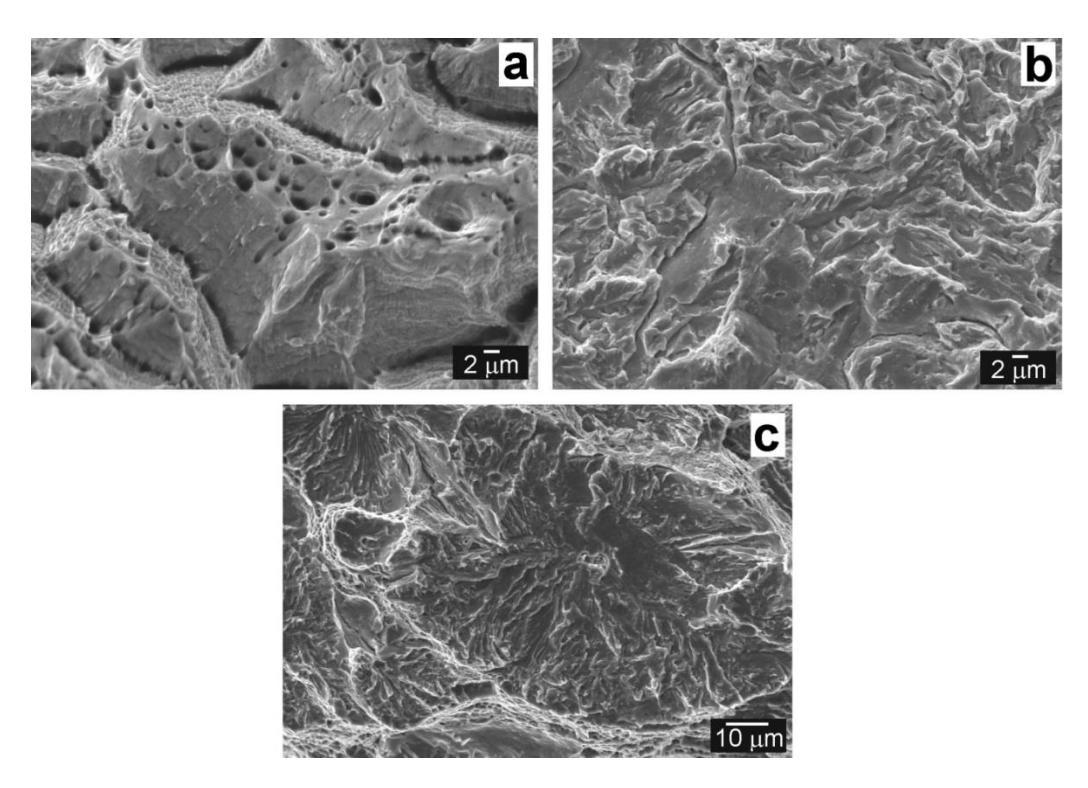
Figure 12. Fracture surfaces of the samples failed after room-temperature tensile test of T92/TP316H dissimilar weldments: state QT PWHT with failure in T316H BM region (**a**); state QT PWHT + H with failure in interfacial region T92 BM/Ni WM (**b**); the view of the "fish-eye" fracture morphology (**c**).

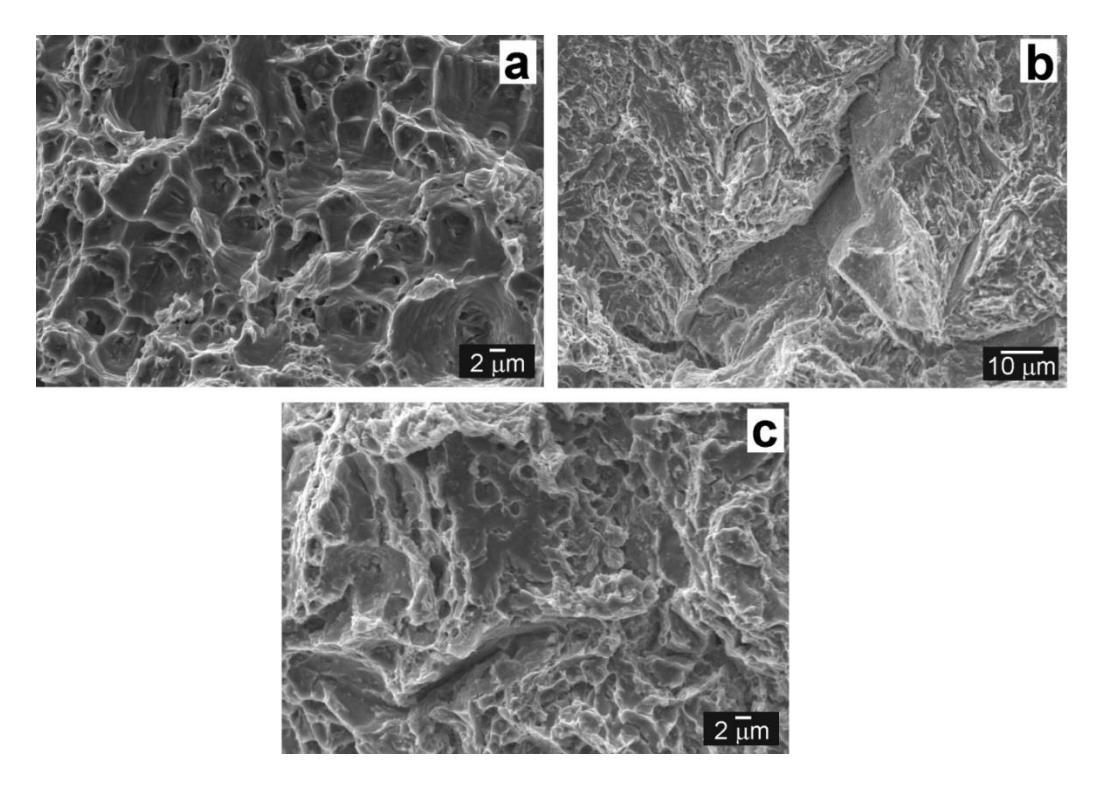
Figure 13. Fracture surfaces of the aged samples failed after room-temperature tensile test of T92/TP316H dissimilar weldments in fusion zone T92 BM/Ni WM: state QT PWHT + 620 °C/2500 h (**a**); state QT PWHT + 620 °C/2500 h + H (**b**); and its detailed view (**c**).

Figure 13 documents the effect of isothermal aging at 620 °C/2500 h and electrochemical hydrogen charging on fracture characteristics of T92/TP316H dissimilar weldments after room-temperature tensile testing. Figure 13a shows the fracture surface of the state QT PWHT + 620 °C/2500 h. The failure of the aged sample can be characterized by ductile dimple tearing with the visible brittle cracked secondary phase particles at the bottom of some dimples (Figure 13a). After hydrogen charging of the aged samples, the signs of observed embrittlement include trangranular cleavage and intergranular decohesion fracture areas (Figure 13b,c). Similarly as in the case of hydrogenated samples without thermal exposure, the most of thermally aged and hydrogen charged samples fractured in the vicinity of T92 BM/Ni WM interface (see Figure 10d).

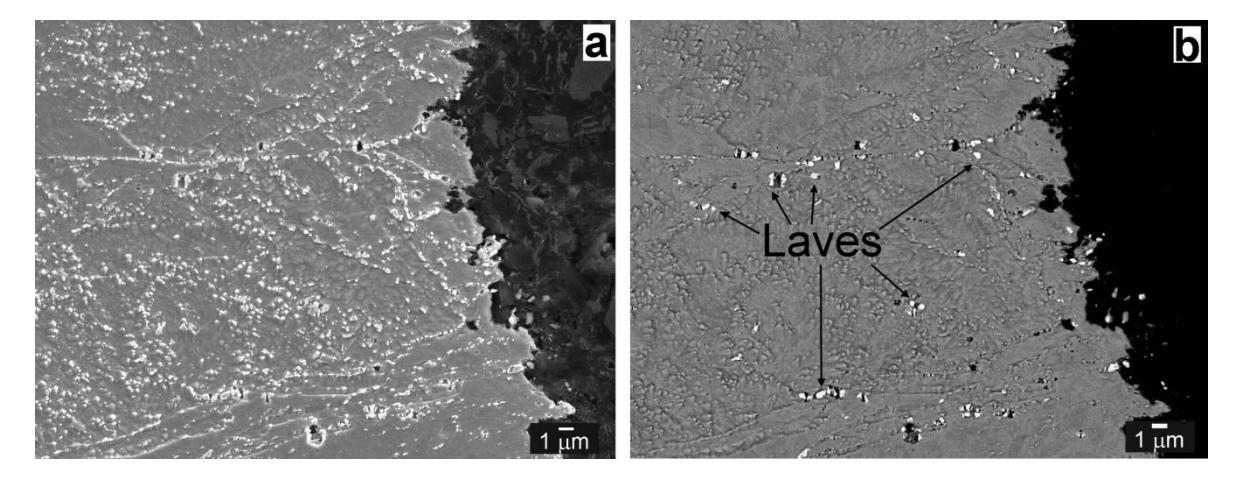
Figure 14. Microstructure and fracture path of the T92 BM region beneath the failure in the vicinity of T92 BM/Ni WM interface, state QT PWHT + 620 °C/2500 h + H: distribution of secondary phase particles in SE mode (**a**) and visualization of Laves phase particles in BSE mode (**b**).

In our present work, the failure of the weldments in both the QT PWHT and QT PWHT + 620 °C/2500 h material states became strongly influenced by hydrogen charging. The fracture surfaces exhibited typical signs of hydrogen embrittlement (Figures 12b and 13b). The failure position of the welds in both material states was located mostly in the vicinity of T92/Ni WM interface. Although one sample of the state QT PWHT + H failed in the TP316H BM region, it may likely be a consequence of local microstructural inhomogeneities in the TP316H BM. It was shown in the previous Section 3.2 that the most of failures of hydrogen embrittlement localization at this type of boundary (Figure 11) as a consequence of the hydrogen embrittlement localization at this type of boundary in Ni WM [37,38,41]. In these cases, the fracture path ran partly also through the T92 BM (Figure 11). The sub-fracture microstructure of the T92 BM region, which failed near the T92 BM/Ni WM boundary, is presented in Figure 14.

The fracture path indicates the presence of both transgranular cleavage and intergranular decohesion fracture mechanisms. Obviously, during tensile straining, the voids arose along the grain boundaries (Figure 14a). Moreover, the cracked secondary phase particles at the grain boundaries can be clearly visible. The preferential secondary phase precipitation and coarsening of the Laves phase particles on grain boundaries is considered the critical factor influencing premature failure of T92 steel in creep loading conditions [7]. In our study it has been confirmed that the highly coarsened secondary phase particles on grain boundaries are mostly the Fe₂(W,Mo) Laves phase particles (see the bright appearing particles in Figure 14b). Similarly, in the microstructure just beneath the fracture surface of Ni WM, the cracked NbC particles and voids formation were observed (Figure 15). Thus, the major mechanism of the plastic properties degradation by hydrogen can be related to the microvoid coalescence, secondary phase particles cracking and final decohesion at matrix/particles interfaces or grain boundaries.

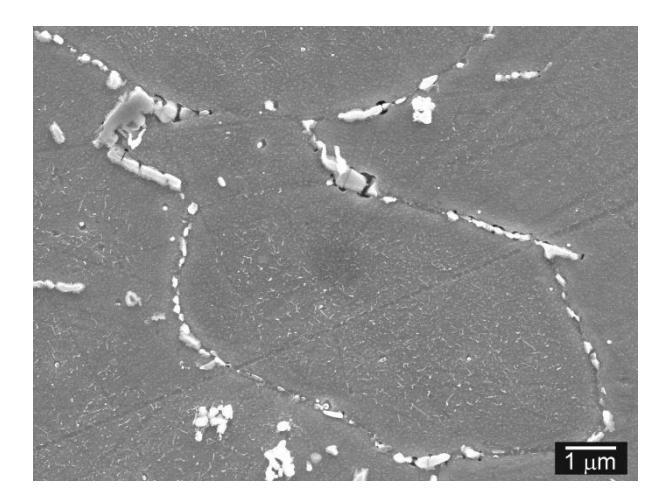
Figure 15. SEM micrograph of Ni WM—detailed view on detached and/or cracked NbC precipitates at grain boundaries.

The complementary analyses of the results obtained from the tensile tests stress–strain data (Figure 9), cross-weld hardness measurements (Figure 10) and fractography (this section) of investigated T92/TP316H dissimilar weldments with Ni-based weld metal after hydrogen charging and tensile straining indicate the competitive behavior between individual weldment regions. Such a behavior between the austenitic TP316H BM and Ni WM regions was also observed by Čiripová et al. [14] for
