A Conceptual Design Approach for Archaeological Structures, a Challenging Issue between Innovation and Conservation: A Studied Case in Ancient Pompeii

Vincenzo Calvanese and Alessandra Zambrano *

Ministry of Culture, Pompeii Archaeological Park, 80045 Pompeii, Italy; vincenzo.calvanese@beniculturali.it * Correspondence: alessandra.zambrano@beniculturali.it

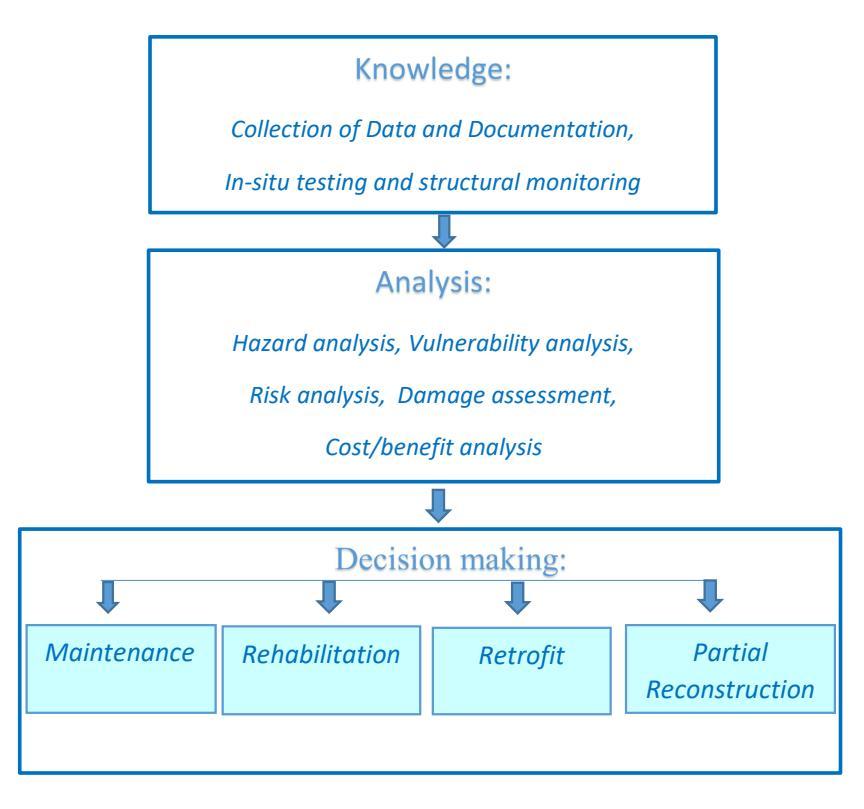
Figure 1. Design process on a historical building.

The structural design of cultural heritage artifacts is conditioned by several constrains: the need to preserve the authenticity of the historical fabric, the presence of decorative surfaces that need to be protected, the existing damage level, the expected benefits and improvement in the structural behavior due to the rehabilitation works, the planned building use, and the time period between two planned consecutive maintenance interventions. The decision making process is clearly articulated, and can be summarized as shown in Figure 1.

Preliminarily, information regarding the material fabric and the construction technique and dimensions of the structures is needed. A measurement survey, experimental testing, studies of previous restoration work documentation, and a hazard analysis to understand the hazards associated with the potential actions are fundamental steps. Then, a structural model permits reliable vulnerability and damage analyses to be performed. The design involves a decision making process, where each possible design solution implies a certain level of intervention, and consequently a corresponding level of safety. Herein, four levels of intervention for archaeological structures have been identified: maintenance, rehabilitation, retrofit, dismantling and reconstruction (generally partial reconstruction).

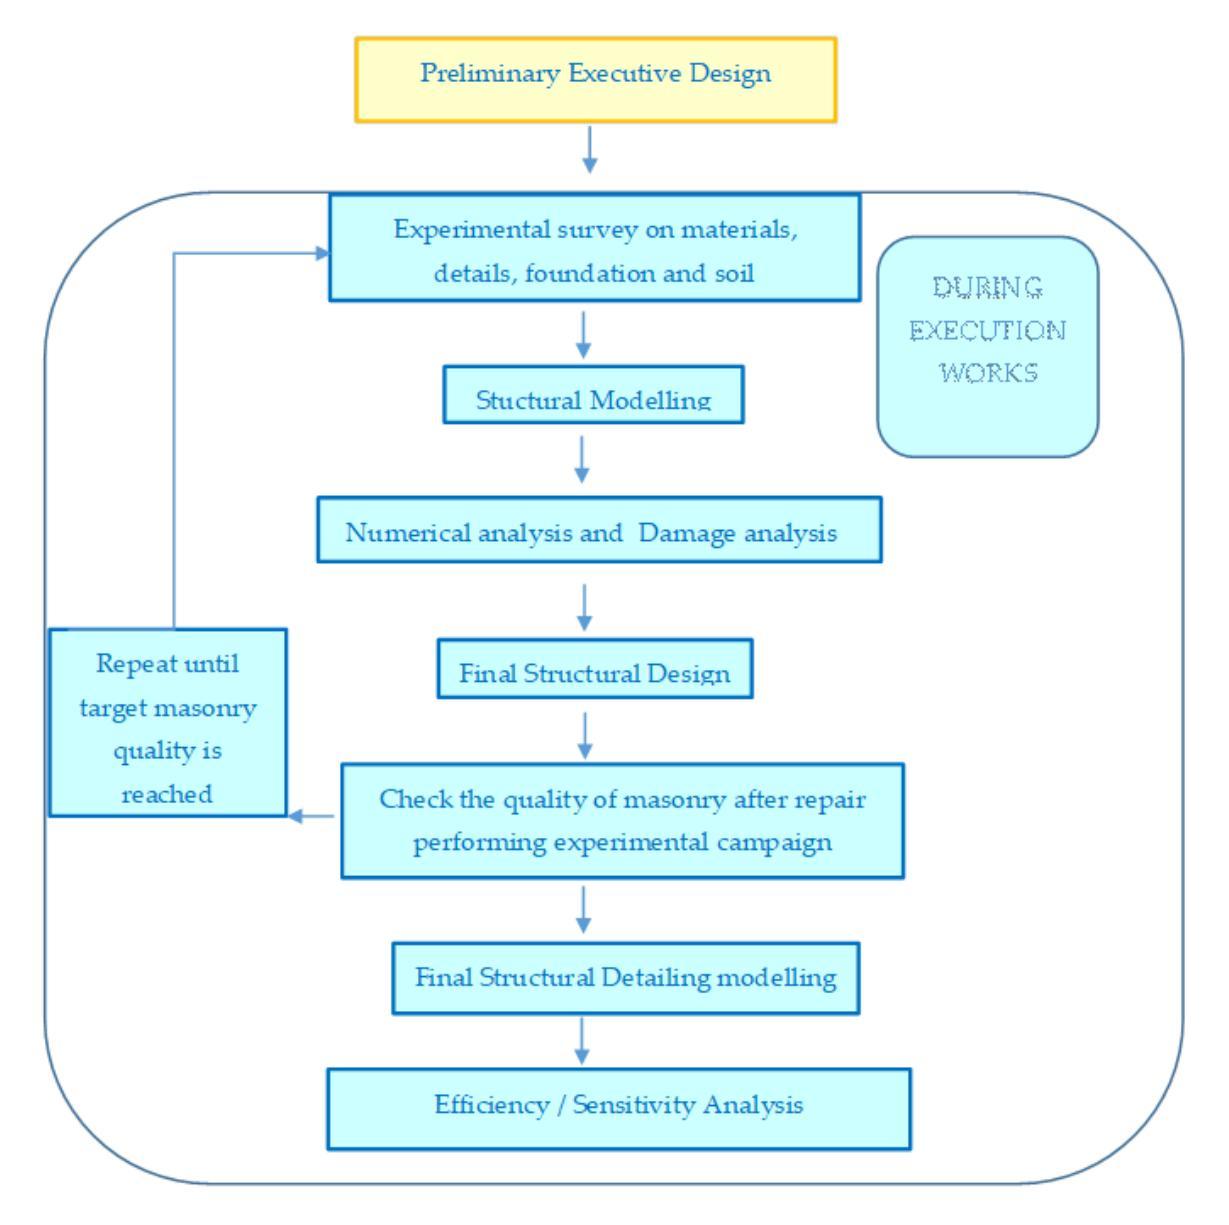
Figure 2. Design procedure on masonry structures at archaeological sites.

In the flow chart in Figure 2, as a first step, a preliminary campaign, a literature review and documentation studies yield a preliminary executive design. Then, after rehabilitation works, but still under construction, a second experimental campaign permits the weak points of the structure to be shown and the design of localized repairs where the rehabilitation works have been less effective. This is an interactive process until the target rehabilitation level is reached. Consequently, the final structural details are defined as soon as a target quality of the masonry is obtained, and the efficiency of the connections is proven with experimental testing. The final structural model then allows for a sensitivity analysis to be performed and to check the efficiency of the repairs and of the proposed solutions.

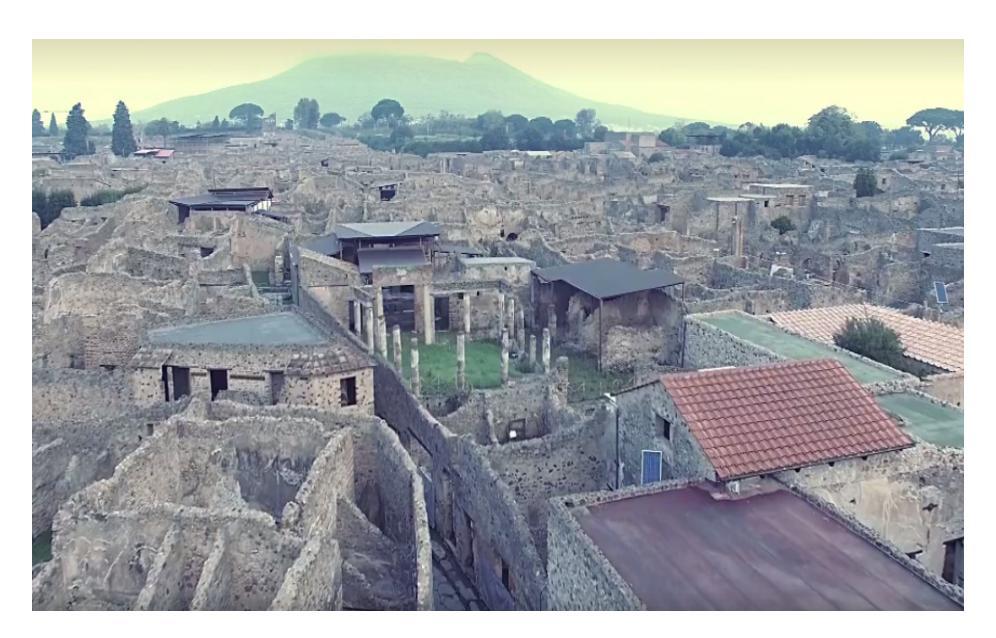
Figure 3. The aggregate of Championnet houses before restoration.

The proposed design approach was applied in the rehabilitation project design of the aggregate of Championnet houses, in the ancient city of Pompeii, Italy. This part of the city of Pompeii was subjected to extensive rehabilitation works in the period 2015–2017 inside the project *Grande Progetto Pompei*. Figure 3 presents the area before the restoration and rehabilitation works.

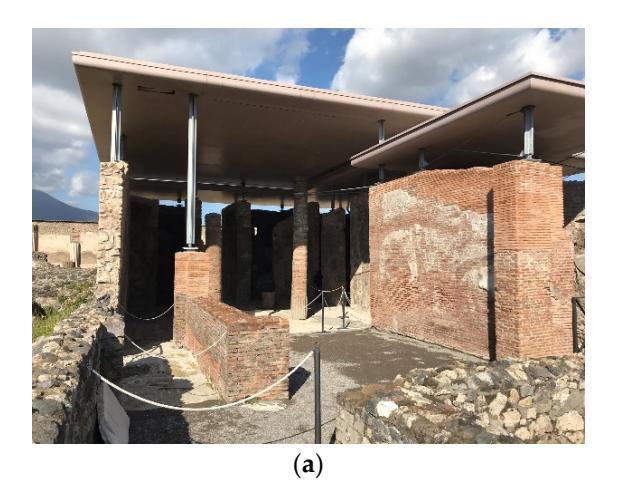
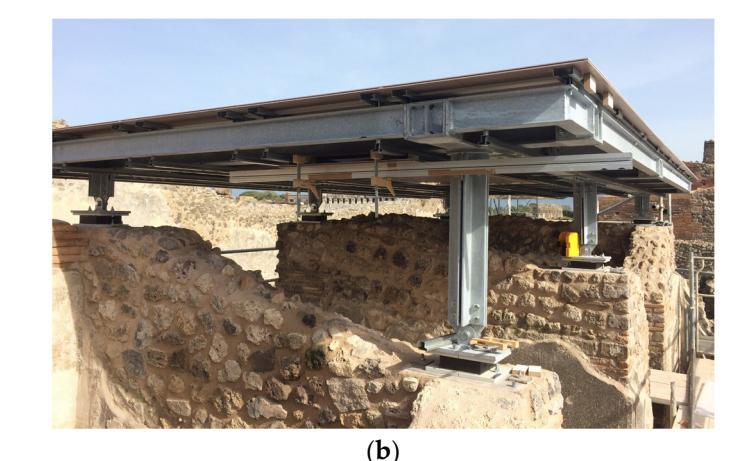
Figure 4. The new roof in the Championnet area. (a) View of the new roof. (b) Steel structures before coating.

In order to preserve the ancient decorative surfaces, a new roof, characterized by a steel structure and Corian slabs, was built over the ancient masonry walls as shown in Figure 4. These design decisions were conditioned by the presence of some precious mosaic decorated floors that needed protection, and their extensions did not allow for the design of a roof standing on a separate structure, which would be too invasive in the archaeological space. The extensive damage level and the limited thickness of the walls have gained great attention in the design of the rehabilitation works. Following the proposed design approach in Figure 2, the final design was reached after four extensive testing campaigns, before and during the execution phase. In the following, the experimental campaigns, the model, the performed analysis, and the design solutions are discussed.

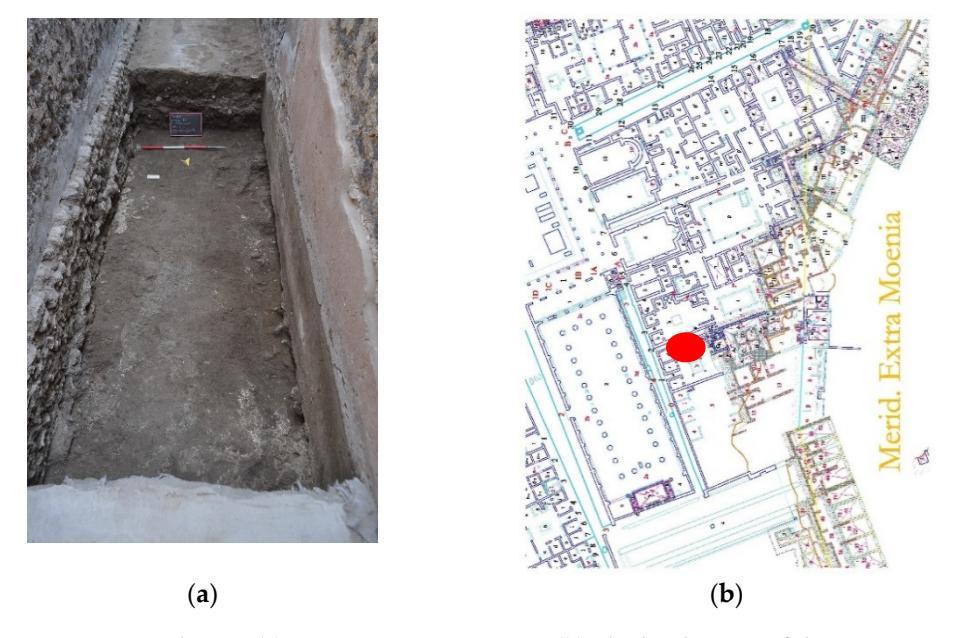
Figure 5. Foundation. (a) Excavation at *Regio VIII*. (b) The localization of the excavation (reported in red).

In order to understand the effective load capacity to be transferred to the ground, during construction works, some excavation essays can be made to identify the depth, nature, and dimensions of the foundation. The excavations revealed that the ancient foundations had underground walls that were thicker 0.30–0.40 m more than the ones in the upper part, and with a more intact and less degraded structure. The excavations revealed that the foundation was not deeper than one meter from the soil surface. The dimensions and depth of these foundations make the structures vulnerable to static and seismic load. For these reasons, the structural skeleton of the new roofs placed on the ancient masonry walls was made of light materials in order to do not overload the thin foundations and the bearing soil of these ancient structures. Figure 5 shows an excavation to reveal the foundation.

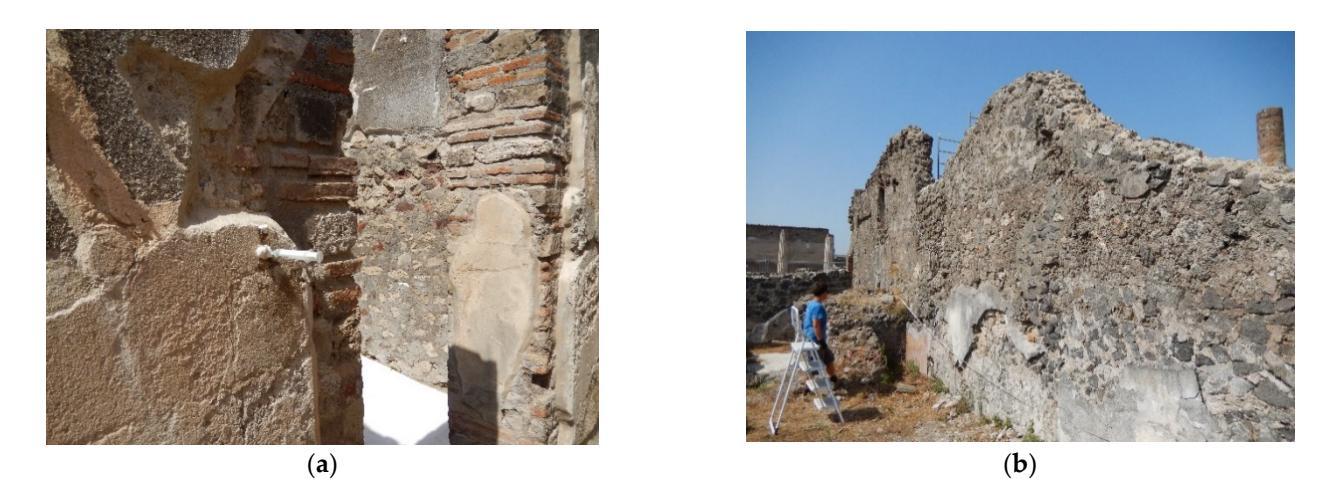
Figure 6. The masonry walls in the Championnet area. (**a**) A sample of the variety of masonry walls. (**b**) A long structural masonry wall before rehabilitation, with evidence of the alveolation and damage.

Most masonry walls are of the type "opus incertum", made of irregularly shaped stones with a more or less flat face. The stones used in the masonry were bound together with mortar. The smaller pieces were added between one stone and another. The whole wall was then sprinkled with a pouring of liquid mortar that was able to expand throughout the masonry. In some walls, the masonry structure is of the type "opus vittatum", which constitutes bricks and small blocks (called "tufelli"). Sometimes, bricks are located in the edges and corners.

The chemical-physical characteristics and damage are extensively varied in the masonry walls, affecting stone elements and mortars. The masonry deterioration concentrated, especially in the first meter in height, even with the loss of elements (ashlar and mortar). In general, rain water and wind erosion have caused the most loss of material. The damage processes are related to the absorption, flow, and stagnation of rain water. In particular, the tops of the walls are subjected to degradation due to the erosion and the breakup of large tracts. Damage is often determined by the nature of the mortar; whenever the mortar is made up of a volcanic aggregate with a variable size of 3–4 cm lithic clasts and fine sands mixed with a low lime component or other binder, this composition made the mortar very vulnerable. The volcanic nature of the aggregate involves the absorption of rain water and the rapid saturation of the top of the walls. This imbibition process leads, over time, to consistent loss and erosion, especially at the top of the walls. In particular, the water absorption of the stones/bricks and the mortar of the walls yield desegregation, with consequent swelling, fracturing, and breaking of the masonry.

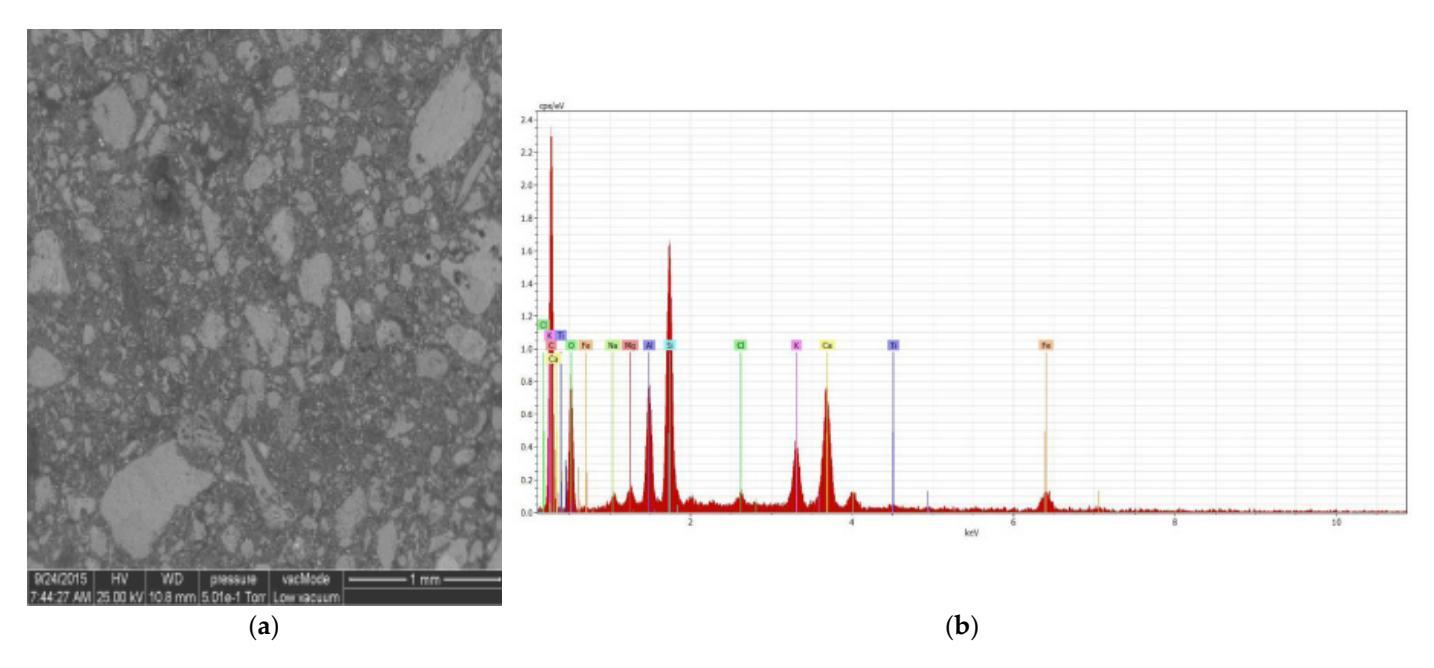
Figure 7. (a) Mortar image with Environmental scanning electron microscope (ESEM) modality low vacuum (LV); (b) energy dispersive spectroscopy (EDS) analysis on the mortar.

The analysis of old mortar has an important role in the preservation of architectural heritage, as soon as detailed knowledge about the materials used and construction techniques yields a program of repair works able to reduce the degradation processes. For this reason, the conservation level of the mortars and the characteristics of the material was evaluated through an electron microscope image in Environmental scanning electron microscope (ESEM) modality at low vacuum (see Figure 7a). The physical-chemical, mineralogical, and microstructural characterization was obtained as shown in Figure 7b. The matrix of the mortar was mainly characterized as a inhomogeneous calcite with the presence of lime (25%), the aggregates were mainly vulcanites (brown and reddish *pozzolane*) (92%), feldspar (3.8%), pyroxenes (3.2%), mono and polycrystalline calcite (0.7%), and micas (0.3%). The porosity of the binder was about 15% due to the presence of micro-cracking. This proves the vulnerability of the mortar to rain water, which yields desegregation and fracture.

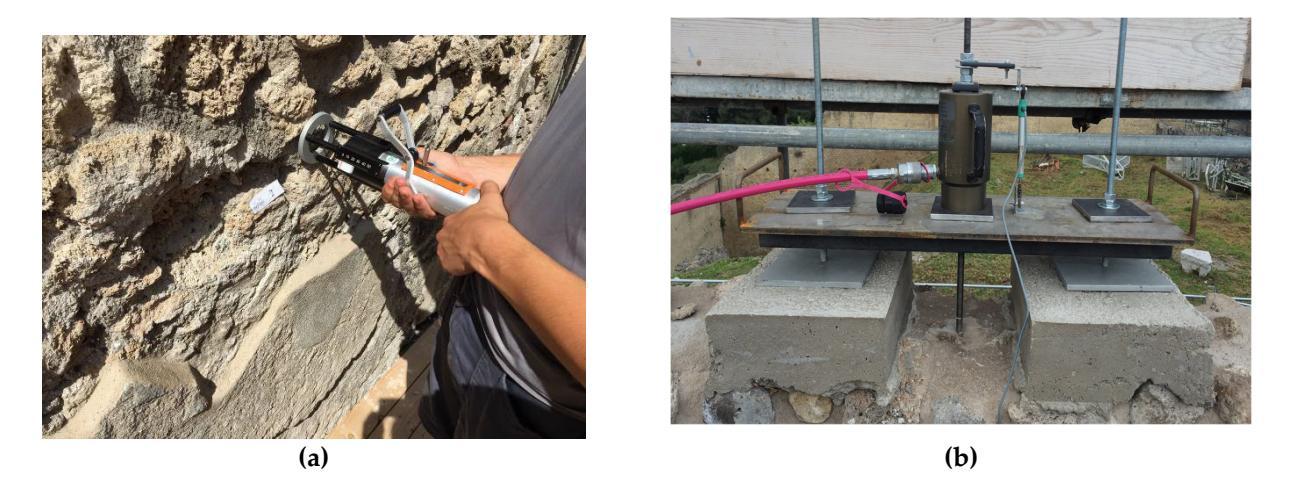
Figure 8. Tests. (a) Penetration test on mortar; (b) Pull-out test on a steel bar, connection the roof on the masonry walls.

A penetrometer test was also performed. The test measures the depth of penetration by inserting a steel needle into the mortar joint. Figure 8a shows the equipment that was used. The test, performed at fifteen points on ancient mortars, measures the penetration of the test needle and the results were interpreted by using correlation analysis in terms of the conservation state of the mortar and then in terms of the mechanical properties. The obtained penetration test results are reported in Table 3. Most values are often less than 0.4 N/mm^2 , which demonstrates the low resistance of the mortar joint.

In order to assess the efficiency of the steel bar and connection of the steel roof skeleton to the underneath walls, three pull-out tests were conducted during the construction phase. During the tests, a maximum load of 2600 daN was reached. This proved the efficiency of the grout injection technique that was used to lock the bar of the steel roof-skeleton inside the masonry walls. Figure 8b shows the pull-out test setup.

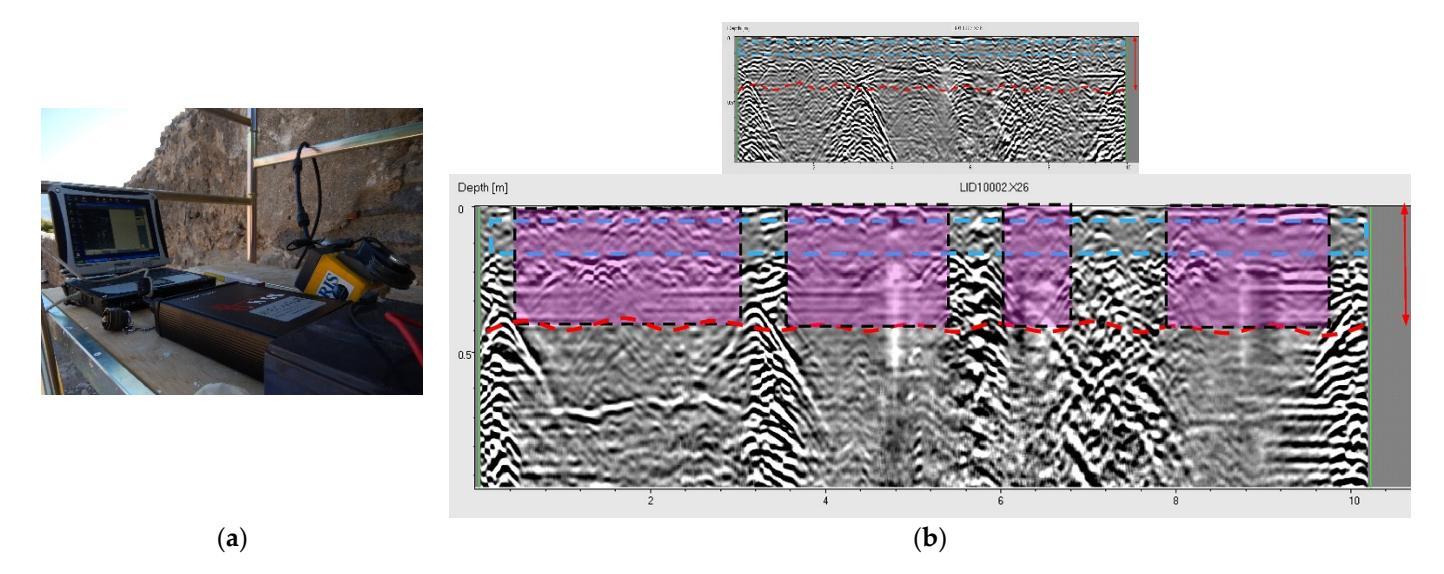
Figure 9 shows the radar test on the masonry walls, in particular, Figure 9a shows the equipment and Figure 9b the diagram results. This test has been used to check the efficiency of masonry consolidation through the grout injection technique and the insertion of basalt fibers inside the mortar joints, which is discussed in the next paragraph. The comparison of the radar diagrams showed evidence of the area of wall where the rehabilitation technique had been less effective, as a consequence, new consolidation work has been planned during the execution works in order to have homogenous structural density in the masonry wall.

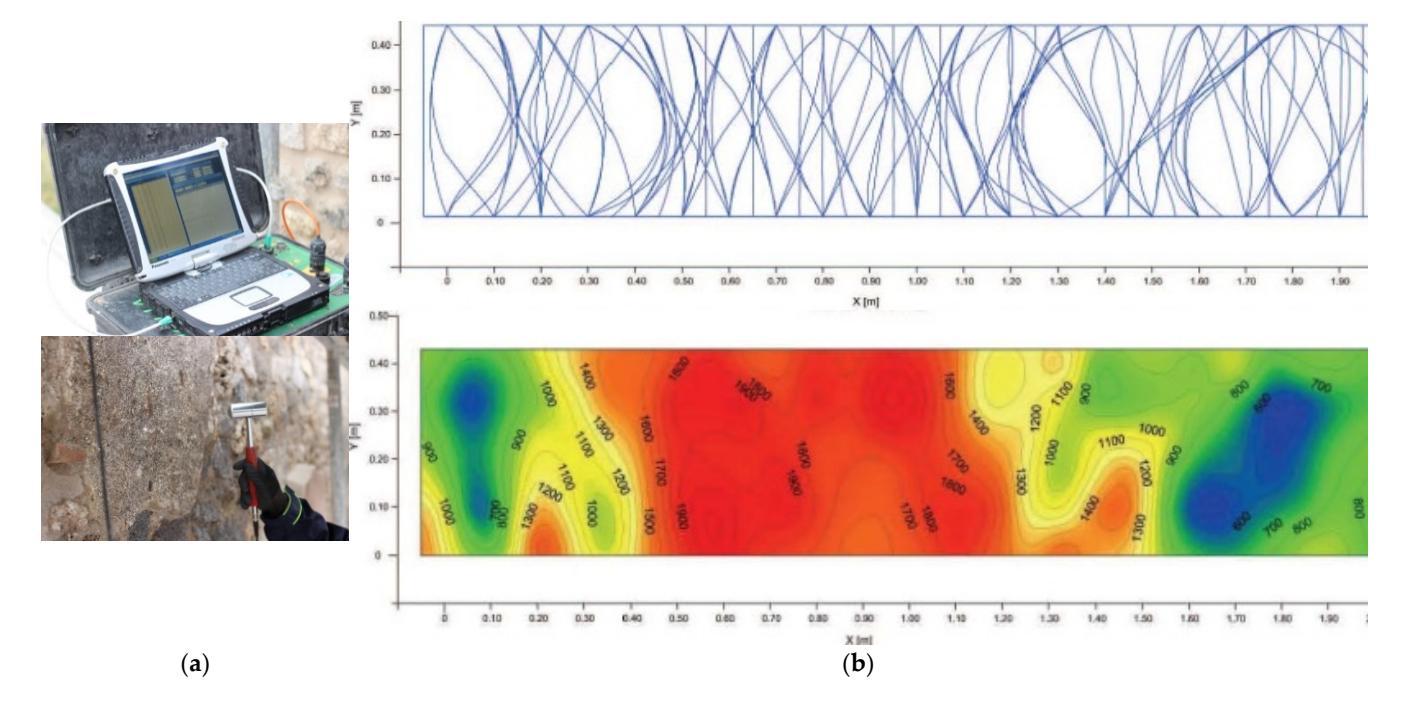
Tomography images, obtained from the sonic test equipment composed of a hammer as exciter and a receiver of the generated waves (in Figure 10a the sonic test equipment), were obtained of selected sections of the walls. The elaboration of signals also allowed us to check the homogeneity of the inner part of the masonry walls and the efficiency of the rehabilitation works. Figure 10b shows the test results of a section of the wall, where both the trajectories of the signal and the tomographic image show the velocities of the waves.

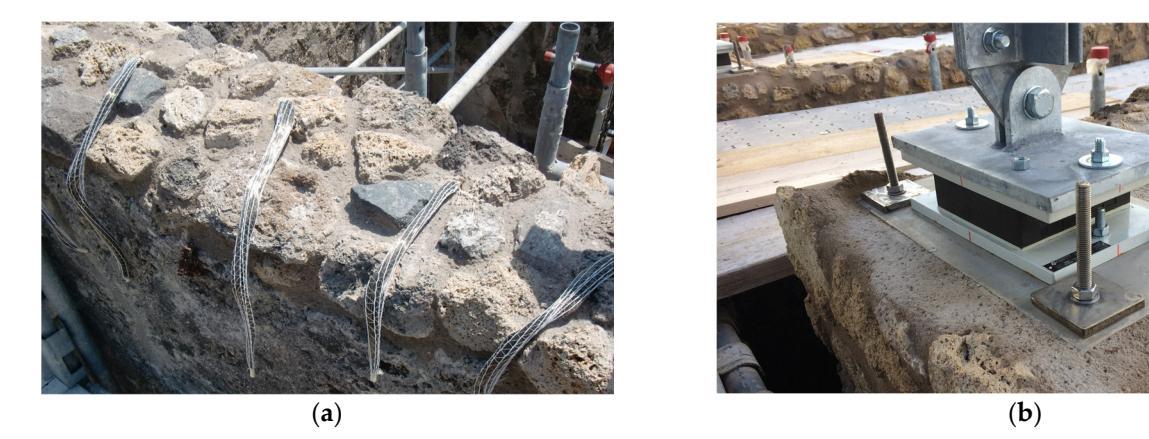
Figure 11. (a) Basalt fiber ropes in the masonry top wall. (b) The rubber support device.

The masonry damage state is characterized by deteriorated mortars and the presence of holes and alveolation. For these reasons, the ancient walls have been consolidated by grout injection as well as the insertion of basalt fiber nets and ropes [31–33]. The choice of natural fibers (Figure 11a) such as basalt in structural rehabilitation is currently a new technique, particularly suited to cultural heritage, as soon as basalt is a natural material with a high level of compatibility with the historical fabric. The use of these fibers, as a connection between the existing masonry and the reconstructed portion, is particularly effective for these ancient walls, as even when burdened by roofing, they increase the structural continuity. Basalt fiber robes have been also introduced inside the mortar joints in the wall facades in order to increase the resistance of all systems made of stones and mortar. The connectors in basalt fibers are characterized by 54 fibers, a warp thickness of 6.48 mm, warp density of 2.6g/cm³, and warp elastic modulus of 87 GPa. The fibers were inserted in the joint using a structural mortar with a compression strength after 28 days greater than 1.5 MPa, with rheoplastic characteristics made of natural hydraulic lime and selected aggregates.

The characteristics of the Elastofip 1.5EF 7.2 device produced by Fip Industriale (Figure 11b) are described in Table 4. The device is a rectangular block of rubber with the insertion of a number of horizontal steel laminated plates, vulcanized to the rubber, which increases the vertical stiffness and improves the stability under horizontal load. The bearings were designed according to European standard EN 1337-3 in which they are classified as type C bearings. The elastomer that forms the core was made of natural rubber of reinforcing plates class S355, while the anchoring counter plates were made of class S275.

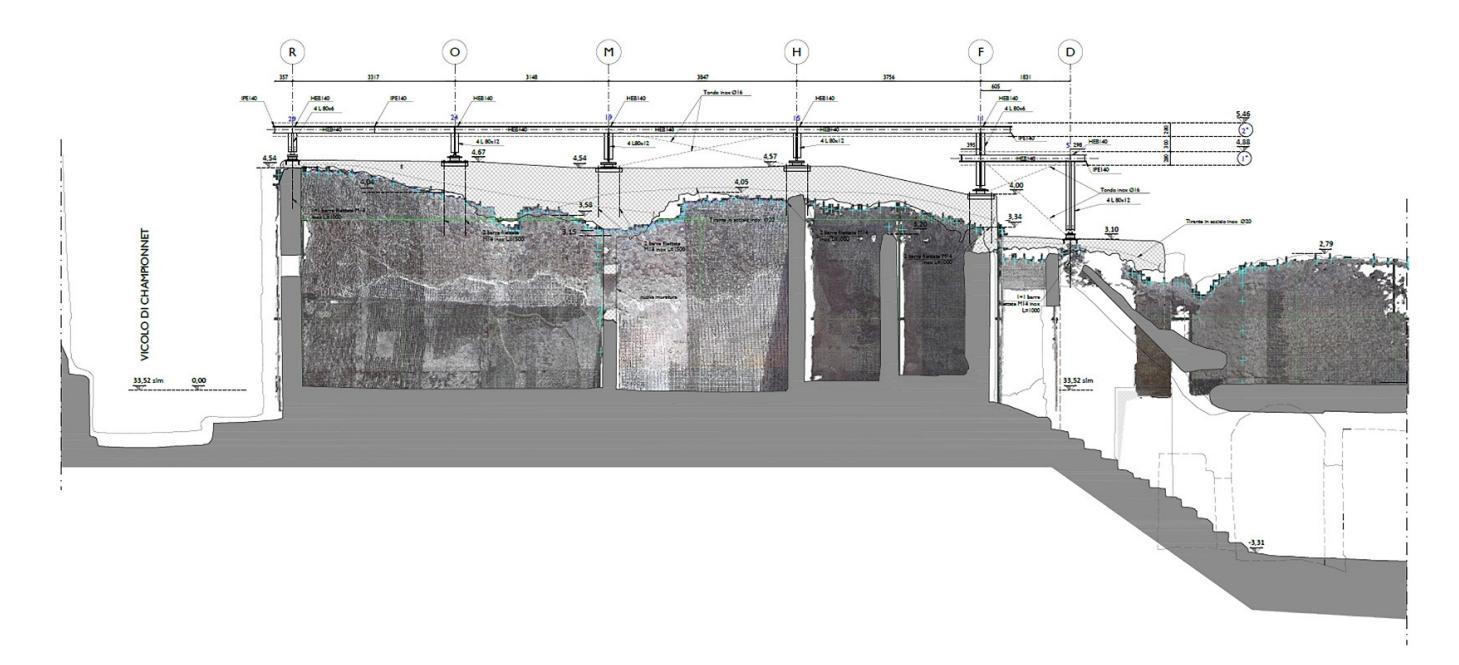
Figure 12. Executive section with cover, supports, and walls.

A steel skeleton and Corian slabs for the roof were chosen in order to limit the structural overweight (Figure 12) on the underneath walls. The atrium of the principal house (at numbers 1 and 2 Championnet Street) is about nine-meters-wide; for this reason, beams of considerable length had to be put in place (Figures 13–15), but the Corian surfaces, characterized by a limit weight compared to other materials on the steel skeleton limit of the roof load on the ancient walls, avoiding high compression stresses in the masonry.

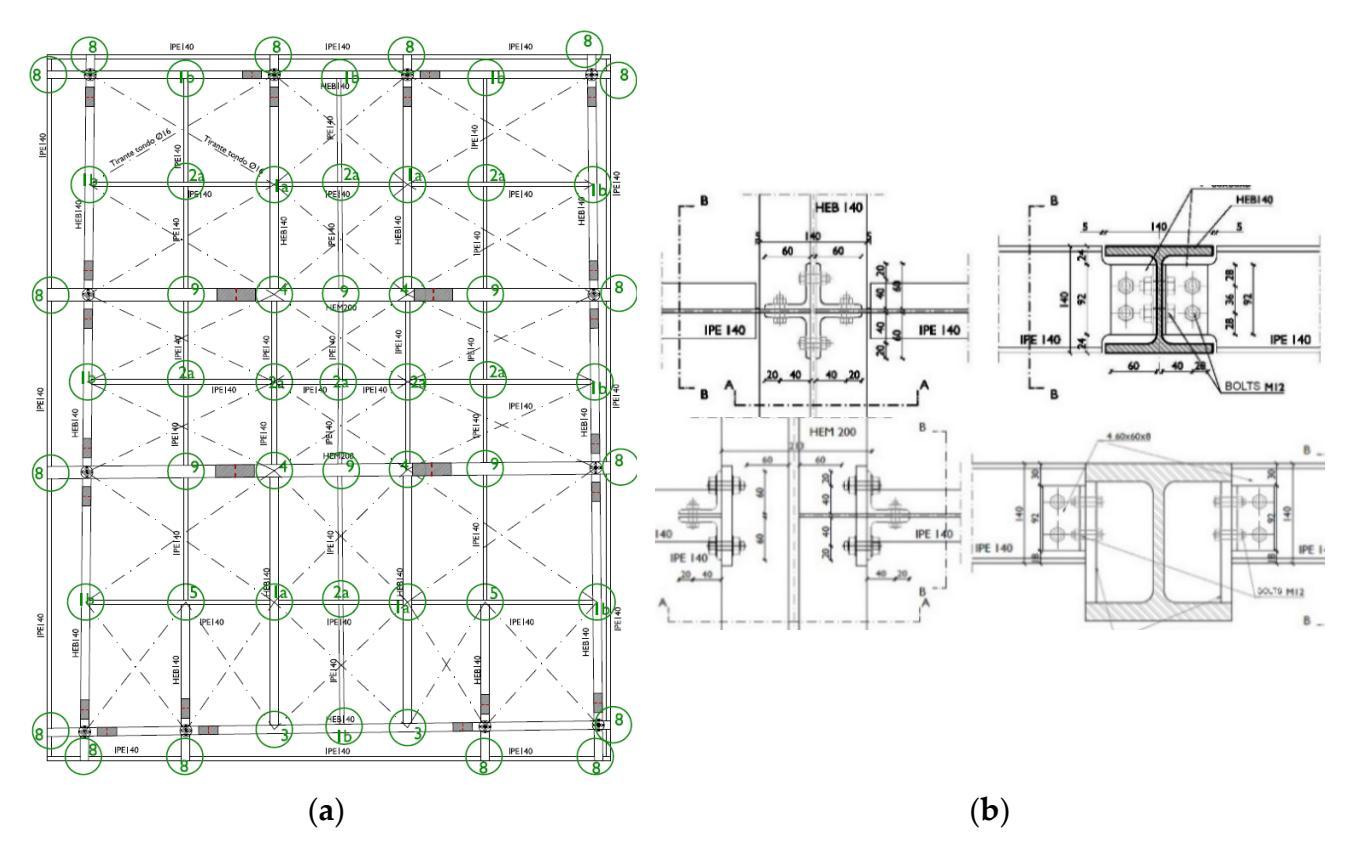
Figure 13. Structural design. (a) Detail of the roofs in plane. (b) Joint detail.

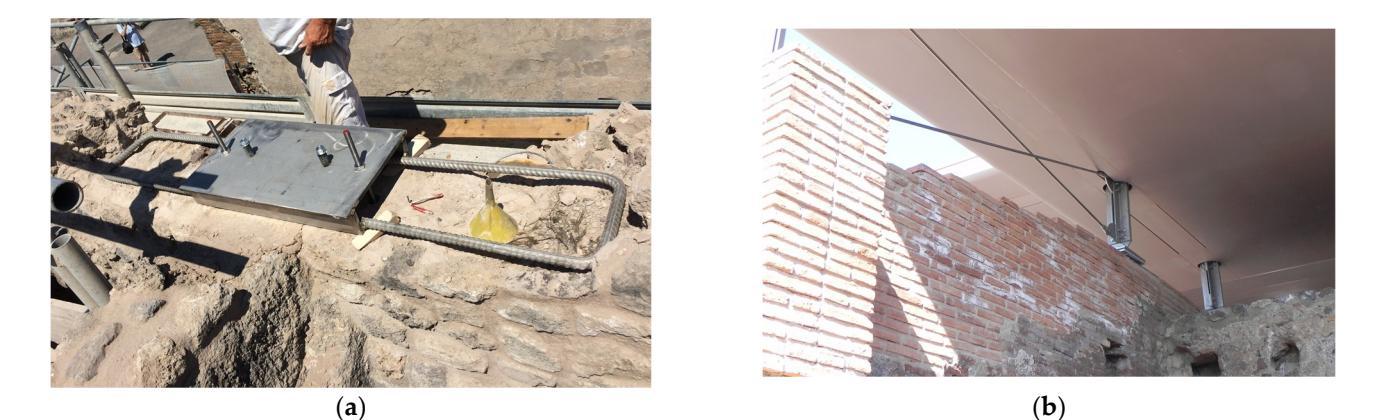
Figure 14. (a) Steel slab detail. (b) Steel rob detail.

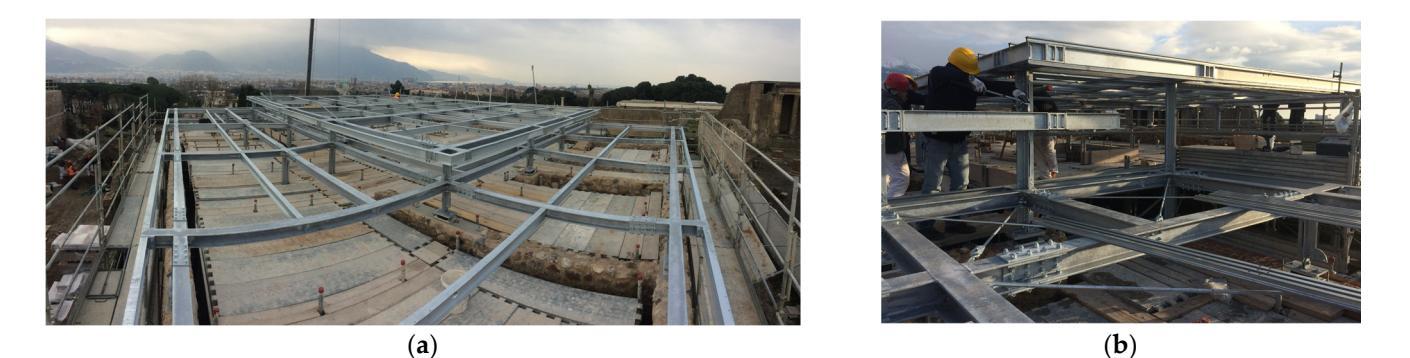
Figure 15. (a) Steel beams during structural work. (b) Details under construction.

The problem of transmitting the load derived from the covering on the underlying masonry was solved by laying stainless steel plates anchored in the masonry with 2 m long bolted steel bars (Figure 14a). During the work execution, some tests were carried out to extract the anchors to check the adhesion strength and the slip resistance for the most severe load conditions such as the ascending wind, as previously discussed in Section 3.1.2. The results of these tests (Figure 8b) confirmed the effectiveness of the bar grouting, and the value of the adhesion strength between the bar and injected masonry was evaluated for the final structural design.

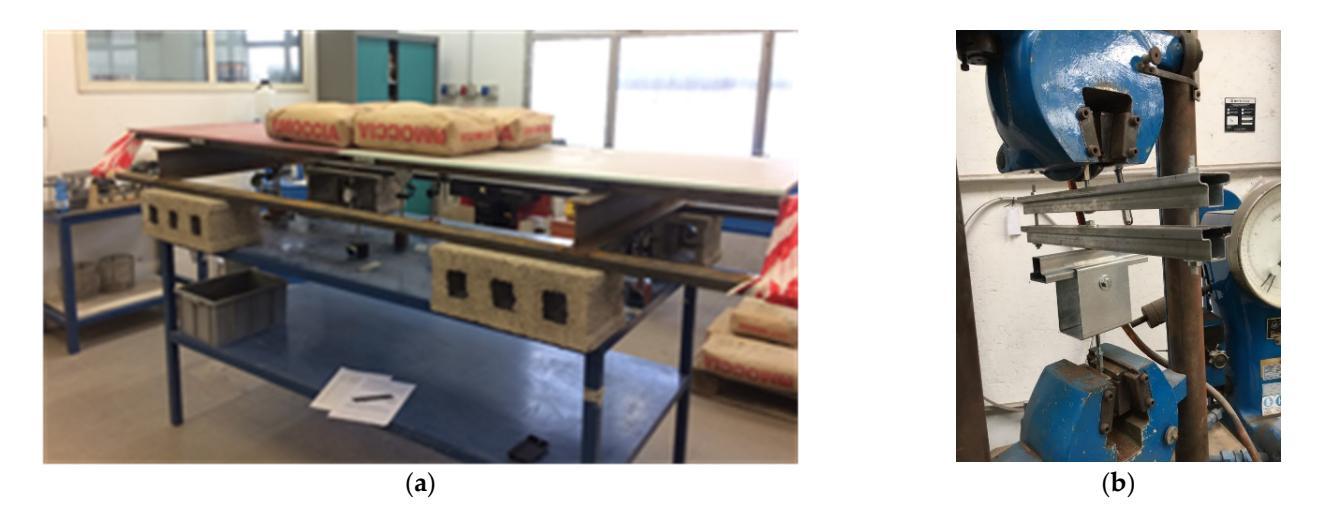
Figure 16. The laboratory testing on the upper and bottom surface of the Corian slabs (a). The flexural test in laboratory (b).

The slabs have been the object of laboratory tests, the structural resistance to flexural actions has been proven, moreover, the connection of the covering layer (the extrados and the intrados of the metallic carpentry) has been the object of test investigations to verify their resistance during the operating phase and in rare load conditions such as the future maintenance phases. Figure 16 shows the test design and the execution of the laboratory test on Corian slabs, in particular, the flexural text in Figure 16a and the tensile test on the connection between the steel skeleton and the slab in Figure 16b.

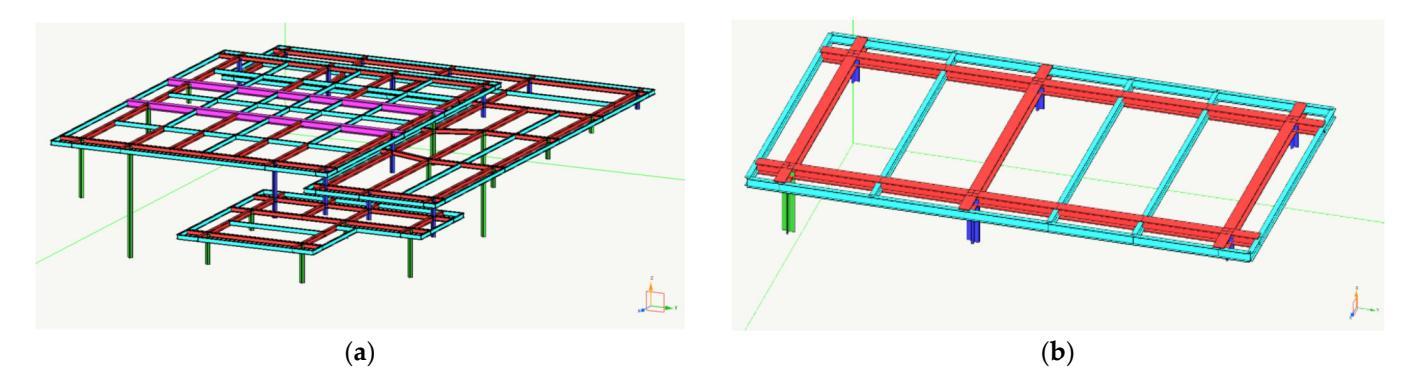
Figure 17. The structural models of the roofs. (a) Championnet n.1-2; (b) Championnet house at n.3.

The model of the new roof was upgraded on the basis of the structural experimental results. The spatial model of the two roofs at civic number 1, 2, and 3 is shown in Figure 17.

At the base of the columns, the bearing device was modeled with elements having the stiffness of the Elastofip 1.5 EF 7.2. The structural detail was designed according to Italian seismic code NTC2008 [12]. The local bearing capacity of the masonry walls were verified according to Eurocodes and the possible overturning mechanisms were assessed according the limit analysis [16]. Figure 13 shows the structural design of the details, while Figures 14 and 15 show the structural elements on place during construction.

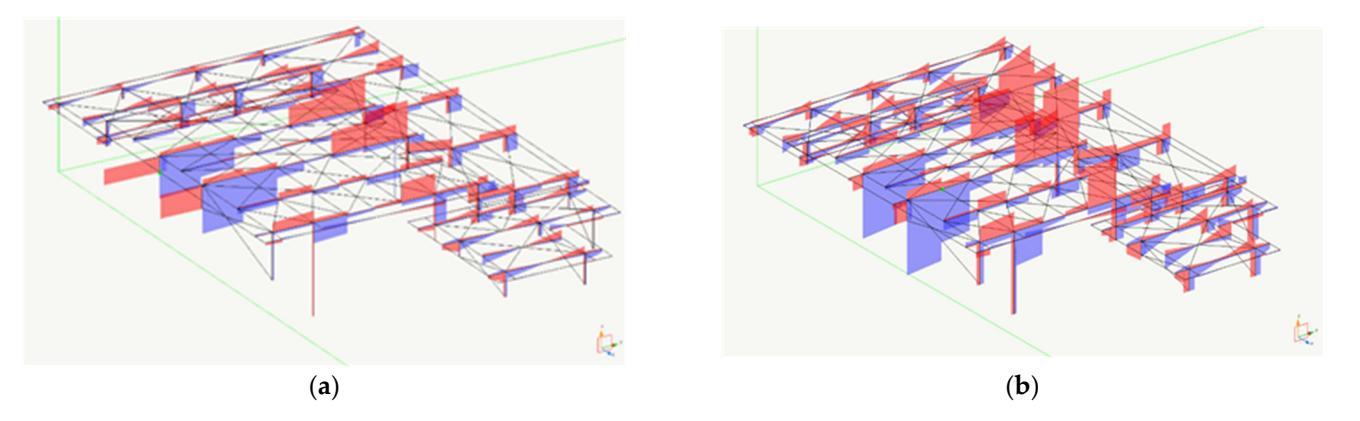
Figure 18. Comparison in terms of shear. (a) Base isolated structure. (b) Fixed base structure.

The efficiency of the structural designed was performed. In the following, a comparison between the isolated structure at the base and a fixed base structure (the same structure modeled with interlocking constraints at the base) is presented, in order to show the benefits induced by the rubber bearing device installation, in terms of shear stresses at the base of the column and at the top of the underlying walls. First, introducing the bearing devices registered a shift in the first natural period of the structure. The result comparison showed a 424% reduction in shear in the base isolated structure (see Figure 18 and Table 5).
