Article

# Performance Evaluation of Different Masonry Infill Walls with Structural Fuse Elements Based on In-Plane Cyclic Load Testing

Andrew Kauffman<sup>1</sup> and Ali M. Memari<sup>2,\*</sup>

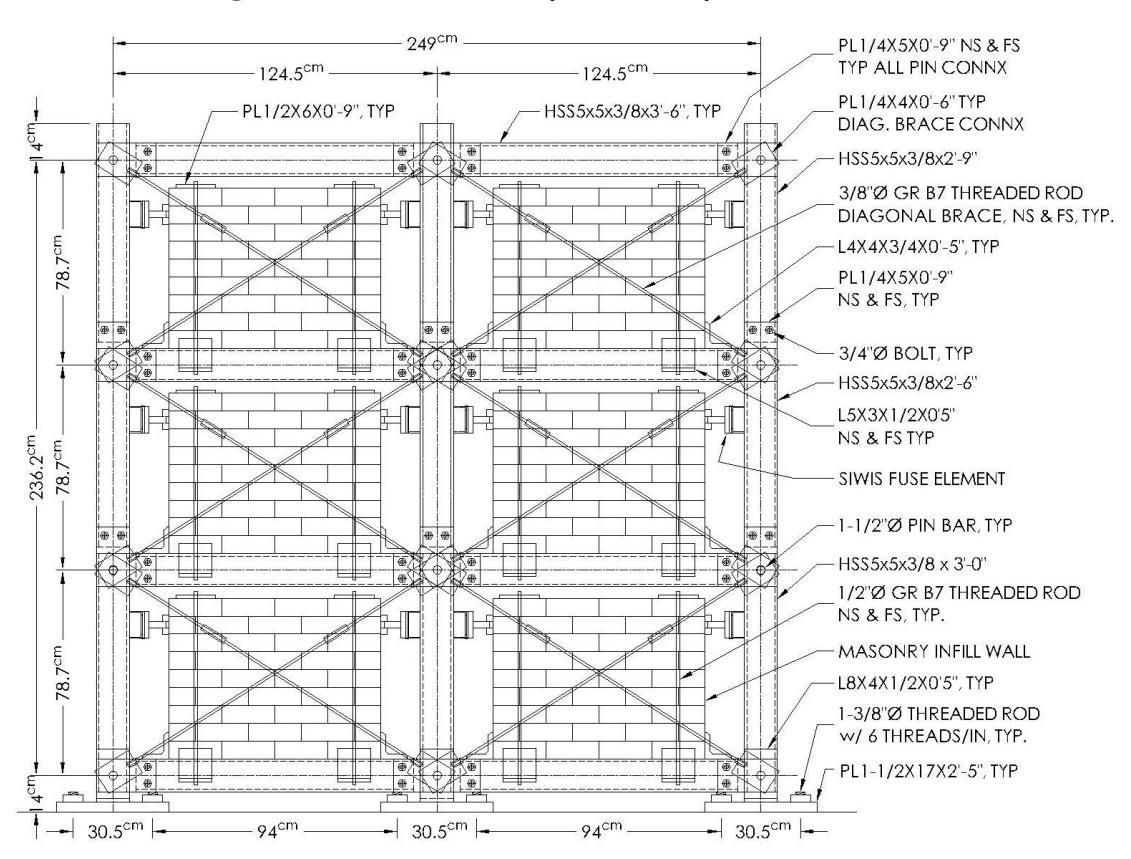
Figure 1. 1/4 scale, two-bay, three-story steel test frame.

Both series of tests were performed on the 1/4 scale, two-bay, three-story steel test frame shown in Figures 1 and 2, respectively. The test frame shown in Figure 1 consists of HSS 127 mm  $\times$  127 mm  $\times$  9.5 mm (5  $\times$  5  $\times$  3/8 in.) hollow structural steel members pin connected using 38.1 mm diameter steel bars to allow for adequate floor movements during racking and to enable the study of the system in a braced (stiff) and partially braced (flexible) configuration. The masonry infill wall specimens were supported by the bottom beam of each bay of the test frame with a 152.5 mm gap between the sides of the walls and the HSS columns, and a gap of between 38.1 mm and 60.3 mm between the top of the walls and the upper beam. Steel angles were welded to the top of the support beams on either side of the infill panels to prevent the base of the walls from sliding in the in-plane direction. Out-of-plane movement at the bottom of the infill panels, steel plates were secured to the top of the walls using 12.7 mm diameter threaded rods bolted to the outstanding legs of these angles.

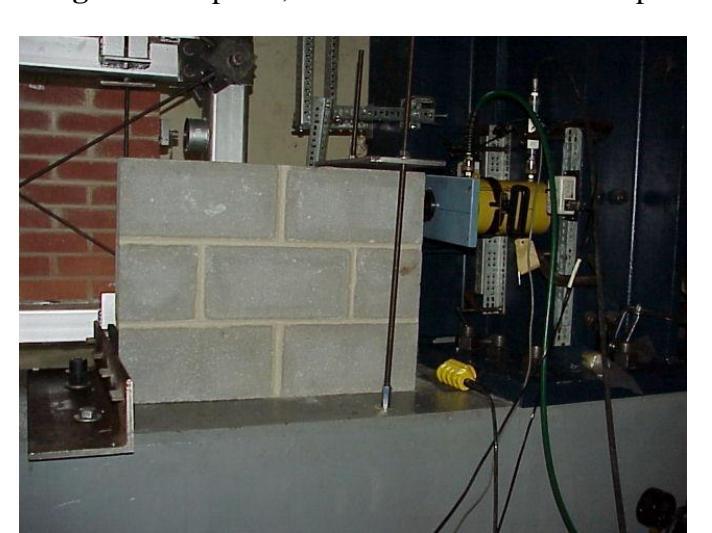
Figure 4. In-plane, destructive shear test set-up.

The masonry infill walls used in the cyclic and parametric tests were constructed in the BCERL test facility by professional masons. Destructive shear tests were performed to determine the in-plane shear strength of each type of masonry wall panel. The brick, CMU, AAC, and hollow clay tile (HCT) infill wall specimens used for this testing program are shown in Figure 3. The brick wall panels were used for the cyclic tests, while the CMU and AAC specimens were used for the parametric study. The HCT infill wall specimens were included in the destructive shear tests, but not used in the structural fuse system tests due to their low in-plane shear capacity. The set-up for the destructive shear tests is shown in Figure 4. The results of these tests are given in Table 1.

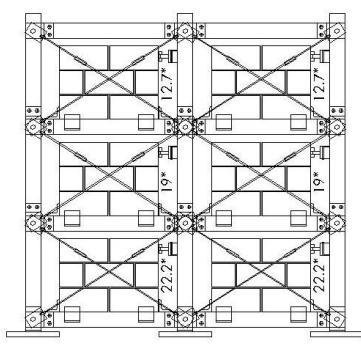
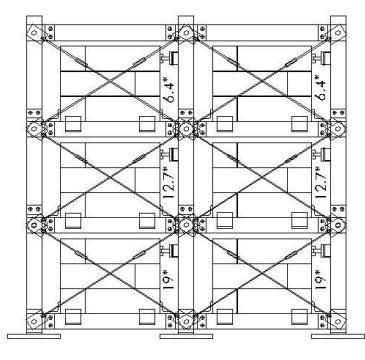
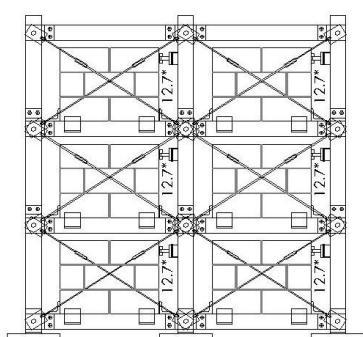
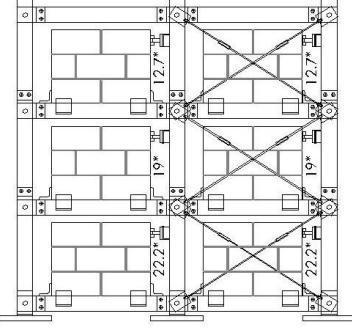
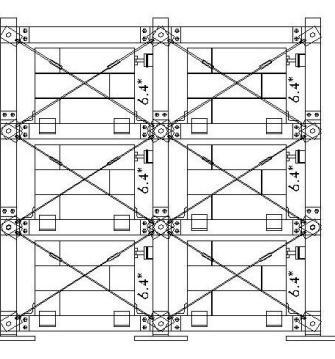
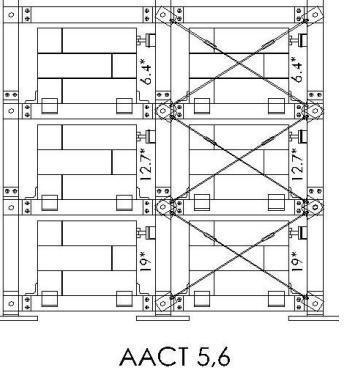
Figure 8. Test frame configurations for parametric testing program.

level 2, and 12.7 mm disks at level 3. For tests CMUT3 and CMUT4, 12.7 mm disks were used at all of the fuse element locations, as shown in Figure 8. As with the monotonic tests performed in the previous study [28], two different bracing configurations were considered in this testing program. The full-brace configuration was used during tests CMUT1–CMUT4, while the half-brace set-up was used for tests CMUT5 and CMUT6.

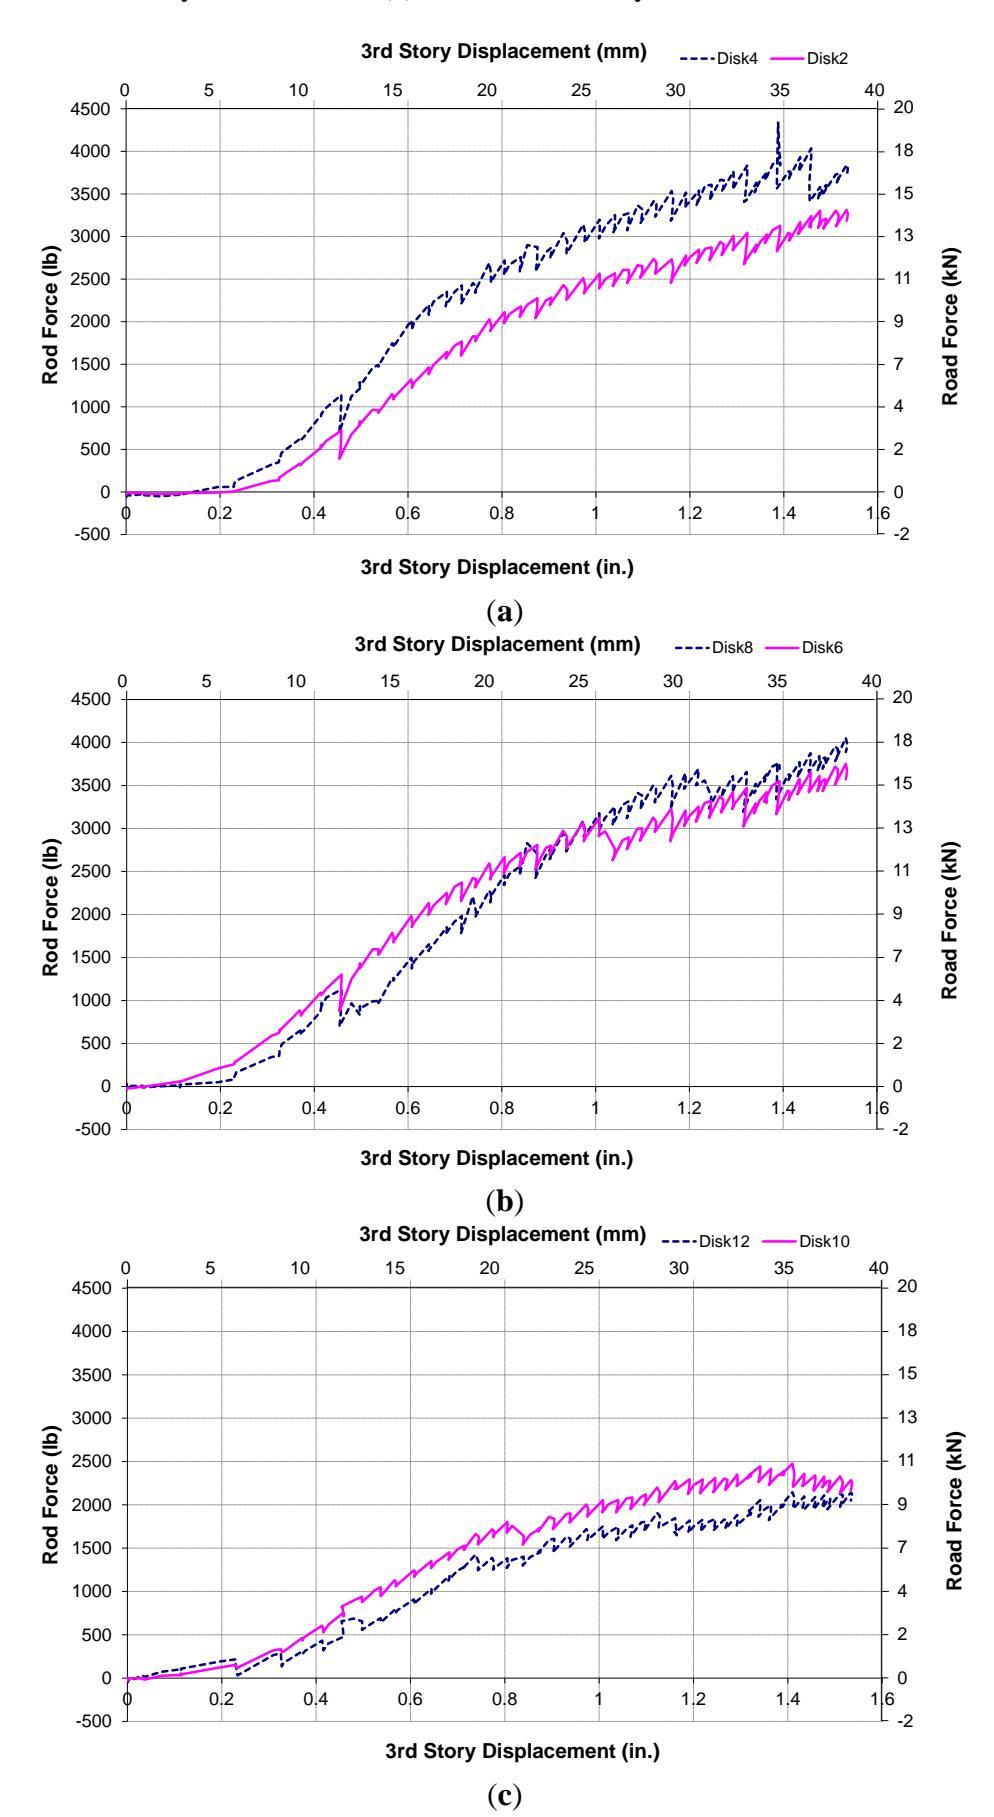
Figure 10. Test FBMT1 punching rod force histories. (a) FBMT1 1st story rod histories;(b) FBMT1 2nd story rod histories; (c) FBMT1 3rd story rod histories.

During both of the full brace monotonic tests, the desired story level displacement ratios were maintained resulting in an inverted triangle displacement shape of the test frame. As with the bare frame monotonic tests, the force applied by the hydraulic cylinder at the third story level was greater than the force applied by the cylinders at the first and second levels. The maximum punching rod forces measured at each disk location during both tests are given in Table 5. Plots of the force in the steel rod at each fuse element location *vs*. the third story frame deflection for test FBMT1 are given in Figure 10.

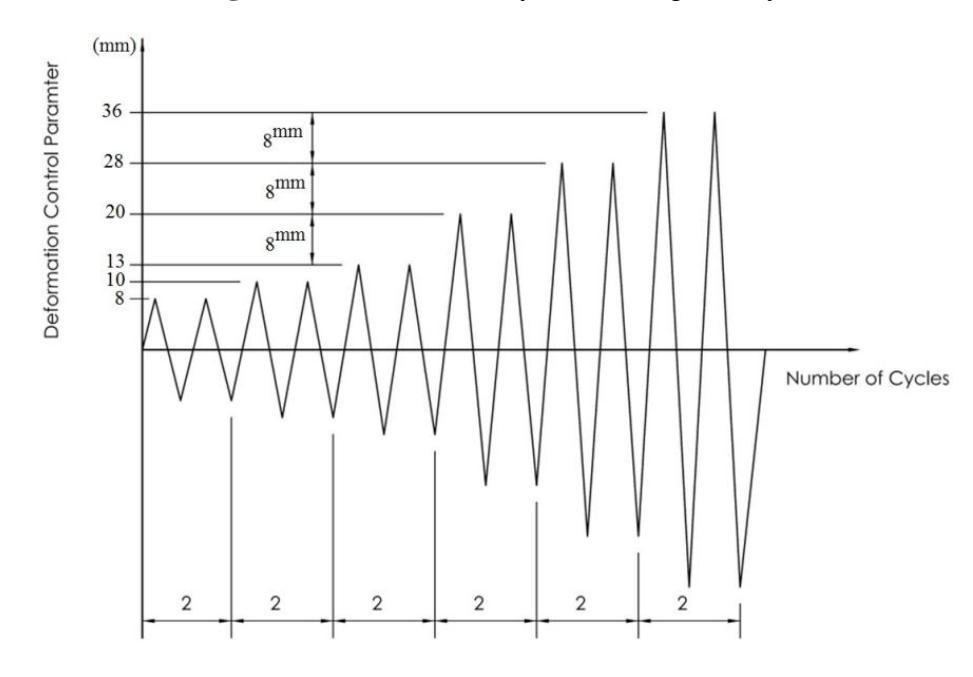
Figure 11. Quasi-static cyclic loading history.

During tests FBMT1 and FBMT2, the first fuse element cracking occurred at a third story displacement of between 7.6 mm and 12.7 mm. Based on these results, the value  $\delta_y$  for the quasi-static loading protocol was set equal to a third story test frame displacement level of 12.7 mm. The upper bound of the third story displacement corresponding to fuse element crack initiation was chosen based on the loading protocol guidelines [32] that at least two load steps be performed before the deformation applied to the test specimen reaches  $\delta_y$ . In order to prevent damage to the steel bracing rods, the maximum third story displacement level applied to the test frame during the cyclic tests was 35.6 mm. To allow for the maximum number of steps in the cyclic loading history, a third story displacement increment of 7.6 mm was chosen for the increment in peak deformation between load steps. A total of two load cycles were performed during each load step. The quasi-static loading protocol used for the cyclic tests is shown in Figure 11.

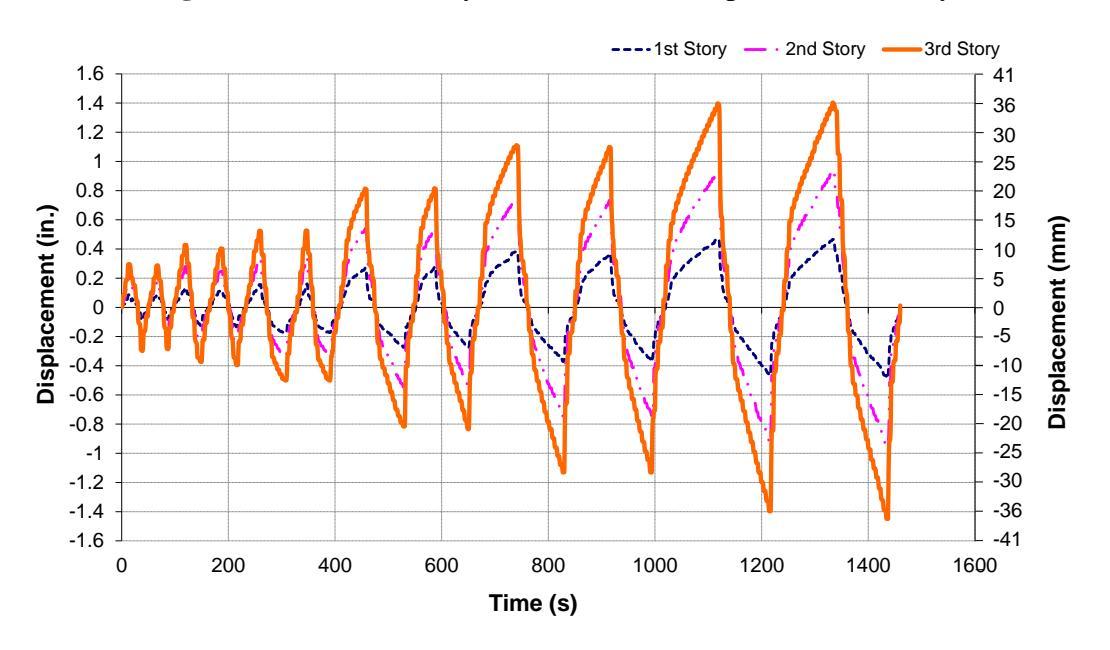
Figure 12. Bare frame cyclic test BFCT1 displacement history.

The bare frame cyclic tests were performed with all of the bracing rods in place on the test frame and no fuse elements. During these tests, displacement controlled loads were applied in both in-plane directions (advance and retract) based on the quasi-static loading protocol shown in Figure 11. The load applied at each story was controlled manually using a separate hydraulic pump attached to each of the load cylinders. The story level displacement histories for test BFCT1 (bare frame cyclic test 1) are shown in Figure 12. The story level load histories for test BFCT1 are shown in Figure 13. The load-displacement, hysteretic behavior at the first, second, and third story levels of the test frame during test BFCT1 is shown in Figure 14. In these figures the load applied at each story of the test frame is plotted *vs.* the displacement measured at that story. The hysteretic plots are fairly symmetrical at story levels two and three for both of the bare frame cyclic tests. This indicates that the work done by the hydraulic cylinders on the test frame at these story levels was similar in both in-plane directions of the load cycle. At the first story level, however, the work done by the cylinders on the test frame was not symmetrical with respect to the direction of the applied load.

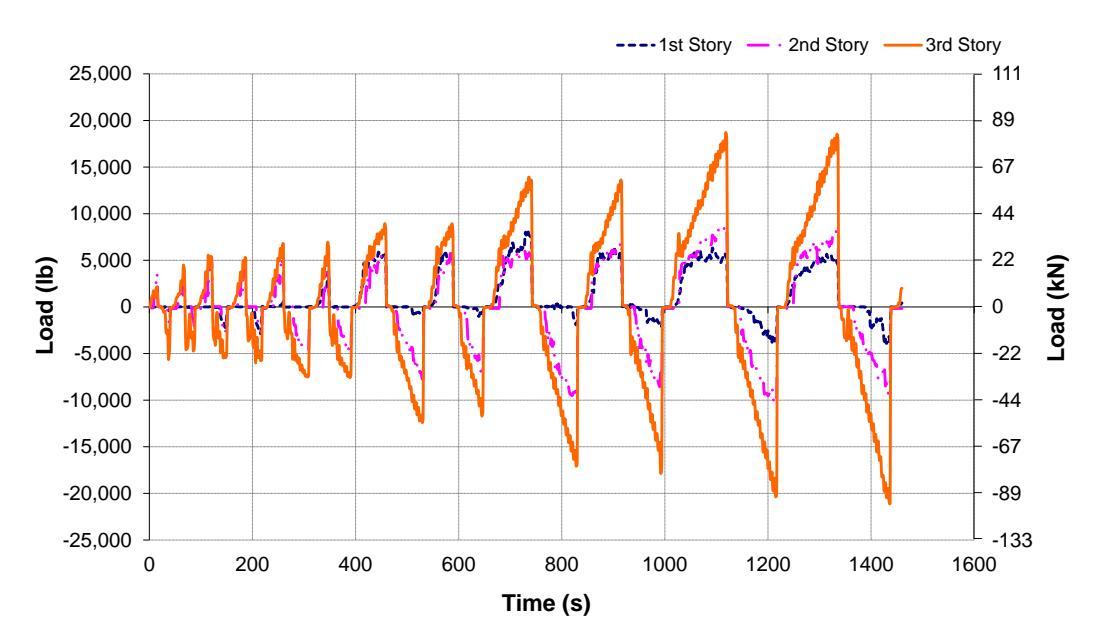
Figure13. Bare frame cyclic test BFCT1 load history.

During both bare frame cyclic tests, the load applied to the test frame by the hydraulic cylinders at the third story level was greater than the load applied at the first and second story levels in the advance and retract directions. This behavior was also observed during the bare frame monotonic tests. For the bare frame cyclic tests, however, a greater percentage of the total in-plane load was applied at the first and second story levels than during the monotonic bare frame tests. Although the displacement controlled loads were applied in the same manner during these tests, the quasi-static loading protocol used for the cyclic tests resulted in more load at the first and second stories. These results show that the quasi-static loading history produces a more realistic seismic loading simulation than the monotonic loading protocol.

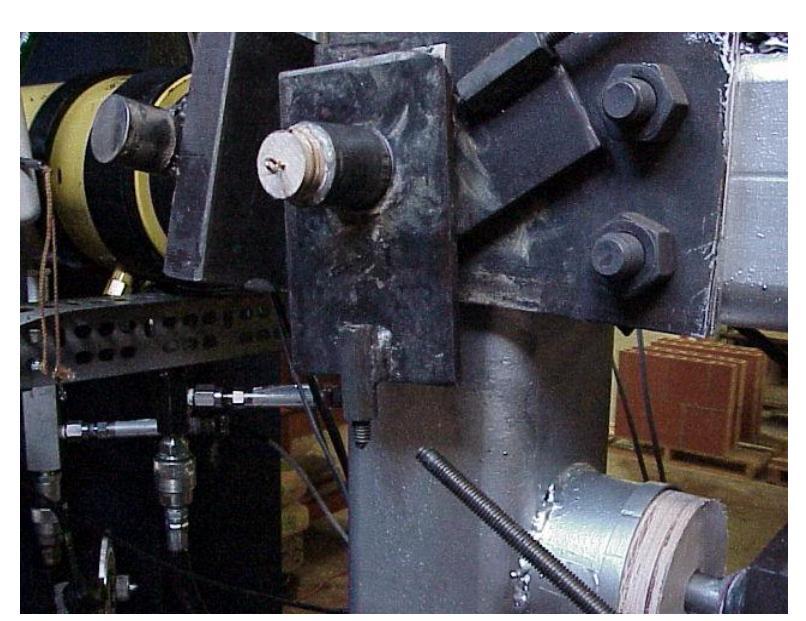
Figure 15. Typical bracing rod failure.

Diagonal bracing rod failures occurred during the final load step of tests FBCT1, FBCT2, and FBCT4. The failures occurred at the ends of the braces near the connection, as shown in Figure 15. Based on the results of rod tension tests performed by Aliaari [19], the bracing rods reach their yield point at a tensile load of around 31.6 kN and have an ultimate capacity of around 37.8 kN. The average total in-plane load applied to the test frame in either direction during both cycles of the final load step was around 141.9 kN. Depending on the proportion of the total in-plane load transferred to the infill walls by the fuse elements during this final load step, the force experienced by the bracing rods at the first story level of the test frame was between 31.1 kN and 35.6 kN. According to this data, the bracing rods were near or at their yield point during the final load step of the cyclic tests.

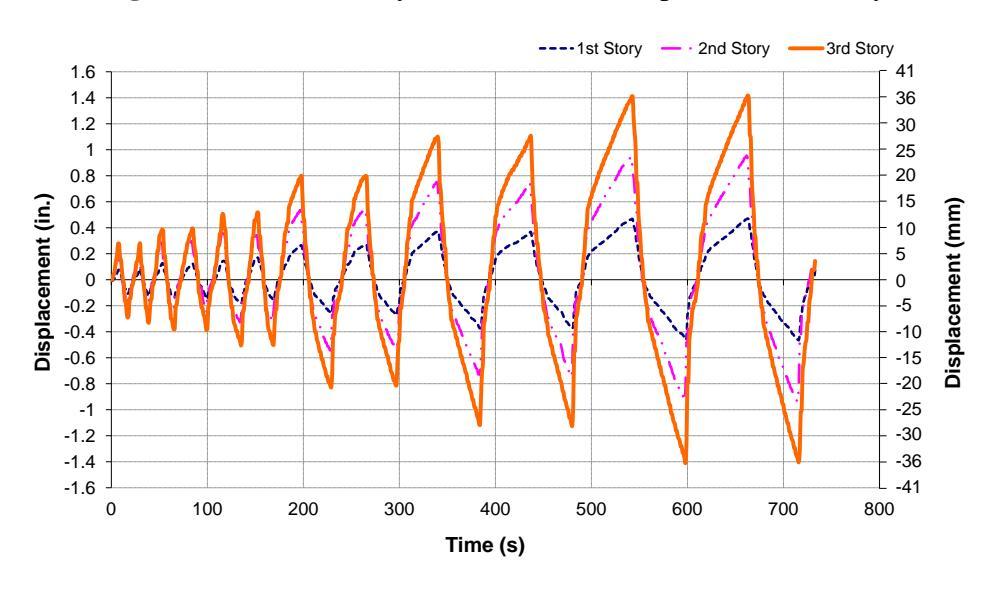
Figure 16. Full brace cyclic test FBCT2 displacement history.

The displacement histories for full brace cyclic tests for tests FBCT2 and FBCT4 are shown in Figures 16 and 17, respectively. The target quasi-static loading protocol was followed closely throughout the full brace cyclic tests. The load histories for tests FBCT2 and FBCT4 are shown in Figures 18 and 19, respectively. Comparison of Figures 16–19 with Figures 12 and 13 shows the effect of the infills on the bare frame including full brace. The load behavior during these tests was not very similar in the forward and retract portions of the load cycles. This was particularly true at the first and second stories of the test frame. Since these tests were displacement controlled, load was applied at these stories only as needed to maintain the desired displacement shape of the test frame. As with the bare frame cyclic tests, the load applied at the first and second stories, however, a greater proportion of the total in-plane load was applied at the first and second stories of the test frame during the cyclic tests. The quasi-static loading protocol used for the cyclic tests resulted in greater loads at the first and second stories of the test frame. This may be due to the cyclic deformation behavior of the lumber disk fuse elements after repeated cycles of damage.

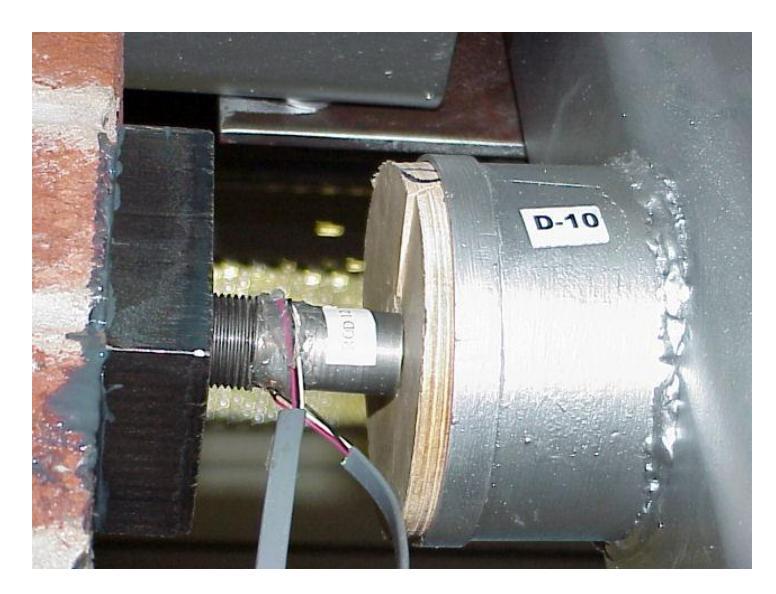
Figure 20. Cracking of 0.5 in. disk at fuse location 10 during test HBCT1.

During test HBCT1 (half-brace cyclic test 1), fuse element cracking was not observed until the displacement at the third story of the test frame reached 17.8 mm. Additional cracking occurred in both displacement directions as the load history was continued and the peak displacements were increased at each story level during subsequent load steps. During this test, the greatest fuse element damage occurred in the 12.7 mm lumber disks located at the third story of the test frame. Figure 20 shows the damage to the 12.7 mm lumber disk at fuse location 10. During test HBCT2, the first fuse element cracking occurred at a third story deflection of 12.7 mm. From this point, increased cracking occurred in the fuse elements as the quasi-static load history was continued.

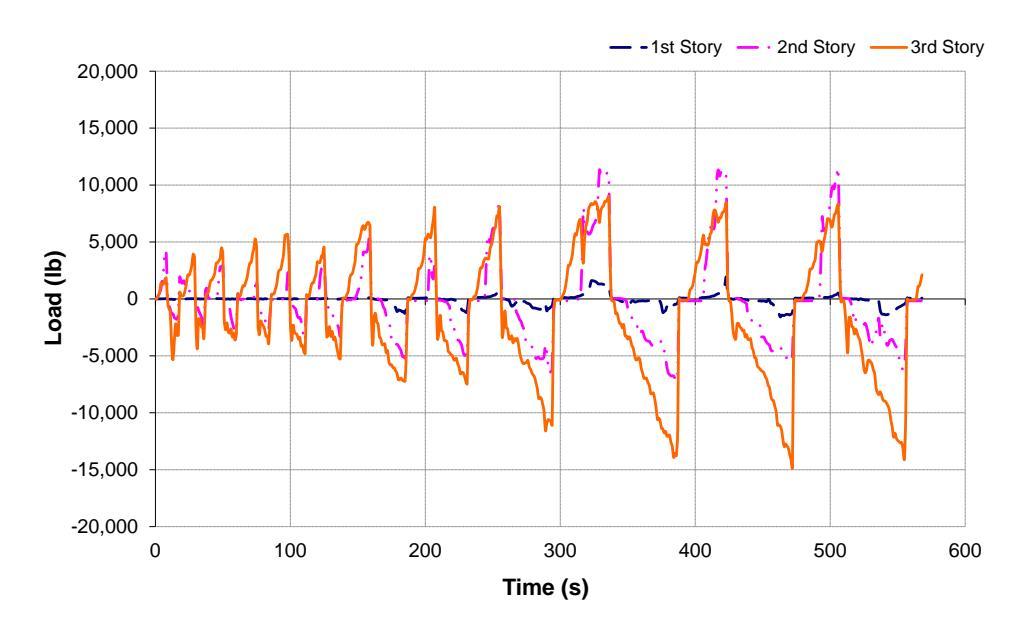
Figure 21. Half-brace cyclic test HBCT1 load history.

The load histories for the two half-brace cyclic tests are shown in Figures 21 and 22. The load behavior during these tests was similar to the full-brace cyclic tests. Comparison of these figures with Figure 13 shows the effect of the infill on bare frame with half brace. As with the full-brace tests, the loads applied to the test frame at each story level were not similar in the advance and retract directions. For these tests, very little load was applied to the test frame at the first story level. The magnitude of the loads at the second story, however, was significant. During the advance portion of several of the load cycles the load applied at the second story level was greater than the load at the third story, particularly toward the end of the tests. Similar behavior was seen for the full brace cyclic tests.

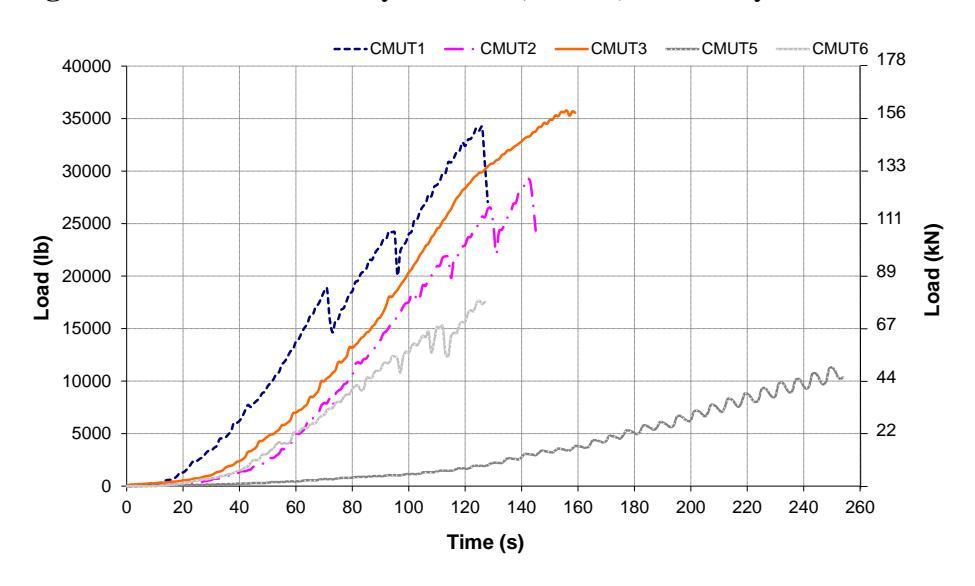
Figure 23. Concrete masonry unit test (CMUT) third story load histories.

The load histories for the CMU parametric tests are shown in Figure 23. During test CMUT4, a problem occurred with the pressure transducer, resulting in a loss of load data for this test. A plot of the load-displacement behavior for each of the CMU parametric tests is given in Figure 24. The load-displacement behavior for tests CMUT1 and CMUT2 was very similar until the displacement at the third story reached around 27.9 mm. At this point of CMUT2, the stiffness of the test frame began to decrease. The stiffness of the test frame during test CMUT3 was slightly less than that of tests CMUT1 and CMUT2. This was expected since 12.7 mm lumber disk fuse elements were used at each story level during this test.

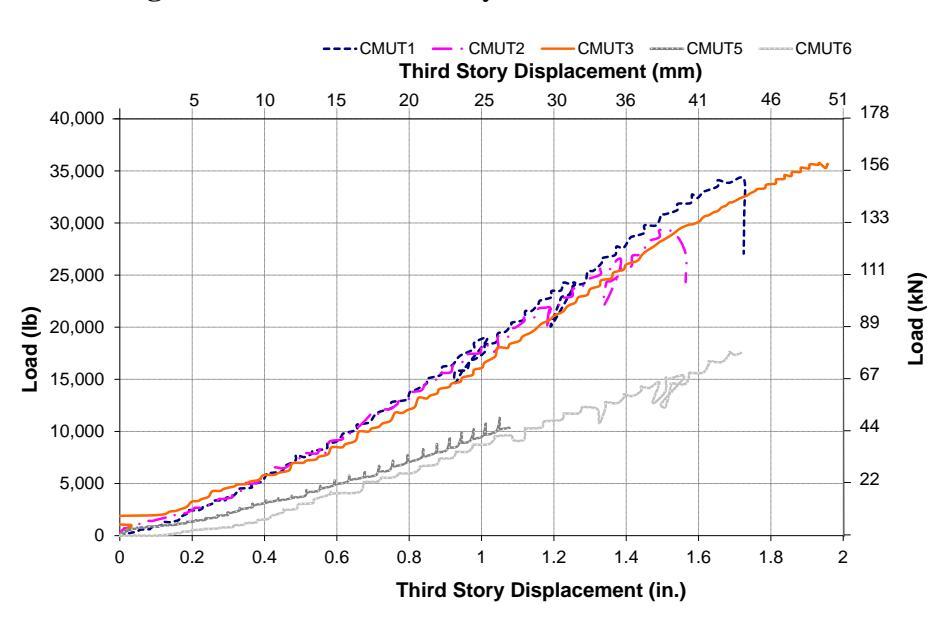
Figure 24. CMUT third story load-deflection behavior.

For tests CMUT5 and CMUT6 the half-brace configuration was used, resulting in significantly less in-plane frame stiffness, as shown in Figure 24. Although the slope of the load-displacement curve was slightly smaller for test CMUT6 than for test CMUT5, the overall load-displacement behavior for these two tests was very similar. In general the load-displacement curves for these tests were fairly linear following the first stage of behavior. During this initial stage, the bracing rods were tightening up, and the 22.4 mm dia. punching rods were just beginning to push against the lumber disk fuse elements. Toward the end of the tests, the slope of the load-displacement curves decreased due to the loss of stiffness resulting from failure of the lumber disk fuse elements and disengagement of the CMU infill panels from the in-plane load resistance.

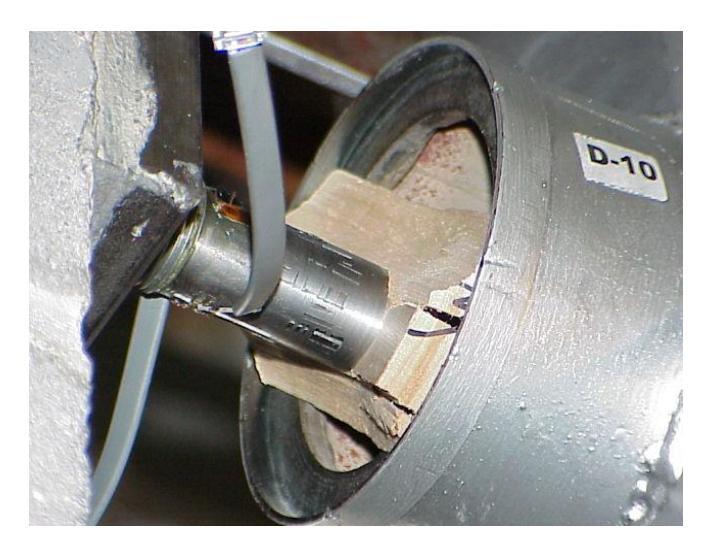
# Figure 25. Damage to fuse 10 during test CMUT2.

For tests CMUT1 and CMUT2, both of the fuse elements at the third story level reached their maximum capacities resulting in failure of the lumber disks and disengagement of the CMU infill panels. This behavior was expected since for these tests, the weakest fuse elements were located at the third story level. For tests CMUT3 and CMUT4, the same fuse element thickness was used at each story level. During test CMUT3, one of the fuse elements at the first story failed, while for test CMUT4, a lumber disk at the second story failed. This behavior demonstrates the importance of using an appropriate fuse element distribution in multi-story structural frames to control the failure sequence of the fuse elements and avoid a soft story mechanism.

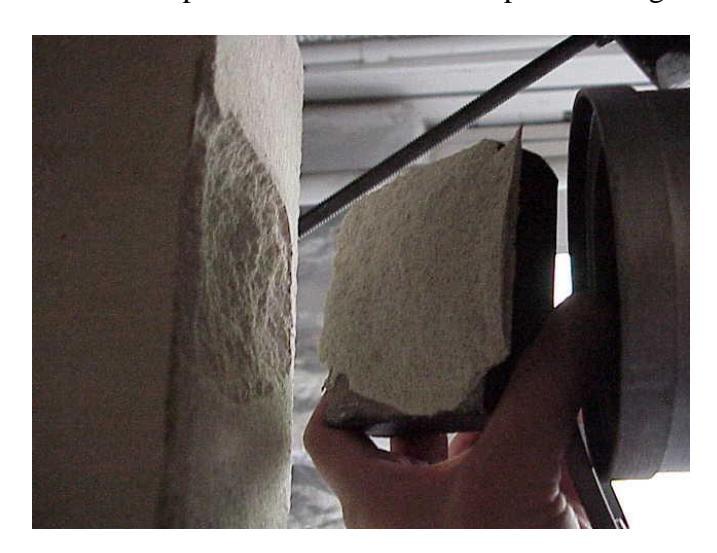
Figure 26. Plate separation from AAC wall panel during AACT3.

At the end of AACT1, the 25.4 mm  $\times$ 76.2 mm  $\times$ 76.2 mm steel bearing plates at fuse locations 6, 10, and 12 were separated from the AAC infill wall panels. This was the result of local crushing failures of the AAC material during the test. The bearing plates were reattached to the wall panels using epoxy. At the end of test AACT3, the 25.4 mm  $\times$ 76.2 mm  $\times$ 76.2 mm steel bearing plate at fuse location 10 also had to be re-epoxied onto the AAC infill wall panel due to local crushing of the AAC material, as shown in Figure 26.

During the AAC parametric tests, in-plane shear failure of the AAC infill panels was prevented by the lumber disk fuse elements. Local crushing failure of the AAC material, however, was observed during these tests at several fuse element locations. This local material failure did not seem to cause a reduction in the in-plane resistance of the AAC panels. Repairs were required to maintain the functionality of the fuse mechanism.

The crushing damage observed during these tests was seen at fuse locations with 6.4 mm, 12.7 mm, and 19.1 mm thick fuse elements. Based on the results of the lumber disk puncture tests, the average maximum capacities of the 6.4 mm, 12.7 mm and 19.1 mm thick lumber disks were 4590 N, 10,657 N, and 19,113 N, respectively. From the in-plane destructive shear tests, the average ultimate shear capacity of the AAC panels was 56.9 kN. Based on this data, the local AAC material failures observed during these tests occurred at load magnitudes that were much less than the ultimate capacity of the AAC wall panels. To avoid this type of premature failure of the AAC material, a different fuse mechanism configuration should be considered for AAC infill panels.
