# The Effect of Balcony Thermal Breaks on Building Thermal and Energy Performance: Field Experiments and Energy Simulations in Chicago, IL

## Irina Susorova <sup>1,2,\*</sup>, Brent Stephens <sup>1,\*</sup> and Benjamin Skelton <sup>2</sup>

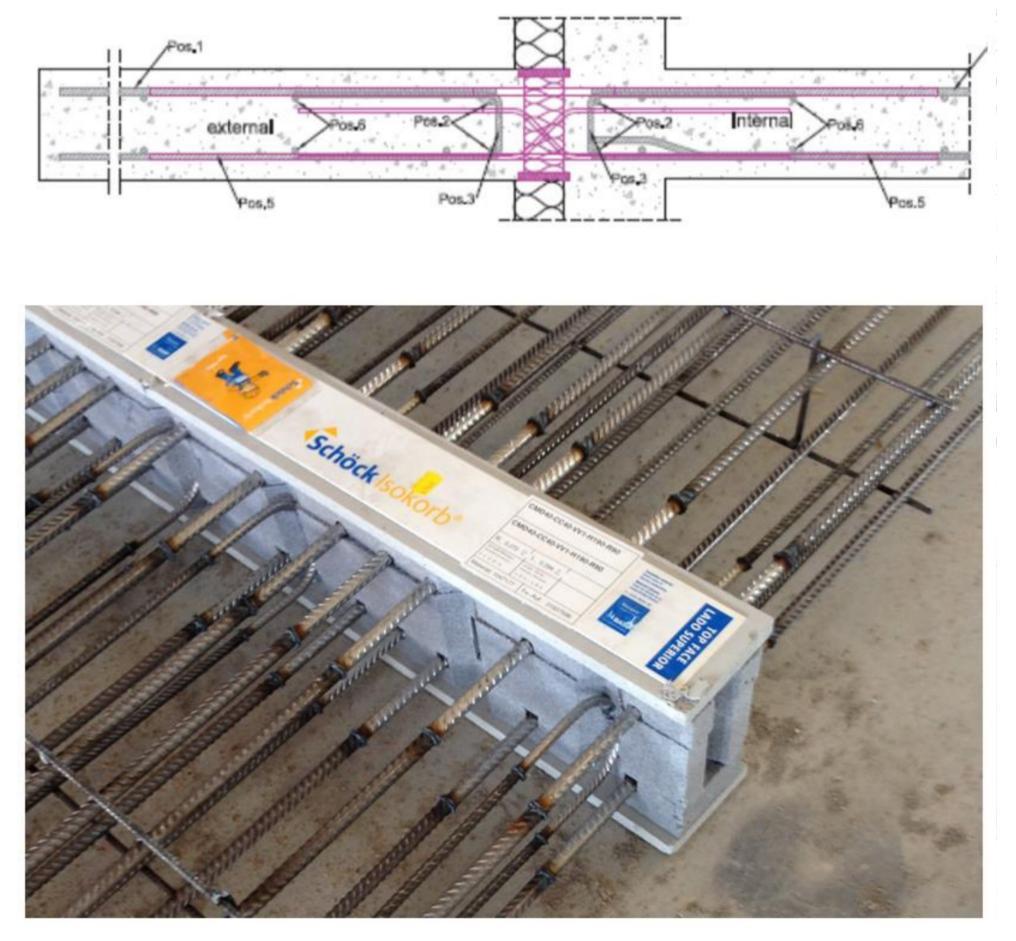
Figure 1. Cross section and detail of the installed balcony thermal break.

To experimentally characterize the in-situ thermal performance of balcony thermal breaks, a 14-story multi-family residential building located in Chicago, IL, which was under construction at the start of the study, was recruited for field measurements. The building had a total of 110 south-facing balconies, all of which except four balconies on the 13th floor, were constructed following the conventional practice of monolithic floor slabs extending beyond the vertical wall plane to create balconies without thermal breaks. The other four balconies on the 13th floor had commercially available thermal break products installed to separate the floor slab and balcony (Schock Isokorb<sup>®</sup> CM40 product) (Figure 1). Note that this was not the best performing thermal break product available from the manufacturer (Schock Isokorb<sup>®</sup> CM30, CM20, and CM10 products have higher nominal insulation values for the same slab thickness) [16]. The installation of the thermal break products on the site is shown in Figure 2.

The thermal break product introduced an interruption in the floor-to-balcony slab using 80 mm thick thermal insulation with stainless steel structural reinforcement (part of thermal break product) protruding through the insulation and connecting with the building rebar on either side. The area of structural reinforcement embedded in the thermal break product was estimated to be ~1.7% of the product's total cross-sectional area based on the number and type of rebar used: 32 12 mm- and 16 6 mm-rebars for the short balcony side and 80 12 mm- and 20 8 mm-rebars for the long balcony side, according to the building's structural details.

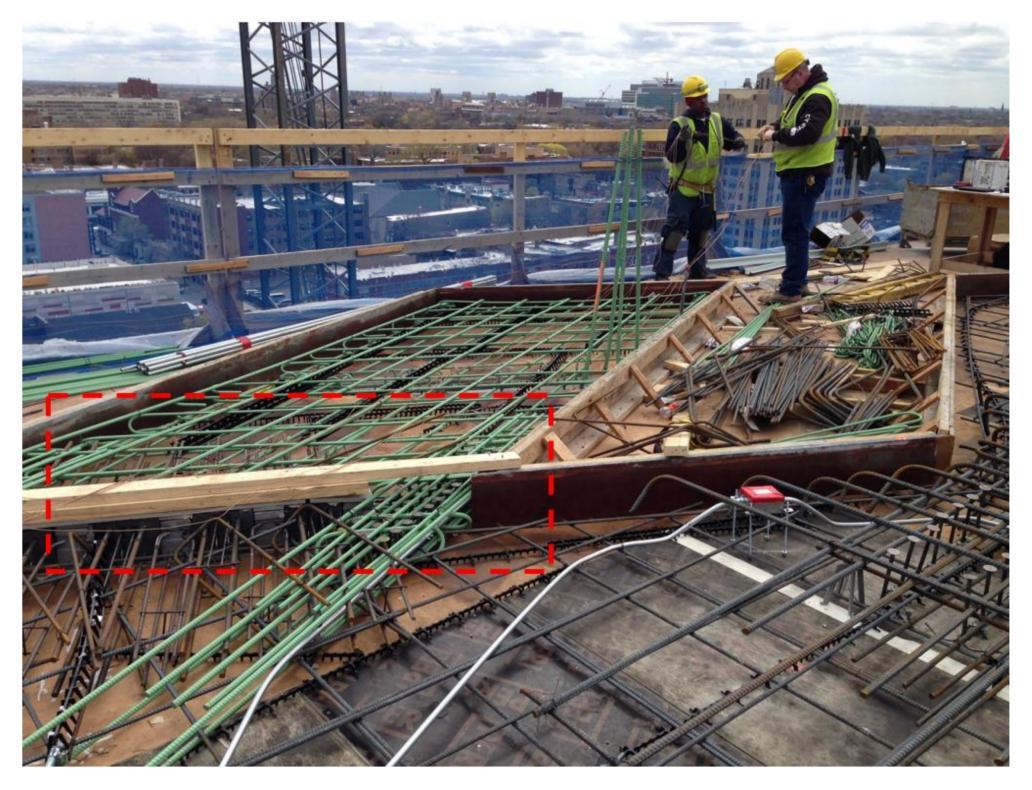
Figure 2. Balcony thermal break product and on-site installation.

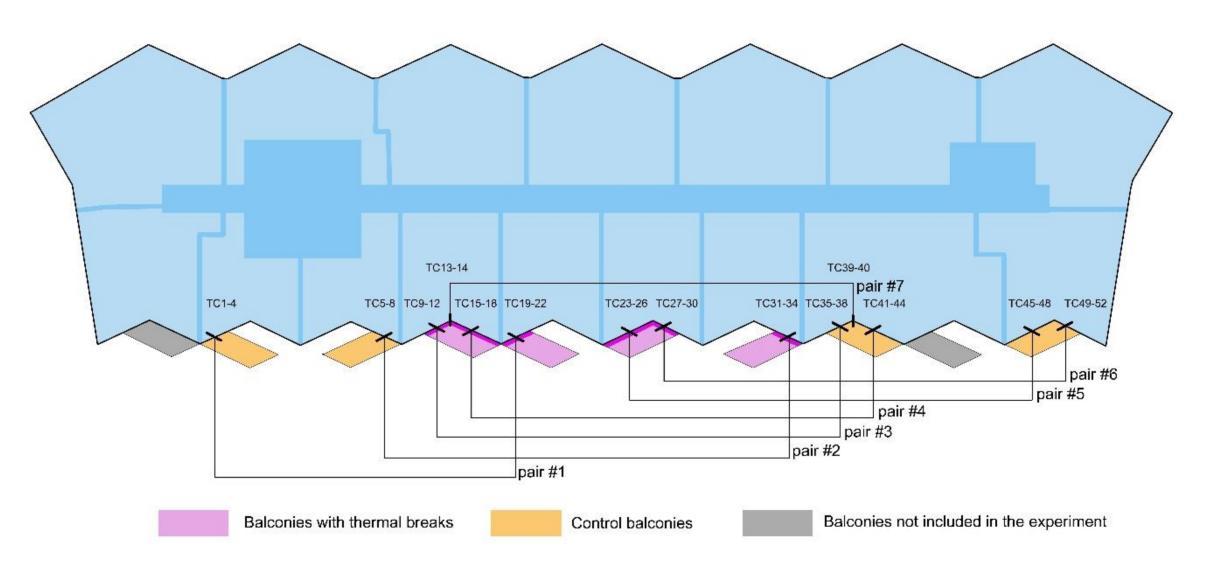
**Figure 3.** Floor plan showing the eight studied balconies on the 13th floor: Four balconies with thermal breaks and four conventional balconies without thermal breaks. Each balcony comparison pair was chosen based on similar geometries. Comparison balcony pairs are labeled pair #1-7. TC = thermocouple.

A total of eight balconies on the 13th floor were selected for making long-term in-situ temperature measurements inside the concrete on both the slab and balcony sides, including: The four thermally broken balconies and four conventional balconies that were selected on the same floor with the same south-facing orientation and with similar geometries to those balconies that were thermally broken. At this elevation, there were no obstructions or shading that could have influenced the results. A typical floor plan with the two balcony groups (i.e., control balconies and thermally-broken balconies) is shown in Figure 3. The typical balcony dimensions were 4.3 m by 2.3 m and the building envelope at the south façade consisted of floor-to-ceiling insulated glazing units.

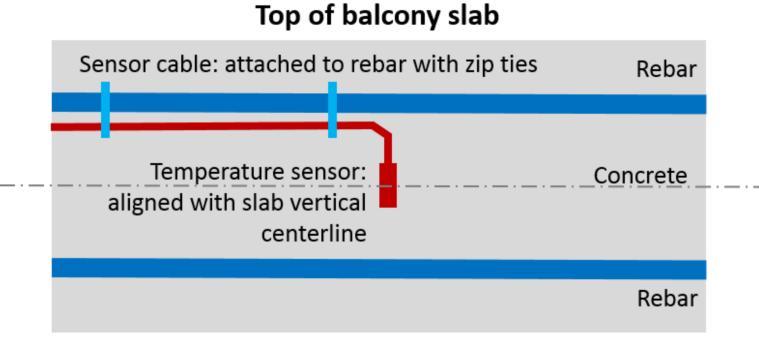
Figure 4. Cross section through a typical balcony.

A total of 52 type-K thermocouple (TC) sensors were embedded into the eight selected balconies and their adjacent interior floor slabs just before concrete was poured to complete construction of the floor slabs and balconies (Figure 4).

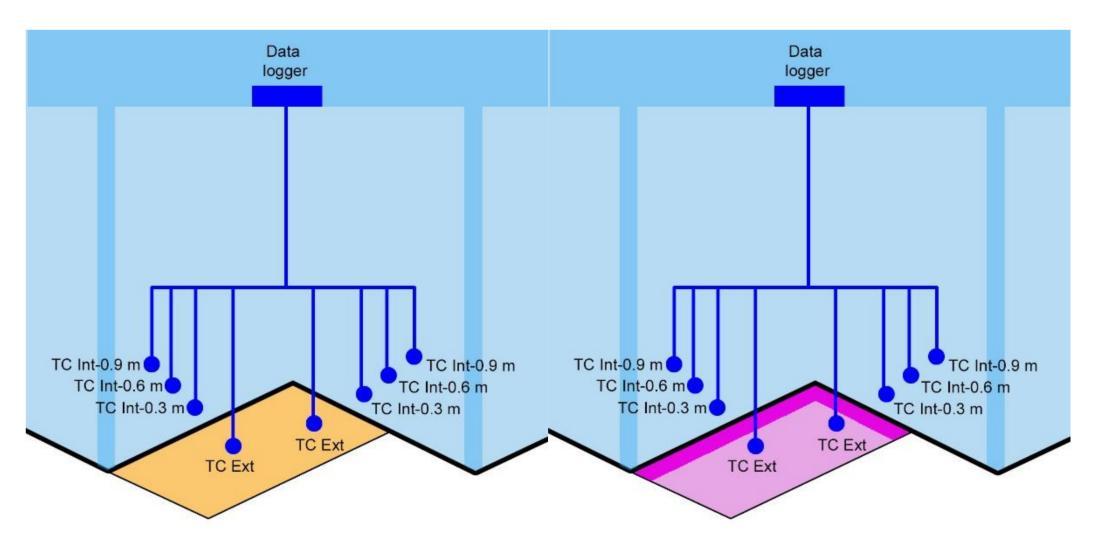
**Figure 5.** Detail of the experimental setup for balcony pair #5 and #6. The conventional balcony is shown on the left and the thermally-broken balcony is shown on the right (this particular balcony is thermally-broken in two places). TC = thermocouple; Int = interior; Ext = exterior.

Each thermocouple was aligned vertically with the balcony centerline and attached to the structural rebar with wire to remain reasonably well fixed during the concrete pour. Each balcony and corresponding housing unit had one exterior thermocouple installed approximately 0.6 m from the connection between the floor-to-ceiling glazing units and the slab, and three interior thermocouples installed at 0.3 m, 0.6 m, and 0.9 m from the wall-slab connection in the opposite linear direction (i.e., toward the inside of the housing unit). Two of the balconies that had thermal break products installed on both of their two sides also had two additional thermocouples embedded in the exterior slab between the thermal breaks and in the interior floor slab at 0.3 m from the perimeter. Since the building balconies were rhomboid in shape and all were oriented at slightly different angles, the thermocouple readings were grouped into seven pairs. Each pair was made to combine a control balcony and a corresponding thermally-broken balcony of the same geometric configuration. All thermocouple wires were run through the interior slab back to a common corridor where they were connected to Onset HOBO UX120 4-channel thermocouple loggers that remained externally accessible to the research team to periodically download the logged data. A detailed drawing of one of the equipment installations for a single balcony (pairs #5 and #6) is shown in Figure 5.

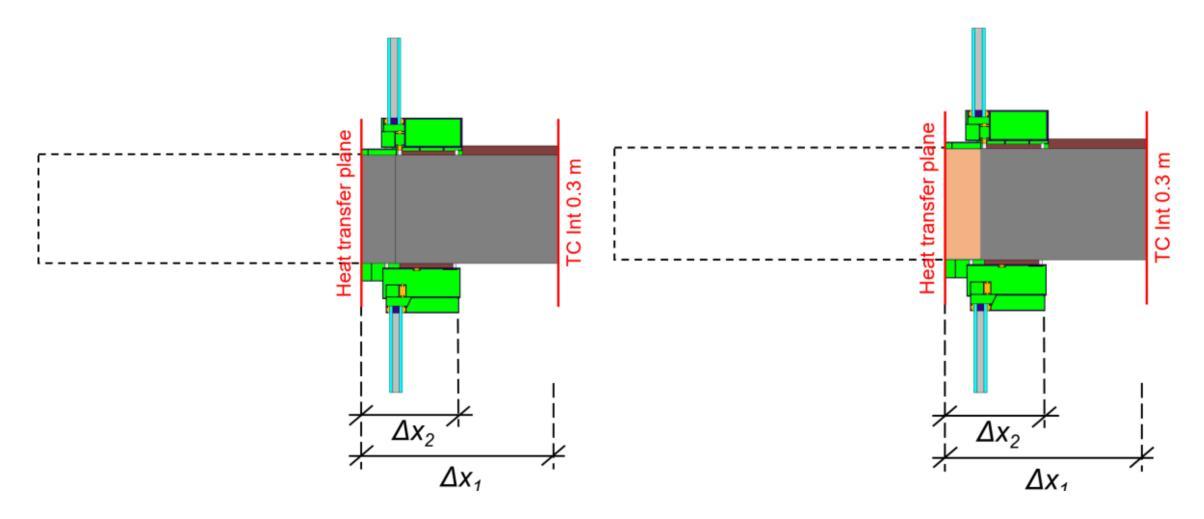
Figure 6. Vertical sections through the control (left) and thermally-broken (right) balcony connections.

Next, a series of steady-state 2-D heat transfer simulations of the case study balconies were conducted using THERM in an attempt to confirm the reasonableness of the estimates of 1-D thermal resistance made using the experimental data. There were two types of balcony connections among all balcony configurations: Along the long side (4.3 m) and along the short side (2.3 m). Each balcony slab connection consisted of cast-in-place concrete and structural reinforcement steel. The thermal breaks did not provide complete thermal separation of the balcony slabs and interior floor slabs. Due to their complex shapes, the balcony slabs had to be supported at the corners with poured-through concrete and regular reinforcement. The THERM analysis included vertical sections through both connections, the sections extending 0.3 m inside from the building perimeter (matching the positions of the thermocouple sensors in the field study), and 0.2 m of the exterior wall above and below the floor slab (Figure 6). Using this geometry, the thermal effects of adjacent envelope elements could also be investigated in addition to modeling the balcony connections alone (which has been done previously in the literature on the effectiveness of thermal breaks).

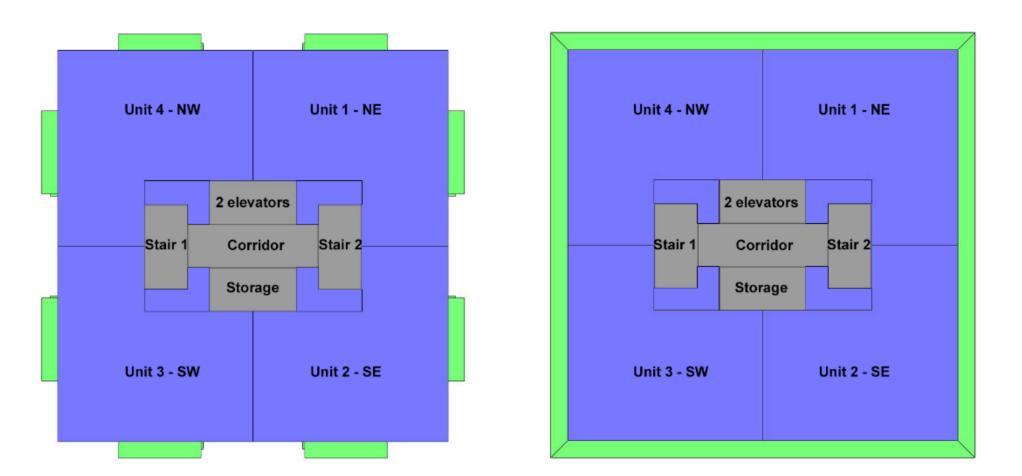
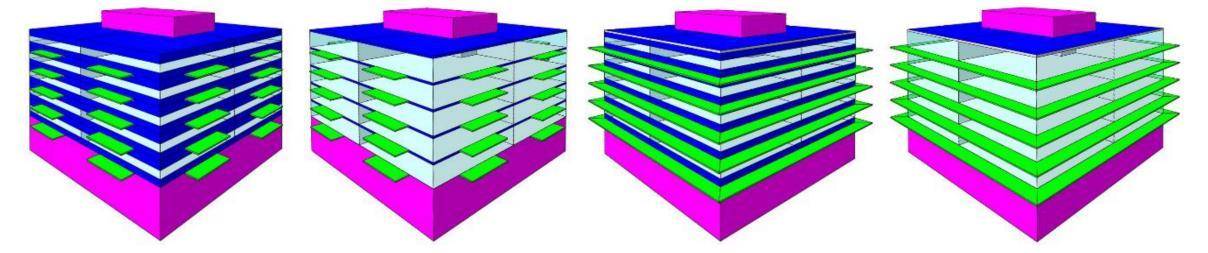
Figure 8. Five-story building models with different window to wall ratio (WWR) and balcony geometry.

Other modeling assumptions are listed below and shown in Figures 7 and 8:

- The modeled building was square in the plan 27 m by 27 m with four residential units per floor occupying the southeast, southwest, northwest, and northeast corners. The square floor plan was selected to minimize the effects of building orientation. The floor-to-floor height was 3 m. Each three-bedroom unit was approximately 162 m<sup>2</sup> with an assumed occupancy of four people per unit. Thus, the five-story building had 20 residential units with a total area of 3,660 m<sup>2</sup> and the 20-story building had 80 units with a total area of 14,680 m<sup>2</sup>.

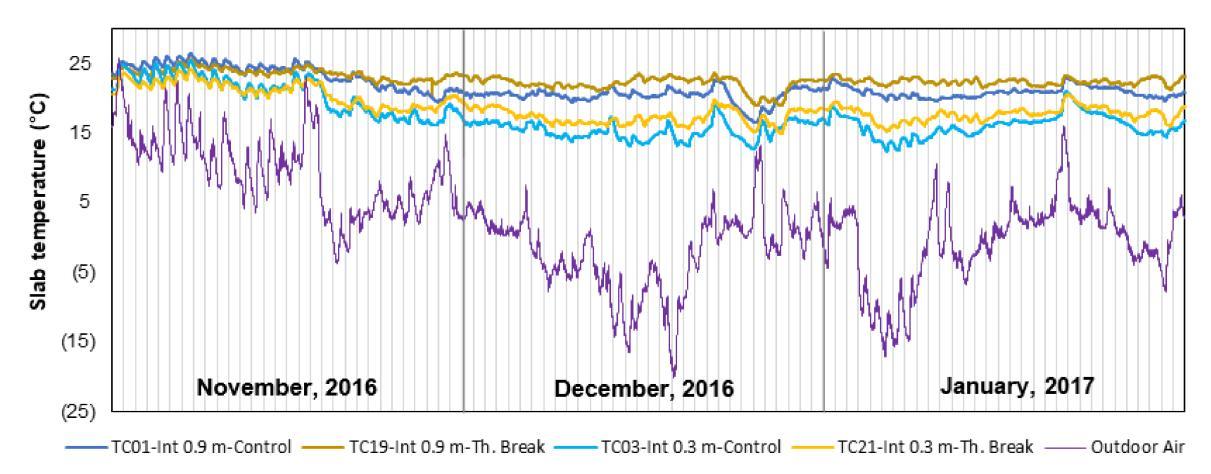
Figure 9. Interior floor slab temperature of the control and thermally-broken balconies (pair #1).

Figure 9 shows the temperature readings for balcony pair #1 for the three winter months of the monitoring periods (November, December, and January) when the effect of thermal breaks was the most pronounced. During periods of very cold ambient temperatures (i.e., below 0  $^{\circ}$ C), the interior

slab temperatures adjacent to the thermally broken balcony were as much as 4 °C warmer than those of the control unit, which further illustrates a positive effect that the thermal break products had in regulating interior slab temperatures. Notably, these measurements are very close to the experimental findings by Finch et al. [6], Murad, et al. [10], and Dikarev et al. [14].

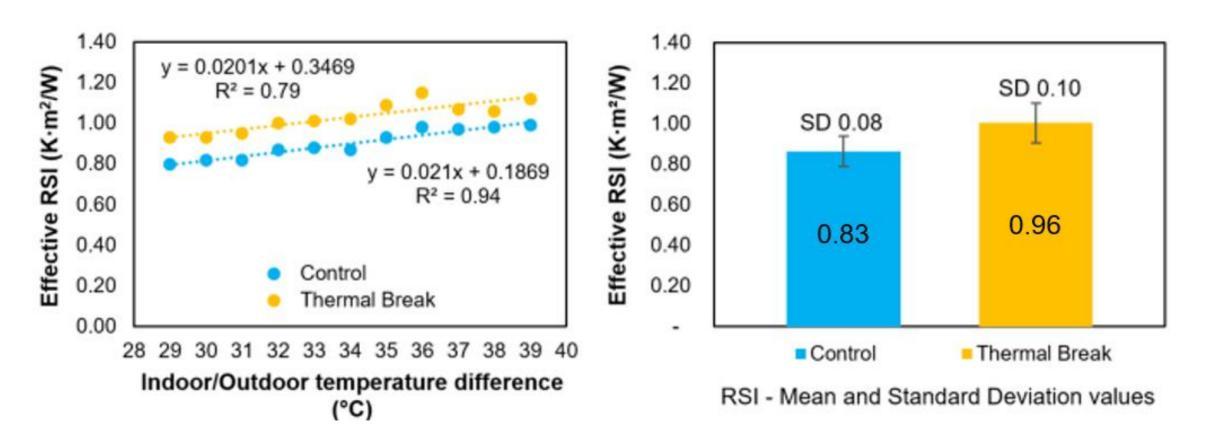
**Figure 10.** The effective 1-D thermal resistance for approximately 1 m length from ~0.3 m to the interior of the curtain wall to ~0.6 m toward the exterior of the balcony for balcony pair#1 estimated using data from November to January during periods when the exterior–interior  $\Delta T$  was greater than 20 °C and when no solar radiation was present.

In practice, the thermal resistance of insulation materials is rated under standardized test conditions in a controlled laboratory environment, typically with a mean simulated indoor air temperature of 21 °C, 50% relative humidity, no air movement, no exposure to solar radiation, and with a relatively high indoor/outdoor temperature differential of at least 20 °C [19]. In order to provide an approximation of the effective 1-D thermal resistance of the balcony assemblies, extending the measurement length from ~0.3 m to the interior to ~0.6 m to the exterior, that is comparable to that measured at standardized rating conditions, our analysis (described in Section 2.2.1) used only the data collected from periods when the indoor/outdoor temperature differential was greater than 20 °C using Equation (4) and when no solar radiation was present, as shown in Figure 10. Buildings 2019, 9, 190

Using this method, the average effective 1-D thermal resistance of the approximately 1 m of floor slab sections was estimated to be ~0.83 K·m<sup>2</sup>/W (±0.08 K·m<sup>2</sup>/W) for the control balcony and ~0.96 K·m<sup>2</sup>/W (±0.10 K·m<sup>2</sup>/W) for the thermally-broken balcony, averaged over all of the winter periods when the indoor/outdoor temperature differential was greater than 20 °C. The effective resistance of the thermal break product in this installation can be calculated as the difference between the resistances of the control and thermally broken slabs (as suggested by [2]), which results in an average value of 0.12 K·m<sup>2</sup>/W. These estimates demonstrate that in this building, the effective 1-D thermal resistance of the balcony with the thermal break product installed, as measured across a length of approximately 1 m, was increased by an average of approximately 14% compared to the monolithic control slab balcony. It is worth noting that if a better performing insulated balcony thermal break product by the same manufacturer had been installed in the studied building, the increase in the effective thermal resistance of this connection likely would have been higher.

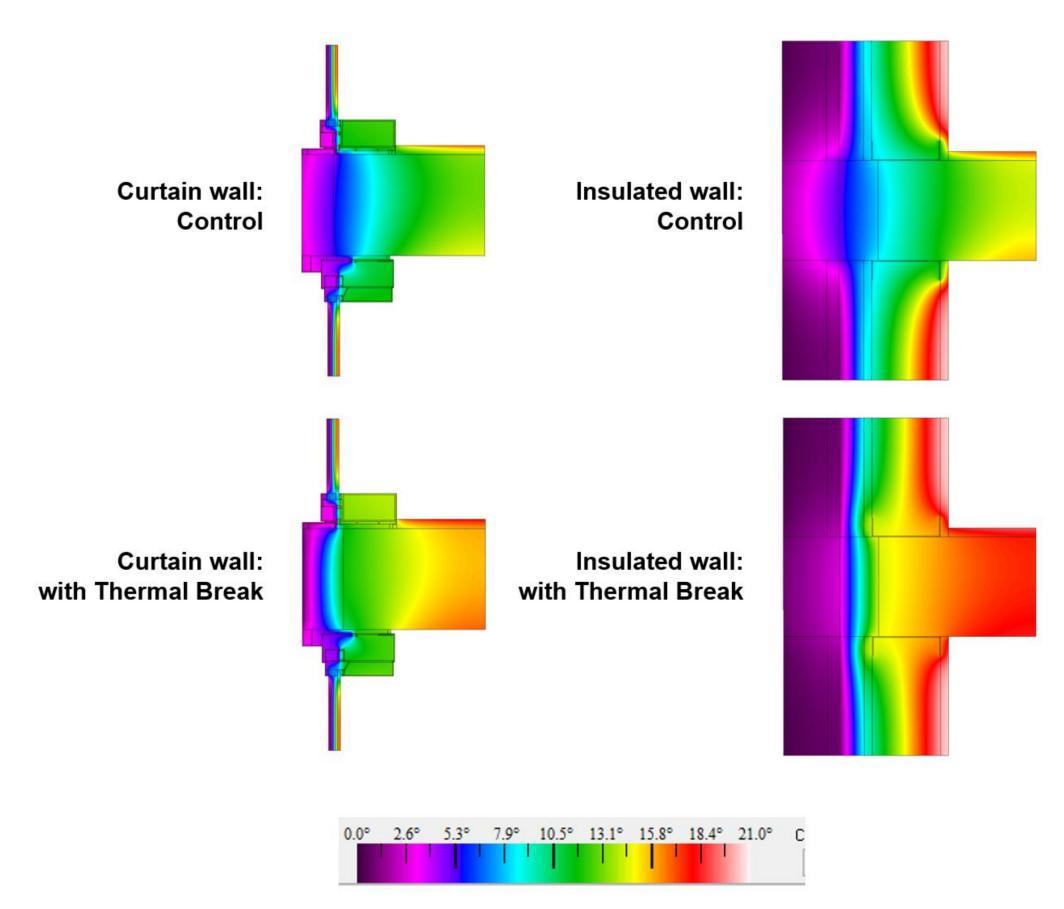
**Figure 11.** Color gradient of temperature distributions for the different balcony connection options and the installed thermal break product.

Figure 11 shows the modeled temperature distributions across the studied sections predicted using THERM. The resulting modeled effective 2-D thermal resistance of the existing balcony slabs (spanning from ~0.3 m to the interior to the exterior wall surface) was estimated to be RSI 0.23 K·m<sup>2</sup>/W for the control balcony and RSI 0.52 K·m<sup>2</sup>/W for the thermally-broken balcony. Thus, the effective resistance of the thermal break product was estimated to be 0.29 K·m<sup>2</sup>/W. The value of the thermal break RSI calculated with THERM (0.29 K·m<sup>2</sup>/W) is higher than that estimated from the field measurements (0.12 K·m<sup>2</sup>/W). The differences in the results obtained by the THERM analysis and calculated from the measured data may be explained in part by the following factors:

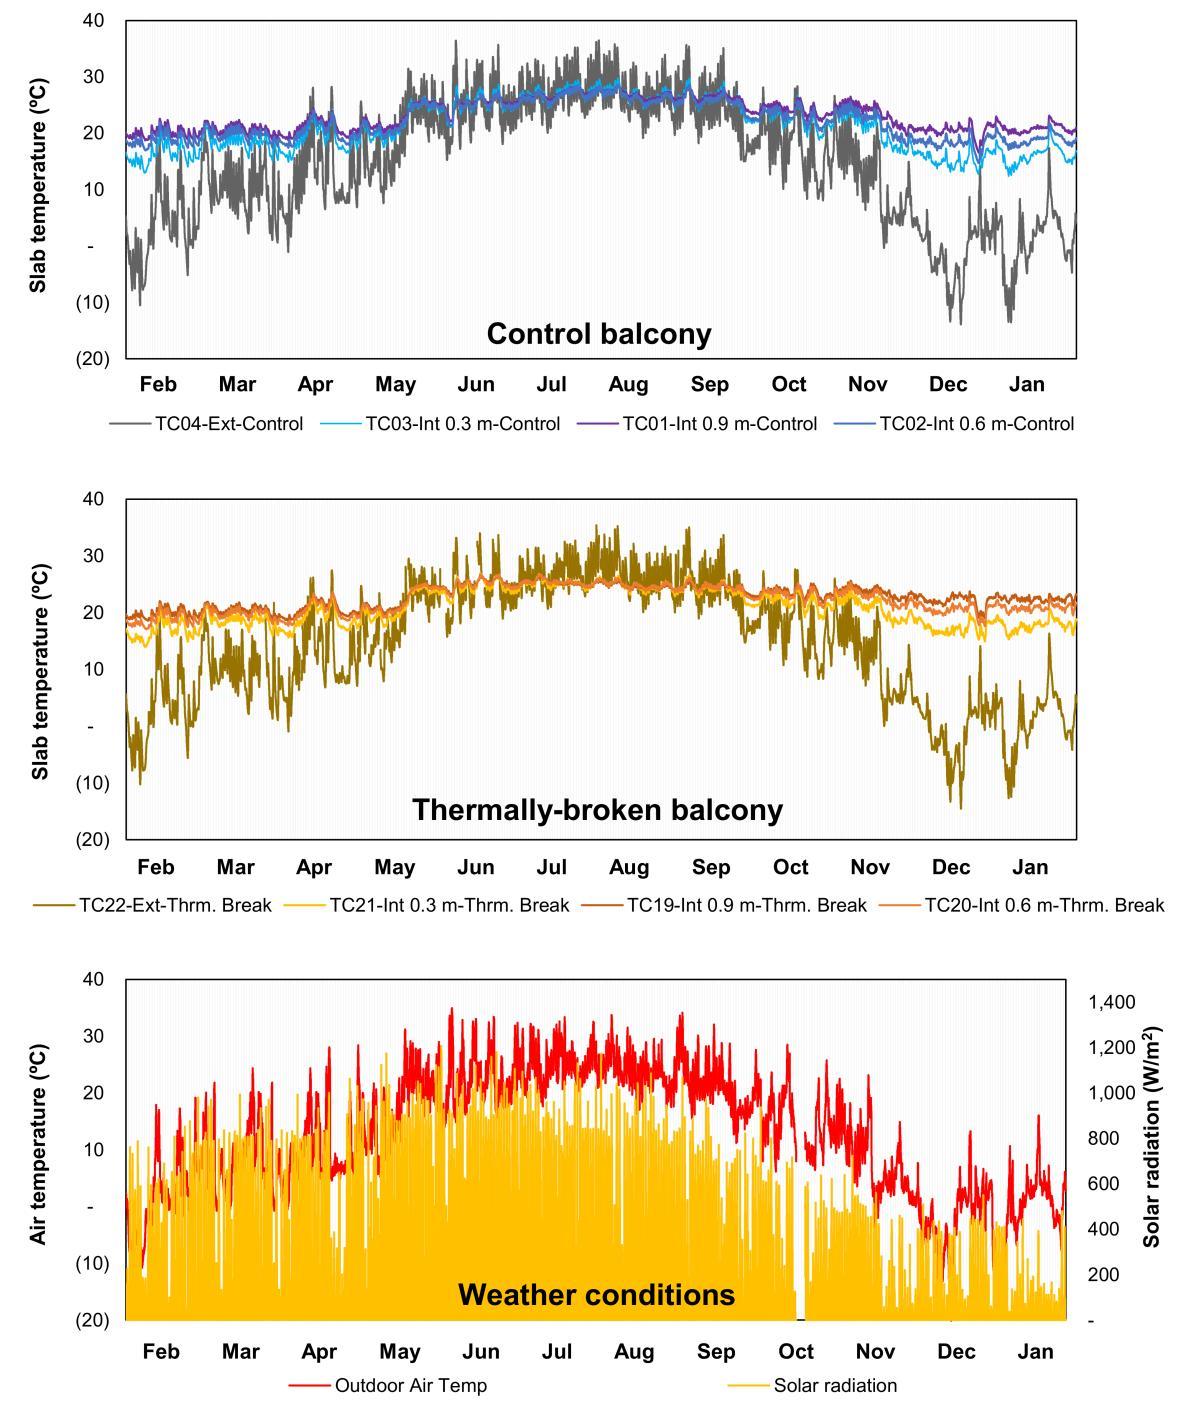
Figure A1. Experimental data for balcony pair #1.

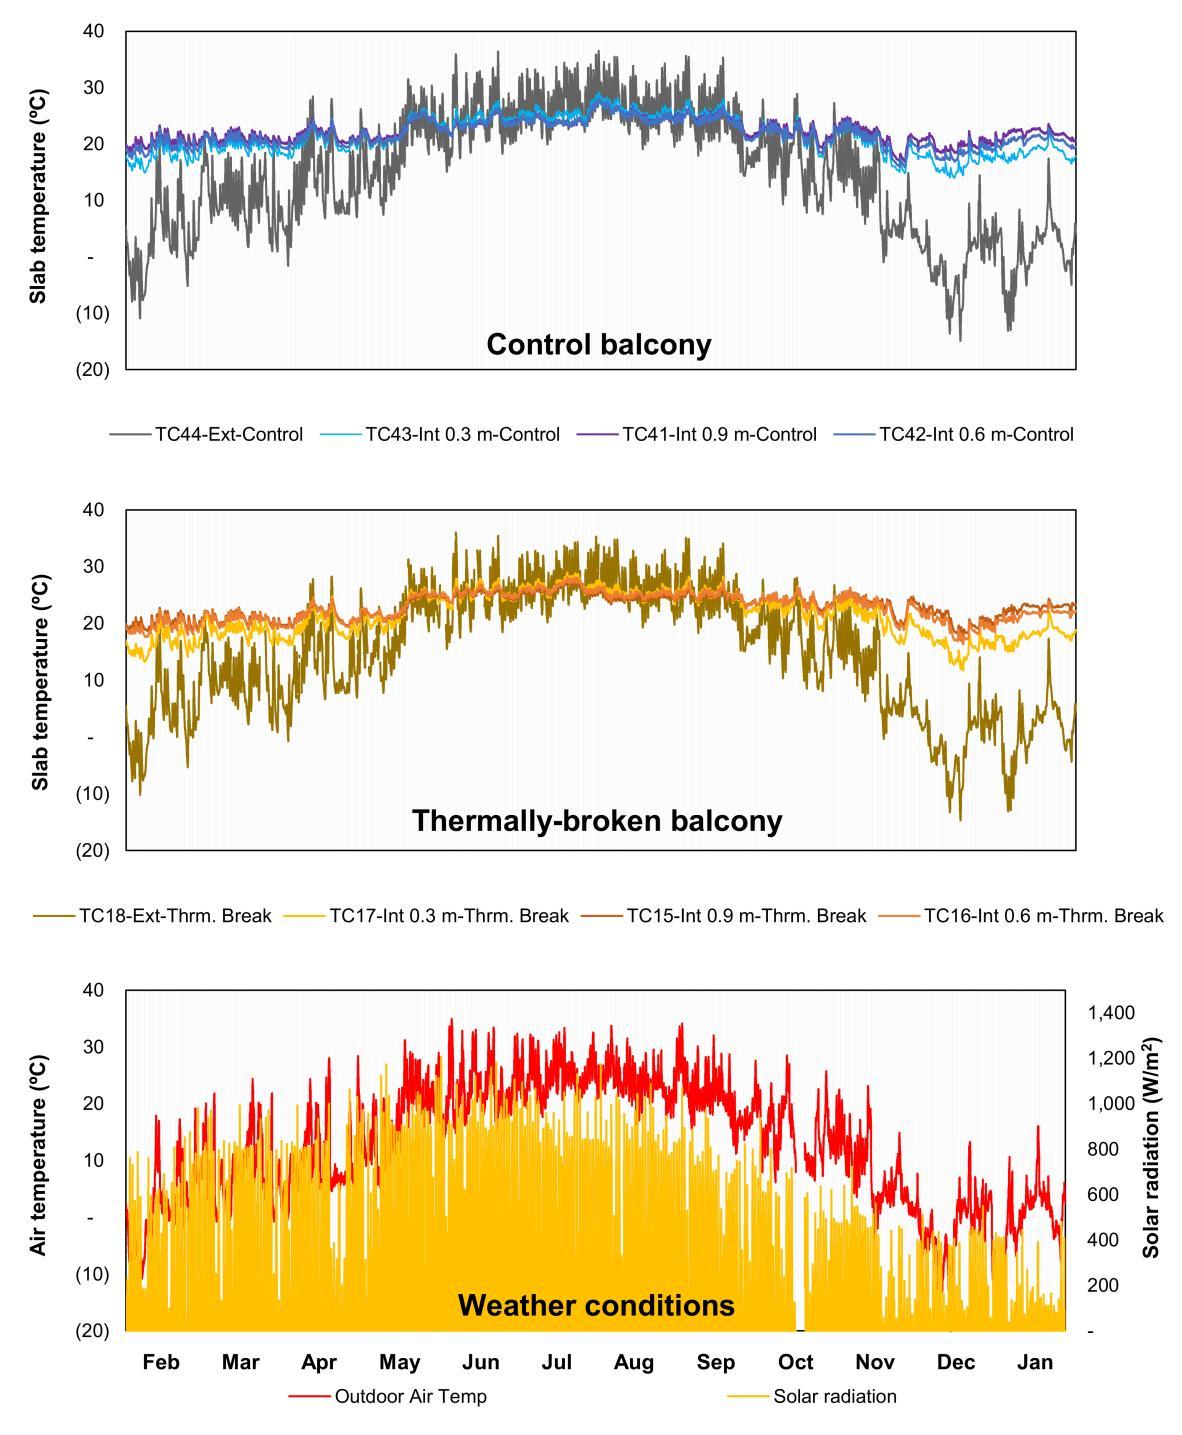
Figure A3. Experimental data for balcony pair #4.

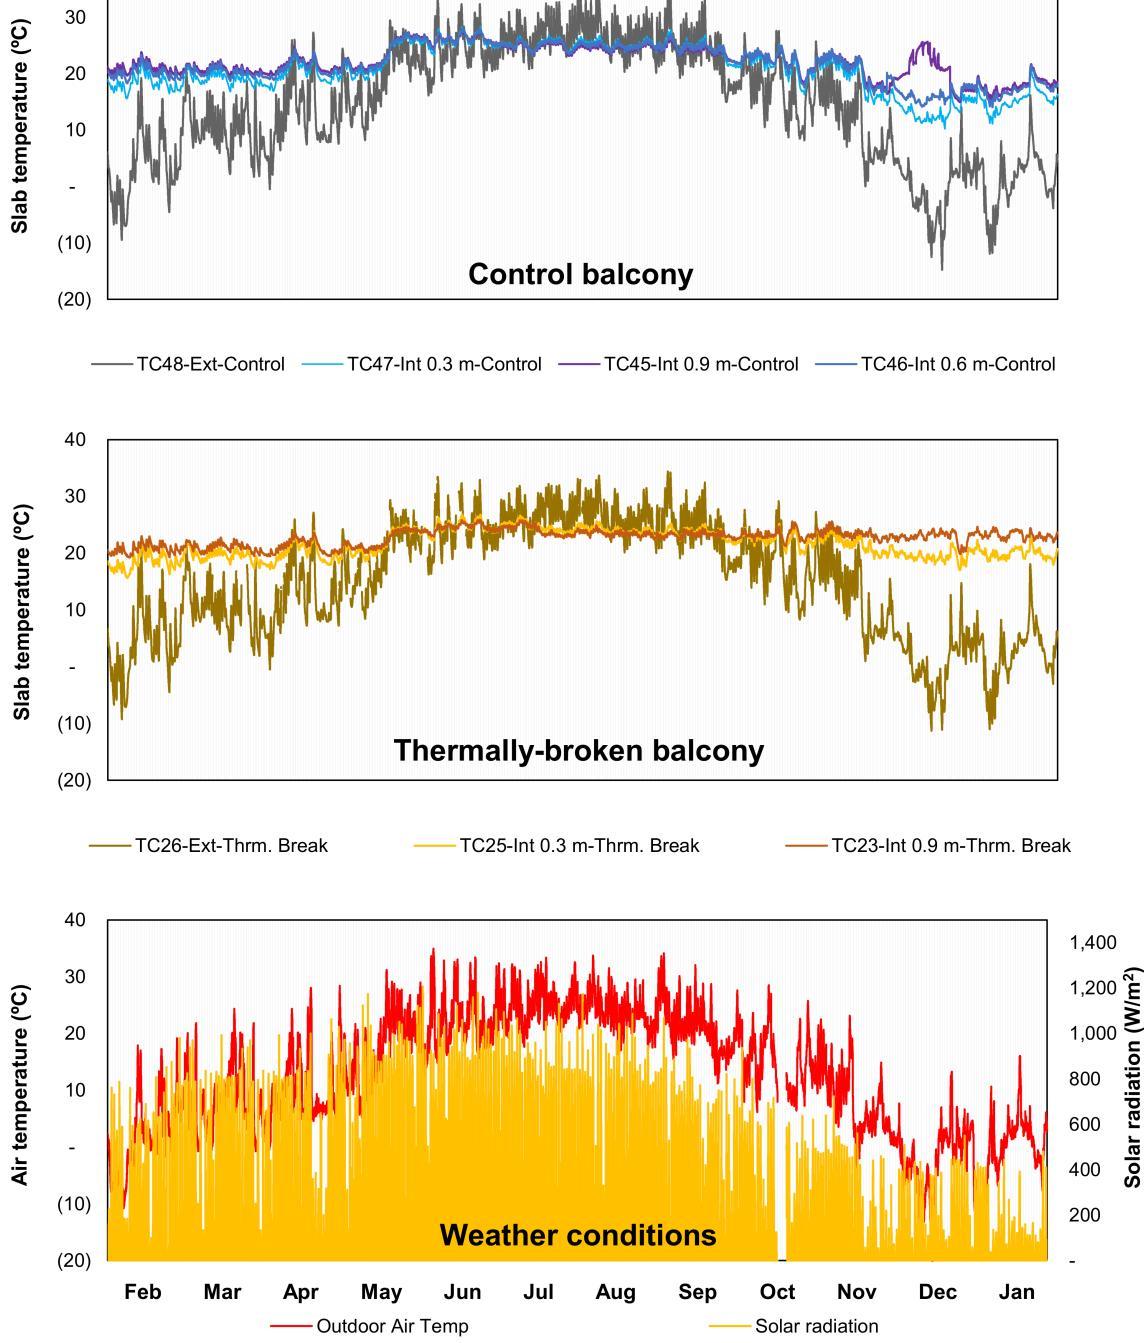
Figure A4. Experimental data for balcony pair #5.

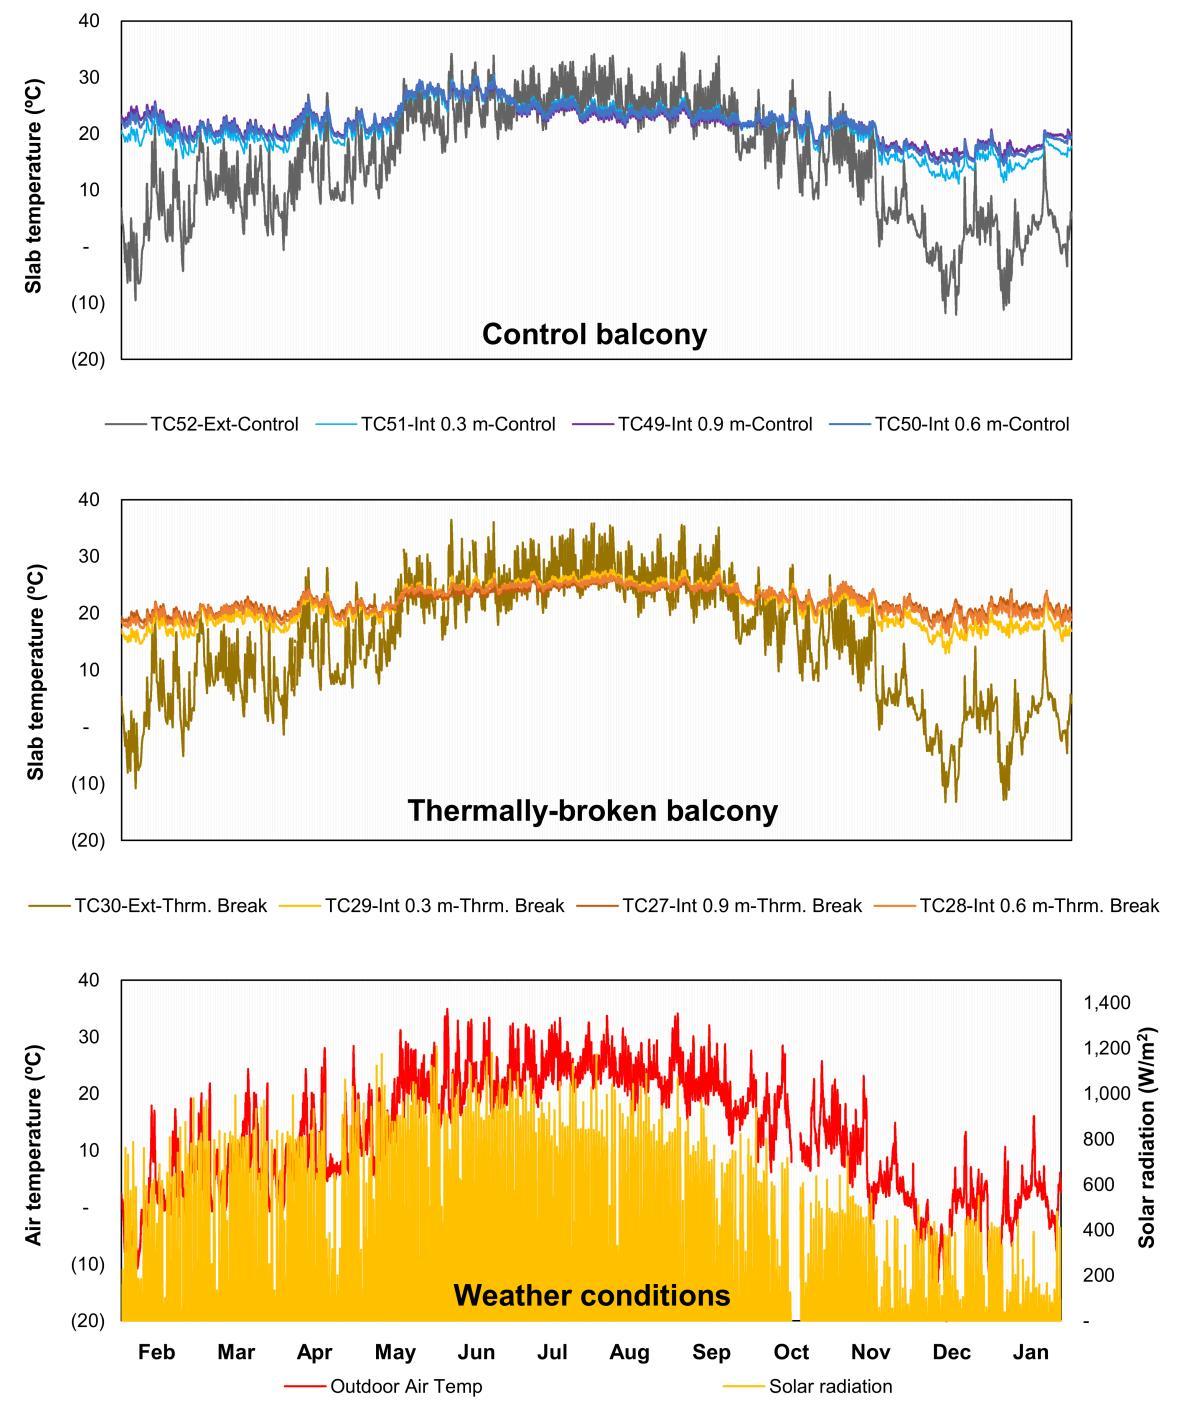
Figure A5. Experimental data for balcony pair #6.

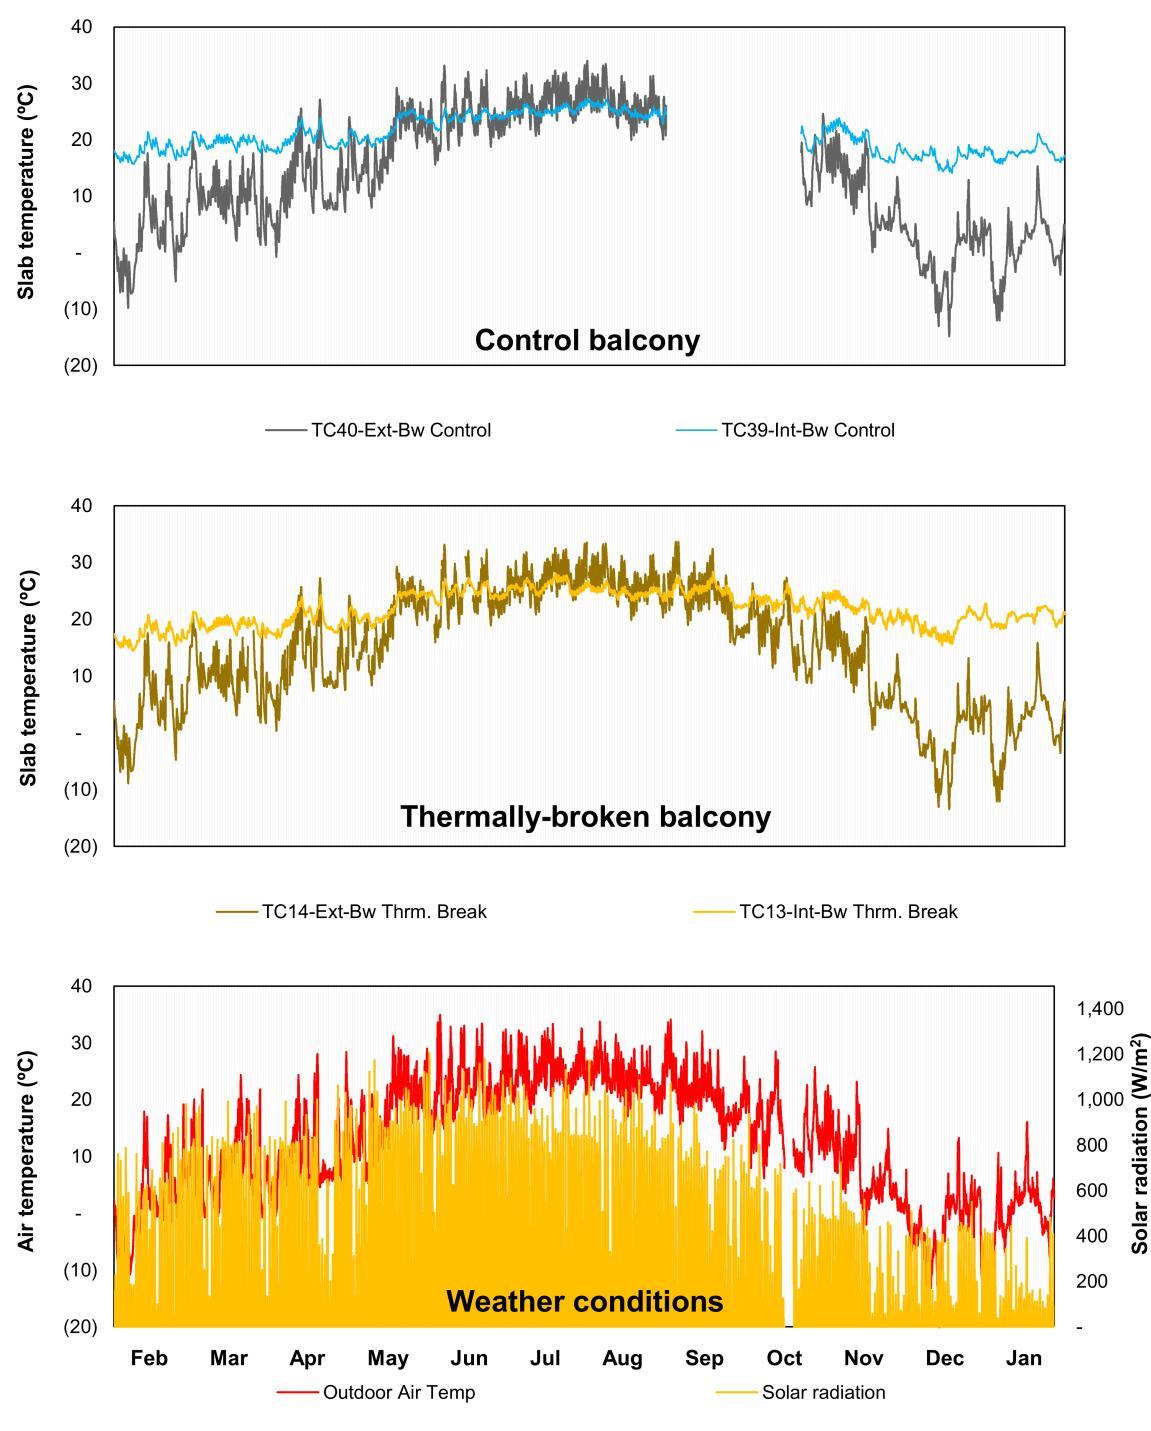
Figure A6. Experimental data for balcony pair #7.
