Article

Identification of Problems Associated with the Usage of Friction (Koeppe) Hoists Based on **Geodetic Measurements**

Agnieszka Ochałek^{1,*}, Wojciech Jaśkowski¹ and Mateusz Jabłoński²

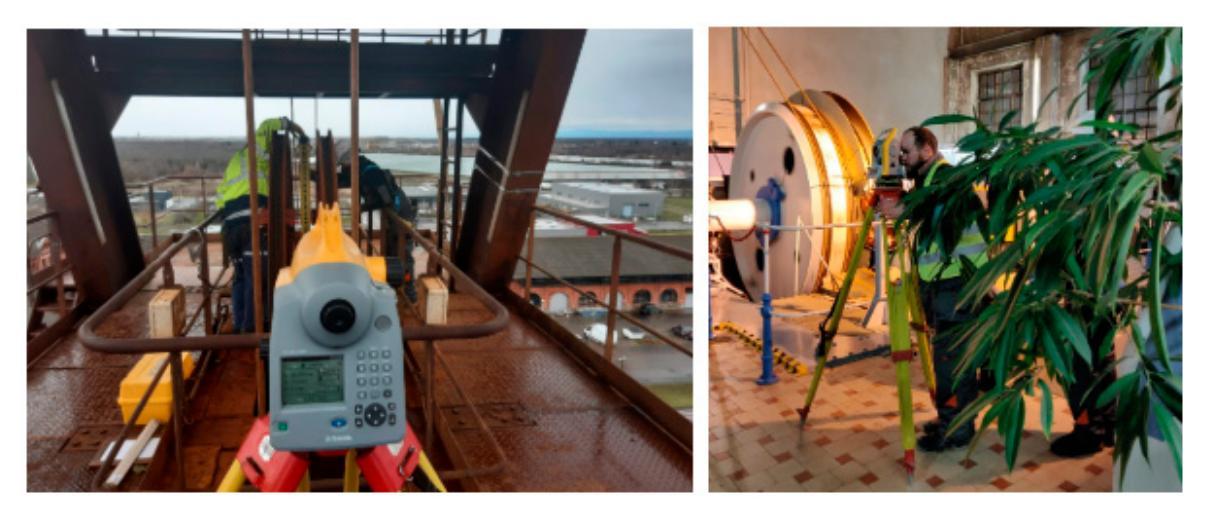
Figure 1. Measurements carried out at the headframe (on the left) and hoisting machine (on the right).

In December 2019, several hoisting assemblies were inventoried by the surveying team consisting of AMC company (Leawood, KS, USA) and AGH University of Science and Technology representatives with extensive experience in this type of research (e.g., [1]). Two of the measured objects had problems associated with the usage of Koeppe friction. The measurements were performed using a panoramic laser scan with the phase scanner FARO FOCUS 3D. The device allows information to be obtained about the measured object with a resolution of 5 mm/10 m distance with an accuracy not worse than ± 2 mm for a single measuring station. Additionally, elements particularly important for the performed analysis (inclination of hoisting machine and rope wheels shafts) have been determined by the precision leveling technique (with the usage of Trimble DiNi 0.3 and the set of invar rods that ensures leveling accuracy below 0.3 mm/1 km). The internal consistency of the point cloud (Figure 1) was ensured by the high accuracy measurements of the geodetic network with a total station (Trimble C3 with an accuracy of 2'' angle and length of 2 mm + 2 ppm.).

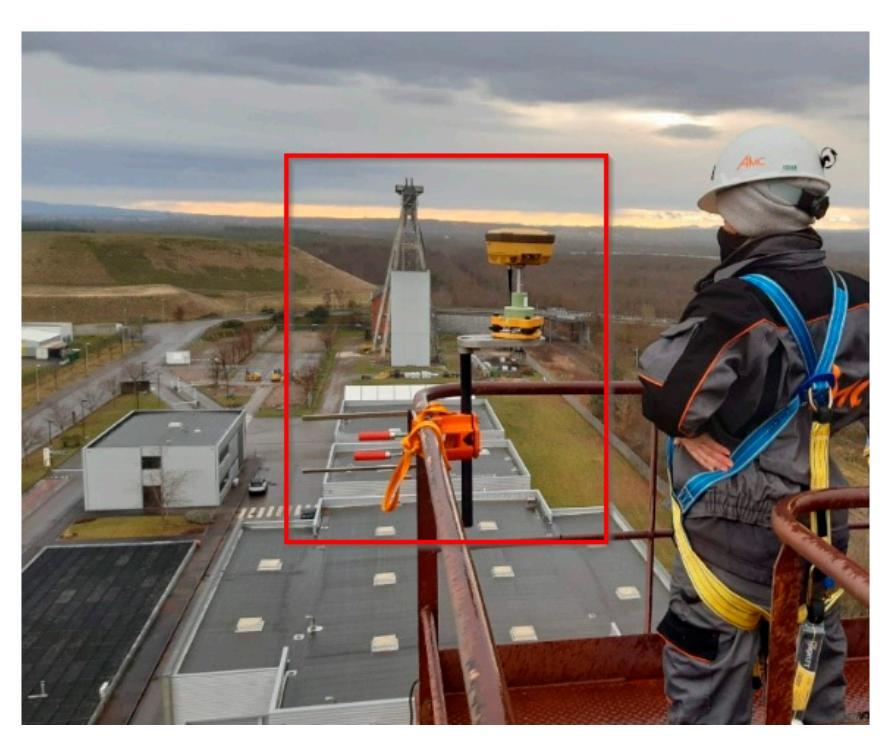
Figure 2. Receiver measuring vibrations of the headframe in the real-time kinematic (RTK) technique.

laser scanning and GNSS measurement in real-time kinematic mode with a receiver located on the shaft tower (Figure 2) with the base station recording data in the static mode [19].

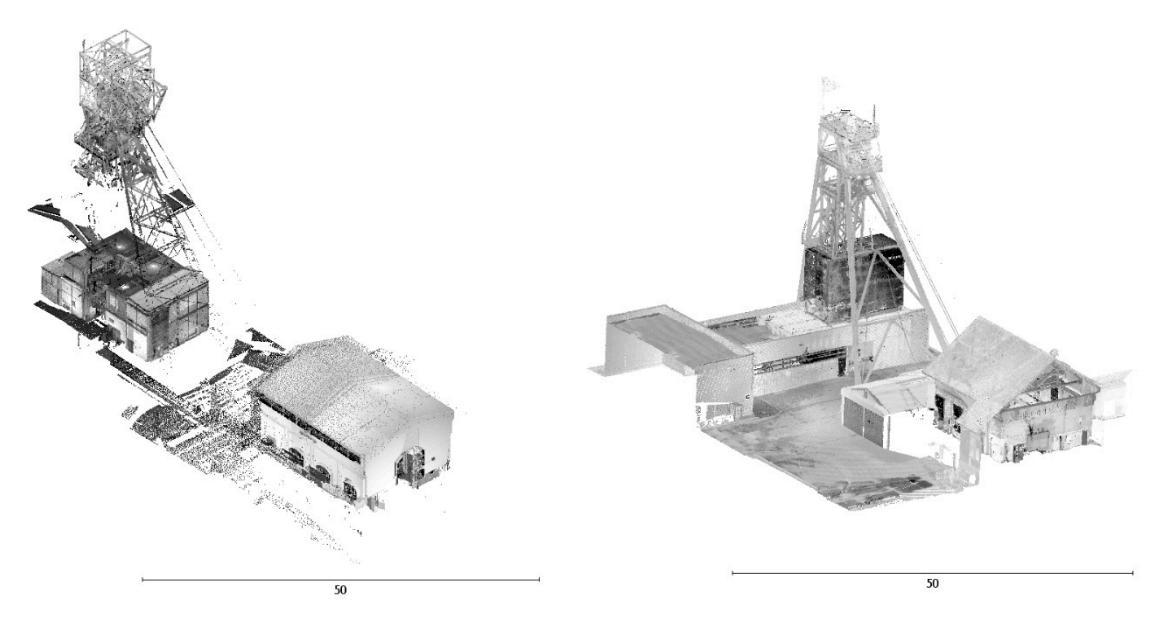
Figure 3. Point clouds of the inventoried headframes (located in Poland on the left, located in France on the right).

The results of the laser scanning measurements (point clouds) allowed us to develop spatial models of inventoried objects [20] (Figure 3). In addition, subsequent computer-based analyses were performed such as determining the characteristic points located on the axles of hoisting machines and cable pulleys, establishing transverse profiles on shaft towers, and the amplitude of vibration of the winding rope. The obtained base of points was used to prepare the spatial arrangement of the axes of the Koeppe drums, pulleys, shaft tower structure, and ropes.

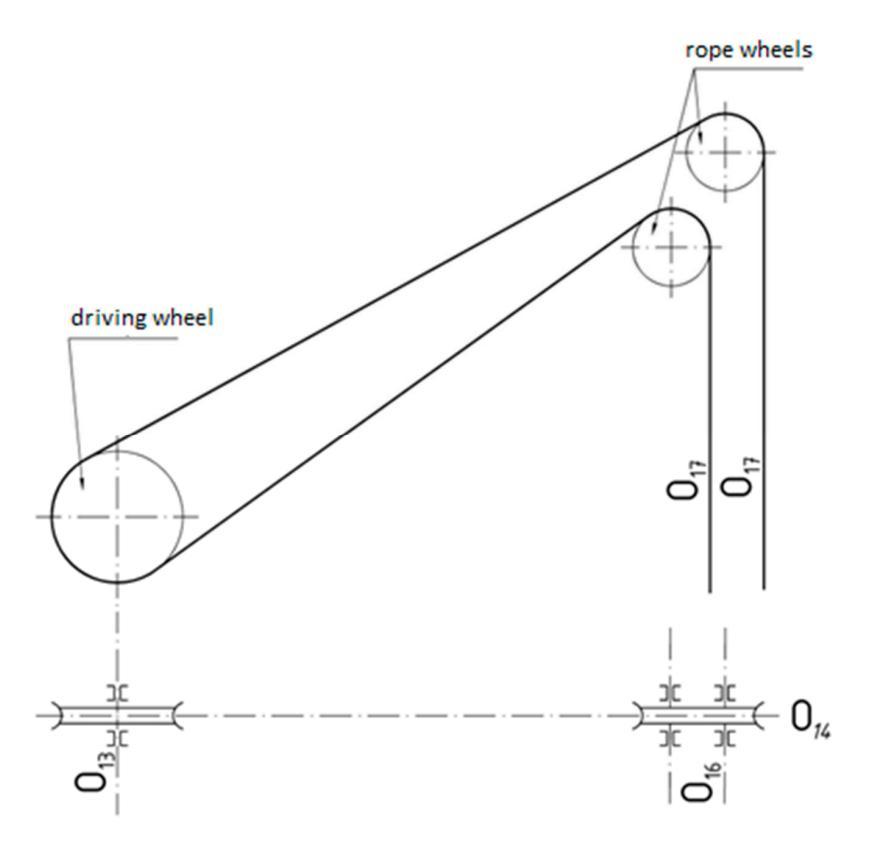
Figure 4. Sketch of the hoisting axle for the machine with the drive wheel (Koeppe) of the pulleys located in one vertical plane.

In the case of a hoisting device with a Koeppe friction and two rope pulleys (upper and lower) associated with it, the friction angles (and shifts of the proper grooves) are determined separately for the upper rope and the lower rope. Therefore, for the upper rope on the upper wheel, the friction angle is determined as the difference in the direction angles of the longitudinal axis of the pulley and the individual pulling axis associated with that pulley. For this upper rope, the friction angle on the Koeppe winder is determined as the difference in the direction angles of the longitudinal axis (plane) of the Koeppe winder and the pull axis associated with that wheel. The apparent friction angles for the bottom rope are determined analogously. In a situation where the hoisting device is a multi-rope friction winder, the apparent rope friction angles are determined for each pair of corresponding grooves on the drive wheel and cable wheel. Two friction angles are determined for each pair, one for the rope on the drive wheel and one for the rope on the cable wheel. To determine these friction angles, it is necessary to know the azimuths (direction angles) of the pull axis for the corresponding set of grooves on the drive wheel and on the cable wheel. This pull axis is defined as the straight line connecting the center of the rope groove on the drive wheel with the center of the pulley groove. The friction angles of the rope on the driving wheel are therefore the differences between the azimuths of the individual grooves on this wheel and the azimuths of the pull axis associated with each of these grooves. Similarly, rope friction angles on cable wheels are the differences between the azimuths of the grooves on those wheels and the azimuth of the pull axis associated with the individual wheel (Figure 4).

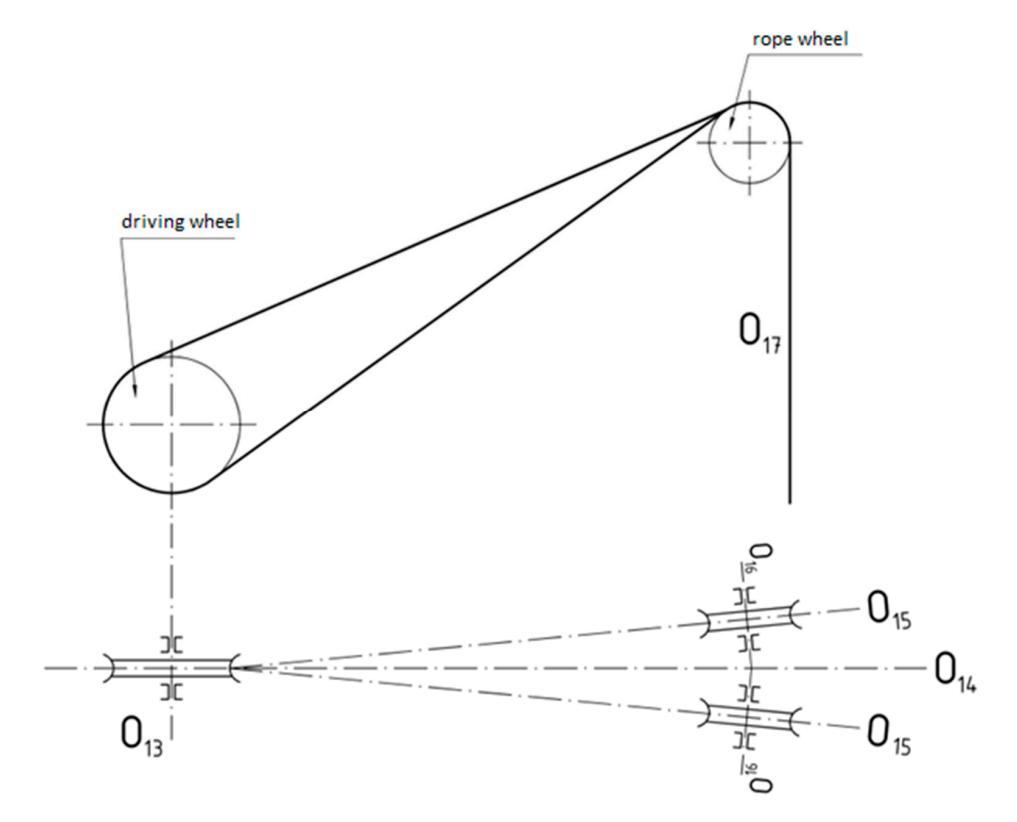
Figure 5. Sketch of the hoisting axle for a machine with a drive wheel (Koeppe) and pulleys arranged side by side.

In the case of the Koeppe winder and two rope pulleys connected to it (positioned next to each other), the angles of friction and the displacement of the grooves are determined separately for the underlap rope and the overlap rope. The friction angle is determined as the difference in the direction angles of the longitudinal axis of the pulley and the rope associated with that pulley. For this rope, the friction angle on the Koeppe winder is determined as the difference of the direction angles of the longitudinal axis (plane) of the Koeppe winder and the pull axis. However, it is not possible to comply with the provision contained in the regulation cited above. Therefore, it should be assumed that the drawing axis should be symmetrical (in the middle between) to the planes of the pulleys (Figure 5).

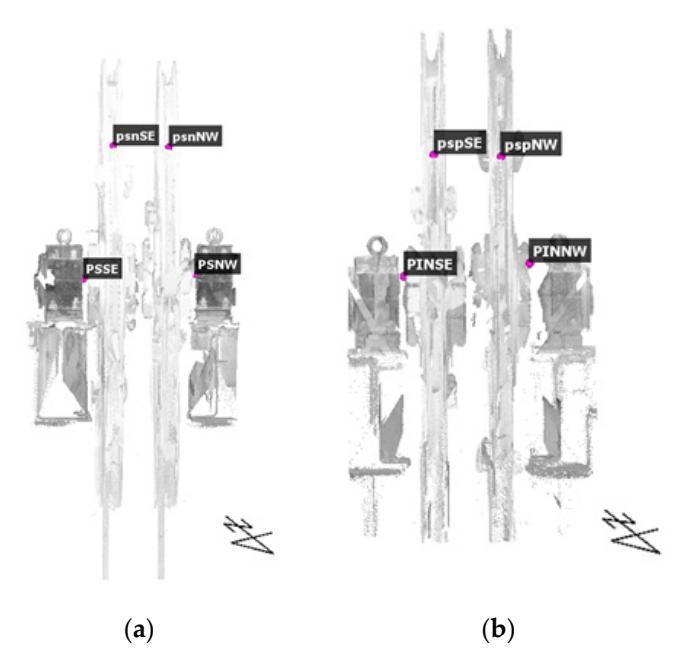
Figure 6. Location of the rope winding points on rope wheels, platform: (a) upper; (b) lower.

In all cases, two axes—the shaft axis of the winding machine (O_{13}) and the drawing axis (O_{14})—are significant to determine the geometrical conditions associated with the winding machine and driving wheels on the shaft tower (Figure 6) and are defined as follows:

- O₁₃—axis of the driving wheel shaft—longitudinal axis of the driving wheel shaft;
- O₁₄—draw axis—straight line which in the case of pulleys positioned in one vertical plane connects point of intersection of the transverse groove plane with its shaft axis (O₁₃) with the point of intersection of the pulley surfaces with their shaft axes (O₁₆); and
- O₁₇—hoisting machine suspension axis—vertical line passing through the center of the rope cross-section at the point where the rope exits the rope pulley.

The first inventoried object was an A-form double backstay headframe with a multi-rope friction Koeppe winder and two levels of wheels (Figures 6 and 7). Multi-rope friction winders are tower mounted, with either cages or skips, and provided with a counterweight. Four ropes are used, operating in parallel and sharing the total suspended load. The hoisting assembly is located in the east of France and supports the closed potassium salt mine. Although currently the shaft tower and the shaft itself are not heavily used, in the near future, a significantly higher load of the tower is planned, both in terms of travel frequency and weight of transported materials. The mine's power engineering department has diagnosed the problem of uneven lining wear at the upper level of the pulleys. According to the observations, at a higher winding speed of the cage (the maximum allowed speed in this analyzed problem was 4 m/s) and a larger load mass, the overlap rope exceeded normal movement amplitude, and the tower had been vibrating more than regularly. This second aspect should not affect the operation of the tower with a steel structure (especially with the low height of the lower and upper pulleys above the shaft station—24 and 28 m). However, it was also decided to analyze this issue. It is worth mentioning that French law does not raise the issue of using shaft towers, periodic technical inspections, or of critical values of deviations. It is the manager's responsibility to maintain the technical condition of the facilities in an appropriate condition. The mine administrator decided to base the assessment on the Polish regulations and experience of the measuring team.

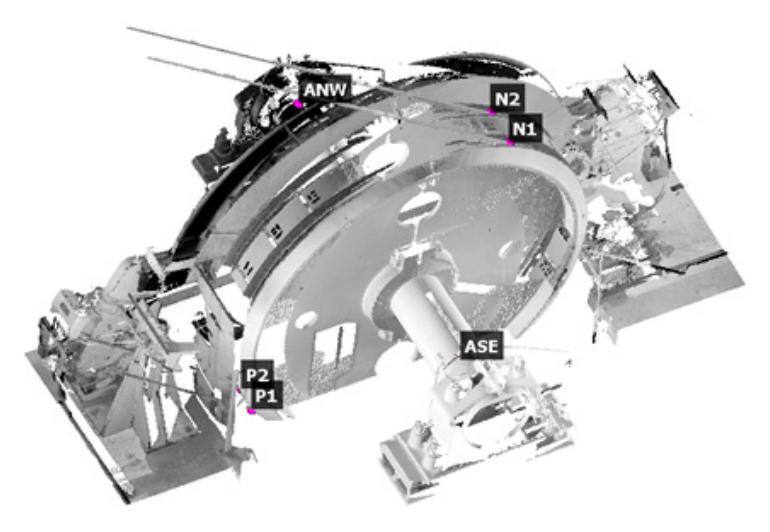
Figure 7. Location of the characteristic points on the Koeppe winding machine drum.

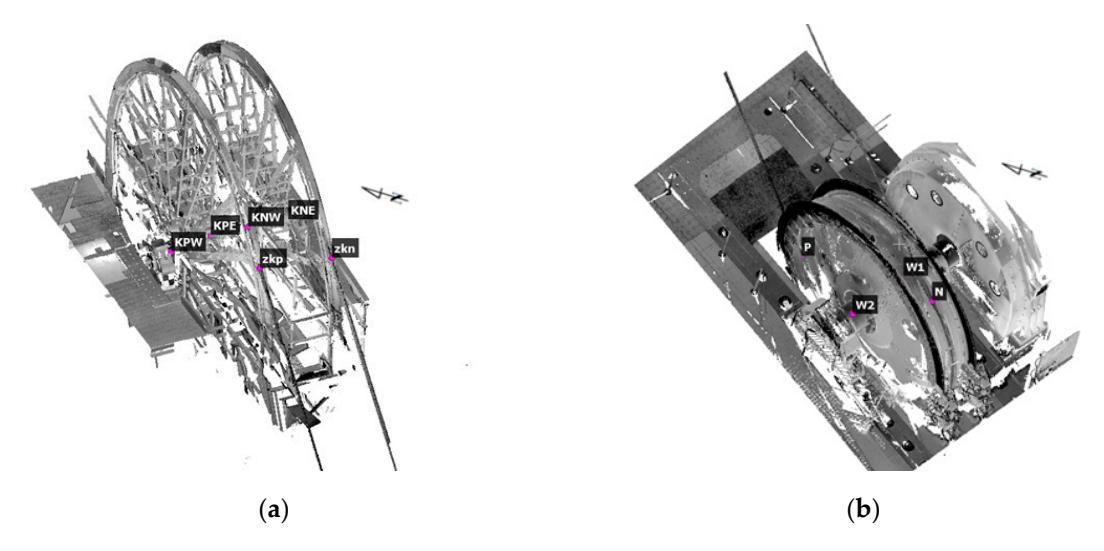
Figure 8. (a) One-rope winding machine, (b) two pulleys located next to each other on one platform.

The second analyzed object was a steel structure shaft tower with a single-rope friction Koeppe winder and pulleys arranged side by side (Figure 8). The shaft tower is situated in Poland (Lower Silesia), therefore, the authors performed their surveys and analyses according to Polish law. From the beginning of the mine's operation, there were two shafts spaced 20 m apart, with two symmetrical perpendicular two-post head frames connected with one headroom building above these shafts. As a result of the mine reconstruction, one shaft and its shaft tower were removed. As a consequence, the attached headroom building was demolished. One compartment was left in the shaft (skip had been removed) and as a result, the perpendicular strut had been dismantled. Now, the shaft tower that was measured looks like one-post head frame and its construction is significantly weakened. The consequences of the above changes can be observed in the inclination of the construction.

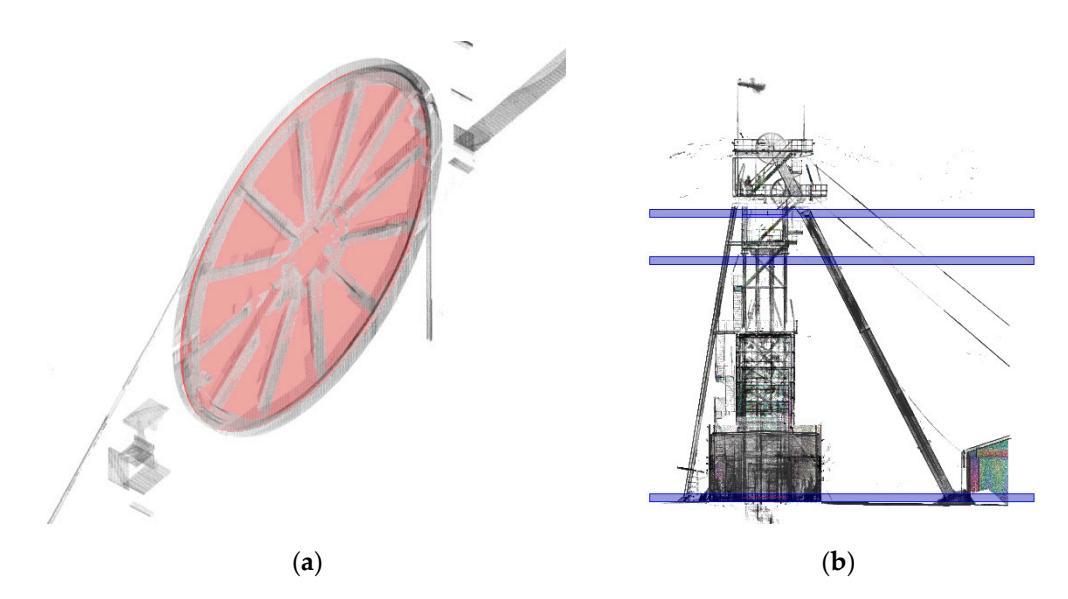
Figure 9. Point cloud processing: (a) modeled plane of the pulley groove, (b) determination of cross-sectional levels for testing the inclination of the tower and its core.

To diagnose the problem and show the value of the groove offsets, very precise geometry analysis is crucial. It is necessary to identify not only the points of departure of the ropes from the propeller shaft and the pulleys, but also the twisting of these elements related to each other and to their shafts. Thus, on very short bases, drawing azimuths are even extrapolated to several dozen meters. This process requires measuring many more points, not just characteristic ones, as it is done using the total station measurements, or the earlier used "ordinate and cut" method. This approach clearly indicates the usage of laser scanning, which allows a point cloud to be generated, representing the entire object and its surroundings in a high resolution. Then, based on the modeling of the point cloud, a spatial model of the shaft axis, wheel surfaces (Figure 9a), and propeller shaft, ropes, and the tower itself with its core (Figure 9b) is created.

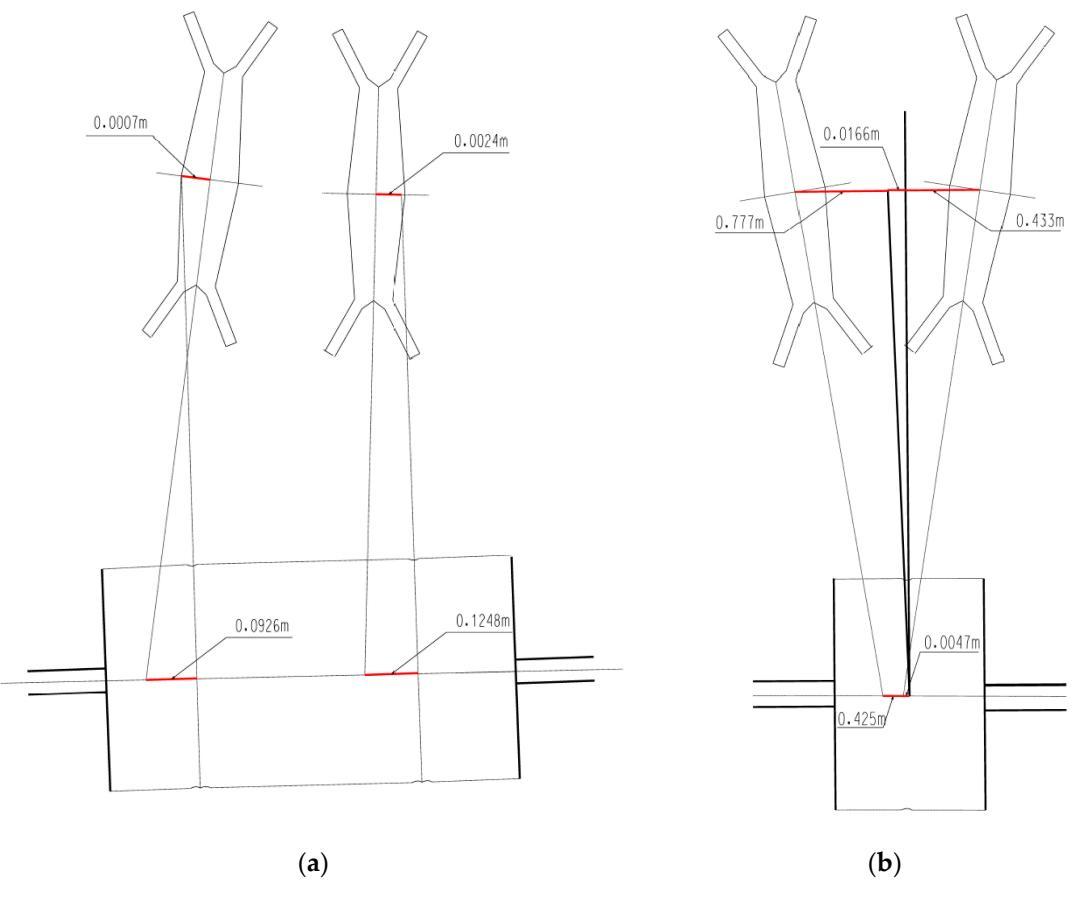
Figure 10. A sketch of the axis shifts of the corresponding grooves at: (**a**) upper pulleys relative to the winding machine in France, and (**b**) cable pulleys relative to the winding machine in Silesia.

In the first analyzed case (France), the upper rope wheels required rectification, but the entire object was inventoried. Thanks to the geodetic points network situated at the shaft room and its surroundings, it was possible to determine the coordinates of black and white scanning targets. These targets were situated at each level of the pulleys, shaft station, and the building with the winder drum and were used to register the point cloud and georeferencing. In addition, the coordinates of characteristic points at the tower shaft construction were determined with reflectorless measurement for better control of the results. Obtained point clouds were post processed. Azimuths of the planes and grooves of the pulleys and the propeller shaft, and also rope and shafts axes were obtained using the spatial model located in the local coordinate system. The azimuth values allowed the determination of rope friction angles on the pulleys and the winding pulley. A digital 3D model of the object was made, which enables a determination of the axis shifts of the grooves. The lower wheels converged with the drive wheel disc at 13 mm, and the upper wheels turned out to be twisted relative to the propeller. Ropes coming out of the winding pulley grooves perfectly hit the upper rope wheels, but when twisted, they showed non-parallelism. The extension of the axis of the grooves of the upper pulleys for the winding pulley showed an error of 92 and 128 mm. Therefore, for rectification, it is required to slightly twist and move the arrangement of the upper pulleys while maintaining the position of the current points of departure of the rope on the winding machine. Changes in the points of descent of the rope to the shaft indicates that its deflection from the vertical will improve.

The second case analyzed (in Silesia) comes down to the verification of the condition that the draw axis should be symmetrically placed in the middle between the rope wheel planes properly twisted to the machine. After analyzing previous surveys and discussions with the mine's power engineering department and surveying-geological department, it turned out that in the context of the displacement of the grooves relative to each other, the deflection of the tower does not play a role because it shows a vector directed toward the winding machine. The research showed that the deflection of the object was within the scope of the permit (1/500 tower height in accordance with the relevant Regulation [21]). The measured displacement of the groove axis on the drive wheel related to the draw axis at the wheel level was 166 mm, whereas the displacement of the groove axis on the drive wheel in relation to the pull axis at the level of the propeller wheel was 425 mm for the underlap rope's wheel and 47 mm for the overlap rope's wheel (Figure 10). The geometry of the object also indicates that the inclination values of ropes going down to the shaft may be problematic in the future. Therefore, the values indicate that the shaft tower should be rectified first. Only after that, should the whole hoist assembly be re-measured and the pulley assembly rectified adequate to the results of the inventory.
