Article

Examination of Sediment Dynamics Based on the Distribution of Silica Fluxes and Flood Sediments in the Otoishi River Related to the Northern Kyushu Heavy Rain Disaster, July 2017

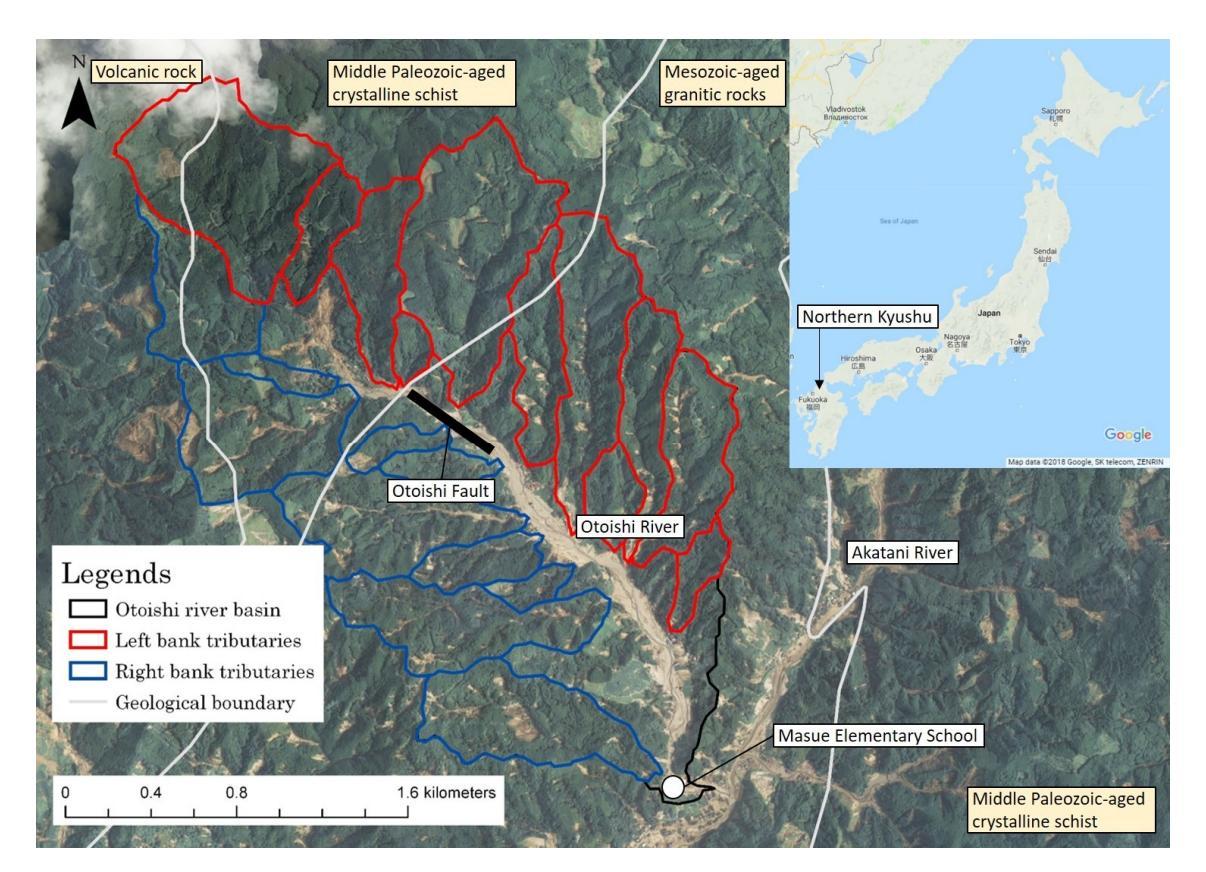
Figure 1. Map of the Otoishi River basin (the background picture is an aerial photograph taken after the disaster, released by the Geospatial Information Authority of Japan).

Figure 1 shows the Otoishi River basin study area. The river is a tributary, on the right bank, to the Akatani River, which is a branch of the Chikugo River [13,14] that flows through Asakura City, Fukuoka Prefecture, Japan. The mainstream direction of the Otoishi River is toward the northwest-southeast and the watershed is surrounded by three mountains. The catchment area is 5.9 km² and consists of 20 or more small tributary areas. The tributaries are regularly aligned—the tributaries on the right bank are aligned in an east-west direction and the tributaries on the left bank are aligned in a north-south direction.

The geology of the Otoishi River basin is mainly Middle Paleozoic-aged crystalline schist in the upstream area and Mesozoic-aged granitic rocks in the downstream area. The distribution is shown in Figure 1. Mesozoic granite is widely distributed in northern Kyushu, for example, at Mt. Seburisan [15] and Mt. Sangunsan [16]. This rocky body can be confirmed from the lattice-like valley topography seen in aerial photographs and is especially noticeable at Mt. Seburisan, located on the boundary between the Fukuoka and Saga Prefectures. The topography is presumably derived from lattice-like cracks that accompanied cooling near the top of the batholith [17] or active structures oriented north-south and north-west [18]. It is thought that the regular distribution of the valley topography is the result of similar phenomena in the Otoishi River basin.

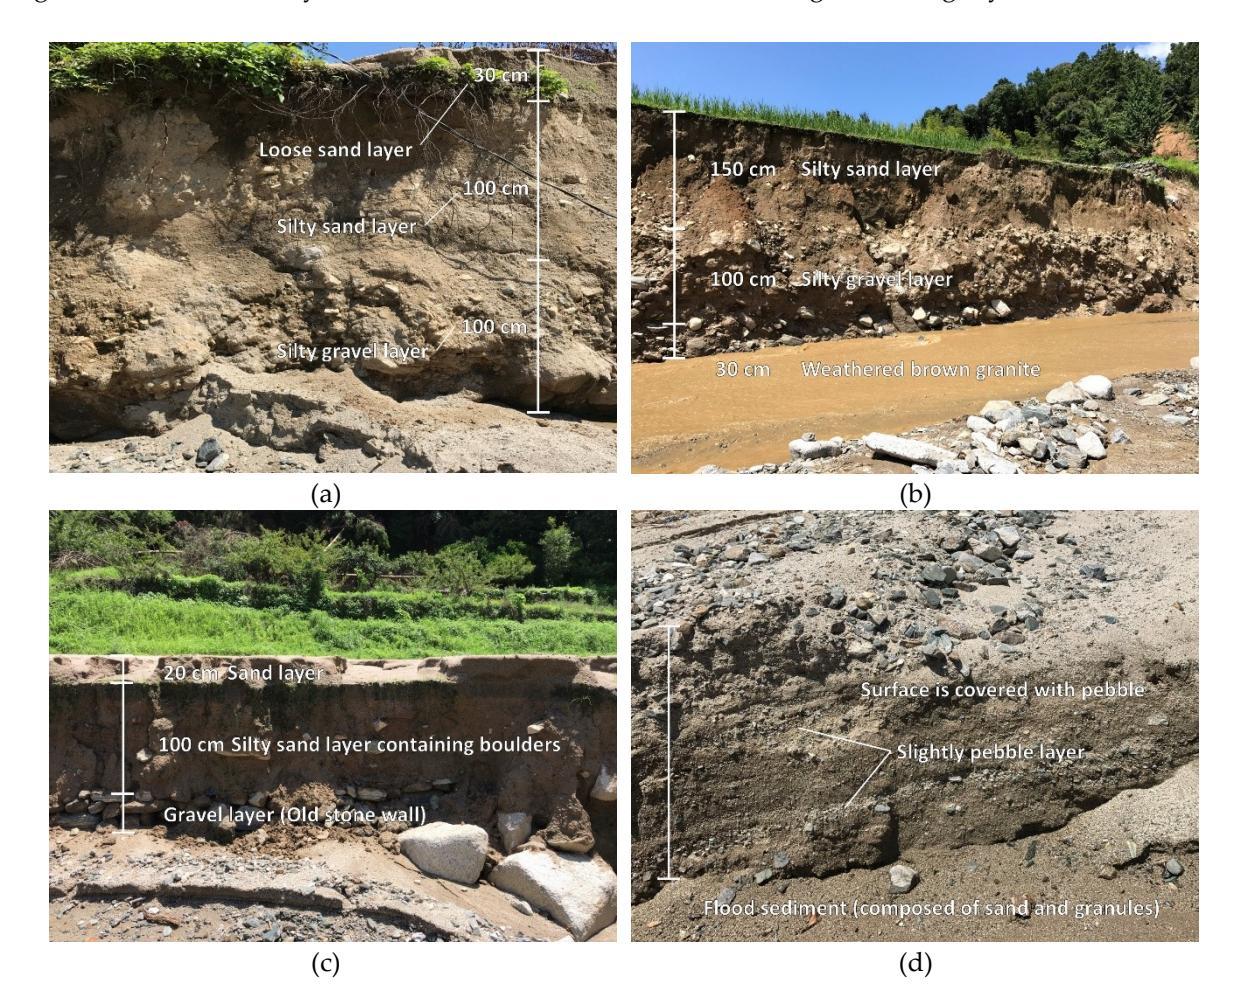
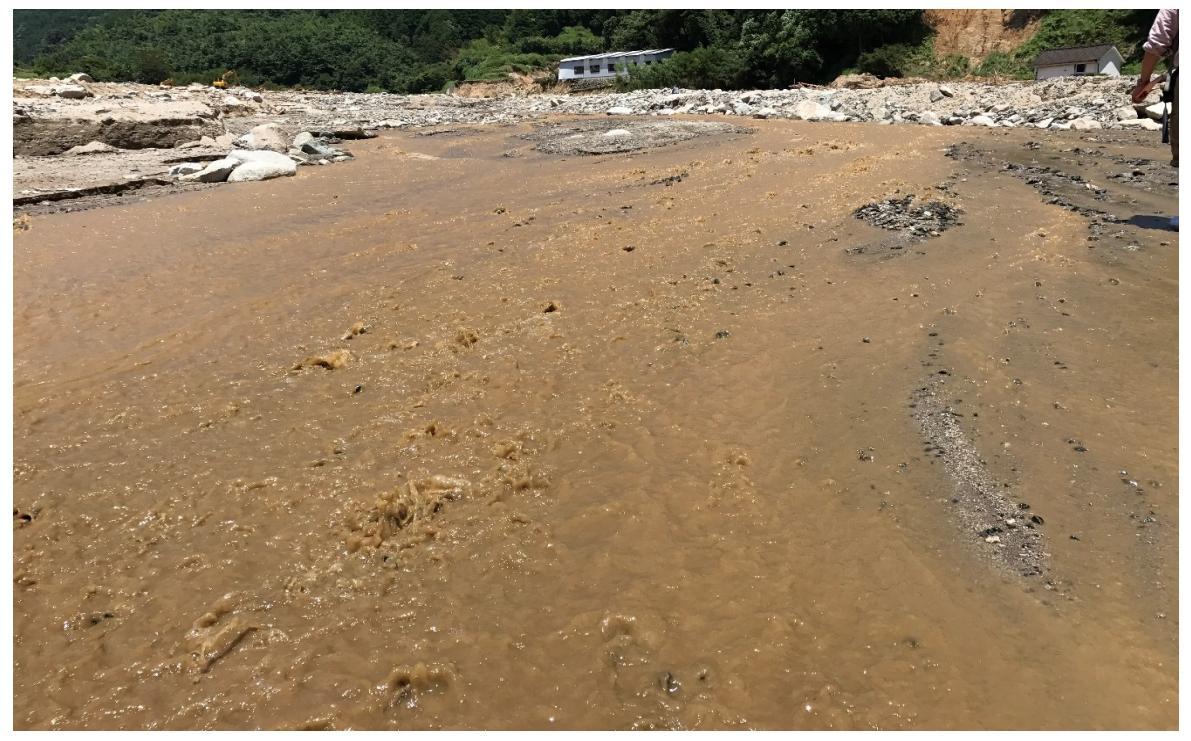
Figure 2. These are photographing about sediment or river environment after the disaster (2 August 2017). (a) Photo of a left bank section exposed by erosion near the Masue Elementary School; (b) photo of erosion of the right bank in the downstream area; (c) photo of a sand layer, including gravel, exposed by erosion; (d) photo of flood sediments comprising a sand and pebble layer; (e) photo showing black gravel rolling on the riverbed due to water-flow.

Figure 2a shows the left bank of the Otoishi River near the Masue Elementary School. It was confirmed that a buried pipeline had been exposed by erosion. A cross-section of the riverbank shows a lowermost 1 m thick silty gravel layer overlain by a 1 m thick silty sand layer, a layer of vegetation, and an uppermost 30 cm thick loose sand layer. The layers below the vegetation are sediments deposited by past disasters, which were exposed by the recent erosion. The gravel layer at the base of the section comprises pebble- to boulder-sized gravel, composed of plate-crystal schist with some granite, without a regular structure. Parallel laminae were seen in the overlying sand layer, near the boundary with the lower gravel layer. The center of this sand layer included some pebble-sized gravel. The loose sand layer overlying the vegetation resembled the sediment on the bottom of the river after the disaster and it is considered to be sediment laid down during the disaster; it is mainly composed of quartz and feldspar sand and fine gravel, including mica, and is generally considered to be decomposed granite.

Figure 2b shows erosion on the right bank, 180 m upstream of the Masue Elementary School. On the left side of the photo, brown granite, weathered to about 30 cm from the water surface can be seen, and a silty gravel layer of about 1 m is distributed over the granite layer. A 1.5 m thick silty sand layer is distributed above this. The granite in the right side of the picture is much thicker, and there is less gravel compared with the left side. There was also a hole, or pipe, in the boundary between the granite and the sand layer, which was able to confirm the washed gravel and gully under the hole.

Figure 2c is a photo of erosion on the left bank, 365 m upstream from Figure 2b. A 1 m thick silty sand layer containing boulders is distributed above the gravel layer, which seems to be an old stone wall. A new 20 cm thick sand layer is distributed over the top of the ground surface at the base of the present stone wall and it was confirmed here that the gravel of the crystal schist overlapped.

Figure 2d shows the flood sediment of this disaster. This sediment was confirmed throughout the Otoishi River basin and it is considered to have been transported from a source of collapsed soil and debris flow sediment accompanying slope failures. It was confirmed that the flood sediment is composed of sand and granules, including a slightly pebbly layer. Characteristically, the sediment is covered with pebbles. There is little clay because it is fragile when dry and crumbles easily.

Figure 2e shows the state of the Otoishi River in August near the location of Figure 2d. The river is turbid but it was possible to confirm that gravel was rolling on the riverbed. The riverbed consisted mainly of sand and granules, which were moved continuously by the water-flow. The pebbles were able to be transported on the riverbed because the riverbed had been smoothed by the moving sand and granules. It appeared that this phenomenon created the deposition seen in Figure 2d. The locations of the photos are indicated in Figure 3, together with the collapsed slopes.

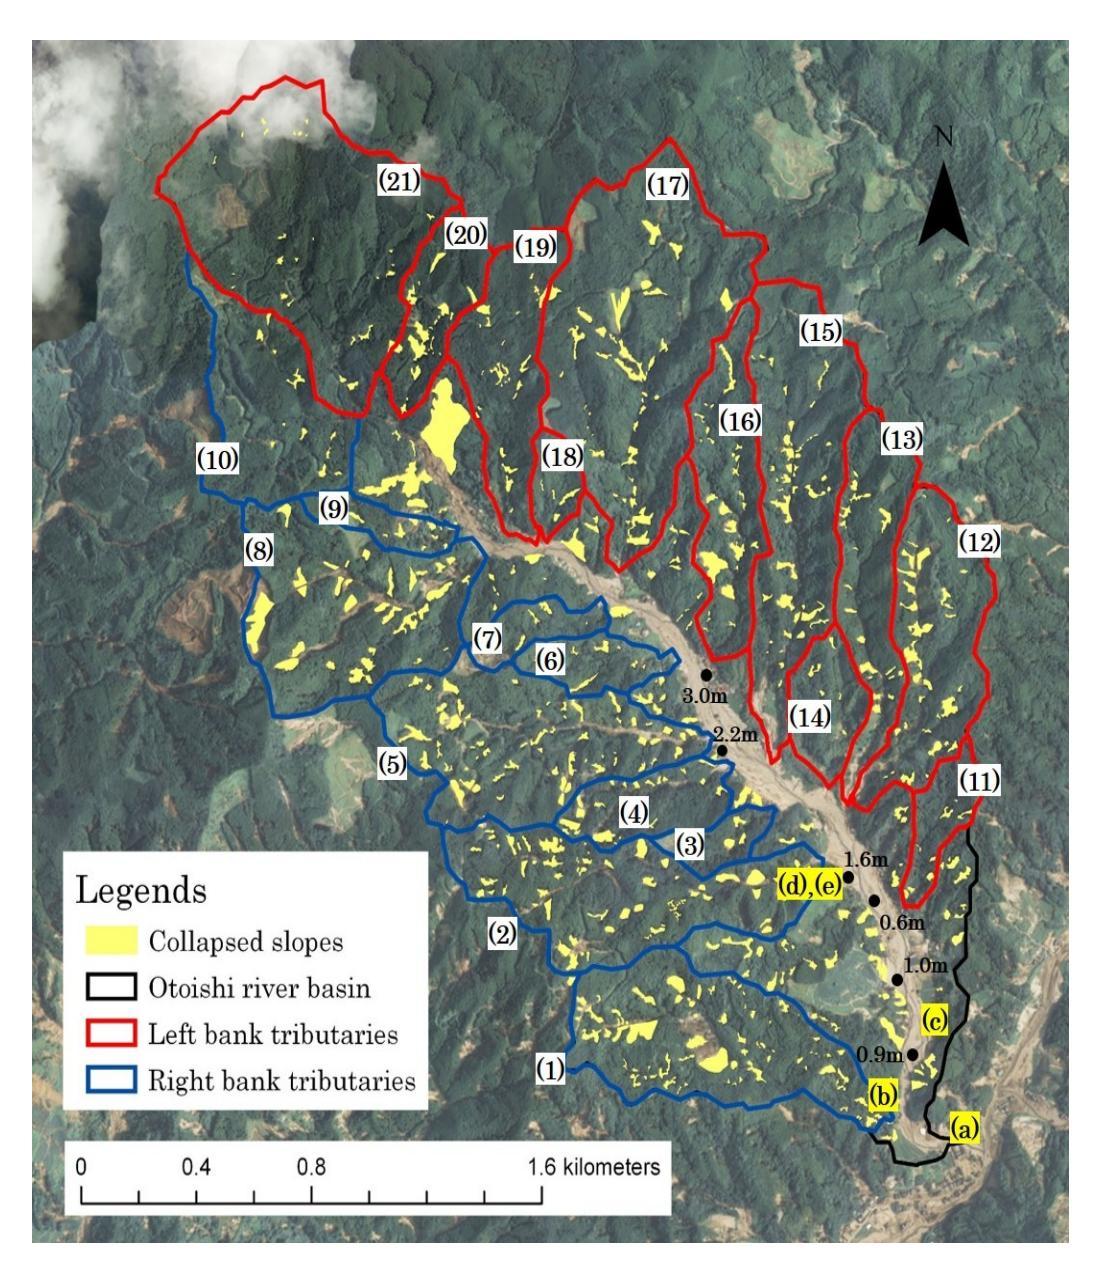
Figure 3. The distribution of collapsed slopes mapped from aerial photographs in the Otoishi River (the photo sites and the sediment thickness are described in this figure).

Sediment thickness was measured at six locations in September, just after river excavation by heavy machinery had begun. The maximum deposit thickness was 3 m. The measured positions and deposition thickness is shown in Figure 3. The thickness was not uniform, and the deposition thickness tended to increase on the upstream side of the valley's narrow pass. Normally, there were many deposits composed of sand and/or granule layers with a pebble layer, as shown in Figure 2d. However, silt deposits, including boulders and pebbles, without laminae were confirmed further upstream. The upstream site where 2.2 m thick sediments are measured is a confluence point with a tributary and 1.8 m thick sediments were deposited over the 40 cm thick flood deposit with no laminae.

Figure 3 summarizes the distribution of the collapsed positions of the mountain slope and the deposition in the river channel, as reported by Ikemi et al. [12], who estimated 100,000 m³ of sediment with 230,000 m³ of erosion, which is more than double the amount of the sedimentation.

Table 1. Statistical data of 21 tributaries (the tributary number is the same in Figure 3).

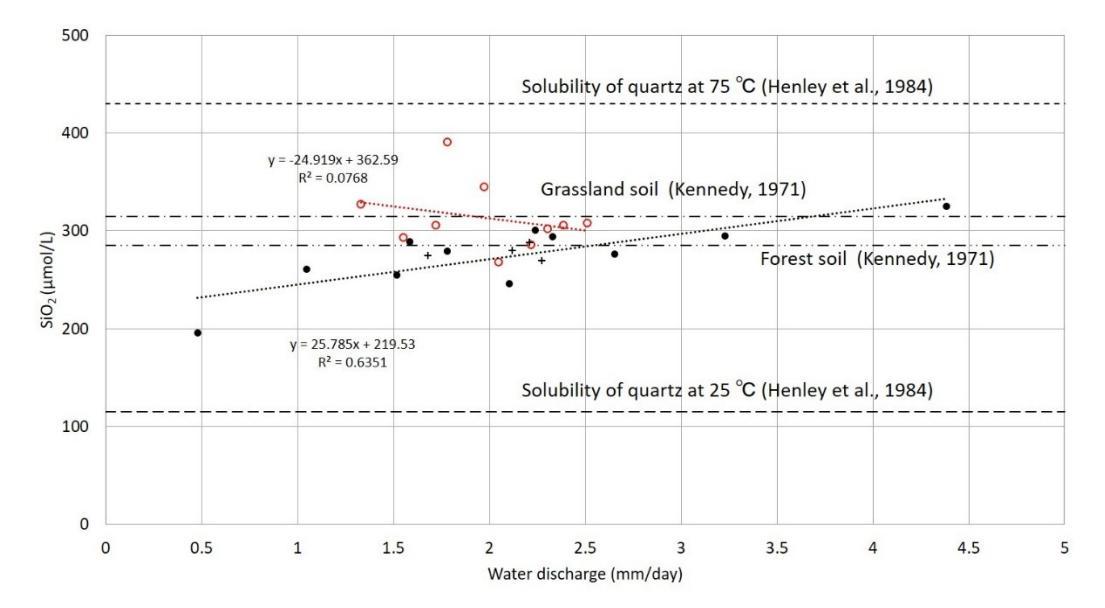
Figure 4 shows the relation between the water discharge (mm/day) of each sub-basin and the dissolved silica concentration (μ mol/L). The values of the right bank tributaries are shown in the red circles and the values of the left bank tributaries are shown in the black circles. The mainstream value is shown in the plus sign. The water discharge ranged from 1 to 3.5 mm/day in the right bank tributaries and from 0.5 to 4.5 mm/day in the left bank tributaries. The dissolved silica concentration was roughly steady, with the highest concentrations found in the right bank tributaries and the lowest concentrations confirmed in the left bank tributaries. The correlation coefficient of these values confirmed that the water discharge had a strong correlation with the silica concentration in the left bank tributaries.

Figure 4. The relationship between the water discharge (mm/day) and the dissolved silica concentration (μ mol/L). (In Figure 4, the black circle shows the data of the left bank tributaries, the red circle shows the data of the right bank tributaries and the plus sign shows the mainstream data. The values of solubility of quartz at 25 and 75 °C are shown in Figure 4 as reference [22]. The reference values of grassland soil and forest soil are also shown [10].).

The silica concentration range is explained by the mixing of various waters; Figure 4 shows the dissolved silica concentration assumed by the water-rock reaction and elution from the soil. The elution of silica by the water-rock reaction depends on the temperature and when quartz and water are in a chemical equilibrium state at 25 °C, the dissolved silica concentration was 200 μ mol/L or less. It reached over 400 μ mol/L at equilibrium with quartz at 75 °C. It is assumed that 25 °C is the common temperature of groundwater and 75 °C is the temperature of hot spring water. It has also been reported that silica is easily eluted from the soil, even at low temperatures, with concentrations of ~300 μ mol/L. The current case corresponds to intermediate-type groundwater flowing through a mountainous slope surface.

The fluctuation of the silica flux, seen in Figure 4, seems to indicate various water-flows and mixing. On the right bank tributaries, a slightly higher silica concentration was observed. Generally, the silica flux was stable because the river water was formed by steadily mixing groundwater and intermediate streams. However, the left bank tributaries showed that the water-flow was diverse in each sub-basin.

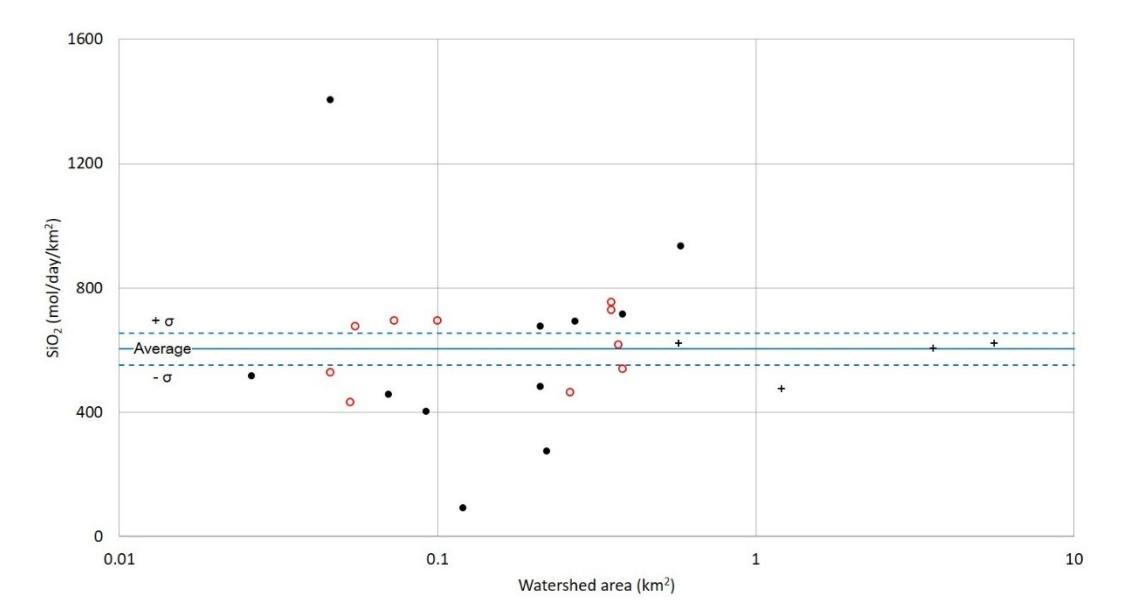
Figure 5 shows the relation between the watershed area (km²) in the sub-basins and the silica fluxes (mol/day/km²) based on the water discharge and concentration. The silica fluxes on the right bank tributaries exhibited a narrow range regardless of the catchment area, whereas the silica fluxes on the left bank tributaries exhibited a wide range. Particularly, it was confirmed that the variations in small catchment area were wider. In Figure 5, the average values of the silica fluxes and the values of the average \pm the standard error (σ) are shown by the blue lines. The silica fluxes of the mainstream were distributed within this range.

Figure 5. The relationship between the watershed area (km²) and the silica fluxes (mol/day/km²). (In Figure 5, the black circle shows the data of the left bank tributaries, the red circle shows the data of the right bank tributaries and the plus sign shows the mainstream data. The blue line shows the average silica flux of all data, the σ represented the standard error from the average.)

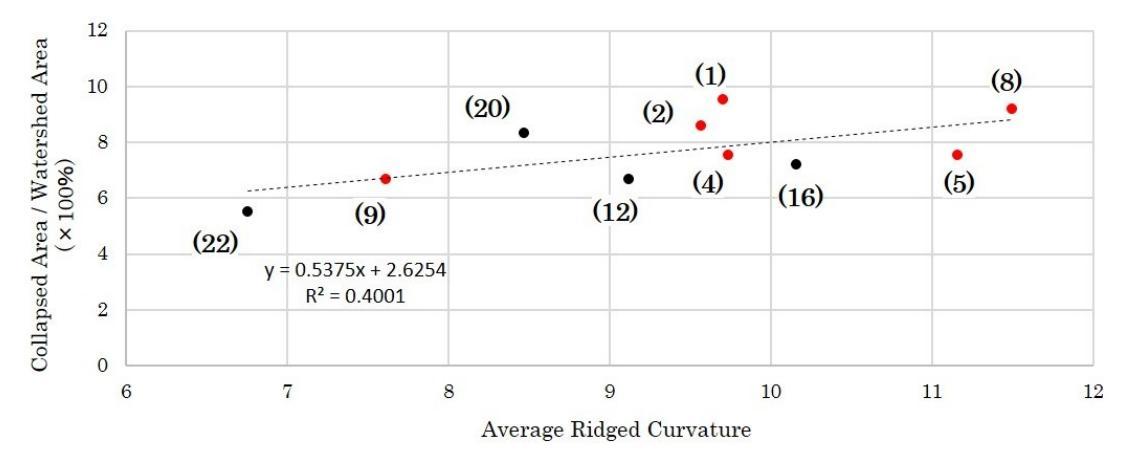
Figure 6. The relationship between the collapsed slope and the ridged curvature. (In this figure, the black circle shows the data of the left bank tributaries, the red circle shows the data of the right bank tributaries).

where *U* is the surface uplift rate. Since *U* is constant in a narrow region, $\nabla^2 z_h$ rises with the erosion of the basin. From Table 1, the relationship between the collapsed slopes and the ridged curvature was examined (Figure 6). The correlation coefficient was ~0.63 for the analyzed tributaries in the case that the collapsed area against the watershed area is more than 5%. It is assumed that the correlation was confirmed only in some tributaries because the stage of geomorphic development is different. The result suggests there are many watersheds that tend to erode in the right bank tributaries.
