# Article Rockfall Investigation and Hazard Assessment from Nang County to Jiacha County in Tibet

Abstract: The influences of rockfall on human engineering have been increasing in Tibet with the rapid development of the western region of China. This study proposed a multi-approach to carry out rockfall investigation and hazard assessment. As a case study, the rockfall hazard from Nang County to Jiacha County in Tibet was assessed. Firstly, we summarized the characteristics of spatial distributions of typical rockfall sources using Digital Elevation Model (DEM) and unmanned aerial vehicle (UAV) aerial images with resolution of 10 m. According to the thresholds of slope angle, slope aspect and elevation distribution of typical rockfall sources, we obtained all of the rockfall source areas in study area semi-automatically in ArcGIS platform. Secondly, we improved the efficiency and accuracy of detailed field investigation by using a three-dimensional (3D) point cloud model and rock mass structure extraction software. According to the analysis result, the dominant joint set was J1, whose orientation was basically consistent with the Yarlung Tsangpo Fault. The combination of J1, J2 and

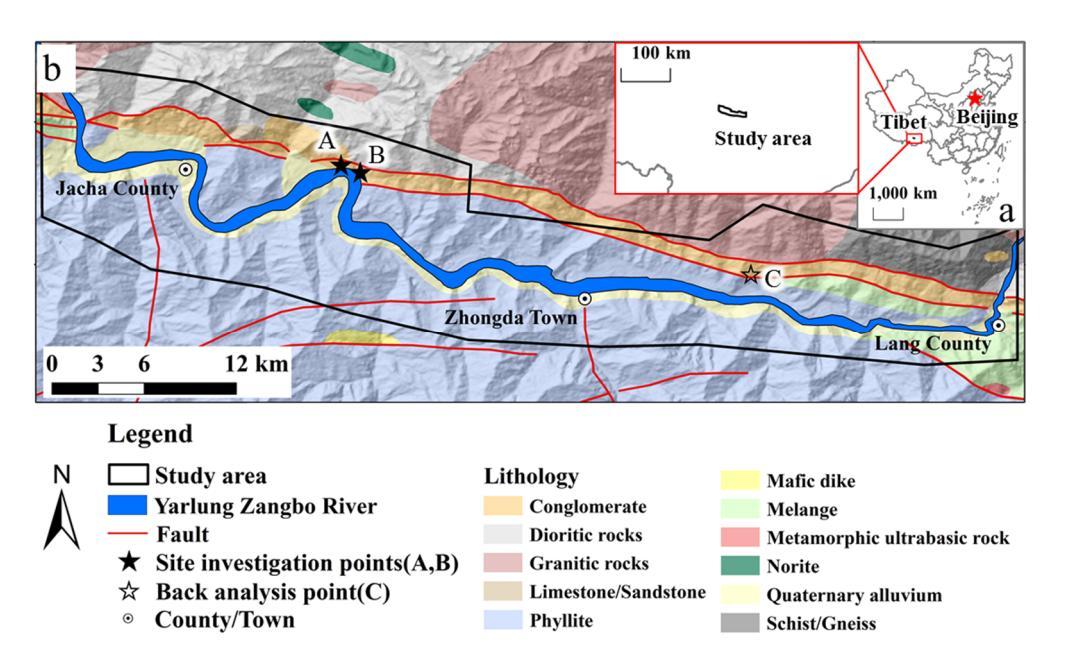
**Figure 1.** Location and regional geological map of study area (**a**). Location of study area (**b**). Regional geological map of study area (modified from [21,22])).

Based on the regional geological background conditions from Nang County to Jiacha County along the Yarlung Tsangpo River, and combining with remote sensing interpretation, field investigation and Rockyfor3D numerical simulation, this paper proposed a multi-approach to carry out rockfall investigation and hazard assessment. With this method, we preliminarily revealed the occurrence mechanism and distribution characteristics of the rockfall in the area from Nang County to Jiacha County, and assessed the rockfall hazard quantitatively. Location of study area is shown in Figure 1a,b.

The study area locates in Yarlung Tsangpo River basin, and contains the range from Nang County to Jiacha County (Figure 1b) in Linzhi City, Tibet autonomous region. It is 56 km long in the east-west direction and about 7 km wide on each sides of the Yarlung Tsangpo River, with an area about 540 km<sup>2</sup>. According to the "Plan for the prevention and control of geological disasters in Linzhi City, Tibet" [23], Linzhi City was divided into nine key geological hazard prevention areas combined with the risk of geological hazards, population density and the scale of major human engineering construction activities. The study area is located in the third key prevention area of Linzhi city, where landslides and rockfalls are the major geological hazards. There are more than 20 habitations including towns, villages and counties in study area, such as Nang County, Zhongda Town, and Nang Town. There are also many major projects, such as provincial highway 306 and Central Tibet Grid Interconnection Project distributed along Yarlung Tsangpo River. These urban settlements, highways, power lines, and other major projects are the main victims of geological disasters along the Yarlung Tsangpo River.

We conducted detailed field investigation at two sites in study area (locations of site A and B are shown in Figure 1b), where the lithologies of the both outcrops are conglomerate rocks. The orientation of slope is  $210^{\circ} \angle 45^{\circ}$  on both site of A and B. We used GPS real-time kinematic (GPS-RTK) technology and DJI Mavic2Pro unmanned aerial vehicle (UAV) to carry out aerial photographic survey, Agisoft Photoscan to build 3D point cloud model, and COLTOP software to extract structural feature of rock mass. The slope was too steep to climb and the limiting flight altitude of DJI Mavic2Pro UAV was 500 m, thus, we could only get the aerial photographs of conglomerate area and phyllite area which were distributed in the lower part of the slope. As mentioned above, phyllite area was not the typical area of rockfall. Therefore, we only analyzed the rock mass structure of the conglomerate area. Figure 5 shows the data of field investigation. The black frames in Figure 5 are the statistical window of joints, with the length of 50 m. According to the results of field measurement and COLTOP analysis, there are four sets of joints for rock masses in study area. The attitudes of J1, J2, J3, and J4 are about 193°  $\angle$ 43°, 311°  $\angle$  81°, 116°  $\angle$  67°, and 232°  $\angle$  80°, respectively. Details for the four sets of joints are shown in Figure 5. J1 is almost dipping towards the valley whose orientation is in accordance with Yarlung Tsangpo Fault. The combination of J1, J2, and J4 cuts the rock mass into wedges. When there are heavy rainfalls, earthquakes, or other trigger factors, it is extremely possible for these unstable blocks to move downward in the form of rockfalls.

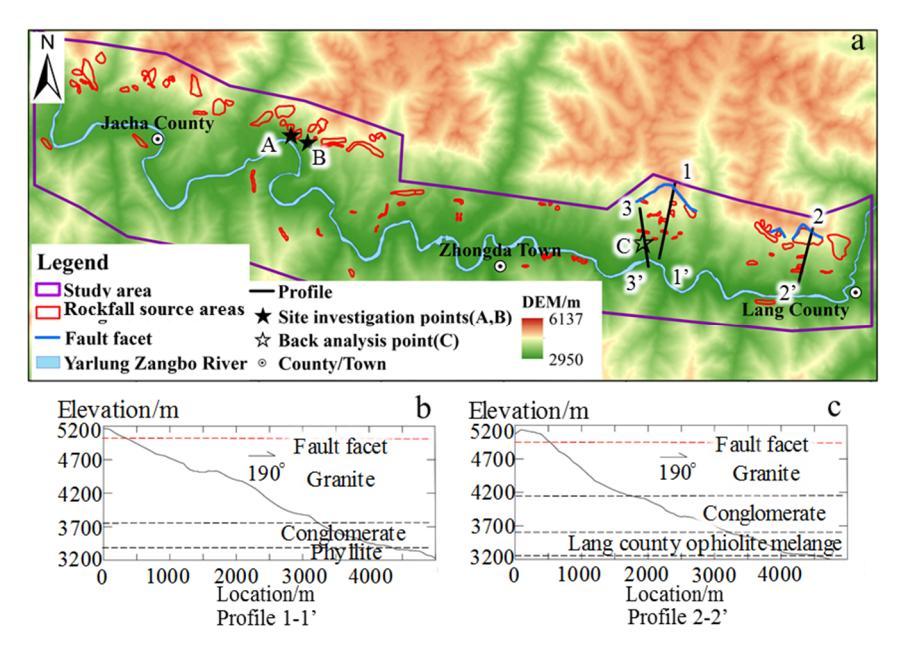
**Figure 2.** Elevation distributions of different lithology and distribution of rockfall source areas in study area (**a**). Distribution of rockfall source areas and positions of typical profiles (**b**,**c**). Elevation distributions of different lithology are in profile 1-1' and 2-2'.

The altitude of the study area is between 3000 m to 5200 m (as shown in Figure 2), and the maximum relief is up to 2200 m, which is the alpine topography in plateau areas. This area crosses the Yarlung Tsangpo Structure Zone (YTSZ) and Gangdise-Nianqintanggula tectonic plate in a north-south direction, located at the north margin of the eastern section of the YTSZ, and adjoins with the southern edge of the Gangdise magmatic arc. Since the Miocene, the Indian plate has been subducting northward, and the Qinghai-Tibet plateau has been uplifted continuously, which lead to extremely strong tectonic activities in the study area. Many researchers have investigated the influences of tectonic activity on geohazards through geomorphological analysis, geophysical surveys, and finite-difference analysis etc., and proved that tectonic activity was one of the main factors impacting the slope stability [24–26]. The faults in the area are mainly distributed along the east-west direction, and the rest are distributed along the north-south direction. The famous Great Count Thrust (GCT) is distributed in parallel with the YTSZ from east to west [27]. Along the YTSZ, earthquakes over magnitude MS7.0 have occurred for many times, such as the MS7.7 earthquake in 1947 in the southeast of Nang County [28], and the MS7.0 earthquake in 1947 in Longzi County [29].

The study area located at the YTSZ. Profiles in Figure 2b,c show that the fault facets are mainly distributed in the granite area within the elevation range of 4800–5100 m, with a dip direction of southwest and dip angle of  $40^{\circ}$ –55°.

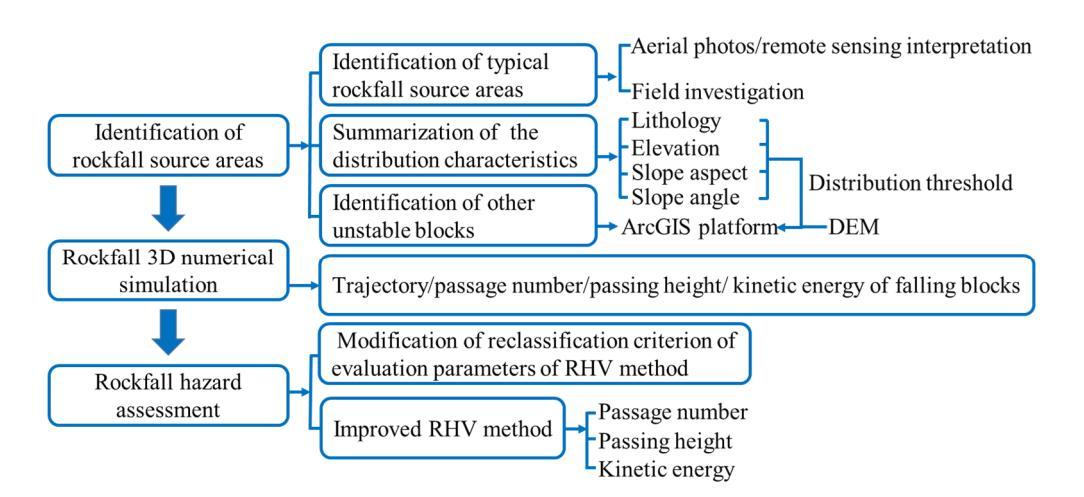
Figure 3. The methodology flow chart of this study.

The methodology flow chart of this study is shown in Figure 3.

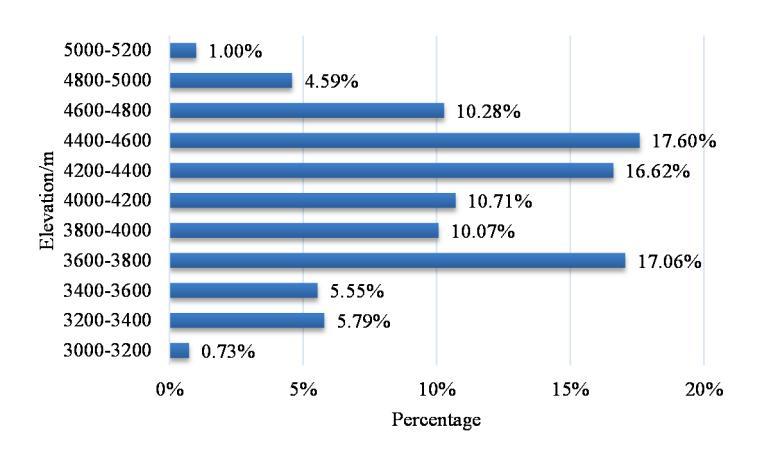
Figure 4. The elevation distributions of rockfall source areas in the study area.

Final identification results show that the sources of rockfalls are mainly distributed in the altitude between 3600 and 4800 m (as shown in Figure 4), and mainly on the adrets (Figure 2a.). The elevation distributions of each lithology in the typical profile are shown in Figure 2b,c. Conglomerate is mainly distributed between 3400–4200 m and granite is above 3700 m. Lang county ophiolite melange and phyllite are distributed below elevation of 3600 m. Comparing the elevation data above, we can obtain that rockfall source areas are mainly distributed in conglomerate and granite areas. We have confirmed the correctness of this conclusion by field investigation works.

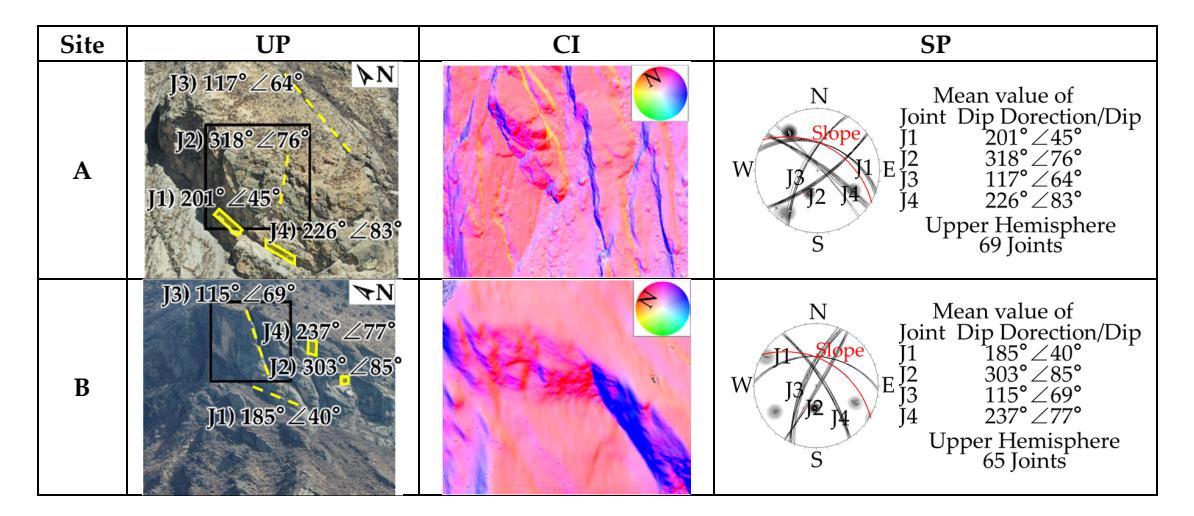
**Figure 5.** UAV photos of the two site investigation areas (UP) (see Figure 1b for locations), Coltop images in colors representing the local orientation (CI) and stereographic projection (SP).

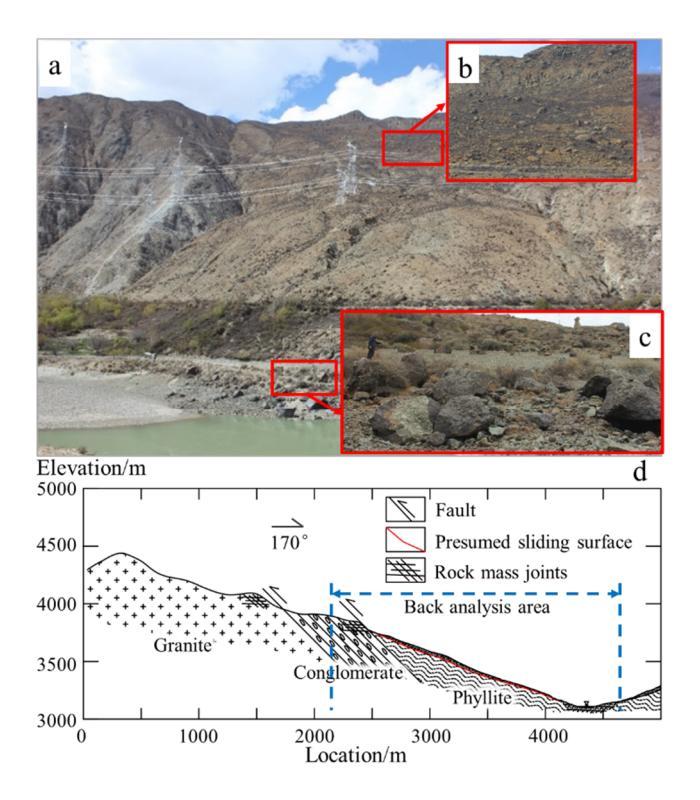
**Figure 6.** Picture of rockfall in Zhaxilin village (**a**). Full view of the rockfall (**b**). The deposition around the rear edge of the slope; (**c**). Deposited rocks along the river bank (**d**). A brief geological profile of the slope (profile 3-3' in Figure 2).

As mentioned above, a typical rockfall in Zhaxilin Village (Figure 6a) was selected as the back analysis area for rebound parameters. The elevation range from the foot to the top of the slope is 3140–5180 m, and the slope direction is 170°. It is an ancient rockfall site, confirmed by the morphology and deposit conditions of rocks around the slope. The rear edge of the slope is extremely steep with sparse shrubs grown around the foot of the relief (as shown in Figure 6b). The Yarlung Tsangpo River passes the front of the slope from west to east. Along the bank of the river, there are many conglomerate blocks deposited with different sizes, in which the maximum volume is up to  $7 \times 5 \times 5$  m<sup>3</sup> (as shown in Figure 6c). The source area of this rockfall is mainly located at the exposed conglomerate belt in back analysis area, as shown in Figure 6b,d.

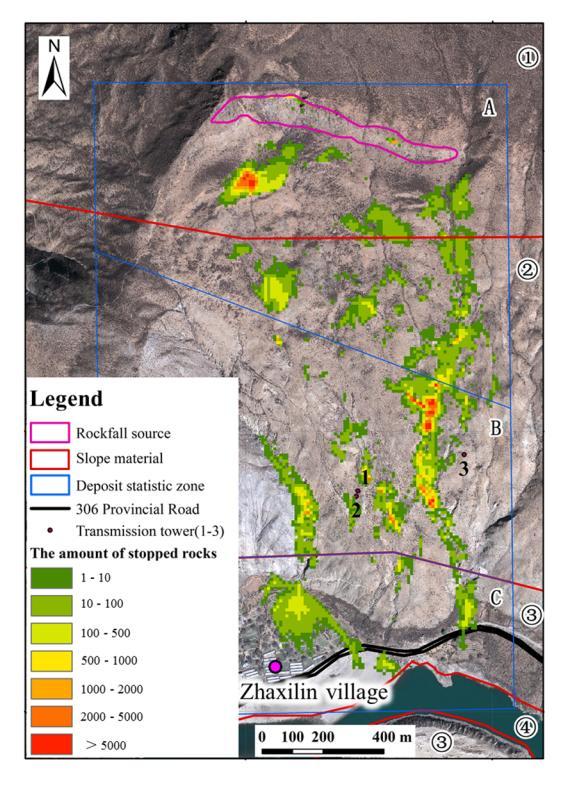
Figure 7. Classification of slope materials and the result of parameter back analysis.

According to the lithology, roughness, and the vegetation coverage, the slope materials from the relief to the other side of the Yarlung Tsangpo River are divided into four categories (as shown in Figure 7). Subareas (1–4), respectively, correspond to the brittle rock zone, soft rock zone, quaternary alluvium zone, and the Yarlung Tsangpo River. For the whole study area, the brittle rock zone contains conglomerate and granite, while the soft rock zone contains phyllite and melange. Due to

the accessibility limitation of the back analysis area, we use conglomerate and phyllite to obtain the parameters of the brittle rock area and the soft rock area, respectively. The selected size of falling block is based on the statistical analysis result of the size of deposited blocks around the slope. The mean size is taken as  $4 \times 3 \times 3$  m<sup>3</sup>, and the size variation range is ±20%. The shape is set as cuboid, and the density of rock mass is set as 2800 kg/m<sup>3</sup> considering the experimental data of conglomerate and granite rocks. In Figure 7, there are 553 grids in the source area. The calculation is set for 1000 times, which means  $5.53 \times 10^5$  blocks are thrown down. Using Rockyfor3D numerical simulation software, based on the distribution of deposited blocks on the slope surface, the parameters for 3D rockfall simulation were back analyzed. It was calculated that the deposited numbers of blocks in the three regions A, B, and C in Figure 7 account for 34%, 61%, and 5% of the total amount of thrown blocks, respectively, which was in line with the distribution characteristics of deposited blocks observed on site. It is considered that the selected parameters were reasonable. The parameters of slope materials obtained by back analysis are shown in Table 1.

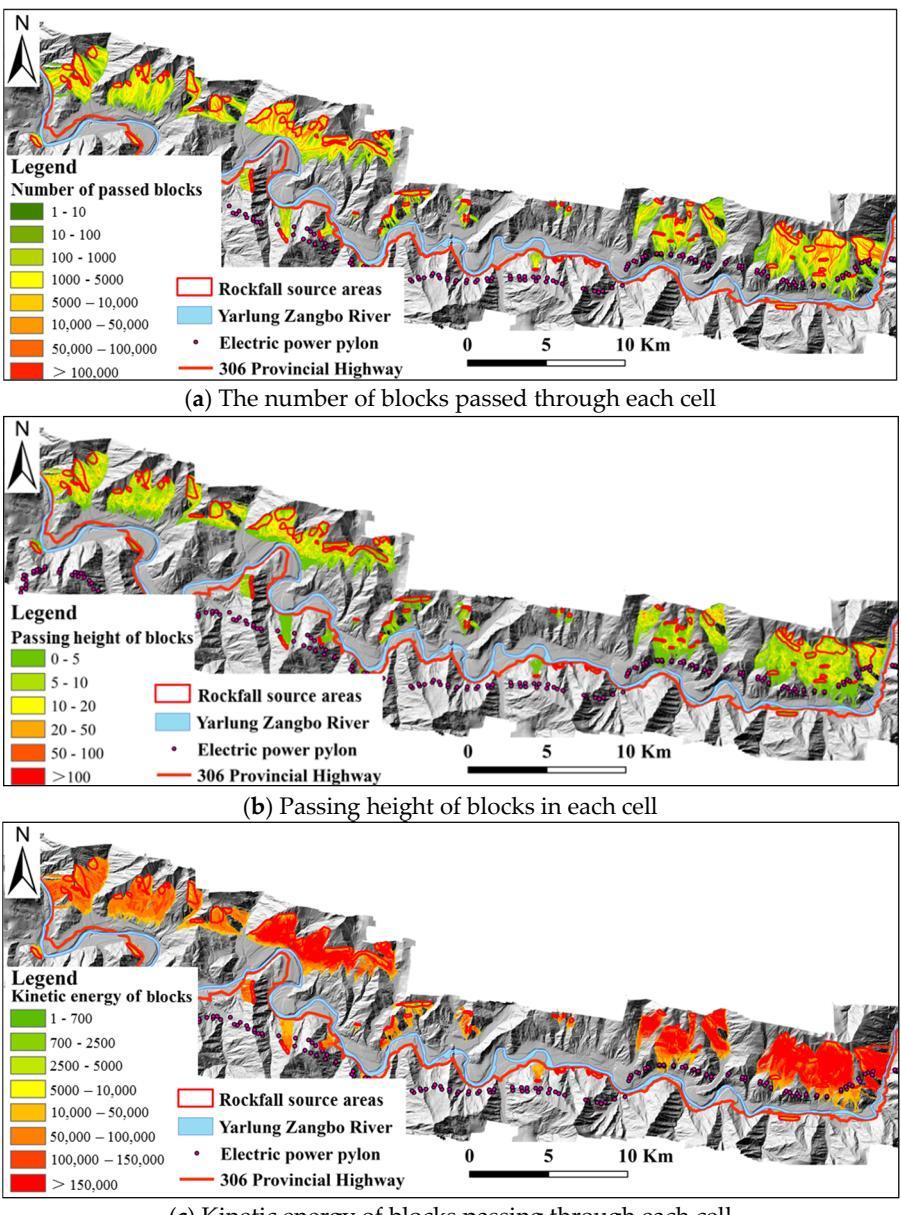
(c) Kinetic energy of blocks passing through each cell

Figure 8. Numerical simulation results of rockfalls in the study area.

Based on the parameters obtained by back analysis and the source areas obtained by the semi-automatic approach, the kinematic characteristics of rockfalls from Nang County to Jiacha County were simulated and analyzed. The results are shown in Figure 8.

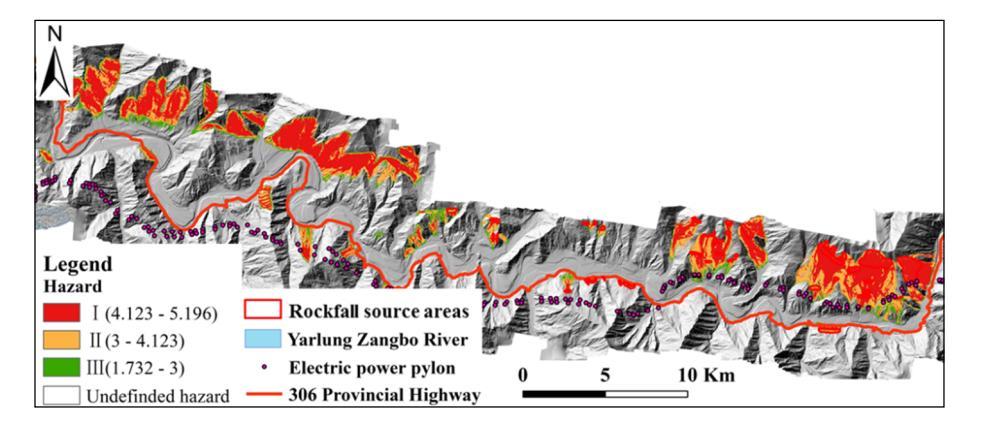
Figure 9. Hazard assessment map of study area.

According to the reclassification results of the kinetic energy, passing height, and passage number of falling blocks, the vector values of (R, H, V) for all the rasters were obtained. According to values of |RHV| (as shown in Table 4), the rockfall hazard in the study area was divided into three levels: I [4.123, 5.196], II [3, 4.123], and III [1.732, 3], corresponding to a hazard level of high, medium, and low, respectively. The hazard mapping results are shown in Figure 9.

Provincial highway 306 in the study area is located on the right bank of the Yarlung Tsangpo River; thus, it is mainly affected by the rockfalls on the right bank. The length of the 306 provincial highway is 91,620 m in the study area, and the length affected by rockfall is 10,010 m, accounting for 10.92% of the 306 provincial highway in the study area. The total length of the transmission line is about 60,860 m in the study area, and the length affected by rockfall is 5710 m, accounting for 9.38% of the transmission line in the study area. The number of pylons affected by rockfall is 17, and the numbers located in high, medium, and low hazard areas are 6, 6, and 5, respectively. Here, we have mentioned that the public infrastructure was exposed at rockfall hazard. According to Corominas et al., this is one of the components of risk [36]. Since the highway and pylons are inanimate objects, the rockfall risks they take basically depend on the rockfall hazards of the locations where they area. The partitions of highway within high risk zones are concentrated on the central and east parts of the study area.
