Detection of Internal Holes in Additive Manufactured Ti-6Al-4V Part Using Laser Ultrasonic Testing

Featured Application: This paper presents a laser ultrasonic testing (LUT) method for the inspection of internal hole defects in a Ti-6Al-4V part produced by additive manufacturing (AM). The LUT system achieved a resolution in sub-millimeter scale, demonstrating its significant potential in the quality evaluation of additive manufactured part.

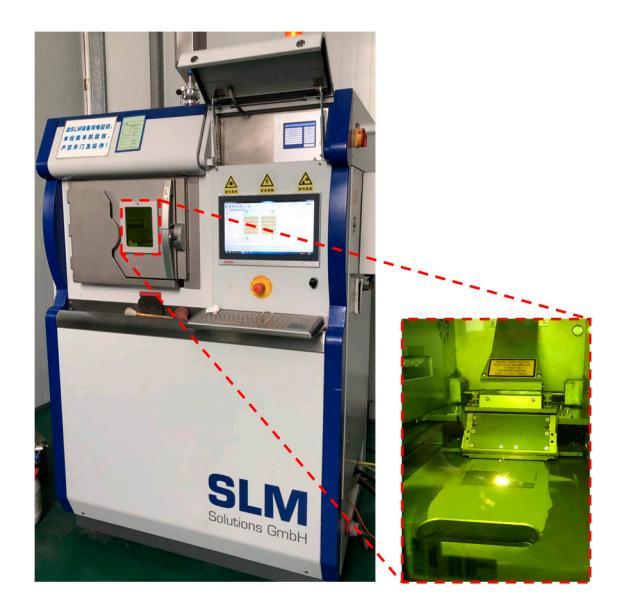
Figure 1. Photograph of the additive manufacturing (AM) equipment (SLM 125). Zoom out viewport: The manufacturing process of the investigated sample.

The sample investigated in this paper was manufactured by using the AM equipment (SLM 125, SLM Solutions NA, Inc., Lübeck, Germany). Figure 1 demonstrates the layout of the AM equipment.

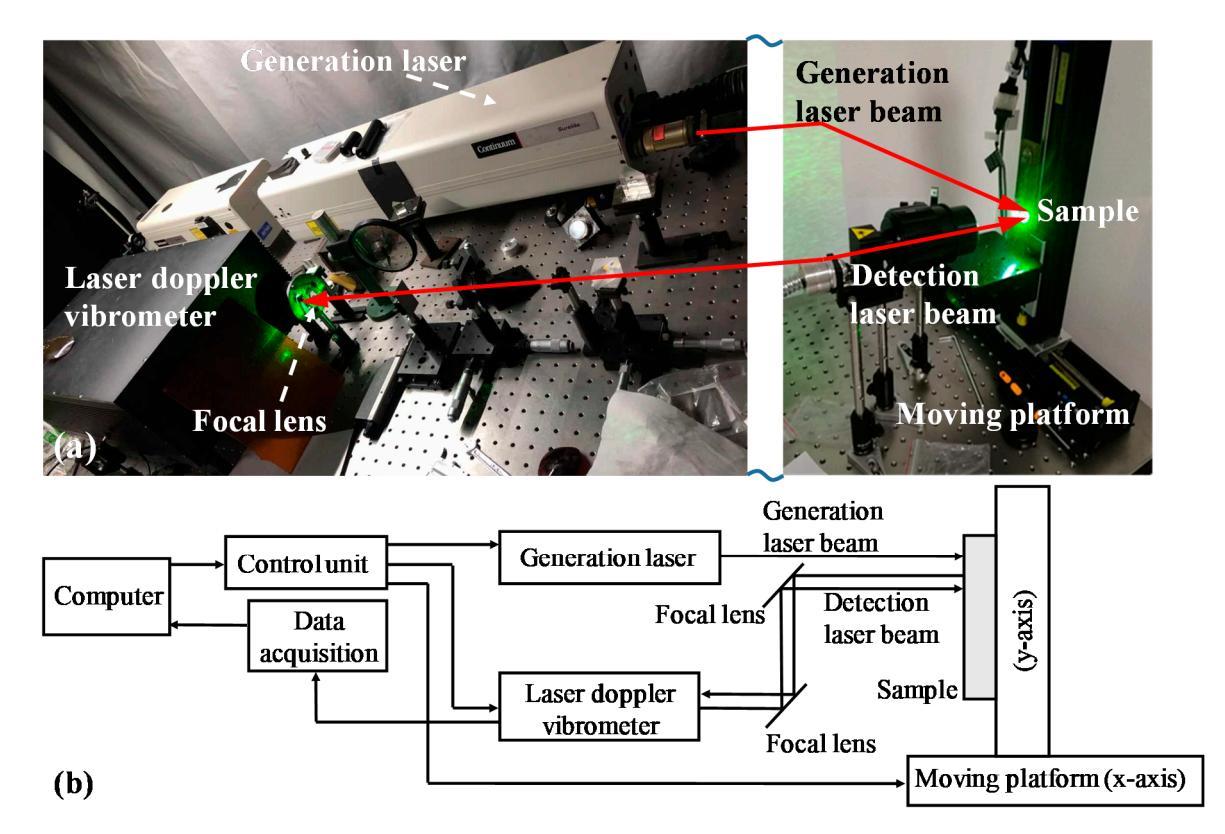
Figure 2. Setup for the laser ultrasonic testing (LUT) system: (a) photography and (b) principle scheme.

The proposed non-contact laser ultrasonic inspection system was utilized. The whole system was set in pulse–echo mode, which is an ultrasonic detection method. Pulse refers to the generation of ultrasonic waves, and echo refers to the signal received from the sample surface. Figure 2 shows the experimental setup of the LUT system. The LUT parameters used for the target sample are shown in Table 2.

As shown in Figure 2, the target sample was fixed in front of the focal lens. The generation laser beam was irradiated on the top surface of the target sample. The inspection was conducted in pulse–echo mode, i.e., the generation laser and detection laser were located on the same side of the sample. During inspection, the generation laser and detection laser were fixed. The spacing of laser irradiation point and detection point was set to 5 mm. The sample was fixed on the moving platform and moved along each scanning path driven by step-motor. The corresponding signals were received by the LDV at the target detection point, as shown in Figure 3. The LUT scanning area of the target sample was $40 \times 8 \text{ mm}^2$, and the spatial resolution along each scanning path (scanning resolution) and between two adjacent scanning paths (index resolution) were 0.1 and 0.2 mm, respectively. The ultrasonic waveforms were averaged 512 times to improve the signal-to-noise ratio.

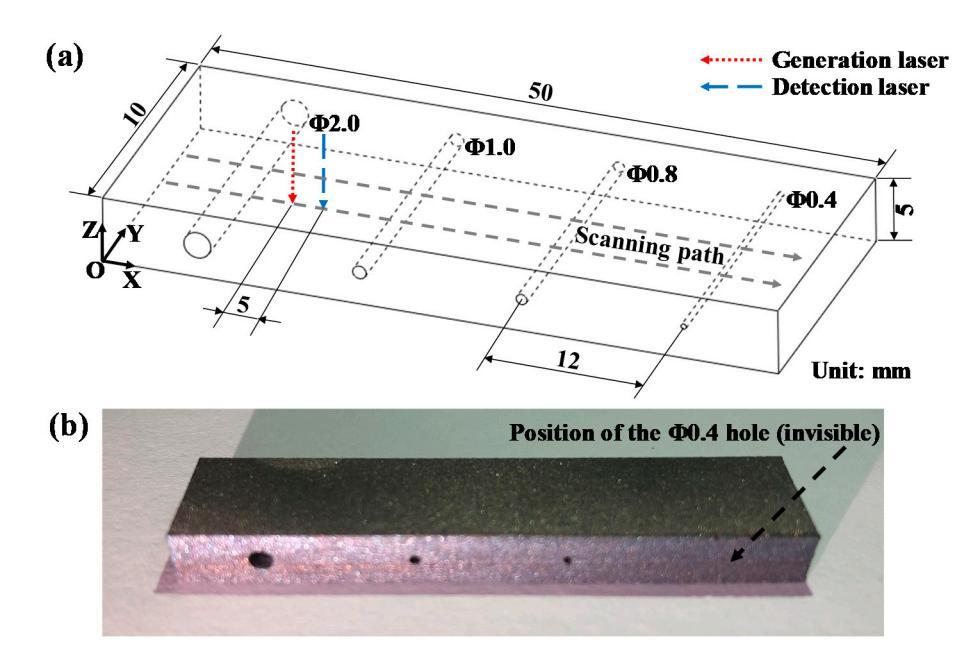
Figure 3. The investigated sample: (a) sketch of CAD model and (b) photography of the AM sample.

The specific AM process parameters are shown in Table 1. The sample with four internal holes with diameters of 0.4, 0.8, 1.0, and 2.0 mm was manufactured. The dimensions of the Ti-6Al-4V sample were set to $50 \times 10 \times 5 \text{ mm}^3$. The center-to-center distance among four holes was designed to be 12 mm. All four holes were located at the center along the thickness direction. During the AM process, these holes were formed as near hole-type defects, thus representing a common defect formed in the AM process. Note that the AM process used a laser beam to manufacture the part in a layer-by-layer style. During AM process, issues including balling and porosity can be formed due to the high-power density [2] and occur in the inner surface of four holes. Next, the sample was cut by using wire-cutting equipment (FH-020C, Suzhou Xingjie CNC Technology Co., Ltd., Suzhou, China). In order to obtain lower surface roughness for better signal reception, the sample was then sand-blasted (BNP-55, Clemco Industries Co., Ltd., Washington, MO, USA) on the top and bottom surfaces of the sample, with the blasting distance of 150 mm and flow rate of 3 m³/min.

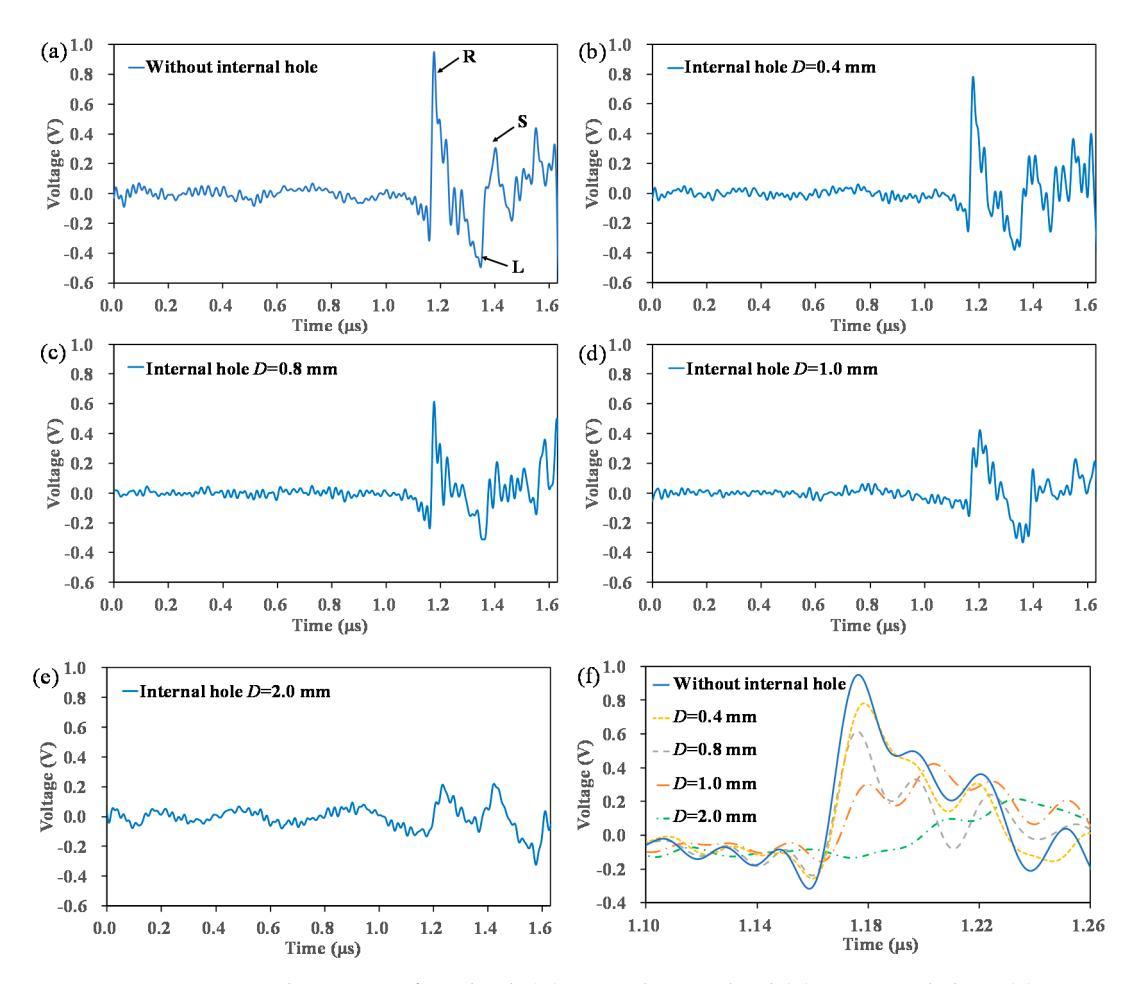
Figure 4. A-Scan signals contain of Rayleigh (R) wave, longitudinal (L) wave, and shear (S) wave of different positions located at the scanning path (Y = 5 mm, along *X*-axis in Figure 3): (**a**) without internal hole, (**b**) internal hole D = 0.4 mm, (**c**) internal hole D = 0.8 mm, (**d**) internal hole D = 1.0 mm, (**e**) internal hole D = 2.0 mm, and (**f**) local amplification of Rayleigh waves.

Figure 4a-e show A-Scan signals of holes with different diameters. The positions of the five different points were located at an interesting scanning path (Y = 5 mm, along X-axis in Figure 3). Longitudinal waves propagated through the sample and were then reflected by the bottom surface. In the near field of incident point, the Rayleigh (R) wave traveling along the top surface was most dominant, and firstly arrived at the detection point. The Rayleigh (R) wave penetrated down the top surface of the sample at the depth of the wavelength λ . The wavelength of the R wave can be calculated by $\lambda = v/f$, where v and f referred to the velocity and frequency of the R wave, respectively. The calculated wavelength of the R wave was 4.17 mm. The depth of the hole was 2.5 mm < 4.17 mm, so the R wave might have interactions with internal holes. Then, the longitudinal (L) wave and shear (S) wave became prevailing in the part as they moved further away from the top surface of the sample. It can be seen that the R wave first arrived at the top surface at around 1.2 μ s, followed by other waveforms, including L and S waves, as shown in Figure 4a. Figure 4f shows a local amplification of Rayleigh waves propagating through the different holes in the time domain from 1.10 to $1.26 \ \mu$ s. The existence of hole defects significantly influenced the amplitude of the ultrasonic waves. The peak value of the Rayleigh wave was reduced with the increasing internal hole diameter. The detected peak voltage of the sample without defects was 0.9499 V, whereas the detected peak voltages were 0.7817, 0.6140, 0.4235, and 0.2204 V for the 0.4, 0.8, 1.0, and 2.0 mm holes, respectively. Figure 5 shows the relationship between the peak value of the Rayleigh wave and internal hole diameter. It can be seen that existences of different holes made significant differences to the amplitude of Rayleigh waves. The amplitude of the Rayleigh waves attenuated approximately linearly with the increasing diameter of the internal hole.

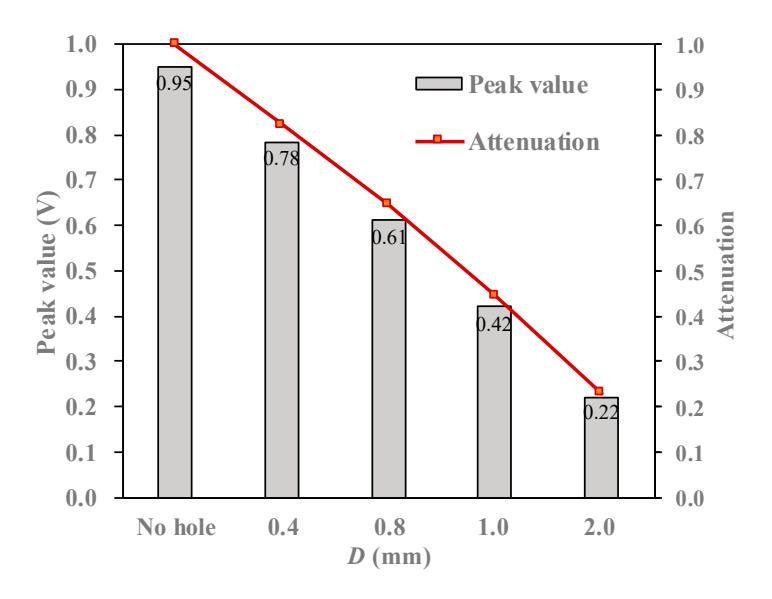
Figure 5. Peak value and attenuation of Rayleigh (R) wave at different hole diameters.

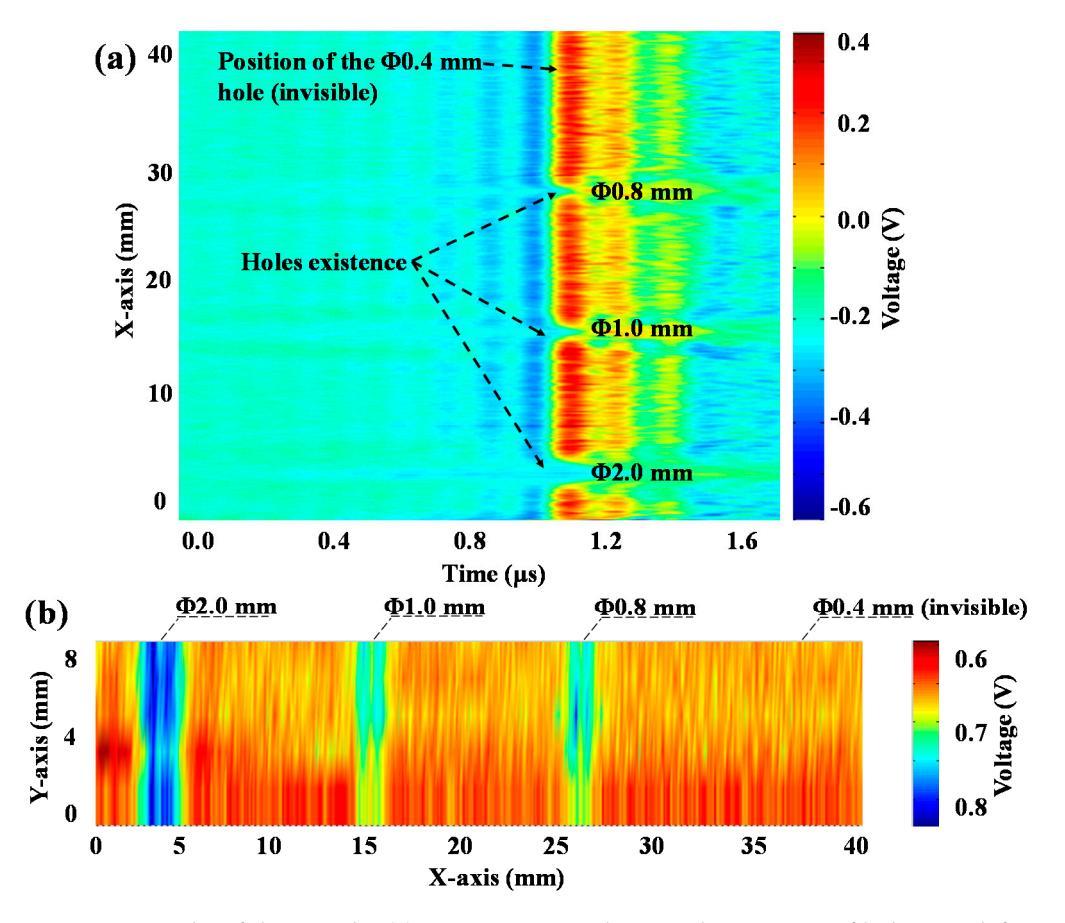
Figure 6. LUT results of the sample: (**a**) B-Scan image indicating the presence of hole-type defects of the plane (Y = 5 mm, in the *X*–*Z* plane in Figure 3) and (**b**) C-Scan image demonstrating internal hole-type defects (parallel to the *X*–*Z* plane in Figure 3).

Figure 6a shows a B-Scan image of an interesting plane (Y = 5 mm, in the *X*–*Z* plane in Figure 3). The highlighted areas represent the arrival of longitudinal waves on the top surface of the sample. It can be clearly seen that three voids occurred in the highlighted bands with an interval of approximately 12 mm along the *X*-axis, indicating the existence of internal holes with diameters of 0.8, 1.0, and 2.0 mm. As the L wave approached the hole, it was diffracted at the edges of the hole and traveled around the hole. The L wave took a longer time to arrive at the top surface of the sample.

Figure 6b shows the C-Scan image obtained from the sample. It scanned the center area of the investigated sample with a size of $40 \times 8 \text{ mm}^2$, i.e., the area displayed in C-Scan image was in the center of the sample surface. The position and size of internal hole defects with diameters of 0.8, 1.0, and 2.0 mm could be clearly identified in the C-Scan image. However, the internal hole defect of 0.4 mm diameter was not visible in either the B-Scan or C-Scan image. Compared with previous work [19,30], the LUT system made improvement and achieved a resolution in sub-millimeter scale. Further work should be done to find the relationship between gate setting and hole parameters (diameter, depth, etc.) and then optimize LUT parameters for the detection of even smaller defects in AM part.

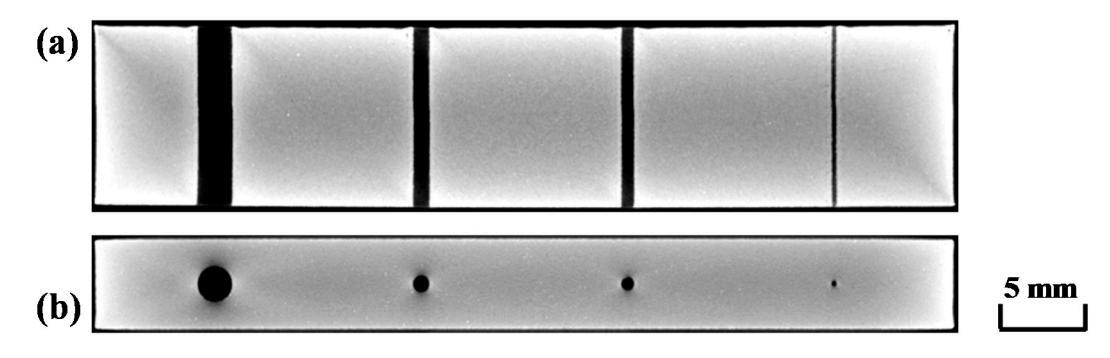
Figure 7. XCT test results: (a) sectional top view and (b) sectional front view.

As shown in Figure 7, artificially designed internal holes with diameters of 0.4, 0.8, 1.0, and 2.0 mm were successfully formed by the AM process. All four holes are through-holes with a center-to-center spacing of 12 mm. The XCT method was able to determine the hole inside the sample with hole

diameters smaller than 0.4 mm. We compared the sizes and locations of holes obtained from LUT and XCT results, and the holes obtained from our LUT system were smaller than those in the previously published work [30]. Therefore, the XCT results validated the results obtained from the LUT system. In addition, the inner surfaces of holes were not completely smooth. It can be explained that, during the AM process of the sample, the powder bed underwent rapid melting and solidification. The metallic material was shocked by the laser-produced plasma and melted by the relatively high laser energy. Therefore, issues such as balling, porosity, and residual stress could occur in the inner surface of the holes, which led to the deformation of the inner surface of the holes. The void fraction of the entire sample was 0.87%. The average size of the porosities was approximately 50 μ m with actual values in the range of 30 to 110 μ m, which was better than the results in previous work [30].
