Influence of Microstructural Changes' Effects on the Linear and Nonlinear Ultrasonic Parameters of Cast Stainless Steels

Yu-Ju Lin ^{1,2,*}, Che-Hua Yang ¹ and Jiunn-Yuan Huang ²

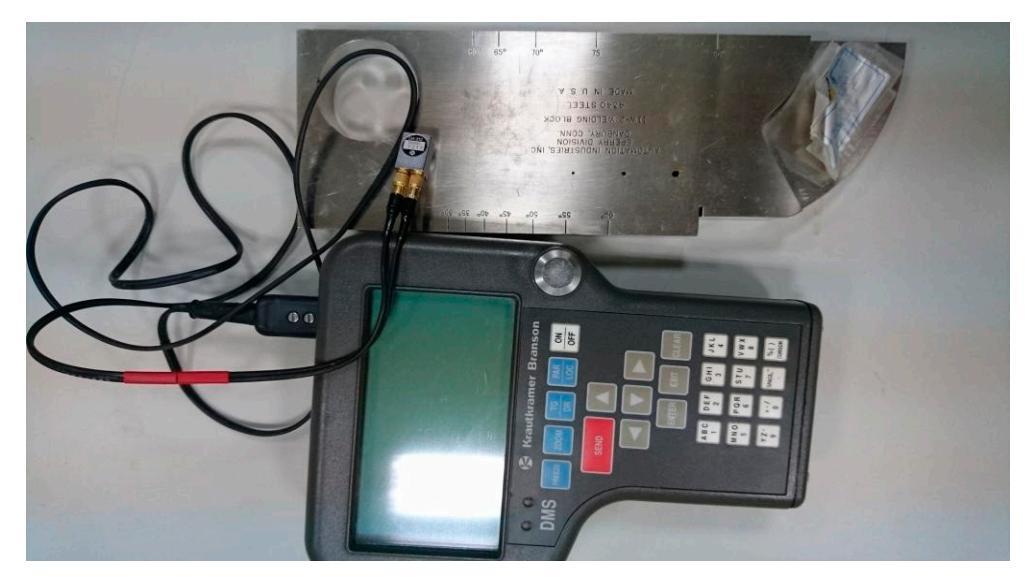
For linear ultrasonic measurement, Figure 1 shows the commercial ultrasonic thickness gauge (Krautkramer Branson, Lewistown, PA USA) and a calibration block for velocity measurement, and Figure 2 shows the schematic sketch of the experimental setup for attenuation measurement. The arm with a weight sensor attached would push on the transducer with the same weight. The weight tested by an electronic scale is shown in Table 2. From Figure 2, there was just a reflect echo from the bottom. Therefore, an ultrasonic thickness gauge was used and calibrated by a calibration block to avoid the zero point error. The velocity could be calculated by measuring the velocity of the calibration block and the thickness of samples. The velocity *v* is given as

Figure 1. The commercial ultrasonic thickness gauge and a calibration block.

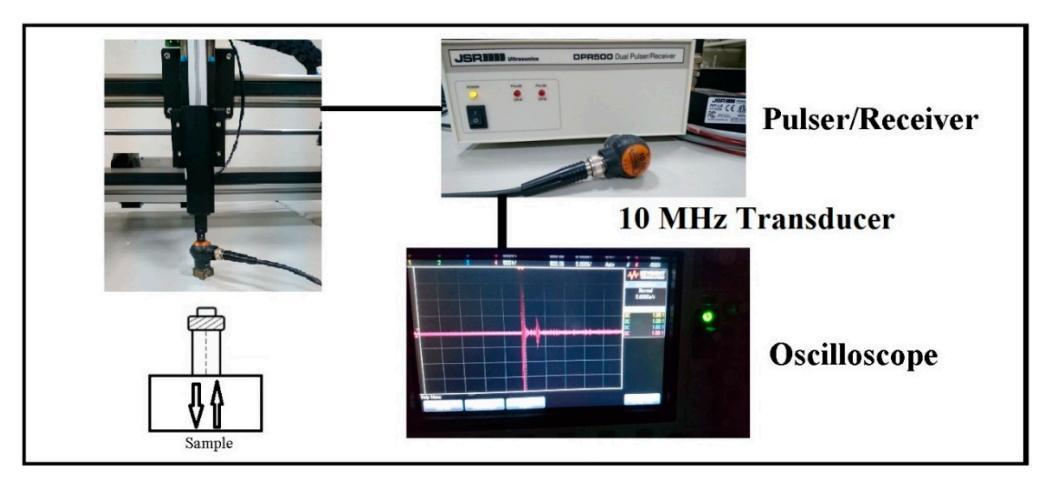
Figure 2. The sketch of the experimental setup for attenuation measurement.

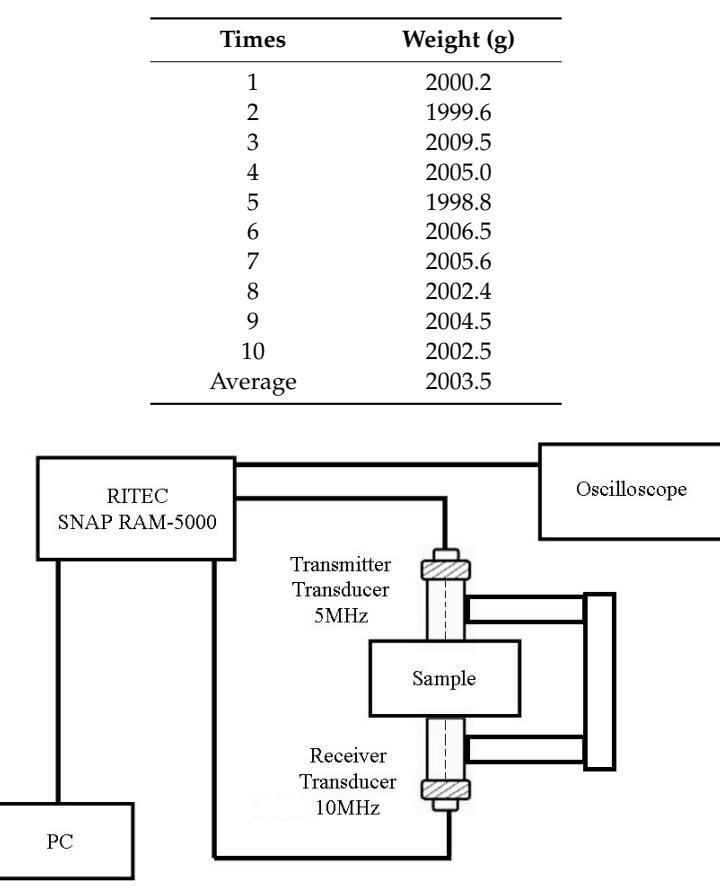
For nonlinear ultrasonic measurement, Figure 3 shows the schematic sketch of the experimental setup. A high power tone-burst amplifier RITEK SNAP RAM-5000 (RITEC Inc., Warwick, RI, USA) was used to excite a longitudinal piezoelectric transducer with a central frequency of 5 MHz to generate 10 cycles tune burst signals. A longitudinal piezoelectric transducer with a central frequency of 10 MHz was used to receive the fundamental and second harmonics of ultrasonic waves. The fast Fourier transform (FFT) was used to convert the first reflect echo of the received signal to the frequency space for all measurements. Figure 4 shows the amplitude of the fundamental and second harmonics from FFT. To control the amount of the coupler, a precise syringe was used to inject 2 mL of gel for each

measurement. To maintain alignment parallelism, the transmitting and receiving transducers were fixed during the course of measurement. The center of samples was measured for three times at the same position to calculate the average value. The signal was recorded by a 2.5 GS/s oscilloscope and stored in a computer. In order to confirm the nonlinear signals which are due to the material nonlinearity, the nonlinear acoustic signal was calibrated by increasing the input voltage. Figure 5 shows the amplitude of the second harmonic wave is linearly related to the square of the amplitude of the fundamental frequency component with the increased excitation voltage. Therefore, it could be concluded that the measured nonlinearity would be reliable.

Figure 3. The sketch of the experimental setup for nonlinear ultrasonic measurement.

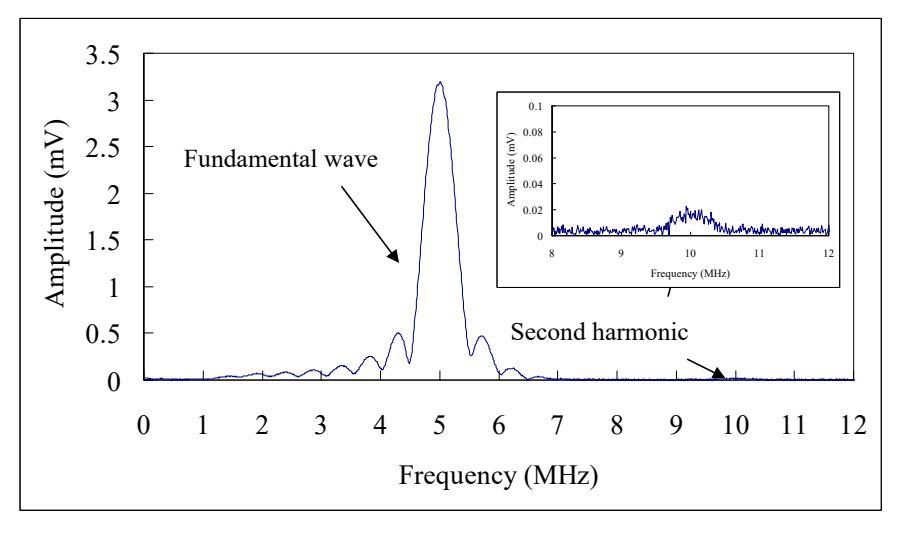
Figure 4. The amplitudes of the fundamental and second harmonics from the fast Fourier transform (FFT).

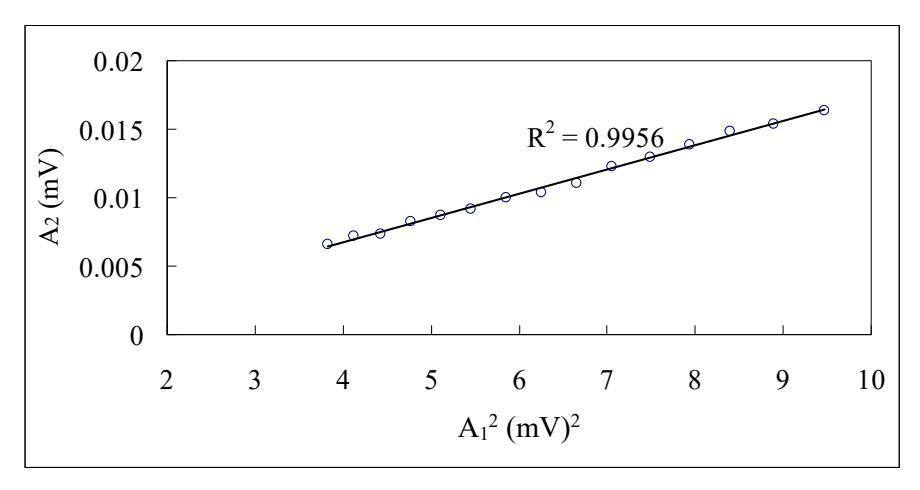
Figure 5. Second-harmonic amplitude A_2 versus the square of the fundamental wave amplitude A_1 with an increase of input voltage.

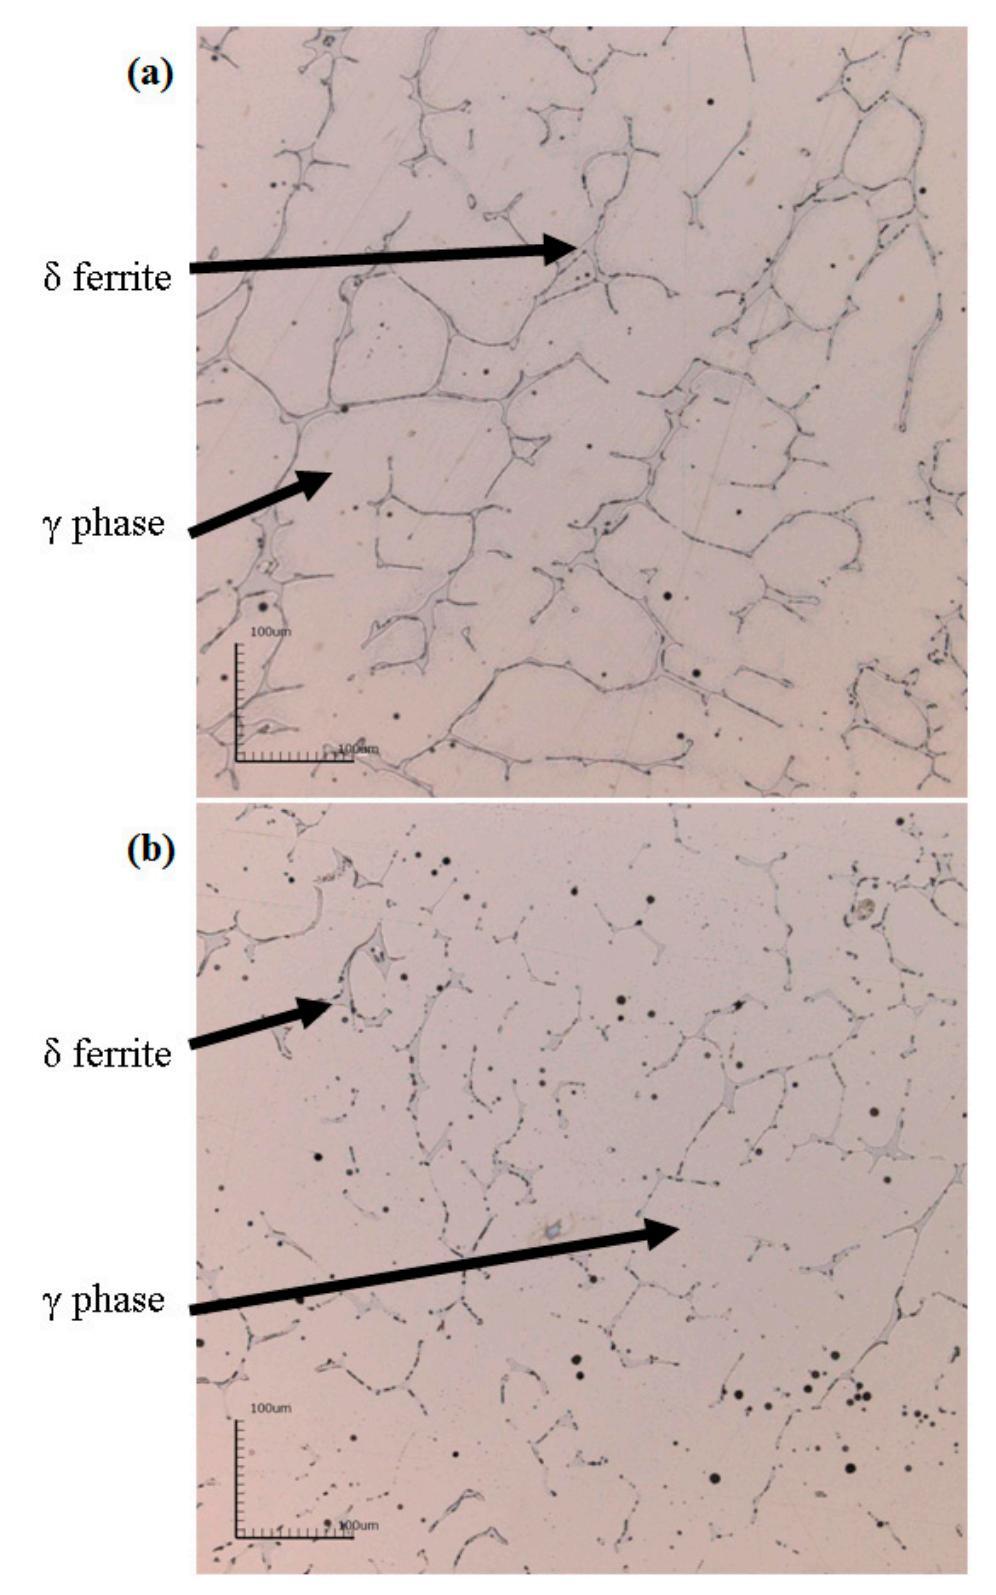
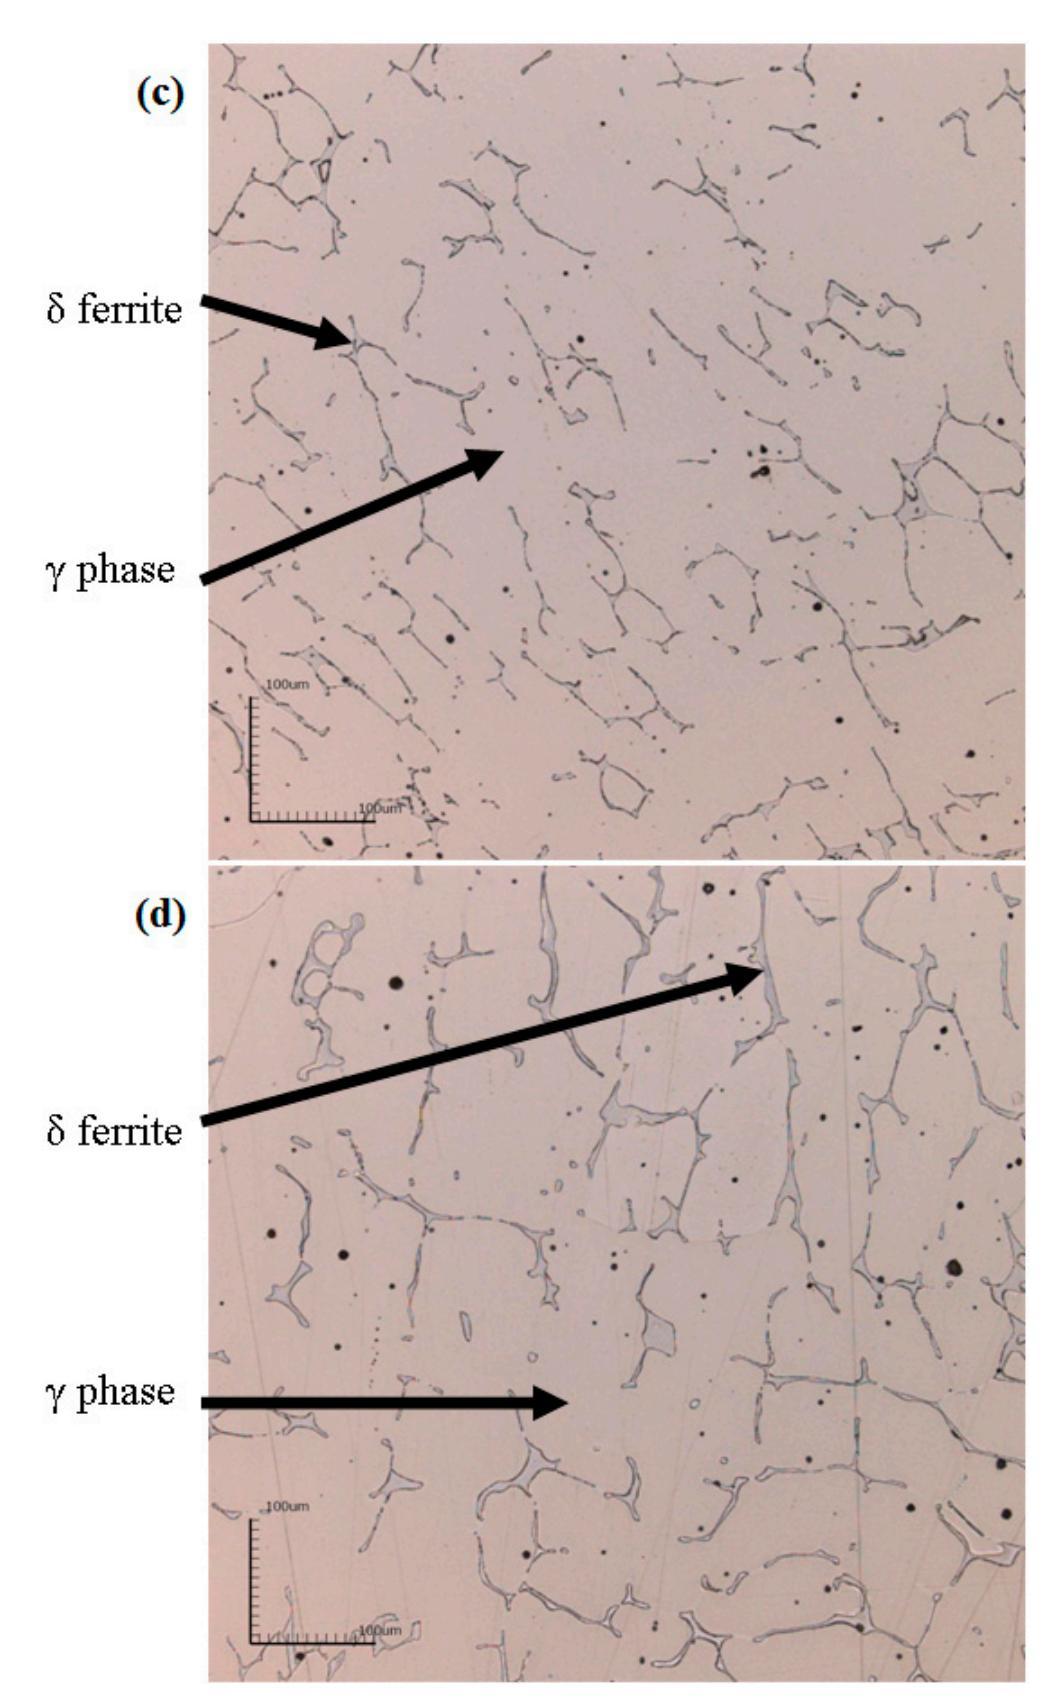
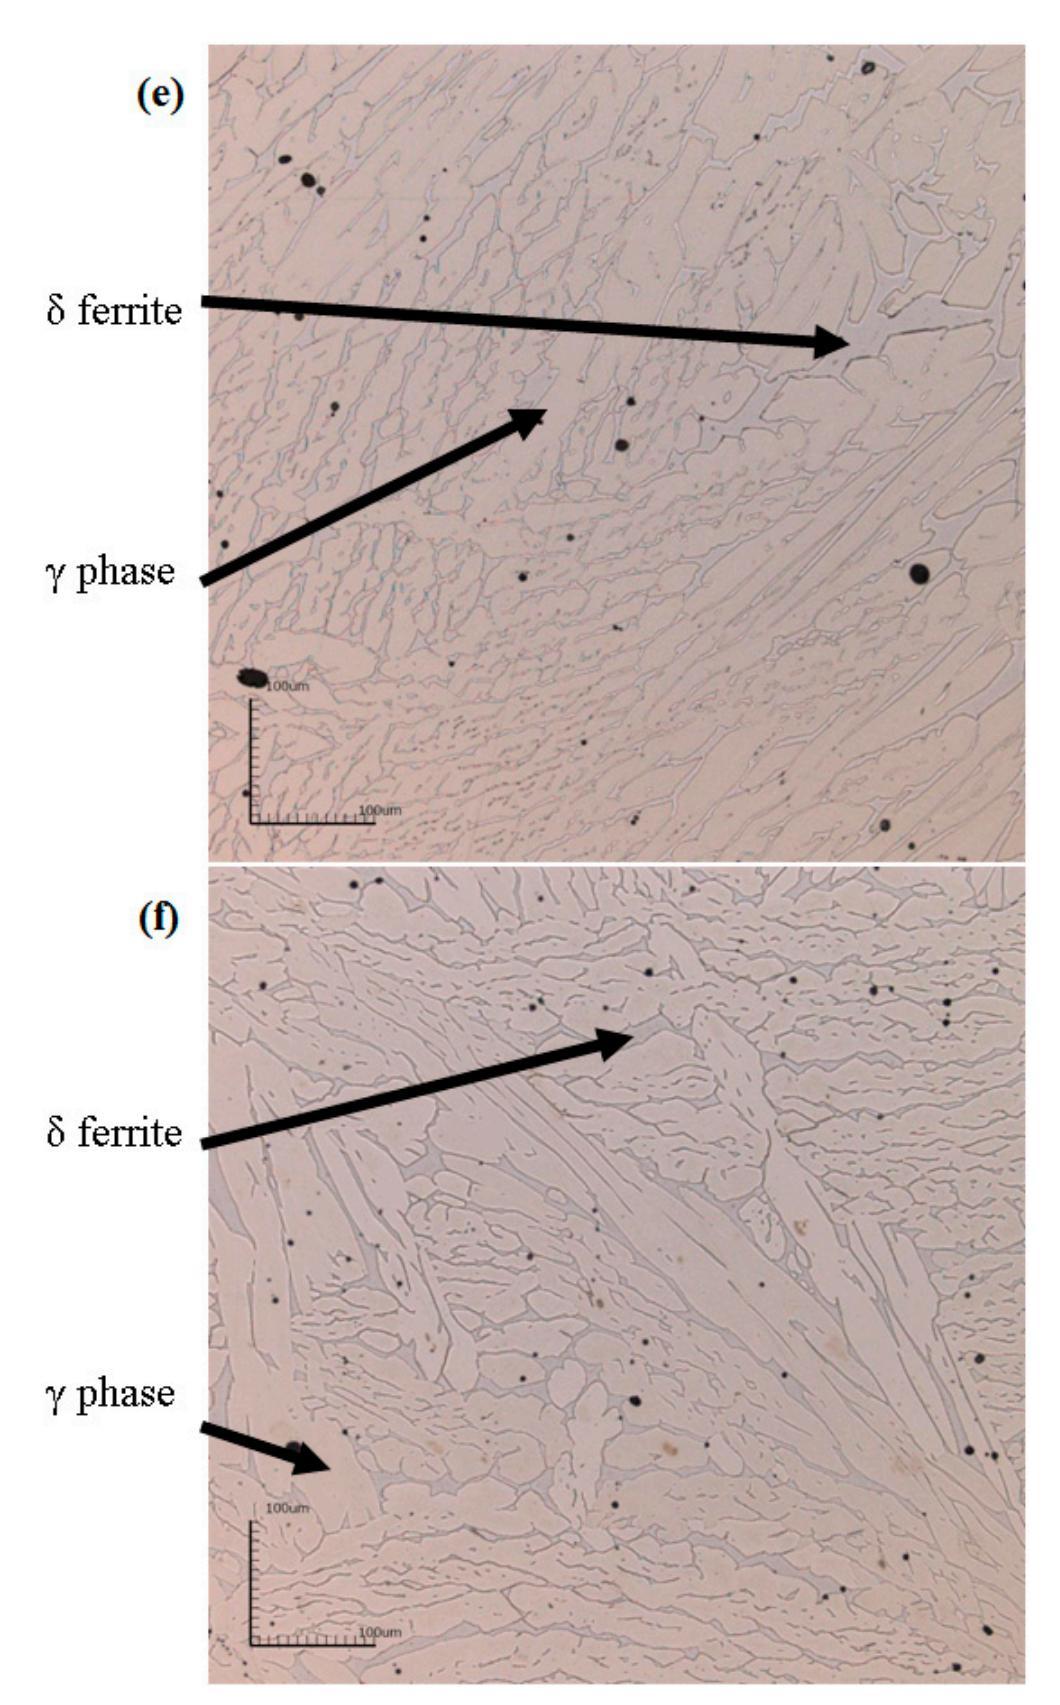
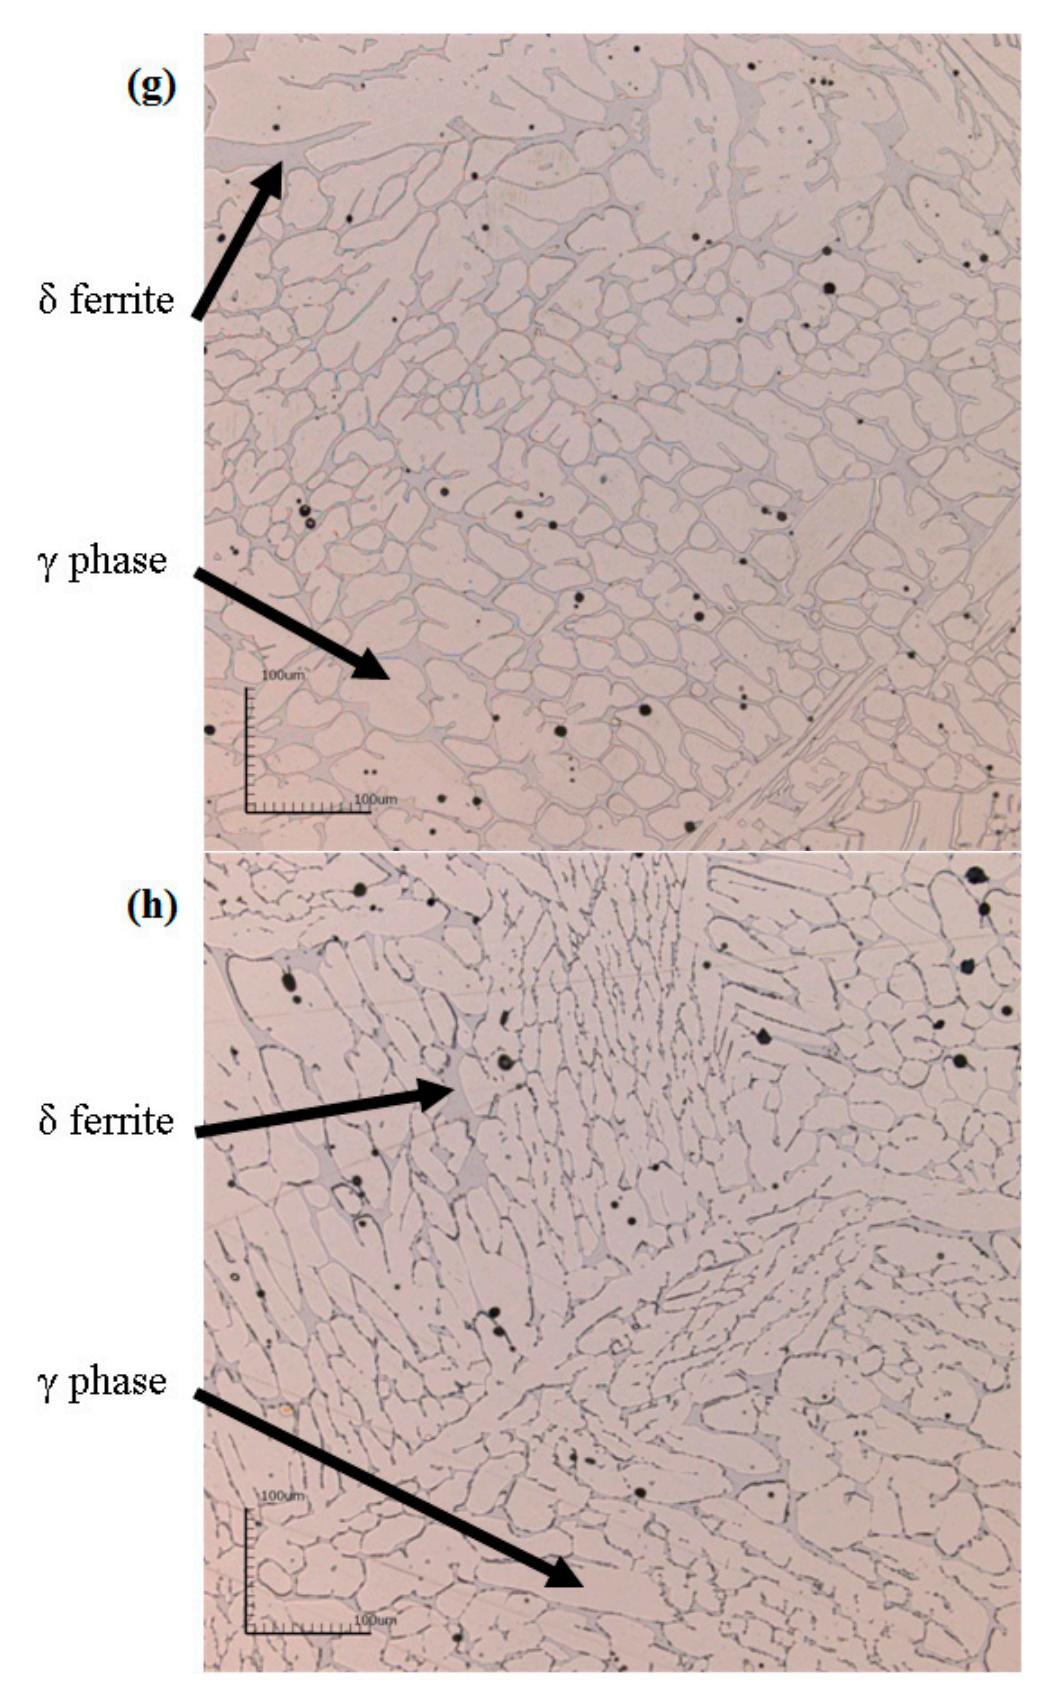
Figure 6. Microstructure evolution of specimens age-treated at 385 °C for various periods of time, (a) low ferrite (LF) 0 h; (b) LF 2400 h; (c) LF 6000 h; (d) LF 30,000 h; (e) high ferrite (HF) 0 h; (f) HF 2400 h; (g) HF 6000 h; (h) HF 30,000 h.

It is well-known that cast stainless steels suffer thermal embrittlement when exposed to temperatures in the range 300–500 °C due to the decomposition of ä-ferrite into chromium-rich α' phase and iron-rich α phase. Figure 6 shows the microstructure evolution of the specimens age-treated at 385 °C for 2400, 6000, and 30,000 h and the unaged samples (0 h), respectively. It can be seen that the island-shaped (LF) or the network-like (HF) ä-ferrite islands are dispersed in the austenite (γ) matrix, and that the specimens show no significant changes of metallographic features with aging time from 0 to 30,000 h. To make better sense of the aging effect, the Vickers and Rockwell hardness tests were carried out. Figure 7 shows the hardness values of the ä-ferrite and ã phase. The hardness values of the ä-ferrite in the unaged samples were HV 183 (LF) and HV 190 (HF). For the specimens age-treated for 2400 and 6000 h, the hardness increased to HV 256 (LF), HV 276 (HF) and HV 306 (LF), HV 391 (HF), respectively. After prolonging the aging time to 30,000 h, the hardness values showed no significant change. Figure 8 shows the Rockwell hardness tests with aged time from 0 to 30,000 h. For the specimens age-treated, the hardness increased with aged time both HF and LF samples. The increase in hardness was attributed to the spinodal decomposition and precipitation [4–7]. To have a comparison of the change in the microstructure, two cold rolled specimens machined from

The attenuation of ultrasonic depends on damping, grain size, and scattering of the material [22]. From Figure 6, the grain sizes are almost the same with aging time from 0 to 30,000 h. In the ultrasonic

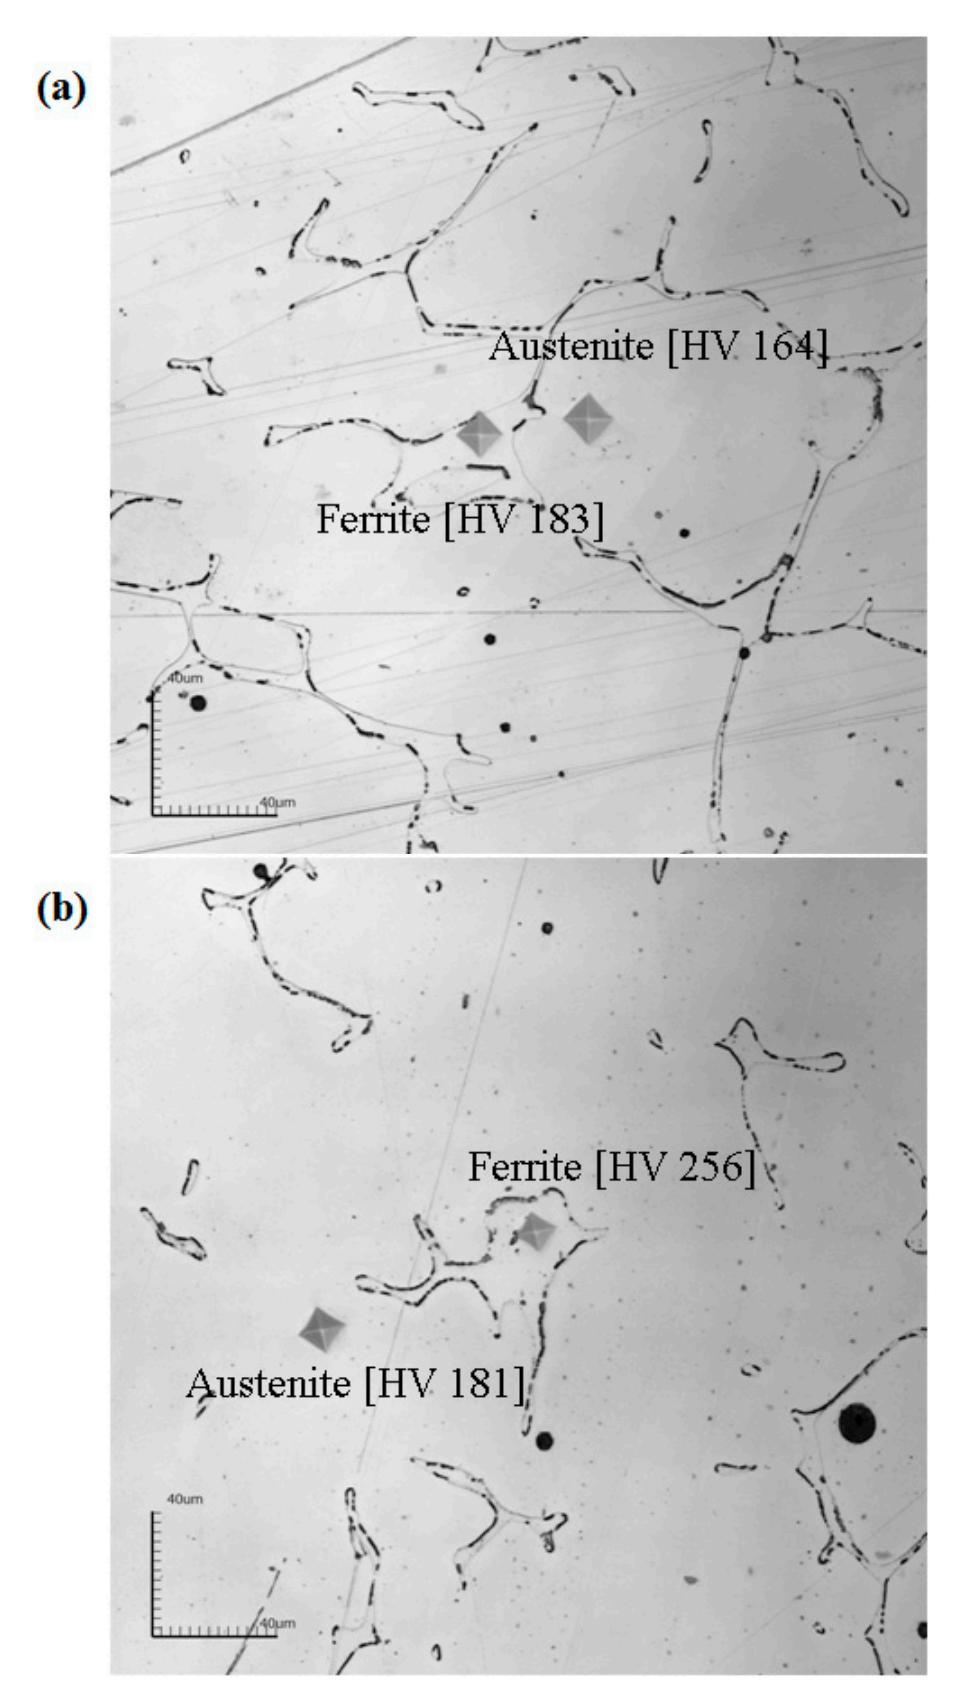
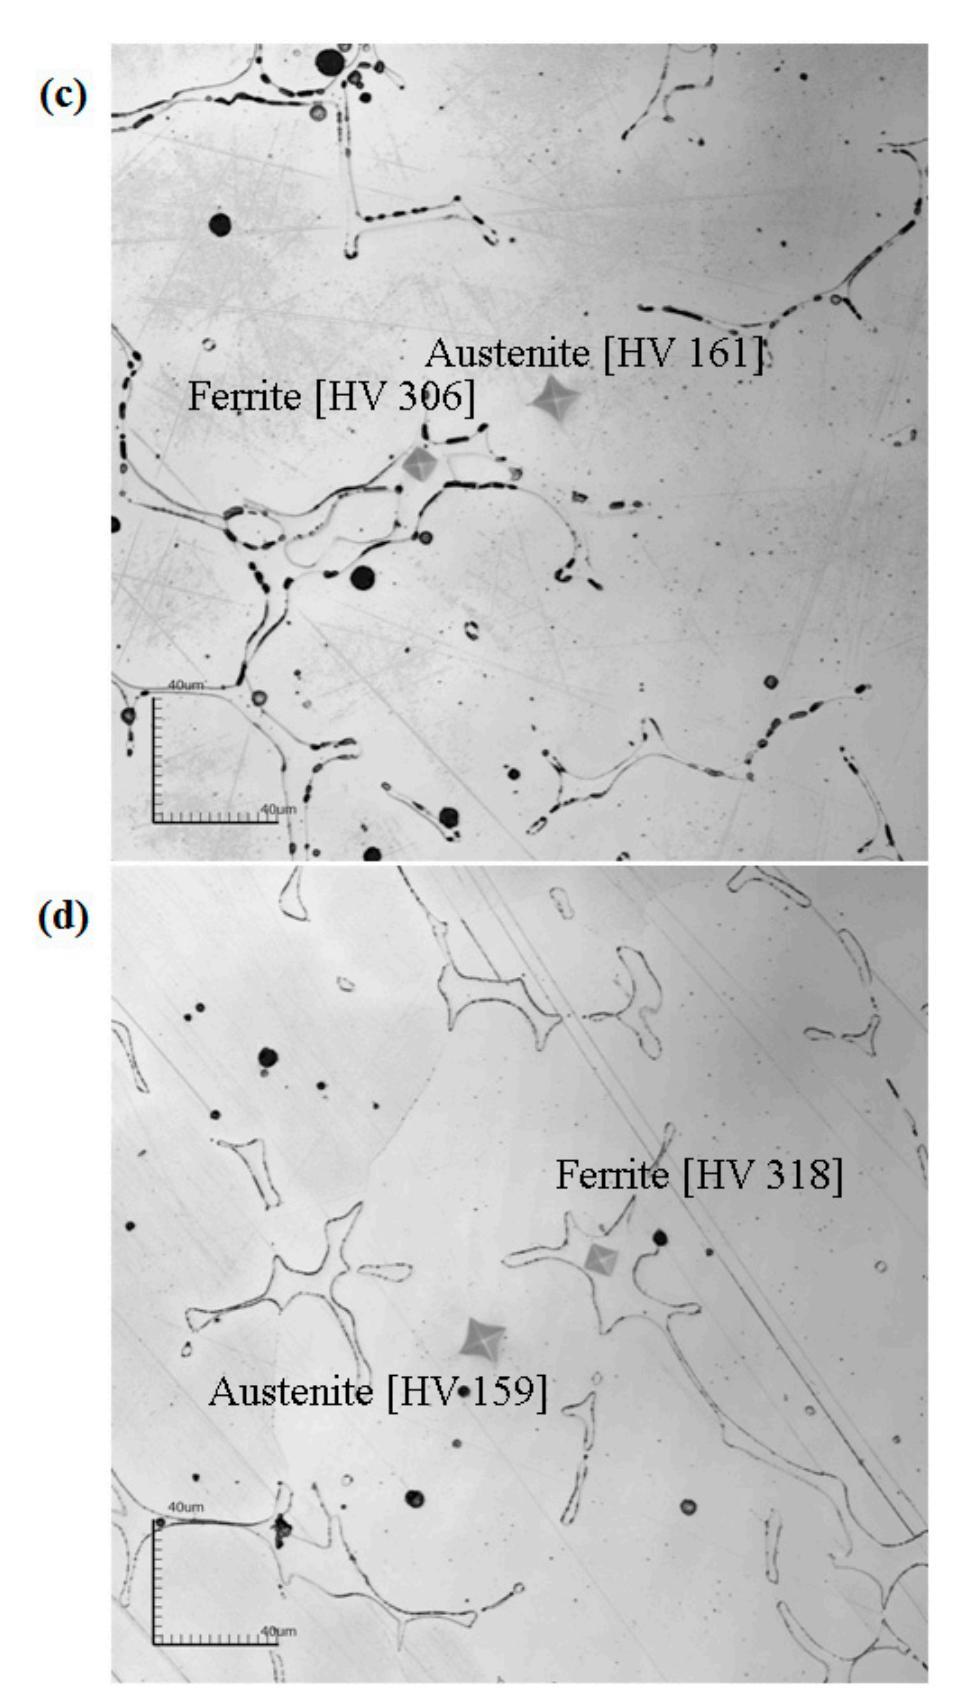
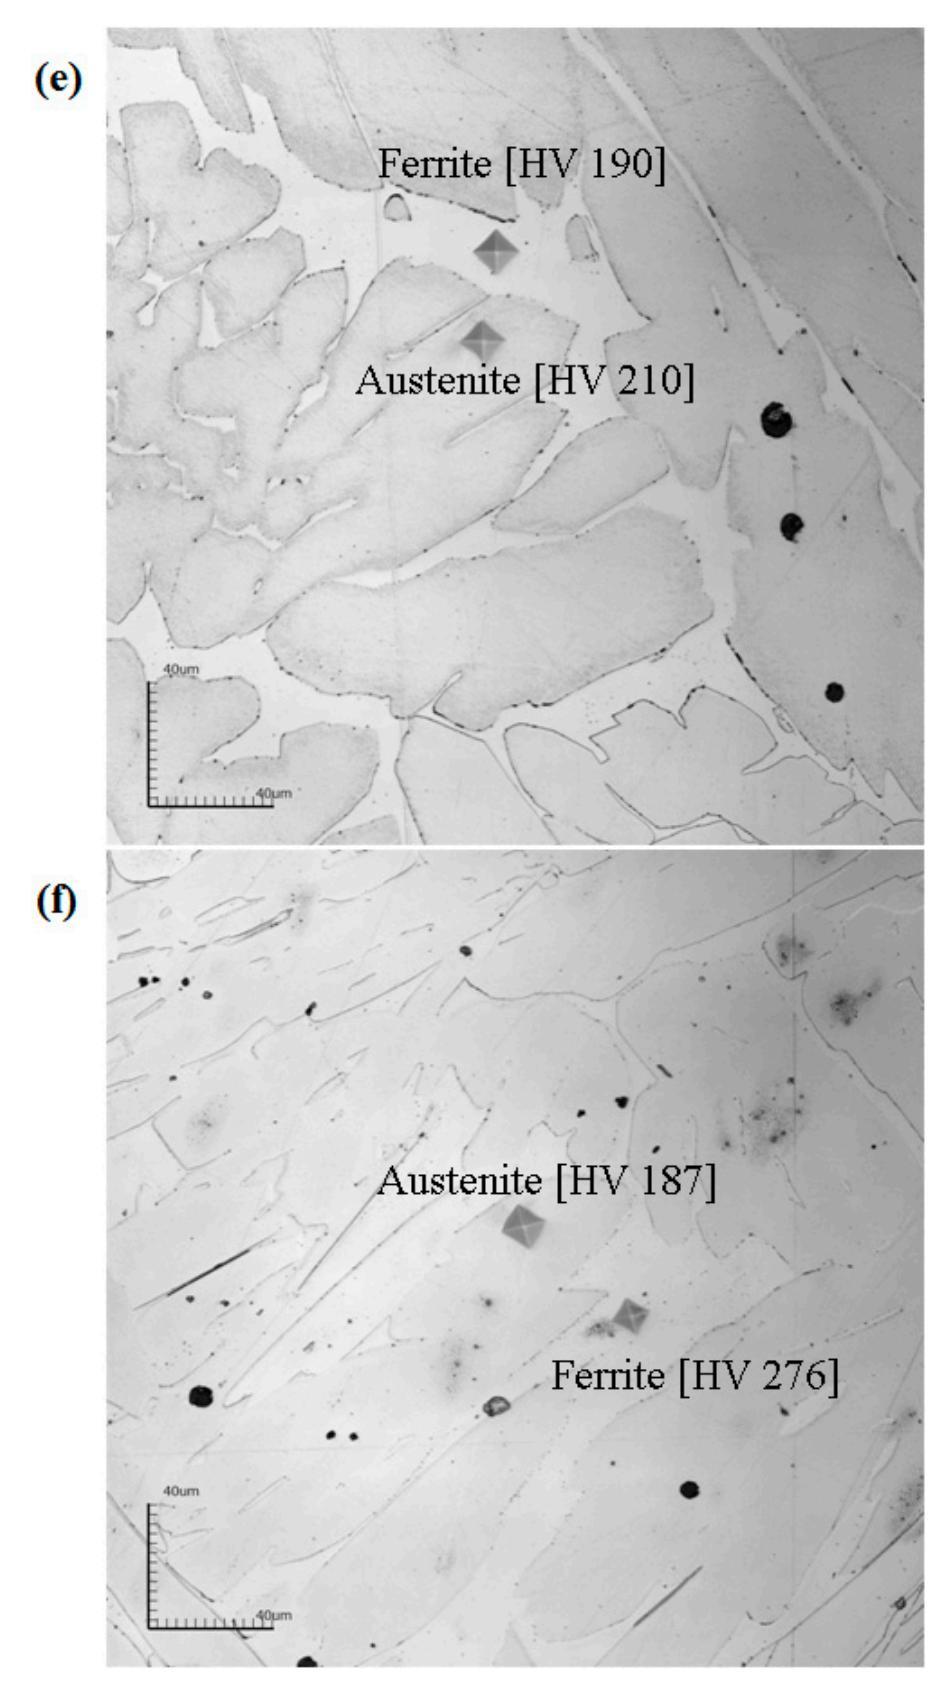
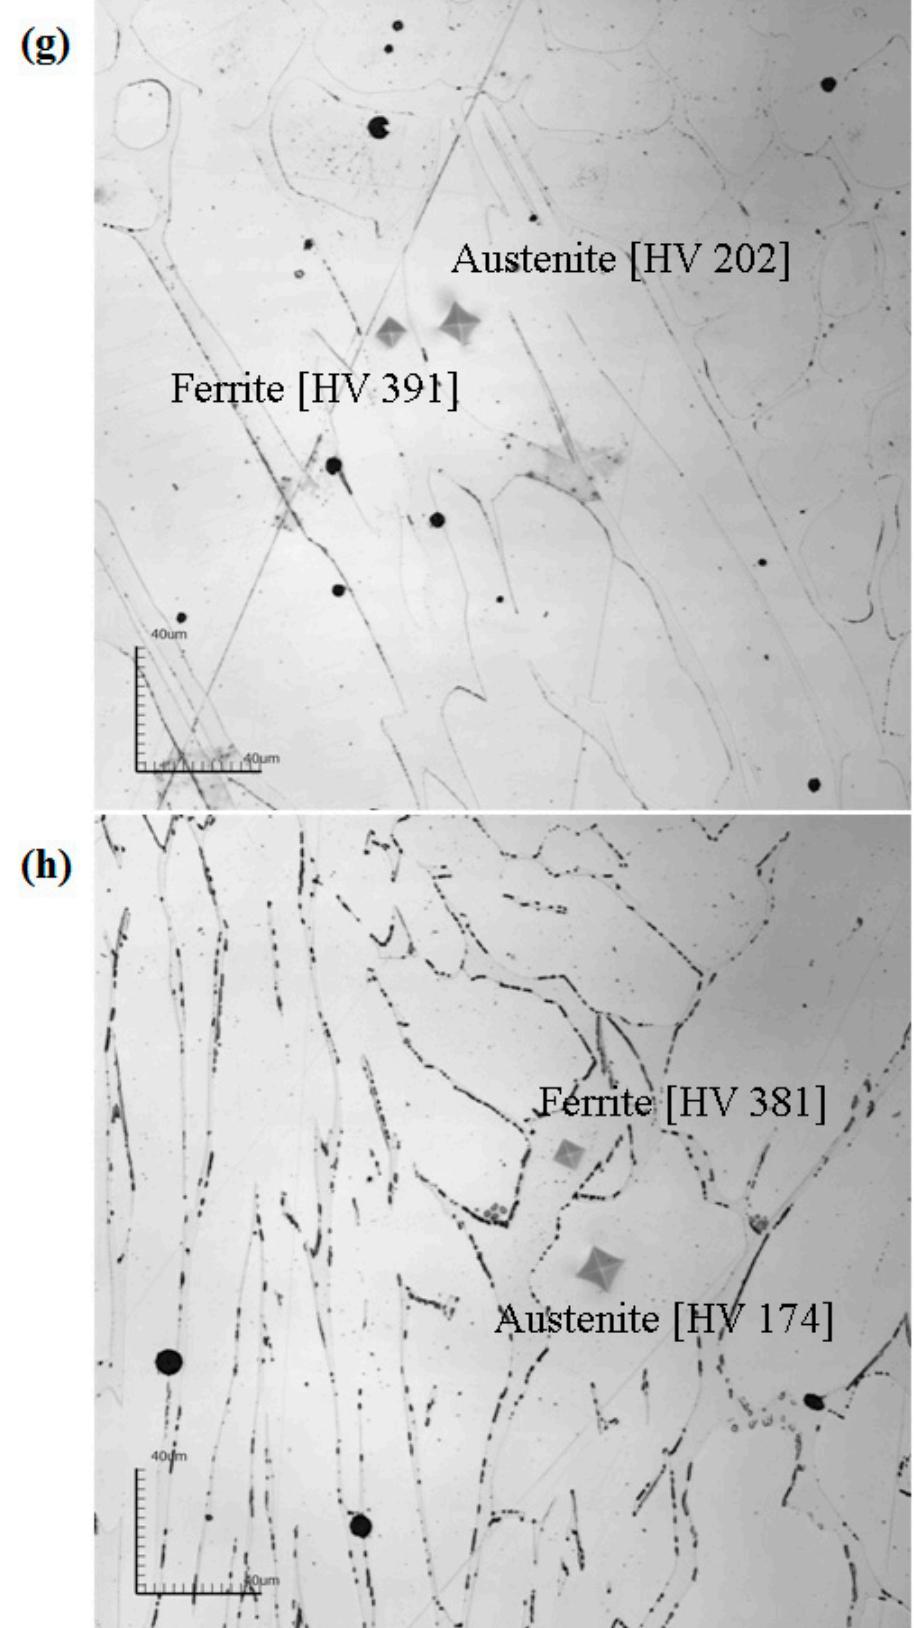
Figure 7. Microstructure and hardness test indentations of specimens age-treated at 385 °C for various periods of time, (**a**) LF 0 h; (**b**) LF 2400 h; (**c**) LF 6000 h; (**d**) LF 30,000 h; (**e**) HF 0 h; (**f**) HF 2400 h; (**g**) HF 6000 h; (**h**) HF 30,000 h.

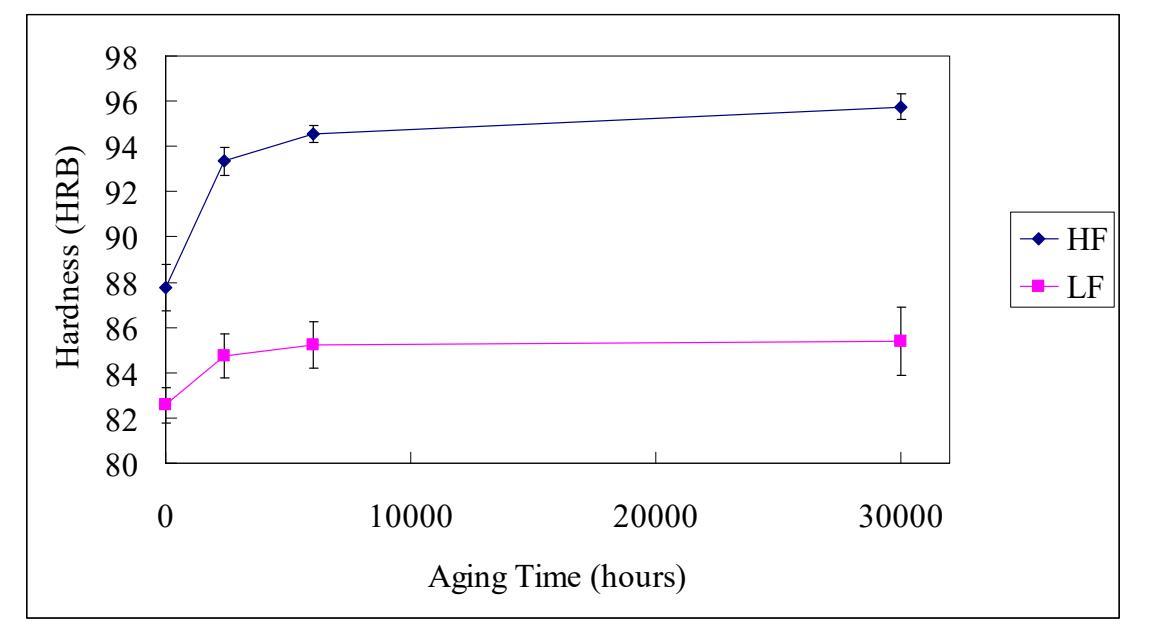
Figure 8. Variations of HRB hardness measurement with aging time.

According to the hardness test and velocity test, the increase in the hardness was observed to increase with aging time up to the 30,000 h. These results are coherent with the results reported by Freitas et al. [21].

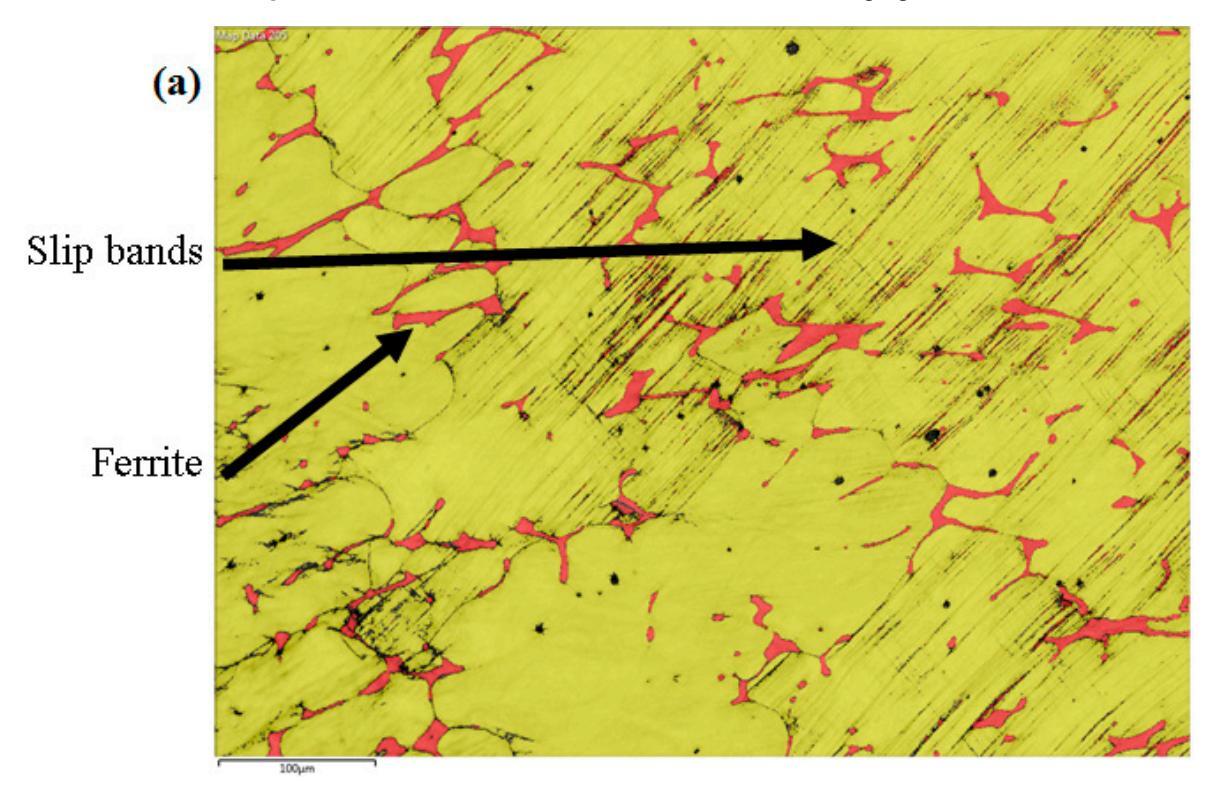
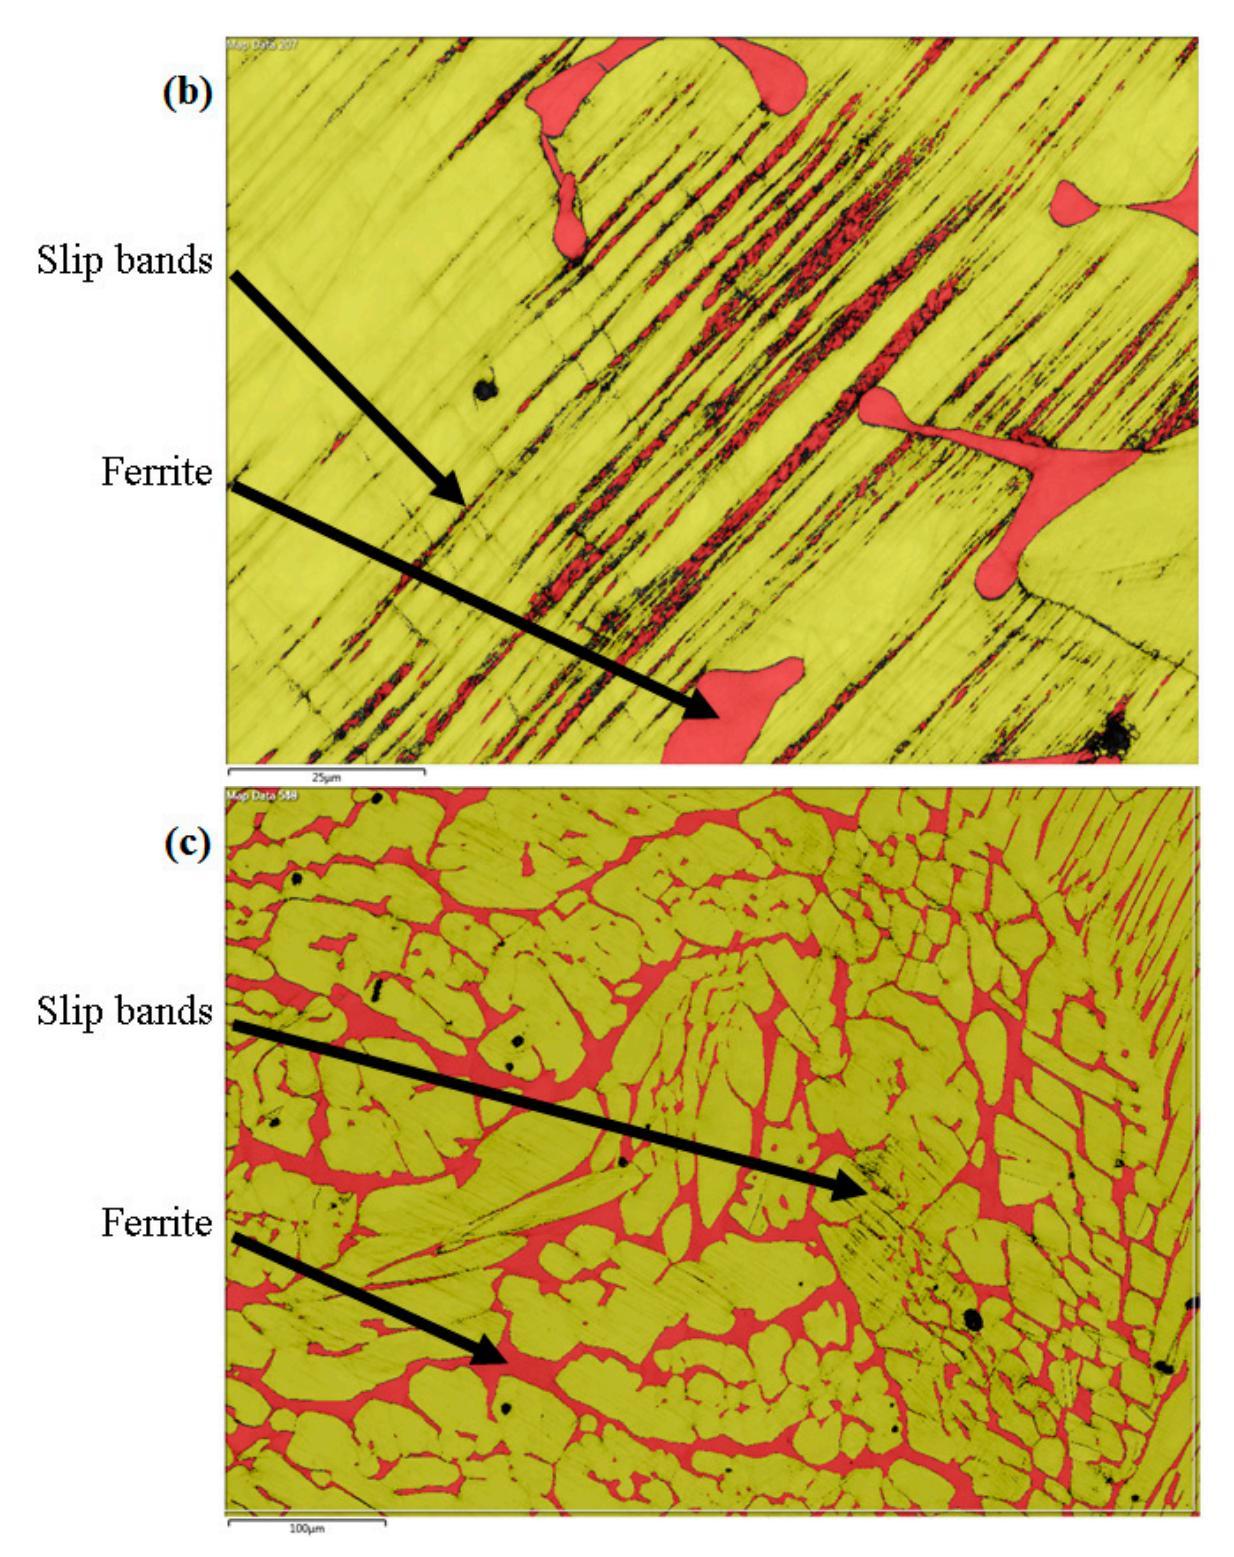
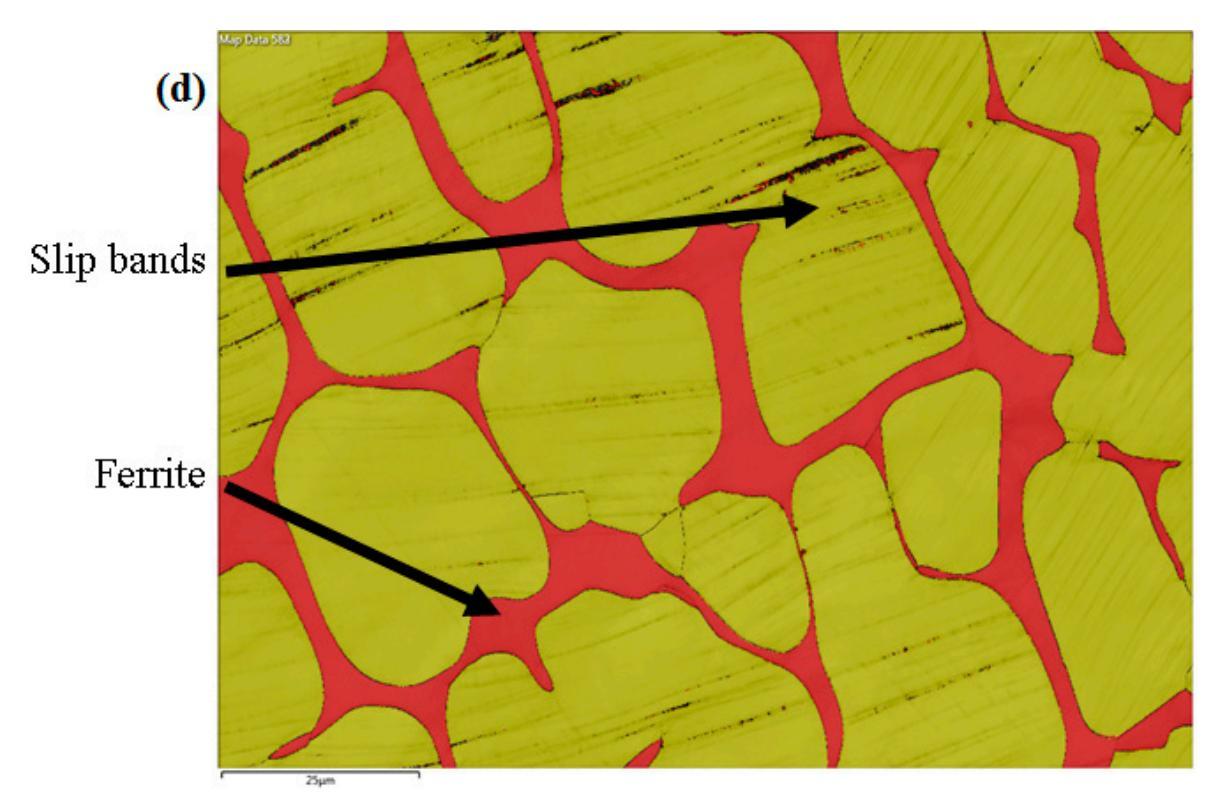
Figure 9. EBSD of 10% deformation, (**a**) LF 10% 200×; (**b**) LF 10% 1000×; (**c**) HF 10% 200×; (**d**) HF 10% 1000×.

the HF and LF static cast stainless steel were analyzed and measured by EBSD and the hardness test. Figure 9 shows EBSD of the HF and LF specimens deformed to 10% cold work, respectively. The slip bands were noticed within the austenite matrix after cold work. Figure 10 shows the hardness values for 10% deformed HF and LF samples. For the specimens machined, the hardness increased both HF and LF samples. The increase in hardness was due to the increase in dislocation density.

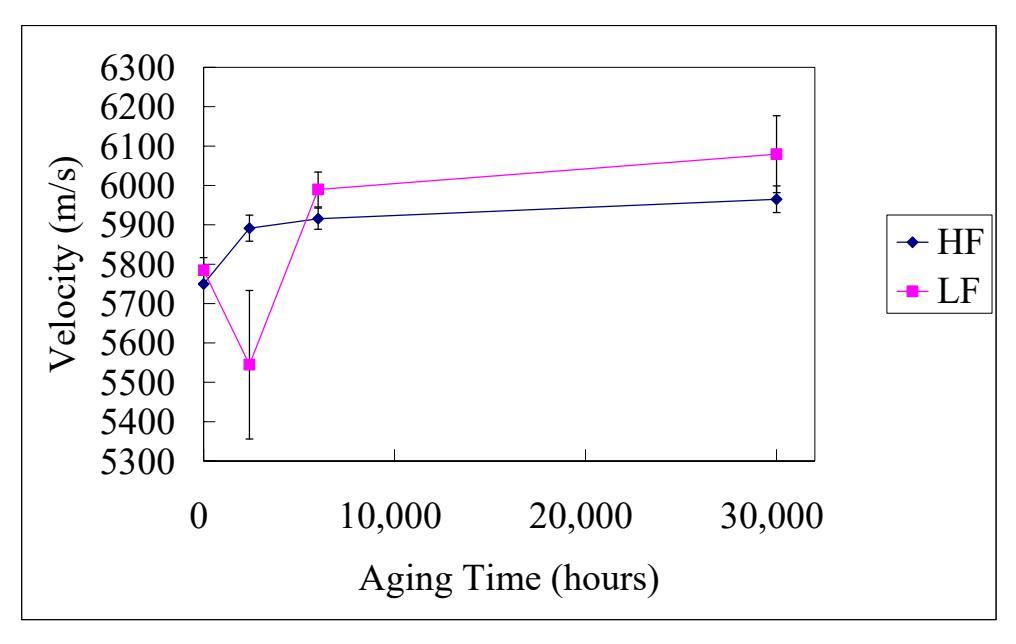
Figure 11. Variation of velocity with aging time.

To grasp the main points of the interaction between microstructural change and ultrasonic signal, the ultrasonic velocity and attenuation measurements were carried out. Figures 11 and 12 show the variations in ultrasonic velocity with aging time and deformation. There was an increase trend in ultrasonic velocity both HF and LF. In addition, the velocity increases both of the deformed samples.
