Influence of Microstructural Changes' Effects on the Linear and Nonlinear Ultrasonic Parameters of Cast Stainless Steels

Yu-Ju Lin ^{1,2,*}, Che-Hua Yang ¹ and Jiunn-Yuan Huang ²

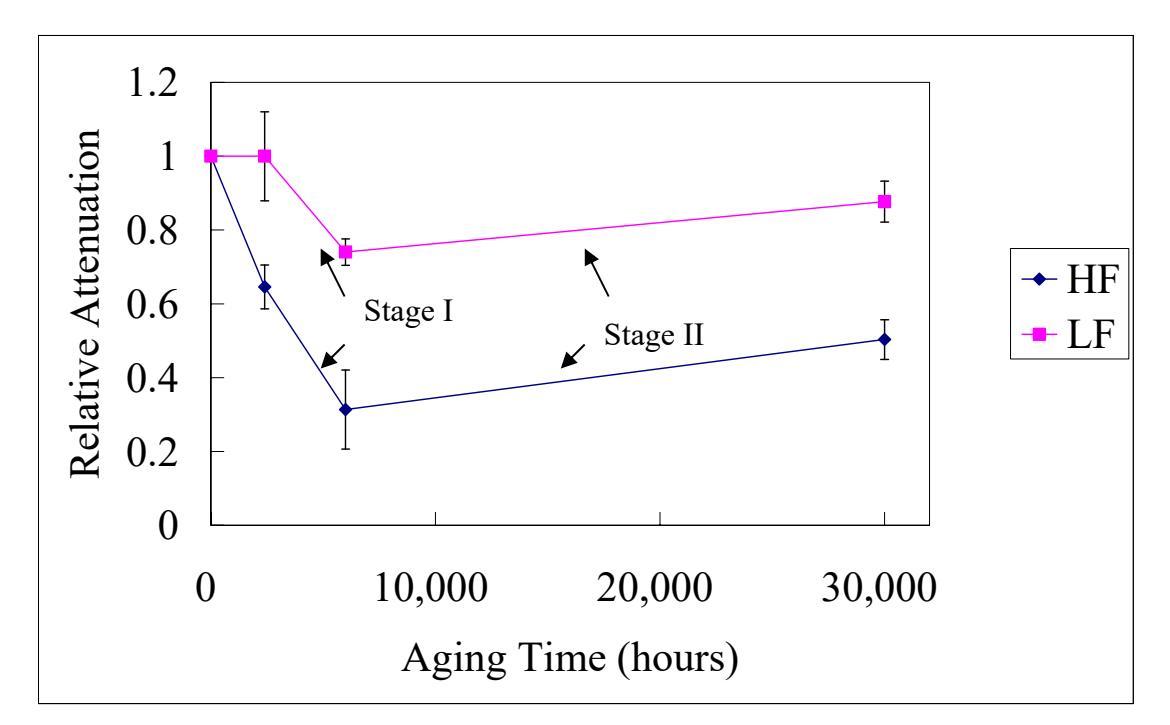
Figure 13. Variation of relative attenuation with aging time.

Figures 13 and 14 show the variations in attenuation with aging time and deformation. There were the same trends that the attenuation parameter ã decreases with aging time from 0 to 6000 h, and increases slightly from 6000 to 30,000 h. For the specimens machined, the ã decreased both HF and LF samples.

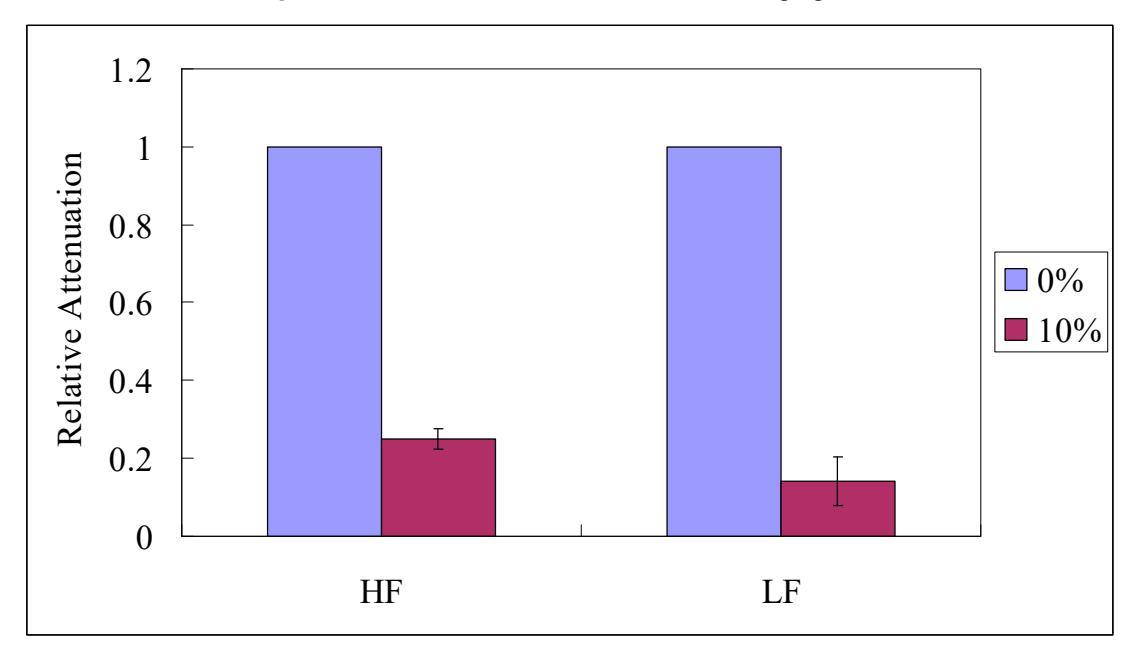
Figure 14. The relative attenuation with 10% deformation for HF and LF samples.

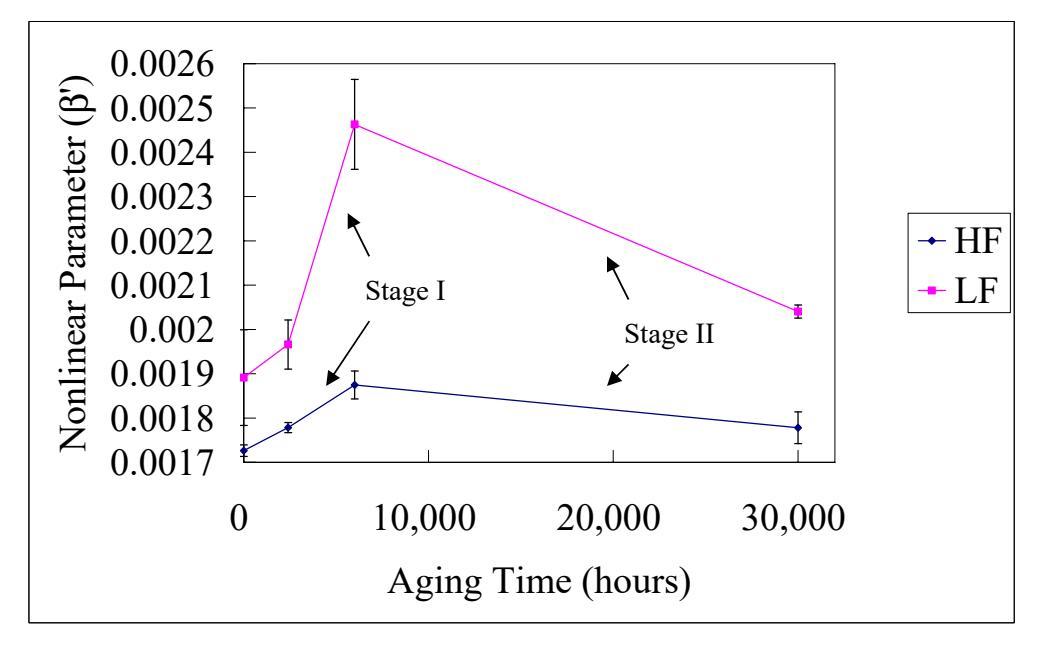
Figure 15. Variations of nonlinear parameters for HF and LF with aging time.

For a better understanding of the relationship between microstructure and nonlinear ultrasonic parameter (β), the magnitudes of 5 and 10 MHz were measured to give an estimated \hat{a}' value with Equation (9). Figures 15 and 16 show the changes in the \hat{a}' values for cast stainless steel specimens with aging time and deformation. It is observed from Figure 15 that the variations in \hat{a}' for HF and LF specimens with aging time are in a similar trend. The value was noted to increase in the early stage of the aging process. After that, a decrease with aging time was observed. For the specimens machined, the \hat{a}' increased both HF and LF samples which were in reasonable agreement with the present investigation [24]. This suggests that the variations in the microstructural change would affect the nonlinear ultrasonic parameter.

In order to elucidate the relationship between microstructures and nonlinear ultrasonic parameter, cast stainless steels with two different ferrite contents were used. From Figure 15, it can be seen that the HF-0h and LF-0h specimens show variations in ultrasonic nonlinearity. This implies that the variation of phase content will induce the change of ultrasonic nonlinearity. According to Xiang et al. [25], a stress-dependence model has been proposed to depict the change in the ultrasonic nonlinearity parameter with the applied stress

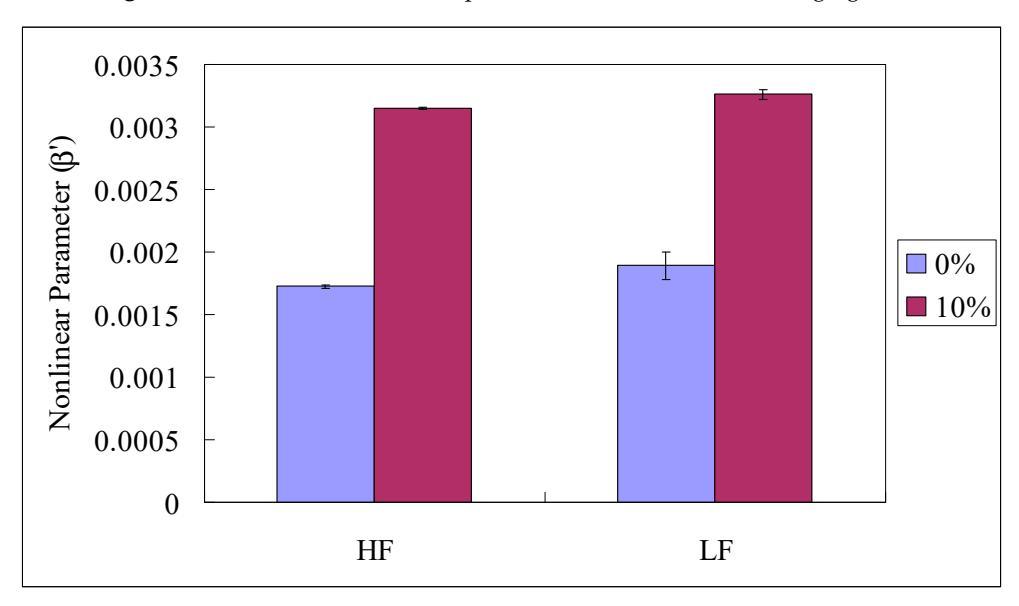
Figure 16. The nonlinear parameters with 10% deformation for HF and LF samples.
