Article Assessment of Mechanical Properties of Corroded Prestressing Strands

Chi-Ho Jeon, Cuong Duy Nguyen and Chang-Su Shim *

Abstract: The corrosion of prestressing steel in prestressed concrete bridges is a critical issue for bridge maintenance. To assess structures with corroded strands, it is necessary to define the mechanical properties of the strands and their influence on the structural behavior. In this study, corroded strands were taken from external tendons in existing post-tensioned concrete bridges and tested to determine the effects of corrosion on their tensile properties. Empirical equations for the tensile strength and ductility of the corroded strands were proposed using test results. The most corroded wire governs the mechanical properties of the strand. Experiments on prestressed concrete beams with a single corroded strand were conducted to investigate their structural behavior. A reduction in the flexural strength and maximum deformation was observed in these experiments. According to the section loss of a wire in a strand and its location in a beam, the flexural capacity can be evaluated using the proposed equation. The reduced ultimate strain of the corrod

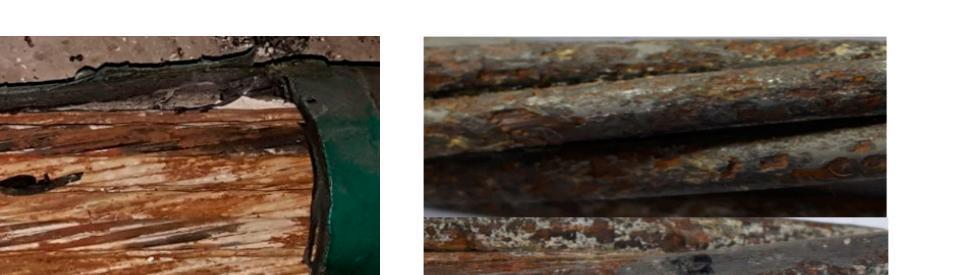
Figure 1. Observed corroded strands in existing bridges: (a) corroded tendon; (b) corroded strand.

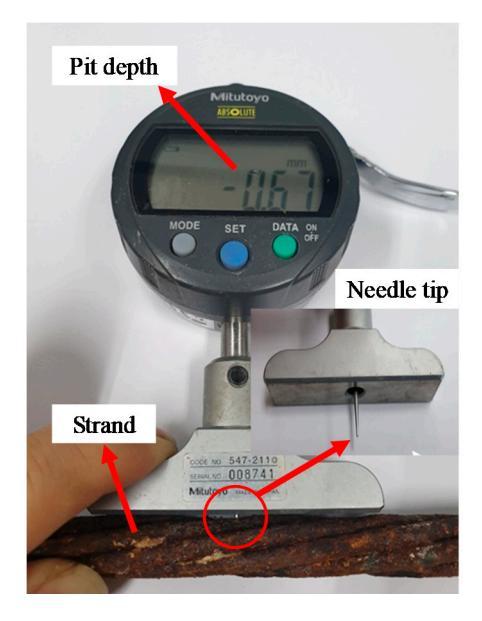
Figure 2. Measuring pit depth of corroded wire.

The corrosion on the strands along the length had very irregular pits, which made it difficult to determine the worst part of the corroded wire by visual inspection. To quantify the corrosion of the specimen, the ASTM G46-94 [8] corrosion measurement method was used, as introduced in a previous study [15]. This method uses a pit-depth gauge (Mitutoyo Corporation, Kanagawa, Japan) to measure the depth of the pit, as shown in Figure 2; however, this method is unable to evaluate the section loss. Therefore, as in the previous research, a section-loss evaluation method using the pit depth was suggested.

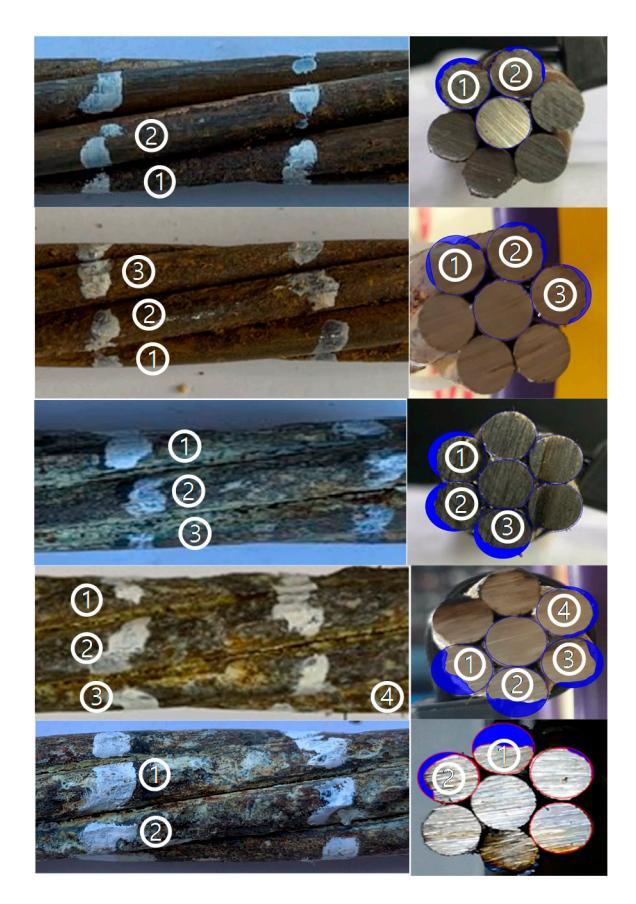
Figure 3 illustrates five cases of corroded strands located near the anchorage and their cut sections. The samples had different levels of corrosion, and the corrosion pits were easily observed when the corrosion is severe. The five samples were divided into corroded and non-corroded parts. Because a high number of strands exist in a tendon bundle, one portion is exposed to the air and another portion is in contact with neighboring strands. This results in the corrosion being concentrated on several strands. These samples were not the specimens used in the tensile test, because the cut section pictures could not be taken before the tensile test.

Figure 3. Corrosion of a strand near the anchor in Bridge B.

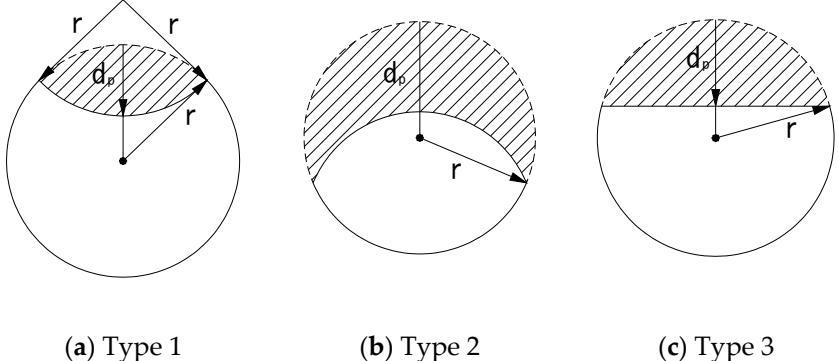
Figure 4 shows an idealized model for the evaluation of each wire's actual section loss pattern and the section loss suggested by previous research [15]. Equations (1)–(3) were used for the evaluation of the section loss for each pattern, using only the measured pit depth of the corroded strands. This approach does result in errors between the actual and measured corrosion values, but it is the most feasible method for an onsite inspector to evaluate the corrosion, and therefore it was used in this research. The remaining corrosion residue on the extracted specimen was removed by a corrosion removal solution. Next, along the strand's length, the depth of the corrosion was measured every 20 mm using a pit-depth gauge, as shown in Figure 5. Excluding the core wire, which could not be evaluated for section loss, the degree of corrosion of each strand was evaluated as the summation of each section loss of the remaining six wires, as given in Equations (1)–(3). The highlighted part in Figure 5 is the section that was determined to be the most corroded (the highest section loss) by comparing the summations of the section losses.

where $A_{sl,1-3}$ are the losses of sectional areas according to the type of pit configuration, *r* is the radius of the wire, and d_p is the pit depth (from 0 to 2*r*) measured by a depth gauge at the deepest location.

Figure 4. Three idealized pit configurations of corroded wires: (a) Type 1: hemispherical pit, (b) Type 2: concave pit, and (c) Type 3: planar pit.

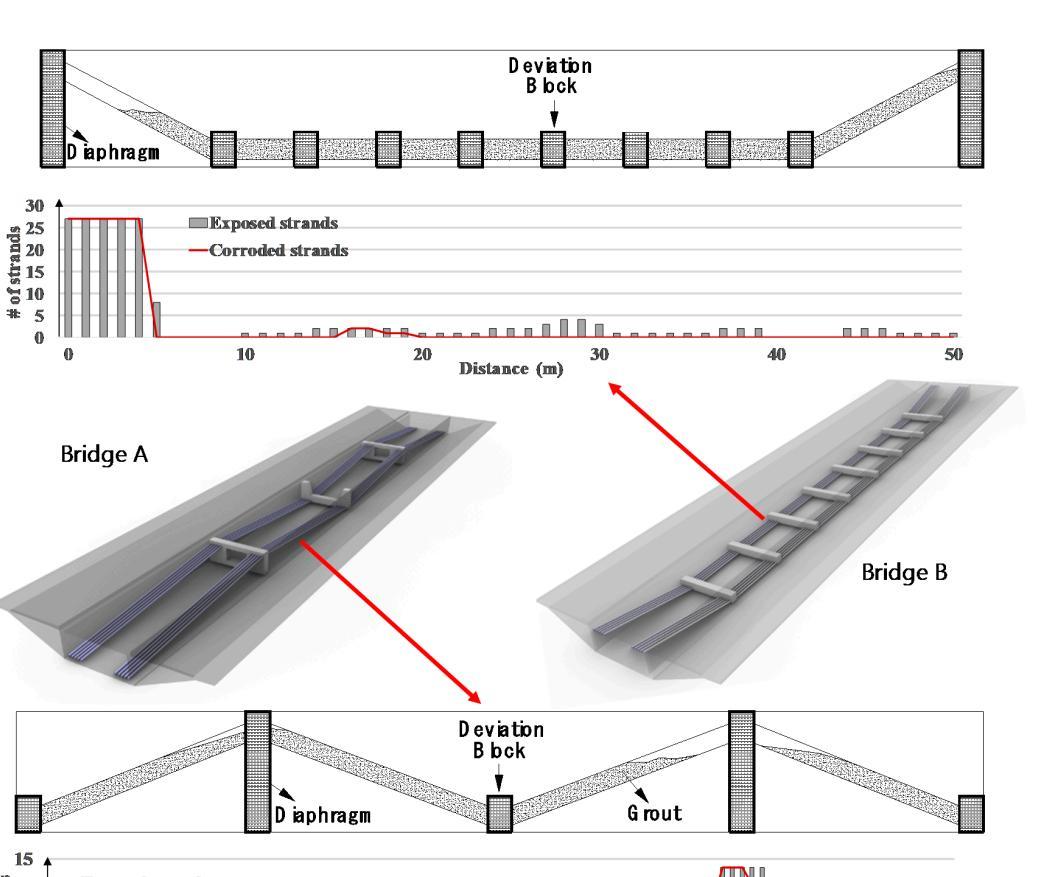
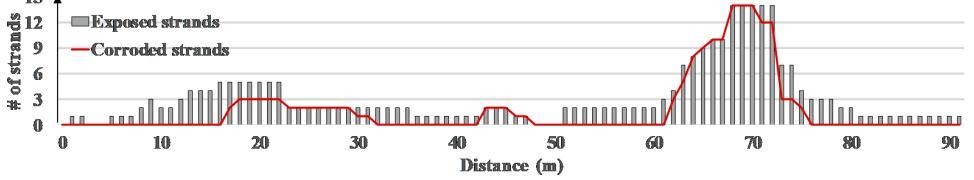
Figure 6 shows the profile of the voids in ducts of external tendons and the number of exposed and corroded strands counted by visual inspection for Bridges A and B. Most of the corroded strands were found in the voids, while strands in the grout in sound condition did not show any corrosion. This means that voids in ducts have a strong relationship with corrosion. The voids not filled by grout were mostly located in upper parts near air vents or anchored at high locations. A possible reason for this is that poor quality of grout causing bleeding water. It is known that bleeding water can occur due to a high w/c ratio and wicking effect. This creates voids after the bleeding water has evaporated. Another possible reason is improper grout injection process. At the time the bridges were built, there would have been no perception that air could be trapped inside due to poor regulation of grout injection. Therefore, the air vent for deflating the air was not properly positioned and was not used properly.

Figure 6. 3D model of tendon profile, state of grout, and corrosion of Bridges A and B.

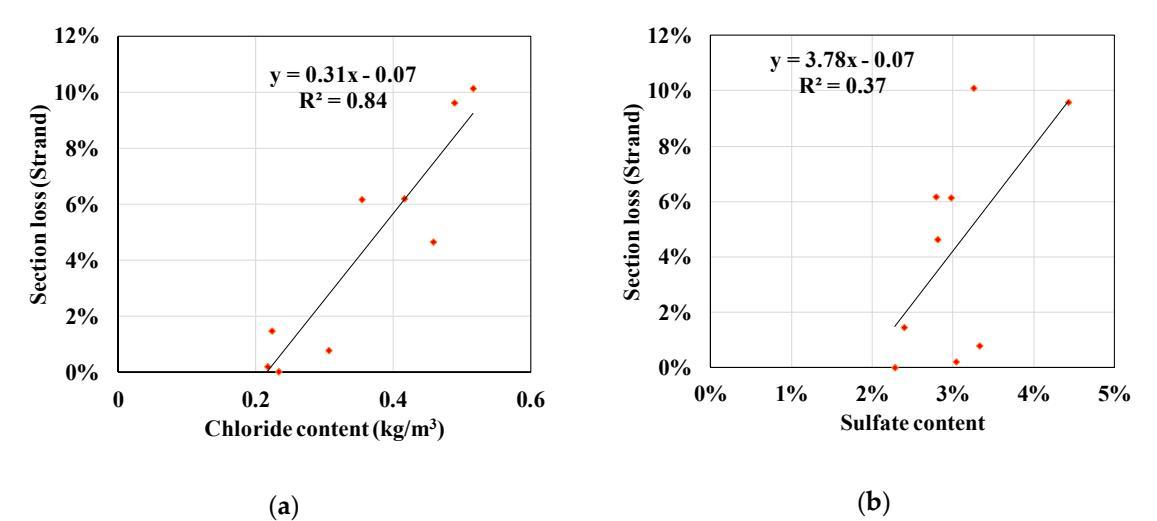
Grout samples from the corroded strands in Bridges A and B were analyzed for chemical content (chloride and sulfate), and the section loss due to the corrosion was measured using Equations (1)–(3)and Figure 5. Strands in areas with no grout were not considered. Figure 7a shows the relationship between the section loss and the chloride content percentage with respect to mass of concrete measured by KS F 2713 from Korean Industrial Standards (KS) [17], and Figure 7b shows the relationship between the section loss and the sulfate content measured by KS L 5120 [18]. This demonstrates that the higher the chloride content, the more severe the corrosion, while the sulfate content had a relatively smaller effect on these bridges.

Figure 7. Relationship between chemical state of grout and section loss of strands due to corrosion: (a) chloride content to section loss, (b) sulfate content to section loss.

In short, voids inside the ducts and chloride content of grouts are major factor influencing corrosion. Therefore, appropriate duct connections and proper grouting sufficient to rule out voids and protect the strands against chlorine ions would be an appropriate way to prevent corrosion.

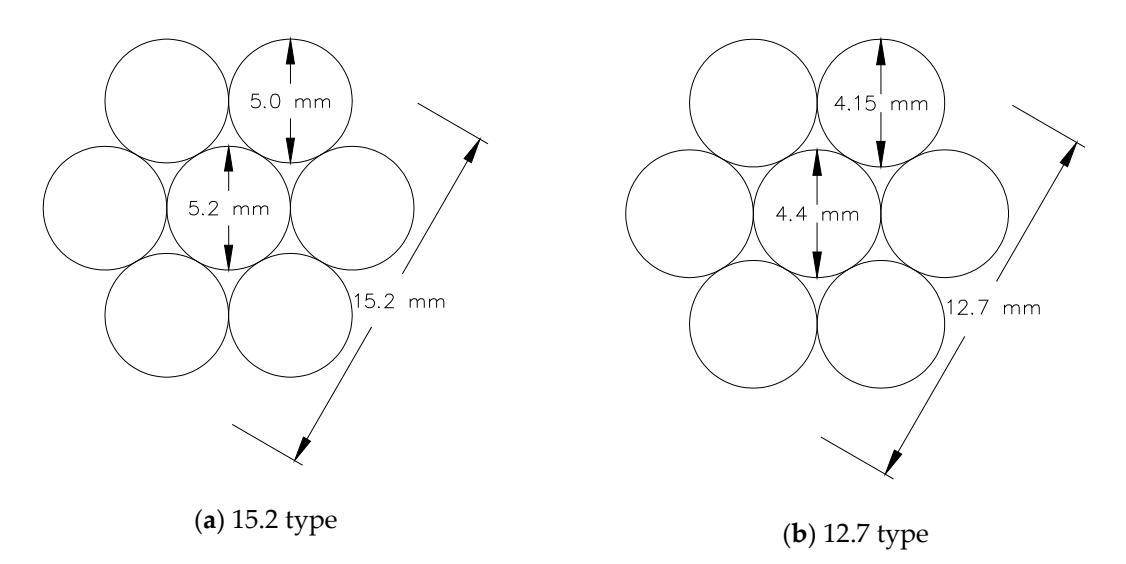
A total of 100 corroded strands taken from Bridges A and B were investigated for corrosion. Among the specimens, a total of 86 seven-wire strands (47 strands from Bridge A and 39 strands from Bridge B) were selected for this study after exclusion of specimens that were too corroded to be used in the tensile test. Figure 8 shows two section profiles of the seven-wire strands. The strands from Bridge A had a nominal diameter of 15.2 mm and a sectional area of 138.7 mm. The diameter of the core wire was 5.2 mm, and the diameter of the outer wires was 5.0 mm. The strands from Bridge B had a nominal diameter of 12.7 mm and a sectional area of 98.7 mm. The radius of the core wire was 4.4 mm, and the radius of the outer wires was 4.15 mm. In this study, these two strands are referred to as the 15.2 type and 12.7 type, respectively.

Figure 8. Section profiles of seven-wire strands.

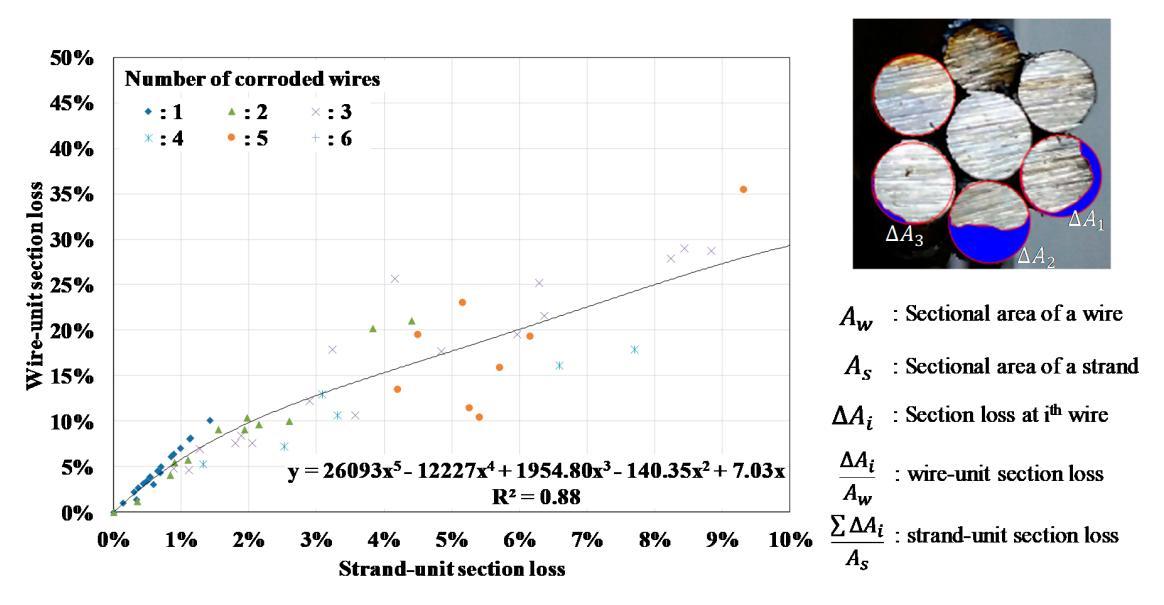
After inspection of the corroded strands, it was found that the wire-unit section losses were different between strands, even though their strand-unit section losses were very similar. Figure 9 shows the relationship between wire-unit section loss of the most corroded wire and strand-unit section loss, considering the number of corroded wires. The figure also shows an example of how the data was collected. If the number of corroded wires was three, for example, the strand consisted of three corroded wires and four non-corroded wires. The maximum number of corroded wires was six because the remaining wire (core wire) was impossible to inspect.

As Figure 9 shows, it was found that strands with a higher number of corroded wires tended to have higher strand-unit section losses as well as higher wire-unit section losses. A higher strand-unit section loss is a natural result, because the strand-unit section loss is the sum of the wire-unit section losses. However, the higher levels of corrosion in the wires have a special meaning. When all wires are exposed to corrosive environmental conditions, they will corrode simultaneously, but the ducts may

Figure 9. Relation between wire-unit section loss of the most corroded wire and strand-unit section loss, considering the number of corroded wires.

In addition, a higher number of corroded wires tends to produce more widely scattered data. This means that pitting corrosion can develop differently in the wires; therefore, the maximum wire-unit corrosion in a strand can be very different between corroded strands, even though they have the same level of strand-unit corrosion. If the strand fracture is defined as the moment of a single wire fracture [15], it is necessary to consider the cross-sectional loss in the wire after at least a 2% section loss in a strand.

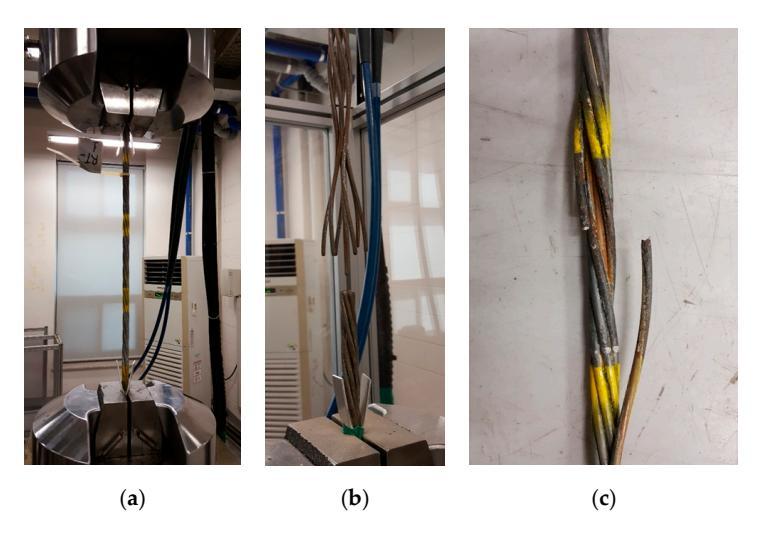
A tensile test was conducted as shown in Figure 10a. The specimens were loaded to failure using the displacement control method with a speed of 5 mm/min. The two ends of the strand were held by the grip. Among the strands extracted from Bridges A and B, three non-corroded strands were defined as reference specimens for the 15.2 and 12.7 types. Table 1 lists the mechanical properties of the non-corroded strands as averages of the test results from the three specimens. Where, f_{py} is 0.2% proof stress of non-corroded strands, ε_{py} is strain corresponding to the 0.2% proof stress, f_{pu} and ε_{pu} are ultimate strength and strain of non-corroded strands, respectively.

Strands with no or little corrosion showed failures of all the wires fracturing at the same moment, as shown in Figure 10b. For the corroded strands, shown in Figure 10c), the most corroded wire fractured earlier than the other wires. Owing to the fracture of the wire, the strand's strength suddenly decreased; however, the remaining wires maintained their structural capacity until the next wire was fractured, as shown in Figure 11a. Furthermore, the amount of load reduction between the moments of the first and second fractures was $\frac{1}{7}f_{pu}$, where f_{pu} is ultimate strength of a corroded strand. This means that the load was evenly carried by the seven wires, and the most corroded wire fractured earlier than the others. In this study, therefore, the failure event of the strand was defined as the moment at which even one wire was broken, and the corresponding strength and strain were used to define the ultimate strength and strain.

Figure 10. (a) Test setup, (b) failure of non-corroded strand, and (c) failure of corroded strand.

In this study, the residual mechanical properties due to corrosion were defined as the relation between the section loss and yield (or ultimate) strength. The section loss is explained in terms of the strand-unit and wire-unit section losses. The reason the wire-unit section loss was considered is because of the assumption that the corrosion of a strand can be localized in a few of the seven wires. A premature wire fracture due to corrosion would be the determining factor in the performance of the corresponding strand. This was validated by the decrease in strength owing to wire-unit fracture shown in the experiment (Figure 10).

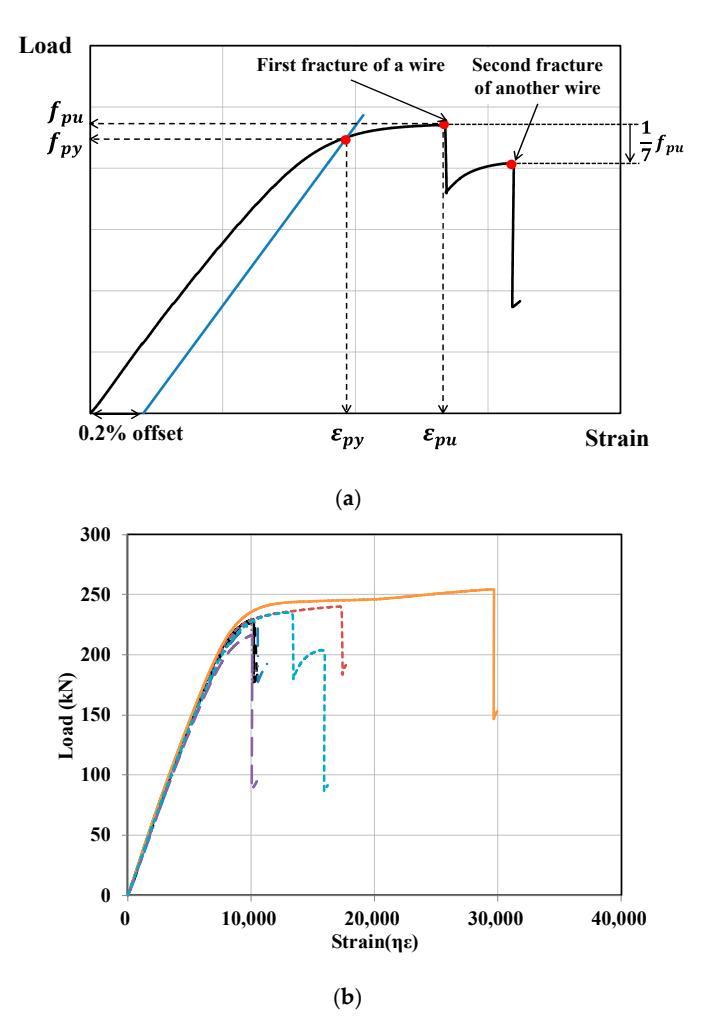
Figure 11. (a) Load–strain curve of a corroded strand and (b) samples from specimens.

Figure 11b shows samples of the test results from the test specimens. The elongation and maximum load due to the fracture showed significant differences among the specimens; however, the yield performances were similar. This is because even if one wire yields first due to a cross-sectional loss, the remaining wires carry the load until they yield.

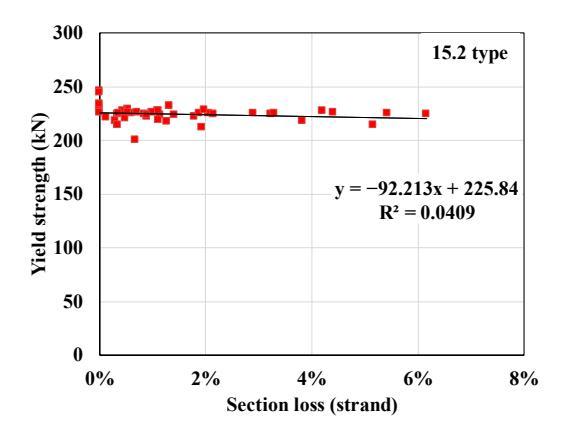
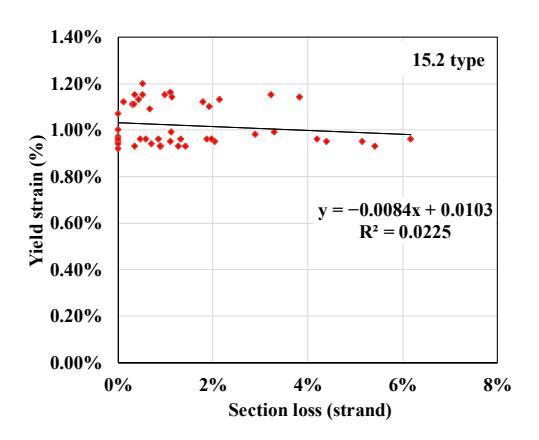
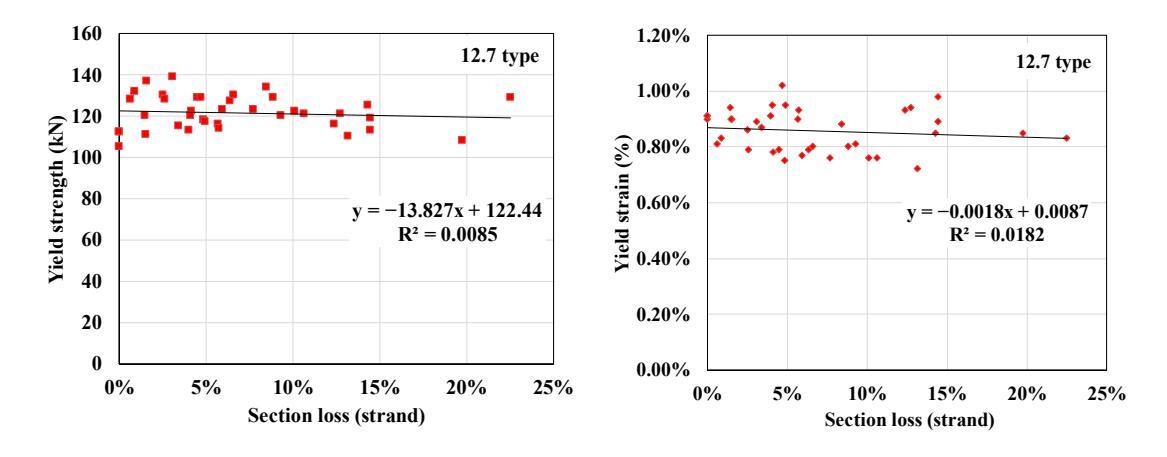
Figure 12a,b shows the relation of a 15.2 type strand's section loss with its yield strength and yield strain, respectively. Figure 12c,d shows the relation of a 12.7 type strand's section loss with its yield strength and yield strain, respectively. The coefficient of determination, R², had a maximum value of 0.0409, which indicated that the regression analysis was ineffective and the correlation of two factors was very low. This means that with the section loss of 22.52% (the most corroded specimen), the yield strength and strain showed no significant gap even under the increase in section loss, as explained in Figure 10b. However, Figure 12b, which includes numerous highly corroded strands, indicates that the yield strength was likely to decrease if the number of corroded wires and corrosion level are high. Figure 13 shows the corroded strands' yield strength and strain according to the section loss of the most corroded wire within each strand. As shown in Figure 12, the yield properties and level of corrosion from the most corroded wire also showed no significant correlation.

(**a**) Yield strength—Section loss relation (based on the strand)

(**b**) Yield strain—Section loss relation (based on the strand)

(c) Yield strength–section loss relationship (based on the strand).

(d) Yield strain–section loss relationship (based on the strand).

Figure 12. Yield properties of corroded strands, evaluated via section loss of strands.

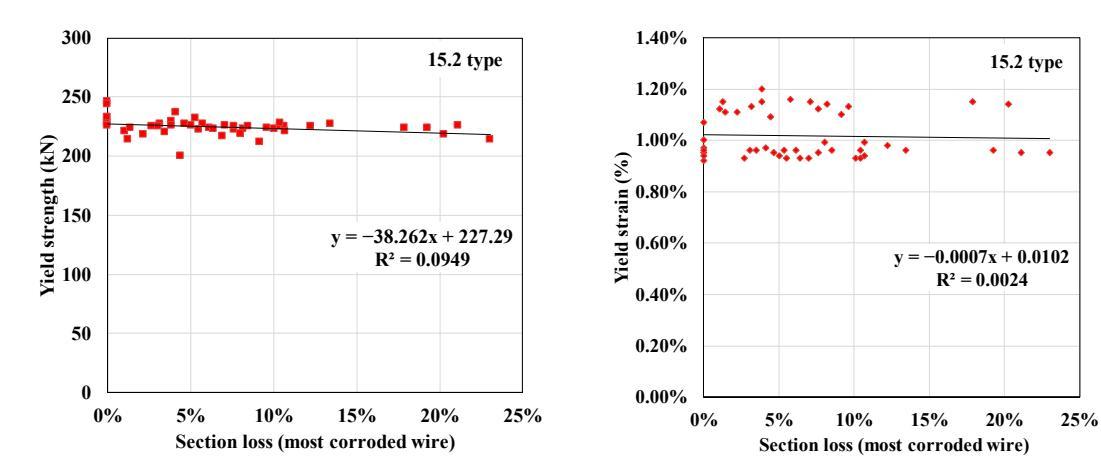
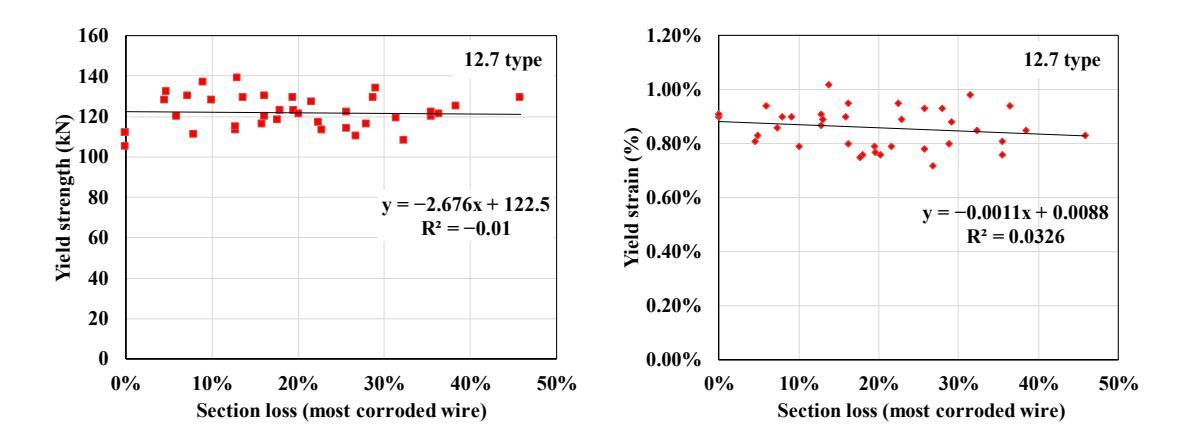
(a) Yield strength-section loss relation (based on the most corroded wire).

(**b**) Yield strain-section loss relation (based on the most corroded wire).

(c) Yield strength-section loss relationship (based on the most corroded wire).

(d) Yield strain-section loss relationship (based on the most corroded wire).

Figure 13. Yield properties of corroded strands, evaluated via the section loss of the most corroded wire in each strand.

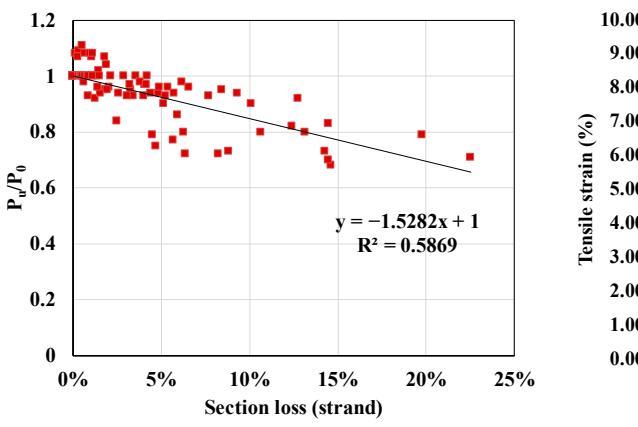
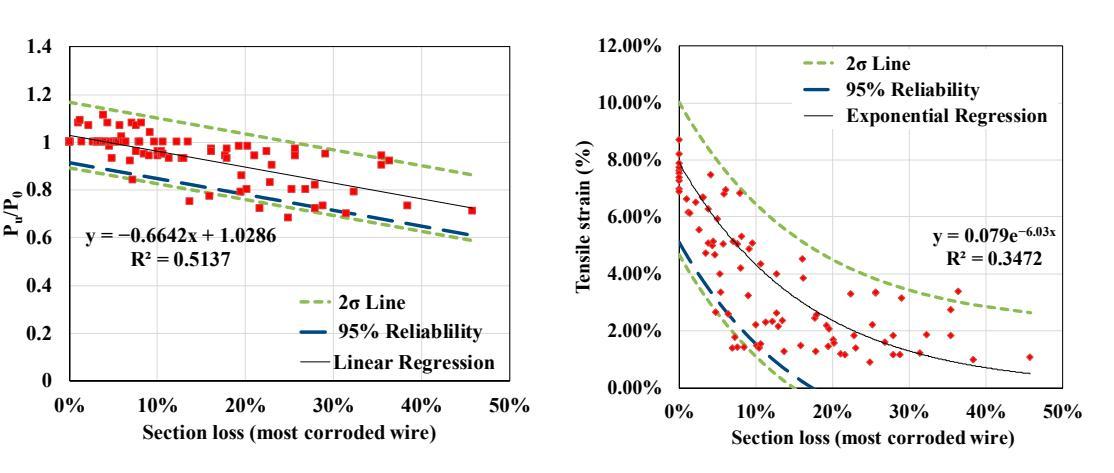
Figure 14a,b shows the relations between the strand-unit section loss and the ultimate strength and strain. As the graph indicates, unlike for the yield strength, the two factors seemed to be correlated. Furthermore, the decrease in ultimate strain could be a more serious problem than the decrease in strength. For example, for a 5% section loss, a 20% maximum strength loss can occur; however, in the case of ultimate strain, for a 5% section loss, an 85% maximum decrease in deformation capacity can occur.

(a) Ultimate load-section loss relation (based on strand).

(**b**) Ultimate strain–section loss relation (based on strand).

(c) Ultimate load-section loss relation (based on most corroded wire).

(**d**) Ultimate strain–section loss relation (based on most corroded wire).

Figure 14. Ultimate properties of corroded strands.

Regarding the test results, the strength of the non-corroded strands ($P_u/P_0 = 1$) and ultimate strain (7.89%, average of the ultimate strain of the two types listed in Table 1) were set as the axis and intercept, and a regression analysis was conducted. The ultimate strain showed a high deviation, implying a low credibility of the index regression analysis result ($R^2 = -0.015$). Furthermore, there were specimens that showed similar strengths and ultimate strains despite having highly varying degrees of corrosion. Such deviations in the test result distribution may have been due to highly localized corrosion pits.

According to lower limit curve of 95% reliability, the ultimate strength proportionally decreased in relation to the maximum corroded wire section loss. The ultimate strength values decreased by 20% and 38% when the section losses were 20% and 40%, respectively. Furthermore, the ultimate strain of the corroded strand at the lower limit curve of 95% reliability could not meet the requirement of the minimum tensile strain (3.5%) from KS D 7002 [21] if the section loss exceeded approximately 4%. The ultimate strain was evaluated as 0 when the section loss was approximately 17%.

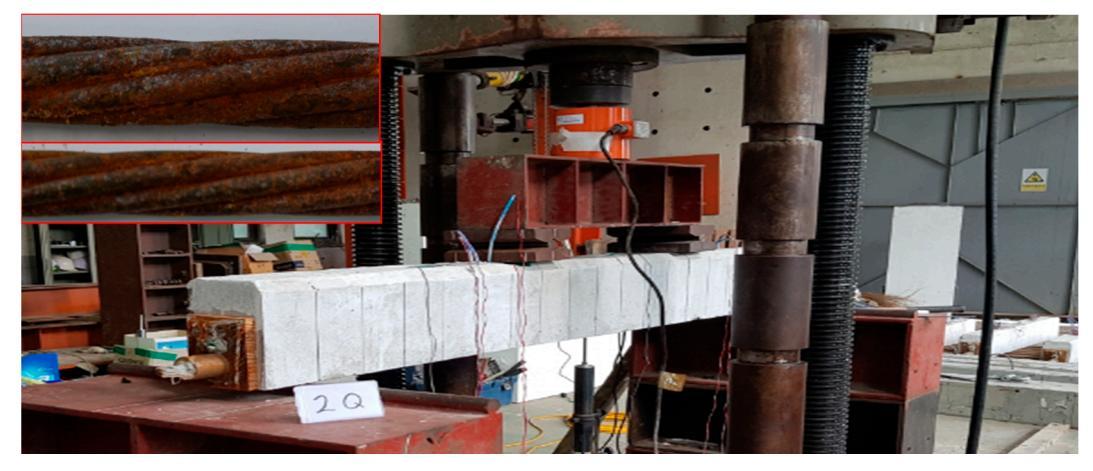
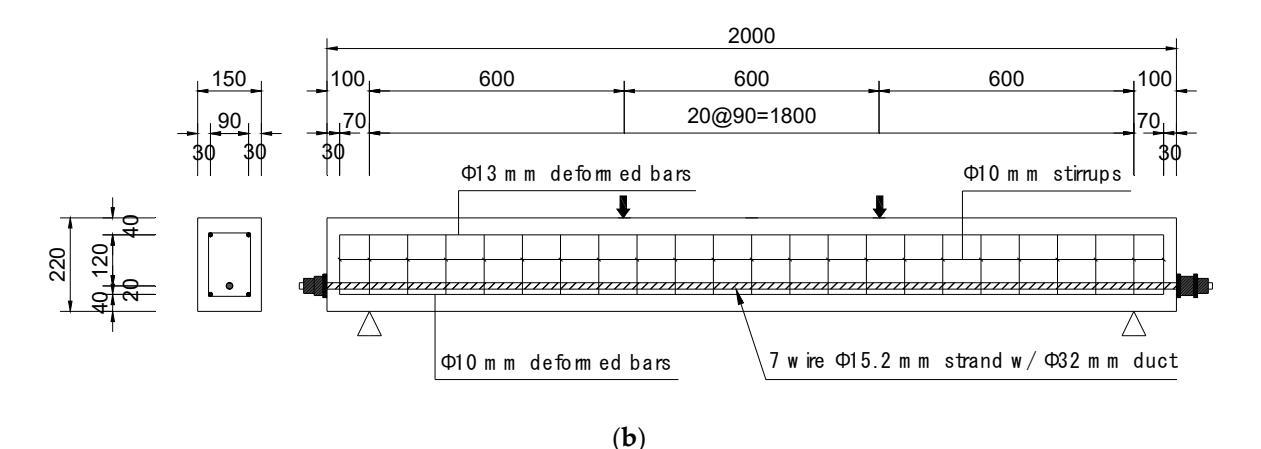
To observe the behavior of the corroded strands in a prestressed concrete member, four simply supported beam specimens were manufactured and tested. The dimensions and details of the specimens are presented in Figure 15. The post tensioned beams had a section of $150 \times 220 \times 2000$ mm with a single seven-wire Φ 15.2 mm strand.

Figure 15. (a) Test setup and (b) detail drawing.

Flexural tests were performed using the displacement control method under a four point bending condition. The span length of the specimen was 1800 mm, and the loading position was 600 mm from a support. Loading was added until the compressed concrete reached a compressive strain of 0.003, even if the strand fractured earlier due to corrosion.

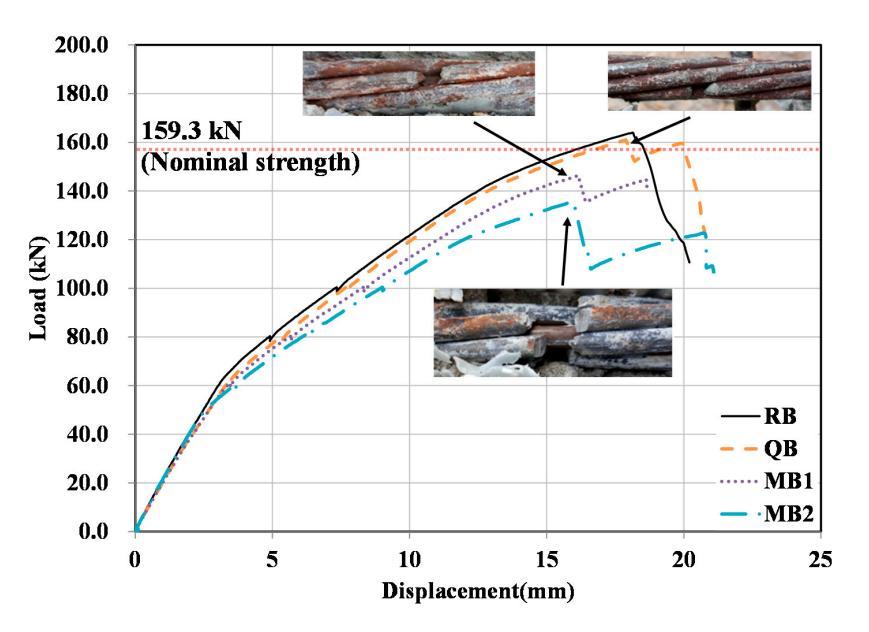
Figure 16 shows the load–displacement curves of the specimens and an image of the wire fractures after the tests were conducted. Table 3 summarizes the strength, displacement, and failure modes of the specimens. Considering the material properties in Table 2, the non-corroded RB's nominal strength was 159.3 kN. The strength and displacement in the experiment were 163.9 kN and 18.40 mm, respectively. After the yielding of the strand and rebar, the compressed concrete reached a crushing failure mode. After the QB member experienced one wire fracture, it then reached a crushing failure. The strength and displacement at the moment of fracture were 161.0 kN and 17.89 mm, respectively. The corrosion reduced the strength and flexural capacity by 1.77% and 2.77% compared to the RB member. This means that the corroded strand had a limited influence on the strength of the member due to sufficient bond between the strand and surrounding grout.

Figure 16. Load-displacement curves of PSC beam specimens.

MB1 and MB2, which had corrosion in the center of the span length, showed strength decreases of 10.68% and 17.27% and decreases in the displacement capacity of 12.28% and 13.15%, respectively. Both specimens experienced a compression failure after two wire fractures. Additionally, four wires failed in MB2, which means that several wires can fail at one time. The corrosion in the strands at the location of the maximum moment significantly influences the ultimate behavior of a PSC beam.

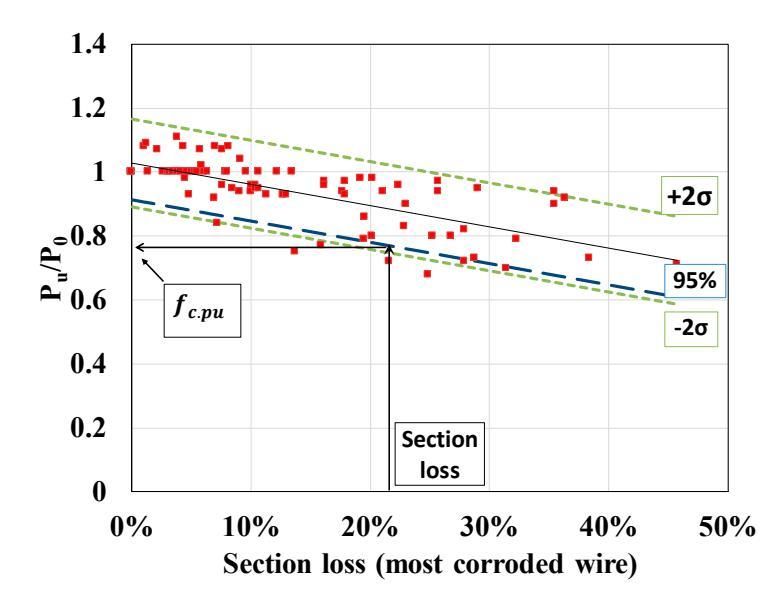
To calculate the flexural strength of a PSC beam, the approximate value of f_{ps} , which refers to the stress of the strand at the moment of the beam's failure, can be obtained from the design codes, or the strain compatibility method can be utilized to derive the value. According to ACI 318-14 [24], Equation (7) is the approximate expression for f_{ps} . $f_{c,ps}$ and $\rho_{c,p}$ refer to the ultimate strength of the corroded strand and steel ratio, respectively. The section loss by corrosion can be calculated from Equations (1)–(3), and the decreased ultimate strength can be calculated using Equations (4) and (5), along with the result of tensile tests given in Figure 17.

Figure 17. Determination of $f_{c,ps}$ from 95% lower reliability limit of ultimate strength.

$f_{c.ps}$ from Equation (7) for each specimen and the corresponding flexural strength are listed in Table 4. The RB, MB1, and MB2 specimens showed reasonable estimations of the strength, while QB showed a value different from the test value. The reason is that the cross-section of corrosion was at 1/4 of the span length, such that a lesser flexural moment was carried than that occurring at the center. Therefore, the governing cross-section for the nominal flexural strength became the center (154.47 kN) rather than 1/4 (211.73 kN), even though the reduced $f_{c.ps}$ is considered. The failure mode, however, showed a wire fracture at the 1/4 of the span length. This means that the reduced ultimate strain of the corroded strand could be the governing factor of the flexural strength. To consider this, the strain compatibility method should be used.
