# Analysis of Collapse Mechanism and Treatment Evaluation of a Deeply Buried Hard Rock Tunnel

Abstract: Collapse is one of the most dangerous geological disasters in tunnel construction, and it is an urgent engineering problem which needs to be solved. Taking the collapse of the top of an actual tunnel face as an example, through field investigation and theoretical calculation methods, the mechanism of tunnel collapse was studied, and the treatment and evaluation of the collapse area were proposed based on field monitoring data. The results show that the extrusion and bulging deformation on the palm surface and the tensile fracture in the top inclined stratum led to the shear slip of the block along the structural surface and the local collapse of the surrounding rock. Based on the block theory, the potential unstable block at the top of the tunnel was successfully identified, and the treatment method of 'protecting before filling and then digging' was proposed. The comprehensive treatment measures of advance bolts, steel arch support, collapse backfill, and step excavation were adopted, with on-site monitoring followed up step by step. Based on the analysis of surrounding rock de

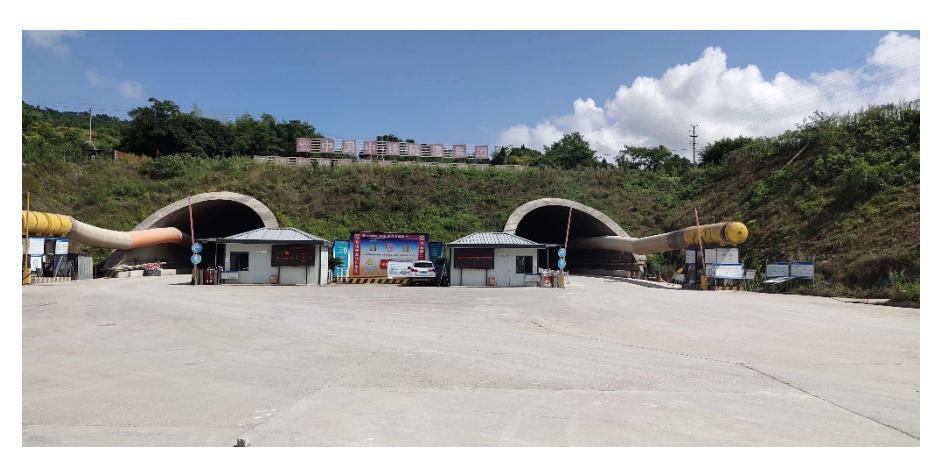
Figure 1. Panoramic view of tunnel exit.

Chenjiashan tunnel is located in Xinchang County, Zhejiang Province, with a total length of 5947 m and a maximum buried depth about 250 m. It is a two-way, four lane expressway tunnel with separate upper and lower sections. The tunnel site is in an eroded and denuded low mountain and hilly area, with undulating mountains and narrow valleys. The route is basically laid along the river and gullies. The tunnel lithology changes greatly and is greatly influenced by the structure. The rock alteration is strong, joints and fissures has been developed, the groundwater is abundant, the hydrogeological conditions are complex, and the integrity is poor. A panorama photograph of the tunnel exit section is shown in Figure 1.

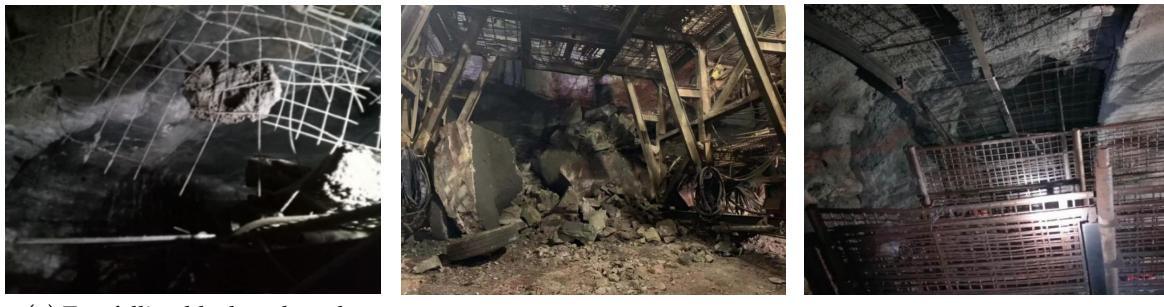
#### Figure 2. Photos of tunnel collapse.

On the morning of 7 May 2018, the left tunnel face was excavated to ZK93 + 467. The surrounding rock fell off at the top of ZK93 + 470 near the face, causing great damage to the steel mesh and the working platform. The on-site staff and construction machinery were immediately evacuated. Soon afterwards, there was a sound of falling rocks, and a small-scale local collapse accident occurred on the vault and left side of the face, causing serious damage to the left side of the working trolley. The longitudinal length of the collapse area was about 2–3 m, the circumferential span was about 3 m, and the collapse height was about 1.5–2 m. The collapse photos of the tunnel site are shown in Figure 2.

(a) Top falling block and mesh peeling

(b) Working trolley damage

(c) Top collapse and voids

According to field conditions and a geological survey of the collapse area: (1) the collapsed rock mass was in a fragmentary structure, hard, unbreakable, with clear knocking sound, rough texture,

and large amount of gray tuffaceous sandstone; (2) the exposed rock mass was in a gravel structure, with a partial fragmentary structure, an inclined structural fracture zone with a fragmentary mosaic structure developed in the middle and left, and extending to the left vault; (3) the structural surface of the collapse rock stratum was wet and smooth, with argillaceous sand body and local argillation; (4) the original design of the construction section was set as Class III surrounding rock, which adopted full section blasting construction, the initial support adopted hanging net and initial shotcreting; and (5) the lithology of the surrounding rock revealed in the geological exploration report was moderately weathered breccia bearing tuffaceous sandstone, tuffaceous sandstone and tuff, with good rock integrity and an integrity coefficient of 0.47–0.81; the comprehensive value was 0.64, the rock was relatively hard, and the uniaxial saturated compressive strength of the rock was between 34.8–63.2 MPa.

According to the comprehensive analysis, the collapse was considered to be a local block collapse of the unstable surrounding rock at the top of the tunnel.

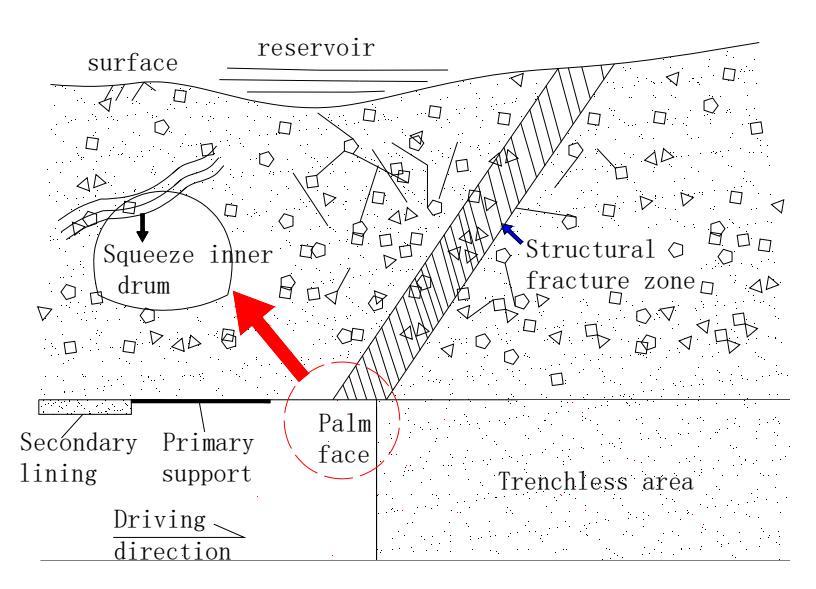
Figure 3. General model of tunnel surrounding rock instability.

Based on the comprehensive analysis, the main factors causing the collapse of the tunnel were as follows: geological structure, groundwater influence, construction method, support measures and timing, survey and design problems. A generalized model of surrounding rock instability has been established (see Figure 3). It has revealed that the main cause of small-scale collapses is the combined action of the face extrusion and bulging deformation and the tension fracture of the inclined structure at the top stratum. In the process of balance arch formation at the arch roof, the support strength is not enough, and the stress release causes compression failure and collapse of the crushed block. The collapse can be classified as a local small-scale instability of the surrounding rock caused by the massive rock mass compression and shear failure along the structural plane.

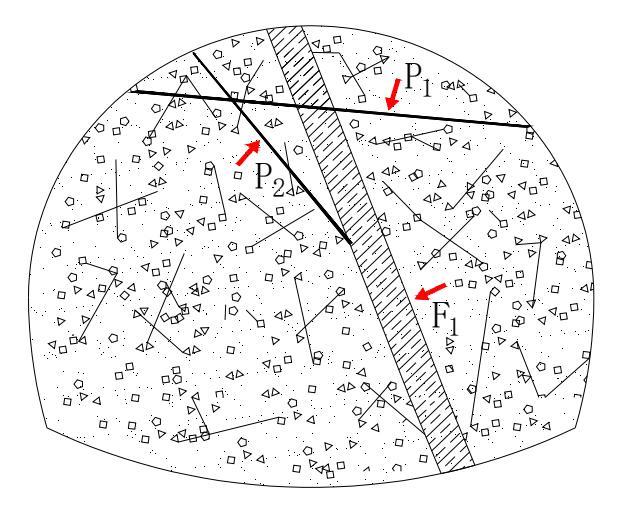
In a tunnel collapse, the collapse of the vault is mainly affected by the structure, and the unstable block is compressed and sheared along the structural plane. Therefore, based on block theory, this paper identifies the key blocks of the tunnel vault, analyzes their mobility, and reveals the collapse mechanism. On-site geological exploration revealed that the tunnel direction in the landslide area was SW5°–10°, intersecting with the tunnel axis at a small angle. There was a gentle fault F1 in the middle part of the tunnel face, and two groups of intersecting structural planes, namely  $P_1$  and  $P_2$ , were exposed at the vault and left arch waist. The structural planes  $P_1$  and  $P_2$  cut each other, which was likely to cause wedge sliding failure. The structural plane of the tunnel excavation face is shown in Figure 4. The characteristics of the structural planes area shown in Table 1.

Figure 4. Structural plane diagram of tunnel face.

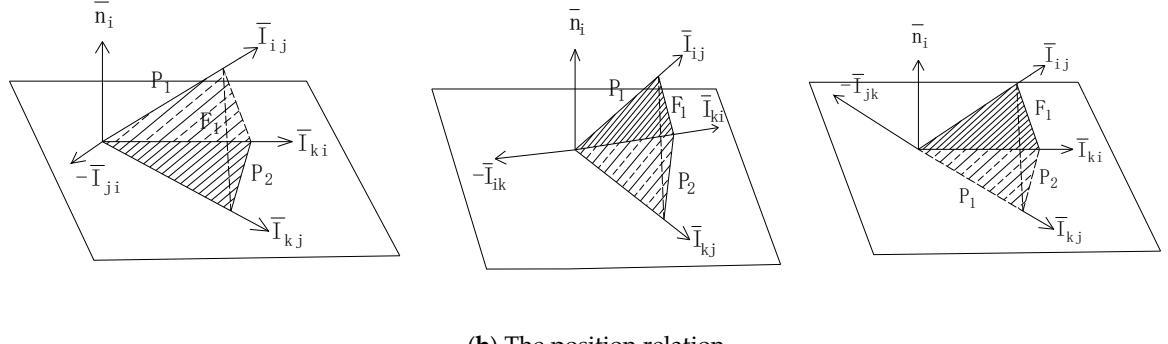
Figure 5. Geometric meaning of direction parameter.

where the angle between  $\vec{I_{12}}$  and  $\vec{n_3}$  is acute,  $\vec{I_{12}}$  is in the upper half space of structural plane  $P_2$ , is shown in Figure 5a. Homology is,

where the angle between  $\vec{I_{13}}$  and  $\vec{n_2}$  is obtuse,  $\vec{I_{13}}$  is in the lower half space of structural plane  $P_1$ , is shown in Figure 5b.

where the angle between  $\vec{I_{23}}$  and  $\vec{n_1}$  is acute,  $\vec{I_{23}}$  is in the upper half space of structural plane  $F_1$ , is shown in Figure 5c.

(a) The position relation between direction vector and  $P_2$ (b) The position relation between direction vector and  $P_1$ (c) The position relation between direction vector and  $P_1$

$\vec{n_1}$ ,  $\vec{n_2}$  and  $\vec{n_3}$  are the unit normal vectors of  $F_1$ ,  $P_1$  and  $P_2$  which are the three structural surfaces as shown in Figure 5 According to the right-hand spiral rule the edge vectors are:

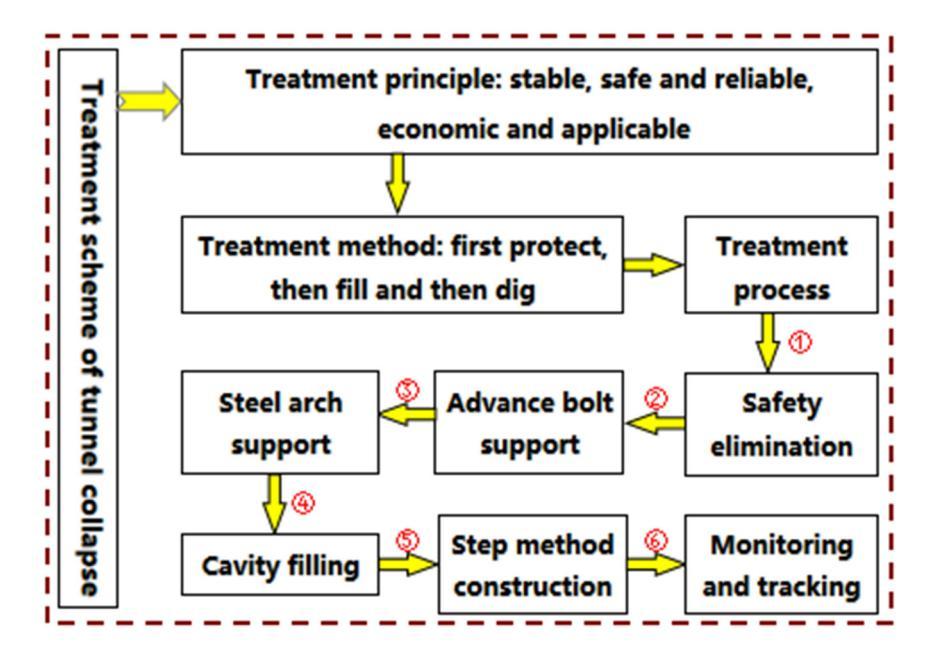
According to the collapse mechanism and characteristics, the treatment method of "first protect, then fill and then dig" is adopted, following the principle of "stable, safe and reliable, economical and applicable". The specific treatment process is shown in Figure 6.

Figure 6. Flow chart of tunnel collapse treatment.

After the tunnel collapsed, all construction was halted, and concrete was sprayed to cover the collapse surface. Dangerous rocks were removed in a timely manner to prevent secondary collapse.

According to the scale and characteristics of the collapse, a  $\Phi$ 25 hollow grouting anchor bolt was installed immediately for advance support after the formation of a safe working face. The length of the anchor bolt was 3 m, and the spacing between the anchor bolts was 1.0 m. According to the plum staggered layout, more bolts were installed around the collapse chamber.

The initial support was strengthened, and the original surrounding rock support design of grade III was changed to that of grade IV (see Table 3). No.16 I-shaped steel was adopted, with a spacing of 0.8 m. Upon completion of the erection of the arch frame, longitudinal connecting steel bars and anchor bolts shall be installed immediately to fix the arch frame.

The surface of the collapsed body shall be closed by hanging steel mesh and shotcrete, and I16 steel arch frame shall be installed after curing. Steel plate bolts shall be used for circumferential connection and  $\Phi 25$  steel bars shall be used for longitudinal connection. After the installation, the system anchor bolt and locking anchor bolt shall be drilled immediately and fixed with the steel arch frame.  $\Phi 25$  hollow grouting anchor bolt was drilled obliquely around the collapse position to reinforce the loose collapse body in the tunnel section. When the strength of the collapsed body meets the requirements, concrete backfill shall be carried out to ensure that the arch back and surrounding rock would be bond together.

According to the excavation principle of "weak blasting, short footage, early support", blasting was strictly controlled, with each cycle footage about 1–2 m after excavation, concrete was sprayed to seal the surrounding rock in time to ensure the timely follow-up of support measures. The basic process was: blasting and excavation of upper stage $\rightarrow$ mechanical hazard check $\rightarrow$ installation of steel mesh $\rightarrow$ erection of steel arch frame $\rightarrow$ installation of system anchor bolt and locking anchor bolt $\rightarrow$ spraying concrete to complete the construction of upper stage. When the upper step is 5–10 m ahead of the lower step, the left and right sides of the lower step should be excavated alternately. Each excavation should be controlled at the spacing between 2–3 steel arches. Meanwhile, the foot locking anchor shall be strengthened to ensure the arch at the foot is stable.

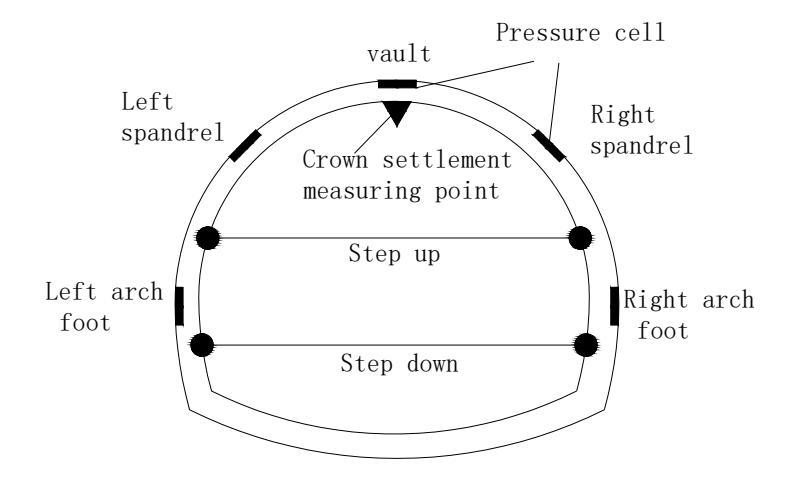
In order to evaluate the stability of the treatment effect of the collapse area, ZK93 + 465 monitoring section was set up on site to monitor the settlement of the vault, the surrounding convergence and the surrounding rock pressure. Among them, the tunnel was constructed by step method, one measuring point is arranged for vault settlement, and two measuring lines for upper and lower steps are arranged for horizontal convergence around the tunnel. By sticking reflectors on the measuring points, ZT30 total station was used for deformation measurement, with the measurement accuracy of 2 mm and 2 ppm. The surrounding rock pressure measuring points are arranged at the arch crown, the arch waist and the arch foot. In the construction process, the BK-1206S vibrating string double-mode pressure box is fixed on the contact surface of the steel arch frame with the force face upward. The maximum measuring range is 0.6 MPa and the measuring error is 0.001 MPa. The data is read by the intelligent pressure acquisition instrument. The layout of the measuring points is shown in Figure 7, and the monitoring results are shown in Figures 8–10.

Figure 7. Layout of measuring points of monitoring section.

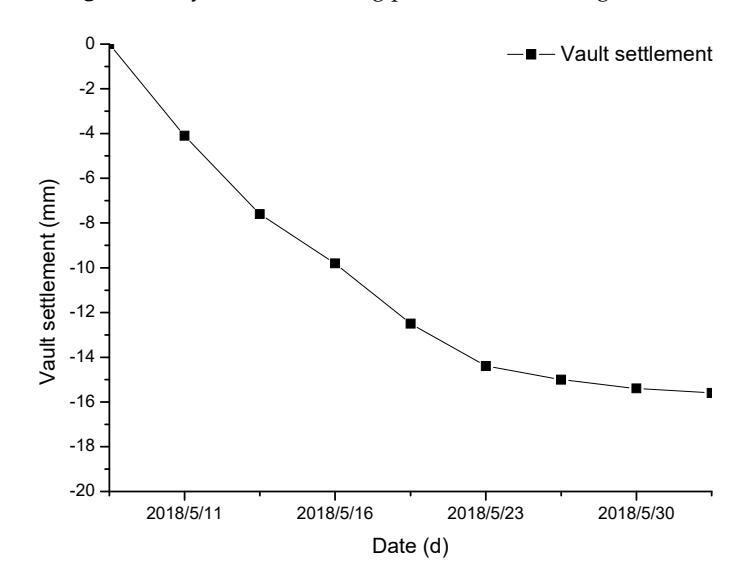
Figure 8. Settlement time history curve of arch crown.

It can be seen that with the completion of treatment measures, the deformation of surrounding rock in the early stage increased rapidly; after about two weeks it began to grow slowly until it was basically stable. During the one-month period, the accumulated deformation of vault settlement and peripheral convergence were within 20 mm, and there was no obvious abnormal mutation or continuous growth trend, which is within the allowable deformation range. It shows that the measures to deal with the collapse of the tunnel are effective and the overall treatment effect is good, which ensures the safe and smooth construction.

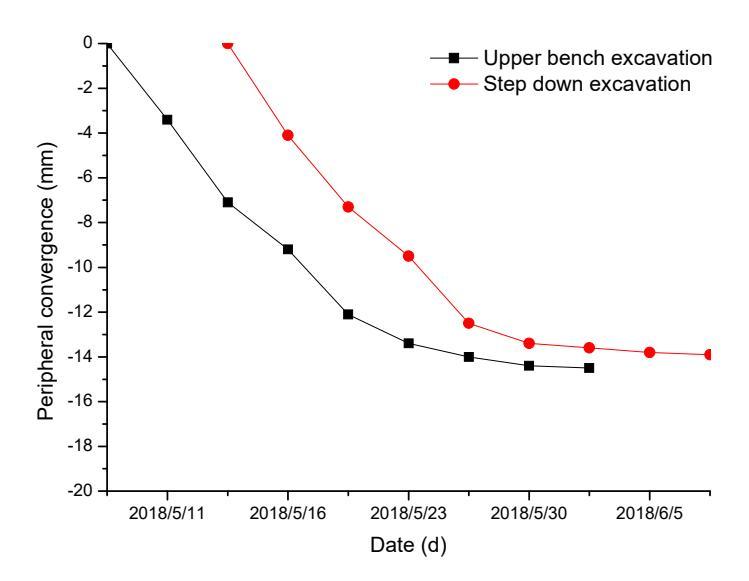
Figure 9. Time history curve of peripheral convergence.

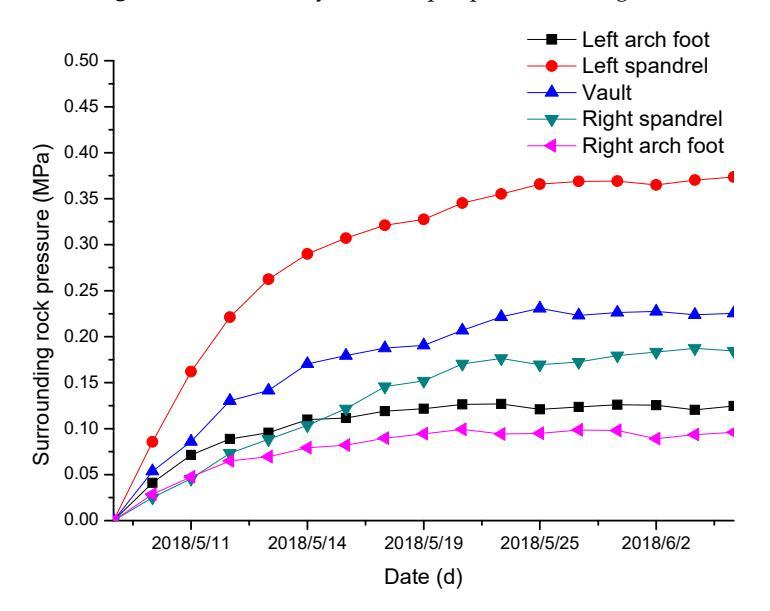
Figure 10. Time history curve of surrounding rock pressure.

It can be seen that the pressure of surrounding rock developed rapidly in the early stage and reached the peak value in about one week. In the later stage, the change was small and gradually stabilized. Among them, the rock pressure of vault and left arch waist changed obviously, with the maximum value of 0.226 MPa and 0.374 MPa This indicates that after the collapse treatment, the supporting effect of the arch crown and left arch waist has been greatly strengthened during the process of stress

release. It is believed that the surrounding rock in this part was relatively broken and with poor stability, which is basically consistent with the actual exposure. Under the action of support resistance, the stability value of surrounding rock pressure at each measuring point is in the controllable range, which indicates that the overall treatment effect of the collapse section is good.
