Ambient Vibration as a Basis for Determining the Structural Behaviour of Watchtowers against Horizontal Loads in Southeast Spain

Featured Application: A methodology is presented based on in situ ambient vibration tests to estimate the fundamental frequency, as well as the global Young's modulus, of different types of watchtowers (13th–18th century) built with masonry, while a number of examples constructed with rammed earth are also analysed.

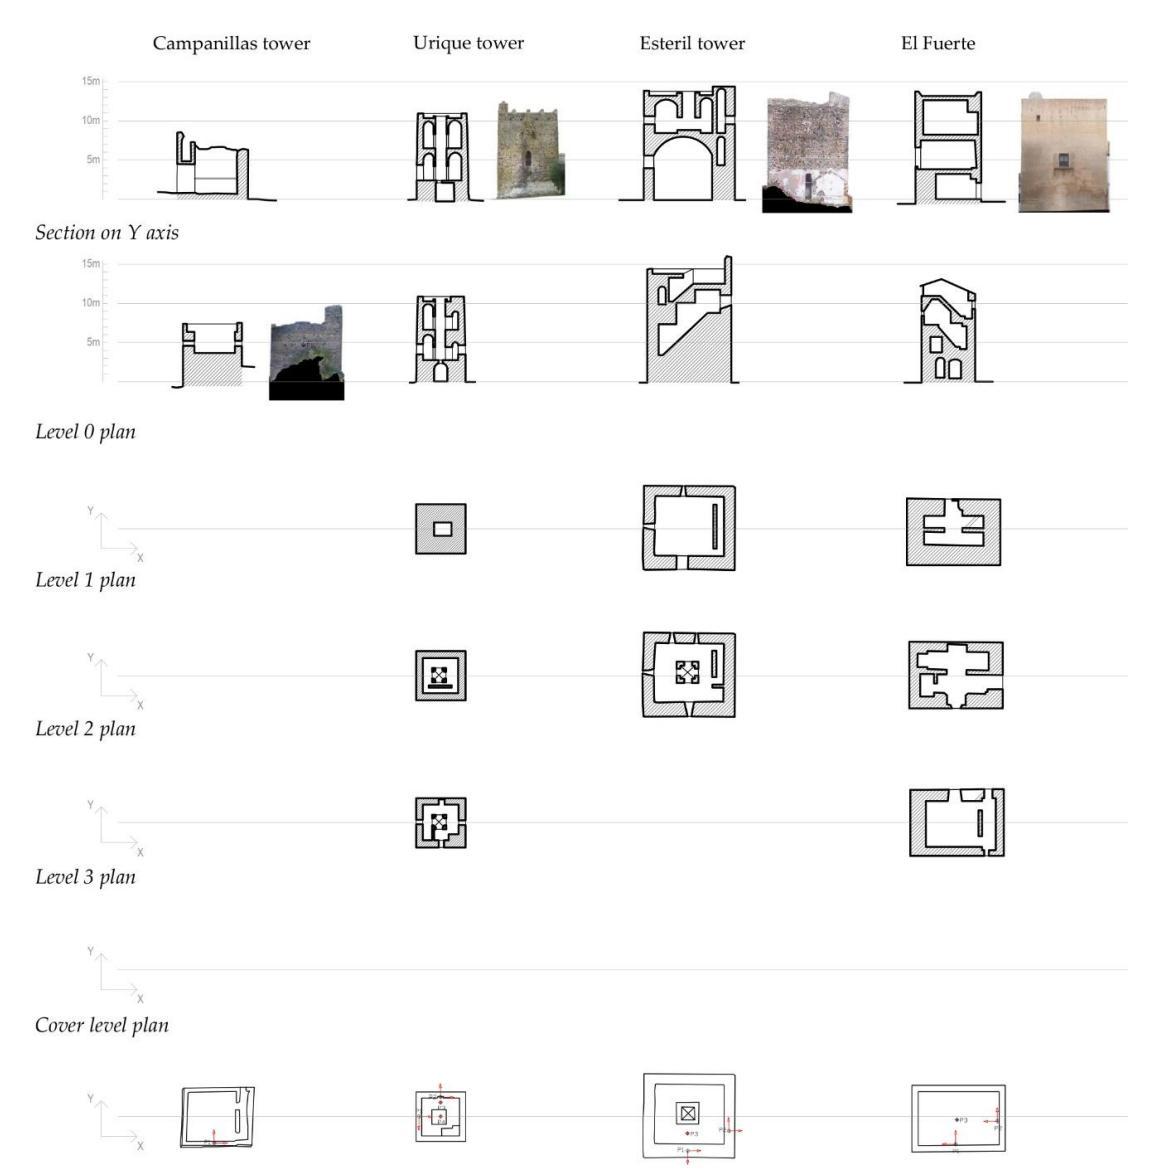
Figure 1. Description of elevations and plans of the towers in this study.

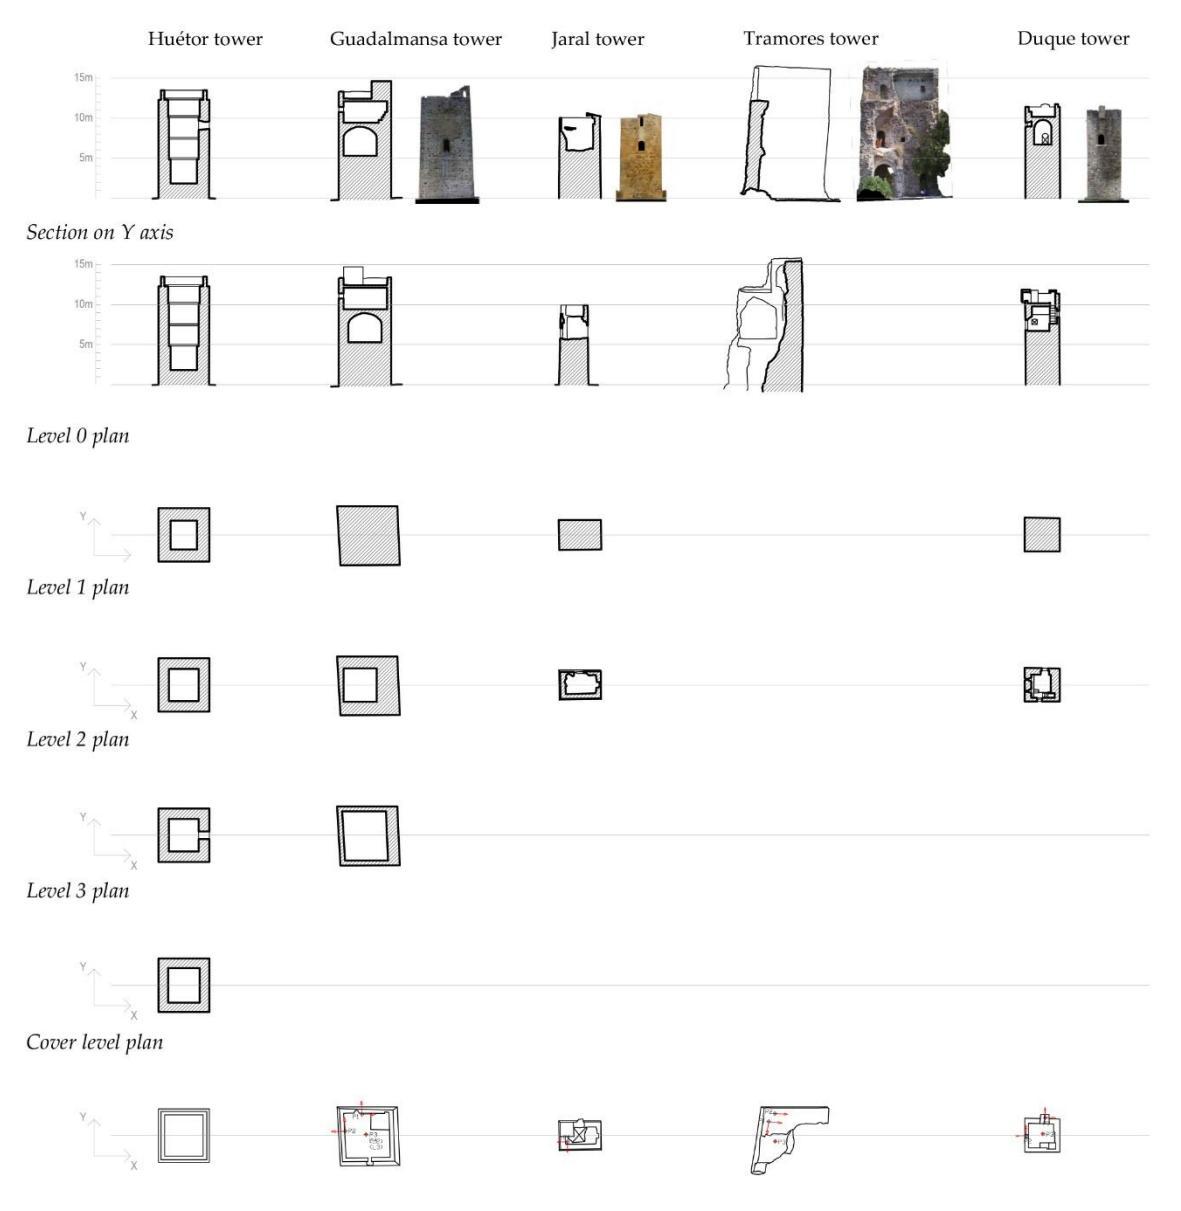
Figure 2. Description of elevations and plans of towers in this study.

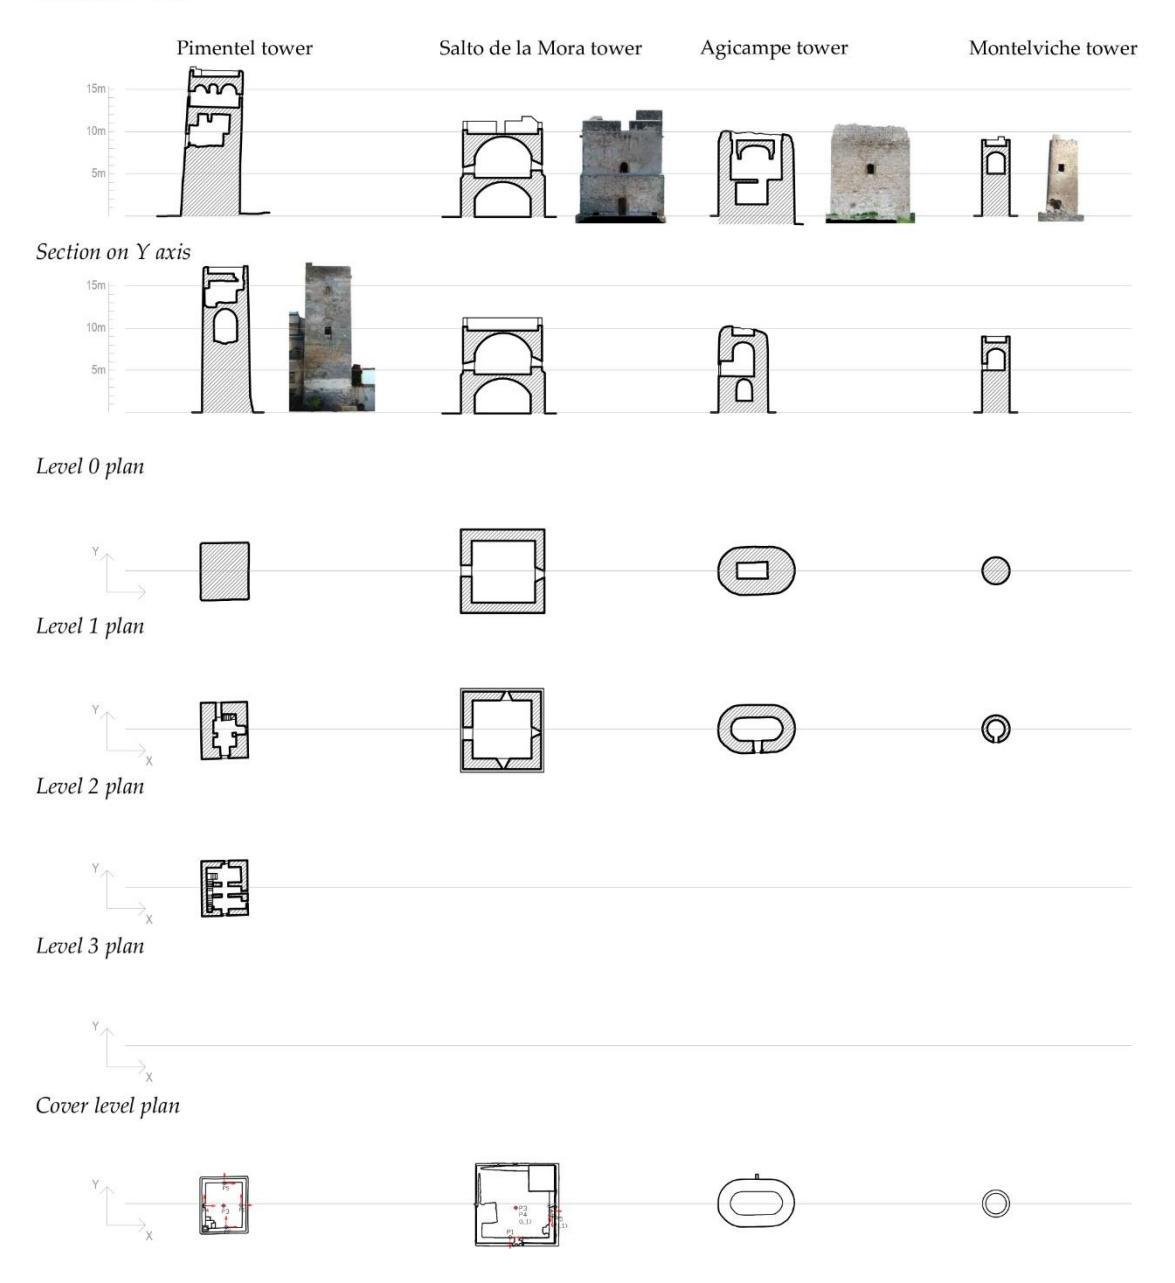
Figure 3. Description of elevations and plans of towers in this study.

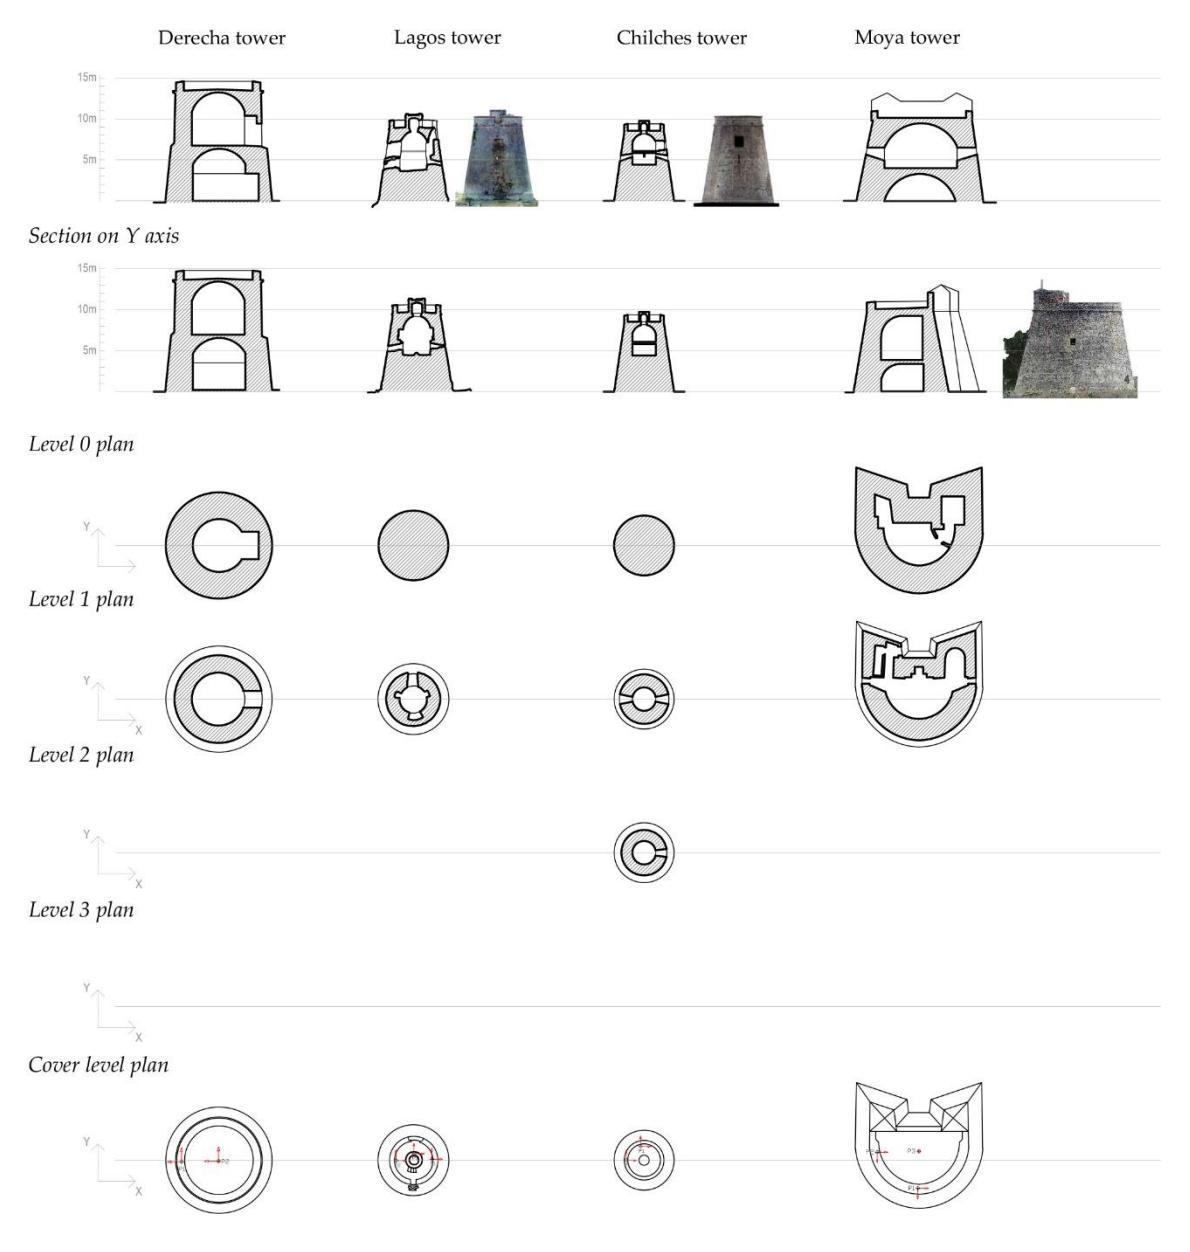
Figure 5. Description of elevations and plans of towers in this study.

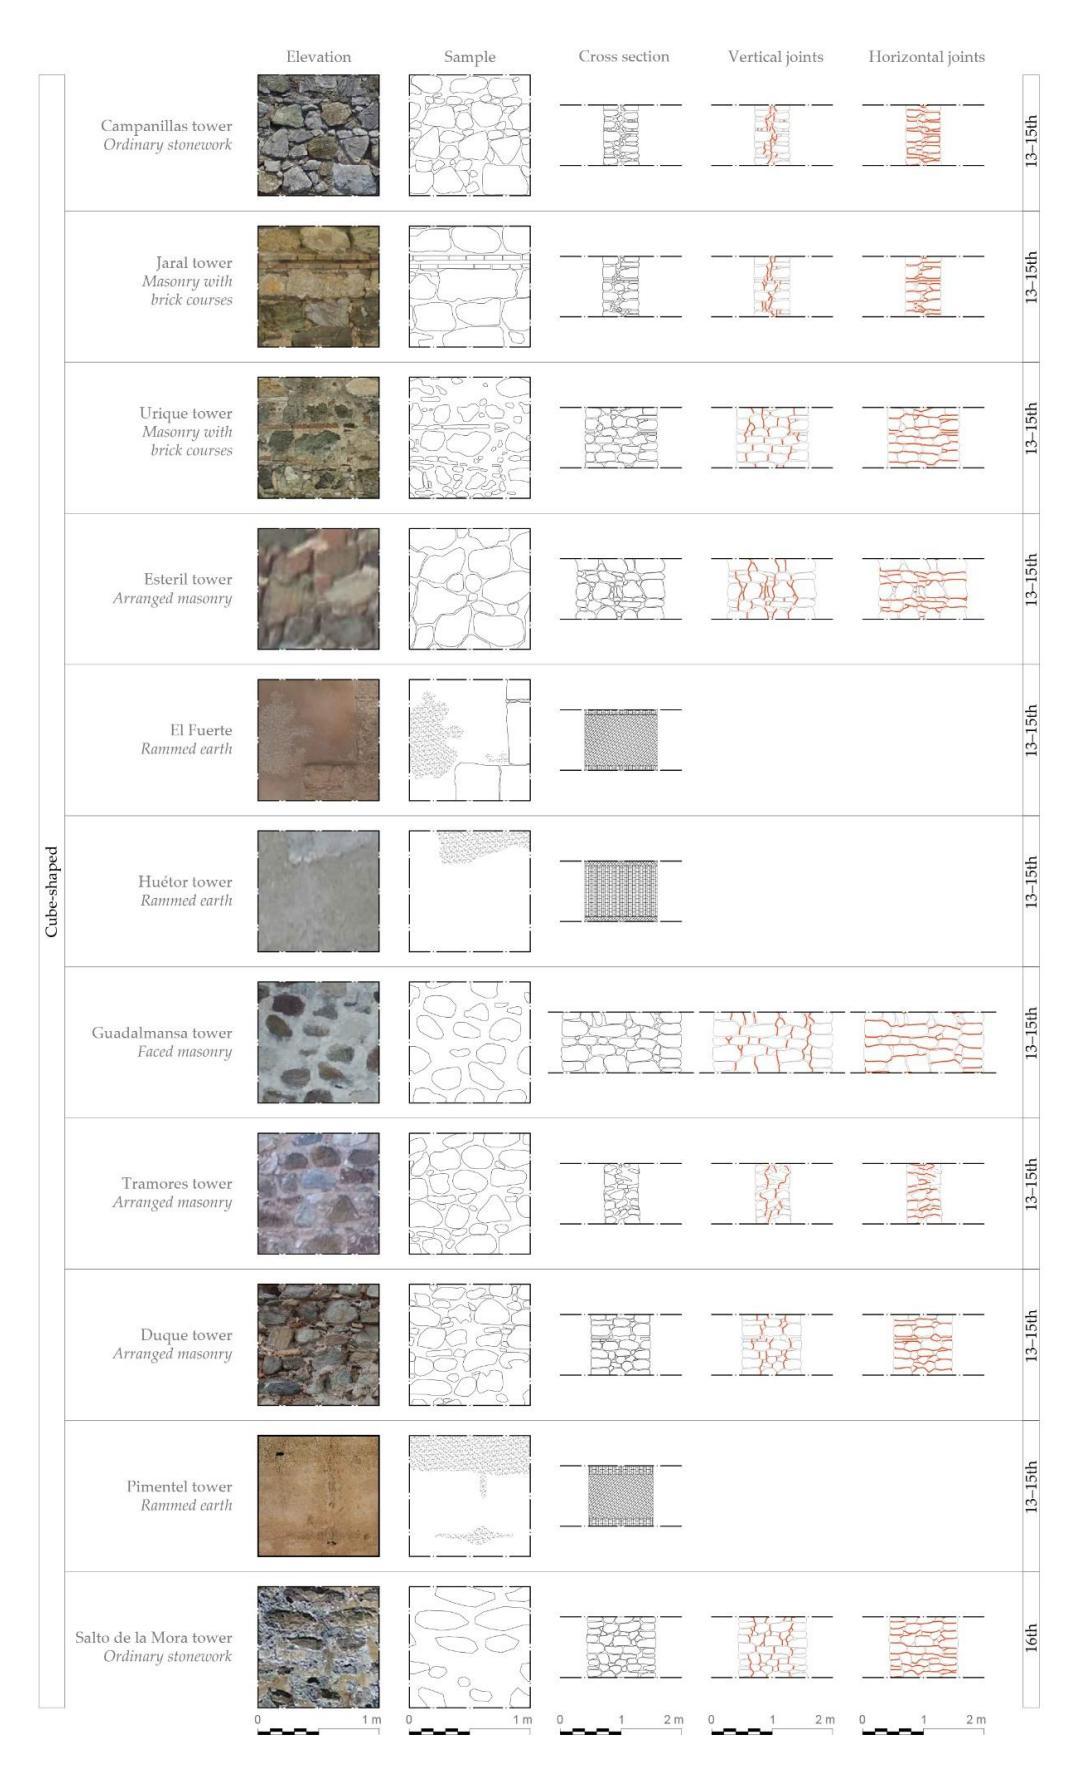
Figure 7. Description of wall construction features in the various towers under study: cube-shaped.

The rest of the towers in the study are built with masonry, although the construction system varies considerably. Standard thickness is in the range of 1.0 m, although it oscillates between 2.0 m and 0.60 m thick at the first level. Figures 7 and 8 show the elevation and section of the wall construction in each of the towers. Because most of the towers have a solid bottom level, the plan of the tower was taken at Level 1. With respect to the wall's cross section, the layout of both the vertical and horizontal joints was studied. This information provides data about the homogeneity of each wall in order to determine its mechanical behaviour. The transverse sections were obtained from different towers where the cross section of the walls was visible, following collapse due to diverse pathologies over their life-span.

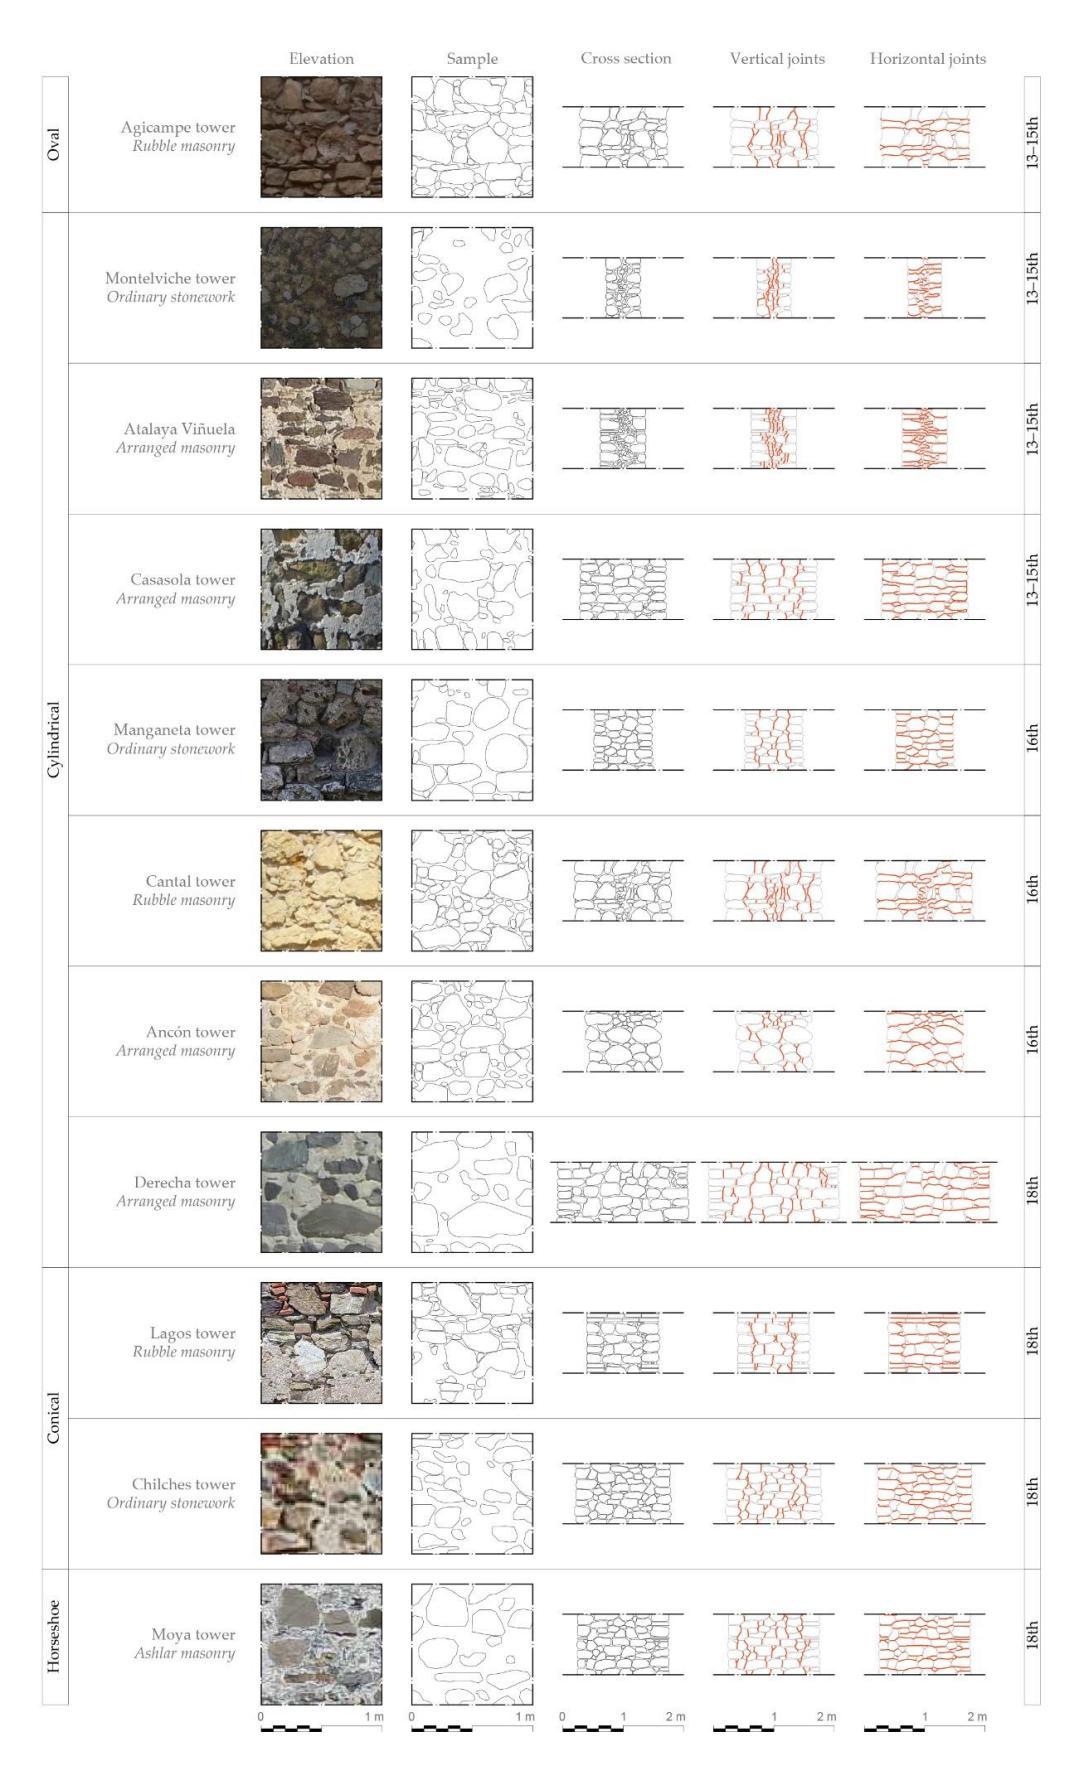
Figure 8. Description of wall construction features in the various towers under study: oval, cylindrical, conical and horseshoe-shaped.

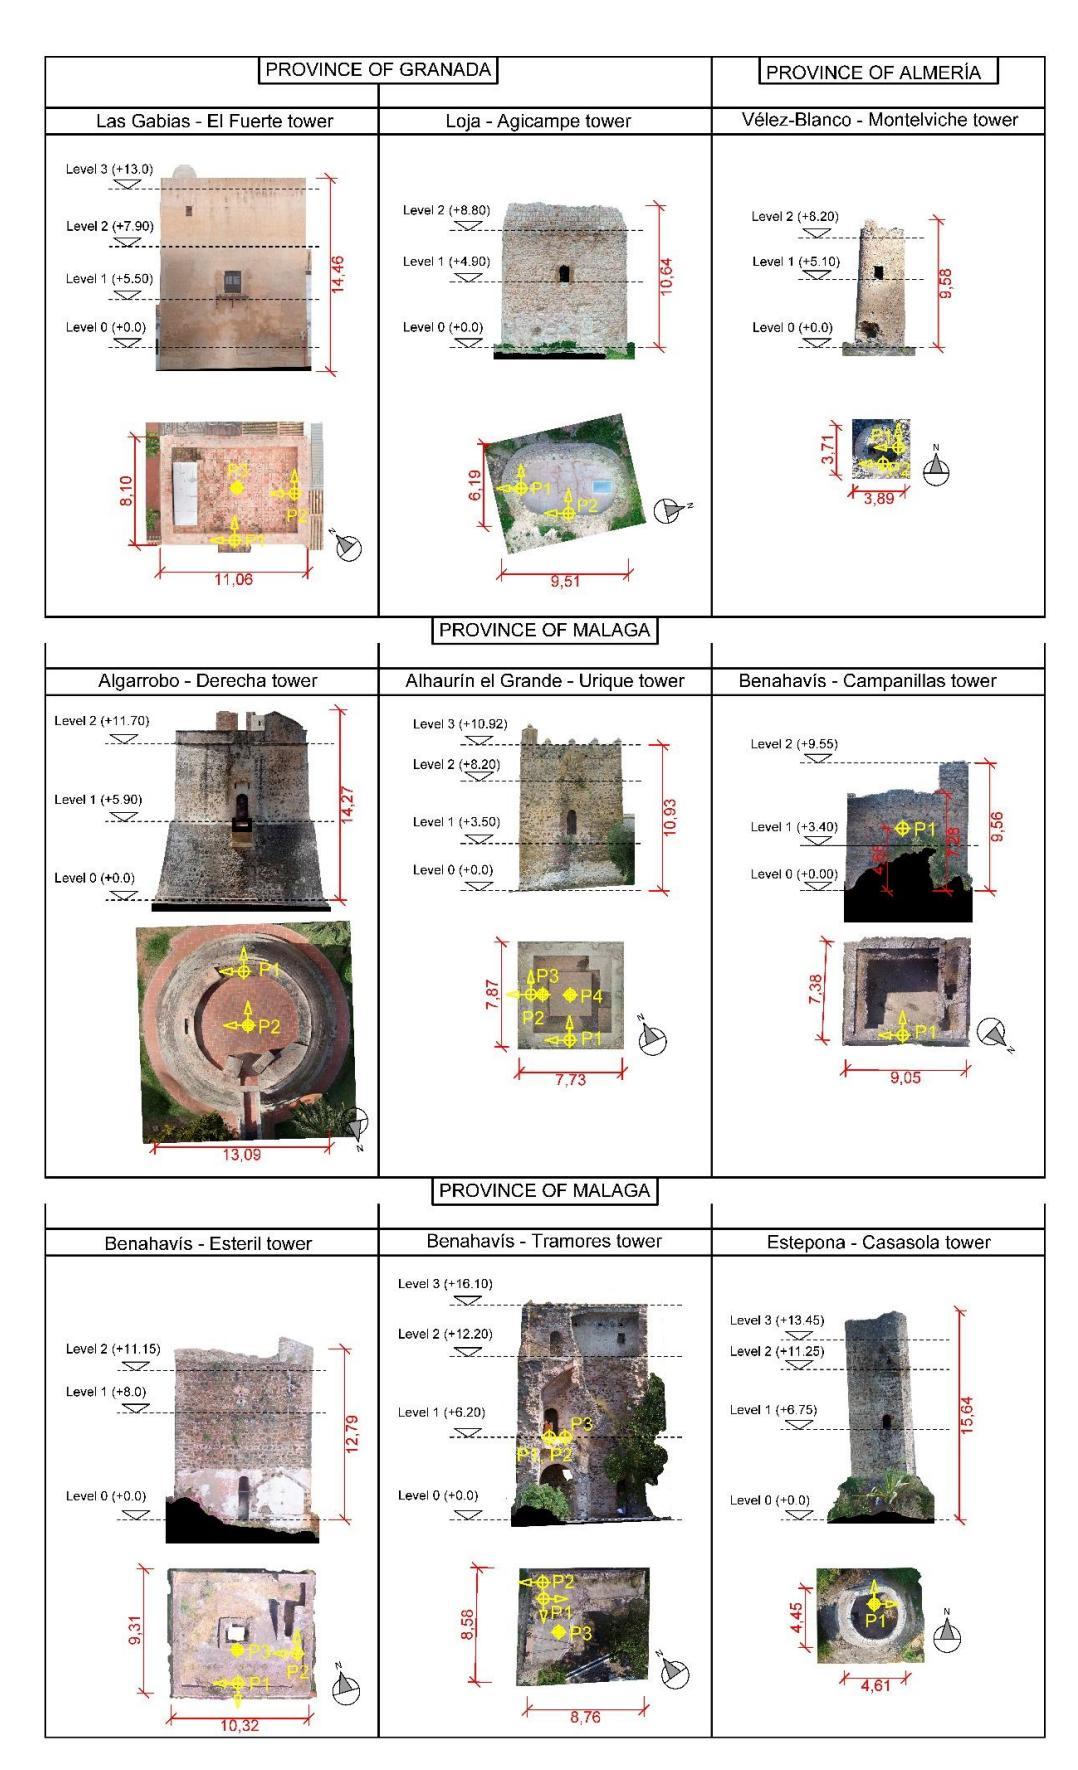
Figure 9. Points where ambient vibration testing was carried out. Towers are sorted by the provinces where they are located—Granada, Almeria and Malaga,—and by municipality.

The tests are performed using a single accelerometer placed on the top floor of the structure, capable of measuring small oscillations, especially those not perceptible by humans. The data registered by the accelerometer are filtered through an analogue–digital converter and the signal is then analysed using appropriate software. Readings were taken with a uniaxial high sensitivity Innomic KB12VD (10,000 mV/g) accelerometer, capable of measuring a frequency range between 0.08 and 260 Hz. The accelerometer was connected by a uniaxial transducer connection signal cable to the digital data capturing system, whereupon the filtered signal was analysed and recorded throughout the test using specific software installed on a laptop. Testing points in the different towers are shown in Figures 9–11, which also display the general dimensions of the towers, as well as the dimensions corresponding to the inner levels and their orientations from North. Except for the Campanillas, Tramores and Sal towers, all tests were carried out on the upper level of the towers. Two readings—parallel and perpendicular to the wall—were taken at each point.

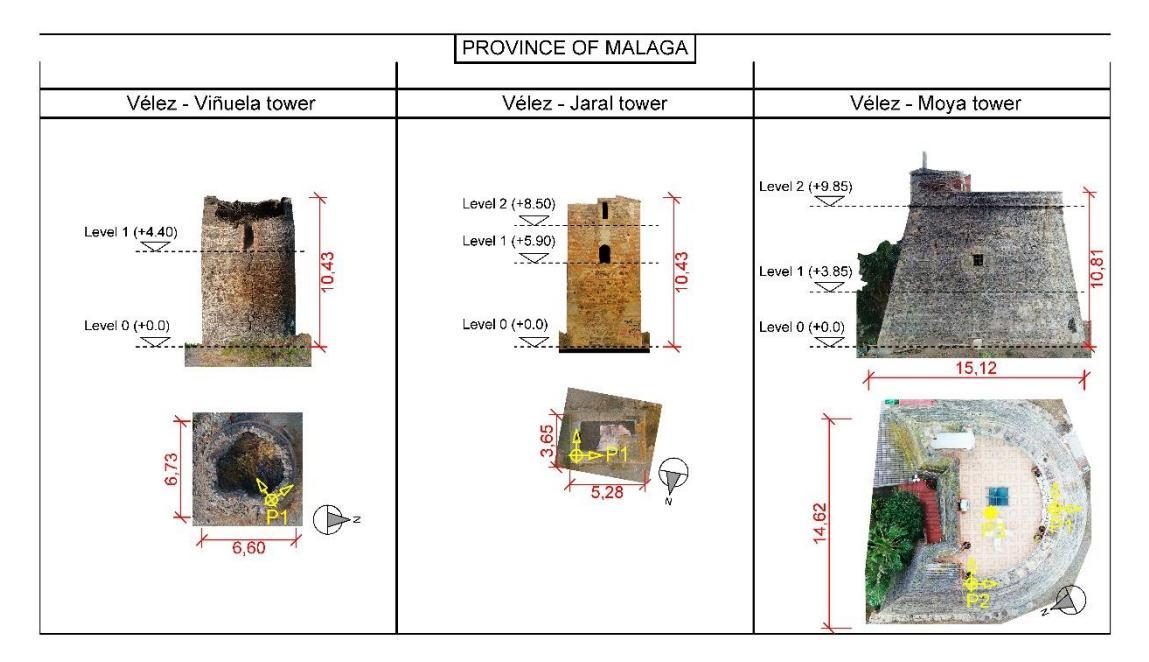
Figure 11. Points where ambient vibration testing was carried out. Towers are sorted by the provinces where they are located—Granada, Almeria and Malaga,—and by municipality.

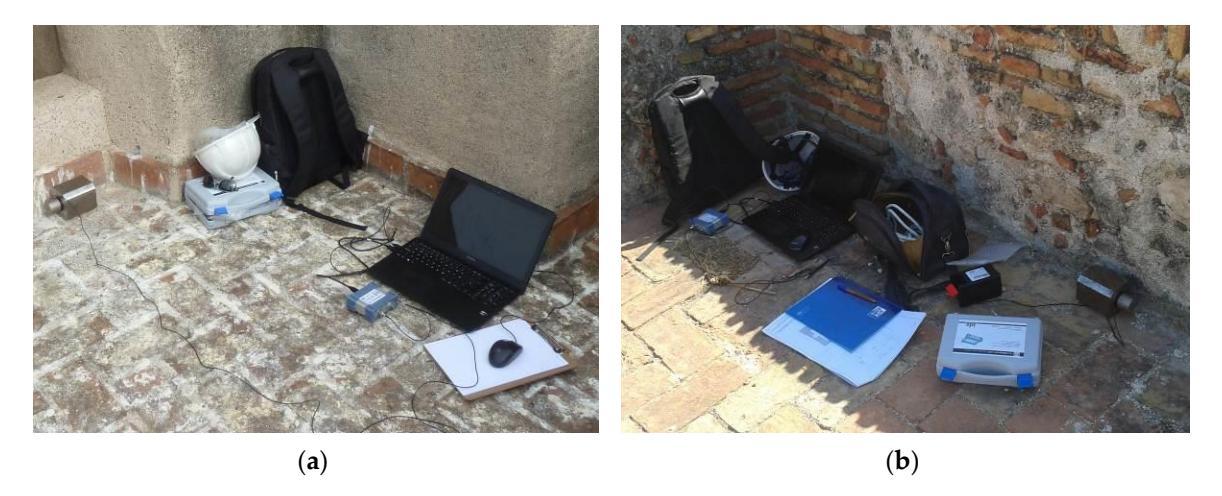
Figure 12 shows the equipment used to take measurements in the Duque (Marbella) and Torremolinos (Malaga) towers: a laptop computer, accelerometer and analogical-digital converter.

Figure 12. Ambient vibration tests at: (**a**) Duque tower (Marbella, Malaga), (**b**) Pimentel tower (Torremolinos, Malaga).

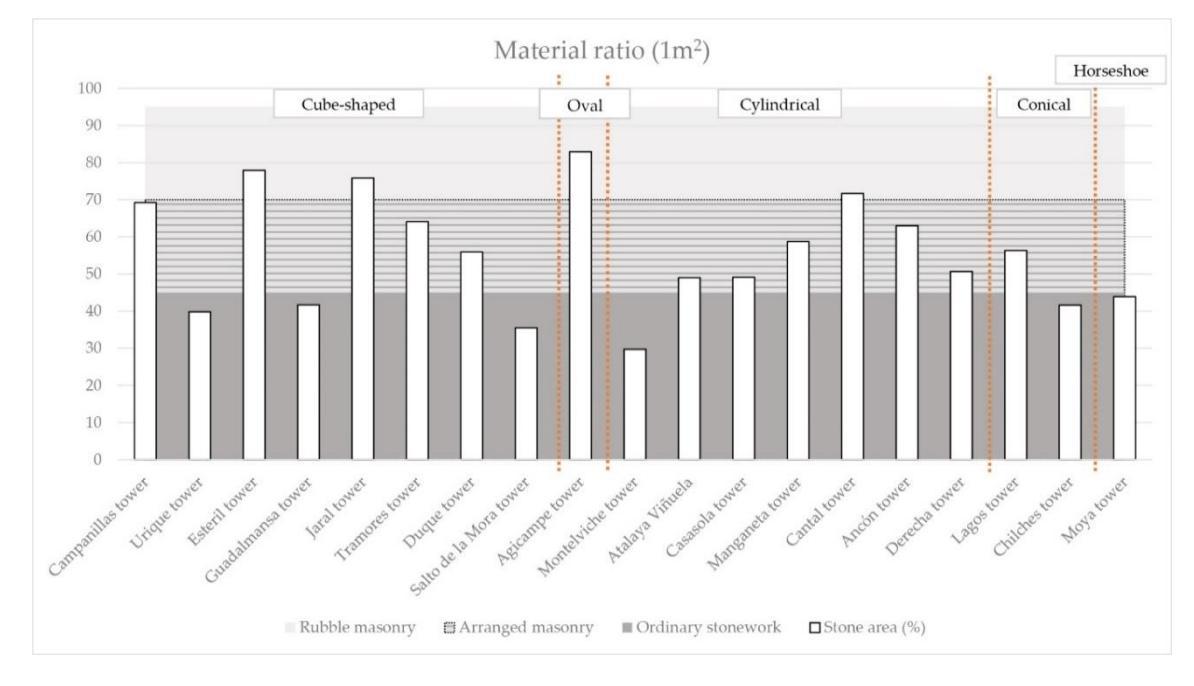
Figure 13. Graph showing the percentage of masonry in each elevation and possible classification of construction systems according to the ratio of materials in masonry constructions.

more or less regularly-shaped polygons to produce a fundamentally flat external surface) masonry, as well as examples of masonry with a lacing course (identified as more rounded stones) and fronted masonry (where dressed stone is only used on the outer face with no specific shapes or size while rubble masonry is used on the inside of the wall). By analysing the proportion of materials visible in the elevation, we were able to classify the standard percentage of rubble in each type of masonry into intervals and thus obtain information about how the materials had been arranged. As part of the same process, the average rubble size was measured for each sample over a certain surface area and length of the horizontal face, as shown in Figure 13. This data was subsequently used to determine the quality of the masonry.

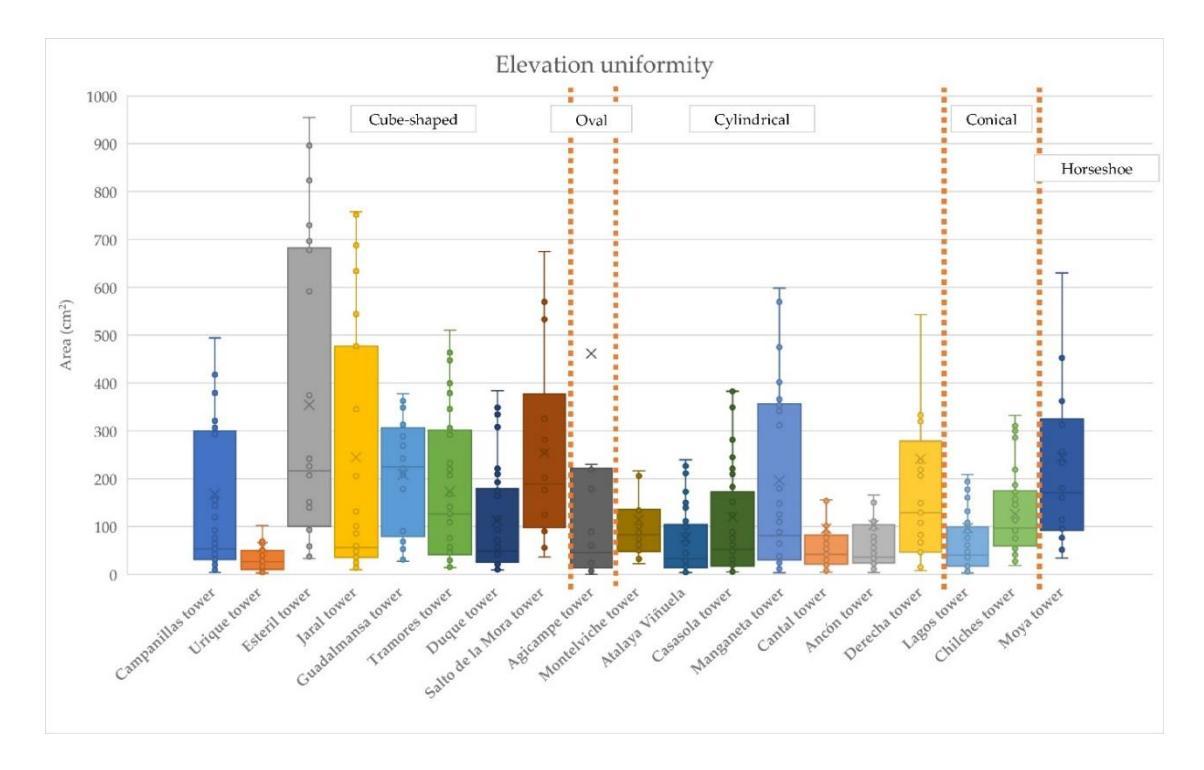
Figure 14. Analysis of masonry homogeneity.

Figure 14 shows the surface area with points of each of the pieces that form the elevation under study, as well as the calculated statistical values for each sample. The height of the boxes represents the degree of dispersion among the surface area data (between the first and third quartile), i.e., the range of surface area values between which 50% of the rough stones in the walls of each tower are

found. The box is divided into two sectors by the median (quartile 2). The vertical lines (whiskers) represent the amplitude of the complete set of values and the arithmetic mean is represented by a cross. To avoid distortion in the graph, maximum values have been omitted, i.e., values over 75 per cent and lower than 25 per cent have not been included.

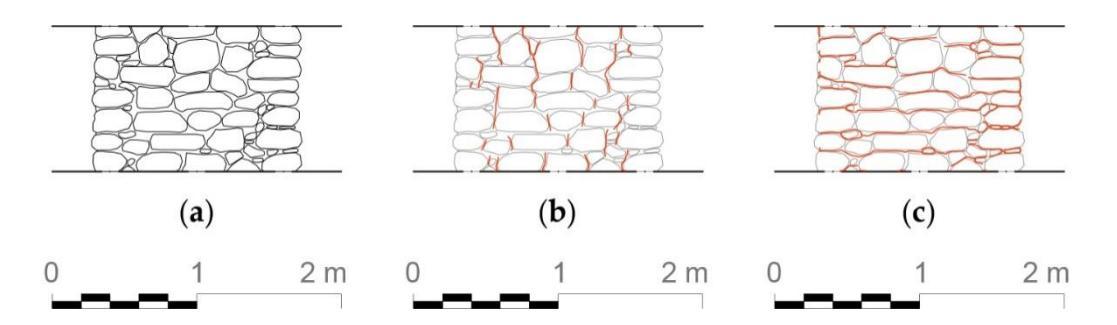
Finally, the joints were studied to complete the characterisation of rough stone distribution in the masonry. This step allowed us to assess the masonry's jointing and the homogeneity of its courses, which is essential to defining the quality of the construction appropriately (Figure 15).

Figure 15. Example of joint assessment in the Casasola tower. The image analysed is the section of wall (**a**) from which the vertical (**b**) and horizontal (**c**) joints are highlighted.

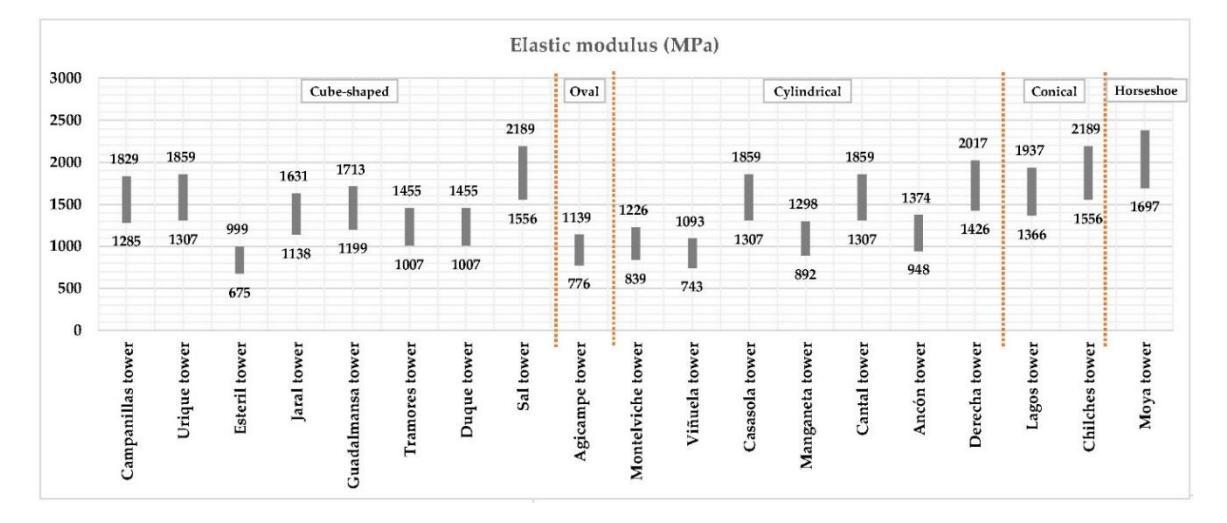
Figure 16. Elastic modulus of the masonry (E).

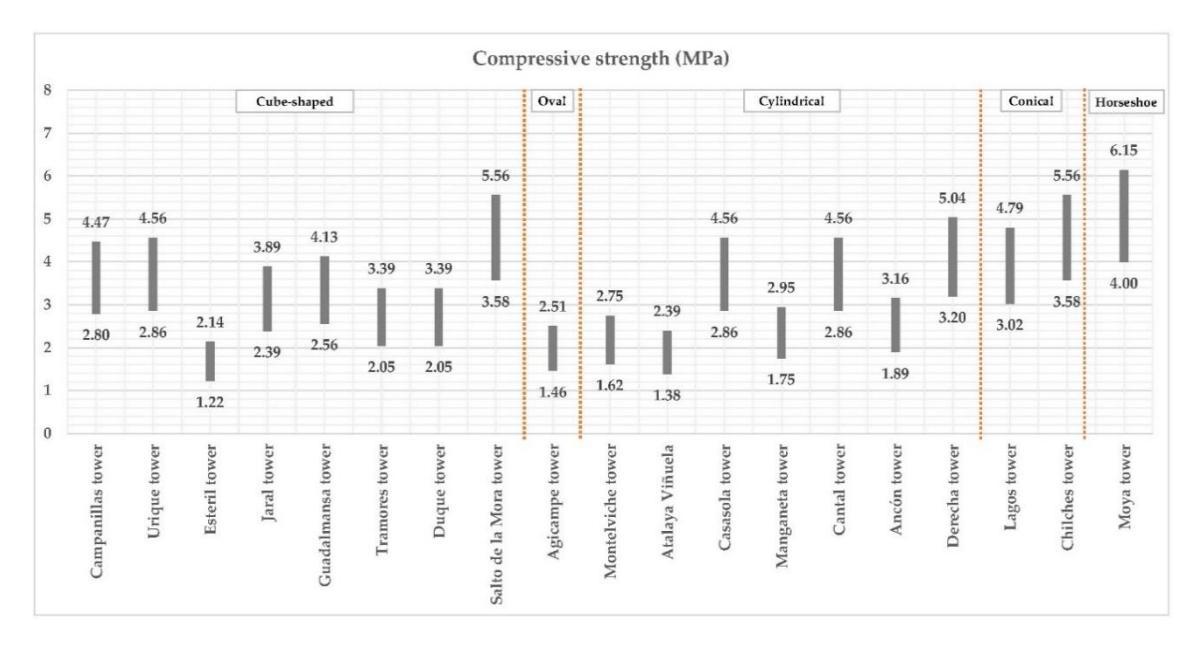
Figure 17. Compressive strength of the masonry (f_m).

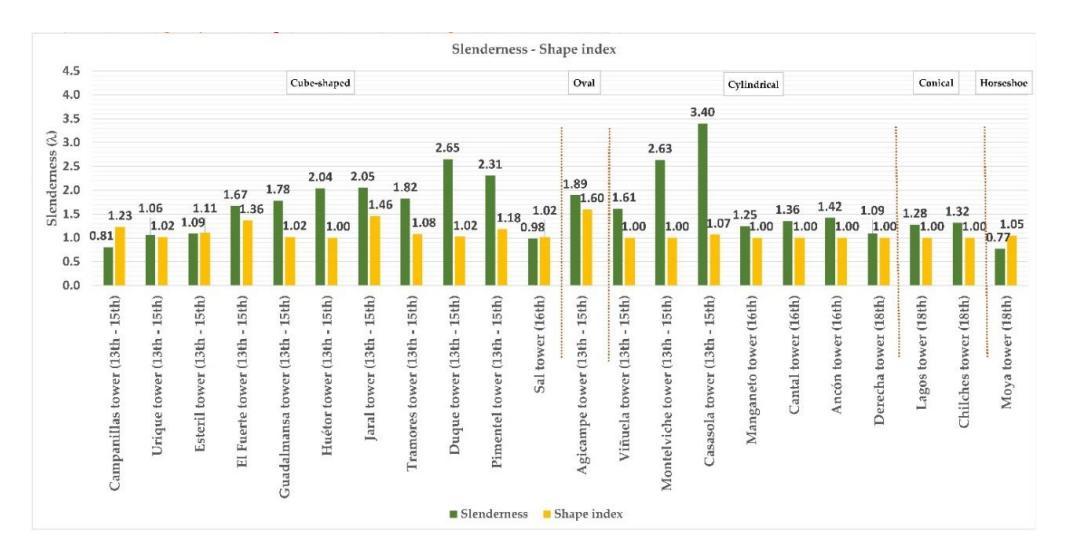
Figure 18 provides data on the slenderness of the towers in the survey. The values are shown together with the shape index, which indicates the ratio between the two main dimensions of the floor plan at level 0 (length/width). This index provides information about the homogeneity of how the structure behaves in relation to a given direction. To enable comparison between the different units, the data was classified according to the morphology of the tower in question.

Figure 18. Slenderness and shape index for the towers under study.

The analysis reveals that tower slenderness decreased over the centuries: Andalusian towers built prior to the 16th century have a higher slenderness index than those built in later times. Thus, the average slenderness for medieval towers is around 1.80 compared to modern towers, which do not exceed 1.5. This reduced slenderness reaches its maximum expression with the modern "horseshoe-shaped" towers of the 18th century, whose slenderness is around 0.8. Such lower slenderness is the result of adaptation to the gradual introduction of long-range weaponry in siege warfare constructions. By the 15th century, weapons had acquired enough firepower to become a significant danger to defensive constructions, which needed to be adapted to withstand their impact by evolving towards more massive buildings, with no protruding edges, steep slopes and lower elevation from the ground.

As far as shape index is concerned, remarkable homogeneity of around 1.0 is found in almost all cases, which demonstrates that most towers had a floor plan of significantly square proportions. The highest dispersion occurs in the Agicampe and Jaral towers, where the index is around 1.5, thus maintaining a ratio of 1:2.

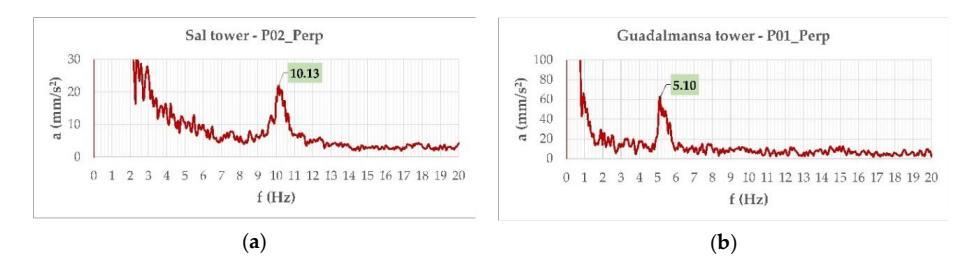
Having completed ambient vibration testing on each of the afore-mentioned towers, their natural frequencies were calculated in the laboratory. The measurements were taken in the frequency domain and an example of the results is illustrated in Figure 19.

Figure 19. Frequency domain measurements from ambient vibration tests performed at (**a**) Sal tower (Casares, Malaga) and (**b**) Guadalmansa tower (Estepona, Malaga).

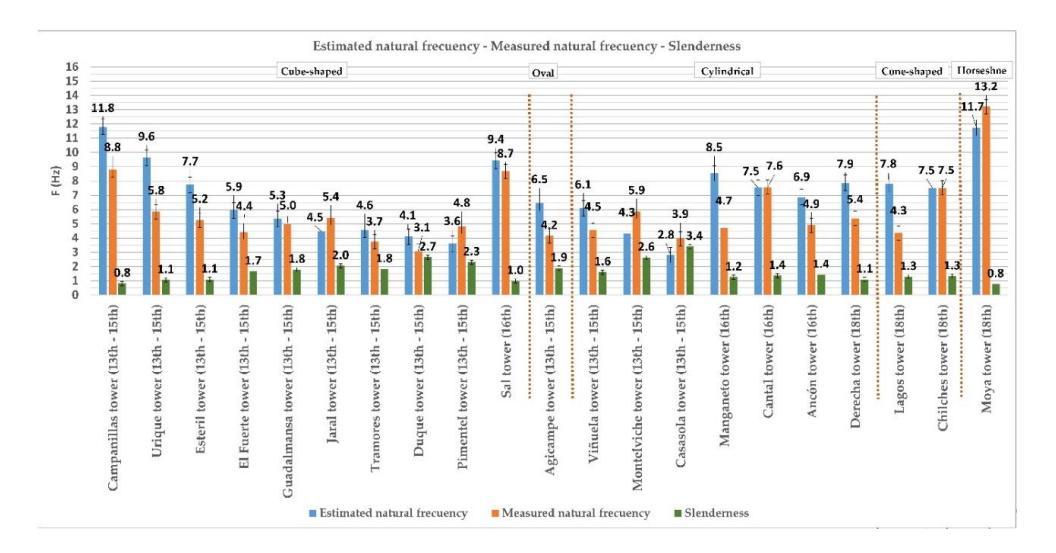
Figure 20 shows the comparison made between the analytically estimated natural frequency and the empirical natural frequency identified through ambient vibration testing. In order to express correlation with the geometric characteristics of the towers under assessment, both measurements in this figure are compared to their slenderness.

Figure 20. Comparison between the estimated natural frequency (blue), measured frequency (orange), and slenderness (green) for each tower.

Comparative analysis of the results indicates there is no direct correlation between the estimation made through empirical formulation and the results obtained from the tests. General analysis shows that, for 20% of the towers, the measurements are similar, while dispersion above the standard error is found in the rest of the towers. At a deeper level, both the estimated historical period of the construction and its morphology were assessed. Thus, for cube-shaped towers with a slenderness of less than 2.0, the estimated frequency is higher than the measured frequency, except in the Duque tower. The ratio is maintained in cylindrical towers with no exceptions. However, that is not the case for the Moya tower (horseshoe-shaped), due to a fact that relates directly to the massiveness of its construction, where the surface area of the walls on Level 0 is 72% of the total figure and 57% on Level 1.

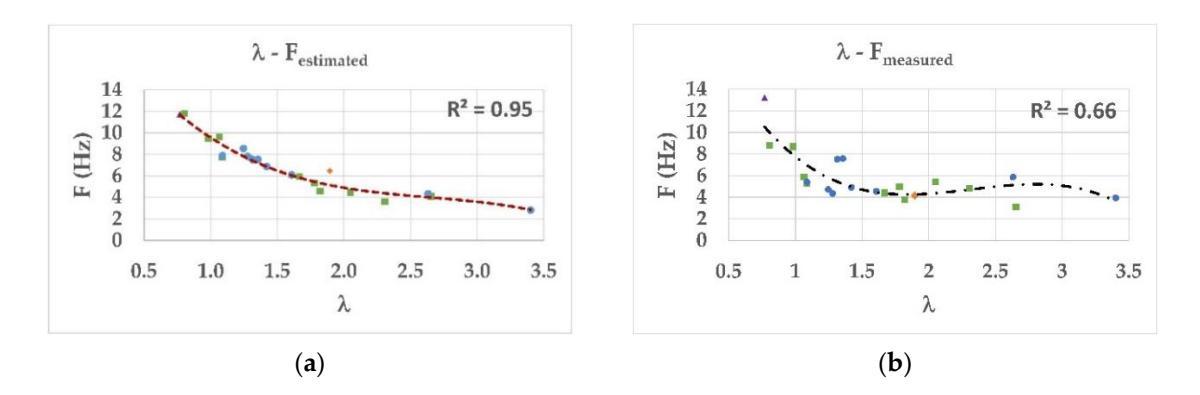
When slenderness is compared with the estimated natural frequency (Figure 21a), it is possible to see how the curve varies with the values obtained, which is logical given that the values for frequency were attained by applying the empirical Equation (2). On the other hand, when the ratio between slenderness and the measured natural frequency is compared (Figure 21b), the curve is seen to adapt less that would appear to be related to the state of conservation of the structures under assessment, which include towers with significant structural damage. In fact, structures whose measured natural frequency is lower than would normally be expected given their slenderness tend to suffer from structural damage. Therefore, towers which reveal significant dispersion below the curve imply a greater presence of structural damage that influences their frequency and, therefore, their level of bracing. On the other hand, if dispersion occurs in the upper part of the curve, the structure has a satisfactory safety index against horizontal loads, most likely related to earlier restoration measures in which the original wall structure has been consolidated or reinforced.

Figure 21. Comparison between (**a**) the slenderness (λ) and the estimated natural frequency; and (**b**) slenderness and measured natural frequency. Green square: cube-shaped; blue circle: cylindrical; orange diamond: Agicampe tower (oval); purple triangle: horseshoe.

Based on the above analysis, the towers of Urique, Esteril, Manganeto, Lagos, Duque and, to a lesser extent, Tramores do not reach the required level of stiffness in respect of their slenderness, which implies that the wall structure has significant damage affecting its bracing. Of the afore-mentioned towers, Duque is worth highlighting in that it has the greatest variation between its measured natural frequency and what could be expected given its slenderness. Intervention to reinforce its strength structure would at least need to attain a natural frequency over 4.5–5 Hz, thus achieving suitable adjustment to the curve proposed in Figure 21b. In any case, both figures clearly show that the lower the natural frequency, the higher the slenderness of the structure, and therefore that both factors are inversely proportional.

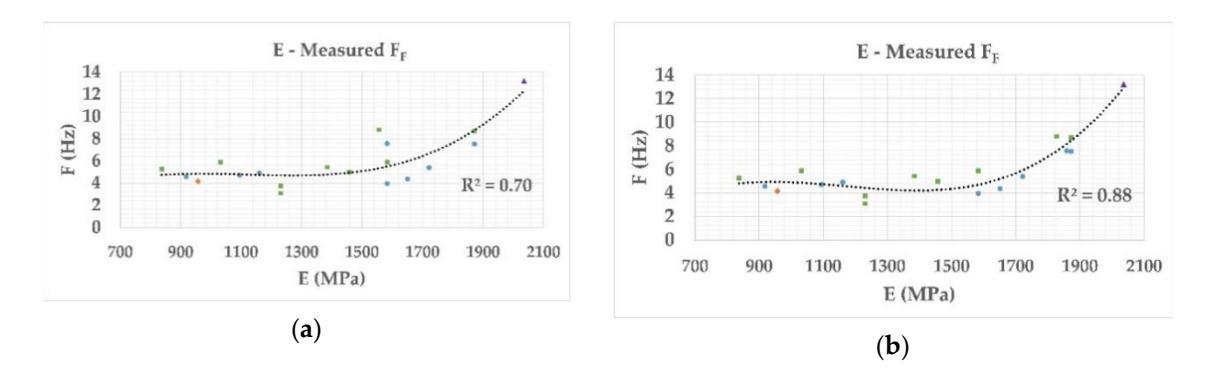
Figure 22. Comparison between the estimated elastic modulus (E) and the measured natural frequency (F). Green square: cube-shaped; blue circle: cylindrical shaped; orange diamond: Agicampe tower (cube-shaped + cylindrical); purple triangle: horseshoe-shaped. (a) Average E value directly based on masonry quality index (MQI). (b) E value adjusted according to masonry resistance analysis.

The resulting curve represents the optimal adjustment between E and the natural frequency of the structure for each type of tower. Dispersion from the curve indicates a need to adjust the value of E, bearing in mind the average value established in respect of the minimum and maximum values included in Table 3, from which the values of E are adjusted for the towers that have higher dispersion: Campanillas and Cantal. In the case of Campanillas, the value changes from 1556 to 1828 MPa, and for Cantal, it varies from 1583 to 1859 MPa. Once the value of E has been adjusted, it is possible to fine-tune the curve and thus obtain an R² value of 0.88. Such adjustment is made coherently with the actual characteristics of the masonry walls in the towers. As far as the numerical analysis of masonry structures is concerned, establishing a value for the structure's global elastic modulus is particularly relevant for an accurate assessment of its overall mechanical behaviour and as a basic starting-point to study its seismic vulnerability and develop non-linear analysis using finite element models [40].
