Article Performance Evaluation of Fiber-Reinforced, Stress Relief Asphalt Layers to Suppress Reflective Cracks

Abstract: In this study, the performance of the fiber-reinforced, stress-absorbing membrane interlayer (F-SAMI) method was evaluated to suppress reflective cracks, which usually occur when the overlay method is applied for the maintenance of existing aged pavement. The F-SAMI method has an effect of suppressing the occurrence of reflective cracks by constructing a material composed of emulsified asphalt, fibers, and aggregates between the surface layer and the base layer. The mechanical performance of the F-SAMI was evaluated through both small-scale (model mobile load simulator 3, or MMLS3) and large-scale (accelerated pavement testing, or APT) pavement acceleration tests on the specimen and pavement structures, respectively, with the F-SAMI layer applied between the surface layer and the base layer. In this study, the base layer was made with an asphalt mixture or a concrete mixture, and the surface layer was made with polymer-modified stone mastic asphalt (PSMA). Evaluation was conducted by applying four types of F-SAMI layer, according to the content of asphalt and ag

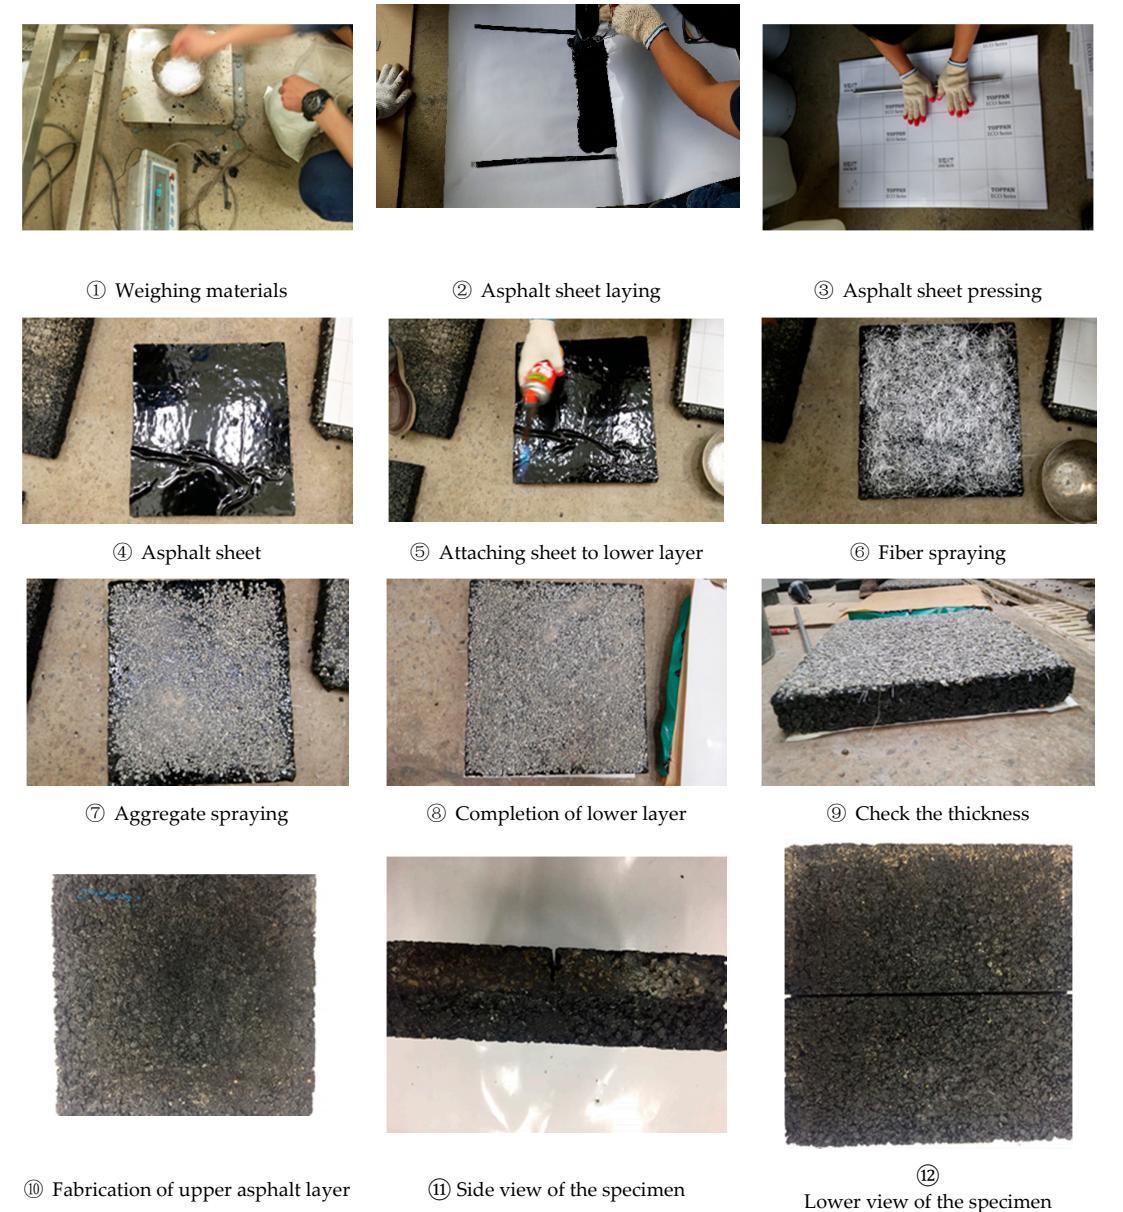
Figure 1. Fabrication of model mobile load simulator 3 (MMLS3) specimen.

To evaluate the performance of the F-SAMI layer, according to the content of the asphalt binder and the use of aggregate, seven types of specimens were prepared, as shown in Table 2. In addition, after the preparation of the specimen was completed, the crack was simulated with a depth of 40 mm and a width of 10 mm in the center of the lower layer specimen, to simulate a reflection crack. The width and depth were determined in order to accelerate the occurrence of reflective cracks among the values mainly applied on expressways, according to Korean standards [2]. Figure 1 shows the whole process of specimen fabrication for the MMLS3 test. An F-SAMI or tack coating layer was installed on the lower layer and then sufficiently cured. After that, the top asphalt mixture was laid and compacted using a slab specimen compactor. It was concluded that there was no problem with attachment, because there was no detachment between the top and lower layers, even after the MMLS3 test.

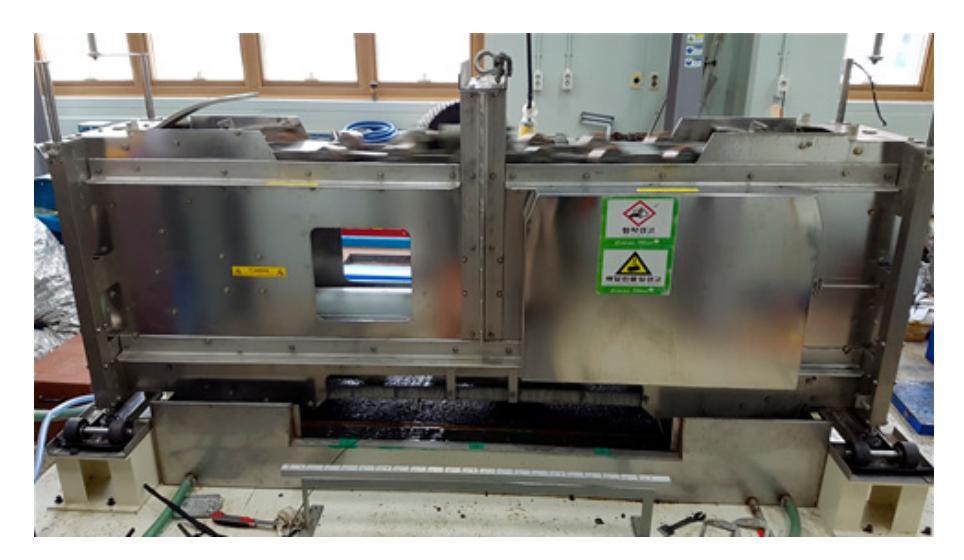
Figure 2. MMLS3 test setup.

The loading conditions of the MMLS3 test were a single wheel load of 2.7 kN and a speed of 10 km/h, and wandering was not used. Four tires with a diameter of 30 cm, which is 1/3 the size of a standard truck tire size, were installed in a row, and the tire pressure was maintained at 690 kPa. In addition, the test temperature was maintained at 20 °C by circulating water to the specimen bath for the entire experiment. Figure 2 shows the test view, in which the fabricated specimen is installed and the MMLS3 test equipment is fixed at the loading position.

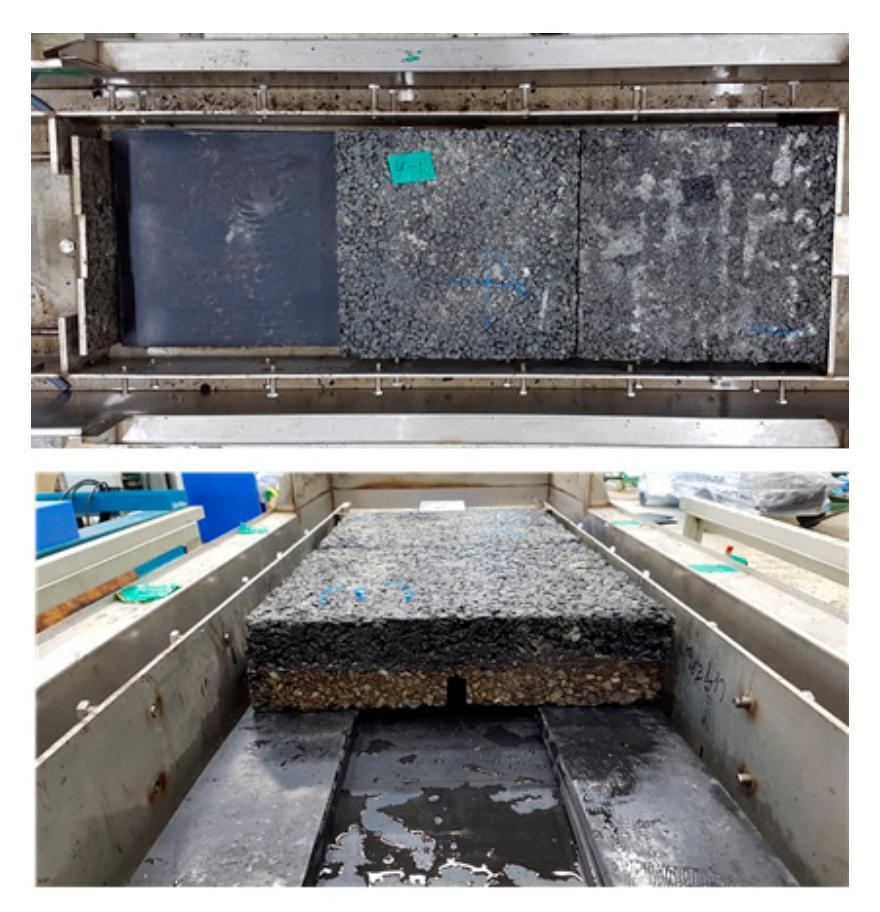
Figure 3. Specimen installation.

The existing MMLS3 test equipment is designed to perform a test by installing a test specimen on the top of a plastic base plate. However, in order to simulate the transition of the reflective crack, it is necessary to increase the tensile stress generated at the bottom of the test specimen under the load of MMLS3—so as shown in Figure 3, three rubber plates of 1 cm thickness were laid on the floor plate, and the test specimen was installed on the top. In addition, in order to secure sufficient tensile stress, the center of the rubber plate was cut out so that the specimen could be sufficiently bent when the MMLS3 load was applied.

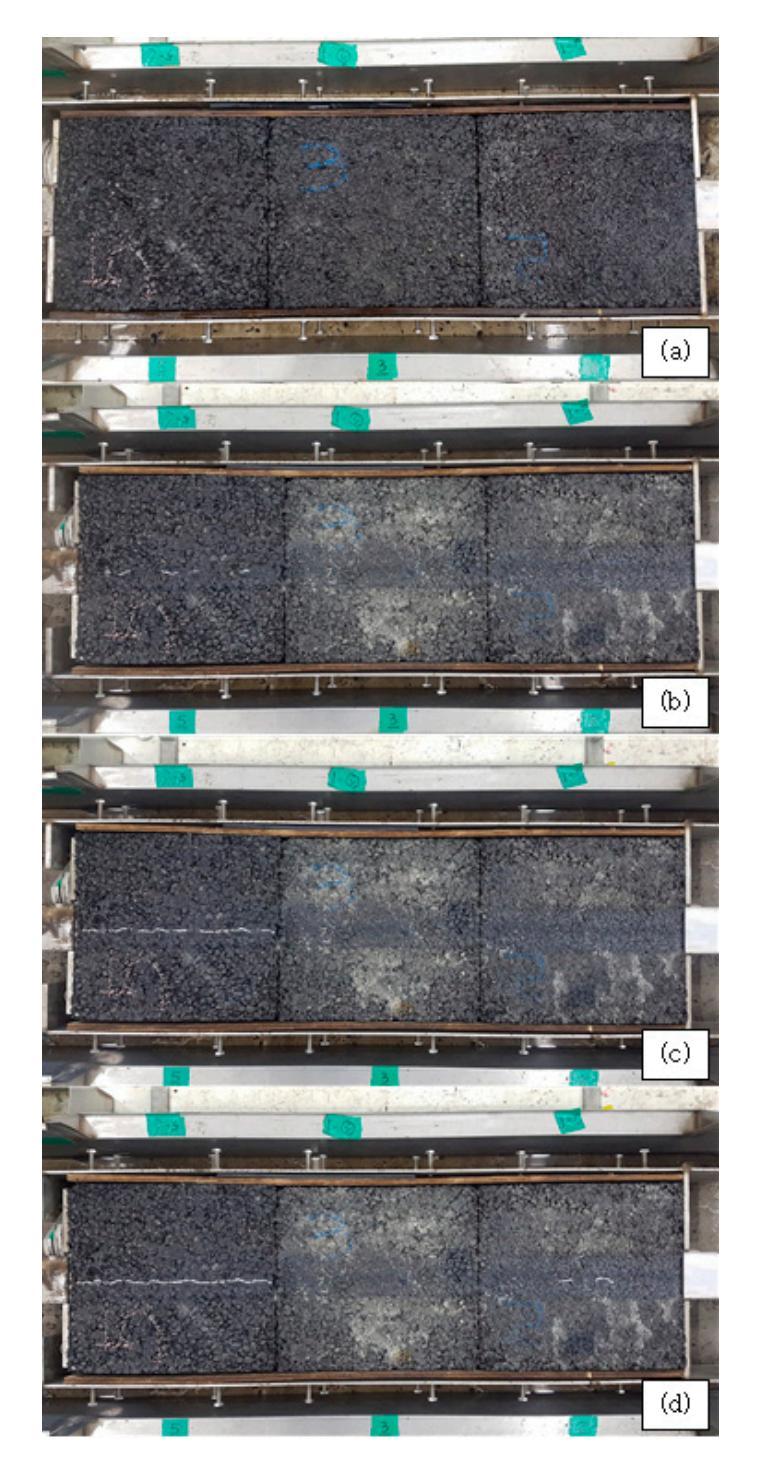
Figure 4 shows the occurrence and progress of reflective cracking in each specimen as the MMLS3 test proceeds. Figure 4a is the specimen top view before the MMLS3 load is applied, and Figure 4b shows that small cracks that occurred on the surface of specimen on the left side. Figure 4c shows that in the specimen on the left side, reflective cracks have occurred entirely on the surface, while in Figure 4d, the cracks occurred gradually in the specimen on the right side.

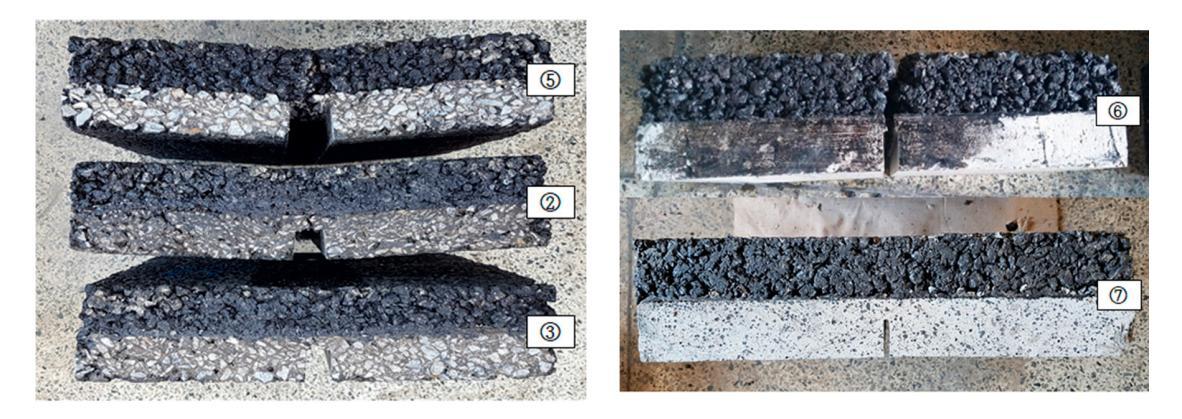
Figure 5. Side view of specimens after the completion of the MMLS3 experiment.

Figure 5 shows the side view of the specimen after the completion of the experiment. The MMLS3 experiment was conducted until the specimen was deflected due to reflection cracking and additional loading was impossible, as seen in specimen 5. From Figure 5, it was found that specimens 5 and 6, to which general tack coating was applied, were completely split due to the reflective cracking.

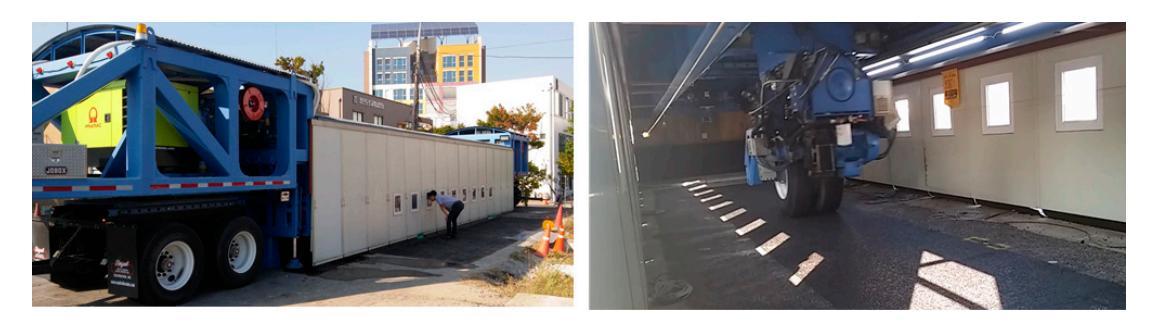
Figure 6. Accelerated pavement testing (APT) facility.

Field performance evaluation for composite pavement, to which the fiber-reinforced stress-relief layer (F-SAMI) method was applied, was conducted through accelerated pavement testing (APT) at the Korea Institute of Civil Engineering and Building Technology (KICT) in South Korea. This APT facility was built in 2014, and has been heavily used to evaluate the performance of various types of asphalt and concrete pavement [23]. The APT facility is shown in Figure 6, and the equipment name is

HVS (Heavy Vehicle Simulator, manufactured by Dynatest, Gainesville, FL, United States). The APT equipment is covered by a temperature chamber to control the environmental effect. The APT is capable of applying a half-axle load of dual tires up to 12.5 tons with one-way travel. The maximum travel speed is 12 km/h, and it can apply lateral wandering within a 1000 mm range.

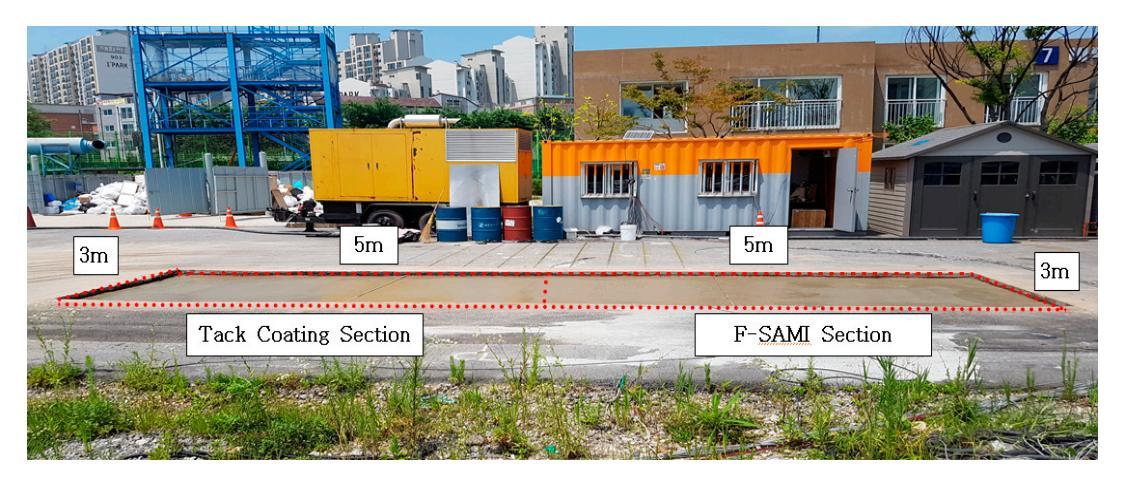
Figure 7. APT test section.

In order to evaluate the performance against the joint reflective cracking, an F-SAMI section $(5 \text{ m} \times 3.0 \text{ m} = 15 \text{ m}^2)$ and tack coating section $(5 \text{ m} \times 3.0 \text{ m} = 15 \text{ m}^2)$ were constructed at the APT facility in the KICT, as shown in Figure 7.

A sub-base layer was constructed, with a thickness of 15 cm on the top of the compacted subgrade layer, and a concrete layer was constructed with a thickness of 15 cm on the top. Joints were constructed at a depth of 15 cm in the middle of each of the F-SAMI sections and the tack coating section. A 1 cm thick rubber plate was installed under the joint to increase the movement of the joint. On the top of the concrete layer, a PSMA surface layer was constructed with a thickness of 5 cm. Table 4 shows the materials used for test section.

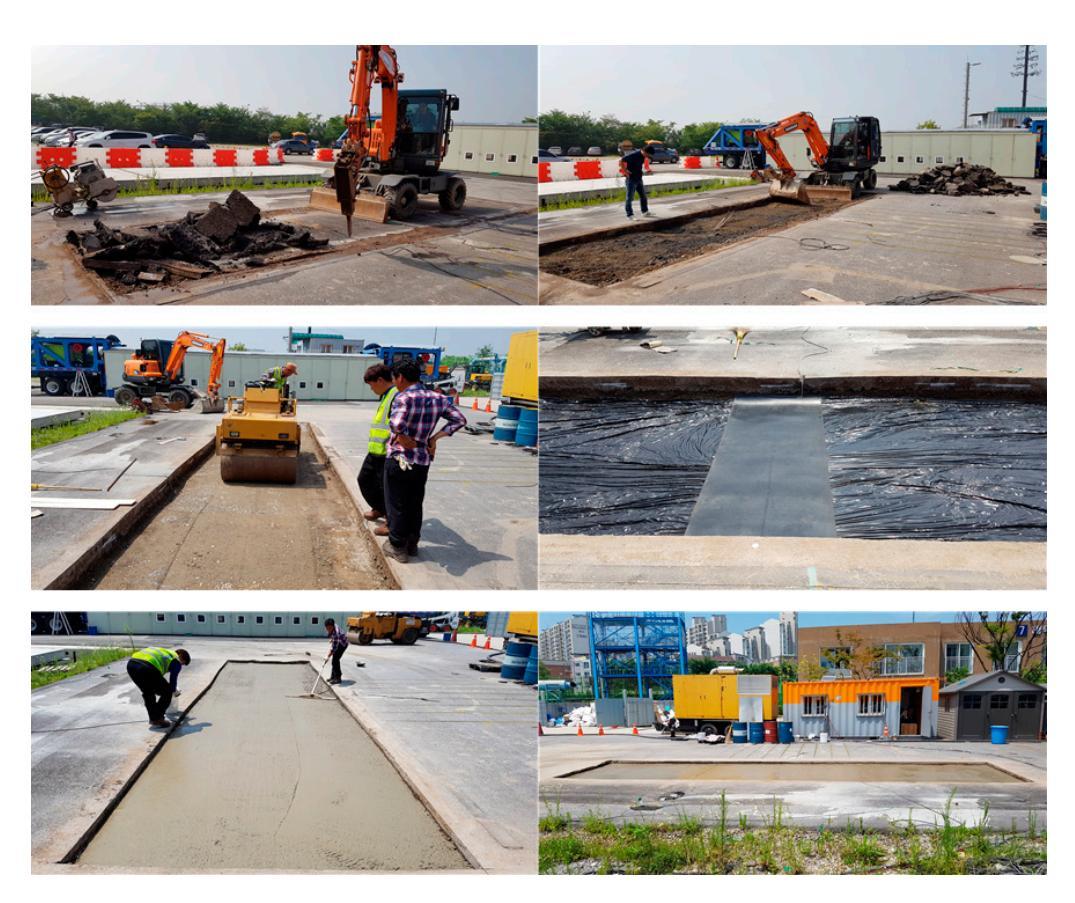
Figure 8. Construction for test section: lower layer.

Figure 8 shows the construction of the sub-base and concrete base layer of the APT test section, and Figure 9 shows the construction of the stress relief layer and the surface layer.

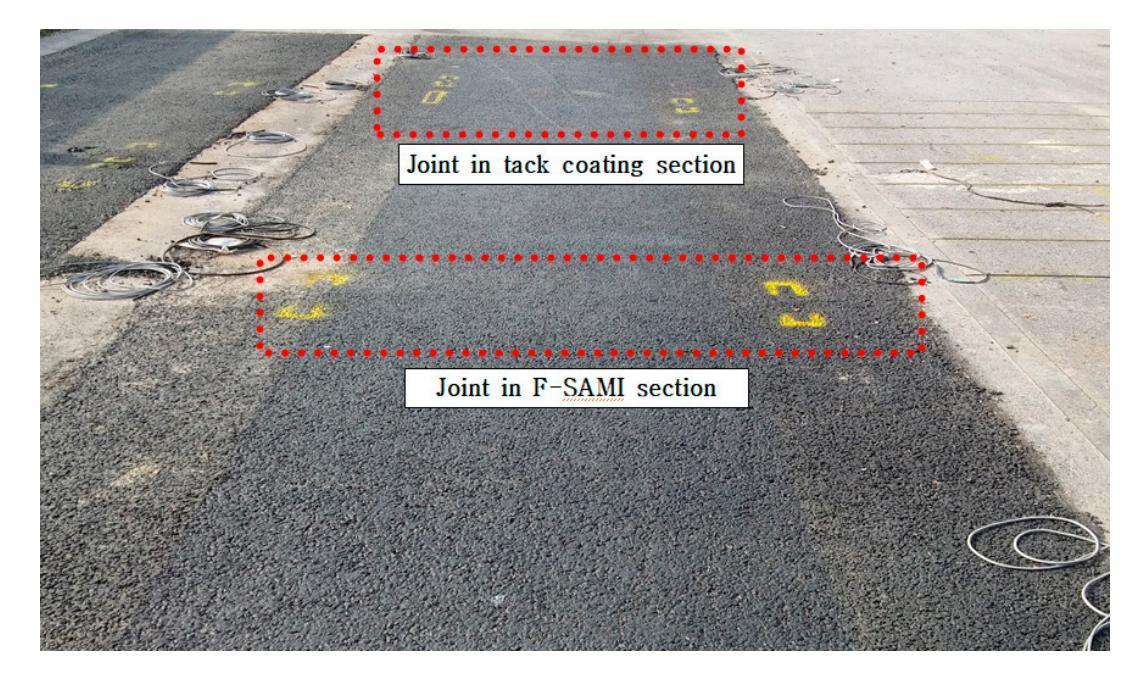
Figure 10. Crack occurring area (top of the joint).

Figure 10 shows the section where cracks occurred at the joints of the test bed. Figure 11 shows the occurrence and progression of cracks in the F-SAMI section and the tack coating section, according to the APT load.

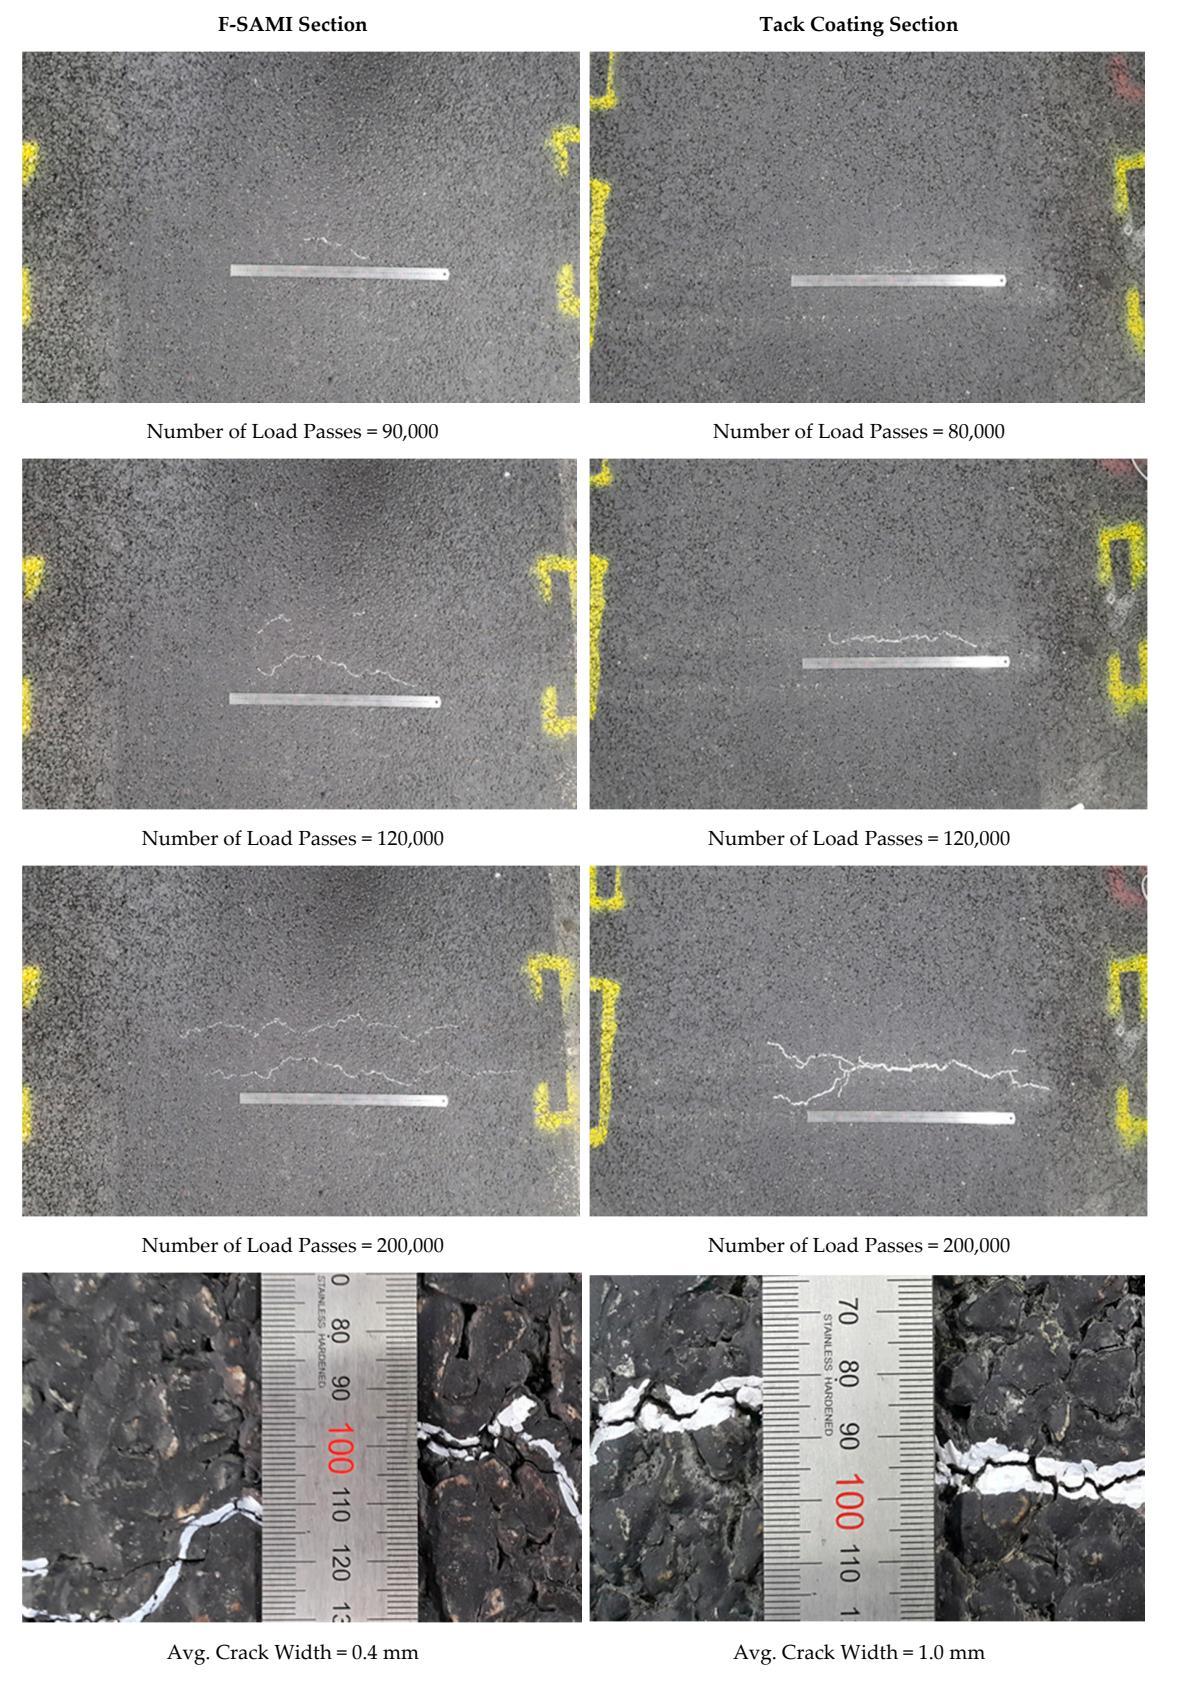
Figure 11. Occurrence and progression of reflective cracks.

As a result of evaluating the cracks generated in each section, according to the APT loading, the initial cracks occurred at 80,000 load passes in the tack coating section and 90,000 load passes in the

F-SAMI section. As a result of the crack propagation evaluation, the tack coating section progressed by cracking at the vertical upper part of the joint, whereas the F-SAMI section developed cracking at a location 7~8 cm away from the vertical upper part of the joint. The crack width of the tack coating section was 0.6~1.3 mm (average 1.0 mm), whereas the F-SAMI section was measured as 0.3~0.7 mm (average 0.4 mm).

When applying the F-SAMI method, compared to the tack coating method, reflective cracks occurred about 10,000 load passes later. Reflective cracks in the F-SAMI section were dispersed, and the crack width was reduced by about half compared to those in the tack coating section. Therefore, in spite of the joint sag of the F-SAMI section, the reflective crack resistance of the F-SAMI method was evaluated to be superior to that of the tack coating method.
