Comprehensive Method to Test the Stability of High Bedding Rock Slop Subjected to Atomized Rain

Abstract: In the construction of high dams, many high rock slope failures occur due to flood discharge atomized rain. Based on the steel frame lifting technique and strength reduction materials, a comprehensive method is proposed in this paper to study the stability of high bedding rock slope subjected to atomized rain. The safety factor expression of the comprehensive method and the evaluation method for deformation instability were established according to the similarity theory of geomechanical model, failure criterion, and mutation theory. Strength reduction materials were developed to simulate the strength reduction of structural planes caused by rainfall infiltration. A typical test was carried out on the high bedding rock slope in the Baihetan Hydropower Station. The results showed that the failure modes of the bedding rock slope were of two types: sliding-fracturing and fracturing-sliding. The first slip block at the exposed place of the structural plane was sliding-fracturing. Other succeeding slip blocks were mainly of the fracturing-sliding type due to the blocking effect of t

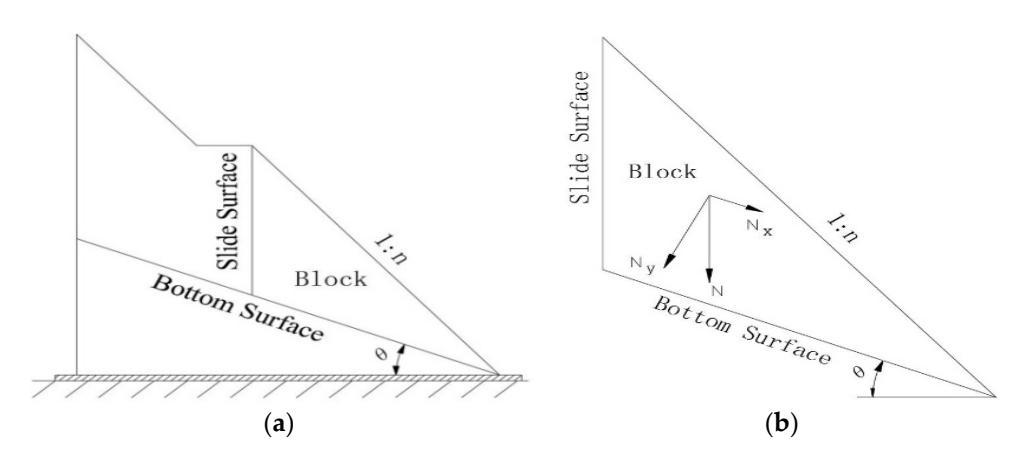
Schematic diagrams of the rock slope under natural condition and under loads are shown in Figure 1.

Figure 1. Schematic diagram of rock slope in natural state and load analysis: (**a**) slope in natural state; (**b**) load analysis.

According to the shear strength formula, the antislide force *F* and sliding force *T* of the slope block are expressed as follows:

where f' is the friction factor of the bottom surface, c' is the cohesion force of the bottom surface, A is the contact area of block per unit width, N is the deadweight of block per unit width, N_x is the horizontal component of N on the bottom surface, N_y is the vertical component of N on the bottom surface, and θ is the dip angle of the bottom surface in the natural state.

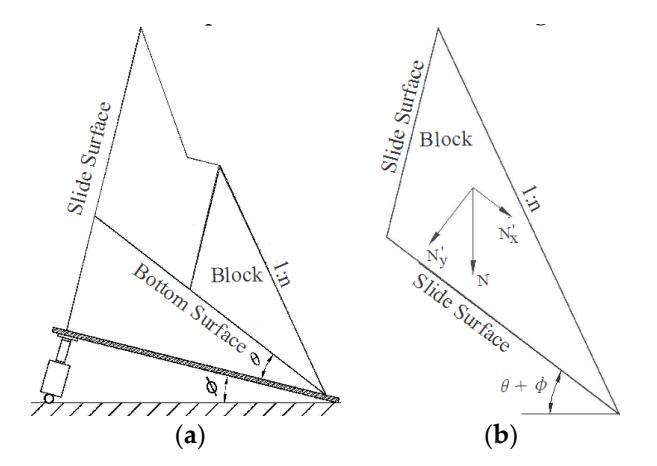
Schematic diagrams of the rock slope and the loads at the lifting state are shown in Figure 2.

Figure 2. Schematic diagram of rock slope in lifting state and load analysis: (a) slope in lifting state; (b) load analysis.

In the overloading method, the increased sliding forces of the slope rock mass are mainly achieved by lifting the steel frame. Here, global slope failure occurs when the uplift angle of the steel frame equals to Φ . The K'_p at the ultimate state is defined as follows:

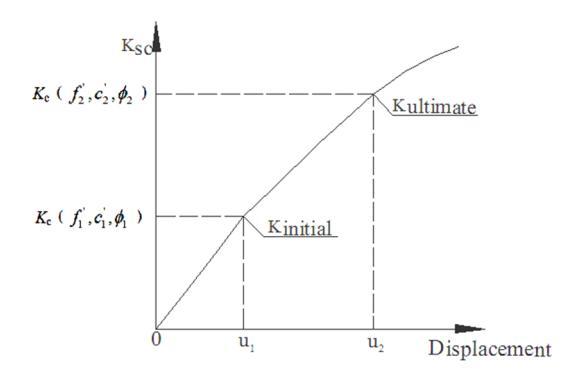
The typical relationship curve of slope displacement vs. K_{sc} for the comprehensive method is shown in Figure 3. From this figure, two feature points of slope deformation can be obtained. One is the initial crack feature point, and the other is the penetrating crack feature point. Thus, the basis for

judging the safety factor of the comprehensive method is defined as follows: the K_c (f'_1 , c'_1 , and ϕ_1) corresponding to the initial crack feature point is the initial safety factor K_{Initial} , and the K_c (f'_2 , c'_2 , and ϕ_2) corresponding to the penetrating feature point is the ultimate safety factor K_{Ultimate} .

Figure 3. Typical relationship curve of slope displacement vs. *K*_{sc}.

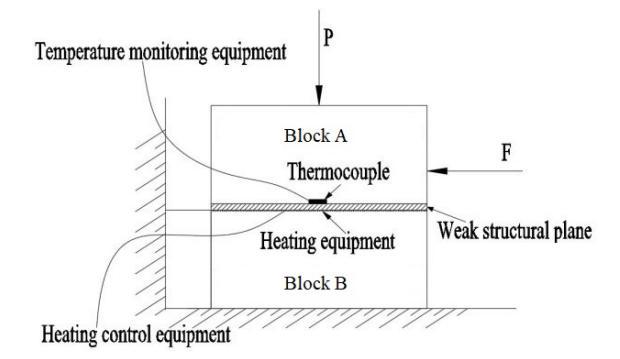
In this study, according to the strength reduction principle of structural plane materials, the heating system and temperature control monitoring system were set in the footwall rock block under the structural plane. The heating system was composed of a heating equipment embedded inside the model and a heating control equipment outside the model. The temperature control monitoring system included a thermocouple embedded inside the model and a temperature monitoring equipment outside the model. The layout of the temperature control system is shown in Figure 4.

Figure 4. Layout of the temperature control system.

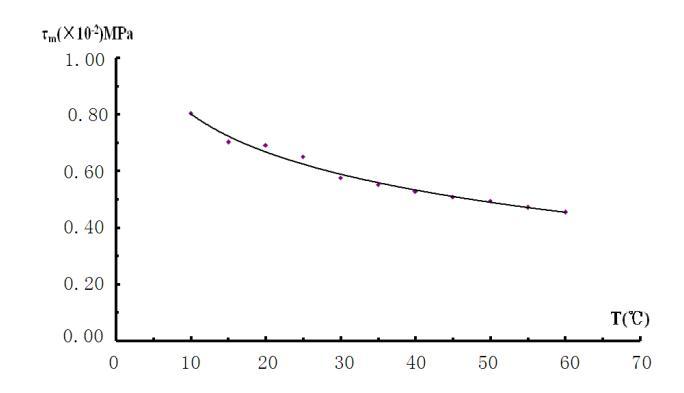
According to the similarity relationship of antishearing strength and deformation modules of structural planes at normal temperature, strength reduction materials were prepared, which were mainly composed of barite powder, machine oil, and fusible polymer. The shear test with the variable temperature process was performed to obtain the relationship curve between the antishearing strength of the material τ (f', c') and the temperature T. A typical τ –T relationship curve of strength reduction material is shown in Figure 5. According to this relationship curve, the mechanical parameters of structural planes can be accurately reduced. This reduction technique provides a strong technical basis for the comprehensive method.

Figure 5. Typical τ -*T* relationship curve of strength reduction material.

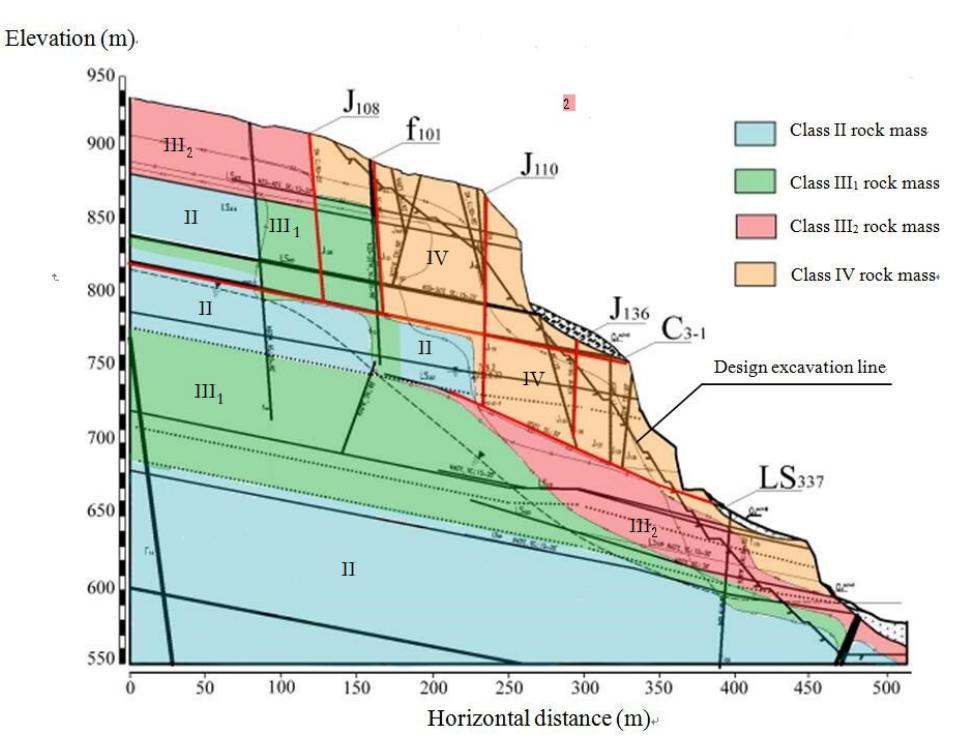
The object of the slope stability study was the I₅ section of the left bank high slope after excavation. The simulation range and the geological structure of the two-dimensional slope model are shown in Figure 6. Physical–mechanical parameters of the structural planes are shown in Table 1. There were six simulated weak structural planes, namely, LS₃₃₇, C₃₋₁, f₁₀₁, J₁₁₀, J₁₃₆, and J₁₀₈, of which LS₃₃₇ and C₃₋₁ were bottom slip planes, and f₁₀₁, J₁₁₀, J₁₃₆, and J₁₀₈ were rear edge planes. The simulated strengthening measures mainly included two small concrete plugs, i.e., #2 and #3 (3 m × 5 m) in the first phase, and a large concrete plug, i.e., #1 (6 m × 8 m) in the second phase on the LS₃₃₇ plane.

Figure 6. Simulation range and geological structure of the I₅ section.

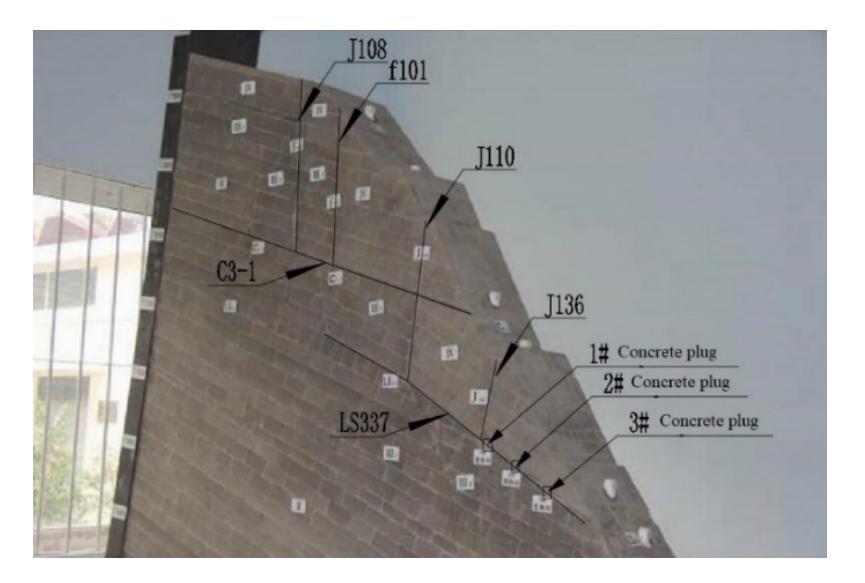
During the modeling process, the four rock classifications (II, III₁, III₂, and IV) were simulated through different materials from their geometric characteristics and spatial locations relative to each other. This test focused on the simulation of six weak structural planes, namely, LS_{337} , C_{3-1} , J_{110} , J_{136} , f_{101} , and J_{108} , in the I₅ section. The model adopted two-dimensional cross control along the river and elevation directions. The two-dimensional geomechanical model of slope is presented in Figure 7.

Figure 7. Two-dimensional geomechanical model of slope.

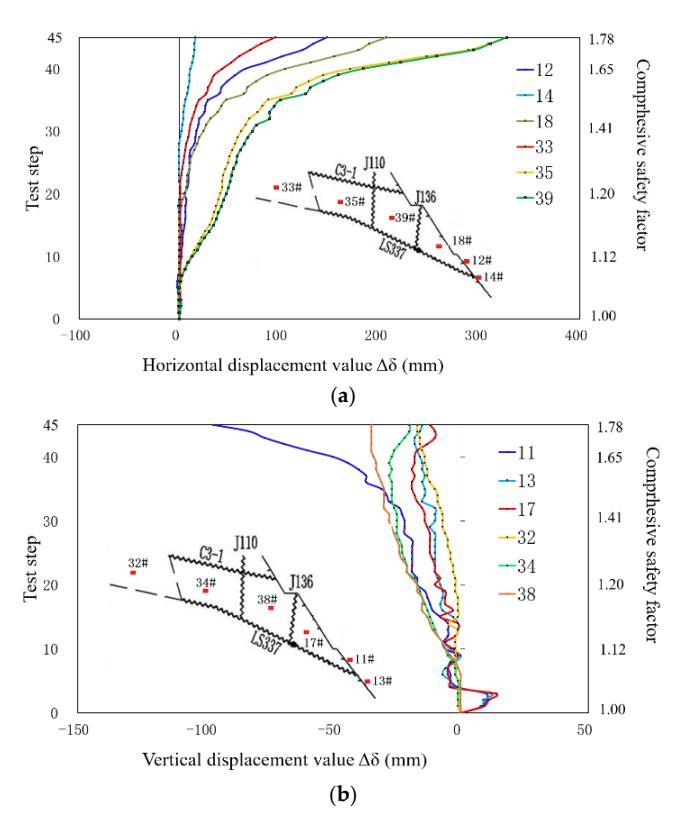
The curves of the slope displacements are shown in Figures 8 and 9. Outward is positive for horizontal direction displacement, while up is positive for vertical direction displacements. According to the distribution characteristics of the slope displacement, the deformation process of the slope consisted of three stages: uniform stage (1st to 35th step), dislocation stage (35th to 37th step), and failure stage (42nd to 45th step).

Figure 8. Typical curve of slope surface displacement (monitoring points near LS₃₃₇). (a) Horizontal displacement; (b) vertical displacement.

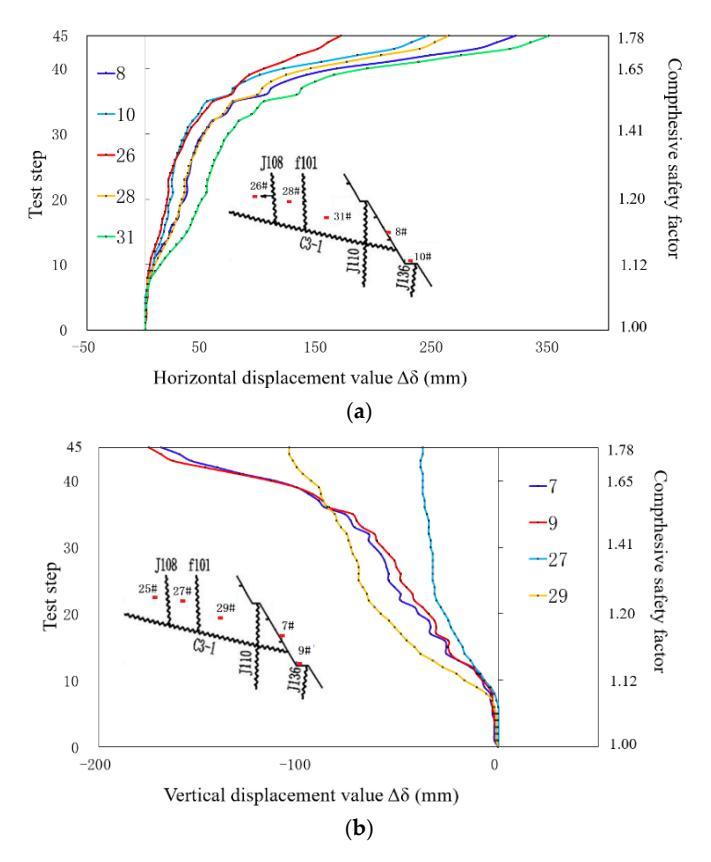
Figure 9. Typical curve of slope surface displacement (monitoring points near C_{3-1}). (a) Horizontal displacement; (b) vertical displacement.

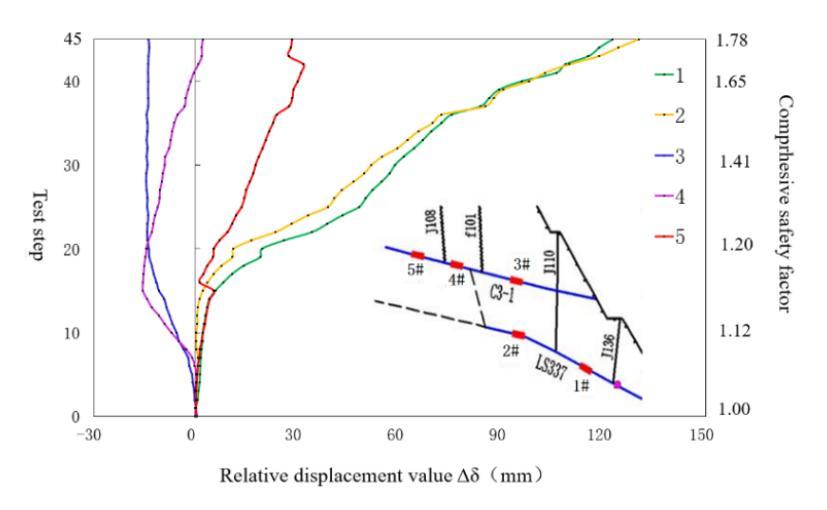
During the second to sixth steps, the displacement curves exhibited a slight fluctuation, and the relative displacement value gradually increased. In particular, the relative displacement of C_{3-1} significantly increased (such as #3 and #4). During the 14th to 16th steps, the displacement curves exhibited apparent fluctuation and transition. At this time, the front edge rock of the slip block #II-1 cracked, and the bottom slip plane and rear edge plane of #I-1 cracked, grew, and intersected each other. During the lifting stage, the relative displacement of LS_{337} significantly increased (such as #1 and #2), but the relative displacement of C_{3-1} increased relatively slowly. This was mainly because C_{3-1} was located within the upper rock of LS_{337} and both the upper and lower rock of C_{3-1} slip along LS_{337} ; therefore, the relative dislocation between the hanging wall and footwall of C_{3-1} was apparently less than that of LS_{337} . During the 35th to 37th steps, the displacement of LS_{337} became greater. At this time, all the structural plane cracks penetrated, leading to the formation of multiple blocks. The blocks slipped outward along the C_{3-1} and LS_{337} , and the slope showed a trend of global instability.

Figure 10. Relative displacement curve of LS₃₃₇ and C₃₋₁.

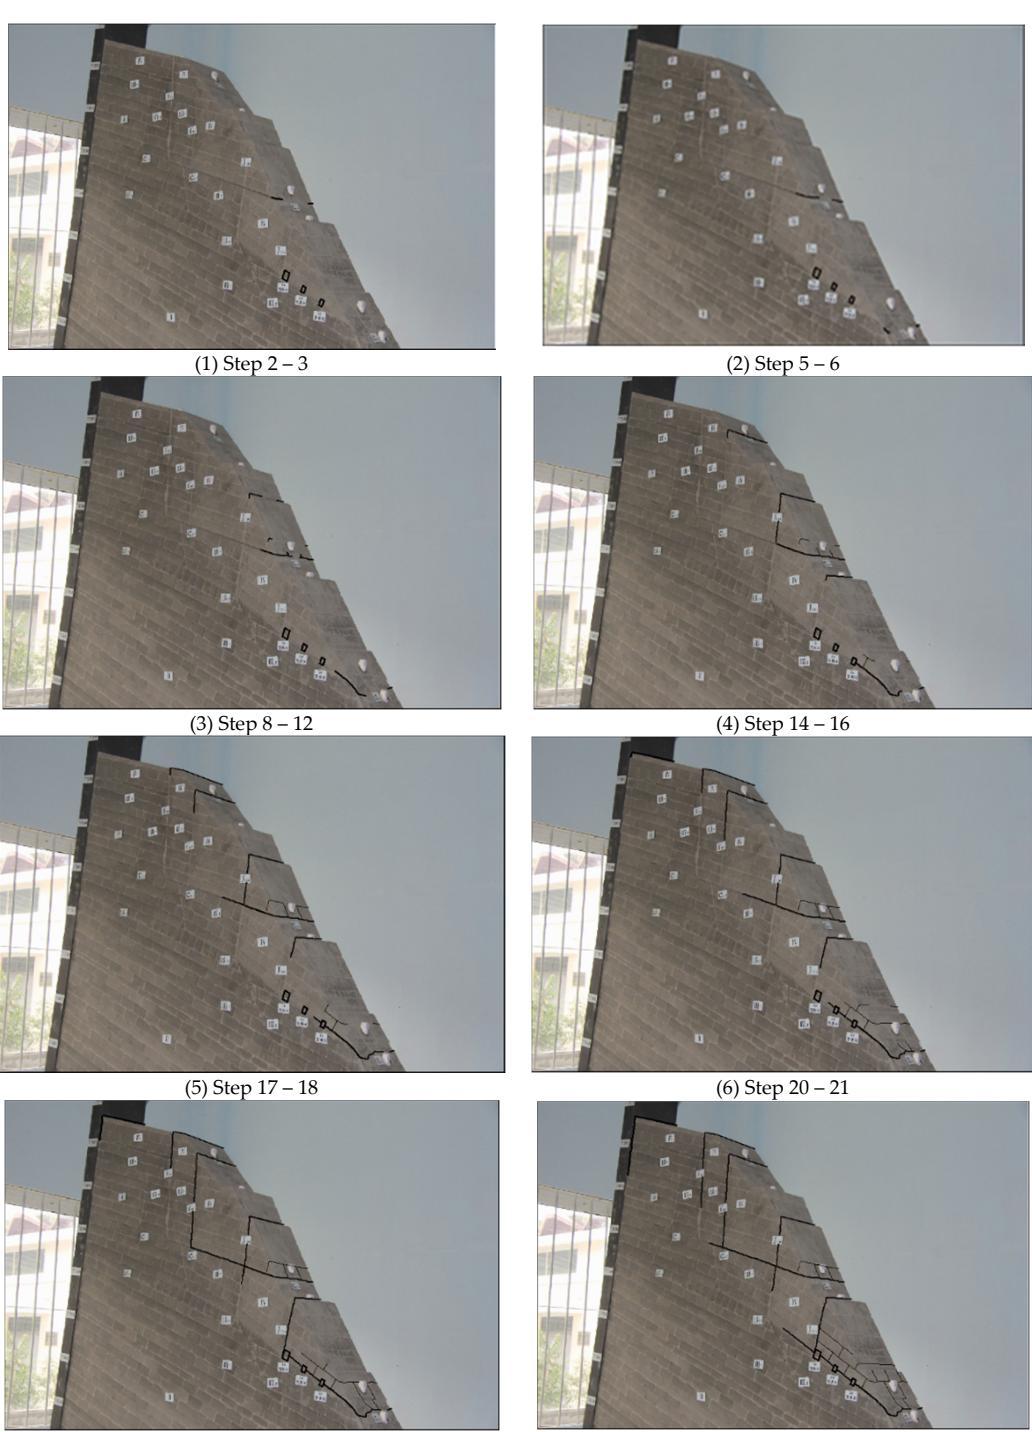
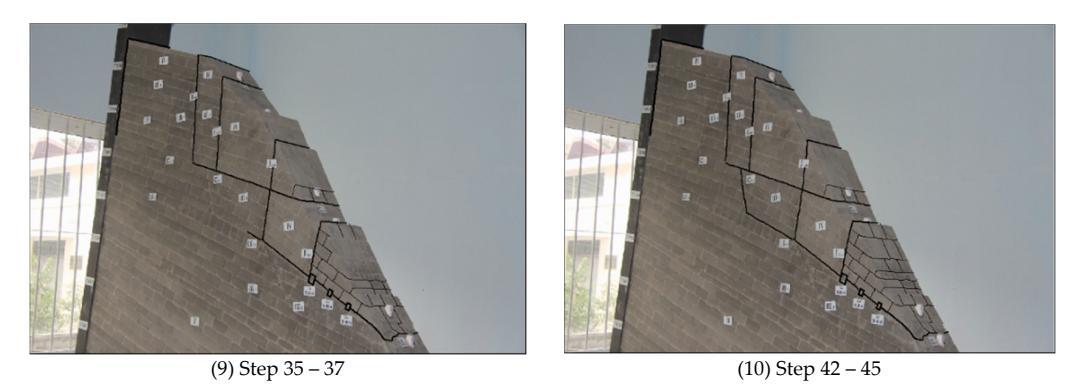
Failure patterns of the full process are shown in Figure 11, where the black line represents an instability crack.

During the second and third steps ($K_S = 1.05-1.059$), C_{3-1} exhibited microcracks at the exit, with a crack length of about 2 cm (Figure 11(1)). After that, the steep structural planes on the back edge of the slip blocks were pulled apart from the exit of the slope surface one after another. After the first block slipped, its rear edge tensile crack surface became the front edge empty surface of the next block. This resulted in the slip of the rear edge blocks one after another, and the failure area gradually developed from the slope surface to the interior.

During the 35th to 37th steps ($K_S = 1.2$, $K_P = 1.272-1.313$), cracks J_{110} , C_{3-1} , and J_{108} grew downward and joined with LS_{337} to form multiple slip blocks. The cracks at the rear edge surface of the slope opened to C_{3-1} . The landslide steps were easily observed at the exit of J_{136} and J_{110} . The blocks between J_{136} and J_{110} sank and formed a landslide step (Figure 11(9)).

During the 42nd to 45th steps ($K_S = 1.2$, $K_P = 1.42-1.487$), all structural planes had been cracked through. The cracks apparently opened and intermingled to form multiple slip blocks, of which the crack gap of J₁₀₈ was relatively large, with a maximum gap of up to 2 mm (model value). The multiple slip blocks exhibited crushing-types of cracks, generated a great number of cracks along the joints, and tended to collapse. The slope showed global instability (Figure 11(10)).

Figure 11. Failure pattern of the full process.

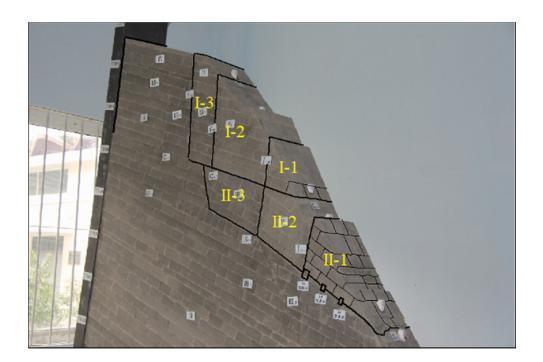
Failure sequence diagram of the slip blocks is shown in Figure 12. The slip blocks were gradually formed along the structural plane. For LS₃₃₇, the failure sequence of the slip block was as follow: I-1 > I-2 > I-3. For C₃₋₁, the failure sequence of the slip block was as follow: II-1 > II-2 > II-3. Therefore, the whole failure sequence of the slip blocks along the structural planes was graded into three levels. The slip blocks along the lower structural planes were formed at a later time than that along the upper structural planes.

Figure 12. Failure sequence diagram of the slip blocks.

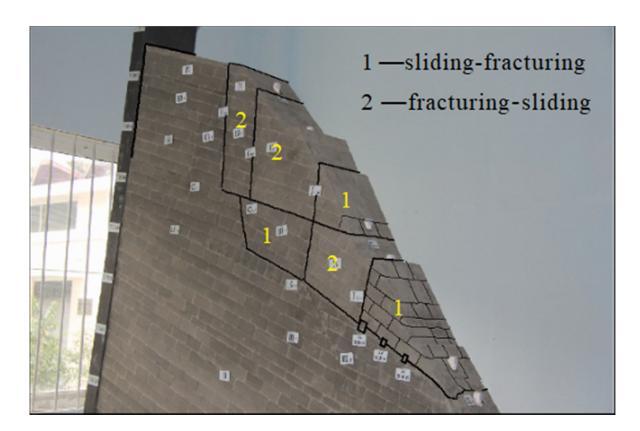
The failure modes of the slope are shown in Figure 13. The failure modes of the bedding rock slope were of two types: sliding–fracturing and fracturing–sliding. The slip blocks of sliding–fracturing were I-1, II-1, and II-3, while the slip blocks of fracturing–sliding were I-2, I-3, and II-2. In summary, the slip block of sliding–fracturing was the first slip block at the exposed place of the structural planes. Due to the blocking effect of the first slip block, the sliding of the lower slope body was restricted. Other blocks that formed behind the first block were mainly fracturing–sliding.

Figure 13. Failure modes of the slope.

(2) The failure modes of the bedding rock slope were revealed as being of two types: sliding–fracturing and fracturing–sliding. The slip block of sliding–fracturing was the first slip block formed at the exposed place of the structural planes. Due to the blocking effect of the first slip block, the sliding action of the lower slope body was restricted. Other blocks formed behind the first slip block were mainly fracturing–sliding.

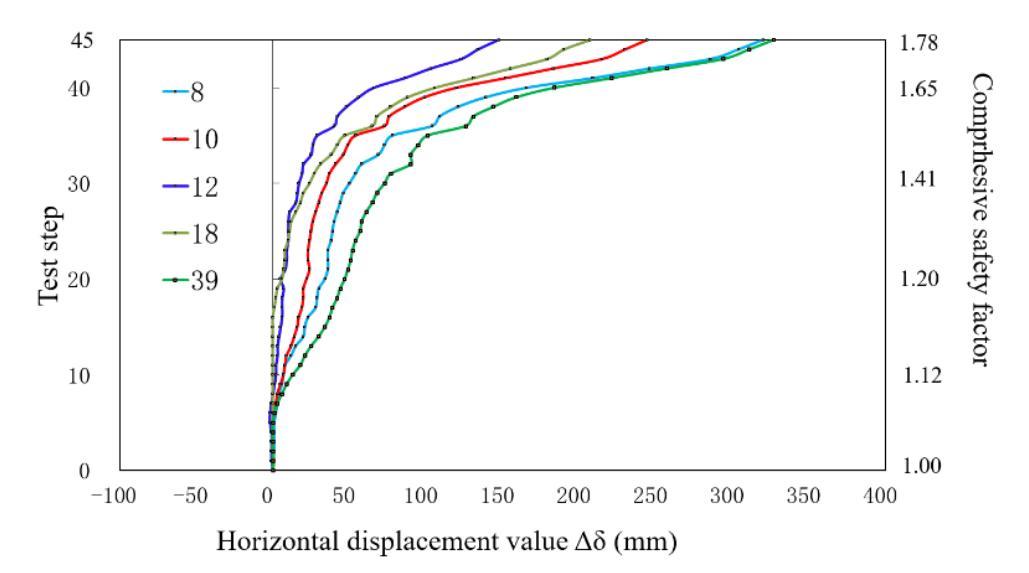
According to typical curve of displacement surface near the concrete plugs (Figure 14), during the 14th to 16th steps, cracks grew down along J_{110} and joined with C_{3-1} to form a complete #I-1 slip block; the crack at the front edge rock of LS₃₃₇ just opened to #3 concrete plug due to reinforcement effects of the concrete plugs. During the 24th to 26th steps, cracks grew downward along f_{101} and joined with C_{3-1} to form a complete #I-2 slip block. Meanwhile, cracks grew downward along J_{136} and joined with LS₃₃₇ to form a complete #II-1 slip block. When the slope exhibited a trend of global instability, all structural planes had been cracked through; the cracks apparently opened and led to the formation of multiple slip blocks.

The test showed that the concrete plugs could improve the shear resistance of structural planes and inhibit the dislocation between two layers. The displacement magnitude near the concrete plugs was relatively smaller. The slip block reinforced by concrete plugs (such as #12 and #18) would be formed later than without it.

Figure 14. Typical curve of slope surface displacement (monitoring points near concrete plugs).

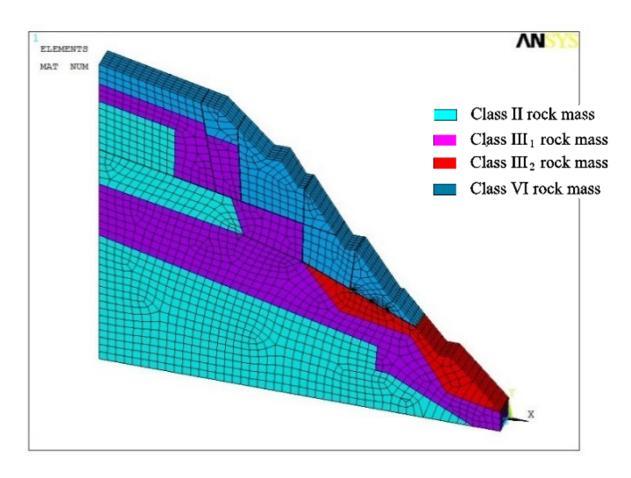
To verify the test results of the comprehensive method, the finite element method was utilized to compare the slope failure process. The two-dimensional calculation grid graph of the left bank slope is presented in Figure 15.

Figure 15. Two-dimensional numerical calculation grid graph of the slope.

The simulation range, load combination, and mechanical parameters utilized in the calculation were consistent with the model test. The finite element software ANSYS was utilized for nonlinear analysis of materials. The Drucker–Prager yielding criterion was utilized for strength criterion analysis. The rock utilized the solid45 element, and the concrete plug utilized the solid65 element. The model contained 9354 discrete elements and 11,476 nodes. The model coordinate system used the X-axis for the horizontal direction with the positive direction to the right, the Y-axis for the vertical direction with the positive direction with the Z-axis for the water flow direction with upstream as the positive direction.

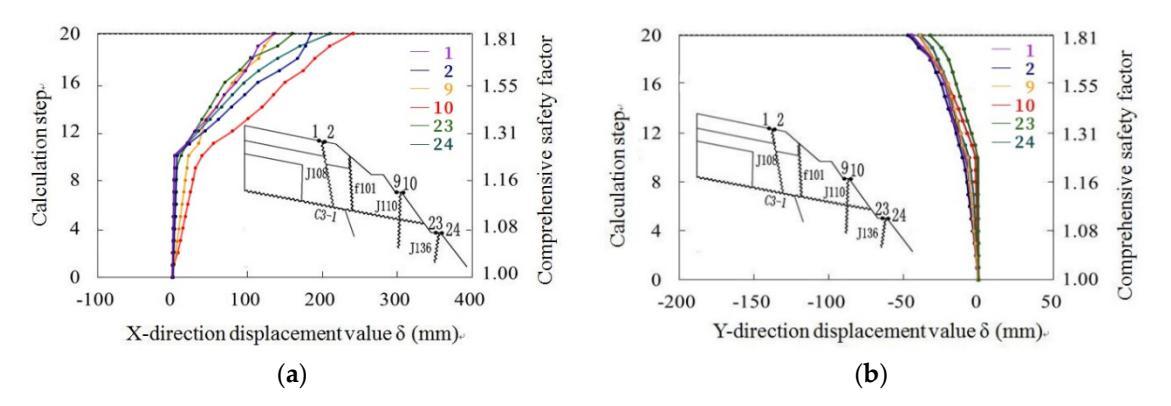
According to the relationship curves of the slope surface displacement (Figure 16), during the fourth to fifth steps ($K_S = 1.08 - 1.10$), the displacement curve showed fluctuation. Prior to the 10th step ($K_S = 1.20$), the surface displacement of the slope was dominated by the vertical settlement toward the valley, and the displacement curve exhibited a steady increase in linear mode with a smaller displacement. During the 16th to 18th steps ($K_P = 1.295 - 1.401$), most of the curves began to turn back, and the displacement gradually increased. The settlement displacements showed apparent increases in both the X and Y directions. The displacements of #10 and #24 in the X direction were very significant, as were #1 and #2 in the Y direction.

Figure 16. Typical curve of slope surface displacement. (a) Horizontal displacement; (b) vertical displacement.

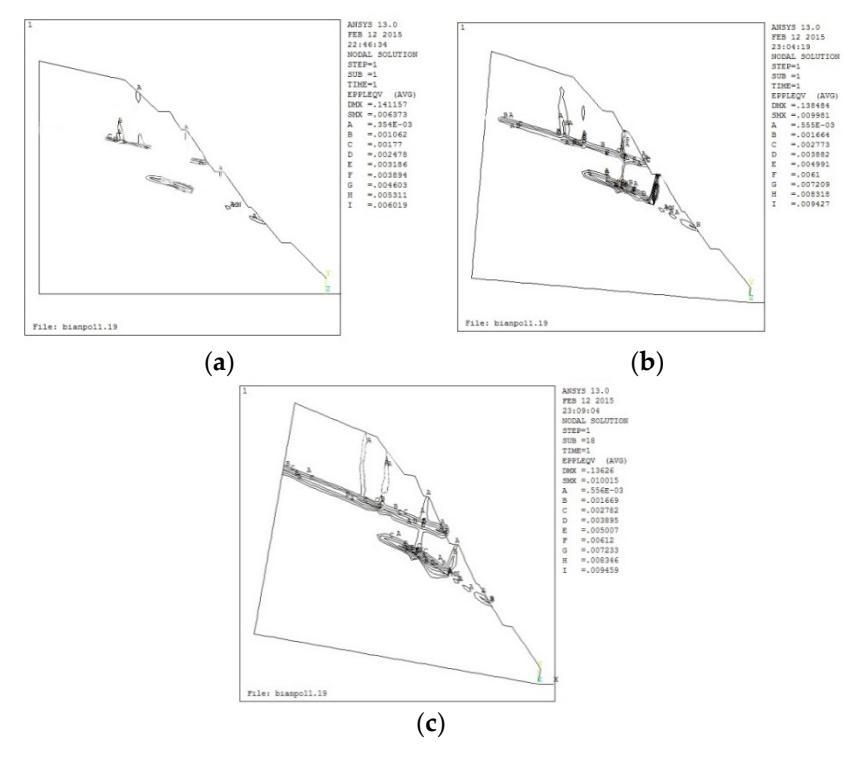
According to the distribution graph of the plastic zone (Figure 17), it was found that under the application of slope self-weight, plastic zones showed up at the exit of C_{3-1} and LS_{337} . The intersected locations of the structural planes between C_{3-1} and J_{108} and between LS_{337} and J_{110} all showed relatively small plastic zones. When the slope model was uplifted 5° ($K_P = 1.243$), the plastic zone on the cracked

plane J_{110} penetrated C_{3-1} and extended to LS_{337} , and the cracked plane J_{136} was penetrated. Thus, multiple slip blocks were formed. When the slope model was uplifted 10° ($K_P = 1.512$), the plastic zones of various structural planes grew, penetrated, and intersected each other, and the slope showed global instability.

Figure 17. Plastic failure process isoline of numerical calculation. (**a**) Under the self-weight; (**b**) $K_P = 1.243$ (with uplift 5°); (**c**) $K_P = 1.512$ (with uplift 10°).

In numerical calculations, the slope was primarily affected by the structural planes. Plastic failure first occurred on these structural planes. When the strength was reduced by a factor of 1.2, the two bottom slip planes and four cracked planes showed plastic failure, and apparent shear failure was observed on the bottom slip planes. With the increase of the uplift angle, the cracked plane was fractured by tension from the upper to the lower part. The plastic zones on the two bottom slip planes grew toward the interior and penetrated. When the slope finally failed, the plastic zones on various structural planes grew and penetrated, intersected with each other, and formed slip blocks and slip channel. Due to the concrete plugs, the plastic zone in the front edge of LS_{337} was not penetrated. The failure pattern was consistent with the model test results.
