# Article Natural Rail Surface Defect Inspection and Analysis Using 16-Channel Eddy Current System

**Abstract**: Trains are used as the fastest mode of transportation for both people and cargo. The train moves along a special path called "rail", where fatigue can be accumulated due to wheel-rail contact load as a result of continuous train operation. Consistent and regularly scheduled safety management is required since corrosion rate of the rails located on outside environment is very high. Researchers have actively investigated and developed rail defect inspection systems employing non-destructive techniques to address these problems. In particular, the eddy current inspection technique does not involve contact with the surface of the test specimen and offers the advantage of excellent rail defect detection sensitivity. Therefore, a 16 Channel array eddy current inspection device was developed to inspect the surface defects of the rail. An equation was derived to predict the correlation between the depth and phase of an artificial defect using the eddy current inspection device, and the derived equation was applied to the natural defect specimen.

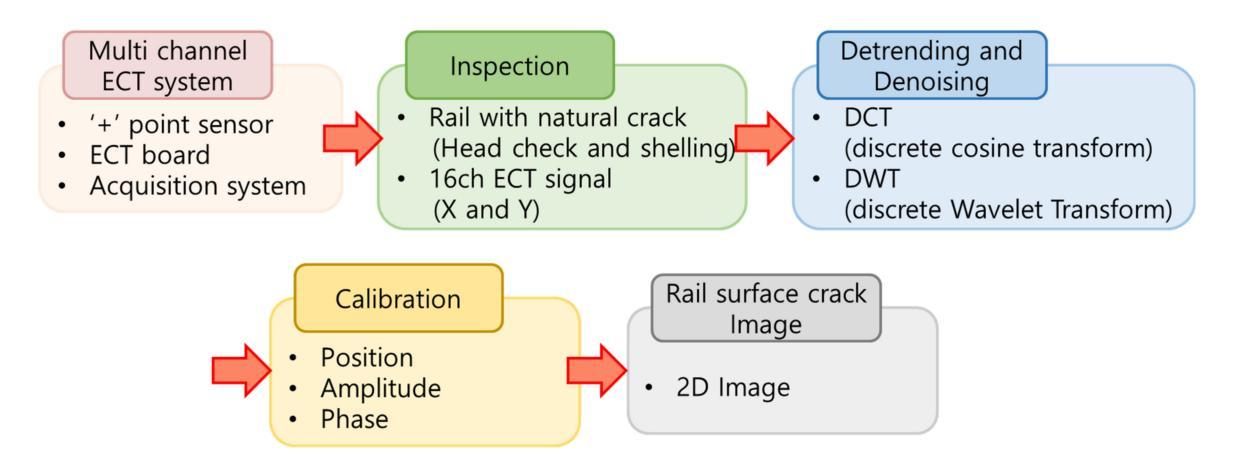
Figure 1. Multi-channel ECT signal analysis.

Figure 1 displays the analysis sequence for multi-channel eddy current testing. The X and Y data of natural rail defect test specimens were collected using a multi-channel sensor, and the data were subsequently subjected to a de-trending and de-noising process. It was possible to acquire the defect image after correcting the difference (amplitude and phase) between the sensors. The procedure is described in detail in Figure 1.

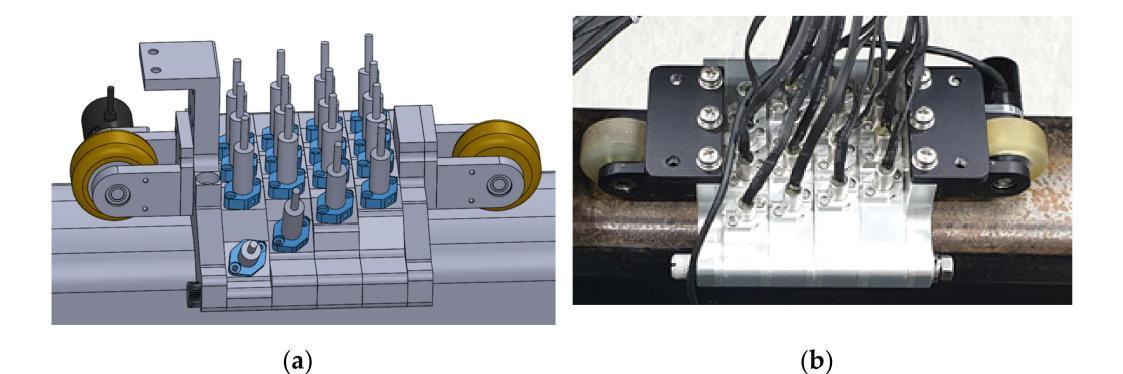
Figure 2. Multi-channel ECT sensor jig: (a) jig design, (b) jig maked.

The jig was constructed as shown in Figure 2a,b such that the 16 sensors could be secured and the entire rail surface could be inspected. The sensor spacing in the direction of rail propagation was set to 18 mm, and to inspect the entire rail head, the sensor spacing between the rail propagation direction and vertical direction was 3.8 mm, which resulted in a total of 57 mm. The jig to which the sensors were connected was divided into four parts and could be disassembled and reassembled. Four sensors were combined onto one jig apparatus, and the arrangement of the sensors could be changed by disassembling and reassembling the jig. Furthermore, a constant lift-off distance from the wheels attached to the jig to the rail surface could be maintained.

As shown in Figure 2 because the sensors are not on a straight line arranged in a  $4 \times 4$  as shown in Figure 5a. Therefore, when scanning the test piece in Figure 4, it was possible to obtain the results shown in Figure 5a. Since the actual defect lay in a straight line, a position correction was required, and a calibration value that minimized the amplitude difference between sensors was required.

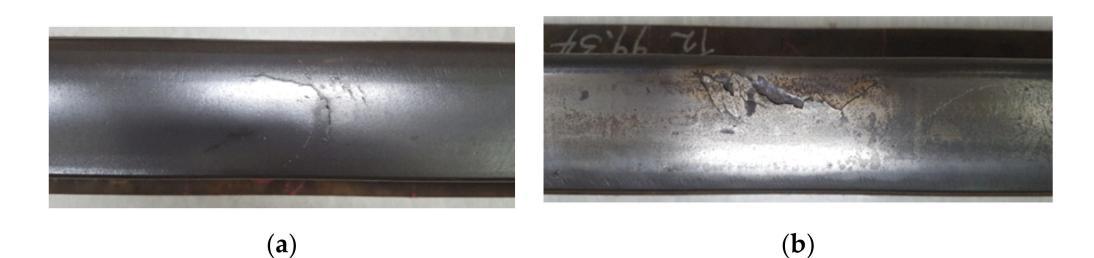
Figure 3. Crack specimen: (a) head check and (b) shelling.

Natural defects occur because of rolling stock operation on the rail and cumulative tonnage (more than 500 million tons) and external environmental factors. Natural defects that occur in general are shown in Figure 3a,b. Figure 3a shows a head check defect on the rail surface, and Figure 3b shows a shelling defect on the rail surface.

A head check occurs as a solid line resulting from slip and frictional stress between the rail and the wheel [15,16]. Shelling occurs because of the development of the head check; it is a defect in which the surface of the rail breaks shallowly because of the continuous load and friction of the train.

The calibration data in Table 1 were applied, and the results of the head check defect inspection shown in Figure 3a using the 16-channel sensors are shown in Figure 14. Figure 14a shows the X data (resistance), and Figure 14b shows the Y data (reactance). As shown in Figure 14a,b, the depth of the head check defect can be expected to vary because the X and Y signals are measured differently.

Figure 15a shows the image results after the shelling defect from Figure 3b was calibrated. The image shown in Figure 15b was used for an exact comparison by overlaying it with the image in Figure 15a with the actual defect, and the deep-pitched position was measured to be at a similar point, but not at the exact same position. The measurement was conducted a total of six times using a 16 Ch array eddy current device, and the average value of the phases was measured at 41.248°. As a result of the calculation by applying the measured phase to Equation (1), the depth of the defect was 6.454 mm.

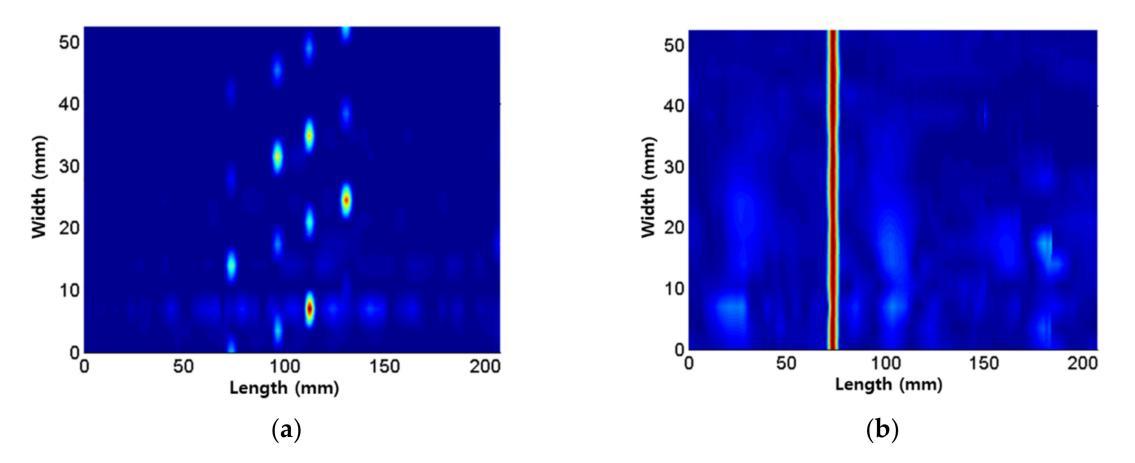
Figure 5. Calibration: (a) before and (b) after.

Figure 5b shows the result of applying the calibration value, and it was confirmed that all had the same amplitude at the same location.

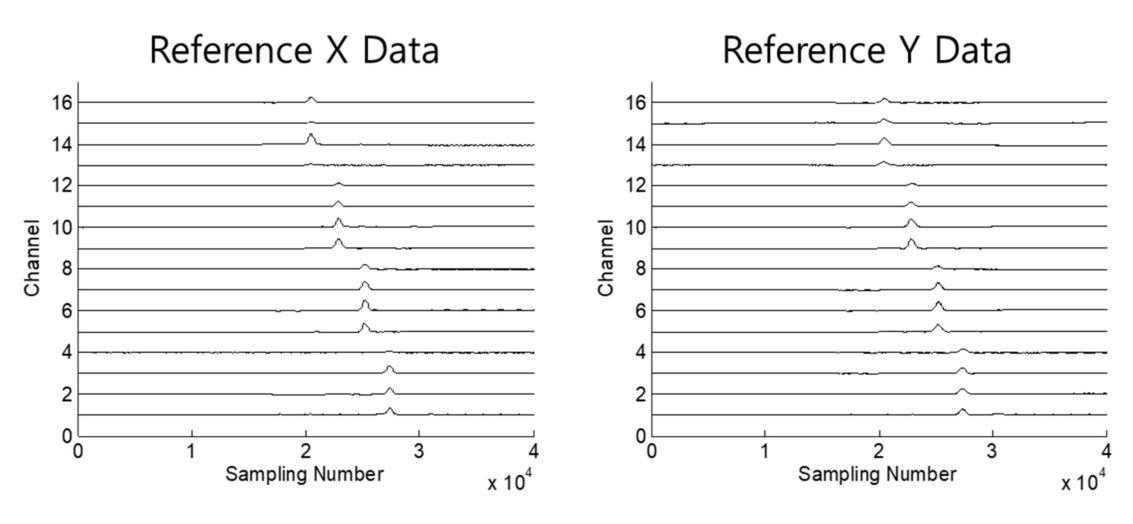
Figure 6. Reference data.

Figure 6 shows the raw data of the 16 Ch eddy current sensor passing the calibration test piece in Figure 4. Since only one defect existed in the calibration test piece, the amplitude change occurred once for each sensor. It can be seen that there was a difference in amplitude depending on the characteristics of each sensor and that sensors 4 and 8 generated a great deal of noise.

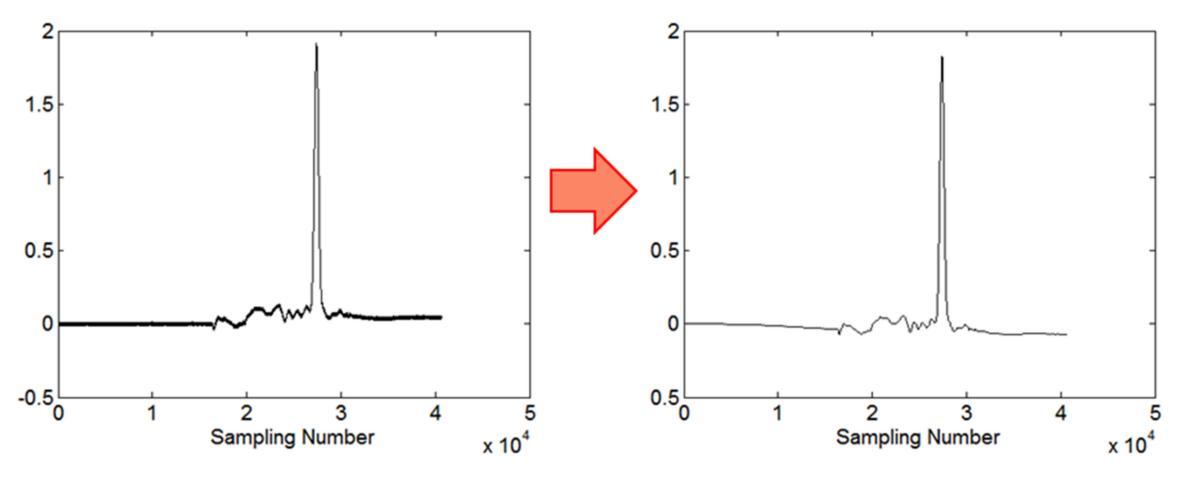
Figure 7. Denoising process.

Since the noise of the signal prevented the identification of the location of the defect or acted as an error in analyzing the size of the defect, noise removal was performed through denoising. The denoising technique used in this study was "DC Offect", and signal processing was performed by applying data between the initially generated low frequency and a specific high frequency. Figure 7 shows the denoising process, and it was confirmed that the noise disappeared as a result of applying "DC Offect".

As can be seen in Figure 7, the denoising data had a certain tendency. Certain trends could also be viewed as noise, and detrending removed certain trends in the data. In this study, the "Polynomial Fitting—Bisquar and Givens" technique was used for detrending. Figure 8 shows the process of detrending the data of Ch4 after the denoising process.

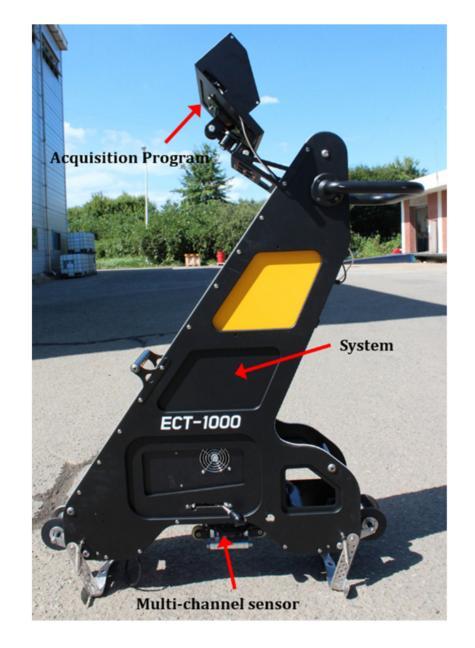
Figure 9. Equipment used in the field.

In order to carry out the inspection at a long distance in the field, the equipment shown in Figure 9 was manufactured. The multi-channel sensor has 16 transducer channels built in, and the system is equipped with power and sensors for collecting signals, and the acquisition program can be installed on a tablet PC to lighten the equipment. The inspection speed of the equipment was set to 2 km/h, compliant with the average walking speed of most people.

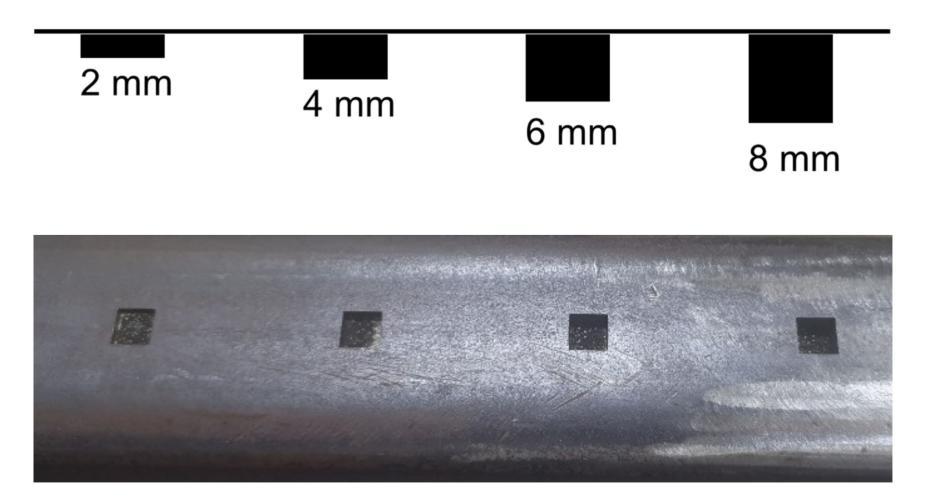
Figure 10. Artificial defect depth change of the specimen.

In order to derive the relationship between the depth and the phase of the defect, as shown in Figure 10, the artificial defect specimen was constructed with four squat defects on the UIC60 sample. The depths of the defects were 2, 4, 6, and 8 mm, and the lengths and widths were all 10 mm.

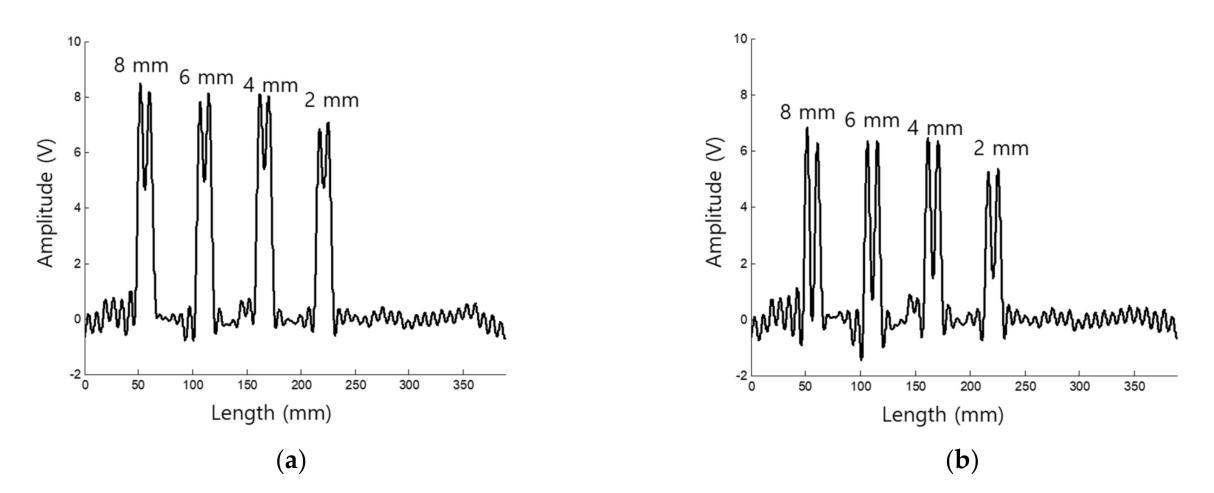
Figure 11. Ch 8 Data: (a) X data (resistance) and (b) Y data (reactance).

Figure 11 shows the results of the scan of the artificial defect specimen. Figure 11a is the X data (resistance) of the eighth sensor, and Figure 11b is the Y data (reactance). As shown in Figure 11a,b, detrending and denoising were performed through signal processing. As a result of applying calibration, it was confirmed that two peaks were generated when the detector passed through the defect. These two peaks are the startand endpoints of the defect, and the length of the defect can be measured using the two peak points.

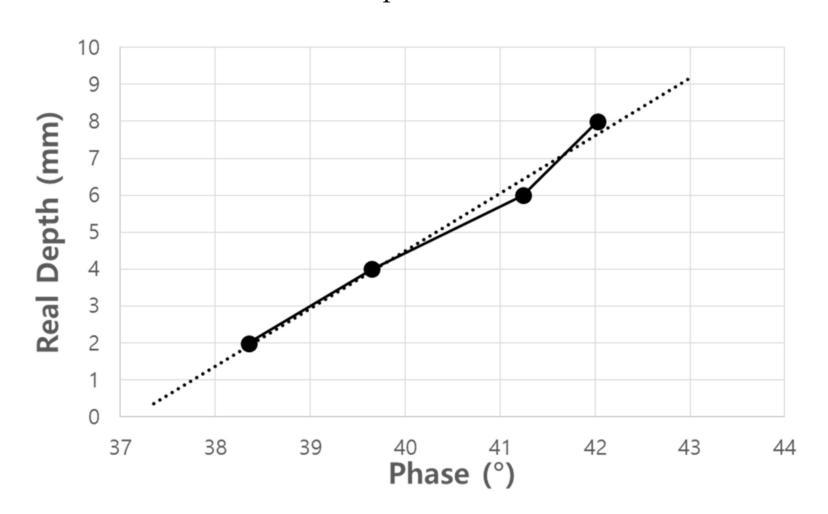
Figure 12. Correlation between depth and phase.

The phase was used to estimate the depth of the defect. Figure 12 shows the relationship for estimating the depths of the defects, and Equation (1) shows the relationship between depth and phase. As a result of the measurement, it was confirmed that the phase increased at a constant rate as the depth of the defect increased.

$$Depth = 1.5593 \times Phase - 57.864$$
 (1)

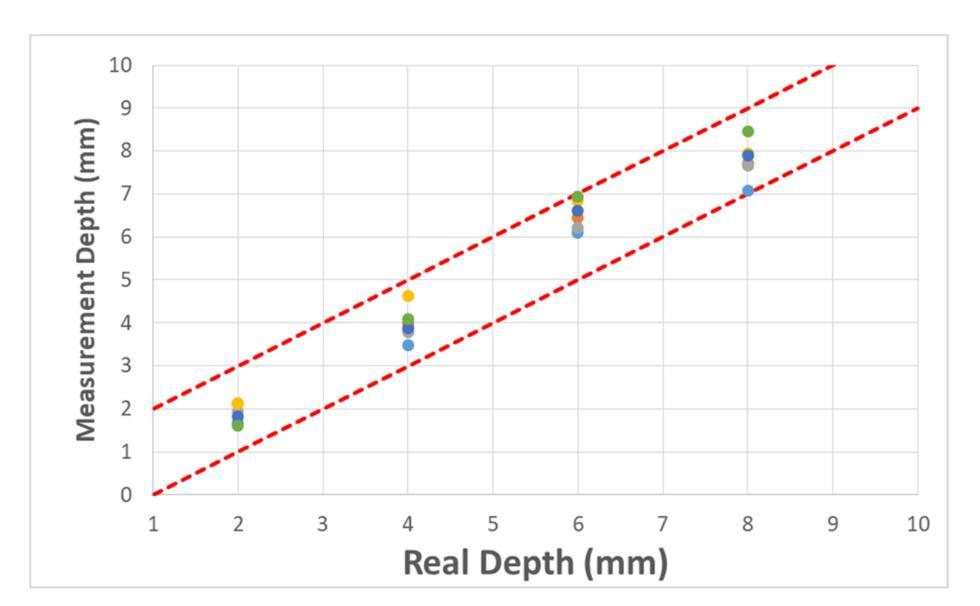
Figure 13. Depth estimation result of the artificial defect specimen.

Figure 13 shows the results of estimating the depth of artificial defects according to the depth change through a total of six repeated experiments. The red dotted line in Figure 13 is an error bar of  $\pm 1$  mm, and it can be observed that there was no point beyond the error bar. Therefore, it is possible to estimate the depth of the surface defects of different specimens using the correlation between the depth and the phase of the derived defect.

Furthermore, to analyze the depth of defects, artificial defects were produced to derive the correlation between the defects and the phase. To confirm the reliability of the derived correlation, it was confirmed that the error range does not exceed  $\pm 1$  mm through a number of experiments. It was confirmed that the depth can be analyzed using the correlation derived from the depth measurement of the natural defects.

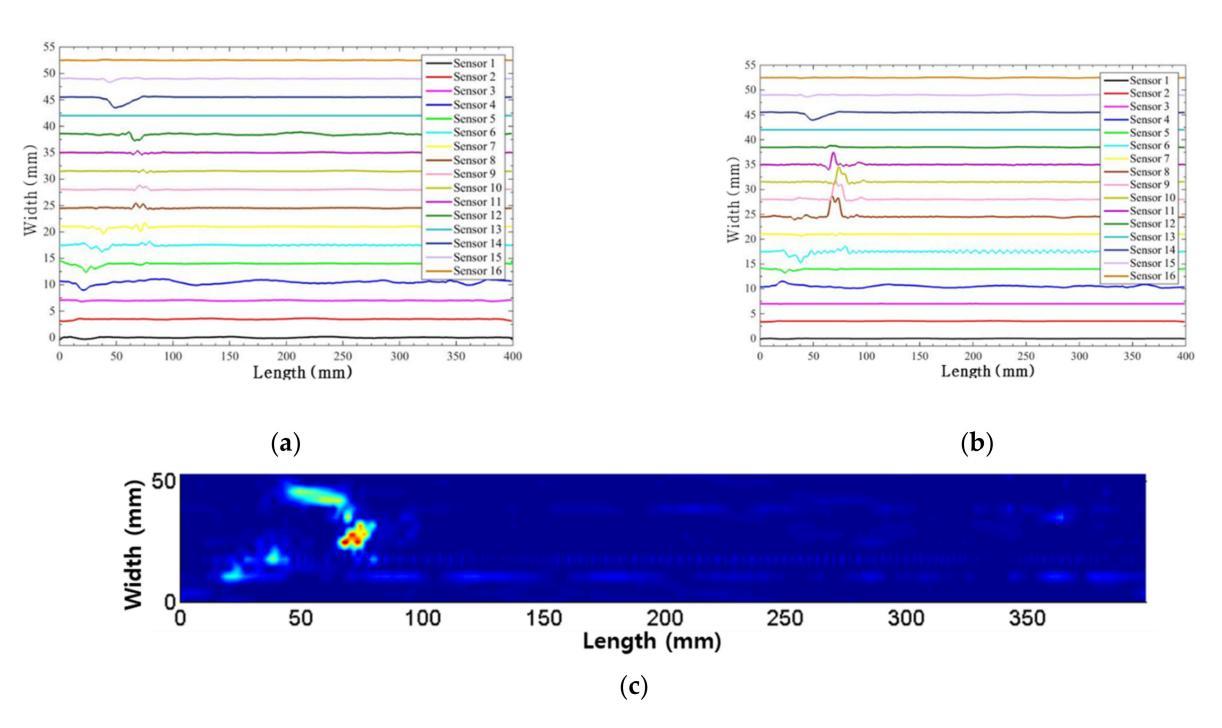
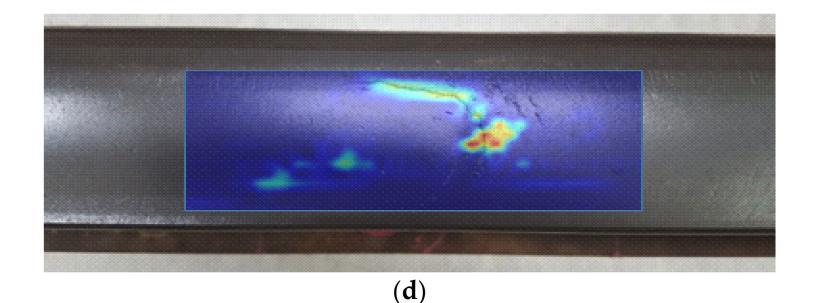
**Figure 14.** Head check signal using 16 Ch array ECT sensor: (**a**) X data (resistance), (**b**) Y data (reactance), (**c**) 2D, and (**d**) real and result crack.

Figure 14c shows an image similar to the shape of the specimen as a result of calibration. The image shown in Figure 14d was used for an exact comparison by overlaying the defect part in Figure 14c with the image of the actual defects, and the results were shown to be consistent with head check defects.

The measurement was conducted a total of six times using a 16 Ch array eddy current device, and the average value of the phases was measured at 40.153°. As a result of the calculation by substituting the measured phase into Equation (1), the depth of the defect was 4.747 mm.
