# Article **Proper Technical Maintenance of Combine Harvester Rolling** Bearings for Smooth and Continuous Performance for Grain **Crop Agrotechnical Requirements**

Eglė Jotautienė, Antanas Juostas and Shankar Bhandari \*

Institute of Agricultural Engineering and Safety, Agriculture Academy, Vytautas Magnus University, LT-53362 Akademija, Lithuania; egle.jotautiene@vdu.lt (E.J.); antanas.juostas@vdu.lt (A.J.)

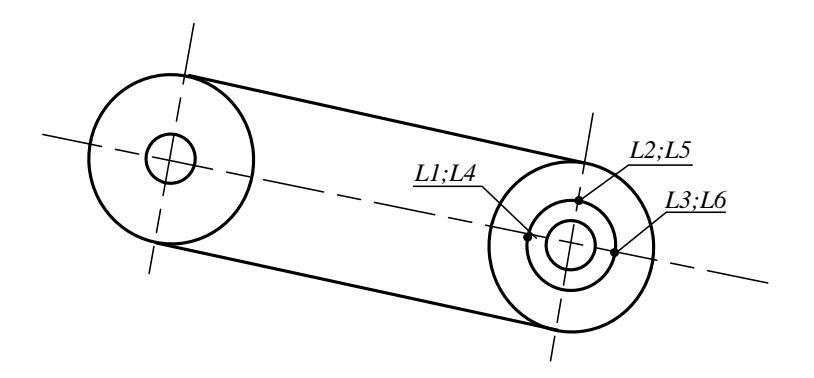
**Figure 1.** Bearing vibration measuring points: L1, L2, L3; accelerometer placed directly on a bearing seat. L4, L5, L6; accelerometer placed on a manufactured bracket.

The locations of the accelerometer placement on the bearing housing of the threshing drum are shown in Figure 1. The vibration measurements were obtained for 600 min<sup>-1</sup>, 900 min<sup>-1</sup>, and 1180 min<sup>-1</sup> threshing drum rotation speeds, used for wheat crop harvesting. The bearing vibrations were measured in three perpendicular radial directions [21] to determine which location provides the most pertinent information on the bearing condition.

The initial vibration measurements at the selected locations of the bearing seat (L1, L2, L3) indicated some differences in their values. It was determined that bearing vibrations could be best characterized at the bearing seat (L2) and at the manufactured bracket (L5), where the largest power force on the belt pulleys is acting in the vertical direction. The manufactured bracket could be used to assist in obtaining vibration data at locations where attaching an accelerometer directly is difficult. Based on these results, the technical condition of a combine's threshing drum bearings can be adequately assessed.

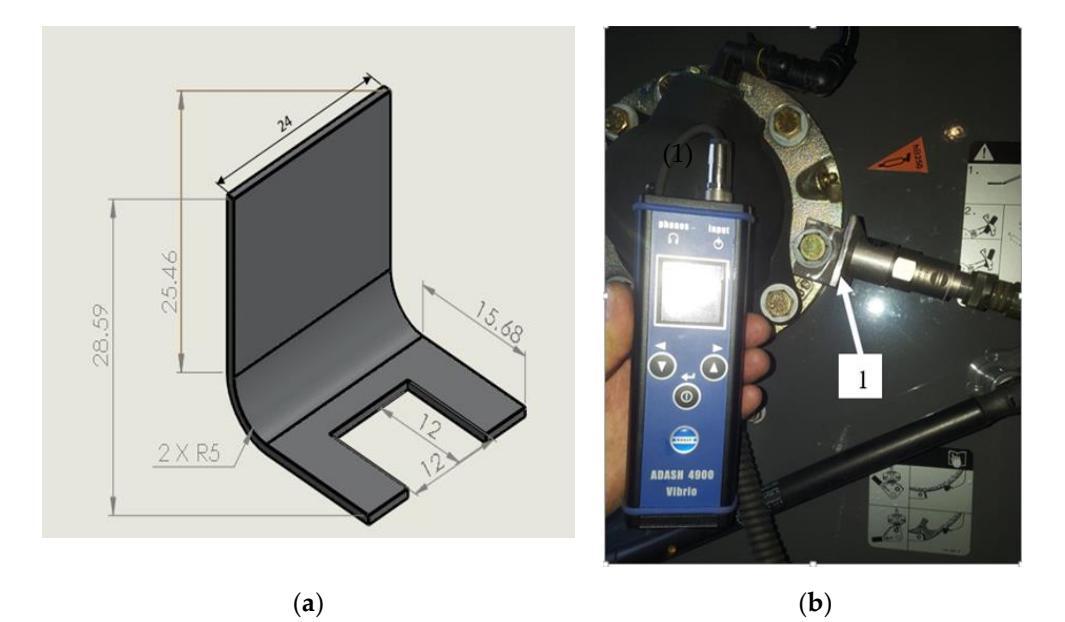
**Figure 2.** Manufactured bracket for vibration measuring points that are difficult to access: (a) dimension of the bracket; (b) accelerometer placed on the bracket (1).

There are many different bearing housings of the combine harvester shaft. The bearing housing can be made of cast iron or steel, with edges large enough to attach accelerometers. However, in cases where the bearing seats are made from a relatively thin metal plate, there is not enough room for accelerometer installation. In these cases, a metal bracket can be manufactured and installed at the bearing seating, to which an accelerometer is attached. In the present investigation, a bracket was constructed and installed, as shown in Figure 2a. Bracket dimensions presented in mm.

bolt and tightened back, to ensure a reliable and stationary connection and proper vibration measurement (Figure 2b). The amount of energy loss for a bolted joint depends on the material, surface finish, contact area, bolt tension, lubrication, and fretting corrosion.

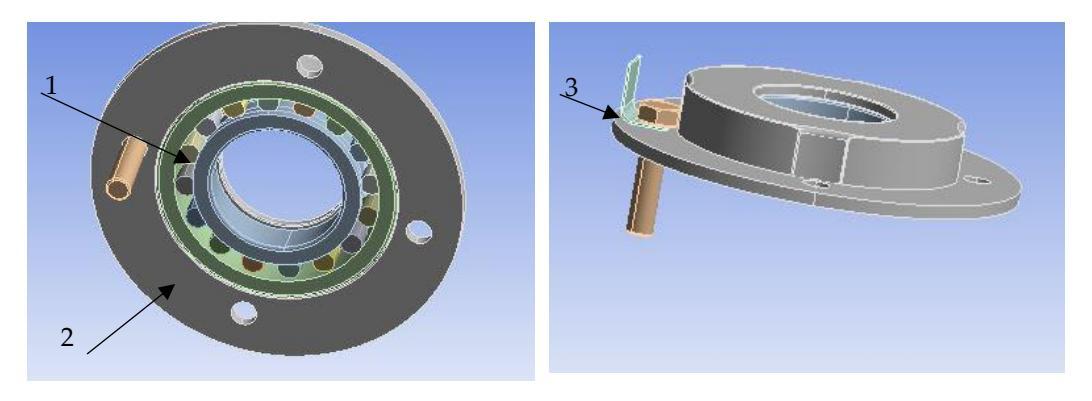
Figure 3. CAD model: (1) bearing type 20213kTVC3; (2) bearing housing; (3) bracket.

To take a genuine vibration measurement of the bearing from the added manufactured materials, it is necessary to develop a suitable design, with appropriate material selection and simulation of that material to avoid the resonance phenomenon. Before conducting vibration measurement using the added bracket, the selection of material was discussed from a material properties point of view. The bracket design aimed to avoid vibration lapse, and modal analysis was undertaken to avoid resonance due to similar natural frequencies in the associated parts. The bearing, bracket, and housing design were molded in SolidWorks, as shown in Figure 3. The material properties of the components used in the modeling are shown in Table 1. The dimensions of the bearing housing and bearing are shown in Figures A1 and A2 respectively.

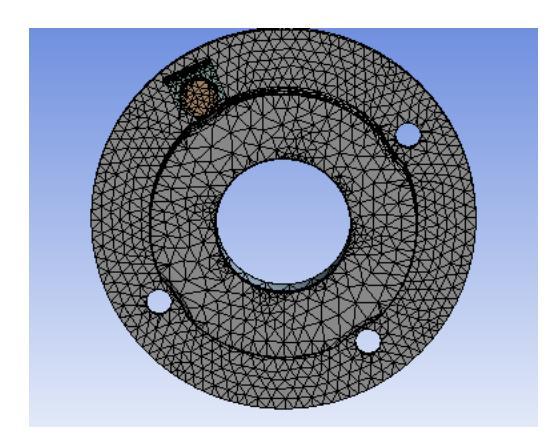
Figure 4. The meshed system.

The meshed system is shown in Figure 4.

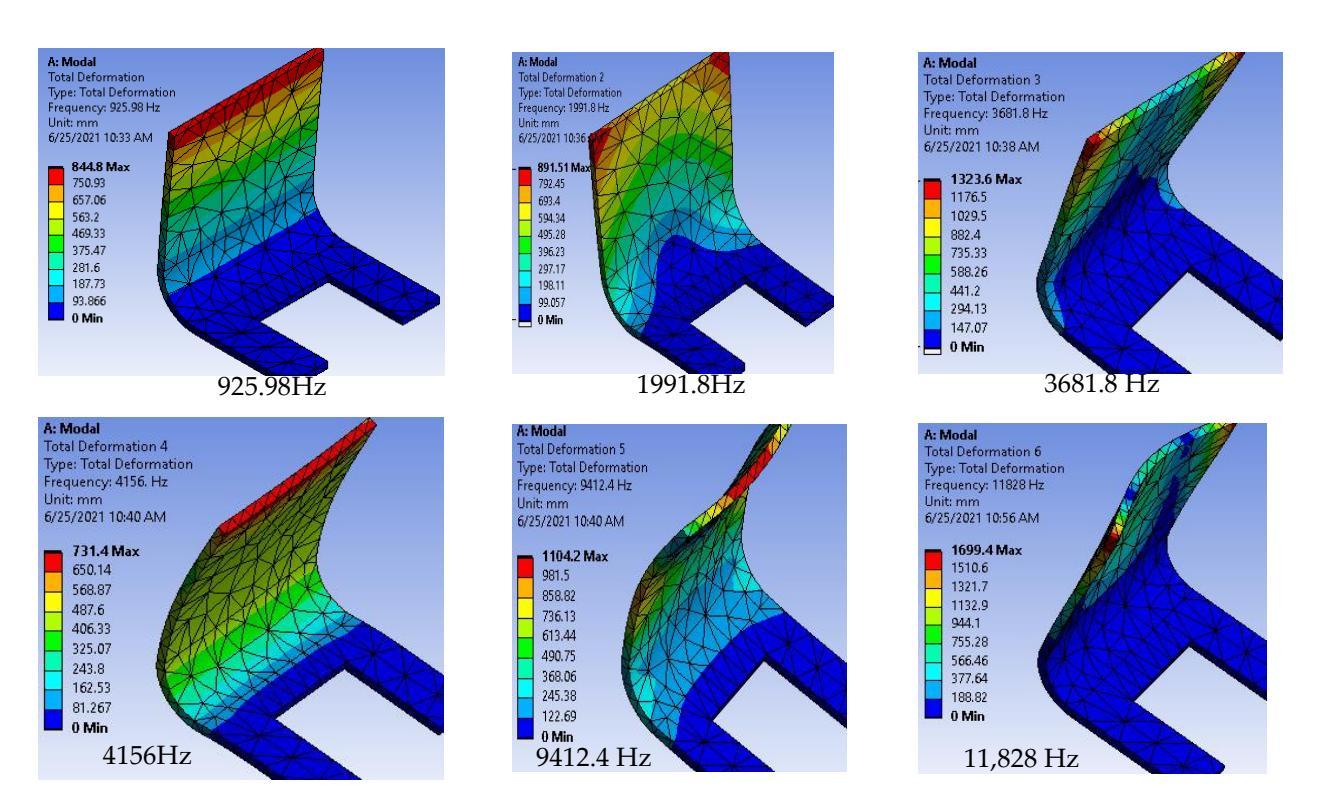
Figure 5. Eigenvalues and eigenvector of the bracket.

The modal analysis of the bracket was performed in ANSYS, and the eigenvalues were 925.98 Hz, 1995.8 Hz, 3681.8 Hz, 4156 Hz, 9412.4 Hz, and 11,828 Hz (Figure 5). These are the first five-mode shapes of the bracket. For modal analysis, the bracket is fixed on the base and at the contact surface region with a bolt. Furthermore, the modal analysis was performed for the system components consisting of the bearing, housing, bolt, and bracket. The frictional connection was defined between the bearing races and housing (0.4), rollers and bearing races (0.21), and bolts and bracket (0.23). The active mode shape for the bracket in the system was 1363.58 Hz, as shown in Figure 6.

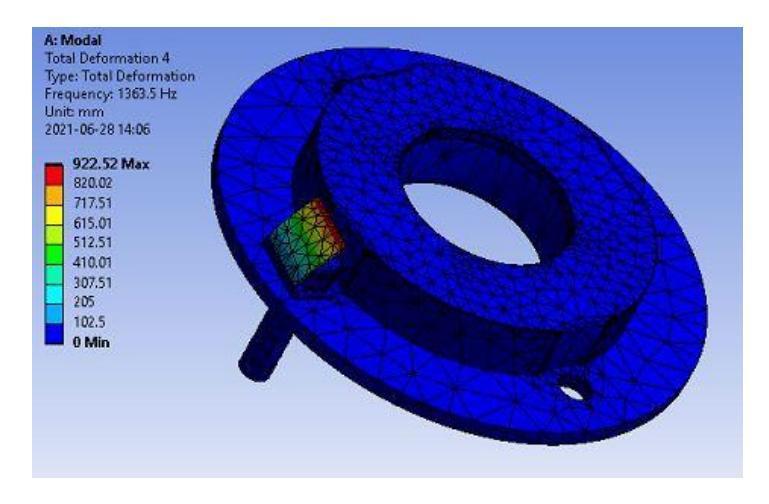
Figure 6. Mode shape of the bracket in the system modal analysis.

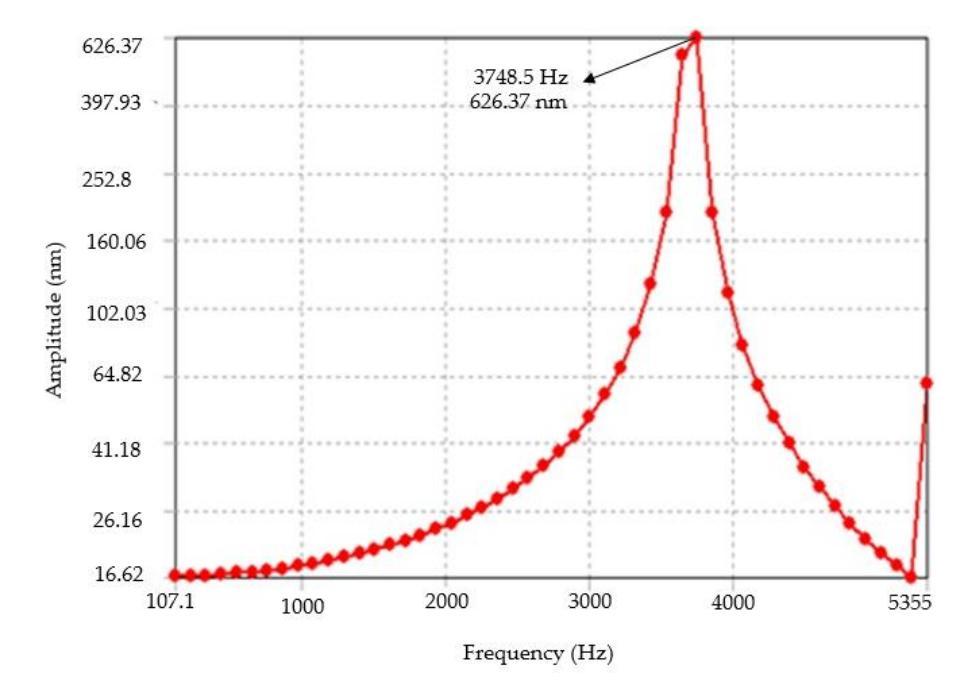
Figure 7. Harmonic response of the bearing.

maximum displacement was found at 936 Hz of 9.322 mm displacement. Thus, frequencies near 936 Hz need to be avoided for other components to avoid resonance in the system. Figure 7 represents the displacement of a bracket in forced vibration using harmonic response analysis.

Similarly, from the modal and harmonic response analysis of bearing housing, the maximum displacement of 0.00062 mm was obtained at 3748.5 Hz (Figure 7) for the radial load applied to the housing. In addition, bearing defect frequencies were calculated [3,25]. The calculated bearing defect frequency of the outer ring (f-RPI) was 118 Hz, the inner ring (f-RPV) was 175 Hz, and the rollers defect (f-RDD) was 45 Hz. Since the eigenvalues of the associated components vary, the steel 45 material and the dimensions were considered for the manufacture of the bracket for vibration analysis.

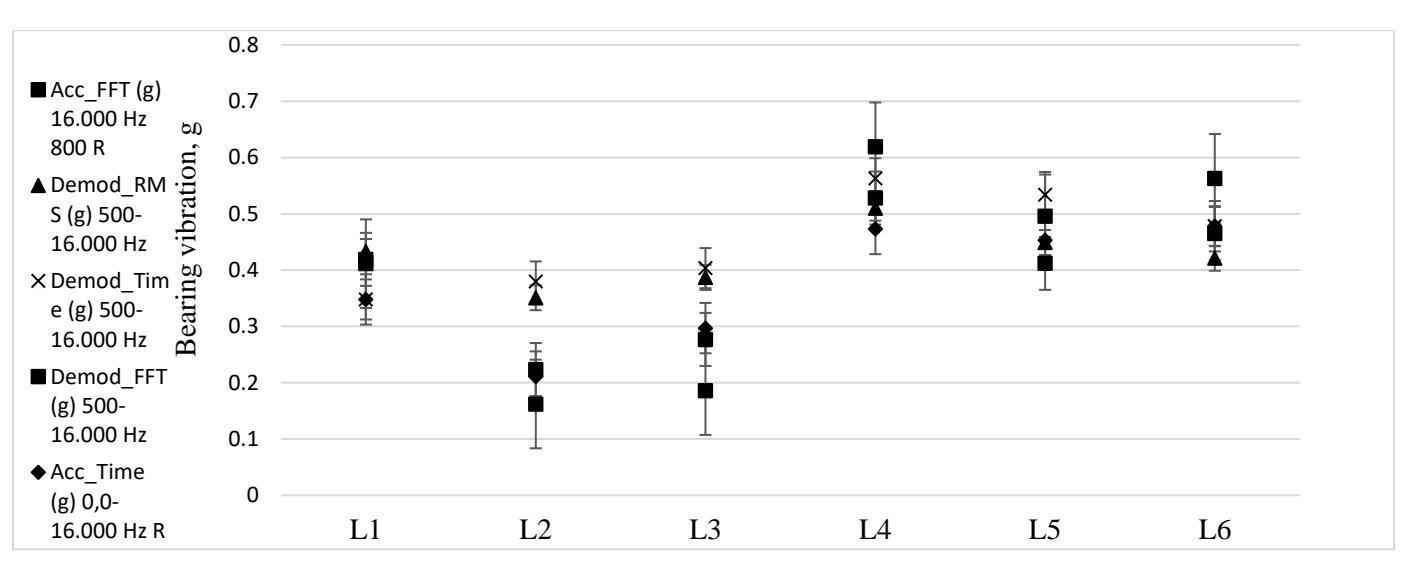
**Figure 8.** Bearing vibration acceleration at 3050 min<sup>-1</sup> speed. L1, L2, L3; accelerometer placed directly on a bearing seat. L4, L5, L6; accelerometer placed on a manufactured bracket.

To determine the bearing vibration differences with and without a bracket, the easily accessible bearing housing of the combine harvester was selected. The measurements were performed comparing the data. The main objective of these measurements was to develop a database to determine the differences between cases with the manufactured bracket and without the bracket. These results are presented in Figure 8. At some locations where the manufactured bracket could be properly fitted to the surface. The RMS data are mostly used for bearing vibration evaluation. The measurement difference was calculated from the obtained results, and the given coefficient was used for evaluation of the threshing drum bearings. The collected data showed 17.92% increased vibration while using the bracket (Figure 8). Thus, if the metal bracket could be properly installed at some locations, the bracket can be used to assist in vibration measurements of the threshing drum bearings.

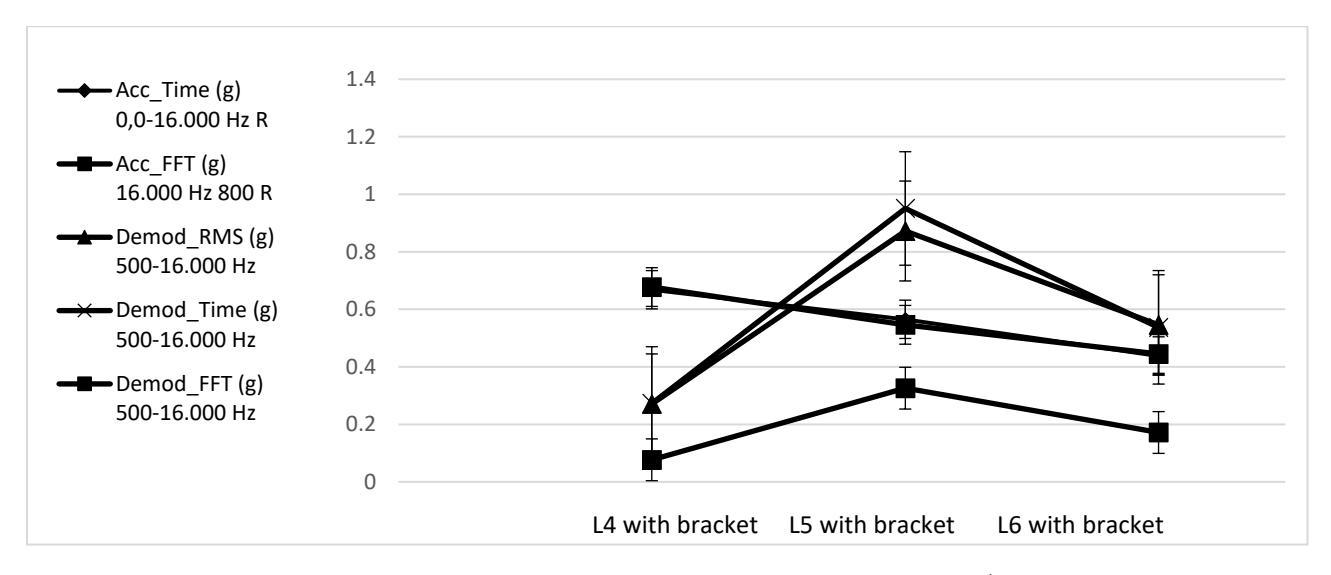
**Figure 9.** Bearing vibration acceleration at a speed of 600 min<sup>-1</sup>.

From the measured vibration results, the most important vibration parameters were selected and further analyzed with Excel 2010 software. A summary of these results is given in Figures 9–11. Then, from the analysis of the vibration data, it was possible to determine key parameters, which most accurately identified possible bearing defects. According to various investigators, analysis using the mean square vibration velocity in the frequency range of 10–1000 Hz cannot be used as the key parameter in the evaluation of the technical condition of slow-rotating bearings. Vibration parameters such as Vrms, g (5–16 kHz), and gr (0.5–16 kHz) do not properly describe the condition of the bearing. The most appropriate assessment of bearing conditions is by FFT spectrum analysis [26,27]. To determine the time before the bearing starts to show the first signs of wear, periodic monitoring of bearing vibrations is needed. The results from the right side of the threshing drum bearing were transferred from the Adash 4900 Vibrio vibration analyzer to a personal computer. The results in the FASIT-type graph represent the bearing vibrations data.

The obtained results indicate that the largest vibrations were at the L5 location, at a rotation speed of 1180 min<sup>-1</sup>. This indicates that the largest vibrations of the bearings

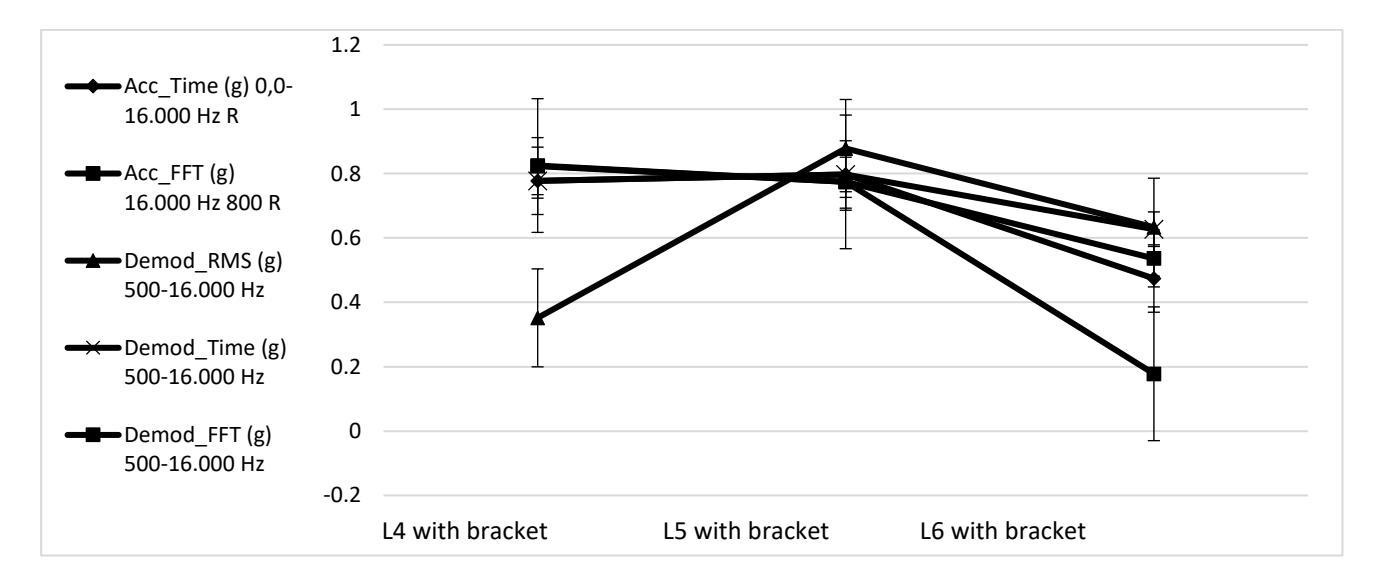
**Figure 10.** Bearing vibration acceleration at a speed of 900 min<sup>-1</sup>.

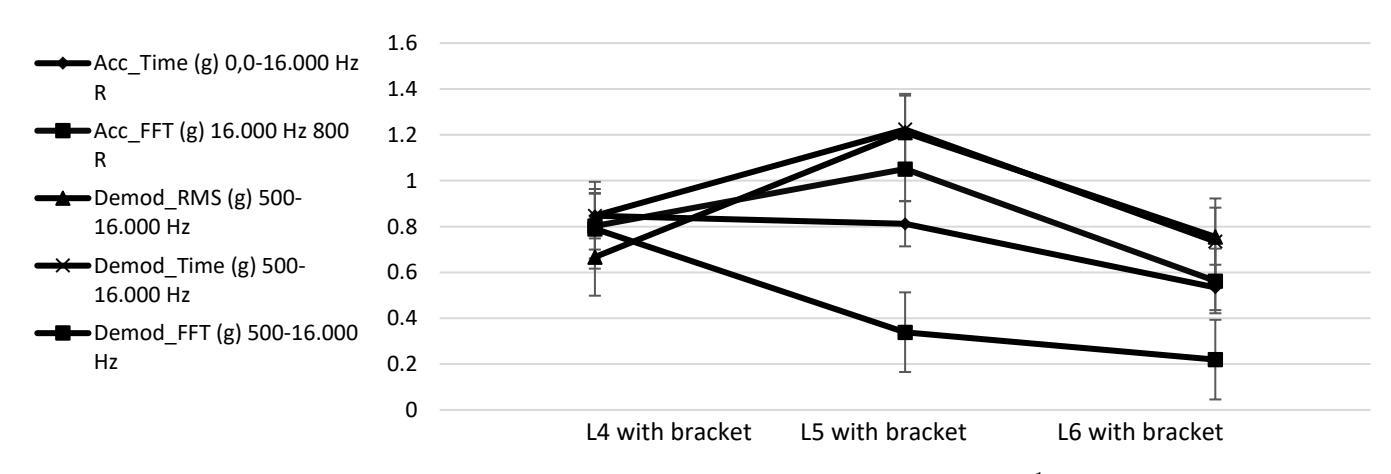
**Figure 11.** Bearing vibration acceleration at a speed of 1180 min<sup>-1</sup>.

were in the vertical direction. The lowest vibrations were measured at locations L4 and L6. After vibration data analysis, it was concluded that this bearing had no defects. From the obtained results and data analysis, it can be stated that the average values of the vibration velocity (in the frequency interval of 10–1000 Hz), in combination with other measured parameters, can be used to assess the combine threshing drum's bearing condition.

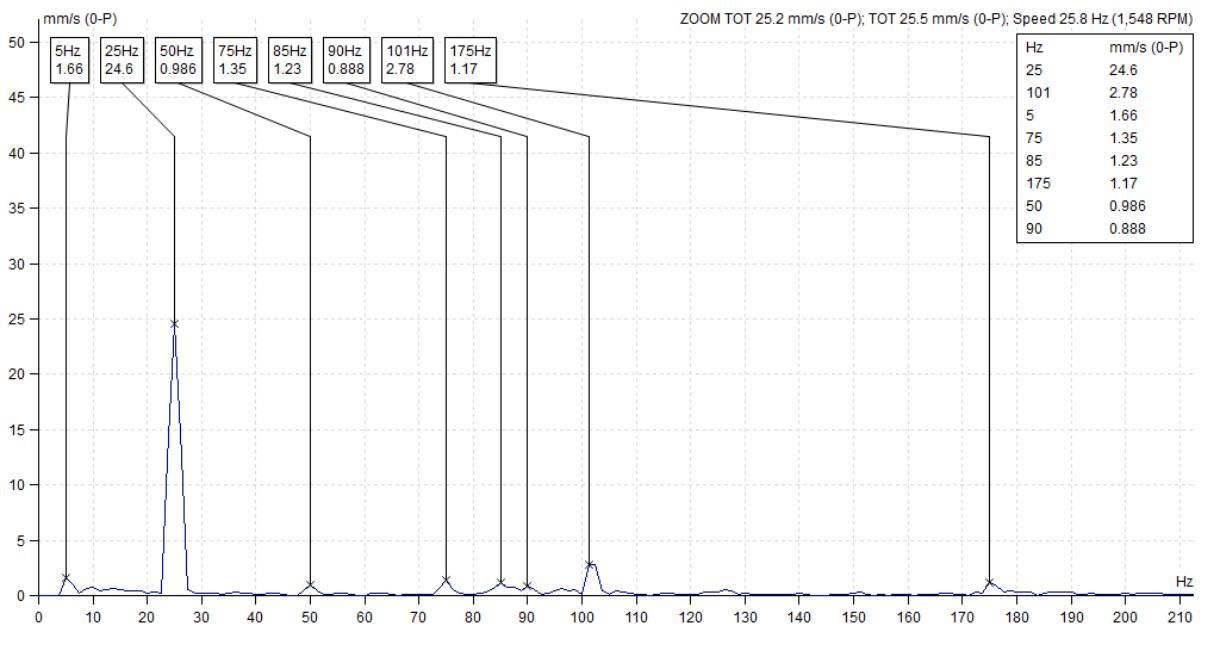
For the study, combine threshing drum bearings with an output of 3590 MH were used. Measurements were taken using the same methodology as for testing new bearings. After performing the analysis using the vibration response spectrum, significant changes in bearing defect frequencies (25 Hz, 101 Hz) were observed (Figure 12). After comparing the theoretically calculated defect frequencies (the defect frequency of the outer ring (f-RPI) was 118 Hz, the inner ring (f-RPV) was 175 Hz, and the rollers defect (f-RDD) was 45 Hz.), it can be stated that the studied bearing vibrations were caused by a defect of the outer bearing ring.

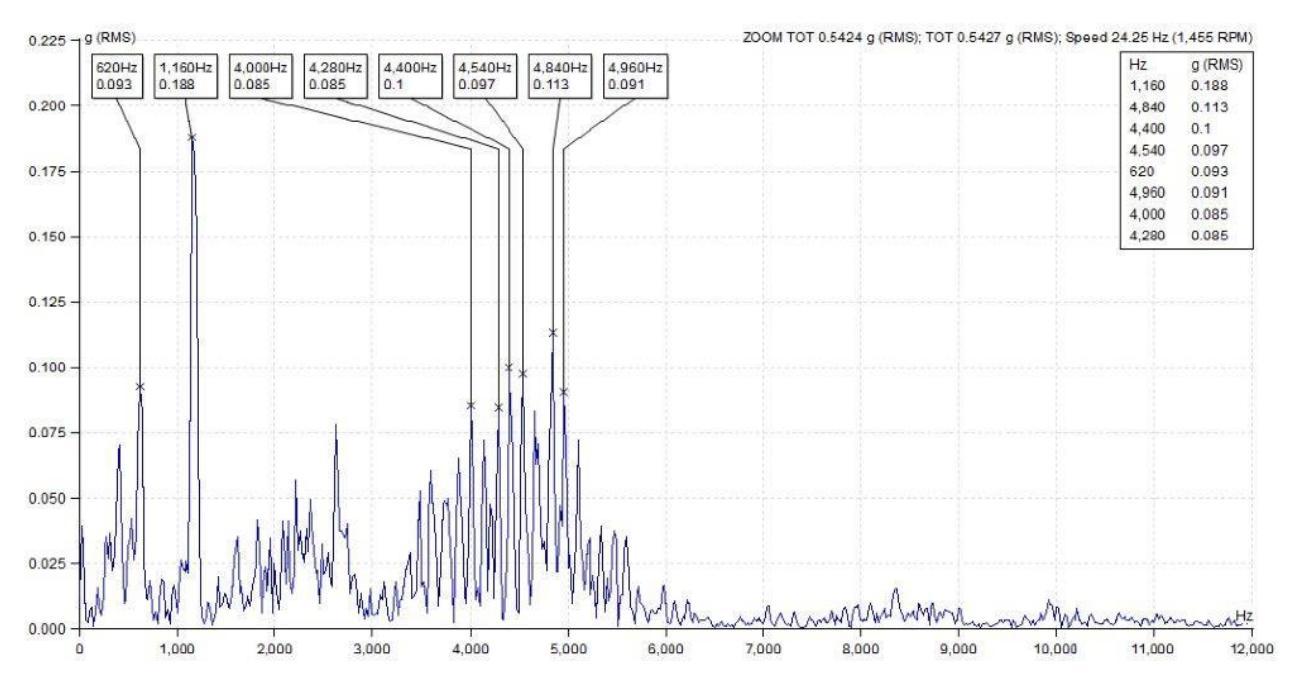
Figure 13. Bearing vibration spectrum in the range of 0–12,000 Hz.

When analyzing the RMS values, these values should be as close to zero as possible. Figure 13 shows that the RMS values of the assessed bearings in the range up to 6000 Hz reached 0.188 g (RMS), which indicates insufficient bearing stability.

To prevent threshing drum failure in the combine, it is recommended to replace the bearing with a new one, or to have it additionally checked by another diagnostic method. A microscope was selected to check the condition of the used bearing again.

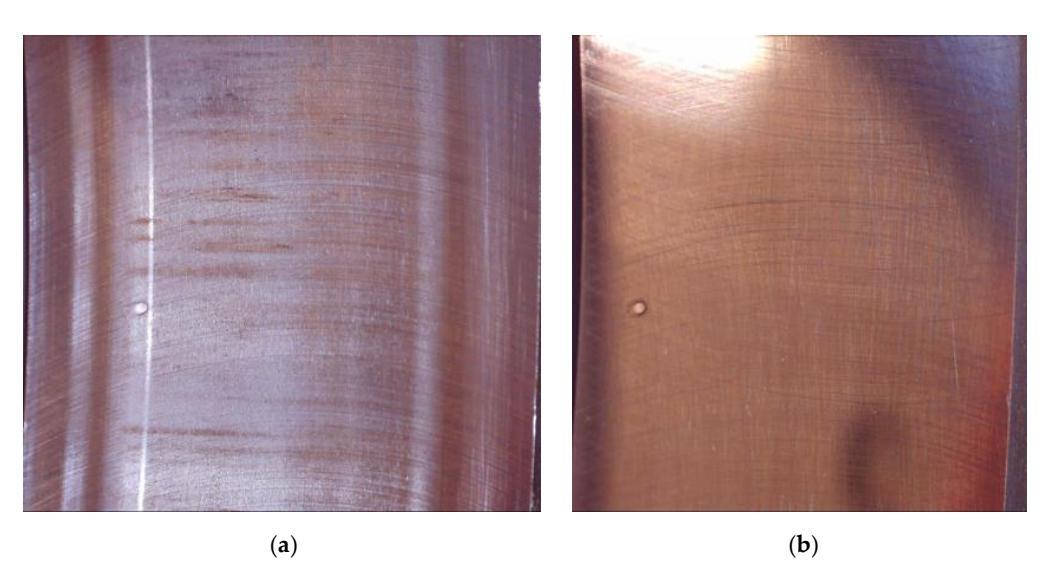
**Figure 14.** Bearing surface view of the inner ring. (a) View of the used bearing inner ring; (b) view of the new bearing inner ring.

Before disassembly of the threshing drum bearing, the vibrations produced by the bearing were measured in a running combine. In addition, a smart 5MP PRO digital microscope was used to identify existing bearing defects after bearing dismounting. The resulting visual material is presented in Figure 14. The image of the used bearing (Figure 14a) clearly shows the surface damage. The damage is presented by cross lines in the inner ring. The inner ring defect determined by the vibration analysis method has been proved by microscope image (Figure 14a). Comparing the microscope image of the new bearing (Figure 14b), the surface of the inner ring is smooth and of good quality.

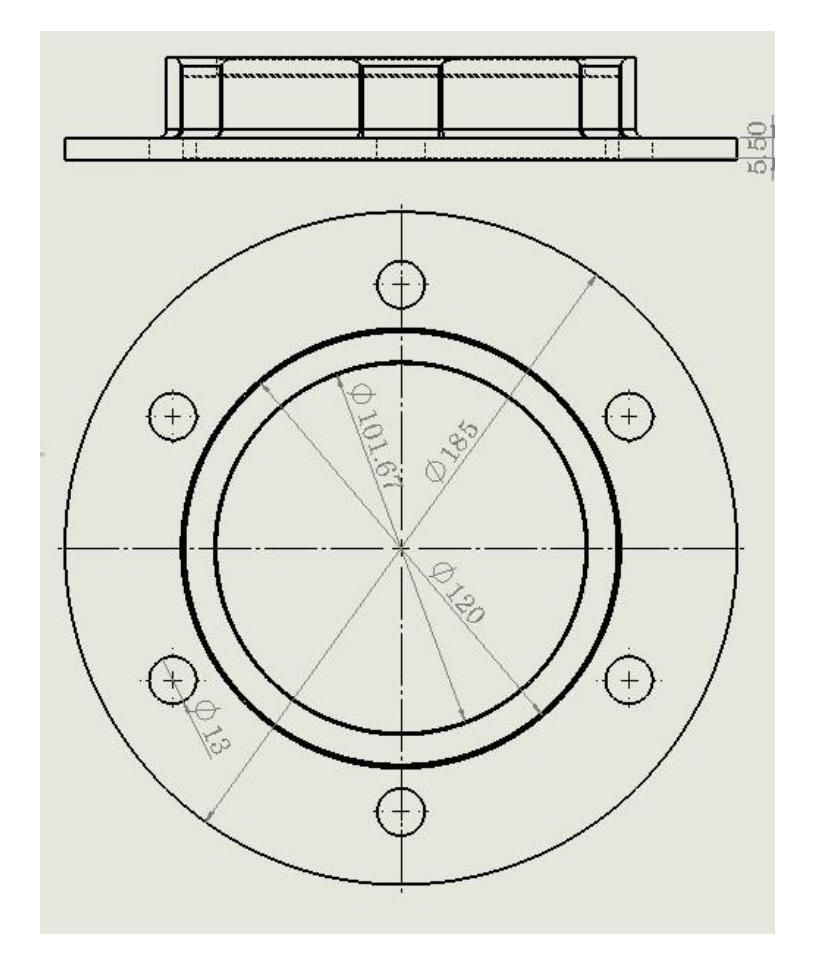
Figure A1. Bearing housing dimensions.

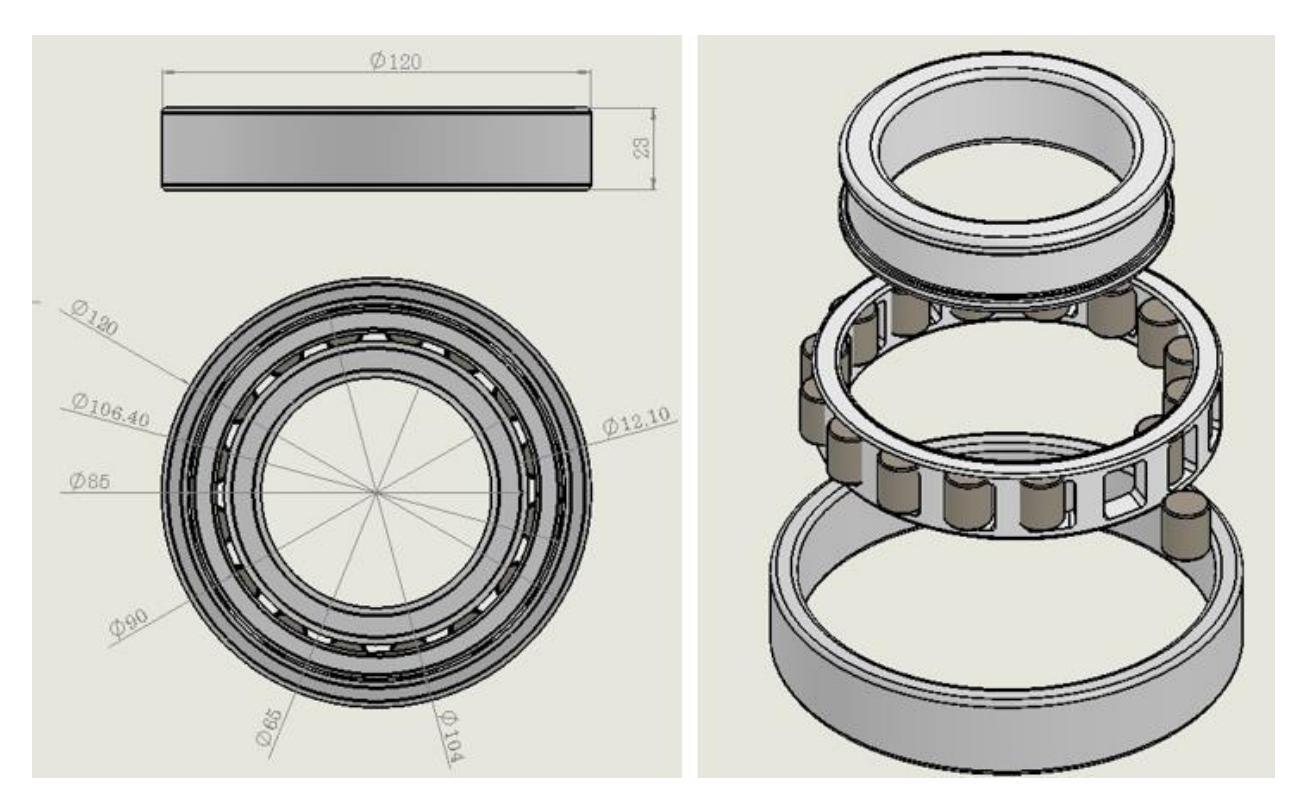
Figure A2. 20213 k TVP C3 bearing dimensions.
