# Technical Note Formation and Failure Mechanism of the Xinfangzi Landslide in Chongqing City (China)

Abstract: At 2:00 a.m. on 1 July 2020, after several days of continuous heavy rainfall, the Xinfangzi landslide occurred in Zhengping Village, Ganshui Town, Qijiang District, Chongqing City, China. The area of the landslide was about  $3.85 \times 10^4$  m<sup>2</sup> and the volume was about  $71.22 \times 10^4$  m<sup>3</sup>. The Xinfangzi landslide can be defined as a push-type landslide. Specifically, the main sliding area pushed the front squeezing area, causing it to slide laterally. The entire slip path of the landslide was a broken line, while the right edge and the front shear outlet position slipped loosely in a circular arc. In this study, finite element numerical calculations were used to compare and analyze the multisection plastic deformation of the landslide under natural and rainfall conditions based on field investigations. The formation and failure characteristics of the Xinfangzi landslide were further revealed. The results show that the cross and longitudinal sections of the landslide were in a critical state of instability under natural and rainfall condition

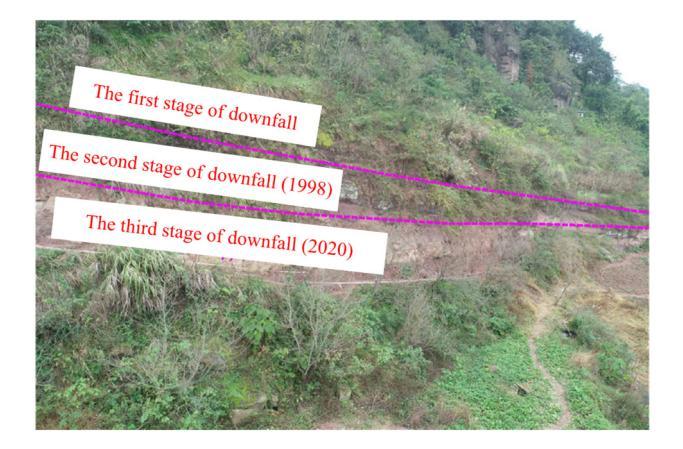
Figure 2. Side edge ridges formed by multiple downward sliding events of the landslide.

*The second stage of deformation.* During the flood season in 1988, large-scale overall slip occurred in the study area. The left side of the landslide slide about 1.5–3.5 m downward (the same position as the new Xinfangzi landslide; Figure 2). A sliding mass of about 5000 m<sup>3</sup> was pushed out at the shear outlet of the landslide, damaging five residential houses on the slope and blocking the G210 national road.

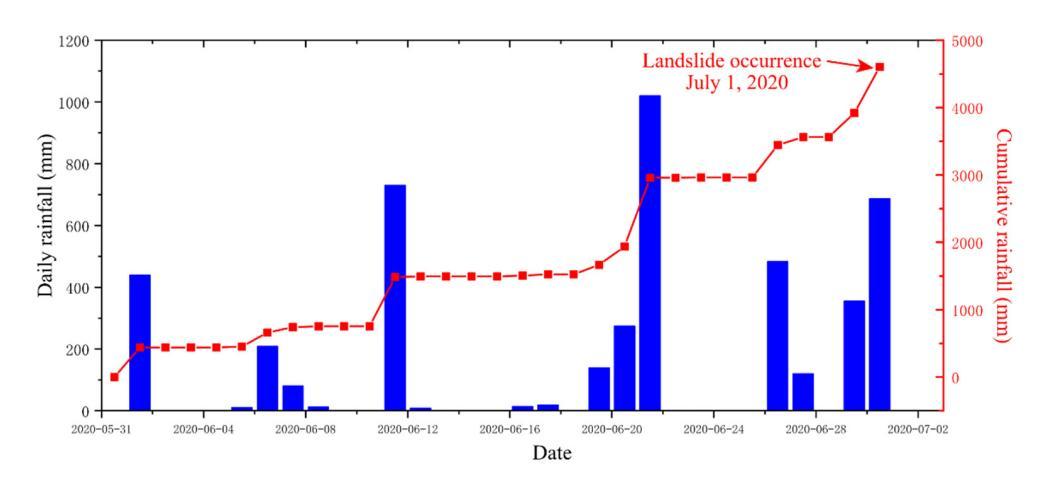
Figure 3. Cumulative rainfall prior to the occurrence of the Xinfangzi landslide.

*The third stage of deformation*. After several days of continuous heavy rainfall (Figure 3), the trailing edge of the landslide began slow creep deformation on 28 June 2020. At about 2:00 a.m. on 1 July 2020, the landslide slipped as a whole. A sliding mass of about 2000 m<sup>3</sup> at the front edge blocked the G210 national road. At the same time, the loosening and deformation of the right boundary of the landslide damaged one house.

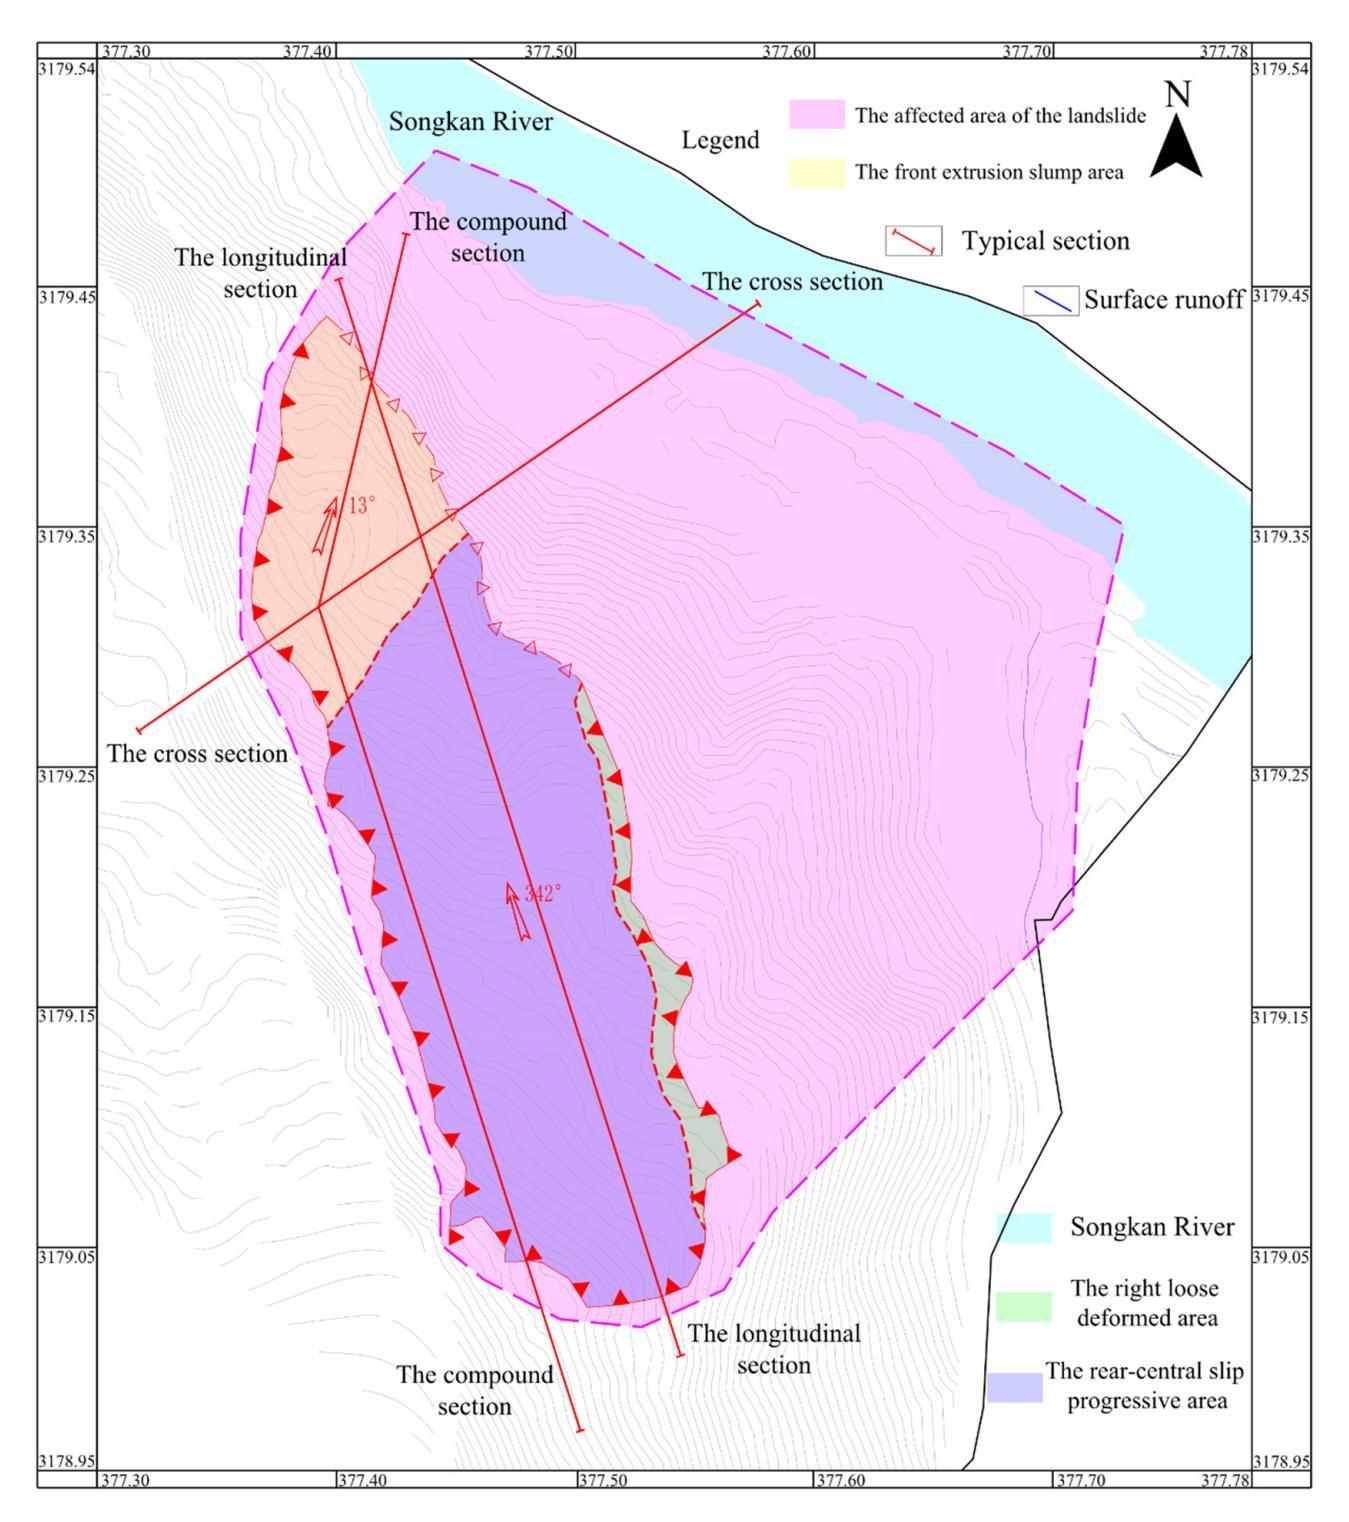
Figure 4. The section layout of the Xinfangzi landslide.

According to the existing deformation of the landslide and the development characteristics of the surface cracks, the landslide can be divided into three areas: the main sliding area in the rear-central slip progressive area, the right loosely deformed area, and the front extrusion slump area (Figure 4).

*The main sliding area in the rear-central slip progressive area (Area I).* The sliding direction of the rear-central area was 342°, which drove the overall sliding of the landslide. Area

I is longitudinal, and is about 302 m long and 104 m wide. It has an area of about  $3.14 \times 10^4$  m<sup>2</sup>, a thickness of 4.1–33.6 m, an average thickness of 19.54 m, and a volume of about  $61.37 \times 10^4$  m<sup>3</sup>. The sliding mass of Area I is mainly composed of ancient landslide debris and later accumulated rocks caused by the collapse. The length of the rear tension crack slot in this area is about 11–16.5 m, the width is about 1.5–3.5 m, and the visible depth is about 1.6–3.9 m. The left boundary of Area I moved downward by about 2.3 to 7.8 m as a whole, and the length of the falling ridge is about 450 m. In addition, the soil of the shear outlet at the right front side is loaded on the slope, causing a local slump.

The right loosely deformed area (Area II). Area II is a long strip with a length of about 240 m and a width of about 3–12 m. It slid in the direction of 45–60° under the control of steep local ridges (rural road slopes). A total of five small landslides were formed in this area, with volumes of about 5 to 400 m<sup>3</sup>, covering the roadbed.

*The front extrusion slump area (Area III).* Area III slid in the direction of  $13^{\circ}$  under the push of Area I. This area is fan-shaped, with a length of about 113 m, a width of about 84 m, an area of about  $0.95 \times 10^4$  m<sup>2</sup>, a thickness of 7.8–25.5 m, an average thickness of 16.3 m, and a volume of about  $15.47 \times 10^4$  m<sup>3</sup>. The deformation of this area was mainly the formation of a penetrating step, with a height of about 0.5 to 2.6 m, on the left backside under push. Plume cracks were formed by squeezing and shearing. Part of the soil in this area collapsed from the front edge of the shear outlet to the G210 national road.

The typical sections involved three types: a cross section, a longitudinal section, and a compound section (Figures 4 and 7). The multiple sections of the landslide were simplified into geo-mechanical models covering the sliding mass, slip zone, and slip bed. In addition, the distribution of the groundwater inside the landslide was considered. According to on-site investigations, after heavy rainfall, the surface soil of the landslide is almost fully saturated, and water flows out on the slope's surface. Therefore, the mechanical state of the landslide was simplified under rainfall conditions, and the sliding mass and the slip zone above the groundwater level were converted into saturation parameters. The impact of heavy rainfall on the landslide will be further analyzed in the discussion part of this paper. Notably, the unsaturated mechanical states were ignored. In this way, the simplification under the rainfall conditions can be better transferred, and the failure mechanism of the landslide with the complicated slip path can be highlighted.

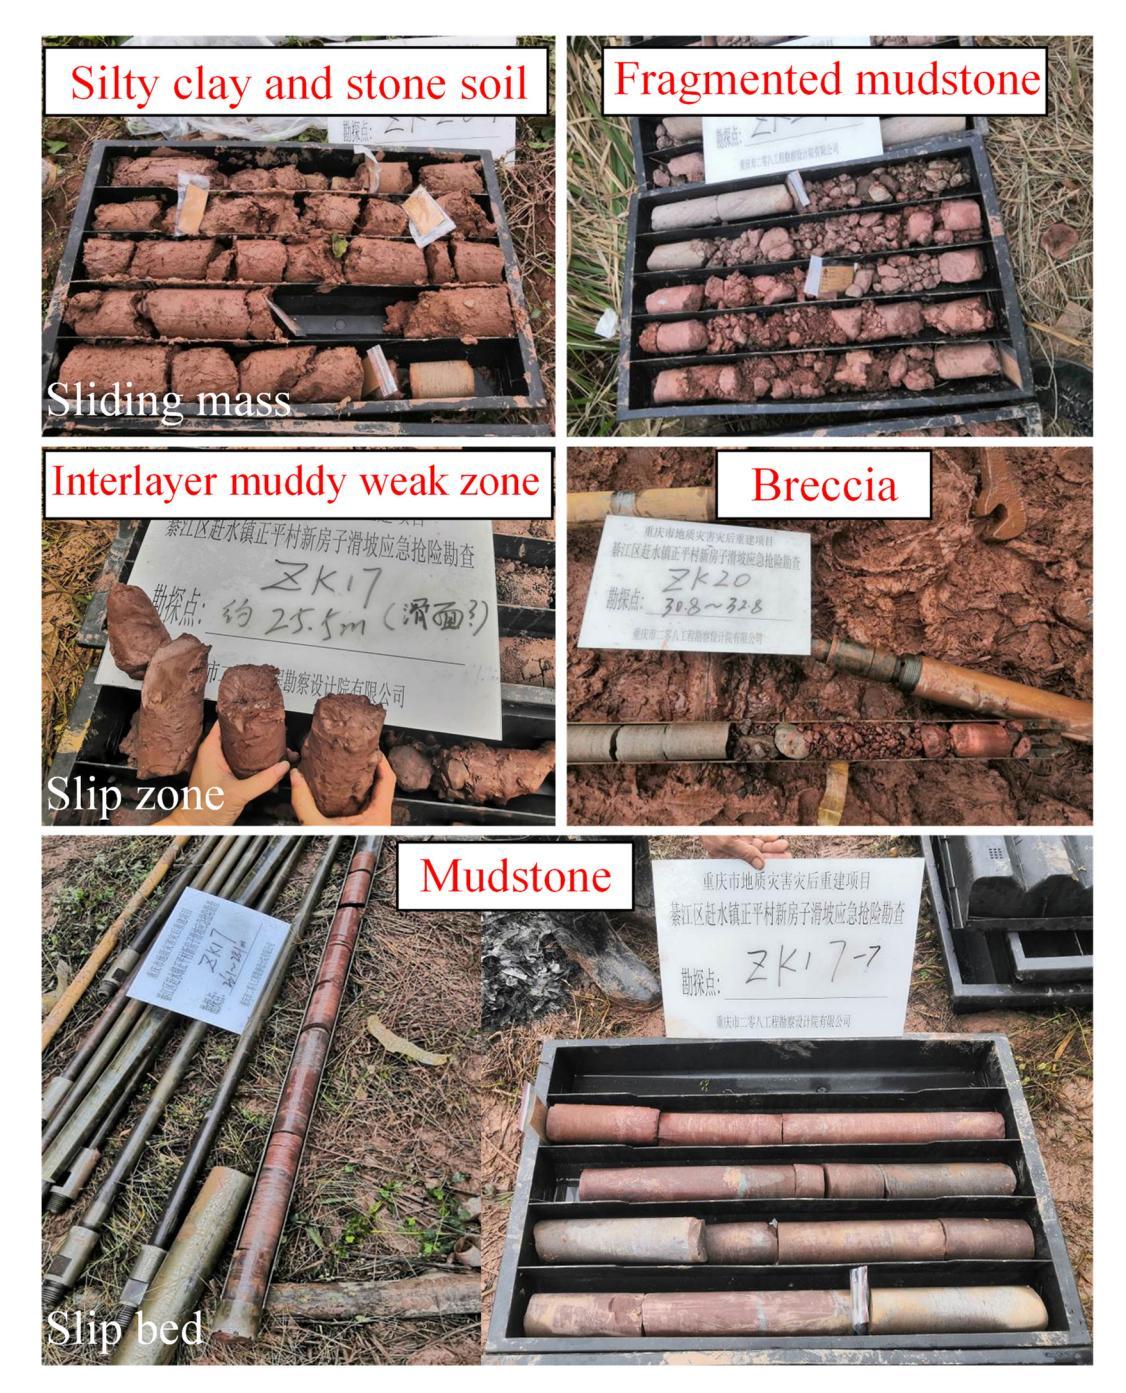
Figure 5. The components of the Xinfangzi landslide.

According to the drilling results (Figure 5), the thickness of the sliding mass is about 4.1–33.6 m, with an average thickness of 18.5 m. The sliding mass at the trailing edge is mainly mudstone intercalated with sandstone residues after slippage disintegration, with a thickness of about 2.7 to 31.8 m. The sliding mass in the middle and front part is mainly composed of silty clay and stone soils, with a thickness of about 23.4 m.

The slip zone in the rear of the fragmented rock is a soft and muddy interlayer between the layers. The drilling results indicate that this part of the slip zone exhibits slip and tension in a 1.50 m area, and obvious scratches were observed. The slip zone in the middlefront part of the soil is the breccia of the rock-soil interface, which has a dense structure and obvious extrusion characteristics.

The slip bed is the bedrock of the interbedded mudstone and sandstone of the Middle Jurassic Shaximiao Formation, with a burial depth of about 4.10–33.6 m. The front and right edges are shallower, and the rear and left edges are deeper.

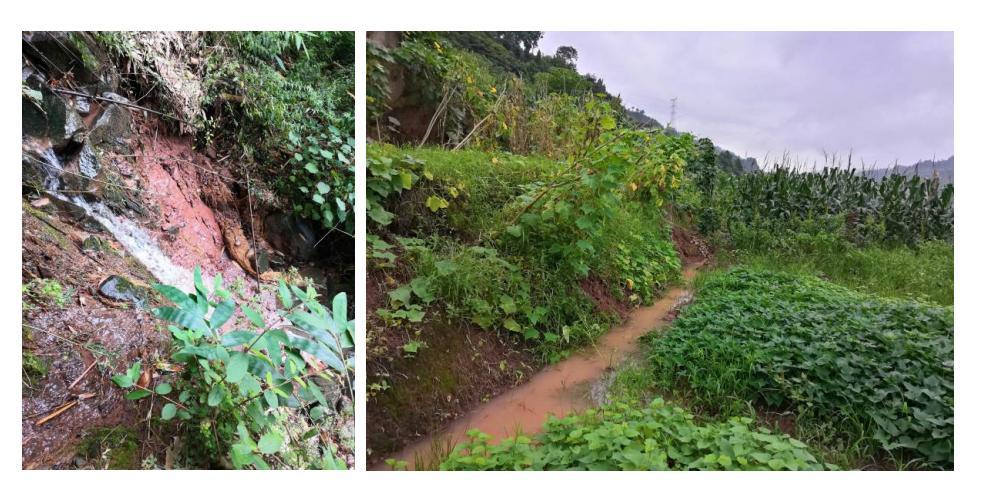
Figure 6. Surface water on the landslide area (8 July 2020).

The groundwater in the study area distributes in loose rock pore, landslide rock debris fissure, and bedrock fissure. The water in the boreholes was drained to observe the dynamics of the water level. After 24 h, the groundwater level at the rear part was 0.20–11.50 m, and that in the middle-front part was 0.2–16.65 m. In addition, the water level in the borehole increased significantly after rainfall. Notably, the groundwater levels in the boreholes were quite different, indicating that there is no stable groundwater level for the entire landslide. This phenomenon is related to the local stagnant water and surface runoff caused by the rainfall (Figure 6).

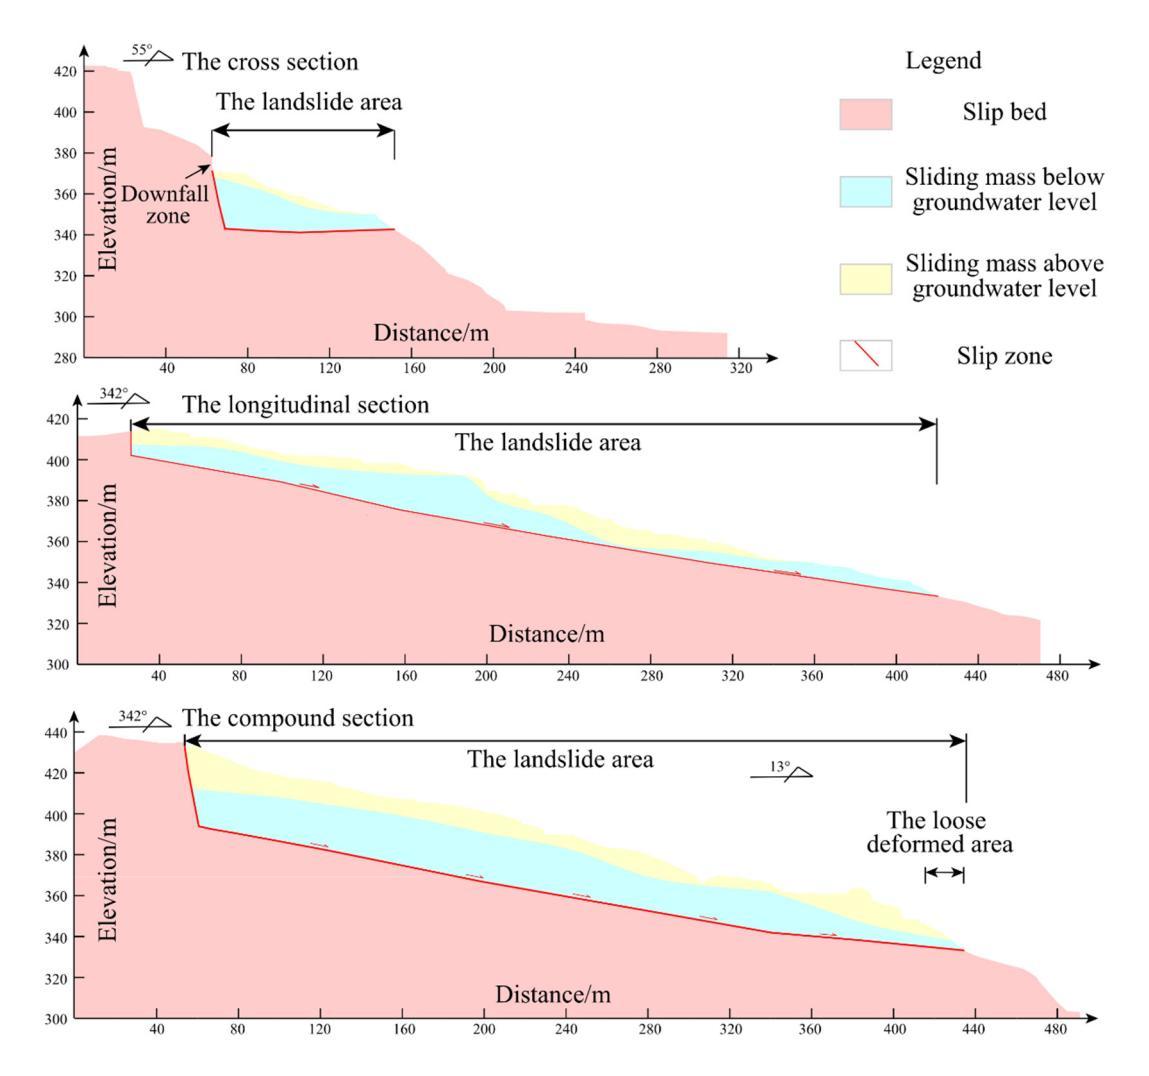
Figure 7. The computational model for multiple sections.

The MIDAS GTS numerical calculation software was used in this study. The Mohr-Coulomb model was selected to characterize the mechanical properties of the landslide. The unit weights and shear strength parameters were obtained from laboratory tests, and the elastic modulus and Poisson's ratio were adapted from the relevant literature [41,42]. All relevant calculation parameters are shown in Table 1. The other parameters, such as the dilatancy angle of the soil, are not considered here.

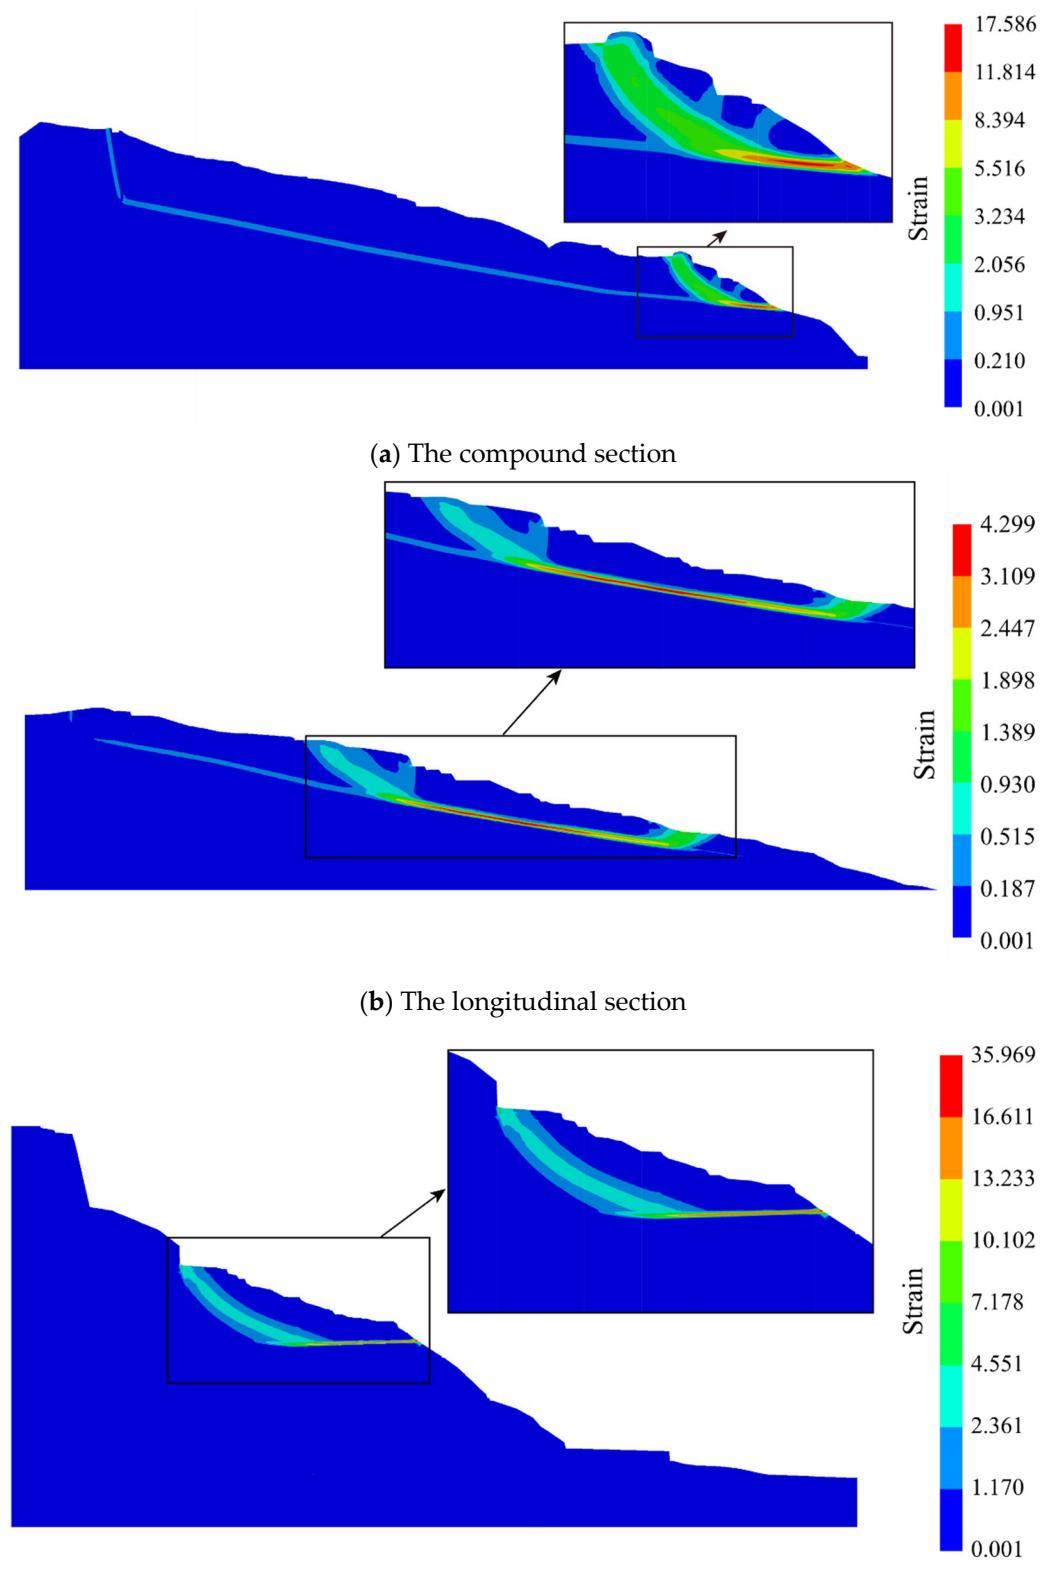
Figure 8. The plastic strain distribution in multiple sections under natural conditions.

By analyzing the plastic strain distribution of each section under natural conditions (Figure 8; Table 2), it was found that the plastic strain of the cross section is the largest, and the strain is concentrated at the front edge of the sliding zone. The plastic deformation area of the longitudinal section is concentrated in the middle and lower parts of the section, and the plastic deformation of the slip zone does not penetrate. The comparison indicates that the cross and longitudinal sections of the landslide are both in a critical state of instability under natural conditions.

Based on this, the compound section of the landslide was analyzed. The plastic zone of the compound section is still not penetrated in the slip zone. Due to the extrusion of the trailing edge of the landslide, the leading edge is in an unstable state (the FOS is less than 1). It should be noted that the compound section of the landslide was established along the slip path based on the cross and longitudinal sections. Under the actual condition, the extrusion caused by the slip of the trailing edge does not directly act on the leading edge of the landslide. Thus, the superimposed compound section amplifies the thrust of the trailing edge, which further reduces the stability of the leading edge.

It can be concluded that the landslide under natural conditions is basically stable as a whole. The possibility of local collapse exists at the leading edge of the landslide, and the sliding of the trailing edge could promote the failure of the leading edge. After the leading edge slips, the overall instability of the landslide may be further induced.

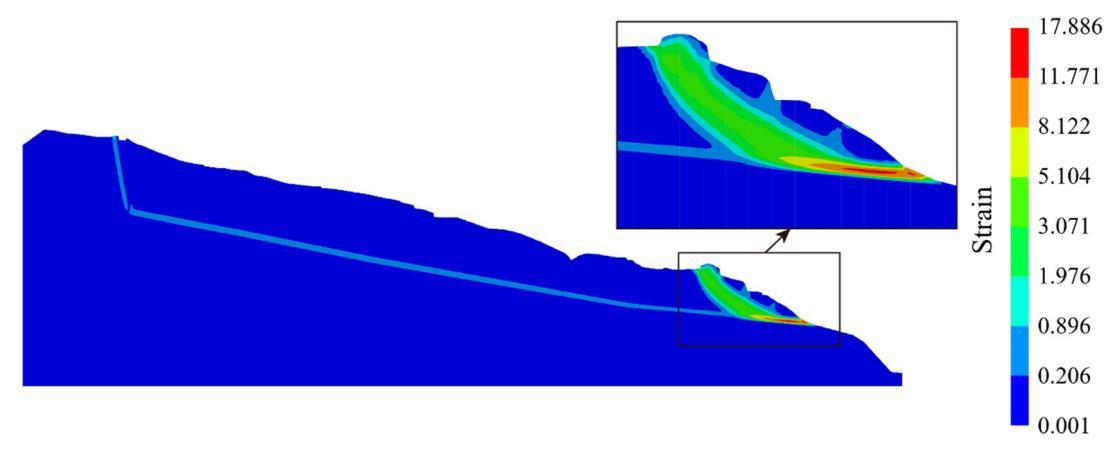
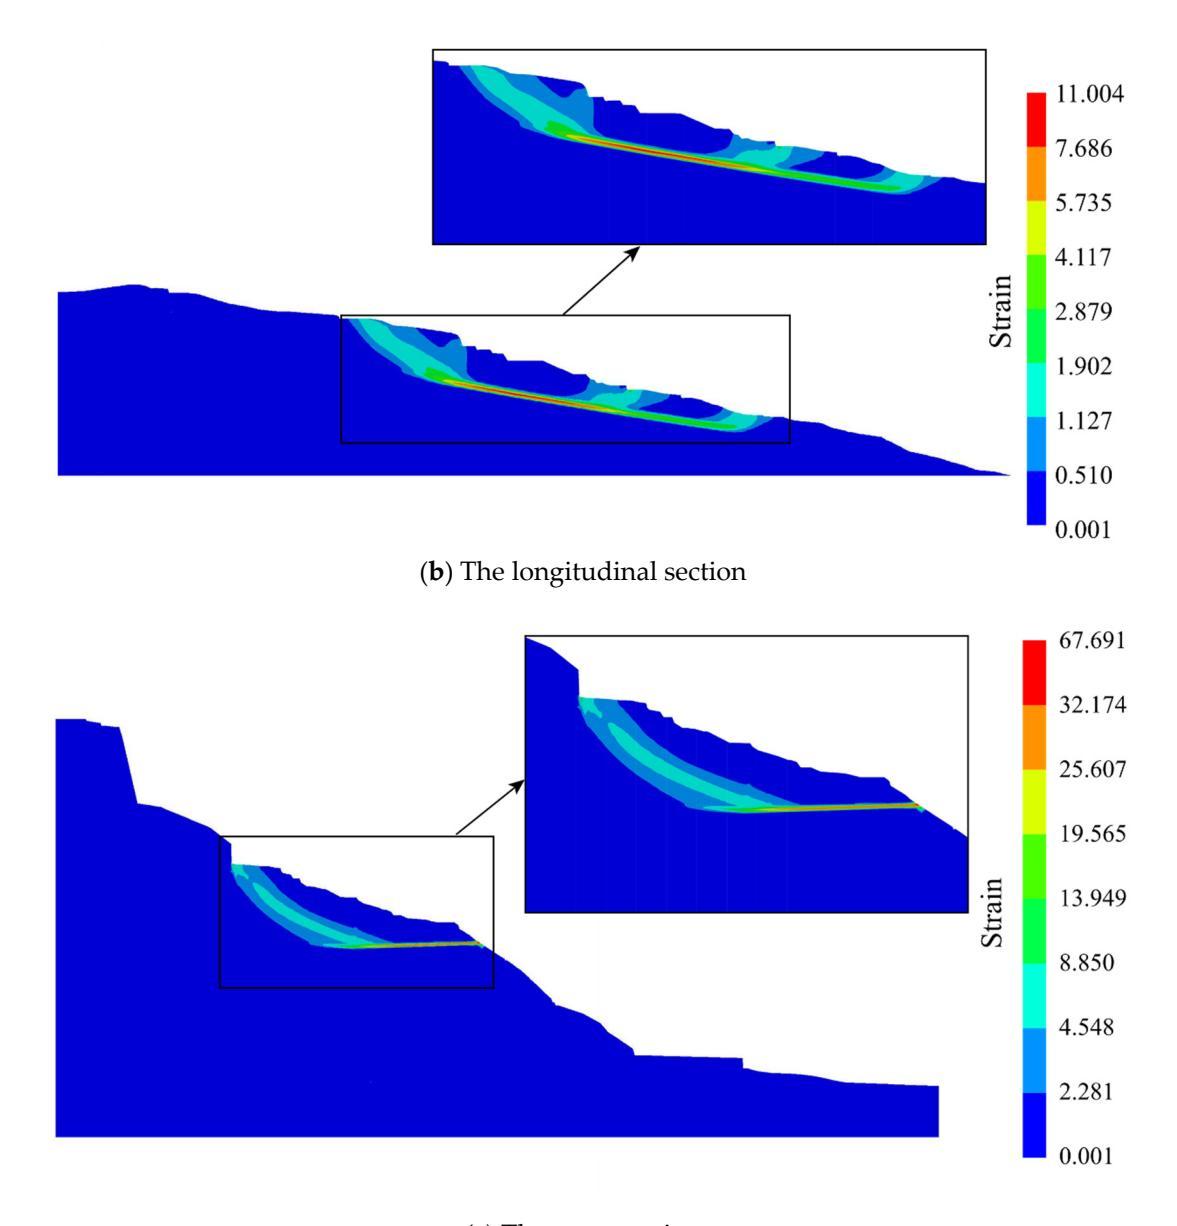
Figure 9. The plastic strain distributions in multiple sections under rainfall conditions.

To explore the impact of short-term heavy rainfall on the Xinfangzi landslide, a further comparative study was performed on the plastic strain distributions in multiple sections under rainfall conditions (Figure 9; Table 2).

The analysis shows that the distributions of the plastic deformation of the landslide under natural and rainfall conditions are basically similar, but to a certain extent, the maximum plastic strain value under rainfall conditions is higher. Specifically, the maximum plastic strain of the compound section has the smallest increase due to rainfall, while the maximum plastic strains in the cross and longitudinal sections under rainfall conditions are about twice those under natural conditions.

The comparison of the FOS under different conditions shows that the cross and longitudinal sections are still basically stable under rainfall conditions. This is caused by the location of the groundwater level in the landslide area. Under natural conditions, the sliding zone, which controls the overall slippage of the landslide, is already below the groundwater level. Under rainfall conditions, the overlying part of the sliding mass becomes saturated. Due to its unit weights increase slightly, the rainfall has little effect on advancing the shear failure of the cross and longitudinal sections.

However, under rainfall conditions, the FOS decreases more in the compound section than in the cross and longitudinal sections. The increase in the unit weight of the sliding mass amplifies the thrust of the trailing edge in the composite superimposed section, which further accelerates the overall sliding of the landslide. Therefore, heavy rainfall may promote local sliding at the leading edge of the landslide and may cause a new landslide to move downward as a whole, just like the previous three large-scale deformations (Figure 2). After many rainy seasons, the local collapse of the leading edge and the progressive penetration of the plastic deformation of the slip zone will continue to promote the overall slippage of the landslide.
