Application of the Proposed Fiber Optic Time Differential BOCDA Sensor System for Impact Damage Detection of a Composite Cylinder

Bo-Hun Choi¹, Dae-Cheol Seo², Yong-Seok Kwon² and Il-Bum Kwon^{2,*}

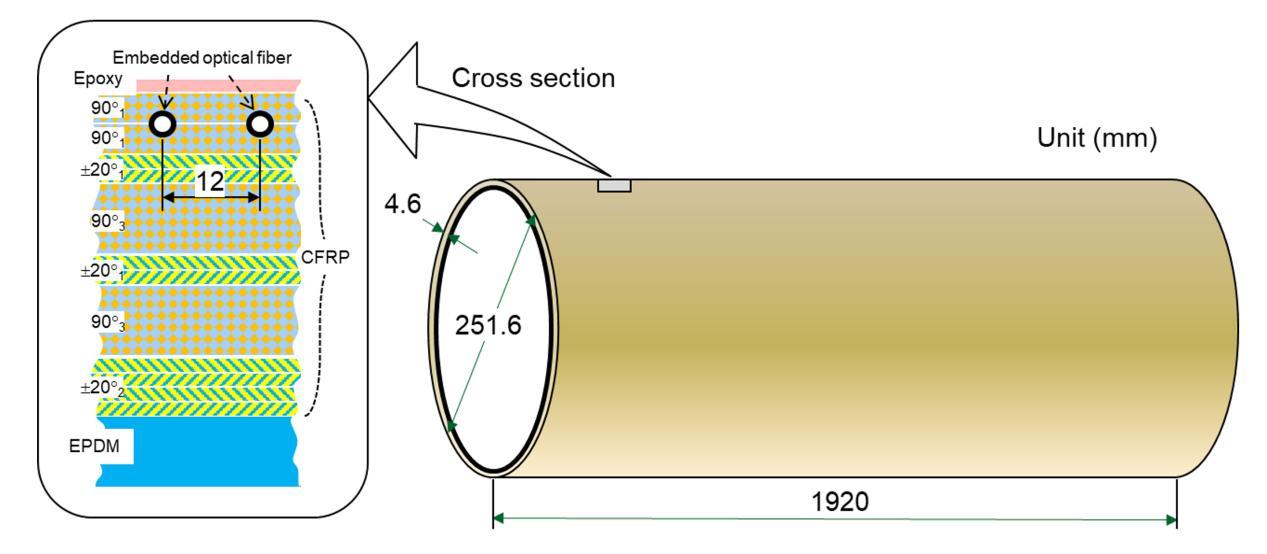
A composite cylinder with an embedded optical fiber was fabricated through a filament winding process using T700 carbon fiber tape; Figure 1 shows its schematic. The lay-up configuration of this cylinder enlarged as the cross section in the figure is $[90^{\circ}_{1}/OF/90^{\circ}_{1}/\pm 20^{\circ}_{1}/90^{\circ}_{3}/\pm 20^{\circ}_{1}/90^{\circ}_{3}/\pm 20^{\circ}_{2}/EPDM]_{T}$. EPDM is ethylene propylene diene monomer, a kind of rubber pad that is used to cover the mandrel of the cylinder. The OF (optical fiber), which was purchased from Fibrecore Co in UK, in the carbon fiberlayers is the sensing optical fiber embedded in this cylinder. All of the 15 carbon fiber layers were fabricated in the CFRP (Carbon Fiber Reinforced Plastic) part. The cross angled lay-up of $\pm 20^{\circ}$ was fabricated to have the longitudinal stiffness of the cylinder, and the hoop winding of 90° was wound for the hoop directional stiffness of the cylinder. This fiber has the same structure and materials as standard single-mode optical fiber (SSMF) for telecommunication, except that, instead of an acrylate coating, it has a polyimide coating. This OF was placed between 90° hoop carbon layers, and processed to move longitudinally at the pitch of 12 mm in one rotation in the filament winding process. The thickness of the total layers was 4.6 mm. During the remainder of the fabrication process, both ends of the optical fiber were handled with care so as not to break, leading to the outside of the cylinder. They were then connected to the TD-BOCDA sensor system. The figure shows

that the diameter and length of the cylinder were 251.6 and 1920 mm, respectively. The length of the optical fiber for one turn around the cylinder was 786 mm. This value was slightly smaller than the outer circumference of the cylinder, 790 mm, so it agrees well with the position of the optical fiber in the multilayer composite structure in Figure 1. The longitudinal distance of the cylinder in which the optical fiber was embedded was 1.8 m, which is slightly shorter than the cylinder length of 1.92 m. The overall number of winding cycles was 160 turns. Therefore, the total optical fiber length in the cylinder was approximately (786 mm \times 160)/1000 \cong 125 m. After the cylinder fabrication with SSMF embedment, the total insertion loss of the optical fiber was measured as less than 1 dB, including the loss of fiber connectors for the measurement.

Figure 1. Schematic of an optical fiber embedded composite cylinder.

In order to apply the fiber optic TD-BOCDA sensor system for impact damage detection of a composite cylinder, a composite cylinder with an embedded optical fiber was fabricated through the filament winding process so that the optical fiber was positioned between the 90° hoop carbon layers to have an interval of 12 mm in the longitudinal direction of the cylinder. The optical fiber was wound 160 turns around the circumference of the cylinder, and the total straight length was about 125 m. The residual strain in the cylinder was measured using the proposed TD-BOCDA sensor system. Both the optical pump and probe in the system were phase-modulated in this measurement system using the same pseudo random bit sequence (PRBS) code pattern of 2¹⁵–1, but with a bit delay relationship between the two. Modulation rates of up to 16 Gbps were applied, which was an eight-fold increase over our past optical-fiber-embedded composite experiments. This made it possible to measure a spatial resolution of 6.25 mm.

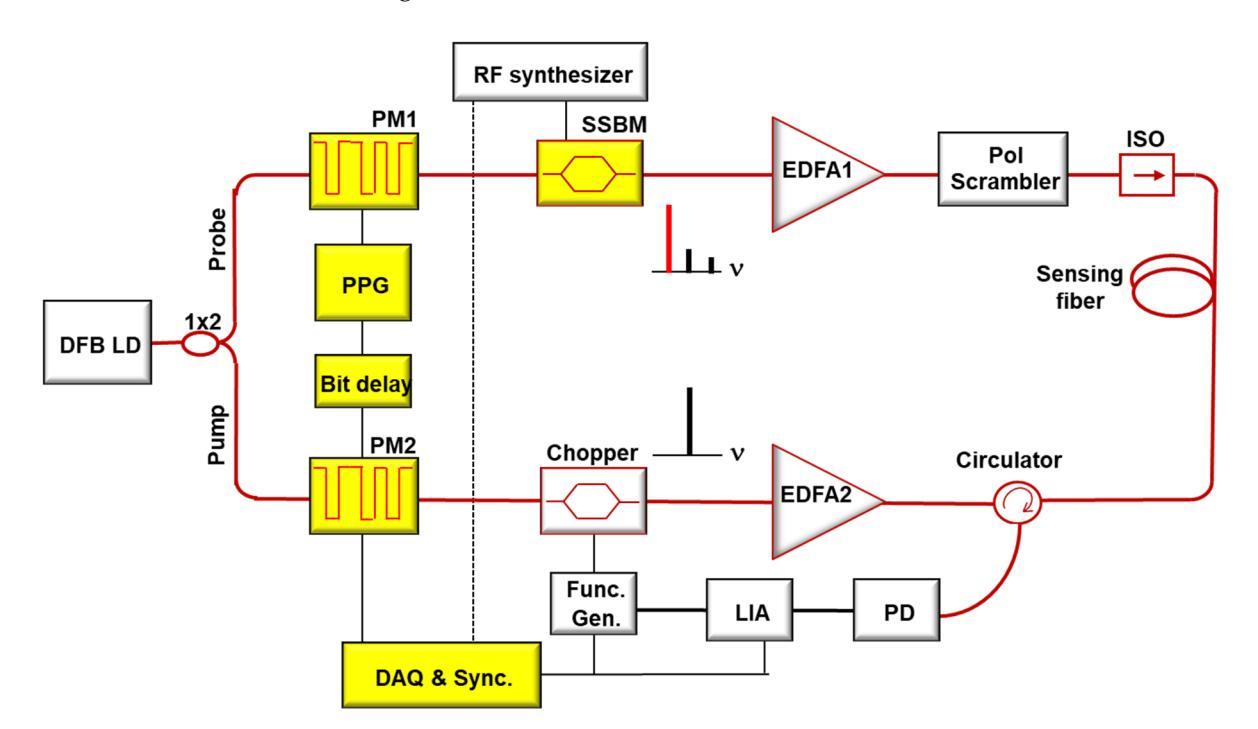
Figure 2 shows that the experimental setup of the TD-BOCDA sensor system was composed of a closed optical fiber loop including a sensing optical fiber. Optical light wave is generated from a distributed feedback (DFB) laser diode (LD) of 15 dBm output. This light is split by a 3 dB coupler into two separate directions for the probe and the pump. The probe light is modulated by a phase modulator (PM) of LiNbO3. This causes the phase of the light to be moved into one of two states between 0 and 180°, according to a pseudo random bit sequence (PRBS) code pattern with a length of 2¹⁵–1. This pattern length was chosen to be longer than the length of the sensing fiber, so that only one correlation peak would produce SBS gain in the fiber. After phase modulation, the probe is again modulated

by a single sideband modulator (SSBM), using a sinusoidal waveform of around 11 Gbps. This causes the peak frequency of the probe light wave to be down-shifted. Thus, the probe and pump are generated from the same light source, but as a result, their frequencies are different. This frequency difference is crucial for SBS gain caused by the correlation between the probe and the pump. The difference that gives the best gain is called the Brillouin frequency. After two modulators, the probe is inserted into a polarization scrambler that removes the polarization dependency of the SBS gain.

The pump is also phase-modulated using the same PRBS pattern as that for the probe, but with bit delay, which is called the time differential, between them. Delayed bits, similar to the time differential between the pump and the probe, cause the position of the correlation peak to move proportionally, and the number of delayed bits decides the measurement position. This is controlled by the computer system. This proposed TD-BOCDA sensor technique makes the traditionally used optical delay unnecessary. The modulated pump is inserted into the chopper and optical amplifier. This chopper is used for SBS gain detection using a lock-in amplifier (LIA). The pump is propagated into the sensing fiber after passing through a circulator. This circulator blocks the propagation of the probe traveling to the pump, and further passes the probe towards the optical receiver. The pump passes through the sensing fiber, and is blocked by the isolator in front of the polarization scrambler. Thus, the circulator and isolator are positioned at the two ends of the sensing fiber.

Figure 2. Experimental setup of the TD-BOCDA sensor measurement system with a sensing optical fiber.

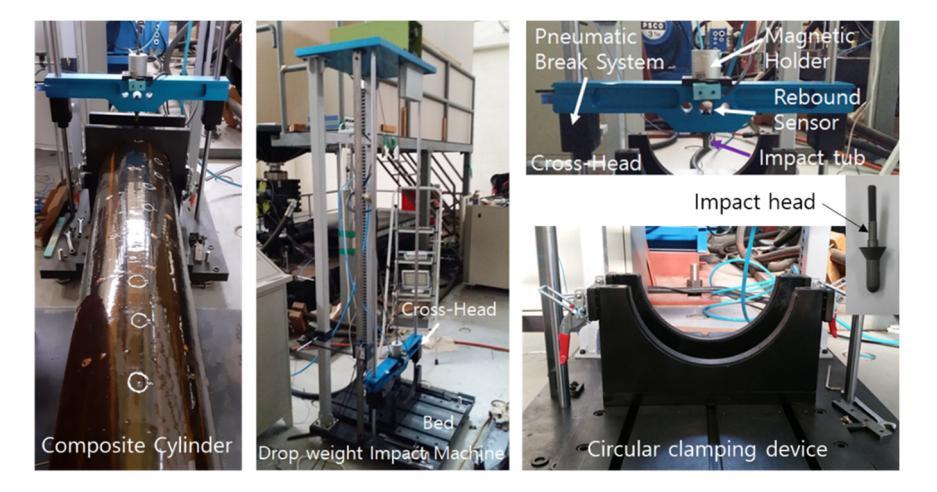
Impact events of four different energy levels from 5 J of the lowest energy to 10, 15, and 20 J were applied to the composite cylinder with optical fiber embedment. These four impact events were repeated three times. Thus, a total of 12 impact events were applied to the cylinder. Even the largest value of 20 J caused an impact on the cylinder that was weak enough to cause BVID. Figure 3 shows that a drop weight impact machine was used for these impacts. The figure shows that the cylinder is firmly held by two external circular clamping devices in the machine, and the blue bar lying horizontally above these clamping devices contains an impactor. When the impactor hits the surface of the cylinder, the effect of each impact event is limited to a 12 cm section between the two circular clamps. The tip

of the impact is hemispherical with a diameter and length of 12.7 and 25 mm, respectively. This blue bar with an impactor is controlled by a brake system to prevent multiple bounces after impact. The white circles mark the locations where the impacts are be applied.

Figure 3. Photo of the drop weight impact machine equipped with an optical-fiber-embedded composite cylinder.

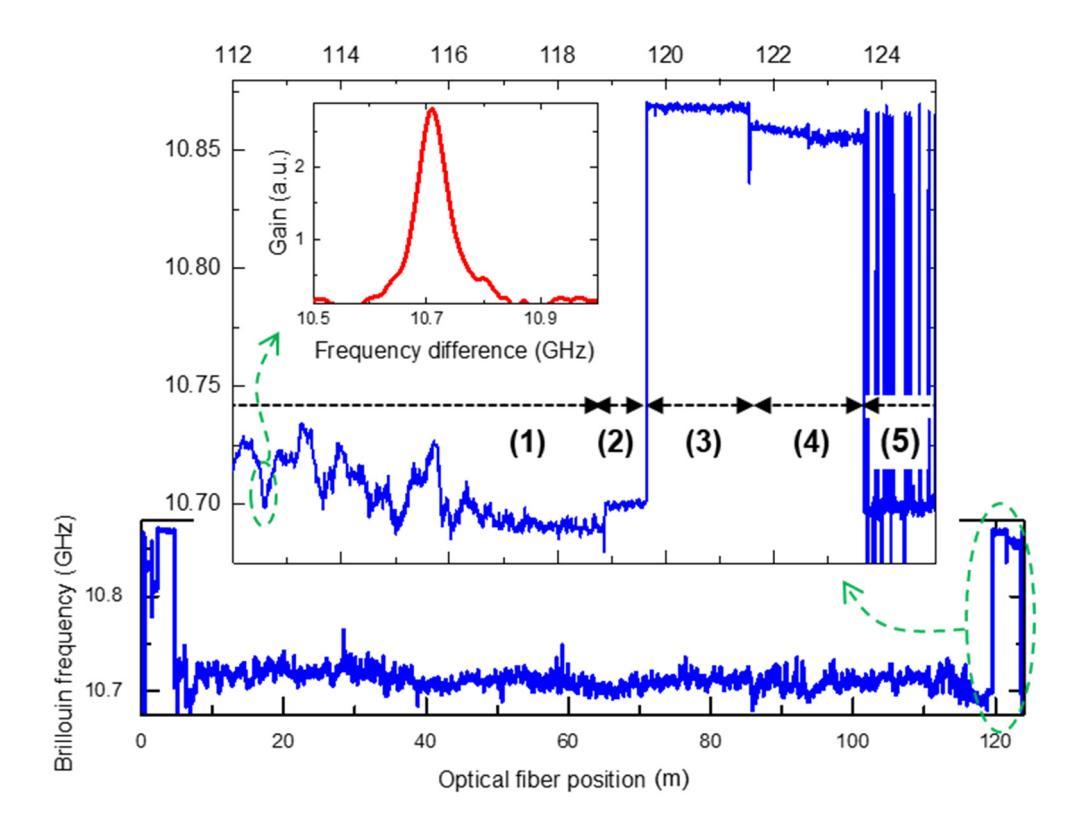
To measure the strain caused by the impact machine, the Brillouin frequencies of the optical fiber before and after impact should be compared. Therefore, first, before the impact events, the Brillouin frequency at each position of the composite cylinder was measured using the TD-BOCDA sensor system of 16 Gbps phase modulation. The frequency difference between the pump and the probe was scanned from 10.5 to 11 GHz. The inset in the top graph of Figure 4 shows the Brillouin frequency as the peak frequency for the highest SBS gain that was obtained at each fiber location. The Brillouin frequency is an intrinsic characteristic of the optical fiber that is determined by the manufacturing conditions and materials used. This intrinsic frequency changes with the stress applied to the material. Figure 4 shows that the changed frequency was measured throughout the whole fiber locations of 125 m. The top graph enlarges the dotted circle area on the bottom graph, which corresponds to one end of the cylinder at around 120 m. The inset in the top graph shows the Brillouin gain spectrum around this end, where the horizontal axis is the frequency difference between the pump and the probe, and the vertical axis is the Brillouin gain in arbitrary units. The peak frequencies were collected from the spectrum measured at each location, and Figure 4 plots them as the Brillouin frequency graph. These measured frequencies on the top graph are divided into five segments for explanation. These segments clearly show the conditions of the sensing optical fiber. Up to segment (1), the sensing fiber is embedded in the composite cylinder. The bottom graph shows that the frequency significantly fluctuates throughout the whole embedded region. This is because, during the filament winding process of embedding the optical fiber, the tension applied to the optical fiber was not uniform, so that the optical fiber was installed inside the cylinder under different tension states according to the location. The frequencies of segment (2) confirm this explanation, where the optical fiber exits the cylinder to connect to the BOCDA sensor system. There are no winding tensions in the fiber, so the frequencies in this segment show the uniform value of 10.7 GHz, as in the graph in the inset of the top graph. This segment is 70 cm, which exactly corresponds to the length of the optical fiber exposed outside the cylinder. Segment (3) shows the frequencies from another SSMF that is spliced to the optical fiber of the cylinder. This fiber in segment (3) is produced by a different company than that of the SSMF embedded in the cylinder, and so the Brillouin frequencies of the two SSMFs are quite different. Segment (4) shows the frequencies for another different SSMF attached to an optical isolator, which was explained as the end of the sensing fiber in Figure 2 of the experimental setup. Its manufacturing company is also different, and so the frequencies differ from those of segments (2) and (3). At the border of

the segments (3) and (4), there is a sharp frequency shift. This shift to low frequency means that compression stress was applied to this location. At its real position, an adaptor for fiber connecters was used to connect these two different SSMFs, and the adaptor mechanically applies a compressive force to the optical fiber at this position. This result means that the TD-BOCDA system can detect the optical fiber adaptor points. In segment (5), the frequency is not specified. This is because, due to the isolator, the pump can no longer propagate to this segment, so there is no peak gain frequency, but only noise.

Figure 4. The Brillouin frequency measured throughout the whole fiber locations of 125 m (bottom graph), and enlargement of the fiber end location (top graph), with the Brillouin gain spectrum (inset).

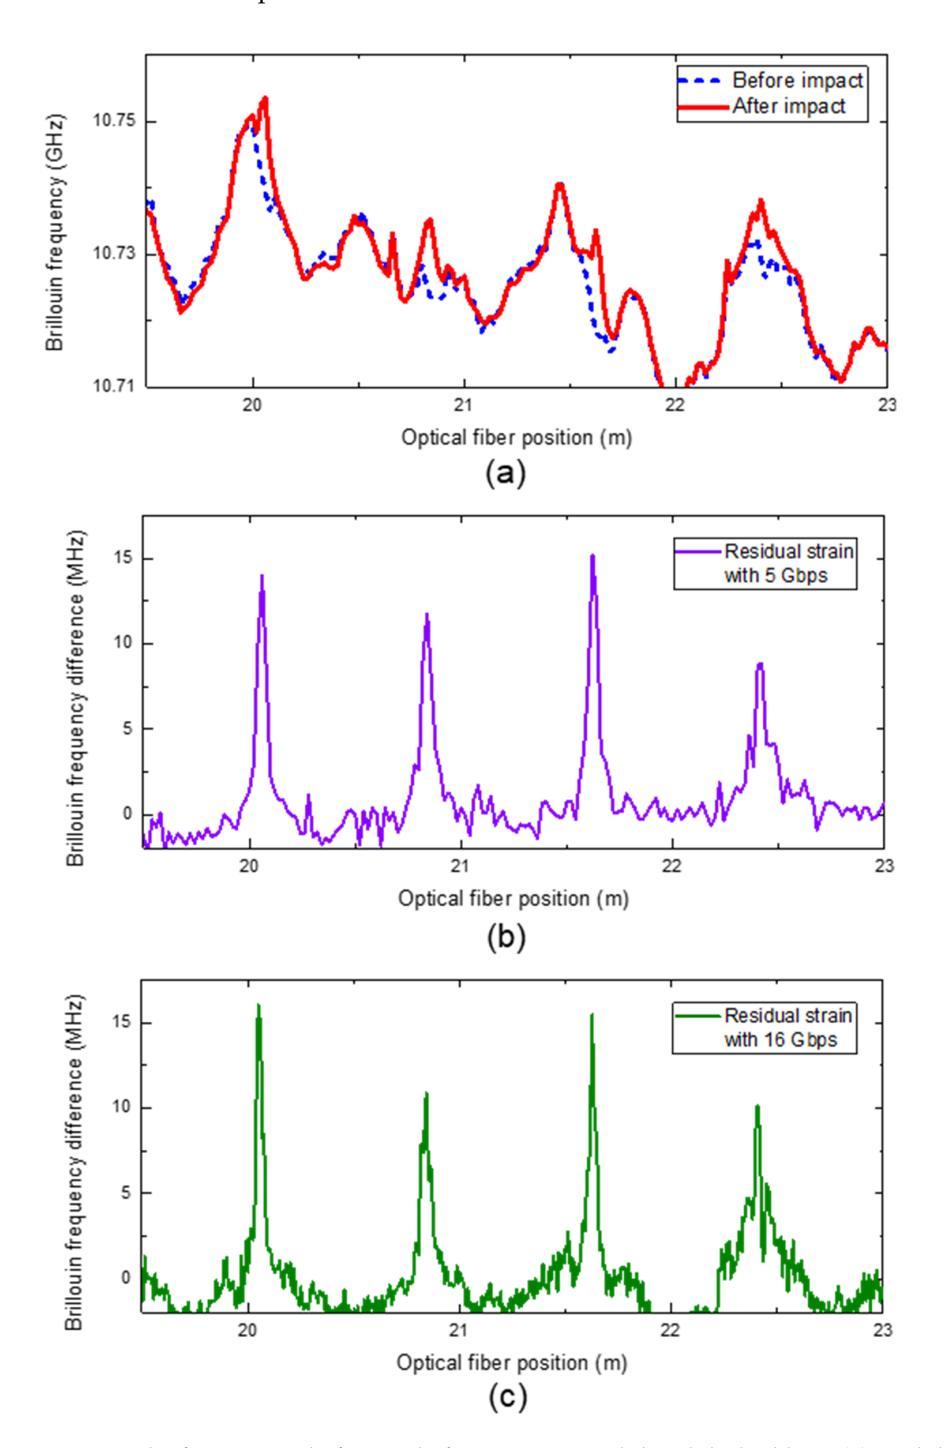
The Brillouin frequencies after impact events were also measured, and the top graph of Figure 5 plots the frequencies before and after impact as solid and dashed lines, respectively. The graph is enlarged for the position of around 21 m out of a total of 125 m, and this is the position impacted by 20 J. The Brillouin frequency difference was measured using three different phase modulations of 5, 10, and 16 Gbps, which correspond to the spatial resolutions of 20, 10, and 6.25 mm, respectively. When the resolution is varied, nothing in the experimental setup needs to be changed. This is the very strong advantage of our TD-BOCDA system. For the conventional BOCDA systems, in order to change the spatial resolution, the optical delay line has to be replaced; moreover, the real fiber location has to be recalculated for the changed phase modulation rate. However, for the TD-BOCDA, no optical delay is needed, and the fiber location only needs to be transferred to their points according to other modulation rates. The middle and bottom graphs give the difference between the two Brillouin frequencies before and after impact for the 5 and 16 Gbps modulations. The peaks in the graphs show the effects after external impacts. These shifts to higher frequency mean that the expansion deformation remains at the impact point. The intervals between these peaks in the graphs are exactly 786 mm, which corresponds to one circumferential turn of the embedded optical fiber around the cylinder. The linewidth of the peaks in the graph with 16 Gbps modulation is much narrower than that in the graph

with 5 Gbps, because the graph with 16 Gbps has more resolvable measurement points than that with 5 Gbps.

Figure 5. The frequencies before and after impact as solid and dashed lines (**a**), and the difference between both frequencies using 5 Gbps measurement (**b**), and 16 Gbps measurement (**c**).

These one-dimensional measurement points in Figure 5 were cut into 79 cm segments of the length of the cylindrical circumference, and Figure 6 rearranges them along the vertical axis of the graph, so this figure realizes the damage map for the cylinder surface of 80 cm \times 190 cm. In Figure 6a, the photo of the cylinder and the points of impact on its surface are marked with white circles, and the amount of impact applied to each point is also marked on the circles. The impact group of 5, 10, 15, and 20 J was repeated three times, as previously mentioned. Figure 6b shows the damage map with 16 Gbps measurement.

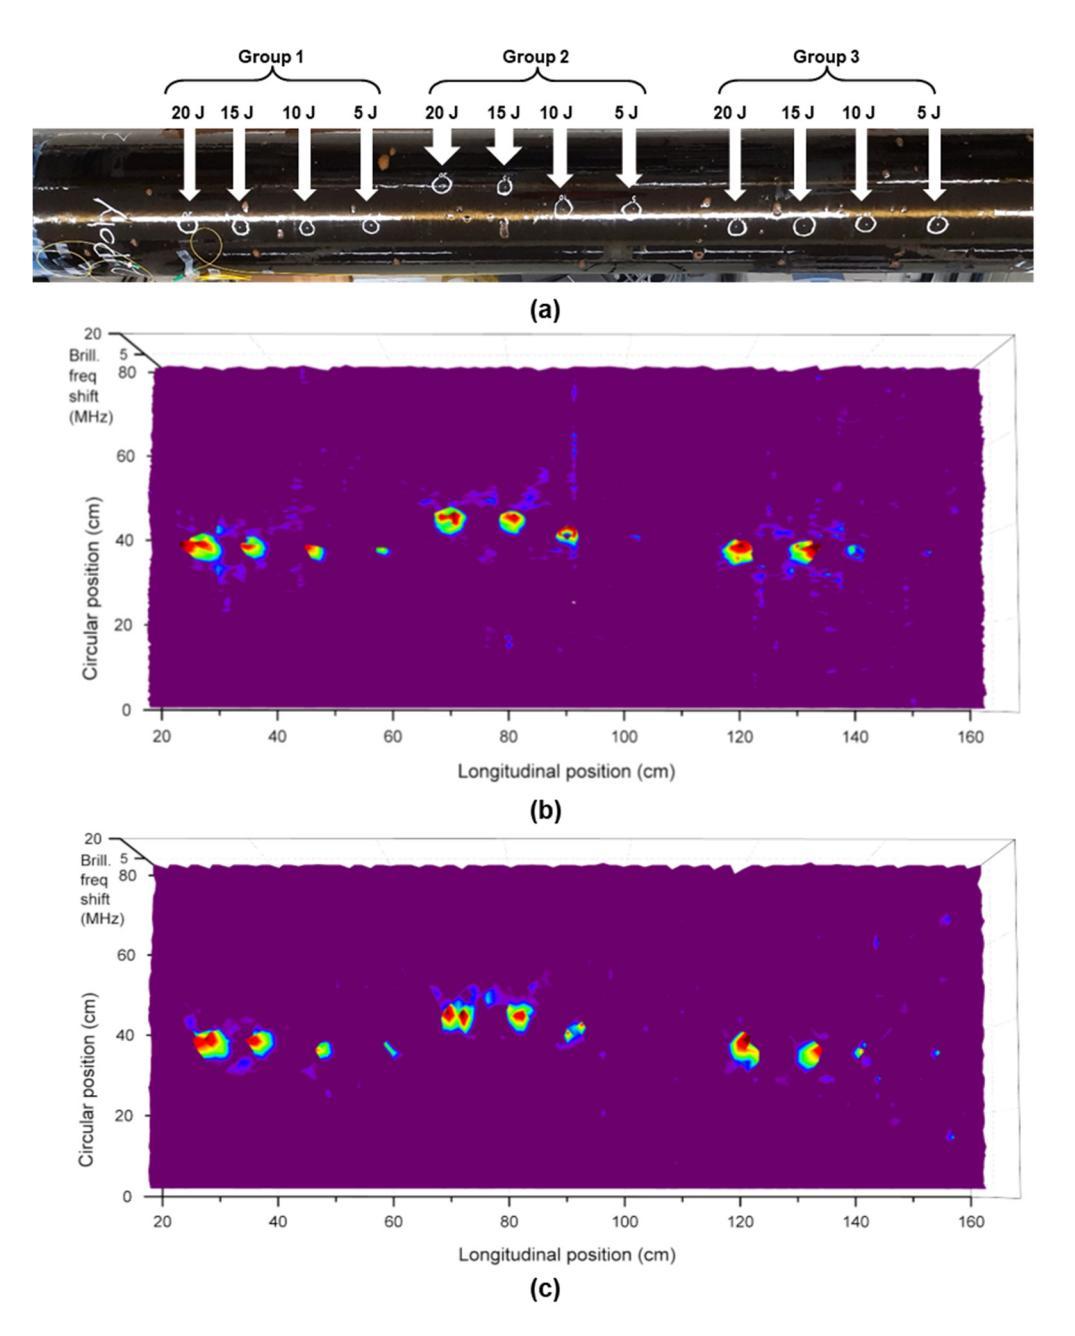
The graph means that the frequency shift increases from purple to red in the order of the colors of the rainbow. All impact points are clearly visible, except for the 5 J impacts in groups 2 and 3. These two points had insufficient damage area in the two-dimensional view, but could be confirmed in the one-dimensional frequency graph. These 5 J measurement results indicate that the system's signal-to-noise ratio needs to be further improved if it is required to detect residual strain of less than 5 J. An important topic in future research will be to increase the accuracy of measurement of the residual strain for impact energy of less than 5 J and obtain its high-resolution damage image. Almost all impact points lie on one horizontal axis, but two impact locations for the 15 and 20 J impacts in groups 2 are off the axis in the cylinder photo. The randomness of these positions is clearly measured in the damage map. For comparison, Figure 6c shows the damage map with 5 Gbps modulation. In this figure, all the impact points are well measured, so the two maps look broadly similar.

Figure 6. (a) Photo of the cylinder marked with white circles for impact points, and the damage maps with (b) 16 Gbps measurement and (c) 5 Gbps measurement.

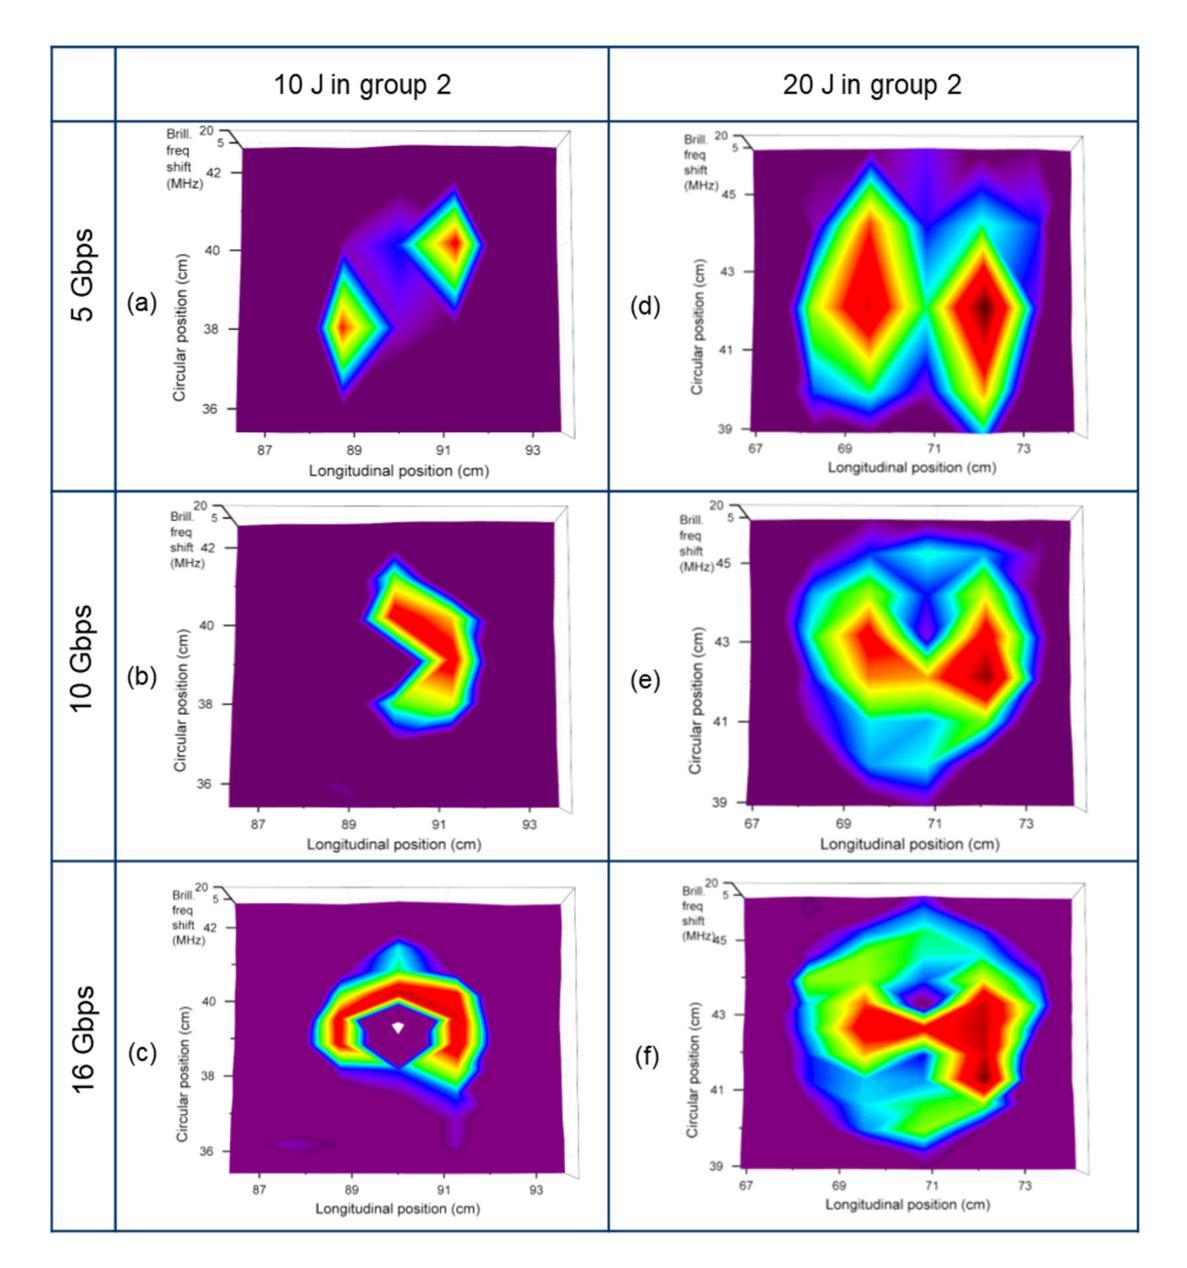
Figure 7 compares the damage maps for the 10 and 20 J impacts in detail, according to the modulation rate. In these six maps, the resolution on the vertical axis for the circular position is varied by the modulation rate, while the resolution on the horizontal axis for the longitudinal position is independent of the rate. The maps all have the same unit scale for both axes. For the 10 J impact in group 2, map (a) of 5 Gbps does not show a sufficient two-dimensionally symmetric damage image, but as the resolution increases to 16 Gbps, a circularly symmetrical damage map is clearly evident. Considering the hemispherical tip of the impactor, point symmetric damage is expected, and the map of 16 Gbps, which has the highest resolution, shows this well. The same trend is also seen for maps (d)–(f) of the 20 J impact. The definite difference between the 10 and 20 J maps (comparison between (a)–(c) and (d)–(f)) is in the size of the damaged image, which means that the large impact left a larger deformation. The multi-circle structure shown in the 16 Gbps maps suggests that the expansion deformation did not occur linearly with respect to the center of the circle.

Figure 7. Damage map comparison for (**a**–**c**) 10 and (**d**–**f**) 20 J impacts according to the modulation rates of 5, 10, and 16 Gbps.

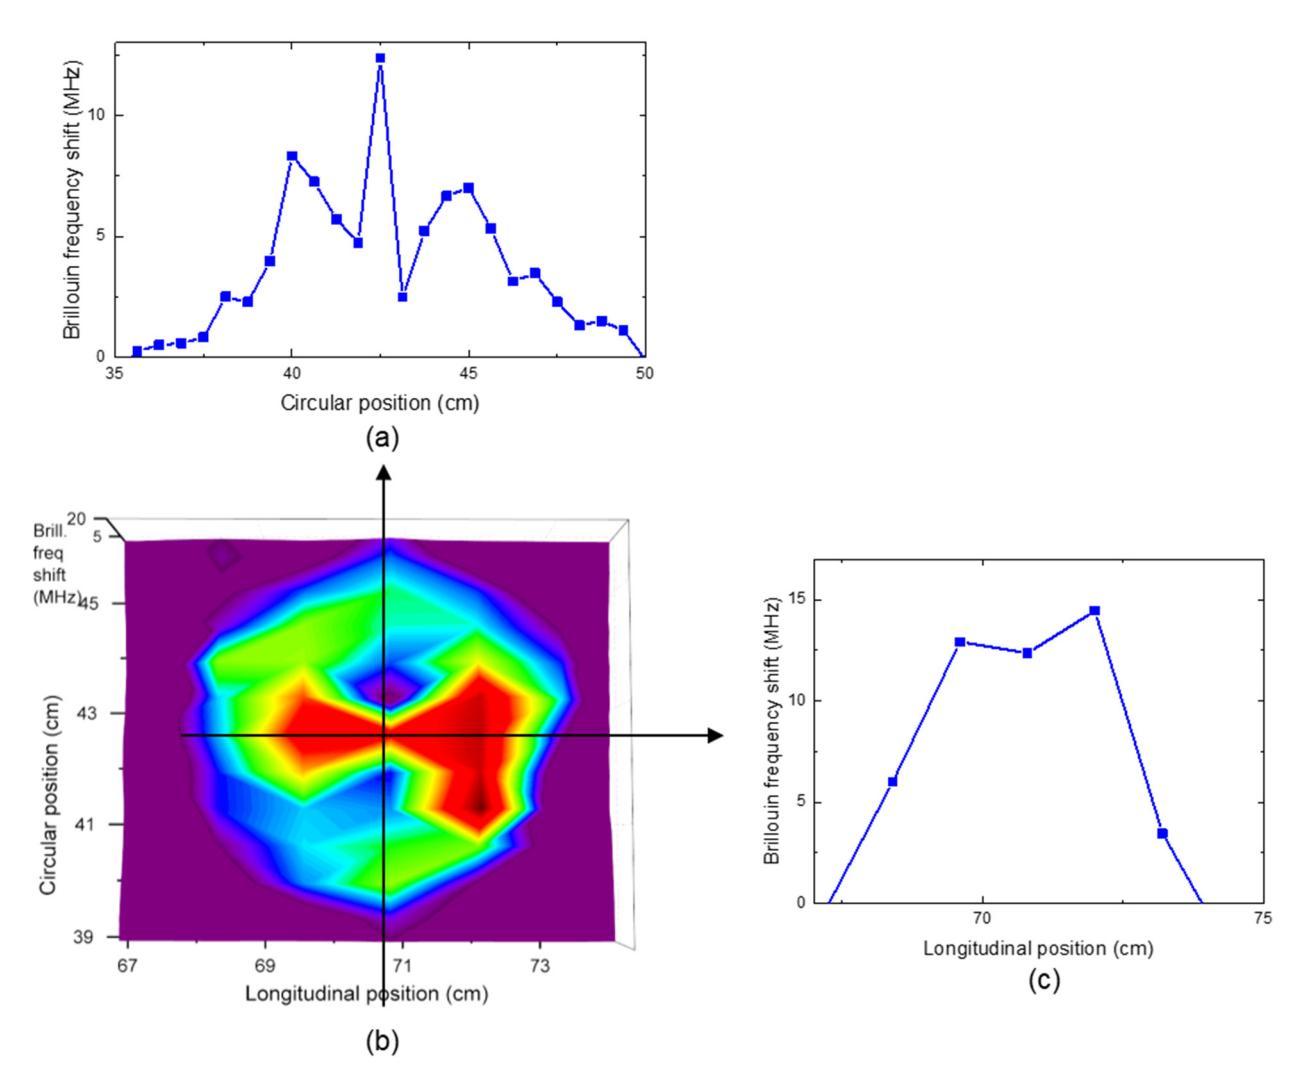
To confirm this, Figure 8 analyzes the 20 J impact map of group 2 with 16 Gbps. The vertical axis for the circular position is about twice the resolution of the horizontal axis for the longitudinal position in the graph of Figure 8b. Figure 8c shows the one-dimensional deformation graph of residual strain along the horizontal axis with respect to the center of the circle. This shows that the expansion deformation due to impact is rather decreased at the center point of the circle. This phenomenon is more evident in another one-dimensional deformation graph of Figure 8a for the vertical axis with high resolution. Both the upand down-shifts of the Brillouin frequency in Figure 8a mean that material expansion and compression alternated with respect to the impact point. It is highly interesting that this is very similar to the deformation of the surface of a liquid shaped by a thrown object. Our previous experiment also observed results similar to this phenomenon [11]. However, in that case, the optical fiber was installed on the composite surface, whereas in this experiment, it was embedded inside the composite. Considering the two experimental results together confirms that the residual strain pattern shown in Figure 8 extends from the surface to the inside of the composite material.

Figure 8. One-dimensional deformation graph along (**a**) the vertical axis, and (**c**) the horizontal axis, respectively, of (**b**) the damage map of 20 J impact with 16 Gbps modulation measurement.

To calculate the total representative amount of residual strain on the impact point, the overall amount of the Brillouin frequency shifts was integrated from the one-dimensional plot on the horizontal axis, and then these values were all added along the vertical axis in Figure 8b. Using this integrated frequency shift and the proportional coefficient between

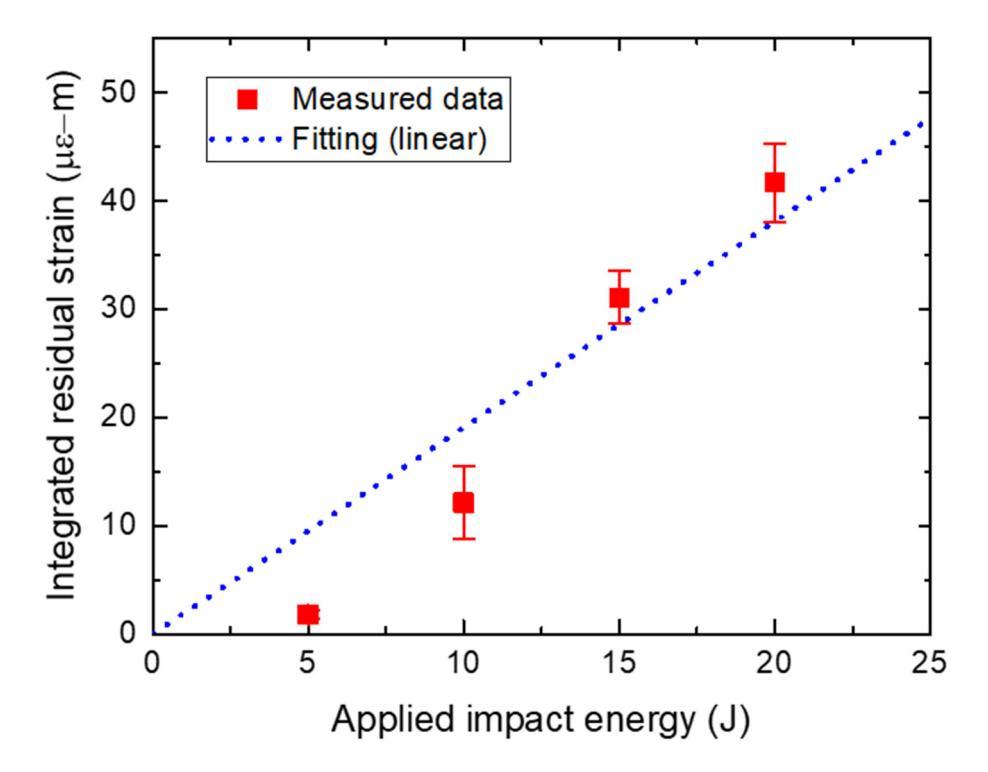
the frequency shift and strain, the total amount of residual strain was obtained at each impact event. Figure 9 shows the result according to the impact energy. Because the impact events of 5, 10, 15, and 20 J were repeated three times, each integrated residual strain is shown with the measurement deviation. The graph shows that the total amount of residual strain at each impact point is linearly proportional to the applied impact energy, although as the impact energy is reduced, there is some difference from the fitted proportional line.

Figure 9. The integrated residual strain according to the applied impact energy.

system compared to the conventional BOCDA sensor system. The expansion deformation in the measured damage map due to the impact was measured at all impact points, and the impact locations on the map were observed to be exactly the same as their actual locations on the cylinder. As the measurement resolution increased, the damage showed a point-symmetrical shape on a two-dimensional plane more clearly. Furthermore, the total amount of measured residual strain at each impact point was linearly proportional to the applied impact energy.
