Article Analysis and Application of Lining Resistance to Water Pressure in Tunnel through Karst Cave

Abstract: Using RFPA software, the hydraulic pressure resistance and damage process of the grouted stone body of a tunnel in the high-pressure karst zone were analyzed, and the hydraulic pressure resistance of the composite surrounding rock and composite structure when the tunnel was expanded through the cavern under the effect of hydraulic coupling was investigated. Then, a new parallel heading expansion scheme for the New Yuanliang Mountain Tunnel was innovatively discussed, and the reliability of the results of the calculation model was verified by a field test. Lastly, the model calculation results guided the project to adopt a 5 m grouting range and advanced secondary lining to ensure that the composite structure's water pressure resistance could reach 3 MPa; by adopting the improved technology of parallel heading expansion based on the CRD method, the safety of tunnel expansion through the cavity was effectively ensured, which can provide a reference for similar projects in the future.

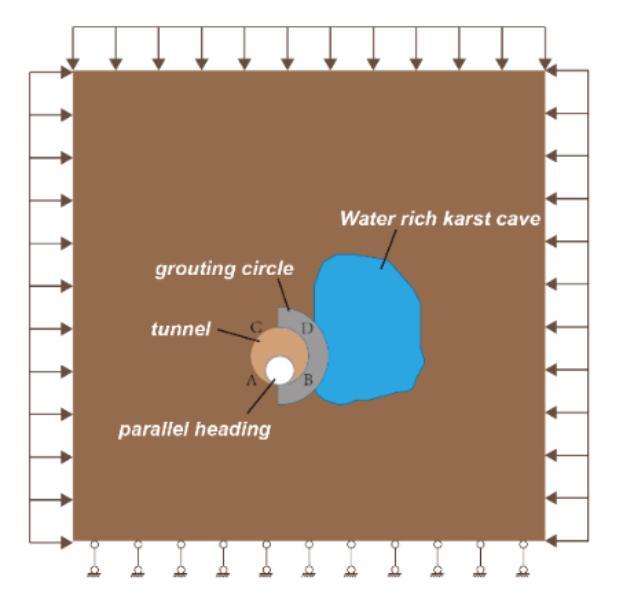
Figure 1. Diagram of the numerical calculation model for the damage of the grouted body.

mean load was about 10 MPa, and the lateral pressure coefficient of rock was taken as 1.5. The calculation model is shown in Figure 1. The model was considered by the plane strain problem, and the modified Coulomb criterion including the tensile cutoff was used as the strength criterion for unit damage. The structural parameters of the surrounding rock level are shown in Table 1.

The calculation steps of all models in this paper were the same. The first step was a steady pressure after grouting for the existing parallel heading; the water pressure load was applied to the inner wall of the water-bearing cavity to simulate the water pressure effect in the cavity, and the initial water pressure in the water-bearing cavity was 0.1 MPa, with a single-step increment of 0.01 MPa. The second step was the construction of the existing parallel heading expansion, and the water pressure in the cavity was calculated to increase until the rupture of the grouted reinforcement circle bursts water.

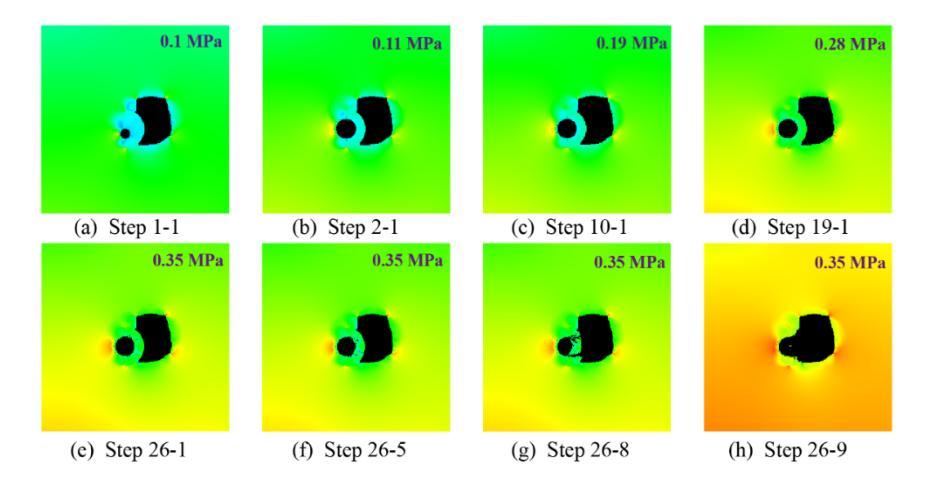
Figure 2. Numerical calculation results of the damage model of the grouted body under the influence of a water-rich cave: (**a**–**h**).

According to the numerical simulation calculation results, the damage pattern results of typical steps were extracted, as shown in Figure 2, corresponding to steps 1-1, 2-1, 10-1, 19-1, 26-1, 26-5, 26-8, and 26-9, with water pressures of 0.1 MPa, 0.11 MPa, 0.19 MPa, 0.28 MPa, and 0.35 MPa, respectively. It can be observed in Figure 2 that, because the initial state of the cavity had 0.1 MPa water pressure, a circular stress zone was distributed around the cavity before the excavation of the existing parallel heading, and no structural damage occurred in the grouted stone body between the cavity and the parallel heading at this time. After the excavation of the existing parallel heading, the original stress balance was broken, and stresses were redistributed around the tunnel, on both sides of the tunnel, as well as at the top and bottom of the arch. In addition, at this time, a very obvious stress concentration appeared in the grouted stone body, and a new stress equilibrium state was finally reached under the influence of the mutual coupling of force and flow fields. Then, with the increase in water pressure inside the cavity, microcracks began to be generated

on one side of the grouted stone body inside the tunnel, and, as the stress concentration on both sides of the grouted stone body further increased, coupled with the minimum restraint on both sides of the grouted stone body, a macroscopic main crack connecting the bottom of the tunnel arch and the interior of the cavity was gradually extended through, and another main crack extending from the interior of the cavity to the right arch of the tunnel was also gradually extended. Eventually, the grouted stone body collapsed to the interior of the tunnel as a whole with the two main cracks as the slipping surface, and the stone body was completely destroyed.

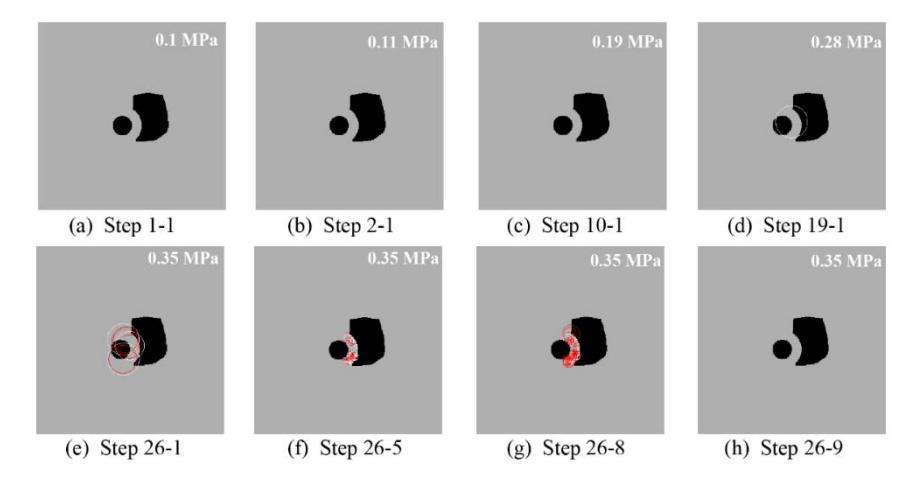
Figure 3. Acoustic emission diagram of the model shown in Figure 1 at different steps: (a-h).

When the surrounding rock unit underwent brittle damage, the elastic energy released from the rock body was released externally in the form of acoustic emission; hence, the acoustic emission characteristics of the rock could reflect the process of rock rupture. The calculated acoustic emission at a typical loading step is shown in Figure 3. A light color in the acoustic emission diagram indicates that the compression damage occurred in the rock unit, and a dark color indicates that the tensile damage occurred in the rock unit. From Figure 3, it can be seen that, after the parallel heading initially expanded the tunnel, as the water pressure in the cavity continued to rise, the grouted rock unit first appeared as a compression shear damage unit; then, as the water pressure in the cavity gradually increased, the compression shear damage unit gradually decreased. When the water pressure in the cavity rose to 0.35 MPa, the grouted rock unit presented cracks, which were mainly caused by tensile shear damage.

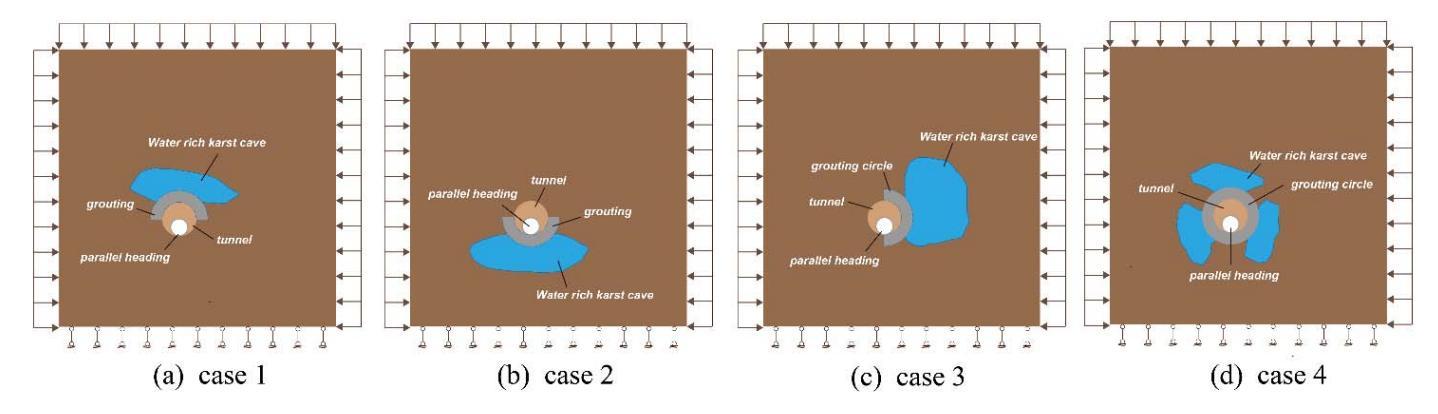
Figure 4. Schematic diagram of the numerical calculation model for different relative positions of tunnel and cave: (**a**) tunnel under the cave; (**b**) tunnel up through the cave; (**c**) tunnel side crossing the cave; (**d**) tunnel through the cave cluster.

The effect of grouting and water plugging reinforcement in karst areas can be influenced by the relative position of the tunnel and the cavity. According to the typical spatial and temporal distribution of karst cavities, the four calculation cases shown in Figure 4 were summarized, and the grouting and water plugging effects were studied under these four tunnel-cavity relative positions. The water pressure resistance and damage mode of different thicknesses of the grouting were analyzed in each case, and the thickness of the grouting circle was taken as 3 m, 4 m, 5 m, 6 m, 7 m, 8 m, 9 m, and 10 m, respectively; the grouting material was superfine cement–water/glass double liquid. According to the numerical simulation results, the structural stability of the grouted body was compared and analyzed under different thicknesses of the grouted reinforcement circle, and the influence of karst morphology on the curtain grouting was investigated. The stratigraphic parameters, model excavation, and cavity water pressure application methods used in the calculations were as described above.

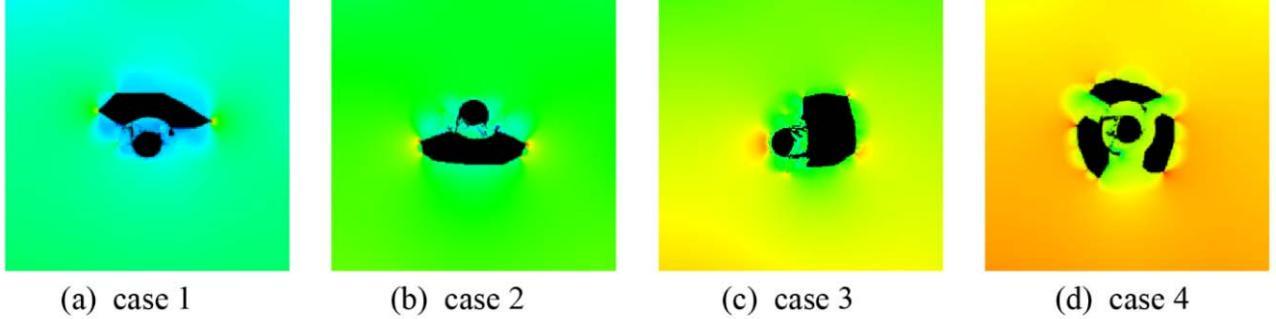
Figure 5. Numerical calculation results of damage characteristics of grouting for different relative positions of the tunnel and the cave: (a) tunnel under the cave; (b) tunnel up through the cave; (c) tunnel side crossing the cave; (d) tunnel through the cave cluster.

The calculated results of the water pressure resistance of the grouted stone body under different relative positions of the tunnel and the cave are shown in Figure 5. It can be found that, in all cases, the main cracks of the grouted rock mass basically sprouted from the two ends of the middle rock column, and then the cracks developed gradually with the increase in water pressure until penetration. Eventually, the grouted rock mass collapsed into the tunnel with complete damage. A further analysis of typical acoustic emission diagrams in various cases is shown in Figure 6. It can be found that the main cracks formed by the grouted stone body were all caused by tensile–shear damage. When traversing the cavern cluster, the grout ring damage was mainly generated and developed from the weakest point, as shown in Figure 6d, and the tensile shear damage was mainly generated at the closest relative distance to the cavern.

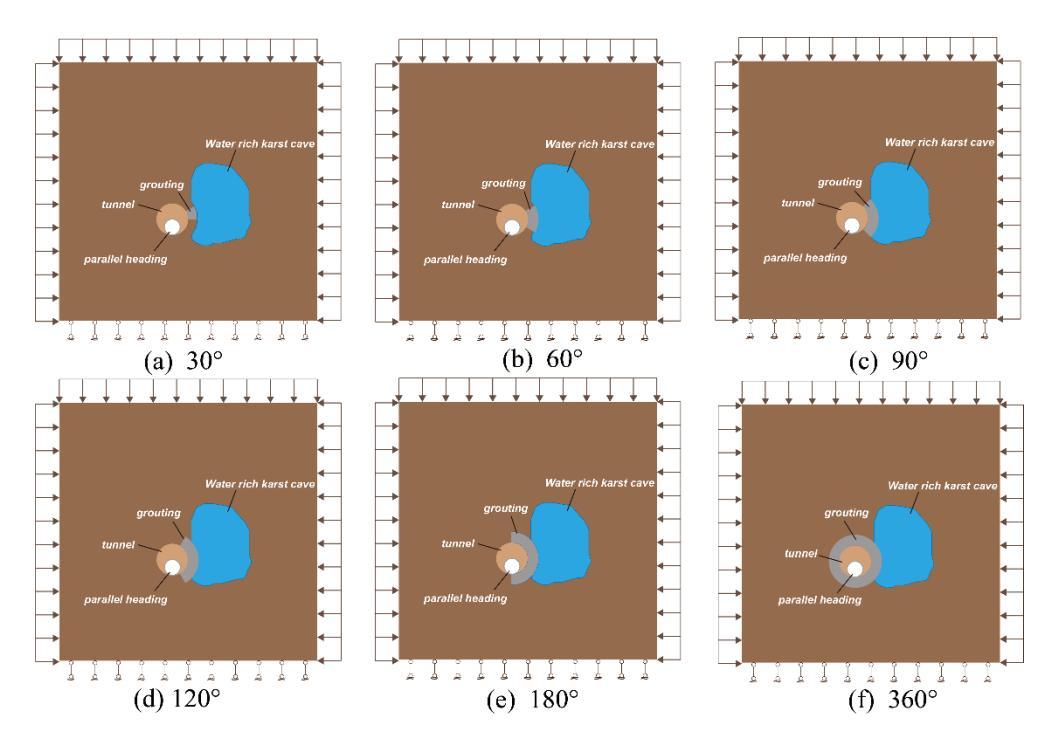
Figure 8. Schematic diagram of the numerical calculation model for different grouting ranges: (a) grouting range of 30° ; (b) grouting range of 60° ; (c) grouting range of 90° ; (d) grouting range of 120° ; (e) grouting range of 180° ; (f) grouting range of 360° .

Since the location of the cavity is more certain in the actual project, precise grouting can not only save resources but also improve the construction efficiency. Therefore, the calculation model took the circle angle of the grouting reinforcement circle as 30° , 60° , 90° , 120° , 180° , and 360° in order to study the influence of different grouting ranges on the water pressure resistance of the grouting circle. The thickness of the slurry reinforcement circle was taken as 5 m, and the corresponding model is shown in Figure 8. The stratigraphic parameters, model excavation, and cavity water pressure application methods used in the calculations were as described above.

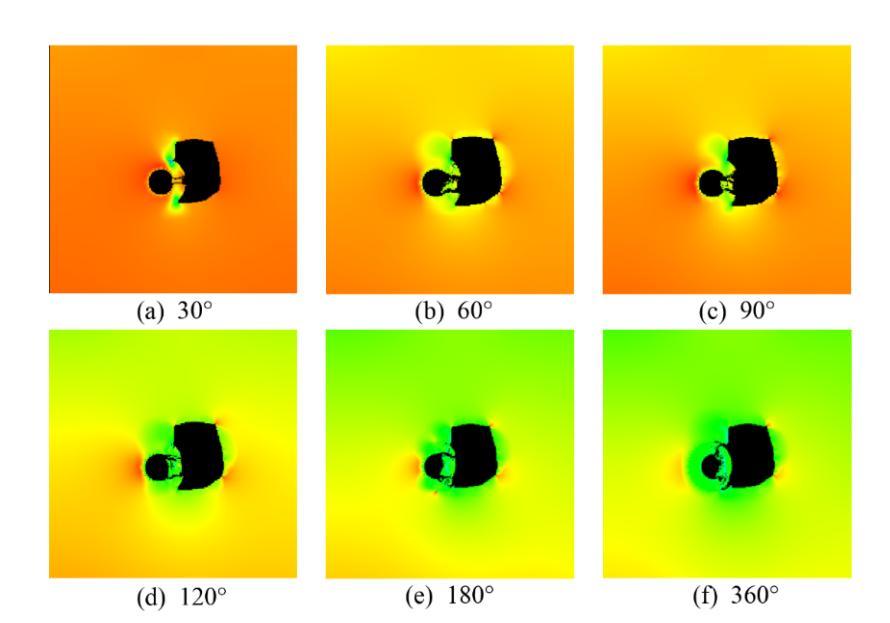
Figure 9. Numerical calculation results of damage characteristics of grouting for different grouting ranges: (**a**) grouting range of 30°; (**b**) grouting range of 60°; (**c**) grouting range of 90°; (**d**) grouting range of 120°; (**e**) grouting range of 180°; (**f**) grouting range of 360°.

The effect of different grouting reinforcement zones on the hydraulic resistance of the grouted stone body during the tunnel side penetration of the cavern was calculated as shown in Figure 9. From the figure, it can be seen that the damage to the stone body at different grouting angles was dominated by tensile-shear damage, the main cracks of the grouted stone body were sprouted from both ends of the reinforcement circle, and the cracks penetrated the structure. With the increase in the grouting angle range, the location of the cracked stone body expanded to the outer side, and, when the grouting range reached 120°, the crack no longer penetrated, which can be considered as a significant weakening of the effect of cavern water pressure on tunnel safety after this time. From the calculation results of typical acoustic emission of different ranges shown in Figure 10, it can be seen that, as the grouting range increased, the energy generated when the stone body was destroyed under critical water pressure gradually increased, and there were more tensile and shear damage units. The damage of the grouting circle at this time tended to have a greater disturbance toward the stable surrounding rock, which indicated that the effect on the tunnel stability after the destruction of the grouted stone body with stronger resistance to water pressure is often greater and needs to be focused on during construction.

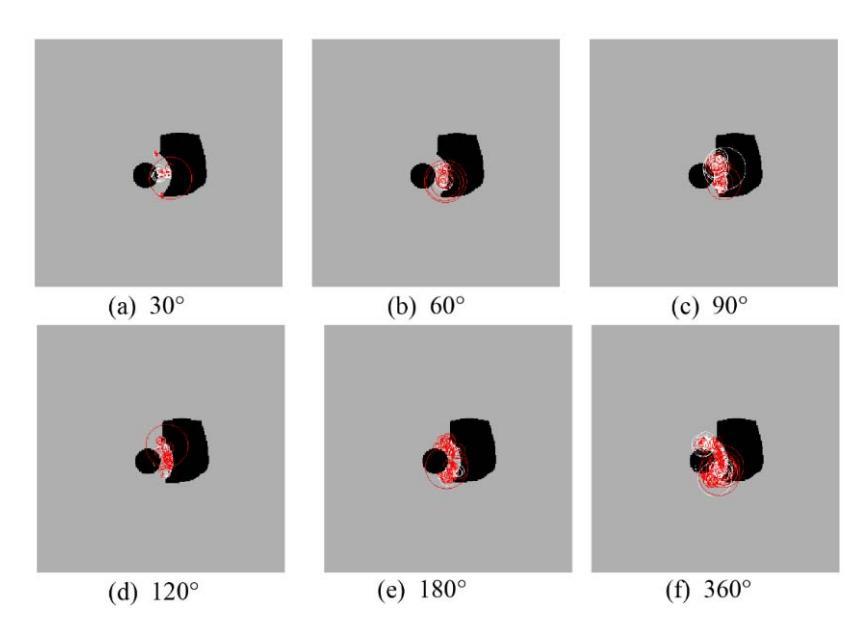
Figure 10. Acoustic emission diagram of grout damage for different grouting ranges: (a) grouting range of 30° ; (b) grouting range of 60° ; (c) grouting range of 90° ; (d) grouting range of 120° ; (e) grouting range of 180° ; (f) grouting range of 360° .

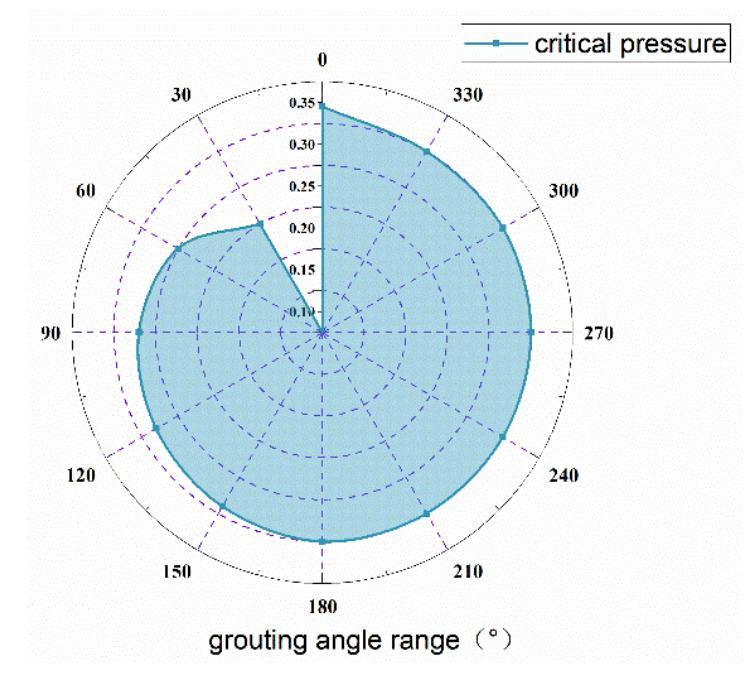
Figure 11. Comparison of water pressure resistance of stone bodies under different grouting ranges.

According to the calculation results, the water pressure resistance of different grouting reinforced areas was analyzed, and the water pressure resistance and damage characteristics of the stone body under various grouting reinforced areas were compared, as shown in Figure 11. It can be found that a larger extent of the grouting reinforcement zone led to a better the effect of grouting stone reinforcement. When the grouting range was enlarged to the extent that the tunnel was separated from the karst, while continuing to increase the range of the grouting reinforcement zone, the effect on improving the water pressure resistance of the grouting reinforcement area and 360° grouting reinforcement area, it can be seen that, for the case of the adopted side cavity calculation, the 180° grouting range and 360° grouting range had no significant effect on the improvement of the karst body's

hydraulic resistance. Therefore, in the actual project, there is no need to grout the side cavities of the tunnel without cavity distribution, and single-side grouting can meet the safety requirements.

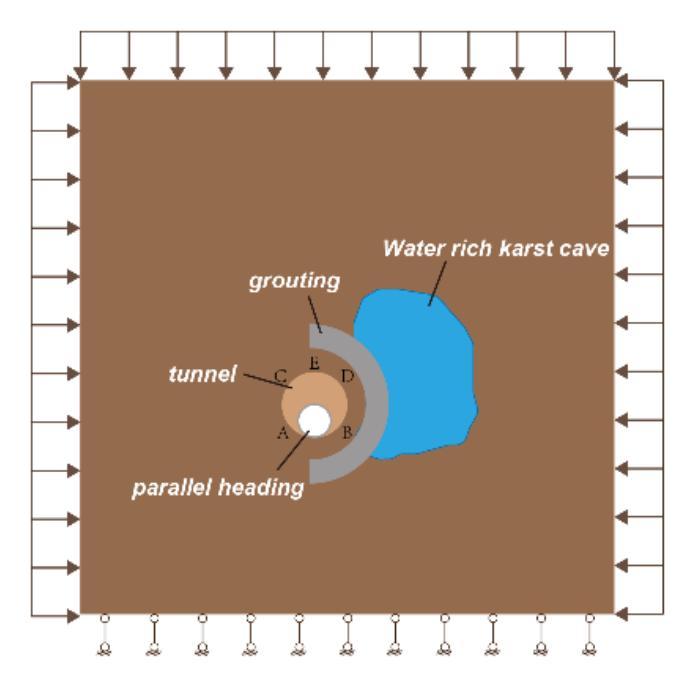
Figure 12. Diagram of the numerical calculation model.

In order to study the hydraulic resistance of the composite structure formed by the grouting circle and the remaining surrounding rock near the tunnel, the following model was established: it was assumed that, after the parallel heading expansion, 3 m thick surrounding rock remained between the tunnel and the side hidden cavity. At this point, the safety thickness of the surrounding rock may not have been sufficient, and the cavity filling needed to be reinforced with grout before the parallel heading expansion. The thickness of grouting reinforcement was 5 m; hence, the 3 m thick surrounding rock and 5 m thick grouted rock body could be regarded as a composite surrounding rock after the parallel heading expansion, and the cavity could be simplified as a water-bearing cavity to carry out a simulation study of the composite surrounding rock's resistance to water pressure. The model is schematically shown in Figure 12. The stratigraphic parameters, model excavation, and cavity water pressure application methods used in the calculations were as described above.

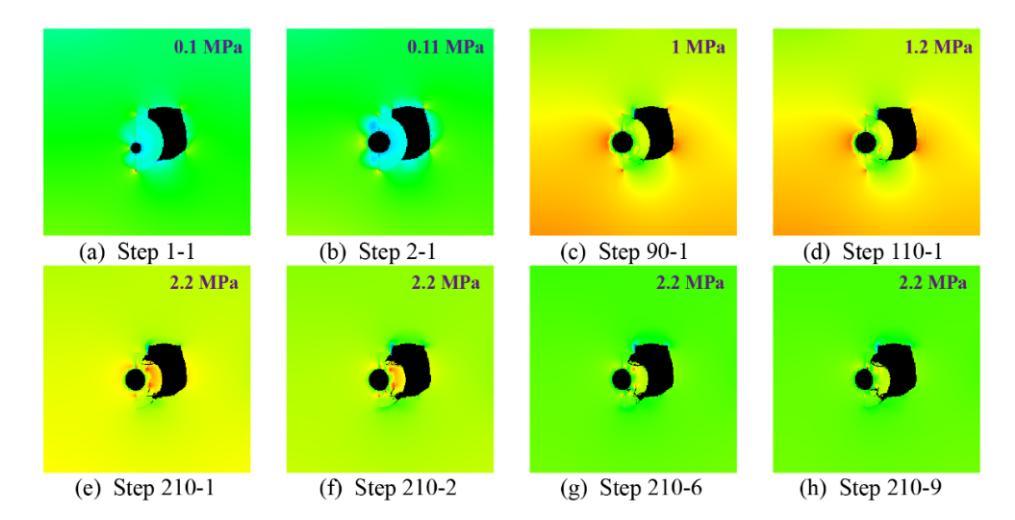
Figure 13. Numerical calculation results of the damage model of the composite surrounding rock under the influence of a water-rich cave: (**a**–**h**).

According to the numerical simulation calculation results, the damage pattern diagrams of typical steps were extracted as shown in Figure 13, corresponding to steps 1-1 (0.1 MPa), 2-1 (0.11 MPa), 90-2 (1.0 MPa), 110-1 (1.2 MPa), 210-1 (2.2 MPa), 210-2 (2.2 MPa), 210-6 (2.2 MPa), and 210-9 (2.2 MPa). Observing the figure, it can be found that, because the initial state of the cavity had 0.1 MPa water pressure, there were circular stress zones distributed before the excavation of the existing parallel heading and around the cavity, and no crack expansion of the composite surrounding rock between the cavity and the parallel heading occurred at this time. After the construction of the existing parallel heading expansion, the original stress balance around the tunnel was broken, and stress redistribution appeared around the tunnel. Furthermore, the composite surrounding rock showed a very obvious stress concentration and finally reached a new stress equilibrium state under the repeated coupling effect of force and flow fields. With the increased water pressure inside the cave, it can be found that a micro-crack had sprouted in the outer layer of the composite surrounding rock of the grouted stone body, and, with the further increase in the stress concentration in the grouted stone body, a macroscopic crack had extended through to the inner layer of the composite surrounding rock body. At this time, the cavity water pressure acted on the surrounding rock through the crack. Then, with the continuous increase in the water pressure in the cavity, the main crack connecting the bottom of the cavity and the bottom of the tunnel arch was extended through. Finally, the whole composite surrounding rock body collapsed to the interior of the tunnel.

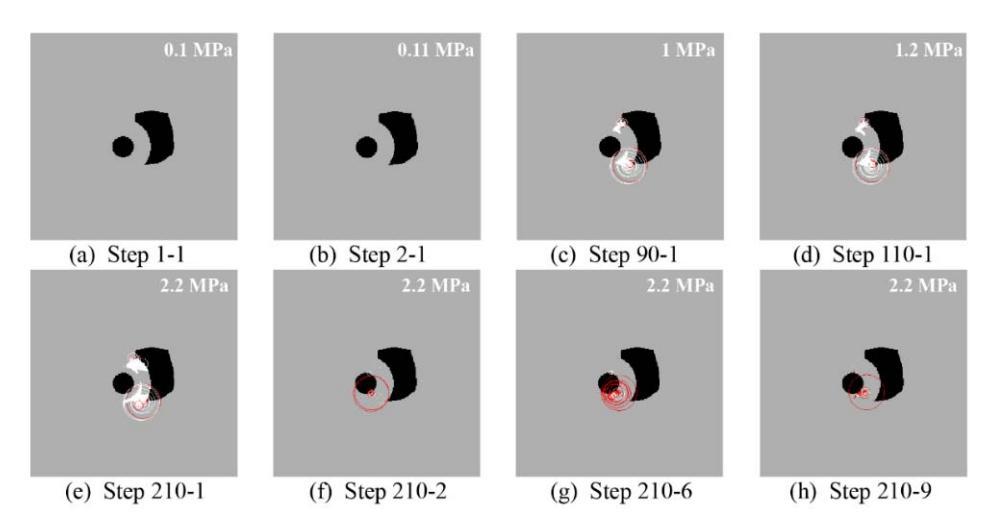
Figure 14. Acoustic emission diagram of the model shown in Figure 12 at different steps: (a-h).

The acoustic emission of the typical loading step obtained from the calculation is shown in Figure 14. As can be seen from the figure, after the parallel heading was just expanded to form the tunnel, the composite surrounding rock structure was intact, and the acoustic emission energy was weak. With the increasing water pressure in the cavity, the acoustic emission energy gradually accumulated. When the water pressure in the cavity rose to 1.0 MPa, the grouted stone body in the outer layer of the composite surrounding rock started to appear as a compression shear unit, and the distribution of the pressurized unit expanded along the cavity toward the tunnel. This feature was reflected in the minimum principal stress diagram as cracks started to appear in the grouted stone body and started to sprout from the inside of the cavity toward the tunnel. Then, as the water pressure in the cavity rose further, the number of compression–shear units on the grouted stone body increased dramatically, reflecting that the structure was being damaged at this time. Eventually, the grouted stone body was damaged, and the water pressure in the cavity acted on the inner layer of the composite surrounding rock body along the fracture of the grouted stone body, which appeared as a tensile–shear damage unit. For the above model, when the water pressure in the cavity reached 2.2 MPa, the surrounding rock body was damaged, and the crack at this time was mainly caused by the tensile–shear damage.

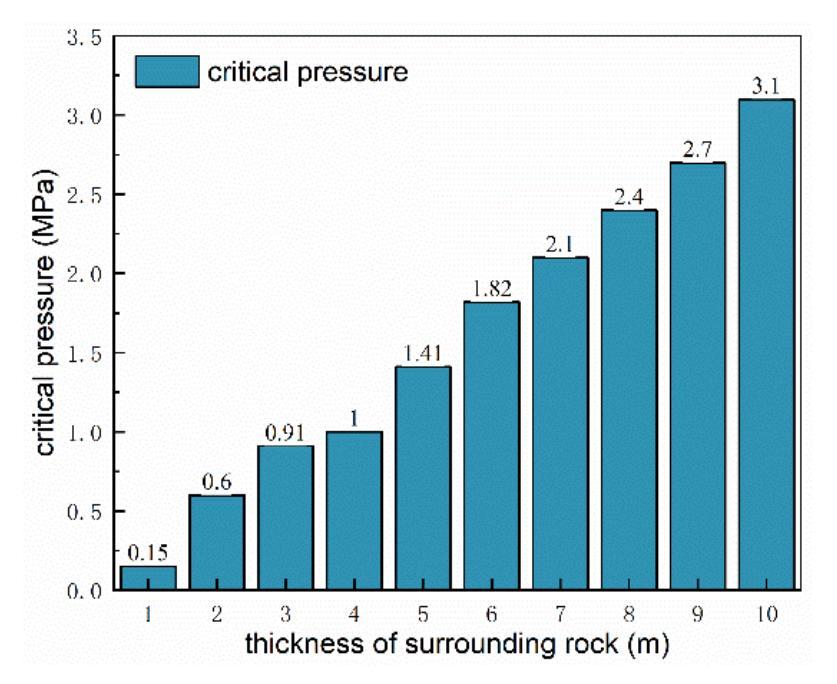
For the case of the hidden cavity on the side of the tunnel, the safety thickness of the surrounding rock was analyzed by the above model. The calculation results are shown in Figure 15, from which it can be seen that the surrounding rock thickness of 1 m could only resist 0.2 MPa water pressure, and the surrounding rock thickness of 2 m could already resist 0.6 MPa water pressure, which doubled the thickness of the surrounding rock and

increased the resistance to water pressure by three times. When the surrounding rock thickness increased to 10 m, the resistance to water pressure reached 3.1 MPa, compared with the surrounding rock thickness of 1 m, the surrounding rock thickness increased by 10 times, and the resistance to water pressure increased by 15.5 times. The water pressure resistance increased by 15.5 times compared with the 1 m thickness of the surrounding rock. It can be found that a thicker surrounding rock led to a stronger hydraulic resistance. The growth process of this showed a linear trend, and the growth rate was almost a constant. This is because, on the one hand, the thicker surrounding rock body had a greater bearing capacity; on the other hand, the influence range of the cavity would have been weakened with the increase in distance between the cavity and the tunnel.

From the research results in Figure 15, it can be seen that, if 3 MPa water pressure was required to be resisted, the surrounding rock thickness needed to reach 10 m, and, when the surrounding rock thickness was less than 10 m after parallel heading expansion, the cavity filling needed to be grouted and reinforced. At this time, the remaining surrounding rock after excavation and the grouted stone body were considered as a whole, the composite surrounding rock safety distance between the tunnel and the surrounding hidden cavity was studied, and the composite surrounding rock safety thickness was calculated together. The calculation model is shown in Figure 12, where the surrounding rock thickness was taken as 1 m, 2 m, 3 m, 4 m, 5 m, 6 m, 7 m, 8 m, 9 m, and 10 m. For each surrounding rock thickness of grouted cobble body was taken as 3 m, 4 m, 5 m, 6 m, 7 m, 8 m, 9 m, and 10 m, respectively.

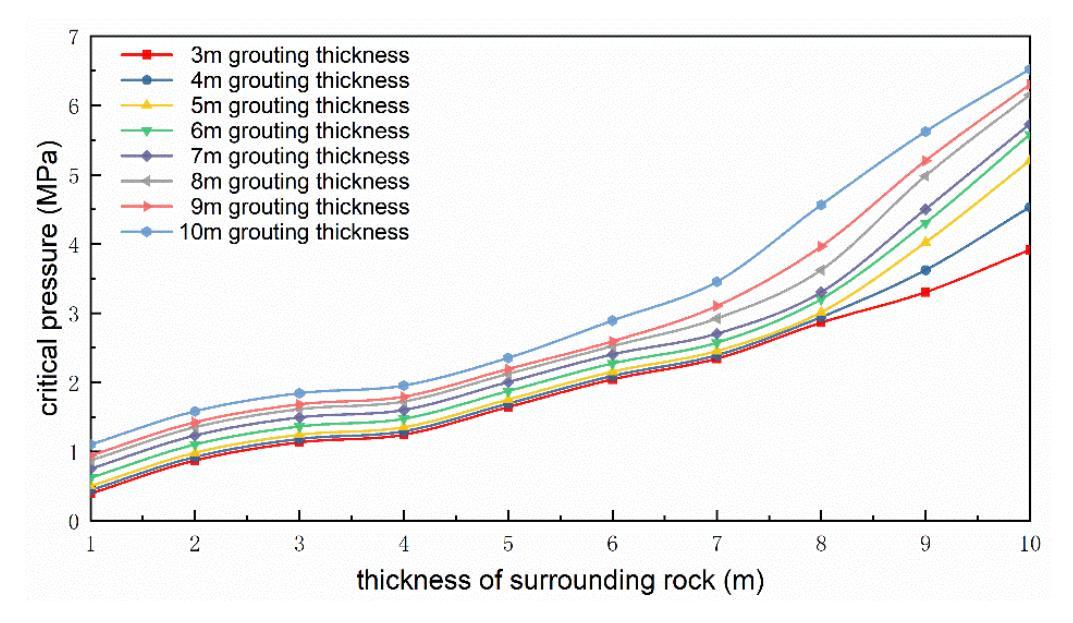
Figure 16. Comparison of water pressure resistance of different composite rock thicknesses.

The comparison of water pressure resistance of different composite rock thicknesses is shown in Figure 16. As can be seen from the figure, a greater thickness of the surrounding rock and a thicker grouted stone body led to a higher corresponding composite surrounding the rock's resistance to water pressure capacity. When the thickness of the grouted stone body was certain, the trend of the composite surrounding rock's resistance as a function of the water pressure capacity increased with the thickness of the surrounding rock, which could be divided into three stages: growth period, stable period, and accelerated period. When the thickness of the surrounding rock was less than 3 m, the composite surrounding rock's resistance to water pressure capacity increased significantly with the thickness of the surrounding rock. When the thickness of the surrounding rock was 3–4 m, the growth rate of the water pressure resistance curve slowed down; when the thickness of the surrounding rock reached above 4 m, the slope of the water pressure resistance curve gradually increased. After analysis, it can be seen that a greater thickness of the composite surrounding rock led to a stronger water pressure resistance; as the thickness of the composite surrounding rock and the distance between the karst and tunnel increased, the influence of karst became weaker relative to the tunnel.

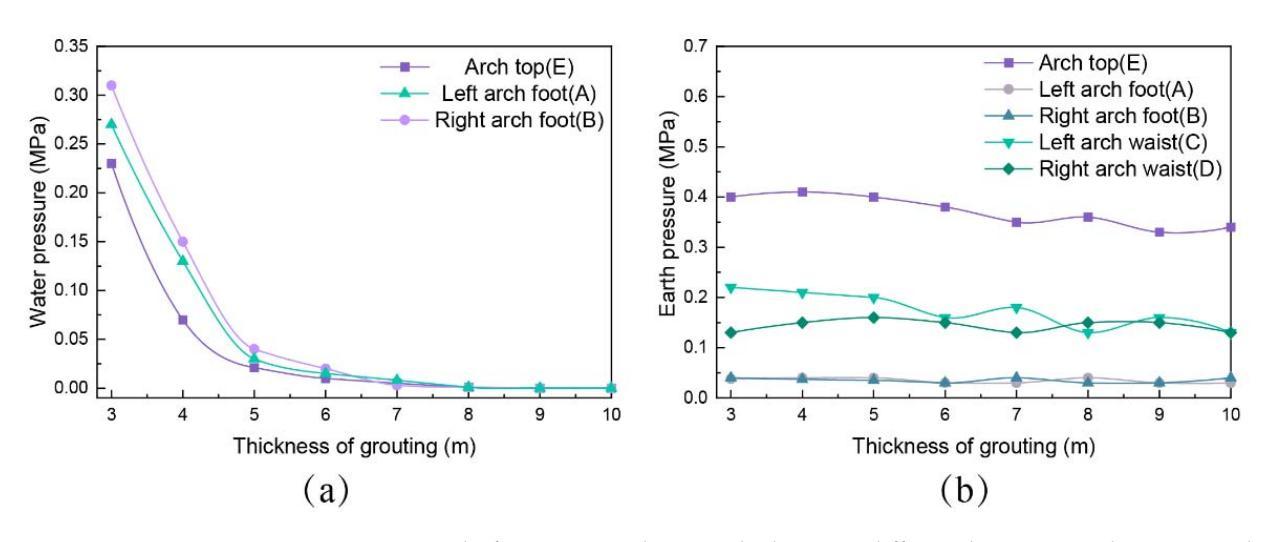
Figure 17. Trend of pressure with grout thickness at different locations in the numerical model: (a) characteristics of water pressure variation with grouting thickness; (b) characteristics of earth pressure variation with grouting thickness.

According to the five locations of observation points shown in the model of Figure 12, the calculated results of pressure at these observation points were extracted to analyze the trend of pressure values at different thicknesses of grouting, and the results are shown in Figure 17. From Figure 17a, it can be seen that with the increase in thickness of grouting, the overall trend of water pressure behind the second lining decreased first and then became stable. When the thickness of grouting increased from 3 m to 5 m, the maximum water pressure at the observation point behind the lining was reduced from 0.3 MPa to 0.04 MPa, after which the water pressure no longer decreased significantly with a further increase in the thickness of grouting. From Figure 17b, it can be seen that, for the earth pressure behind the second lining, the effect of the thickness of grouting on the earth pressure was not obvious. With the increase in thickness of grouting from 3 m to 10 m, the earth pressure at all observation points always fluctuated around a stable value, which may be due to the fact that the self-weight load generated by the rock was basically carried by itself after being reinforced, and the self-supporting capacity of the surrounding rock was given full play at this time. To summarize the results, it is recommended that a grouting thickness of 5 m selected for site construction can effectively reduce the pressure behind the second lining. At this time, the numerical calculation results showed that the water pressure behind the second lining of the arch was about 0.025 MPa, and the water pressure of the left and right arch foot was 0.03 MPa and 0.04 MPa, respectively, while the earth pressure at the top of the arch was about 0.4 MPa, the earth pressure at the left and right arch foot was about 0.04 MPa and 0.035 MPa, and the earth pressure at the left and right arch waist was about 0.2 MPa and 0.16 MPa, respectively.

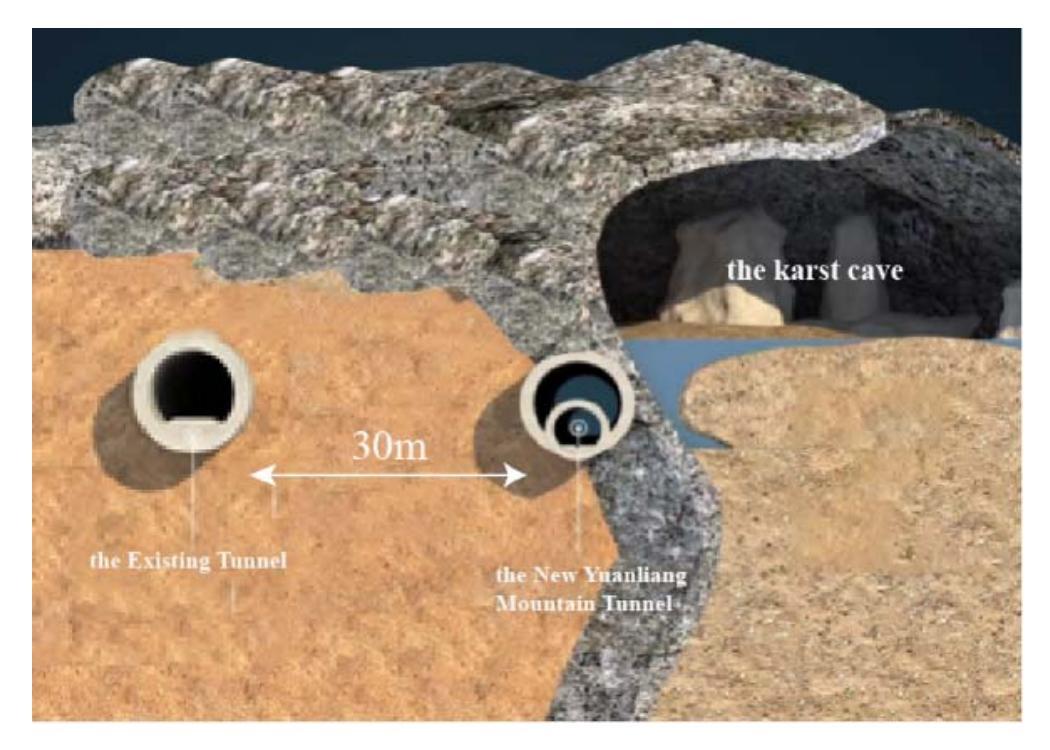
Figure 18. The New Yuanliang Mountain Tunnel geological profile.

The New Yuanliang Mountain Tunnel is a tunnel project formed by expanding the existing parallel heading of the established Yuanliang Mountain Tunnel on the Yuhuai I-line. The maximum depth of burial is about 774 m, with a total length of 11.1 km. the clearance size of the parallel heading is $4 \text{ m} \times 4 \text{ m}$, and the size of the expanded tunnel section is 7 m \times 10 m. The lithology of the strata in this section is mainly carbonated rocks and clastic rocks deposited in the Paleozoic and Mesozoic, with a loose accumulation of the Fourth Series accounting for some. The tunnel continuously crosses the Mao Ba slope and Tong Ma Ling back slope. The karst cave is located in the core of the Mao Ba slope, 3060 m from the entrance, 60 m long, and 579 m deep. The cave is characterized by obvious dissolution fissures and large water surges, with a strong correlation between water pressure and surface rainfall. The cavity filler is powder clay and clayey fine sand, with poor self-stabilization ability. The main difficulty of the project is that the tunnel main cavern suffers from a cavern water pressure of about 3.013 MPa, and the cavern area parallel heading expansion can lead to no remaining surrounding rock between the tunnel and the surrounding hidden cavern or an insufficient safety thickness of the surrounding rock. Therefore, there is a great risk of sudden water and mud. The cross-section of the tunnel and cave location is shown in Figure 18.

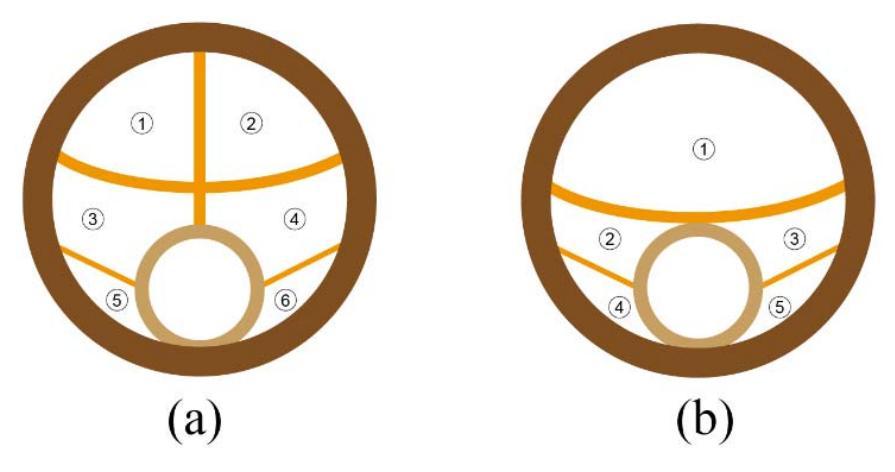
Figure 19. Construction diagram of CRD method and CD method. (a) CRD method construction procedure diagram, in which excavation sequence installation (1-2)-(3-(4-5)-(6)) was carried out; (b) CD method construction procedure diagram, in which the excavation sequence installation (1-2)-(3-(4-5)) was carried out.

diaphragm method (CRD) and center diaphragm method (CD) were compared and analyzed by numerical calculations, and the characteristics of the construction steps of both are shown in Figure 19. The calculation results are shown in Figure 20, revealing that the maximum amount of settlement deformation in the monitored section was 8.64 mm and the maximum horizontal convergence deformation was 2.52 mm when the CRD method was adopted for excavation expansion. However, the maximum amount of settlement deformation in the monitored section was 12.28 mm and the maximum horizontal convergence deformation was 5.86 mm when the CD method was adopted. It is obvious that the CRD method restricted the displacement of the surrounding rock and controlled the plastic zone of the surrounding rock more effectively by turning the excavation surface into zero and reducing the area of one excavation at the palm face. According to the characteristics of the New Yuanliang Mountain tunnel project, the CRD method was finally selected for the tunnel construction of the cavern section from a safety point of view.

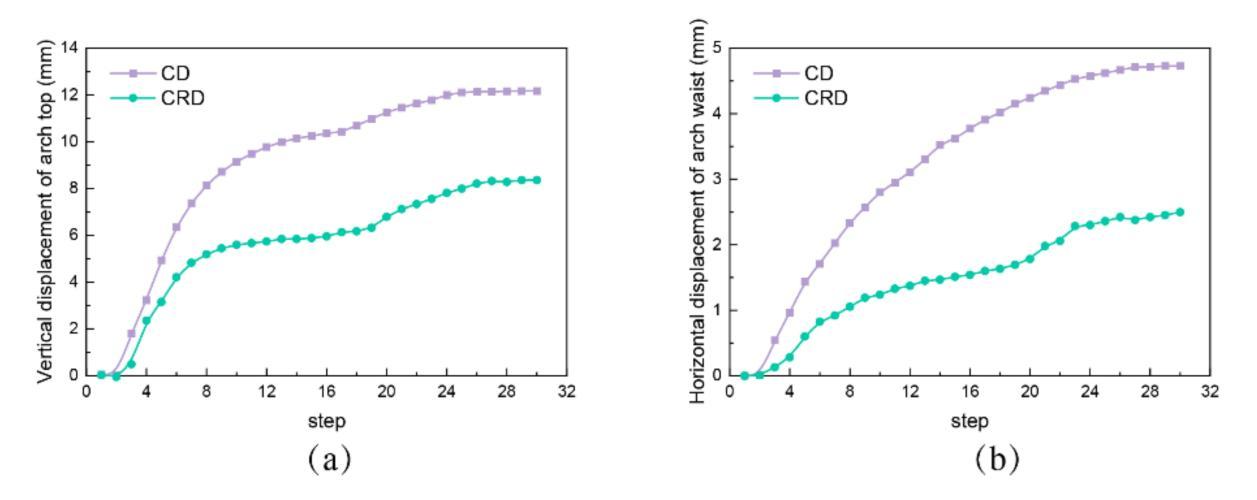
Figure 20. Comparison of tunnel settlement caused by CRD method and CD method during excavation: (**a**) comparison of vertical settlement of archtop; (**b**) comparison of horizontal convergence of arch waist.

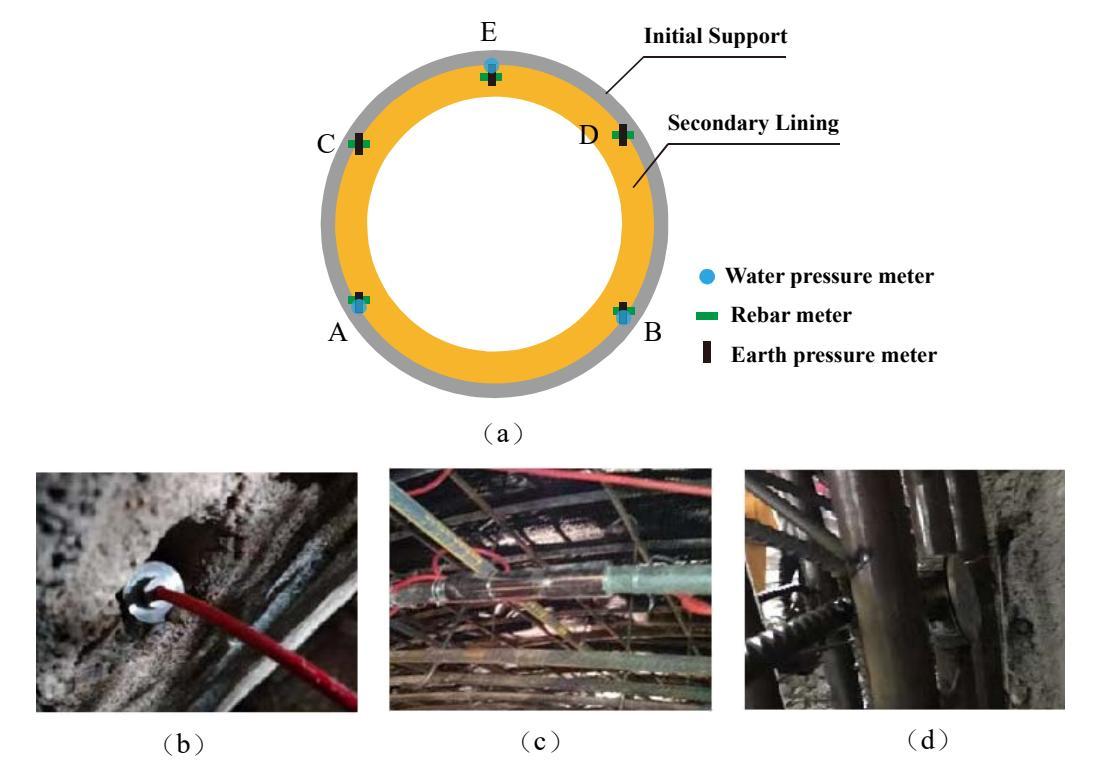
Figure 21. Diagram of the layout of the monitoring section measurement points and the installation of instruments on site: (**a**) monitoring section measurement point layout diagram; (**b**) on-site water pressure meter installation diagram; (**c**) on-site rebar meter installation diagram; (**d**) on-site earth pressure meter installation diagram.

To verify the reliability of the above numerical calculations, relevant field tests were performed on the water resistance of the structure after the construction of the tunnel at the New Yuanliang Mountain. During the rainy season, the water pressure in the cavity section was monitored and measured, and the selected sections DK340+300 and DK340+377 were tested for the water pressure between the initial support and the secondary lining, the stress on the secondary liner rebar, the contact pressure between the initial support and the secondary lining, etc. The sensor arrangement and field installation of each monitoring section are shown in Figure 21.

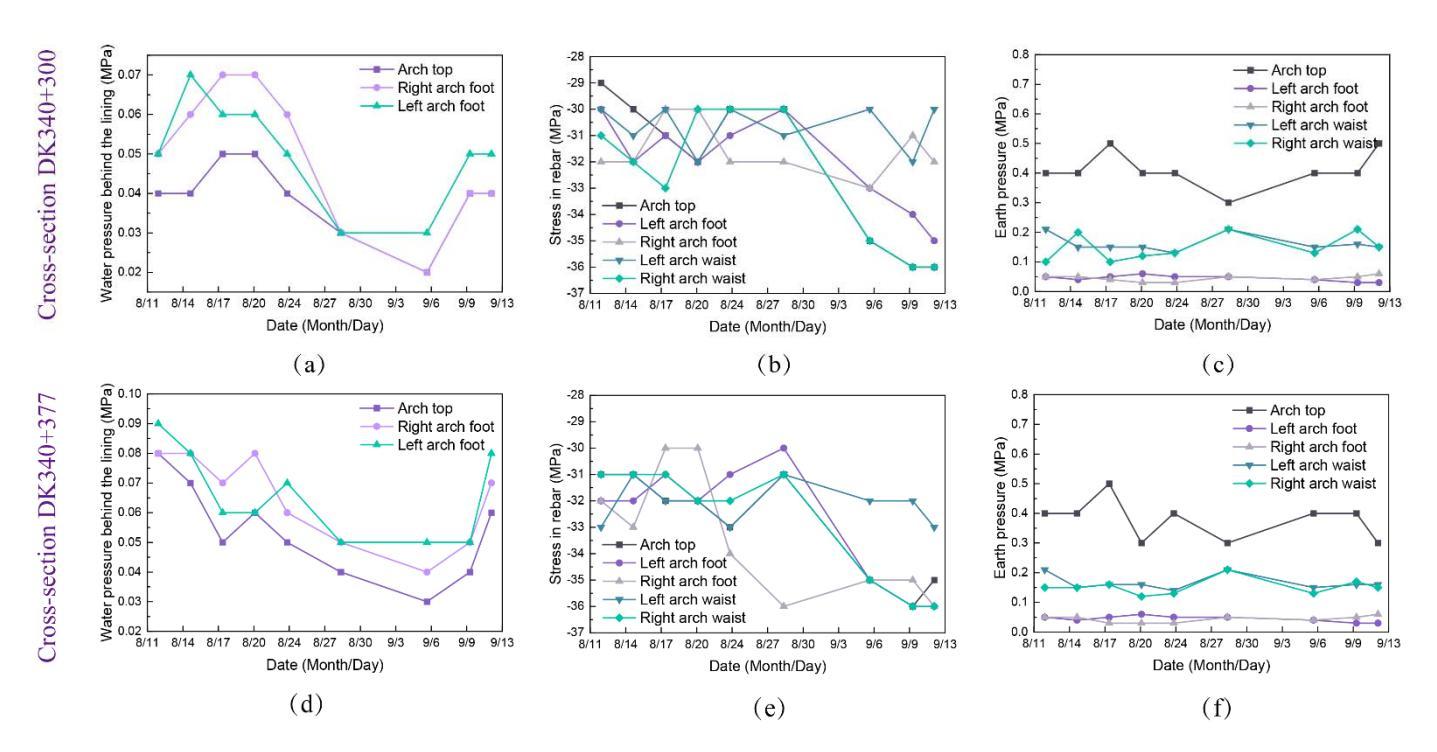
Figure 22. Results of field measurements at monitoring sections: (**a**) results of water pressure monitoring at section DK340+300; (**b**) results of rebar stress monitoring at section DK340+300; (**c**) results of earth pressure monitoring at section DK340+300; (**d**) results of water pressure monitoring at section DK340+377; (**e**) results of rebar stress monitoring at section DK340+377; (**f**) results of earth pressure monitoring at section DK340+377.

The results of field monitoring are shown in Figure 22, which showed that, during the month-long monitoring at the rainy season, the results of all monitoring points of the two sections with respect to the water pressure behind the lining were lower than 0.1 MPa, reflecting the obvious efficiency of the above construction water resistance technology. The monitoring results of the rebar meter inside the second liner were all around 30 MPa, which indicated that the second liner was stable in force, and that the structure had good performance in resisting water pressure. As for the contact pressure between the initial support and the secondary lining, the pressure at the top of the arch was slightly larger than that at the foot and waist of the arch, about 0.5 MPa, and the pressure at the foot of the arch was the smallest, about 0.4 MPa, which was because the top of the arch featured vertical pressure, while the foot of the arch featured lateral pressure. The pressure at the waist of the arch was just between the two, consistent with the actual situation. Summarizing the results, it can be obtained that the actual construction using the abovementioned grouting excavation scheme allowed the grouted stone body and the lining structure to effectively meet the requirements of the project for the hydraulic pressure resistance, which qualitatively reflected the accuracy of the numerical results.

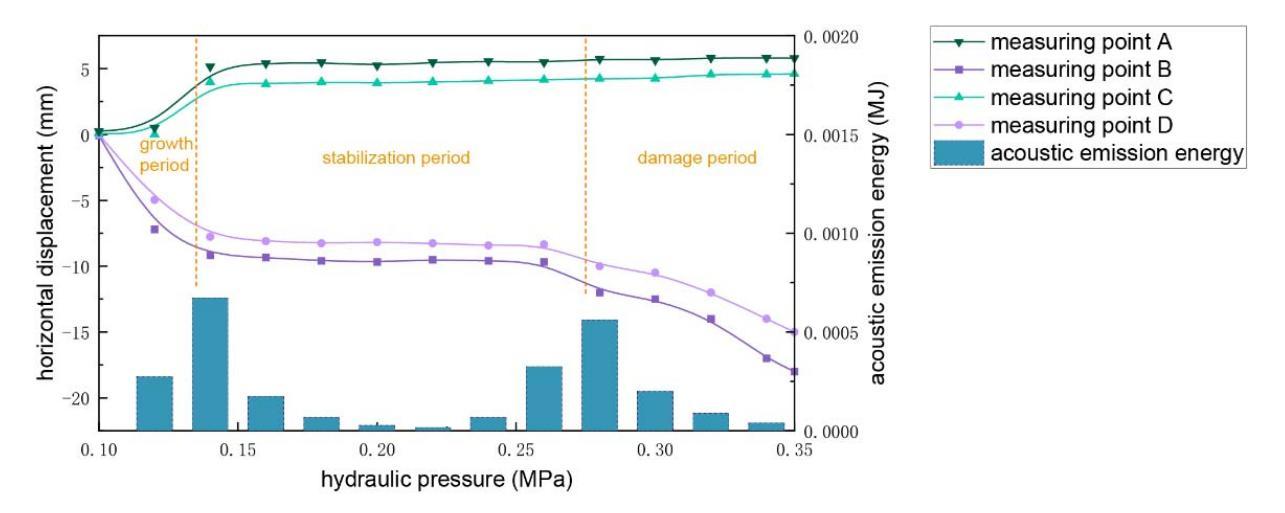
Figure 23. The relationship between the acoustic emission energy and the convergence deformation of the measurement point with the water pressure of the karst cave for model 1.

From Figure 23, it can be seen that the unloading caused by the expansion of the parallel heading would cause the release of stress in the surrounding rock. When the parallel heading was first expanded, the four measurement points A, B, C, and D all experienced certain displacements, with the largest displacement at point B near the cavity, which remained the largest displacement until the final destruction. This indicates that, if the convergence deformation on one side of the tunnel construction is larger than the other side in the karst area, attention should be paid to the uneven stress distribution on that side of the site. At this point, a special geological environment was revealed on that side, such as the possible existence of hidden pressure cavities. For the A and C measurement points, due to their distribution being far from the cavity, the cavity water pressure was less affected. After the parallel heading extension, the measurements remained unchanged until the destruction of the grouted stone on the right side of the tunnel. For points B and D, it was obvious that their displacement curves could be roughly divided into three stages:

growth period, stabilization period, and dramatic damage period. At the beginning of the parallel heading expansion, the displacement curve of the two points developed rapidly, and the acoustic emission energy accumulated slowly at this time. Then, the displacement of measurement points entered the stable period after reaching the peak, during which the displacement almost did not increase, and almost no acoustic emission energy was generated, indicating that the stone body finally reached a relatively stable state through the continuous redistribution of internal stress. When the water pressure in the cavity reached 0.28 MPa, the displacement of measurement points B and D increased dramatically, and the acoustic emission energy was also generated suddenly and increased rapidly. This stage corresponded to the destruction of the grouted stone body, which gradually dissipated during the destruction process. Finally, when the water pressure in the cavity reached 0.35 MPa, the grouted stone body was completely destroyed.
