Article Analysis and Application of Lining Resistance to Water Pressure in Tunnel through Karst Cave

Abstract: Using RFPA software, the hydraulic pressure resistance and damage process of the grouted stone body of a tunnel in the high-pressure karst zone were analyzed, and the hydraulic pressure resistance of the composite surrounding rock and composite structure when the tunnel was expanded through the cavern under the effect of hydraulic coupling was investigated. Then, a new parallel heading expansion scheme for the New Yuanliang Mountain Tunnel was innovatively discussed, and the reliability of the results of the calculation model was verified by a field test. Lastly, the model calculation results guided the project to adopt a 5 m grouting range and advanced secondary lining to ensure that the composite structure's water pressure resistance could reach 3 MPa; by adopting the improved technology of parallel heading expansion based on the CRD method, the safety of tunnel expansion through the cavity was effectively ensured, which can provide a reference for similar projects in the future.

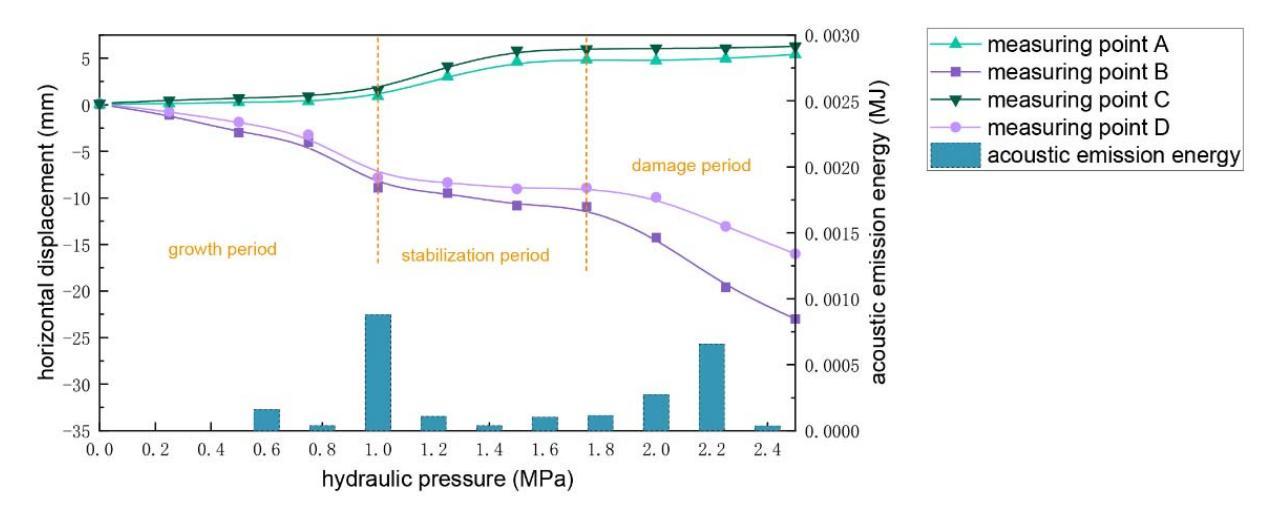
Figure 24. The relationship between the acoustic emission energy and the convergence deformation of the measurement point with the water pressure of the karst cave for model 2.

The changes in displacement and acoustic emission energy with the water pressure in the cavern in Figure 24 showed a consistent trend with Figure 23 as a whole. At the beginning of the parallel heading expansion, the displacement injection of B and D points increased; when the water pressure in the cavern reached 1 MPa, the displacement of the measurement points entered a stable period, after which the displacement hardly increased. When the water pressure in the cavern reached 1.5 MPa, the displacement curves of B and D measurement points presented an inflection point, and the curve entered a dramatic increase period. Finally, when the water pressure in the cavity reached 2.2 MPa, the surrounding rock was damaged. The difference between Figures 23 and 24 is because the composite surrounding rock structure formed by the grouted stone body and the surrounding rock together had better resistance to water pressure, the displacement change curve was more gentle in the growth period, and the change in displacement did not cause the accumulation of acoustic emission energy immediately in the destruction period due to the better stability of the composite surrounding rock structure. This resulted in a certain lag effect in the peak of acoustic emission energy compared to the displacement variation curve. In summary, it can be seen that the damage to the surrounding rock can be predicted or judged by monitoring the acoustic emission energy of the structure in the actual project, and the results of field measurements also verified its reliability. In the construction of karst tunnels, if there is an accelerated development of displacement convergence on one side and the acoustic emission energy increases sharply, the focus should be on the force state of the structure, and one should remain alert to the possibility of sudden water and mud disasters to avoid generating subsequent disasters.

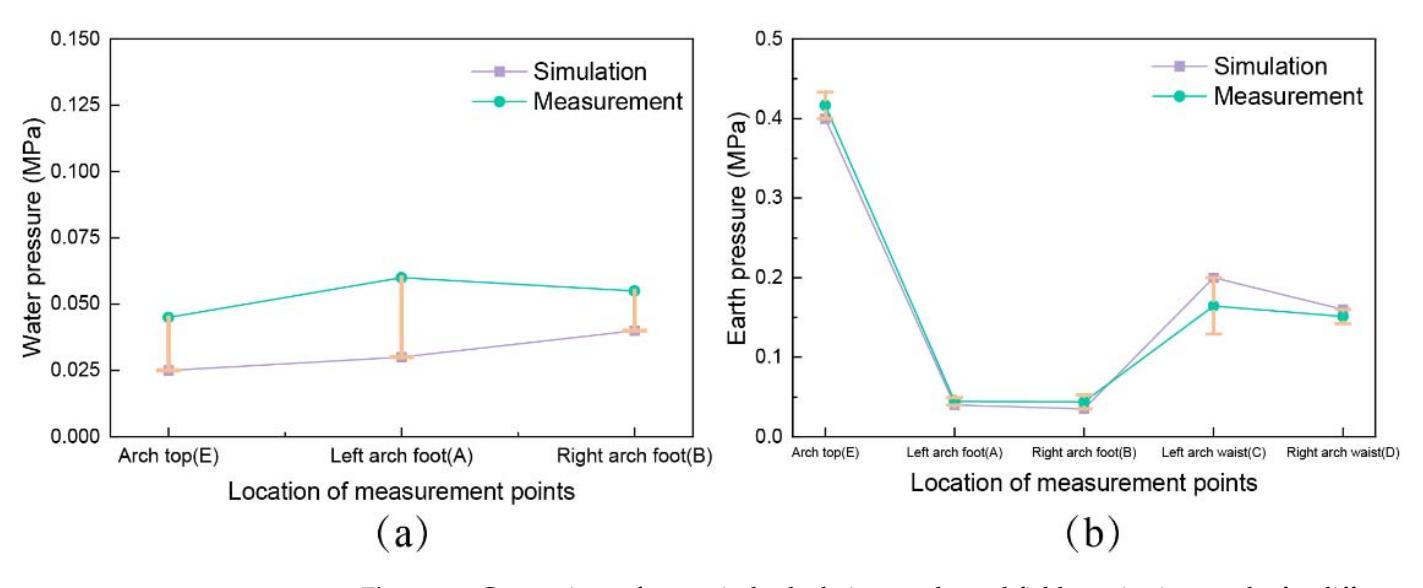
Figure 25. Comparison of numerical calculation results and field monitoring results for different locations: (**a**) water pressure results comparison graph; (**b**) earth pressure results comparison graph.

In order to verify the reliability of the results of numerical simulation, the results of the numerical calculation were compared and analyzed with the results of the field measurements. The earth pressure and water pressure at the observation point when the thickness of grouting was 5 m in Figure 17 were extracted and compared with the earth and water pressure obtained from the field monitoring in Section 4.3; the results are plotted in Figure 25. From Figure 25a, it can be seen that the overall numerical calculation results were lower compared to the actual measured water pressure in the field, but the error was basically within 0.03 MPa. The reason for the lower calculation result is that the actual grouted stone was not homogeneous due to the limitation of the construction process on site; however, in the numerical calculation, the model was too idealized, resulting in the hydraulic pressure resistance being better than the actual situation. In Figure 25b, it is shown that, for earth pressure, the numerical simulation results were in good agreement with the field test results, and the average error was within 0.01 MPa. The above-discussed results reflect that the numerical calculation model of this paper has good reliability in general and can be used to guide field construction.
