Article Assessment of the Applicability of a Thawing-Guided Drainage System for Old Railway Tunnel Icicle Prevention in Cold Weather

Sangjoon Kang D, Taehoon Koh * and Hanju Yoo *

Track and Trackbed Research Department, Korea Railroad Research Institute, 176 Chuldobangmulgwan-ro, Uiwang-si 16105, Gyeonggi-do, Republic of Korea

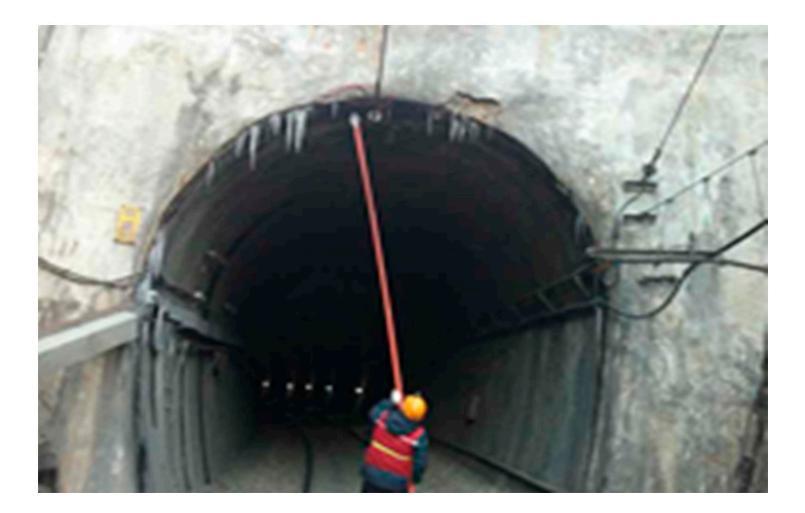
Figure 1. Icicle removal using manpower. Adapted with permission from Ref. [6]. Copyright 2021 by Korea Railroad Research Institute all rights reserved.

Annually, an average of about 1.4 million icicles are removed from railway tunnels (158 sites), and a budget of about 1.5 million US dollar is expended on manpower for icicle removal as shown in Figure 1 [6]. Nonetheless, 14 catenary defects had occurred over 7 years due to icicle growth in the tunnel, and accordingly, the railway operations are encumbered every year [7]. Therefore, the prevention of icicle formation would be extremely useful for safe services and efficient maintenance.

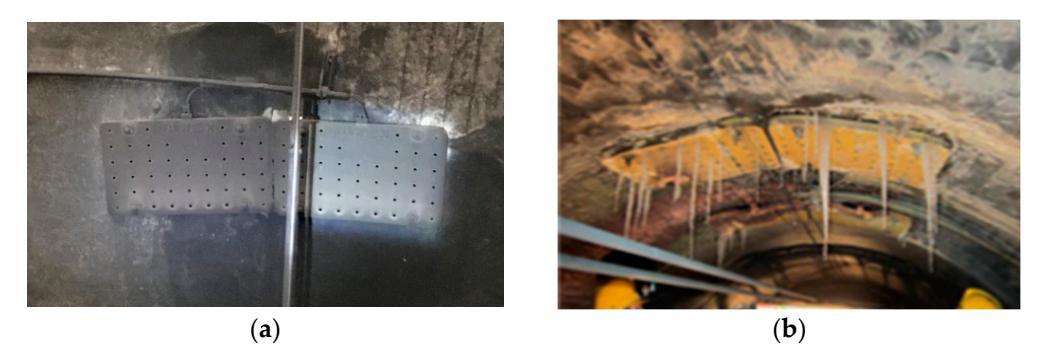
Figure 2. Examples of conventional automated icicle removal device installations: (**a**) example installation of ordinary icicle removal device; (**b**) icicle formation on the joint part of an icicle removal device.

In Korea, fan heater systems were suggested for removing icicle formations [12–14]. The fan heater methods, however, have low thermal efficiency and significant power consumption. Through numerous amounts of research on preventing and removing icicle formations in railway tunnels, the automated icicle removal device was installed and has been operated in Korea, as shown in Figure 2a. This system consists of a few heating parts and a control part. Although the icicle removal device had been operated in tunnels, water leakage was constantly found at the joint part of the device. In addition, the leakage water led to the icicles forming on the exterior of the system, as shown in Figure 2b. When these icicles melt, the water may flow through the holes in the heating plate and form icicles again. In addition, the bolt of the joint part for the icicle removal device may fall onto the tracks and cause an accident.

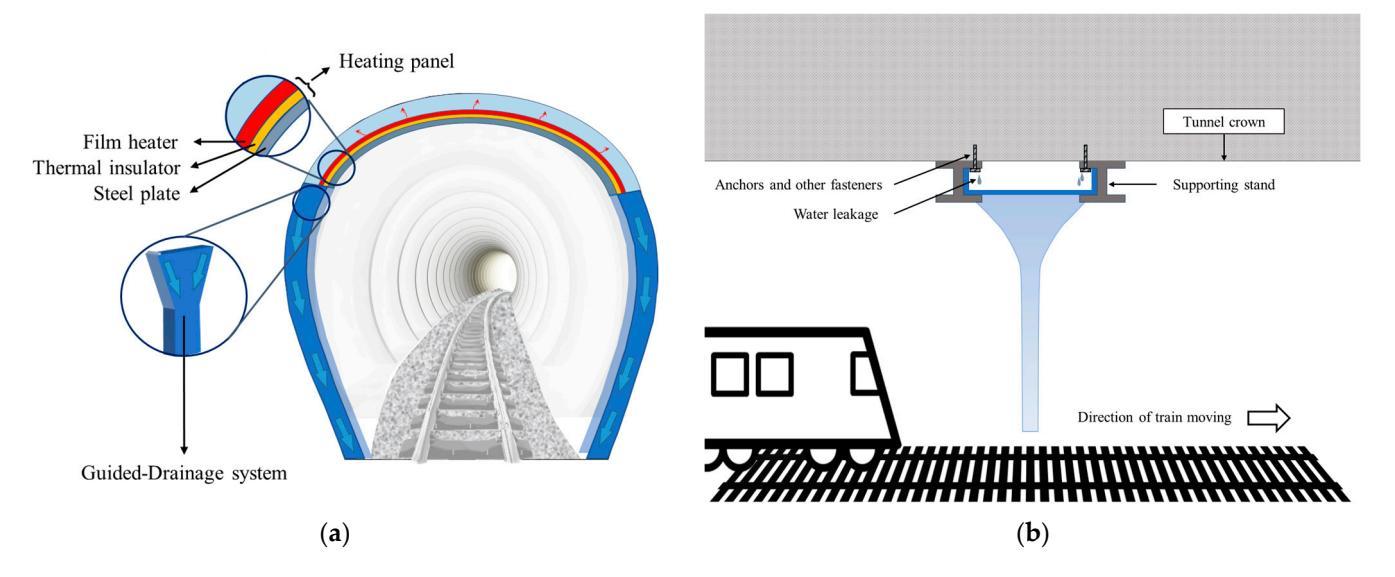
Figure 3. The conceptual design of the thawing-guided drainage system (**a**) and a cross-sectional diagram of the supporting stand (**b**).

The developed thawing-guided drainage system consists of heating panels, supporting stands arranged along the tunnel surface with a fixed distance away from the tunnel surface, and the drainageways for discharging leaked water (thermally melted icicles) to the outside of the tracks. A heating panel is composed of a film heater, thermal insulator, and a steel plate. The heater installed on a steel plate supplies the heat source to prevent icicle formation. Here, supporting stands that were designed into H-beam-shaped brackets are located at both sides of each unit heating panel and are fixed onto the crown line of the tunnel with anchors and fasteners to support the heating panels. The whole system is designed as a closed system that all fasteners are not exposed outside of, so the water leaking through those parts also directly flows to the drainageway inside the system. The conceptual design of the proposed system and a cross-sectional diagram of the supporting stand are shown in Figure 3a,b.

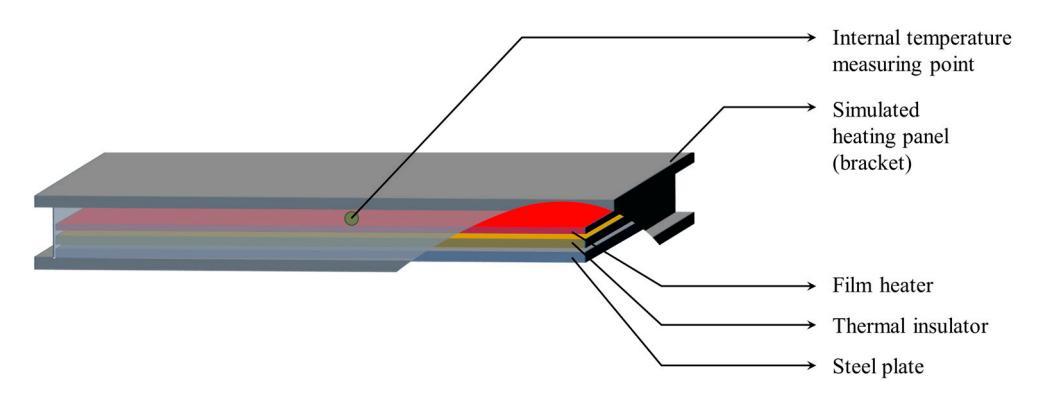
Figure 4. Conceptual design of the testing device.

Considering the attached area of the system within the actual tunnel, a film heater was attached onto the steel plate, and a thermal insulator was applied to simulate the actual thawing-guided drainage system. The conceptual design of the testing device is shown in Figure 4.

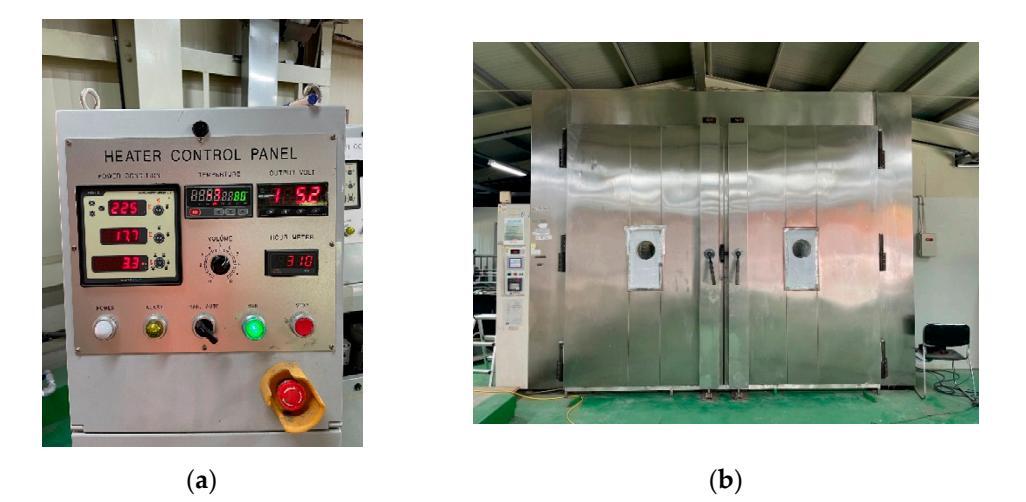
Figure 5. The voltage control device (**a**) and the test chamber (**b**).

A voltage regulator was connected to the testing device fixed in a chamber. The voltage regulator is a device that receives the electric power from the power source and provides the adjusted electric power to the system. The maximum capacity of the voltage regulator is 10 kW, and the power can be controlled from 0 to 230 V through the installed jog. A temperature and Humidity Constant Chamber (NFEC-2005-12-043872) was used to simulate the cold weather and control the temperature, adjusting it from –40 to 80 °C and the humidity from 30 to 98%.

The voltage control device and a chamber are shown in Figure 5a,b. The test device was set in the test chamber with -15 °C for the setting temperature. The changes in the internal temperature of the testing device were measured during one hour of heating. The result for the measured internal temperature is illustrated in Figure 6 for each level of power consumption during one hour of heating at a chamber temperature of -15 °C.

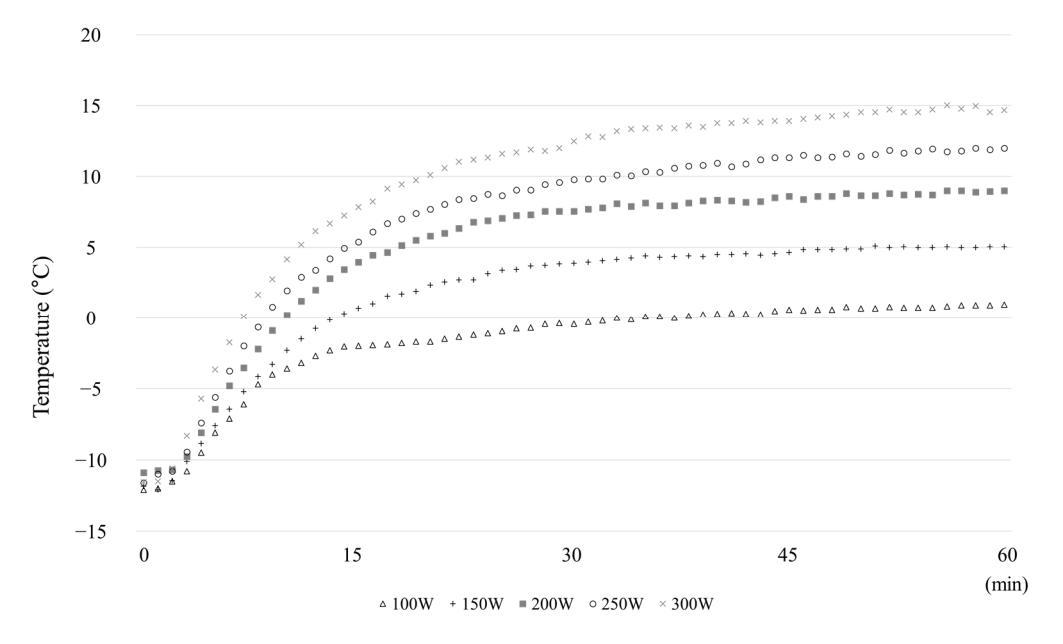
Figure 6. Changes in the internal temperature of the testing device depending on power consumption.

In the case of a 100 W heater, the temperature of the system was raised to about -0.4 °C after 30 min, and 0 °C or above after 35 min. The temperature of a 150 W heater was about 3.9 °C after 30 min of operation and about 5.1 °C after one hour. After 30 min of operation, a 200 W heater raised the temperature to about 7.6 °C and raised it to about 9.0 °C after 60 min. The 250 W and 300 W heaters raised the temperature to about 12.4 and 12.0 °C, respectively, and about 14.7 °C for both with one hour of operation. The heater

At an ambient temperature of about -15 °C, the 100 W heater reached 0 °C or above after about 35 min. The temperatures of the 150 W, 200 W, 250 W, and 300 W heaters rose above 0 °C in 13 min, 9 min, 8 min, and 6 min after operating, respectively. If the power of the 100 W or less is used, it takes more than 30 min for the temperature of the heater to reach 0 °C or above. Therefore, it is judged that more than 150 W of power is necessary. The unit power consumption of the heater for the developed system was specified at 150 W.

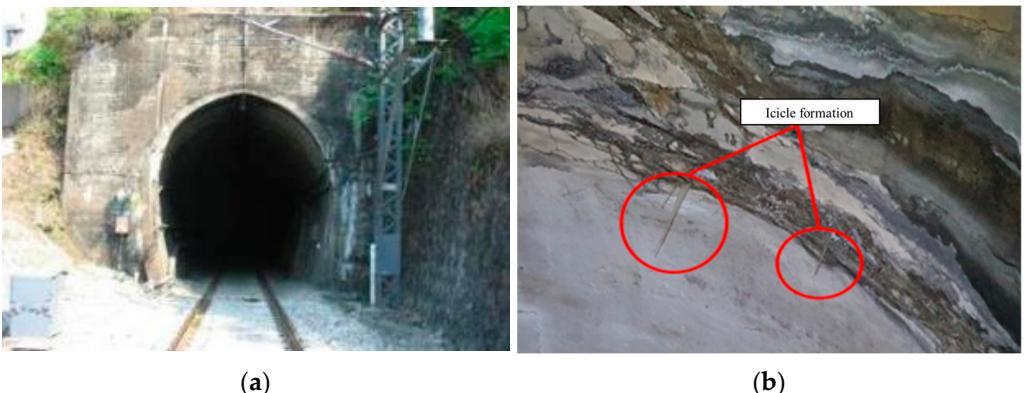
Figure 7. Photographs of Seungbu tunnel: (a) the external view of Seungbu tunnel; (b) icicle formation in Seungbu tunnel.

The Seungbu Tunnel, located in Socheon-myeon, Bonghwa-gun, Gyeongsangbukdo, was chosen for the field test of the thawing-guided drainage system. This tunnel is horseshoe-shaped and has been operated since 1956 as a single line which is located within the Yeongdong Line by Korea Railroad. Investigations of the tunnel showed deteriorated damages such as cracks, scaling, and delamination across the crown surface of the tunnel. An external view of the tunnel and icicle formation due to the water leakage from the cracks in the tunnel is presented in Figure 7a,b, respectively.

Cracks, spalling, efflorescence, and the deterioration of the concrete surface have been observed throughout the tunnel lining in Seungbu tunnel. At a point of about 50 m from the tunnel entrance, the cracks on the crown line were noticeably observed where icicles had formed due to water leakage at lower temperatures during winter. This icicle formation area was determined as the location for the installation of a thawing-guided drainage system.

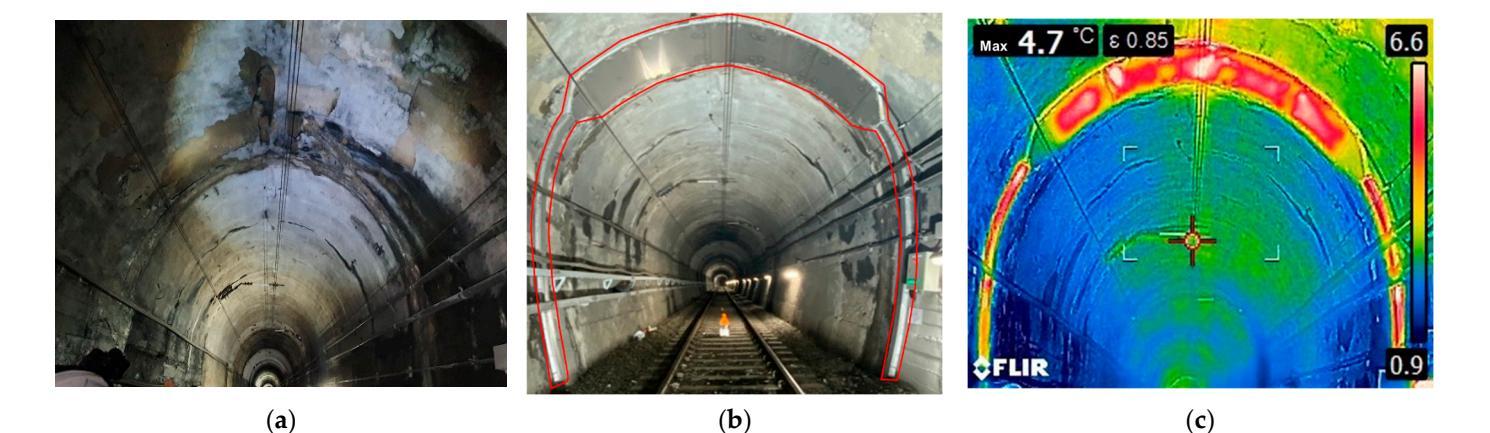
Figure 8. Installation of thawing-guided drainage system: (**a**) location of installation in Seungbu tunnel (location of crack); (**b**) system installation; (**c**) infrared image of operating system.

For the field test, five heating panels with brackets for support and a control panel for adjusting the temperature were installed in Seungbu tunnel. The system has been installed at a point about 50 m from the tunnel entrance, where cracks appeared on the crown line of the tunnel (the area of icicle formation in Figure 8b). The views before and after installation of the system are shown in Figure 8a,b, alongside a thermal image of the installation during operation in Figure 8c.

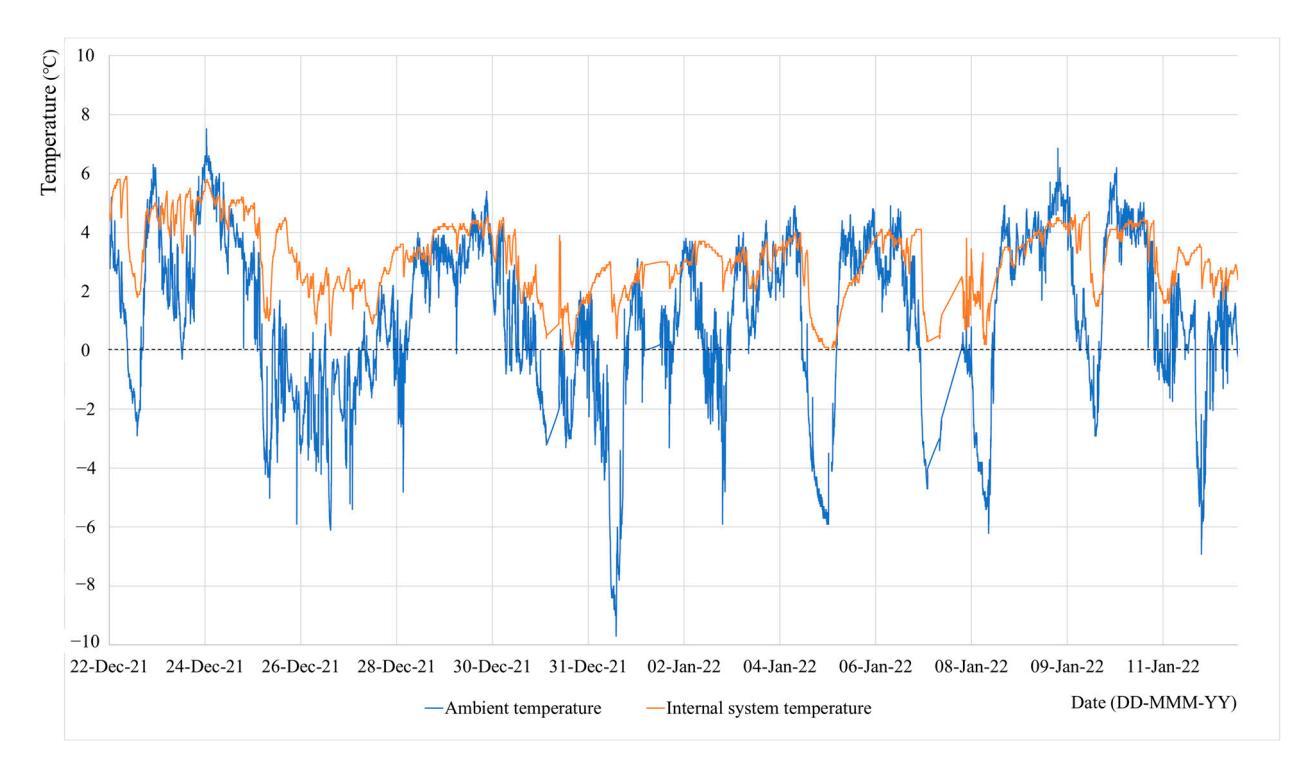
Figure 9. The recorded ambient temperature and the internal system temperature (at the field test site) over the 3-week test duration.

Monitoring of the developed system installed at Seungbu tunnel, was performed from 22 December 2021 for three weeks in order to estimate its applicability. The thawing-guided drainage system was operated with 150 W of power, based on the lab test for optimal electric power consumption. The internal temperature of the thawing-guided drainage system and the ambient temperature are illustrated in Figure 9. The maximum, minimum, and average values of the internal temperature of the system and the ambient temperature for each day over the 3-week test duration are arranged in Table 4.

Although the anti-freezing effect was confirmed because the average internal temperature was above 0 °C, the temperature temporarily dropped below 0 °C for the whole test period. For example, on day 2, the ambient temperature dropped up to -2.9 °C, and the internal system temperature simultaneously indicated a temperature lower than 0 °C. The internal temperature of the system indicated 0.1 °C when the ambient temperature was lowest at -9.7 °C during the test period. It is remarkable that the internal temperature of the system was maintained above 0 °C over the 3-week test period. The average internal temperature of the internal system for 3-week test period was 3.1 °C, and the ambient temperature was 1.2 °C. Therefore, a 150 W heater prevents the icing of leakage water in the conditions of Seungbu tunnel at which the field test was conducted.
