Abstract: The purpose of this research was to analyze the applicability of infrared thermography in assessing the condition of an e-bike battery. The main challenge was to interpret the surface radiation detected by a thermal imaging camera. In addition to basic challenges of thermography, such as determining the emissivity, the angle of image acquisition, the problem of low resolution and thermal inertia, it was necessary to understand the physical behavior of the elements inside the battery and battery pack that respectively determine the dynamics and shape of the thermal pattern. E-bike batteries are mainly composed of 18650 format Li-ion cells, and the topology of the battery cell is related to the energy profile of the system. With the aim of establishing a link between the surface radiation patterns and the parameters of the individual 18650 cells that dictate the internal thermal behavior, a detailed analysis of the battery pack interior, upon its lifetime, was performed. Based on the results of the capacity analysis of the individual cells and determination of the exact position of the cells within the structure of the battery, a visualization and comparison with the thermo

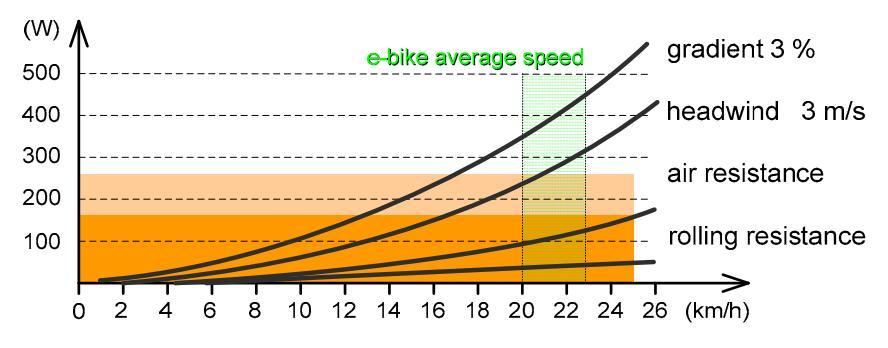
When riding, the biggest problems for the rider are hills and strong winds. The average rider develops 100 W recreationally and up to 200 W when in a good physical condition. A professional rider can normally produce 200 W to 300 W during a non-competitive session and in races of up to 400 W continuously over a distance of 14 km. The power requirements for riding are best described in Figure 1 [29]. The green interval indicates the average operational cycling speed that prevails during a cycling session, the orange-colored intervals present a maximum value of the power required, and a light-orange one is a power requirement in the event of the mean wind occurrence at the cycling site.

Figure 1. Power intervals required for cycling.

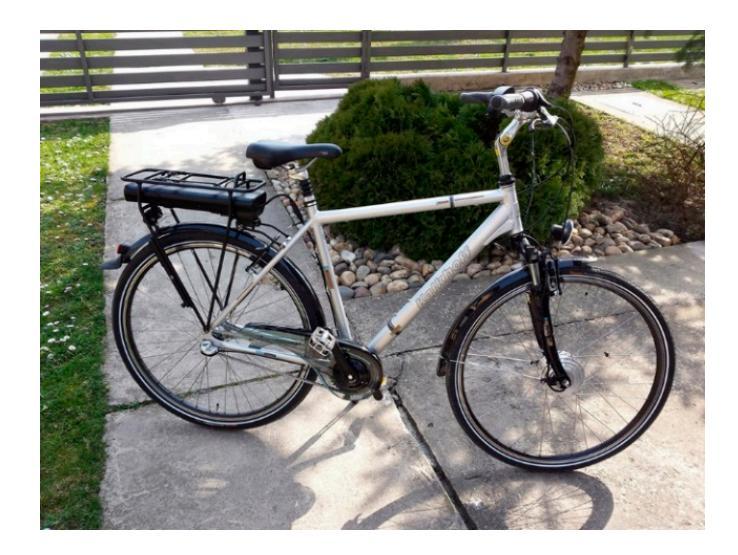
The "Bicycle Kalkhoff Groove 28", which was used as a real-world test bed for the analysis in this article, has been used since 2014. It has a replaceable battery located in the vehicle above the rear wheel, Figure 2.

Figure 2. "Kalkhoff Groove 28" bicycle.

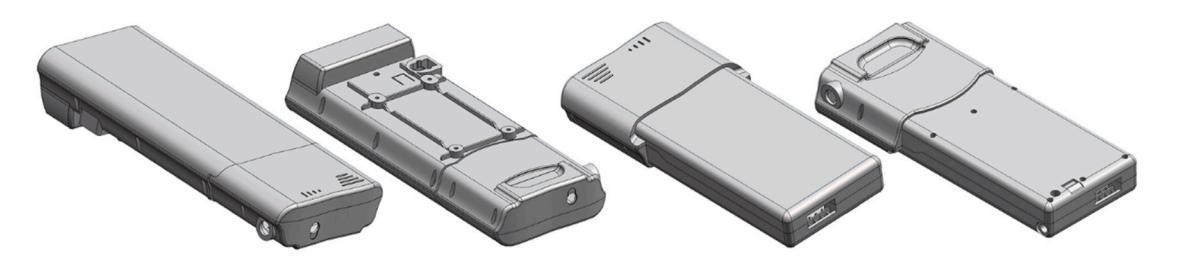
The bicycle battery, which is the subject of the further analysis, is shown in Figure 3, in the form of a CAD modeled object placed in its holder/carrier assembly. The reason for the CAD modeling of the Kalkhoff battery is closely related to the need for the further analysis involving the parameterization of the geometric variables of the circuit components (battery cells, enclosures, and BMS systems) and the application of the infrared thermography analysis. In Figure 3, the leftmost drawing shows a top view of the holder and the inserted battery, and the mid-left drawing shows a bottom view, while the mid-right and rightmost drawings show what the battery itself looks like when it is pulled out of the holder.

Figure 3. Kalkhoff Groove 28" battery pack model.

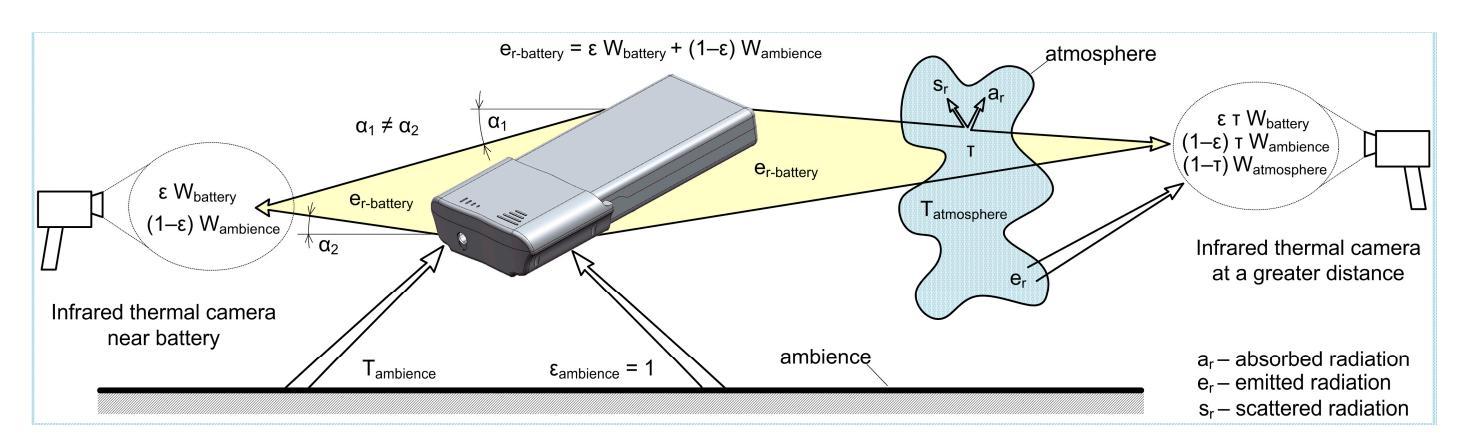
Infrared thermography is a contactless method for determining the temperature distribution on the surface of an observed object by measuring the intensity of radiation in the infrared region of the electromagnetic spectrum. Thermography is often used as a maintenance tool. In the field of electric power engineering, thermography is an unavoidable test method closely associated with the measurement of electrical parameters [30]. Contrary to popular belief that an infrared thermal imager/camera measures temperature, it actually registers electromagnetic radiation in the infrared portion of the spectrum, to which it assigns temperature values depending on the imaging parameters. Figure 4 graphically shows the components of the radiation registered by the infrared thermal imaging camera.

Figure 4. Components of longwave infrared radiation registered by the infrared thermal camera.

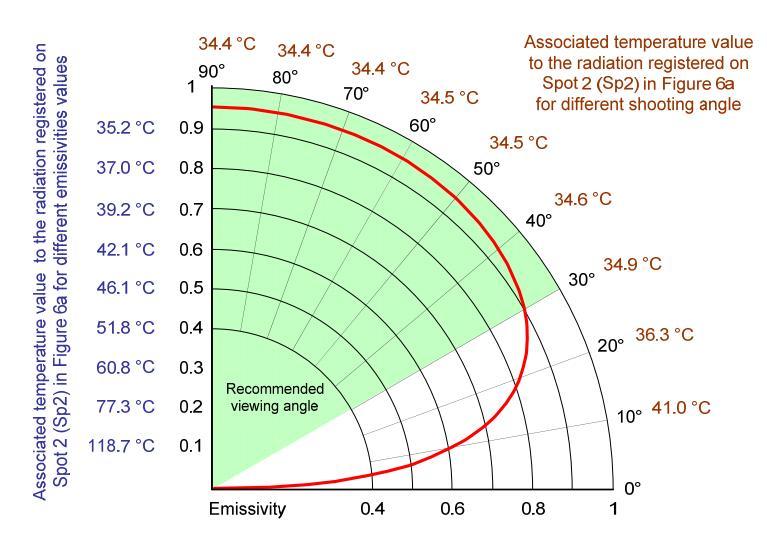
Given the distance, the atmosphere may have an effect on the registered radiation. The distance of the camera depends mainly on the optical angle of the camera lens. The closer the camera gets to the object to be analyzed, the weaker the influence of the atmosphere becomes, but the possibility of reflection of the operator's radiation increases. In addition to the fact that the power dissipation inside the battery is higher, its radiation becomes dominant, and the influence of the ambient radiation on the overall balance becomes smaller. The smaller distance to the object has another effect—namely, the radiation captured at different angles relative to the normal on the surface. The acquisition angle is important because of the change in emissivity, which can be seen in detail in Figure 5. Emissivity is the most important parameter and can change depending on the viewing angle or different materials used. The emissivity also depends on the wavelength at which the object is observed [31]. The emissivity of the plastic, used for the housing, is 0.95. It is confirmed by sticking a strip of reference tape on the battery housing, which is not visible on any of the thermograms, thus confirming the choice of the correct emissivity. In Figure 5, in addition to the emission values at each angle shown with a red line, we see (in brown) the temperature value that the camera would associate with the same amount of radiation at different angles for the spot measurement from Figure 6a. A significant error in the choice of emissivity would result in the display of an incorrect temperature value, shown in blue in Figure 5.

Figure 5. Dependence of the emissivity of the battery pack and influence of emissivity changes on the temperature displayed by the thermal camera.

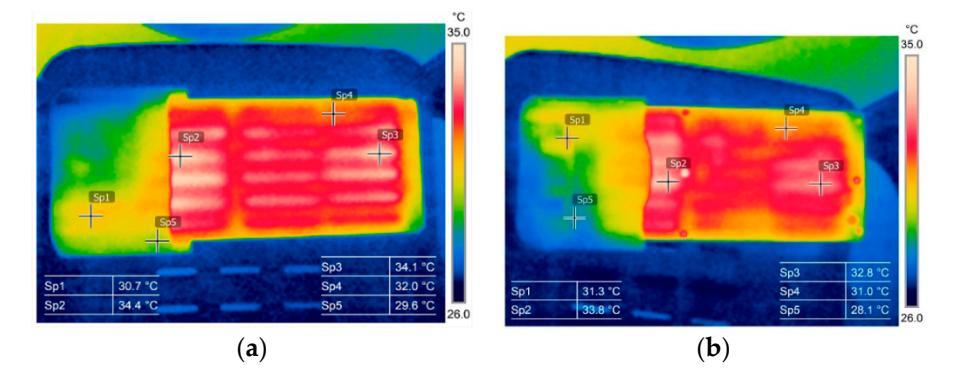
Figure 6. Functional battery pack charging thermal patterns near the end of its life, (**a**) top view (**b**) bottom.

We can conclude that in the case of plastic enclosures, variations in the angle of capture do not significantly affect the measurement result, especially if we take into account the ± 2 °C accuracy of the thermal imaging cameras used in this study, Table 1. Based on the details of the thermograms, it is clear that a camera with a higher resolution was used for the analysis. The higher resolution gives a clearer pattern but not necessarily better measurement results.

Next, irregularities in the thermal patterns, shown in Figure 6, are a consequence of changes in the internal ohmic resistance of individual battery cells as well as their capacity. That fact leads to improper and spatially irregular thermal dissipation within the battery pack confinement space. When the battery started to show signs of reaching the end of its service life, the bicycles started to shut off/down unexpectedly. Soon after noticing the aforementioned first signs, the thermographic analysis of the bike battery pack was performed, and thermal hot spots were noticed. Additionally, asymmetry and spatial irregularity of heat dissipation within the pack now was augmented significantly, Figure 8. Hot spots with a temperature difference of ≥ 2 °C represent a possible battery defect that warrants further investigation, according to NETA (International Electrical Testing Association). The pattern disturbance is located in the spatial center of the battery and is normal since it represents the core of the entire battery. Furthermore, the comparison of the thermograms in Figures 7 and 8 inevitably leads to the conclusion that a homogeneous heat distribution pattern may indicate a healthy condition or proper battery behavior.

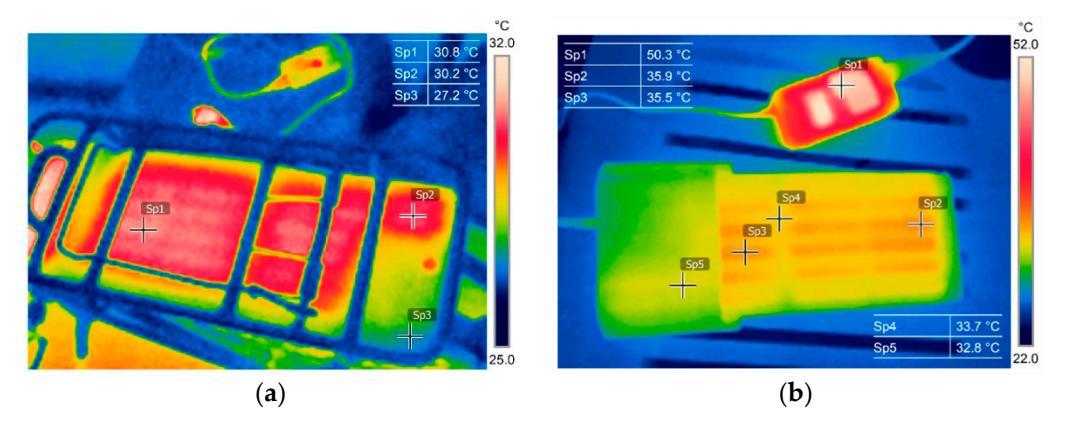
and diagnosing faults arose from the fact that the available range is constantly decreasing after each full charge cycle. Thus, there was a need for a non-invasive analysis method that would not interfere with the functionality of the battery under operating conditions. Figure 6 shows a thermographic recording of the battery pack during charging, near the end of its life. The image was taken when the range of the bike was significantly decreasing. Figure 7 shows the same battery and its thermographic pattern during charging, taken when the battery was at the beginning of its life, long before the images in Figure 6 were taken. The battery in Figure 7 shows a nearly uniform thermal pattern of a fully functional battery that is in excellent condition. However, this uniform thermal pattern has a slight disturbance in the heat distribution pattern caused by the spatial distribution of heat sources in the battery pack or cells.

Figure 7. Thermal pattern of the healthy battery pack: inside the bike holder (a) and outside (b).

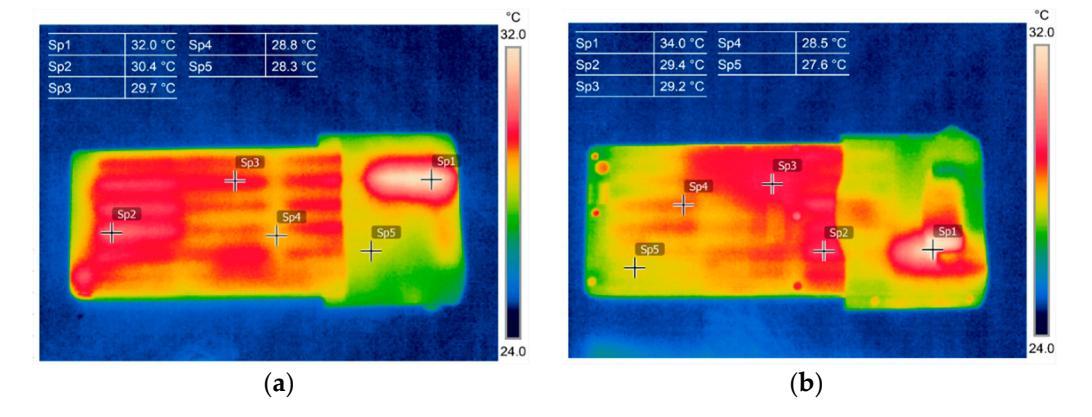
Figure 8. Battery pack assembly thermal pattern, at the end of the lifetime, (a) top layer, (b) bottom layer.

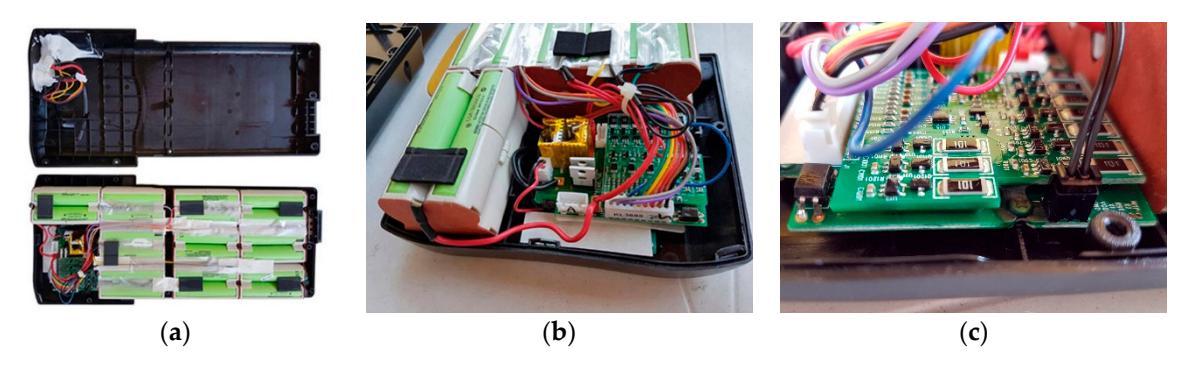
Since the battery was no longer suitable for cycling, it was disassembled, and the internal circuits and visual condition of the battery cells were analyzed. Figure 9 depicts the interior of the subjected battery pack, fully disassembled with focus on areas where the hotspots are noticed (suspected faulty cells and a BMS circuitry).

Figure 9. Disassembled battery pack (a), cells that produce the hot spots (b), a BMS circuitry (c).

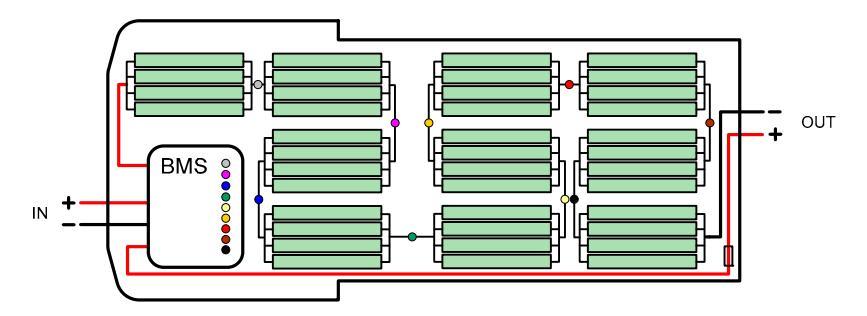
The battery pack structural analysis resulted in a circuit principal diagram, shown in Figure 10. The results can be summed up as follows: the battery pack consists of 40 cells Panasonic CGR18650CG type, cells nominal voltage is 3.6 V and nominal charge capacity of 2250 mAh, individual cell weight is 45 g [33]. The electrical connections arrangement was made in the form of ten cell blocks connected in series (10s), and each cell block consists of four parallel connected cells (4p)—a so-called the 4p10s battery cluster. The way cells are joined together is crucial for packet behavior [34,35]. The balancing leads connection points, for the sake of clarity, are marked with colored circles at the BMS and in between cellblocks. Each balancing line has temporally thermal overcurrent protection accomplished by Polymer PTC Resettable Fuse of JK-D Series; furthermore, the BMS has two additional thermal monitoring and protection probes.

Figure 10. Principal structural diagram and electric schematic of 4p10s battery pack.

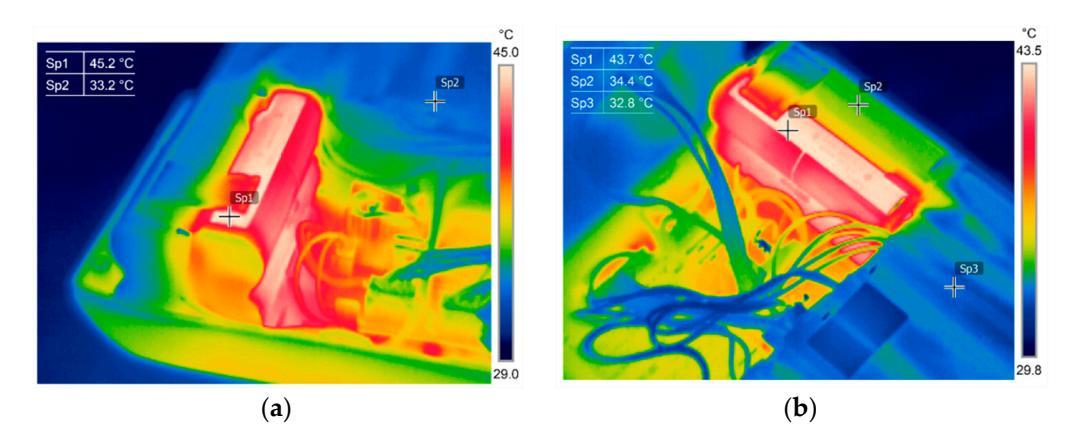
The further analysis was followed by connecting the open battery to a charger device, and at the same time, the pack was monitored with a thermal imager during the charging process—charging cycle. The thermographic analysis of the thermal pattern of the pack's cells shows that the first two pack cells were significantly warmer than the adjacent cells and that remedial action must be taken according to [30]. The reason for building up the heat in some cells is supported by the fact that ohmic resistance of all cells in the block is not approximately equal anymore—i.e., it is noticeably different. Instead of equally distributed charge current among all (four) cells within the block, the current is unevenly, reversely proportionally distributed through the cells according to their ohmic resistance. In our case, only two cells take all charge current, and other two in the cell block have significantly higher ohmic resistance. Contrary to intuition with infrared thermography, the healthy cells warm up while the defective cells look cooler, Figure 11.

Figure 11. Overheated healthy cells that conduct the overall battery pack current (a view from different perspectives), (**a**) from rear side and (**b**) from top side.

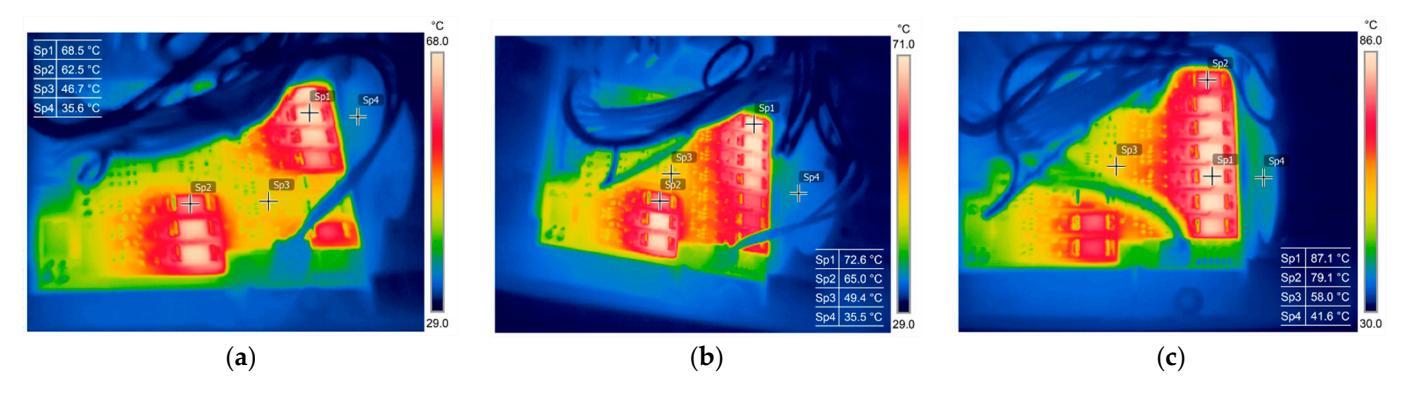
Further, in order to determine the condition of other cells in cellblocks, a different indirect thermal and electrical parameter observation method had to be used. For this purpose, a balancing resistor thermal throttling observation combined with the thermal imaging analysis was applied. The thermogram shown in Figure 12a illustrates that there is no dissipation on the two resistors, which means that only two parallel connections are still in the charging process and that most of the parallel connections are in a similar state. Additionally, that points to the fact that the battery blocks are not homogeneous in their electrical (resistive/ohmic) properties. Figure 12 visually describes the dynamics of BMS operation as well as dissipation, which leads to an increase in the pack ambient temperature of 6 $^{\circ}$ C, while the maximum temperature of the active resistor at the time of recording increases by 19.6 $^{\circ}$ C.

Figure 12. BMS thermal load during charging process at: (a) 1:45 PM; (b) 1:58 PM; (c) 2:05 PM.

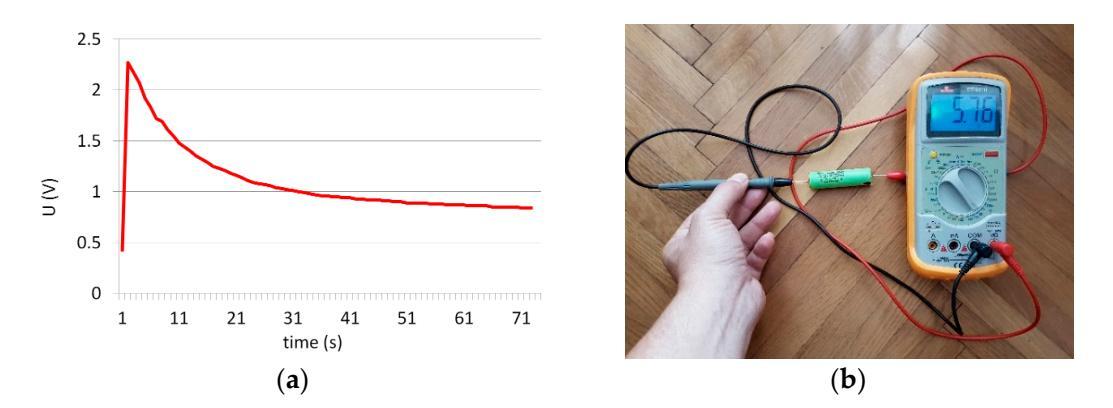
The first two faulty cells, marked with 1 and 3 in Figure 13, do not show voltage within expected, normal operating range. The cells discharged during the measurement despite the high internal resistance of the device. An example of an extreme is cell 1 whose diagram of discharge, via a voltmeter, is shown in Figure 14a. When cell 1 was removed from the cellblock, it mechanically caused a slight perforation of the battery tab weld [37], making it unsafe to handle further. During the cell recharge, cell 3 received voltage values of 5.76 V, which is significantly higher than the maximum allowed values of 4.2 V, Figure 14b. The fact that there was no inflammation clearly indicates the degree of degradation.

Figure 14. Cell No. 1 high impedance load discharge graph (**a**) and overcharged cell No. 3, temperature and structurally stable (**b**).

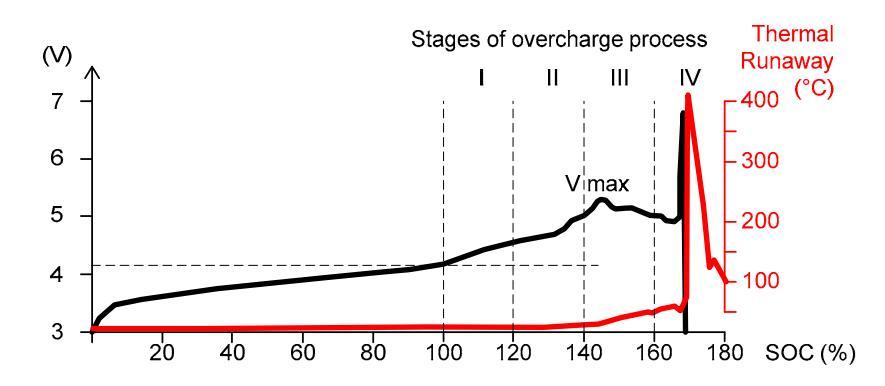
The behavioral properties, electro-chemical characteristics, and energy transformational mechanisms of battery cells based on Li-ion chemistry are well described and explained in detail in the articles by Xuning et al. in *Thermal runaway mechanism of lithium-ion battery for electric vehicles* [38], and by Minggao et al. in *Overcharge-induced capacity fading analysis for large format lithium-ion batteries with LiyNi1/3Co1/3Mn1/3O*₂ + *LiyMn*₂*O*₄ *composite cathode* [39]. According to the behavioral properties of such battery cells for the measured voltage of 5.76 V, a temperature of more than 50 °C is expected to be reached, but the cell remained at ambient temperature. That 50 °C temperature marks a breaking point when the cells start to change their structure mechanically and the deformation of the cell becomes visually noticeable. The absence of the above indicates a significantly impaired capacity of the cell. Figure 15 depicts a charge-thermal dynamic of an overcharged cell in relation to its measured voltage.

Figure 15. Li-9on cell charging process and stages of overcharge states [38,39].

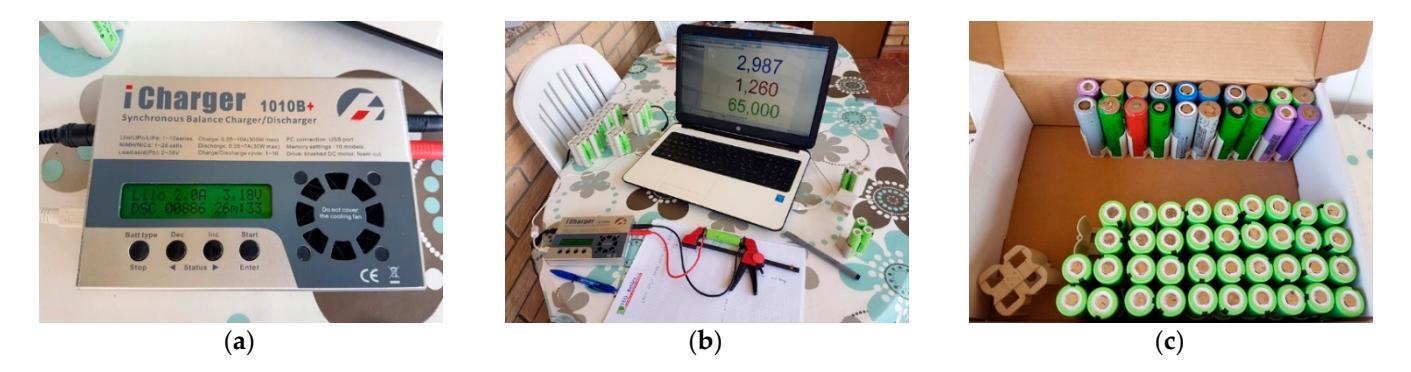
The measurement setup, shown in Figure 16, consists of a universal Li-ion charger (leftmost), the JUNS iCharger 1010B+, and current clamps (middle image) with a clean contact surface for achieving the lowest possible clamp contact resistance. Furthermore, the same figure (rightmost) shows the contents of the disassembled e-bike battery pack without 2 pack-origin defective cells and with 10 replacement cells acquired from the used laptop battery packs. Replacement cells from the used battery packs were originally planned to be a replacement source and eventually to replace all defective cells of the initial e-bike battery pack [40]. Among newly sourced cells, we found two battery cells that matched in appearance and labeled exactly as those in the original e-bike battery pack, so we placed them at cell positions 1 and 3 in the initial battery pack layout. With that substitution, the battery pack was restored back to the operational state, thus making the further investigation and analysis possible to continue and the battery pack usable again to some extent.

Figure 16. A system charger (a); battery cell current clamp (b); and disassembled battery pack cells (c).

In order to preserve the e-bike function by revitalizing its battery pack, we decided to use the batteries from Figure 16c (used laptop battery cells) to assemble the new functional pack. The availability of such cells is a rather limiting factor for making a proper selection, and in case of a larger quantity, it is necessary to check all the cells and choose the best performing [48]. Due to the different cells, which are not designed for the currents expected from e-bike batteries, it was decided to lower the discharge current by 20% to obtain more accurate capacity values. Table 5 shows cells' charge states and cells' capacities after discharging all cells with current of 1.8 A. The higher cell resistance values are the result of oxidation of the contacts [42]. The reused cells 21 and 14 show a higher capacity due to the lower discharge begins. The overcharge is the result of using a simple charger to shorten the charging time.

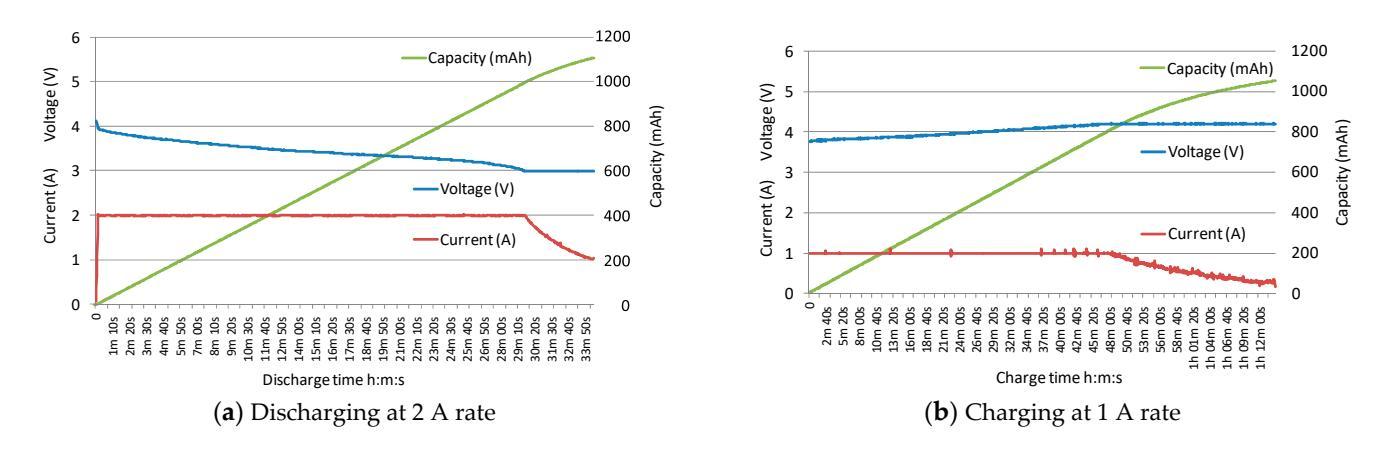
The evaluation of the cells' condition and the parameter measurements showed that the cells' condition in the pack was poor. The best one of all cells had only 48.93% of the initial and nominal capacity. Despite the fact that the resistance values, read by the charger, depend significantly on the cell's electromechanical connection [42], it still can be confirmed that the cells with a higher capacity had the lowest value of internal resistance [43]. The current–voltage (C-V) discharging dynamics of the best cell, cell no. 21, and the cell with the highest capacity, are shown in Figure 17a.

Figure 17. Comparison of discharge (**a**) and charge (**b**) current–voltage (C-V) characteristics of best performing cell, cell No. 21.

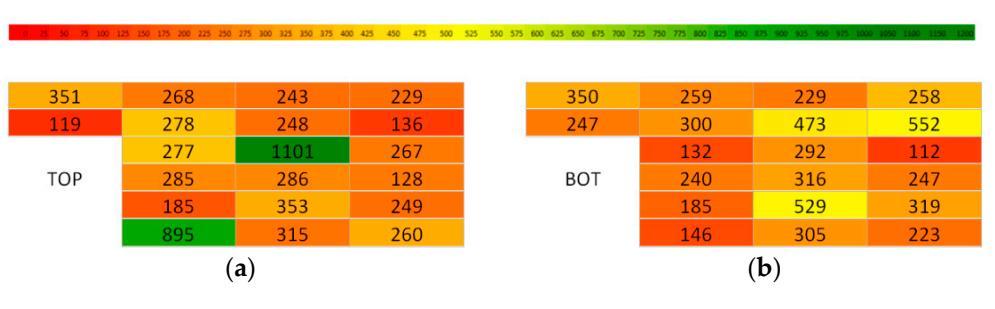
Finally, discharge-based capacity assessment of all cells within the pack led to a visually representative spatial allocation of cell capacities for both pack assembly layers (TOP and BOT), Figure 18. The results confirm the poor state of the pack assembly and a high level of degradation.

Figure 18. Spatial distribution of TOP/upper- (a) and BOT/lower-layer (b) pack cells capacities.

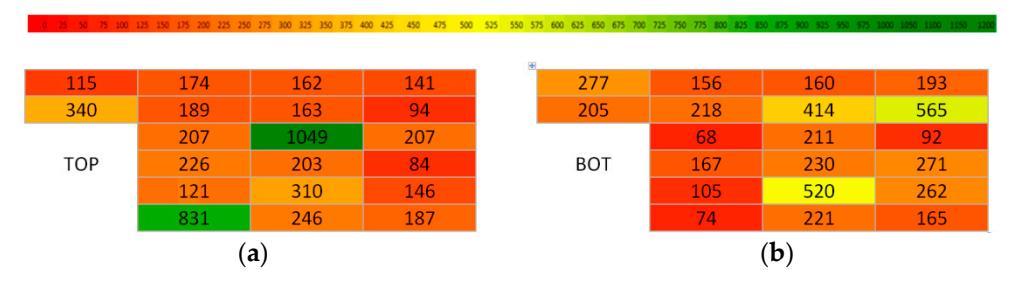
The results in Table 3, a charge-based capacity assessment approach, validate and confirm the results of the cell capacity determination method that utilized the *discharging* approach. Finally, a charge-based approach yielded similar visually representative cell spatial mapping for both pack assembly layers (TOP and BOT), as shown in Figure 19.

Figure 19. TOP/Upper- (**a**) and BOT/lower-layer (**b**) cell capacities determined with 1 A cells charging method.

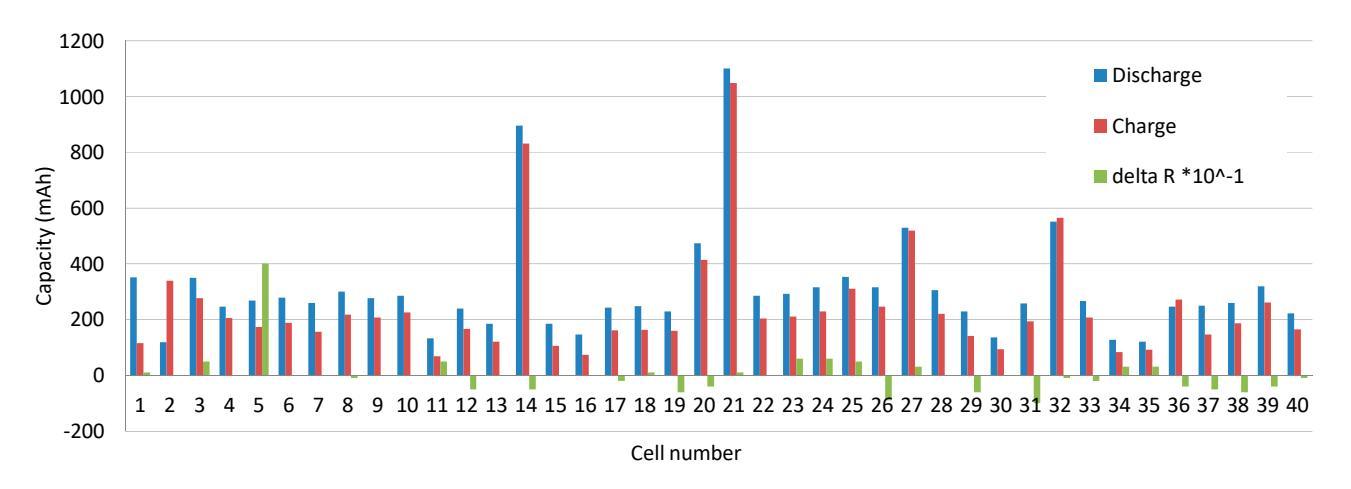
The results support the confirmation of the poor pack assembly state and cells degradation determined by the discharging method. The comparison of cells capacities, determined with the charging and discharging method, shows a capacity deviation in accordance with the expectation [41,44], as presented in Figure 20. A cell parameters degradation was expected [45,46], but in the case of the analyzed battery pack, it occurred rather quickly.

Figure 20. Comparison of cells capacities determined with the charging and discharging method.

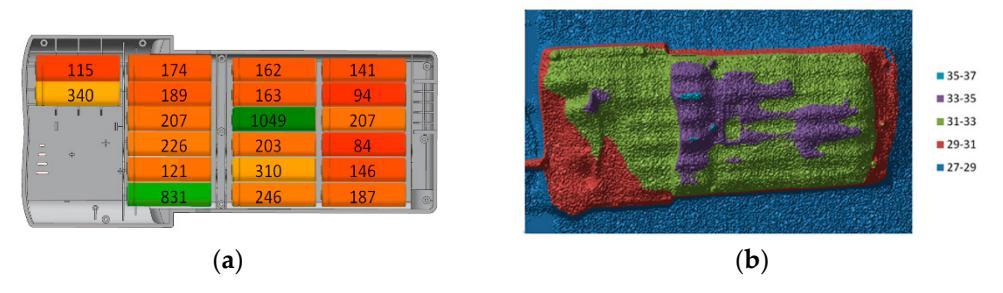
The visualization of the spatial capacity distribution within the battery pack as well as the corresponding temperature distribution are shown in Figures 21 and 22. Unlike the previously presented thermograms, we decided to export the radiometric data to a more readable and convenient form for a further analysis—a CSV file—and to display it in a different form by processing in a basic spreadsheet tool.

Figure 21. Comparison of (**a**) TOP layer capacity distribution in (mAh) and (**b**) measured temperature values in (°C).

Figures 21 and 22 clearly depict that the thermal distribution pattern and cell state of capacity cannot be correlated. The reason is in the inertia of the thermal process [47] and in the balancing dynamics shown in Figure 12. Among all the cells in the analyzed battery pack, only two can be used to make a new package—cells 14 and 21. Attempting to assemble a battery from these cells would be pointless, as none of the parallel cells would be able to match the capacity of a healthy cell, Table 4.

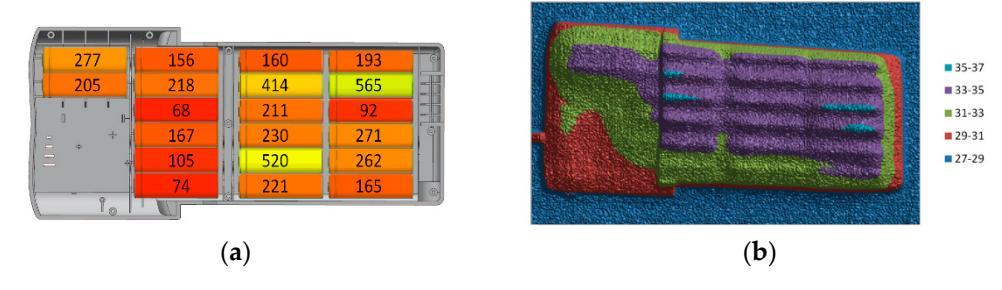
Figure 22. Comparison of (**a**) BOT layer capacity distribution in (mAh) and (**b**) measured temperature values in (°C).

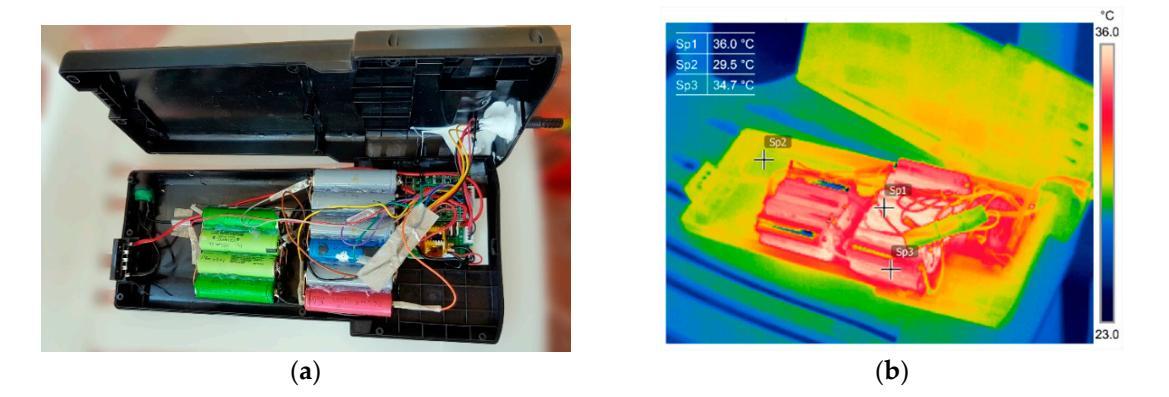
After an optimal structure of the 2p10s pack was determined, the new pack parameter assessment was conducted, Table 6. As is shown in Figure 23, a repaired battery pack now

has 35% of the capacity of a new one. However, it still has three times the capacity of a pack that has reached its end of service, when it has only 11% of the initial capacity and two defective cells in a pack assembly. In addition to Figure 23, there is a thermogram that monitors the equilibrium of the items during the initial fill that shows a fairly uniform thermal load on all cells. Such uniform distribution of the thermal load across the cells in the pack is a strong indicator that the battery pack is now recovered to some degree, as determined by the characteristics of the cells used.

Figure 23. Repaired and revived battery pack: an assembly (a) and its thermal footprint (b).

The new battery pack, shown in Figure 23, is only a temporary solution that allows the bicycle to be used until a new battery pack is manufactured or otherwise acquired. It will be restructured by the means of its mechanical construction and cooling system, which makes the new battery pack lighter and longer lasting. The previous experience of modeling systems, based on the principle of air cooling [49,50], as well as analyzing various forms of battery packs [51], will take into account the models of individual cells [52], and serve to build a CAD model of the battery pack using a feature-based parametric modeling system. In addition, due to the poor thermal management of the current battery pack, optimization of the thermal management system of the new battery pack must be performed. The optimization will be based on a computational fluid dynamics analysis (CFD) that also takes into account the electrical parameters of the cells, such as the variable cell resistance, the state of cell charge, and ancillary components. The analysis of a new battery pack will rely on CFD simulations of different pack models [53], taking into account the characteristics and specifics of the electric bicycle application.
