Article Modified "Rockfall Hazard Rating System for Pakistan (RHRSP)": An Application for Hazard and Risk Assessment along the Karakoram Highway, Northwest Pakistan

Abstract: Rockfall is a natural mountain hazard posing a severe threat to people, infrastructure, and vehicles along the transportation corridors. In this research, the standard Rockfall Hazard Rating System (RHRS) is slightly modified for the mountainous terrains of Pakistan through the quantification of animal activity along the highways. In the modified Rockfall Hazard and Rating System for Pakistan (RHRSP), animal activity is scored based on permanent and random animal tracks, shallow and higher altitudes, and shoulder width. The model is applied along the Karakoram Highway (KKH), which traverses a suture between Besham and Dasu (\approx 78 km), for Rockfall hazard and risk assessment mapping. An inventory of rockfalls, topples, and debris slides is compiled at 30 stations. Results show that rockfalls are mostly of the wedge and topple type failures. Fifty-seven percent of the area falls under the very-high to high hazard zone, 18% under moderate hazard, and 25% covers the low to very low hazard zone. Sixty-seven p

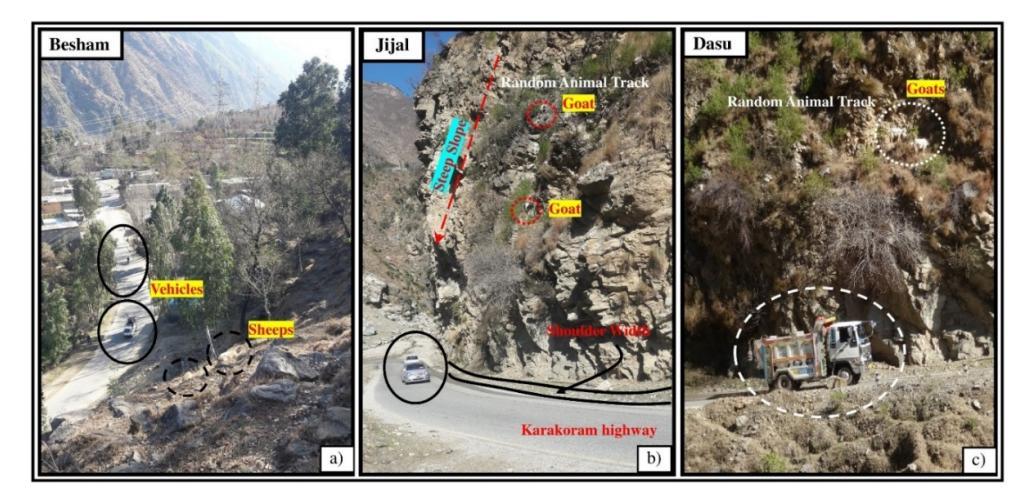
Figure 1. Quantification of rockfall activity caused by animal movement at lower and higher altitudes. (a) Sheep grazing at the gentle slope and lower altitude can push stones, which might cause moderate damage. (b,c) Stone falling caused by goats grazing at the steep slope and at the random track can directly damage the vehicles.

To quantify the animal activity along the study area at shallow or higher altitudes, a strong emphasis was given to animal movements, locating their random and permanent tracks, grazing altitude and steepness of the slope, and the shoulder width of the road

(Figures 1 and 2). From Besham to Dasu, much of the slope is steeper, therefore the stones reaching the road is primarily controlled by grazing height plus the shoulder width. In some cases, grazing animals at higher altitudes push stones that are captured by shrubs during downslope movement. Conversely, a large stone pushed from a higher altitude might gain momentum and becomes dangerous for humans and vehicles. A higher rating has been given to the situation when animals are grazing very close to the road and at shallow altitudes with no or extremely low shoulder width. In this situation, even a small stone directly approaches the road very quickly (Figure 1). A minimum score is assigned in the case where grazing will take place at shallow or higher altitudes, but the chances of falling stones reaching the road is minimal. This is mainly due to the gentle slope and plentiful shoulder width. (Figure 2). In mountainous regions, as with the KKH, shoulder width plays an important role in accommodating falling stones. In the study area, shoulder widths do not have standard limits and are therefore classed as a major factor in the quantification of rockfall by animal activity.

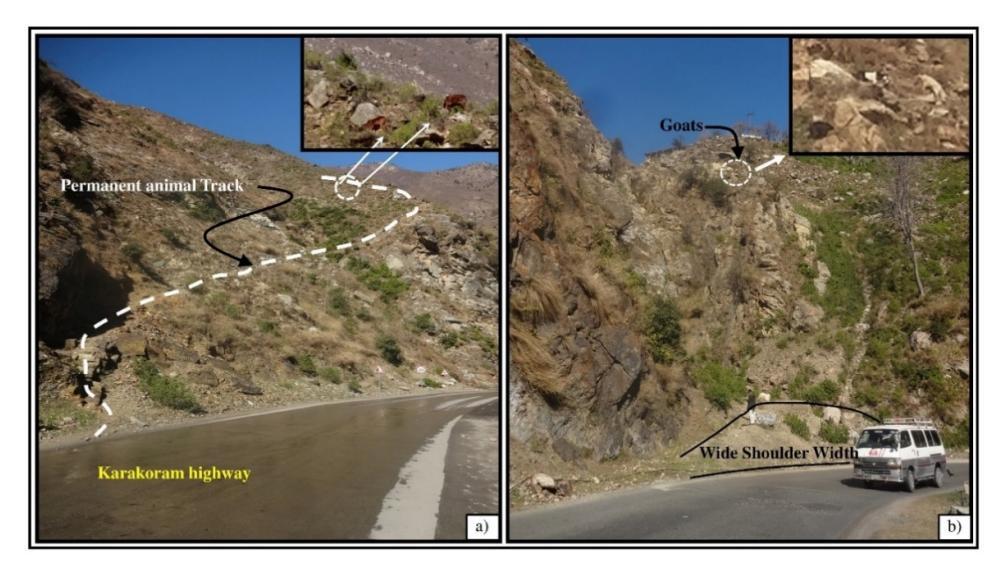
Figure 2. (a) Animals always follow a permanent track to reach the grazing altitude. Cows push larger stones compared to goats. (b) Goats grazing at a random track push stones that might not reach the road due to wider shoulder width.

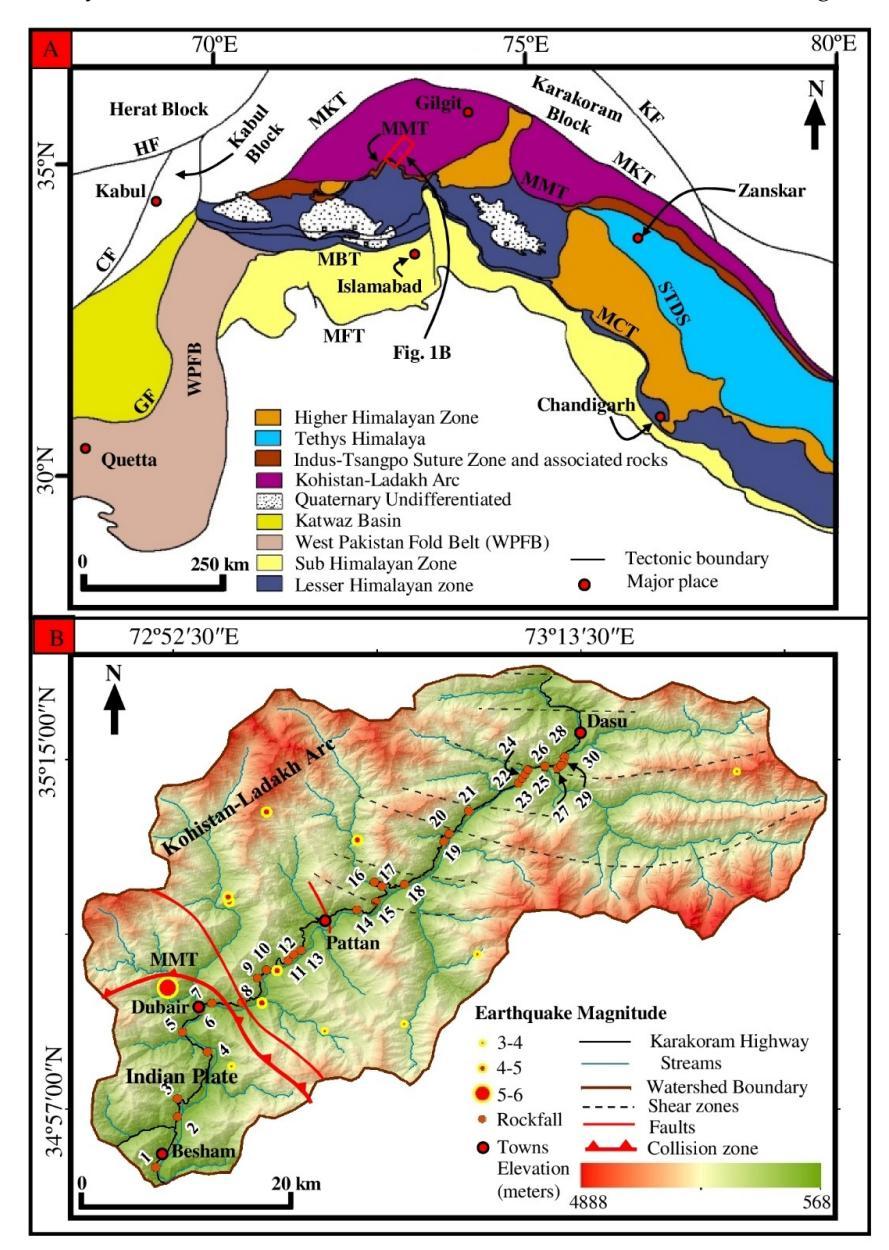
Figure 3. (**A**) Regional tectonic framework of the northwest Himalaya. The study area is shown with a red box. (**B**) Location map and point inventory of 30 rockfall stations in the study area. Active faults, Kamila-Jal structural features, and seismicity are the dominant factors controlling the distribution of rockfalls from the Besham to Dasu section.

The study area is located in the Kohistan district and is a 78 km stretch of the KKH in the Indus Valley. (Figure 3). The study area is bounded within the longitudes 72°51′49.44″ E, 73° 13′19.55″ E and latitudes 34°54′42.48″ N, 35°16′22.46″ N. Altitude in the area ranges from 568 m ASL at Besham to 4888 m snowy peaks on both sides of the Indus River. The world's ninth highest mountain peak, Nanga Parbat, with an elevation of 8125 m, is located in this region. Nanga Parbat Haramosh Syntax, located over a peninsula of the basement of the Indian plate, divides the Kohistan and Ladakh Island Arc terranes. The valleys in Kohistan have steep slopes and thin dispersed alpine-type vegetation, with snow cover mostly in the winter season [51]. The Indus River is the main drainage artery of the area.

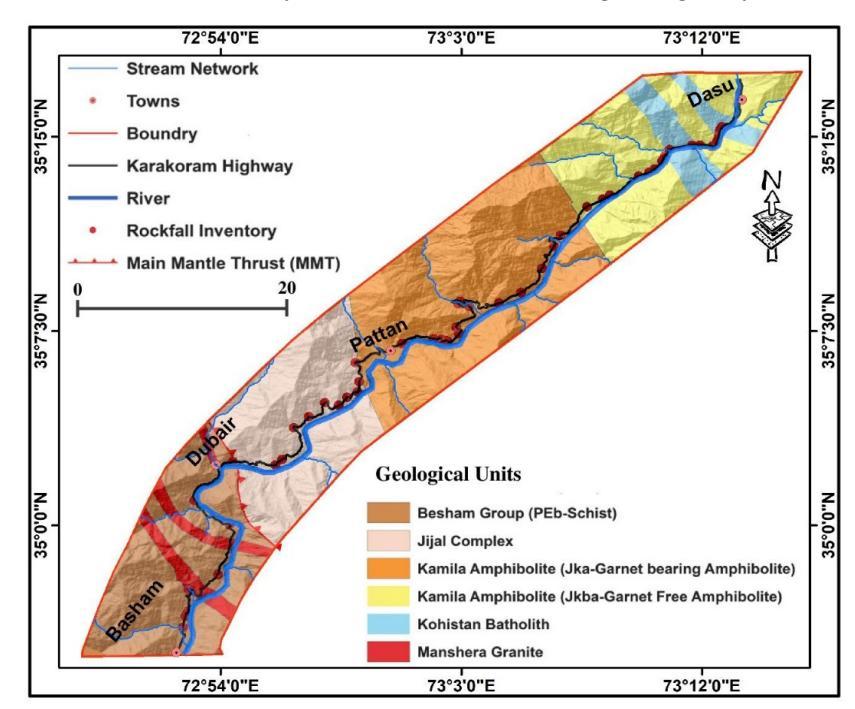
Figure 4. Geological Road log showing the locations of rockfalls, debris slides, and topples along the highway (Modified from Geological Survey of Pakistan Road Log).

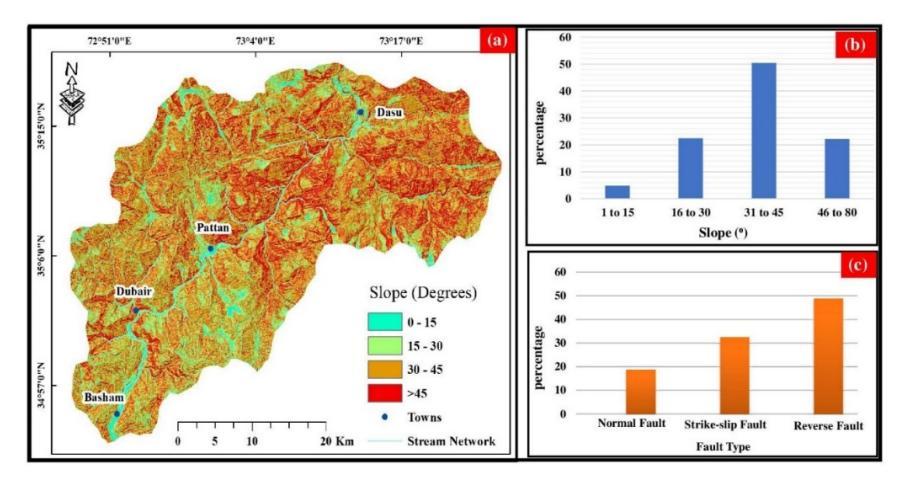
Figure 5. (a) Variation of slope in the study area. (b) More than 70% of the slope in the study area is greater than 30°. (c) Compressional stresses are dominant in the study area followed by strike-slip and normal faulting.

The main factors of rockfall and debris slide are the highly fractured hard rocks of steep slopes. Due to the slope factor, failures along the fractures are common in the Indus gorge and especially in the study area. Rockfalls and debris slides are accelerated by ground-shaking due to earthquakes and facilitated by heavy rains in the region. This steep slope promotes rockfall activity and is mostly concentrated along the highway from Dubair to Dasu (Figure 5a). The slope percentage of the two upper classes, i.e., 30° to 45° is 50.45% and 45° to 70° is 22.18%, which collectively makes 75% of the slope in the area, is greater than 30° (Figure 5b). Compressive stresses (thrusting) due to convergence are dominant, followed by strike slip and extensional stresses (Figure 5c).

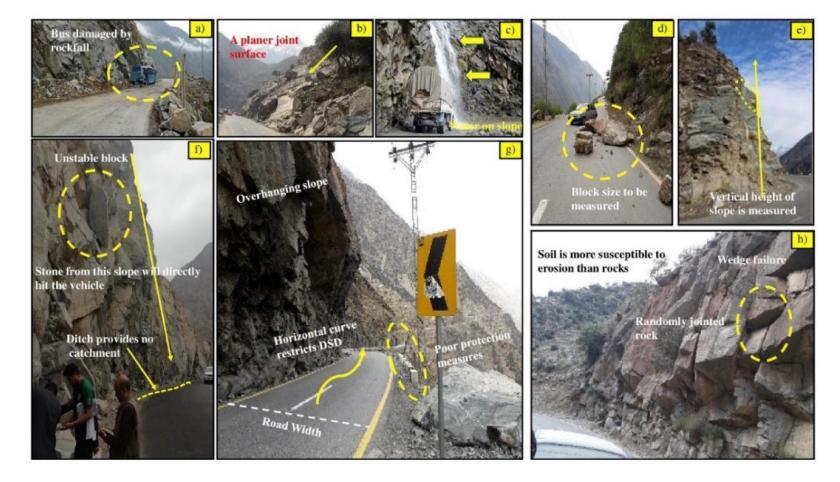
Figure 6. An overview of the measurement of field parameters for the RHRSP model. (**a**) A bus was damaged by a rockfall in the Kohistan district. (**b**) A planar joint surface. (**c**) Continuous water on the slope is a source of constant disruption of the road. (**d**) block size or volume per event is measured in the field. (**e**) Vertical height of the slope is measured rather than slope length. (**f**) Hanging block will directly hit the vehicle or human from a steep slope with an ineffective ditch. (**g**) Overhanging slopes and sharp horizontal curves restrict the Decision Sight Distance (DSD). (**h**) Multiple fracture sets are measured in the field. Soils are more susceptible to erosion. Wedge type is a common mode of failure.

slope is mostly gentler, around 20° to 30°, with one station where the slope gets steeper to 50°. Rock slope height changes from 5 m to 30 m between the stations. Slope height was measured from the highest point where boulders are expected to fall. (Figure 6e) The rocks are moderate to highly weathered and are highly fractured and jointed with a continuous and planar joint pattern. (Figure 6b,h) The distance between the discontinuities is from 1 cm to 70 cm. Ditch effectiveness falls in the limited to moderate category, posing a continuous threat for heavy traffic passing through this route. The maximum length and width of fallen blocks are measured as 15 m and 9 m, respectively (Table 2). Slopes are covered with vegetation at a few locations, but animal activity is almost nonexistent between these six stations at higher altitudes. Water on the slope falls into the moderately well-drained category. Shoulder width provides an emergency shelter during driving or maintenance activities and is an area for drivers to maneuver to avoid crashes. Here, inner and outer shoulder width varies from1–3 m between the stations, which is very short, bearing in mind the strong rockfall activity coupled with the steep slopes. (Figure 6g).

Dubair and its surrounding areas fall in the vicinity of the Main Mantle Thrust (MMT), providing a driving force for potential slope failures [58]. The severity of rockfall activity around the MMT is also mentioned by Ali, et al. [59]. Field data for five stations near Dubair show that elevation varies from 652 m to 882 m. Slope varies between 23° and 43°, and the cut slope is approximately 5 m to 41 m in height (Table 2). The road is 7 m wide, but the shoulder road is 1–3 m on either side of the road, with no protection measures for the instabilities, and therefore ditch effectiveness is assigned a none value. (Figure 6f,g). Weathering degree is low to moderate. Animal activity is common at higher altitudes, causing routine stone falling. In addition, several wedge failures, debris slides, and hanging rock blocks can be observed along the rock slope. The failed rocks are 20 m in diameter at a few places. The rocks are highly fractured and jointed with a joint spacing of 0.5 m to >1 m. It is also observed that the rock exposures have 2–3 prominent discontinuity sets. One joint set is responsible for wedge-type failure, whereas the other joint set initiates toppling failure (Figure 6h).

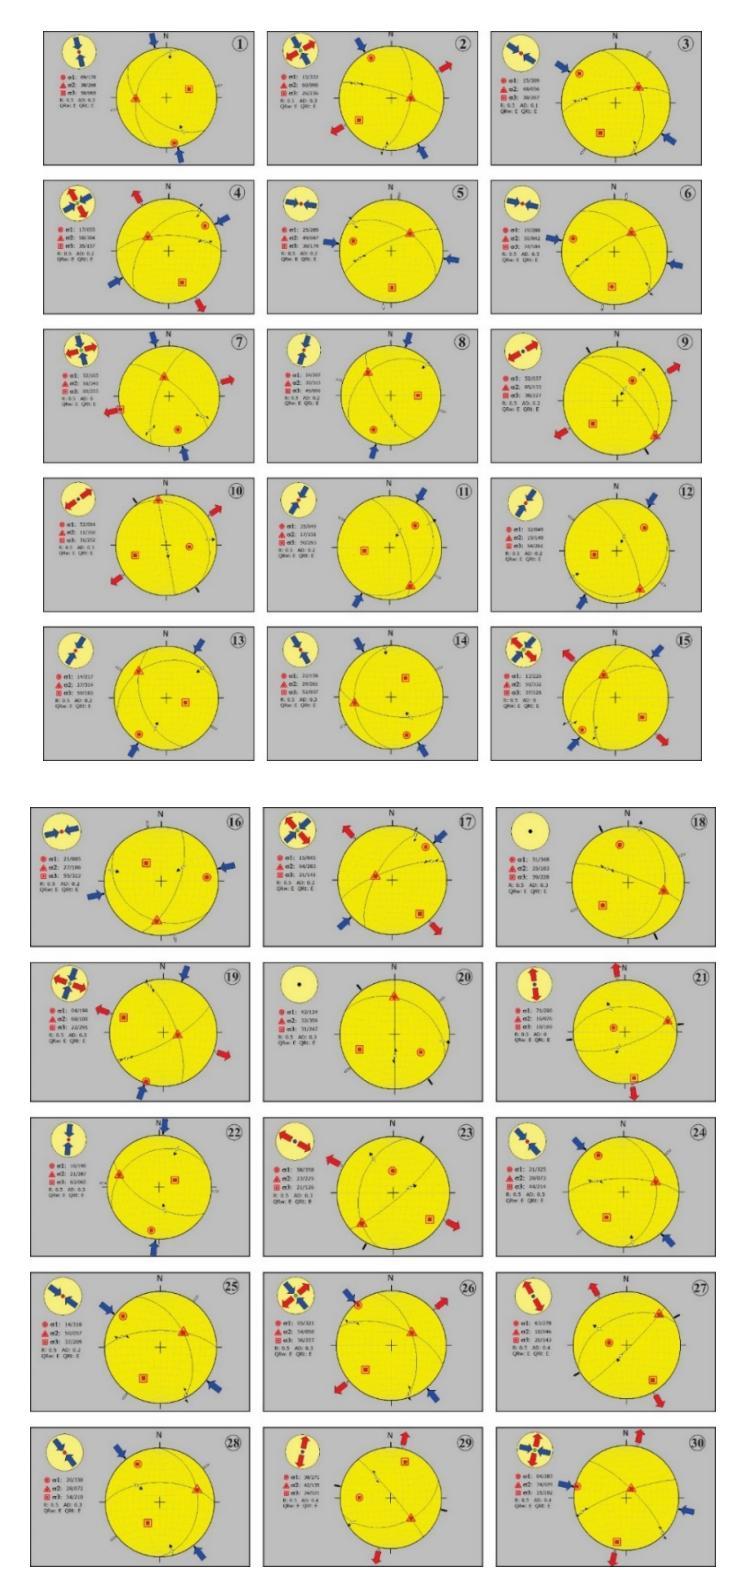
Figure 7. Stereographic projection of conjugate fracture data of 30 stations from Besham to Dasu along the KKH. Strike-slip stresses are dominant from stations **2–7**. Stations **8–30** are further divided into minor groups, depicting a dominant compression followed by strike-slip and extensional stresses.

The second group consisted of stations 8 to 30, distributed over the Kohistan–Ladakh arc between Jijal and Dasu (Figures 1 and 7, stations 8–30). This group is further subdivided into four minor groups. These minor groups consisted of stations 8 to 13, 14 to 18, 19 to 21, and 22 to 30 due to their close proximity. Station 8 is located close to the MMT in the southern exposure of the Jijal complex, and fracture data shows northeast–southwest directed thrusting. Meanwhile, stations 9 and 10 are located in the central part of the Jijal complex, and fracture data shows northeast–southwest directed thrusting. In this group, the major fractures show a thrusting component that matched well with the regional northeast–southwest compression in this region. However, the two extensional set of fractures located in the central part could be associated with local folding that causes extension in the hinge zone.

stations 25, 26, 29, and 30 show strike-slip dominance, and the data at stations 23 and 27 shows extensional dominance (Figures 1 and 7).

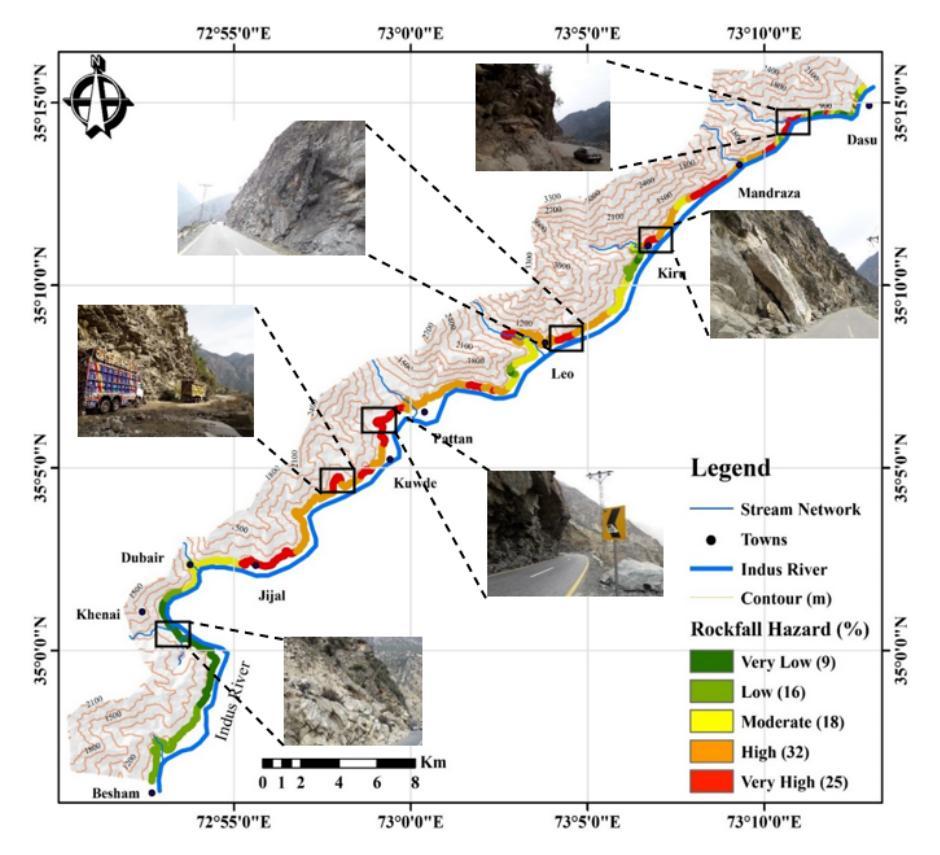
Figure 8. Rockfall Hazard map along the Karakoram highway from Besham to Dasu.

Rockfall hazard along the KKH from Besham to Dasu is shown in Figure 8. From the figure, it is evident that rockfall hazard is acute in 57% and moderate in 18%, whereas it is low to very low in only 25% of the area along the entire road section at various places. High and very high hazard zones are not a continuous path along the highway; rather, they are concentrated around various places such as Jijal, Pattan, Leo, Mandraza, and the surrounding area of Dasu. The Besham to Dubair section falls into the low to moderate hazard zone, and is associated with comparatively gentler slopes and a lower population. Rockfall hazard is high surrounding the Jijal area. From Jijal to Pattan, rockfall hazard is high to very high due to active high-frequency debris flow gullies, shallow landslides, and steep slope coupled with narrow highway and intense human and animal activity at higher altitudes due to settlements. The danger of rockfall hazard from Pattan to Dasu also fluctuates between moderate to high and very-high owing to 35° to 79° slope variation and the dominance of suspended mass, favoring toppling failure. Rockfalls and debris slides routinely occur after every rainfall in the area, with the KKH being blocked for a few hours or days. Generally, the rainfall activity is more intense from March to October. Therefore, rockfall and debris slides are expected to occur more frequently from March to October, during the rainy spells of the year, with the exception of ground shaking due to earthquakes.

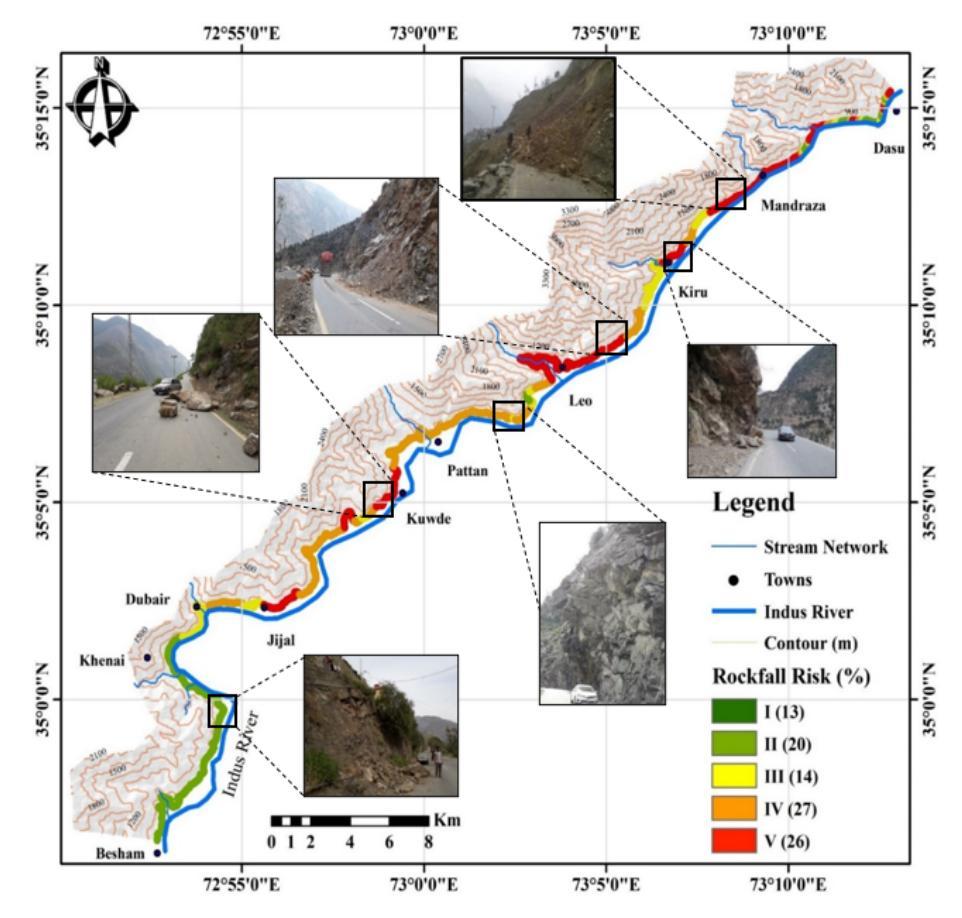
Figure 9. Rockfall Risk map along the Karakoram highway from Besham to Dasu.
