# Article Centrifugal Model Study of Seepage and Seismic Behavior in a Homogeneous Reservoir Dam with Parapet

**Abstract:** This study examines the effectiveness of parapets in preventing overtopping failures of small-scale homogeneous reservoir dams under seismic loads. In this study, a parapet covered the entire width of the dam crest and was designed to ensure its weight is transmitted to the dam crest. The test included four modes: initial mode, first seepage, seismic, and second seepage. The results show that without parapets the crack length and width expand significantly in the dam crest during the seismic mode, and the effect was large in the second seepage mode. The crack depth increased by 11.3–24 times during the seismic mode and expanded up to 73.3% of the dam height in the longitudinal direction along the axis of the crack formed in the dam crest during the second seepage mode. These findings suggest that the earthquake weakened the dam body, making it vulnerable to penetration. In contrast, the parapet structure effectively suppressed most of the tensile cracks by increasing the constraint force. Additionally, no crack expansion or tearing occurred during the second

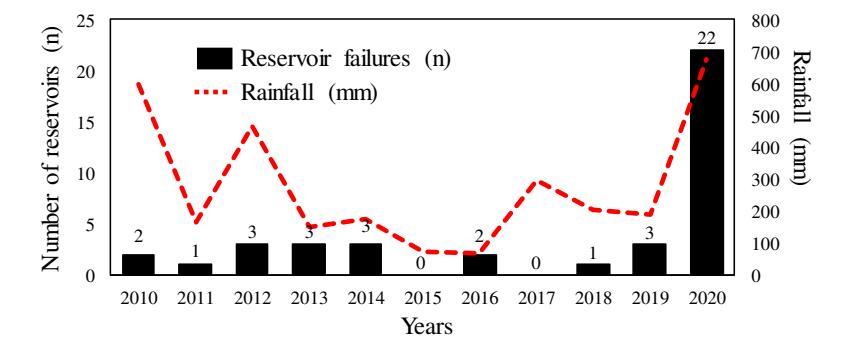
Figure 1. Relationship between rainfall and reservoir failure (Korea).

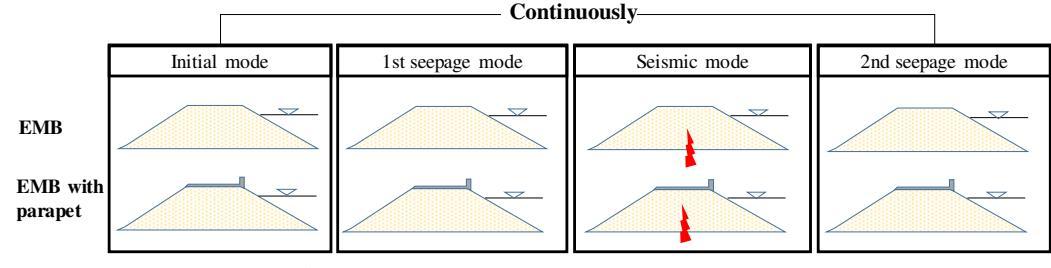
EMB : Embankment : Seismic motion

### Figure 2. Scenario setting.

is reached when the pore water pressure in the downstream embankment zone increases. Based on the initial model, the study confirms the hydraulic behavior in the first infiltration mode, stress behavior during seismic motion, and state changes in the dam model during the second infiltration mode after the earthquake in each mode. The study comprises four processes, with each experimental mode classified as either with or without parapet, as shown in Figure 2.

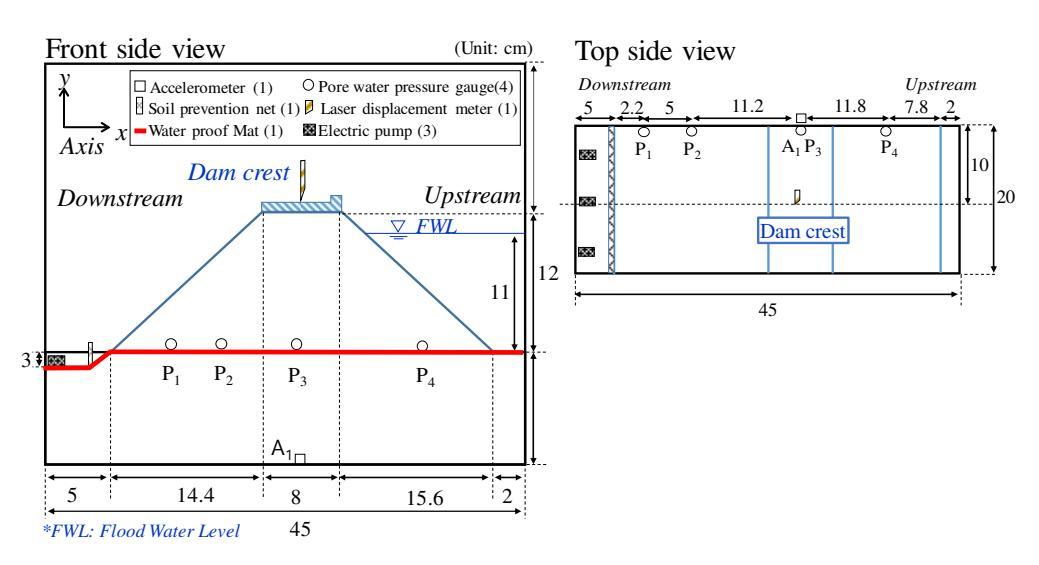
Figure 3. Design conditions and cross-sectional drawings for the model dam.

The reservoir dam prototype was a homogeneous small-scale reservoir with a height of 6 m, dam crest width of 4 m, and slopes of 1:1.2 and 1:1.3 on the downstream and upstream sides, respectively. Figure 3 shows the design conditions applied to the model dam construction. A silicon mat (thickness: approximately 2 cm) was installed at the boundary between the model dam and foundation to ensure seepage only within the embankment. The foundation was 15 cm deep, comprising hard sand with over 95% compaction. Accelerometers and three water pressure gauges were used to measure seepage and seismic behavior. Additionally, three small pumps were used to circulate water and maintain the upstream water level during the experiment. The small pump was designed to pass water only through a wire mesh to prevent failure due to soil mixing. The parapet was made of cement with dimensions of  $30 \times 20 \times 200$  mm (height × width × depth) and a weight of 2.07 kg. The upstream water level was applied to the viscous fluid. For 100% saturated soils, the physical properties of the soil, such as strength and stiffness, are not affected by viscous fluids [19].

In the centrifugal model test, instantaneous failure may occur owing to comparatively fast seepage flow caused by massive gravitational acceleration. Consequently, the viscous fluid was designed to have the same viscosity (50 G) as that of the scale factor of the model. For monitoring equipment, an action camera was placed in front of the model to observe cracks caused by the weight of the parapet structure and deformation of the dam. Additionally, DIPP-Motion V image analysis software was used to numerically track the deformation of the model dam after centrifugal loading [20]. For image analysis, a marker was assigned to the model image captured by the camera and used to calculate the deformation displacement before and after the experiment by tracking the RGB value of a specified pixel. Displacement can be measured and described in both longitudinal and transverse directions.

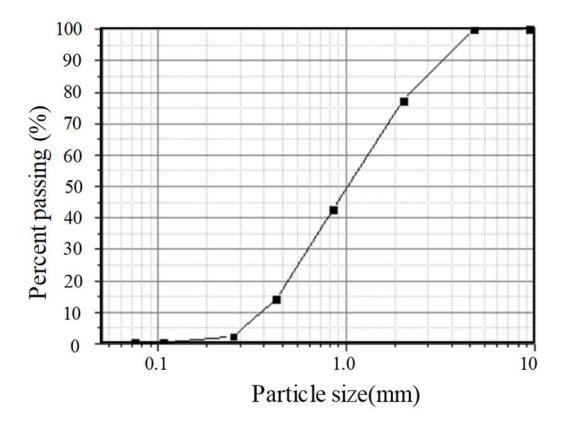
Figure 4. Grain size distribution of construction material.

Weathered granite, predominantly sandy soil, has often been used as construction material for embankments, contingent on the construction environment. Depending on the degree of rock weathering, the distribution of components such as sand, silt, and gravel, can exhibit a wide range of properties and may have low stability compared to other soil types [21]. In this experiment, weathered granite soil was selected, considering that small-scale earth dams constructed in the past had abundant sandy soil [14]. Figure 4 shows the grain size distribution of the weathered granite soils. In the laboratory test, weathered granite soil exhibited horizontal permeability ( $k_h$ ) of 7.45  $\times$  10<sup>-6</sup> m/s and a specific gravity ( $G_s$ ) of 2.65. The maximum dry unit weight ( $\otimes \otimes \otimes$ ) was 1.89 (t/m<sup>3</sup>) and the optimum water-content ratio ( $w_{opt}$ ) at this time was 7.5%. Generally, weathered granite soil has a permeability in the range of  $10^{-4}$  m/s (sandy soils) to  $10^{-6}$  m/s (silty soils) [22]; thus, the coefficient of permeability measured in the laboratory is considered suitable as a construction material. However, it should be noted that differences in materials and construction methods used may result in potential variability between the strength calculated using laboratory tests and field tests [23]. This variability suggests possible limitations in evaluating the stability of the dam body with a reduced model.

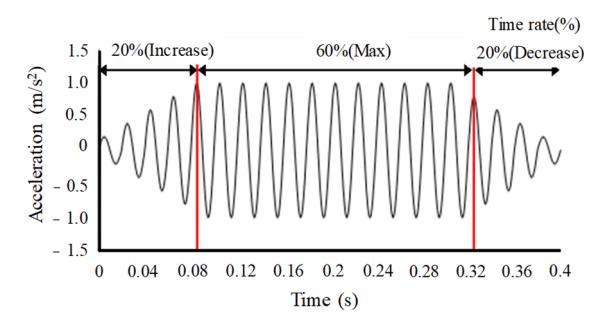
Figure 5. Input seismic motion.

Korea is located on the Eurasian Plate, and earthquakes of magnitude (M) 3 or higher have been recorded since digital measurement began in 1978. According to the earthquake classification, M 4.1–5.0 (9%), M 5.1 or greater (2%), and M 3.1–4.0 (88%) have been recorded to date [24]. The maximum possible earthquake on the Korean Peninsula is estimated to be M 6.5. However, unlike newly constructed dams, small aging earth dams may be vulnerable to infiltration and earthquakes due to poor construction environments. The construction materials of old reservoir dams in Korea have problems such as high sand content, high slope angle (about 1:1.5), and no seismic design. In Japan, old small earth dams with high sand content have been damaged and collapsed in an M 5.4 earthquake, suggesting that an M 6.5 earthquake could be too strong for identifying seepage and stress behavior in small old reservoir dams. Therefore, to avoid exaggerated test results, this experiment determined an acceleration of  $1.1 \text{ m/s}^2$  (approximately 0.1 g) based on the collapse history of a small-scale earth dam that experienced M 5.4 (0.1 g) acceleration in Japan [14]. Figure 5 illustrates the input seismic motion used in this study. It is crucial to select the right earthquake motion records that minimize variables in the test results due to the scale model of the earth dam to obtain accurate test results [25,26]. A sine wave was used to monitor the behavior of the small earth dam at a specific frequency in a basic experiment. Although sine waves produce more severe conditions in terms of the number of load cycles, they enable effective monitoring of the structure's behavior, which is useful for comparing the effects of different seismic motion types on the behavior of structures and soils. During the experiment, 50 G was applied for 0.4 s. The scale of the prototype is 20 s. The sine wave's amplification gradually increased and remained constant at maximum acceleration for a period before gradually decreasing. This gradual increase in amplitude prevented abrupt changes in the load that may create shock or impact and affect the structure or sensors used for measurement. Gradually increasing load allows the structure and instrumentation to adjust to the changes in a more controlled manner, enabling a more accurate measurement of the response.

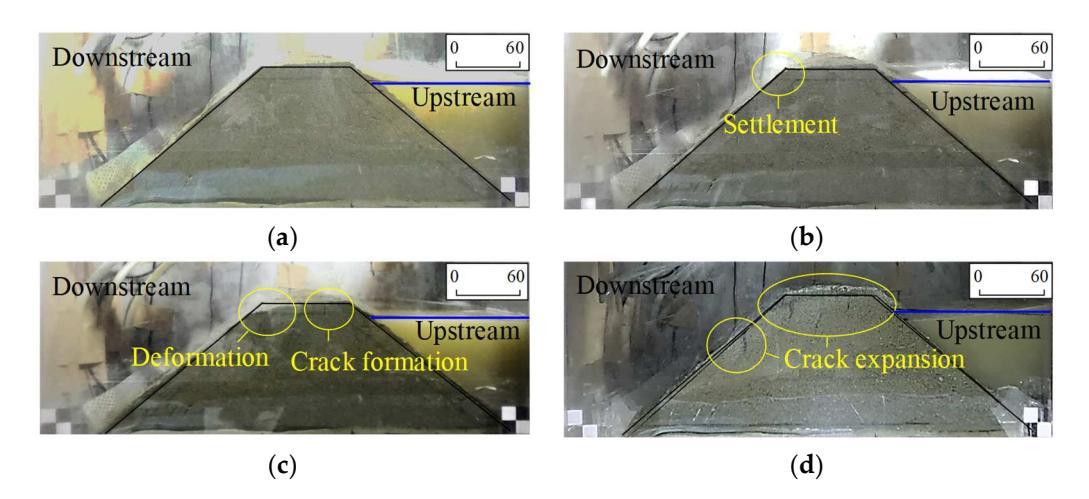
**Figure 6.** EMB model deformation: (**a**) initial mode, (**b**) 1st seepage mode, (**c**) seismic mode, and (**d**) 2nd seepage mode (unit: mm).

Considering overtopping failure is related to the embankment state, deformation was observed inside the embankment zone along the parapet and dam crest. Figures 6 and 7 show the conditions without and with a parapet, respectively. In Figure 6a, only the upstream flood water level (h = 11 cm) is set as the initial condition of the model dam; Figure 6b illustrates the condition in which only seepage is applied under 50 G; Figure 6c depicts the condition in which an earthquake with an acceleration of 1.0 (m/s) is applied after penetration; Figure 6d shows the condition of seepage after the earthquake.

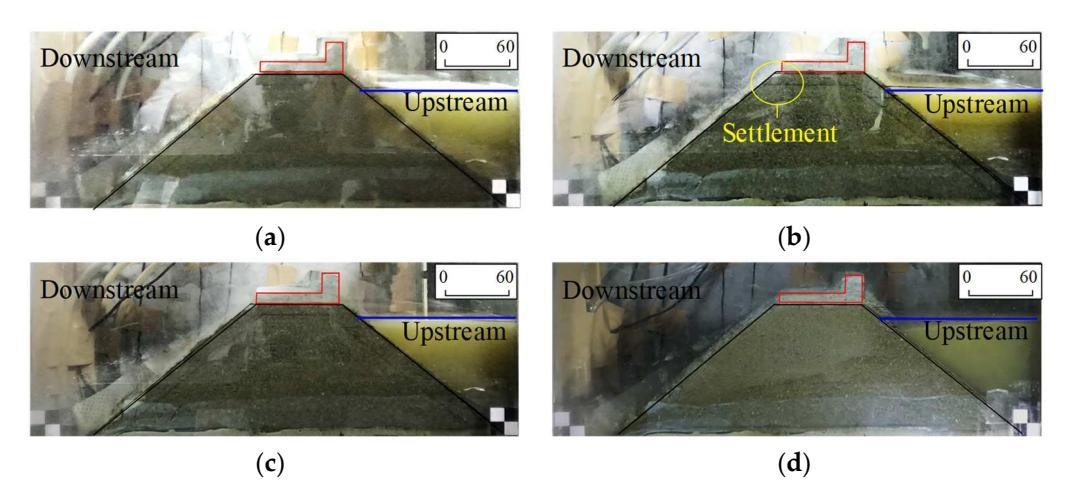
In the EMB model, as with the first seepage mode, a deformation of 3 mm depth was evident in the downstream dam crest, indicating vulnerability at the top of the downstream slope. In the seismic mode, a settlement of 8–13 mm occurred from the center of the dam crest to the top of the downstream slope, indicating the widening of the vulnerable area formed in the first seepage mode. As the top of the downstream slope was located at the narrow cross-sectional area, it may have been vulnerable to hydraulic pressure or seismic stress. In the second seepage mode, it extended to 73.3% of the embankment height, i.e., the depth from the dam crest (32 mm), along the crack axis formed in the seismic mode. Additionally, a crack depth of approximately 20 mm was observed in the center of the downstream slope. These findings suggest that after an earthquake, the dam body may experience accelerated durability degradation, leading to conditions in which cracks can easily expand, which could significantly threaten the stability of earth dams if left without any maintenance.

The first seepage mode in the parapet model was similar to that in the EMB model, as a slight deformation of 3–4 mm depth was evident at the top of the downstream slope. However, deformation was not observed in seismic mode, indicating a large difference from the EMB model. These results suggest that the parapet's weight acted on the dam crest and suppressed the deformation. Additionally, no other cracks or deformations were observed in the second seepage mode; therefore, it is believed that the effect of parapet weight also suppressed penetration. The deformation results suggest that the top of the downstream slope is vulnerable to pore water pressure and earthquakes. The displacement

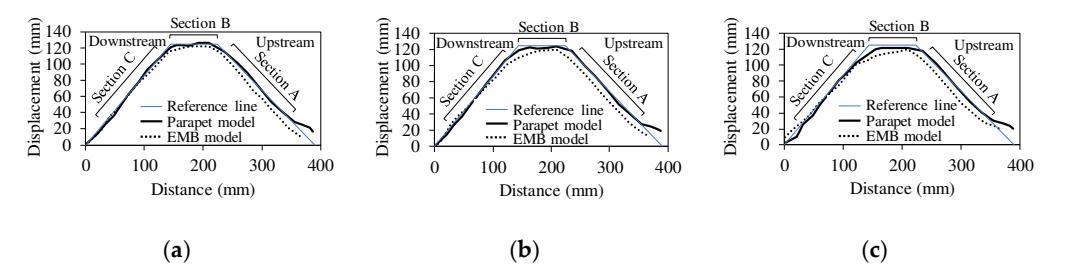
**Figure 8.** Displacement comparison in the EMB model and parapet model: (**a**) 1st seepage mode, (**b**) seismic mode, and (**c**) 2nd seepage mode.

of the model dam, presented in Figure 8, was computed using DIPP-Motion V image analysis software. Displacement calculations were performed for Section A (downstream slope), B (dam crest), and C (upstream slope), as shown in the figure, with the maximum displacement values for each section listed in Table 3.

The upstream slope of the EMB model experienced a settlement of 11–14 mm, which remained constant until the seismic and second seepage modes. In contrast, the parapet model exhibited minimal displacement in all modes, probably due to the weight of the structure slowing down the seepage rate. During the seismic mode, the dam crest of the EMB model experienced a rapid increase in settlement resulting in a displacement more than twice that of the first seepage mode. This displacement continued to increase after the earthquake, indicating the significant effect of earthquakes on the hydraulic deformation of the dam. During the experiment, the downstream slope swelled slightly in the transverse direction; however, the displacement due to earthquakes or pore water pressure was relatively small in all modes.

In contrast, the parapet model exhibited a relatively stable tendency with a gentle increase in displacement in all modes. Interestingly, no lateral displacement occurred due to the slip phenomenon, despite no measures being implemented to prevent slip between the parapet and the dam crest because the parapet designed in this study had a structural shape that made it difficult for displacement to occur. Additionally, as a constant weight was applied to the entire width of the dam crest, the dam crest damage through the lateral movement of the parapet was difficult. This finding suggests that parapet load was distributed across the entire area of the dam crest, helping suppress lateral displacement.

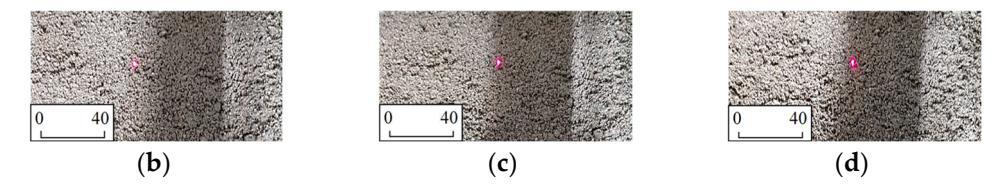
**Figure 10.** Parapet model: (**a**) initial mode, (**b**) 1st seepage mode, (**c**) seismic mode, and (**d**) 2nd seepage mode (unit: mm).

In the parapet model, the parapet was removed to confirm the effect of the parapet in detail, and the dam crest crack shape was observed. In the dam crest, no cracking was observed for all scenarios used in this study. Clearly, the parapet (W: 2.07 kg) improved the seismic performance by increasing the constraint force of the dam crest, even at a weight level of approximately 18% of the model dam (W: 11.2 kg).

In the parapet model, after removing the parapet, the condition of the dam crest was inspected under the first seepage mode, seismic mode, and second seepage mode. Unlike the EMB model, no tearing or crack expansion was observed in the dam crest; therefore, no crack size was recorded.

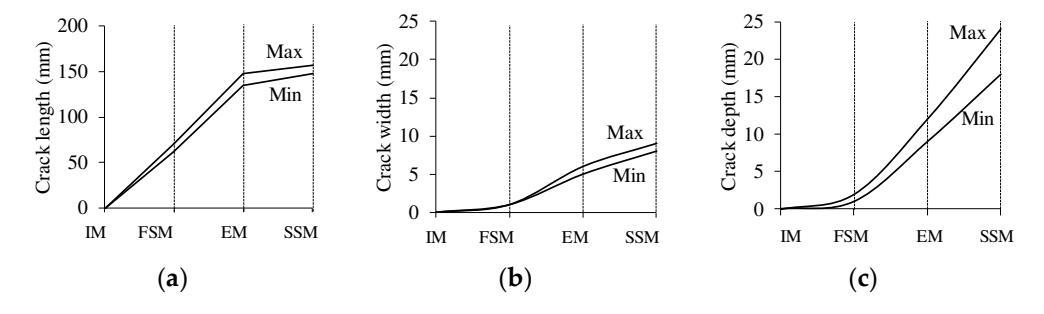
**Figure 11.** Dam crest crack size: (a) crack length, (b) crack depth, and (c) crack width. IM: initial mode; FSM: 1st seepage mode; EM: seismic mode; SSM: 2nd seepage mode.

Figure 11 illustrates the length, width, and depth of the cracks, with crack size calculated based on the first seepage mode. The crack length generated in the first seepage mode increased by 2.1–2.4 times in the seismic mode. In the second seepage mode, the expansion of the crack length was insignificant as it increased by approximately 1.1 times. The crack width generated in the first seepage mode increased by 5.0–8.0 times in the seismic mode. In the second seepage mode, the expansion of the crack width was insignificant as it increased by about 1.2 times. The crack length and crack width results showed that the earthquake rather than the hydraulic pressure affected dam crest cracks. In contrast, crack depth showed a different pattern compared to crack length and width. The crack depth increased continuously after the earthquake, ranging from 11.3 to 24 times in the seismic mode and 22.5 to 48.0 times in the second seepage mode, enlarging the deformation caused by the pore water pressure in the embankment.

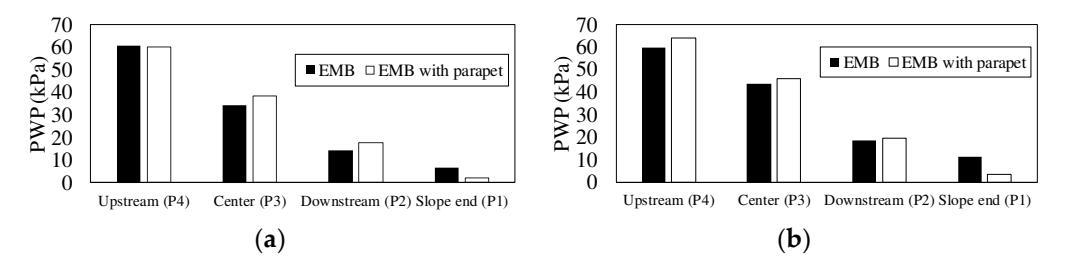
**Figure 12.** Comparison of pore water pressure between the EMB and parapet models: (**a**) 1st seepage mode and (**b**) 2nd seepage mode.

In this comparison, the pore water pressure of the upstream side (P4) of the first seepage mode was the same. However, in the EMB model, the pore water pressure at the center of the embankment (P3) and the downstream side (P2) was relatively lower, whereas the slope end (P1) was relatively higher. This result is attributed to the relatively lower pore water pressure at P3 and P2 as the EMB model infiltrated to the end of the slope in the first seepage mode.

The increase in P1 indicates that seepage water in the embankment rapidly reached the slope end. In the parapet model, P1 showed a remarkably low pore water pressure, indicating that the seepage rate at the end of the slope was relatively slow during the same time, with the infiltration progress inhibited by the parapet's weight.

In the second seepage mode, both the EMB and parapet models exhibited pore-waterpressure change patterns similar to the first seepage mode for P4, P3, P2, and P1. However, the pore-water-pressure levels increased for all, compared to the first seepage mode. Thus, it can be considered that the pore water pressure measured in the first seepage mode increased after the earthquake, in which the dam body changed to a more porous condition. The only difference between the first and second seepage modes was the change in pore water pressure for P4. In the second seepage mode, P4 of the EMB model showed a relatively lower pore water pressure than that of the parapet model. This result suggests that infiltration in the embankment progressed rapidly in the EMB model, despite the increase in pore water pressure in both the EMB model and the parapet model.

In contrast, in the parapet model, P4 and P3 showed an increase in pore water pressure of 6–8 kPa compared to the first seepage mode, whereas P2 and P1 showed an increase of 2–3 kPa, with the change in pore water pressure considered insignificant. As a result, the parapet model was found to have a suppressing effect on seepage flow in the dam body after an earthquake. The slope end is an area where the self-weight of the embankment is relatively small due to the trapezoidal shape of the embankment, making it a structurally vulnerable area for erosion. As the parapet induces low pore water pressure at the end of the slope, it provides a reinforcing effect in terms of disaster prevention.
