Article Localization of Cracks in Concrete Structures Lacking Reference Objects and Feature Points Using an Unmanned Aerial Vehicle

Abstract: Information on the location of cracks in concrete structures is an important factor enabling appropriate maintenance or reinforcement measures to be taken. Most studies related to concrete cracks are limited to crack detection and identification, and studies related to crack location information are insufficient. The novelty of this study is to develop application technology related to crack localization by proposing a methodology that can estimate the location of concrete cracks even when reference objects or feature points are lacking using an unmanned aerial vehicle and image processing techniques. For the development and verification of the proposed method, aerial photography and image acquisition were performed using mounting a laser pointer model on an unmanned aerial vehicle. To build the analysis data, image distortion correction and feature point extraction were performed using the homography matrix and scale-invariant feature transform algorithm. Spatial information was established using the point cloud technique and image stitchin

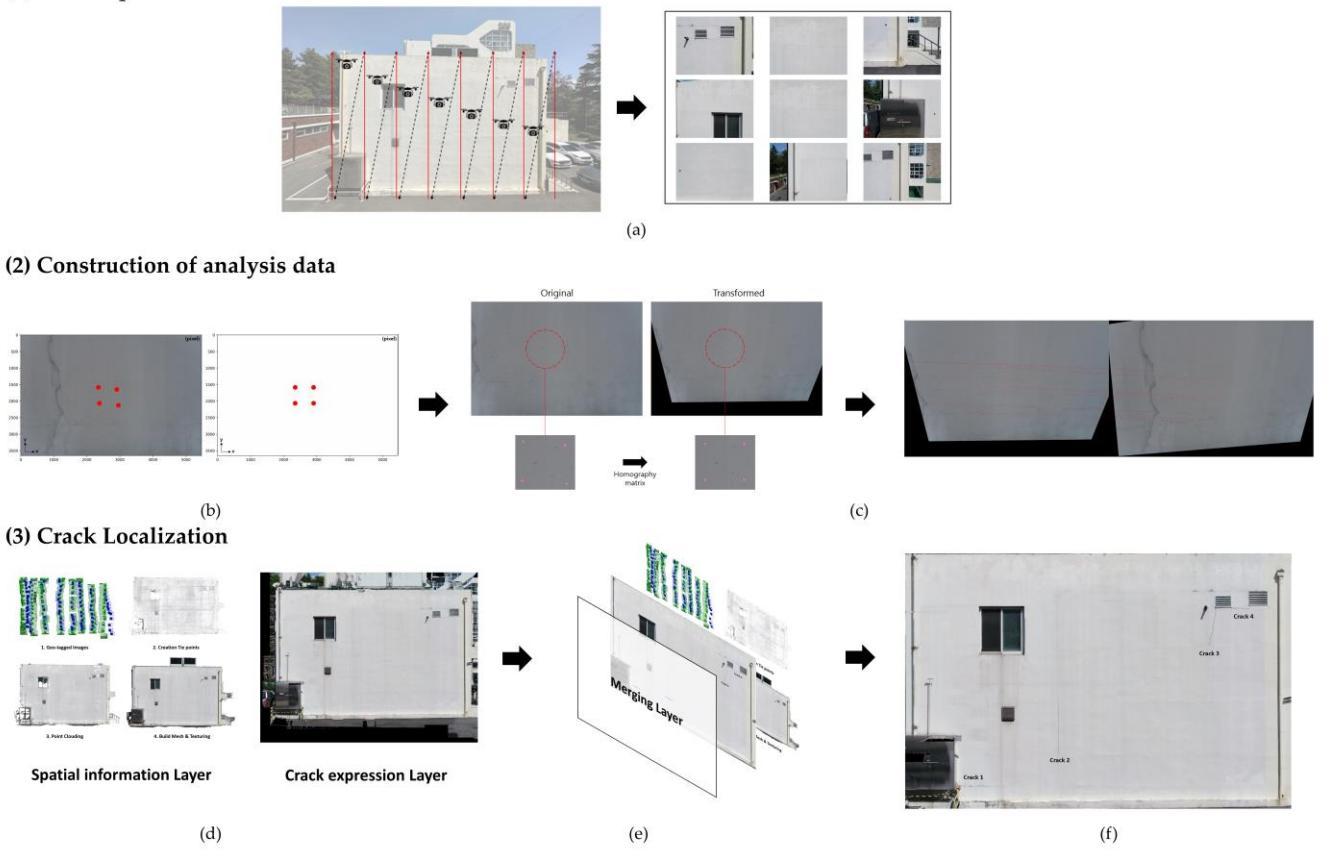
Figure 1. Visualizing flow chart for estimating the location of cracks in the exterior walls of buildings using unmanned aerial vehicles when without the reference objects in the image: (a) UAV-based aerial photography; (b) Distorted image correction using homography matrix; (c) Feature point extraction using SIFT algorithm; (d) Construction of spatial information using image processing techniques; (e) Merging of spatial information layers based on point cloud technique and image stitching technique; (f) Crack localization and Data validation.

Through this, the accuracy of image matching and location estimation can be improved, images are corrected using distortion correction and matching algorithms, and the location of cracks is estimated. Finally, we intend to conduct a position estimation experiment via the spatial information constructed using the aerial image obtained by operating the unmanned aerial vehicle equipped with the laser pointer model and the image processing technique. Figure 1 depicts the visualized flow chart for estimating the location of cracks in the exterior walls of buildings using unmanned aerial vehicles without the reference objects in the image. The proposed method comprises the following steps: (1) Data Acquisition: UAV-based aerial photography. (2) Construction of analysis data using image processing technique: (a) Distorted image correction using homography matrix and (b) Feature point extraction using SIFT algorithm. (3) Crack localization: (a) Construction of spatial information using image processing techniques, (b) Merging of spatial information layers based on point cloud technique and image stitching technique, and (c) Crack localization and Data validation.

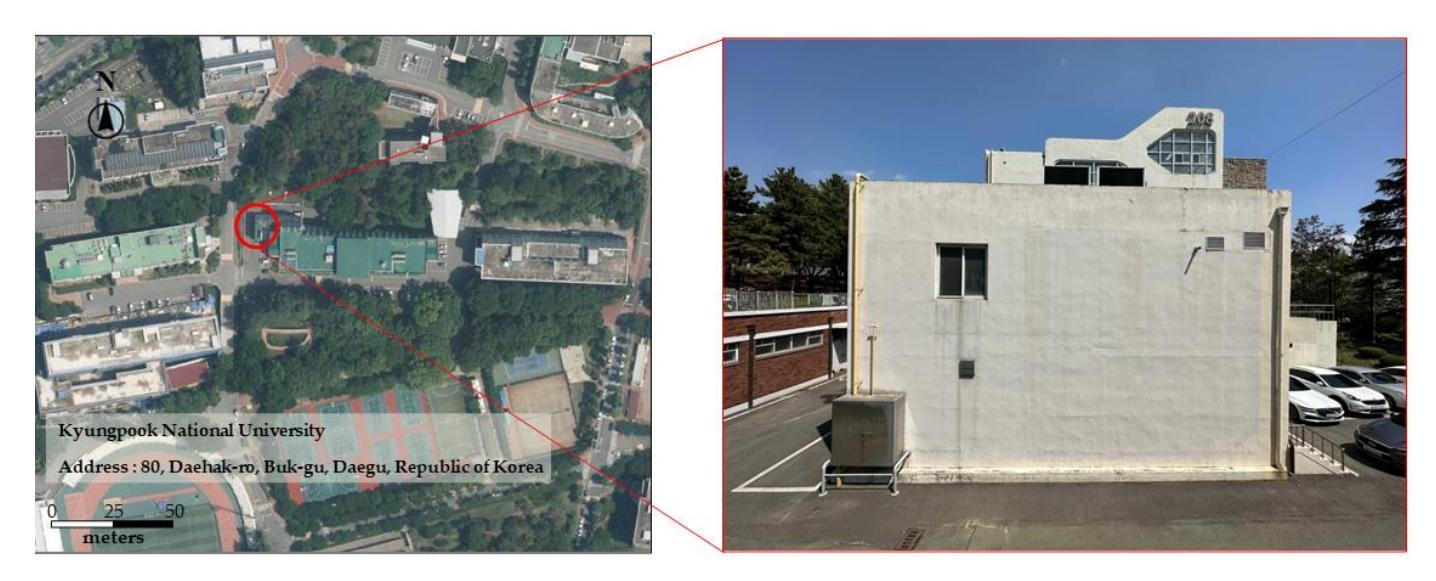
Figure 2. Overview of the target site.

In this experiment, a Laser Pointer model was developed that can be attached to an unmanned aerial vehicle's camera sensor. Aerial photography was conducted on the exterior wall of a concrete building located in Buk-gu, Daegu, Republic of Korea. In the case of the exterior wall of the building selected as the test subject, there is a feature object that can be defined as a reference object, but there are no surrounding obstacles during aerial photography, and there are parts that are judged to have insufficient feature points on the exterior wall of the building. Therefore, an experiment was conducted by selecting a target for the methodology presented in this study. The overview of the target area where aerial photography was performed in this study is shown in Figure 2.

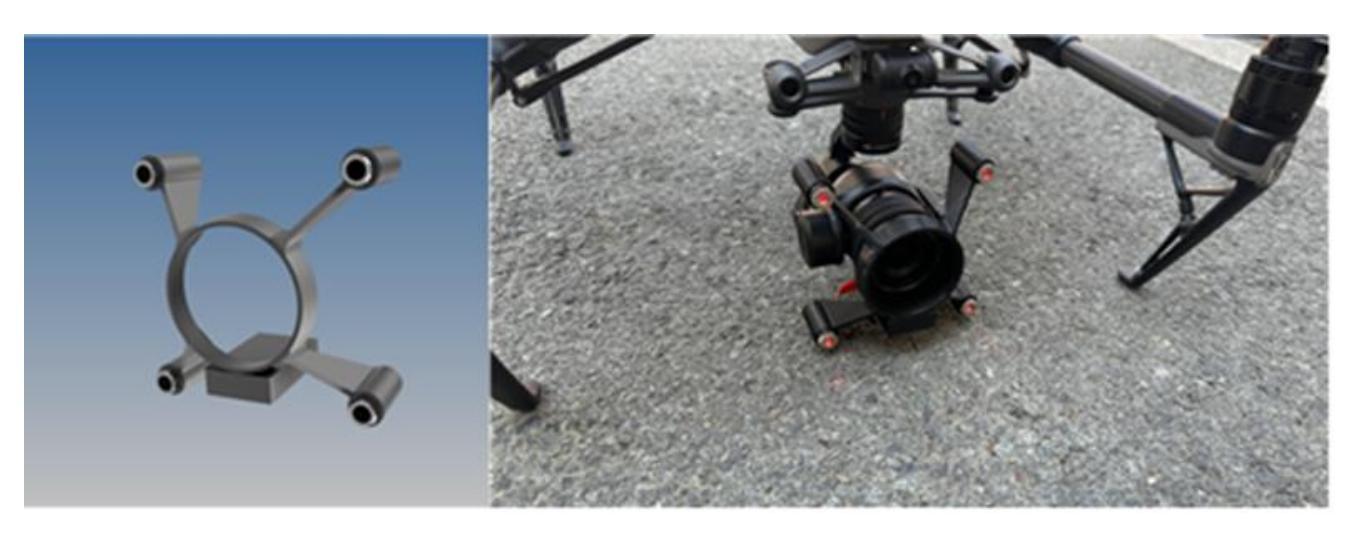
Figure 3. Laser Pointer model and mounting on the camera sensor.

UAV and camera sensor used in this study are the Inspire 2 and Zenmuse X5S models from DJI in Shenzhen, China. The upward infrared sensor can detect surrounding obstacles up to 5 m, the downward vision system ranges from 0.1 to 5 m, and the forward vision system operates between 0.7 to 30 m. The Field of View (FOV) can identify objects within a horizontal range of 60° and a vertical range of 54° . The camera lens has a focal length of 15 mm, and the image sensor size is 17.3 mm × 9.7 mm for CMOS 4/3''. The resolution is 5280 × 2970 with a 16:9 aspect ratio, allowing for capturing photos with a maximum resolution of 20.8 MP. Additionally, the Laser Pointer model developed for mounting on the camera sensor was designed and manufactured using a 3D printer, as shown in Figure 3.

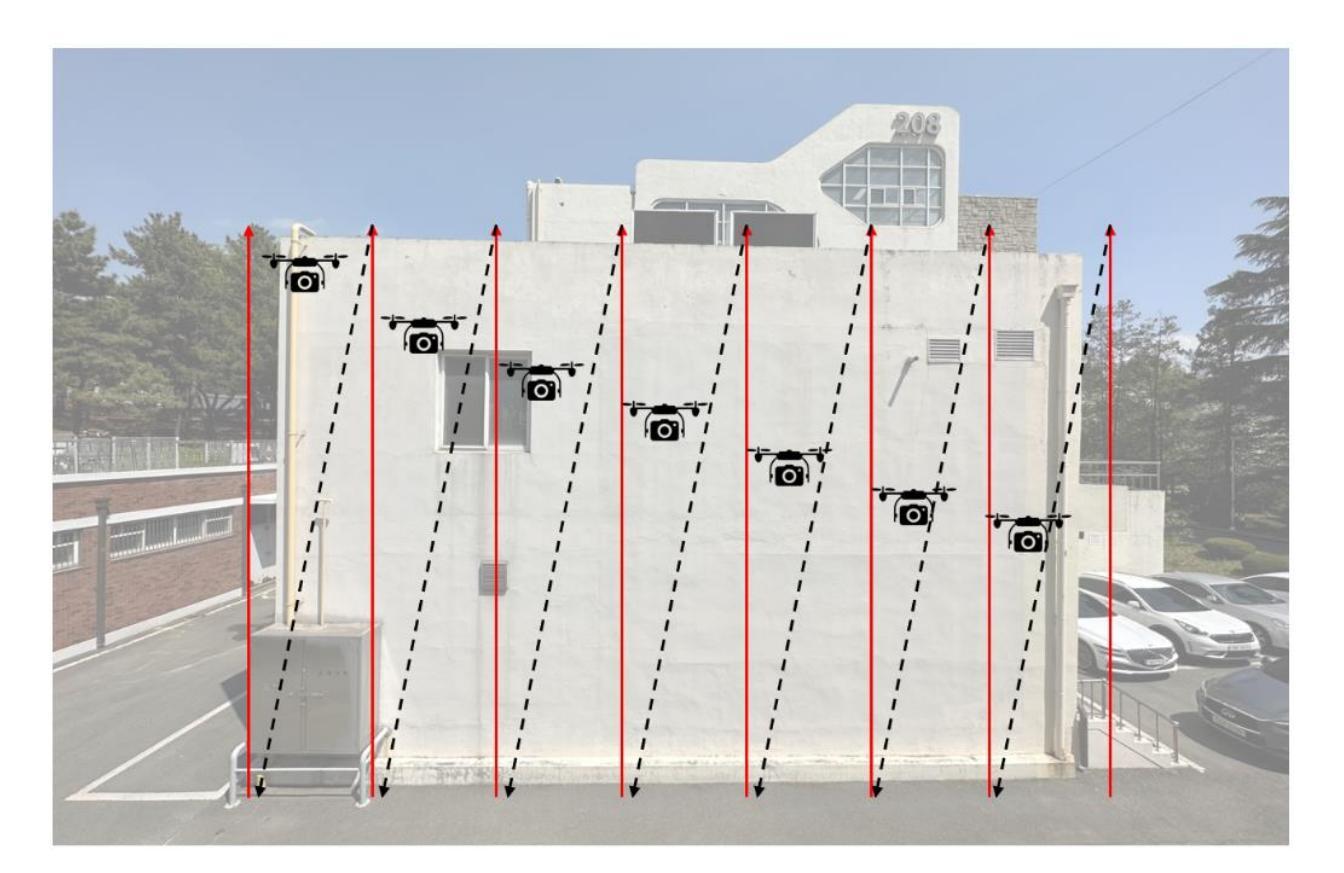
Figure 4. UAV shooting path plan.

For the flight path, the exterior wall of the target building was planned in a single grid format, and the angle of the exterior wall of the building and the camera sensor were set vertically. The UAV shooting path planned in this study is shown in Figure 4.

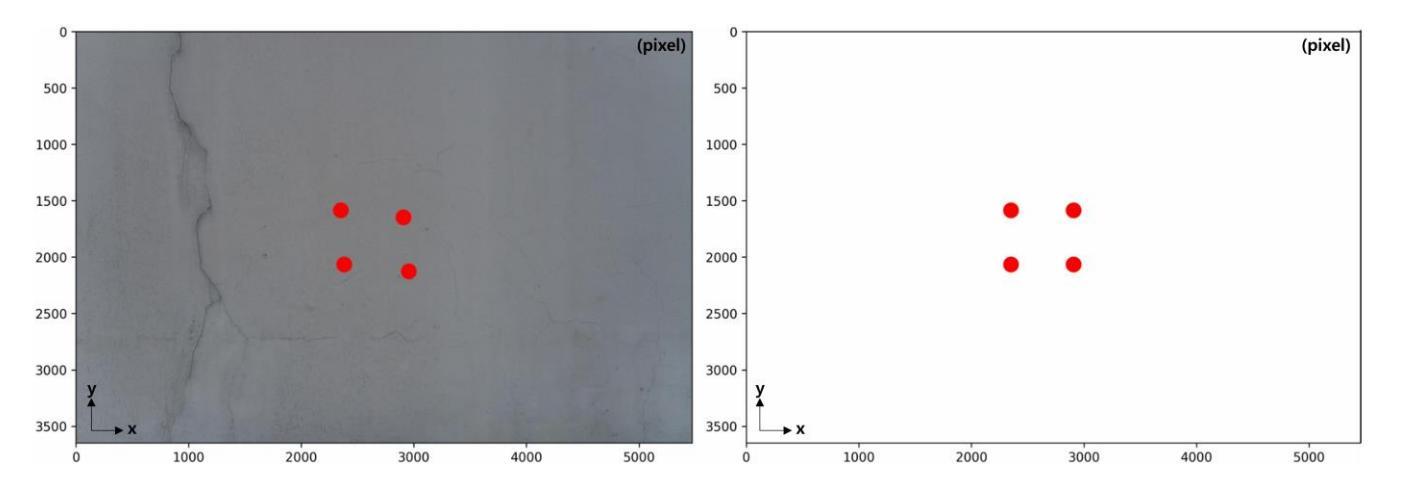
Figure 5. Four points and corresponding points are set for homography matrix.

In this study, aerial photography was performed using a UAV equipped with a laser point model to estimate the location of cracks on the exterior wall of a building without a reference object. In order to correct the distortion of the aerial image obtained using aerial photography, four laser points identified in the raw aerial photography image were selected, and image correction was performed using a homography matrix. The four points and corresponding points set for homography matrix conversion are shown in Figure 5.

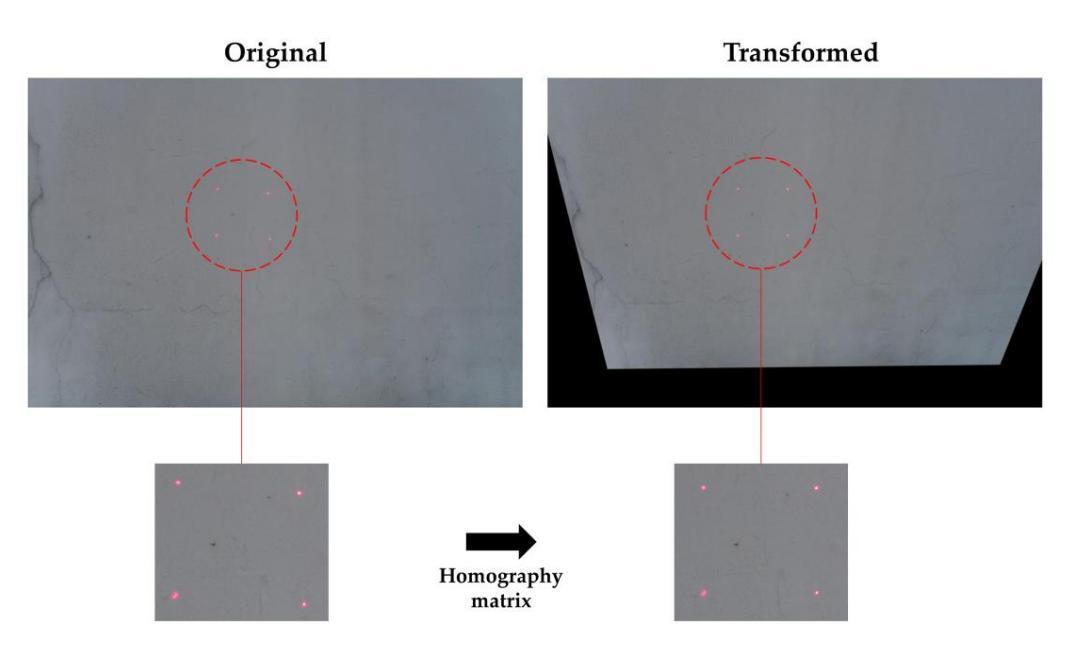
Figure 6. Result of image correction using homography matrix.

Correspondence points were set for the distorted laser points of the raw image using model design information, and image distortion correction was performed for the original images acquired using aerial photography using a homography matrix. The following Figure 6 is the result of image correction using the homography matrix.

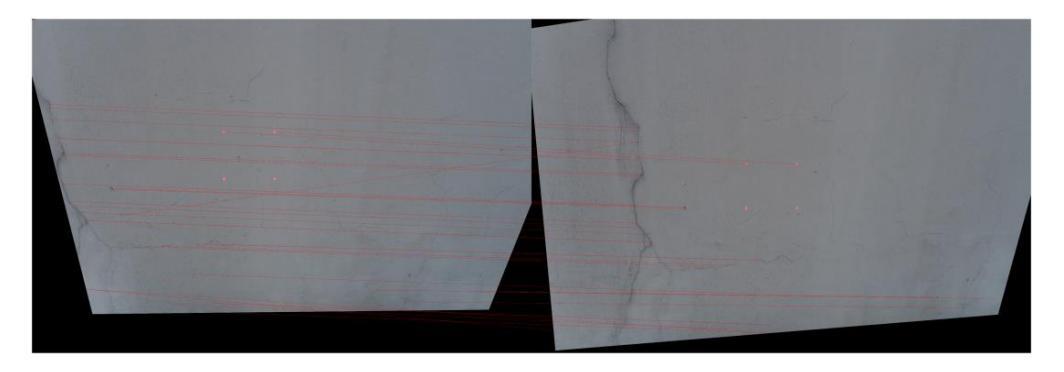
Figure 7. Result of feature point detection and matching using SIFT algorithm.

Next, feature point detection and matching were performed using the SIFT algorithm to confirm the availability of the distortion-corrected image, and the results are shown in Figure 7.

As a result of the experiment, it was confirmed that the image generated using the image distortion correction and feature point extraction method proposed in this study can be sufficiently utilized for image processing techniques.

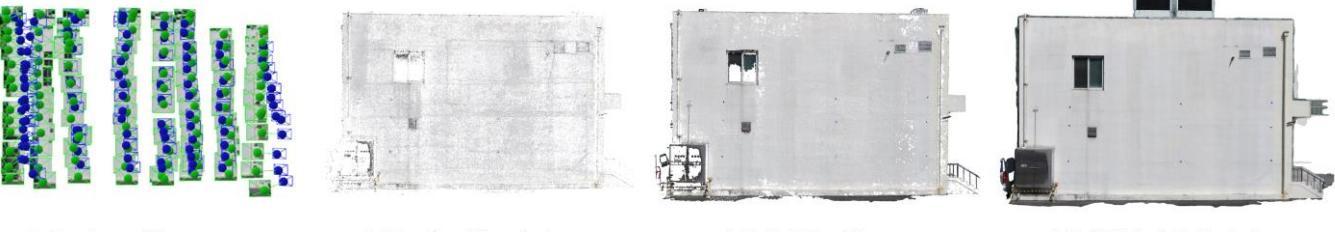
1. Geo-tagged Images

2. Creation Tie points

3. Point Clouding

4. Build Mesh & Texturing

Figure 8. Process of spatial information construction using Point Cloud technique.

In this study, a background model was generated in the target building using the Point Cloud technique based on aerial photography images with recorded location information. The spatial information construction using the Point Cloud technique was carried out using Switzerland PIX4D company's PIX4D mapper software (Prilly, Switzerland). The following Figure 8 shows the spatial information construction process for the background model generation.

A total of 107 aerial images were used to build spatial information using the Point Cloud technique for creating a background model, and the location accuracy of the constructed spatial information was RMSE X = 0.65 m, RMSE Y = 0.33 m, and RMSE Z = 0.40 m.

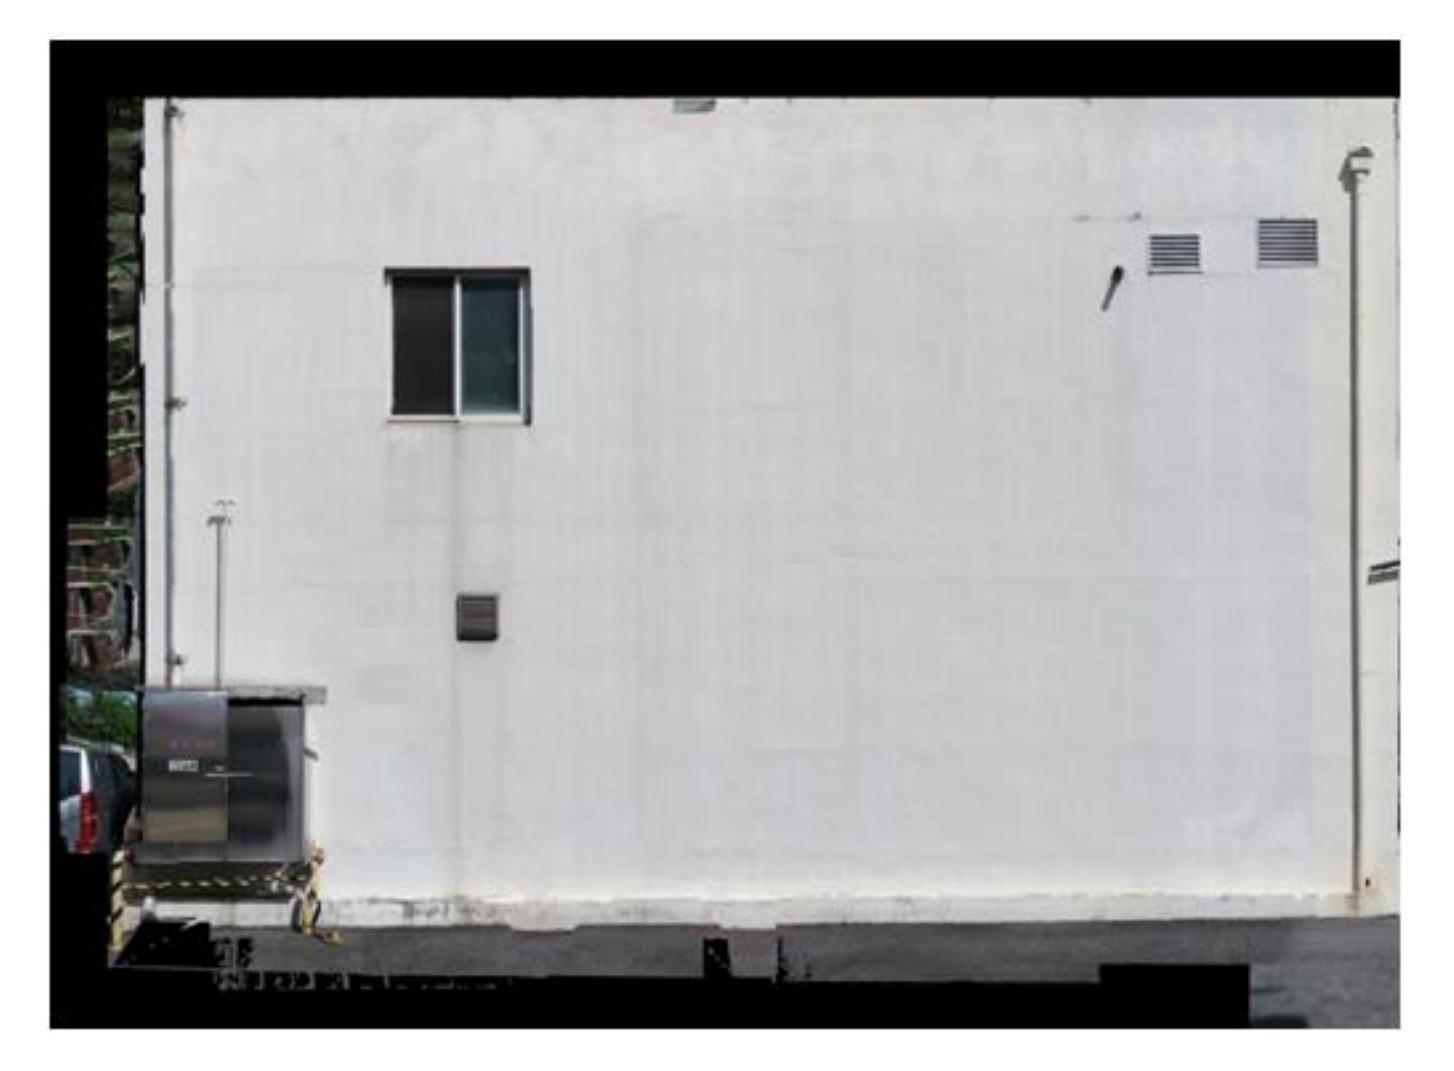
Figure 9. Result of spatial information using image stitching technique.

Next, the spatial information of the target building was constructed using the image stitching technique to generate high-resolution images and acquire crack expression information. The image stitching technique for constructing spatial information applied a feature-based stitching technique that utilizes the feature points of each image and used a data set previously constructed through image distortion correction and feature point extraction. The spatial information of the target building created by using the image stitching technique to acquire crack expression information is shown in Figure 9.

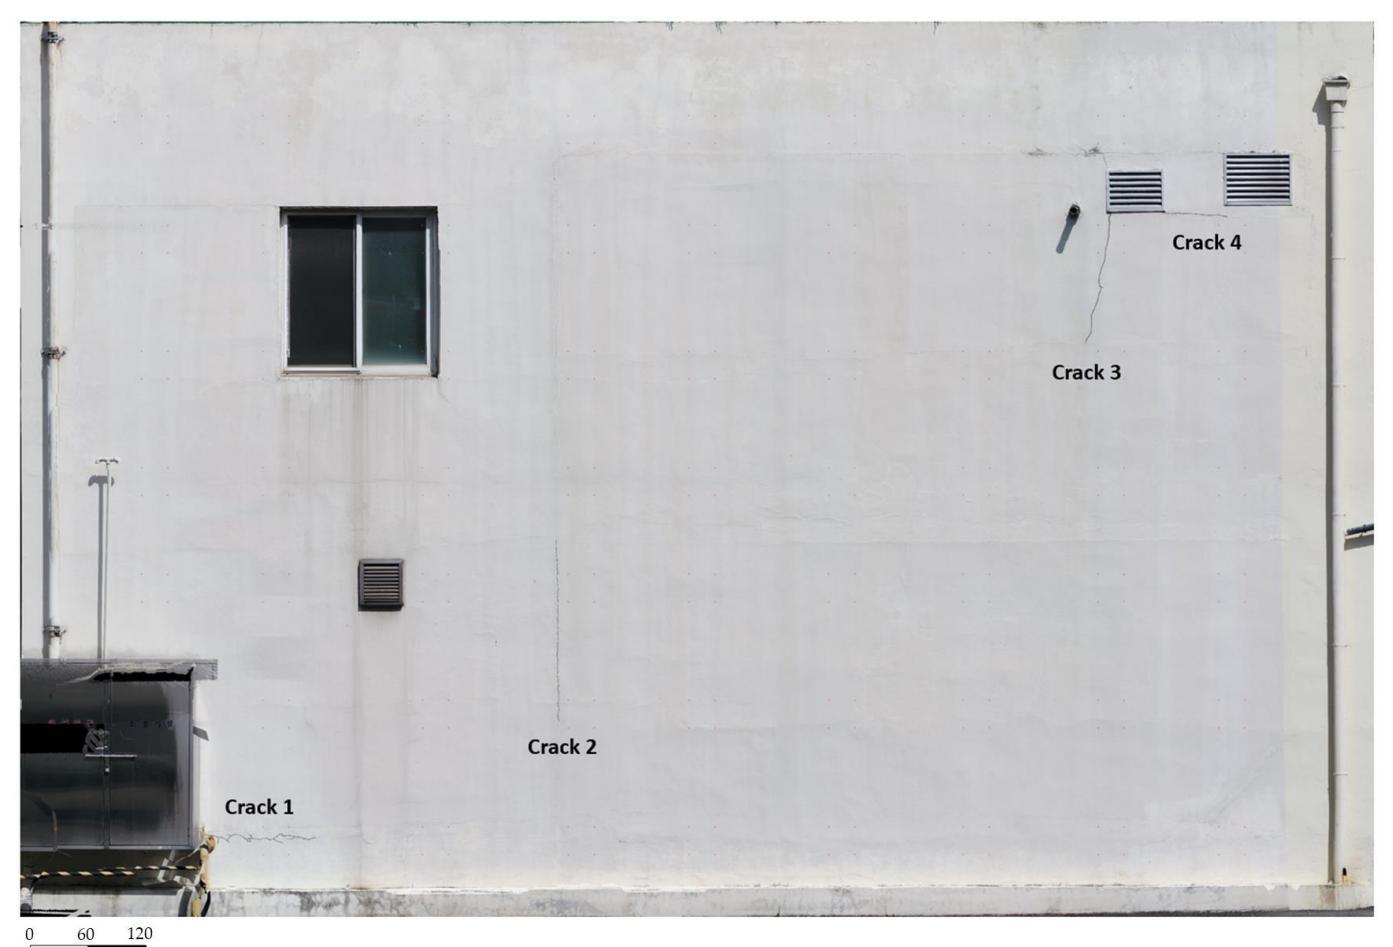
Figure 10. Analysis data after merging spatial information layers.

Next, the analysis data was constructed by merging the spatial-information-based background model (using the Point Cloud technique) with the location information obtained using image stitching, which expressed the crack locations in high resolution. The merging of the spatial information layers was performed using AutoCAD 2023 software from Autodesk in San Francisco, CA, USA. The merging was achieved by matching the relative coordinates of the stitched image data, where the crack locations were expressed in the orthomosaic of the building, with coordinate values obtained using the background model. First, standardization was performed by adjusting the 1:1000 scale orthomosaic. After that, to overlap the orthomosaic and stitching image data of the target building, the starting point of the lower left corner of the building was set as the reference point (0, 0), and the relative distance from the reference point was converted into (x, y) coordinates to estimate relative location information. Superposition was performed using the analysis of data built using layer merging, which is shown in Figure 10.

Using the analysis data established by merging layers, four cracks were identified in the building at the target site, and their locations were estimated. To estimate the crack locations, we set the lower left end of the target building as the reference point (0, 0) in the constructed analysis data. The location information of the concrete cracks was then estimated by converting the reference point and the crack locations into relative distance coordinates (x, y). Therefore, to estimate the relative location of the cracks, we determined the starting point (x_1) and ending point (x_2) of the horizontal axis crack and the starting point (y_1) and ending point (y_2) of the vertical axis crack from the reference point (0, 0) of the building. In this study, we expressed the vertical/horizontal start and end points of the crack as (x_1, y_1) and (x_2, y_2) coordinates to estimate their relative positions. The estimated relative locations of the concrete cracks based on the scale are shown in Table 1.
