# **Application of Electrical Resistivity Data Sets for the Evaluation of the Pollution Concentration Level within Landfill Subsoil**

Abstract: The paper presents complex analyses of geophysical site investigation results. The electrical resistivity method was used to investigate the potential pollutant migration pathways within areas of existing and former landfill sites. For the purpose of the present study, there were four municipal waste landfills and one industrial landfill chosen for further comprehensive analyses. The landfill bottom was isolated using geomembrane liner. However, ground water monitoring results revealed that the base was not leakage-free. Another two landfills were established in the past, when no containment systems were legally required. The geoelectrical investigation was the final part of an overall analytical assessment of the contaminated sites. The study was aimed at pollution spatial migration analyses and the interpretation of results, for further design of the reclamation and restoration plans. A clear correlation between pollution indicators such as salt compounds and electrical resistivity, allow aerial analyses and the precise determination of

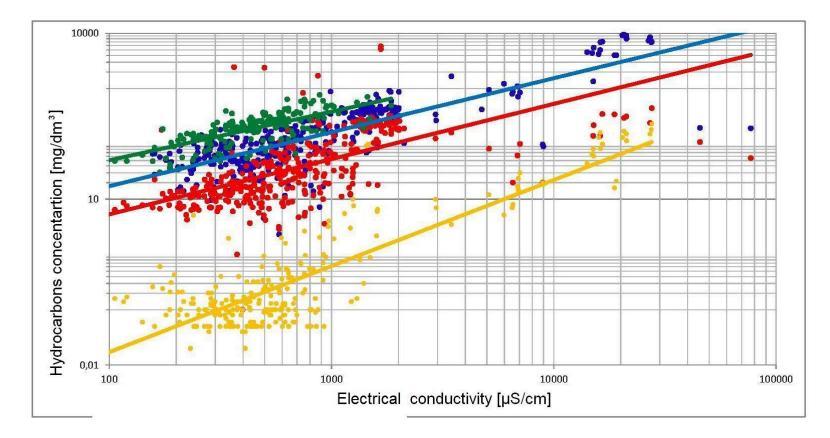
**Figure 1.** Correlation between EC and hydrocarbons (• set of 194 data points), sulfate (• set of 380 data points), chlorate (• set of 392 data points), ammonium (• set of 248 data points).

There is a direct correlation between the electrical conductivity (EC) and the amount of elements dissolved in water, and a similar correlation can be seen for the content of other elements and the water quality (chlorides, sulphates, and petroleum). Practically, even small, dissolved elemental changes in water affect the conductivity [31,32]. Thus, it can be used as a way of recording the changes in water composition, which is also influenced by contamination of the groundwater. This feature, when properly calibrated and based on analytical assessment, could be used as valuable information for a soil-water environment quality assessment [24,33].

Water is not an efficient electrical conductor; it's electrical conductivity is  $5 \times 10^{-8} \mu$ S/cm (at temperature 25 °C). In dissolved suspensions, the EC is proportional to the concentration. The higher the concentration of a suspension is, the better the electrical conductivity will be. This is because there is a better dissociation of the elements into ions, in dissolved suspensions. In particular ranges, the relationships between the conductivity and electrolyte concentration are linear functions. Figure 1 presents the collection of data concerning the relationship of electrical conductivity and selected chemical solutions. During a number of investigations, it was also noticed that the conductivity of the electrolytes increases with a temperature rise of about 2%/1 °C. It is mainly caused by a decrease in the suspension viscosity and an increase in the mobility at higher temperatures. The EC of natural water falls in a range of 50 to 1000  $\mu$ S/cm, but leachate conductivity can exceed 10,000  $\mu$ S/cm. It is assumed that, for shallow groundwater, potentially affected by anthropogenic activity, values of EC above 1000  $\mu$ S/cm indicate water contamination.

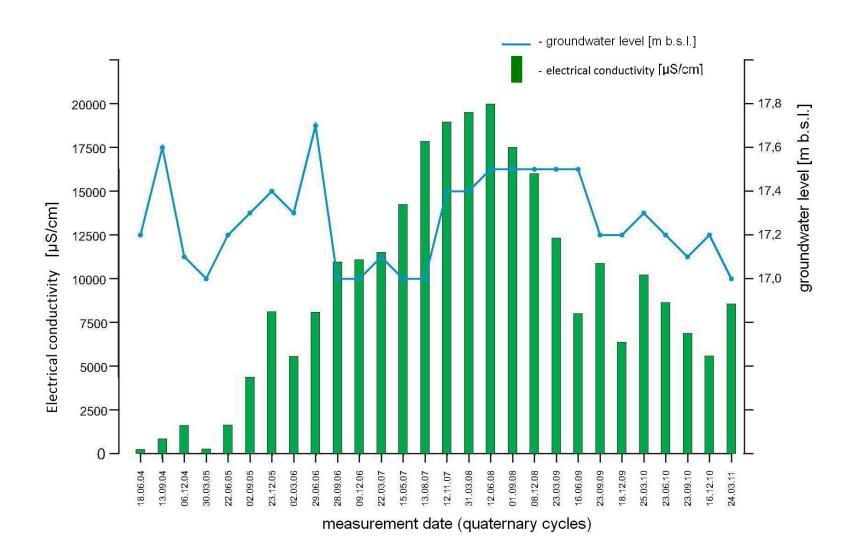
Figure 2. Electrical conductivity (EC) and ground water table changes over time.

The investigation was performed due to the EC and TOC (total organic carbon) present in groundwater samples, collected from a selected piezometer. The piezometer was located where groundwater was discharged from the landfill (south western part). The changes of EC and TOC with ground water table fluctuations over time, are presented in Figures 2 and 3. From the monitoring results, it was determined that the leakage had appeared in 2005 and had been most intensive in the following three years. The later drop in EC and TOC values was achieved by applying remediation solutions at the site (purifying pumping). The results of selected indicators of a groundwater quality assessment, are presented in Table 1. According to Polish standards, the salinity parameters indicate a IV and V quality class [34].

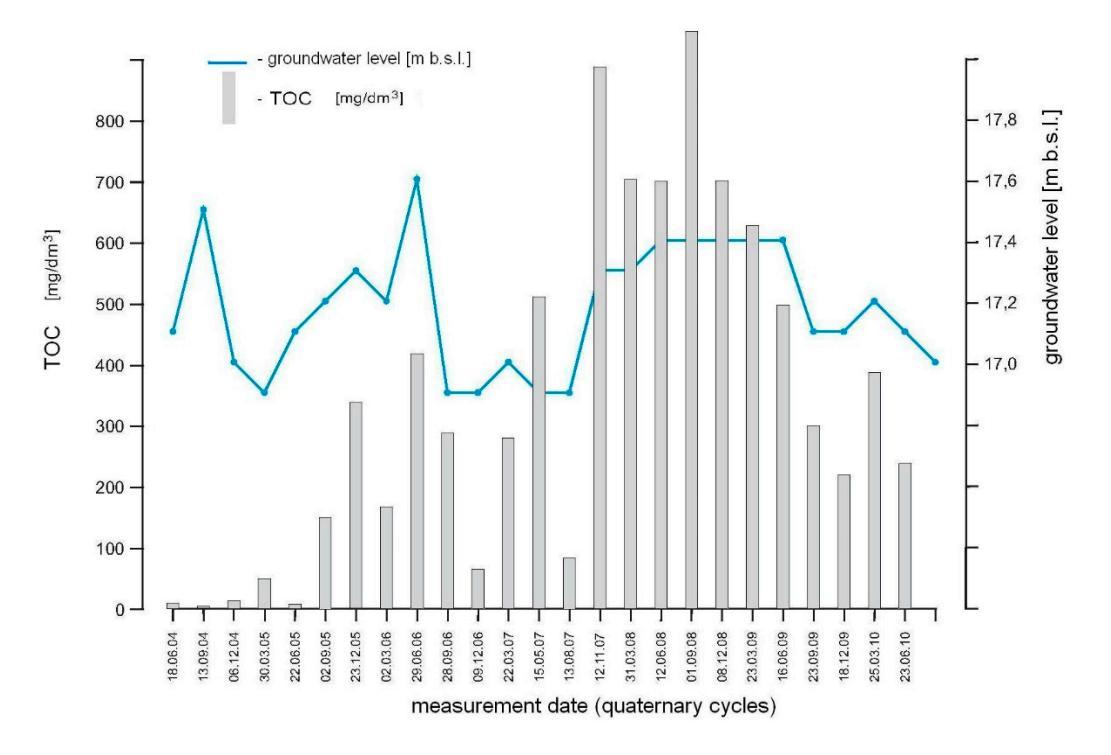
Figure 3. Total organic carbon (TOC) and ground water table changes over time.

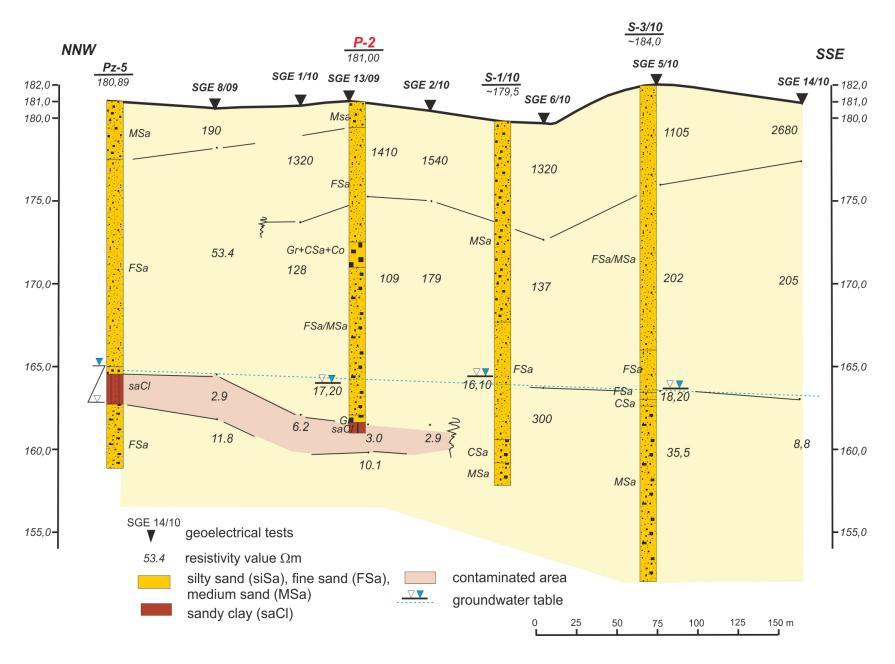
Figure 4. Geoelectrical cross-section of the landfill subsoil.

For the site investigation purposes, geophysical investigation was performed to identify the leakage zones. The electrical resistivity method was used to distinguish the top of the less permeable layers of clay in the landfill's subsoil. The purpose of the tests was also to investigate the depth of the groundwater table and to confirm the direction of the groundwater flow in the south eastern part, where the leakage had occurred. The distance between testing points allowed an investigation of the subsoil as deep as 35 m below the ground level. The quantity interpretation gave a full picture of the resistivity characteristics, which are listed in Table 2. The interpretation and testing results are presented in Figure 4.

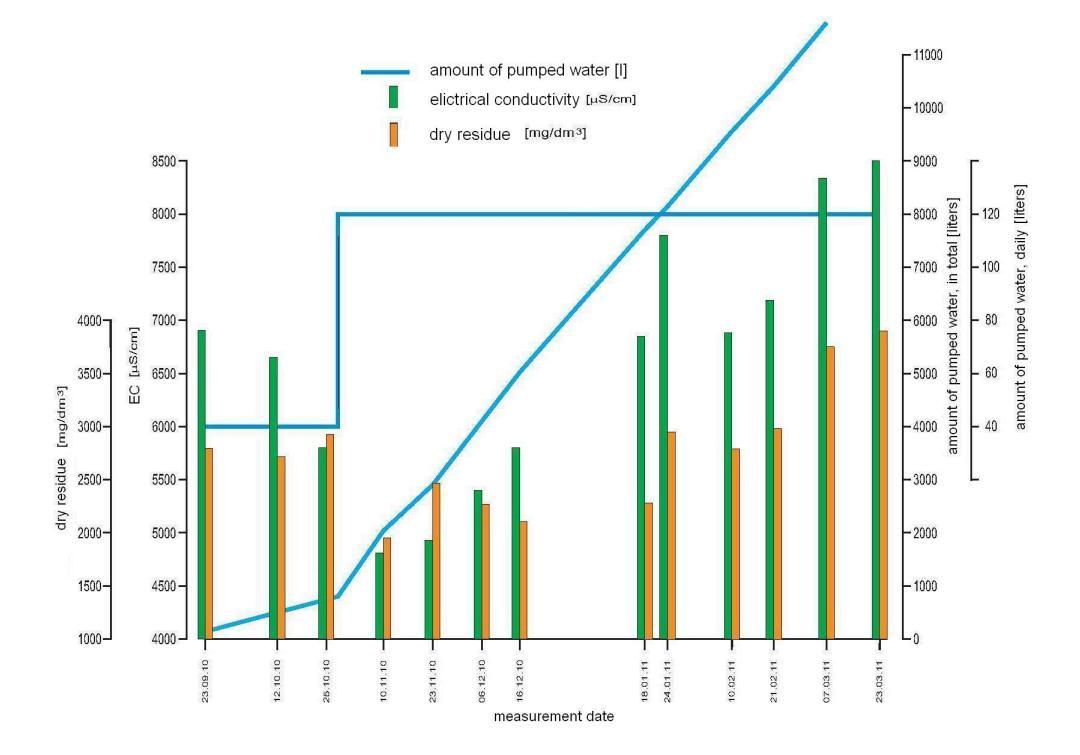
**Figure 5.** Changes of EC, dry residues, and the amount of pumped water at the landfill site (daily and in total).

The changes of EC, the mass of sewage sludge, and the amount of pumped water, is present in Figure 5.

Due to the high values of EC, tests of the residual dry mass were also performed for collected water samples. This is a water class indicator that is used in hydrogeology and is determined in the laboratory. It is expressed as a mass of sediment left after evaporating 1 dm<sup>3</sup> of water at a temperature of 105 °C, and drying the residue in a temperature which does not exceed 105 °C. The dry residue, which is also an indicator of water mineralization, is expressed in mg/dm<sup>3</sup>. The mineral matter content, which is the dry residue, is a principal classification of highly mineralized water, with the content exceeding 1500 mg/dm<sup>3</sup>.

Pumping out 12,930 dm<sup>3</sup> of water did not result in a significant increase in the water quality in piezometer P-2. At the beginning, pumping was carried out at a capacity of 40 L per day (blue line at Figure 5). The values of EC within this time decreased from 6961 to 4752  $\mu$ S/cm, and the mass of dry residue (dried sewage sludge) decreased from 2804 to 1944 mg/dm<sup>3</sup>. Following this, the pumping capacity was tripled to 120 L per day. As a result, the EC increased to 8589  $\mu$ S/cm, and the mass of the dry residue increased to 3916 mg/dm<sup>3</sup>. The increase of EC after the intensification of pumping could be a result of:

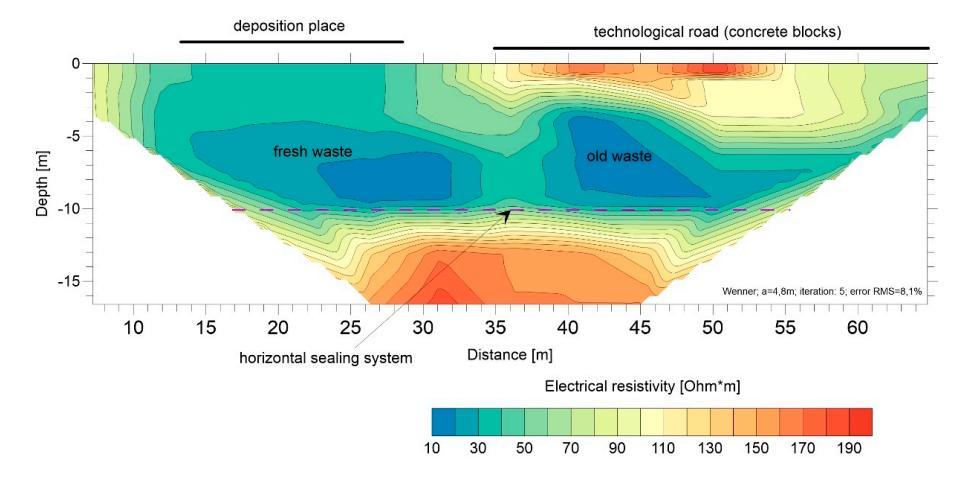
Figure 6. The electrical resistivity cross-section of waste disposal with a bottom sealing system.

An occurrence of the glacial clay and sandy clay loam deposits of a thickness of approximately 4 m, lined with sands and gravel with an unknown floor depth was determined, based on the data from the boreholes. A free water table was observed at 16.3 and 17.5 m below the ground level. The electrical resistivity tomography (Figure 6) was performed by using electrodes spaced 4.8 m apart and a total measured length of 72 m.

In the middle and right side of the profile, the electrical resistivity was 150–200  $\Omega$ m, mainly due to the location of an access road to the landfill facilities. An old waste layer with an electrical resistivity of approximately 30–40  $\Omega$ m is located just below the road. The facilities, where the deposited municipal wastes are mixed, featured an electrical resistivity of less than 50  $\Omega$ m, on the left side of the profile.

The other distinguished part of the profile is its middle section and the boundary between the landfill body and the soil below the liner. The section, of a depth between 12 and 16 m below the ground level, has an electrical resistivity of more than 160  $\Omega$ m, which indicates the occurrence of sand deposits. The layer was also observed in the geological profile investigated before the construction

of the landfill. The electrical resistivity tests did not indicate leakage at the bottom or slopes of the landfill, since no areas of low electrical resistivity were detected in the sand layer below the landfill. The ground water monitoring and water sample chemical analysis from the standpipe piezometers also did not show any leakage from inside the landfill sealing.

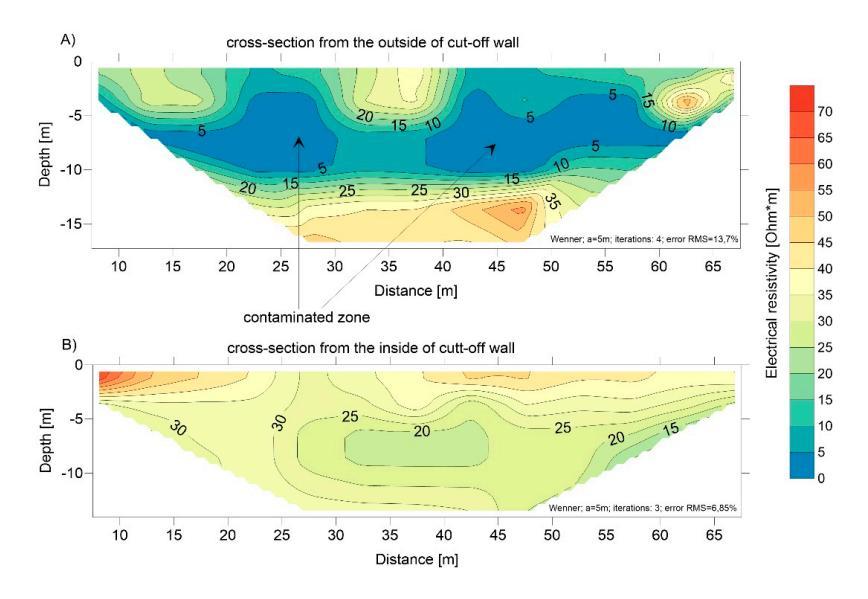
Figure 7. The electrical resistivity cross-section inside (A) and outside (B) the cut-off wall.

Another example is the way in which the electrical resistivity test results were used to determine the integrity of a cut-off wall constructed around the MSW disposal, near a large metropolitan area. A vertical cut-off wall in the form of a slurry wall was constructed around the landfill at the end of the 1990s. The field tests included electrical resistivity tomography (Figure 7), to indicate any possible cut-off wall leakage, as well as points of the material permeability tests. The electrical resistivity tomography was used along the sealing at a distance of approximately 5 m from the cut-off wall, on the outside and on the inside of the separated area. Areas with reduced electrical resistivity were observed (less than 1  $\Omega$ m) in the profile, on the inside of the cut-off wall (Figure 7). It confirms the occurrence of soils contaminated with the landfill leachate. The electrical resistivity outside the cut-off wall (second profile, Figure 7) is between 20 and 70  $\Omega$ m for the entire profile. The test results did not show any contamination from the landfill and prove that the cut-off wall material has maintained its properties and is impermeable.

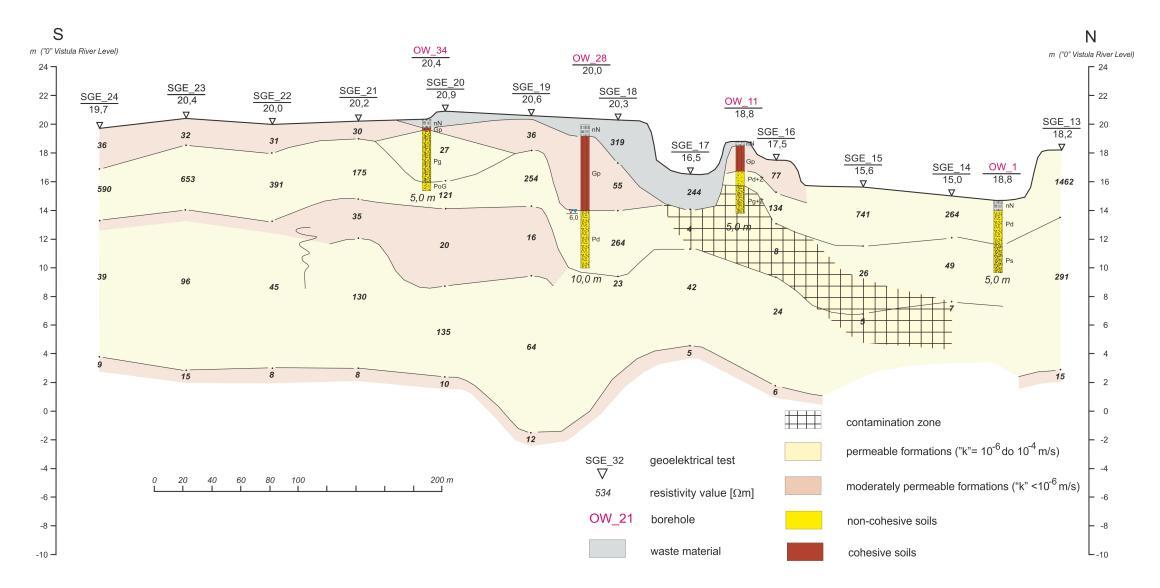
Figure 9. Geophysical cross-section of the landfill subsoil—Section I.

The measured resistivity distribution indicated a long-term emission of contaminants from the landfill, within the first aquifer layer (the groundwater table at 6 m b.s.l). The results of the geoelectrical tests are presented in Figures 9 and 10, as subsoil cross-sections.

The migration in the upper part of the zone is vertically directed; however, within the saturation zone, the contaminants flow in the direction of the groundwater stream.

The zones of the cross-sections where the resistivity is low are hatched. The contaminated zones are mainly located in former sand pits where the cohesive top soil was removed, and which initially created weak liners of the landfill bottom. From Figure 10, it can be seen that the pattern of the contamination zone overlies the direction of groundwater flow and moves towards the top of the lower permeability soil layer.

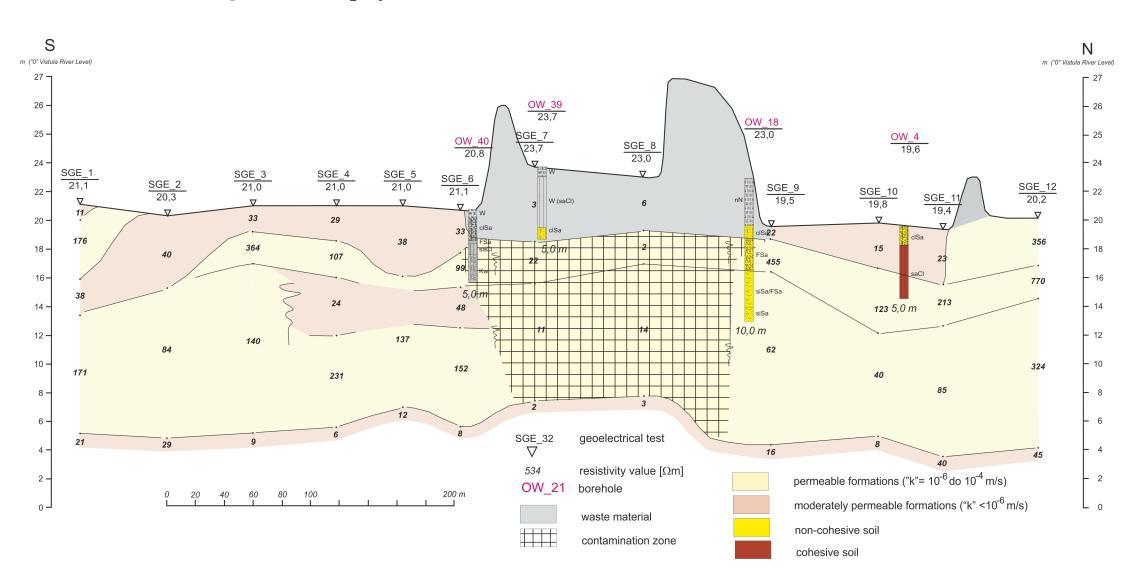
Figure 10. Geophysical cross-section of the landfill subsoil—Section II.
