Article Collapse Responses of Concrete Frames Reinforced with BFRP Bars in Middle Column Removal Scenario

Abstract: Six concrete beam-column frame sub-assemblages reinforced with basalt fiber-reinforced polymer (BFRP) bars in the frame beams were designed to investigate the collapse resistance after a middle column removal. Effect of parameters, including span to depth ratio of frame beams, prestressing, as well as material types of stirrups in the beams, on the collapse resistance of the sub-assemblages, was investigated. Experimental results showed that the initial stiffness of the frame beams was apparently lower due to low elastic modulus of BFRP bars. The collapse resistance of the sub-assemblages presented wave-like increasing tendency with the vertical displacement of the failed middle column, and it mainly attributed to the cracking or crushing of concrete and rupture of BFRP bars in the frame beams. Top longitudinal BFRP bars at the beam ends near to the side column (BESCs) and bottom longitudinal BFRP bars at the beam ends near to the middle column (BEMCs) kept tensile during the loading process, which played an important role in resisting structural collapse. Adjacent s

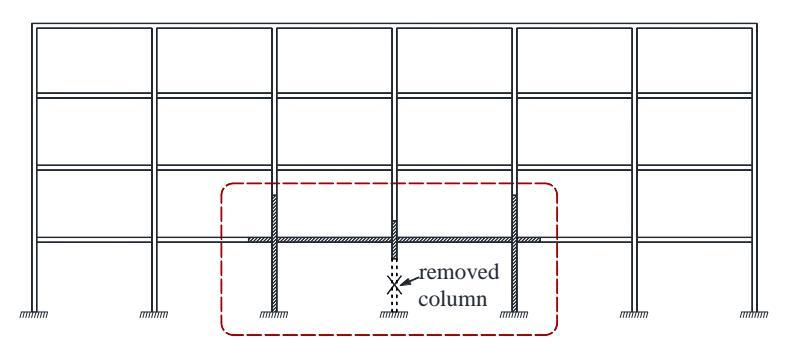
Figure 1. Prototype structure.

The specimens were designed in accordance with concrete design code of China, Both the live load, LL, and the dead load, DD, of the floor were taken as 2.5 kN/m^2 for the prototype structure, and the combined design load is calculated by 1.2 DD + 0.5 LL. The position of the beam-column sub-assemblages in the prototype structure is enclosed with dotted lines, as shown in Figure 1. Six 1/4reduced scaled sub-assemblages, named as S1 to S6, were designed referring to the prototype, and each sub-assemblage consists of two beams and three columns. The dimensions and reinforcement details of the control specimen, S1, are shown in Figure 2. Longitudinal steel reinforcement in the columns was welded on steel plates embedded in the columns, BFRP bars were used as longitudinal reinforcement of the frame beams. The design details of the sub-assemblages are listed in Table 1, in which S2 and S3 were designed to investigate the influence of prestress action modes, including unbonded prestress (UP) and bonded prestress (BP). The steel prestressing strand is 9.5 mm in diameter and arranged in parabolic shape as shown in Figure 3. Figure 4 illustrates the anchorage of BFRP bars in the frame beam stubs, i.e., BFRP bars were anchored in steel hollow tubes with 40 mm in diameter and 200 mm length, which were filled with epoxy mortar. BFRP bars were manufactured in the factory in advance and used as the alternative of steel stirrups of the frame beams for S5. The actually measured average axial compressive strength of the concrete after 28 days according to Chinese code from tests of three prismatic specimens was 29.3 MPa, and the concrete tensile strength, as well as the elastic modulus, were 2.6 MPa and 3.5×10^4 MPa respectively. The mechanical properties of steel reinforcement and the prestressing strand are listed in Table 2, and the nominal mechanical values of BFRP bars reported in the manufacturer data sheet is also listed in Table 3.

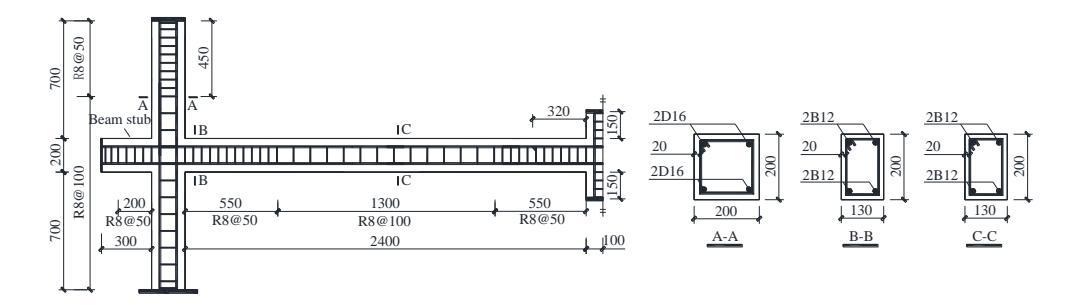
Figure 2. Dimensions and reinforcement of the control specimen S1.

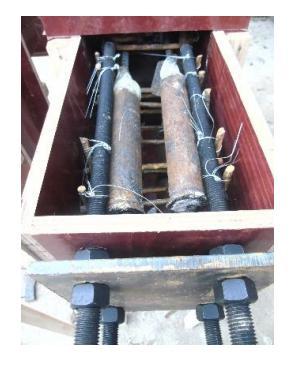
Figure 4. Mechanical anchorage of basalt fiber reinforced polymer (BFRP) bars in the frame beam stubs.

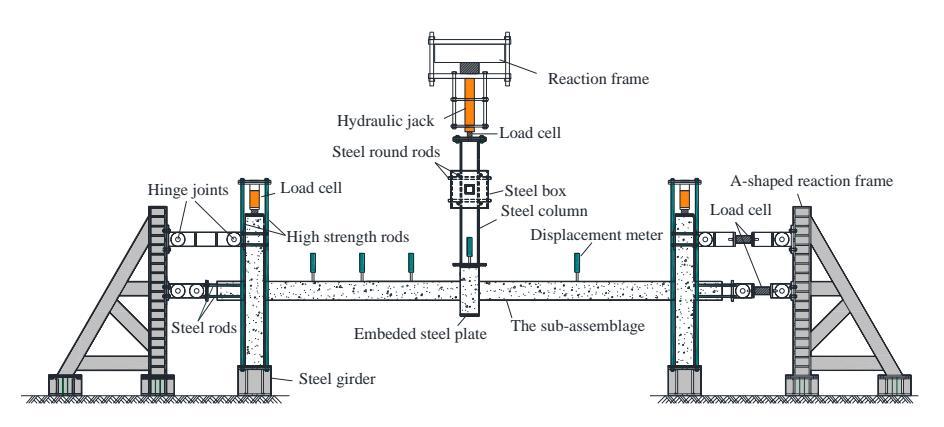
Figure 5 illustrates the details of the loading setup for the static collapse tests. The vertical load was applied on the top of the failed middle column through a steel column by a hydraulic jack with a stroke of 700 mm. The steel column passed through a steel box with eight steel rods of 30 mm in diameter arranged in the orthogonal directions. The frame beams extended outward about 300 mm from the side columns, and four steel rods were embedded in the extended beam stubs to connect with A-shaped reaction frames. The foot of the side columns were fixed on the steel girders, which were fastened on the strong test bed. The upper parts of the two side columns were also connected with the A-shaped reaction frames through steel hinges, and the distance from the horizontally constrained positions of the side columns to the top surfaces of the frame beams was about 450 mm.

Figure 5. Loading setup and measuring instruments.

During the static collapse tests, vertical load and horizontal reaction forces were measured by load cells, and displacement meters were distributed along the frame beams to measure the overall deformation. The strain of BFRP bars at the beam ends was also monitored during the tests. The distribution of the measuring instruments is shown in Figure 5.

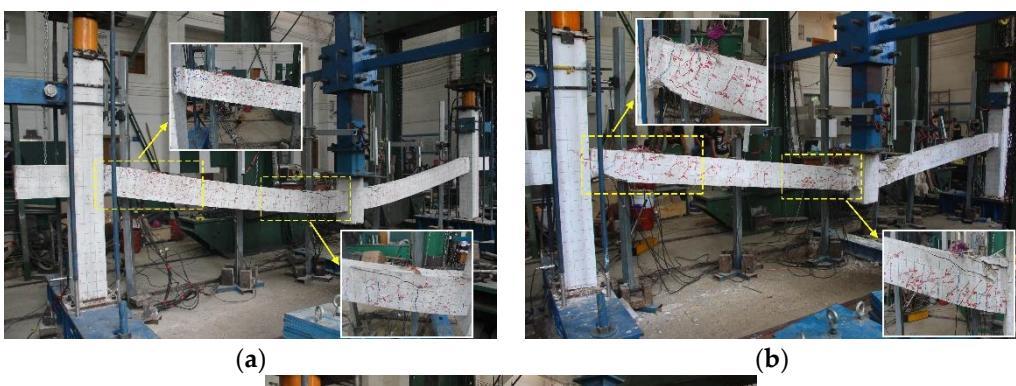
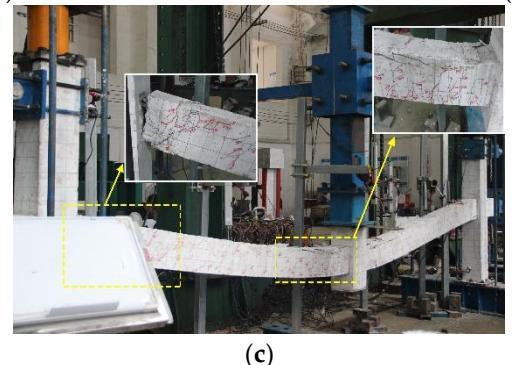
Typical failure modes are shown in Figure 6, taking S1, S3, as well as S5 as examples. In most cases, concrete at the top BEMCs and bottom BESCs was crushed successively, and the crushed regions at the BEMCs were usually larger than those at the BESCs. Cracks on the tested frame beams were commonly wider than that of common RC frame beams. Once BFRP bars fractured, the load bearing capacity dropped rapidly. The tested span to depth ratios of the frame beams had no significant influence on the failure modes of the sub-assemblages. Comparing S1 with S5 showed that, when steel stirrups in the frame beams were replaced by BFRP bars, the crushed regions at the BEMCs significantly increased. In addition, applying to prestress on the frame beams strengthened the initial stiffness of the beams. During the tests, only several cracks were observed at the foot of the side columns.

Figure 6. Typical failure modes of the specimens: (a) S1, (b) S3, (c) S5.

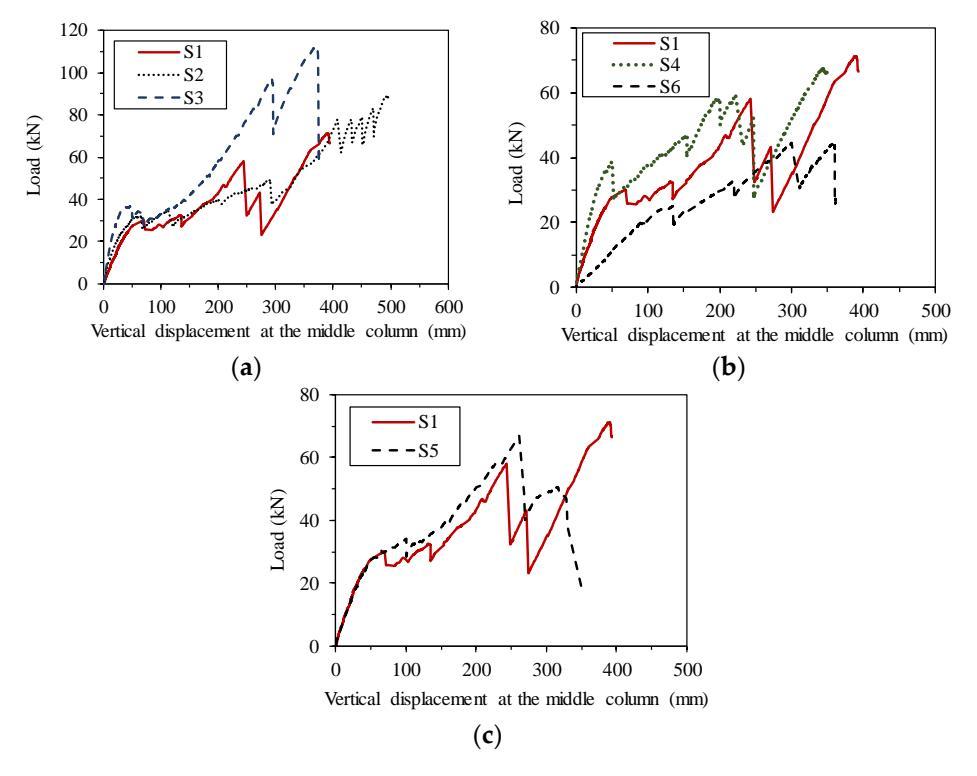
Figure 7 illustrates the relationship between load and vertical displacement at the failed middle column. The characteristic load values of the sub-assemblages are listed in Table 4. The comparison showed that: (1) The group of S1, S2, and S3 was used to investigate the influence of prestress on the collapse responses of the sub-assemblages reinforced with BFRP bars. Based on Figure 7a, it is easy to find that S3, which was prestressed with bonded prestressing strand, possessed the highest initial stiffness, followed by S2 and S1 in turn. In the initial loading process, the vertical displacement at the middle column of the sub-assemblages almost increased linearly with the applied load. At the final failure stages, the maximum load-bearing capacity ranked in descending order was S3, S2, and S1, which indicated that the prestressing strand benefited to improve the ultimate resistance of the structures. In addition, integral stiffness of S2 was obviously weaker than S3, it should relate to the prestress loss after the failure of the middle column. (2) The group of S1, S4, and S6 was designed to investigate the influence of span to depth ratio of frame beams on the collapse resistance. Figure 7b indicates that the smaller the span to depth ratio, the greater the integral stiffness of the sub-assemblages. In terms of ultimate load bearing capacity, S1 and S4 had a similar load bearing capacity, which was apparently higher than that of S6. (3) Comparing with S1, S5 possessed similar

Figure 7. Relation of load-vertical displacement at the failed middle column: **(a)** Influence of prestress, **(b)** Influence of span to depth ratio, **(c)** Influence of material types of stirrups.

deformability and higher load-bearing capacity before final failure occurred. Therefore, it is feasible to replace steel stirrups of the frame beams by BFRP bars as an alternative without affecting the structural collapse resistance.

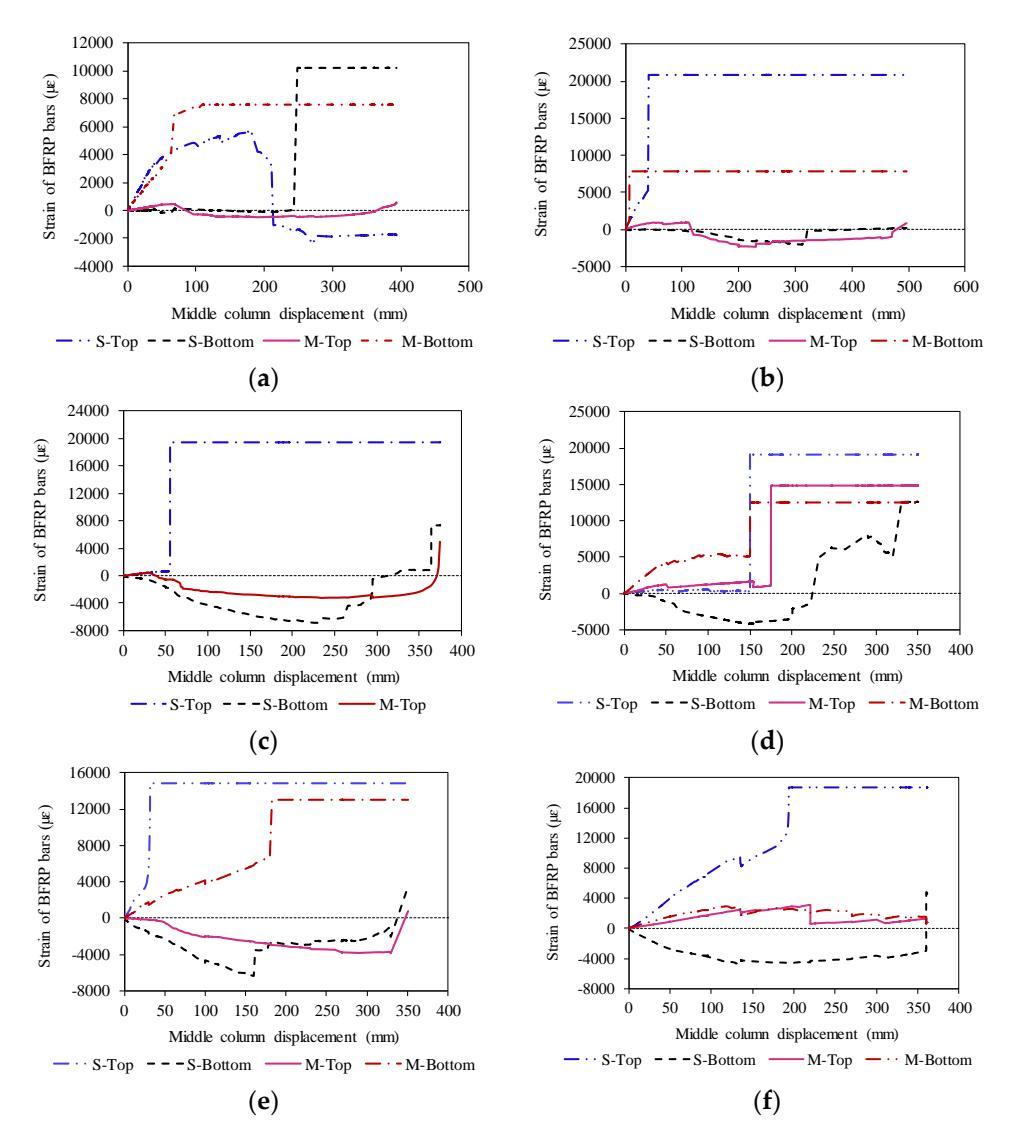
The strain of BFRP bars was monitored during the tests as shown in Figure 8, where S-Top and S-Bottom represent the top and bottom BFRP bars in the BESCs respectively, M-Top and M-Bottom mean the top and bottom BFRP bars in the BEMCs correspondingly. It can be seen that in most cases the S-Top and the M-Bottom BFRP bars kept tensile before the final failure occurred. While strain of the S-bottom and M-Top BFRP bars usually underwent fluctuation, commonly, they were firstly subjected to compression and then to tension. In general, the strain of the S-Bottom and M-Top BFRP bars was lower than that of the S-Top and the M-Bottom BFRP bars. It is noted that the strain of the S-Top and the M-Bottom BFRP bars increased fast in the early loading stages, this is related to the severe cracking of concrete at the beam ends due to low elastic modulus of BFRP bars.

Figure 8. Relationship of strain of the BFRP bars and vertical displacement: (**a**) S1, (**b**) S2, (**c**) S3, (**d**) S4, (**e**) S5, (**f**) S6.

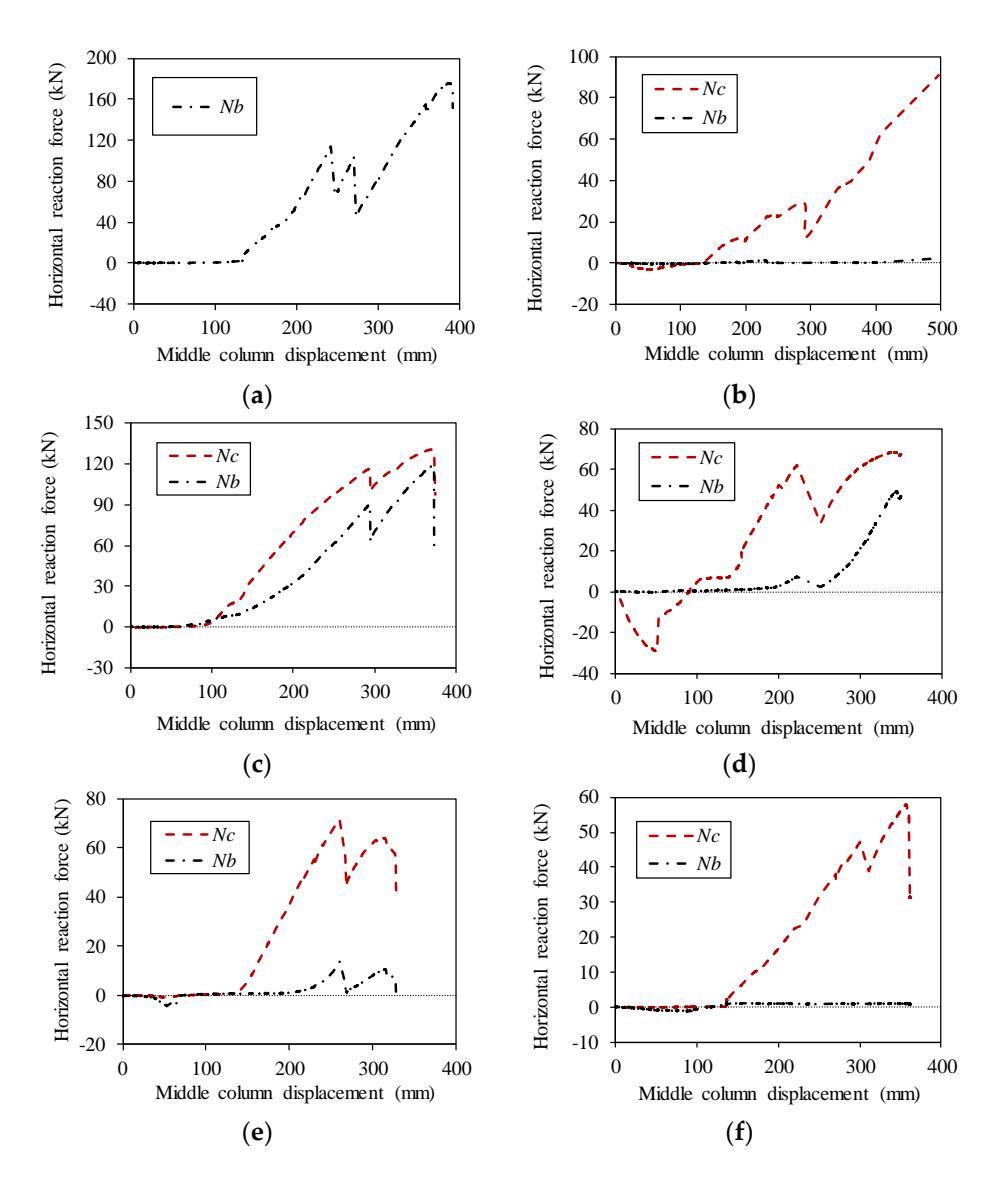
Horizontal reaction forces could illustrate the effect of adjacent structures on the sub-assemblages. Figure 9 shows the horizontal reaction forces versus vertical displacement curves, where N_c represents forces acting on the upper parts of the side columns, and N_b represents horizontal forces acting on the frame beam ends. It can be found both N_c and N_b are very small in the initial loading stage. However, N_c increased faster than N_b in the following loading process (N_c for S1 was not recorded due to the failure of the load cell). The horizontal reaction forces confined the free deformation of frame beams, which helped to mitigate the collapse risk of the residual sub-assemblages. As the upper parts of the side columns suffered great horizontal forces in this scenario, horizontal progressive collapse might happen once the upper adjacent columns had no enough shear resistance.

Figure 9. Horizontal reaction forces versus vertical displacement curves: (**a**) S1, (**b**) S2, (**c**) S3, (**d**) S4, (**e**) S5, (**f**) S6.

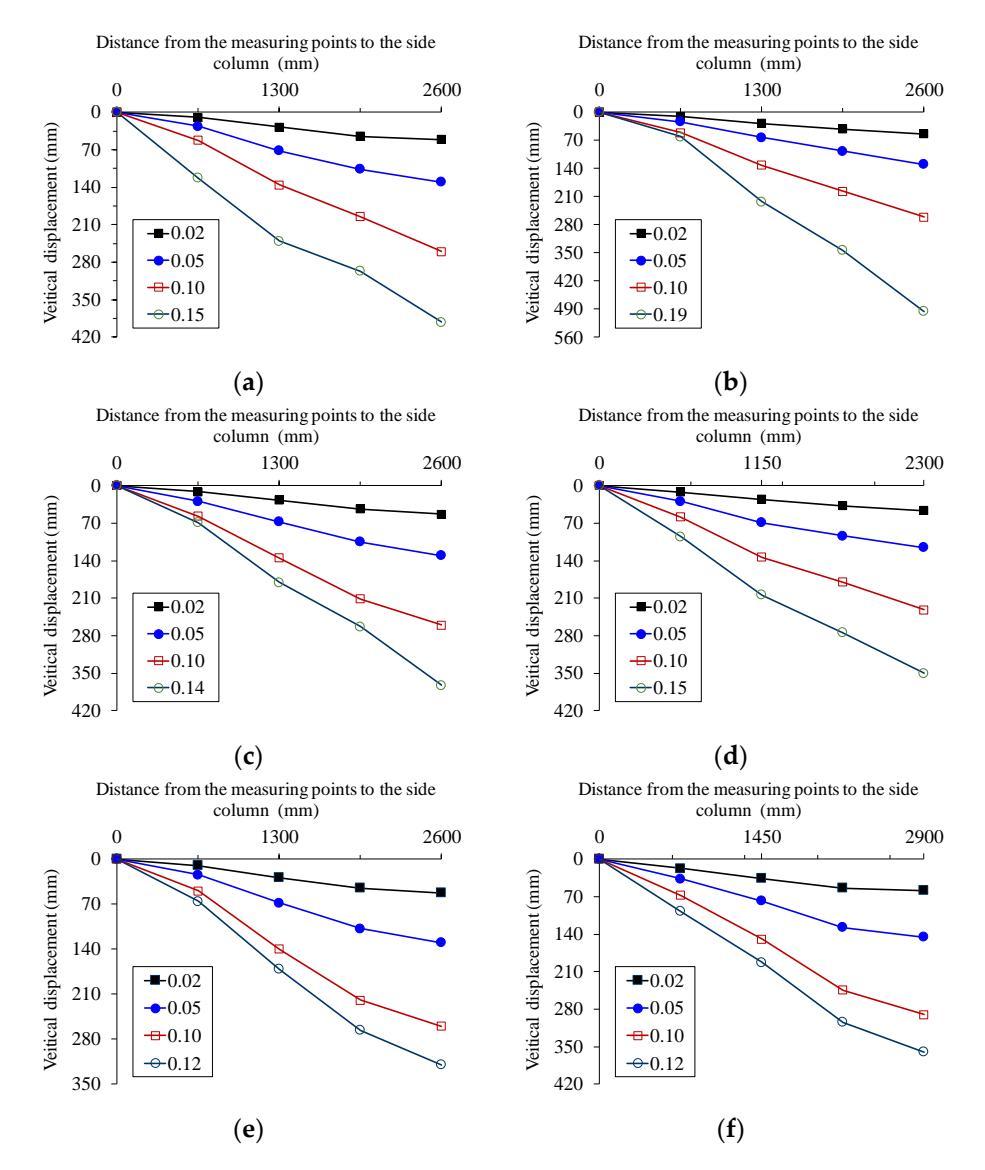
Vertical deformation of the frame beams under different load level was shown in Figure 10, in which the four values in the legends were the ratios of the vertical displacement at the failed middle columns to the beam span, and the last value corresponded to the final failure stage. It was found that after the middle column failed, the deformation of the frame beams was nearly linear and proportional to the vertical displacement of the failed middle column. In addition, the ratios of the vertical displacement of the failed middle column at the final failure to the beam span varied from 0.12 to 0.19, which could provide a reference for the evaluation of the final failure of the frame structures reinforced with BFRP bars after the middle column loss.

Figure 10. Overall deformation of the frame beams: (a) S1, (b) S2, (c) S3, (d) S4, (e) S5, (f) S6.

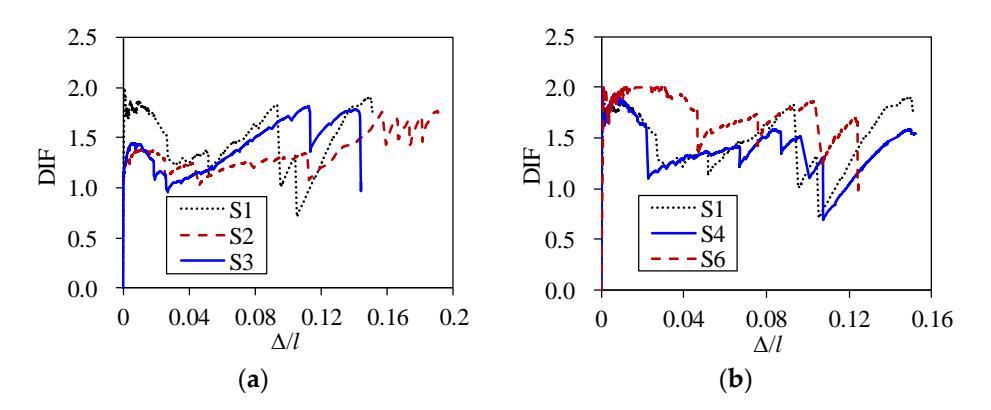
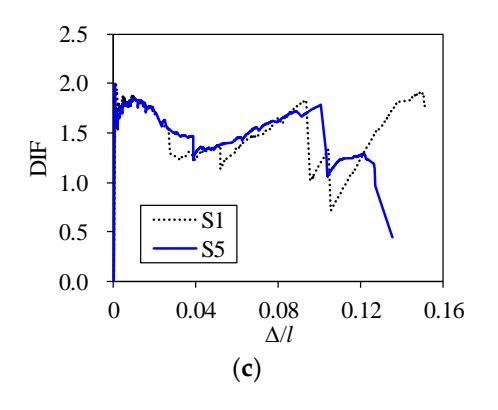
The curves of DIF values versus vertical displacement in the middle column are shown in Figure 11. It can be seen that (1) the maximum DIF values of the sub-assemblages reinforced with BFRP bars in frame beams were close to 2.0 in the initial loading stage, while those for S2 and S3 were 1.38 and 1.44, respectively, due to the action of prestress. (2) In accordance with Figure 11b, the specimen with greater span to depth ratio possessed higher DIF values. (3) From Figure 11c, it can be seen that DIF values of the sub-assemblage were little affected during collapse when steel stirrups of the frame beams were replaced by BFRP bars. Based on the analysis above, it is suggested that the DIF values for the non-prestressed sub-assemblages should be conservatively taken as 2.0, while DIF values for the prestressed sub-assemblages could be taken between 1.44 and 2.0.

Figure 11. Relationship between dynamic increase factor (DIF) and vertical displacement (**a**) Influence of prestressing. (**b**) Influence of span to depth ratio. (**c**) Influence of material types of stirrups.
