Impact Fretting Wear of MoS₂/C Nanocomposite Coating with Different Carbon Contents under Cycling Low Kinetic Energy

Junbo Zhou¹, Lin Zhang^{1,*}, Yuan Ding², Xudong Chen² and Zhenbing Cai²

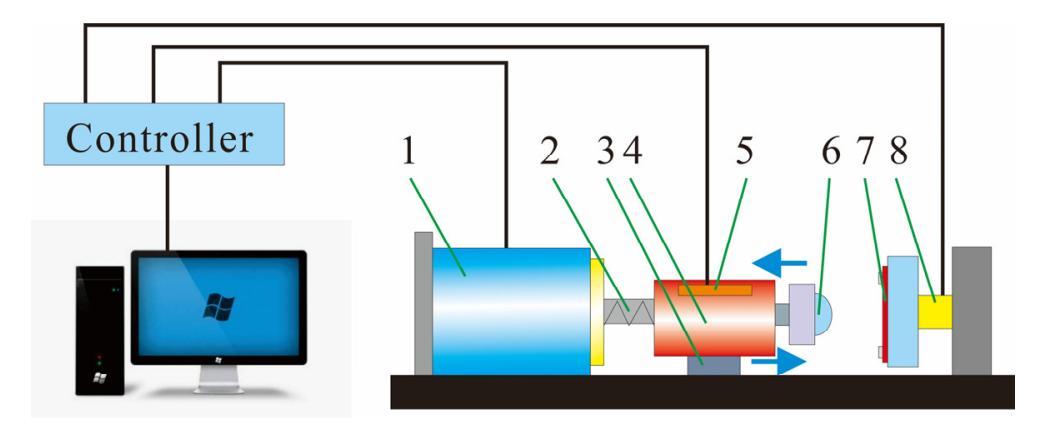
The tribological properties of the coatings were evaluated by using a low-velocity impact wear machine (Figure 1) [34,35]. This device was driven by a voice coil motor and can reciprocate in the positive/cosine mode. The damping punch drove the mass under the excitation of the motor. Owing to the low friction coefficient of the rail (approximately 0.006), the mass could be considered to maintain a constant velocity when impacting and detaching the plane specimen.

Figure 1. Low-velocity impact wear machine: (1) voice coil motor, (2) damping punch, (3) rail, (4) impact block, (5) motion detector, (6) impact ball, (7) sample, (8) force sensor.

The tribological performance of the coating was tested at room temperature. The mass of the impact block was 110 g, and the impact velocity was 50 mm/s. The number of cycles was 10,000. The impactor was a GCr15 steel ball, with a diameter of 9.525 mm. Before the experiment, the flats and impactors were cleaned by using anhydrous ethanol in an ultrasonic bath. The same parameters were tested in the substrate as a reference. Each test was repeated twice.

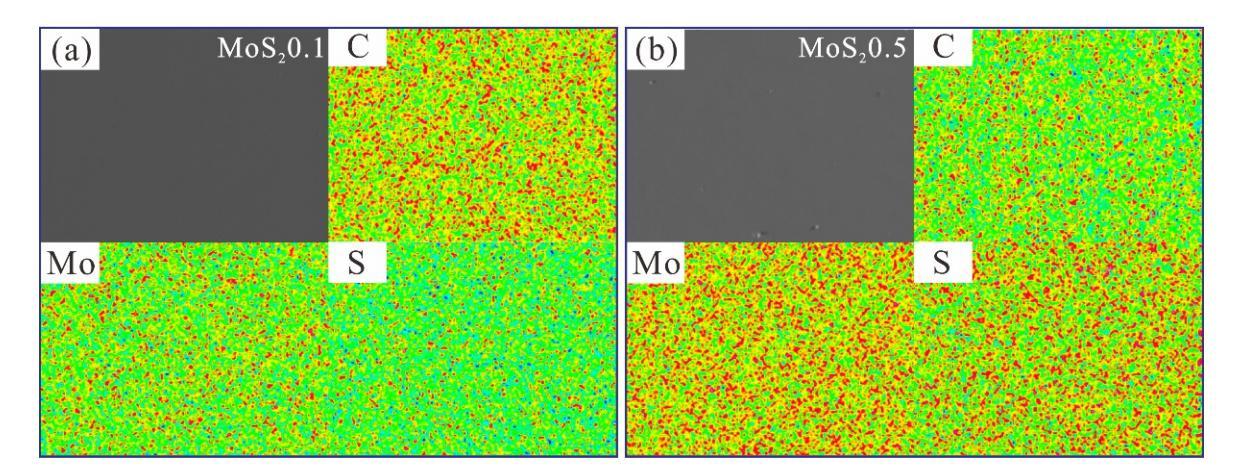
The surface morphology and element distribution of $MoS_20.1$ and $MoS_20.5$ are shown in Figure 2. The results were obtained by EPMA. The elemental distributions of C, S, and Mo are even, which indicates that the deposition process was in line with the expectations, and the coating surface composition was consistent.

Figure 2. SEM micrographs and element distribution of MoS₂/C composite coating. (a) MoS₂0.1, (b) MoS₂0.5.

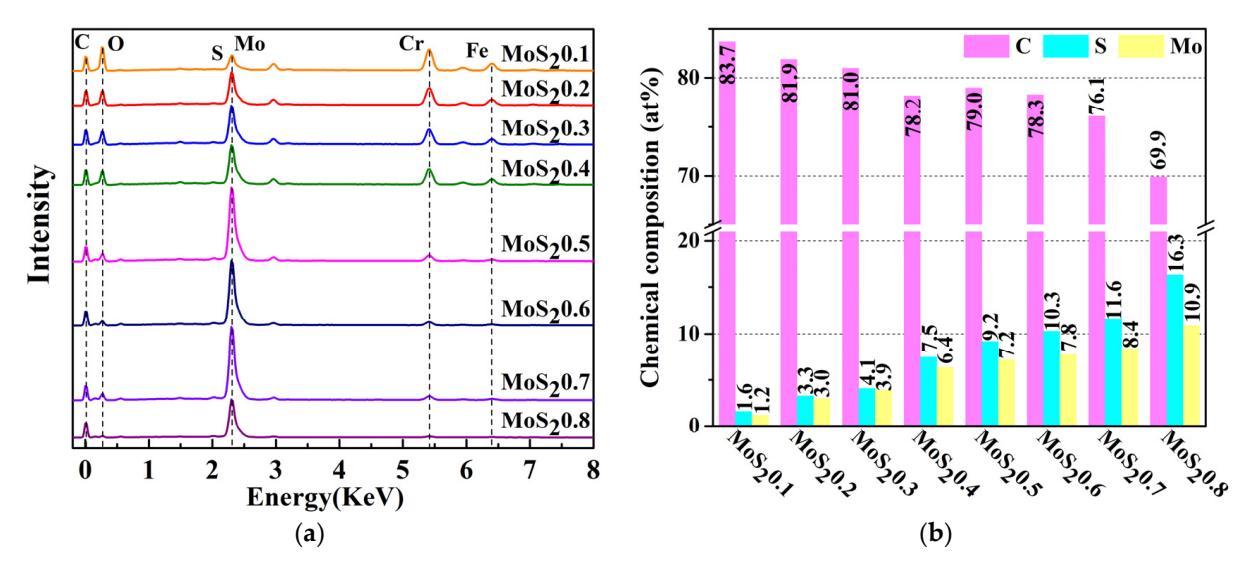
The chemical composition of the MoS_2/C films with different deposition conditions are shown in Figure 3. As the MoS_2 target current increased, the C content in the coating decreased, whereas the Mo and S contents increased. Meanwhile, the S/Mo content ratio was approximately 1.26, which was lower than the theoretical value of two because S was easier to sputter from the surface than Mo, and Ar⁺ erosion reduced the S content in the coating [24]. The marks, $MoS_20.1$ – $MoS_20.8$, in the first column refer to the target currents of MoS_2 during sputtering.

Figure 3. Chemical composition of the MoS₂/C films. (a) EDX and (b) Chemical composition of EDX.

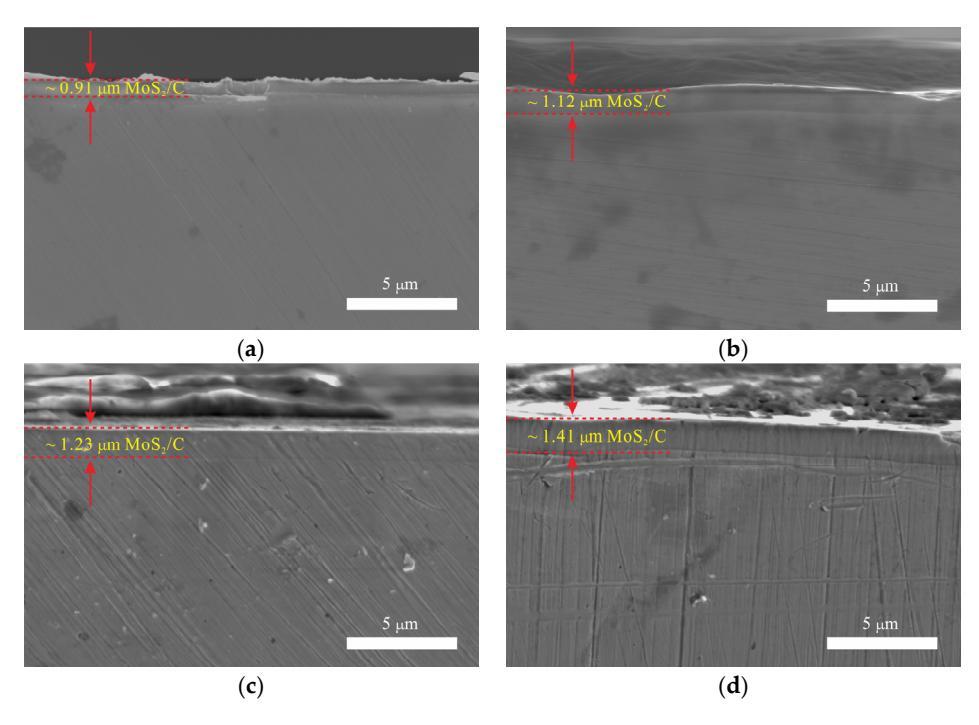
The cross-section morphology of the coatings is shown in Figure 4. The thickness of $MoS_20.1$ was approximately 0.91 μ m, while the thickness of $MoS_20.8$ was approximately 1.41 μ m. As the MoS_2 target current increased, the thickness of the coating thickened. To determine the mechanical properties of the coating, the coating should not be destroyed during the impact test. Therefore, we selected a light mass and a small impact velocity.

Figure 4. Cross-section morphology of MoS₂/C composite coating. (**a**) Cross-section of MoS₂0.1, (**b**) Cross-section of MoS₂0.5, (**c**) Cross-section of MoS₂0.6 and (**d**) Cross-section of MoS₂0.8.

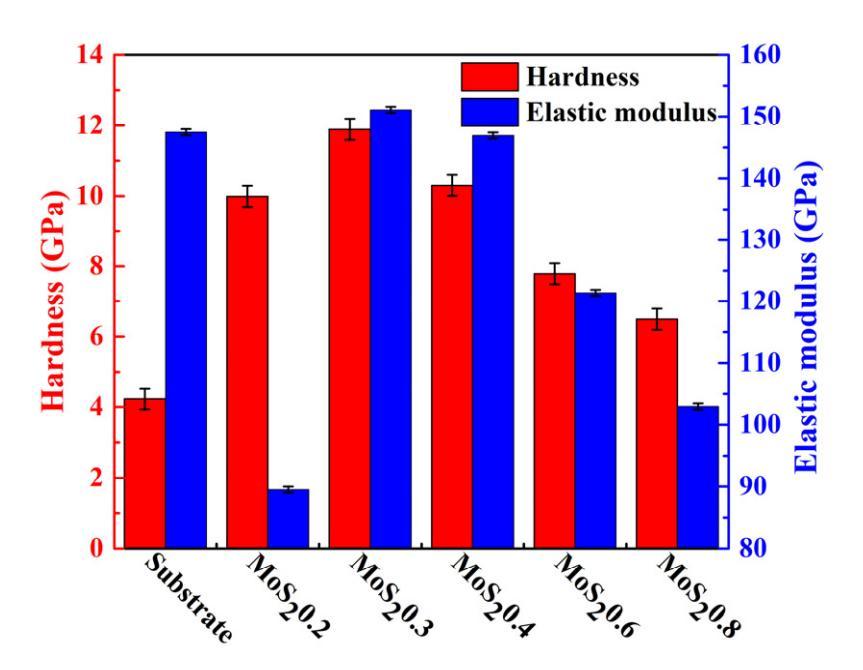
The hardness and elastic modulus of the MoS_2/C coatings are shown in Figure 5. As the MoS_2 target current increased, the hardness and elastic modulus of the coating increased first and then decreased and reached the maximum when the target current of MoS_2 was 0.3 A. The hardness of the pure MoS_2 coating was 2.6 GPa and the elastic modulus was 48 Gpa [36], which were much lower than those of the MoS_2/C coatings. The hardness of the coatings was higher than that of the substrate, which means that the MoS_2/C coatings exhibited good mechanical properties. The load–displacement curve indicates that as the MoS_2 target current increased, the elastic recovery of the composite film decreased linearly, which may refine the film load-bearing capacity in the same way.

Figure 5. Hardness and elastic modulus of the MoS₂/C coatings.

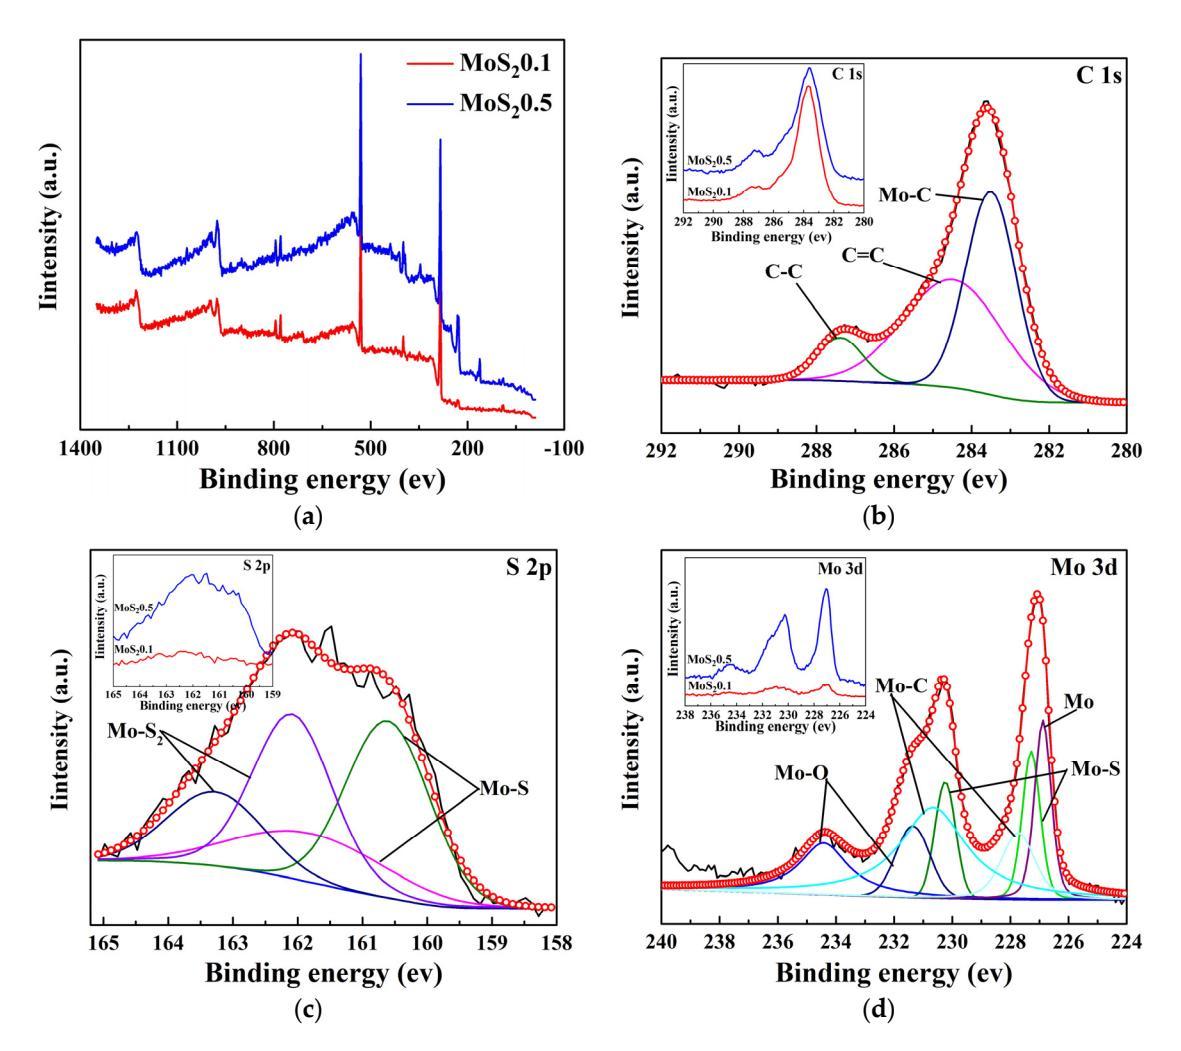
XPS analysis was performed to explore the chemical composition of the MoS_2/C coating. Figure 6 shows the XPS spectra of the MoS₂/C0.5 films. The C 1s, S 2p, and Mo 3d spectra of $MoS_20.5$ were fitted by the Guassian–Lorentian function to analyze the chemical forms. In the S 2p and Mo 3d spectra, the intensity decreased with carbon content. Figure 6b shows the C 1s XPS spectrum of the composite coatings with different C contents. The C 1s spectrum was fitted into three components, representing the C-C bond (287.0 eV), the C=C bond (284.5 eV), and the molybdenum carbide (283.6 eV) [37]. Figure 6c shows the S 2p XPS spectra of the coatings with different carbon contents, which were fitted into four components, representing the MoS₂ structure (163.2 eV and 162.1 eV) and MoS₂ structure (161.8 eV and 160.6 eV) [18]. In Figure 6d, the peaks are observed in the Mo-S (227.5 eV and 230.69 eV) and Mo-O (231.3 eV and 234.6 eV) structures. The Mo 3d spectrum of all samples showed a small shoulder at approximately 226.9 eV, which was represented by the Mo 3d peak [38,39]. The Mo-C bond was confirmed in the Mo 3d spectra at 227.9 and 231.0 eV, which was consistent with the analysis of the C 1s spectrum [32]. The appearance of Mo-O indicated that the surface of the coating was oxidized. The Mo-C and Mo-S peak intensities in the film and the oxygen content increased with the MoS₂ content.

Figure 6. XPS spectra of MoS2/C composite coating. (a) XPS spectra, (b) C 1s of MoS₂0.5, (c) S 2p of MoS₂0.5 and (d) Mo 3d of MoS₂0.5.

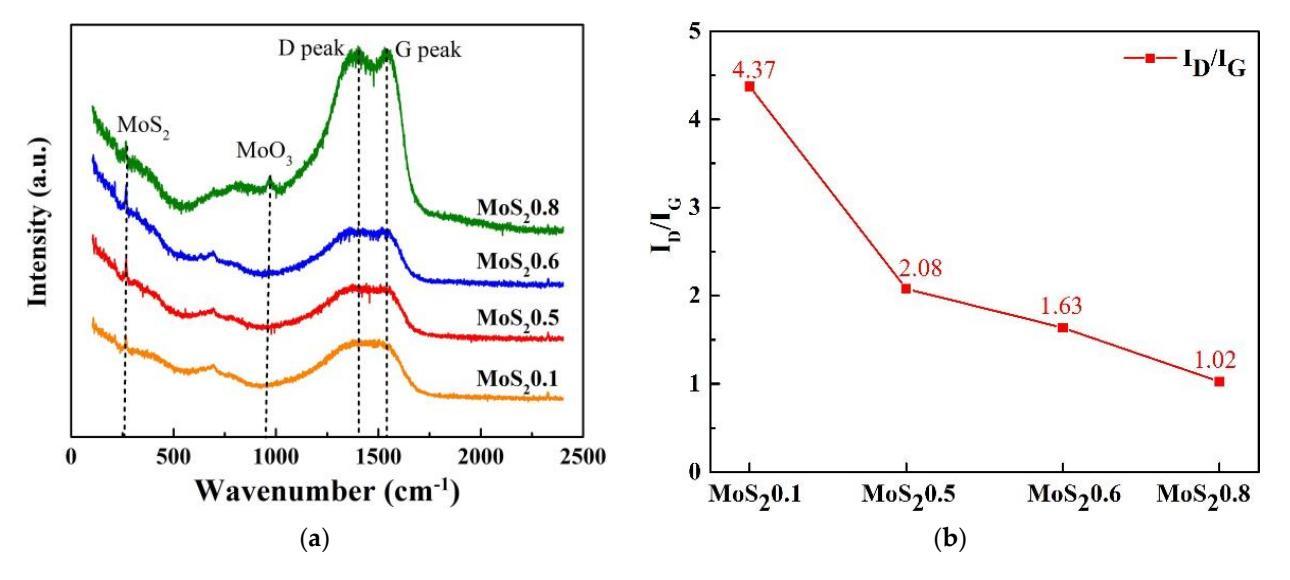
To further investigate the structure of the composite coatings, Raman spectra are presented in Figure 7. The Raman spectra can be divided into three parts, namely, MoS_2 (250–500 cm⁻¹), MoO_3 (750–1000 cm⁻¹), and C (1000–1700 cm⁻¹) [24]. Two major peaks are observed (approx. at 1396 and 1510 cm⁻¹) corresponding to carbon, and peaks in MoS_2

(260 cm^{-1}) and MoO₃ (910 cm^{-1}) are also observed. The relatively sharp peaks of MoS₂ in the deposited film can be attributed to thermal crystallization through its high laser energy during the Raman test [31]; the sharp peaks disappear when a low laser energy is used. The intensity of the MoS₂ peaks increased with the MoS₂ target power, which is consistent with the XPS results. According to the ID/IG, as the content of C element decreases, the defects of C element crystal lessen, so it is recommended to strictly control the target current of C when preparing MoS₂/C by this method.

Figure 7. Raman spectra of MoS₂/C composite coating. (a) Raman spectra, (b) ID/IG.

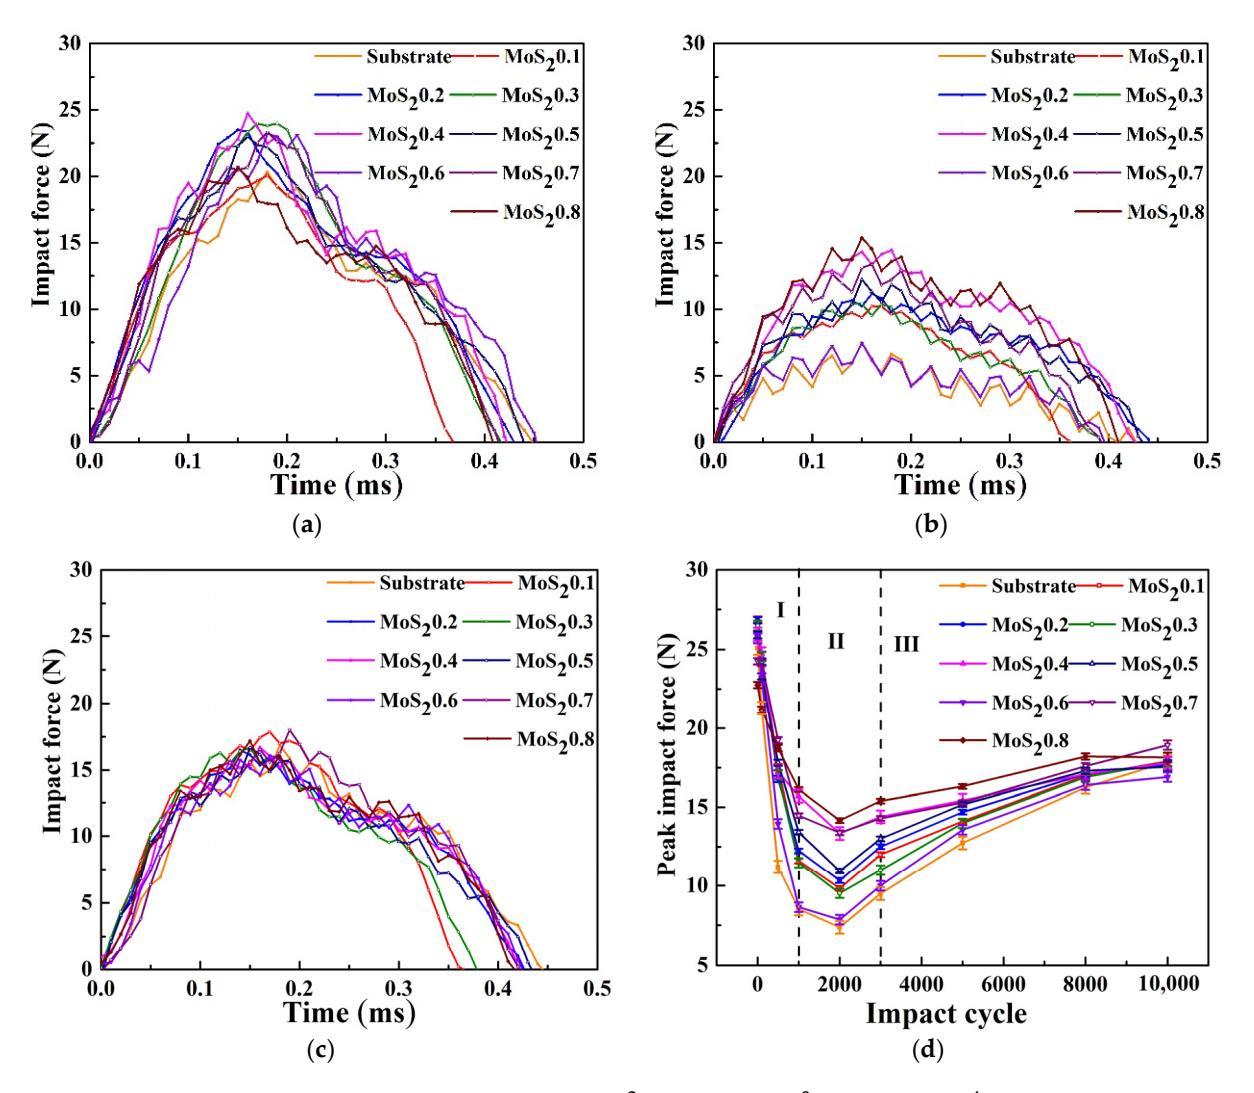
Figure 8 shows the evolution of impact force for different material parameters. As another form of dynamic response in impact testing, the waveform of the impact force also changes with different materials. The peak force of MoS_2/C is higher than that of the substrate, indicating that the hardness of the coating was higher. The impact forces at different cycle times are shown in Figure 8a–c. The impact force of the coatings is higher than that of the substrates. The peak impact force of $MoS_20.4$ is always the largest, while that of the $MoS_20.6$ is the smallest. Furthermore, the contact time of the MoS_2 coating is lower than that of the substrate as expected. Figure 8d shows that the evolution of peak impact force has three stages. In stage I, the impact force decreases because the wear scar increases with the cycles of impacts, resulting in an increase in the contact area of the ball with the plate. In stage II, the impact force remains basically the same because the wear scar has reached the maximum at this time, and the contact area no longer increases. In stage III, the impact force increases because work hardening occurs.

Figure 8. Impact force under different cycles. (a) Cycle = 10^2 , (b) Cycle = 10^3 , (c) Cycle = 10^4 and (d) Evolution of peak impact force.

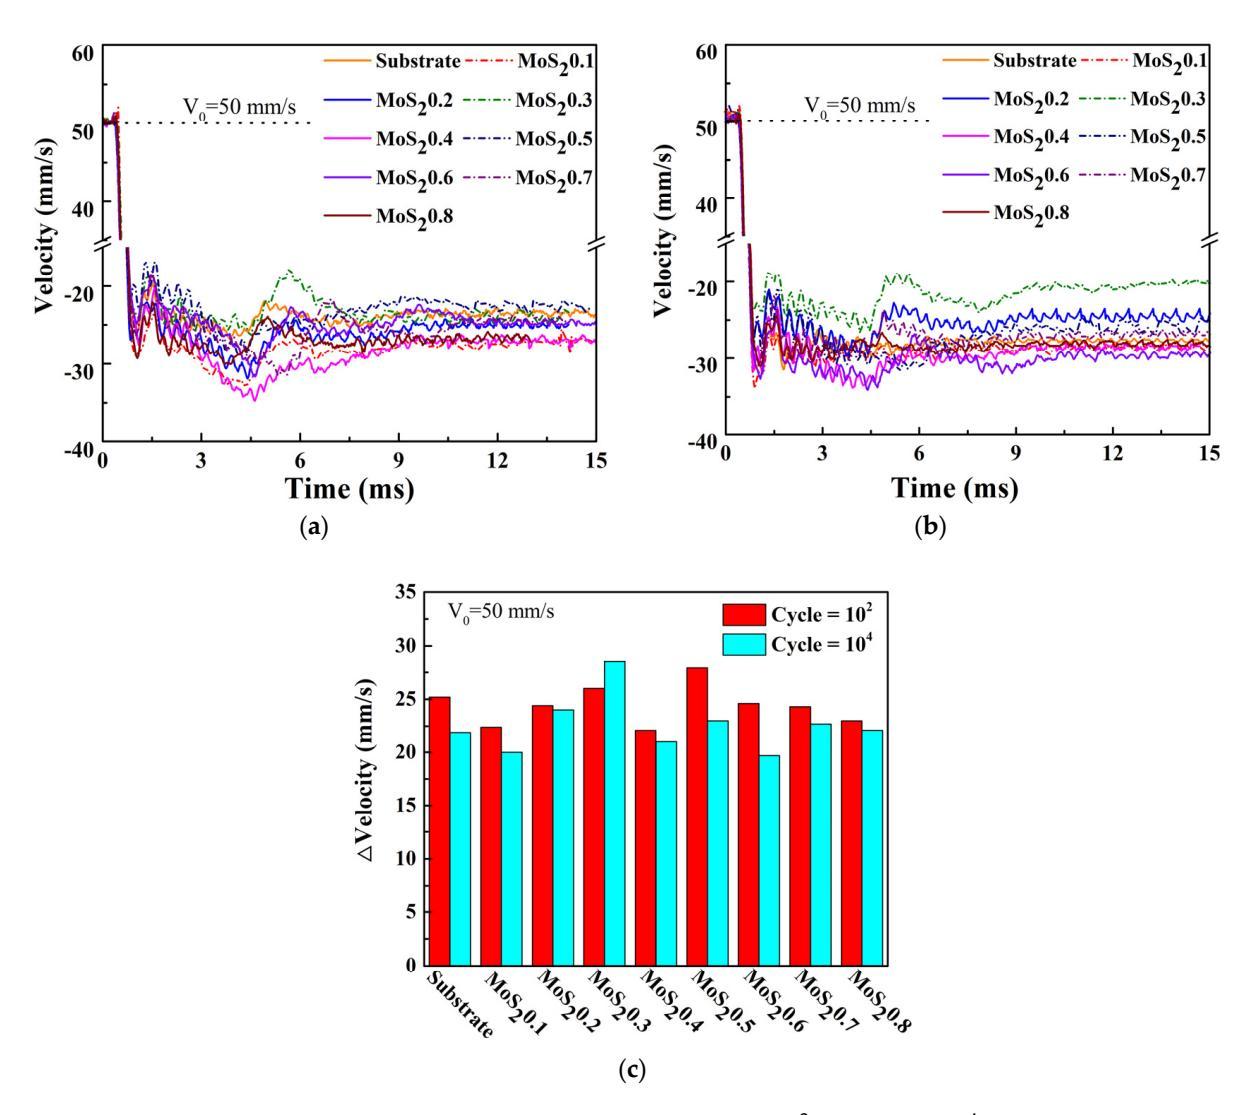
Figure 9 shows the dynamics velocity response under different cycles. The initial impact velocity was 50 mm/s, and the difference in rebound velocity reflects the difference in energy absorption. The rebound velocity of the coatings first decreased and then increased with the decreasing carbon content. The trend of the rebounded velocity was consistent at both 100 and 10,000 cycles, but ΔV gradually increased, because the wear scar gradually deepened as the number of impacts increased, and work hardening occurred at the contact position.

Figure 9. Dynamics velocity response under different cycles. (a) Cycle = 10^2 , (b) Cycle = 10^4 , (c) ΔV in different cycles.

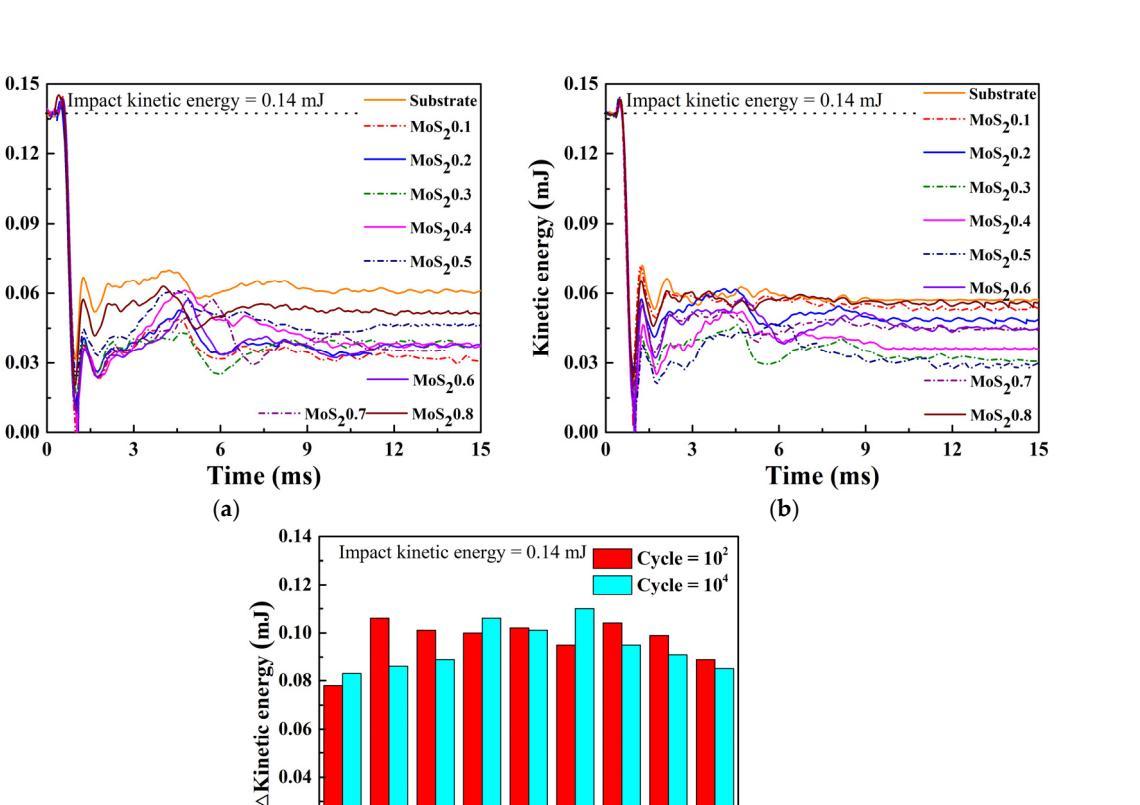
Using the same materials, the lower the rebound speed was, the more energy the sample would absorb. Figure 10 shows the curve of the kinetic energy during the test; the kinetic energy is calculated by a simple formula, $E = 1/2 \text{ mv}^2$, where v is the data from Figure 9, and m is the mass of the impact block, which is 110 g. Therefore, the initial impact kinetic energy is 0.14 (±5%) mJ. The absorbed energy of the MoS₂/C coatings was higher than that of the substrate. The absorbed energy first decreased and then increased with the decreasing carbon content, which indicates that MoS₂0.3 absorbs the most energy, while MoS₂0.6 absorbs the least energy.

Figure 10. Change in kinetic energy during varied impact cycles. (a) Cycle = 10^2 , (b) Cycle = 10^4 , (c) ΔE in different cycles.

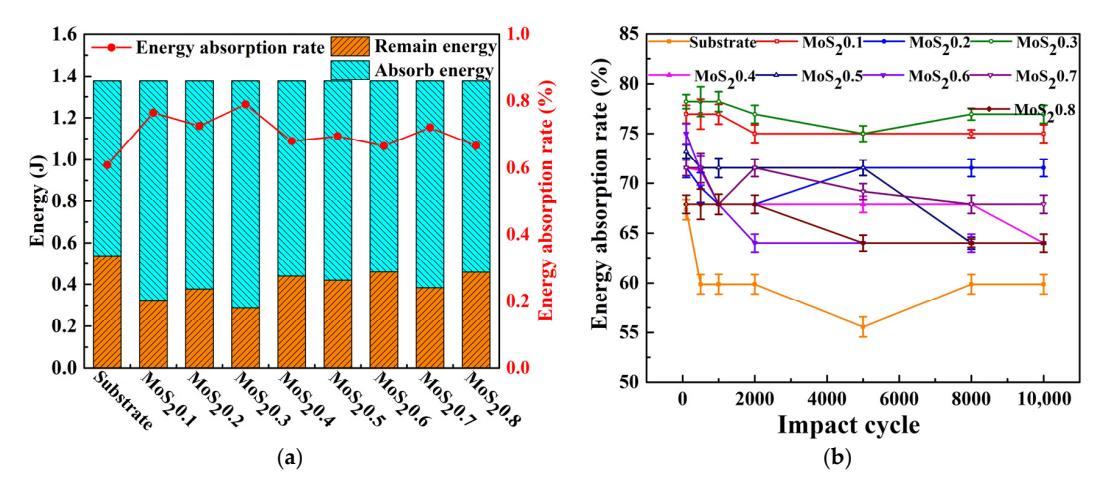
Figure 11a shows the energy distribution and energy absorption rate of different material parameters. Total energy is the sum of the initial kinetic energies in 10^4 impact experiments. Remaining energy is the sum of the returning kinetic energies in 10,000 impact experiments. Absorbed energy is the difference between total energy and remaining energy. The energy absorption rate of the coating was approximately 0.65–0.78 higher than that of the substrate. The results show that the MoS₂/C coating absorbed more energy than the substrate under the same experimental conditions. The specific causes of this phenomenon are discussed in Section 3.3.

Figure 11. Energy distribution and energy absorption ratio. (a) Total energy and its distribution and (b) Evolution of energy ratio.

The evolution of the energy absorption ratio of MoS_2/C and its substrates is shown in Figure 11b. The energy absorption ratio of MoS_2/C slowly decreased and then stabilized at approximately the 2000th cycle. At the beginning of the test, the contact between the impact ball and the plane sample could be regarded as a point contact. At this time, the contact area was small, resulting in a high contact stress between the interfaces and increasing the susceptibility of the sample to plastic deformation and material removal. Therefore, in this process, the coating and the substrate exhibited a high level of energy absorption ratio. As the test progressed and material damage accumulated, the contact area increased and resulted in a decrease in contact stress. In addition, the surface of the wear scar resulted in work hardening during the impact test, which increased the surface strength and improved the wear resistance. Figure 12 shows the deformation of different coatings and substrates, which was obtained by integrating velocity. Consequently, the deformation gradually increased.

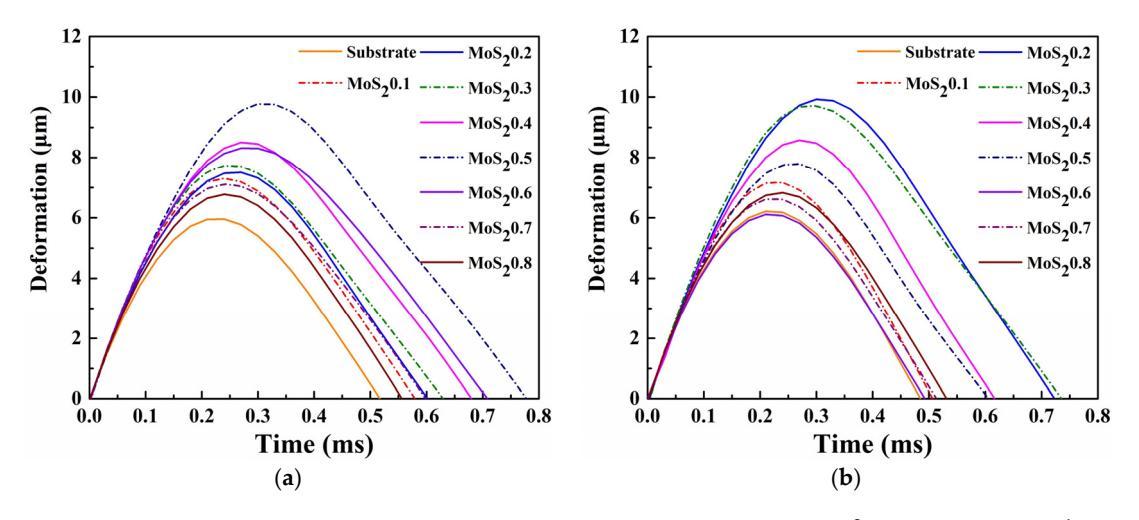
Figure 12. Deformation of different coatings and substrates. (a) Cycle = 10^2 and (b) Cycle = 10^4 .

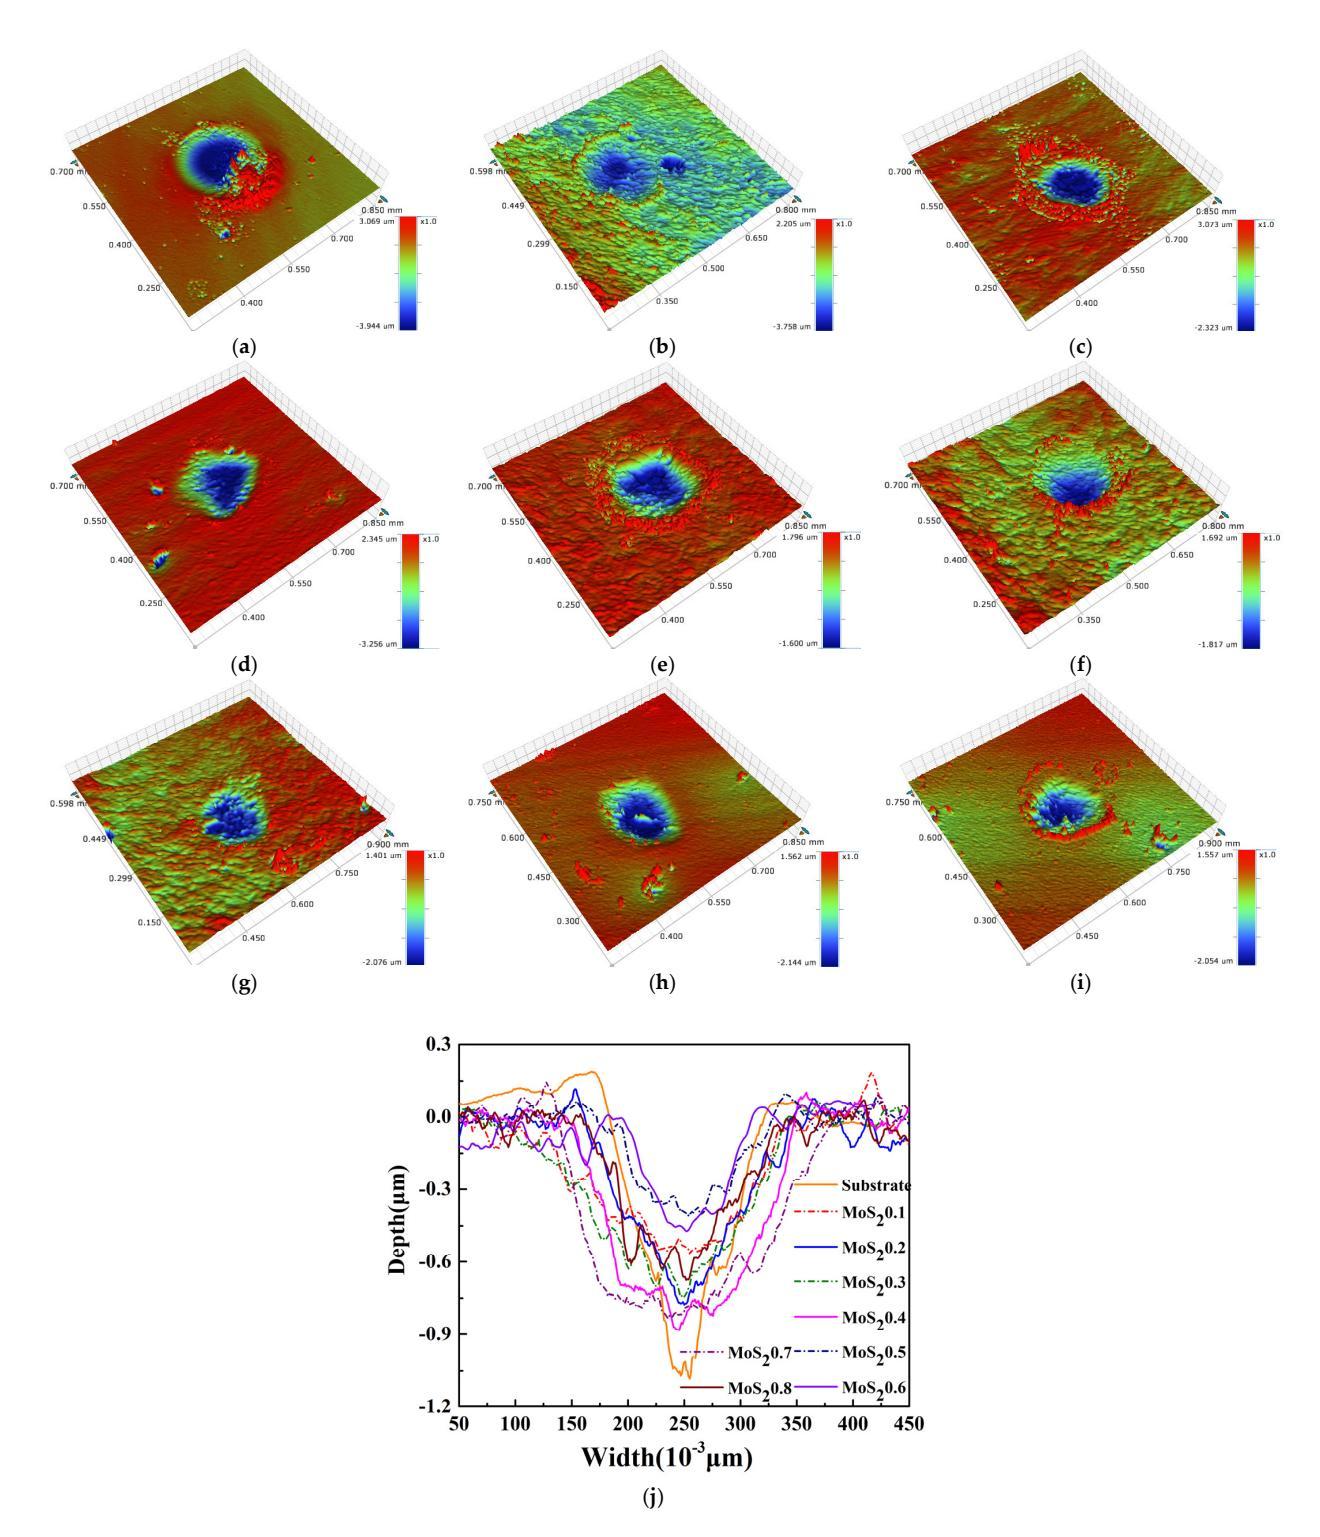
The 3D profile of impact damage was observed through the 3D morphology, and the wear volume was calculated. The results are shown in Figure 13. The wear of the substrate was serious, and severe deformation and accumulation had occurred. Meanwhile, a large amount of abrasive debris had accumulated on the surface of the wear scar. The wear scar area of $MoS_20.1$ was relatively large, but the depth was shallow. The damage of $MoS_20.3$ was worse than that of $MoS_20.1$, which indicates that the wear scar area was similar but that of MoS₂0.3 was deeper. MoS₂0.4 had a larger and deeper wear scar area, while MoS₂0.6 had a lower wear scar area with the slightest wear volume than those of the other samples. The wear of the coating was consistent with the dynamic response in the experiment. Impact damage mainly consisted of plastic deformation and interface wear, depending on the mechanical properties of the material. Under the same experimental conditions, MoS₂0.4 absorbed more energy and had serious damage, while MoS₂0.6 absorbed less energy and had less damage, demonstrating that $MoS_20.6$ has a better performance. In Figure 11, the energy absorption ratio of the substrate is lower than that of the MoS_2/C coatings, but the wear damage is more serious. This shows that during the impact process, the coating absorbs more energy with little damage, and their mechanical properties are better than the substrate. Figure 13 shows the cross-sectional profiles of all the samples. After 10^4 cycles of impact test, the wear volume of the substrate is larger than those of the coatings.

Figure 13. Three-dimensional morphology and cross-sectional profiles. (a) Substrate, (b) MoS₂0.1, (c) MoS₂0.2, (d) MoS₂0.3, (e) MoS₂0.4, (f) MoS₂0.5, (g) MoS₂0.6, (h) MoS₂0.7, (i) MoS₂0.8, (j) Cross-sectional profiles.

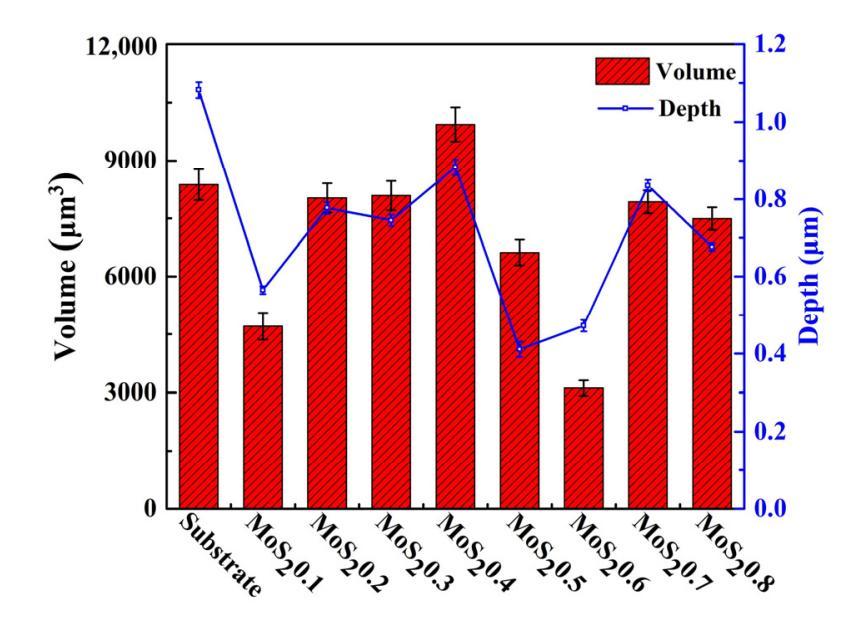
Figure 14a shows the maximum wear depth of the samples after the impact test. The substrate had a maximum wear depth of 1.082 μ m, while the coatings had a smaller wear depth. Figure 14b shows the wear volume of all the samples. MoS₂0.4 had the largest wear volume of approximately 9937 μ m³, and MoS₂0.6 had the smallest wear volume of approximately 3117 μ m³. Except for MoS₂0.4, all other coatings had a smaller wear volume than the substrate. Thus, MoS₂0.6 has a good impact resistance and can provide good protection for its substrate.

Figure 14. Maximum wear depth and wear volume.

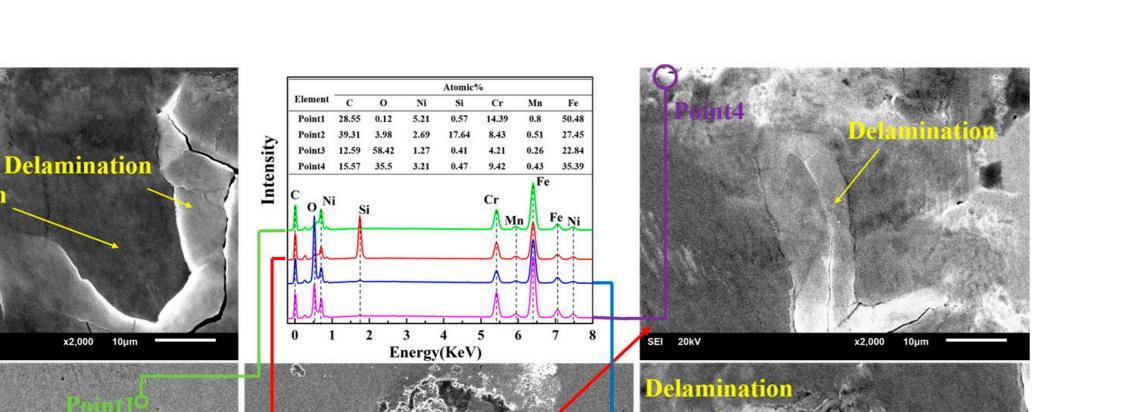
To determine the wear mechanism during the impact process, SEM and EDX were used to observe the wear scar and measure the element distribution. Figure 15 shows the SEM images and EDX of the substrate; a significant peeling of the material in the upper part of the worn area is observed. According to the analysis results of EDX (point 1 is the distribution of substrate material elements), the C and Si contents of point 2 increased greatly, while the Fe element content decreased, so point 2 should be sandstone impurities; at point 3, the C and Fe contents decreased, and the O content increased greatly. Meanwhile, point 3 was in the crack area, so the material at point 3 should be frictionally oxidized, and the material failed and cracked; the element distribution at point 4 was similar to that at point 3, so point 4 should be the accumulation of material after frictional oxidation. In summary, the substrate underwent friction oxidation during the impact process, causing the oxide film to peel and aggravating the material loss. Figure 16 shows the SEM images and EDX of MoS₂0.4. The wear volume of MoS₂0.4 was the largest, so elemental distribution analysis was carried out to explore its wear mechanism. The wear scar of MoS₂0.4 was relatively flat, with no obvious cracks or defects. The analysis result shows that the element contents in the two regions were basically the same. Plastic deformation occurred on the surface of the material during the entire impact process and no obvious chemical reaction occurred. The SEM images and EDX of $MoS_20.6$ are shown in Figure 17. Compared with the element distribution of point 1, the oxygen content in the area where the wear debris accumulated (point 2) was greatly increased, while the element contents of C, S, and Mo decreased, demonstrating that frictional oxidation probably occurred. Point 3 shows a different surface morphology than point 1. Analysis shows that the composition was the same as that in point 1 because of the fault left by the surface peeling of the material. Compared with point 1, the oxygen and carbon contents of point 4 increased, and the S and Mo contents decreased, which should have been the accumulation of materials.

Figure 15. SEM images and EDX of the substrate.

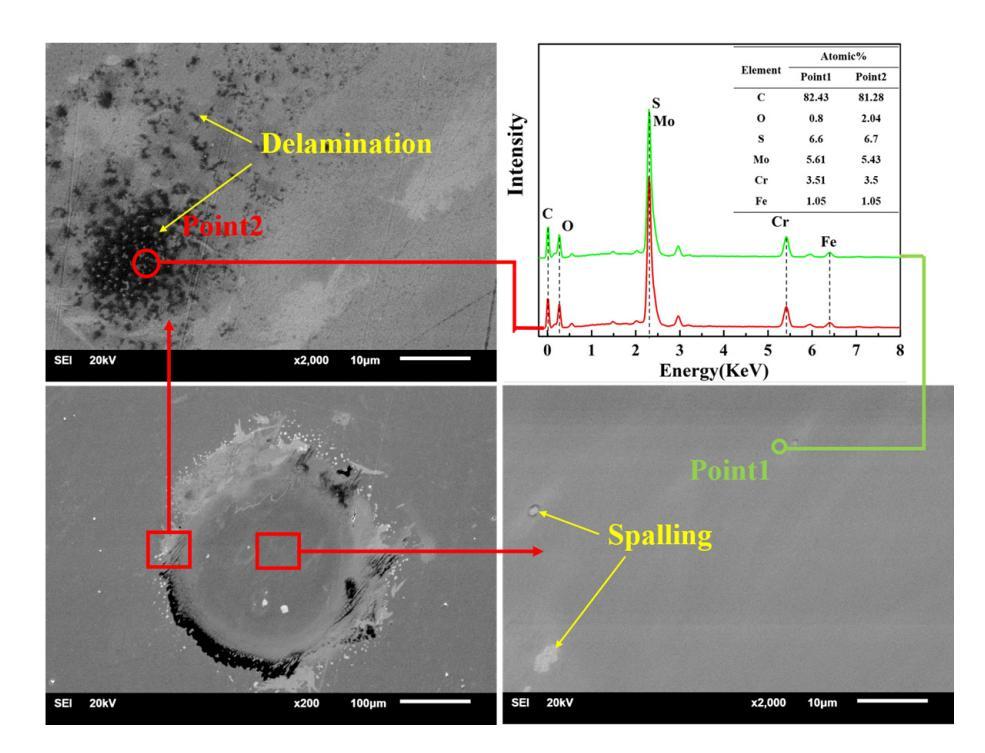
Figure 16. SEM images and EDX of MoS₂0.4.

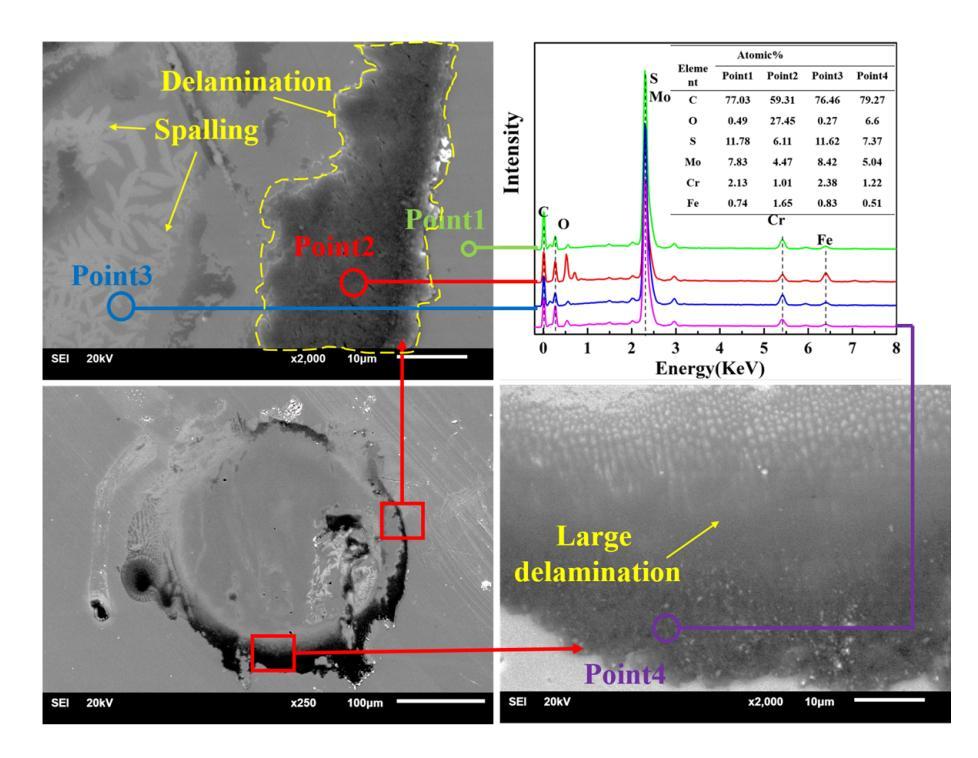
Figure 17. SEM images and EDX of MoS₂0.6.

- (4) The wear scar and the volume loss analysis show that MoS₂0.6 has a good impact resistance and can protect the substrate. The wear mechanism of coatings presents fatigue delamination and spalling, which are caused by cyclic shear stress. In addition, frictional oxidation occurs, especially in the stratified zone.
