# Water Vapor Corrosion Behavior of Yb<sub>2</sub>SiO<sub>5</sub> Environmental Barrier Coatings Prepared by Plasma Spray-Physical Vapor Deposition

**Abstract:** Tri-layer Si/mullite/Yb<sub>2</sub>SiO<sub>5</sub> environmental barrier coating (EBC) was prepared on the SiCf/SiC ceramic matrix composite (CMC) by plasma spray-physical vapor deposition (PS-PVD). The EBC samples were carried out with water vapor corrosion at 1300 °C for 200 h. After steam corrosion, Yb<sub>2</sub>SiO<sub>5</sub> layer forms a gradient porous structure. This is mainly due to the inclusion of SiO<sub>2</sub>-rich layer which is precipitated from the gasification inside the coating and existing a small amount of Yb<sub>2</sub>O<sub>3</sub> separately. During the corrosion process, water vapor infiltrates into the coating and reacts with the SiO<sub>2</sub> and Yb<sub>2</sub>O<sub>3</sub> to generate volatile substances. This forms a porous structure to make the coating brittle, resulting in mud cracks finally. In addition, the results show that the Yb<sub>2</sub>SiO<sub>5</sub> can react with the water vapor at the coating surface, forming an Yb<sub>2</sub>Si<sub>2</sub>O<sub>7</sub> top layer.

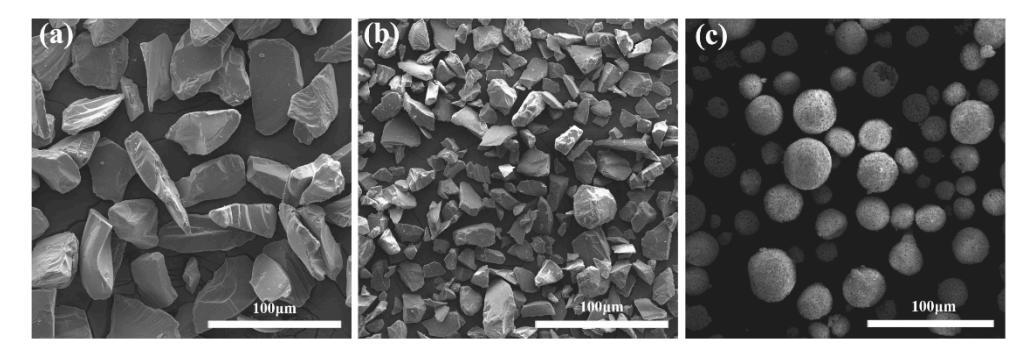
Figure 1. Micrographics of feed powders: (a) Si; (b) mullite and (c) agglomerated Yb<sub>2</sub>SiO<sub>5</sub> powders.

Tri-layer Si/3Al<sub>2</sub>O<sub>3</sub>-2SiO<sub>2</sub>(Mullite)/Yb<sub>2</sub>SiO<sub>5</sub> dense environment barrier coatings was deposited in SiCf/SiC CMC (2 mm × 3 mm × 50 mm) by PS-PVD. Before spraying, the substrate was cleaned with ethanol. The thickness of Yb<sub>2</sub>SiO<sub>5</sub> top layer, Mullite transition layer and Si high-temperature oxidation resistant bonding layer were all controlled within 50 µm. In order to make the powder conductive, the powder was spread flat on the conductive tape and sprayed with gold to obtain its microstructure. Si (99%,  $-75 + 15 \mu$ m, signed 4810, see Figure 1a) and Mullite (99.9%,  $-45 + 5 \mu$ m, signed 6150, see Figure 1b) powder for spraying were purchased from Oerlikon-Metco Ltd. (Freienbach, Switzerland). In addition, agglomerated Yb<sub>2</sub>SiO<sub>5</sub> powders ( $-40 + 10 \mu$ m, Figure 1c) were prepared during this work through spray drying. Before deposition of each layer, the substrate was preheated (Si at 500 °C, Mullite at 1000 °C and Yb<sub>2</sub>SiO<sub>5</sub> at 830 °C) to avoid any defects such as microcracks which can be caused by the excessive stress due to phase change during the deposition process. The specific spraying parameters are shown in Table 1.

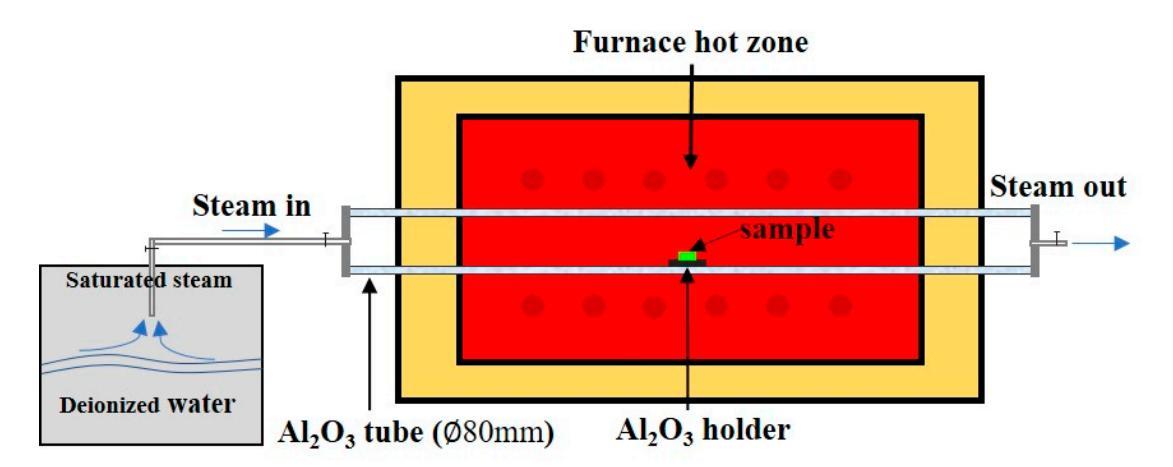
Figure 2. Schematic diagram of the steam corrosion device.

Prior to the water vapor corrosion, the as-sprayed coating needs to be oxidized at 1300 °C for 3 h [21]. Then, the heat-treated sample was placed in the steam corrosion device as shown in Figure 2 for 200 h at 1300 °C. The steam velocity in the tube furnace was about 0.2 m/s.

AS-sprayed EBC samples were subjected to the heat treatment at 1300 °C for 3 h and the partially decomposed ytterbium oxide and silicon oxide were regenerated through the solid phase reaction to form stable ytterbium silicate. The sample was placed in the corrosion device shown in Figure 2 (1300 °C, 200 h, 0.2 m/s) and the section morphology after corrosion is shown in Figure 10. The composition and structural evolution of Yb<sub>2</sub>SiO<sub>5</sub> coating under high temperature water vapor were analyzed by TEM. Sample blocks 15  $\mu$ m deep were excavated on the near-coated surface by FIB. It can be seen that a reaction layer of 3–5  $\mu$ m was formed on the surface and a network of porous structures formed by steam corrosion exists below the reaction layer. This structure generates greater stress, leading to more microscopic cracks. The Yb<sub>2</sub>SiO<sub>5</sub> coating after 200 h corrosion is divided into two zones—(I) surface reaction zone, which is connected with the external steam environment; (II) vapor permeable corrosion layer, where the vapor permeated into the coating and reacted with the decomposition products Yb<sub>2</sub>O<sub>3</sub> and SiO<sub>2</sub> to form Yb(OH)<sub>3</sub> and Si(OH)<sub>4</sub>.

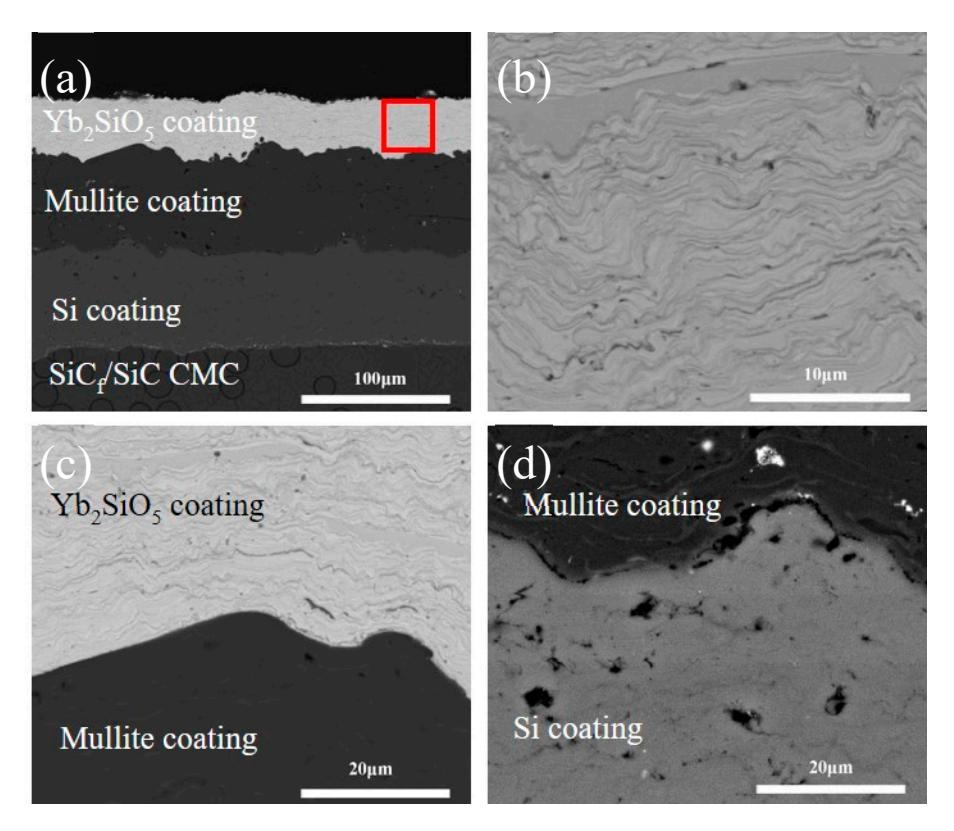
**Figure 3.** Back scattering electron(BSE) microstructures micrographs of EBC: (**a**) multi-layer structure; (**b**) Yb<sub>2</sub>SiO<sub>5</sub> coating; (**c**) Interface of Yb<sub>2</sub>SiO<sub>5</sub> and Mullite; (**d**) Interface of Mullite and Si.

The cross-section microstructure of EBC is shown in Figure 3. It can be seen that in general, the coating is compact, and the layers are closely bounded together with no obvious pores and cracks. The interfaces between Yb<sub>2</sub>SiO<sub>5</sub> (CTE 7.23 × 10<sup>-6</sup> K<sup>-1</sup>), Mullite (CTE 5.48 × 10<sup>-6</sup> K<sup>-1</sup>) and Si (CTE  $3.5-4.5 \times 10^{-6}$  K<sup>-1</sup>) layers are clear. A good thermal compatibility is seen in Figure 3c,d. In the plasma flame flow, the temperature in some area is much higher than the melting point of Yb<sub>2</sub>SiO<sub>5</sub> leading to the decomposition of particles forming Yb<sub>2</sub>O<sub>3</sub> (~2346 °C) and SiO<sub>2</sub> (~1650 °C). In the deposition process, SiO<sub>2</sub> generates gas-solid transition and forms a small number of pores in the coating. The concentration of the two phases in the gas-liquid phases in the deposition process is significantly different due to their different melting points. This leads to the distinct stratification during the deposition process as shown in Figure 3b.

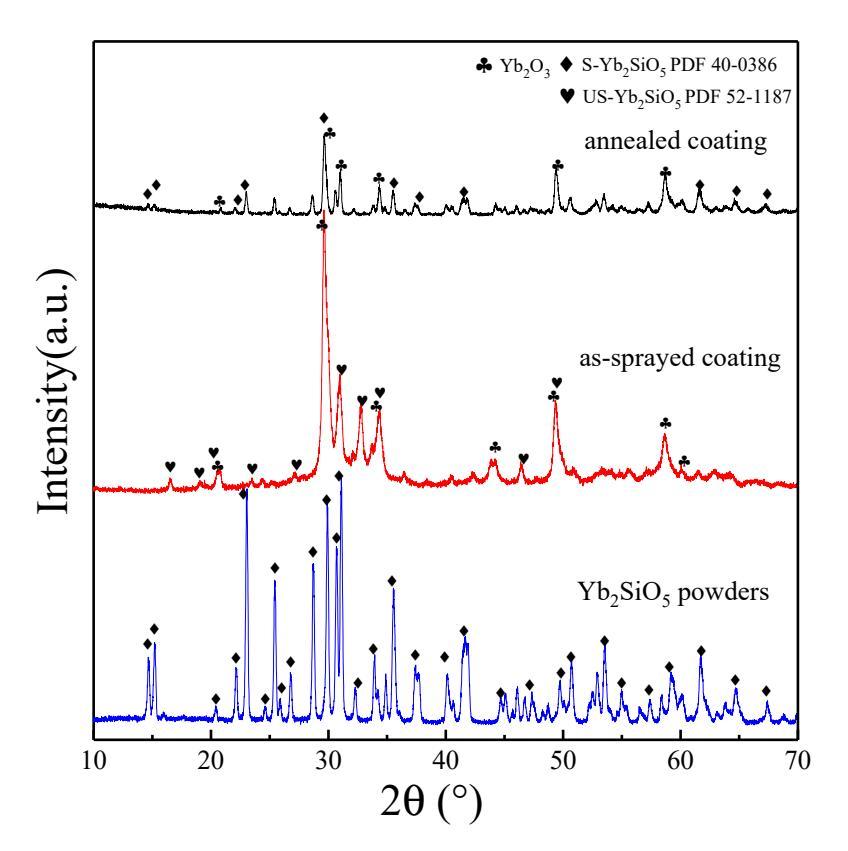
**Figure 4.** X-ray diffraction (XRD) patterns of Yb<sub>2</sub>SiO<sub>5</sub> agglomerate powders, as-sprayed coating and annealed coating.

The raw powder of ytterbium silicate layer was prepared by solid phase reaction (ytterbium oxide and silicon oxide were sintered at 1800 °C). The X-ray diffraction (XRD) pattern of the ytterbium silicate before and after spraying shown in Figure 4 suggests that there has been high-temperature decomposition in the spraying process. The original powder is a standard ytterbium silicate monocline phase (Stable phase, PDF 40-0386). However, in the high temperature of the plasma flame flow in non iso-thermal temperature field during the process of spraying, ytterbium silicate was formed (Unstable phase, PDF 52-1187) [22]. In addition, there is Yb<sub>2</sub>O<sub>3</sub> on the surface of as-sprayed Yb<sub>2</sub>SiO<sub>5</sub> coating as reflected in the XRD spectrum diffraction peaks obviously. This indicates that in the spraying process, part of the ytterbium silicate in the local high temperature region occurred thermal decomposition (Equation (1)).

The gasification point of SiO<sub>2</sub> is about 2230 °C which is lower than the temperature of plasma beam flow, leading to the loss of silica gasification. Since the unstable phase is not stable at high temperature (~1300 °C), it can be easily changed to the ytterbium silicate with a stable structure. Therefore, after spraying, the coating needs to be kept at 1300 °C for 3 h to transform into the stable phase. The phase changed during the heat treatment and the crystallinity of Yb<sub>2</sub>SiO<sub>5</sub> after recrystallization is lower than that of the original powder.

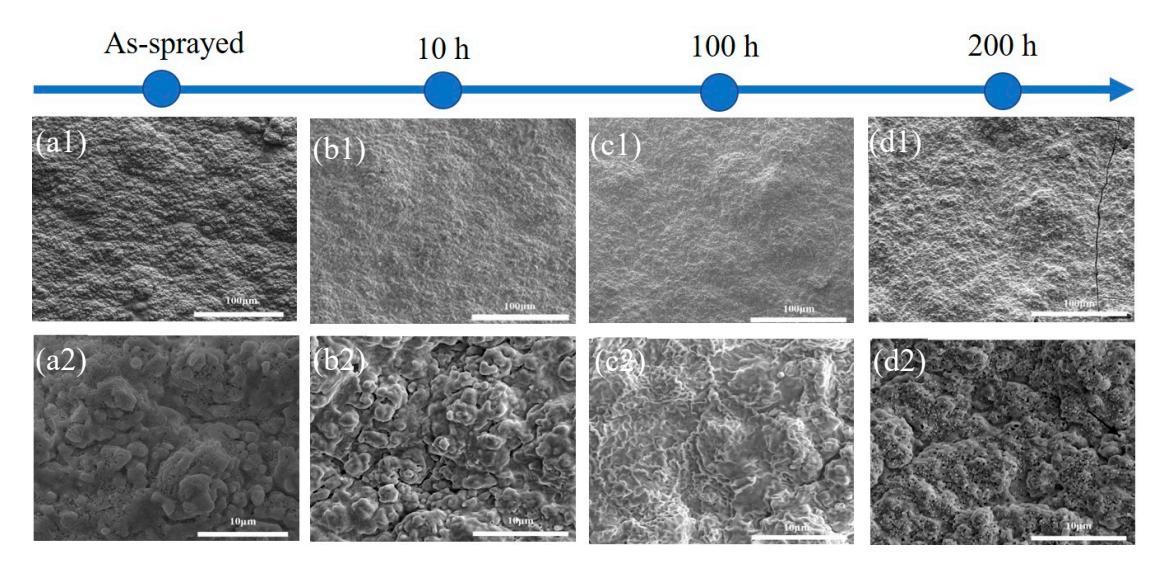
**Figure 5.** Scanning electron microscope (SEM) images of Yb<sub>2</sub>SiO<sub>5</sub> coating surface morphology after steam corrosion at 1300 °C for different time: (**a1,a2**) as-sprayed; (**b1,b2**) steam corrosion for 10 h; (**c1,c2**) steam corrosion for 100 h; (**d1,d2**) steam corrosion for 200 h.

Figure 5 shows the surface microstructure evolution of the coating under different vapor phase corrosion time. As shown in Figure 5a1, the coating in the spraying state is relatively dense, with a small amount of molten micro-plane particles deposited on the surface. The enlarged shows that the surface is mainly composed of agglomerated nanoparticles due to the dispersion of agglomerated Yb<sub>2</sub>SiO<sub>5</sub> powder in the carried gas and plasma. This has changed from solid to gas-liquid mixed phase and then was formed by recrystallization. In longer corrosion time, no obvious change in the coating surface is observed by the low power scanning electron microscopy (SEM). However, observing the surface corrosion of the steam after 50 h under the high magnification SEM shows that the number of grains had been significantly decreased and the microcosmic surface has changed to smooth oxide form (i.e., silica and ytterbium oxide). The internal coating reacts with water vapor on the surface and forms a few escape holes. After 100 h corrosion,  $Yb_2SiO_5$  sample is oxidized in the steam environment and there is obvious contrast bulge at the grain boundary on the surface. These ridges were formed by the volatilization of silica in the unstable corrosive medium Yb<sub>2</sub>Si<sub>2</sub>O<sub>7</sub>, leaving a stable Yb-monosilicate [13]. After 200 h of steam exposure, it can be seen from Figure 5d1,d2 that the ridge structure gradually decreases, and a few cracks are appeared on the surface. The porous structure increases the brittleness of the coating and produces stress cracks. In addition, a large number of discrete bright spot particles can be observed under the high power scanning electron microscope since corundum tube is exposed to the high-temperature steam over a long period of time. Alumina also reacts with the water vapor to produce gas products, which are transferred to the coating and react with the coating surface to form nanoparticles.

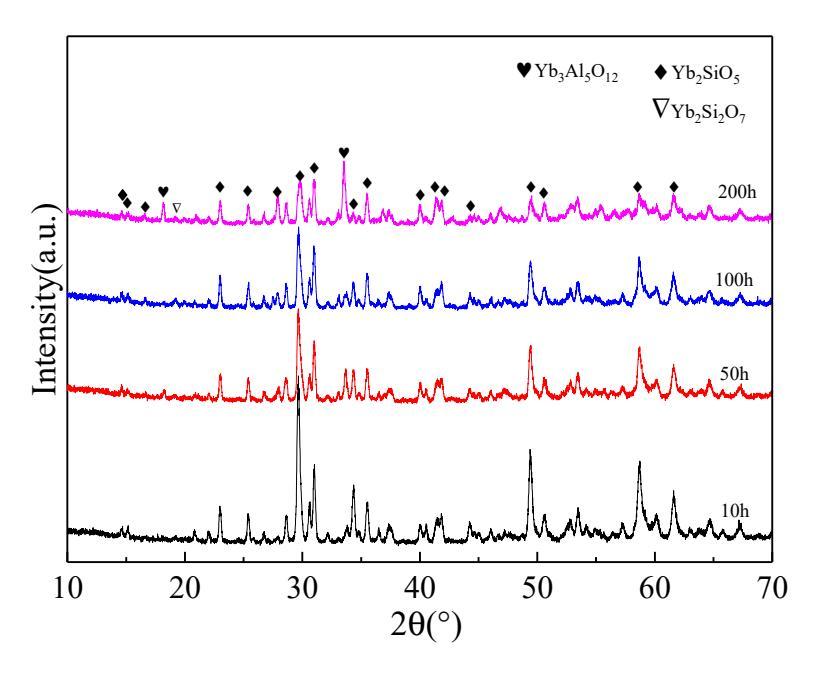
Figure 6. XRD patterns of different corrosion duration.

The XRD patterns of the coatings after different corrosion time are shown in Figure 6. At longer exposed time, the diffraction peak of  $Yb_2SiO_5$  becomes gradually weaker, indicating that its relative content decreases due to the steam corrosion reaction as shown in Equations (2) and (3). In addition,  $Yb_2SiO_5$  grains also grew in the high temperature environment seen in Figure 5d2. The corrosion mesophase of  $Yb_2Si_2O_7$  accumulates on the surface, which could be confirmed from the gradual enhancement of its diffraction peak:

The surface phase is mainly dominated by  $Yb_2SiO_5$  and  $Yb_2O_3$  before the corrosion. After water vapor corrosion, the  $Yb_2SiO_5$  and  $Yb_2O_3$  content in coating surface significantly decreased, especially the  $Yb_2O_3$  which is no residue on the surface. At 200 h corrosion, the  $Yb_3Al_5O_{12}$  peaks appear because under the environment of high temperature and water vapor,  $Yb_2O_3$  reacts with water, as well as with  $Al_2O_3$  from the corundum tube (Equations (4) and (5)). The results are consistent with Richards that the corundum tube interferes with the testing process [23]:

It can be clearly seen in the BSE mode that the coating has a significant corrosion reaction layer near the surface from the Figure 7c. The energy disperse spectroscopy (EDS) elemental analysis was conducted on the dark upper layer (point 1) and lower layer (point 2). The element content ratio of Yb, Si and O indicates that the dark reaction layer is mainly Yb<sub>2</sub>Si<sub>2</sub>O<sub>7</sub>, while the lower reaction layer is Yb<sub>2</sub>SiO<sub>5</sub>. The above conclusions also verify the XRD analysis results in Figure 6.

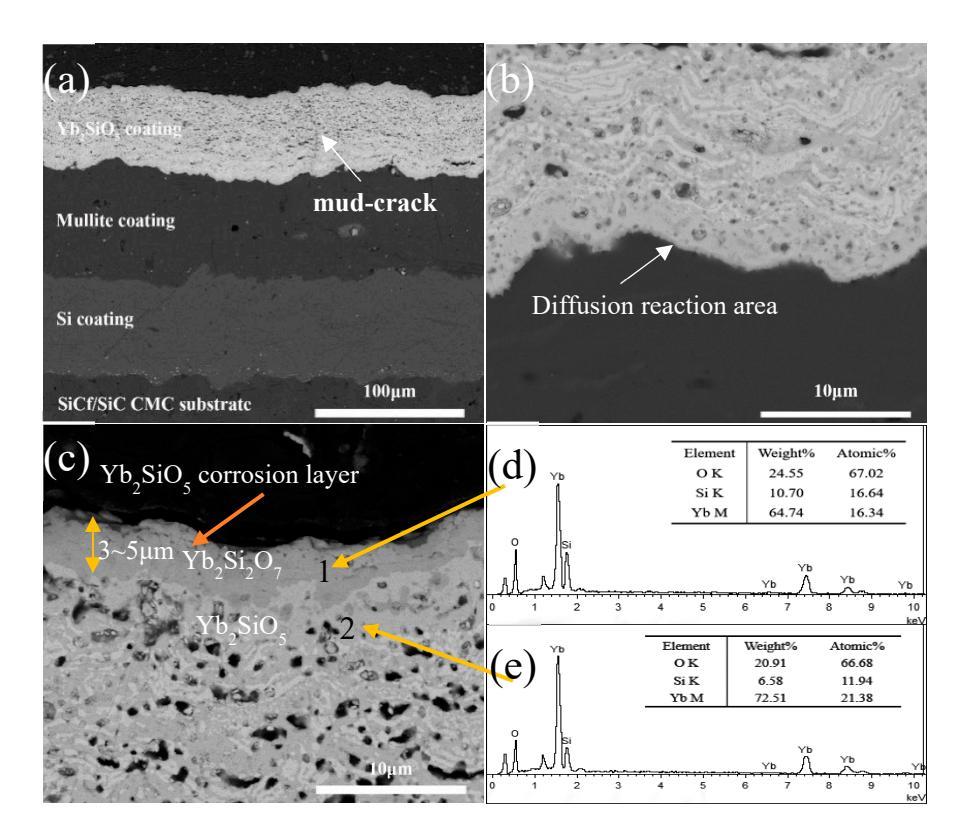
**Figure 7.** Cross-sectional micrographs of the coatings after 200 h water vapor corrosion: (**a**) overview EBCs; (**b**) interface of Yb<sub>2</sub>SiO<sub>5</sub> and Mullite; (**c**) near-surface of Yb<sub>2</sub>SiO<sub>5</sub> layer; (**d**,**e**) Energy dispersive spectrometer(EDS) elemental analysis.

The cross-section microstructure of Si/Mullite/Yb<sub>2</sub>SiO<sub>5</sub> environmental barrier coatings after 200 h of water vapor corrosion is shown in Figure 7. In general, the adhesive layers (Si/Mullite) and the substrate are not obviously eroded after the coating was exposed to the steam for such a long time. This indicates that Yb<sub>2</sub>SiO<sub>5</sub> barrier layer has a good water-oxygen permeability resistance. However, many pores area are appeared inside the coating. Mud-cracks are also appeared throughout Yb<sub>2</sub>SiO<sub>5</sub>. The pores are mainly concentrated in the upper layer of ytterbium silicate as shown in Figure 7a. The reason is that a large amount of SiO<sub>2</sub> is mixed with gasification and decomposition inside the coating and constantly reacts with the water vapor in the tube furnace (Equation (6)) to generate volatile gas Si(OH)<sub>4</sub>.

This continuously penetrates and corrode inside the coating and forms a network and porous structure resulting in brittle cracks inside the coating. In addition, ytterbium oxide, which exists separately in the coating, also reacts with the water vapor.

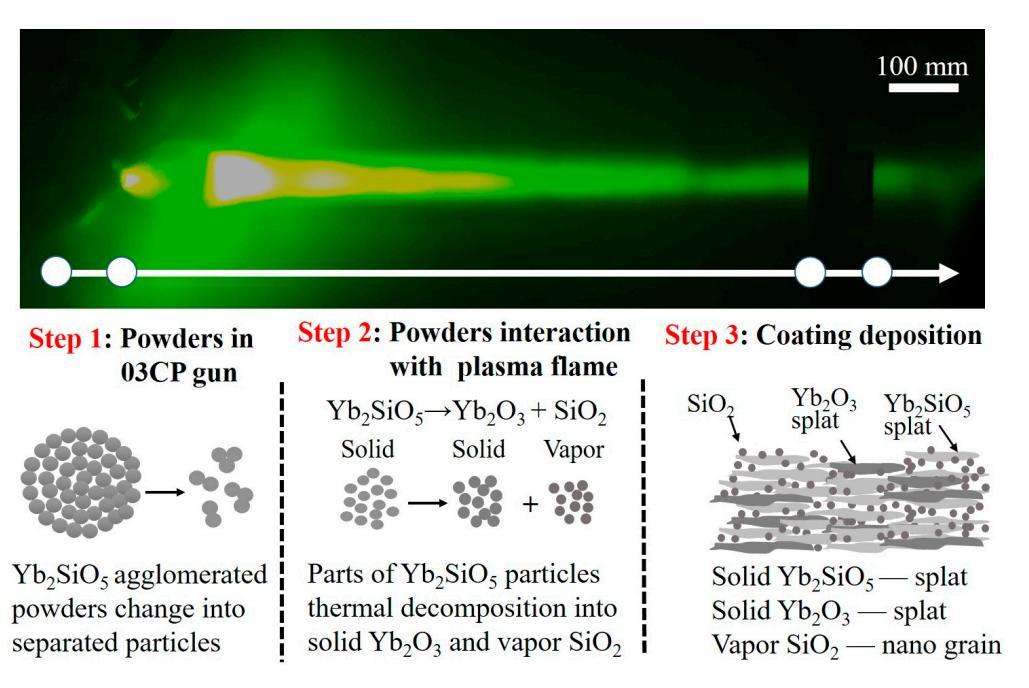
Figure 8. Dynamic changes of Yb<sub>2</sub>SiO<sub>5</sub> particles in the plasma beam using PS-PVD.

Dense EBCs can be prepared by PS-PVD. However,  $Yb_2SiO_5$  can be easily transformed into unstable US-Yb\_2SiO\_5 under the high temperature (~4000 °C) [24] and ultra-low pressure (~150 Pa) during the process. In addition, some of the powder can be decomposed into ytterbium oxide and silicon oxide. State changes of Yb\_2SiO\_5 particles during the spraying are shown in Figure 8. This process can be divided into three steps—firstly, under the impact of carrier gas, the ytterbium silicate aggregated powder was dispersed into micro nanoparticles; Then, the lattice distortion occurs under the combined action of high temperature plasma beam and ultra-low pressure. In the energy concentration region of the beam center, the microscopic stress of unstable phase is decomposed into ytterbium oxide and silicon oxide. Due to the different density of these materials, the distribution in the beam has obvious gradient and expansion and dissipation of part of the gas SiO<sub>2</sub>; therefore, deposition morphology on the substrate also shows obvious layered structure.

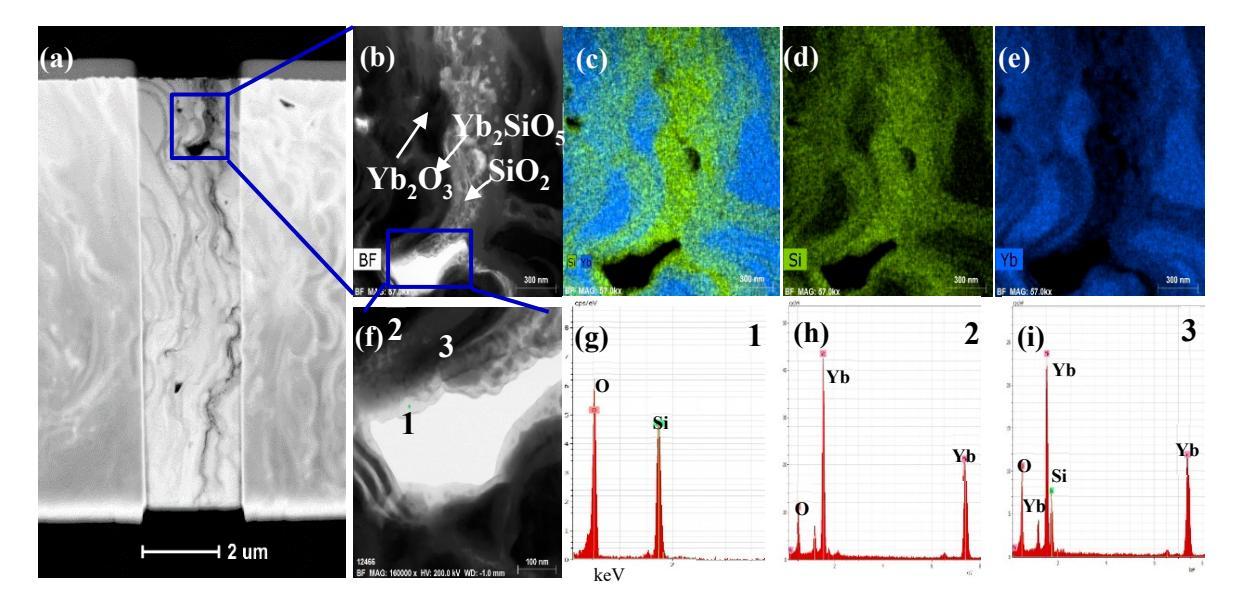
**Figure 9.** Microstructure and element analysis of Yb<sub>2</sub>SiO<sub>5</sub> coating: (**a**) Bright field transmission electron microscope (TEM) image of Yb<sub>2</sub>SiO<sub>5</sub> coating; (**b**) dark field magnification of figure **a**; (**c**–**e**) EDS mapping of figure **b** showing Si, Yb; (**f**) magnified TEM image of figure **a**; (**g**–**i**) EDS element analysis of points 1, 2 and 3 in figure **f**.

Figure 9 shows the transmission electron microscope (TEM) analysis results of the ytterbium silicate sprayed layer. The layer has light and dark stripes generated by different element distribution. There are also a few holes concentrated near the dark stripes. In order to quantify the element differences in the stripes with different contrast degrees and determine the phase composition of different layers, EDS analysis was conducted. Figure 9c–f also show the element plane scanning and point analysis conducted on the selection in Figure 9b. The results indicate that  $Yb_2SiO_5$  decomposition did exist in the deposition process. Due to the different gasification temperatures of  $Yb_2O_3$  and  $SiO_2$ , the vapor  $SiO_2$  formed after decomposition contracted in volume after solidification, so obvious pores were formed.  $Yb_2O_3$  and  $Yb_2SiO_5$  are dispersed in the coating seen in Figure 9f.

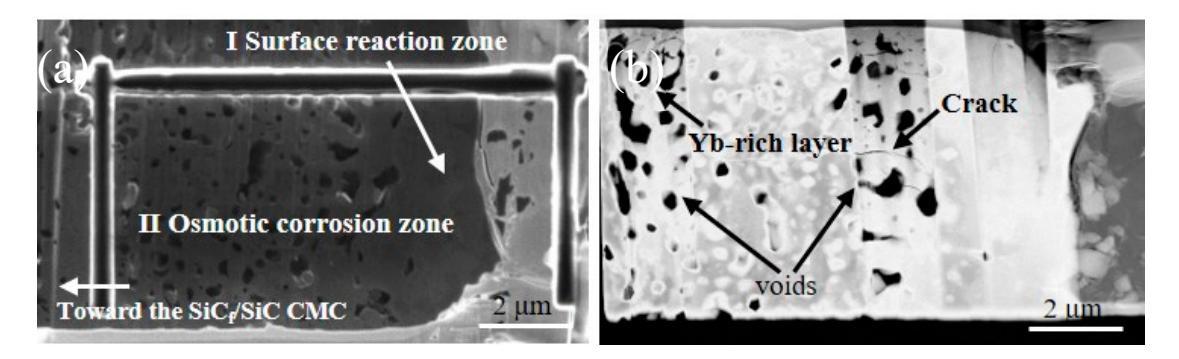
Figure 10. (a) TEM analysis area cut by FIB; (b) Bright field image of figure a.

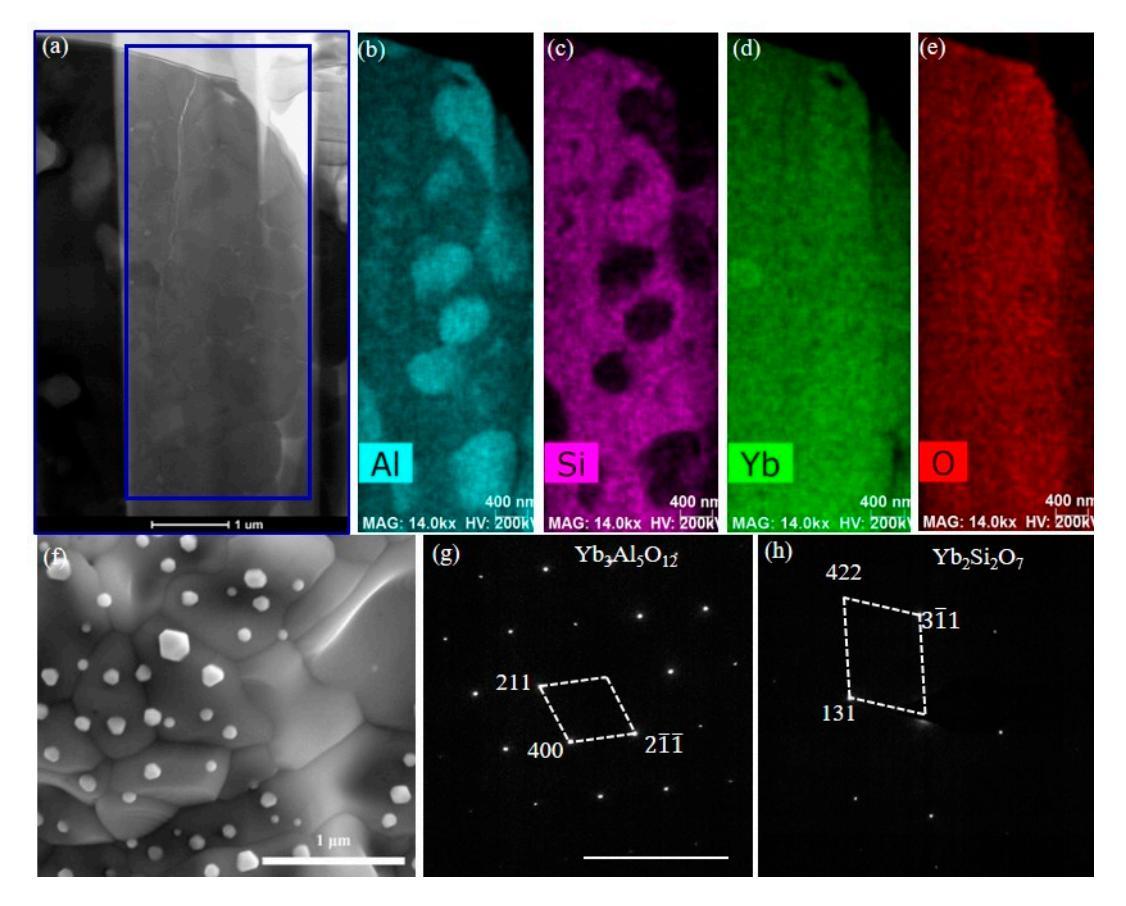
**Figure 11.** Phase analysis of surface reaction zone I: (**a**) cross-sectional dark field image of grain growth layer in zone I; (**b**–**e**) Al, Si, Yb and O elements EDS mapping of zone I; (**f**) SEM of surface reaction layer; (**g**) Selected area electron diffraction(SAED) of rich-Al grains in Zone I and (**h**) SAED of none-Al grains in Zone I

The corrosion process of the top coating under high temperature water vapor will be analyzed from the coating surface to the CMC matrix. After 200 h of corrosion, it produced equiaxed crystals with obvious grain boundaries on the surface of the coating, as shown in Figure 11a. Based on the previous analysis results, the white nanocrystals which were aluminum oxide nanoparticles brought by the external environment. Through the analysis of the elements and phase of the near surface area I, Al elements from the surface to the coating permeability, as shown in Figure 11b. For the surface reaction zone under TEM bright field, the large amounts of nano grain accumulation growth. The area I is composed of two phases according to the EDS analysis—one is the Al-rich phase and the other is Si-rich phase. Yb and O no obvious difference in the two phase distribution. The surface grains were analyzed further by selective area electron diffraction (SAED). After calculation and analysis, the Al-rich phase is Yb<sub>3</sub>Al<sub>5</sub>O<sub>12</sub>, while the Si-rich phase is Yb<sub>2</sub>Si<sub>2</sub>O<sub>7</sub>, which was consistent with the XRD phase analysis results on the surface at 200 h. No significant Al-phase was found inside the coating of Yb<sub>2</sub>SiO<sub>5</sub>, indicating that Al was transferred from the outside (corundum heating tube and furnace plug) to the coating surface and reacted.

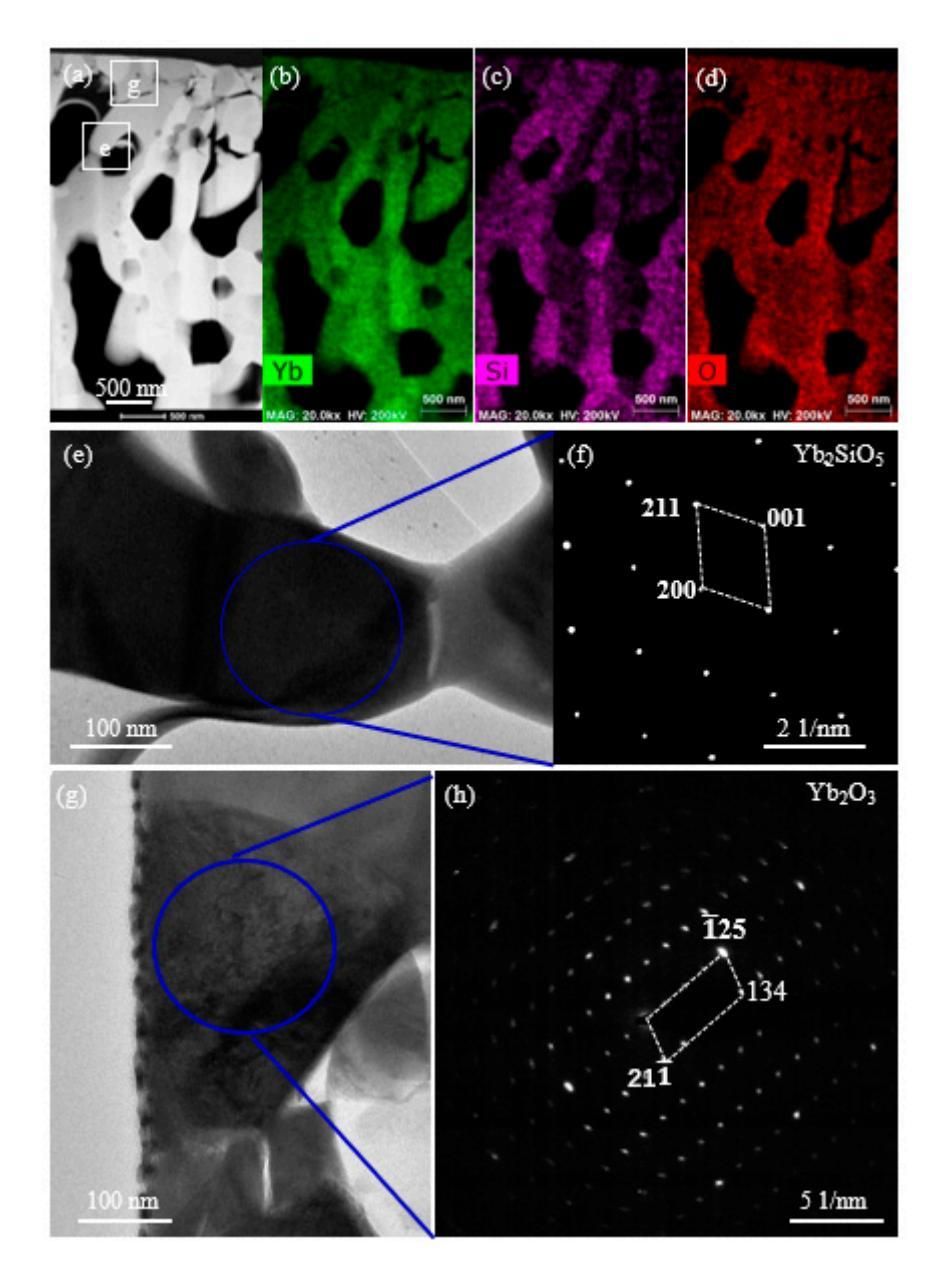
**Figure 12.** Phase and element analysis in II internal corrosion zone: (**a**) bright field image in zone II; (**b–d**) Yb, Si and O elements scanning in figure **a**; (**e–f**) morphology and SAED analysis of dark fringe phase in figure **a**; (**g–h**) microstructure and SAED analysis of bright fringe in figure **a**.

Below the surface reaction zone is the internal corrosion zone II. As shown in Figure 12, After 200 h of corrosion, network holes were formed. At the same time, due to the reaction, a large amount of internal stress is generated, resulting in more microscopic cracks in the coating. The coating of ytterbium silicate after corrosion in TEM bright field images had a typical reticulated porous structure and there were still light and dark phase streaks similar to that of the as-sprayed coating as shown in Figure 12a. Elemental analysis of this region shows that the bright fringe is a Yb-rich phase with high O content, while the dark fringe contains more Si element. The phase structure of the light and dark fringe phase was analyzed by selecting diffraction. After calculation and analysis, the PDF-22019 database was used for the comparison of crystal surface spacing and the dark fringe was confirmed as Yb<sub>2</sub>SiO<sub>5</sub>. The bright fringe represents the phase Yb<sub>2</sub>O<sub>3</sub>. The pores are mainly concentrated in the bright streaks, which in the coating, the rare earth decomposition products cannot be stable in the high-temperature water vapor, forming gaseous products volatilization. There was no SiO<sub>2</sub> residue, so water vapor reacted preferentially with SiO<sub>2</sub> to produce Si(OH)<sub>4</sub> and then with Yb<sub>2</sub>O<sub>3</sub> to produce Yb(OH)<sub>3</sub>, which destroyed the structural integrity of the coating, resulting in holes and cracks.

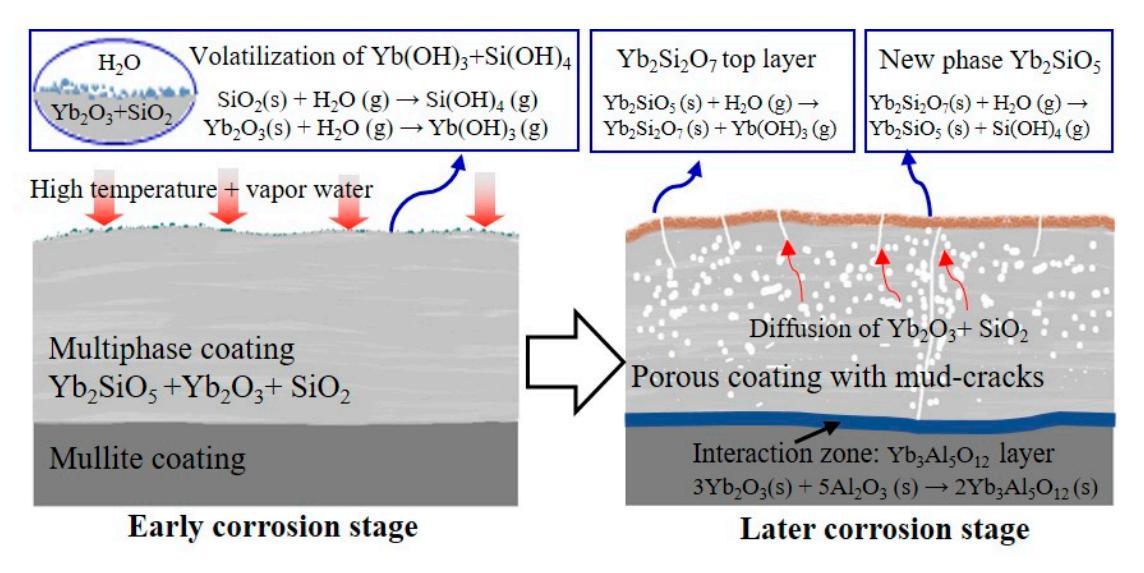
Figure 13. Structural evolution model of vapor corrosion of Yb<sub>2</sub>SiO<sub>5</sub> coating.

Based on the above characterization and analysis, we established the physical model shown in Figure 13 to reflect the corrosion behavior of ytterbium silicate coating prepared by PS-PVD when exposed to water vapor at 1300 °C for 200 h. The corrosion is divided into two stages—(1) The early stage, due to the thermal decomposition of ytterbium silicate during the spraying process, a large number of Yb<sub>2</sub>O<sub>3</sub> nanoparticles (SiO<sub>2</sub> has volatilized) were collected on the surface, which reacted with water vapor first. After the reaction, the coating surface became dense and smooth and the main component was ytterbium silicate; (2) The later corrosion, when Yb<sub>2</sub>O<sub>3</sub> on the surface reaction is completed, the water vapor begins to corrode and permeate along the coating microcrack and the oxide aggregation area decomposed in the coating. At this time, the Yb<sub>2</sub>SiO<sub>5</sub> coating produces a network of porous channels gradually densified from the surface to the inside of it. With the prolonged time of vapor exposure, a large amount of vapor accumulated on the surface of the coating, except a small part of vapor penetrated into the interior of the coating. Combined with the change results of the surface phase and EDS element analysis, it was speculated that a slow reaction occurred on the surface

(Equations (2) and (3)) and the transition product  $Yb_2Si_2O_7$  accumulated on the surface, forming a dense equiaxed crystal region. In addition, in the long-term high temperature environment, the interdiffusion zone between  $Yb_2SiO_5/Mullite$  coating interfaces will also occur and  $Yb_2SiO_5$  and  $Al_2O_3$ react to form a bar-shaped  $Yb_3Al_5O_{12}$  [25]. Eventually, corrosion holes in the coating of ytterbium silicate extend into the bonding layer, which will result in the coating and CMC matrix fail quickly.
