Article

Microstructure and Properties of the AlCrSi(O)N Tool Coatings by Arc Ion Plating

Keywords: arc ion plating; AlCrSi(O)N coating; microstructure; mechanical property; friction and wear; cutting test

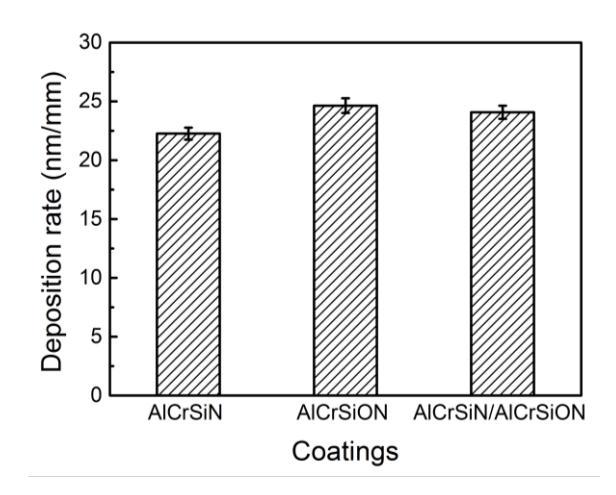
The deposition rates of the AlCrSiN coating, AlCrSiON coating, and AlCrSiN/AlCrSiON duplex coating are shown in Figure 2. It can be seen that the difference among them is not obvious. The deposition rate of AlCrSiN coating is about 22.3 ± 0.6 nm/min, and that of AlCrSiON coating is the about 24.5 ± 0.7 nm/min, while that of AlCrSiN/AlCrSiON duplex coating is somewhere in between. The above tendency was attributed to the addition of oxygen, the rapid oxidation reaction resulted in the formation of oxide substance with bigger volume, so the deposition rate was increased slightly. Whereas the time of oxygen input was reduced during the deposition of the AlCrSiN/AlCrSiON duplex coating, which led to a slight decrease in the deposition rate.

Figure 2. Deposition rates of the AlCrSiN coating, AlCrSiON coating, and AlCrSiN/AlCrSiON duplex coating.

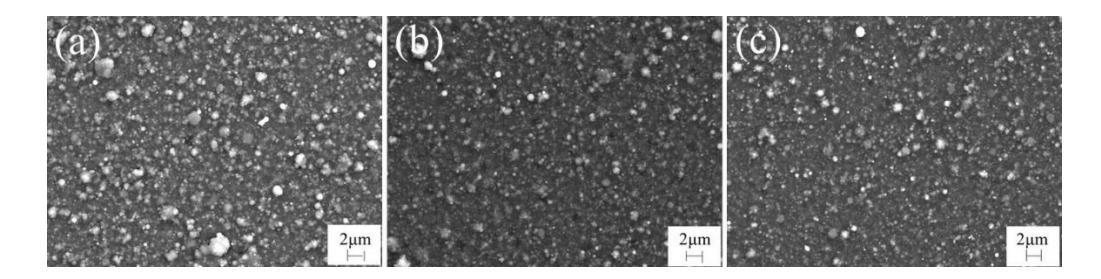
Figure 3 presents the typical surface morphologies of the AlCrSiN coating, AlCrSiON coating, and AlCrSiN/AlCrSiON duplex coating, respectively. It can be seen that there are some defects such as macro particles, pinholes and solid droplets on the surface of the three coatings—which were due to the ion cluster collision during the coating process to form large particles or the metal droplets evaporated from the target surface—which were directly deposited on the substrate, and rapid cooling and shrinkage formed defects occurred with the decrease in temperature [22,23]. Compared with the AlCrSiN coating (Figure 3a), both the amount and size of macro particles on the AlCrSiON coating (Figure 3b) and AlCrSiN/AlCrSiON duplex coating (Figure 3c) were significantly reduced. There are two possible reasons for this. One is that the droplets emitted from the target surface were usually positively charged from metal ions. Oxygen reacts with metal ions more easily than nitrogen to generate neutral particles due to the higher activity of former. Moreover, if the droplet is bigger, the oxidation reaction is more sufficient. In the negative bias electric field near the substrate, these neutral particles could be accelerated, which induced smaller and fewer of macroparticles formed on the resulted coating surface [24]. The other reason is attributed to the well-known target-poisoning effect as oxygen is introduced. The gradual accumulation of weakly electrically conductive oxide films on the target surface further hindered the evaporation of many larger droplets, which formed the smoother coating surface [25]. However, more pinholes can be observed in Figure 3b,c than those in Figure 3a, which is attributed to the change in the tissue volume caused by the formation of oxides.

Figure 3. Surface morphologies of the three coatings: (a) AlCrSiN coating, (b) AlCrSiON coating, (c) AlCrSiN/AlCrSiON duplex coating.

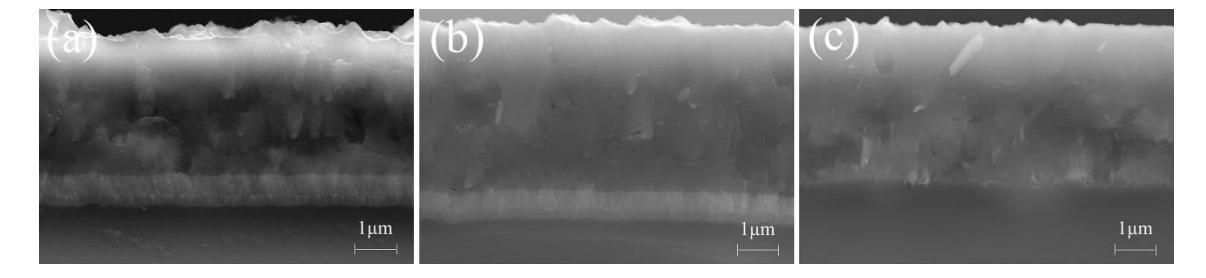
The fractured cross-sectional images of above three coatings are shown in Figure 4. All the coatings presented a featureless glassy microstructure, and no obvious boundary could be observed between the AlCrSiN layer and AlCrSiON layer in the AlCrSiN/AlCrSiON duplex coating. The AlCrSiON coating and AlCrSiN/AlCrSiON duplex coating are denser than the AlCrSiN coating. This indicates that the introduction of oxygen enhanced the forming ability of the nanocomposite structure. Namely, the amorphous layers inhibited the nanocrystal growth by surrounding them, which led to a dense microstructure. The three coatings were also well bonded to the substrate, which is due to the gradient change in the bias voltage during coating deposition. The kinetic energy of the evaporated particles was adjusted by changing the substrate bias. The variation in the bombardment effect could change the surface energy of the coating and make an internal stress gradient distribution along the direction of the coating growth, which avoided the stress concentration and resulted in denser coating tissues [26]. A good adhesion was also obtained which was especially suitable for thick coating preparation. In Figure 4, all the CrN transition layers presented a columnar structure which grew perpendicularly to the substrate surface. Moreover, there was a thin Cr layer at the bottom of the CrN transition layer. This is because the decrease in substrate bias in the later stage of ion bombardment cleaning reduced the ion energy and caused a thin Cr layer deposit on the substrate surface.

Figure 4. Fractured cross-sectional SEM images of the three coatings: (**a**) AlCrSiN coating, (**b**) AlCrSiON coating, (**c**) AlCrSiN/AlCrSiON duplex coating.

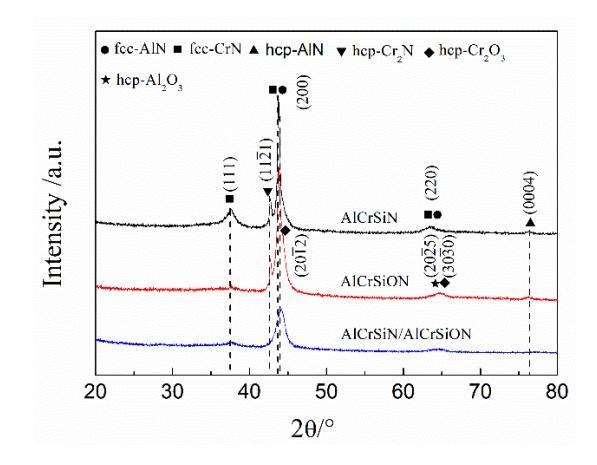
Figure 5 showed the X-ray diffraction patterns of the AlCrSiN coating, AlCrSiON coating, and AlCrSiN/AlCrSiON duplex coating. It can be seen that the main phase of the three kinds of coatings was the fcc-(Al,Cr)N phase. The strongest diffraction peaks of the three coatings were partially overlapped diffraction peaks of the fcc-CrN and fcc-AlN grains when 2θ was 43.7° and 43.9° , and both grew along the (200) crystal plane. Moreover, the diffraction peak intensity of the AlCrSiN/AlCrSiON duple coating was significantly reduced, which may be due to the increase in internal stresses between the two coatings, leading to a distorted crystal structure, and structural defects could also cause the decrease in the diffraction peak intensity [14]. In addition, the fcc-CrN diffraction peaks on the (111) crystal plane at $2\theta = 37.5^{\circ}$ were detected for all the coatings, and the peak intensities of the AlCrSiN coating and AlCrSiN/AlCrSiON duplex coating were significantly lower than that of the AlCrSiN coating. This may be due to the partial substitution of nitrogen atoms by oxygen atoms, which led to the weakening of the CrN diffraction peak and also refined the grain growth. Moreover, the AlCrSiN

coating and AlCrSiON coating exhibited the diffraction peaks of hcp-Cr₂N on the (1121) crystal plane

and the diffraction peaks of hcp-AlN on the (0004) crystal plane as 20 was 42.6° and 76.4°, respectively. As the diffraction angle 20 was 63.5° and 63.9°, the weak diffraction peaks of fcc-CrN and fcc-AlN grains on the (220) plane were detected in the AlCrSiN coating. The hcp-Al₂O₃ and hcp-Cr₂O₃ phases could also be identified in the AlCrSiON coating at $20 = 64.6^{\circ}$ and 65.1° , respectively. In all the XRD patterns, no diffraction peaks of silicon nitride or compounds containing silicon were detected, they maybe exist in the form of amorphous [8].

Figure 5. X-ray diffraction patterns of the AlCrSiN coating, AlCrSiON coating, and AlCrSiN/AlCrSiON duplex coating.

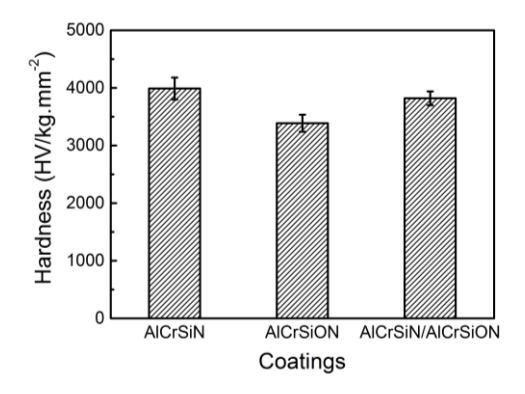
Figure 6 showed the hardnesses of the AlCrSiN coating, AlCrSiON coating, and AlCrSiN/AlCrSiON duplex coating. It can be seen that the coating hardness decreased to some extent after adding oxygen. The AlCrSiN coating possessed the highest hardness of 4000 ± 190 HV. The hardness of the AlCrSiON coating decreased sharply to 3400 ± 140 HV after oxygen doping. However, the hardness of the AlCrSiN/AlCrSiON duplex coating maintained about 3800 ± 120 HV. Combined with the XRD spectrum (Figure 3), it was found that the high hardness of the AlCrSiN coating was mainly caused by the hard (Al,Cr)N phase, while the other two coatings impaired hardness due to the incorporation of oxygen [29]. The formation of brittle oxide made the cracks easy to initiate and expand, which led to the decrease in the coating hardness. In the AlCrSiN/AlCrSiON duplex coating, the heterogeneous interface played an important role in prohibiting the crack propagation, grain boundary sliding, and dislocation movement, so a certain strengthening effect was achieved. In addition, the harder underlying AlCrSiN layer also provided hard support. As a result, the hardness of the AlCrSiN/AlCrSiON duplex coating was between the AlCrSiN coating and AlCrSiON coating.

Figure 6. Hardnesses of the AlCrSiN coating, AlCrSiON coating, and AlCrSiN/AlCrSiON duplex coating.

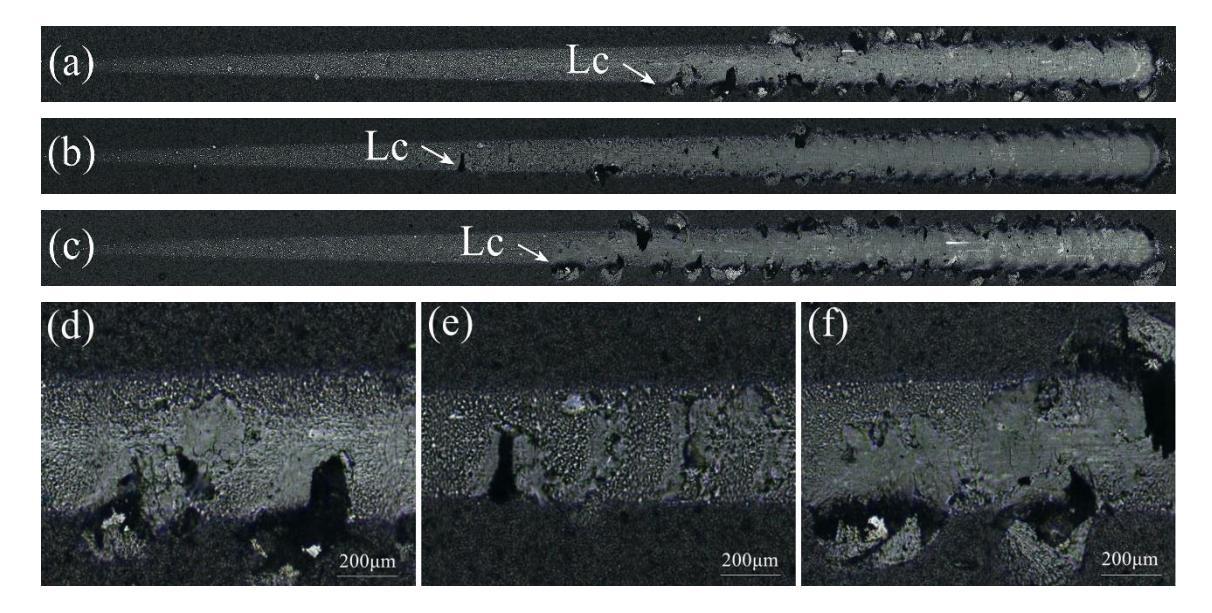
The scratch profile views of the AlCrSiN coating, AlCrSiON coating, and AlCrSiN/AlCrSiON coating shown in Figure 7a–c, and Figure 7d,e are partially enlarged views of the failure position of the three coatings. The scratch test is generally divided into three stages. One is the stage of micro cracks just entering the running, although the coating has slight cracks, and is not yet invalid. In the second stage, the coating begins to peel off locally, and the functionality of the layer is affected and the coating begins to fail. The load at this time is also defined as the critical load (Lc) indicating the adhesion between the coating and substrate. In the third stage, the coating is completely peeled off

and the substrate is exposed, so the coating loses its function [30]. In this work, all three coatings did not exhibit the third stage when undergoing the maximum normal load of 150 N, which suggests an excellent adhesion between the coating and substrate. Figure 8 showed the critical loads of the three coatings. The AlCrSiN coating possessed the highest adhesive strength, and its critical load was about 80.9 ± 1.5 N; the AlCrSiON coating presented the lowest critical load of 50.6 ± 2.2 N; the critical load of AlCrSiN/AlCrSiON duplex coating was 70.7 ± 1.8 N. From Figure 7, it can be seen that the AlCrSiN coating and AlCrSiN/AlCrSiON duplex coating were accompanied by relatively large local spalling on both sides of the scratch scars, and much debris with a fish scale shape could be found. This is because a large number of brittle cracks occurred when the rockwell C diamond stylus moved across the hard coating surface. There was less local peeling on both sides of the scratch scar of the AlCrSiON coating, although its critical load was the lowest. The low hardness of the AlCrSiON coating was an important reason for the above phenomenon.

Figure 7. Images of scratch scar and partial enlargement of the three coatings after scratch tests, (**a**,**d**) AlCrSiN coating, (**b**,**e**) AlCrSiON coating, (**c**,**f**) AlCrSiN/AlCrSiON duplex coating.
