Article

Tribocorrosion Performance of Cr/CrN Hybrid Layer as a Coating for Machine Components Used in a Chloride Ions Environment

Marcin Kowalski^{1,*} and Arkadiusz Stachowiak²

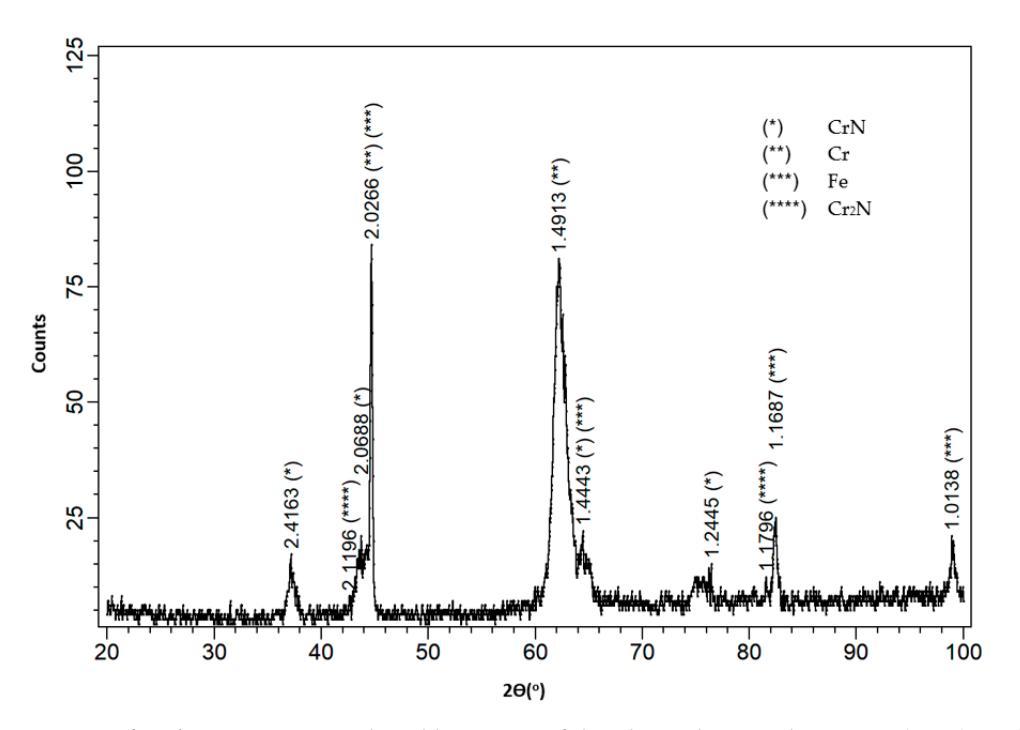
It can be concluded from Figure 1 that in the hybrid layer composed of Cr and CrN there occur CrN phases with a regularly centered grid and Cr_2N with a hexagonal grid. The examination also shows the presence of chromium and iron phases.

Figure 1. XRD pattern of Cr/CrN coating produced by means of the physical vapor deposition (PVD) method on AISI 1045 steel.

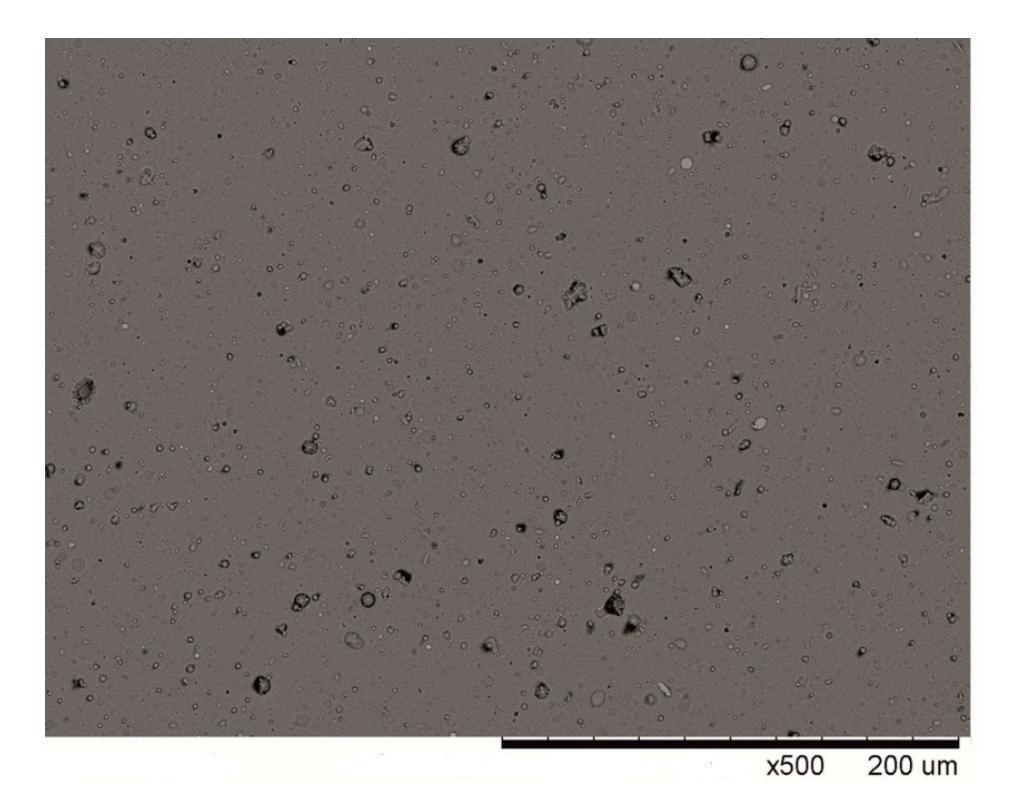
The surface of the Cr/CrN PVD coating at $500 \times$ magnification is shown in Figure 2. An analysis of the surface morphology of the obtained hybrid coating has shown a homogeneous structure with a small number of droplets. The tested thickness of hybrid coating was 4.7 µm. However, a thin coating of Cr was approximately 1 µm and thickness of CrN was about 3.7 µm.

Figure 2. An image of the hybrid layer produced using a scanning electron microscope, consisting of Cr layer and CrN, produced on AISI 1045 medium carbon steel.

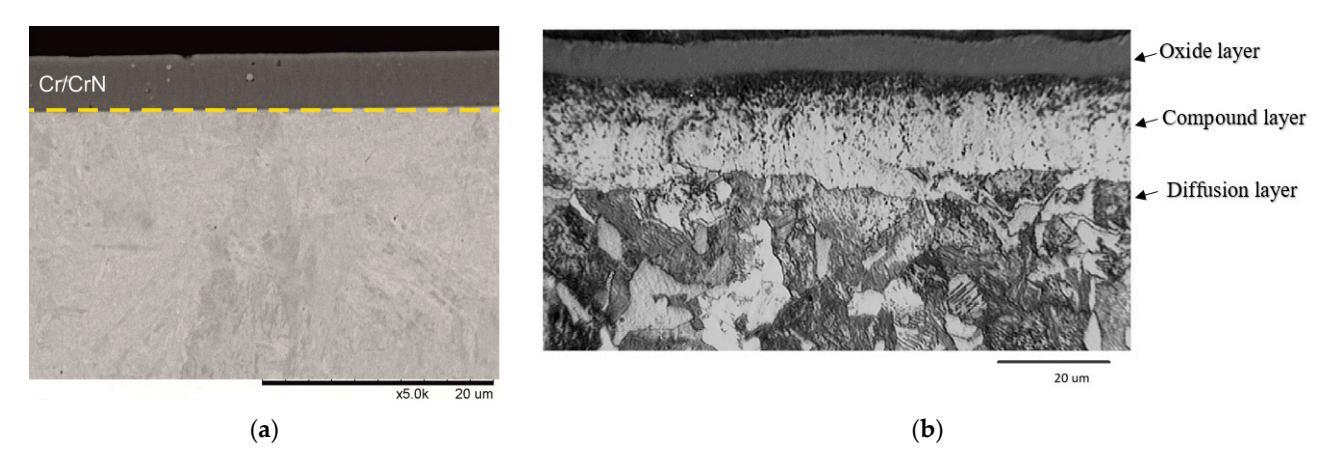
A microstructure investigation of the coatings produced on the surface of AISI 1045 steel was also carried out, and it is shown in Figure 3. The gas nitride coating with subsequent oxidation was disclosed by means of nital etching of metallographic cuts. The total thickness of the coating was about 27 μ m. However, the thickness of the oxide layer was about 6 μ m and the thickness of the nitrided gas only was about 21 μ m. The microstructure of the Cr/CrN coating was obtained on polished metallographic cro

Figure 3. The microstructure of the tested coatings produced on AISI 1045 steel (a) Cr/CrN PVD, (b) gas nitrided with subsequent oxidation and impregnation.

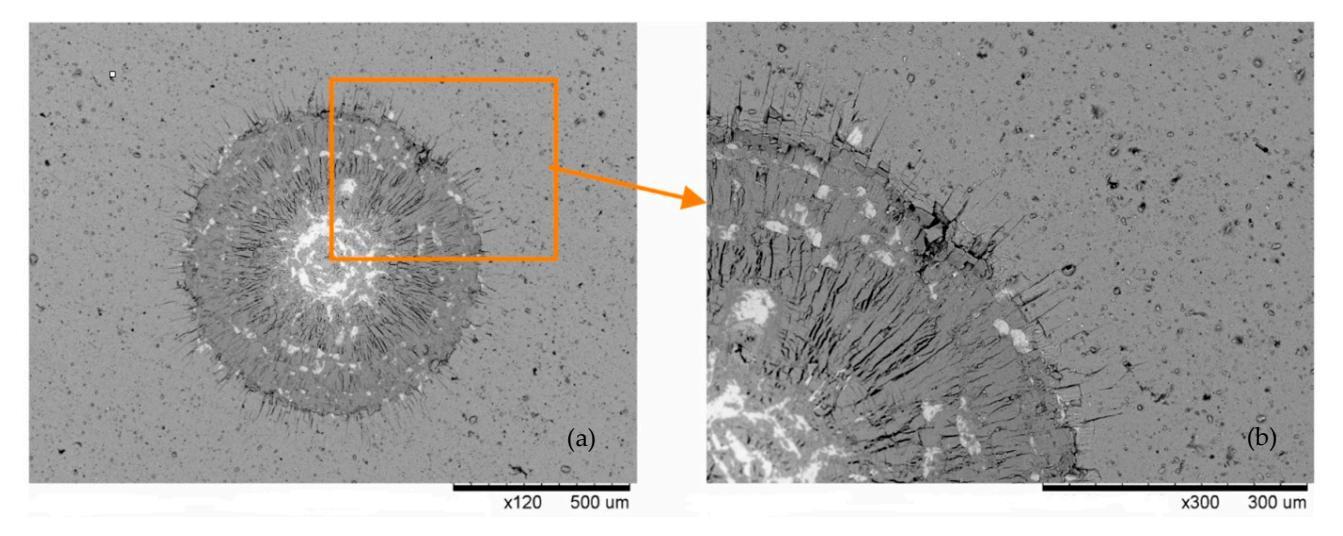
The analysis of the results of hardness measurements showed that the tested Cr/CrN PVD coating is characterized by a higher hardness than the gas nitrided coating. The Young's modulus of the Cr/CrN hybrid coating is 337 GPa. The hardness and the Young's modulus of the samples made from AISI 1045 steel are 235 HV and 202 GPa, respectively [22]. The images shown in Figure 4 make it possible to estimate the coating adhesion with the use of the indentation method.

According to the destruction classification forms presented in [24], the adhesion assessment may be assigned to grade HF2. It indicates good Cr/CrN coating adhesion to the AISI 1045 carbon steel substrate.

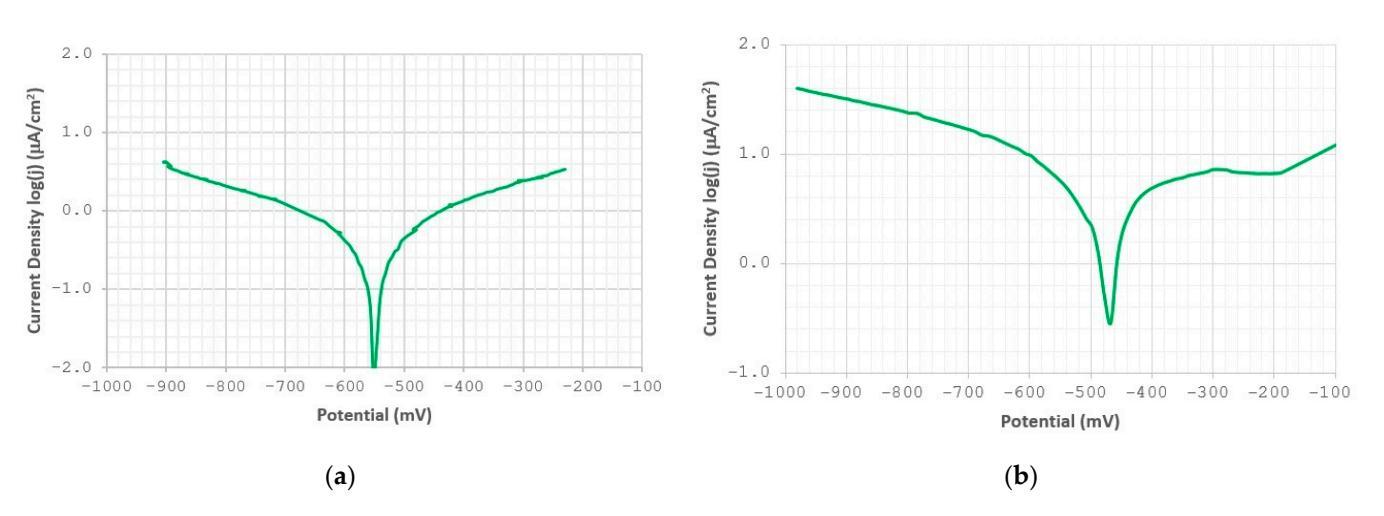
Figure 5 shows the polarization curves of the tested coatings—Cr/CrN PVD and gas nitrided with subsequent oxidation and impregnation. The polarization curves were utilized to indicate the corrosion potential and the corrosion current density. The corrosion potential of the gas nitrided coating with subsequent oxidation and impregnation is Ecorr = -468 mV and Ecorr = -553 mV for the Cr/CrN PVD coating, while the corrosion current density, i_{corr} , is 4 and 0.5 μ A/cm², respectively.

Figure 5. Polarization curves of the tested coatings: (a) Cr/CrN PVD, (b) gas nitrided with subsequent oxidation and impregnation.

The actual contact zone in the friction node is smaller for the Cr/CrN PVD coating. Consequently, the separated material comes from a smaller area due to frictional interactions. It correlates directly to the intensity of tribocorrosion wear. The tribocorrosion processes are generally initiated on the surface that is exposed by mechanical removal of the material. In the case of the harder PVD coating, tribocorrosion processes occur on a smaller area and are not as intense as in the case of the gas nitrided coating (Figure 5).

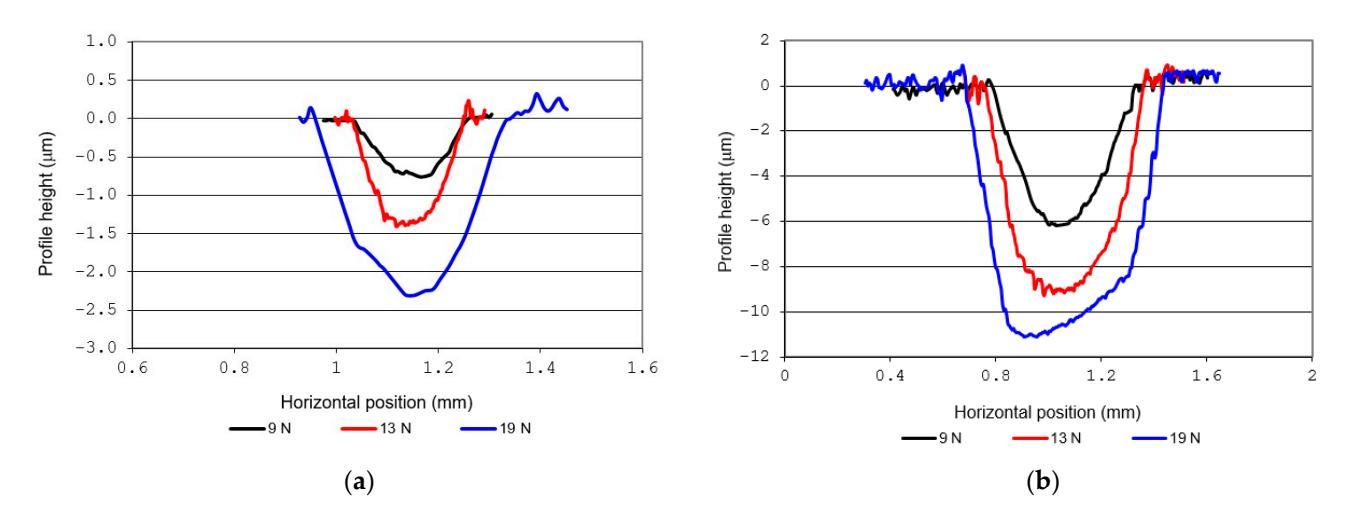
Figure 6. Profile shapes of the wear trace of the investigated coatings after tribocorrosion tests at an open circuit potential, E_{OCP} : (a) Cr/CrN PVD, (b) gas nitrided with subsequent oxidation and impregnation.

The tribocorrosion test results of the Cr/CrN PVD coating provided under the load of 9 N show the depth of the wear trace of about 1 μ m. However, under the load of 19 N, it was approximately 2 μ m. These values for the gas nitrided coating are approx. 6 and 12 μ m, respectively. The smallest tribocorrosion wear volume in the case of AISI 1045 steel with the gas nitrided coating is 0.011 mm³, and it corresponds to the 9 N load, whereas the largest wear volume—0.027 mm³—corresponds to the force of 19 N. In the case of Cr/CrN PVD coating, the material loss increases when the loads in the contact zone are enhanced. The tribocorrosion wear volume varies from 0.00064 to 0.00203 mm³ related to the changes of the acting force. All the presented results clearly show that the material loss in the case of Cr/CrN PVD coating is lower than in the case of the gas nitrided one with subsequent oxidation and impregnation coating in the chloride ions environment.

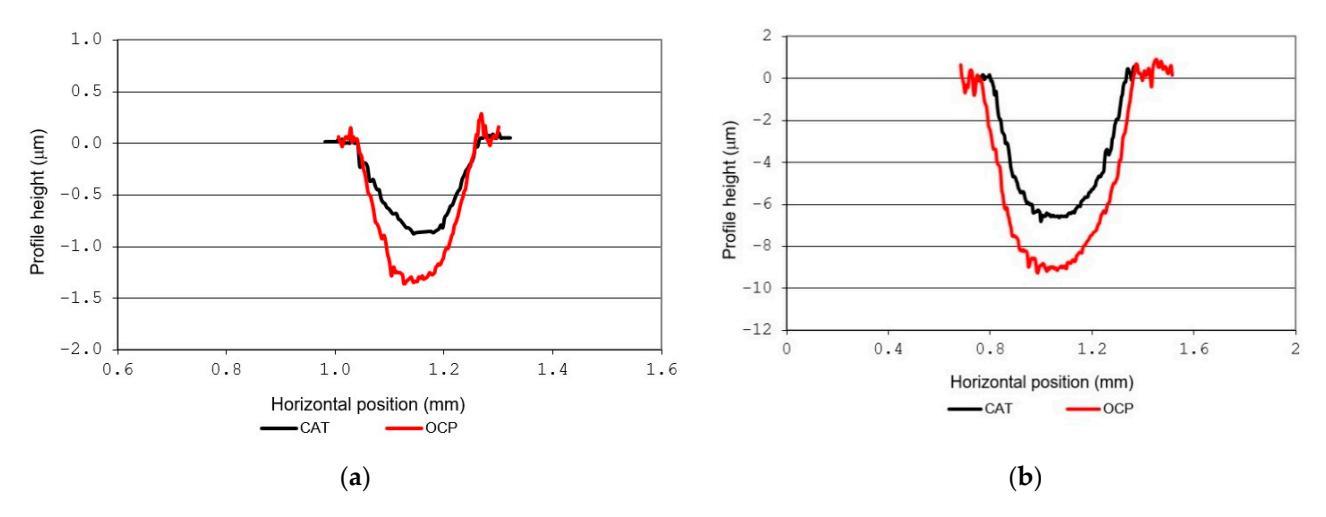
The pure mechanical wear was estimated on the basis of the test with cathodic potential polarization in 3.5% NaCl environment (approx. 900 mV vs. SCE). Exemplary wear profiles obtained for the cathodic polarization are shown in Figure 7. The mere corrosive wear (C_0) was calculated on the basis of the corrosion current density by using the Faraday equation (Table 6). In the total tribocorrosion wear of both tested materials, the mechanical wear and the corrosion synergy effect can be observed. It is above 30%.

Figure 7. Profiles shape comparison of the wear traces of the investigated coatings after tribocorrosion tests at an open circuit potential and cathodic potential: (a) Cr/CrN PVD, (b) gas nitrided with subsequent oxidation and impregnation.

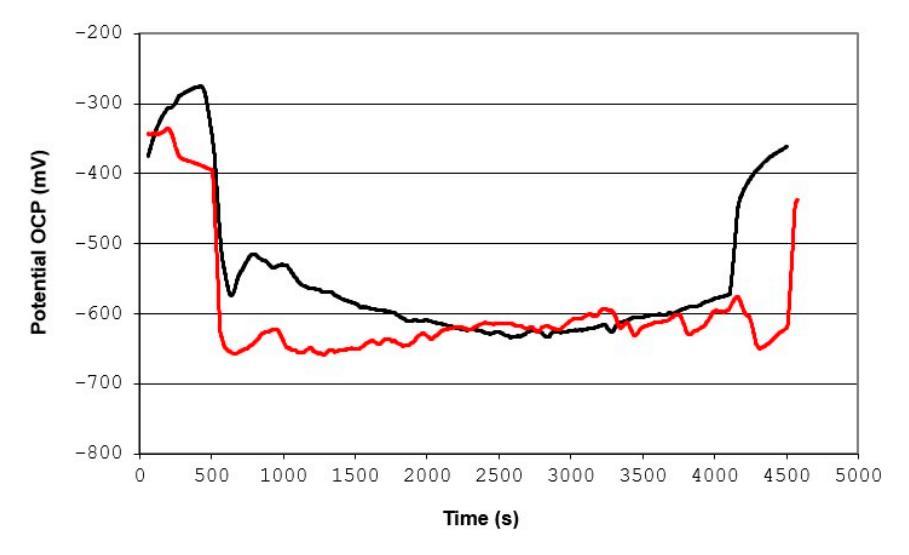
Figure 8 presents the potential changes during the tribocorrosion tests under the load of 19 N. Both tested coatings present similar potential characteristics, showing passivation capability. This is demonstrated by the decrease in the potential when the test was initiated with a ball movement. The ball displacement removes the passive layers on the sample surface. When the ball stops and the wear process is completed, the potential increases. A passive oxide layer occurs again on the wear trace surface.

Figure 8. Time evolution of the potential during the tribocorrosion test for the tested coatings at an open circuit potential, E_{OCP} : Cr/CrN PVD (the red line) and gas nitrided with subsequent oxidation and impregnation (the black line).

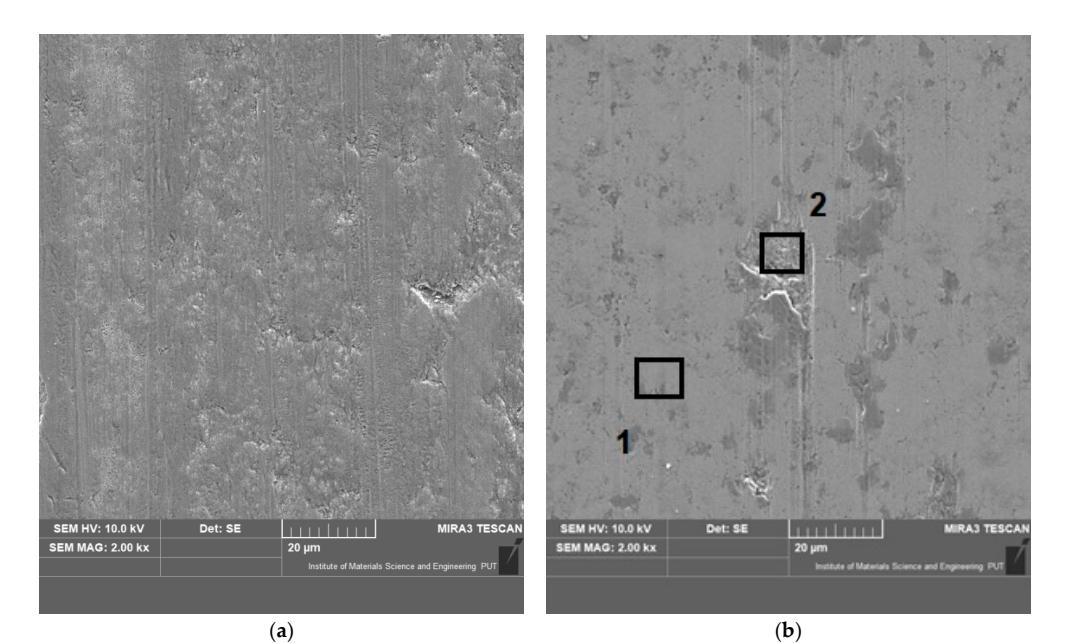
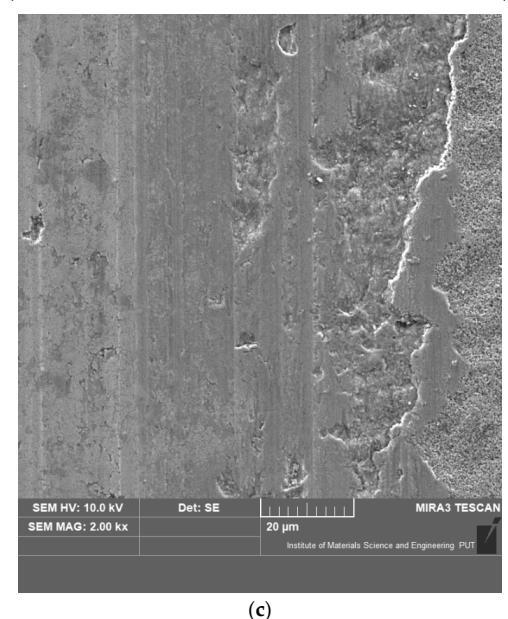
In order to verify this assumption, the elementary mechanisms of tribocorrosion were identified by observing the wear to the surface. Figures 9 and 10 show traces of wear on the tested coatings under various loads in the friction contact zone. The images depict the diversity of the wear mechanisms (their type and intensity). It can also be seen that the pressure in the contact zone affects the tribocorrosion process.

Figure 9. Pictures of the wear trace surface for the gas nitrided coating at an open circuit potential, *E*_{OCP}, under specific loads: (**a**) 9 N, (**b**) 13 N, (**c**) 19 N.

For the lowest load value in the contact zone the abrasive wear prevails in the case of the gas nitrided coating. (Figure 9a). The parallel grooves are noticeable on the surface of the wear trace that correspond to the movement direction of the counter-sample. When the tests were completed under the load of 13 N, local cavities along the friction path occurred (Figure 9b—area 2). These are most likely due to the corrosive nature of the environment in places where the material separation (a phenomenon of local nature) had previously occurred as a result of friction. Such a mechanical separation of the material can also result from cracking of the hard surface layer. The area of the local cavity was analyzed in terms of its chemical composition. The obtained result differs from the chemical composition of the tested material in the area of a uniform material loss. The sites where the chemical composition was analyzed are marked in Figure 9b. The results of the analysis are presented in Figure 11. The difference (a lower nitrogen content) may indicate a large depth of the defect. A local cavity can create a synergy of friction and corrosion in the total tribocorrosion wear. Under the cyclic conditions, crack initiation may occur as a

result of fatigue processes leading to the separation of larger material part around cavities (pits). These forms of wear are indicated following the test under the highest load value (Figure 9c). The numerous material detachments along the friction path may also be a result of plastic deformation. The implemented force of 19 N during the test facilitates the described material damage, especially around local pits. The authors of [33–35] have also found that the tribocorrosion of nitride steel causes local indentation that initiates material loss caused by fatigue.

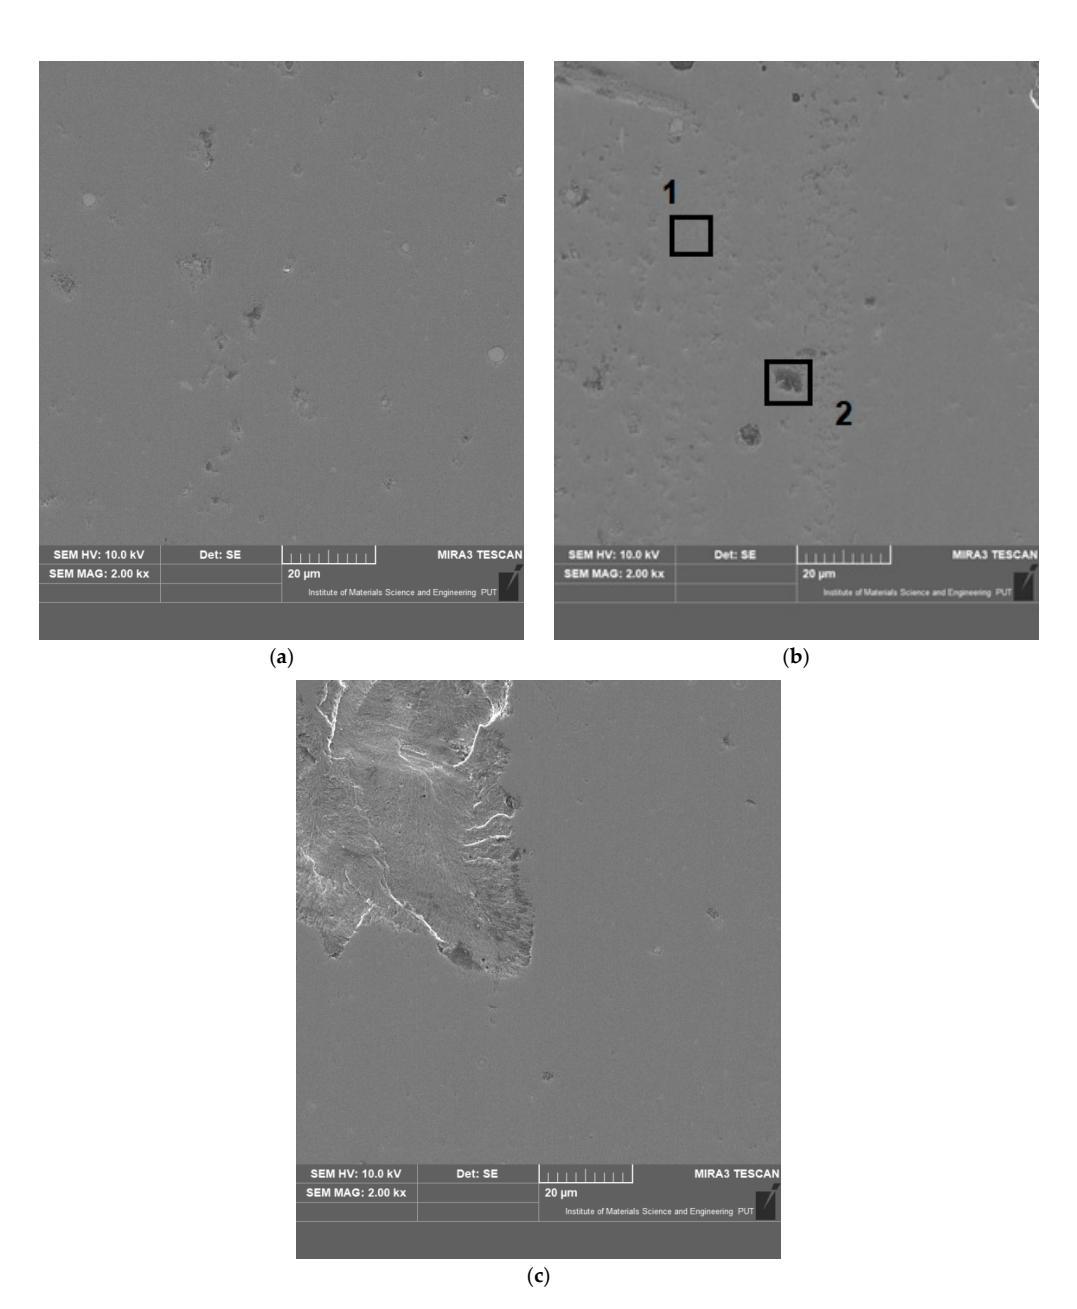
Figure 10. Pictures of the wear trace surface for Cr/CrN PVD coating at an open circuit potential, *E*_{OCP}, under specific loads: (**a**) 9 N, (**b**) 13 N, (**c**) 19 N.

The Cr/CrN PVD coating is characterized by a higher hardness and better corrosion resistance in a 3.5% NaCl environment. The above-mentioned properties of the coating determine the course of elementary wear mechanisms in the tribocorrosion process. At the lowest tested load value, the PVD coating (Figure 10a) has a milder abrasive wear (shallow grooves) compared to the gas nitrided one. In the case of an average tested load value (13 N), the grooves appear less frequently, and the wear is of a milder form (Figure 10b). Figure 12 compares the chemical composition of the sample inside the local cavity (Figure 10b—area 2) and within its vicinity in the area of a uniform material defect (Figure 10b—area 1). The significantly lower content of chromium and nitrogen may indicate a large pit depth. The higher hardness of the Cr/CrN PVD coating ensures greater resistance to plastic deformation and adhesion. Therefore, the detachment of larger fragments of the material occurs only locally at the highest loads (Figure 10c). Similar tribocorrosion mechanisms were observed in other studies [17,35–37].

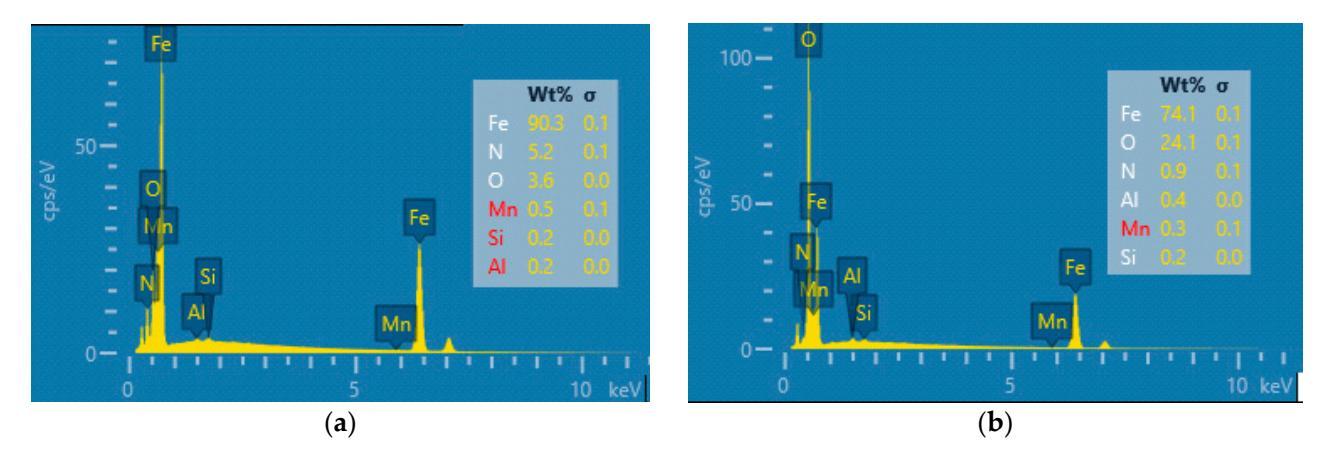
Figure 11. An analysis of the chemical composition of the wear trace for the gas nitrided coating (13 N): (**a**) the area of a uniform material loss (Figure 9b—area 1), (**b**) local cavity (Figure 9b—area 2).

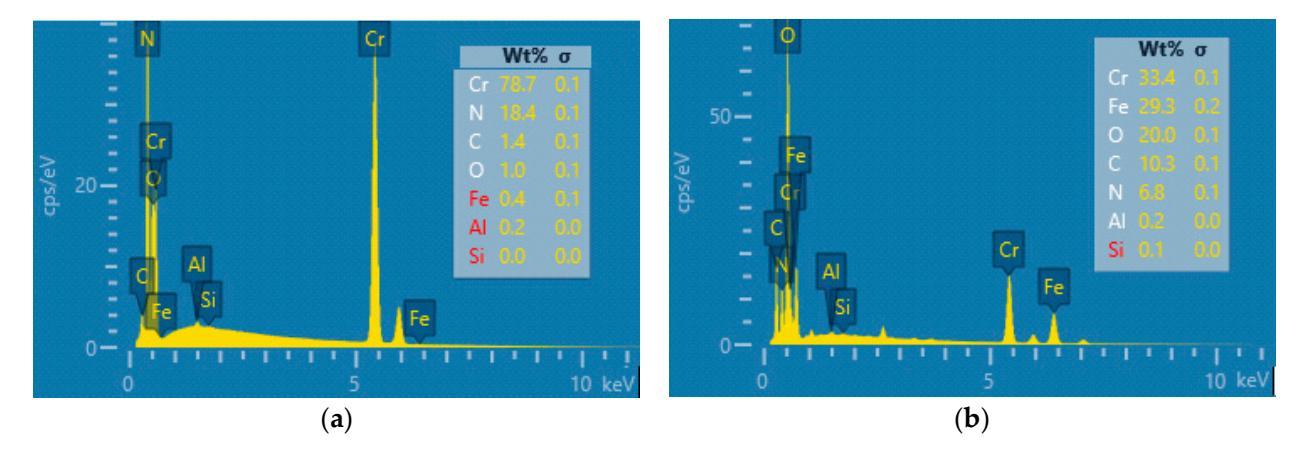
Figure 12. An analysis of the chemical composition of the wear trace for Cr/CrN PVD (13 N): (**a**) the area of a uniform material loss (Figure 10b—area 1), (**b**) local cavity (Figure 10b—area 2).

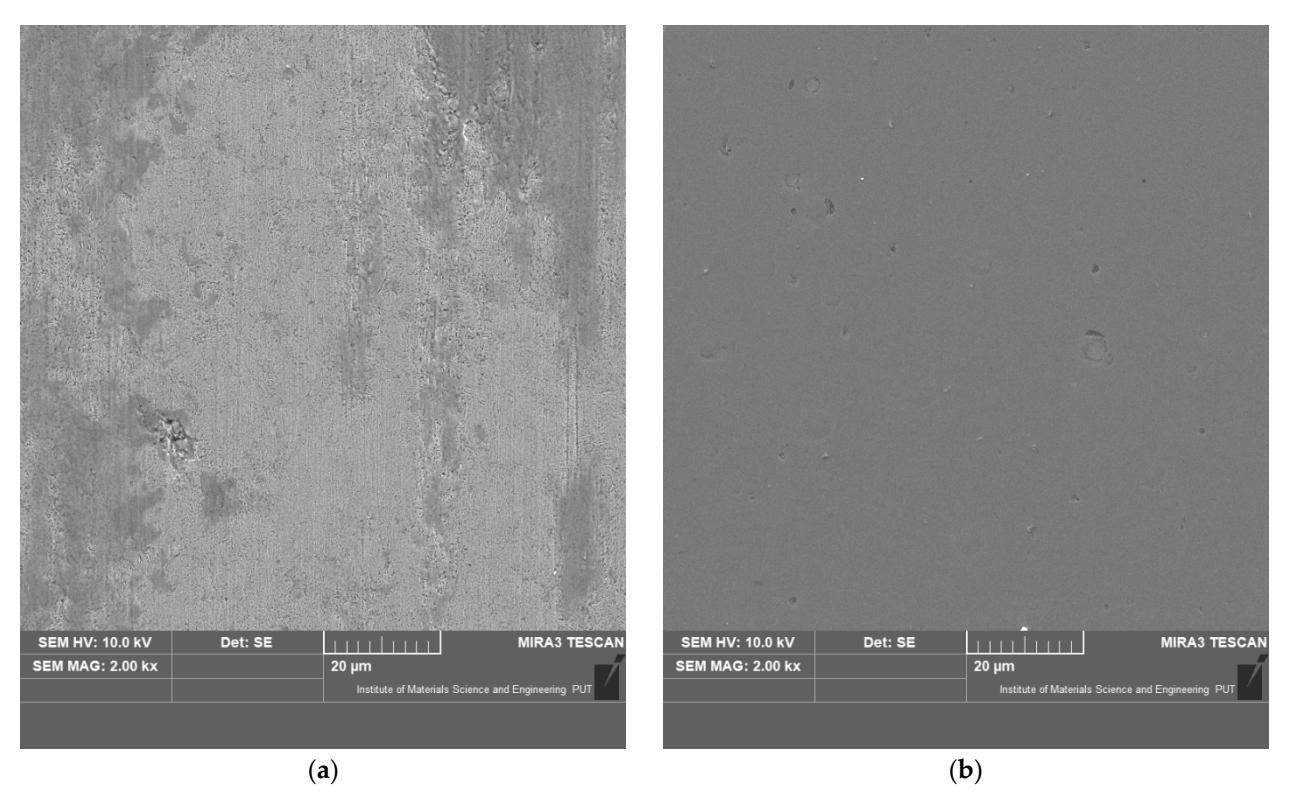
Local cavities in the wear trace, which are important for the formation of the synergy of friction and corrosion, are the result of local corrosion processes. It may be proved by the fact that such forms of damage do not occur under conditions of cathodic polarization. The surface of the wear trace following the tribocorrosion tests under cathodic polarization is shown in Figure 13. In comparison with the traces obtained at the OCP potential, there are no visible local pits (for both materials). Such pits do not form under cathodic polarization conditions. Generally, material loss occurs as a result of abrasive wear.

Figure 13. Pictures of the wear trace surface at an open circuit potential, E_{OCP} , under the load of 13 N: (**a**) gas nitrided with subsequent oxidation and impregnation, (**b**) Cr/CrN PVD.
