Article Effects of Heat Treatment and Erosion Particle Size on Erosion Resistance of a Hypereutectic High-Chromium Cast Iron

Keywords: high-chromium cast irons; solid particle erosion; heat treatments; microstructure

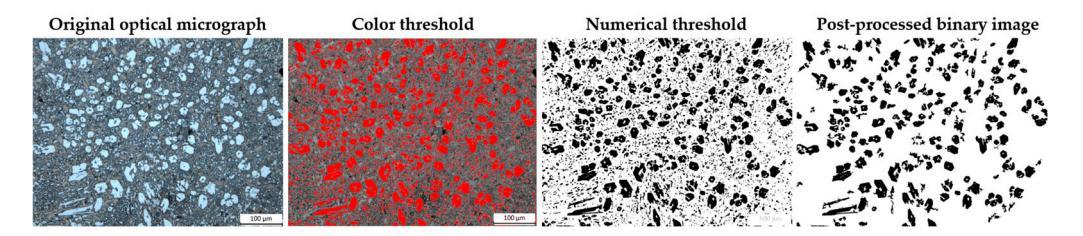
Figure 1. Image post-processing sequence to evaluate the edge-to-edge distance between carbides: original optical micrograph, color threshold value setting, numerical threshold setting, and post-processed binary image.

To investigate the role of the particle size of the erodent powder on erosion resistance, an analysis of the microstructural features of the HCCI was developed. By using the ImageJ image analysis software (Version 1.53e, 2020, National Institutes of Health, Bethesda, MD, USA) [29], the relative distances (named edge-to-edge distance) between primary M_7C_3 carbides were evaluated. Image analysis was conducted on each of the 9 samples used for the erosion tests: the surface was divided into 6 regions of interest (ROI), and the edgeto-edge distances were obtained for each ROI, covering a total area of 9 mm² per sample. More in detail, from the raw optical micrograph, the edge-to-edge (E-E) distances between carbide and its adjacent ones were evaluated by the image post-processing sequence displayed in Figure 1. From the original optical micrograph, the color threshold value for the identification of the features under examination was set, the numerical threshold for the evaluation of only the primary M_7C_3 carbides was set, and finally, the post-processed binary image to obtain the matrix distances of each carbide and its adjacent ones was obtained. To analyze the relative distances, a tailored Matlab[®] code was employed. Based on these findings, the sizes of the erodent powder were determined by considering two possible conditions: (i) the edge-to-edge distance greater than the mean diameter of the erodent powder, and (ii) the edge-to-edge distance less than the mean diameter of the erodent powder. Note that, from the same image analysis procedure, the area of the carbides was also evaluated and used to determine the so-called carbide volume fraction (CVF).

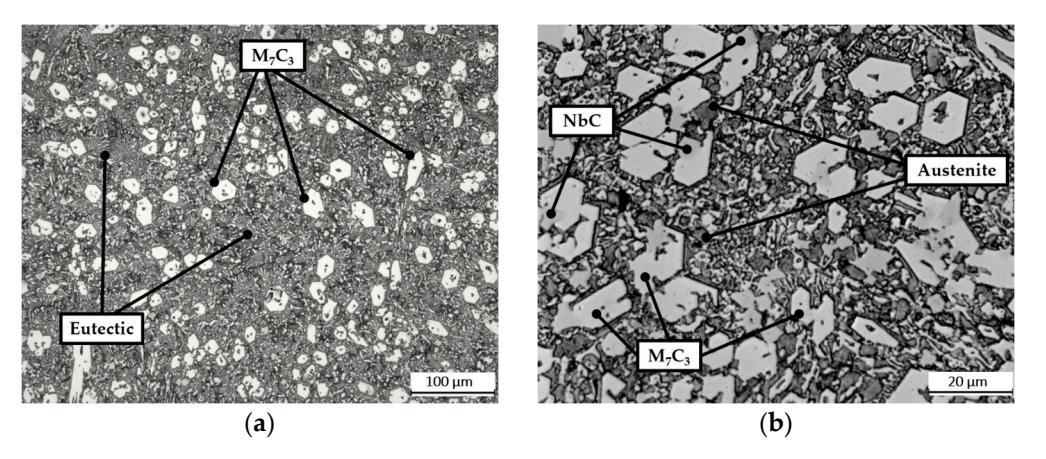
Figure 2. Optical micrographs of the investigated HCCI in the as-received condition: (**a**) pro-eutectic M_7C_3 carbides together with the eutectic constituent; (**b**) M_7C_3 and NbC carbides, austenite.

Figure 2 displays optical micrographs of the investigated HCCI in the as-received condition. The microstructure comprised pro-eutectic carbides of the M_7C_3 type, both in hexagonal and elongated forms, appearing as light polygons. The observed morphology, i.e., an irregular polygonal shape with hollows at the center and gaps on the edge, has been widely analyzed in numerous studies [10,34]. The disclosed morphology resulted from solidification conditions occurring during the welding deposition of the hardfacing onto the steel substrate, as observed by Chung et al. [15]. Compacted NbC carbides, integrated with Cr-rich carbides, can be observed in the microstructure (Figure 2b). This form has been related to the growing process: NbC carbides may have acted as nucleators of M_7C_3 primary carbides, similarly to the nucleation of austenite dendrites [16,35].

The quantitative image analysis of the observed microstructure revealed a mean CVF of $24 \pm 3\%$. Several authors propose to relate the CVF parameter with the erosion resistance of the material [17,18,36]. However, this parameter does not account for the shape and distribution of the carbides but only indicates the fraction of the area occupied by them. Hence, to obtain an effective parameter addressing the role of microstructure and erodent powder characteristics, the edge-to-edge distances of adjacent M₇C₃ primary carbides were evaluated. From the image analysis, the mean E-E distances resulted in $12 \pm 2 \,\mu$ m, $9 \pm 3 \,\mu$ m, and $11 \pm 2 \,\mu$ m for the as-received HT1 and HT2 conditions. This experimental observation aligns with earlier research [14], indicating that eutectic carbides remain largely unaffected by heat treatments, while the treatments primarily induce microstructural modifications in the matrix, as detailed below.

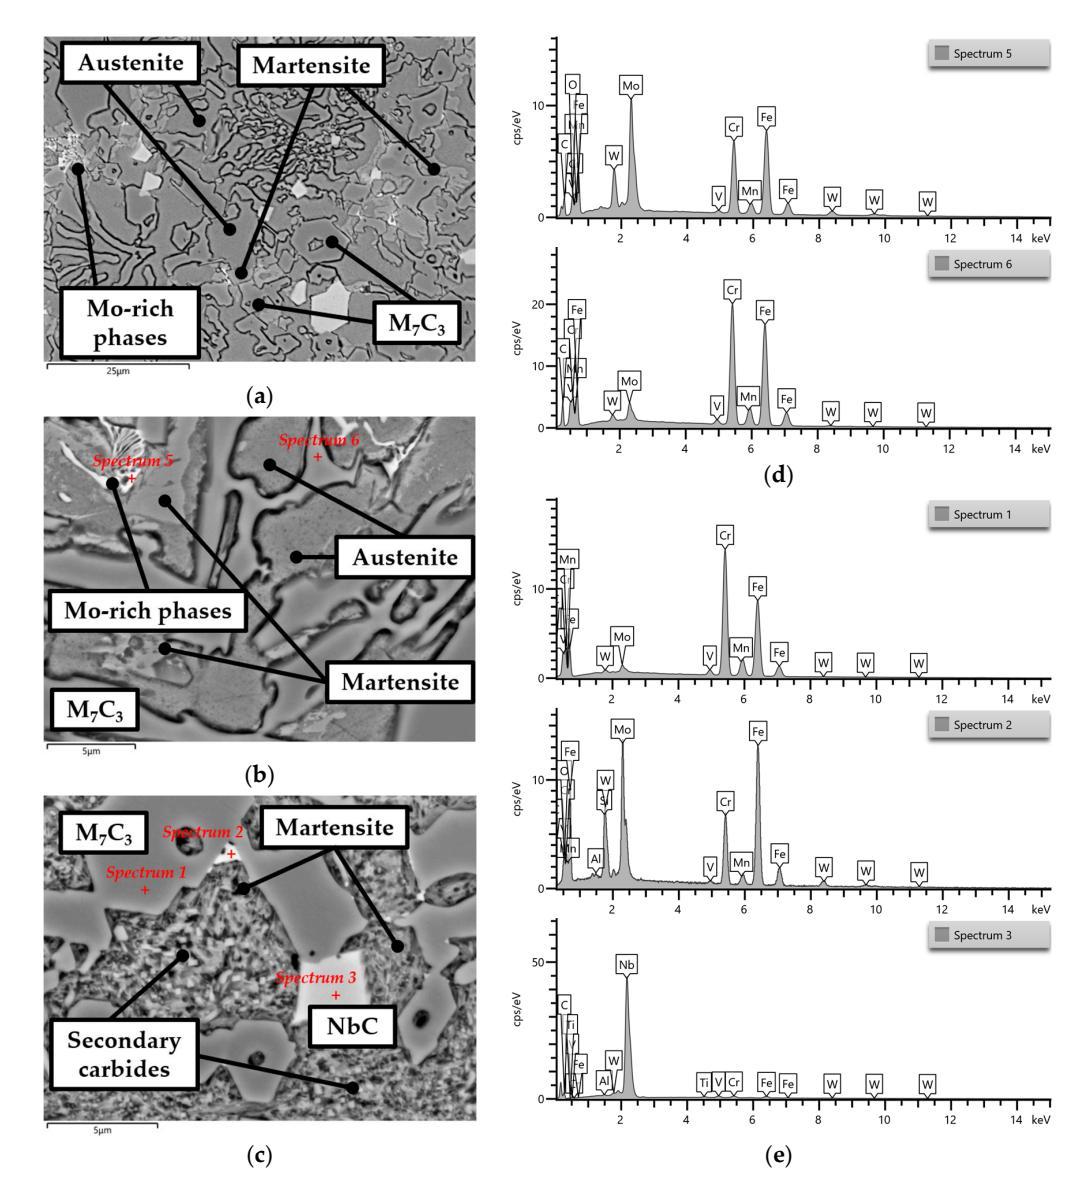
Figure 3. BSE-SEM micrographs (**a**–**c**) and EDS spectra (**d**,**e**) of the investigated HCCIs in: (**a**) as-received, (**b**) HT1, and (**c**) HT2 conditions. (**d**) EDS spectra for the point analyses in (**b**); (**e**) EDS spectra for the point analyses in (**c**).

SEM analyses of the HCCIs were conducted on as-received and heat-treated conditions to detect the microstructural changes that occurred (Figure 3). As for the as-received condition (Figure 3a), the BSE-SEM micrograph revealed a microstructure consisting of pro-eutectic M_7C_3 carbides surrounded by a matrix of eutectic carbides, austenite, small amounts of martensite, Nb-rich carbides, and Mo-rich phases. These microstructural constituents were observed and characterized in a previous study by the Authors [21], where the coupled SEM and X-ray diffraction analyses enabled the identification of the austenitic microstructure and traces of martensite at the matrix/carbide interface, as the result of the local depletion of the austenite from alloying addition, as reported by Tabrett and Sare [37]. After the HT1 tempering treatment, as reported by previous studies, a reduction of the amount of retained austenite in the matrix and residual stress occurs [22,34]. Moreover, it has been recently pointed out that the primary and eutectic carbides do not change significantly with tempering parameters [38]. After tempering, see the BSE-SEM micrograph of Figure 3b, together with the corresponding EDS spectra of Figure 3d, the microstructure revealed the same microstructural constituents. Finally, the HT2 destabilization treatment (Figure 3c and the corresponding EDS spectra of Figure 3e) promoted the overall transformation of austenite into martensite, with the dissolution of eutectic carbides and the precipitation of secondary carbides. In a previous study by the Authors [21], it was detected through X-ray diffraction analyses that such destabilization treatment led to an increase in the martensite content (from 22.3 wt.% for the as-received condition to 56.9 wt.% after the destabilization), which was related to the reduction of the retained austenite content that was reduced from 33.3 wt.% for the as-received condition to 1.1 wt.% after the destabilization.

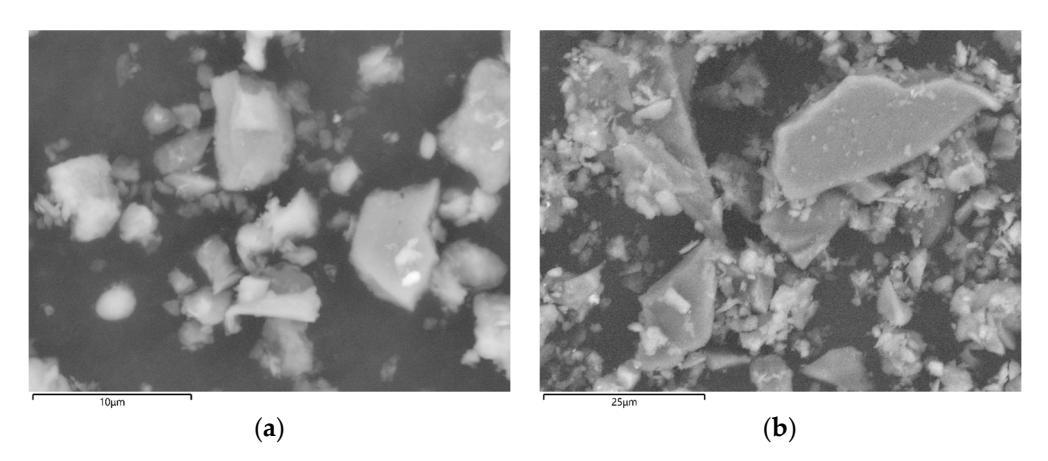
Figure 4. BSE-SEM images of the Arizona dust quartz bunch powder used in erosion tests: (a) UF powder with a dmean = $4.8 \mu m$ and (b) M powder with a dmean = $25.5 \mu m$.

Based on the results of the image analysis, two mean particle diameters of the standard Arizona dust quartz powder were chosen: dmean = $4.8 \mu m$ and dmean = $25.5 \mu m$. The powder characterization comes from a specific size characterization using the Mastersizer 3000 laser diffraction analyzer (Malvern Panalytical, Malvern, UK). The powder with smaller mean particle sizes was labeled as UF, while the larger one was labeled as M. The BSE-SEM images of the adopted powders are presented in Figure 4, where the irregular grain shape can be detected.

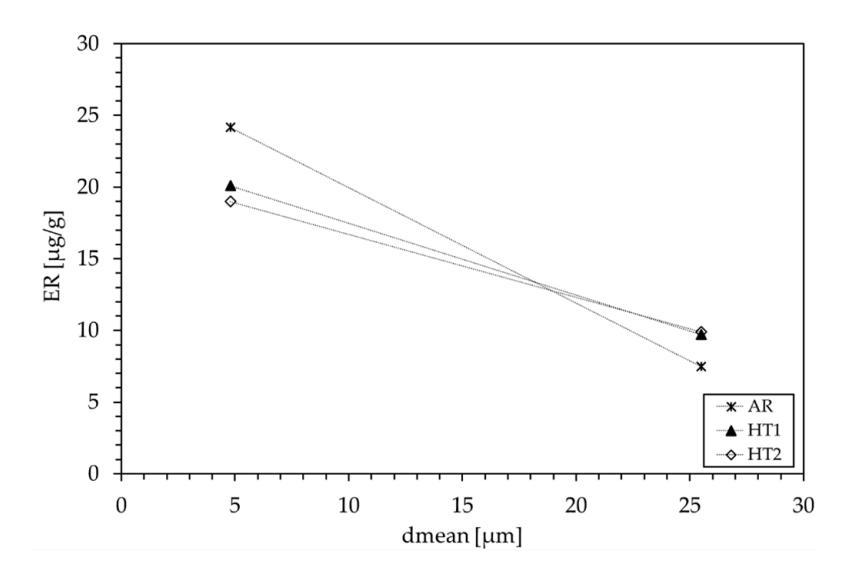
The combined effects of substrate microstructure and the erodent particle characteristics on the erosion resistance of the investigated HCCIs are summarized in Figure 5, which displays the ER as a function of the mean particle diameters of the erodent powder for the investigated conditions, namely AR, HT1, and HT2. Note that the uncertainty band associated with the ER measurements has the same size as the markers on the charts. As observed, regardless of the substrate conditions, the ER decreases with increasing the mean particle diameters of the erodent powder, indicating that the severity of the erosive phenomenon is greater for particles with smaller mean particle diameters. This result is in line with previous studies that investigated the dependence of particle impact velocity on erosion resistance and detailed the factors affecting the velocity exponent value [41–43]. In this condition, the size of the particle drives the erosion phenomenon. Looking at the effects of the heat treatment for the HT1 and HT2 conditions, a reduction of the particle velocity effects is recognizable. The differences between high-velocity and low-velocity conditions were reduced in the heat-treated samples with respect to the as-received ones. The modification of the matrix characteristics due to the heat treatment modified the overall erosion resistance characteristics of the substrate, as detailed below.

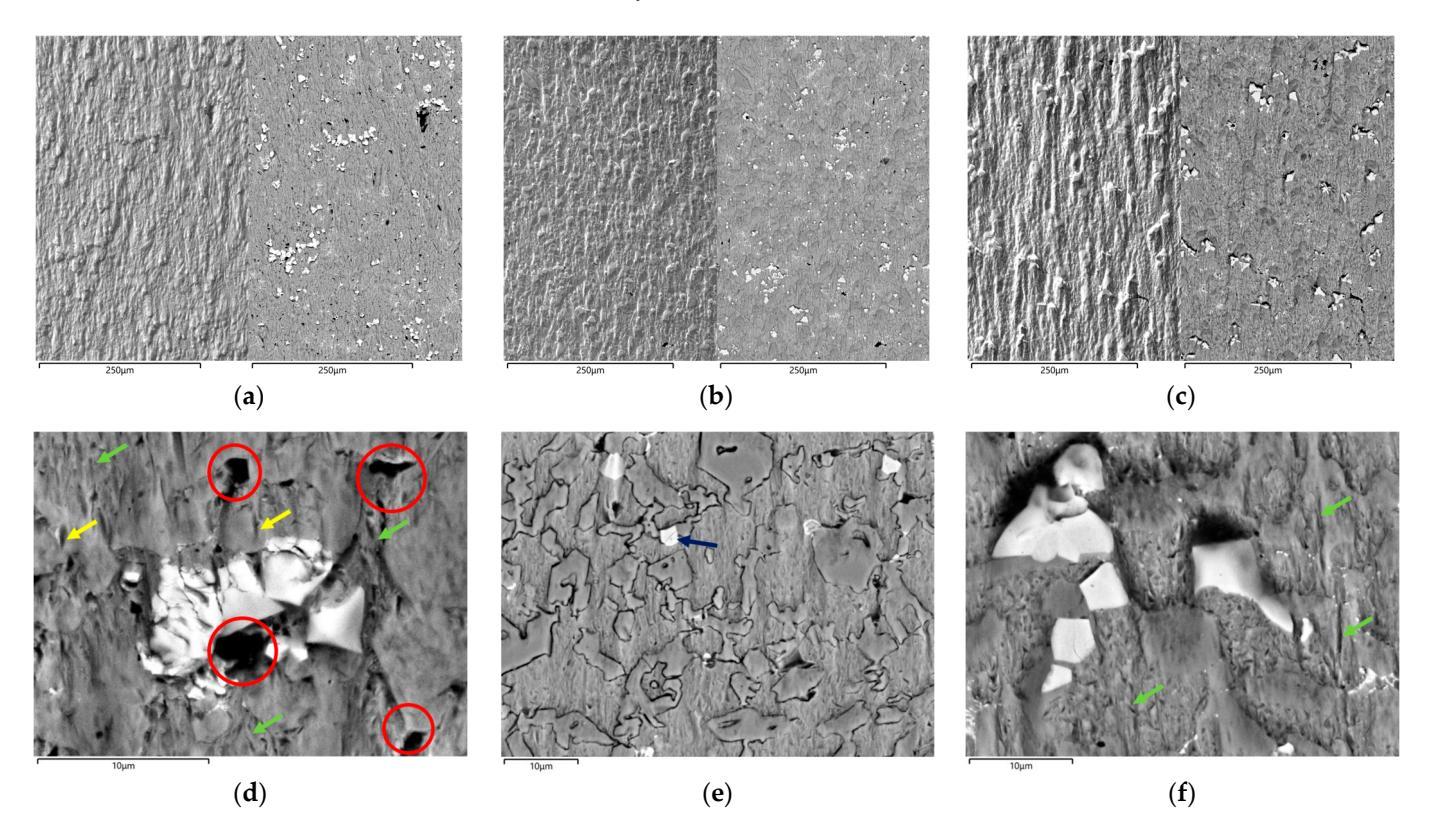
Figure 6. SEM micrographs of the worn surfaces for the AR (**a**,**d**), HT1 (**b**,**e**), and HT2 (**c**,**f**) conditions. Surfaces eroded by powder with a dmean = $4.8 \mu m$. (**a**–**c**) report the SEI-SEM image on the left and the BSE-SEM image on the right; (**d**–**f**) are blow-ups of (**a**–**c**), respectively.

The SEM analyses of the worn surfaces for the AR, HT1, and HT2 conditions are summarized in Figures 6 and 7 for the UF and M powders, respectively. The low-magnification SEM micrographs (Figures 6a–c and 7a–c) report the SEI-SEM image on the left and the BSE-SEM image on the right. By comparing the worn surfaces of the HCCIs eroded by UF powder (dmean = 4.8 μ m), see Figure 6, with the ones eroded by M powder (dmean = 25.5 μ m), see Figure 7, the contribution of the mean diameter of the erodent appeared predominant to the substrate conditions. Remarkable and wide surface damage can be detected (see Figure 6), and the particles' flow direction (from the top to the bottom of each image) can be identified (see the SEI-SEM images of Figure 6a–c).

From the blow-ups (see Figure 6d–f), the role of the microstructure was deepened. In the as-received condition (Figure 6d), the Nb-rich carbides appeared fractured and cracked due to their high hardness and brittleness. In addition, craters (red circles) and microcutting (green arrows) damage were detected on the matrix; plow scars were detected on the eutectic carbides (yellow arrows). In the HT1 heat-treated condition (see Figure 6e), the Nb-rich carbides appeared fractured (dark blue arrow), although the eutectic carbides were less damaged in comparison with the as-received condition. It is likely that the tempering treatment, promoting the relaxation of residual stresses, reduced the overall brittleness of the microstructure. On the contrary, the HT2 condition displayed wide surface damage: deep and straight plow scars (green arrows) were visible. As seen, the Nb-rich carbides, which act as a barrier to plowing, were fractured, and due to the high hardness of the matrix, they tended to fall off, as already observed in a previous study [44]. Such damage was further detailed by the EDS elemental maps in Figure 8, which displays the worn surfaces for the HT2 condition eroded by UF powder. As reported elsewhere [45], for the heat-treated conditions, the plastic deformation of the matrix is less pronounced; in addition, the primary and secondary carbides enhance the erosion resistance of the alloys. Harder Nb-rich carbides, which act as protection from erosion damage, resulted in cracking and being pulled out of the matrix, as suggested by the altered morphologies on the worn surface (Figure 8).

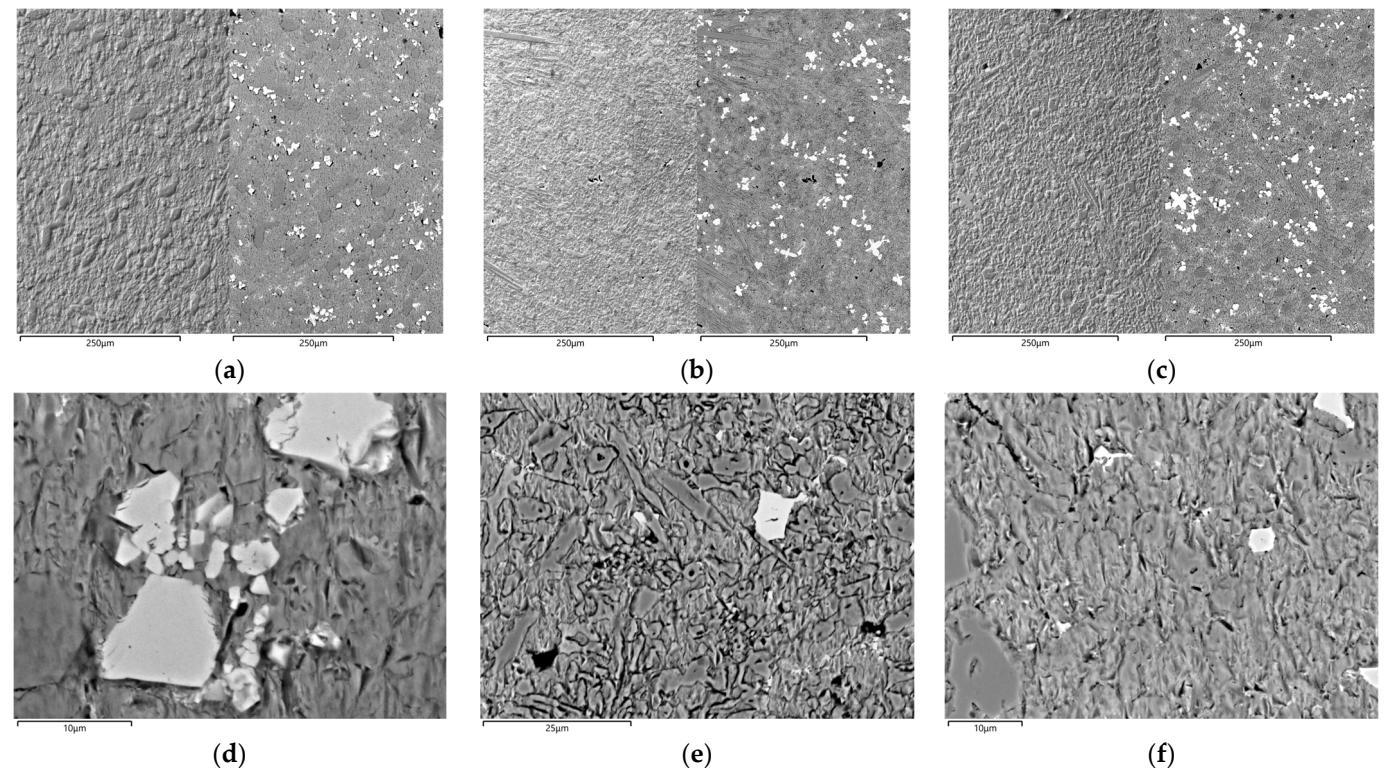
Figure 7. SEM micrographs of the worn surfaces for the AR (**a**,**d**), HT1 (**b**,**e**), and HT2 (**c**,**f**) conditions. Surfaces eroded by powder with a dmean = 25.5 μ m. (**a**-**c**) report the SEI-SEM image on the left and the BSE-SEM image on the right; (**d**-**f**) are blow-ups of (**a**-**c**), respectively.

Concerning the analysis of the worn surfaces of the HCCIs eroded by M powder (Figure 7), the particles' flow direction was not detectable, and all the surfaces appeared uniformly damaged. The BSE-SEM observations suggest that the worn surfaces eroded by M powder, see Figure 7a–c, contain a higher amount of NbC carbides with respect to the worn surfaces eroded by UF powder, see Figure 6a–c. From the blow-ups of Figure 7d–f, the role of Cr-rich and Nb-rich carbides was deepened: due to the higher erodent's particle dimension, the impact on the substrate was faced by a greater number of carbides, and thus, each of these was subjected by a lower amount of energy. From the EDS elemental

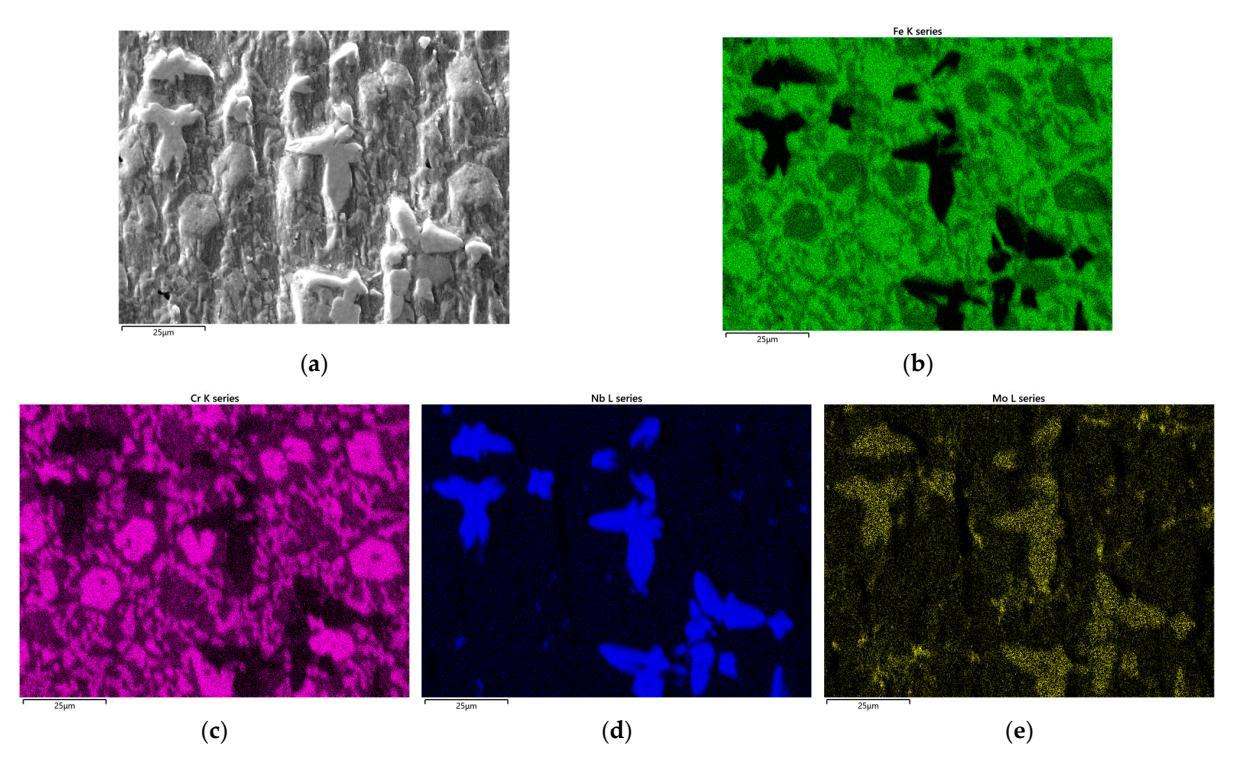
Figure 8. (a) SEI-SEM micrograph of the worn surfaces for the HT2 condition. Surfaces eroded by powder with a dmean = $4.8 \mu m$. (b–e) EDS maps of the elemental distribution of iron, chromium, niobium, and molybdenum, respectively.

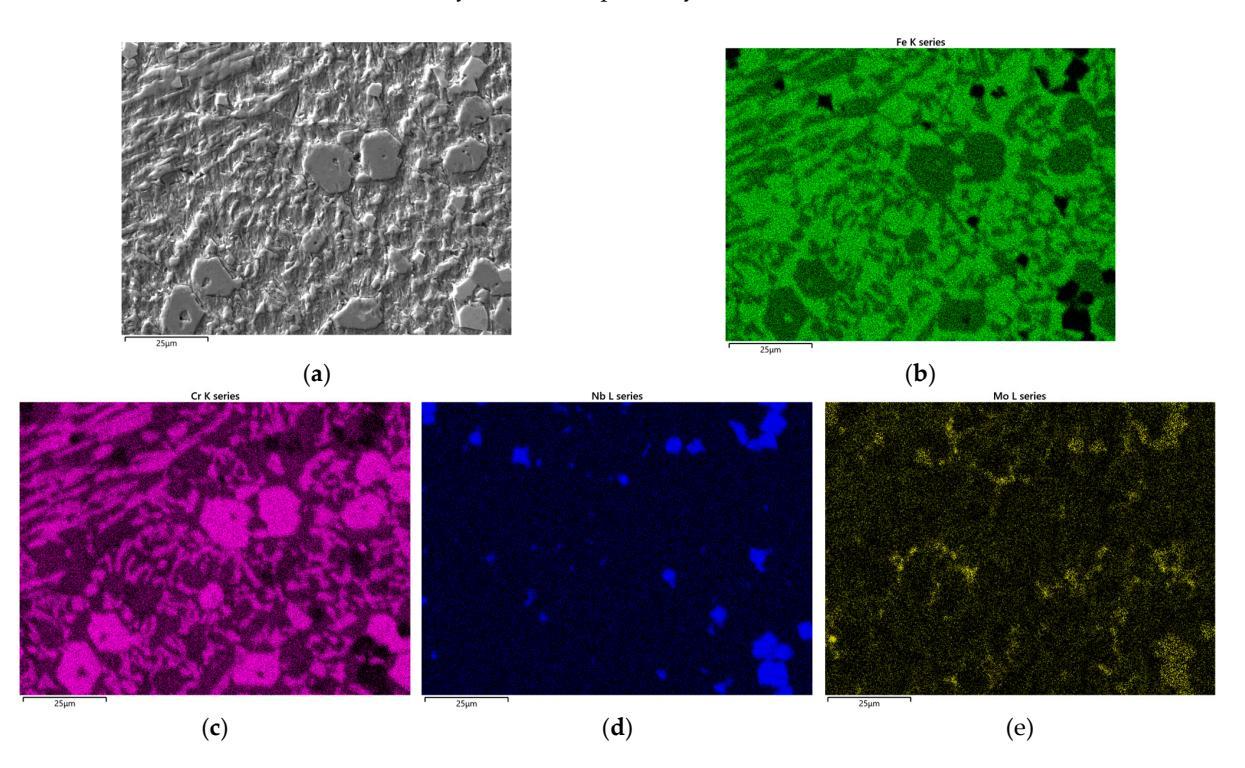
Figure 9. (a) SEI-SEM micrograph of the worn surfaces for the HT1 condition. Surfaces eroded by powder with a dmean = $25.5 \mu m$. (b–e) EDS maps of the elemental distribution of iron, chromium, niobium, and molybdenum, respectively.

maps of the worn surfaces of the HT1 condition eroded by UF powder (Figure 9), the contribution of the mean particle diameter is predominant to the microstructural changes, as also confirmed in the above-reported ER outcomes.
