# Laser Cladding of Ti-Based Ceramic Coatings on Ti6Al4V Alloy: Effects of CeO<sub>2</sub> Nanoparticles Additive on Wear Performance

**Abstract:** Ti-based ceramic coatings on Ti6Al4V substrates were successfully prepared through a laser cladding process using pre-placed starting materials of TiCN + SiO<sub>2</sub> mixed powder without or with adding a 3 wt % CeO<sub>2</sub> nanoparticles additive, aiming at improving the wear resistance of the Ti6Al4V alloy for biological applications. The effects of the CeO<sub>2</sub> nanoparticles additive on the microstructure, microhardness, and wear performance of the coatings were analyzed in detail. The observations showed that the main compositions of the cladding coating were TiCN and TiN phase. Compared to the coatings without  $CeO_2$ , the coatings modified with  $CeO_2$  nanoparticles led to more excellent mechanical properties. The average microhardness of the coatings modified with  $CeO_2$  nanoparticles was approximately 1230 HV<sub>0.2</sub>, and the wear volume loss of the coatings modified with CeO<sub>2</sub> nanoparticles was approximately 14% less than that of the coatings without CeO<sub>2</sub> under a simulated body fl

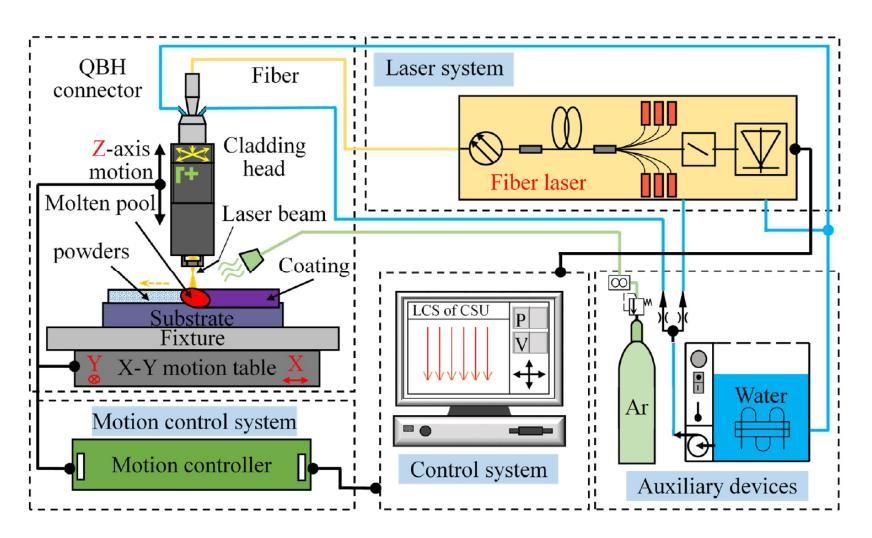
Figure 1. Schematic diagram of the laser cladding system.

Multitrack cladding coatings were prepared on a laser cladding system designed and assembled by ourselves, as presented in Figure 1. The laser system was mainly made up of an RFL-C500 fiber laser (Wuhan Raycus Fiber Laser Technologies Co., Ltd., Wuhan, China) with a maximum power of 500 W and a BT-230 laser head (RayTools AG, Burgdorf, Switzerland) that integrated a lens with a diameter of 75 mm and a focal length of 250 mm. A fiber with a core radium of 25 µm and a laser head were joined by a QBH connector [14]. During the laser cladding process, a laser beam was irradiated on the surface of the pre-placed powder layer, and then the pre-placed powder and a thin layer of the substrate melted rapidly. Meanwhile, the specimen moved zigzag with the motion table, and a continuous cladding coating formed on the surface of the substrate. The sample was placed in a container that continuously transported argon to provide shielding for the melt pool during the laser cladding process. The selected parameters for the laser cladding experiments were the optimal process parameters obtained in our previous orthogonal process experiments, listed in Table 3.

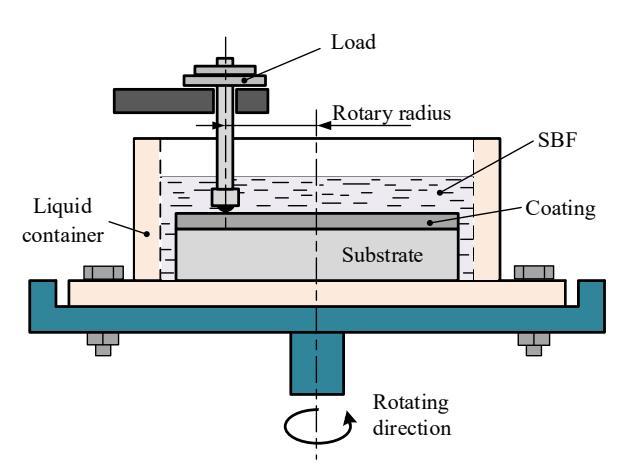
Figure 2. Schematic illustration of the wear tests for the coatings.

The wear properties of the coatings without CeO<sub>2</sub>, the coating modified with CeO<sub>2</sub> nanoparticles, and the Ti6Al4V substrate were tested on a ball-on-disk tribometer under a simulated body fluid (SBF) lubrication environment. The SBF (aseptic) was mainly composed of NaCl, KCl, K<sub>2</sub>HPO<sub>4</sub>·3H<sub>2</sub>O, MgCl<sub>2</sub>·6H<sub>2</sub>O, CaCl<sub>2</sub>, Tris, NaHCO<sub>3</sub>, etc. After aseptic treatment, pH = 7.4. The schematic diagram of the wear tests is presented in Figure 2. The counter-bodies used in the wear tests were tungsten–cobalt alloy grinding balls with a diameter of 5 mm. The experimental parameters of the wear tests are listed in Table 4.

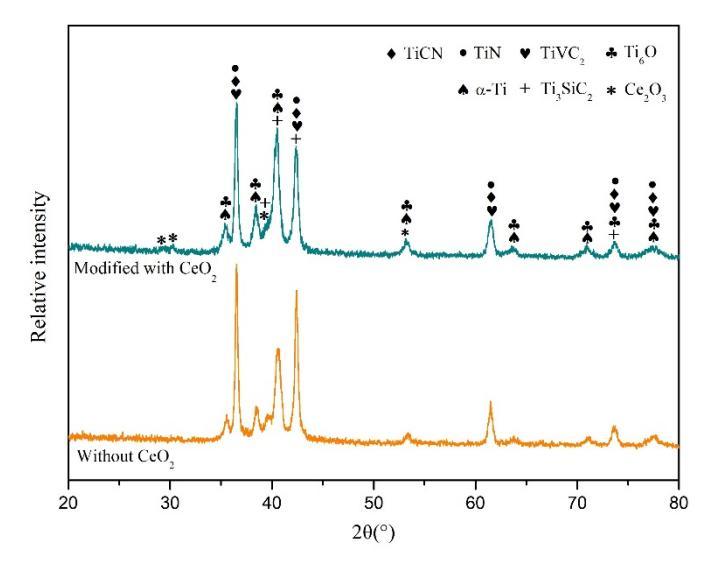
Figure 3. XRD spectrum patterns of the Ti-based ceramic coatings.

The XRD spectrum patterns of both the coating without CeO<sub>2</sub> and the coating modified with CeO<sub>2</sub> nanoparticles are respectively presented in Figure 3. The XRD pattern of the coating without CeO<sub>2</sub> was very similar to that of the coating modified with CeO<sub>2</sub> nanoparticles. It can be seen in Figure 3 that the Ti-based ceramic coatings mainly consisted of TiCN, TiN, TiVC<sub>2</sub>, Ti<sub>6</sub>O, Ti<sub>3</sub>SiC<sub>2</sub>, and  $\alpha$ -Ti phase. During the laser cladding process, the low-melting point SiO<sub>2</sub> powder (1650 °C) was melted first and formed a liquid phase, which had a wetting effect on the unmelted TiCN powder. TiCN particles were dissolved into the melt pool under the effect of melt pool convection and melted subsequently. Meanwhile, elements such as Ti and V from the substrate entered into the melt pool due to the effect of dilution. It was also noted (Figure 3) that the diffraction peaks of SiO<sub>2</sub> and TiC did not appear in the XRD spectrum patterns of the coating modified with CeO<sub>2</sub> nanoparticles was that a diffraction peak related to Ce<sub>2</sub>O<sub>3</sub> was observed in the XRD pattern. There existed some chemical reactions in the melt pool, which caused the formation of the various phases mentioned above.

Furthermore, as the 3 wt % CeO<sub>2</sub> nanoparticles additive was added into the pre-placed materials, it was seen that some weak diffraction peaks of Ce<sub>2</sub>O<sub>3</sub> appeared in the diffraction pattern, while the diffraction peak of CeO<sub>2</sub> was undetectable. This was the result of the decomposition reaction of CeO<sub>2</sub> under the high temperature. According to the report of Graciani [28], the chemical reaction is described as follows:

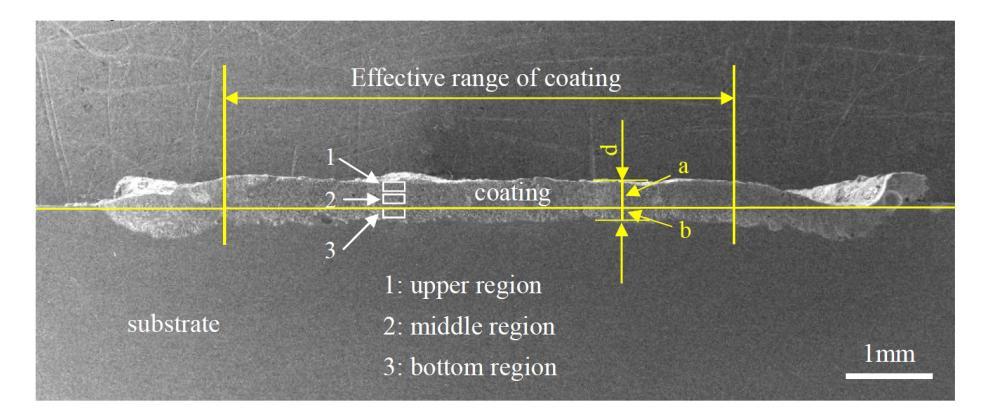
Figure 4. Typical cross-section morphology of the coating.

The cross-section SEM images of a coating modified with CeO<sub>2</sub> nanoparticles is shown in Figure 4. It can be clearly observed from the figure that there was a good metallurgical bond between the coating and the substrate. The parameters in the figure were measured by Auto CAD 2014. The thickness of the coating was  $d = a + b \approx 0.4$  mm, the average penetration depth of the bead was  $b \approx 0.13$  mm, and the average height of the coating above the substrate was  $a \approx 0.27$  mm. Therefore, the dilution rate of the coating could be calculated from the following formula:

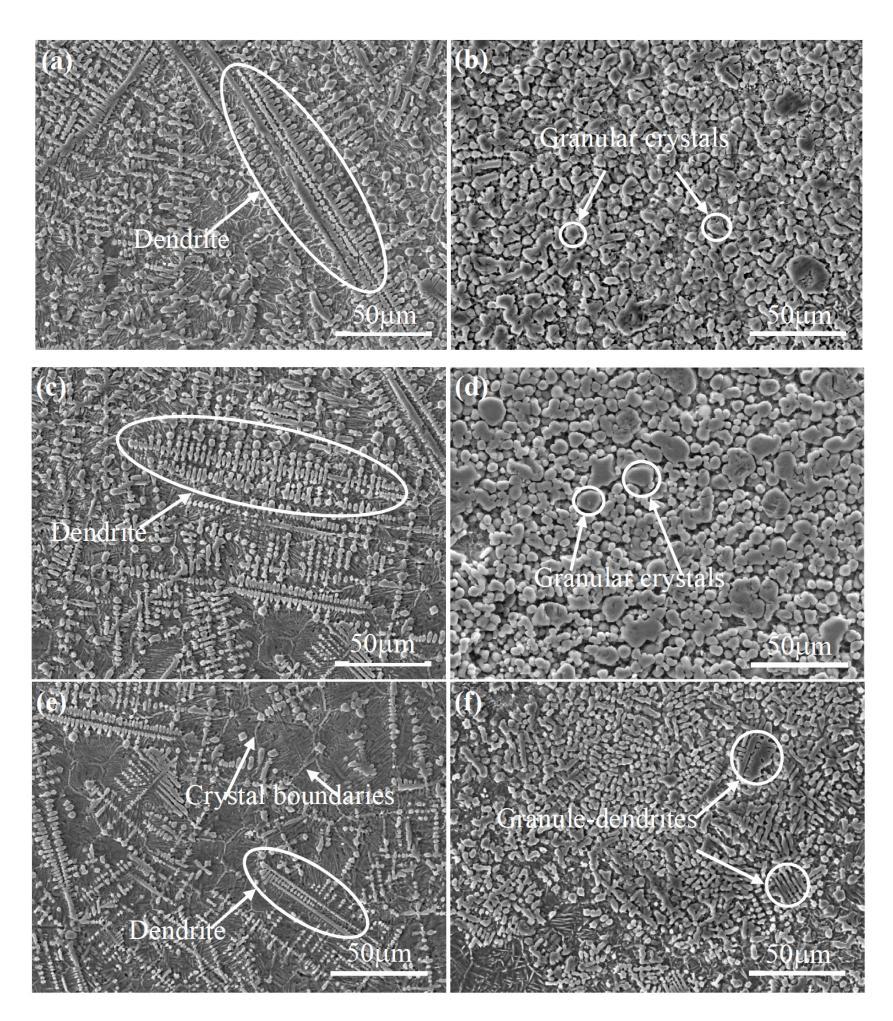
**Figure 5.** The cross-section microstructure images of the coatings (a,c,e) without CeO<sub>2</sub> and (b,d,f) modified with CeO<sub>2</sub>: Upper (a,b), middle (c,d), and bottom (e,f) regions of the coatings.

In order to understand the effect of the CeO<sub>2</sub> nanoparticles additive on the microstructure of the coating, cross-section images of the upper, middle, and bottom regions of the coatings were observed by SEM, as presented in Figure 5. It can be observed in this figure that the crystalline grain morphologies on the cross-section of the two coatings were of great difference. It can be seen in Figure 5a,c,e that the grain morphologies in the upper, middle, and bottom regions of the coating without CeO<sub>2</sub> were dendrites, and that the dendrites in the upper and middle regions were larger. In addition, some of the dendrites in the bottom region did not grow completely, so the dendrite distribution in the bottom region was sparser than that of the upper and middle regions. The microstructure images of the

coating modified with CeO<sub>2</sub> nanoparticles are presented in Figure 5b,d,f. It could be known that the crystal grain size of the coatings modified with the CeO<sub>2</sub> nanoparticles additive was smaller than that of the coatings without CeO<sub>2</sub>. The crystal grain morphology in the upper and middle regions of the coating modified with the CeO<sub>2</sub> nanoparticles additive was homogeneous and compact granular crystal, which was beneficial to improve the microhardness and wear resistance of the coating [29]. The reason for the above phenomenon was that the CeO<sub>2</sub> nanoparticles could modify and refine the microstructure of the coatings [30,31], because CeO<sub>2</sub> as a surface-active material could reduce the critical nucleation radius and restrain the growth of crystal grains [32]. Therefore, compared Figure 5 a,c,e with Figure 5b,d,f, the CeO<sub>2</sub> nanoparticles additive had an important influence on the microstructure of the coatings.

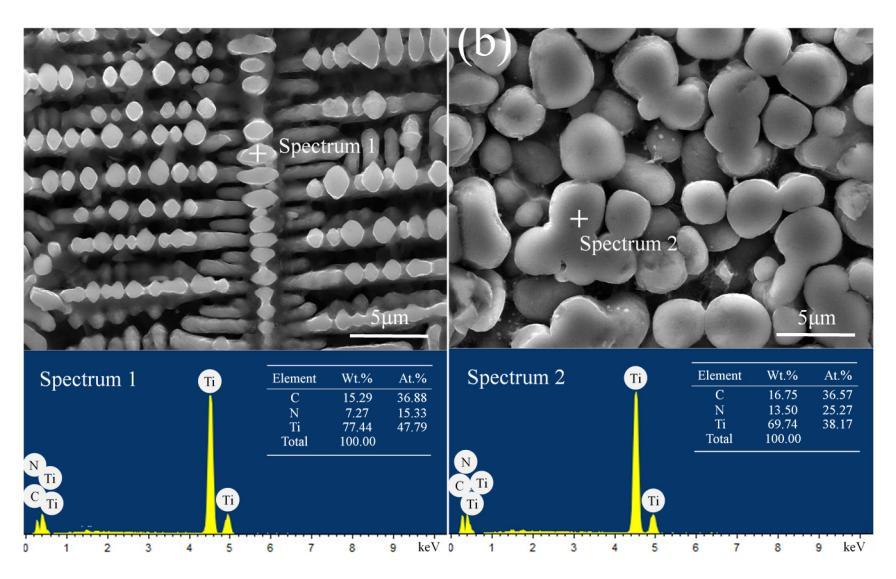
**Figure 6.** The EDS results of the typical grains in the coatings (**a**) without  $CeO_2$  and (**b**) modified with  $CeO_2$ .

To understand comprehensively the effects of the  $CeO_2$  nanoparticles additive on the coatings, the EDS results of the element compositions of typical crystal grains in the coating are shown in Figure 6. The EDS results showed that the element compositions of grains in the coating without  $CeO_2$  and the coating modified with  $CeO_2$  nanoparticles were similar, and the two types of crystal grains were mainly composed of Ti, C, and N elements. Moreover, the intensity of the diffraction peaks of each element in the patterns of the two kinds of coatings were also similar. Therefore, the  $CeO_2$ nanoparticles additive did not change the element compositions of the crystal grain in the coating, but changed the crystal grain morphology and refined the microstructure of the coating.

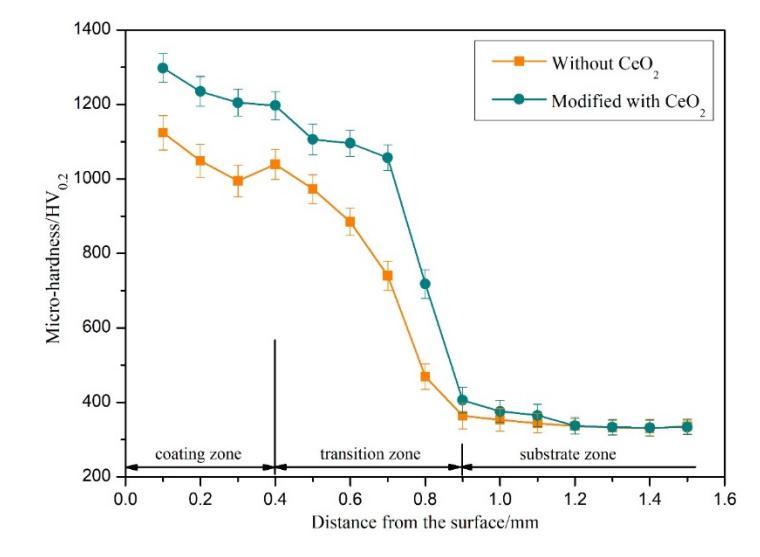
**Figure 7.** Microhardness distributions along the depth direction of the coatings without CeO<sub>2</sub> and the coatings modified with CeO<sub>2</sub> nanoparticles.

The profiles of the microhardness distribution along the depth direction from the coating top surface to the substrate are plotted in Figure 7. It can be observed in the figure that the microhardness distribution profiles could be divided into three zones: A coating zone, transition zone, and substrate zone, and the two kinds of coatings had similar microhardness distributions. Microhardness decreased gradually with an increase in the distance from the top surface, and the coating zone exhibited much higher microhardness compared to the substrate zone. The average microhardness of the coating without CeO<sub>2</sub> was approximately 1050HV<sub>0.2</sub>, which was three times that of the substrate (about  $340 \text{ HV}_{0.2}$ ). The enhancement of microhardness was mainly due to the solid solution strengthening of the TiN and TiCN [33]. TiN and TiCN are interstitial compounds, and the N and C atoms in the solid solution could cause lattice distortion [34], which increased the resistance of the dislocation movement and prevented lattice slip. It can also be observed in Figure 6 that the microhardness of the coating modified with  $CeO_2$  nanoparticles was obviously higher than that of the coating without CeO<sub>2</sub>. The average microhardness of the coating modified with CeO<sub>2</sub> nanoparticles was about 1230  $HV_{0,2}$ . The (important) reason was that the CeO<sub>2</sub> nanoparticles additive played the role of fine-grain strengthening and dispersion strengthening, making the crystal grain in the coating more uniform and compact. According to the report of Jang [35], finer crystalline grain is conducive to enhancement of toughness and strength. Therefore, the microhardness of the coating modified with CeO<sub>2</sub> nanoparticles was more improved.

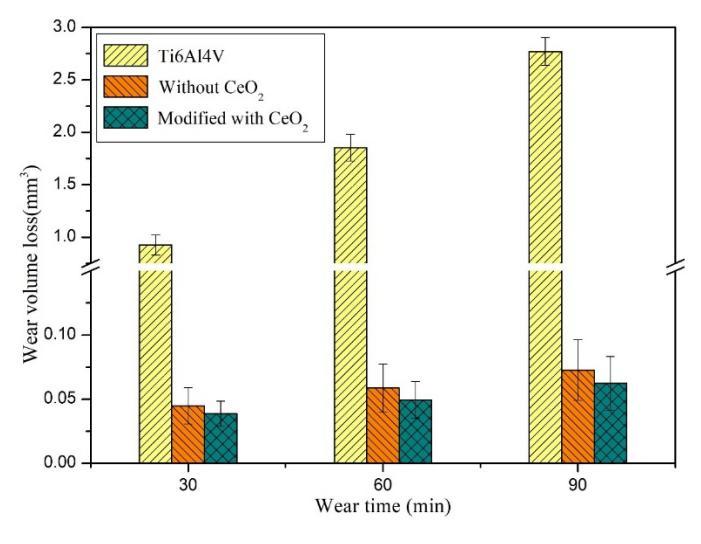
**Figure 8.** Wear volume loss of the Ti6Al4V, the coatings without  $CeO_2$ , and the coatings modified with  $CeO_2$  nanoparticles at different wear times.

The results of wear volume loss of the Ti6Al4V substrate, the coatings without CeO<sub>2</sub>, and the coatings modified with CeO<sub>2</sub> nanoparticles at different wear times are respectively plotted in Figure 8. It can be observed in Figure 8 that the wear volume loss of the substrate was significantly larger than that of the coatings at the same wear time. At 90 min of wear time, the wear volume loss of the substrate was 38.1 times and 44.5 times that of the coating without CeO<sub>2</sub> and the coating modified with CeO<sub>2</sub> nanoparticles, respectively. In other words, the wear volume loss of the ceramic coatings was about 2.2% of the wear volume loss of the substrate after a 90-min wear test, which indicated that the wear resistance of the Ti-based ceramic coatings was significantly superior to the substrate. It is also seen in Figure 8 that the wear volume loss of the coating modified with CeO<sub>2</sub> nanoparticles additive could, to some extent, improve the wear resistance of the coatings. According to Section 3.1 and Figure 5, the heterogeneous nucleation effect of CeO<sub>2</sub> nanoparticles increased the amount of nucleation, which was conducive to refining and compacting the crystal

grains in the coatings. Furthermore, in order to equilibrate the energy of distortion,  $CeO_2$  nanoparticles easily converged toward grain boundaries, which could restrain the growth of the grains, and played a key role in strengthening and purifying the grain boundaries [36,37]. As a consequence, the wear resistance of the coating modified with  $CeO_2$  nanoparticles was further enhanced compared to the coatings without  $CeO_2$ .

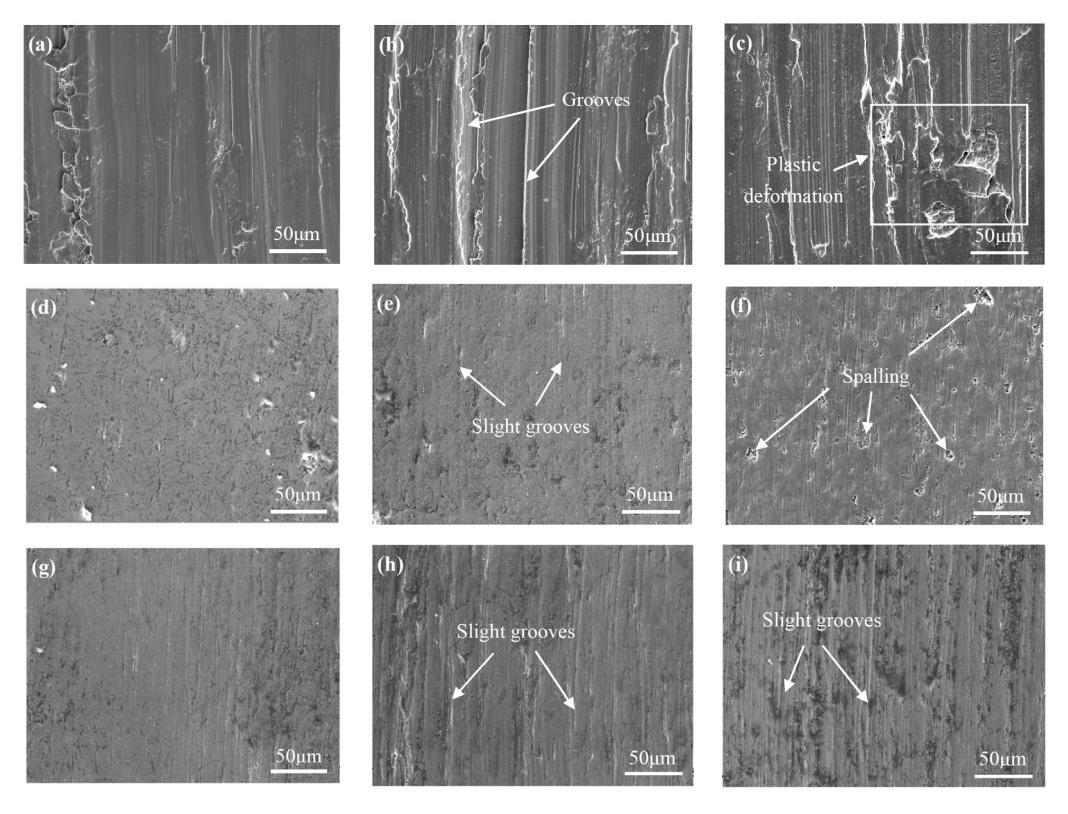
**Figure 9.** Typical worn surface morphology images of (**a**–**c**) the Ti6Al4V substrate, the coatings (**d**–**f**) without CeO<sub>2</sub>, and (**g**–**i**) modified with CeO<sub>2</sub> at (**a**,**d**,**g**) 30, (**b**,**e**,**h**) 60, and (**c**,**f**,**i**) 90 min wear time, respectively.

Typical microscopic morphology images of the worn surface of the coatings at 30, 60, and 90 min wear times were respectively observed by SEM, as shown in Figure 9, and the worn surfaces of the Ti6Al4V substrate are also shown in Figure 8 as a control group. All samples were cleaned ultrasonically in alcohol and deionized water before being observed by SEM. It is known from this figure that the worn surface of the specimens became coarser with an increase in the wear time, and the worn degrees

of the coatings were significantly slighter than those of the Ti6Al4V substrate. Moreover, it was also seen that the worn surfaces of the substrate and the coatings exhibited various worn characteristics. There were a lot of deep grooves and plastic deformation on the worn surface of the Ti6Al4V substrate. During the sliding wear test, the hard and sharp asperities on the counter-body penetrated easily into the surface of the Ti6Al4V substrate because of low hardness, and formed a micro-cutting effect or induced plastic deformation on the surface, which indicated that the wear process of the Ti6Al4V substrate was governed by a micro-cutting mechanism [38]. In contrast, the worn surfaces of the coatings were relatively smooth compared to the worn surface of the Ti6Al4V substrate. There were only some shallow and narrow grooves on the worn surface of the coatings, and no plastic deformation on the worn surface, which indicated that the coatings with a high microhardness characteristic could exhibit excellent resistance to micro-cutting and plastic deformation. Therefore, the asperities on the counter-body hardly penetrated into the surface of the coatings, and only some slight grooves on the worn surface of the coatings formed (called abrasive wear), whereas there were a large number of spalling pits with different sizes on the worn surface of the coating without CeO<sub>2</sub> when the wear time increased to 90 min, as shown in Figure 9f. The spalling pit was caused by peeling of the chips from the coating surface due to microcracks on the worn surface under the effect of the alternating contact stress produced by the counter-body ball (called fatigue wear). In contrast, the additive of CeO<sub>2</sub> nanoparticles obviously changed the worn surface morphology characteristics, as shown in Figure 9g-i, as the worn surface of the coatings modified with CeO<sub>2</sub> nanoparticles was relatively smooth with only some fine grooves (called abrasive wear), and no spalling pits were found on the worn surface of the coatings, which was attributed to the  $CeO_2$  nanoparticles additive that refined the grain. According to the classic formula of Hall–Petch, the finer the grain, the more grain boundaries there are, and the higher the strength and toughness of the material [39]. Therefore, the coatings modified with CeO<sub>2</sub> nanoparticles had better resistance to fatigue wear.

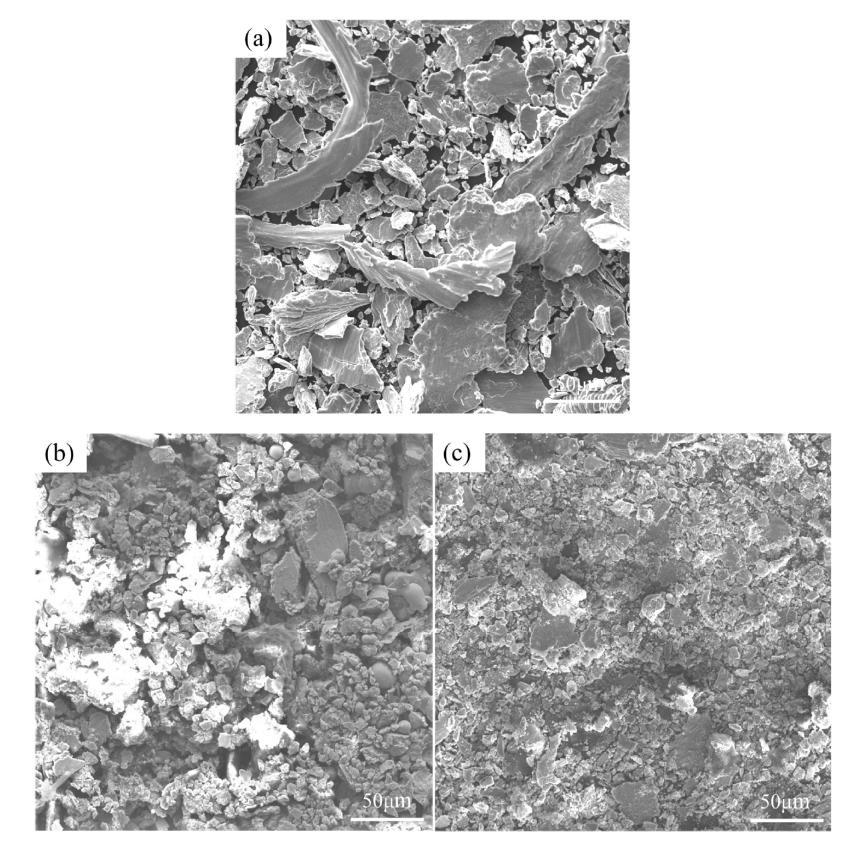
**Figure 10.** SEM images of the wear debris of (**a**) Ti6Al4V, and the coatings (**b**) without CeO<sub>2</sub> and (**c**) modified with CeO<sub>2</sub>.

The morphology images of wear debris from the substrate and coatings observed by SEM are shown in Figure 10 to confirm the above speculation of wear mechanisms. It is seen in Figure 10 that the sizes of the three types of wear debris were different. Among them, the average size of wear debris from the substrate was largest, which revealed that the substrate suffered from severe wear. The average size of the wear debris from the coatings was smaller than that of the substrate, and the average size of the wear debris from the coatings modified with CeO<sub>2</sub> nanoparticles was the smallest. It is also known from Figure 10 that the morphology characteristics of the three types of wear debris were different. The morphology of the wear debris from the Ti6Al4V substrate was plate-like. It could be deduced that it was formed by asperities on the counter-body micro-cutting the surface of the Ti6Al4V substrate, as shown in Figure 10a. In contrast, the morphology of the wear debris from the coating without CeO<sub>2</sub> was granular, which was greatly different from that of the Ti6Al4V substrate. It could be speculated that the granular wear debris was mainly produced by the fatigue wear on the coating surface, whereas the morphology of the wear debris from the coating modified with CeO<sub>2</sub> nanoparticles was flake-like. It could be inferred that the worn surface of the coatings modified with CeO<sub>2</sub> nanoparticles mainly was formed by abrasive wear, which was attributed to the enhancement of the microhardness and toughness of the coatings modified with CeO<sub>2</sub> nanoparticles.

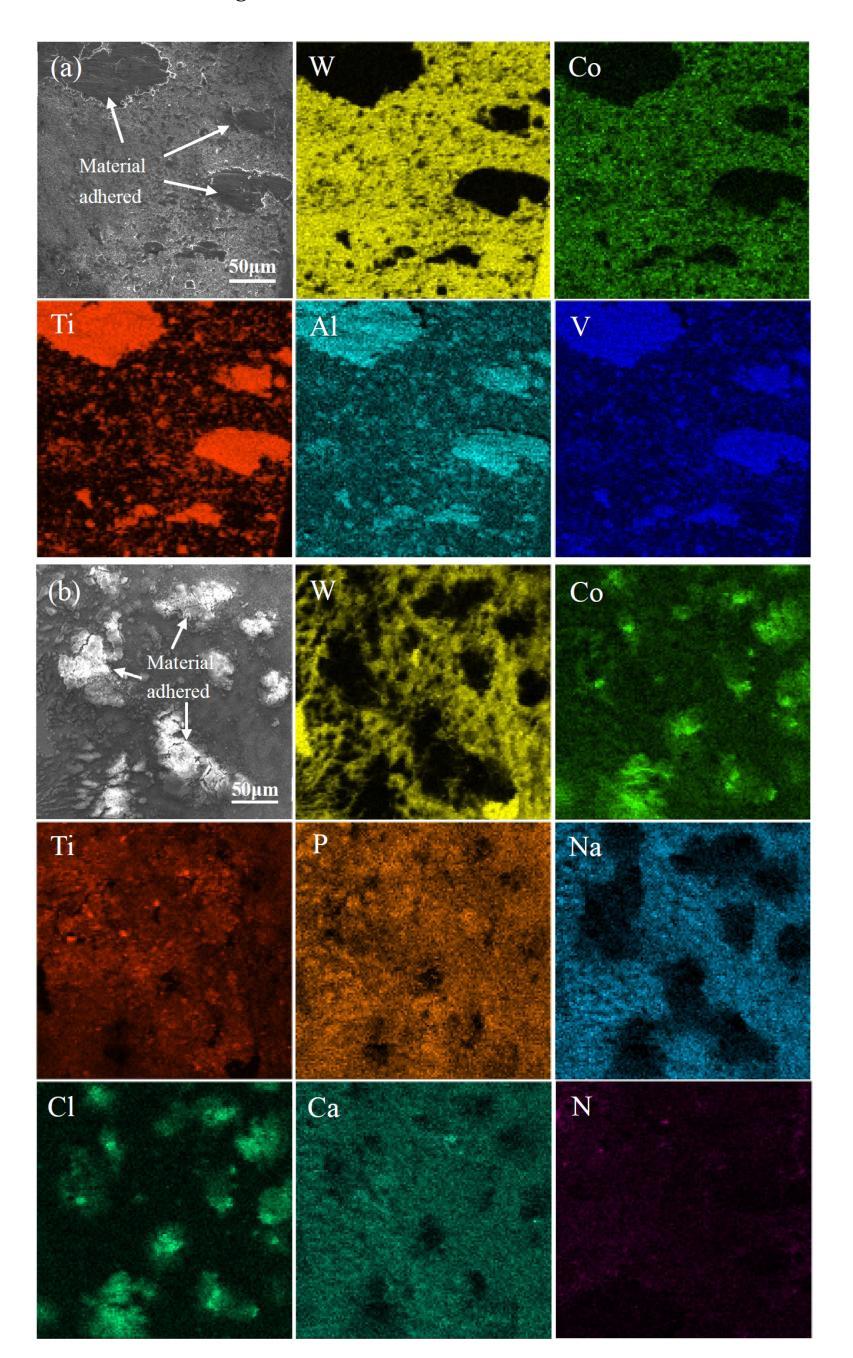
**Figure 11.** The worn surface images of the counter-body ball against (**a**) the Ti6Al4V substrate and (**b**) the coating modified with CeO<sub>2</sub>, and the corresponding EDS surface scanning results.

To investigate more comprehensively the wear mechanisms of the coatings, typical surface morphology images of the counter-body balls against the Ti6Al4V substrate and the coating modified with CeO<sub>2</sub> nanoparticles are presented in Figure 11. Because the worn surface image of the counter-body ball against the coating without CeO<sub>2</sub> was similar to that of the counter-body ball against the coatings modified with CeO<sub>2</sub> nanoparticles, it is not shown in this paper. It can be seen in Figure 11 that the surfaces of the two types of counter-body balls were attached by some materials that did not belong to the counter-body itself. It could be inferred that both the substrate and coating

surfaces transferred some material to the counter-body surface in the wear test. Therefore, the worn surface of the substrate and coatings suffered adhesive wear behavior.

It could be obviously found (Figure 11) that the EDS results for the material adhered onto the surfaces of the two counter-body balls were greatly different. W and Co elements were from the counter-body itself, while Ti, Al, and V elements were also detected on the material adhered onto the surface of the counter-body ball against the Ti6Al4V substrate, as shown in Figure 11a. It could be inferred that the materials on the surface of the counter-body ball transferred from the Ti6Al4V substrate during the wear process, whereas it can be observed in Figure 11b that the material adhered onto the surface of the counter-body ball against the coating contained not only Ti and N elements from the coatings, but also contained a large number of Ca, P, and Cl elements from SBF. It was supposed

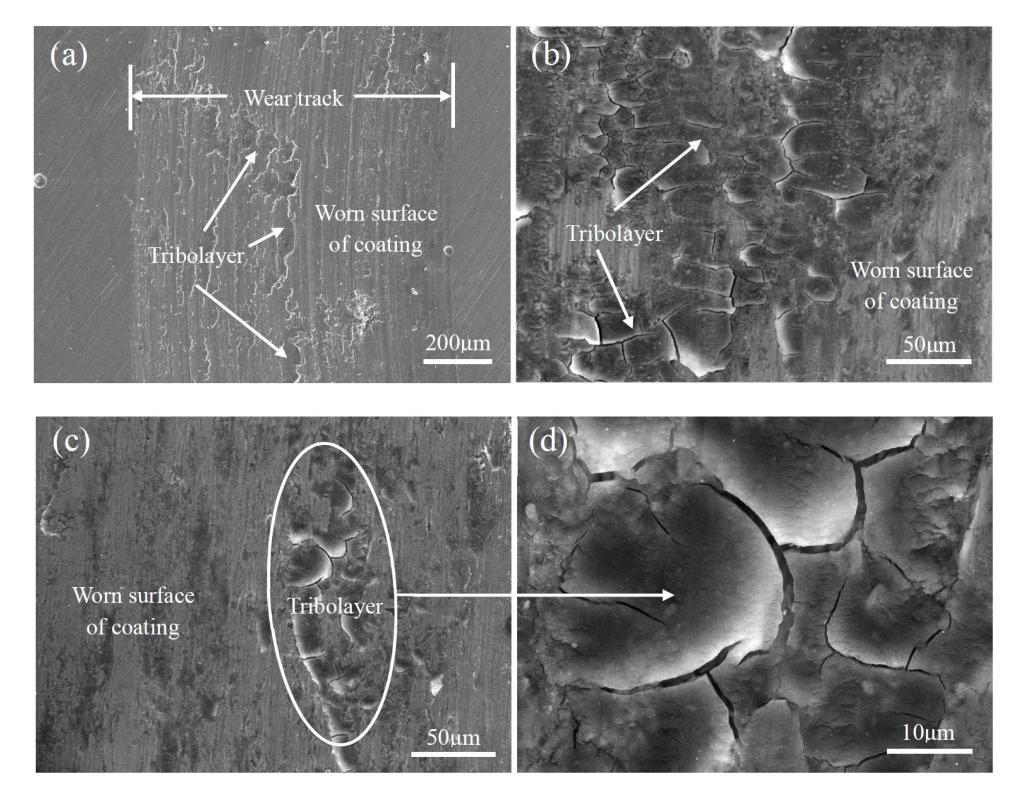
**Figure 12.** Typical morphology of (**a**) the wear track, (**b**,**c**) the tribolayer on the worn surface of the coating, and (**d**) the microtopography of the tribolayer.

that the surface of the coating may generate some substances under the wear environment of SBF, and a part of the substance was transferred from the surface of the coating to the counter-body ball due to adhesive wear. Rynio et al. [40] have reported on the wear behavior of an Ni-based pin on a cast iron disc at 25 and 300 °C. It was found that the wear oxidation behavior on the surface of a material formed protective oxide layers, referred to as a glaze layer, which formed at ambient temperatures but showed bad adherence to the substrate and easily spalled off. According to the report of Anandkumar [41], there was a tribolayer formed on the worn surface of a coating during dry sliding wear tests due to the interaction between the coating and the counter-body, which contained a large proportion of oxides of the elements both of the coating and the counter-body. The wear tests in this work were carried out in an SBF environment, and therefore it could be supposed that a material similar to the tribolayer formed probably on the surface of the coating during the wear process. To identify the above speculation, the wear tracks on the coatings were observed by SEM. In order to retain the worn characteristics on the wear track surface of the coating, only deionized water was used to clean the surface of the samples before being observed by SEM. It is seen in Figure 12 that there was a quasicontinuous layer, namely a tribolayer, which unevenly covered some areas of the wear track surface of the coatings. What was the formation mechanism of the tribolayer and the effect of the tribolayer on the wear mechanism of the coating?

debris from the coating, the wear debris from the counter-body, and SBF. Possible explanations for the formation mechanism of the tribolayer are (1) a part of the wear debris accumulated on some areas of the surface of the wear track under the constant squeezing action of the counter-body ball, and (2) the wear debris mixed with the SBF adhered and boned to the worn coating surface and became a tribolayer, as shown in Figure 12.

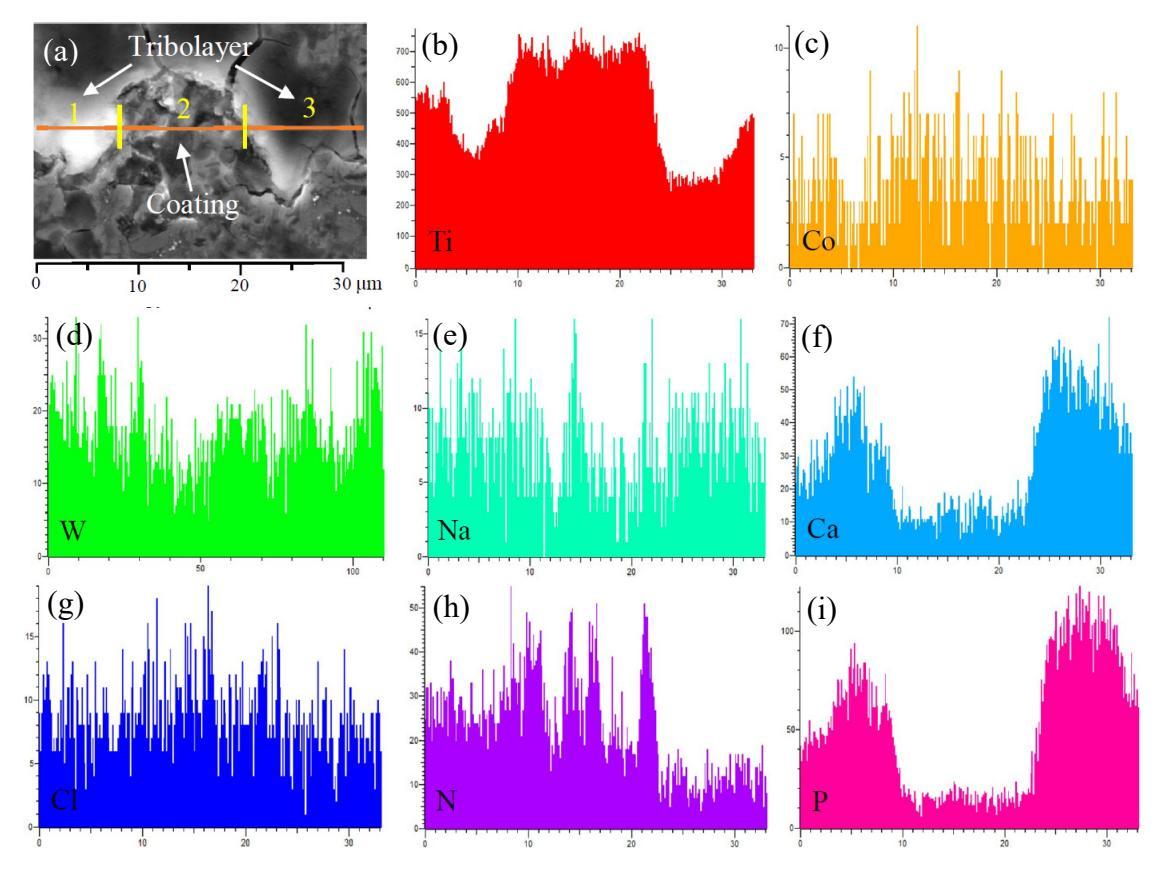
**Figure 13.** EDS line scanning results of the tribolayer. (**a**) EDS line; (**b**)Ti; (**c**)Co; (**d**) W; (**e**)Na; (**f**) Ca; (**g**) Cl; (**h**)N; (**i**) P.

To be aware of the formation mechanism of the tribolayer, EDS analysis was carried out on the tribolayer. The scanning line passed successively through the three zones: The tribolayer zone, the worn surface of the coating uncovered by the tribolayer, and the tribolayer zone, and the scanning results are shown in Figure 13. It could be found that the elements in the area without a tribolayer cover were mainly Ti and N elements, which was consistent with coating elements. The tribolayer zones were rich in elements such as Ca and P elements, which were the elements from the SBF. In addition, tribolayer zones also contained W, Co, Ti, and N elements, which were from the counter-body ball and coating. Therefore, the tribolayer did not belong to the coating itself, which was a mixture of the wear

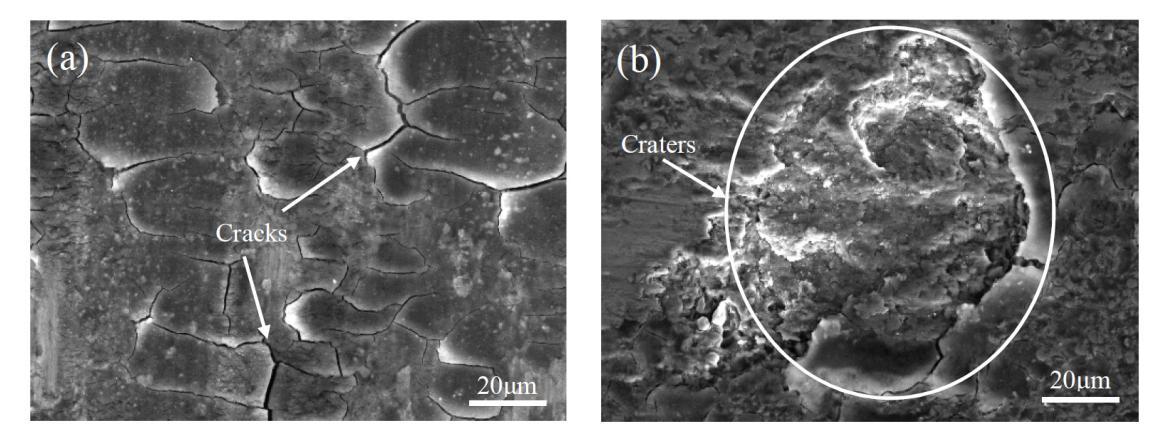
Figure 14. Two typical defect features on the tribolayer: (a) Network cracks and (b) craters.

The possible influence of the tribolayer on the wear mechanisms of the coating could be explained by the failure mechanism of the tribolayer. It is observed in Figure 14 that there were two typical defect features related to the failure mechanism: Cracks and craters. Cracks formed on some areas of the tribolayer due to the contact stress produced by the counter-body ball, and the cracks propagated along the interface between the tribolayer and the worn surface of the coating [41], which eventually led to delamination damage and formed craters on the tribolayer. Thereafter, the worn surface zone of the coating previously covered by the tribolayer was exposed again and continued to be worn. In addition, the tribolayer continuously generated on the area where the wear debris accumulated on the wear track surface of the coating, which was a dynamic procedure. The area of the wear track covered by the tribolayer was protected from wear in the subsequent wear process. In view of the analysis of Figures 11b and 13, the material adhered onto the counter-body ball against the coating was mostly tribolayer material. Therefore, it could be known that the tribolayer suffered most of the adhesive wear, so the tribolayer could reduce wear to some extent.
