# Article DDR4 BER Degradation Due to Crack in FBGA Package Solder Ball

Muhammad Waqar, Geunyong Bak D, Junhyeong Kwon and Sanghyeon Baeg \*

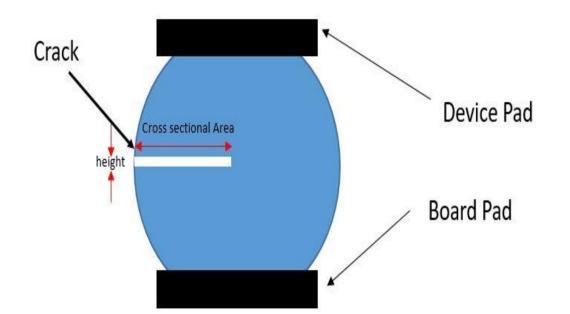
Crack in solder ball can form at the solder ball and device interface, in the solder ball or at the solder ball and printed circuit board interface. Figure 1 shows crack at the center of the solder ball. The crack divides the solder ball into the connected part and the separated part. The cross section area of the disconnected part can be calculated using the length of the crack. Figure 1 shows the height of the crack and cross sectional area of the crack.

Figure 1. Crack in solder ball.

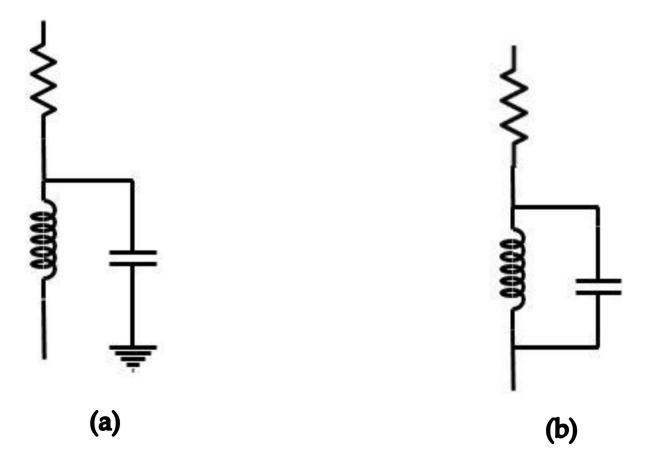
The solder ball electrical model is shown in Figure 2a [15]. There is inductance due to the length of the solder ball, parasitic capacitance between the solder ball and the ground. The DC resistance is due to finite conductivity of the solder ball material. At higher frequencies the resistance increases due to the skin effect. The crack in solder ball

changes the electrical model of the solder ball as shown in Figure 2b [11]. There is parallel capacitance due to the crack, as the crack creates empty space in the solder ball.

Figure 2. (a) electrical model of the solder ball (b) electrical model of the crack in solder ball.

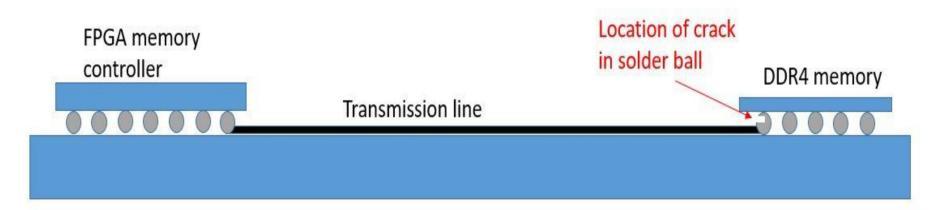
The simulation setup to see the effect of crack in DDR4 data channel and the simulation results are described in this section. Figure 3 shows location of crack in DDR4 FBGA package solder ball. The crack occurs at the solder ball of the DDR4 data channel. The data eye is measured at the DDR4 receiver. The simulation setup consists of FPGA memory controller connected to DDR4 memory through a transmission line. The vias, DIMM socket, and pcb stack are not included in the simulation. There is no random jitter or noise in the simulation and the simulation qualitatively shows the effect of crack.

Figure 3. Diagram of simulation setup.

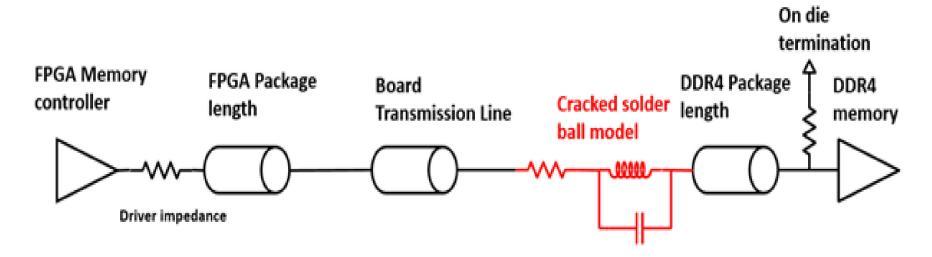
The DDR4 data channel containing the cracked solder ball is shown in Figure 4. FPGA memory controller IBIS model is used for simulation [17]. Driver impedance is set to 40 Ohms. The package length describes the pin delay due to trace length in the package. R, L, C pin parameters for FPGA are used. Board transmission line is a microstrip line having 40 Ohms characteristic impedance. The electrical model for cracked solder ball is used in the simulation. The self-resistance of the solder ball is 6.9 milliohm. The self-inductance of the solder ball is 69 picohenry. The capacitance due to crack in the solder ball is 325 picorfarads. DDR4 package length describes the pin delay due to trace length in the

package. R, L, and C pin parameters for DDR4 memory are used. The on-die termination for DDR4 is 40 Ohms. Micron DDR4 IBIS model is used [18].

Figure 4. DDR4 data channel containing the cracked solder ball.

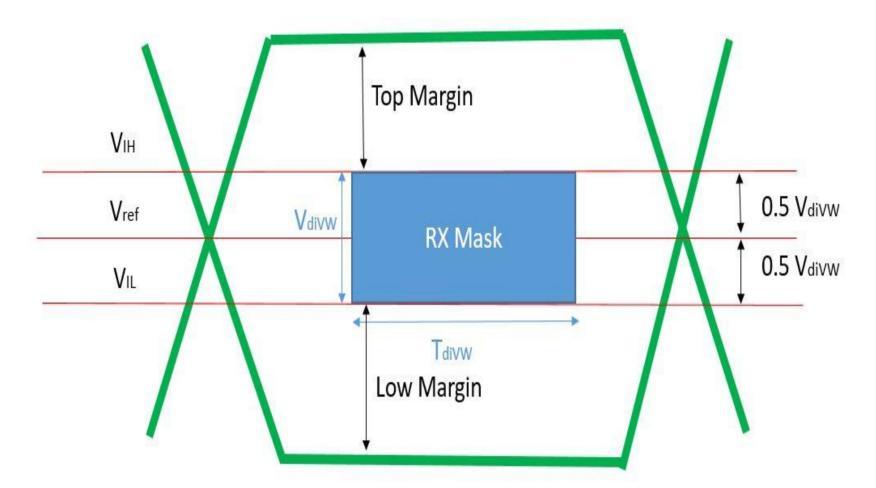
JEDEC standard defines DDR4 receiver mask (RX Mask) as shown in Figure 5. Time data input valid window ( $T_{divw}$ ) defines RX mask along time axis. Voltage data input valid window ( $V_{divw}$ ) defines RX mask along voltage axis [1]. The top margin is defined as the voltage margin between top of the RX mask and top of the data eye. Low margin is defined as the voltage margin between the lower part of the RX mask and low part of the data eye. The width of the data eye is the horizontal opening of the data eye at either  $V_{IH}$  or  $V_{IL}$ , whereas  $V_{IH}$  and  $V_{IL}$  are voltage high and voltage low thresholds, as shown in Figure 5.

Figure 5. DDR4 data eye showing receiver RX mask, eye width, top and low margin.

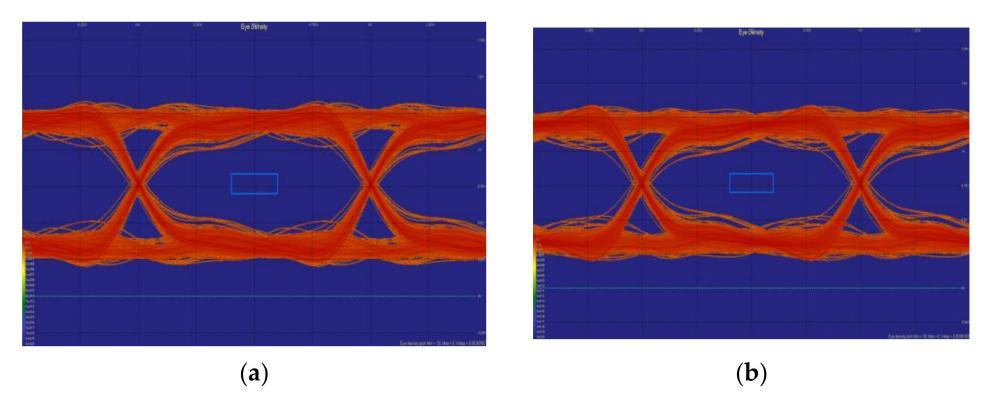
Figure 6a shows 2.133 Gbps PRBS signal for DDR4 data channel when there is no crack in the DDR4 package solder ball. The rectangle inside the data eye shows the DDR4 receiver RX mask. Figure 6b shows a data eye when there is a crack in the solder ball. The width of the data eye for Figure 6a is 0.8598 UI and the width for Figure 6b is 0.8414 UI,

where UI is unit bit interval. The top margin of data eye when there is no crack is 0.1726 V and the top margin is 0.1653 V when there is crack in solder ball. The low margin is 0.1864 when there is no crack and the margin is 0.1726 when there is a crack in solder ball. The crack decreases the data eye width, top margin and low margin. This will result in increased bit error rate.

Figure 6. (a) 2.133 Gbps data rate channel with no defect (b) data channel with crack in solder ball.

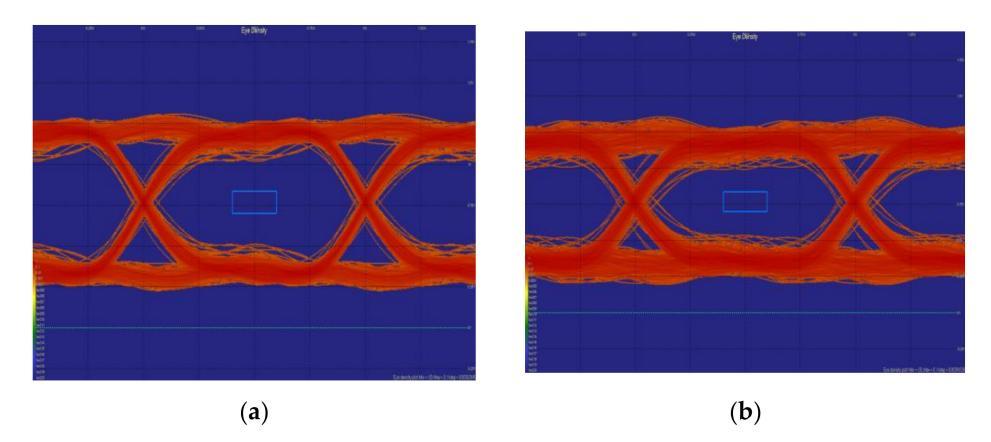
Figures 7 and 8 show PRBS data eye for data rate of 2.666 Gbps and 3.2 Gbps, respectively. As the data rate increases the data eye becomes more closed due to crack in solder ball. PRBS signal with higher data rate contains higher frequencies and attenuation of these high frequencies due to crack causes more data eye degradation.

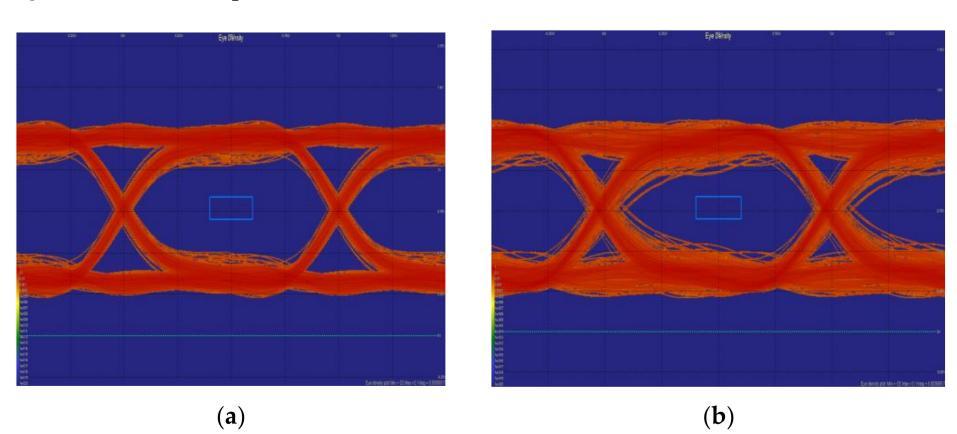
Figure 8. (a) 3.2 Gbps data rate channel with no defect (b) data channel with crack in solder ball.

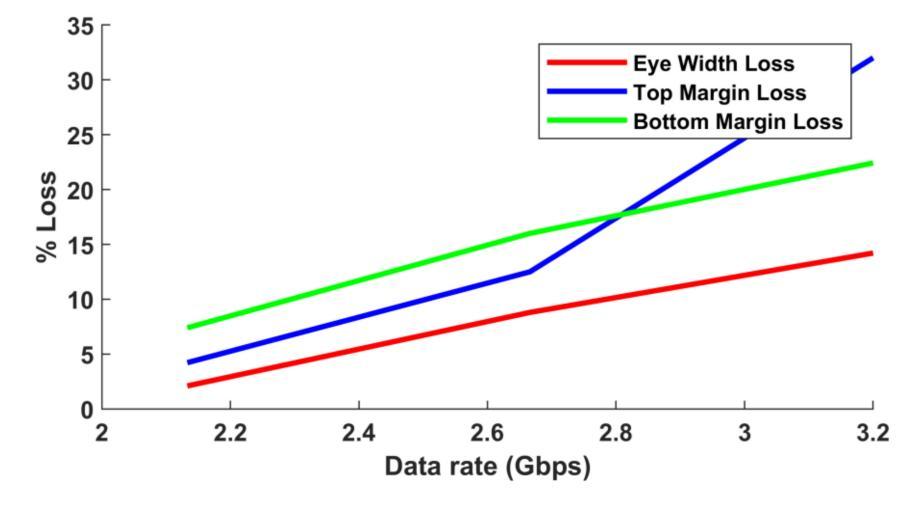
Figure 9 shows effect of crack on data eye for different PRBS signal data rates. Higher data rate means there are higher frequencies in the signal spectrum. There will be more data eye distortion for higher data rates. Eye width loss increases as data rate increases and decreases the available timing margin for the system. Top margin and low margin loss also increases with higher data rate, thus decreasing available voltage margin for the system. This decrease in timing margin and voltage margin will cause bit error rate degradation.

Figure 9. Eye width loss and voltage margin loss with increasing data rate.

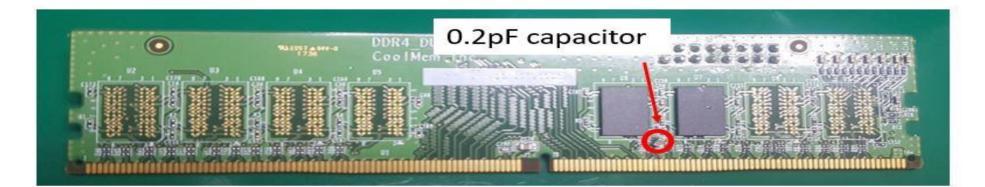
The crack in solder ball can be mimicked by loading the data line with a capacitive element [12]. The value of capacitive element corresponds to the dimensions of the crack. Figure 10 shows a DDR4 RDIMM module with a 0.2 pF capacitor loaded on the data line. The RDIMM module is used for studying the effects of crack in memory systems in running environment. FPGA based memory controller is used for running PRBS pattern on DDR4 memory channel. FPGA board is standard 16 layer board with 50 Ohm transmission line between the FPGA and DDR4 memory. Figure 11 shows the system board with the FPGA and DDR4 RDIMM module. There are discontinuities in the data channel due to FPGA to

Figure 10. DDR4 RDIMM test fixture with a capacitor loaded data line.

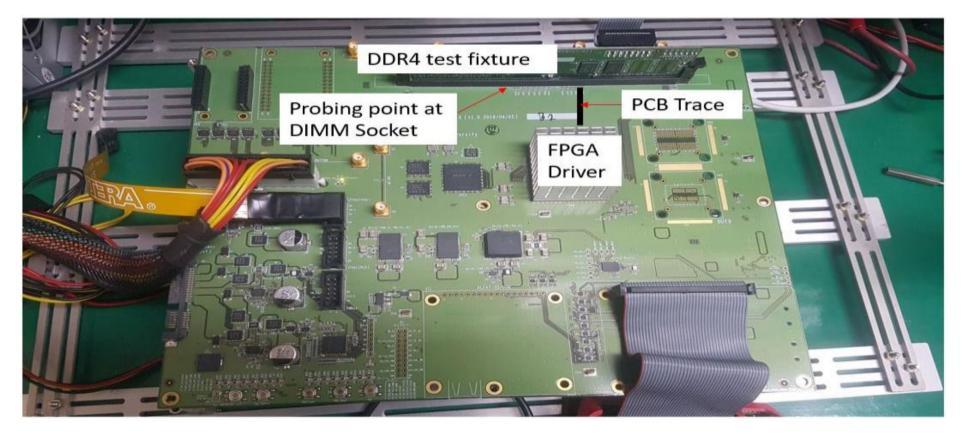
**Figure 11.** Measurement system showing memory FPGA based memory controller and DDR4 test fixture.

The data channel is probed from behind the DIMM socket as shown in Figure 11. The measurement of the data channel from this point effects the data eye measurement. For analysis two DDR4 data channels are measured. DQ3 channel has no defect in solder ball and DQ2 channel has 0.2 pF capacitor loaded on the data line to mimic the effect of crack in the solder ball. DQ3 channel is compared with DQ2 channel to show the degradation in data eye due to defect. This degradation of data eye results in bit error rate degradation as shown by bathtub plots.

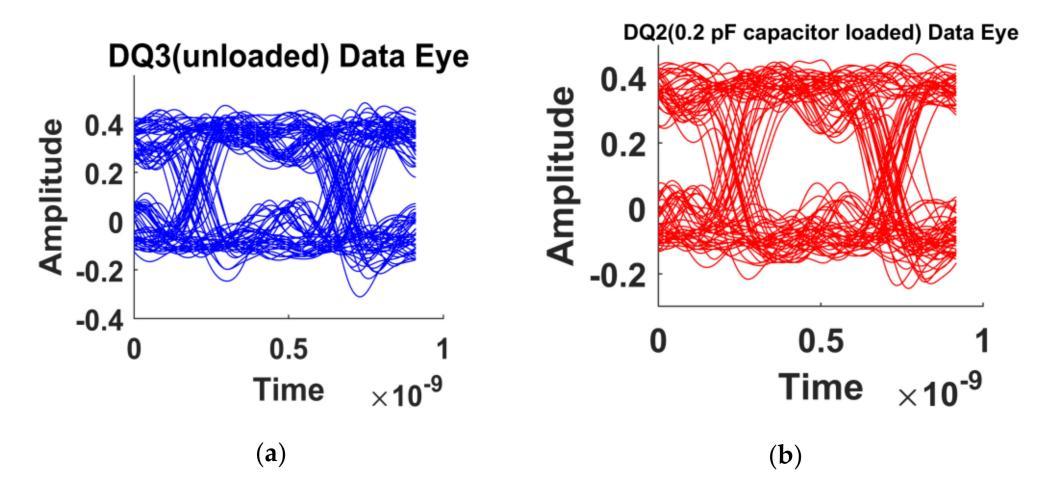
Figure 12a shows DQ3 channel data eye. The width of the data eye is measured at either Vih or Vil. The channel loss gives losses in data channel due to transmission line and discontinuities in the channel. The channel loss is measured by subtracting eye opening from unit bit interval [19]. For DDR4 operating at 2.133 Gbps the unit interval is 468.8 ps. The data input valid window ( $V_{diVW}$ ) for micron DDR4 is 136 mV [20].  $V_{diVW}$  is the vertical opening of the DDR4 receiver RX Mask. DQ3 data channel has no defect in solder ball. DQ3 data eye width and channel loss measurements are given as following.

- DQ3 data eye width = 303.8 ps
- DQ3 channel loss = 165 ps

Figure 12b shows DQ2 channel data eye. DQ2 channel has capacitive loading to mimic the crack in solder ball. DQ2 data channel data eye width and data channel loss measurements are given as following.

- DQ2 data eye width = 267.8 ps
- DQ2 channel loss = 201 ps

The comparison of DQ2 and DQ3 shows that DQ2 channel has 36 ps more channel loss due to the eye width decrease introduced by the data eye degradation.

**Figure 12.** (**a**) Data eye for DQ3 channel with no defect (**b**) data eye for DQ2 channel with cracked solder ball.

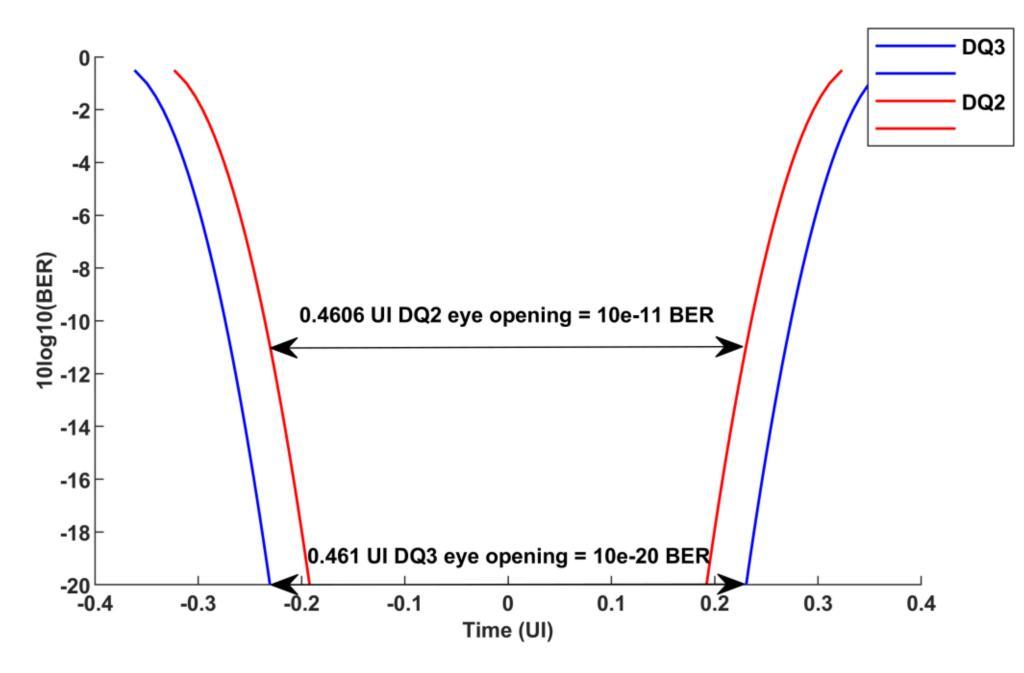
DQ2 and DQ3 data eyes are used to create bathtub plots, as shown in Figure 13. DQ3 channel bathtub plot shows that it has more eye opening for same bit error rate as DQ2. DQ2 channel with the solder ball defect has smaller eye opening for same bit error rate as DQ3. Figure 13 also shows that if both DQ2 and DQ3 have eye opening of 0.46 UI, DQ2 has bit error rate of 10e-11 whereas DQ3 has bit error rate of 10e-20. This shows how the crack degrades the bit error rate of DDR4 data channel.

Figure 13. Bathtub plots for DQ2 (crack defect in solder ball) and DQ3 (no defect) data channel.
