Article Numerical Analysis Results of Debonding Damage Effects for an SHM System Application on a Typical Composite Beam

Abstract: In the aeronautical field, the damage that occurs to a carbon-fibre-reinforced polymer (CFRP) structure analysis is a crucial point for further improving its capability and performance. In the current the state of the art, in fact, many issues are linked to the certification process more than to technological aspects. For the sake of clarity, it should be added that regulations call for technological solutions that are invasive (in terms of weight and manufacturing costs) or exploit technologies that are not fully mature. Thus, the truth is in between the above statements. One of the possible solutions to bypass this issue is the assessment of a structural health monitoring system (SHM) that is sufficiently reliable to provide a full-state representation of the structure, automatically, perhaps in real-time, with a minimum intervention of specialized technicians, and that can raise an alert for safe maintenance whenever necessary. Among the different systems that have been proposed in the scientific and technological literature, SHM systems based on st

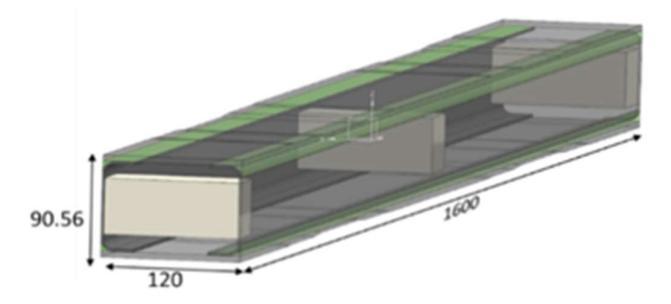
Figure 1. Schematic of the referred test article, a composite wing beam made of four main elements: C-beams (in green) and two cover plates (transparent). Manufacturing fillers are shown as white parallelograms [14,25].

The used test article is a representative component of a typical aircraft win -box. It is a composite beam with a rectangular cross-section. It is made of two C-type spars, symmetrical deployed, with their flanges forming the external vertical walls of the composite beam, and two flat plates, forming the top and bottom skins. The upper one has a variable thickness in order to keep the deformation value to a constant. An essential schematic is displayed in Figure 1. Production fillers are therein shown as white parallelograms. The beam elements (C-beams and plates) are all made of unidirectional CFRP material. A structural paste adhesive was applied to the caps of the C-beams so that they bonded to the cover plates.

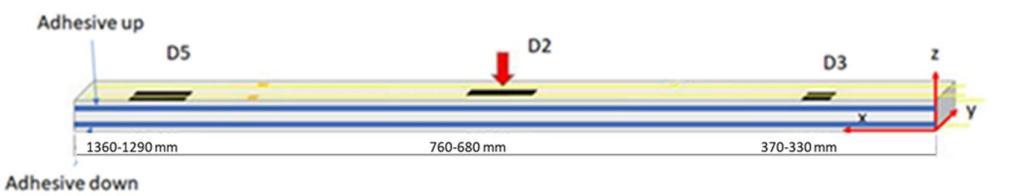
Figure 2. Schematic of the referred test article, with the imposed damage locations, position of the symmetric concentrated external load, and the adopted reference system.

Three damage areas were introduced between one of the caps of a single spar as well as the upper skin to simulate local disbonding. The de-bonded areas, appearing as D2, D3, and D5 in Figures 2 and 3, are part of a wider experimental arrangement that includes other flaws. The consideration of only these flaws with the structure containing a larger number of anomalies is viable since damage generally produces very local effects. In other words, they vanish at a small distance from the flaws, and thus the rest of the structure is minimally influenced, if at all.

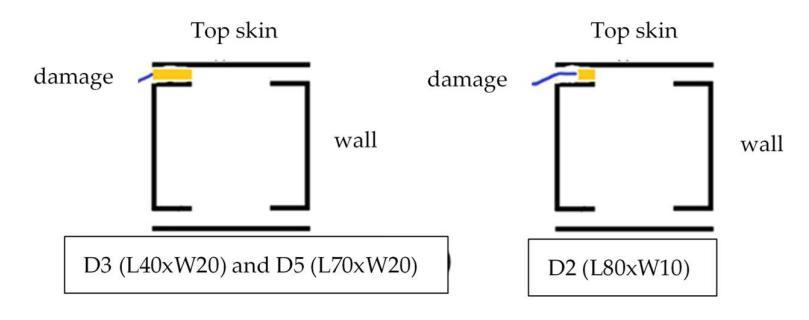
Figure 3. Test article section with details on the flaws' extension both in the longitudinal direction (text reported under the picture) and along its width (orange rectangle in the sketch). Numbers report the measures in mm. L—length; W—width.

These imposed flaws can be experimentally realised by interposing a Teflon layer between the spar caps and the upper plate in the designated regions. In the simulation, such discontinuities were replicated by imposing a very small elastic modulus to the relevant material. Previous experiences, carried out by other authors [14,26], indicated that this approach was equivalent to the removal of the corresponding FE. In the Figure 4, a parametric study of the effect of Young's modulus reduction is shown (the results corresponding to element removals have been fictitiously reported as a Young's modulus reduction of 1×10^{16} , and the same results obtained for a reduction of 1×10^{6} up to four significant digits are shown).

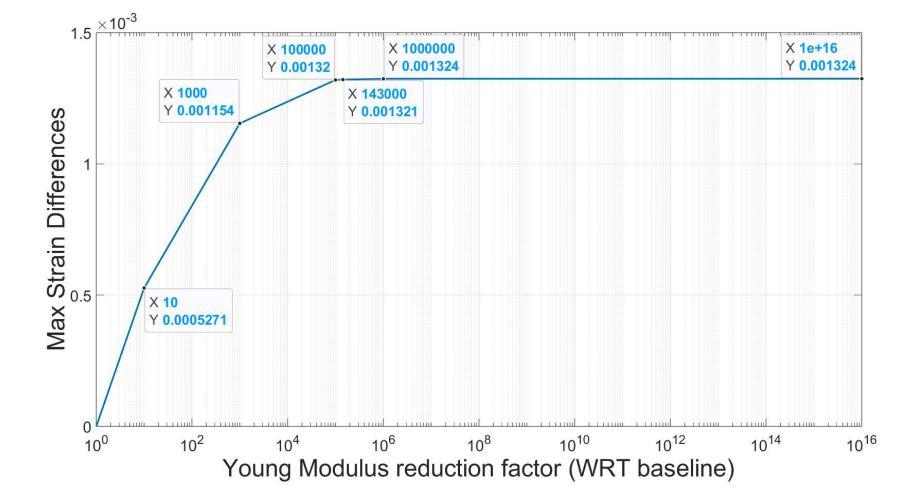
Figure 4. Parametric study of the effect of Young's modulus reduction to simulate debonding.

The modulus reduction approach implemented in this study is largely faster in terms of modelling and safer from the point of view of the risk of running into errors. The general length density of the mesh is equal to 8 mm, but it was made denser in the flaws area, with the aim of obtaining the best resolution in terms of strain description and attention to the damage effect in terms of strain, which was expected to be larger than the actual discontinuity; see Figure 5. In order to prevent change of the mesh density from affecting the strain outcome in the de-bonded regions, the flaw area was extended to 5 times the damage length for a total extension of 350 (D5), 400 (D2), and 200 (D3) mm, respectively. Additionally, simulations with varying mesh densities (namely 0.5, 1.0, and 8.0 mm) were performed: after realizing that the results with mesh density of 0.5 mm for the subsequent strain investigations.

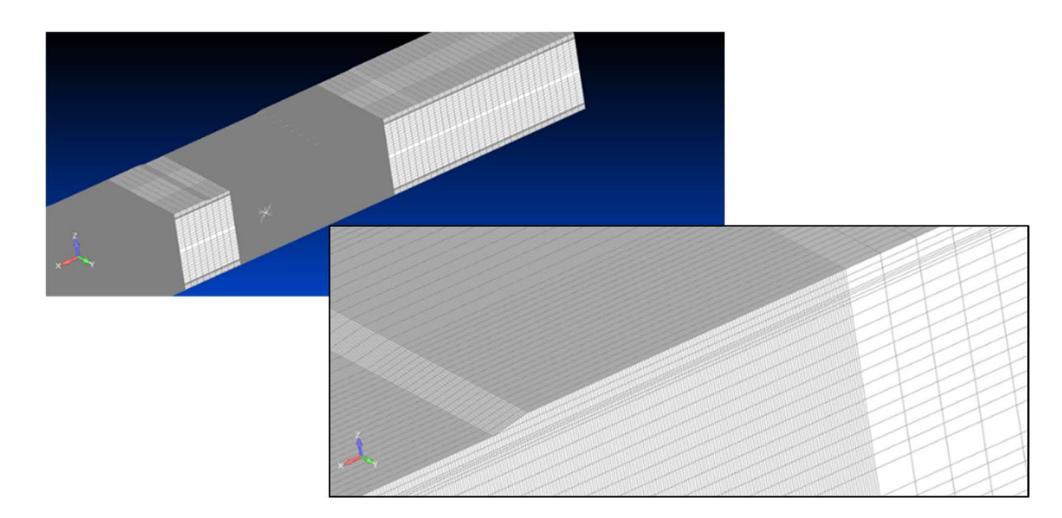
Figure 5. A representation of the FE model of the referred test article (**top**) with details on the mesh refinement (**bottom**).

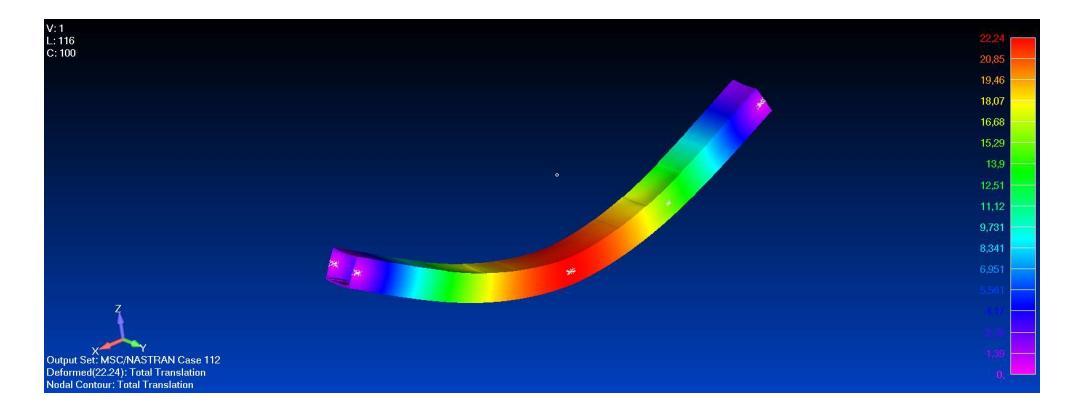
Figure 6. Deformed shape of the reference beam, supported simply, under a symmetrical load.

The considered constraints simulate typical three-point bending tests. Supporting regions are schematized close to the beam extremities, allowing rotations, but inhibiting positive and negative vertical translations. In this configuration, as a representative load arrangement, a symmetrical excitation was chosen, consisting of a perpendicular concentrated force acting at the centre of the beam and spread along the width. The resulting deformed shape is shown in Figure 6.

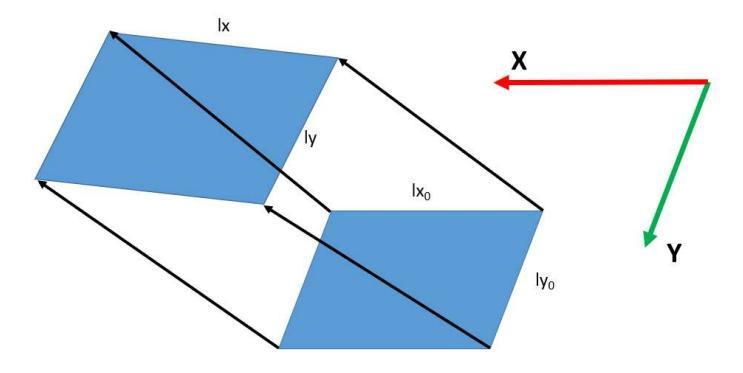
Figure 7. Parameters involved in the computation of the strain along the X and Y directions.

where $l_{0x,y}$, $l_{x,y}$, and $\Delta l_{x,y}$ are the original length along the X and Y axes, the corresponding length modified after the action of the load system, and their variation, respectively. An illustration of the implemented concept is shown in Figure 7.

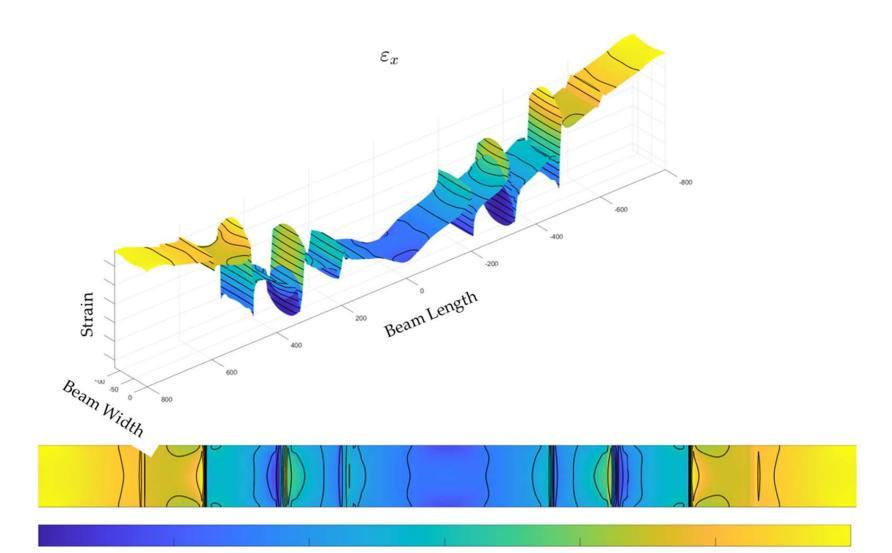
Figure 8. Strain along the X-axis.

The elaborations are reported in the figures below, ranging from Figures 8–13. First, the strains evaluated in the longitudinal (spanwise) and transversal directions (along the width) are reported in Figures 8 and 9. It is immediately discernible that the strain field is mainly affected by the sharp variability of the thickness as clearly indicated by the singularity lines appearing on the diagrams corresponding to the thickness steps. Such discontinuities can be avoided by acquiring the deformations in the inner part of the structural system and specifically in the bonding layer or even in the internal components (for instance, at the bottom side of the cap). In this case, however, it was chosen a challenging region to allow some peculiarities of the strain field to arise. The scale is not reported in the graph, but it is sufficient to state that the values are in the order of thousands of microstrain under a load that is representative of the actual operation of the composite beam herein investigated.

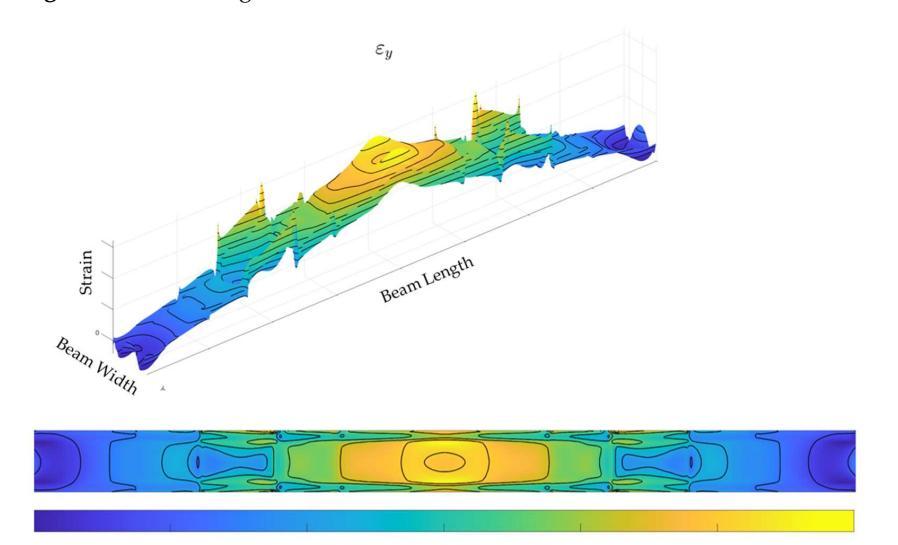
Figure 9. Strain along the Y-axis.

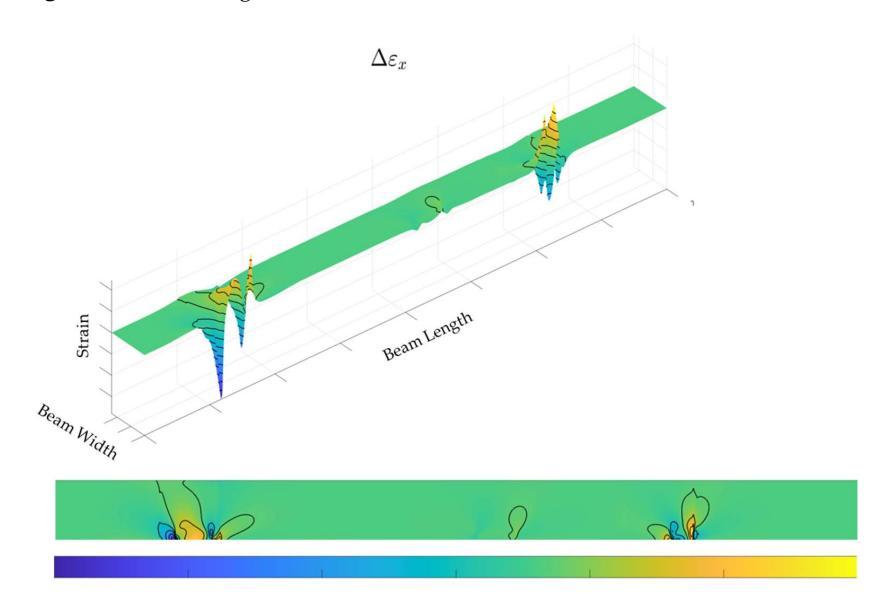
Figure 10. Strain along the X-axis, difference between damage and undamaged configuration.

The graphs are very similar in the damaged and undamaged case, so it is difficult to appreciate significant variations between the two cases. However, there is a difference in the structural response in terms of strain between the damaged and undamaged case (indicated as $\Delta \varepsilon_x$ and $\Delta \varepsilon_y$, respectively, for the difference between the strain along *x* and along *y*, in the damaged and undamaged configurations), as seen in Figures 10 and 11, giving rise to the following observations:

- The structural discontinuity effects (i.e., the contributions linked to the thickness steps), disappear. This can be considered a trivial result since they are present in both the circumstances analysed in this study, which does not change in the two configurations (damaged and undamaged). However, it does also mean this kind of imposed damage (debonding) does not affect the structural response macroscopically.

- More generally, the entire structural response flattens, and only the damaged regions emerge. This outcome is consistent with the first one, and it should indicate that the flaws generate a very local effect, which does not extend outward much from the occurrence area. While this may appear to be simple confirmation of other results already reported in literature, this new representation highlights how the discontinuity propagates along the top panel, albeit in a very limited way. In this case, such variations may be measured, in the analysed case, around hundreds of microstrain (i.e., a magnitude less than before). The values are nonetheless far from the bottom threshold of usual fibre optics which should not go under tens of microstrain (i.e., a further magnitude below).

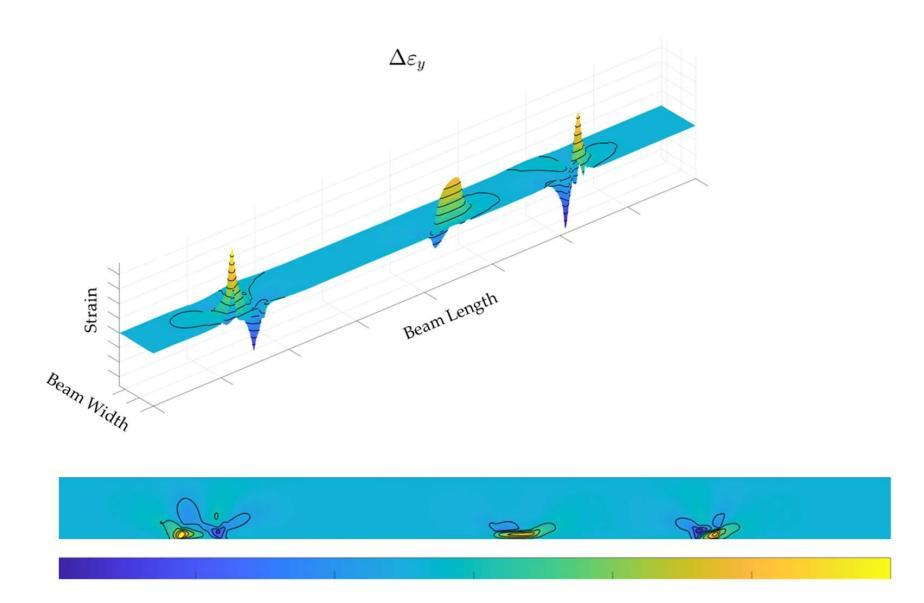
Figure 11. Strain along the Y-axis and the difference between the damage and undamaged configuration.

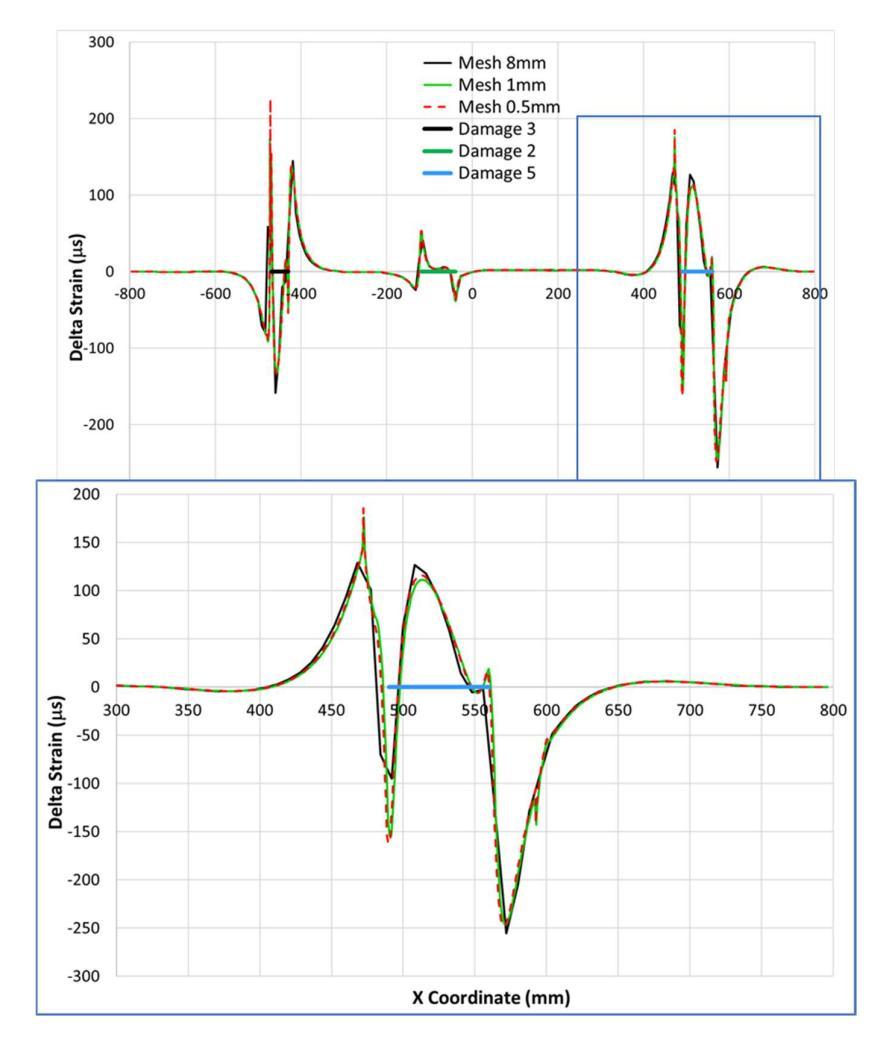
Figure 12. Comparison of delta strain for three dimensions of the model mesh (8, 1, and 0,5 mm) with a focus on damage 5 (blue rectangle).

The results in terms of strain variations obtained by the FE models with different mesh densities (8, 1, and 0.5 mm), are shown in Figure 12. The very first impression is that the outcomes are very similar. This is very important in the sense of confirming the reliability of the outcomes. However, deeper analysis reveals that the finest meshes yield the smoother results; furthermore, differences between the 1- and 0.5-mm step models are barely appreciable. Then, it is reasonable to state that the FE numerical model is approaching its convergence at these levels of detail. For the sake of clarity, it should be stated that these specific analyses were carried out for uniform meshes, extended all over the beam, while further investigations considered a refinement limited to the damaged regions.

Other considerations arise with a closer observation of the strain functions in the different cases. The 8 mm mesh leads to emergence of four small, but still evident, peaks. All such marked discontinuities correspond to structural irregularities, whether in terms of skin thickness variations or at the beginning and the end of the flaw. In turn, this indicates that a non-appropriate mesh could exacerbate the effects of any kind of variation in the considered architecture, which could lead to modification of the local stiffness (directly affecting the local strain values). This outcome is in line with the well-known characteristic of the discretization models leading to local, unrealistic peaks in the proximity of holes, for instance. In this case, it should be also underlined that the mesh was ten times denser than the typical flaw dimension in the considered direction, and that this is not sufficient to obtain reliable results.

The differences were computed to be around 20–30% at the discontinuity regions, and were almost non-existent elsewhere. Such variations seem more evident for the flaws that are deployed near to the thickness variation zones (namely, D3 and D5), than they are for damage in a plain zone (D2). Finally, the complex strain function that was obtained for D3 and D5, with respect to what was achieved for D2, may be at least partially attributable to a sort of interaction between the two concurring discontinuities. It should be noted that since a linear analysis was conducted, the strain levels did not affect the strain function on the external skin surface, where the deformation differences are expected to be larger (as the skin itself is irregular).

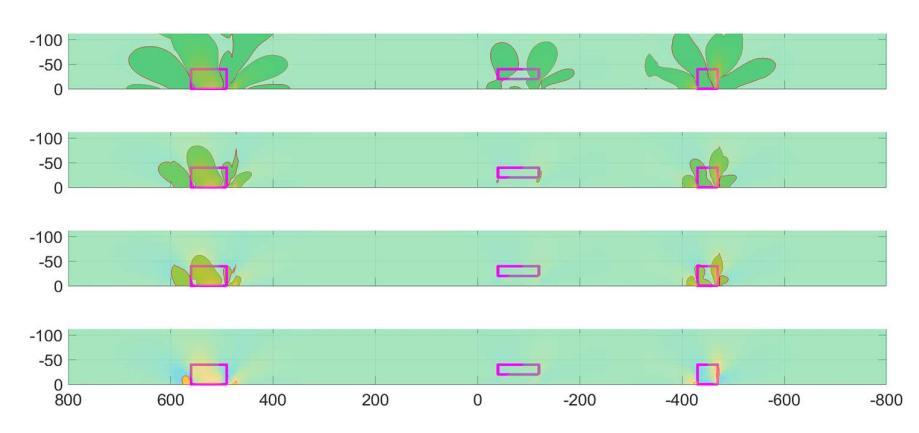
Figure 13. Strain variation (ε_x) between the damaged and undamaged conditions, with the evaluation in the top panel, which was then filtered by cancelling the values below an established threshold and fixed at 10, 50, 100, and 350 µs (top to bottom). In the pictures, the actual flaw boundaries are reported in violet.

The ability to detect a damage is a function of the induced deformation pattern and its corresponding levels. These parameters should be compared to the minimum threshold that the monitoring system is able to detect. Then, it is reasonable to investigate how the strain difference outlines, such as for the instance proposed in Figures 10 and 11, and modifies the graphs by introducing a minimum recognizable level. In Figures 13–16, such a proposed process is applied to the strain variations between the damage and undamaged

conditions ε_x and ε_y . There, the areas of the beam surfaces are highlighted, where the strain variations exceed some established thresholds fixed at 10, 50, 100, and 350 microstrain.

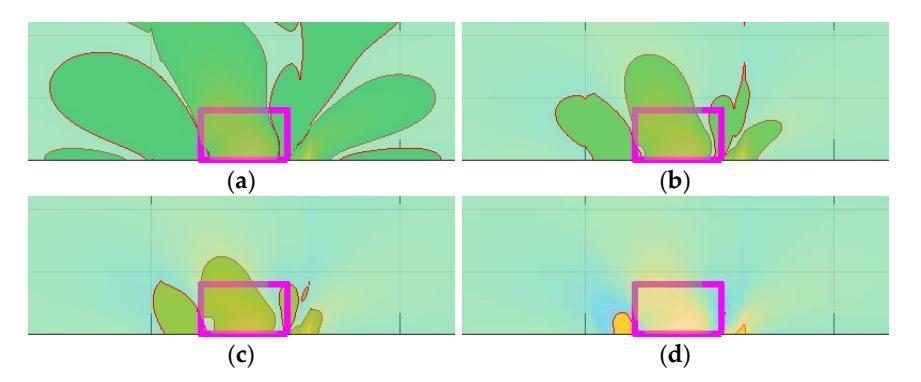
Figure 14. Focus on $\Delta \varepsilon_x$ for damage 5 at levels: (a) 10 µs, (b) 50 µs, (c) 100 µs, and (d) 350 µs.

To have a deeper view of the phenomenon here described, a focus on a selected and representative damage area is reported, D5, for both of the in-plane deformations. In Figure 14, ε_x is first considered. The first aspect that arises is a sort of a multilobe effect due to the presence of the damage to the surrounding area, which extends all over the plate up to the other extremity. Therefore, the localization of the flaw effect should be considered within this limit. It is also apparent that as such an effect is very small, it is drastically resized as the strain detection window is lowered to just under 50 microstrain, which can be considered a first conservative, highly observable value. The highlighted area shrinks almost conformally, i.e., keeping its original shape. This process continues in the same way as the limit level is brought to 100 microstrain: the shape appearance of the flaw effect on the strain field is kept almost constant but is slightly reduced. Finally, when the observability threshold is moved under 350 microstrain (an arbitrarily selected value), it can be seen that the relevant effects concentrate only on the borders of the interested area, which represent the discontinuity lines. This behaviour is repeated almost equally for the other strain component, $\varepsilon_{\rm v}$; see Figure 16. Some difference may be appreciated in the lower absolute values, as the detected areas are smaller for the considered observability levels. Although the effect zones keep their shape as the process moves on, it seems that this redesign converges towards the flaw borders faster than before, as mentioned above. In particular, already at the 100 microstrain window, the effect is concentrated on the flaw area limits, while at 350 microstrain, a single lobe appears on the first edge.

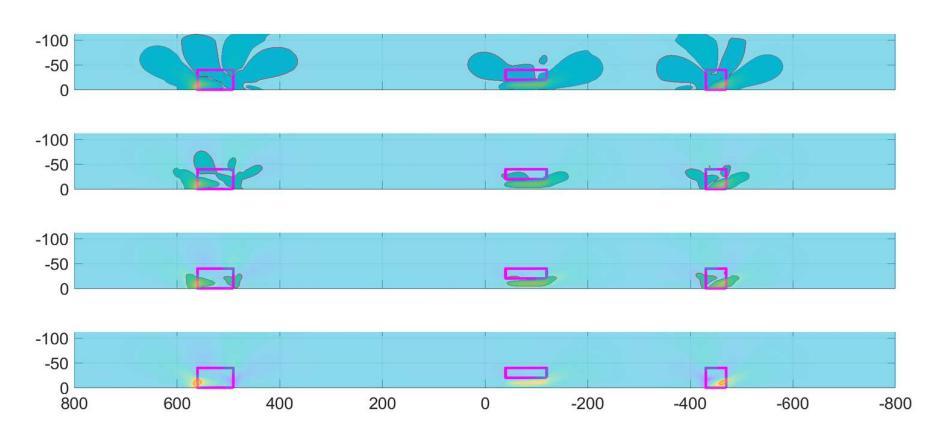
Figure 15. Strain variation (ε_y) between the damaged and undamaged conditions, with the evaluation on the top panel, which were then filtered by cancelling the values below an established threshold and fixed at 10, 50, 100, and 350 µs (top to bottom). In the pictures, the actual flaw boundaries are reported in violet.

As expected, the detectable area drastically reduces as the threshold increases. If this phenomenon decreases the probability that a monitoring system is able to point out the existence of a flaw, conversely, it also restricts the observable region to the actual damage zone (i.e., the area interested by a structural discontinuity), therefore augmenting the resolution of the tool. It is important to observe that such a process should be handled with extreme care since some weaker damage (such as with D2) is shown almost to vanish, even for small reductions of the threshold. This one, however, may only be a minor drawback since less relevant flaws have limited importance in the evaluation of the structural health, or equivalently, in the estimate of residual strength. Surprisingly enough, such an aspect

is less evident for the spanwise deformation (ε_x) than for the strain measured along the transversal direction (along the width, ε_y).

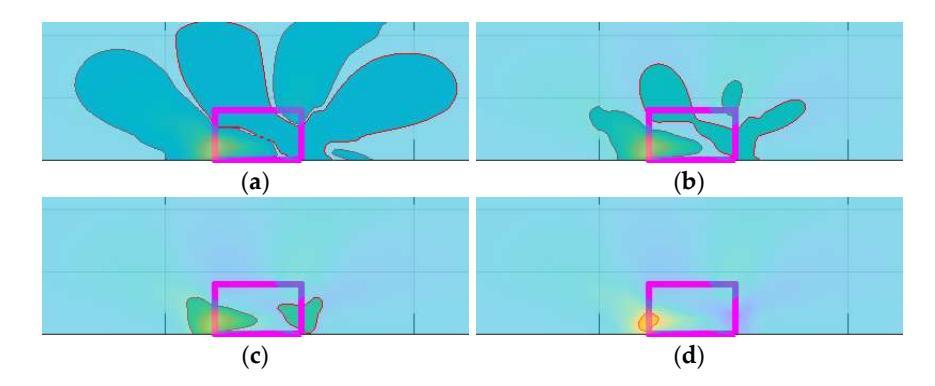
Figure 16. Focus on $\Delta \varepsilon_{y}$ for damage 5 at levels: (a) 10 µs, (b) 50 µs, (c) 100 µs, and (d) 350 µs.

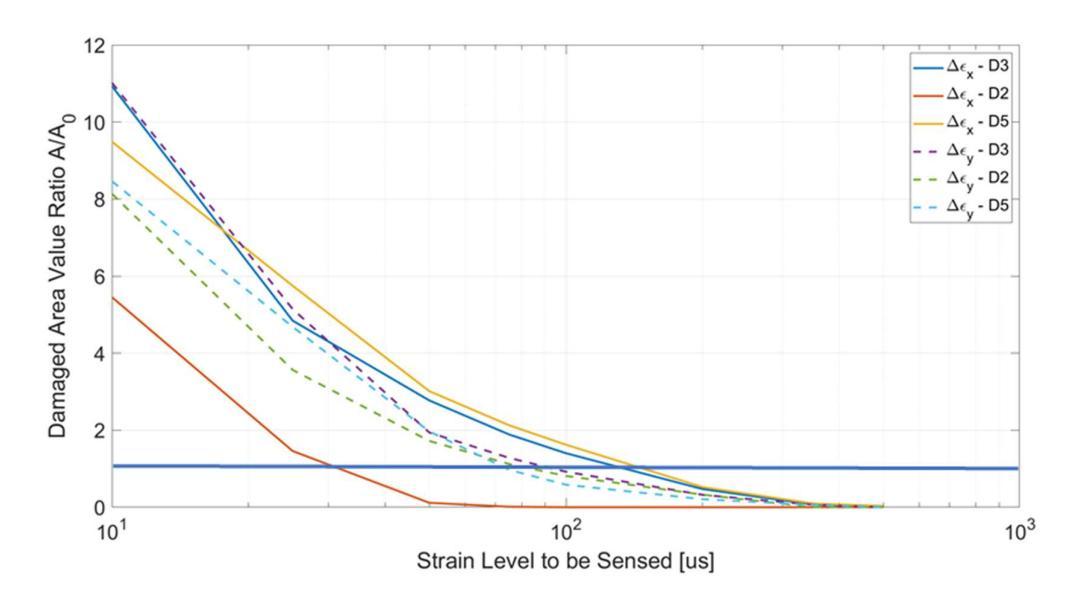
Figure 17. Damage ratio vs. (assumed) detectable threshold level.

A synthesis of such an analysis is reported in Figure 17, where a diagram is shown, portraying a parameter representative of the detectable area associated with the Y-axis, and the imposed visibility threshold, associated with the X-axis. This figure is particularly important because it summarises the occurrences for all the three considered flaws, while the former analysis is limited to the evidence for D5 only. The parameter indicative of the detectable area is synthesized as the ratio between the extension of the region along which a significant strain variation occurs as a consequence of the flaw presence with respect to the undamaged configuration and the actual extension of the flaw. This suggested process reduces the areas to a nondimensional parameter, which allows for the representation of all the imposed irregularities on a single picture. There, the horizontal blue line identifies the original dimension of the fault; i.e., when the ratio approaches 1, this means that the detectable area has the same size of the original flaw (its shape could be different however). Such a unit value could be considered, in a first approach, as the limiting acceptable level of the detection system or the one capable of identifying at least the actual flaw measure. The reported graph in Figure 17 displaces a logarithmic scale for the X-axis, while a classical linear scale is associated with the Y-axis. For the sake of clarity, investigated thresholds have been drawn as vertical thin blue lines.

It may be observed that, for ideal system capabilities (i.e., threshold levels under 10 microstrain, a good performance not very far from that obtained with available commercial systems), all the imposed flaws may be detected with a large margin. The selected characteristics however collapse as such a threshold approaches 100 microstrain. As expected, the curve describing the damage D2 is the one that moves more rapidly towards the assumed detection limit (unit horizontal line, blue); however, confirming the previous observations, such a behaviour is more evident for ε_x than for ε_y . Irrespective of the relative sizes, the tendency is more homogeneous for the deformations along y (flaws D2, D3, and D5), while it is noticeably different for the strain along x (the D2 characteristic is well beneath the others). In other words, the two all-width flaws (D3 and D5) have a similar behaviour, while D2 is distinct. At the fixed level of 100 microstrain, the following occurrences are found:

- D2, ε_x, well under the assumed identifiability limit;
- D2, D3, and D5, ε_{y} , at the limits of the assumed observability threshold;
- D3, and D5, ε_x , well over the assumed detectability level.

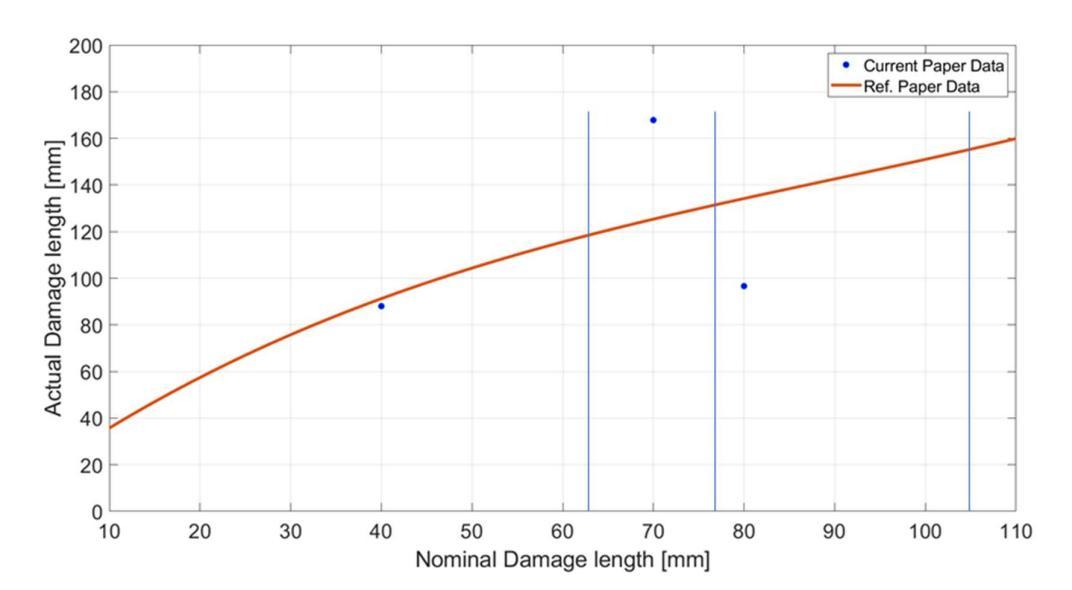
Figure 18. Damage effect length vs. Nominal Damage length.

In Figure 18, the dots represent the three analysed flaws for flaw detection thresholds equal to 25 μ s, while the continuous red line is the function evaluated in a former analysis [26], linking the flaw length and the flaw effect length. In this figure, the nominal damage lengths are reported along the X-axis, while the synthetic damage effect length is reported along the Y-axis. It is worth noting that the function represented in Figure 18 (red line) was constructed via reference to a parametric study focused on a specific position of a certain damage on the same reference structure; in the current article, three different flaws were analysed instead, each located in the specific places of the test article, and one of them exhibiting a remarkable geometric variation (it extended for just a half-width of the cap). Therefore, it is not surprising that the data are not perfectly matching; instead, the not-so-distant variations with respect to the original line are sufficiently encouraging for further studies. This correlation was meant to be a first step towards producing a possible enhancement of this estimated function.

A good agreement is obtained, which seems to break only for the D2 flaw, as expected (since the previous study considered only full-width discontinuities). In spite of the very limited comparison, this evidence permits the conclusion that the process seems to produce coherent values with an independent investigation. Additional tests are necessary to further prove this preliminary result, which could also be directed to test the validity of the introduced 1D synthetic descriptor which could have a significant relevance in further studies.
