Abstract: The sintered zinc oxide (ZnO) electro-ceramics are a brittle class of hard-to-cut materials such that shaping them with the post-finishing operations necessitates careful handling and precision machining. The conventional machining approach using the grinding and lapping processes represents limited productivity, an inability to produce the required geometries and frequent uncontrolled chipping of the edges of the final products. This study thus investigates the turning performance of dense sintered ZnO varistors and chip formations to obtain the parametric range (cutting mechanism) which causes the chipping or the trans-granular/sudden failure in these brittle materials. With the analysis of the cutting tool vibration in relation to the machining parameters (*f* and *V*_C), the vibration-induced chipping correlations are made and interlinked with the occurrence of grain pull-out during the turning operation. The results show that the reflected vibratory motion of the tools is directly correlated with the chip formation mechanisms in the turning of ZnO ceramics and thus provide robust measurements for quality assurance in final products.

Citation: Dugar, J.; Ikram, A.; P

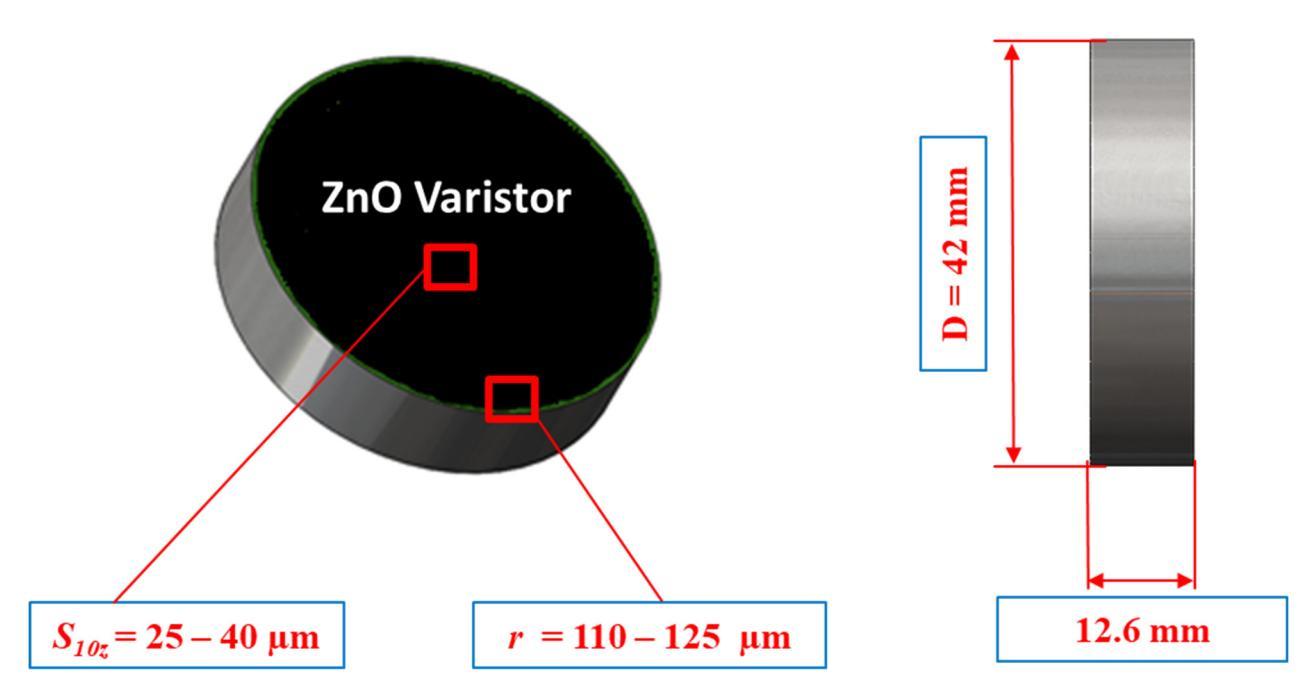
The measured geometric specifications of the ZnO varistors are presented in Figure 1. They had a diameter of 42 mm, a thickness of 12.6 mm, an edge radius r > 110 μ m, a surface roughness (average height of selected area) classified in ranges S_a ~ 1–1.4 μ m and the maximum height of the selected area from 10 averaged points by S_{10z} = 25–40 μ m.

Figure 1. Geometric specifications of the varistor ceramics used in the turning operation.

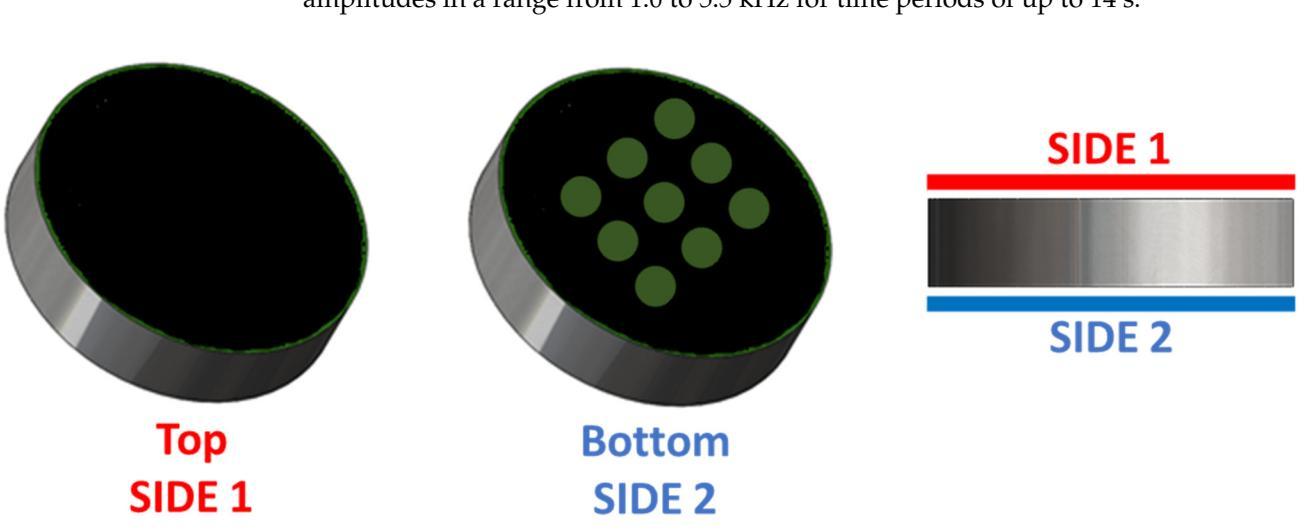
The ZnO varistors were fabricated with the uniaxial pressing of the green compacts prior to the sintering operation and the two sides may have had different turning characteristics; therefore, color markings were introduced as shown in Figure 2 to identity the variation in the collection of the accelerometer signals related to surface roughness and material removal. The top side marked with the red color indicated the side which received the bulk of the compaction pressures during the uniaxial pressing which indicates a higher relative surface density on the top (red) part, whereas the blue (bottom) part indicated the fixation away from the pressure plungers. This illustrative scheme of the red and blue sides will be consecutively used in the results and discussion sections.

Figure 2. The division of the ZnO ceramics turning operations into two sides, illustrative of the uniaxial pressing of green compacts prior to the sintering operation.

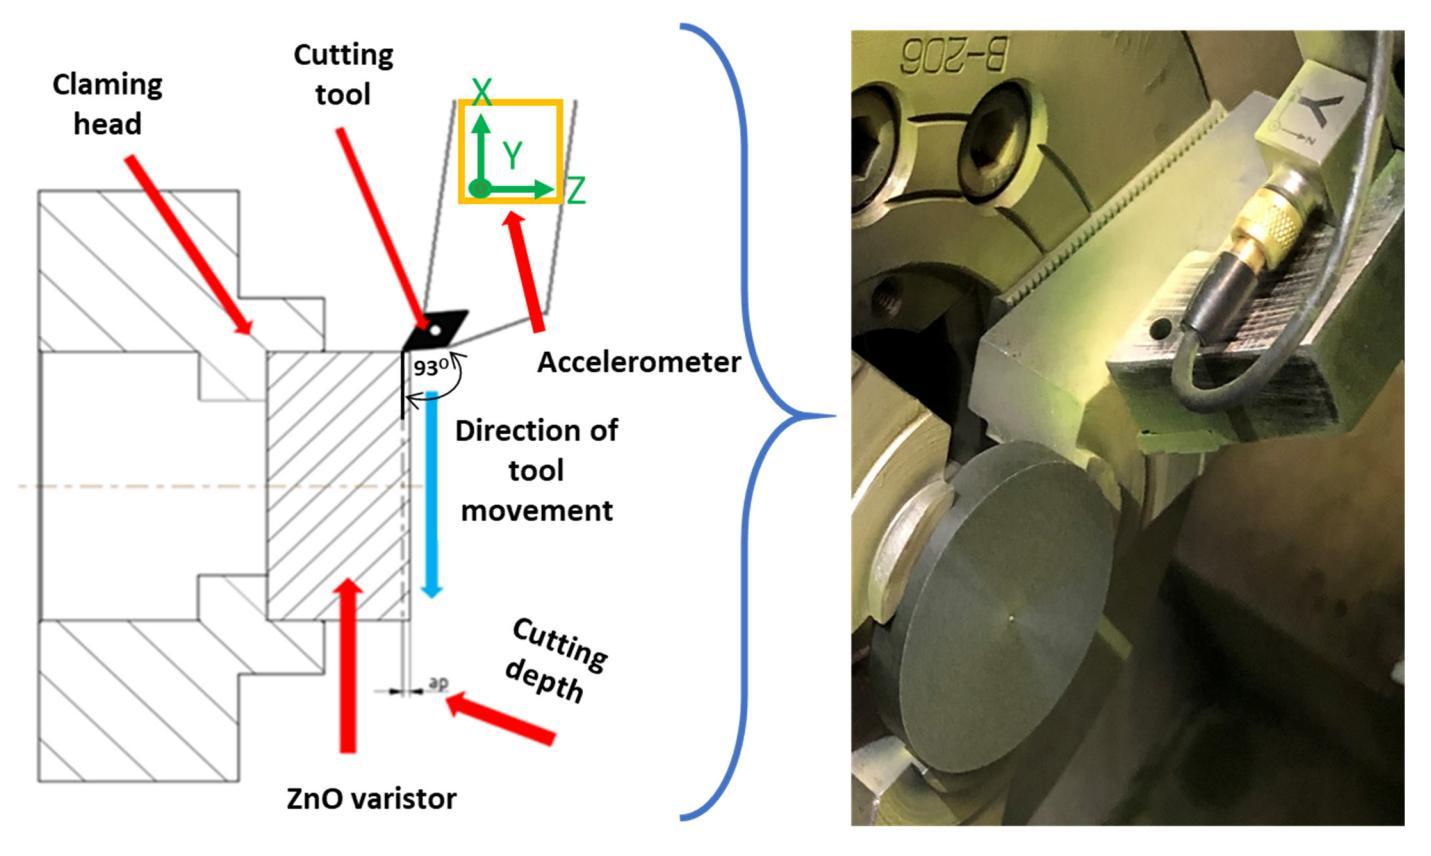
Figure 3. Schematics of the turning operation on a ZnO varistor.

The schematic of the turning operation is presented in Figure 3. The depth of cut (a_p) was maintained at 0.5 mm and the feed rate (feed velocity— f_n) was varied from 0.1 mm/rev and 0.15 mm/rev to 0.2 mm/rev, while the cutting speed (V_c) was kept at = 100 m/min and the spindle rotation speed (n) was kept at 3000 rpm, in-line with the preliminary studies with laser milling [1]. The surface integrity analysis was based on the surface roughness of the machined ceramics and the vibrational amplitude was based on the edge chipping

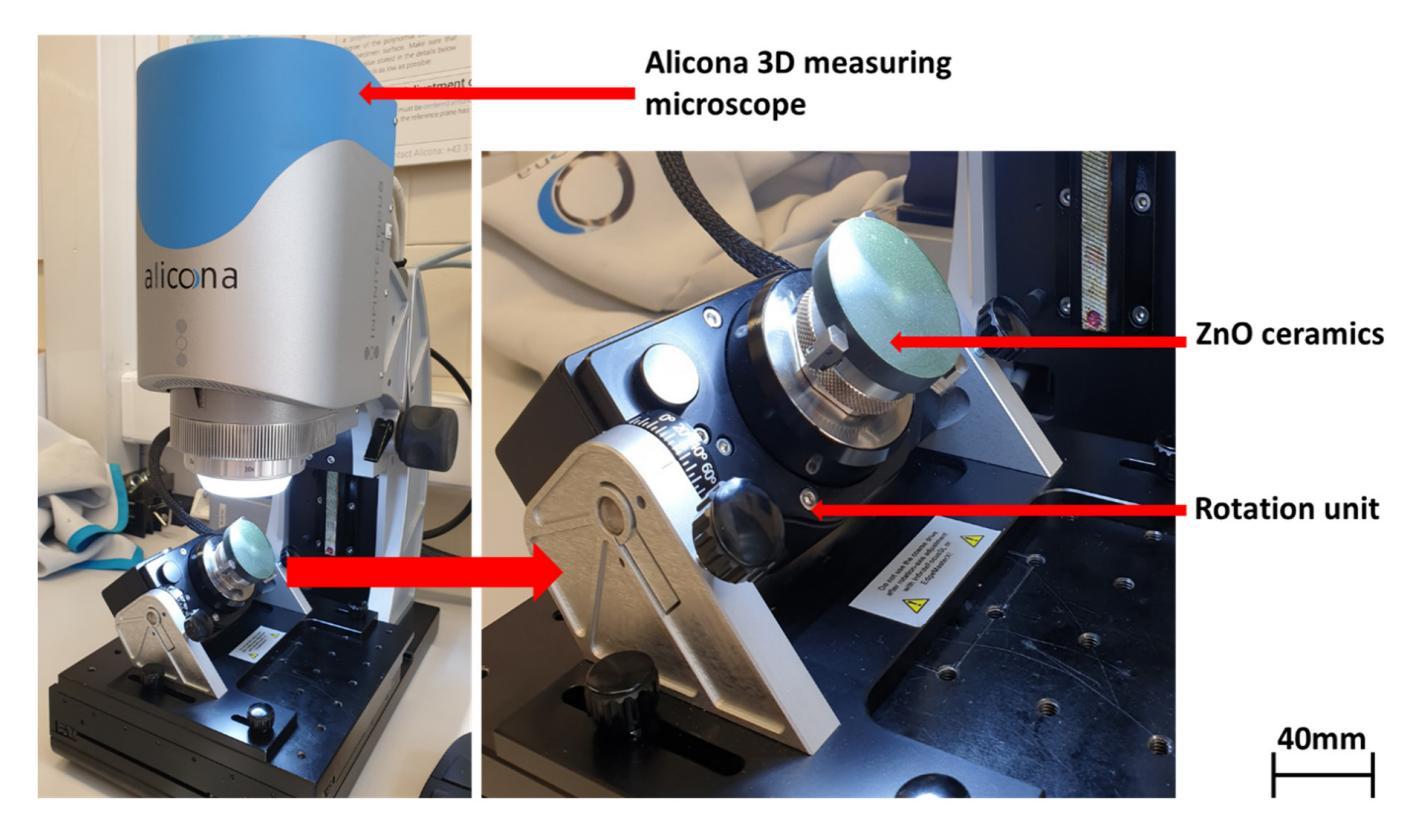
The evaluation of the surface integrity was made with an Alicona InfiniteFocusSL measurement system in the form of three-dimensional scans of the surface and edges, generated in two passes. The topographical features were resolved with the Alicona three-dimensional optical microscope system utilizing the ISO 25178 method to compute the areal roughness and to calculate the S_a and S_{10z} parameters. Figure 4 illustrates the three-dimensional surface integrity setup with the ceramic workpiece mounted in the tilted position within the specimen holder and the top-down optical light illumination. The Alicona microscope takes advantage of the shallow depth of field of the optical system by vertical scanning (z-axis with precise piezoelectric positioning system) and obtains data on topography (in the form of a color scheme) by changing the focal length. The minimum measurable profile roughness R_a at $10 \times$ and $20 \times$ magnification was 0.3 µm and 0.15 µm, respectively.

Figure 4. Surface roughness measurement setup with an Alicona 3D microscope.

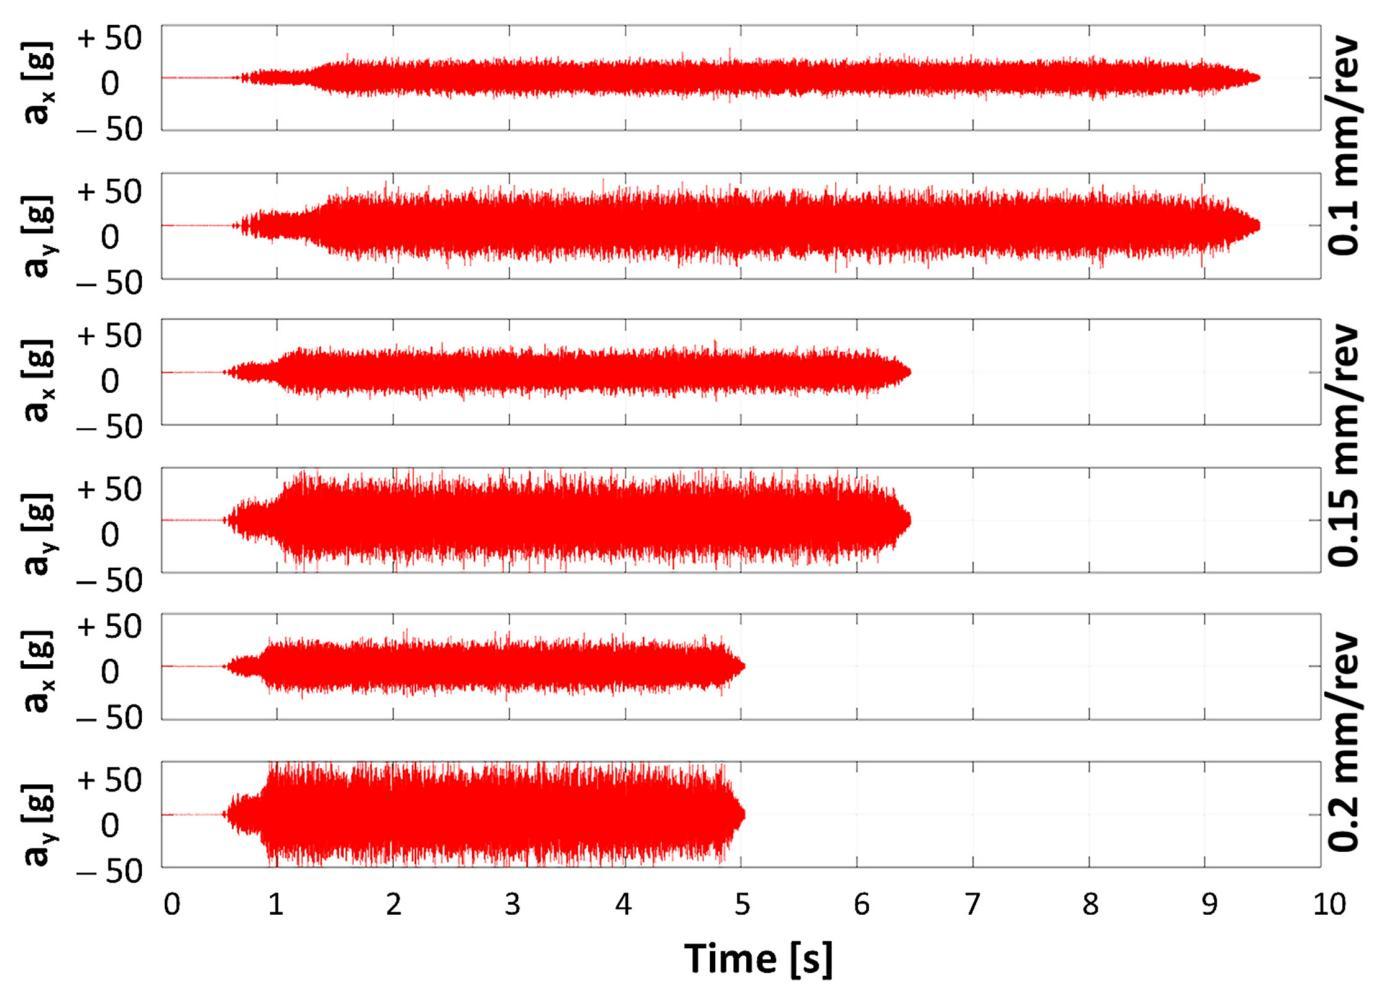
The investigation of the vibration signals during the turning operation was performed with the accelerometer, to corelate the surface topography with the chipping frequency and the optimal machining characteristics of ZnO varistors. These accelerometer measurements accounted for the time and frequency domain FFT signals of the spectral power density obtained by the real-time vibrational feedback [20,21]. The FFT graphs presented in Figure 5 illustrate the time domain variation of the feed velocities exhibiting a higher signal attenuation from 0.1 mm/min to 0.2 mm/min, with measurements along the x-coordinate (a_x) showing the variation in the feed rate and the measurements along the y-coordinate (a_y) showing the variation in the cutting force in the form of vibrations. The results of the time domain FFT indicate that for a depth of (a_v) kept at 0.5 mm and in the case of a lower feed velocity of 0.1 mm/rev, the cutting operation was completed in slightly over 9 s. In contrast, the machining operation was performed at 6.3 and 5 s for 0.15 mm/rev and 0.2 mm/rev feed rates, respectively. Considering the a_y segment of the time domain FFT plots, a similar result can be inferred: for a higher feed rate there is a proportional relationship of force feedback vibrations with the time series as the vibrations are higher for a 0.2 mm/rev feed rate. However, the difference with 0.15 mm/rev was insignificant. On the contrary, an inverse linear relation exists between the cutting force and the vibrational attenuation of the force feedback with time series: a higher cutting force resulted in a reduced time to complete the turning task. The vibrational feedback obtained from 0.2 mm/rev signifying the higher cutting force in play is quite evident in Figure 5; however, the requirement for the cutting force was lower for the higher feed velocities in the time domain to complete the respective turning operation on a sintered ZnO ceramic. In short, the turning operations finished faster with higher feed velocities and the process was completed in a shorter time frame at 0.2 mm/rev as compared to 0.1 mm/rev, which is in line with the projections from the accelerometer data related to machining processes [8,11,17].

Figure 5. FFT plots of the acceleration signal in *x* and *y* coordinates with respect to time for the top side of the ZnO ceramic under different feed velocities.

Figure 5 for the 0.2 mm/rev condition. Looking at the BSE images of different turning conditions in the edge region of the top surface of electro-ceramics, the grey ZnO matrix remained in pristine condition after turning at 0.1 mm/rev (Figure 10d). As the feed rate was increased to 0.15 mm/rev and 0.2 mm/rev, the ZnO matrix was subsequently replaced by the darker contrast voids which represent pores due to grain pull-out at higher feed rates. The bright Bi_2O_3 -rich IP and the spinel phase grains can be seen distributed at triple junction regions and finer ZnO grains. Since this bright phase distribution appears more as a secondary phase, rather than grain boundaries in the machined surface on the top side, this may produce undesirable chipping due to the non-uniform distribution of the eutectic liquid phase during solidification along the ZnO grain boundaries owing to rapid heat exchange at the edges [1]. As the vibrational attenuation in the time and frequency domains suggested that for higher feed rates there were vibrational peaks around 8000 Hz at the edge regions, this must be from chipping which was also verified by the three-dimensional surface topographical analysis shown in the next section. The presence of voids in the edge region only appeared once the feed velocity was increased to 0.2 mm/min, but when we looked at the inside segment of the ceramic, shown in Figure 10g-i, it became quite evident that due to the radial cutting force distribution at the central region, the chipping was pronounced for higher feed rates and thus the resulting surface was rougher. The BSE imaging in Figure 10 j–l shows a similar concentration of bright constituents as secondary phases rather than grain boundaries and the resultant grain pull-out from the central part of ceramic was much more pronounced that the edges, which is visible from the vibrational plots in Figure 6.

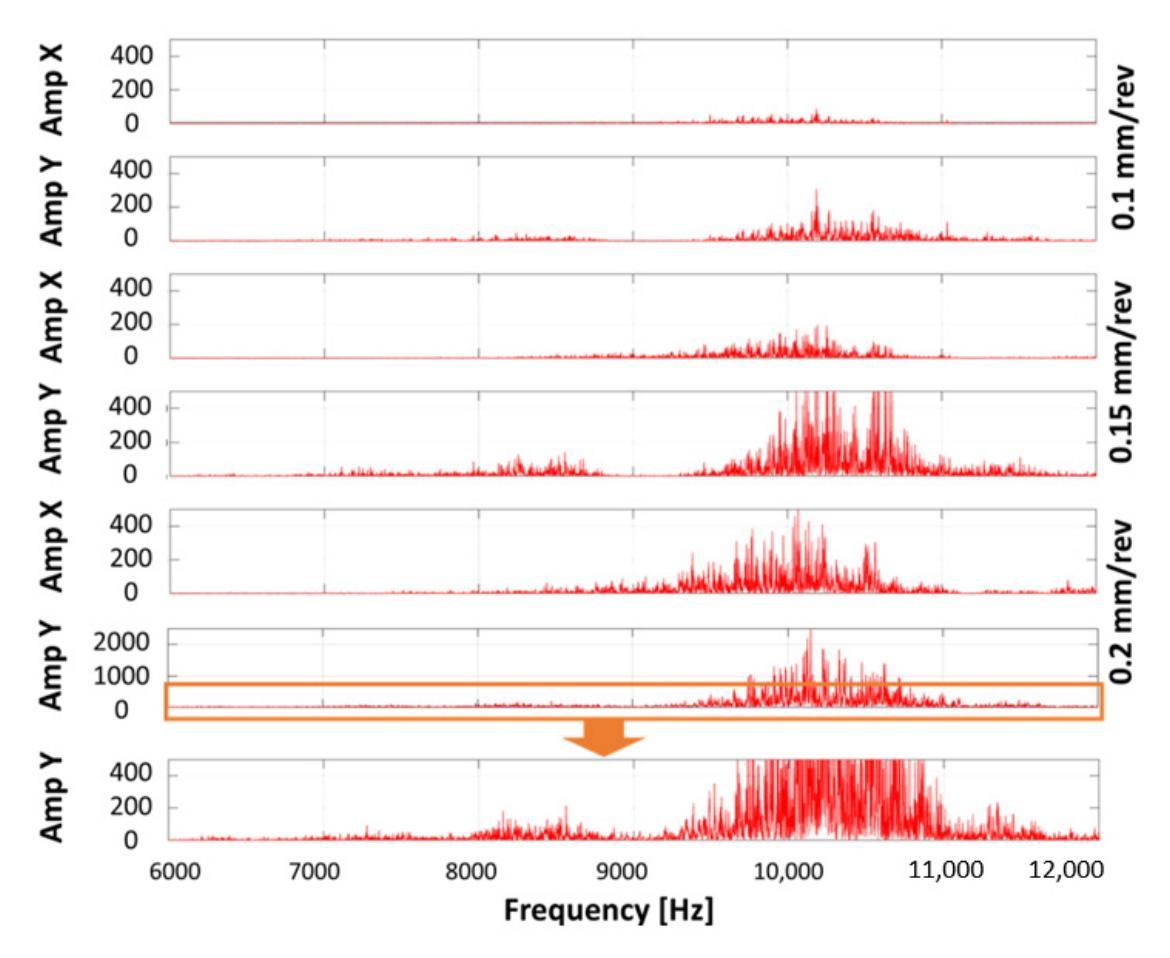
Likewise, for the top side of the ZnO varistor where uniaxial pressure was applied prior to sintering, the frequency domain FFT plot is illustrated in Figure 6. The frequency response designates the maximum possible deviation of sensitivity over the frequency range, which was set at 12 kHz for the turning operations. Typically, the frequency response generated at the high frequency amplitudes primarily denotes the mechanical resonance of the sensor. The amplitude along the *x*-coordinates shows the variation in the feed velocities, while the amplitude signal produced along the *y*-coordinates refers to the variation in the cutting forces. In the case of the turning operations along the y-coordinates, the incremental rise in the vibrational amplitudes with the feed rates suggests higher cutting forces from 0.1 mm/rev to 0.2 mm/rev. As can be seen in Figure 5, the vibrational signal from the edge regions was small at a low feed velocity (0.1 mm/rev) between the frequency range of 7000 and 9000 Hz along the y-coordinates, whereas it became momentous when the feed rate was increased from 0.15 mm/rev to 0.2 mm/rev. The vibrational attenuation in the frequency domain was significantly pronounced at the central part of the ceramic as compared to the edges and the amplitude signals suggest significantly high cutting forces applicable in the frequency range from 9000 to 11,500 Hz on the surface section of the ceramic at 0.2 mm/rev feed velocities.

Figure 6. Frequency domain FFT plots in *x* and *y* coordinates for the top side of the ZnO varistors turned with different feed velocities.

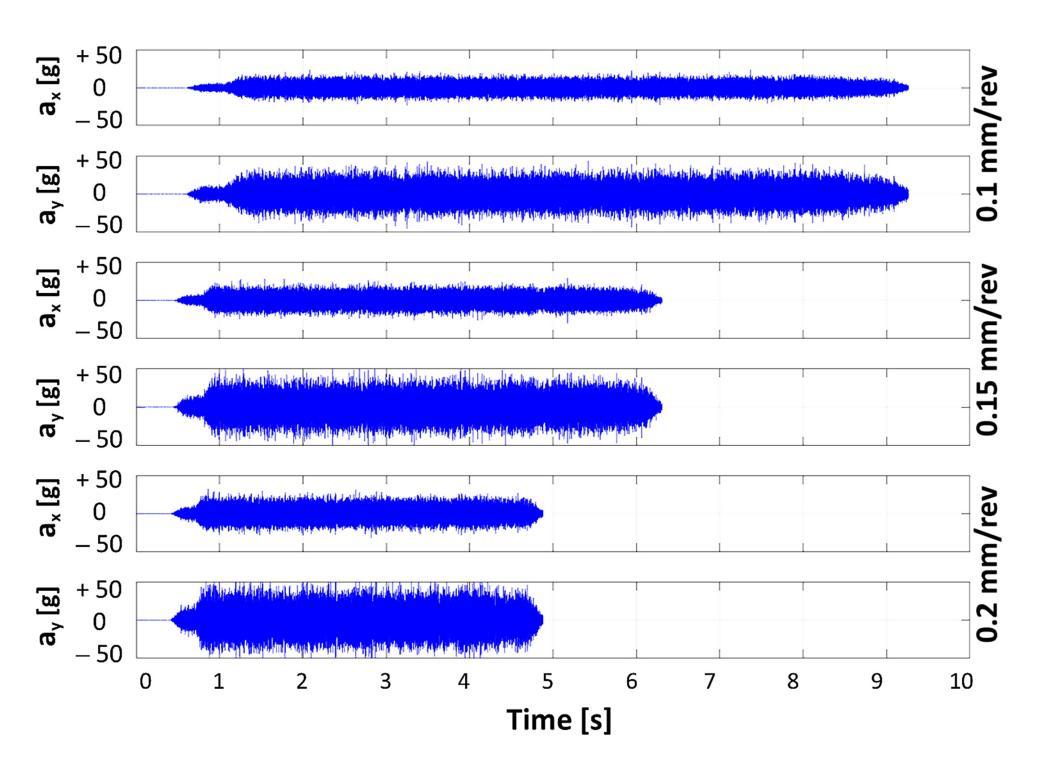
Similarly, the acceleration signal during the turning operation under different feed velocities of the bottom part of the ZnO ceramic is shown in Figure 7. The subsequent patterns of the acceleration signals a_x (feed rate variation) and a_y (cutting force variation), respectively along the (*x*,*y*)-coordinates for the bottom side of ceramic were similar to the

Figure 7. FFT plots of the acceleration signals in *x* and *y* coordinates with respect to time for the bottom side of the ZnO ceramic under different feed velocities.

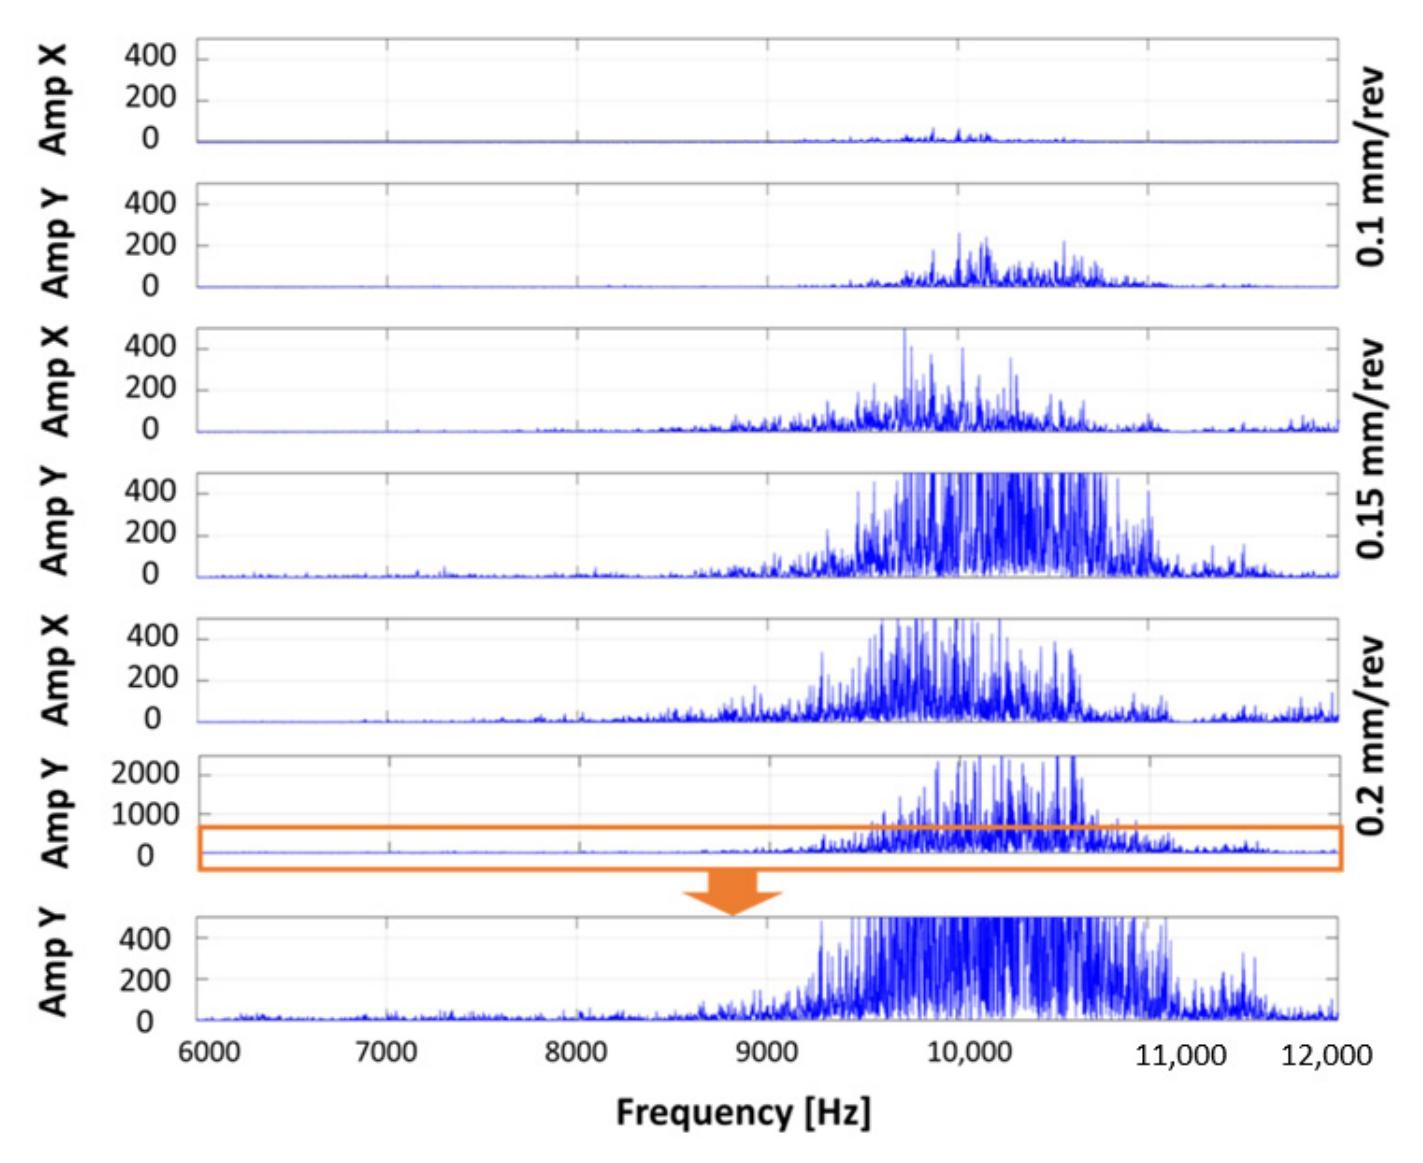
The amplitude FFT graph for the bottom part is presented in Figure 8 for the *x* and *y* coordinates with respect to the different feed velocities. The two generic differences observed in the frequency domain illustration of the turning operations on the bottom surfaces are firstly, the lack of vibrational signals at the edges in the range from 7000 to 9000 Hz and secondly, the amplitude feedback (Amp Y—cutting force variation) during the machining for the 0.15 mm/rev and 0.2 mm/rev feed rates in the central segments of the sintered ceramics were slightly on the higher side. The spread of the frequency signals for 0.2 mm/rev was also broader for the bottom side, which implies that higher applied cutting forces result in shorter cutting times on higher feed rates.

Figure 8. The FFT plots of the frequency domain in the *x* and *y* coordinate for the bottom side of the ZnO ceramic under different feed velocities.

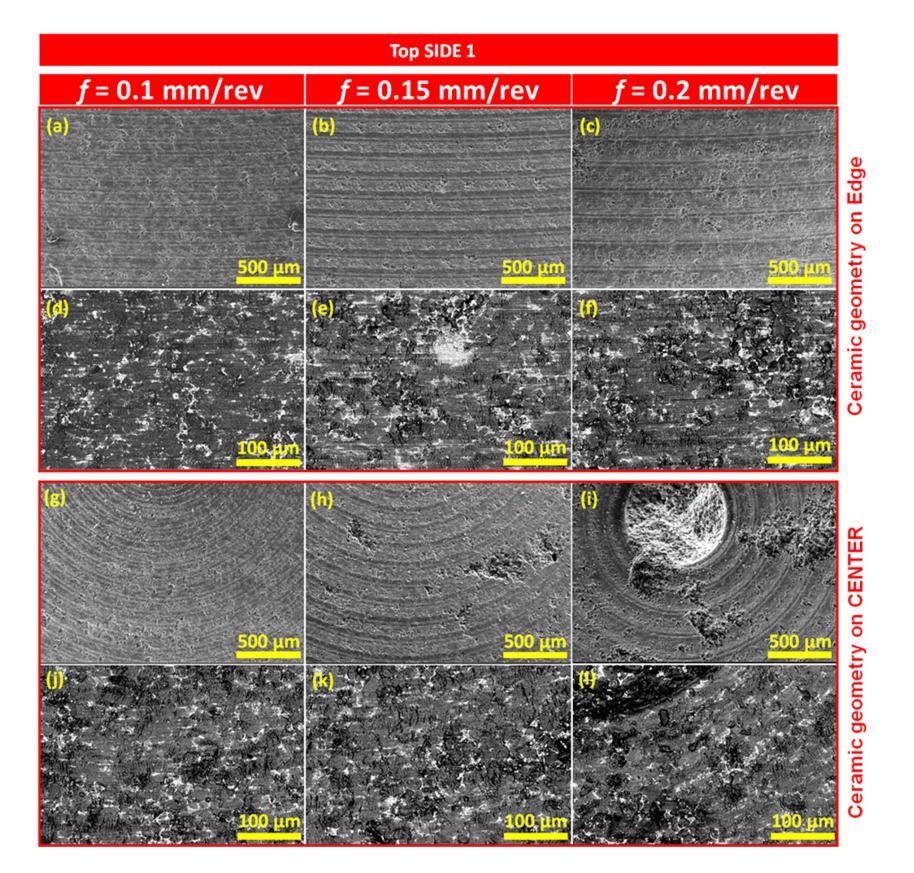
The machining characteristics were analyzed under high resolution scanning electron microscope to corelate the surface topography (in secondary electron—SE mode) after turning with the phase contrast imaging (backscattered electron imaging—BSE) to evaluate the microstructure evolution during the sintering on different sides of green compacts with dissimilar relative densities due to the pressure constriction in uniaxial pressing. The microstructural analysis in Figures 10 and 11 was made at the edge sections (a–f) and the central regions (g–l) of the ZnO varistors.

Figure 10. SEM analysis of the top side where pressure was applied during green compact processing indicating the variation in the turning characteristics of ZnO varistors for different feed rates (horizontally). SE imaging of the topographical contrast of the surface features after turning in the edges shown from (**a**–**c**) with an increasing feed velocity. BSE phase contrast imaging of the edge region is depicted by (**d**–**f**) with horizontal increases in the feed velocity. The topographical SE imaging in the center of the ZnO varistor is shown for consecutive increases in feed velocities by (**g**–**i**) at 100× magnification, whereas the phase contrast imaging of the central segment of the ceramic is demonstrated from (**j**–**l**) at 500× magnification.

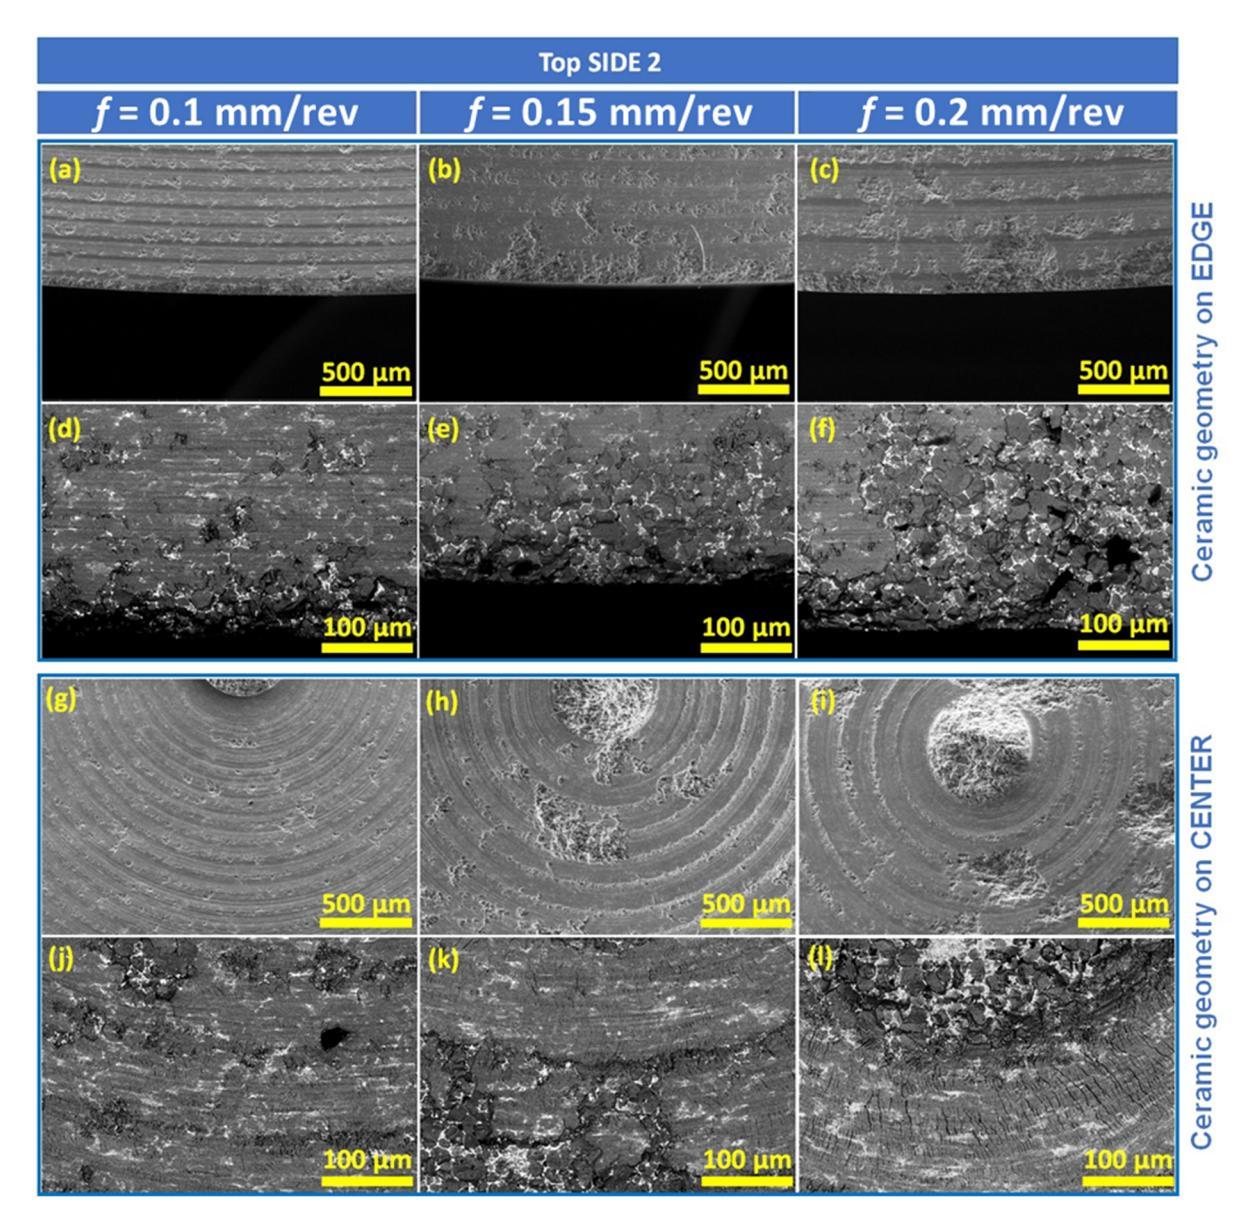
Figure 11. SEM analysis of the static bottom side where the uniaxial pressure was not applied during the green compact processing of ZnO varistors representing the variation in the turning characteristics for different feed rates (horizontally). The SE imaging of the topographical contrast of the surface features after turning at the edges is shown from (**a**–**c**) for an incremental feed velocity at $100 \times$ magnification. The BSE phase contrast imaging at $500 \times$ magnification of the edge region is shown by (**d**–**f**) for a subsequent increase in the feed velocity. The topographical SE imaging at the center of the ZnO varistor is presented for successive surges in feed velocities by (**g**–**i**), while the phase contrast imaging of the central section of the turned ceramic is illustrated from (**j**–**l**).

For the bottom part of the ZnO varistor, during turning at lower feed velocities the microstructural trend was a reflection of the vibrational feedback from the accelerometer. Conversely, for this case and as the cases shown in Figure 11a–c, we did observe pronounced edge chipping as compared to the top surface in Figure 10a–c, which must have been due to a higher distribution of the spinel phases at the edges. The BSE imaging in Figure 11d-f for the increasing feed velocities confirms that the bright phase distribution was more adequate between the grain boundaries and the secondary phases at the interpunctions or triple pockets; however, the chipping became prominent at the terminal parts of the varistor due to sustained high cutting forces for 0.2 mm/rev. The spinel phases were extremely brittle and were easily ejected from the matrix with a reduction in Bi_2O_3 IP towards the edges. Comparing the central segments of the ceramic in the SE topographical imaging, the 0.1 mm/rev showed a lack of surface deterioration, which progressed further as the feed velocity increased up to 0.2 mm/rev, resulting in more pronounced chipping rather than grain pull-out due to the effect of the tangential shear cutting forces [1,3,4]. This roughness of the ceramic edges is yet more protuberant in the phase contrasting images in Figure 11d–f in linear relation with the feed velocities.

Moving to the central part of ceramic, the surface apparent in Figure 11g showed cleaner topographical features at 0.1 mm/rev, whereby a limited grain-pull out was obvious for 0.15 mm/rev in Figure 11h and it extended to surface chipping due to the shear cutting forces at an applied feed rate of 0.2 mm/rev. Therefore, as a customary practice for turning ZnO varistors, we suggest 0.1 mm/rev as the optimal feed velocity for the given cutting parameters: cutting speed (V_C) kept at = 100 m/min and spindle rotation speed (n) kept at 3000 rpm. The phase contrast microscopy revealed that the surface area of the secondary phases was relatively higher for the bottom side, which suggests the distribution of a bright α -Bi₂O₃-rich intergranular phase (IP) at the ZnO–ZnO grain boundaries in Figure 11j–l. Apparently, the chipping-induced fracture topographies on the surface originated from the grain boundary junctions rich with the liquid phase, but due to the brittle nature of the ZnO ceramics, the shear cutting forces induced increased chipping on the surface at 0.2 mm/rev in the central segment, matching the vibrational feedback from the accelerometer. Due to higher shear forces converging at the center, the inside region of the ceramic experienced increased chipping with an increase in the feed velocities, and although the pores were less frequent on this side, the chipping surface fracture was more pronounced in the coarser

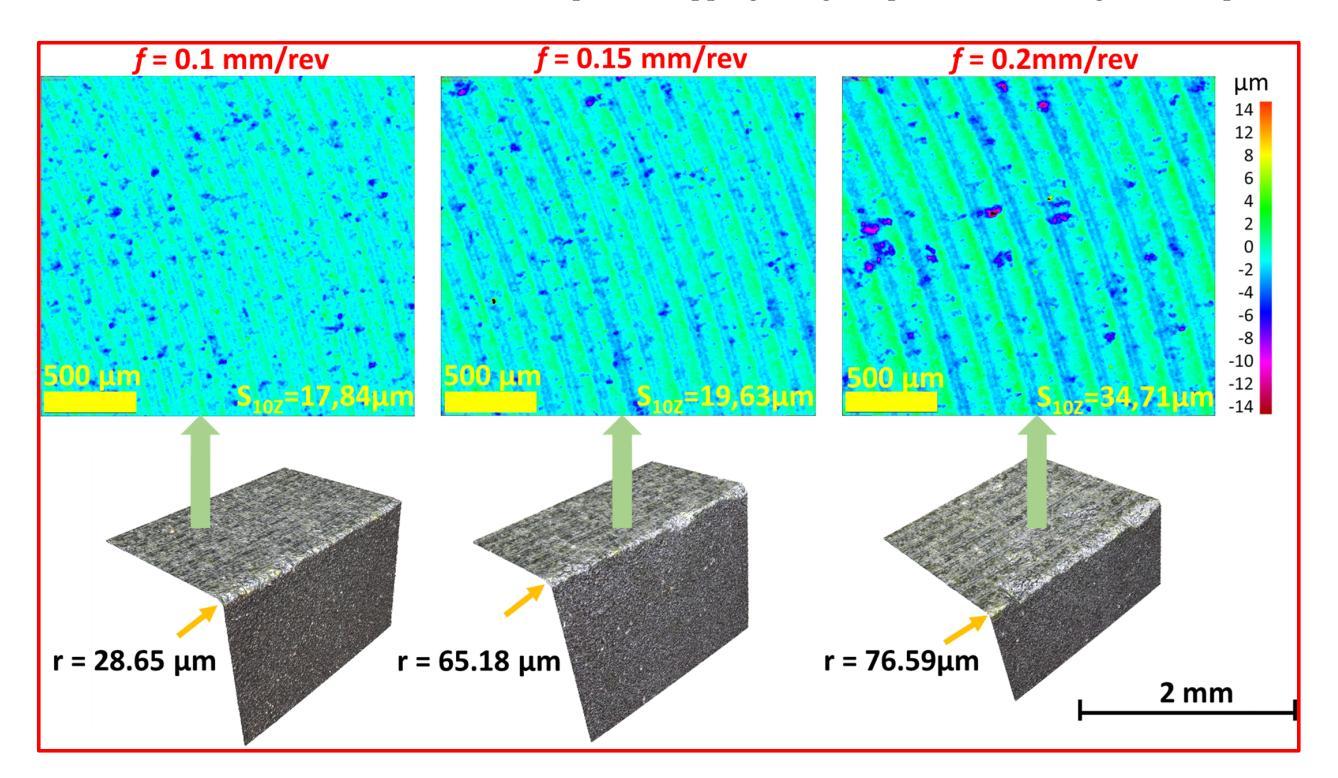
The roughness measurements with the Alicona three-dimensional microscope are shown in Figure 12 and Figure 14 to expose in detail the topographical variations (surface) and in Figure 12 and Figure 14 for the edge surface (profile) characterization for the respective sides of the sintered ZnO ceramic. Figure 12 refers to the top part of the ceramic which was identified by the electron microscope to exhibit a pronounced grain pull-out at higher feed rates, leading to a rough surface topography. The three-dimensional microscope scanned the regions at the edges to understand the mechanism of material removal with respect to the feed rates [1]. So, for an increase in the feed velocities, the surface roughness by definition of the S_{10z} parameter increased from 17.84 μ m (at 0.1 mm/rev) to 34.71 μ m (0.2 mm/rev). Likewise, the edge radius after the turning operation increased from 65.18 μ m at 0.15 mm/rev to 76.59 μ m at 0.2 mm/rev, which was considerably fine and consistent at 28.65 μ m for 0.1 mm/rev. The three-dimensional optical microscopy images for the edge sections indicated uniformity and a low surface roughness at 0.1 mm/rev which contributed to partial chipping and grain pull-out in the edge of the top surface.

Figure 12. The surface roughness profile analyzed for the side 1 i.e., top part of the ceramic.

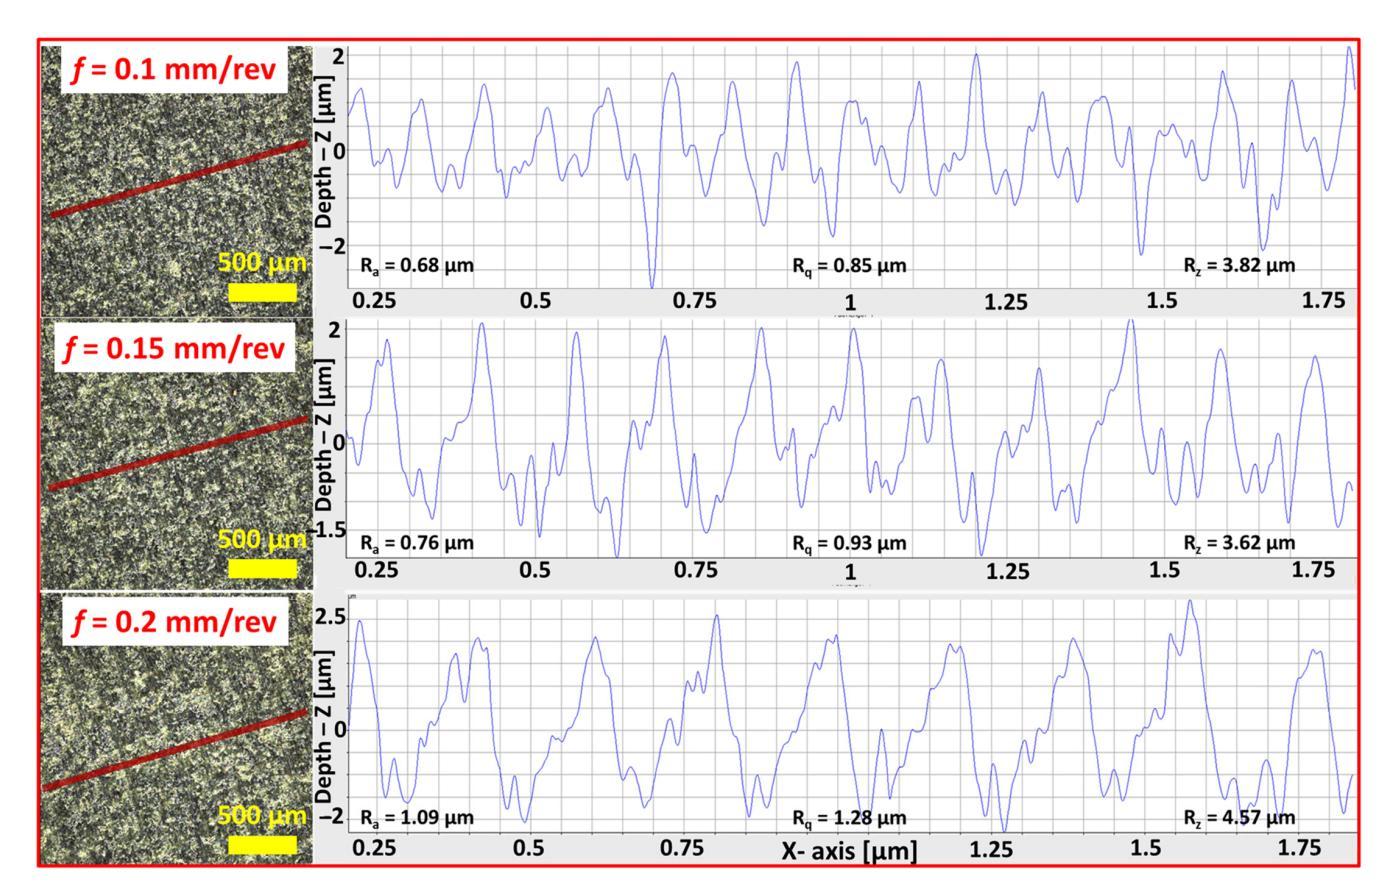
The profile measurements were also evaluated by 2 \times 2 mm area profilograms, as shown in Figure 13 for the top side. The edge roughness parameters such as R_a (average roughness, integral of absolute roughness value), R_q (Root Mean Squared roughness value), and R_z (average peak to valley profile height) were also quantified to validate the turning optimization. The values for R_a, R_q and R_z increased linearly with the feed rates from 0.1 mm/rev to 0.2 mm/rev which was in-line with the results obtained from surface roughness measurements in Figure 12. These profile roughness parameters were quite closely spaced for 0.1 and 0.15 mm/rev feed rates. The z-axis or height feedback in

Figure 13 was slightly higher for the rapid feed rates. The profilograms shown in Figure 13 show the widening of the roughness profile for the feed rate 0.2 mm/rev, which implies that a higher degree of surface roughness is imparted if the duration of turning is reduced by one half. Thereby, for an optimal machining scenario and to retain machinability with a diamond PCD cutter up to 1000 passes, the feed rate can be reduced to 0.1 mm/rev.

Figure 13. The profilograms measuring the variation in the edge roughness parameters for the top side by changing the feed velocities.

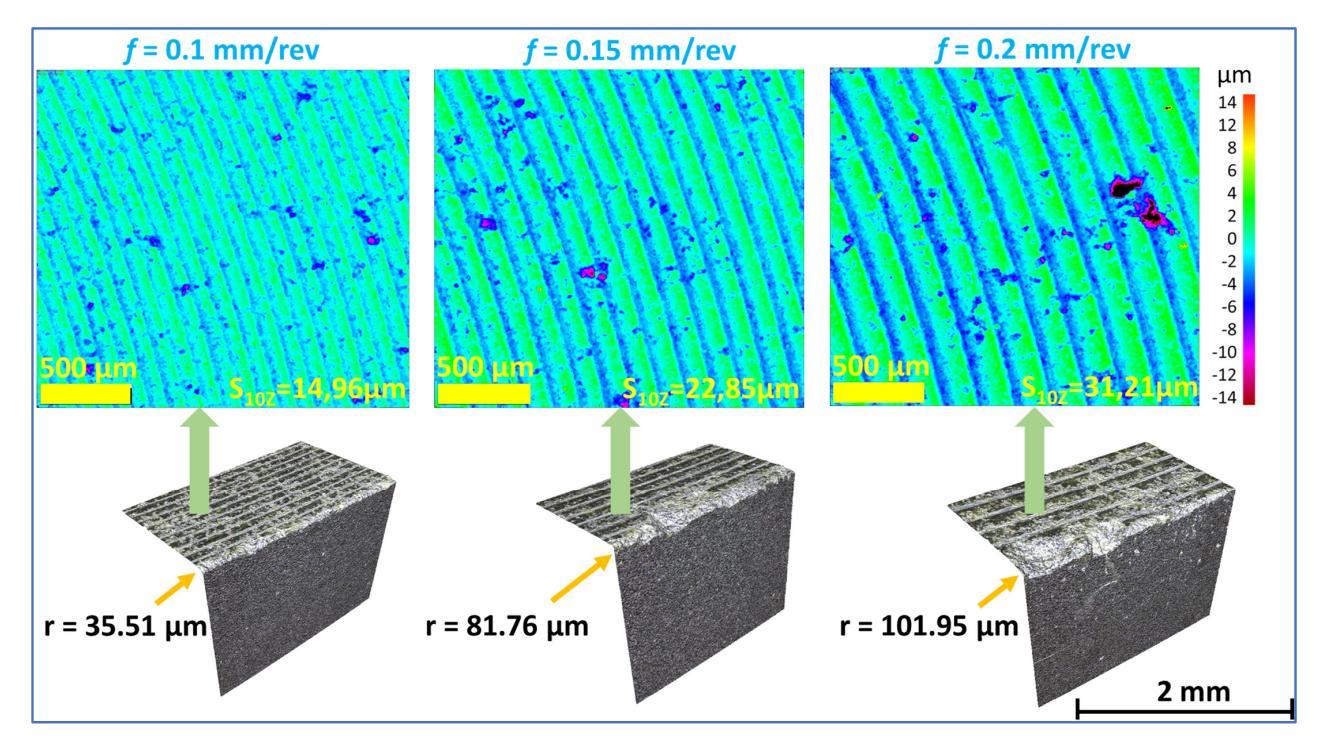
Similarly, comparing the bottom surface with the top part of the ceramic, we can deduce that the edge roughness worsened, and the topographical variations became turbulent for the highest 0.2 mm/rev feed velocity. From Figure 14 it is also possible to suggest that the depth of the cut was deeper than in Figure 12; however, at 0.1 mm/rev the surface roughness parameter S_{10z} was measured at 14.96 μ m which modestly increased to 22.85 µm for 0.15 mm/rev and successively to 31.21 µm at a 0.2 mm/rev feed velocity. As a comparison, these values for the edges of the bottom part after turning were slightly lower than the circumference measurements of the top surface. The edge radius in Figure 14 for the lowest feed rate was $35.51 \,\mu\text{m}$ which increased three-fold to approximately $101.95 \,\mu\text{m}$ with 0.2 mm/rev turning conditions. The three-dimensional topographical imaging of the edges suggests that lower feed rates do exhibit surface chipping, which increases their radius in comparison to the top part, in agreement with previous studies [4]. Noticeably, this edge chipping worsened the edge roughness as the radius of the machined edge at 0.15 mm/rev of the bottom half was inferior to the top surface in a 0.2 mm/rev turned ceramic. This effect is related to a combination of edge chipping and grain pull-out on the bottom side of the ceramic as indicated by the topographical color maps in Figure 12, whereas the top surface experienced a more conspicuous grain pull-out which resulted in more uniform edges even at a higher feed velocities [1]. The initial value of R for the pristine non-machined ZnO samples was averaged from 55–109 μ m ($S_a = 1.37 \mu$ m) as shown in Figure 1. With the geometric specifications of the samples and by the optimization of

Figure 14. The surface roughness profile analyzed for the bottom section i.e., side 2 of the ceramic.

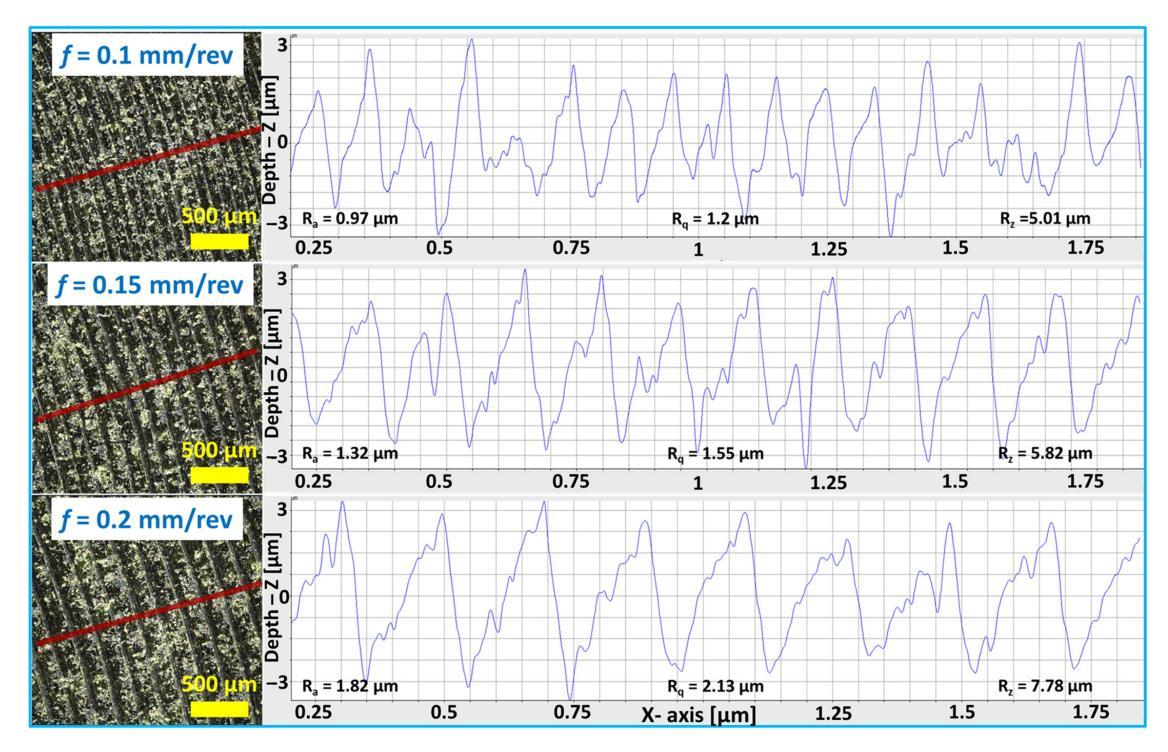
The edge profile for the bottom part was also analyzed to develop a relationship with the surface roughness and the edge profilograms for the varying feed rates are shown in Figure 15. It can be clearly seen that the average profile roughness R_a , R_q and R_z of the bottom part was higher than the top side and these values increased simultaneously with the upsurging feed velocities. The average R_z roughness values of the top side at 4.57 µm for 0.2 mm/rev was still marginally lower than that of the bottom part at 5.01 µm for the 0.1 mm/rev setup. The highest obtained $R_z = 7.78$ µm for 0.2 mm/rev on the bottom side was approximately two-folds higher than the top side and this trend in the roughness profiles was similar for the R_a , and R_q values as well. The z-axis peak height and the cutting width separation in the 0.2 mm/rev turning setup as shown in Figure 15 implies that the higher material removal rate was more detrimental than beneficial for the turning optimization and led to a rougher surface over the slower feed rate options.

Figure 15. The edge roughness profilograms analyzed for the bottom section i.e., side 2 of the ZnO ceramic for different feed rates during turning.
