Abstract: The sintered zinc oxide (ZnO) electro-ceramics are a brittle class of hard-to-cut materials such that shaping them with the post-finishing operations necessitates careful handling and precision machining. The conventional machining approach using the grinding and lapping processes represents limited productivity, an inability to produce the required geometries and frequent uncontrolled chipping of the edges of the final products. This study thus investigates the turning performance of dense sintered ZnO varistors and chip formations to obtain the parametric range (cutting mechanism) which causes the chipping or the trans-granular/sudden failure in these brittle materials. With the analysis of the cutting tool vibration in relation to the machining parameters (*f* and *V*_C), the vibration-induced chipping correlations are made and interlinked with the occurrence of grain pull-out during the turning operation. The results show that the reflected vibratory motion of the tools is directly correlated with the chip formation mechanisms in the turning of ZnO ceramics and thus provide robust measurements for quality assurance in final products.

Citation: Dugar, J.; Ikram, A.; P

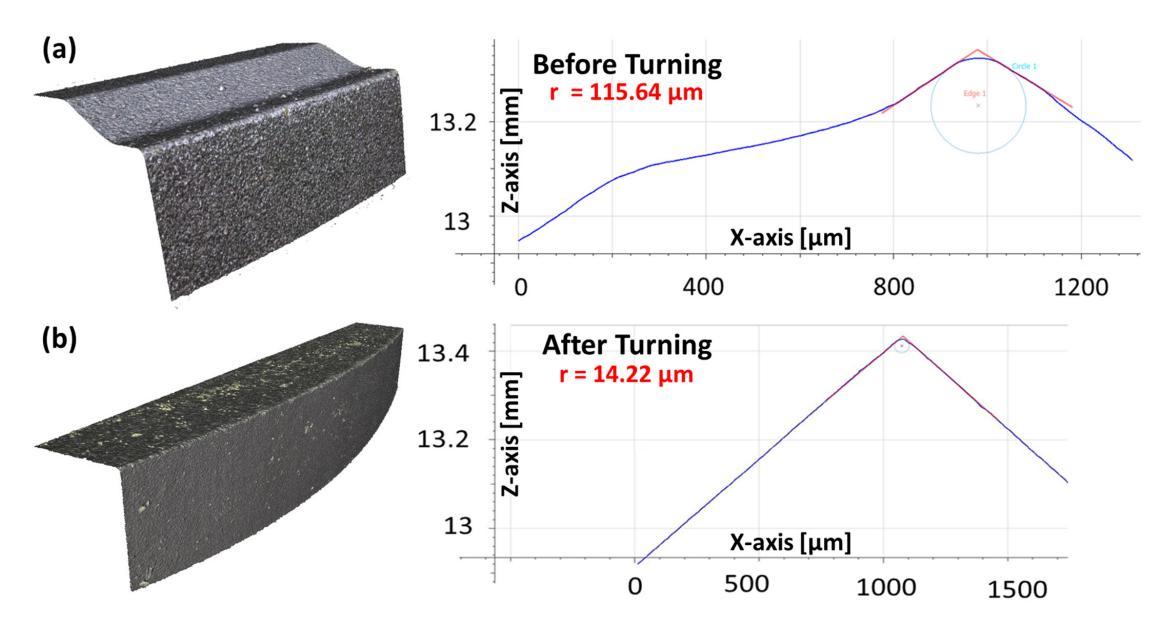
A comparative edge profile assessment was also carried out on the pristine ceramic before performing the turning operations which can be seen in Figure 16a. The edge radius of the ceramic prior to turning was in the range of 100–125 μ m as indicated in Figure 1, whereas the top side of the ceramic measured by the Alicona system shown in Figure 16a had an edge radius of 115.64 μ m, rendering the necessity of turning and a high requirement for material removal. Utilizing the most optimal turning setup at 0.1 mm/rev, with the depth of cut (a_p) maintained at 0.5 mm and the cutting speed (V_C) kept to 100 m/min rendered the final profile radius at 14.22 μ m. The corresponding value of the finer edge radius in Figure 16b was even slightly better than the obtained value in Figure 12, but since the ZnO ceramic edge profile sits in a dormant range, a tight geometric control is still possible with the conventional machining and turning setups as explained in this study.

Figure 16. The edge profile comparison between the (a) non-machined and (b) optimally turned ZnO ceramic.
