Article Mechanical Behavior of Repaired Monolithic Crowns: A 3D Finite Element Analysis

Abstract: This study evaluated the mechanical behavior and risk of failure of three CAD-CAM crowns repaired with different resin composites through a three-dimensional (3D) finite element analysis. Three-dimensional models of different cusp-repaired (conventional nanohybrid, bulk-fill, and flowable resin composites) crowns made of zirconia, lithium disilicate, and CAD-CAM resin composite were designed, fixed at the cervical level, and loaded in 100 N at the working cusps, including the repaired one. The models were analyzed to determine the Maximum Principal and Maximum Shear stresses (MPa). Complementary, an in vitro shear bond strength test (n = 10) was performed to calculate the risk of failure for each experimental group. The stress distribution among the models was similar when considering the same restorative material. The crown material affected the stress concentration, which was higher for the ceramic models (\pm 9 MPa for shear stress; \pm 3 MPa for tensile stress) than for the CAD-CAM composite (\pm 7 MPa for shear stress; \pm 2 MPa for tensile stress). The shear bond strength was hi

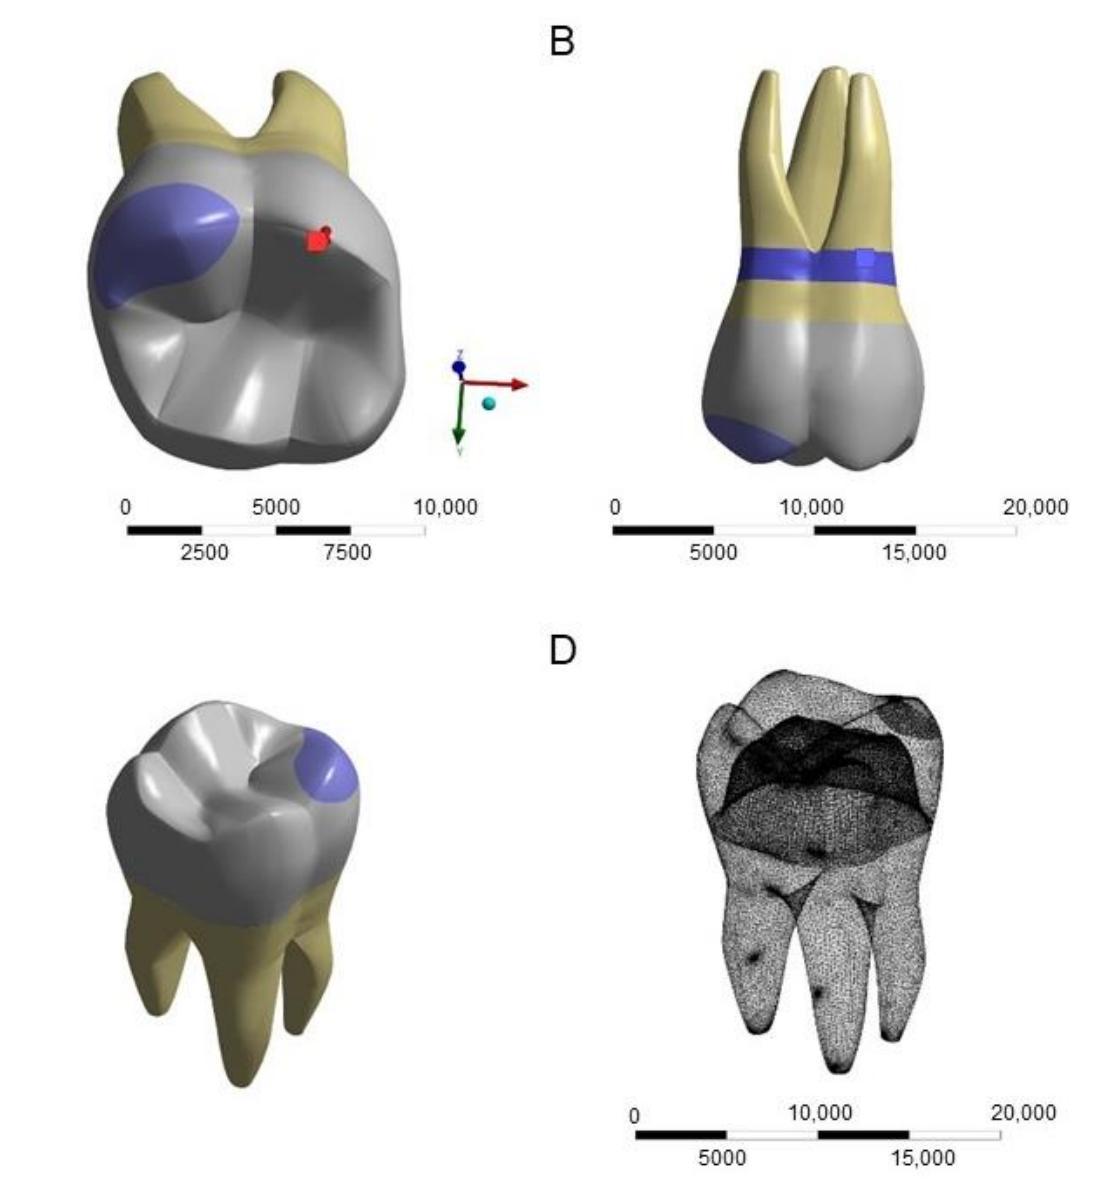
Figure 1. Study model presenting the cusp fracture of monolithic restorations. Occlusal view (**A**), buccal view (**B**), isometric view (**C**), and meshing (**D**).

Three-dimensional models of different composite-repaired (Tetric Evoceram, Tetric PowerFlow, and Tetric PowerFill, Ivoclar AG, Schaan, Liechtenstein) crowns made of zirconia (Yz—IPS e.max ZirCAD MT, Ivoclar AG), lithium disilicate (Ld—IPS emax CAD, Ivoclar AG), and CAD-CAM resin composite (Tc- Tetric CAD, Ivoclar AG) were designed in the modeling software (Rhinoceros version 5.0 SR8, 2013, McNeel North America, Seattle, WA, USA). The first molar crown model was described in a previous study [18], imported, and then modified into CAD software to present a cusp-repaired monolithic crown, according to each evaluated material. Different views of the models and the meshing are depicted in Figure 1.

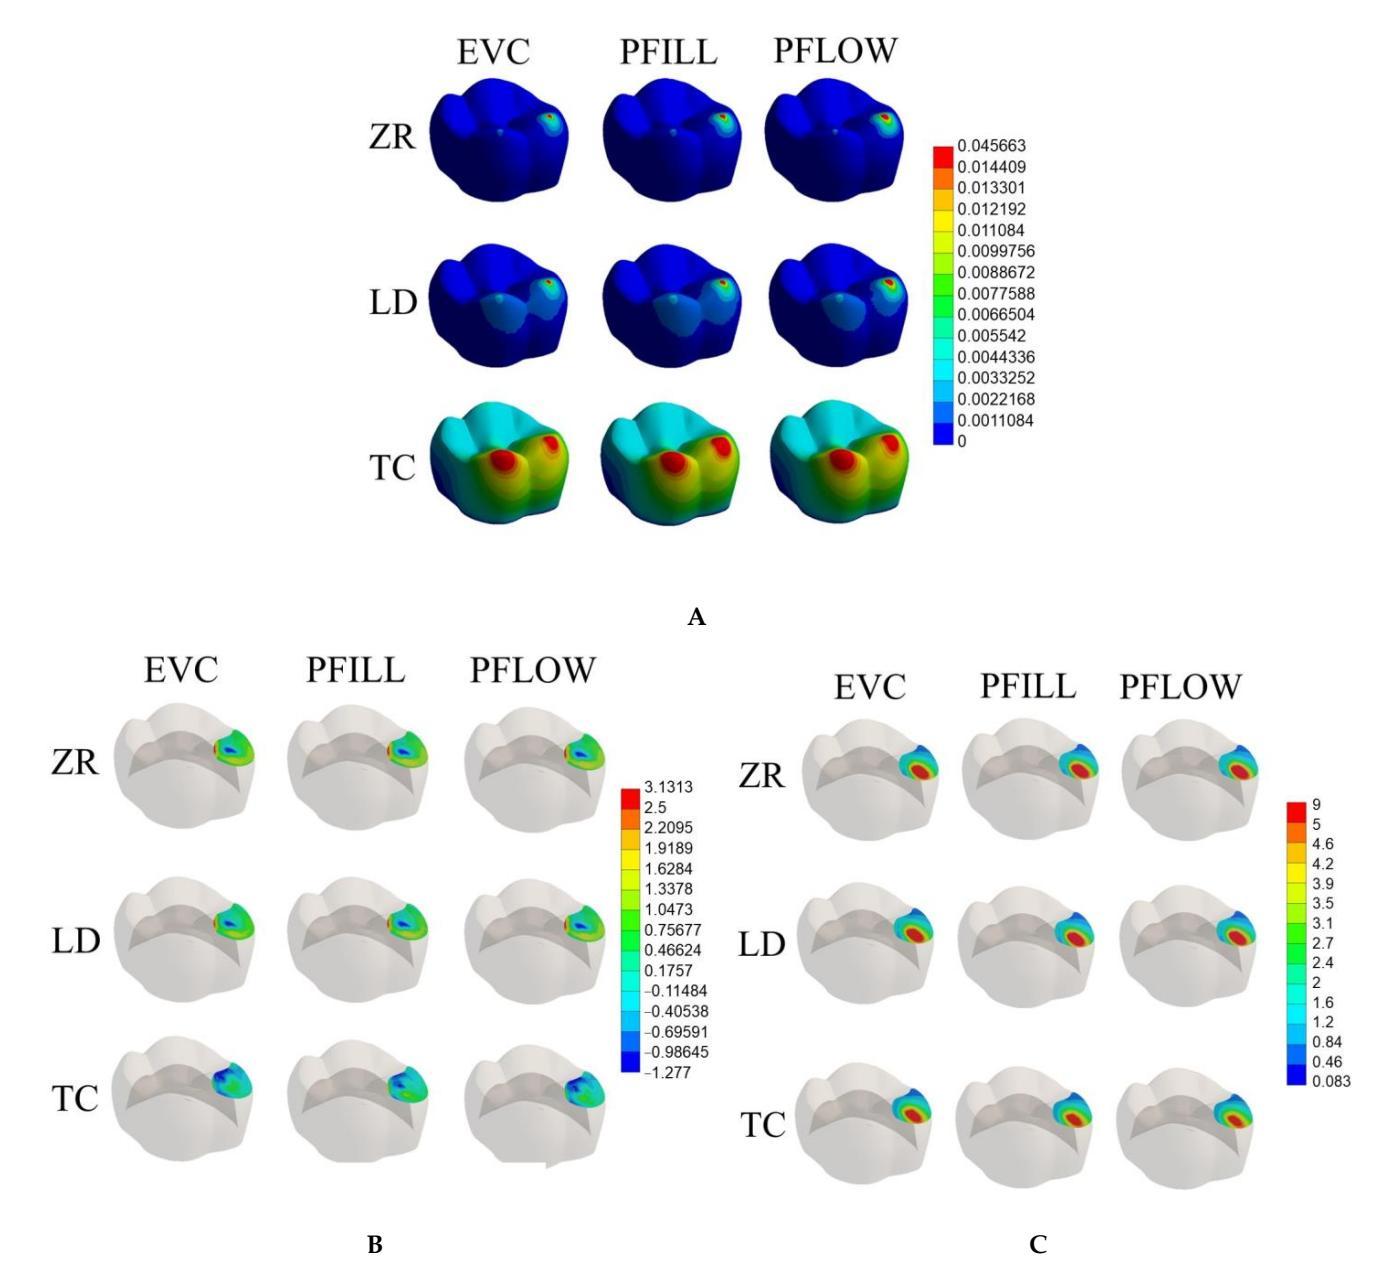
Figure 2. Total deformation per model according to different restorative materials and resin composite repairs (**A**). Tensile stress map per model according to different restorative materials and resin composite repairs (**B**). Shear stress map per model according to different restorative materials and resin composite repairs (**C**).

The mean results of Maximum Principal and Shear stresses are depicted in Table 2. Figure 2 shows the model's deformation according to each generated stress, restorative material, and repair composite.

The crown material affected the results, with the tensile and shear stresses being 36.6% and 17.1% higher for the ceramic models (zirconia and lithium disilicate) than for the CAD-CAM composite model, respectively. Also, the CAD-CAM composite crown suffered more deformation during the load application, regardless of the repair material (Figure 2).

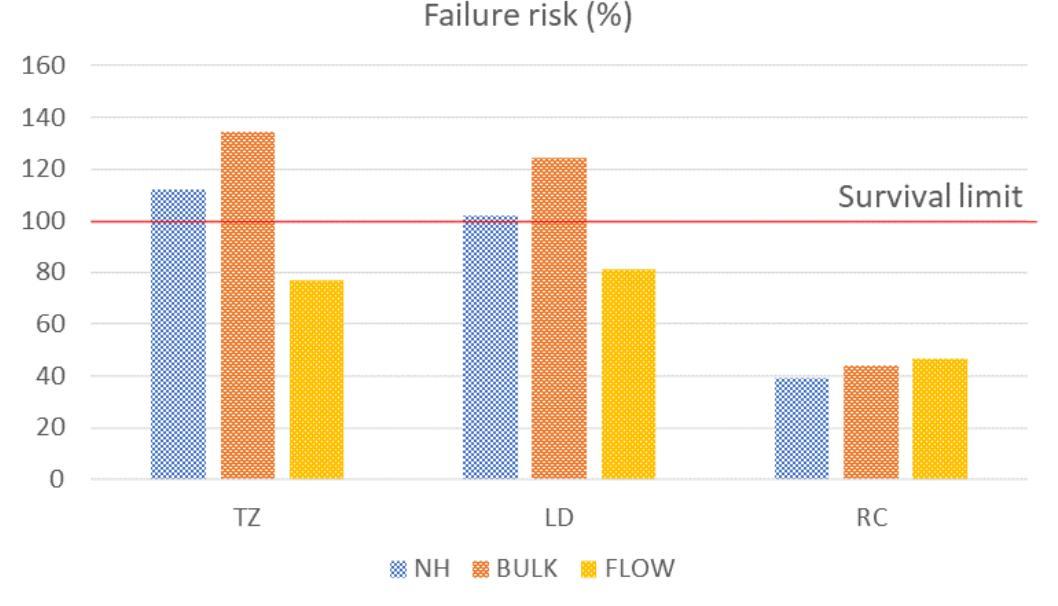
Figure 3. Risk of failure for each group. The red line represents 100% of the risk (survival limit). Translucent zirconia and lithium disilicate repaired with nanohybrid and bulk-fill resin composites trespassed the survival limit, while the CAD-CAM-resin-composite-repaired crowns presented the lowest failure risks.

Regarding the risk of failure, the translucent zirconia and lithium disilicate crowns repaired with bulk-fill resin composites presented the highest percentages of risk and trespassed the survival limit (135% and 124% risk, respectively), followed by TZ and LD repaired with a nanohybrid resin composite (112% and 102% risk, respectively). Therefore, it is expected that lithium disilicate and translucent zirconia ceramics repaired with nanohybrid and bulk-fill resin composites would fail after 100 N of load application. CAD-CAM-resin-composite-repaired crowns showed the lowest risk of failure for all repair materials (Figure 3).

Despite showing similar mechanical responses when loaded, the different resin composites present different compositions and bondability with ceramic materials. In this sense, resin composites with higher bond strength withstand more stress at the adhesive interface than the ones that present a weaker link to the substrate. The in vitro shear bond strength test showed that the values between the repair composites and ceramic materials range from approximately 7 MPa to 18 MPa, with the shear bond strength values being higher for CAD-CAM resin composite crowns. Even so, when repairing ceramic restorations with a flowable resin composite, the bond strength values were similar to those achieved for the CAD-CAM composite restoration (Table 2). A flowable resin composite presents more monomers and less viscosity due to its lower filler content and smaller size of particles, thus providing more probability to adapt on a bonding surface when compared to other conventional resin composite materials, with promising results in terms of bond strength showed in previous studies [34–36]. As a result, the adhesive interface may exhibit more contacting surfaces and consequently, a greater resilience to stress when repairing monolithic ceramic crowns using the flowable resin composites. Thus, a lower risk of failure may be expected in this scenario, as corroborated by the findings of the present study (Table 2, Figure 3).
