Proceedings The Contribution of Infrared Thermography to Impact Testing of Composite Materials ⁺

Carosena Meola ‡

Department of Industrial Engineering—Aerospace Division, University of Naples Federico II, 1-80125 Napoli, Italy; carmeola@unina.it

- Presented at the 15th International Workshop on Advanced Infrared Technology and Applications (AITA 2019), Florence, Italy, 17–19 September 2019.
- [‡] Keynote Speaker of the Conference.

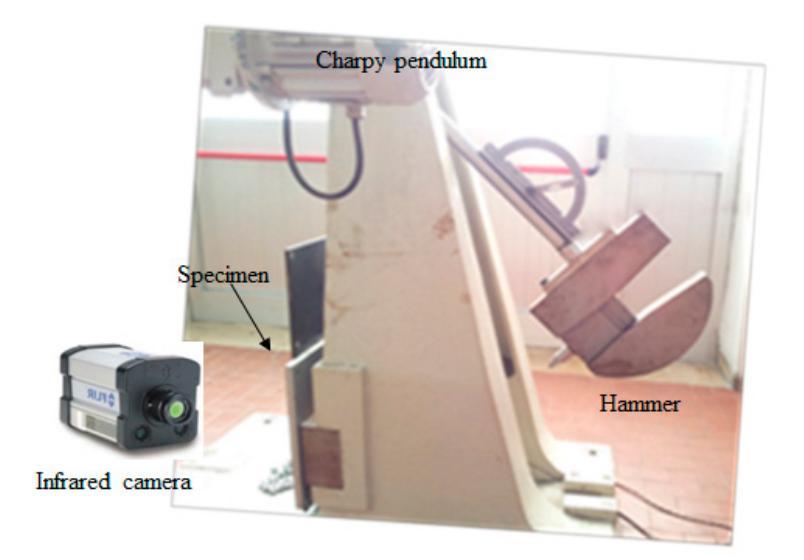
Figure 1. Sketch of the test setup.

Impact tests are carried out with a modified Charpy pendulum which allows enough room for positioning of the infrared camera to view the surface of the specimen opposite to the impact (Figure 1). Each specimen is placed inside a special fixture which allows for the contact with the hammer from one side and likely optical view by an infrared imaging device from the other one. The impact energy is set by suitably adjusting the falling height of the Charpy arm. The impact energy is varied with each specimen, in consideration of both material characteristics and thickness so as to obtain results involving two basic conditions:

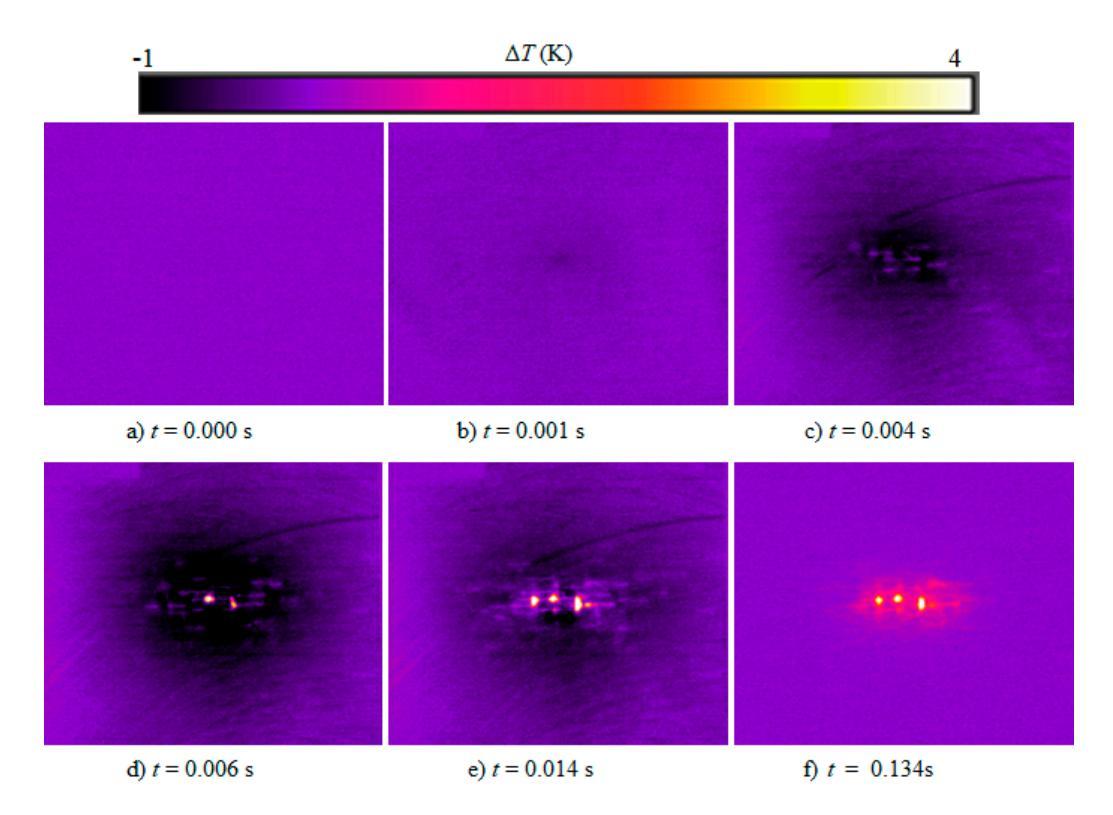
Figure 2. Some ΔT images of a GFRP specimen impacted at E = 8.3 J.

As an example, some ΔT images, taken with the SC6800 infrared camera at a frame rate of 960 Hz, are shown in Figure 2. These images are relative to a glass/epoxy (GFRP) specimen impacted at energy E = 8.3 J [6]. As expected, the first image (Figure 2a), taken before impact, displays a surface at an almost uniform $\Delta T = 0$ value. The second image (Figure 2b) presents a dark stain in the central part; this means that the surface is cooling because of the volume variation undergone under the hammer pushing force (the infrared camera views the surface that is in tension). Such a dark stain first strengthens (Figure 2c–d) as the surface bending proceeds and after weakens (Figure 2e) and disappear (Figure 2f). In the meantime, lighter (hot) spots appear on the dark stain (Figure 2d) accounting for formation of cracks and so for damage initiation. These hot spots grow while the dark stain vanishes (Figure 2e). Finally, the dark zone is replaced by a warm zone (Figure 2f) which accounts for the whole extension of the damage.

The ΔT images can be further post-processed and analysed to get valuable information about: initiation, propagation and extension of impact damage and about the characteristic times of the material's reaction to the impact [3,6]. In particular, the characteristic times when the hammer gets in

touch with the specimen surface and when it leaves that surface can be evaluated by focusing the attention on cooling phenomena. A simple way is to extract negative (minima) ΔT values, plot them against time and by analysing the trend of such values with time; in fact, negative ΔT values account for bending of the material under the hammer pushing force. Conversely, being the warming up linked to dissipative damage coupled effects, the damage initiation can be recognized following the trend of positive ΔT value plots.

Another important aspect is the possibility to evaluate the damage extension from the extension of the warm area. A method has been specifically developed [9] which allows for the evaluation of the extension of delamination up to the boundary with sound material. It is worth noting that delamination becomes via via thinner while approaching the sound material. Practically, once the impact is finished the two borders of a delaminated area tend to tightly adhere; the resulting very thin delamination is hard to be discovered with the available non-destructive testing techniques including also the same infrared thermography.
