Article An Experimental Study of the Cyclic Compression after Impact Behavior of CFRP Composites

Abstract: The behavior of impact damaged composite laminates under cyclic load is crucial to achieve a damage tolerant design of composite structures. A sufficient residual strength has to be ensured throughout the entire structural service life. In this study, a set of 27 impacted coupon specimens is subjected to quasi-static and cyclic compression load. After long intervals without detectable damage growth, the specimens fail through the sudden lateral propagation of delamination and fiber kink bands within few load cycles. Ultrasonic inspections were used to reveal the damage size after certain cycle intervals. Through continuous dent depth measurements during the cyclic tests, the evolution of the dent visibility was monitored. These measurements revealed a relaxation of the indentation of up to 90% before ultimate failure occurs. Due to the distinct relaxation and the short growth interval before ultimate failure, this study confirms the no-growth design approach as the preferred method to account for the damage tolerance of stiffened, compression-loaded composite laminates.

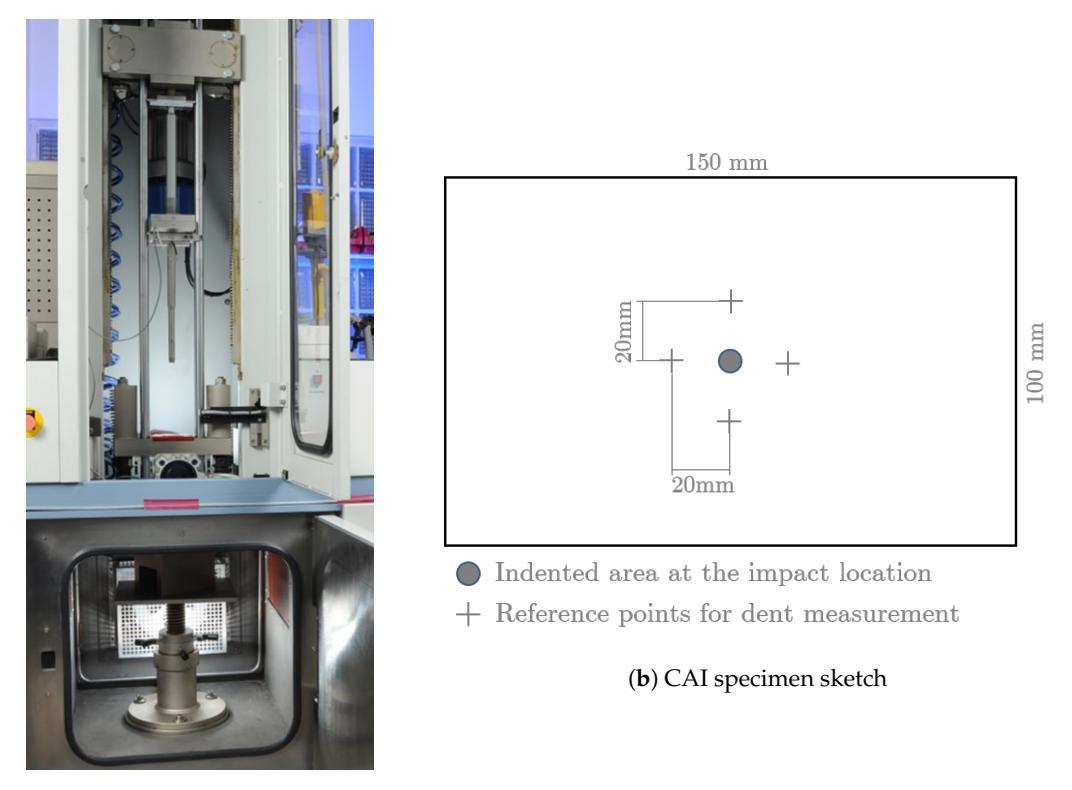
(a) Impact drop tower

Figure 1. CEAST Fractovis impact drop tower for the impact tests (**a**) and a sketch of the CAI standard specimen (**b**) according to AITM 1.0010 [17].

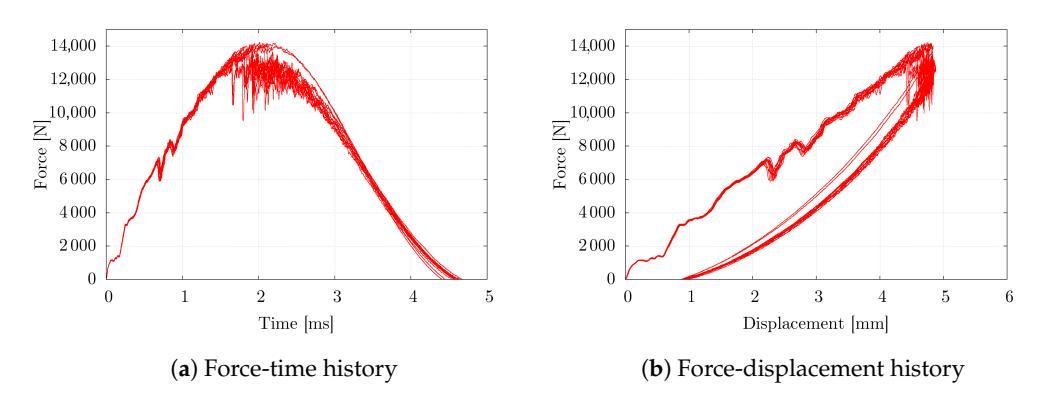
Figure 2. Set of force-time and force-displacement history curves of the 35 J CAI impacts .

response curves of three specimens deviate from the set of curves after the peak force is reached. The major force drop which occurs in most cases around [12 kN] did not happen during these impacts. This might indicate that a certain damage, like a fiber fracture in a particular ply or a delamination in a particular interface did not occur in these tests.

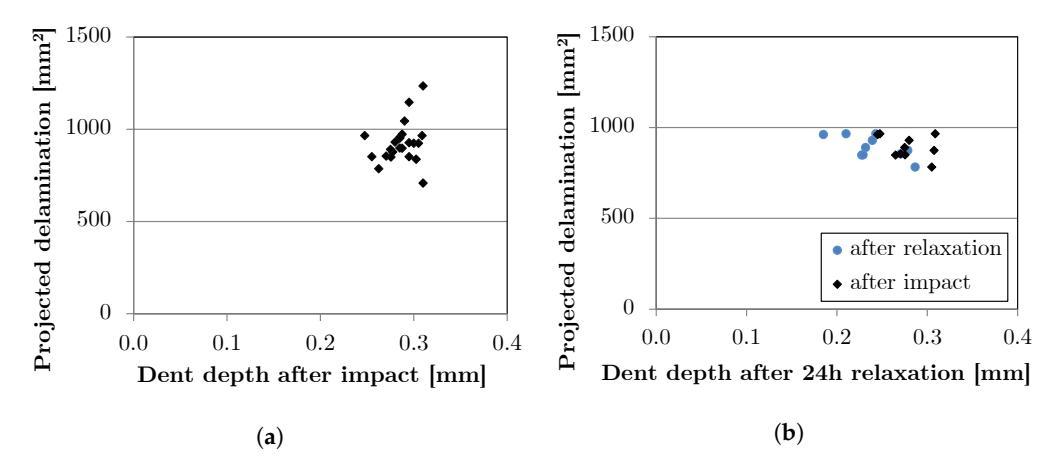
Figure 3. Data points of the measured dent depths and the projected delamination area of the 35 J impact experiments Not all specimens were subjected to a dent measurement after relaxation. Hence, not each data point in the diagram Figure 3a corresponds to a data point in the diagram Figure 3b. (a) Measurement after the impact, (b) Measurement after 24 h relaxation.

Commonly, the impact energy correlates positively with the dent depth and this in turn with the delamination area [44,45]. However, for this coupon test series on the same impact energy level, the values of the dent depth scatter (cf. Figure 3). There is no significant correlation for the dent depth and delamination area on the same energy level. The dent depth after relaxation appears to be slightly negatively correlated (cf. Figure 3b), however the data does not allow the generalization of this observation, particularly due to the fact that the number data points with a same dent depth do not offer sufficient statistical certainty.

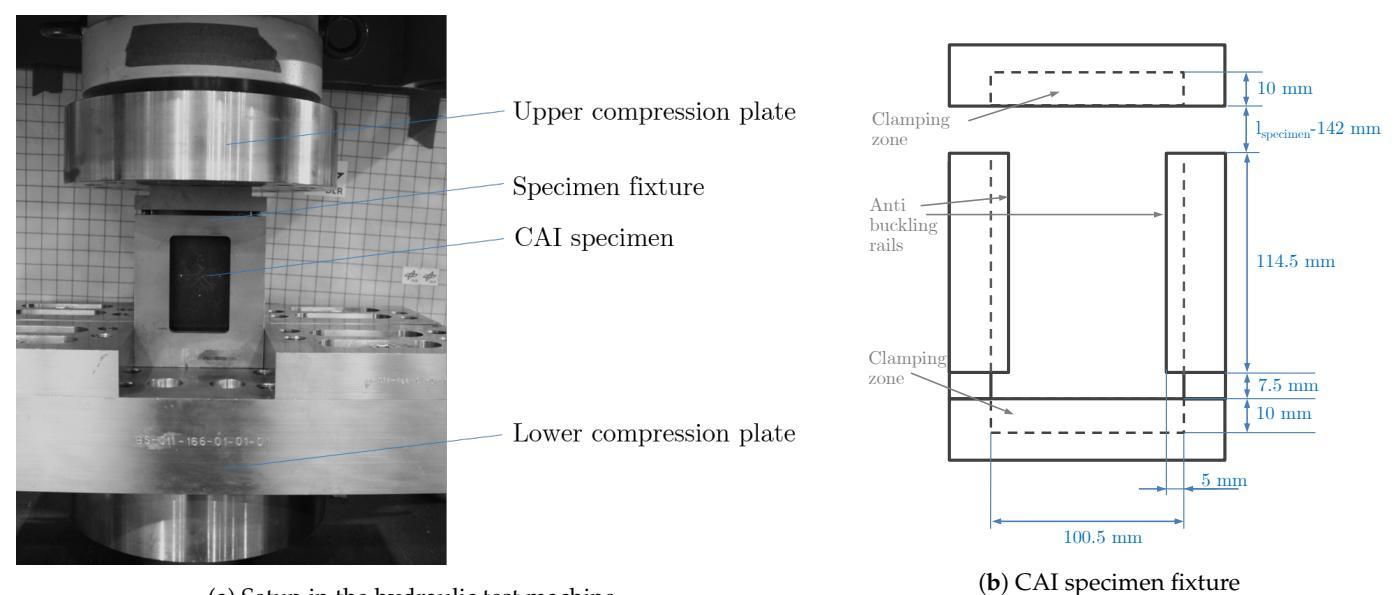
(a) Setup in the hydraulic test machine

Figure 4. Test setup (**a**) and a sketch of the fixture (**b**) for the compression after impact tests.

The compression after impact tests were conducted on a 400 kN hydraulic testing machine equipped with compression plates. Figure 4 shows the experimental setup, where the CAI specimen fixture is placed in the test machine. To prevent lateral movement of the fixture, limit stops were mounted on the lower compression plate. The CAI specimen fixture prevents the global buckling of the specimen through vertical anti-buckling rails which are located around 10 mm from the specimen edges.

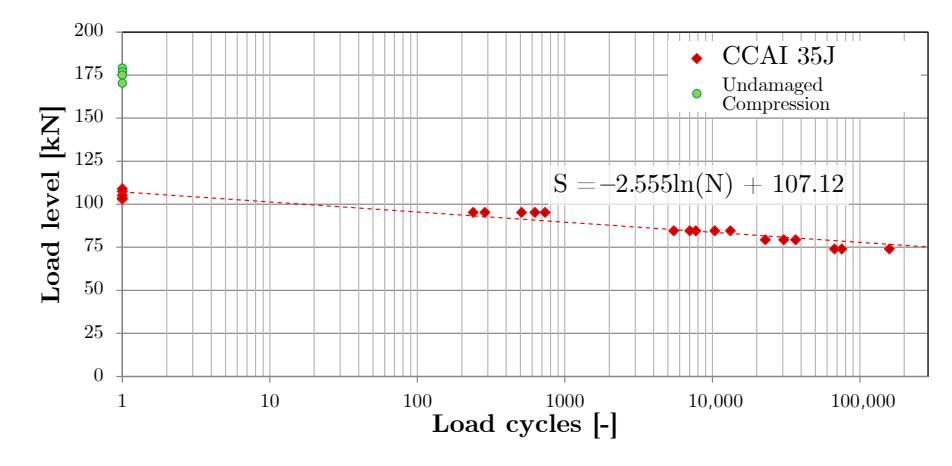
Figure 5. S-N-curve of the CCAI experiments with 35 J impact damage.

A primary result of a CCAI experiment is the endurance of each specimen. The combined results from each load level result in the respective endurance limits, which permits us to derive an stress-life curve (S-N curve) as shown in Figure 5. The strong endurance increase for smaller load levels leads to a particularly flat S-N curve, which

appears to be a typical phenomenon for compression/compression fatigue and was also observed by Post et al. [47]. Up to 300,000 load cycles were conducted. The specimens on the 50% and 30% load level as well as one specimen on the 75% load level did not fail after 300,000 cycles and were therefore excluded from the S-N-curve. For the specimen on the 75% load level a possible explanation can be found in the impact damage. The respective specimen corresponds to one of the impact history curves without the major force drop (cf. Section 2.1). This is due to fewer fiber breaks that occurred on the surface and as a consequence the endurance of the specimen increases.

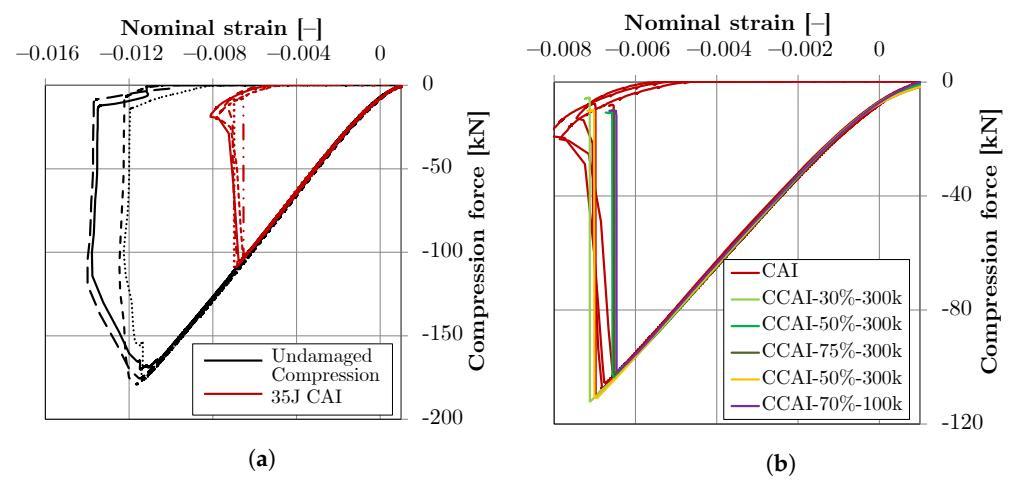
Figure 6. Force-strain history of the compression tests with the virgin specimens, the impacted CAI specimens, and the CCAI specimens with a cyclic load history. (**a**) Compression and CAI specimens. (**b**) CAI and CCAI specimens.

Further, the influence of the cyclic loading on the residual strength was investigated. The force-strain curves for all quasi-static compression experiments are depicted in Figure 6. The first diagram in Figure 6a compares the compression tests with the CAI tests. The curves reveal a 1.0% stiffness decrease by the impact damage. Due to negligible scatter of the stiffness, this small value is statistically significant. The strength decrease is severe and constitutes 40%. Hence, the impact damage affects the strength more severely than the stiffness while the failure strain reduces proportionally to the strength. An observation which confirms that a sudden event—likely the sublaminate buckling—initiates the ultimate failure. The qualitative failure mode differs between the damaged and the undamaged specimens. While impact damaged specimens have their weakest zone where the damage is located, a virgin specimen has its weakest zone in the unsupported length where the anti-buckling rails end (due to the geometry of the CAI fixture, cf. AITM 1.0010 [17]). The failure emerges in this unsupported length. Due to this failure at a different weak point, the true undamaged reference strength of the CAI specimen is higher than this measured value.

The diagram in Figure 6b compares the CAI tests of the impacted specimens with those that were additionally subjected to cyclic loading. A significant stiffness decrease

due to the cyclic load could not be measured in these tests. The experiments also didn't reveal a significant strength decrease. The ultimate failure load of most CCAI specimens is in the range of scatter of the CAI specimens. A similar behavior was observed for the cyclic tension after impact behavior in an earlier study [41]. Remarkably, there are two exceptions which revealed a higher failure load than the reference CAI tests. Whether these values shall be considered as a consequence of a natural scatter or whether there is indeed a cause for this is not clear. One possible explanation are the initial differences in the delamination size and shape before cyclic loading. In this case an increased sample size for the CAI specimens should reveal if the two specimens with higher values for the residual strength are consequence of the initial differences. Another possible explanation is that ply-debris shifted by cyclic loading into the interfaces might in certain cases impede sublaminate-buckling of the open delaminations and therefore slightly increase the residual strength.

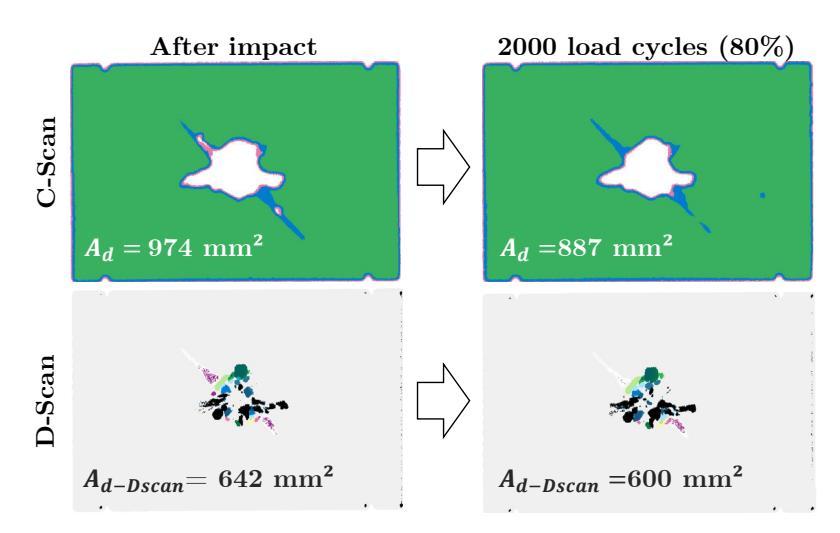
Figure 7. Example for the apparent shrinking of the delamination area A_d after 2000 load cycles at a load level of 80%.

For the damage evolution investigation in this campaign, the decrease of the delamination area has to be quantified. According to the conducted measurements, a maximum decrease of 15% and an average decrease of $9 \pm 3\%$ were identified. Depending on the load level, the minimum measured delamination area was found after less than one hundred cycles and or even after nearly 100,000 cycles, as the damage growth curves in Figure 8 show.

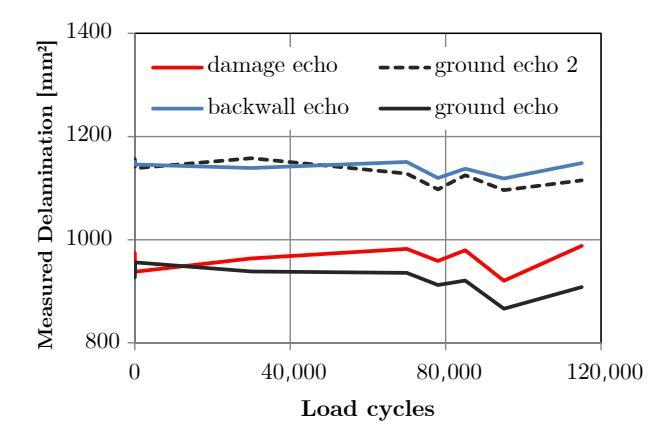
Figure 8. Evaluation of the different ultrasonic results for the sample specimen (70% load).

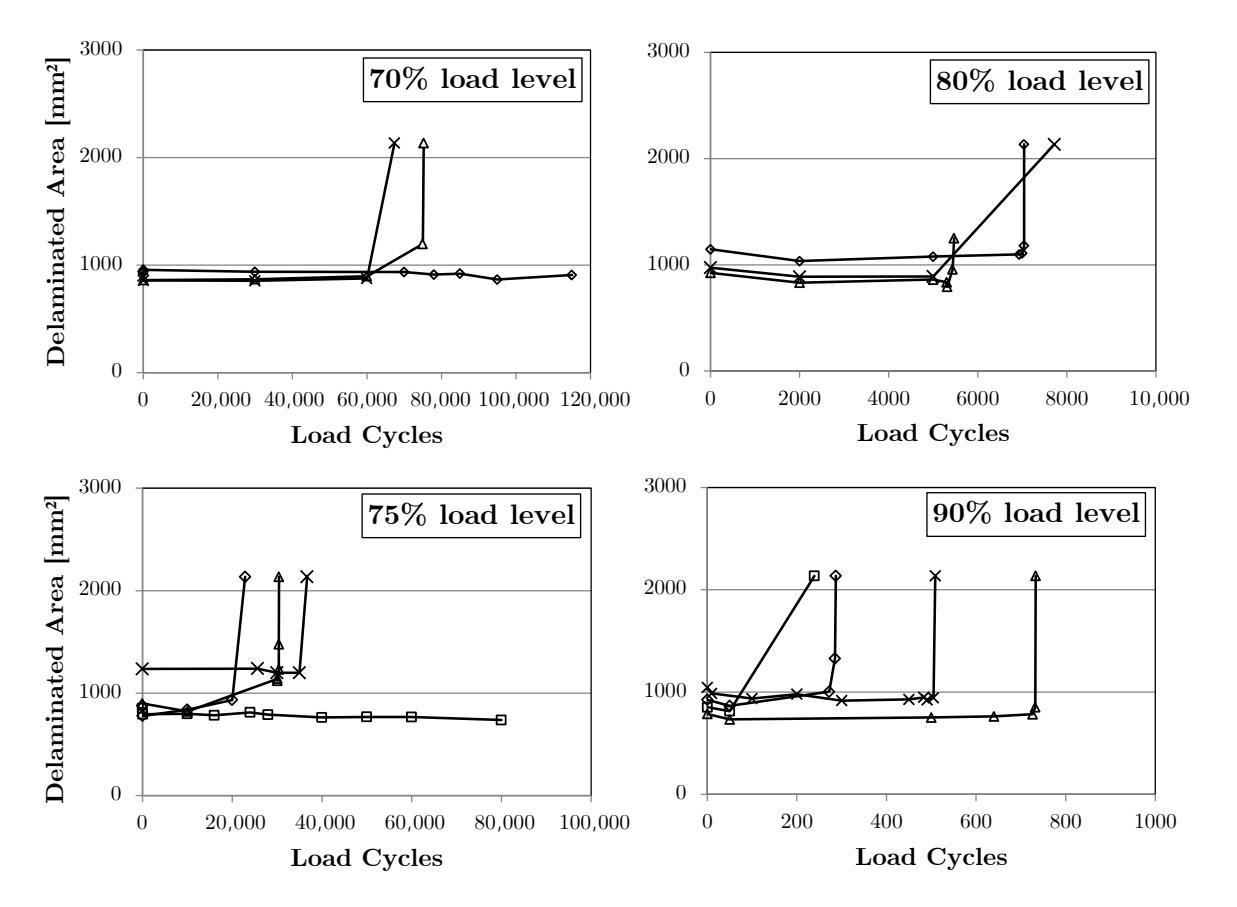
Figure 9. Delamination history of the specimens per load level obtained from the ultrasonic scanning between the load interval. The last data point of each curve represents the final failure.

The quantitative delamination history for three specimens on each load level is shown in the four diagrams in Figure 9 (on the load levels 50% and 30%) no damage growth occurred). Further, the Figures A1–A3 depicts the D-scan images of all inspected specimens.

It is clearly visible that a considerable damage growth does not occur until a few cycles before the final specimen failure. On all four load levels, the specimens failed suddenly. In some cases, it was not possible to conduct an ultrasonic scan closely to the ultimate failure. The earliest detected damage growth is visible on specimen 21 in Figure A2. After 60,000 cycles—80% of the life until failure—a small increase of a delamination close to the back face was detected.

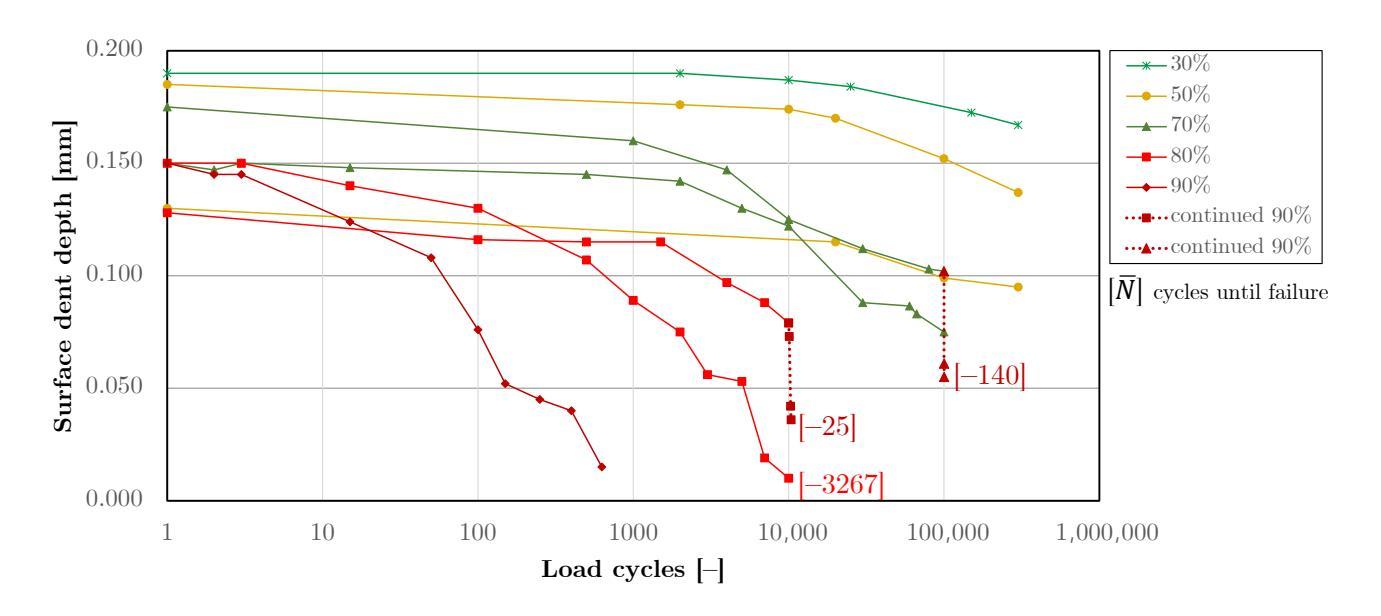
Figure 10. Relaxation of the dent depth at the impact spot depending on the cyclic load. \bar{N} represents the number of cycles until ultimate failure under cyclic load for the specimens concerned.

The diagram in Figure 10 depicts the measured relaxation throughout the cyclic tests. The curves approve a significant relaxation which increases with the load level. Both the relaxation velocity and the maximum achievable dent relaxation depend on the load level. While the loading with 90% and 80% caused the dent depth to reach nearly zero, the relaxation velocity of other specimens slowed down significantly after a certain limit value was reached. However, cycles with an increased load level, confirmed that this limit could be overcome and the relaxation continued. In contrast to the claim of Thomas [20], a lower limit for a load level where no load-driven relaxation occurs, was not found in this study. Nonetheless, in the experiments of Feng et al. [48] a relaxation of approx. 10% was reported on a load level of 40%.

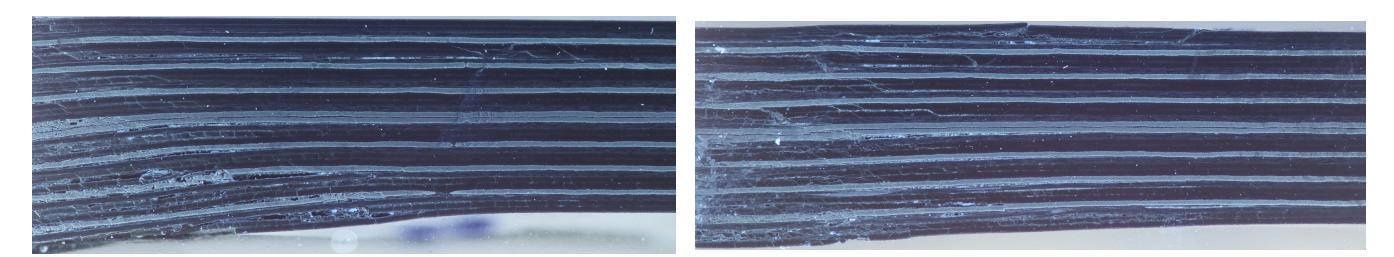
(a) Directly after the impact

(b) After relaxation through 627 load cycles at 90%

Figure 11. Polished cross sections of 35 J impact damage of one specimen cut after the impact (**a**) and a second specimen cut after relaxation due to fatigue loading (**b**).

The causes of the dent relaxation and the seemingly decreasing delamination area were further investigated through polished cross sections of the impacted specimens. Two sample specimens were cut to gain insight on the damage mechanisms caused by the cyclic load. The first specimen, depicted in Figure 11a, was cut directly after the impact. The visible damage in this picture reveals open delaminations and inter-fiber fracture. This effect is already known by the work of Bouvet et al., who found that small resin debris prevents delamination cracks from closing [15].

The second image in Figure 11b corresponds to a specimen which was subjected to cyclic load which lead to a dent relaxation from 0.15 mm to 0.015 mm. Apparently, the cyclic load affects the crack pattern in the laminate. Through the continuous loading and unloading, the ply debris shifts enabling closure of previously blocked cracks and the cracked ply realigns. This further relaxation has direct influence on the surface dent depth

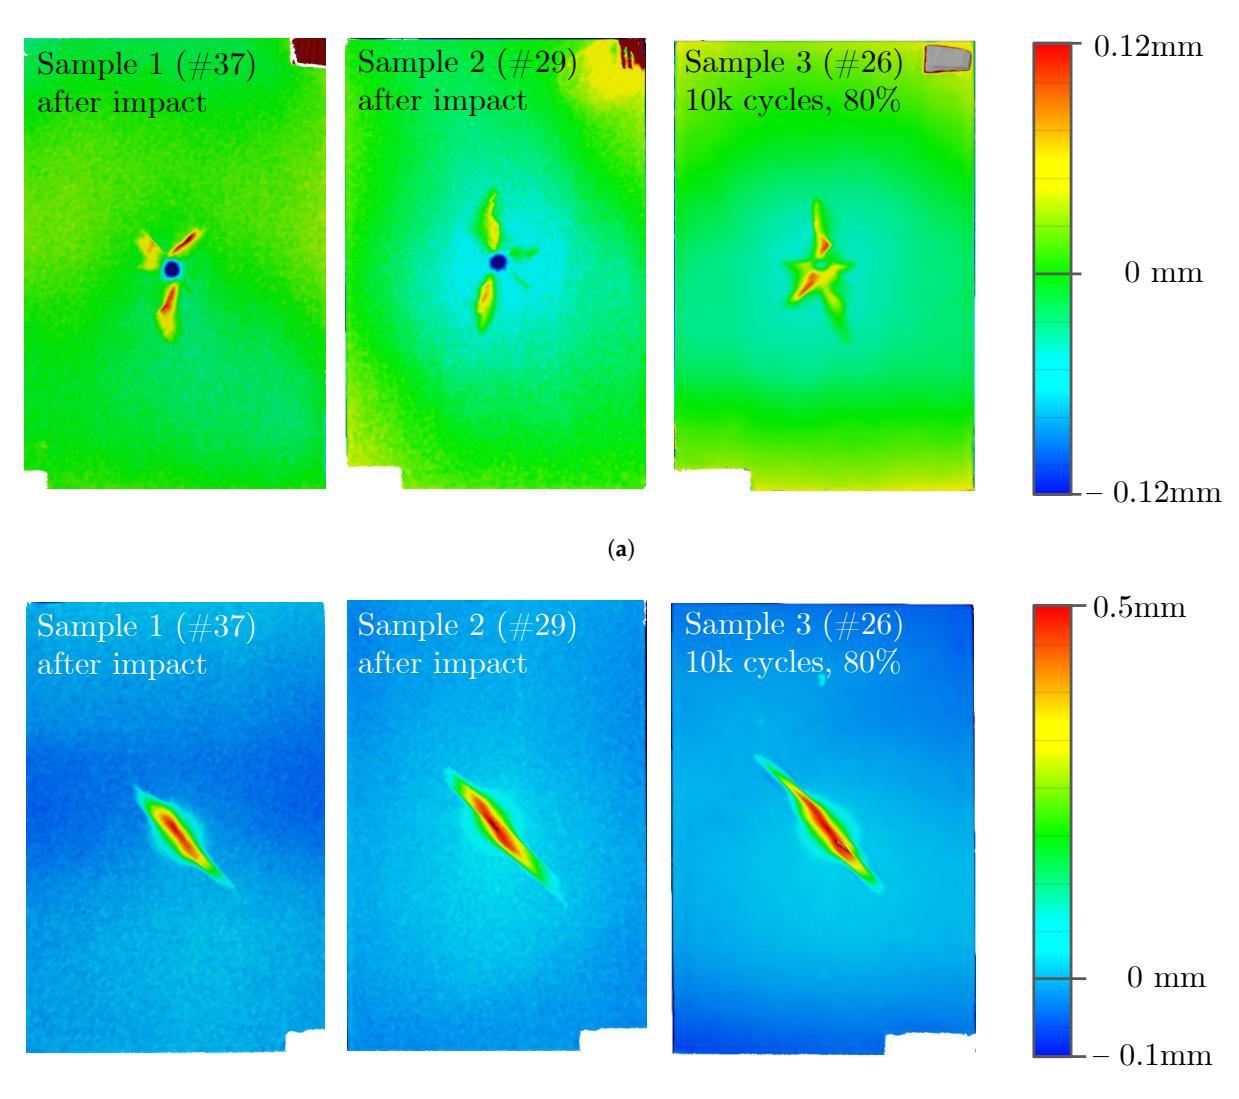
Figure 12. Surface geometry measured through 3D scanning directly after the impact (two specimens) and one specimen after the relaxation over 10k load cycles (one specimen). (**a**) Scans of the impact side, (**b**) Scans of the back side.

For the further investigation of the relaxation phenomena, the geometry of selected specimens was measured through 3D scanning by an ATOS digital image correlation test equipment (https://www.gom.com/en/products/3d-scanning/atos-compact-scan, accessed on 9 November 2021). The results of these measurement can be seen in the Figure 12. Two specimens were scanned directly after the impact, a third specimen was scanned after 10,000 cycles at a load level of 80%. Obviously, the deformation at the impact location is dominated by a significant dent (blue) on the impact side. This dent vanished entirely, in case of the third specimen which was subjected to cyclic loading. The deformed state on the back side is driven by a different phenomenon. A fiber bundle sticking out due to small fiber fracture combined with the ply splitting which occurs on the back side. This deformation on the back side is qualitatively similar for the specimens before and after the load-driven relaxation. In agreement with this discovery, no relaxation on the back side could be measured. The stick out height remained constant over the time and cyclic load. Eventually, the scans reveal a slight imperfection of the specimens, pertaining the deformation mode of the impact load. This deformation can be observed before and after the cyclic load. From these observations, it is concluded that the relaxation primarily affects the local dent at the impact location.

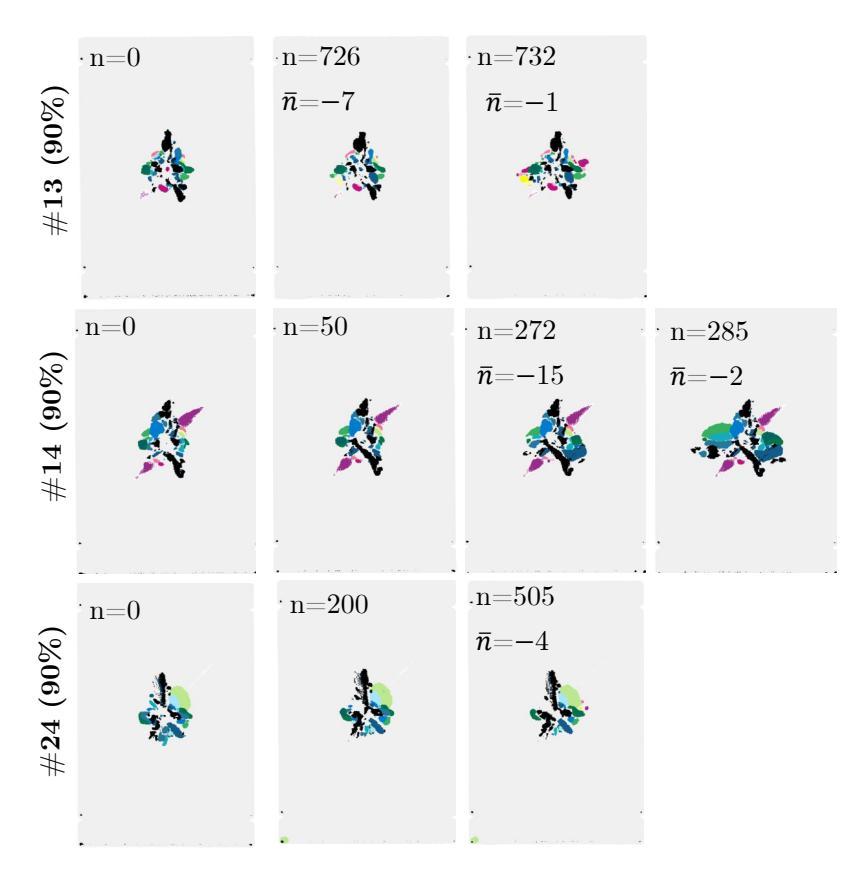
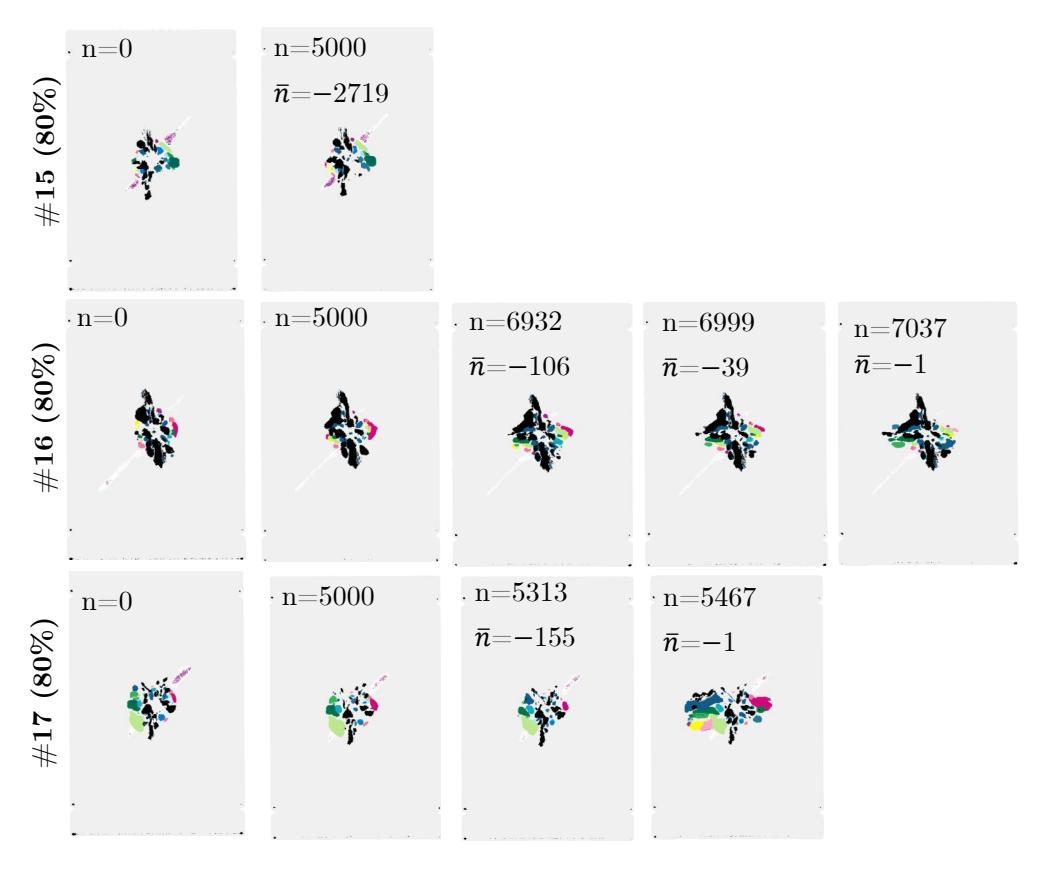
Figure A1. Observation of the delamination growth in the ultrasonic D-scan of selected specimens on the load levels 90% and 80%.

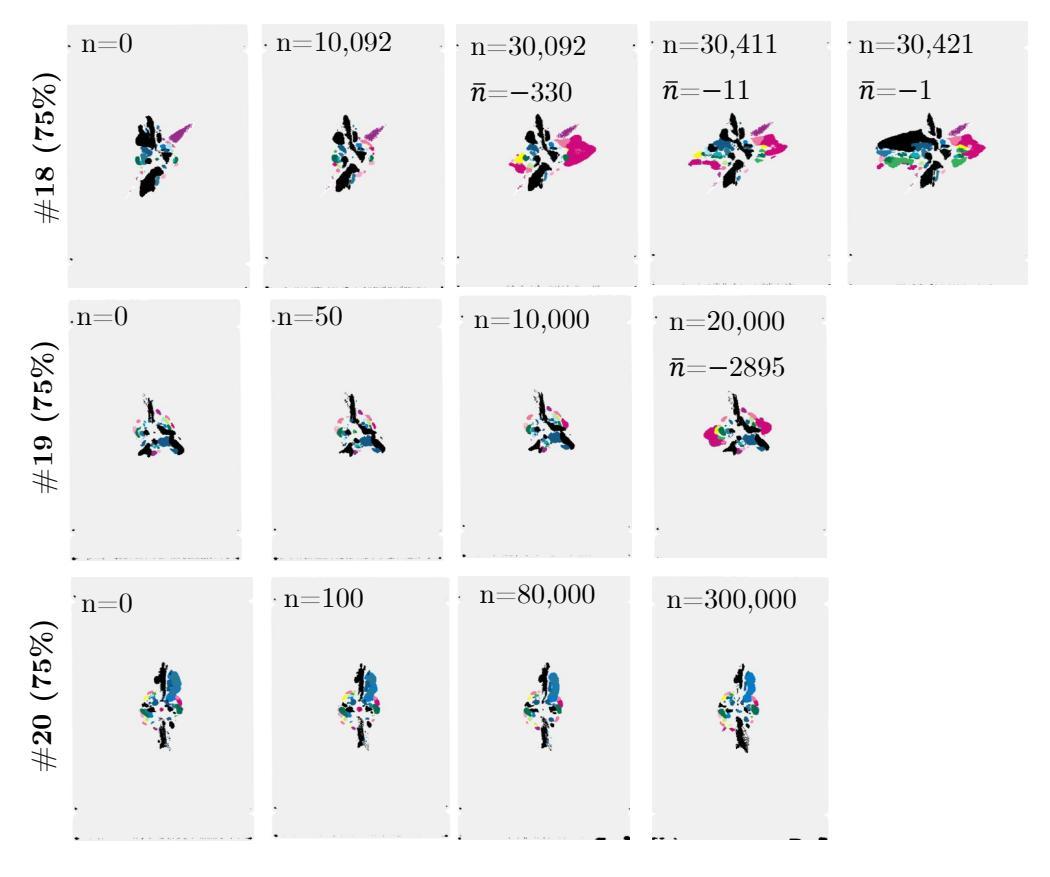
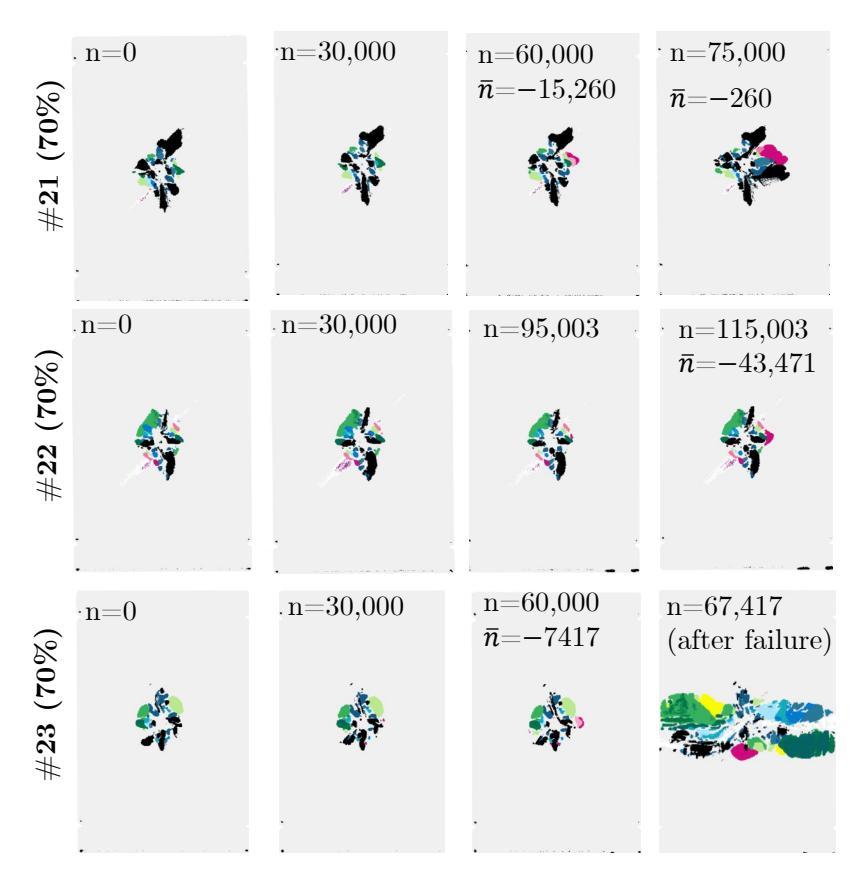
Figure A2. Observation of the delamination growth in the ultrasonic D-scan of selected specimens on the load levels 75% and 70%.

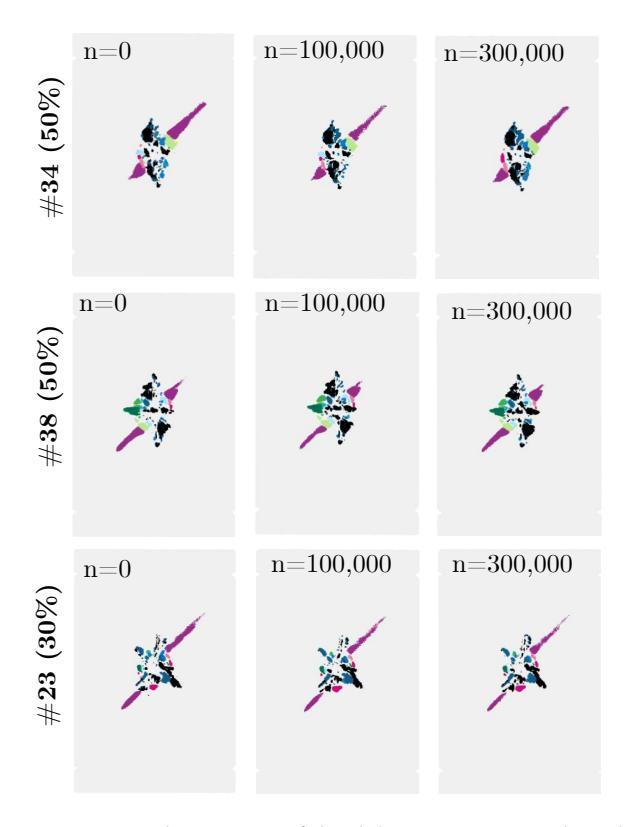
Figure A3. Observation of the delamination growth in the ultrasonic D-scan of selected specimens on the load levels 50% and 30%.

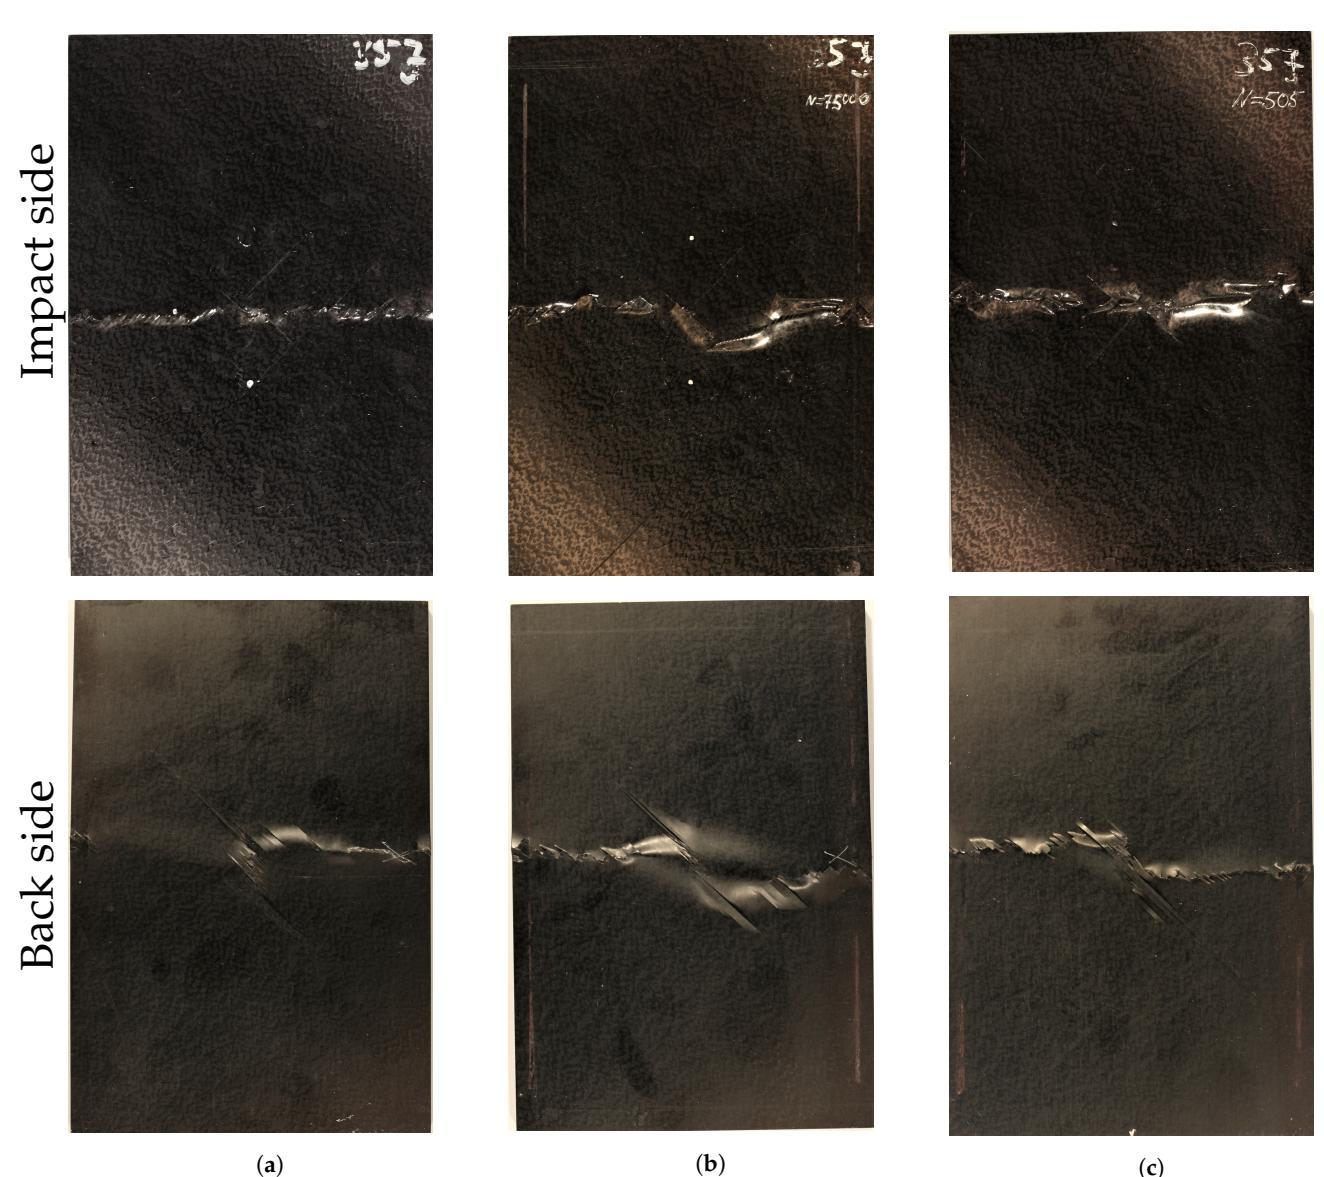
Figure A4. Exemplary images of three specimens after ultimate failure. The upper row shows the impact side, the lower row the back side. (a) Failure type I (Quasistatic failure, example: CAI failure), (b) Failure type II (Cyclic failure, example: 70% load level), (c) Mixed failure type (Cyclic failure, example: 90% load level).

To assess the influence of the cyclic load on the ultimate failure under compression, the observed damage pattern after a quasi-static test is compared with the damage pattern observed after failure through cyclic loading. The 35 J impact damage analyzed in the presented test campaign includes significant compression-driven fiber failure on the impact side. The impact back side shows hardly any fiber failure but ply splitting through interfiber failure. The typical damage pattern of the compression after impact experiments emerges through a fiber kink band which results from the propagation of the preexisting fiber cracks in the upper plies. As the images of a specimen after the quasi-static CAI test shows in Figure A4a, the kink band causes an actual crack in the uppermost ply over the entire specimen width. In contrast to that, no visible fiber cracking emerges on the backside of the same specimen. Instead, the lower plies buckle and sublaminates separate from the other plies. This crack pattern, which is referred as type I failure in the following, was observed on all five specimens subjected to quasi-static CAI tests.

The failure pattern of the specimen that were subjected to cyclic load was found to differ from the above-described failure type I. The Figure A4b,c show two specimens which failed under cyclic load on the load levels 70% and 90%, respectively. Instead of a fiber kink band with broken fibers, the uppermost ply buckles with the fibers remaining intact

for the most part. This pattern is referred as failure type II. In some cases, broken fibers on the impact side were still observed, for instance on the left side on of the specimen in Figure A4c, which we interpret as a mixture both failure types. Also, on the coupons' back side differences between the quasi-static failure and the cyclic failure were found. Instead of the ply buckling with intact fibers, the cracking of fibers in the lowermost ply can be observed. In Figure A4c such cracking comprises the entire specimen width, in case of the specimen depicted in Figure A4b broken fibers emerge only in the edge regions. Failure of type II was not observed on any specimen after quasi-static failure in the CAI test. Nonetheless, in case of ultimate failure under cyclic load different types emerged. Finally, the residual strength tests with specimens previously subjected to cyclic loading revealed a behavior which resembles the CAI failure. The Table 3 provides an overview about the number of specimens for each test type and the respective failure type.
