Article Influence of Defects in Surface Layer of Al₂O₃/TiC and SiAlON Ceramics on Physical and Mechanical Characteristics

Abstract: The paper studies the influence of diamond grinding, lapping, and polishing on the surface layer and defectiveness of the Al₂O₃/TiC and SiAION ceramic samples. The index of defectiveness I_D , which is the product of the defect density and the defective layer's thickness (R_t), and a method for its evaluation are proposed to quantify the defectiveness of the ceramic surfaces. Lapping reduces the R_t parameter by 2.6–2.7 times when the density of defects was decreased by 2 times. After polishing, the R_t parameter decreases to 0.42 µm for Al₂O₃/TiC and 0.37 µm for SiAION samples. The density of defects decreases many times after polishing: up to 0.005 and 0.004, respectively. The crack resistance of the polished samples increased by 5–7%. The volumetric wear of polished samples decreased by 1.5–1.9 times compared to the ground ones after 20 min of abrasion wear. The polished samples show a decrease in the coefficient of friction at 800 °C and a decrease in the volumetric wear by 1.5 and 1.3 times, respectively, compared to the ground ones after 200 m o

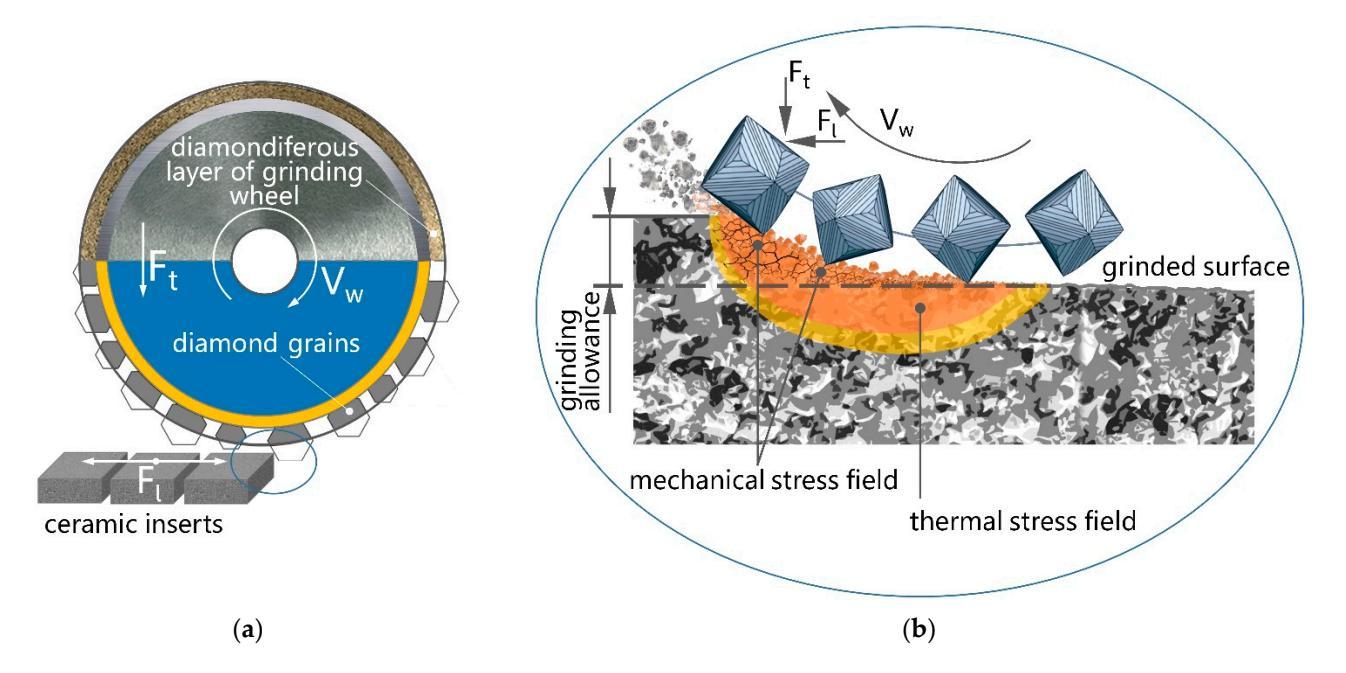
Figure 1. Schemes of diamond grinding of ceramic cutting inserts (**a**) and the diamond grains' impact on the surface layer of a ceramic workpiece when removing the allowance in grinding (**b**).

Diamond grinding of ceramics is a highly energy-intensive process in which the removal of a ceramic workpiece's surface layer (allowance) to the required depth occurs due to creating stresses in it; the level of which, exceeds the fracture stress of tool ceramics [55,56]. Figure 1 shows diagrams of diamond grinding of ceramic cutting inserts and the impact of diamond grains on the surface layer of a ceramic workpiece when removing the allowance in grinding. The scheme proposed by the authors clearly illustrates that the sintered ceramic workpiece is subjected to a combined thermomechanical action during grinding, which destroys and removes the specified allowance. In this case, the thermal and mechanical impact area extends deeper than the cut allowance's value.

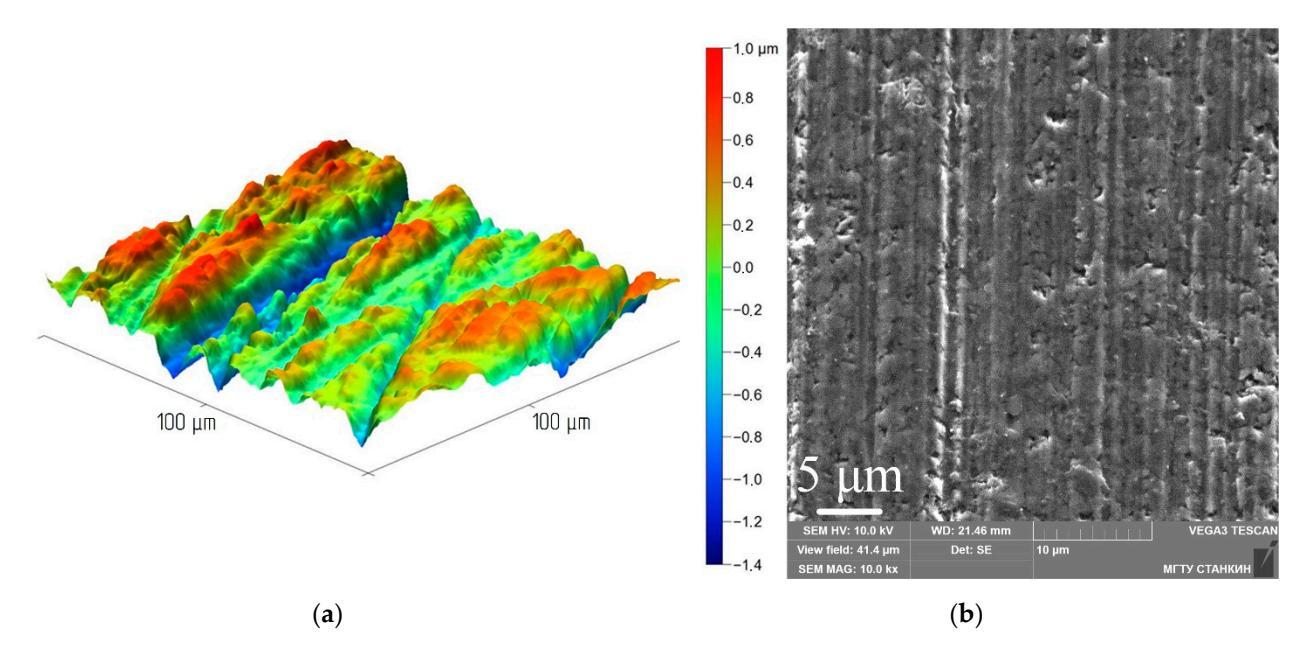
Figure 2. 3D profilogram (**a**) and SEM image (**b**) of the typical surface layer of a SiAlON ceramic sample after diamond grinding.

due to the slipping of "passive" diamond grains over the ceramic surface, and numerous craters due to grain eruptions under the action of force loads (Figure 2). The described morphology of the surface layer is typical for manufacturing ceramic products in mass production (in particular, ceramic cutting inserts) when diamond grinding is performed at high-performance modes.

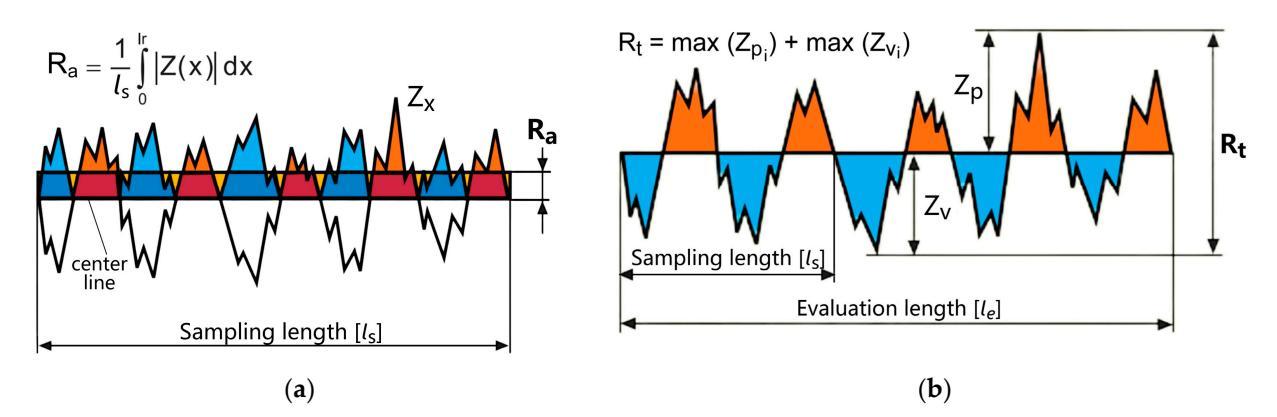
Figure 3. Schemes for various parameters estimating the state of the surface layer of ceramic samples after diamond grinding: arithmetic mean deviation of the profile, R_a (**a**); total profile height, R_t (**b**).

As confirmation that the use of the R_a parameter in a number of cases is not informative for assessing the level of defectiveness of the surface layer, let us consider the SEM images and 3D profilograms of the surface layer of samples made of Si₃N₄ tool ceramics after diamond grinding and polishing (Figure 4). After grinding, the value of the R_a parameter was 0.29 µm, and after polishing, the parameter decreased by 9.6 (to 0.03 µm). However, the result does not indicate a significant reduction in defectiveness, which is clearly seen in the presented SEM images. Polishing minimized external micro-irregularities (microprotrusions) but exposed the many existing craters in place of torn grains or their particles, which are not detected in evaluating the R_a parameter. At the same time, they negatively affect the physical and mechanical characteristics of the material. Therefore, it is necessary to search for alternative parameters for structurally inhomogeneous materials, which include ceramics and are characterized by the formation of numerous grooves, craters, and cracks during abrasive processing.

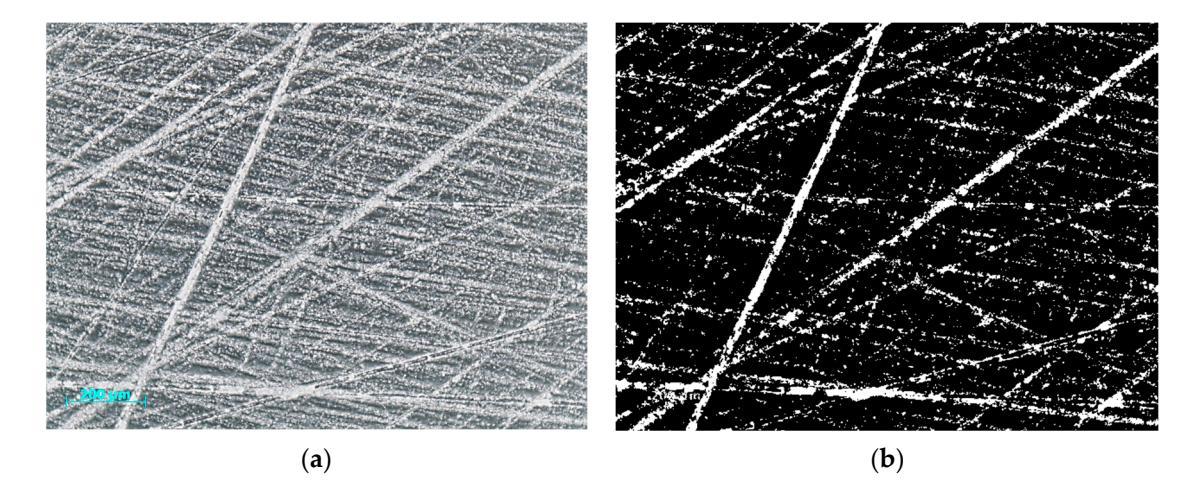
Figure 5. Optical image of a sample of SiAlON ceramics after diamond grinding (**a**) and contrasting the surface with oblique illumination to assess the density of defects (**b**).

In practice, the most informative parameter that could be used to study the defectiveness of the surface layer of ceramic products is the R_t parameter which is the total height of the profile (Figure 3), estimated as the sum of the highest peak height of the profile (Z_v) and the most significant depth of the profile trough (Z_v) within the evaluation length, which contains several values of the length of the sample in the X-axis direction. The value of the R_t parameter allows us to take into account all possible grooves, furrows, cracks, and craters present in the surface layer and, in fact, the thickness of the defective layer. Considering that only one parameter (R_t) is insufficient for an objective assessment of the surface layer state, the authors of this work propose to evaluate the density ρ of defects (total area per unit area) on the surface of a ceramic sample in addition to it. It is proposed to use a technique based on contrasting surface defects with oblique illumination of the surface during the analysis of a stereoscopic image to assess the density of defects. Figure 5 shows an example of contrasting defects in the surface layer of a sample made of SiAlON tool ceramics when the axis of the illuminating beam is located at an angle of 75° concerning the microscope's optical axis. Thus, the defects contrast with the main plane of the ceramic sample, where a dark color is the main plane and a light one is the surface layer defects. With the help of specialized software for image analysis (Thixomet Pro software, version 5.3.1, Saint Petersburg, Russia), the number of light pixels on the test sample is calculated. The ρ parameter value is calculated based on the data obtained for ceramic samples as the ratio of the total area of defects to the unit area of the ceramic sample under consideration. In the study, the calculation was performed for an area of $250,000 \ \mu m^2$.

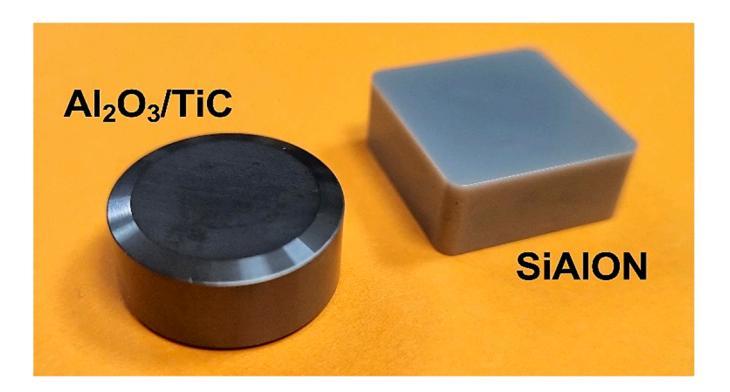
Figure 6. Al₂O₃/TiC and SiAlON ceramic inserts used in experiments.

Two types of cutting inserts made of Al_2O_3 /TiC ceramics (round shaped) and SiAlON ceramics (square shaped) were used (Figure 6) in conducting experimental studies. X-ray diffraction patterns of samples made of Al_2O_3 /TiC and SiAlON ceramics are shown in Figure 7. The analysis was performed on a Bruker D8 Advance diffractometer with

- The round Al₂O₃/TiC ceramic inserts were 19.05 mm in diameter and 7.94 mm in thickness. Characteristics of the ceramic: microhardness of 19.0 GPa; density of 4.15 g/cm^3 ; fracture toughness K_{1c} (volumetric material) of $4.1 \text{ MPa} \cdot \text{m}^{1/2}$.
- The square SiAlON ceramic inserts were 19.05 mm in inscribed circle diameter and 7.94 mm in thickness. Characteristics of the ceramic: microhardness of 16.5 GPa; density of 4.6 g/cm³; fracture toughness K_{1c} (volumetric material) of 6.4 MPa·m^{1/2}.

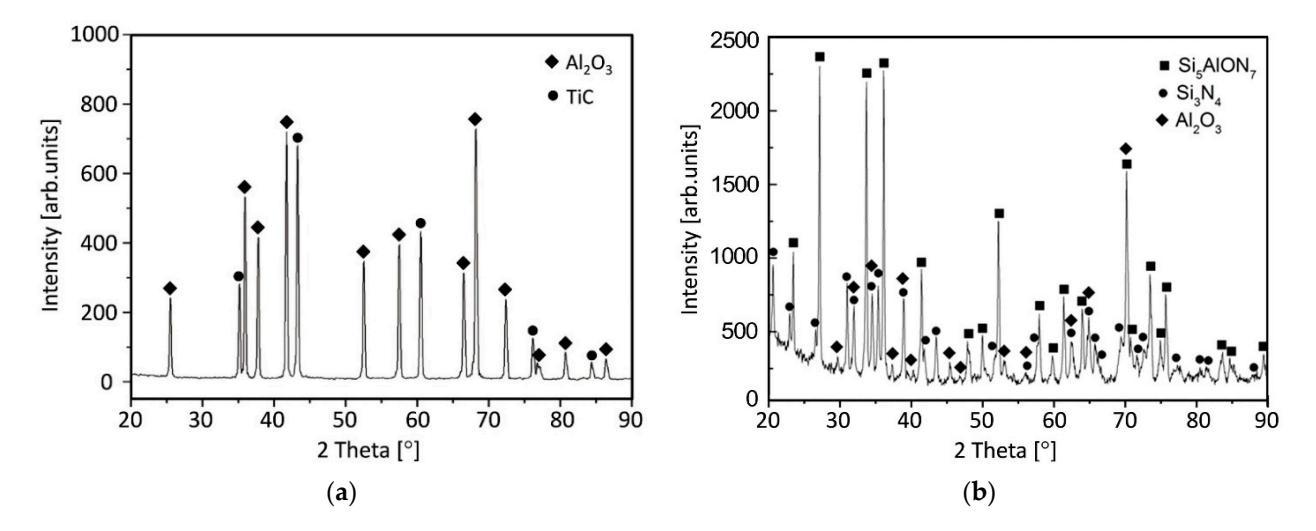
Figure 7. X-ray diffraction patterns of ceramic specimens: Al₂O₃/TiC (a); SiAlON (b).

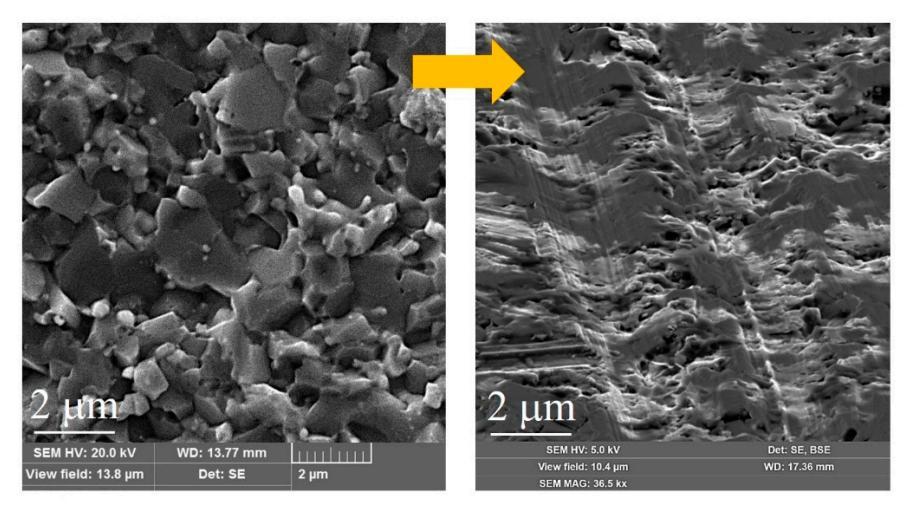
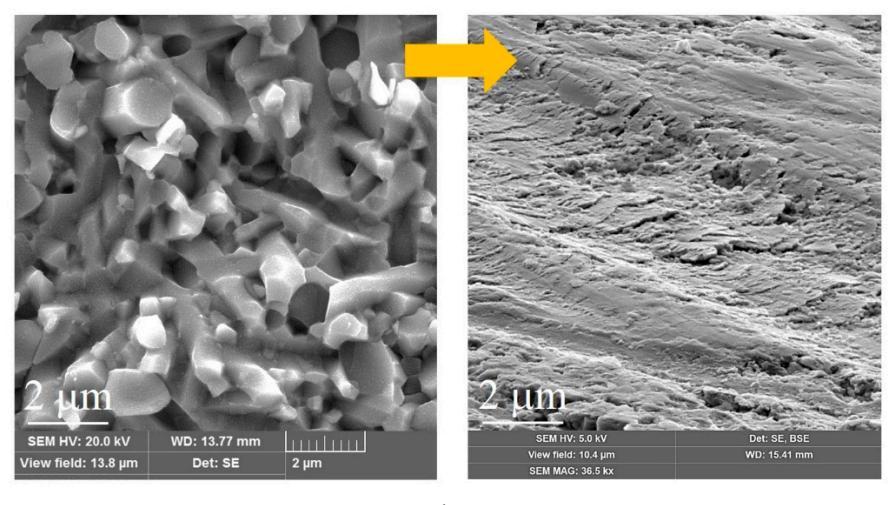
Figure 8. Structural transformation of the surface layer of samples made of Al_2O_3 /TiC (**a**) and SiAlON (**b**) sintered ceramics occurred under the exposition of a diamond wheel in grinding: SEM images of fractures of sintered ceramic samples on the left; SEM images of the ground surface layer on the right.

Figure 8 shows the SEM images that illustrate the transformation in the microstructure of the surface layer of sintered Al₂O₃/TiC and SiAlON ceramic samples, which occurs after grinding as a result of the impact of diamond grains of the grinding wheel and local plastic

deformation during high-speed heating and subsequent cooling of the subsurface layers. It can be seen that diamond grinding significantly changes the surface microstructure of the ceramics that were formed at the stage of their sintering. It should be noted that the initial microstructure is shown on the sample's fractures. The structurally transformed surface layers of Al_2O_3 /TiC and SiAlON ceramic specimens contain numerous defects, such as deep grooves, microcracks, and craters in the place of torn grains. The defective surface layer perceives the entire complex of operational loads, and its condition is paramount for the friction and wear processes of the ceramic sample contact surfaces.

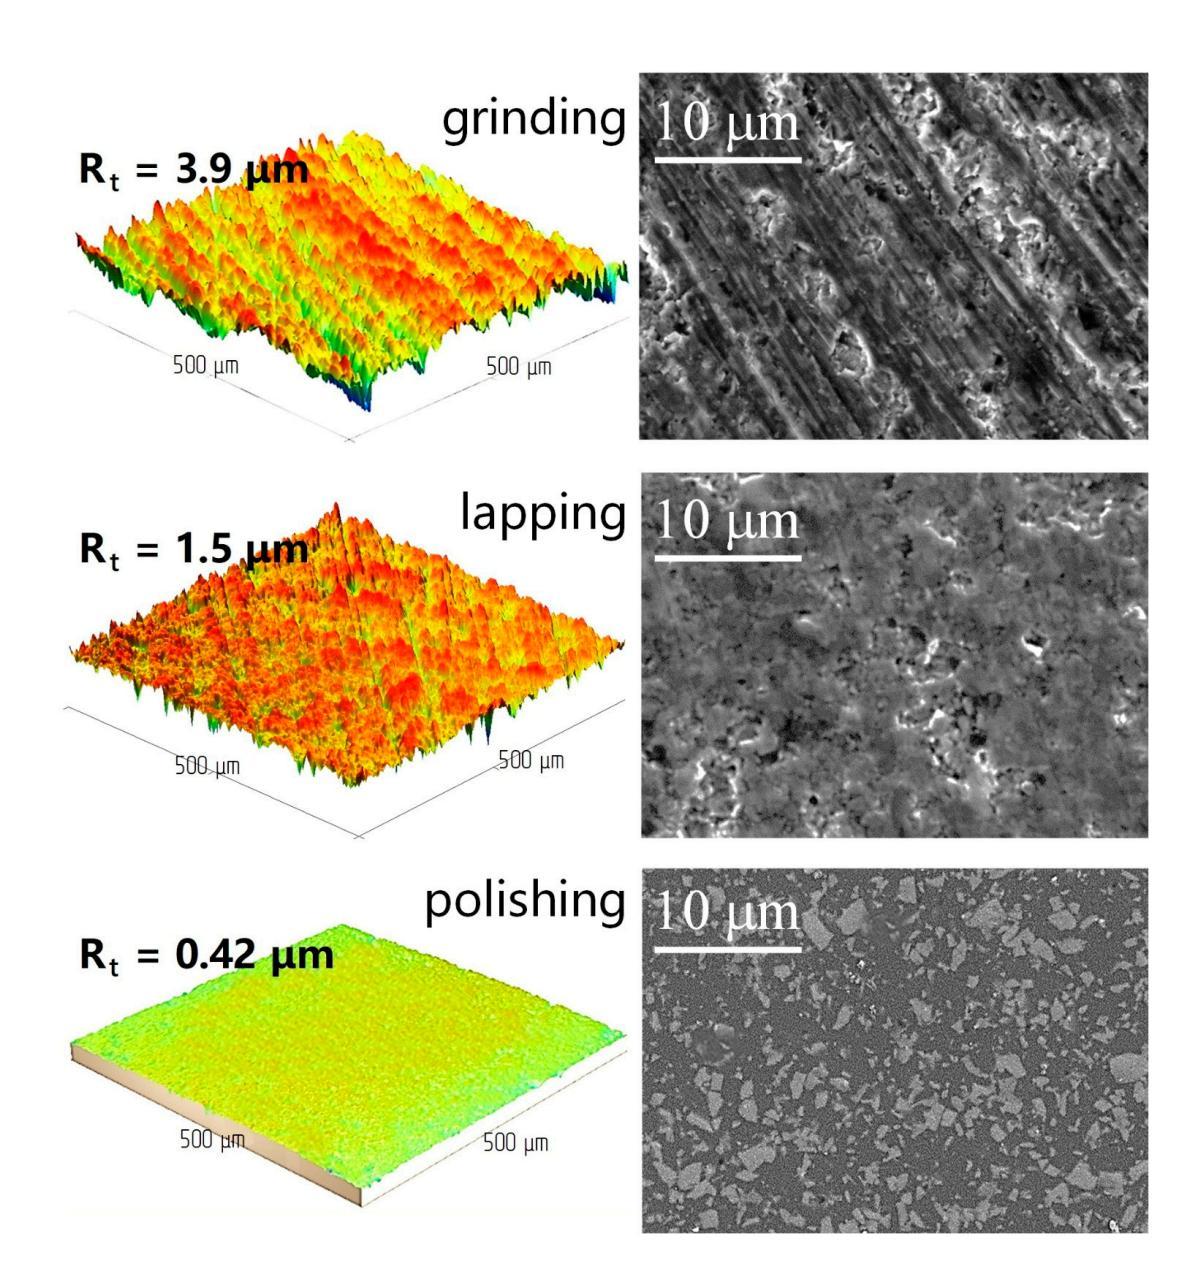
Figure 9. 3D profilograms and SEM images of the microstructure of the surface layer of Al₂O₃/TiC ceramic samples after various types of abrasive processing: grinding; grinding and lapping; grinding, lapping, and polishing (top-down).

The use of additional processing, such as lapping and polishing for the ground ceramic samples, leads to pronounced changes in the surface layer state. Typical 3D profilograms and SEM images of the microstructure of ceramic samples after various processing options are shown for Al_2O_3 /TiC (Figure 9) and SiAlON ceramic samples (Figure 10). The use of additional lapping significantly reduces the depth of the defective layer in terms of the R_t parameter (by a factor of 2.6–2.7):

- from 3.9 μ m to 1.5 μ m for Al₂O₃/TiC;
- . from 3.6 μ m to 1.5 μ m for SiAlON.

A decrease in the depth of furrows and craters is observed, but there remains a significant amount of defects on the surface. The density of defects after lapping decreases by about 2 times following experimental data provided in Table 1 for Al_2O_3 /TiC samples and in Table 2 for SiAlON samples: from 0.4 to 0.206 and from 0.354 to 0.153, respectively. The value of the R_t parameter decreases to 0.42 µm for Al_2O_3 /TiC and to 0.37 µm for SiAlON after lapping and polishing: pronounced defects on the surface of ceramic samples were not detected visually. In addition, the density of defects on the surface of ceramics decreases many times after polishing:

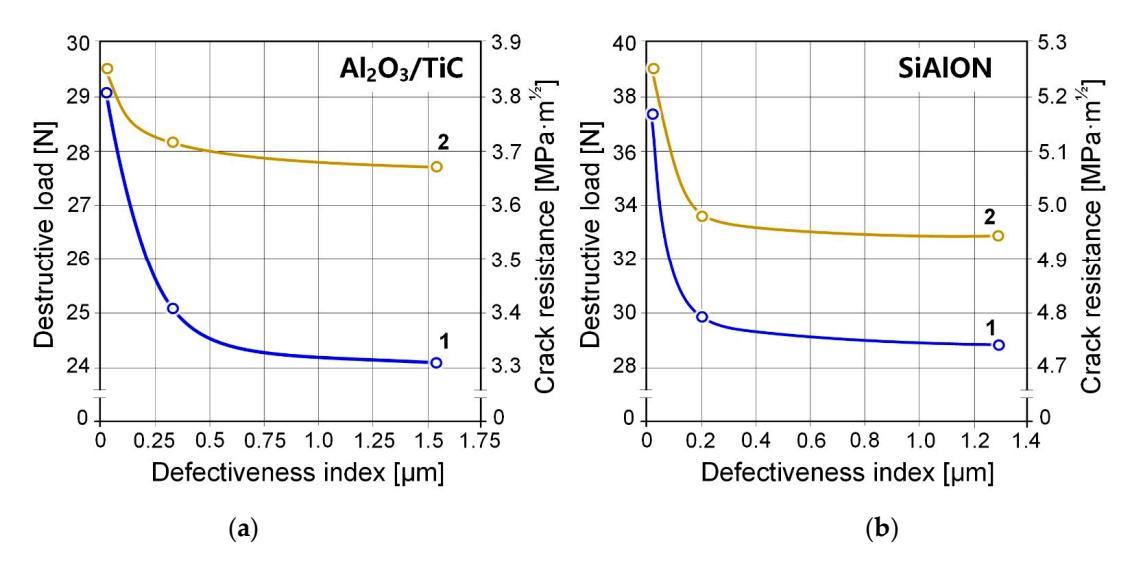
Figure 11. Dependences of the breaking load during edge chipping (1) and crack resistance (2) on the state of the surface layer of ceramic samples, characterized by the index of defectiveness: Al_2O_3/TiC (**a**) and SiAlON (**b**).

Figure 11 shows the correlation between the state of the surface layer of Al_2O_3/TiC and SiAlON ceramic samples, characterized by the index of defectiveness, and the value of breaking loads at the moment of edge chipping identified by the spectrum of the acoustic emission (AE) signal. It can be seen that with an increase in the index of defectiveness (from P to G samples), the ability of the cutting inserts to resist chipping decreases sharply. The average breaking load was 29.1 and 37.6 N for the P group of specimens with minimum I_D of 0.002 µm for Al_2O_3/TiC and 0.0015 µm for SiAlON. A decrease in the magnitude of the breaking load by 20 and 30% was recorded for the G group of specimens with maximum I_D of 1.56 and 1.27 µm, respectively. At the same time, the differences in the magnitudes of loads at which chipping of the edges occurs for G and L samples were insignificant.

A similar trend was revealed when assessing the relationship between the index of defectiveness of the surface layer of ceramic samples and crack resistance measured by indentation (Figure 11). However, the change in the crack resistance with a change in the

surface layer state (I_D) was insignificant and amounted to about 5–7% compared to the experimental data for G and P groups. At the same time, the differences in crack resistance values for G and L samples were minimal for both ceramics under study.

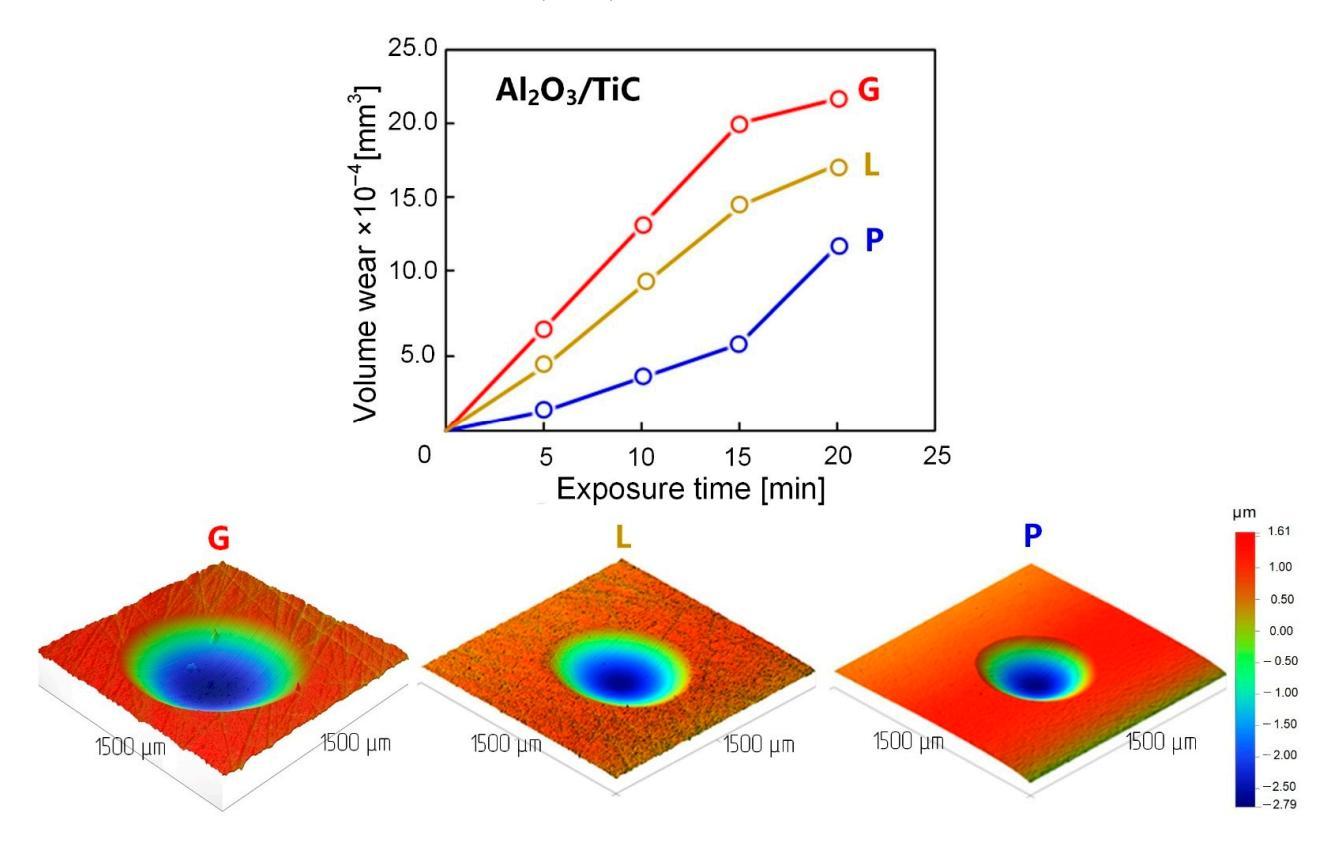
Figure 12. Dependences of the volumetric wear of Al_2O_3/TiC ceramic specimens with a different state of the surface layer on the time of abrasive exposure for ground samples (**G**), ground and lapped samples (**L**), and ground, lapped, and polished samples (**P**).

Figures 12 and 13 show the dependences of the volumetric wear of Al_2O_3 /TiC and SiAlON ceramic specimens on time of abrasive exposure and 3D profilograms of specimen wear holes after 20 min of testing. The presented dependences show the wear kinetics of ceramics with a different state of the surface layer (the index of defectiveness) and their resistance to abrasive wear. It is noticeable that the high defectiveness of the surface layer (G samples) significantly reduces the ability of ceramics to resist abrasive wear. The P samples with a minimum index of defectiveness, which underwent additional lapping and polishing compared with other groups of the ceramic inserts under study, showed significantly lower volumetric wear values throughout the tests. The values of volumetric wear of the P samples made of Al_2O_3 /TiC and SiAlON, which have a minimum index of defectiveness, were by about 1.5–1.9 times less than for samples from other control groups (G and L samples) after 20 min of abrasive action. Thus, additional lapping and polishing of ceramic cutting inserts significantly improve their resistance to abrasion wear under normal conditions (20 °C).

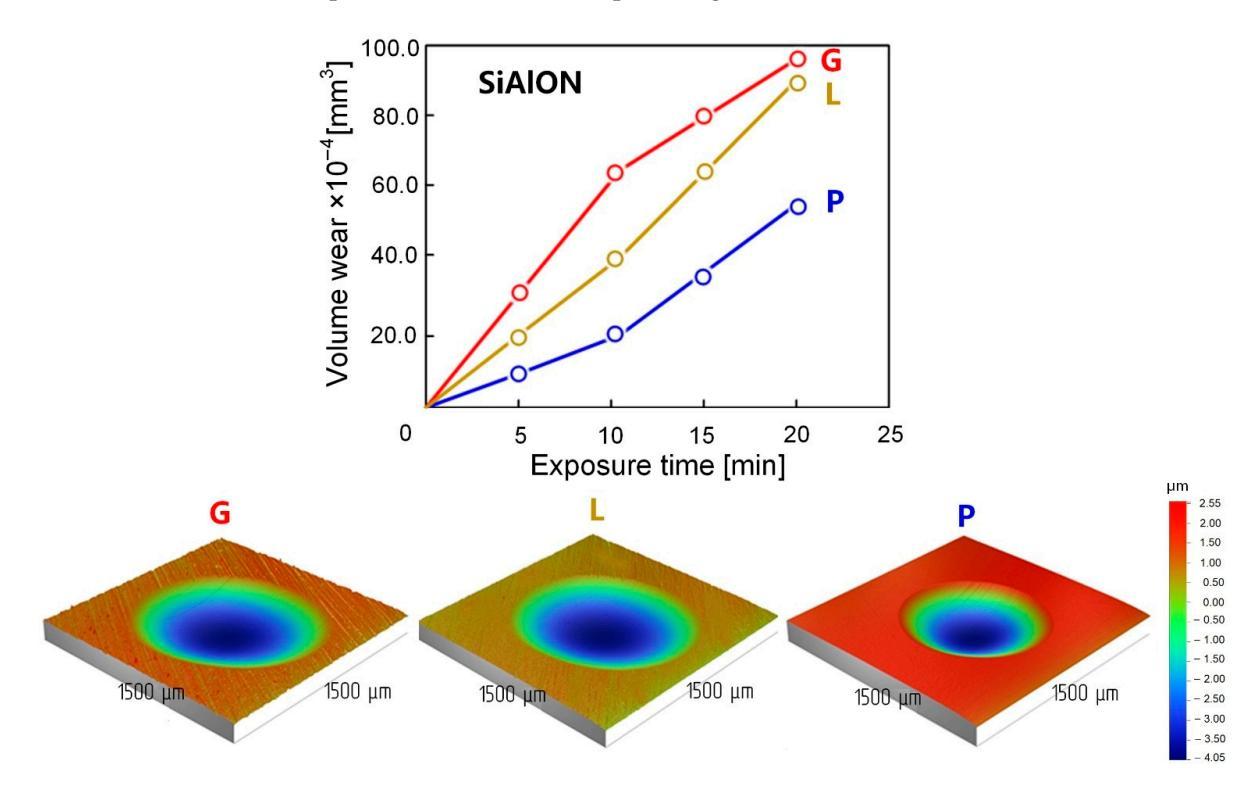
Figure 13. Dependences of the volumetric wear of SiAlON ceramic specimens with a different state of the surface layer on the time of abrasive exposure for ground samples (**G**), ground and lapped samples (**L**), and ground, lapped, and polished samples (**P**).

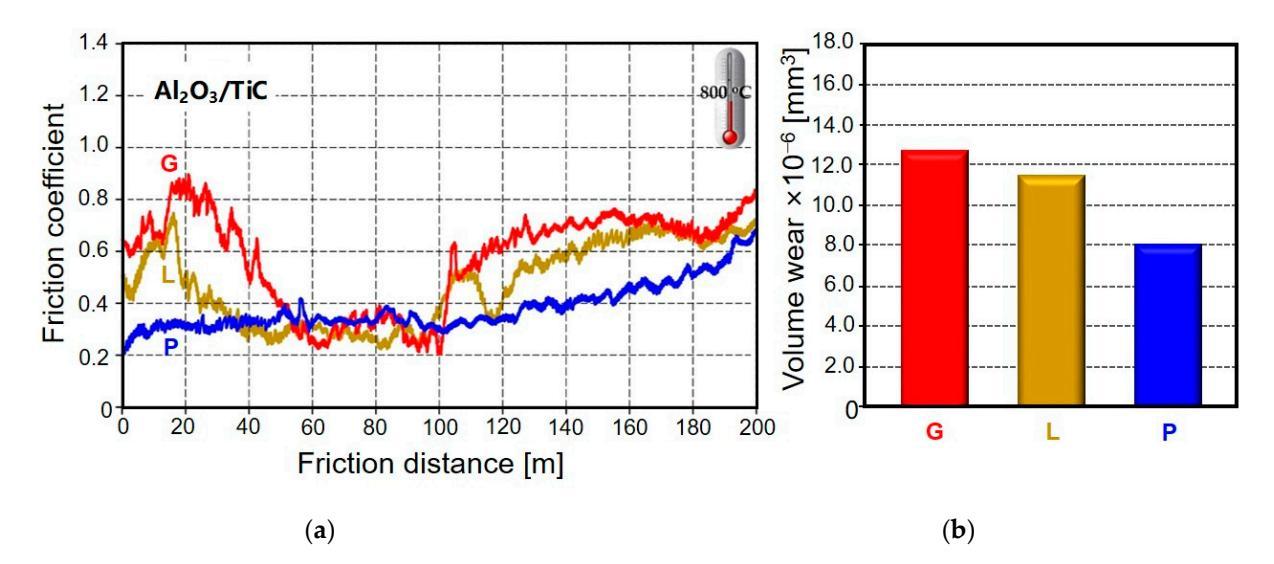
Figure 14. Change in the coefficient of friction depending on the friction distance of Al_2O_3/TiC ceramic samples with a different state of the surface layer (**a**) and volumetric wear of the samples (**b**) after passing a distance of 200 m at high-temperature friction of sliding.

The experimental curves presented in Figures 14 and 15 show that the samples with the lowest index of defectiveness (P samples) compared to other groups (G and L) of the samples under study show a slight decrease in both the average value of the coefficient of friction when heated to a temperature of 800 °C and also the nature of the change in the coefficient of friction over time. The coefficient of friction changes abruptly for samples with the highest index of defectiveness (G samples). Especially, for the samples made of Al_2O_3/TiC : first, the coefficient of friction increases, reaching maximum values, then sharply decreases, increases again, and only stabilizes with time. Such a nonmonotonic change is the result of the alternation of the processes of the adhesion of contact surfaces and

the destruction of the "bridges" of adhesive bonds. The change in the coefficient of friction over the entire friction path is monotonic for Al_2O_3/TiC and SiAlON ceramic samples that underwent additional lapping and polishing (P samples), which indicates more favorable conditions for frictional interaction with the counter body. It can be assumed that the noted changes in the nature of the contact interaction under the friction of sliding conditions are also associated with a significant decrease in the roughness of the surface layer of ceramic samples, which occurs after polishing [69,70].

Data on the volumetric wear of ceramic samples of Al_2O_3/TiC and SiAlON with different surface layer states at high-temperature friction of sliding (800 °C) are provided together with the data on the change in the coefficient of friction (Figures 14 and 15). As in the case of abrasive wear, the high index of defectiveness of the surface layer (G samples) significantly reduces the ability of ceramics to resist abrasion wear when interacting with a counter body under thermal heating conditions. The samples with the minimum index of defectiveness that underwent additional lapping and polishing (P samples), compared to the samples of ground ceramic inserts (G samples), showed a decrease in the value of volumetric wear after 200 m of friction distance: by 1.5 times for Al_2O_3/TiC samples and 1.3 times for SiAlON samples, respectively. In addition, additional lapping and polishing (P samples) demonstrated a more negligible effect than the ground and lapped samples (L samples): the volume of wear decreased by 1.3 and 1.1 times for Al_2O_3/TiC and SiAlON samples, respectively. Thus, additional lapping and polishing of ceramic cutting inserts slightly improve their resistance to abrasion wear under the conditions of the thermal loads (800 °C). The effect is more noticeable for Al_2O_3/TiC ceramics.

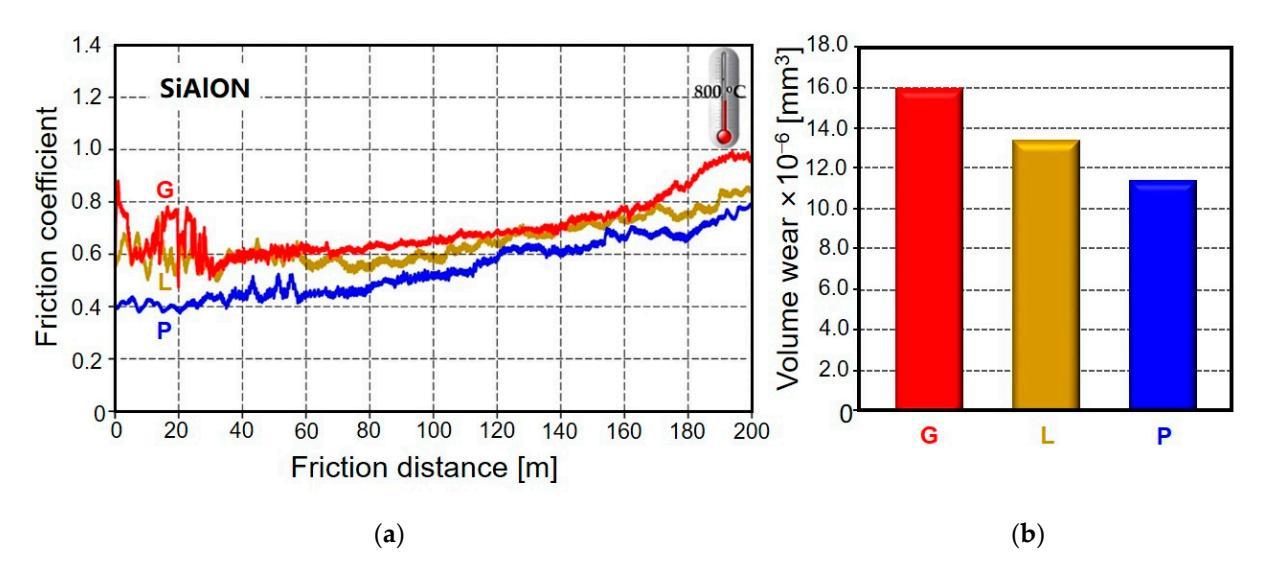
Figure 15. Change in the coefficient of friction depending on the friction distance of SiAlON ceramic samples with a different state of the surface layer (**a**) and volumetric wear of the samples (**b**) after passing a distance of 200 m at high-temperature friction of sliding.

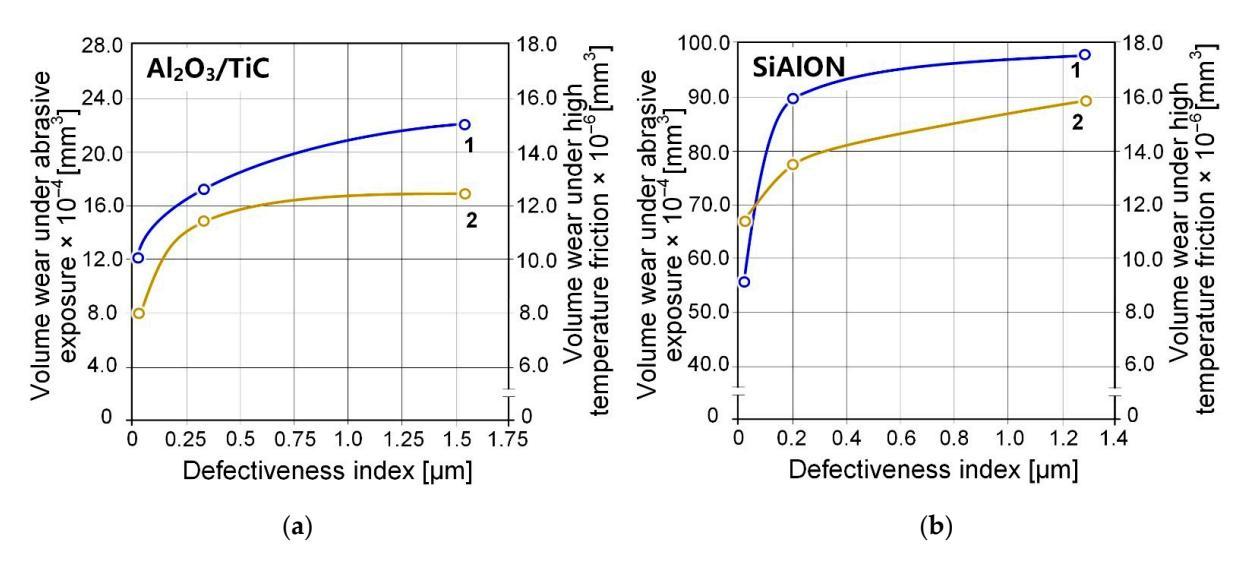
Figure 16 shows the correlation between the state of the surface layer of Al₂O₃/TiC and SiAlON ceramic samples, characterized by the index of defectiveness, and the value of volumetric wear during abrasive action and high-temperature friction at 800 °C. It can be seen that the intensity of wear of inserts made of the two ceramics under study significantly increases under various conditions of external influence, with an increase in the index of defectiveness (from P to G samples). The amounts of volumetric wear during abrasive action were about 12.1 and 55.1×10^{-4} mm³ for specimens of the P group with the minimums I_D of 0.002 µm for Al₂O₃/TiC and 0.0015 µm for SiAlON, respectively. Increases in volumetric wear by 85 and 80% were recorded for specimens of the G group with the maximums I_D of 1.56 and 1.27 µm. A similar trend was revealed in assessing the relationship between the index of defectiveness of the surface layer of ceramic samples and volumetric wear at high-temperature friction of sliding. The volumetric wears for Al_2O_3 /TiC and SiAlON ceramics corresponded to the values of 8.0 and 11.2×10^{-6} mm³ for specimens of group P (I_D of 0.002 µm for Al₂O₃/TiC and 0.0015 µm for SiAlON), and the volumetric wears increased by 55 and 42%, respectively, for specimens of group G (I_D of 1.56 μ m for Al₂O₃/TiC and 1.27 μ m for SiAlON). The nature of the dependences is the inversely proportional exponential of $(a-e^{-bx})$ type, where a and b are empirical constants and can be interpolated.
